SITE INSPECTION AND RECOMMENDATIONS REPORT

2016 INSPECTION OF

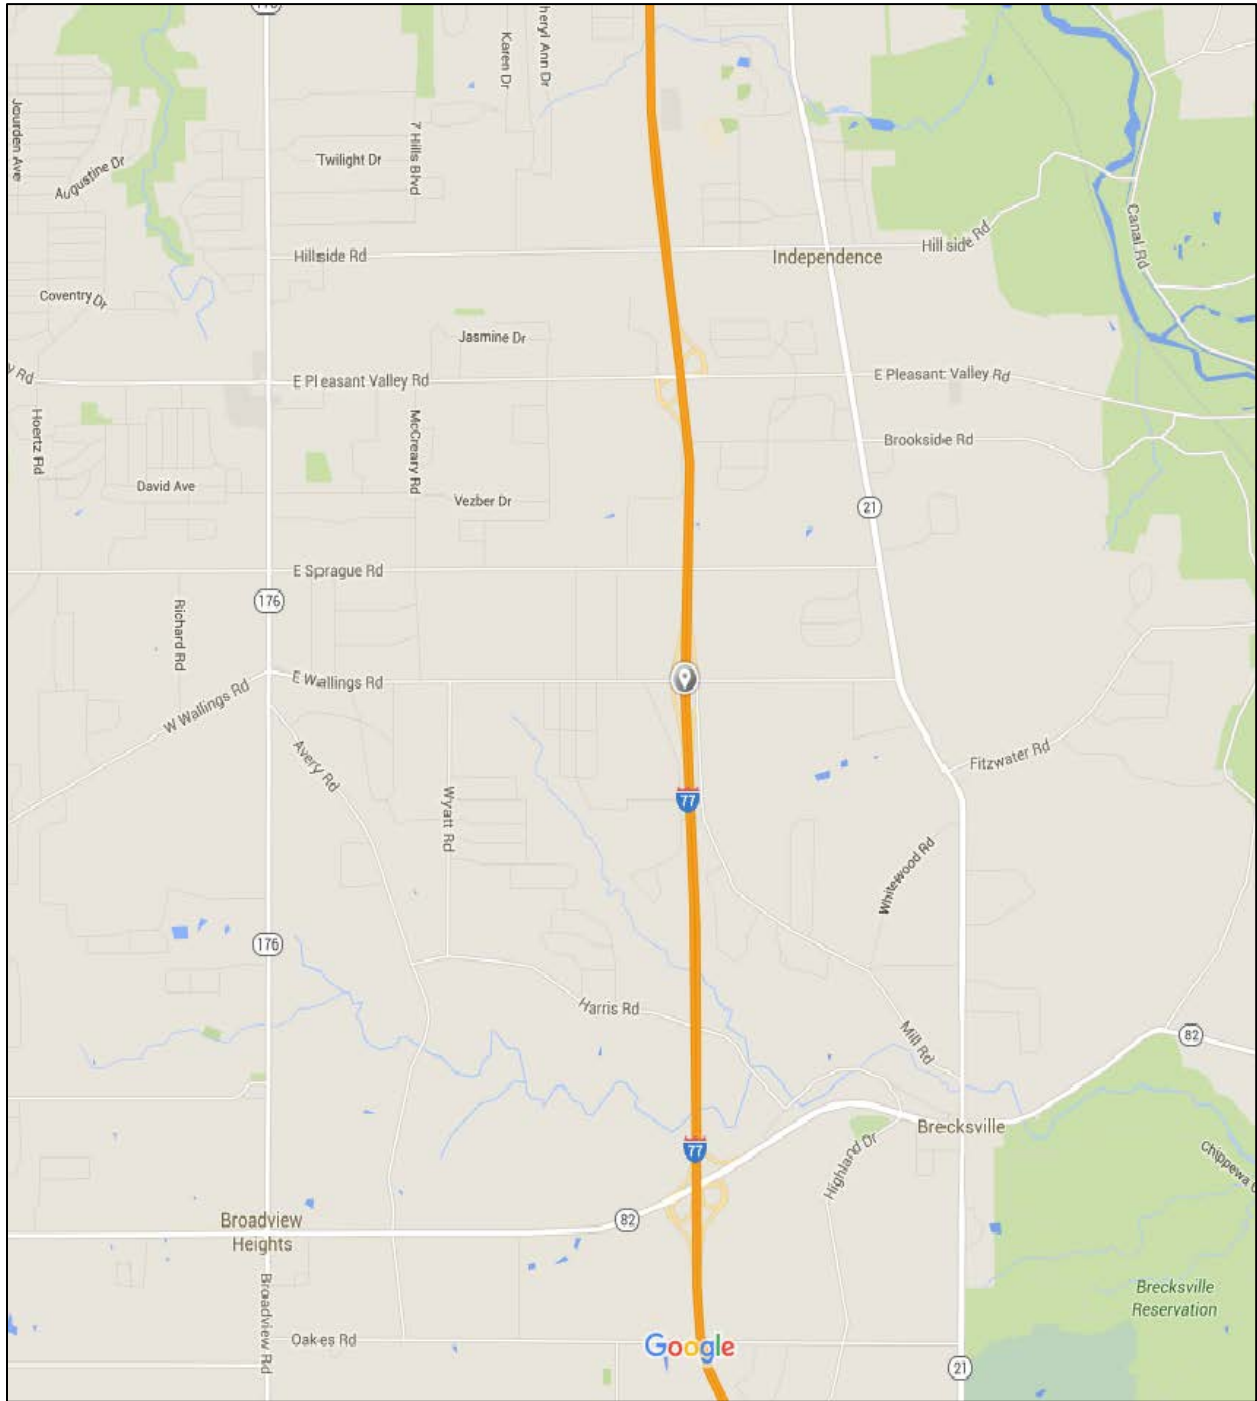
SITE INSPECTION AND RECOMMENDATIONS REPORT FOR CUY-077-0479 (Wallings Road over I-77)

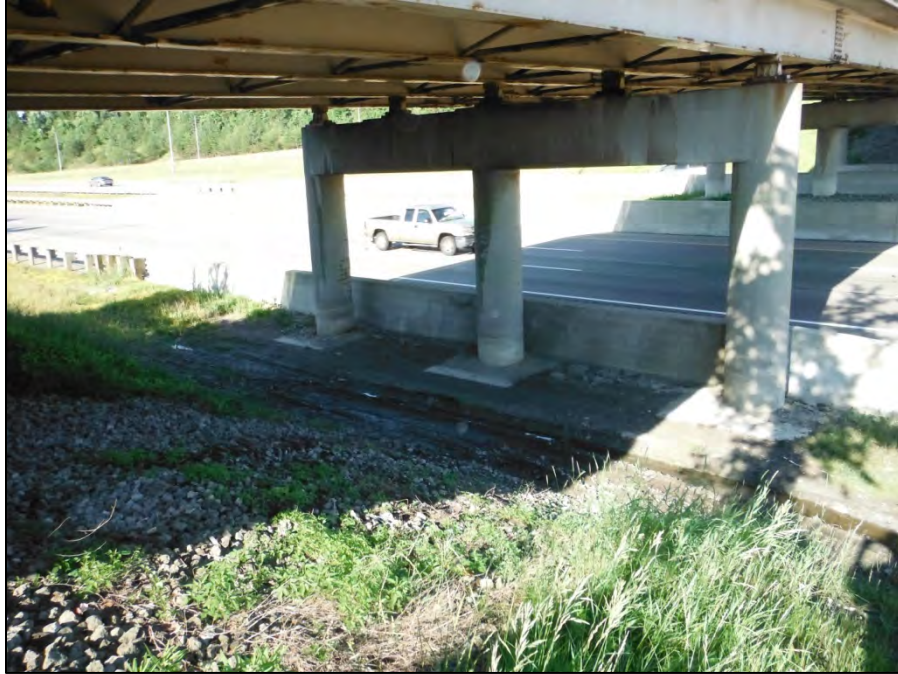
Photo 1: Typical view under the bridge looking at pier 3. Note the south column deterioration.

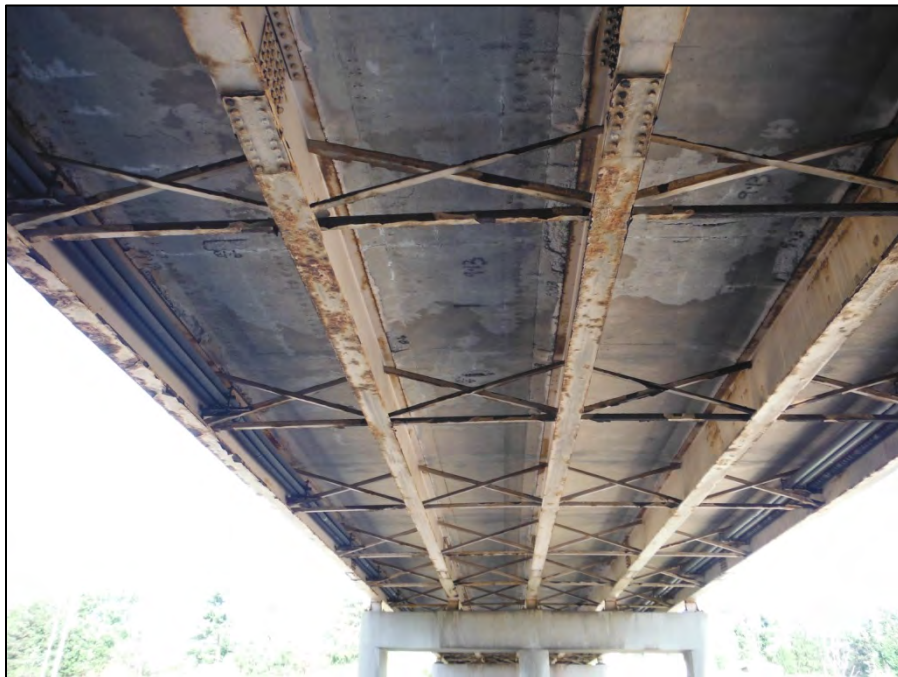
Photo 2: Looking west over the northbound lanes at deck spalling/delaminations.

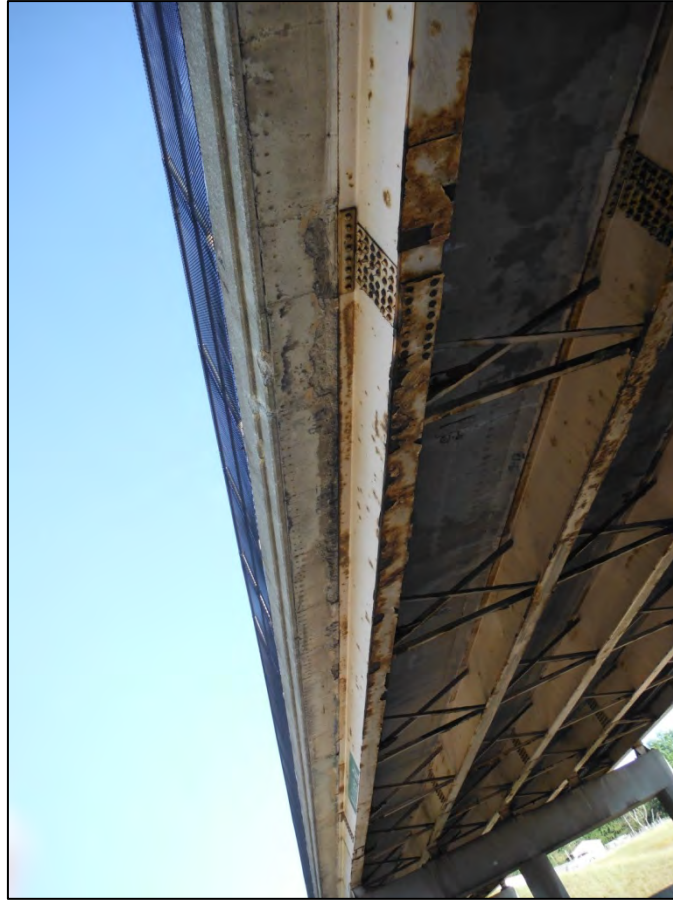
Photo 3: Looking west over the northbound lanes at deck spalling under the south fascia. The loose material should be removed, but it may be impractical to install a timber subdeck outside of the beams (north side fascia is in better condition does not appear to be a problem).

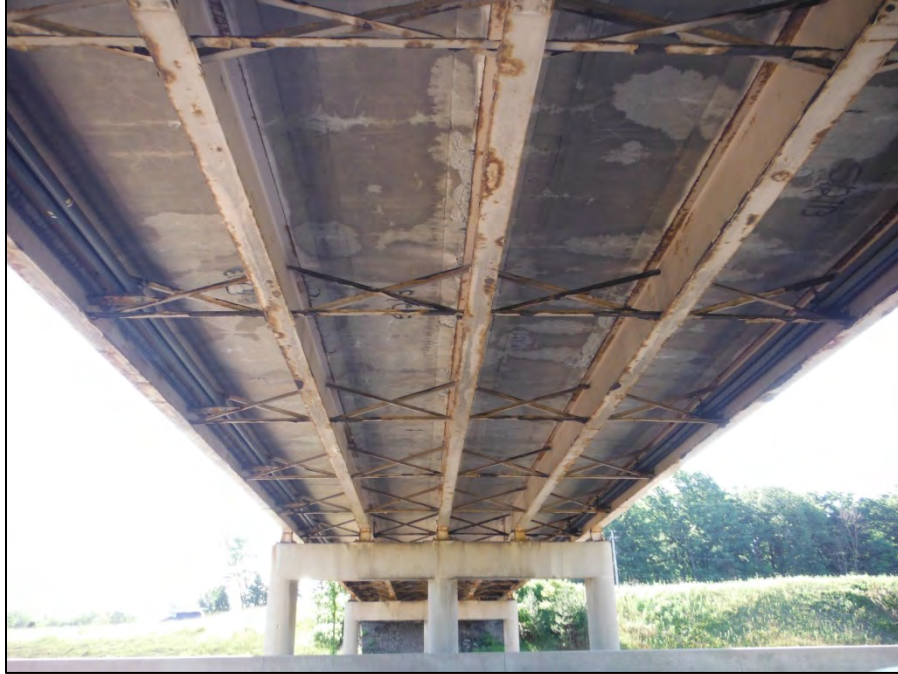
Photo 4: Looking east over the southbound lanes at deck spalling.

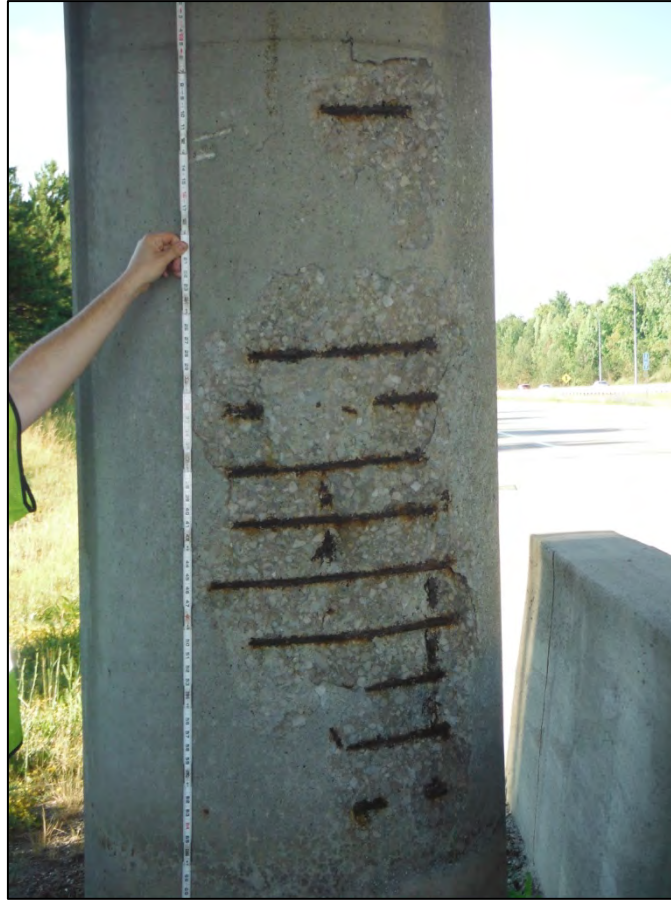
Photo 5: Pier 3 south column spalling and deterioration

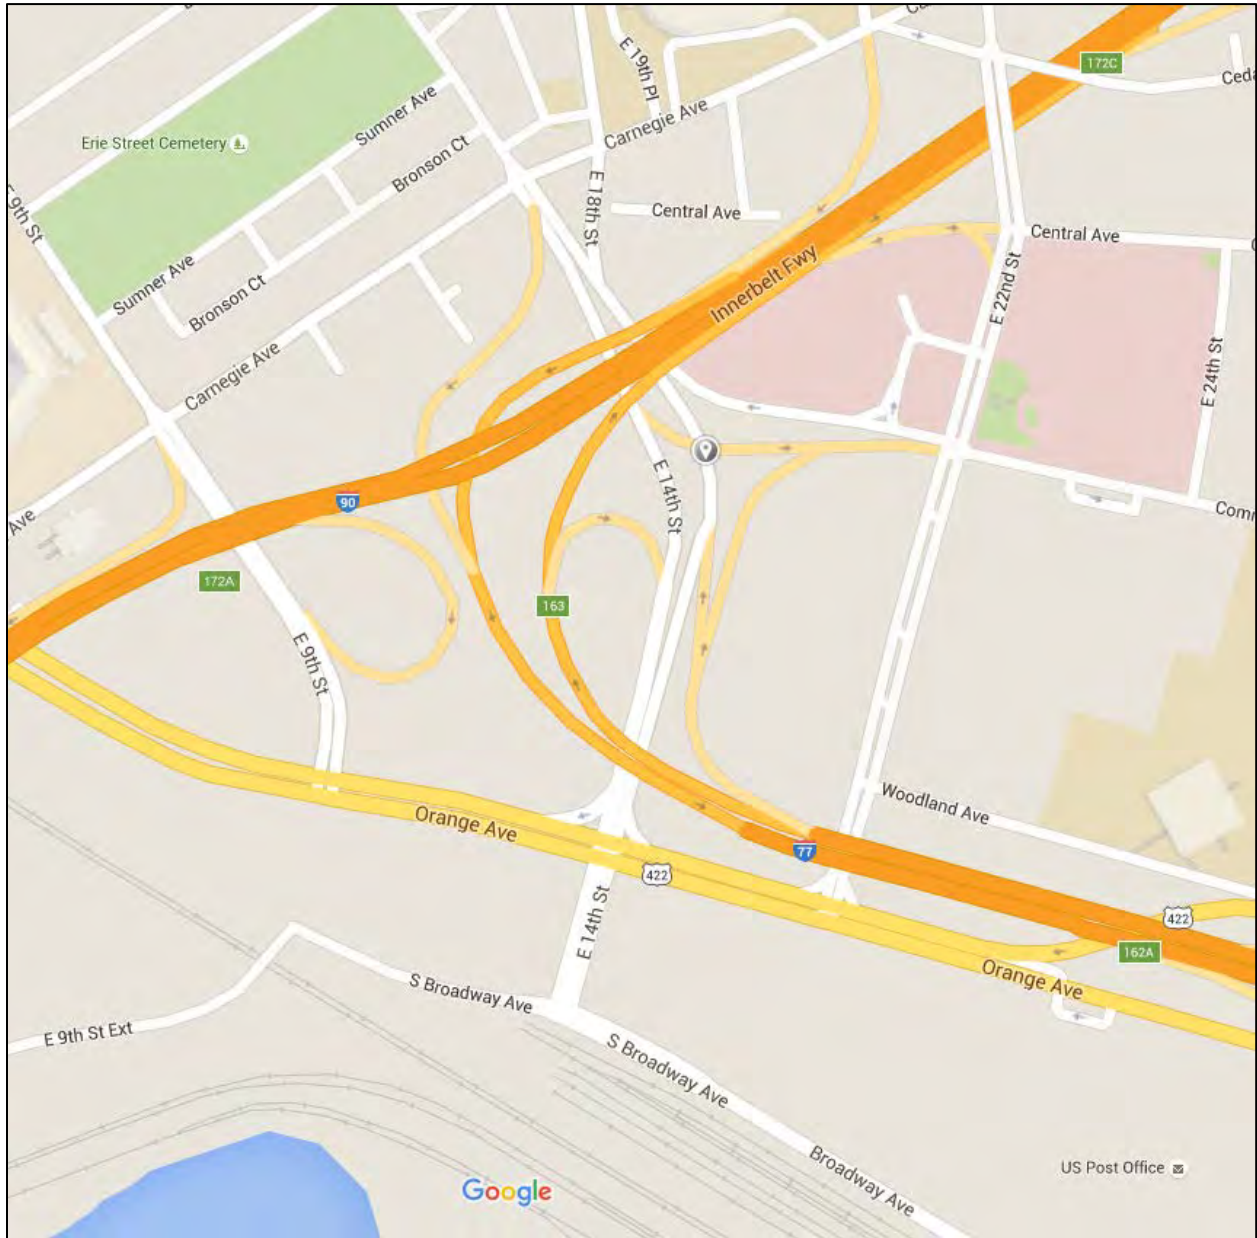
SITE INSPECTION AND RECOMMENDATIONS REPORT FOR CUY-077-1575SN (East 14th Ramp over East TOGO East 22nd over IR-77 Ramp)

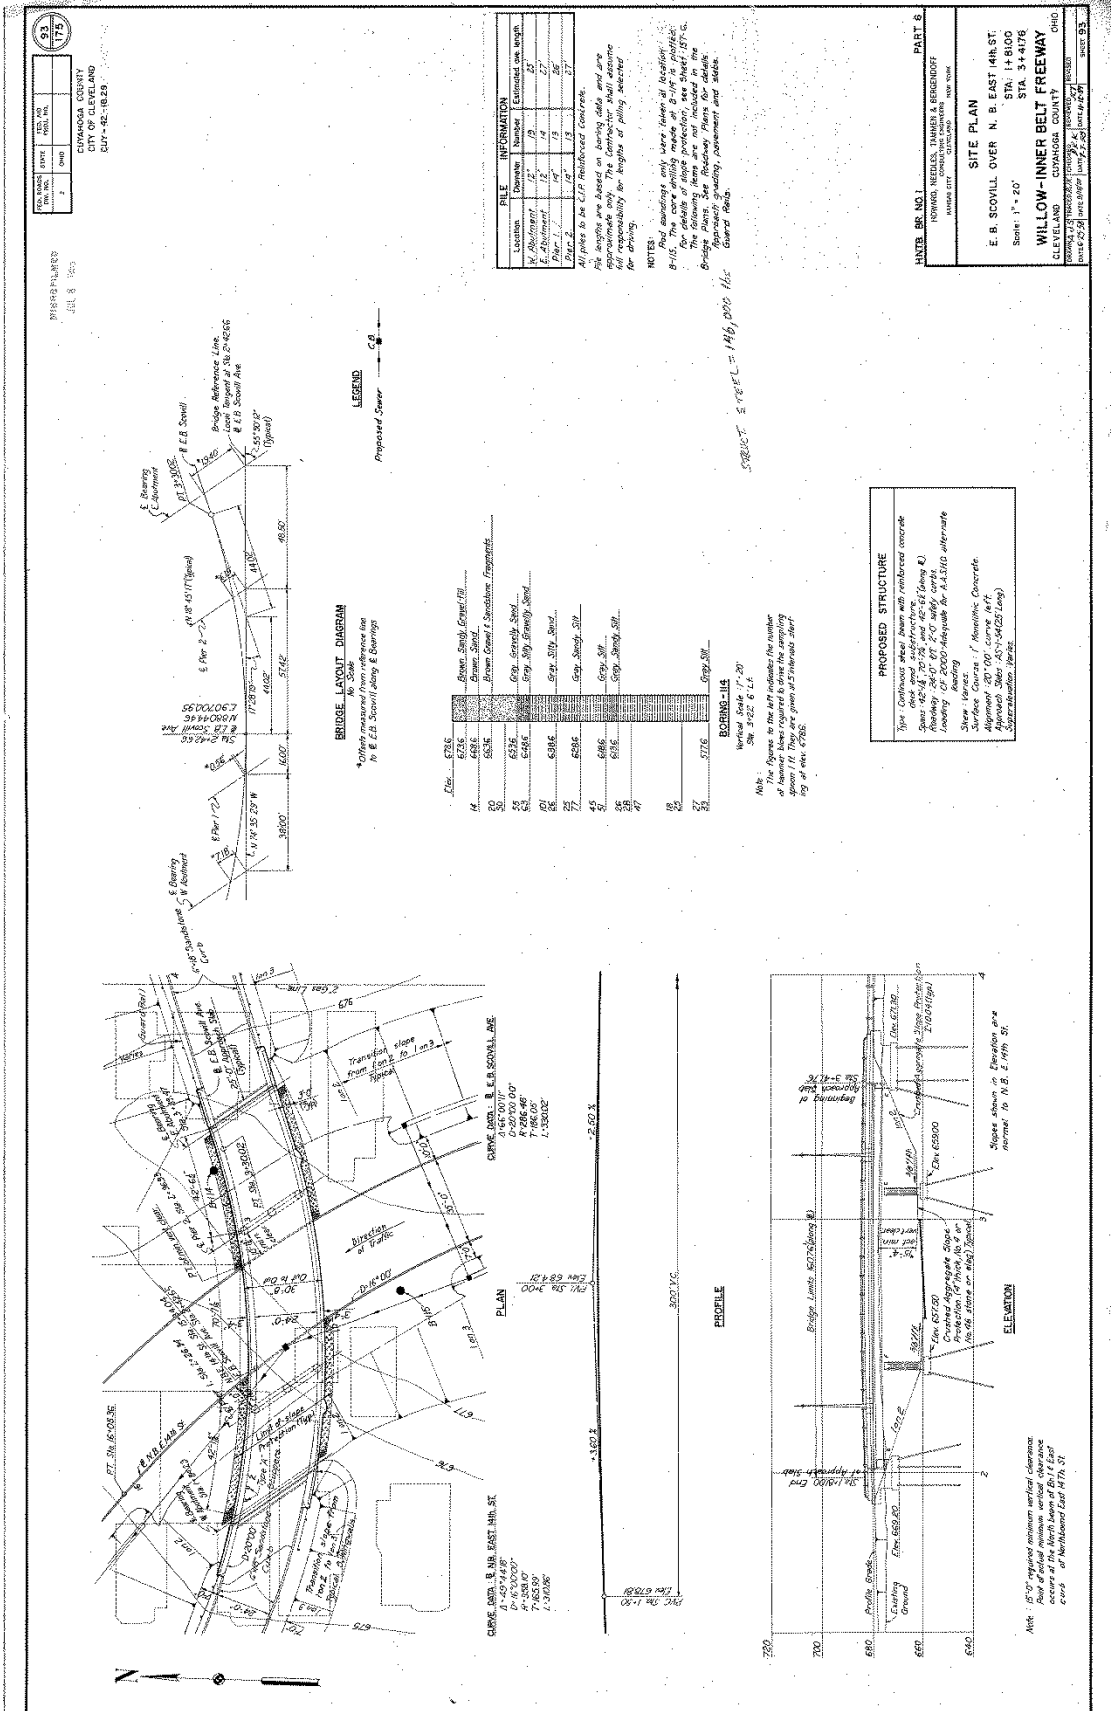
SITE INSPECTION AND RECOMMENDATIONS REPORT FOR CUY-077-1575SN (East 14th Ramp over East TOGO East 22nd over IR-77 Ramp)

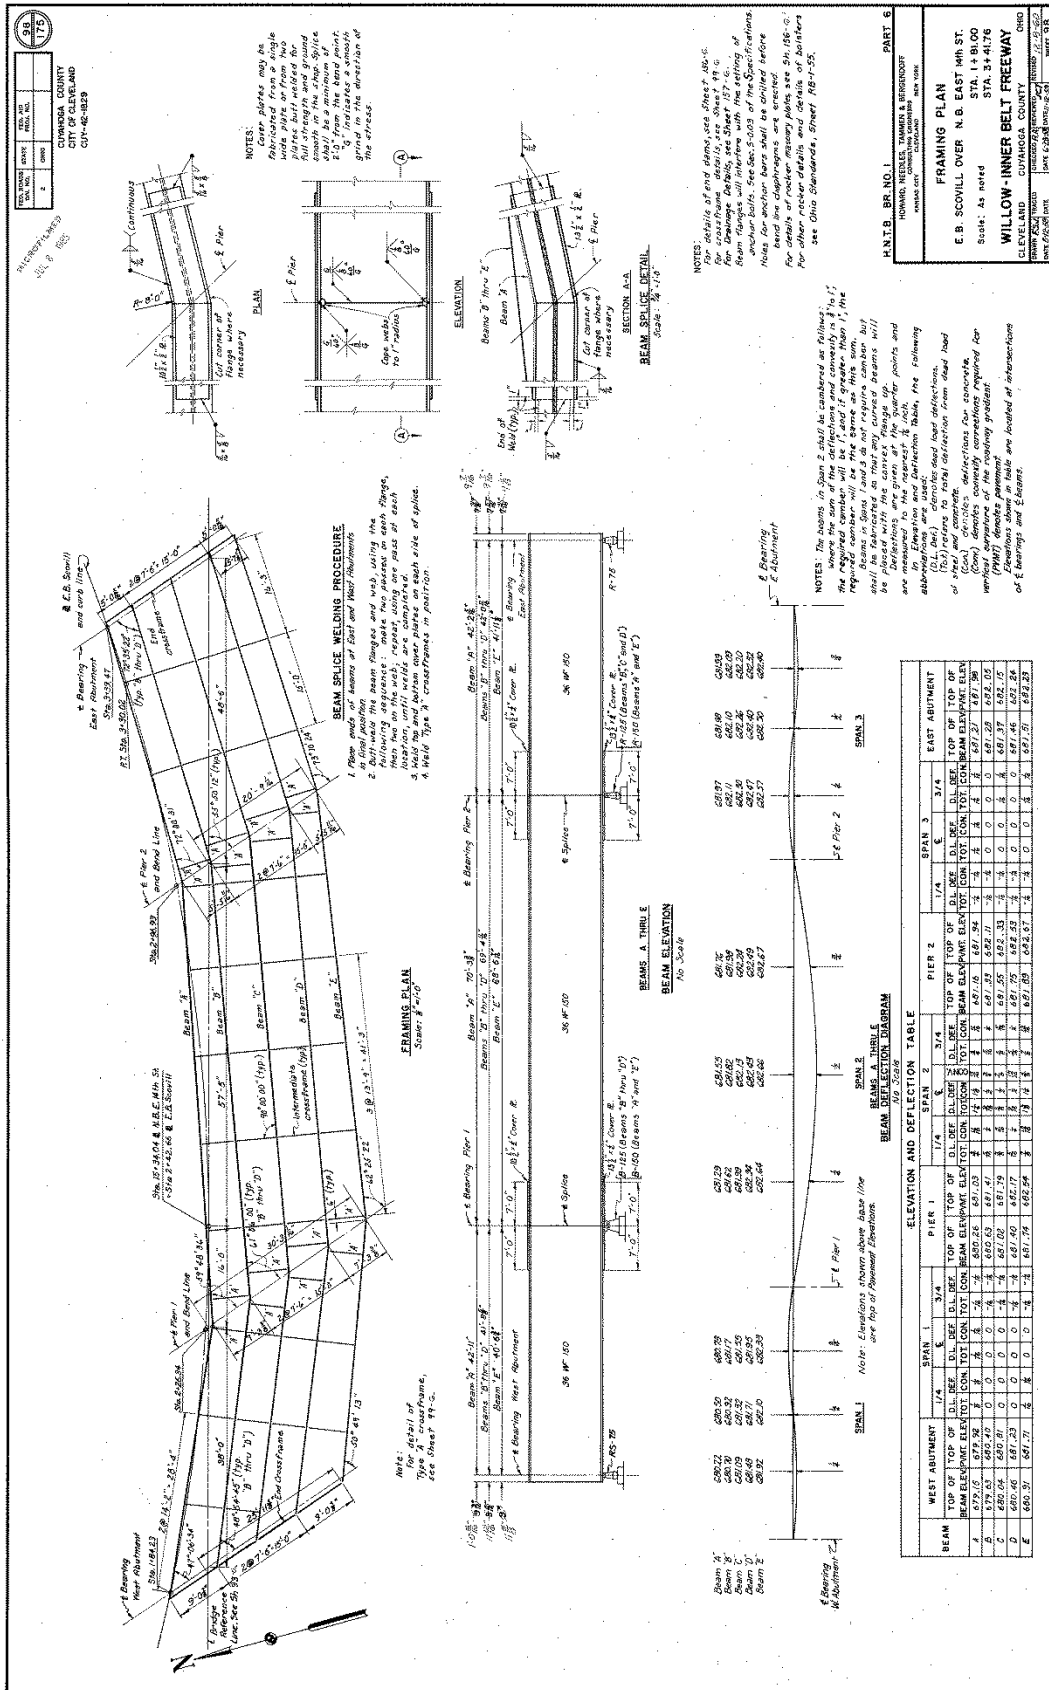
SITE INSPECTION AND RECOMMENDATIONS REPORT FOR CUY-077-1575SN (East 14th Ramp over East TOGO East 22nd over IR-77 Ramp)

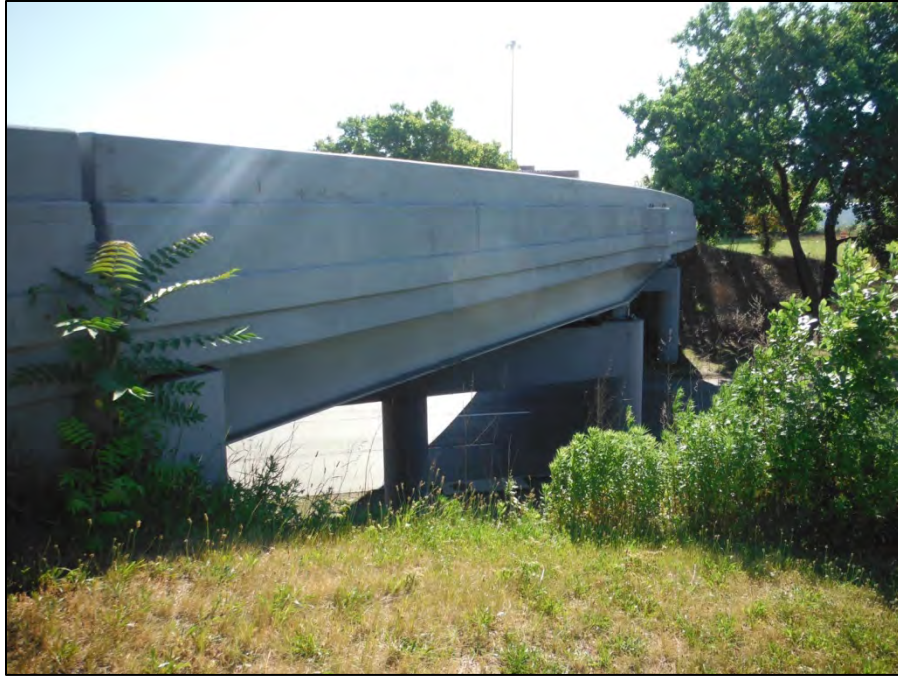
Photo 1: View looking east along the south parapet.

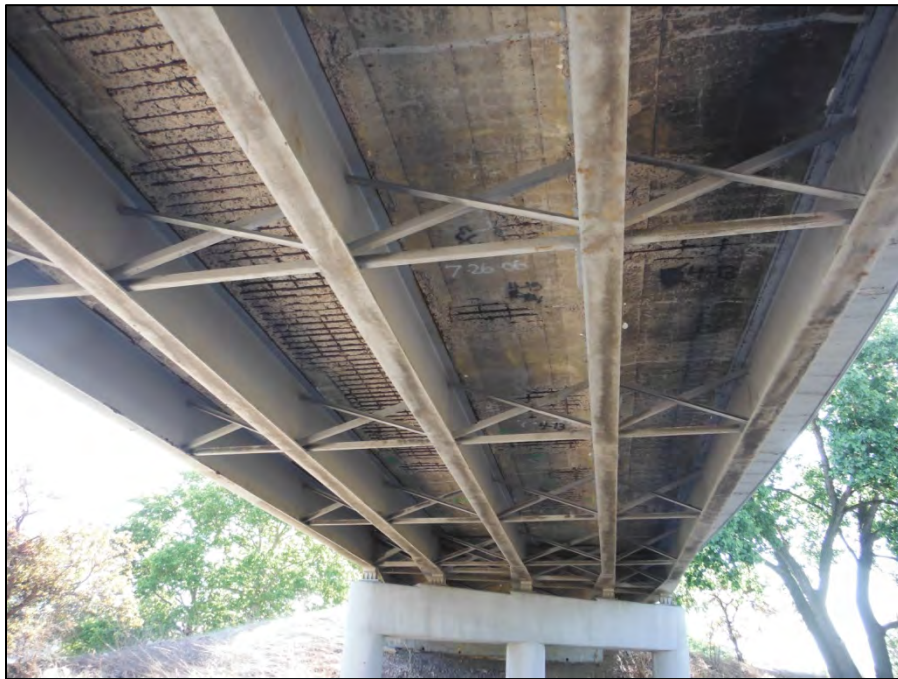
Photo 2: Looking east over the three lane north/west bound ramp at the deck spalling.

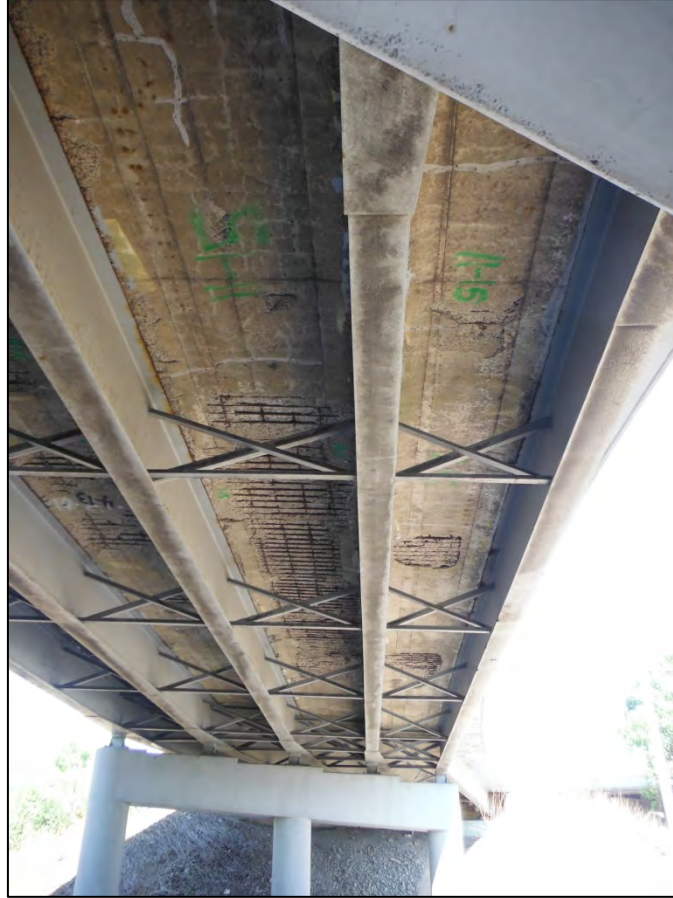
Photo 3: Looking west over traffic lanes.

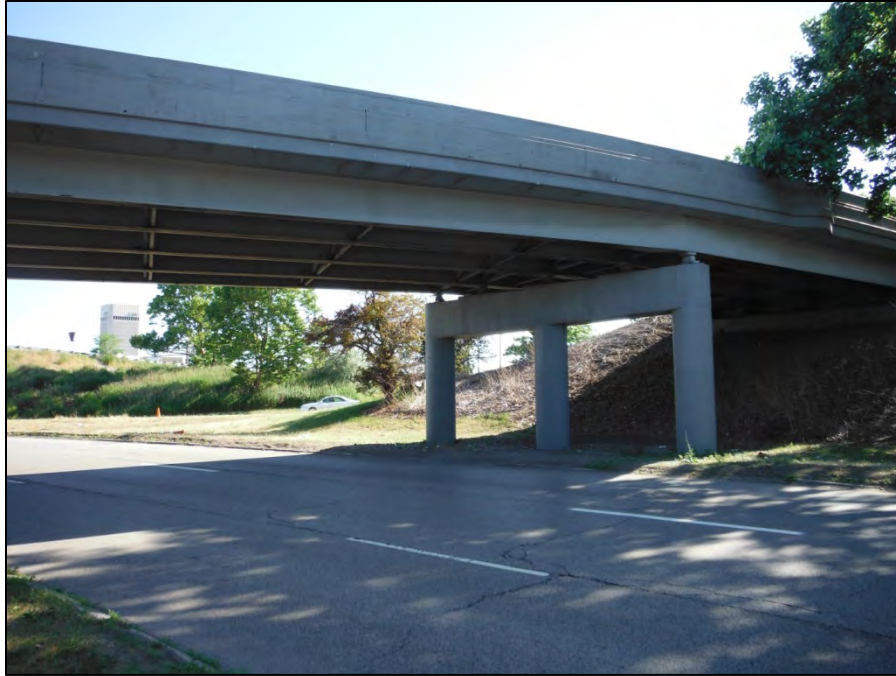
Photo 4: Looking north at the three lanes under the bridge.

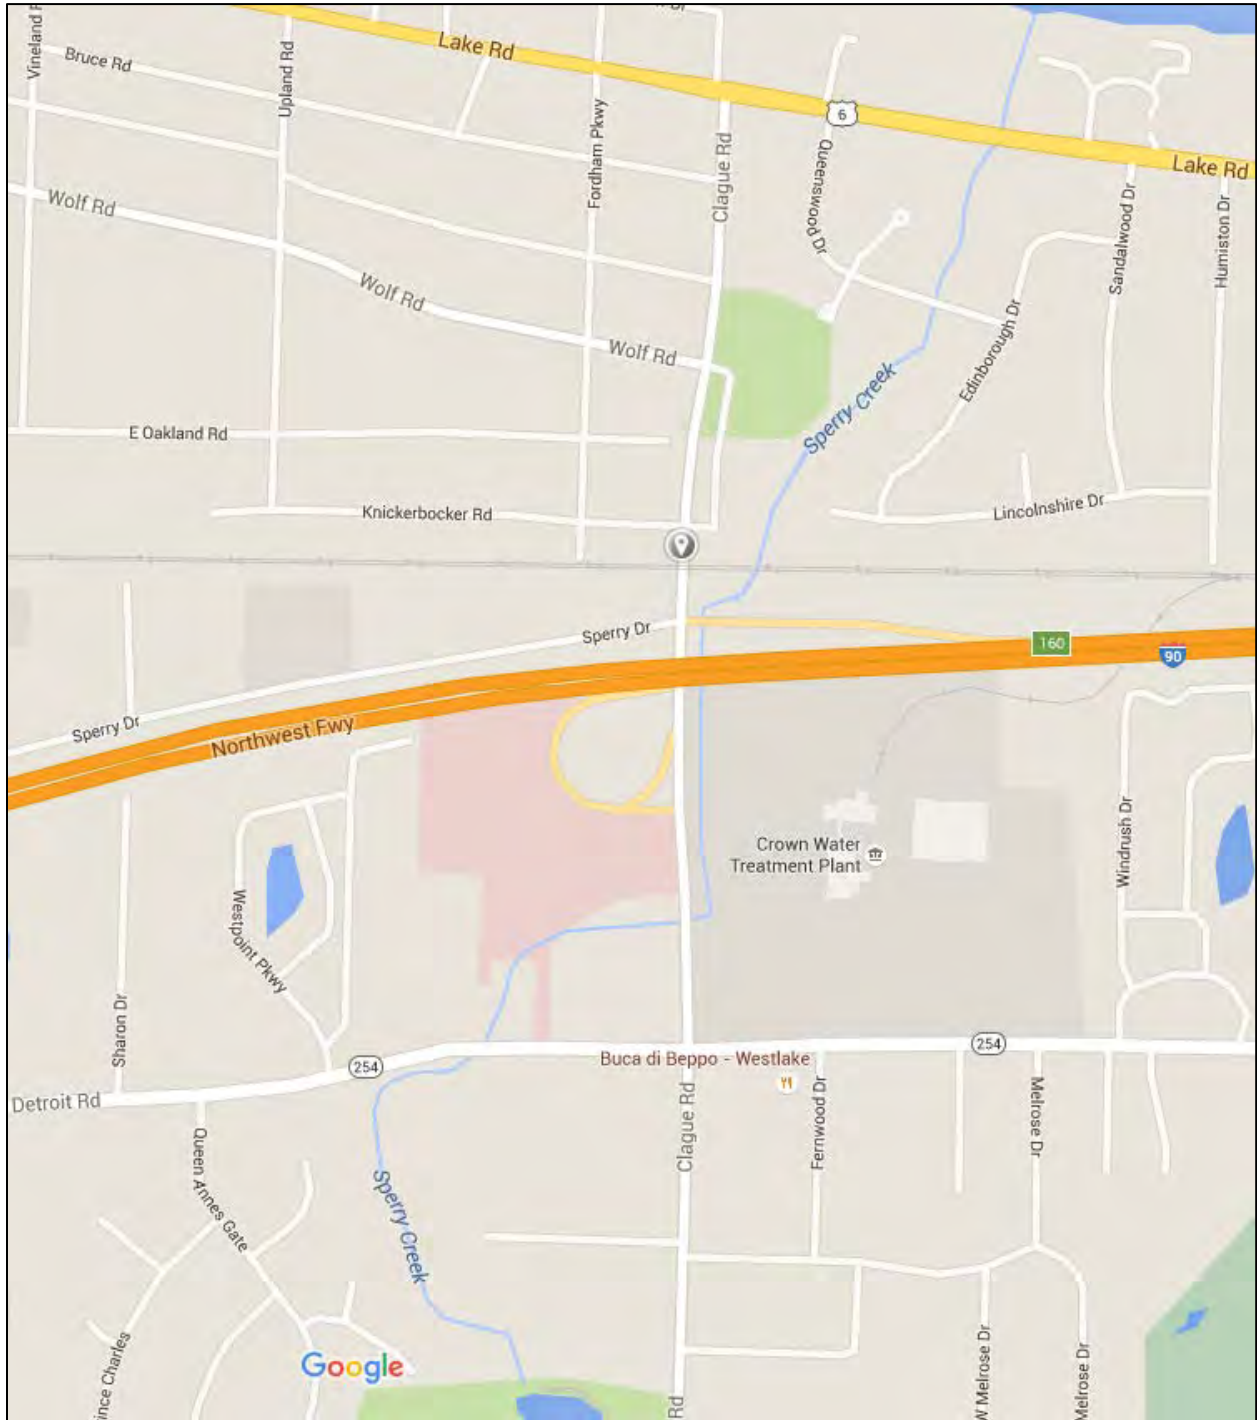
SITE INSPECTION AND RECOMMENDATIONS REPORT FOR CUY-090-0458 N (Clague Road over NSC RR & Knickerbocker Road)

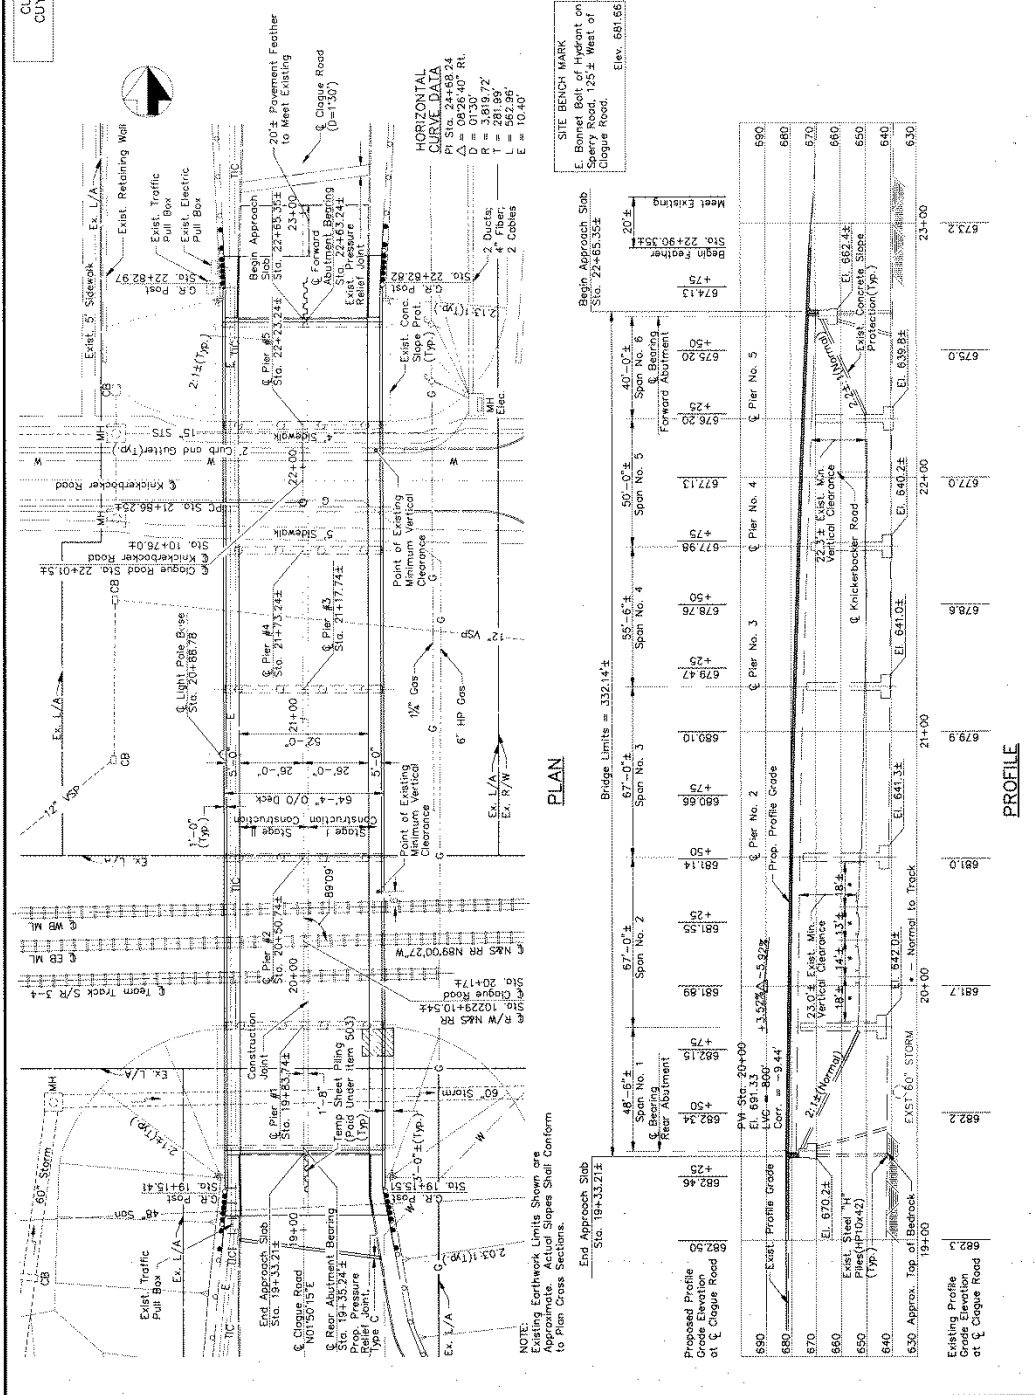
SITE INSPECTION AND RECOMMENDATIONS REPORT FOR CUY-090-0458 N (Clague Road over NSC RR & Knickerbocker Road)

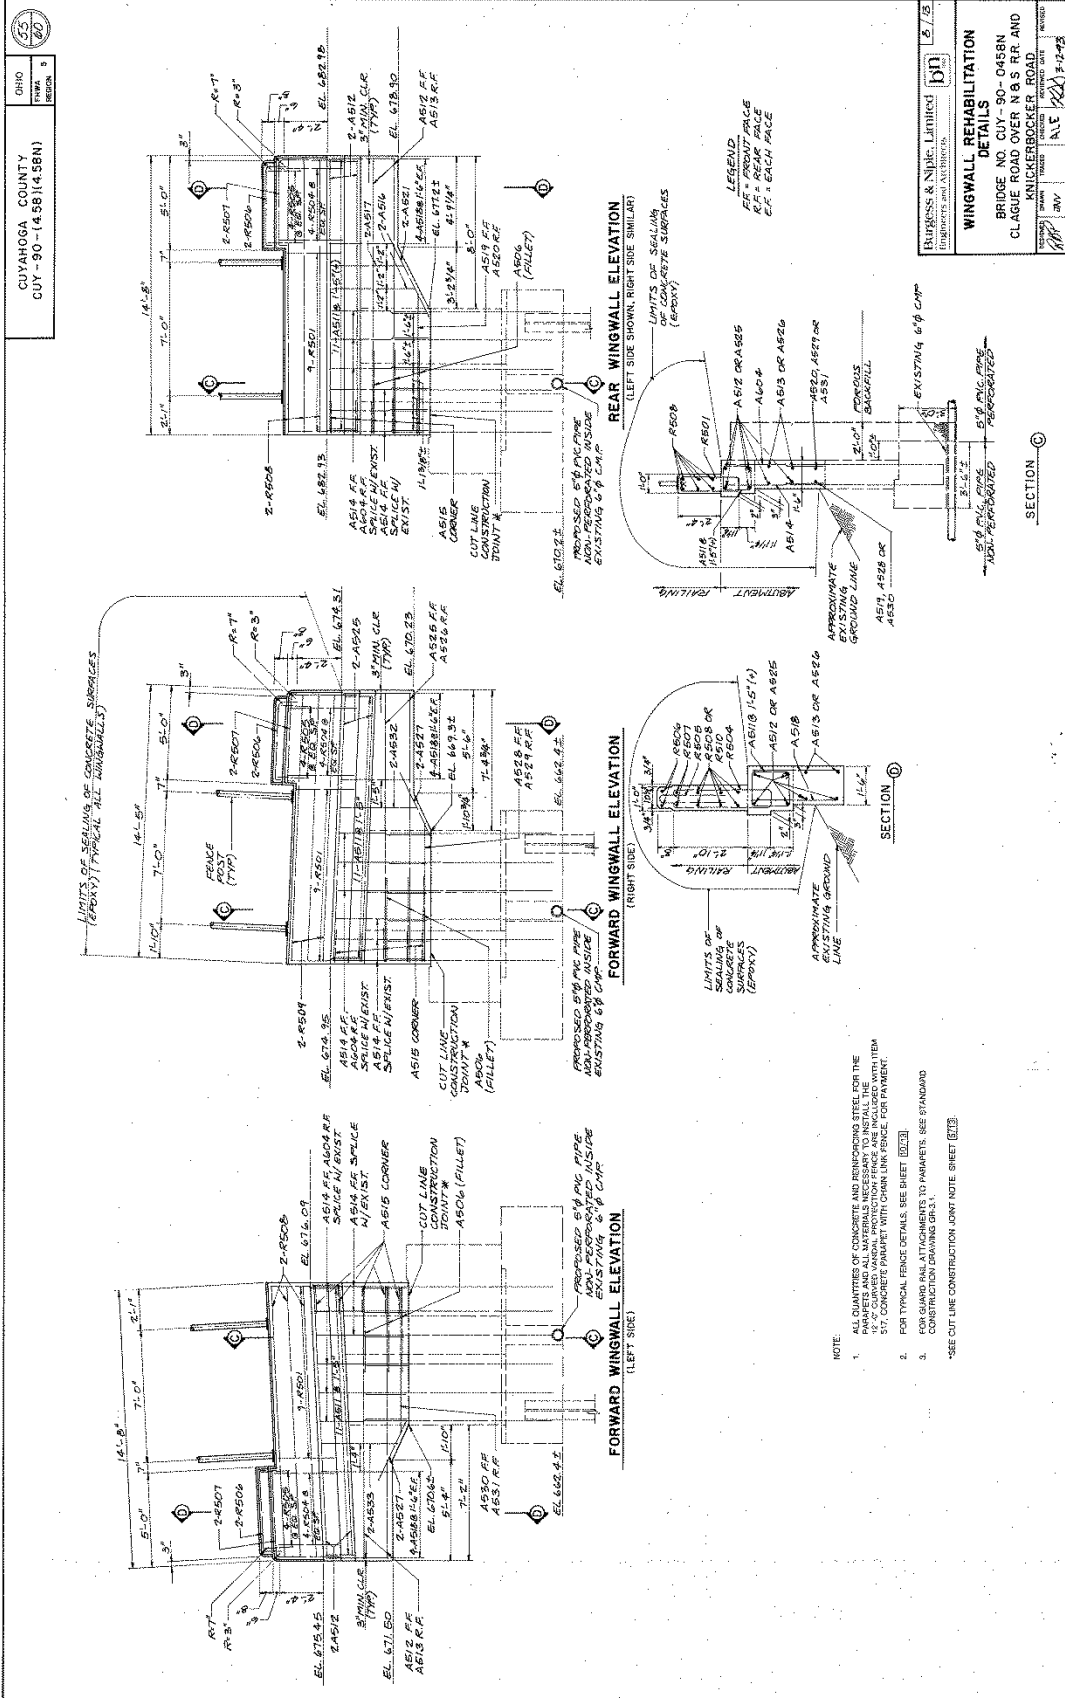
SITE INSPECTION AND RECOMMENDATIONS REPORT FOR CUY-090-0458 N (Clague Road over NSC RR & Knickerbocker Road)

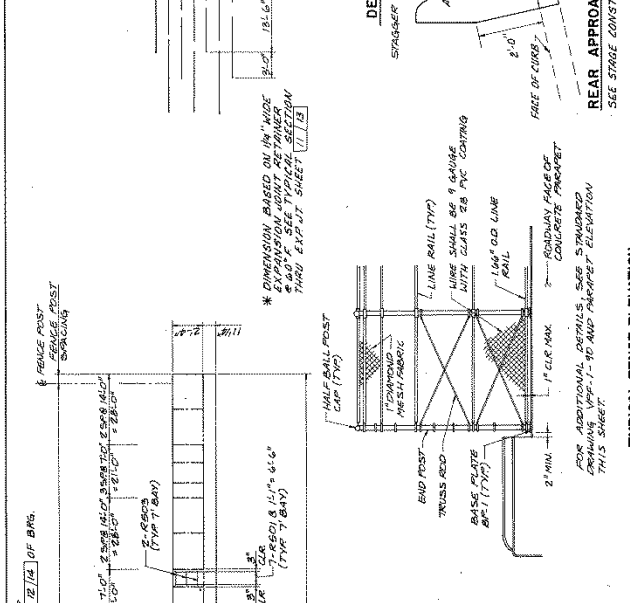
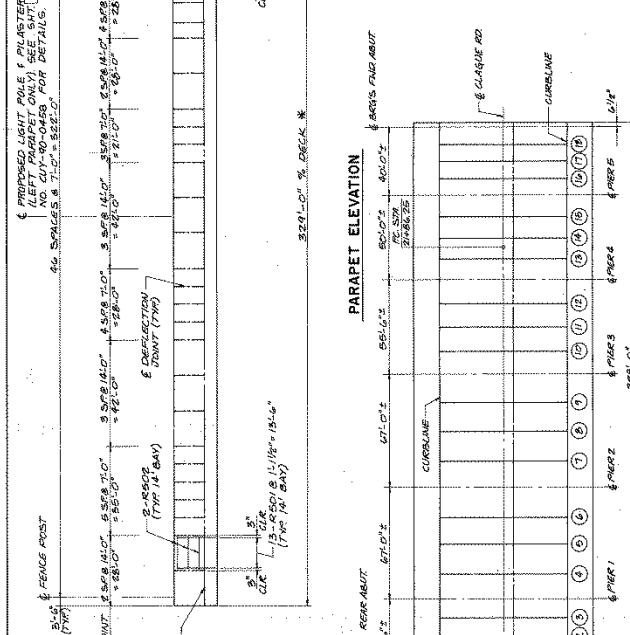
OHIO
 CUYAHOGA COUNTY
 CUT - 90 - (4.58) (4.58N)

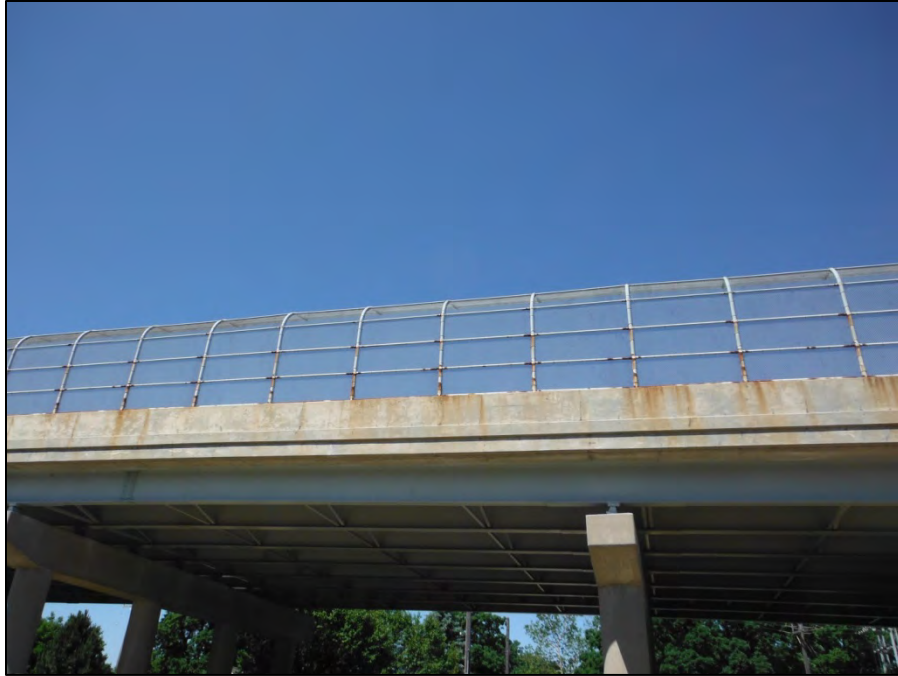
Photo 1: Typical view of east fence and parapet. Note fence post and rail rusting and the staining of parapet.

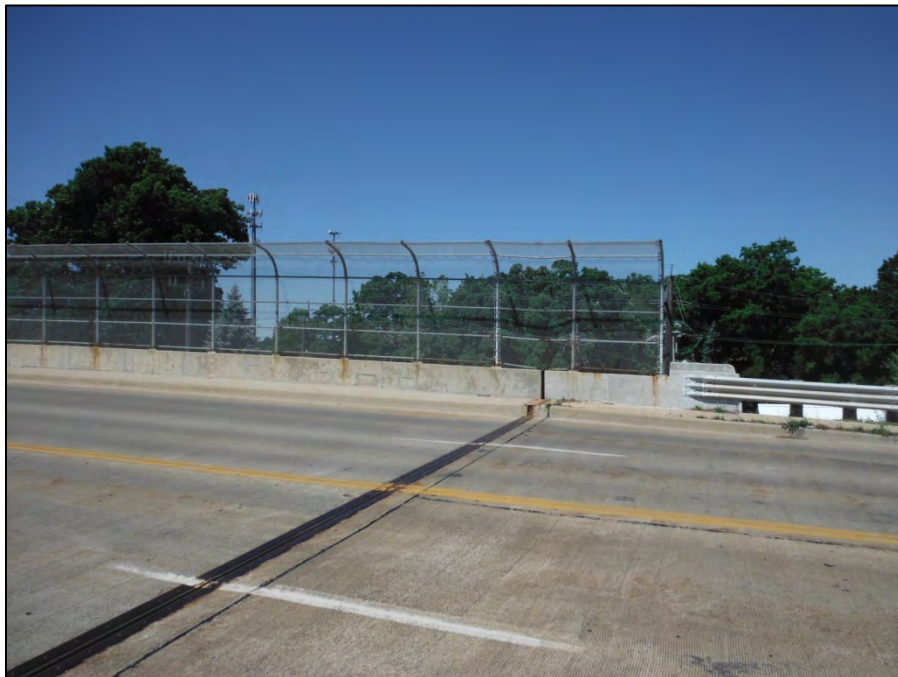
Photo 2: Looking west at north abutment joint. Note the deflection of fence and horizontal rail members due to bridge expansion.

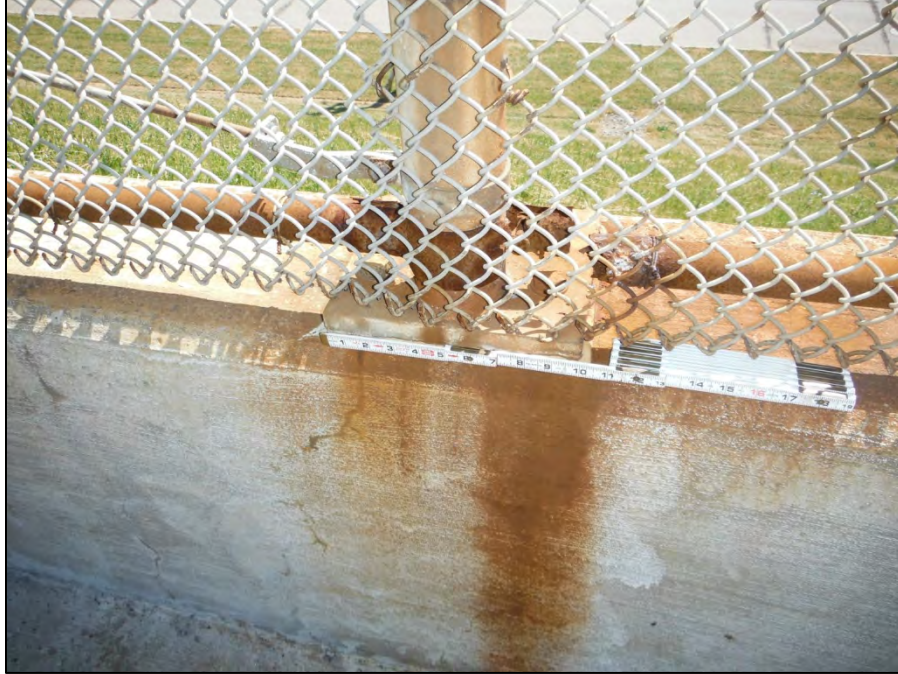
Photo 3: Typical fence deterioration that is primarily located in the lower portion of the fence.

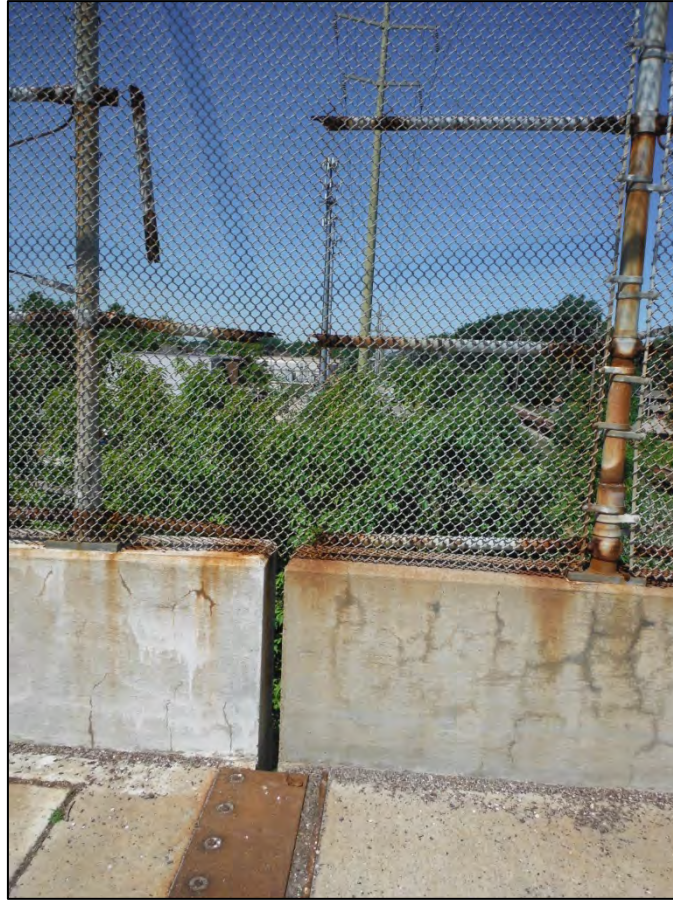
Photo 4: Looking west at south abutment joint at failed fence members.

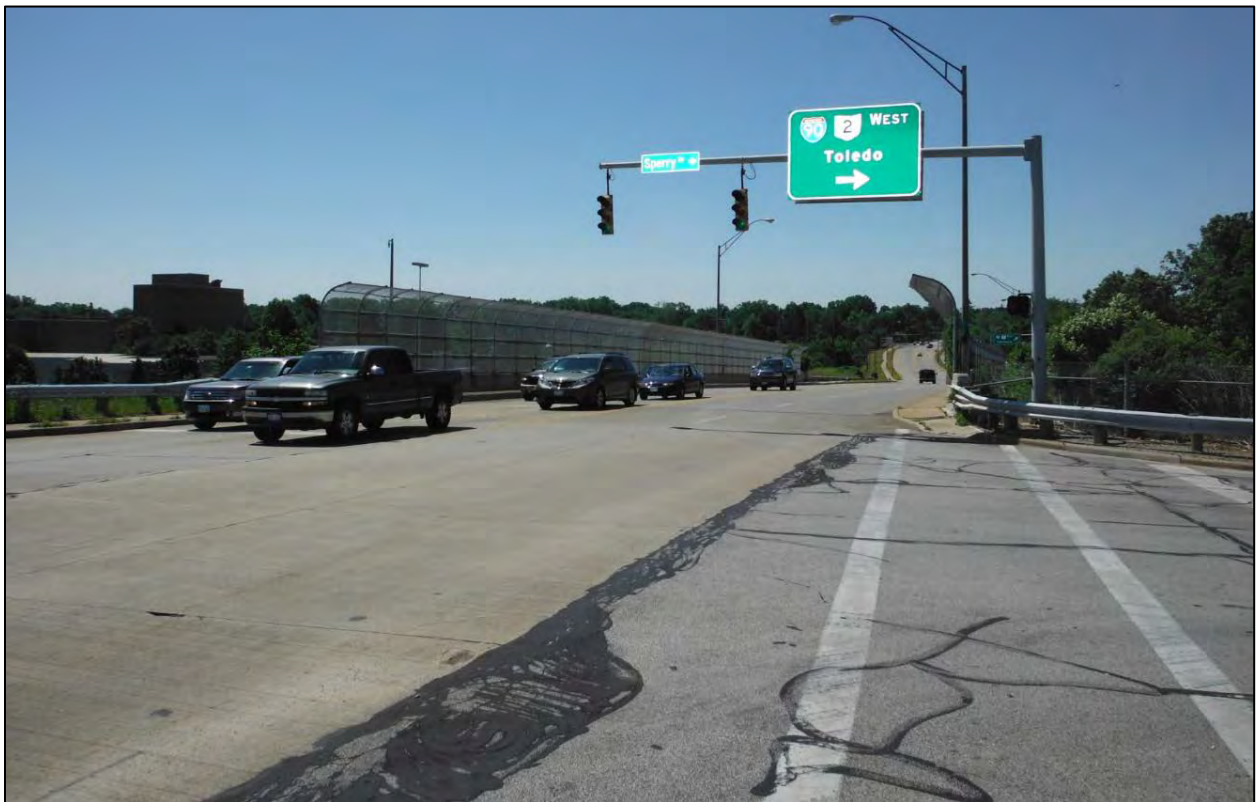
2016 INSPECTION OF
CUY-090-0458 [Clague Road over IR 90]
GROUP 1 BRIDGE IN
ODOT DISTRICT 12

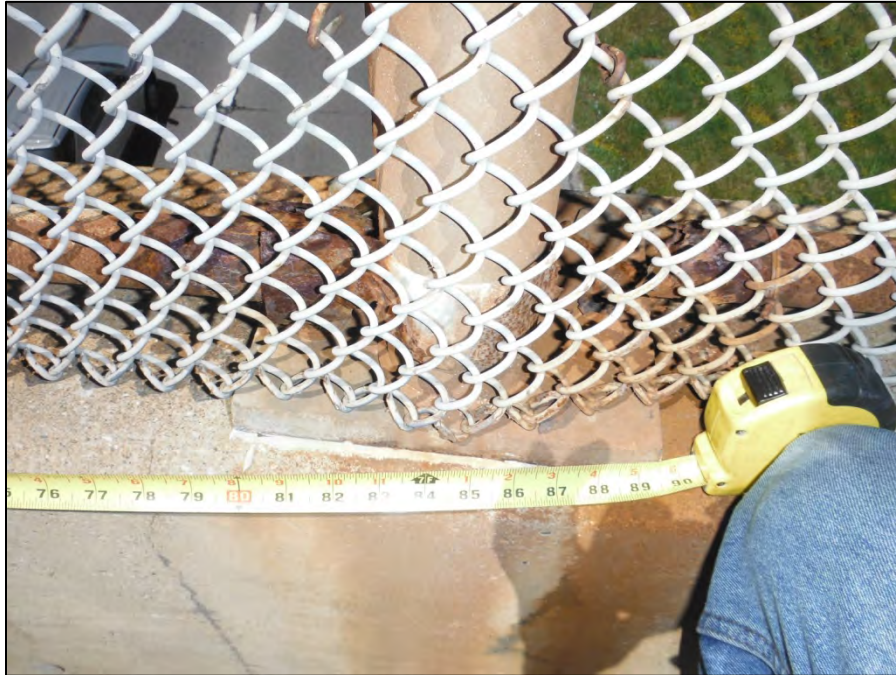
Photo 1: Typical view of east fence and parapet. Note fence post and rail rusting.
