SITE INSPECTION AND RECOMMENDATIONS REPORT

2016 INSPECTION OF

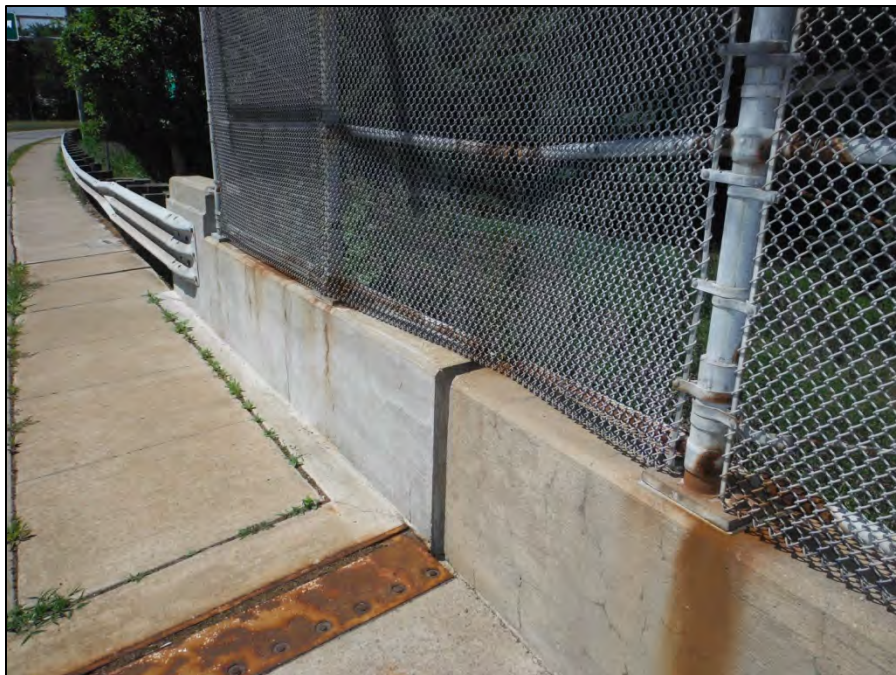
Photo 2: Looking at north abutment joint west railing. Note the deflection of fence and horizontal rail members due to bridge expansion.

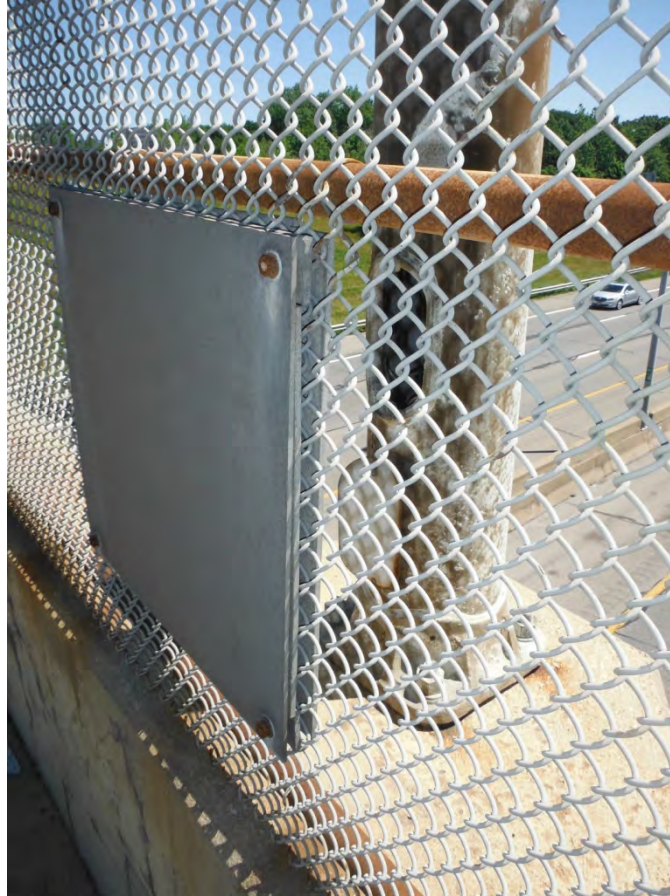
Photo 4: Light pole on east parapet (there is also a light pole on the west parapet).

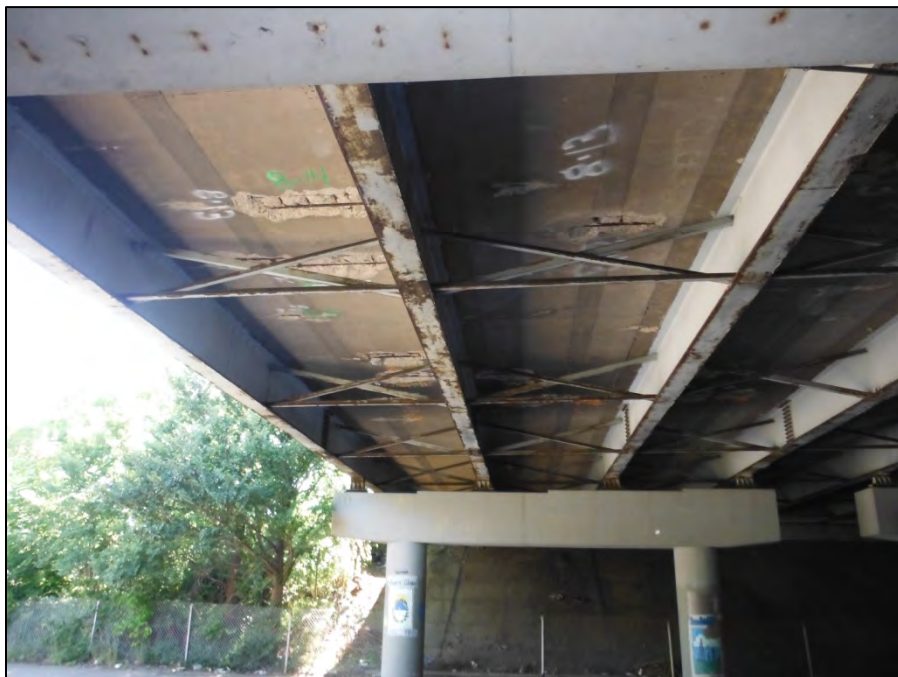
Photo 5: View under the bridge looking east under north portion of westbound lanes.

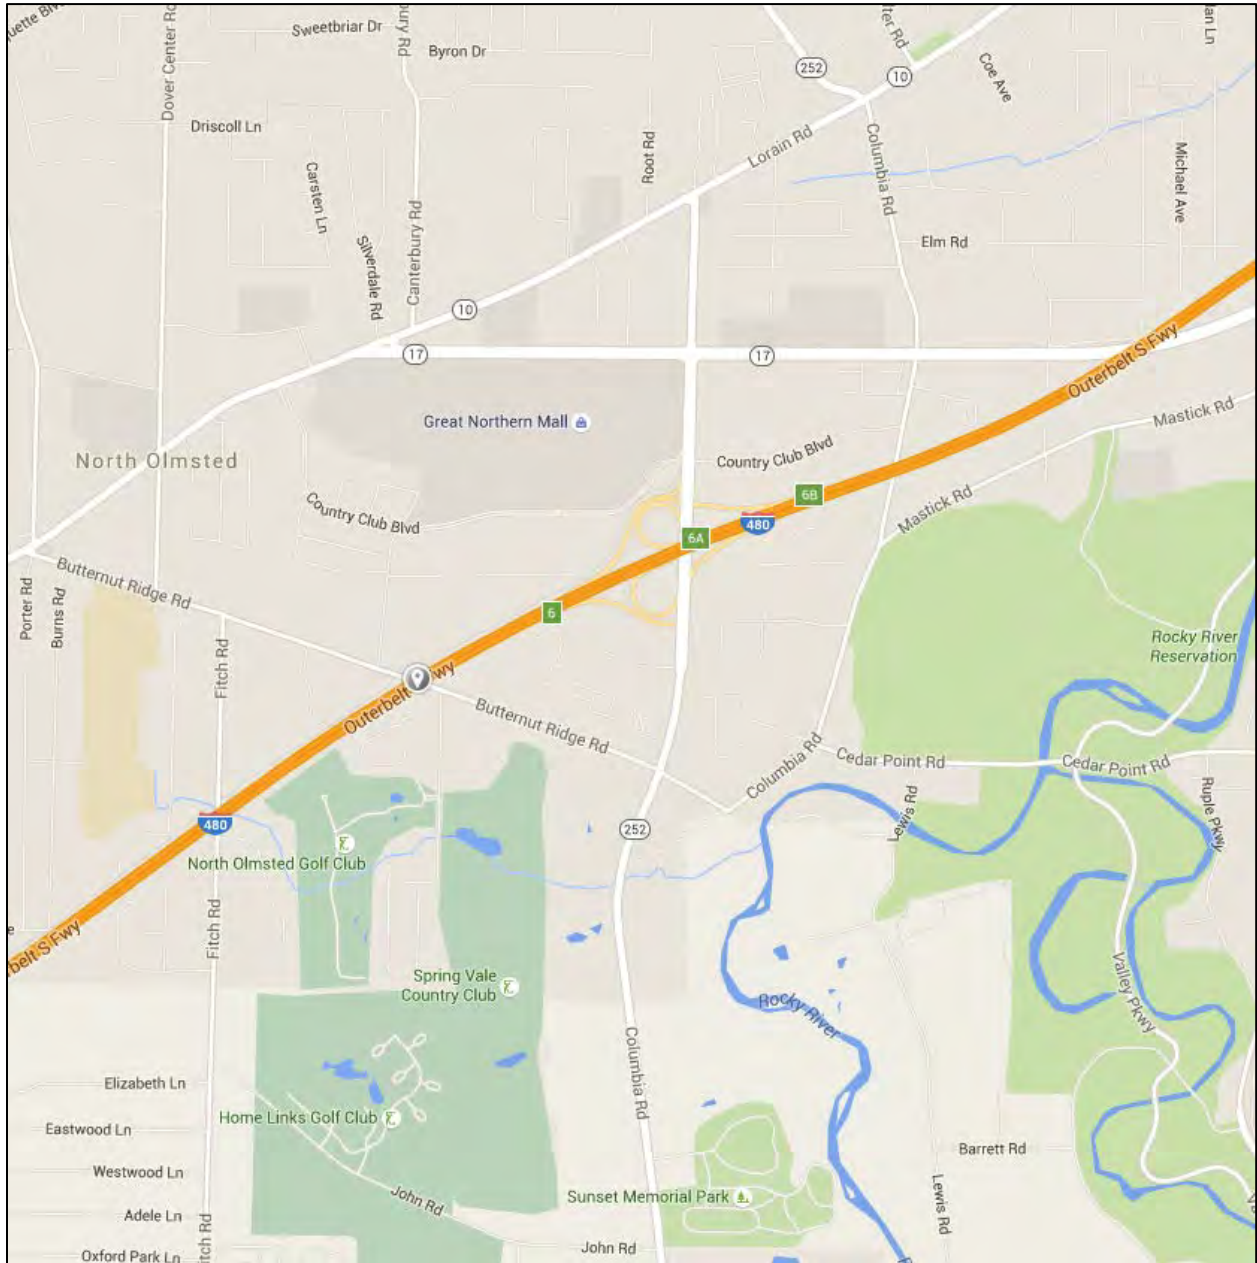
SITE INSPECTION AND RECOMMENDATIONS REPORT FOR CUY-480-0335 (Butternut Ridge Road over IR 480)

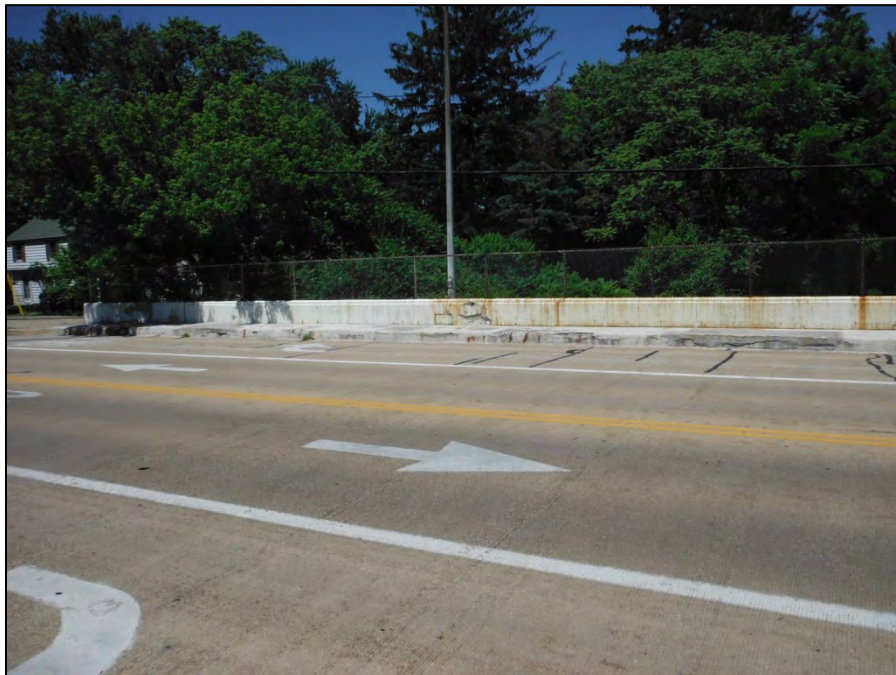
Photo 2: Looking at north railing. Note sidewalk and curb deterioration.

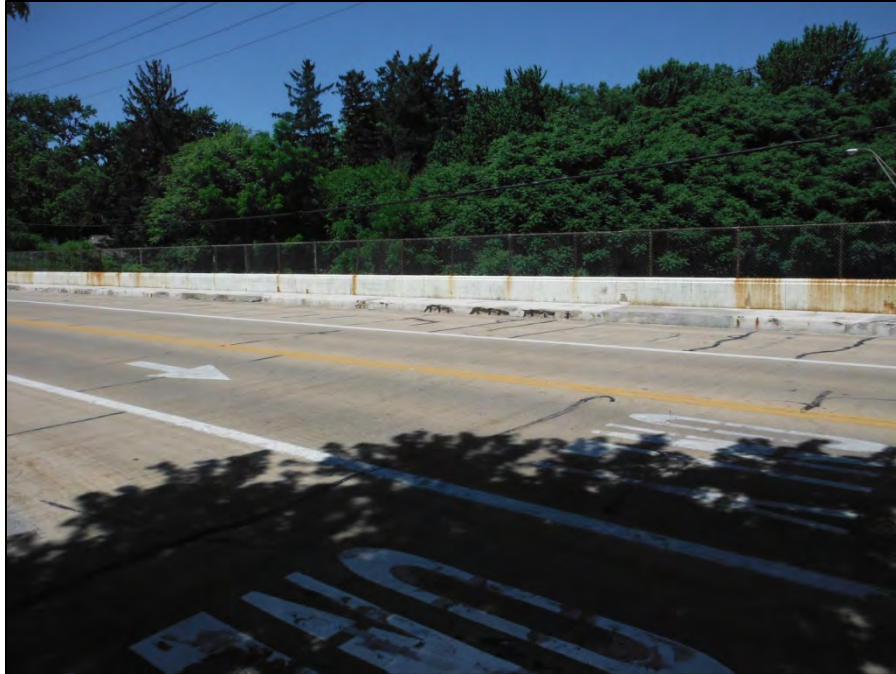
Photo 3: Looking at the north railing and deteriorated curb near the center of the bridge.

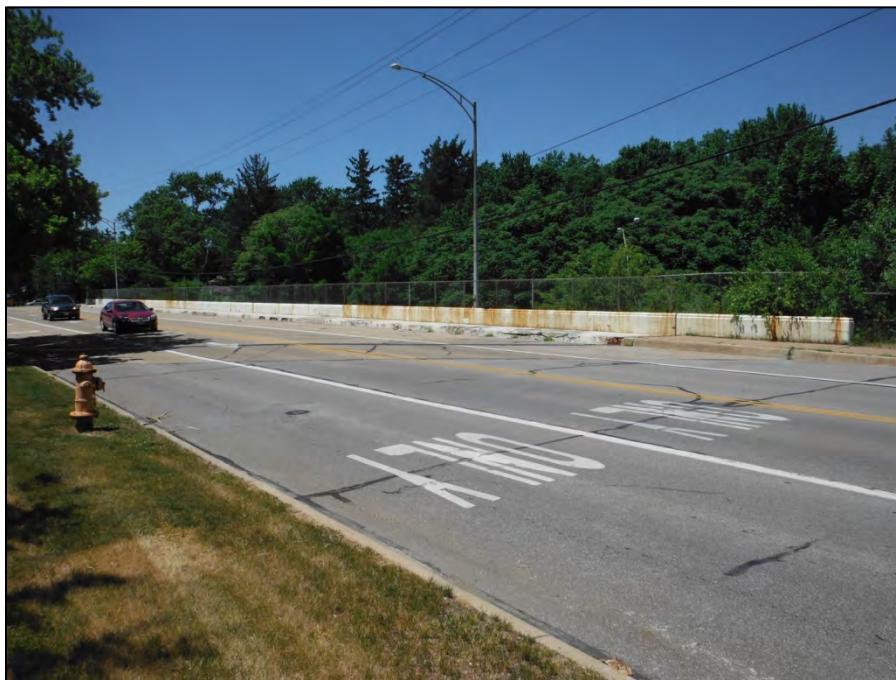
Photo 4: East end of the north railing and sidewalk. This is the worst curb deterioration on the structure.

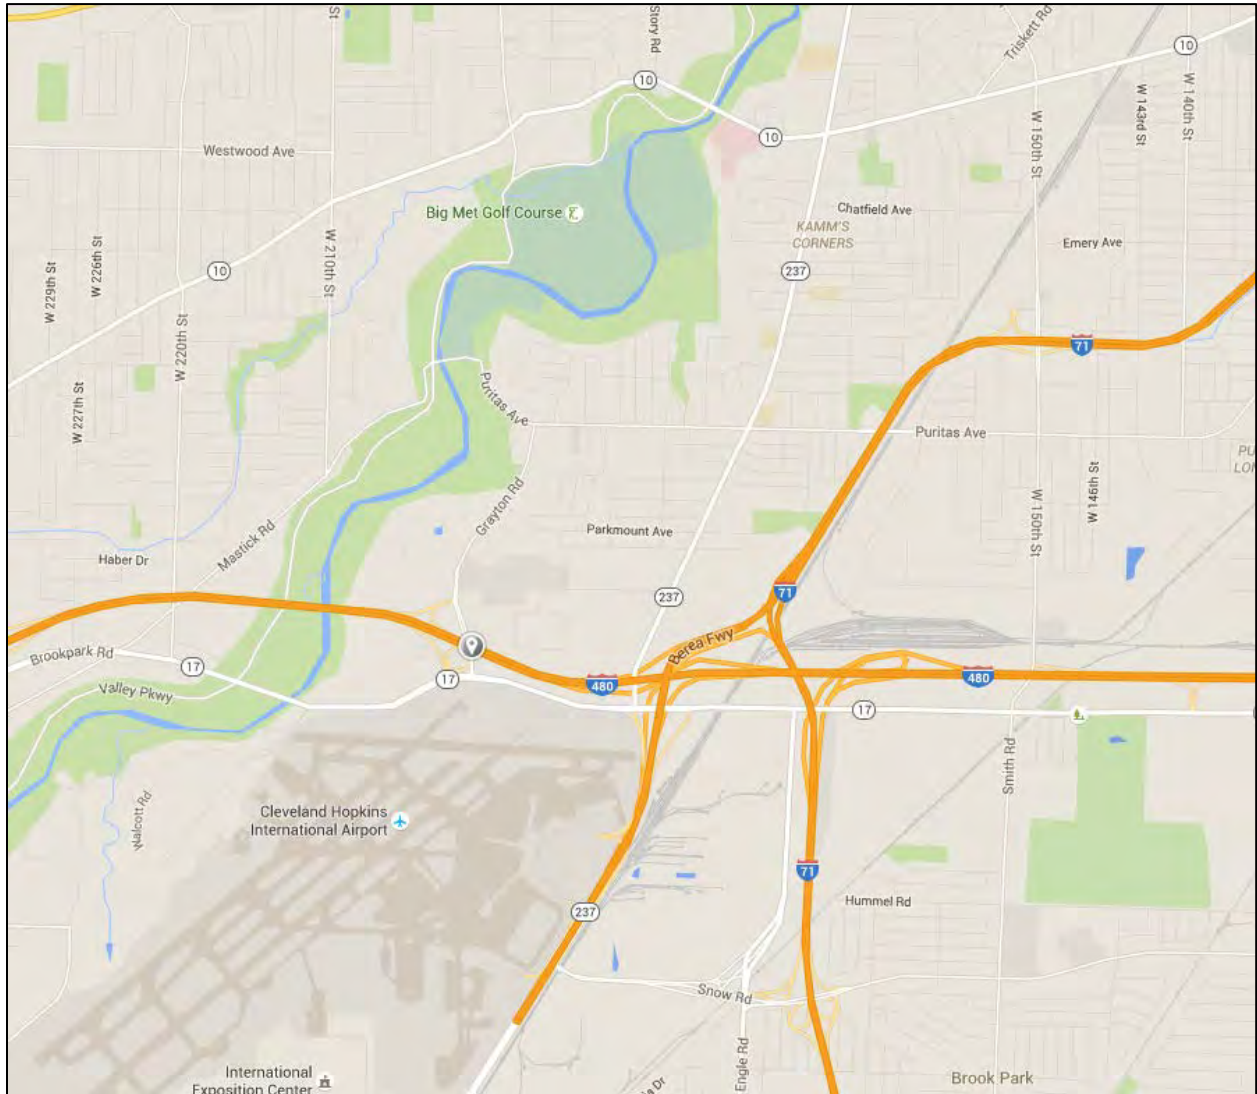
SITE INSPECTION AND RECOMMENDATIONS REPORT FOR CUY-480-0727 (Grayton Road over IR 480)

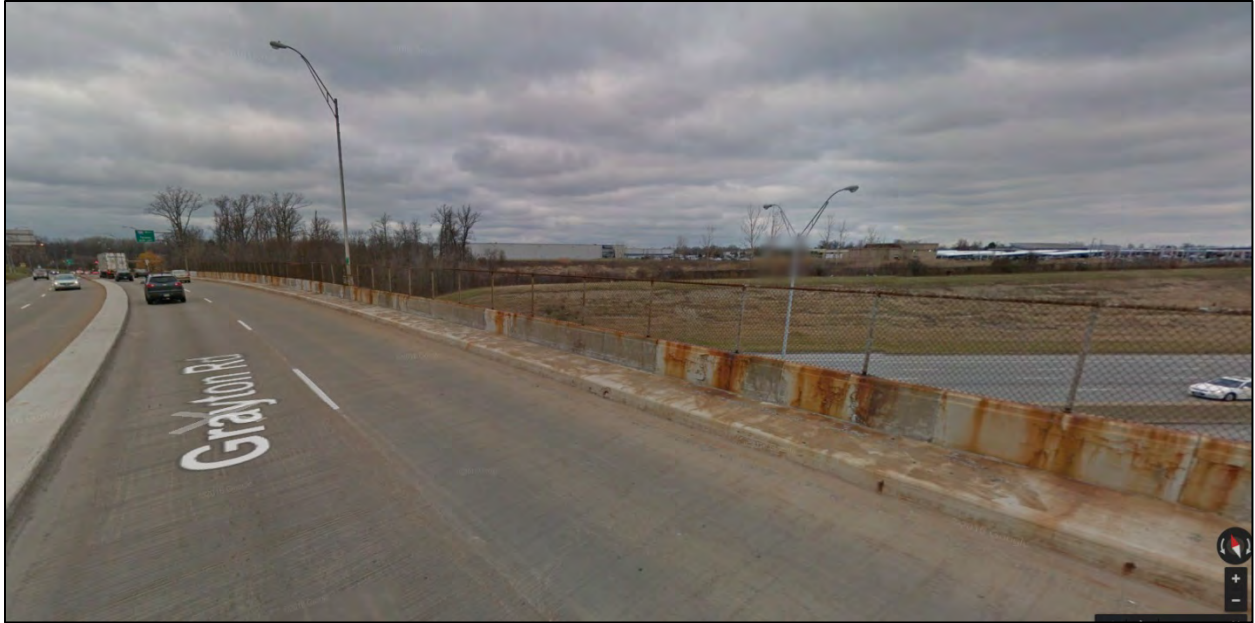
Photo 1: Looking north at east fence and railing. Note rusty fence, railing cracking and previous patching.

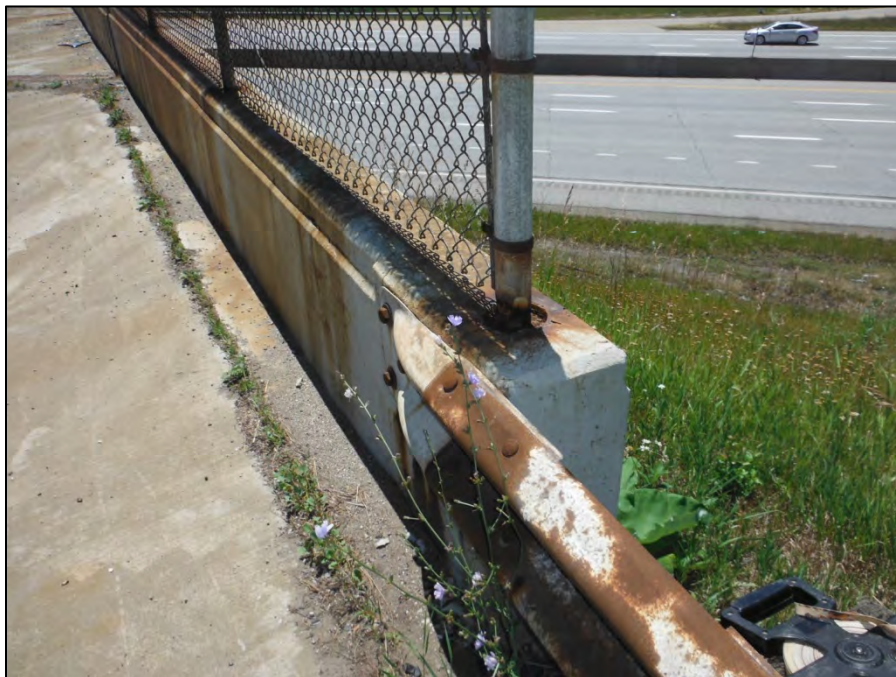
Photo 2: Looking at northwest corner of east railing. Note the fence post pipe sleeves embedded in the concrete railing and no base plates.

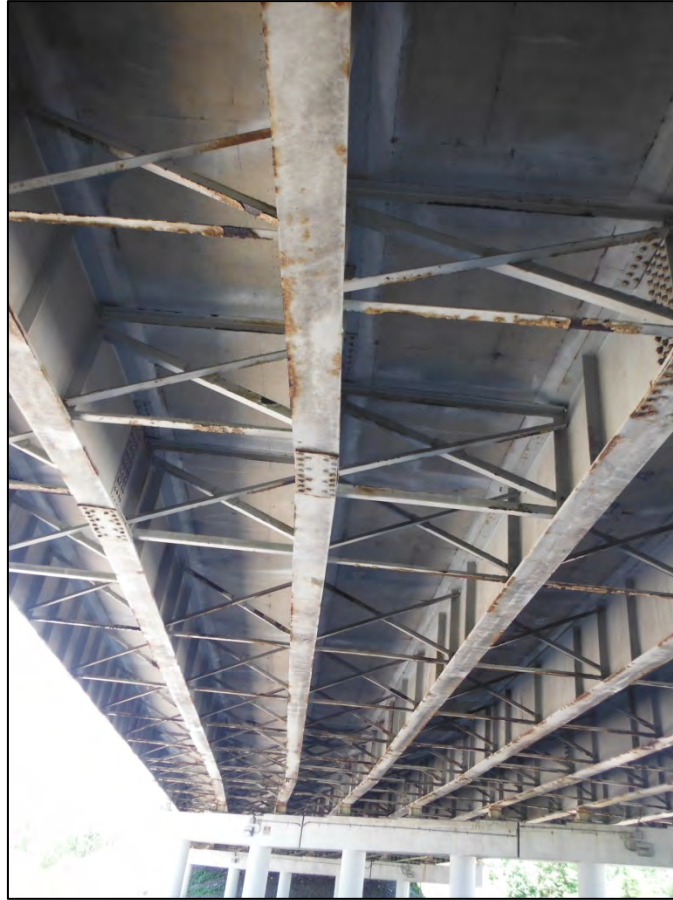
Photo 4: Looking north over eastbound lanes at deck delamination. Generally, the south end is not in as bad of condition as the north portion of bridge.

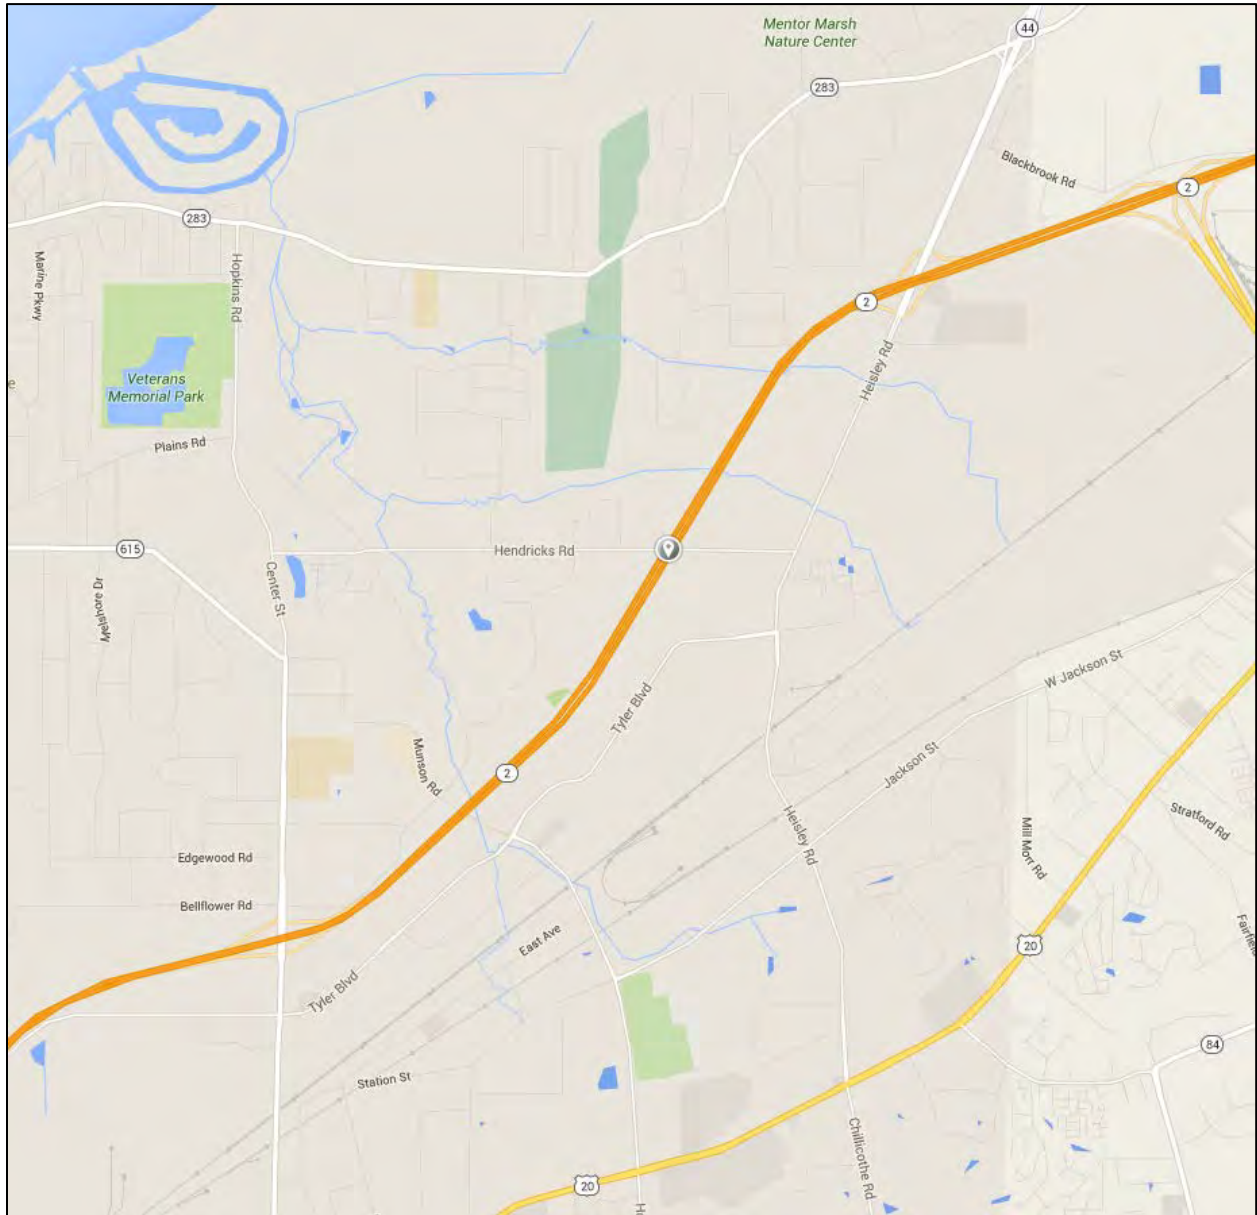
SITE INSPECTION AND RECOMMENDATIONS REPORT FOR LAK-002-1141 (Hendricks Road over SR2)

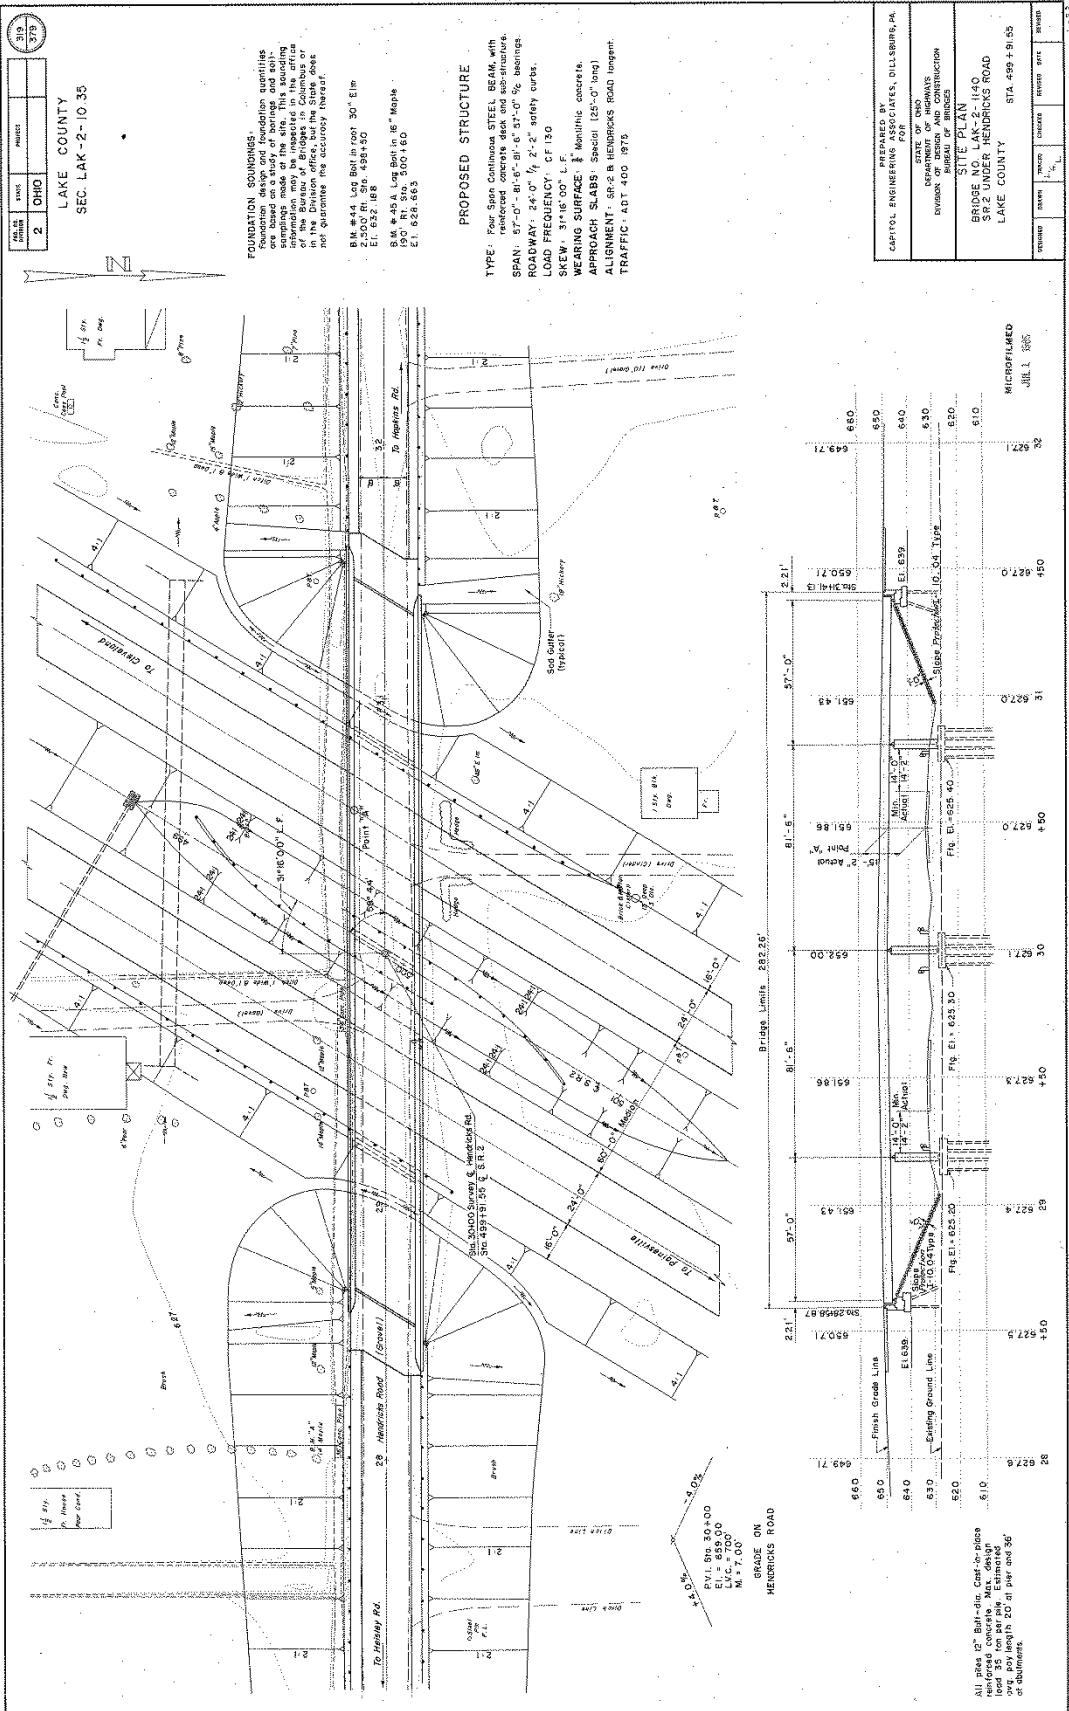
DATE	PROJECT
2/22/07	
2	OHIO

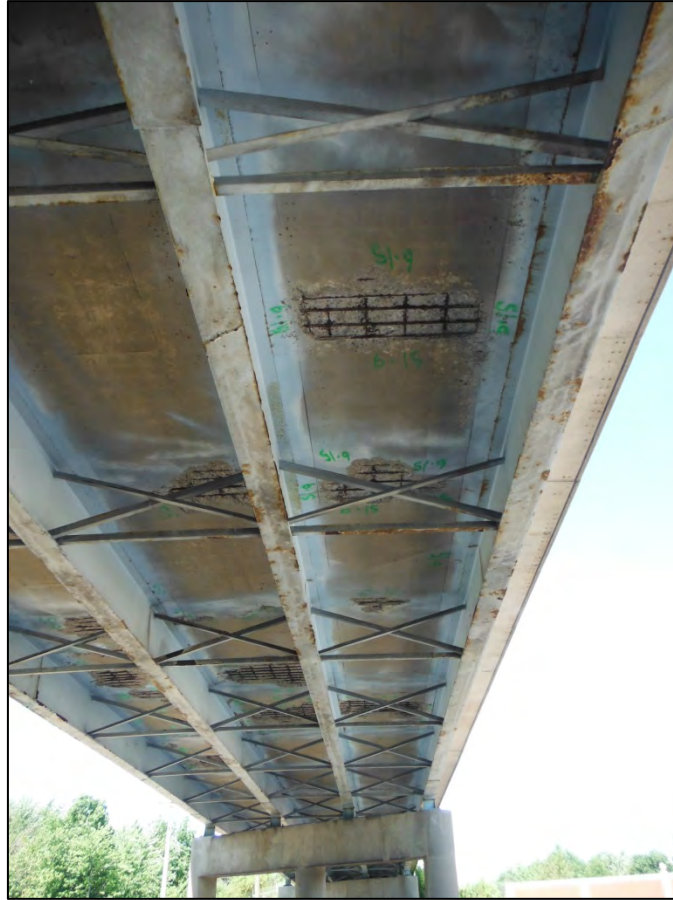
Photo 2: Looking north over the eastbound lanes at deck spalling. This appears to be the worst area.

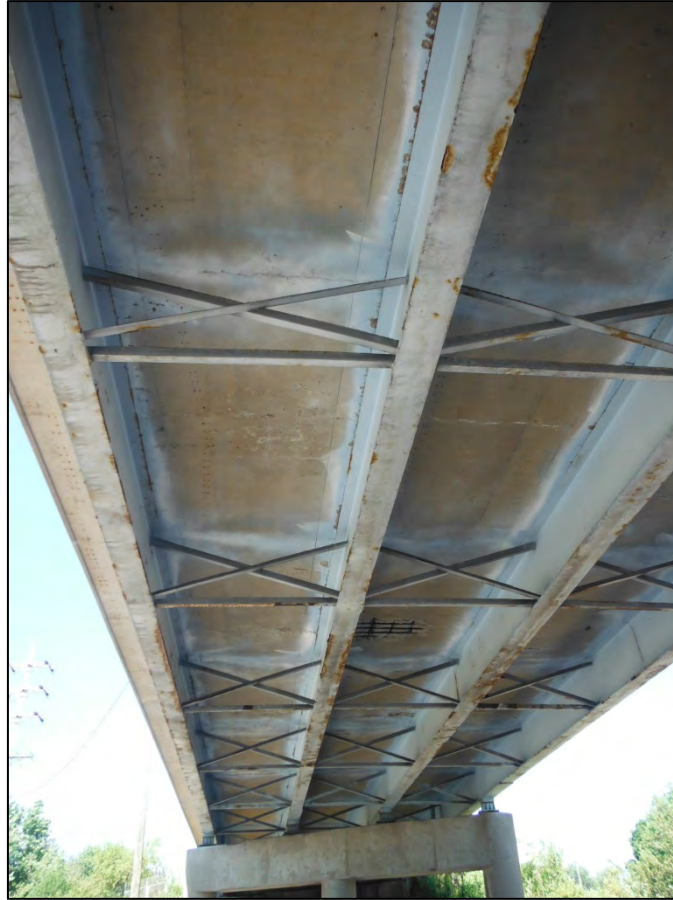
Photo 3: Looking north over the westbound lanes at deck spalling.
