Ohio Department of Transportation 2015 Physical Condition Report

Main Avenue Bridge over Cuyahoga River Bridge No. CUY-2-1441

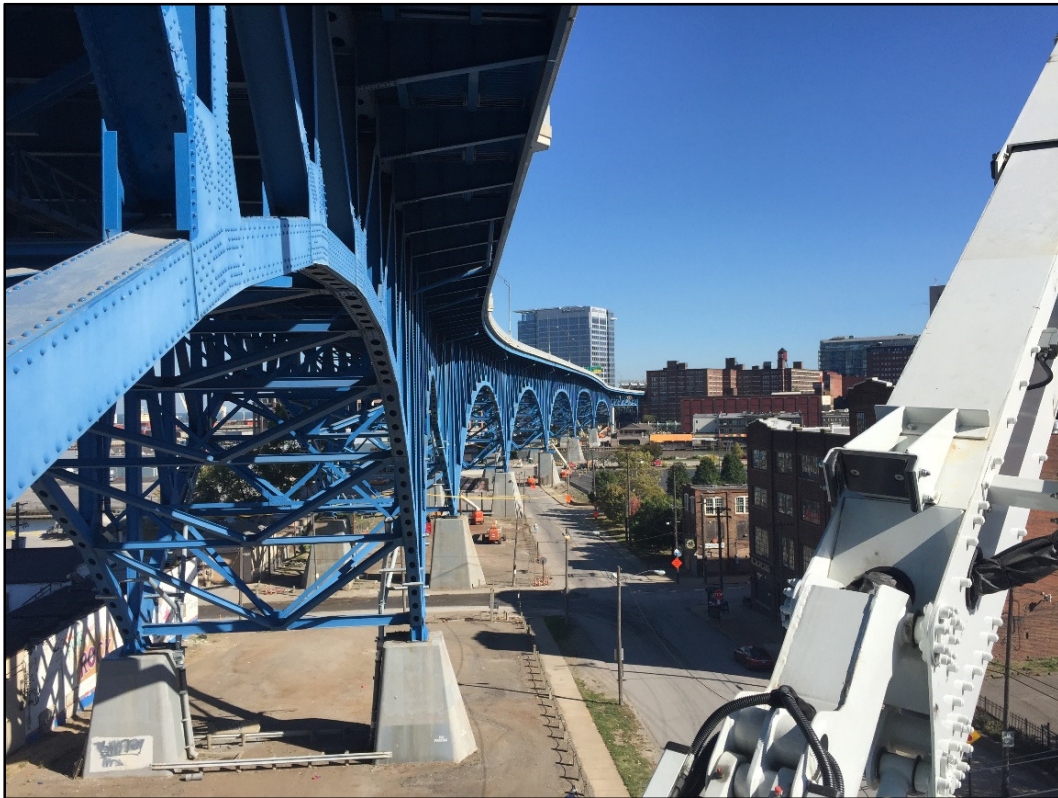
Photo 1 – South Elevation, Main Truss Spans.

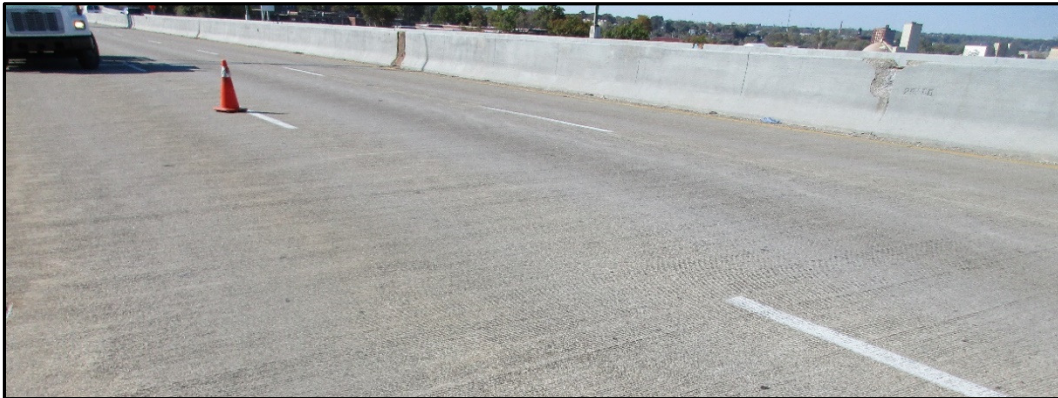
Photo 5 – Typical Good Condition of Slab.

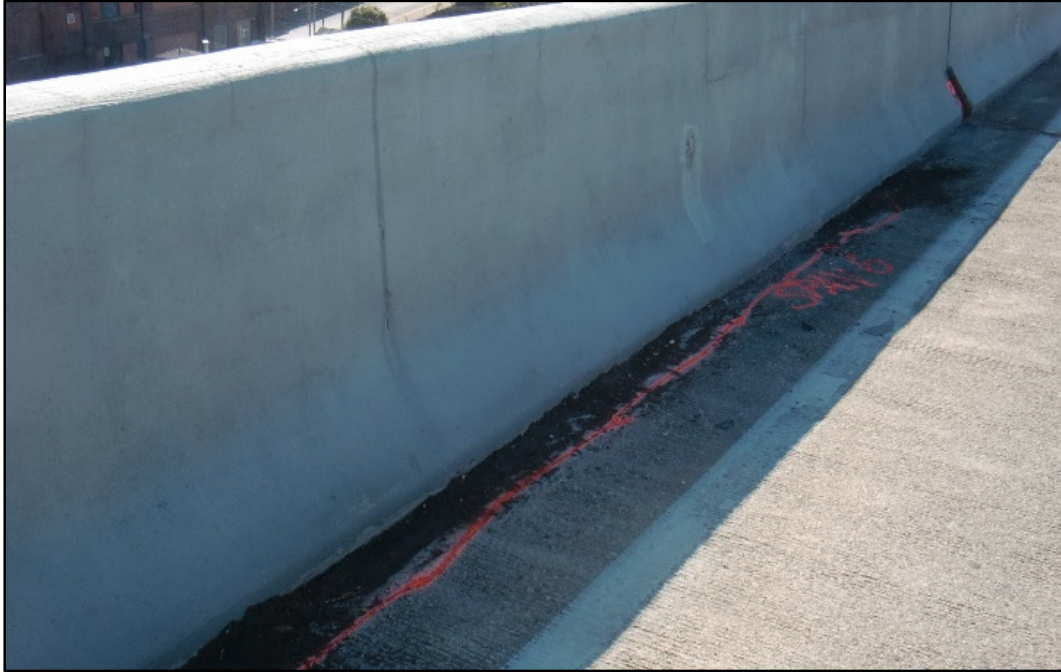
Photo 7 – Typical Gutterline Spalling, Wearing Surface.

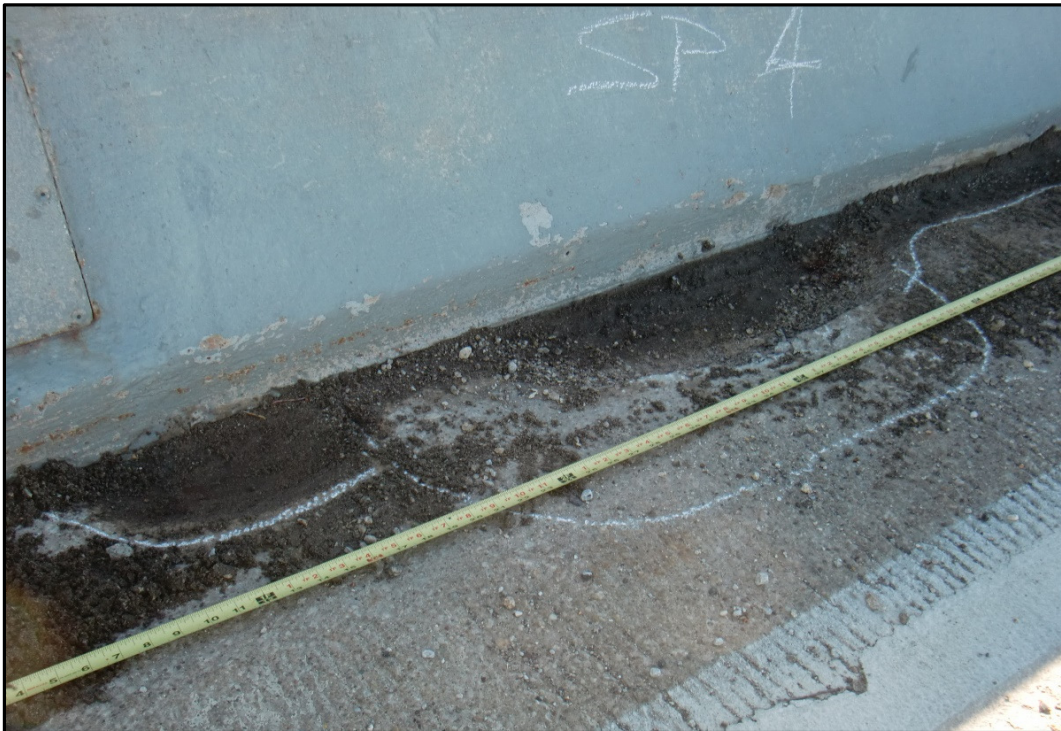
Photo 8 – Wearing Surface Spall Along Gutterline, Span 4.

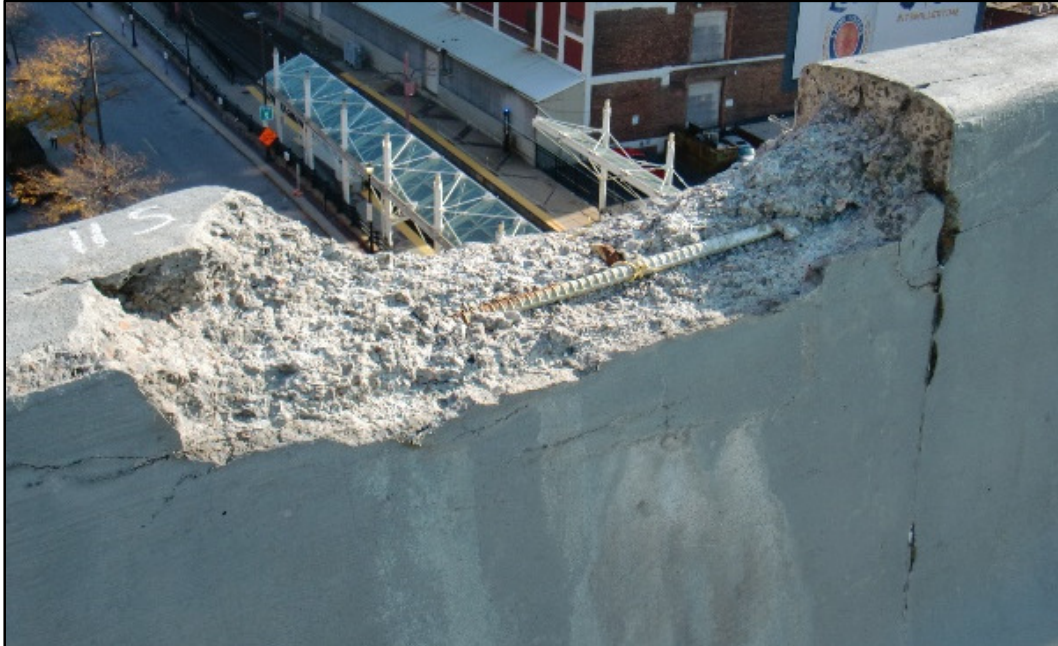
Photo 9 – Typical Top of Railing Spall without Corrosion, Span 7 South Railing.

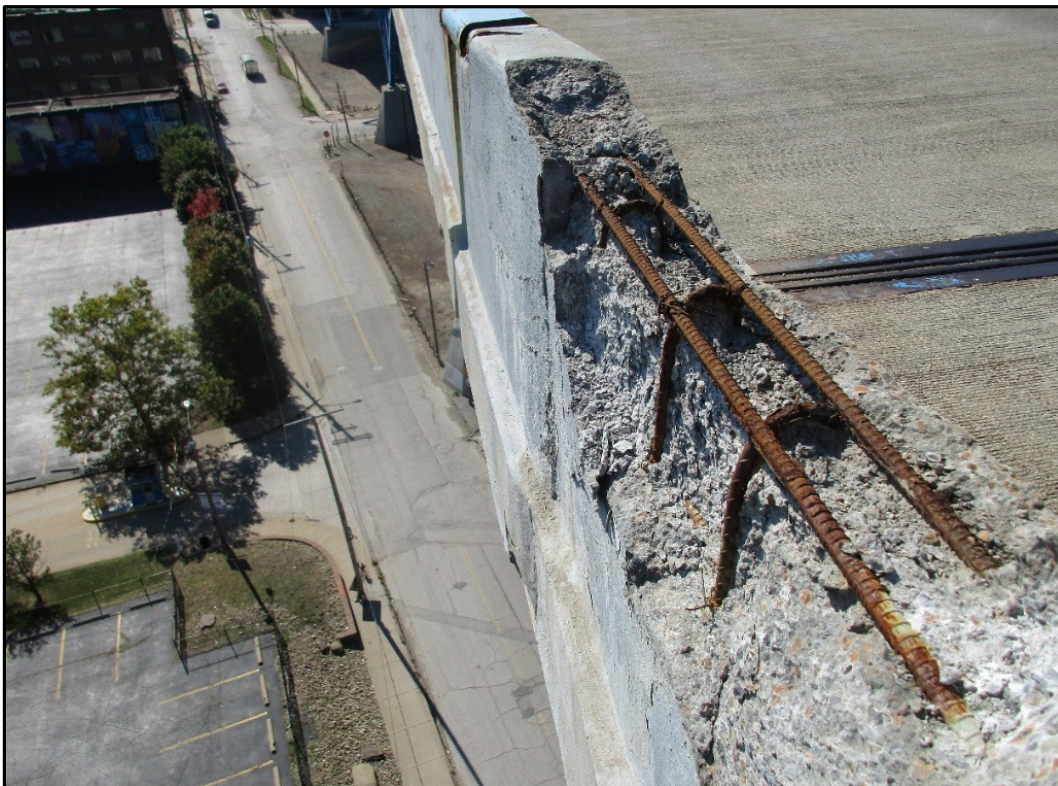
Photo 10 – Typical Top of Railing Spall, Span 7 South Railing.

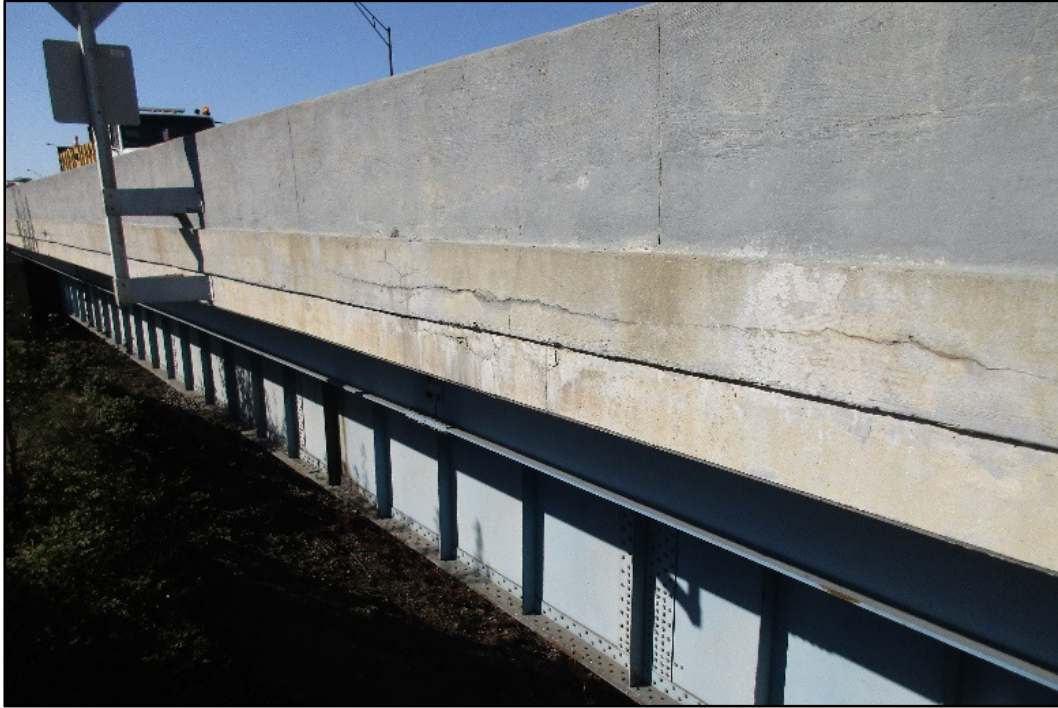
Photo 11 – Early Stage of Railing Deterioration.

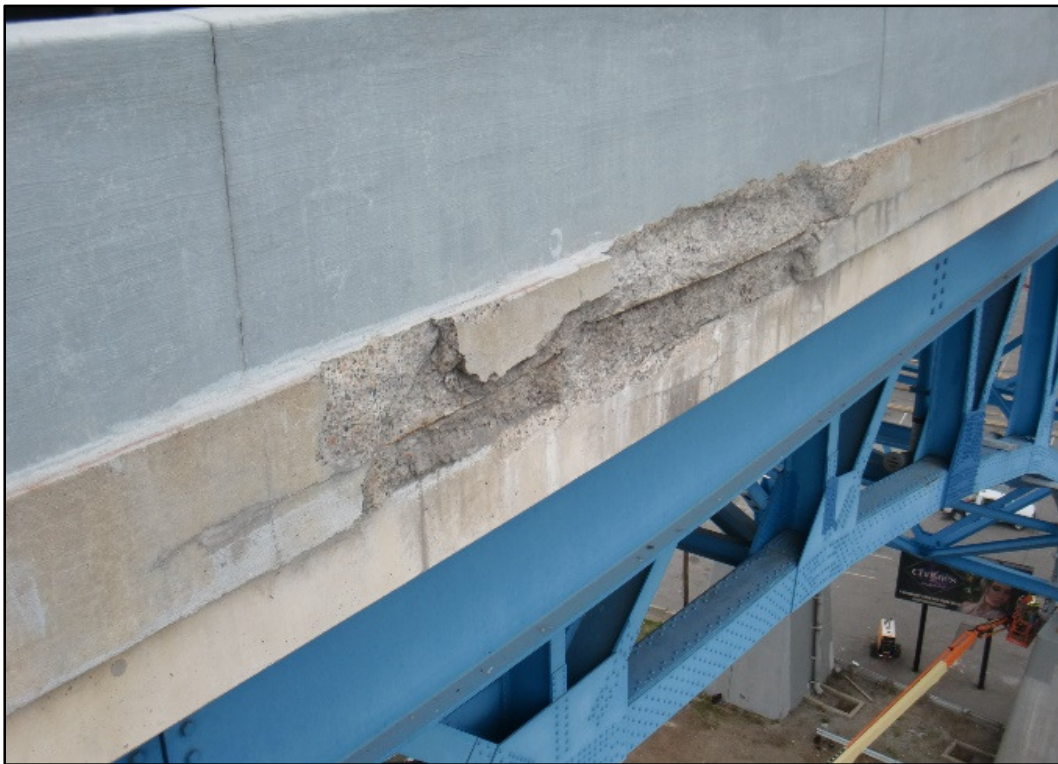
Photo 12 – Typical Spall and Delamination, Edge of Deck & Exterior Face of Parapet over Traffic.

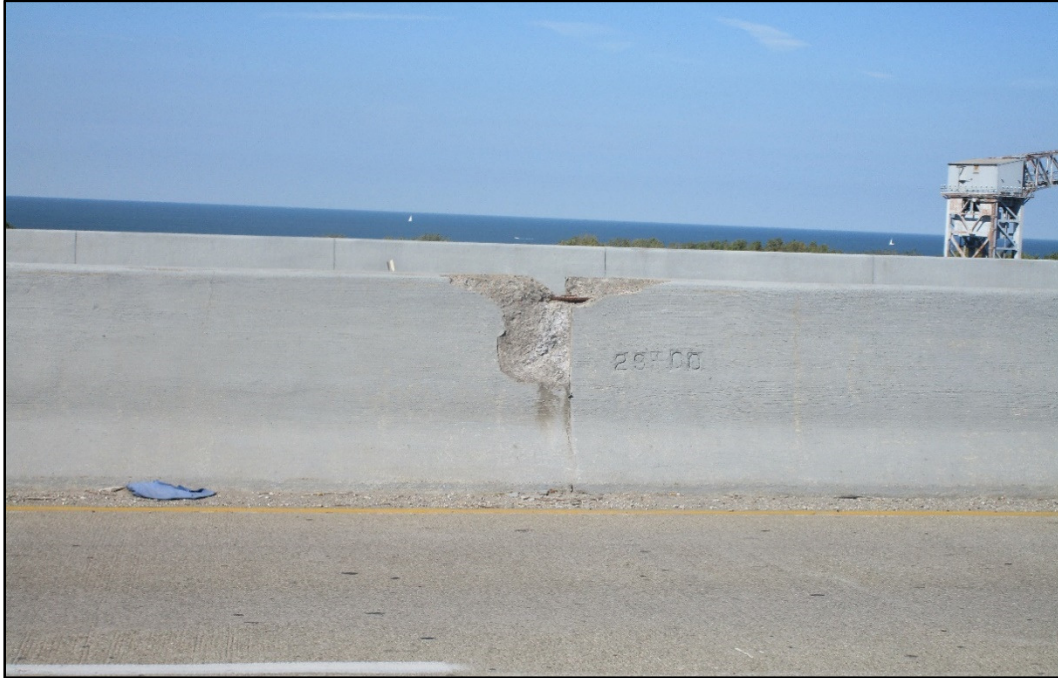
Photo 13 – Spalling of Median Parapet with Exposed Reinforcing, Span 4.

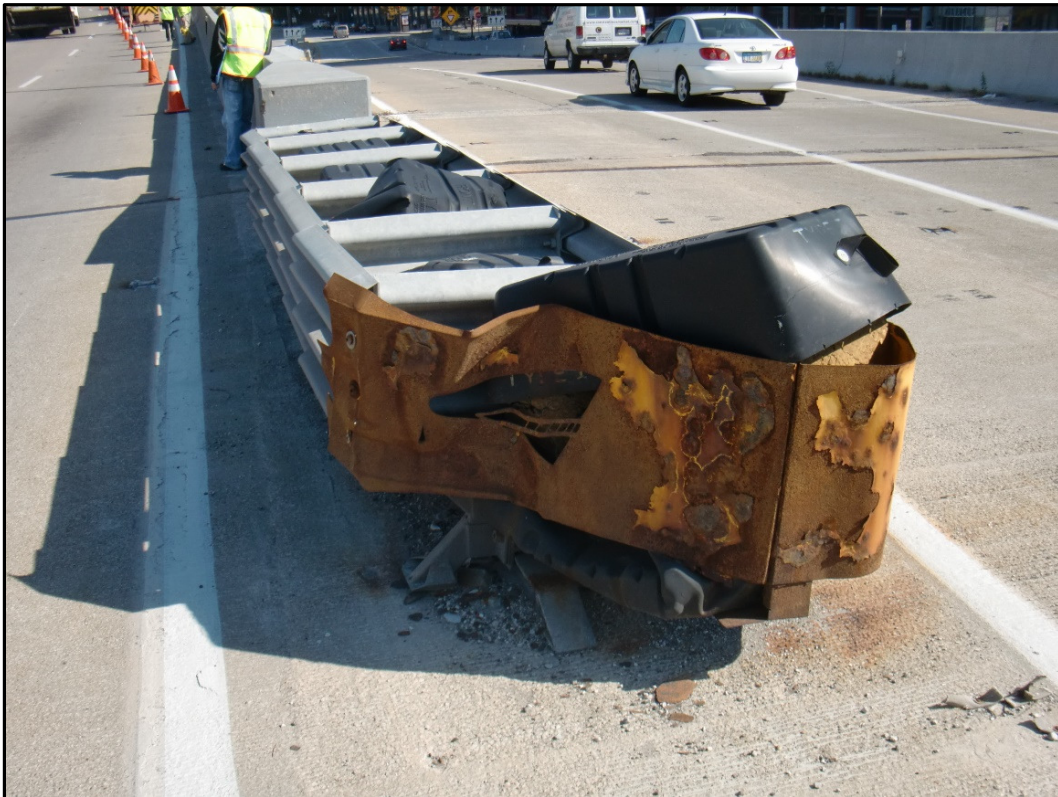
**Photo 14 – Damaged Impact Attenuator, Lakeside Ramp - East Approach.
(Note: Attenuator was repaired after inspection.)**

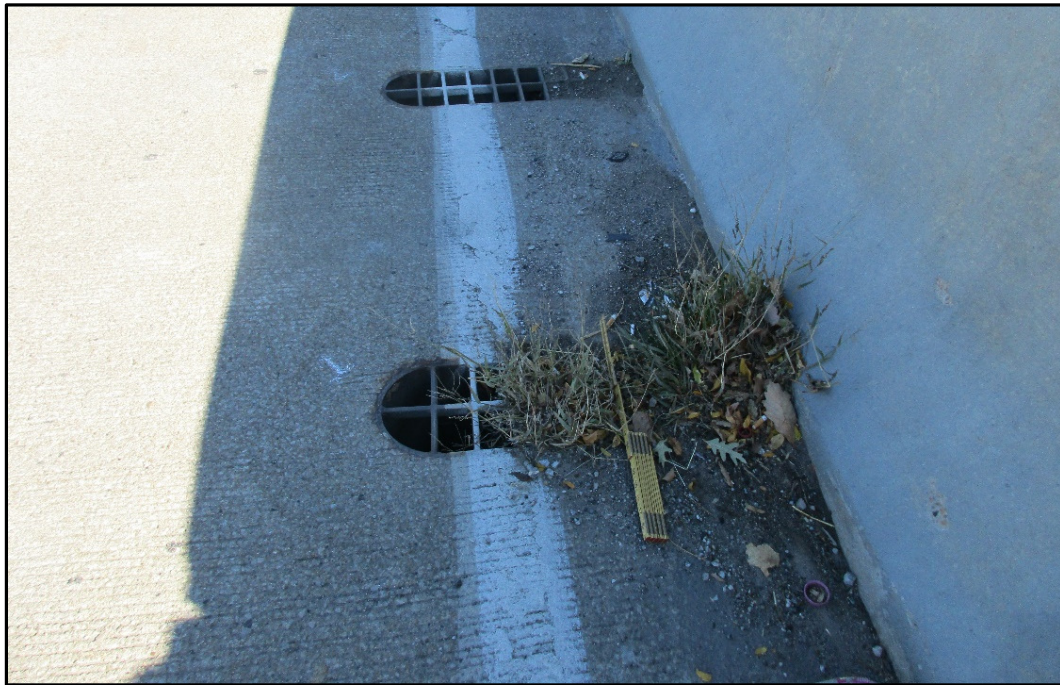
Photo 15 – Typical Partially Clogged Scuppers.

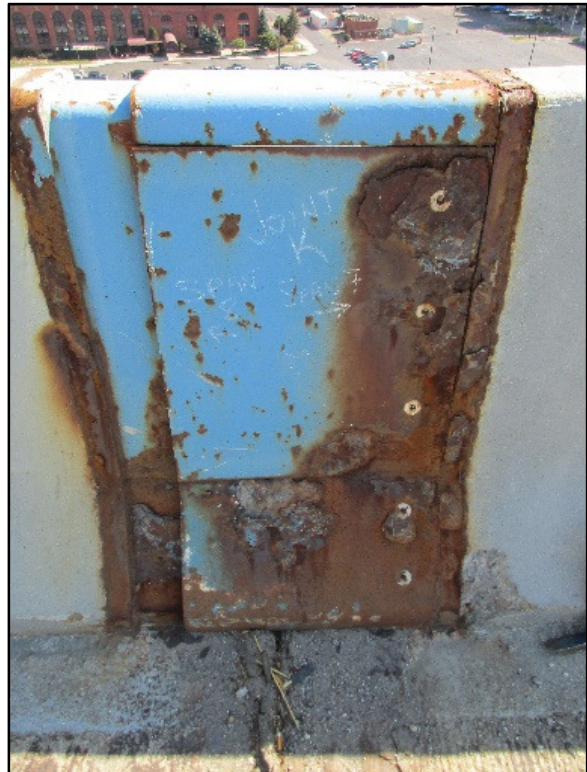
Photo 18 – Typical Corrosion Debris on Parapet Expansion Joint Armor.

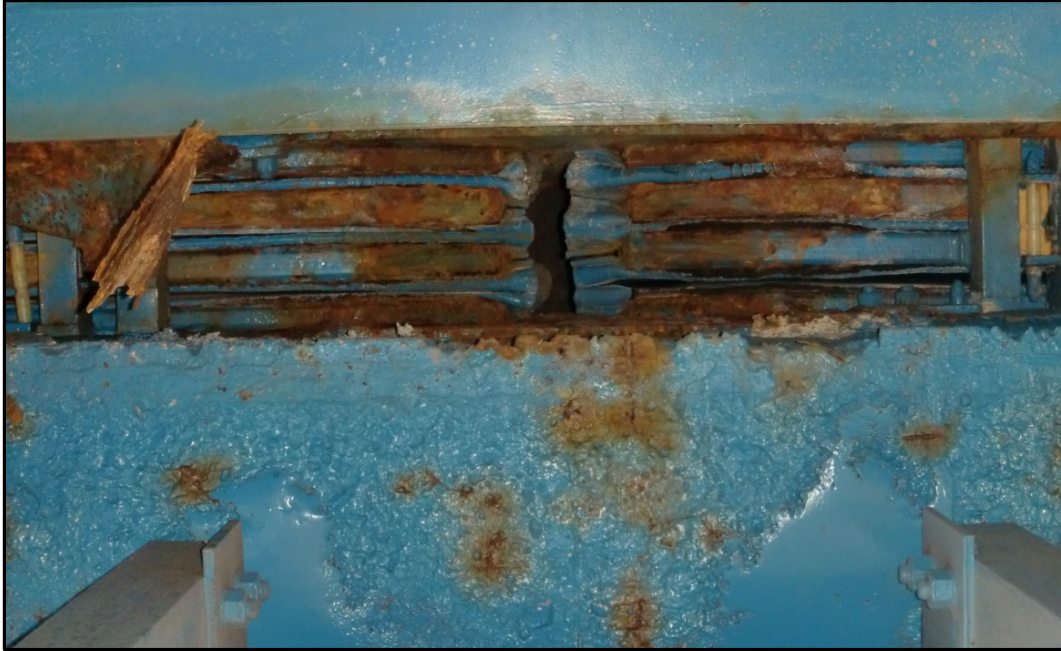
Photo 19 – Corrosion to Bottom of Modular Expansion Joint.

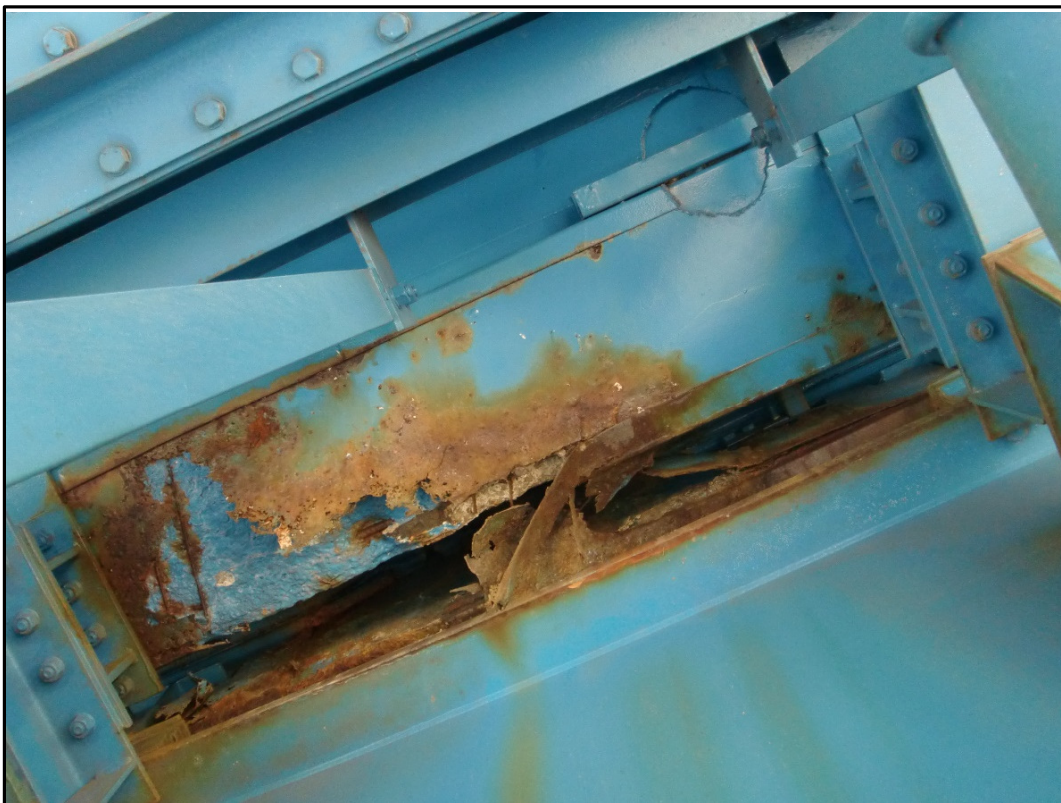
Photo 20 – Leakage through Damaged Joint Membrane, East Approach - Forward Section.

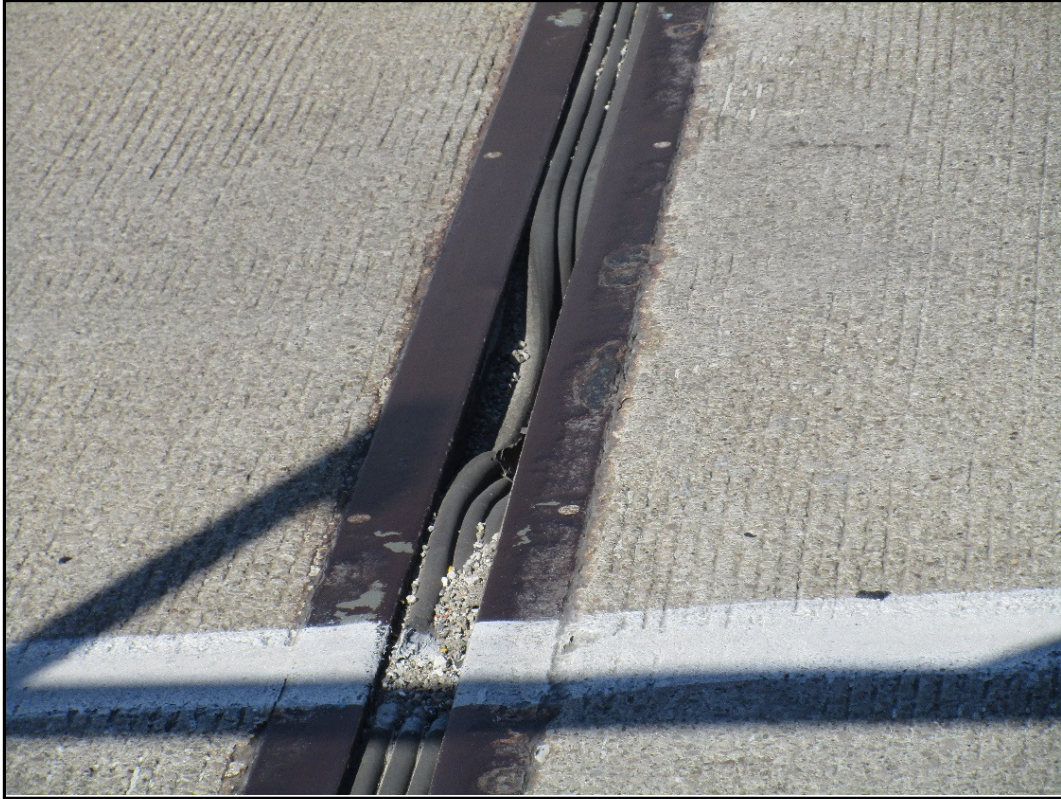
Photo 21 – Detached Joint Seal.

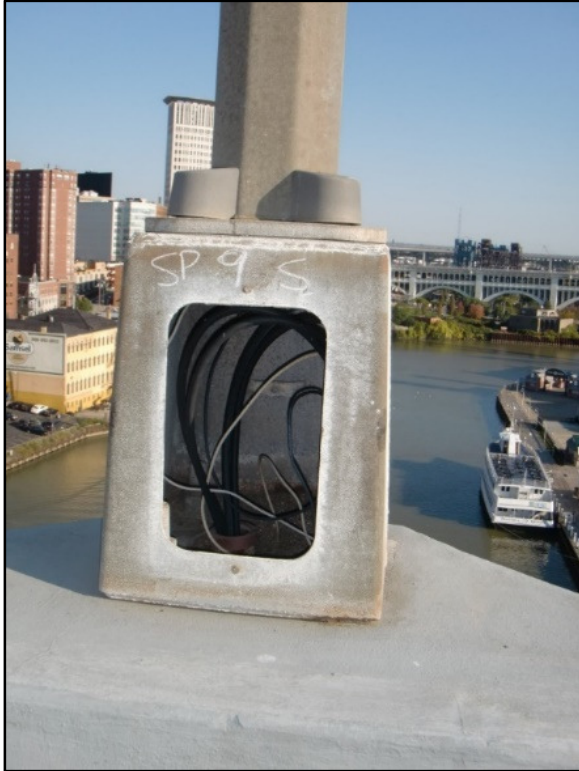
Photo 22 – Open Pull Box, South Railing, Span 9.

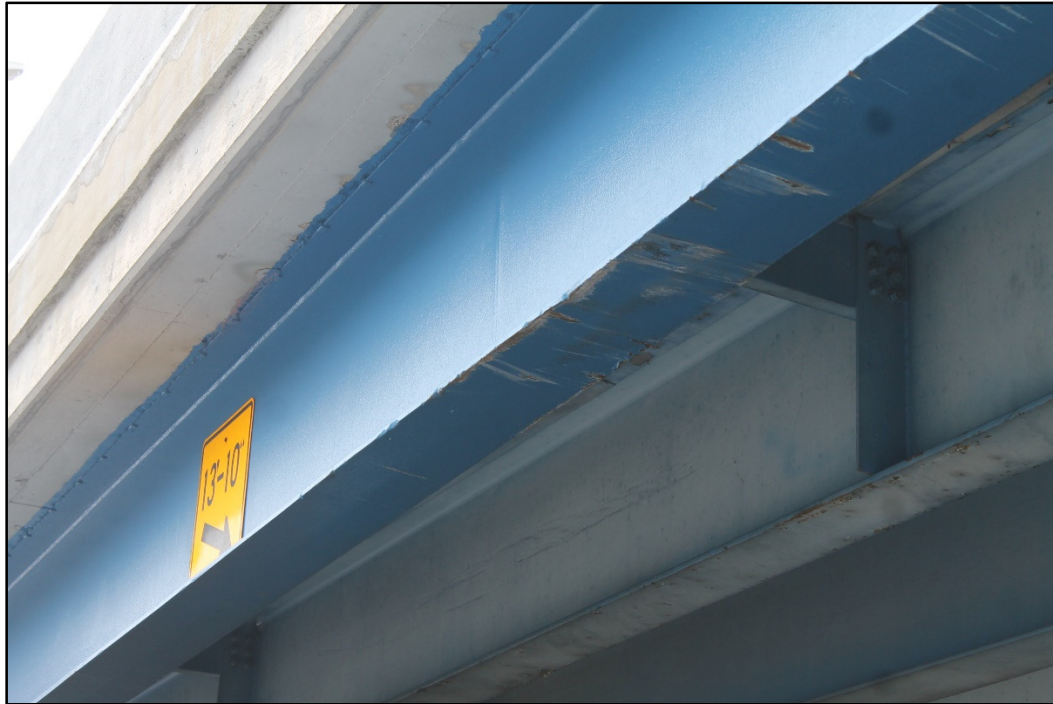
Photo 23 – Heat-Straightened & Repainted Beam FSS with New Vehicle Scrapes, over West 9th Street.

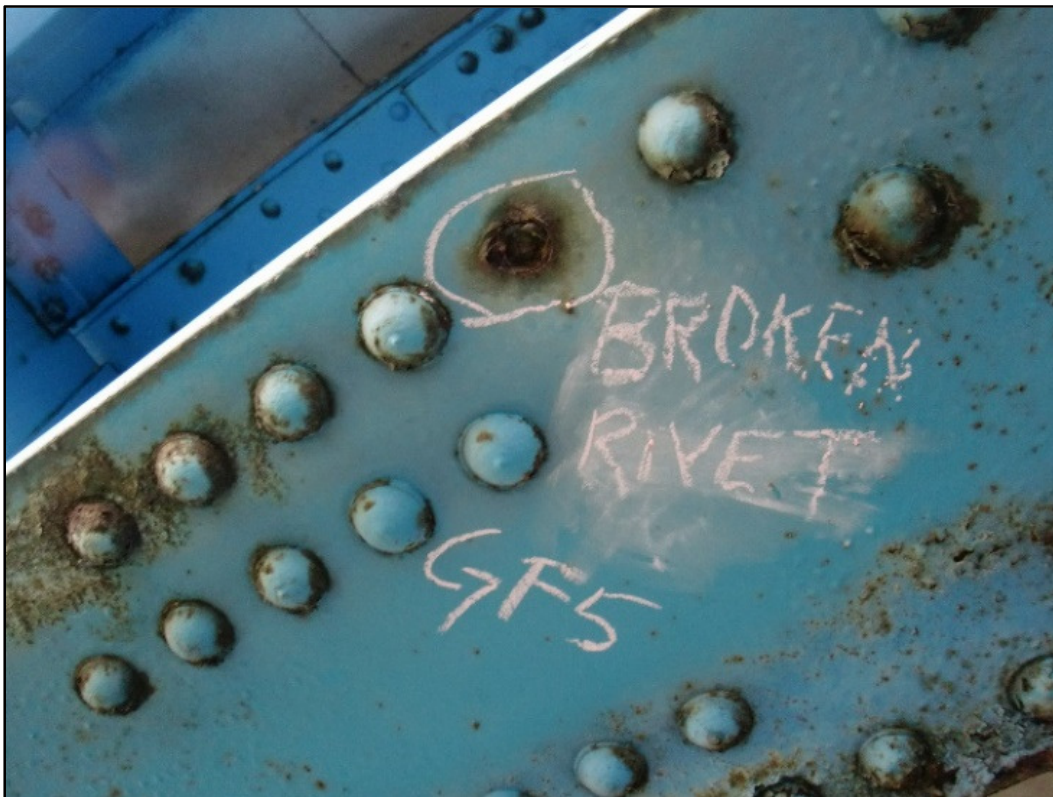
Photo 24 – Broken Rivet, Bottom Flange of Girder GF5, West Approach.

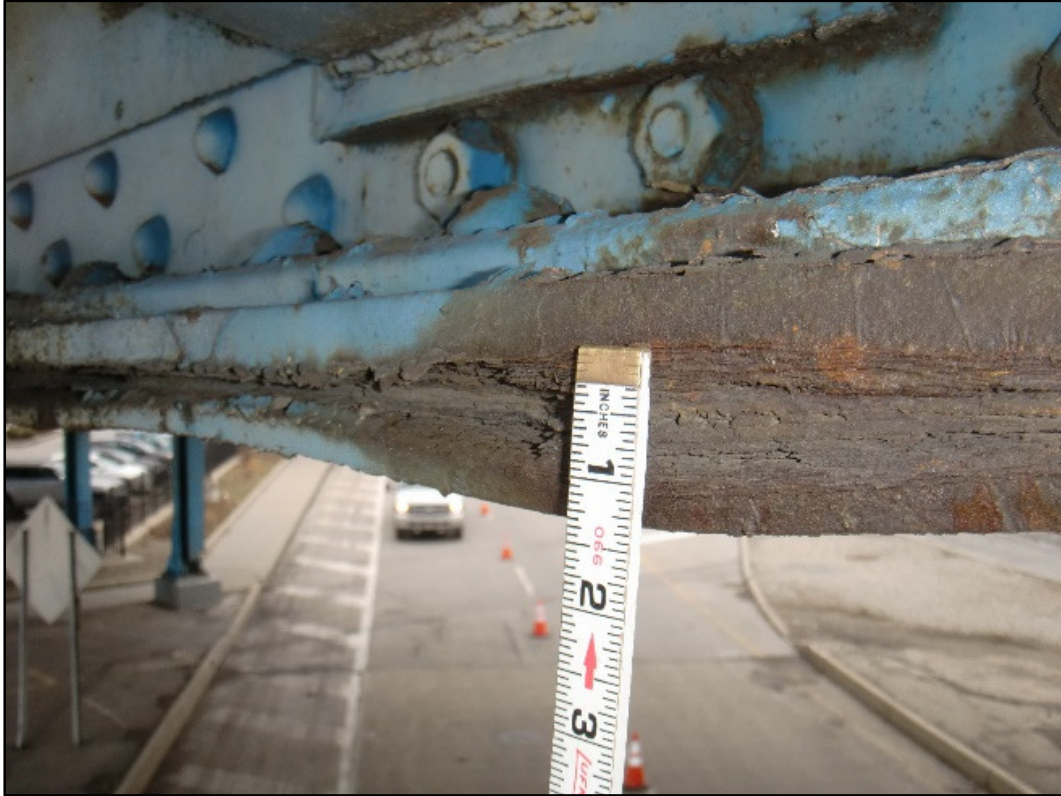
Photo 25 – Typical Pack Rust on Bottom Flange, Lakefront Trestle - East Approach.

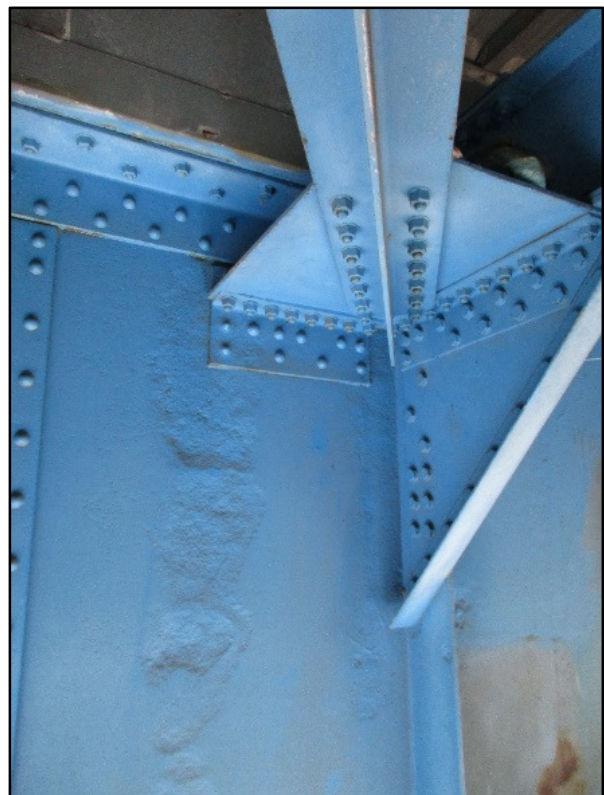
Photo 26 – Typical Surface Pitting, Lakefront Ramp - East Approach.

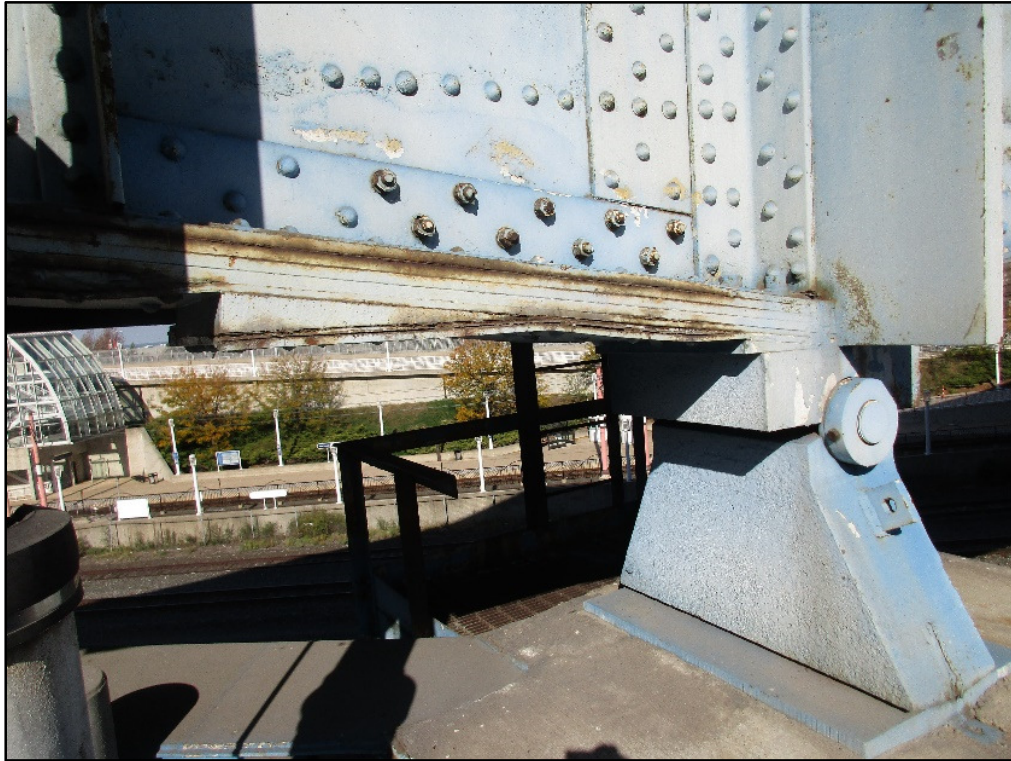
Photo 27 – Typical Pack Rust at Moment Plate, Lakefront Ramp - East Approach.

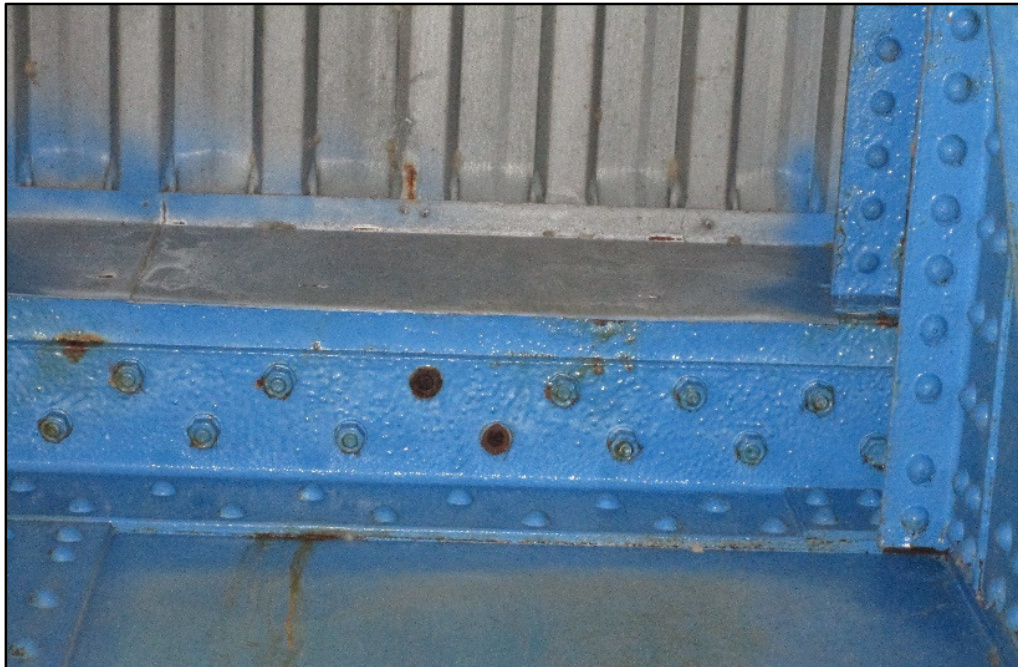
Photo 28 – Missing Bolts, Lakefront Ramp - East Approach.

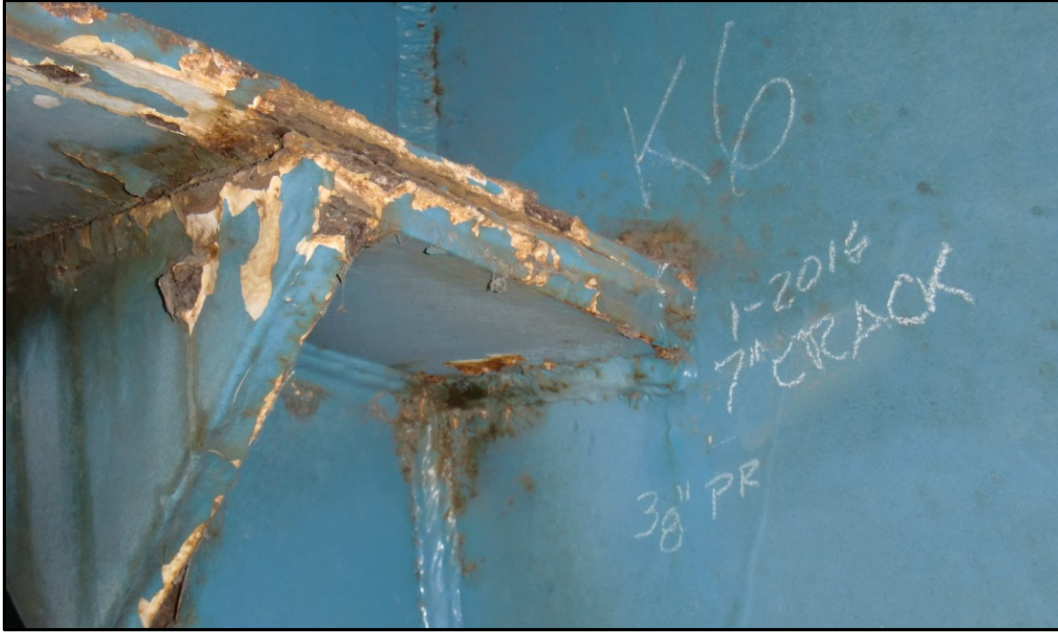
Photo 29 – New Pack Rust Induced Crack at Floor Beam Cantilever Seat at Column K6, Unit K (SR 2 EB over West 28th Street).

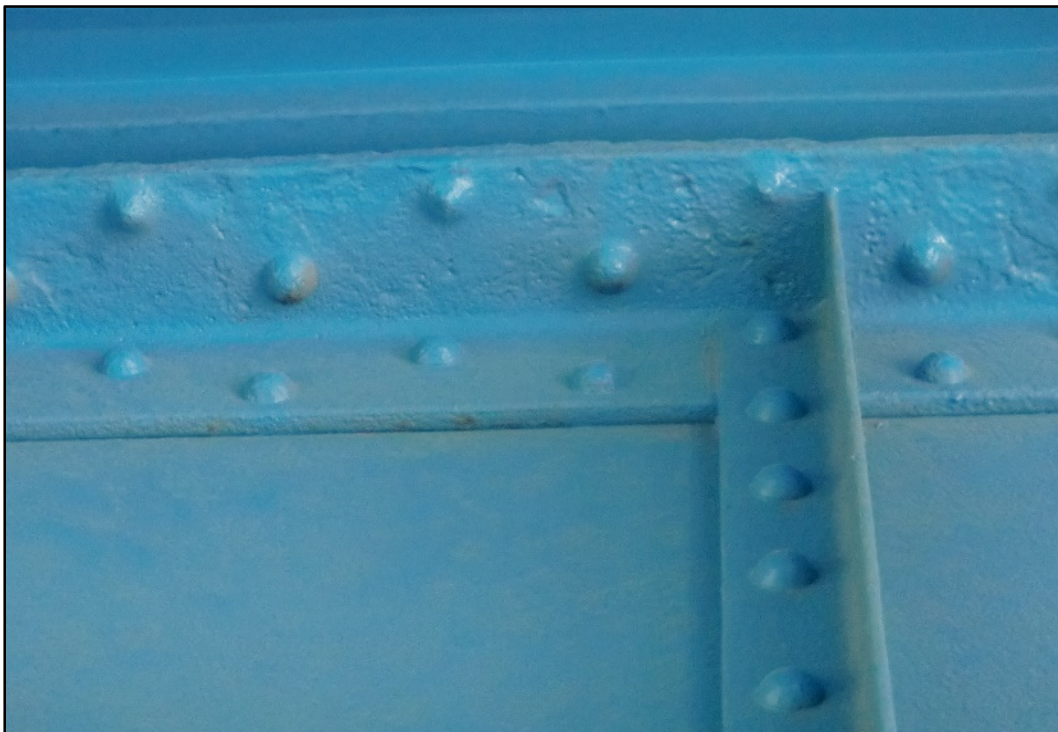
Photo 30 – Typical Top Flange Surface Pitting, Main Truss Floor Beam.

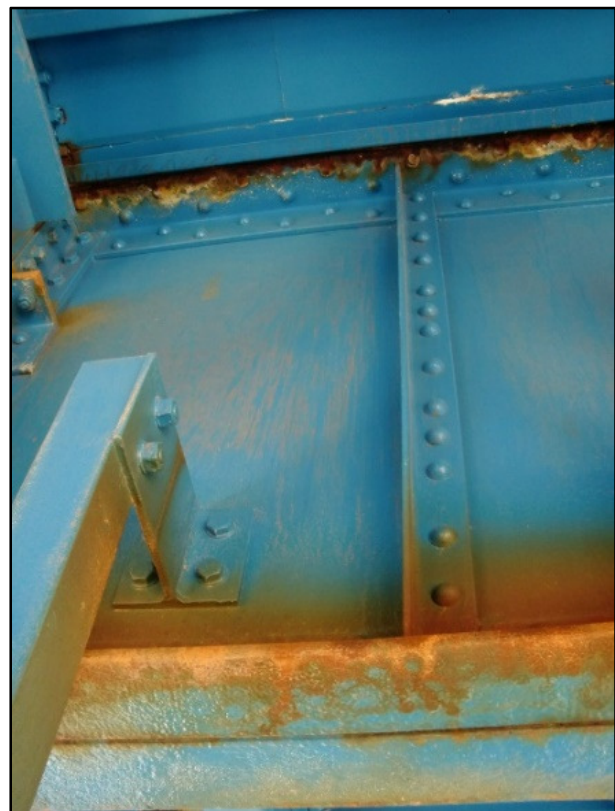
Photo 32 – Typical Rust Staining on Main Truss Floor Beam Under Deck Joint.

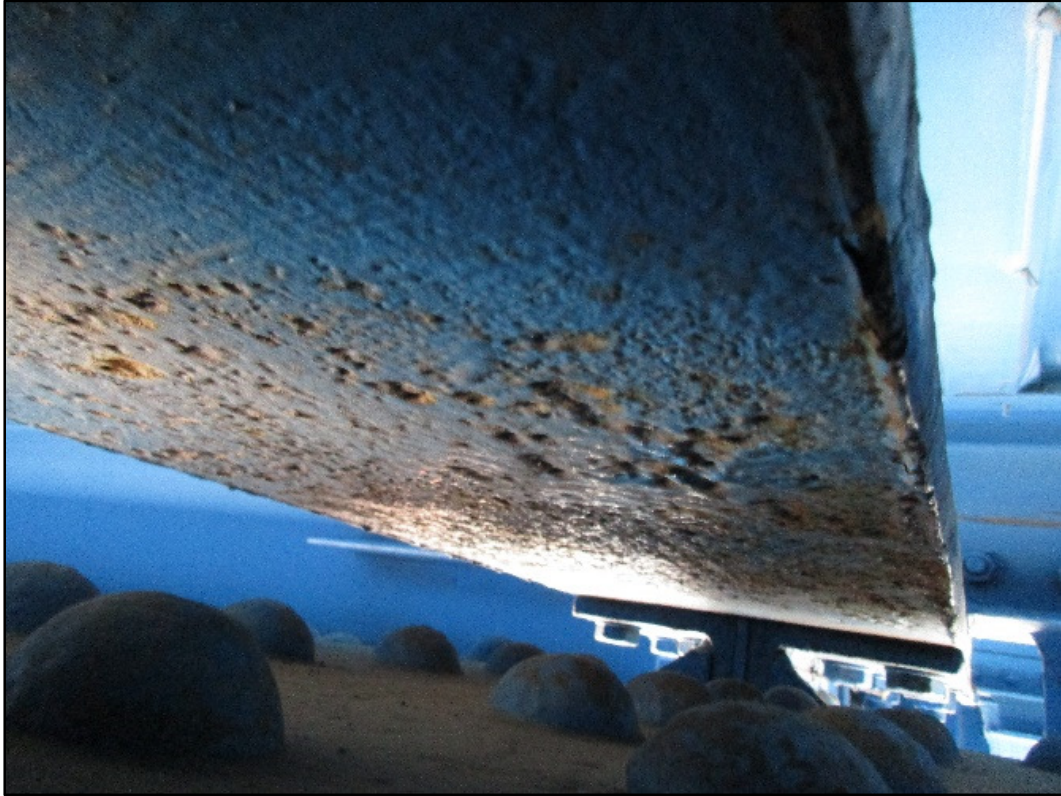
Photo 33 – Typical Top Flange Tension Tie Plate Surface Pitting, Floor Beam, Main Truss.

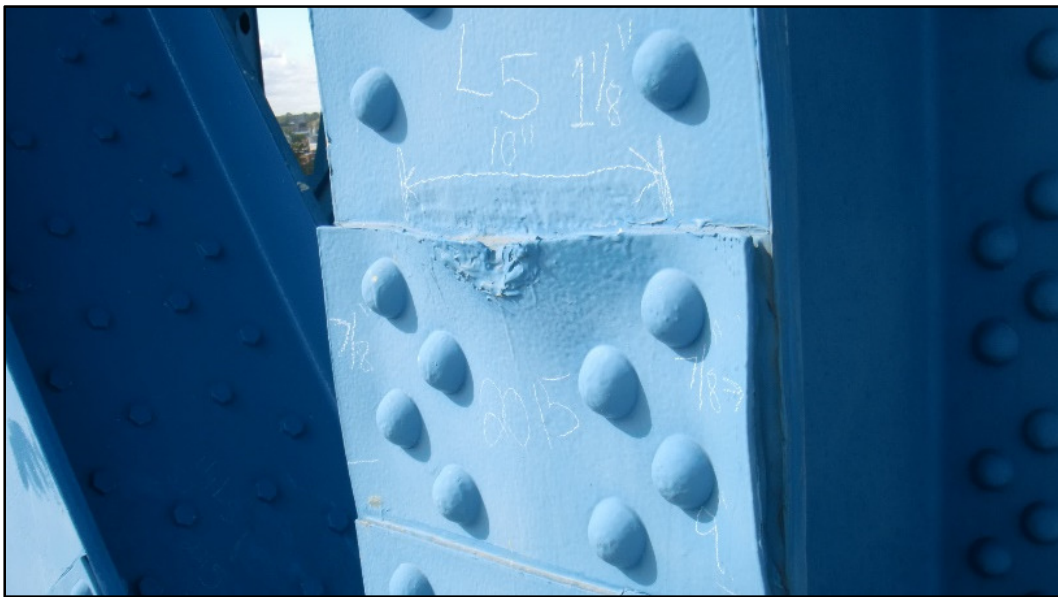
Photo 34 – Typical Pack Rust on Fill Plate, Main Truss Vertical.

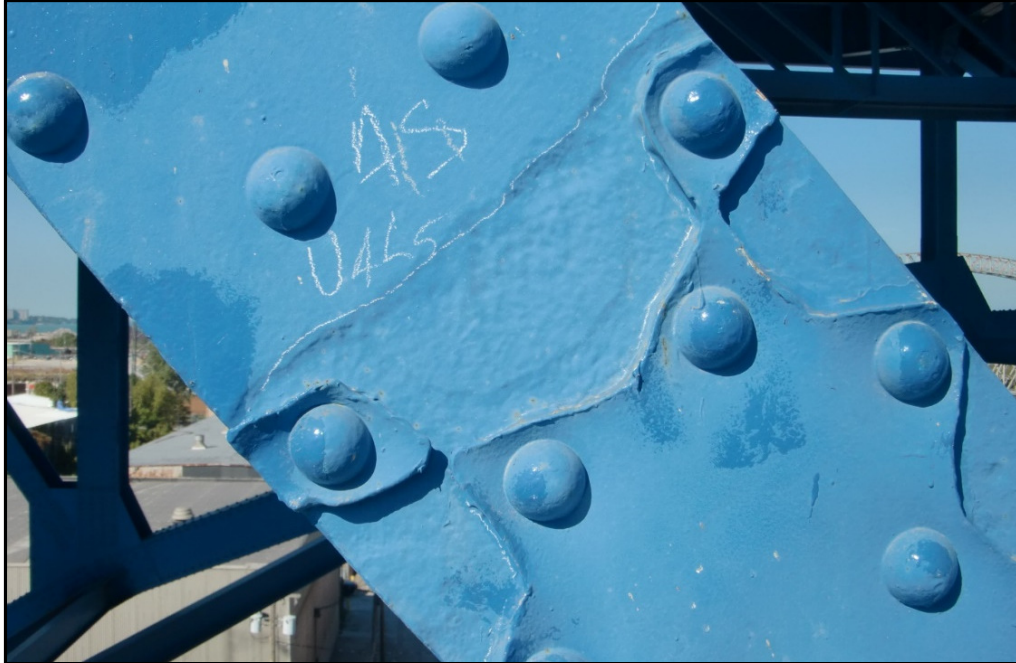
Photo 35 – Typical Fill Plate Section Loss, Main Truss Diagonals.

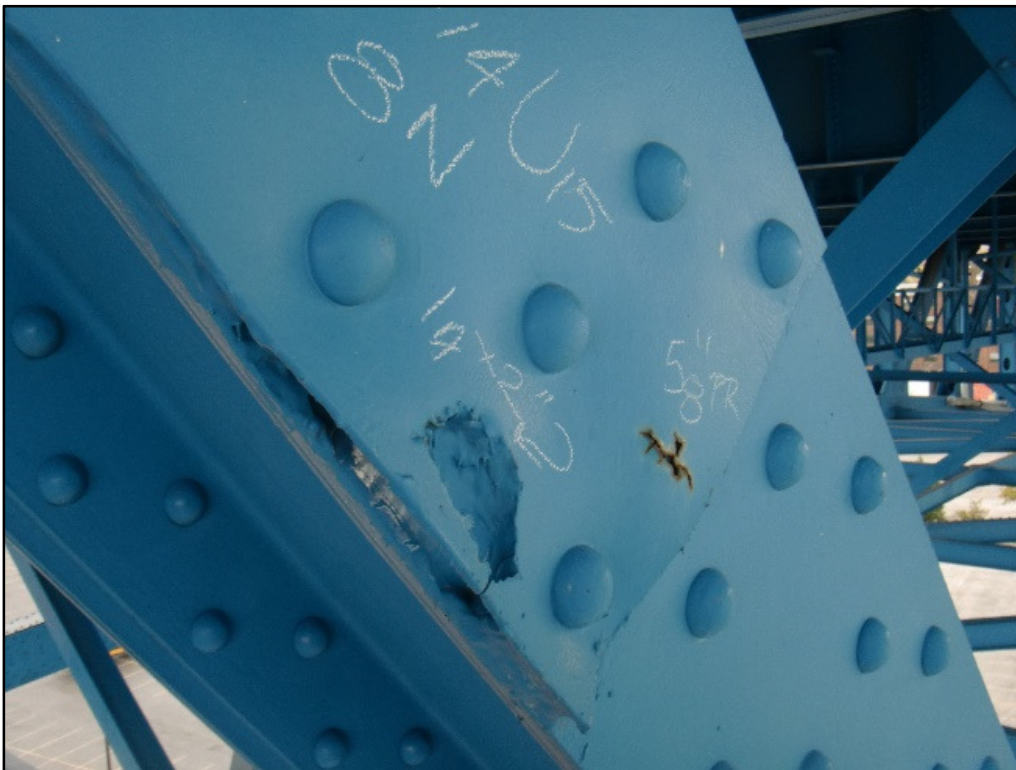
Photo 36 – $\frac{5}{8}$ " Pack Rust Crack & Perforation in Fill Plate from Pack Rust, Diagonal U₁₄U₁₅, Span 8.

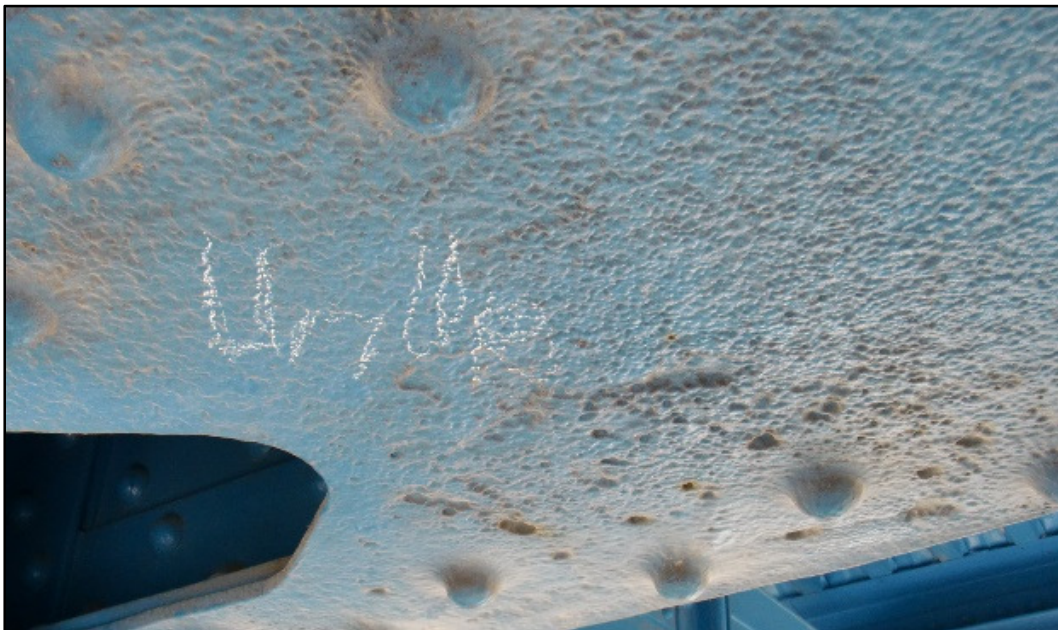
Photo 37 – Typical Surface Pitting, Main Truss Upper Chord.

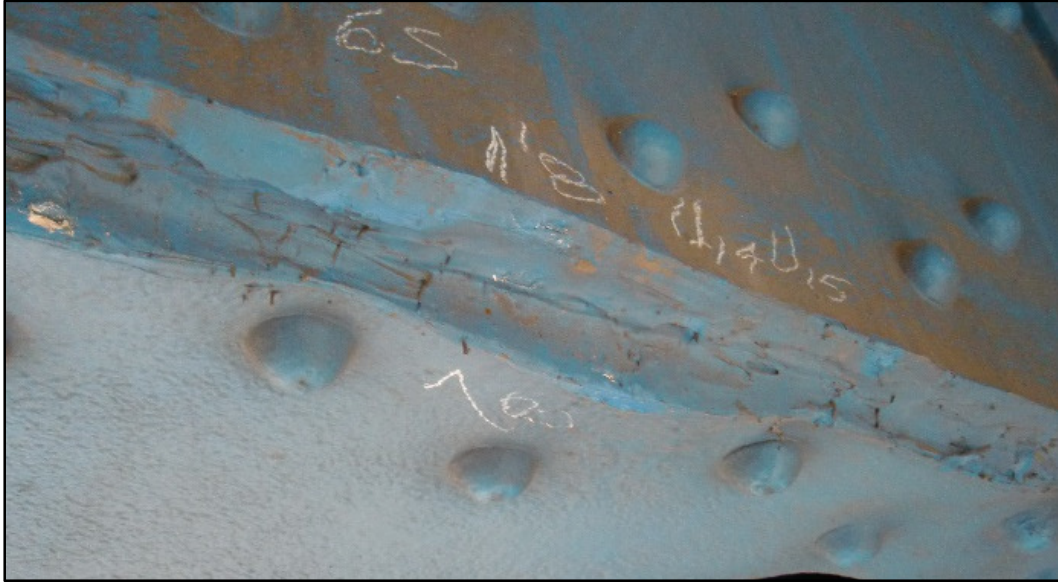
Photo 38 – Typical Pack Rust, South Main Truss, Span 6, U₁₄U₁₅.

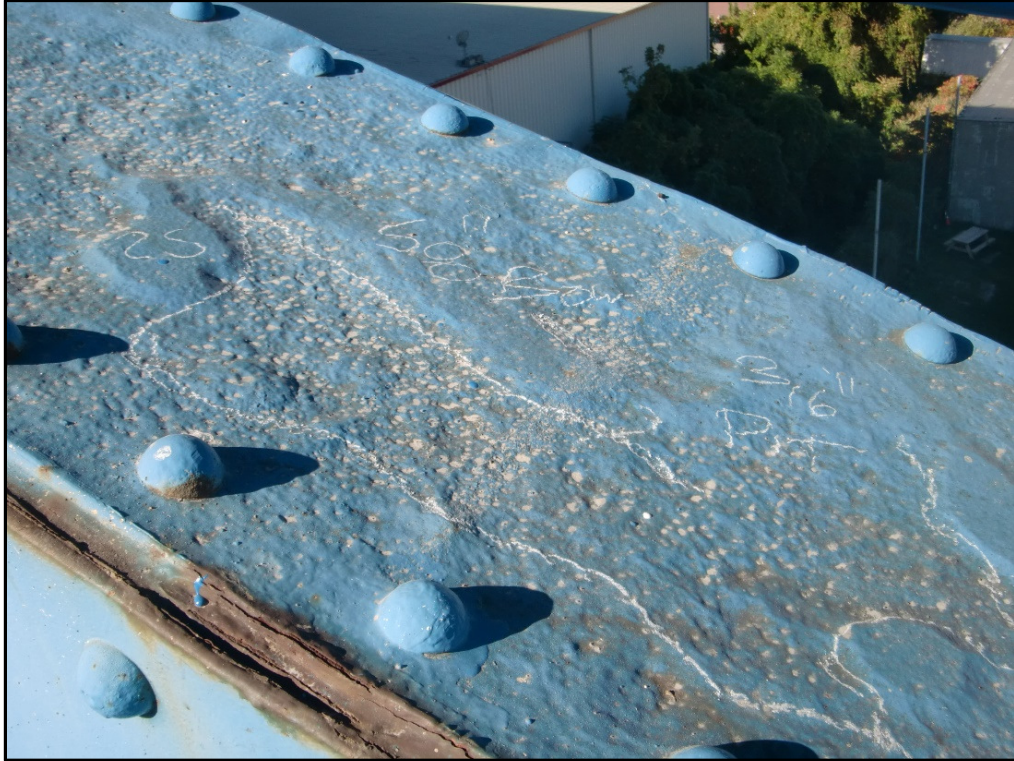
Photo 39 – Typical Pitting of Lower Chord Top Plate.
