Ohio Department of Transportation 2015 Physical Condition Report

Main Avenue Bridge over Cuyahoga River Bridge No. CUY-2-1441

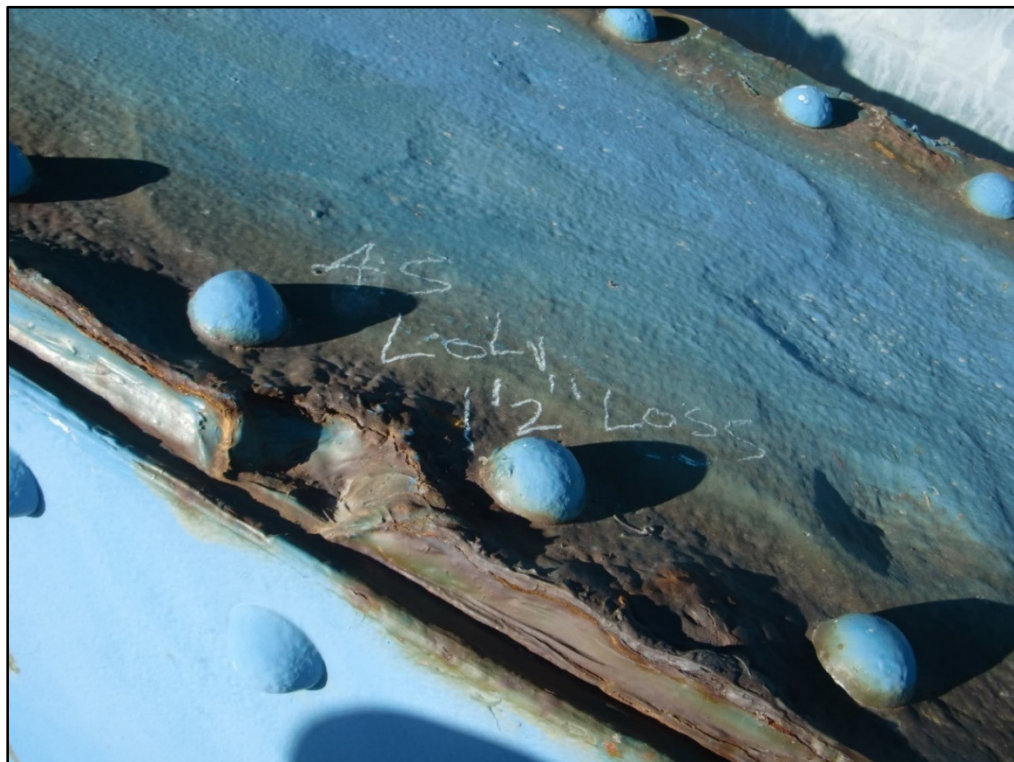
Photo 40 – Typical Lower Chord Pack Rust & Section Loss.

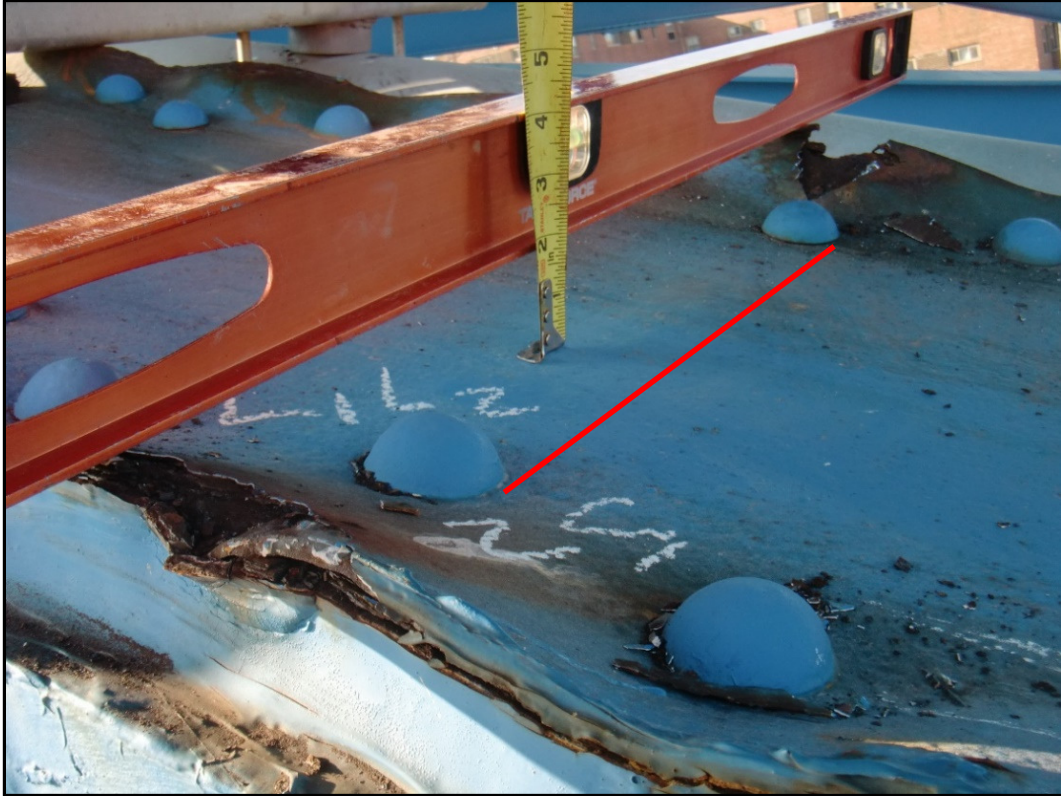
Photo 41 – Typical Lower Chord Plate Distortion Due to Pack Rust Distortion
(Note: top plate is flat between inner rivets, shown by red line).

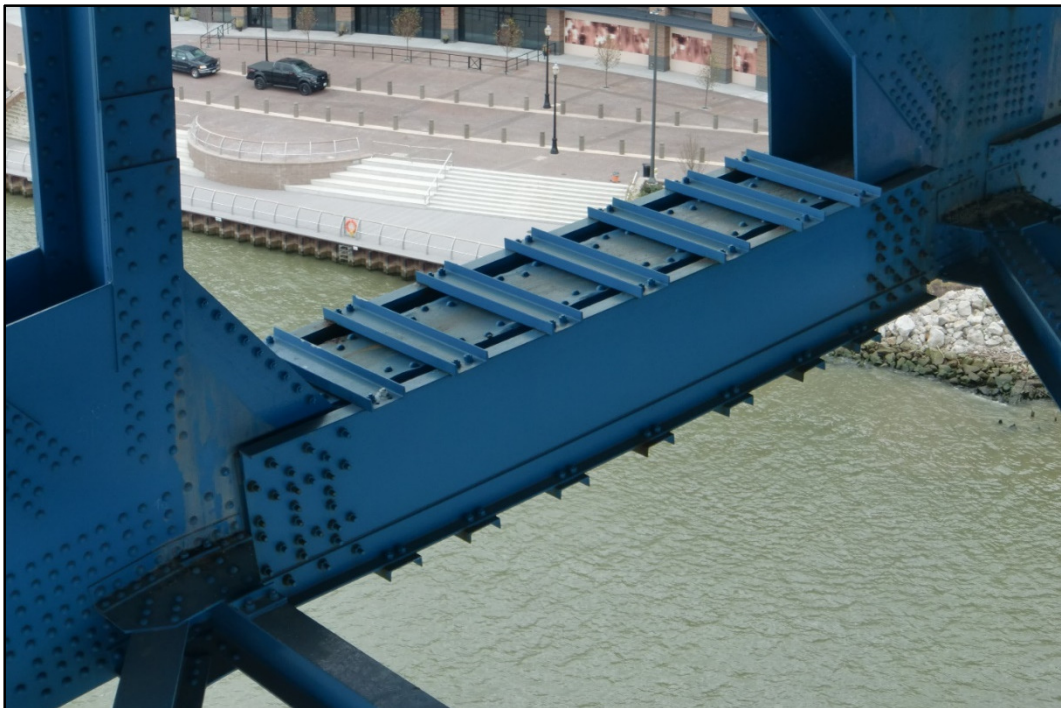
Photo 42 – 2007 Lower Chord Retrofit, L₂₄L₂₅, Span 8.

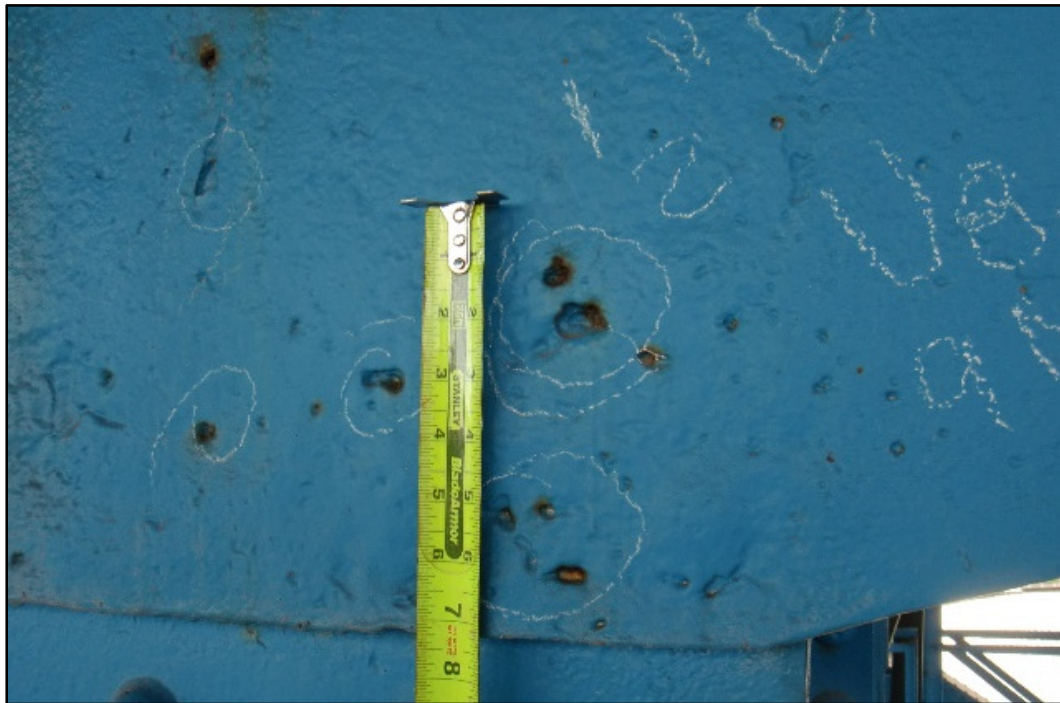
Photo 43 – 1/2-Inch Deep Pitting of Gusset Plate, U₈ North, Span 9.

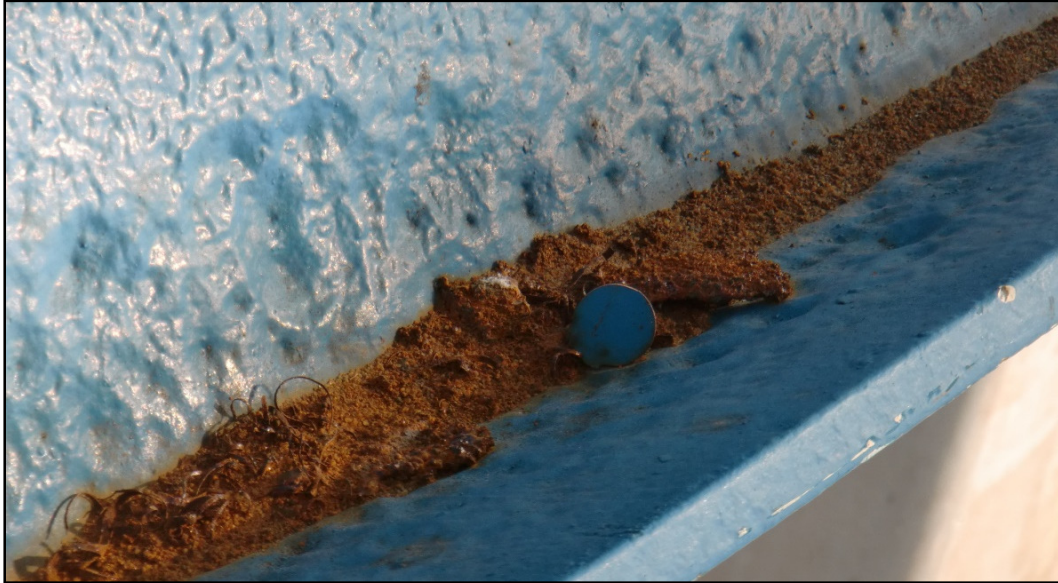
Photo 45 – Common Construction Debris left on Lower Lateral Bracing.

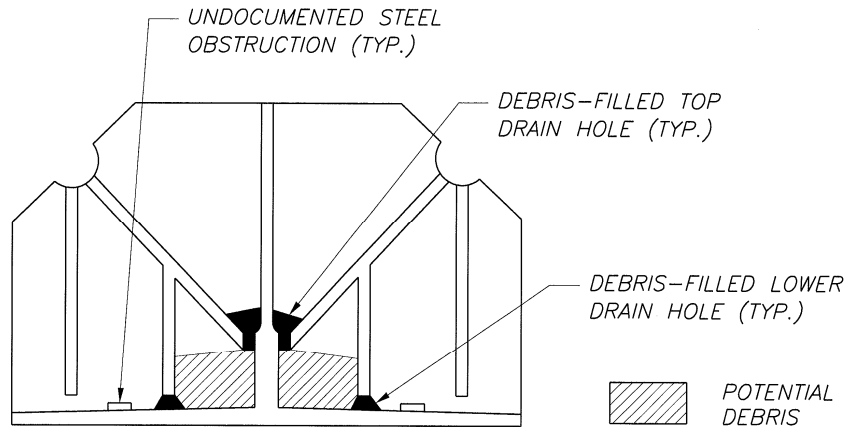
Figure 5 – Location of Typical Drain Hole Blockages, Truss Bearing Castings.

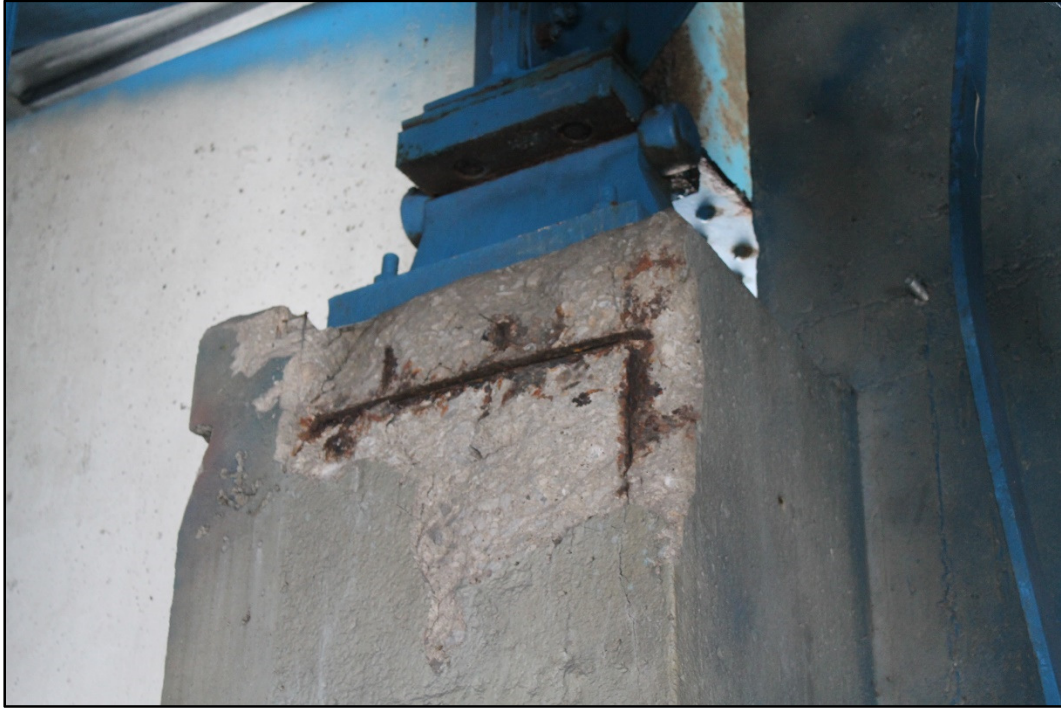
Photo 47 – Spall Undermining of South Bearing Plate, Bent 37.

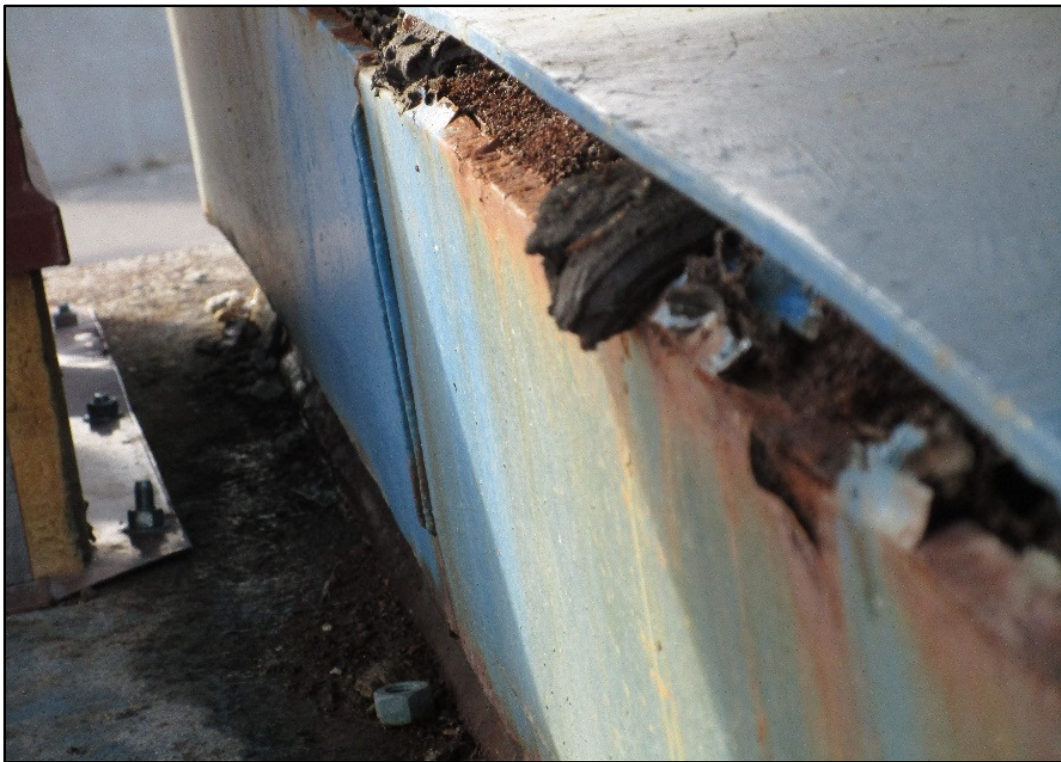
Photo 48 – Close-up of Debris & Steel Shot Blast within Expansion Bearing Box.

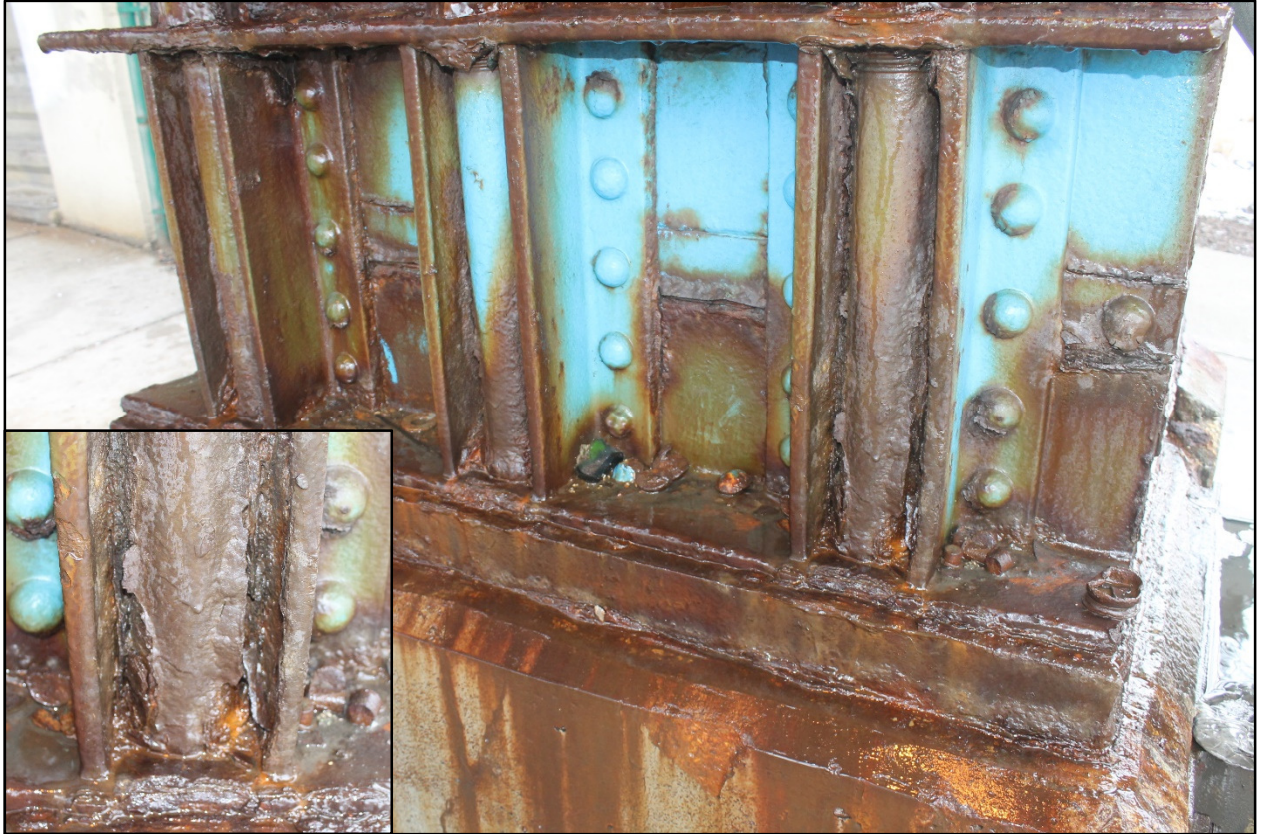
Photo 51 – Active Corrosion within Anchor Bolt Stiffener Chamber, Forward Approach.

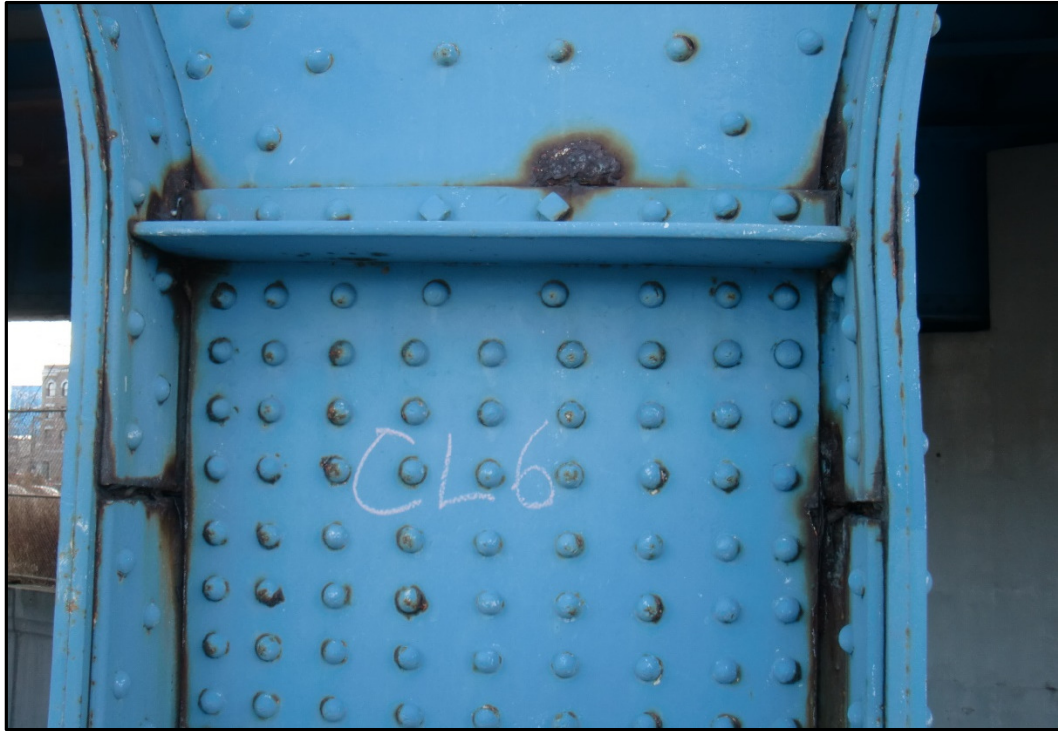
Photo 52 – Typical Local Seam Corrosion, West Approach Superstructure.

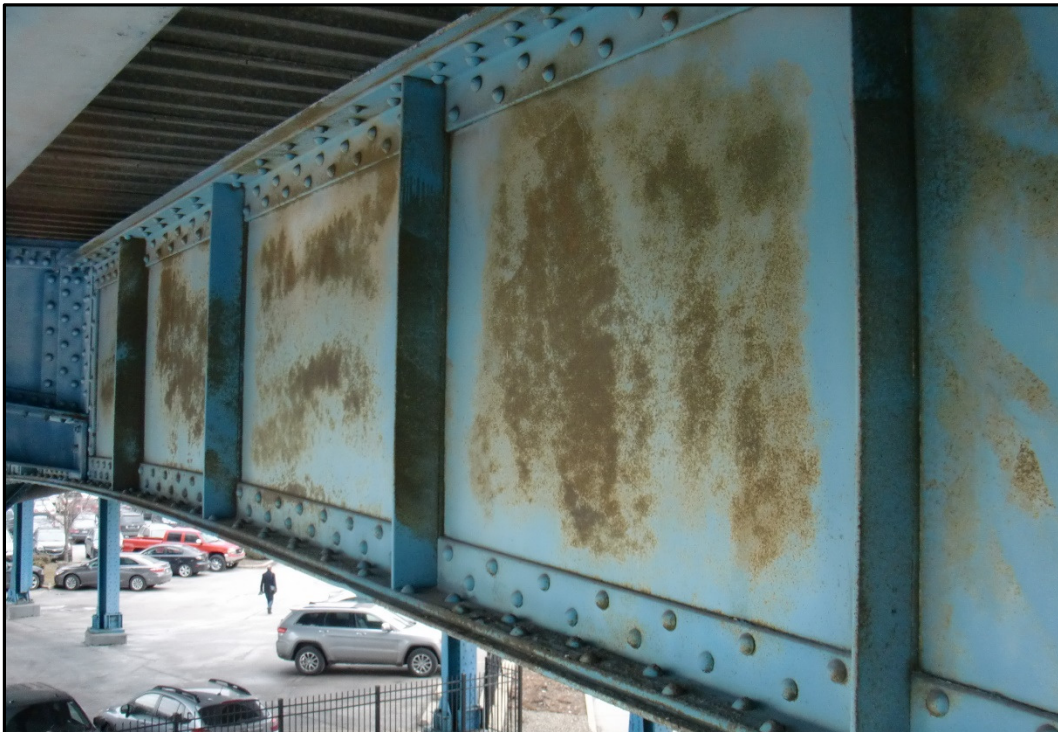
Photo 53 – Common Worn Protective Coating on Girder Web, Lakefront Trestle.

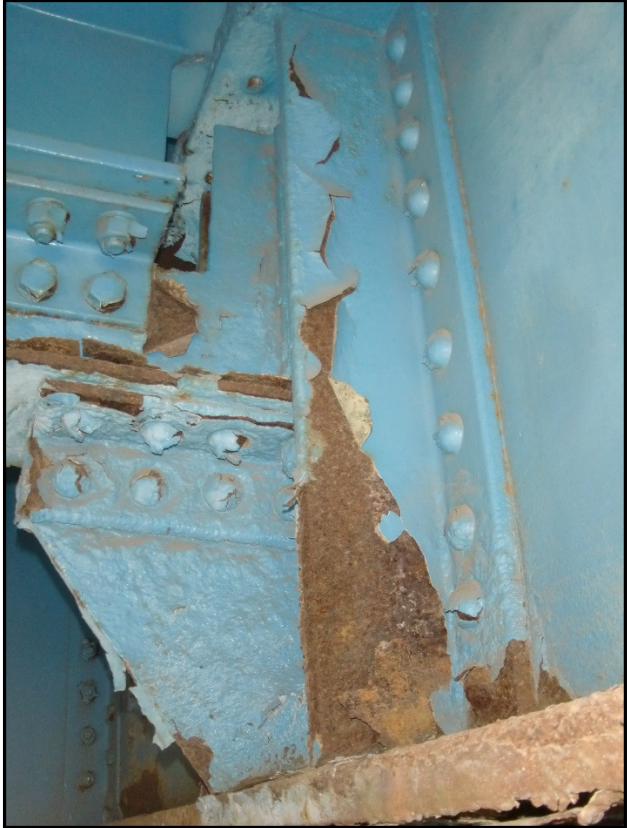
Photo 54 – Common Cracked & Flaked Protective Coating, Lakefront Trestle.

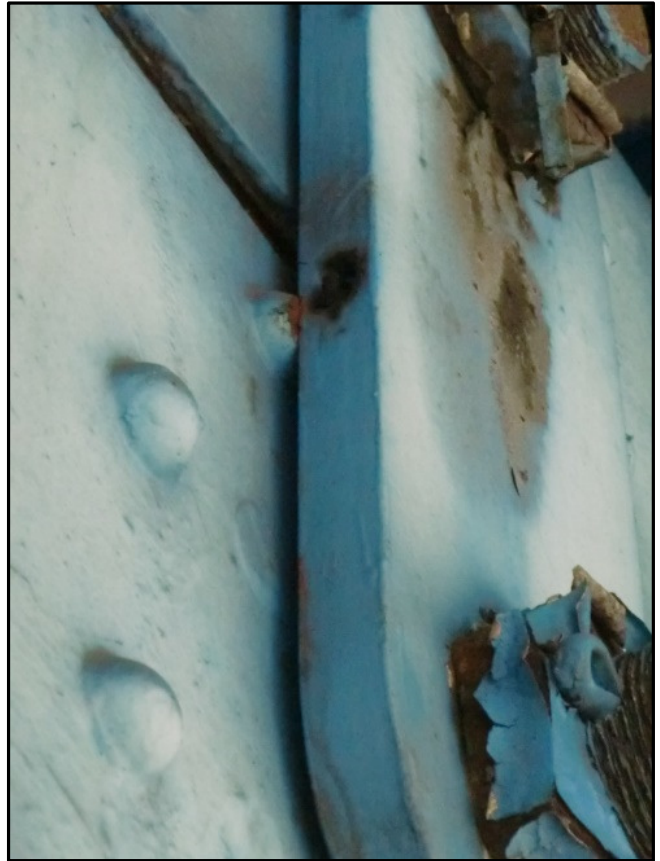
Photo 55 – Common Rivet Interference with Hanger, East Approach Spans.

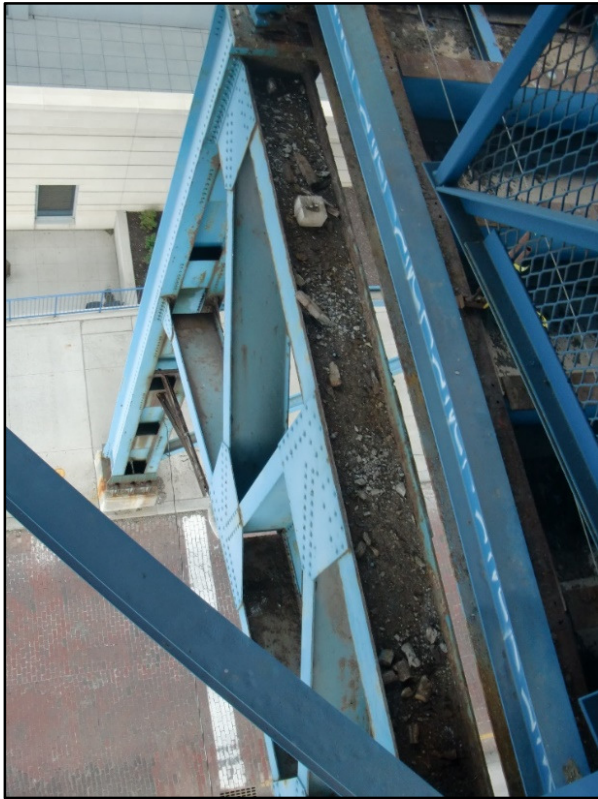
Photo 58 – Light Corrosion & Debris on Pier Bent 0/Pier 11.

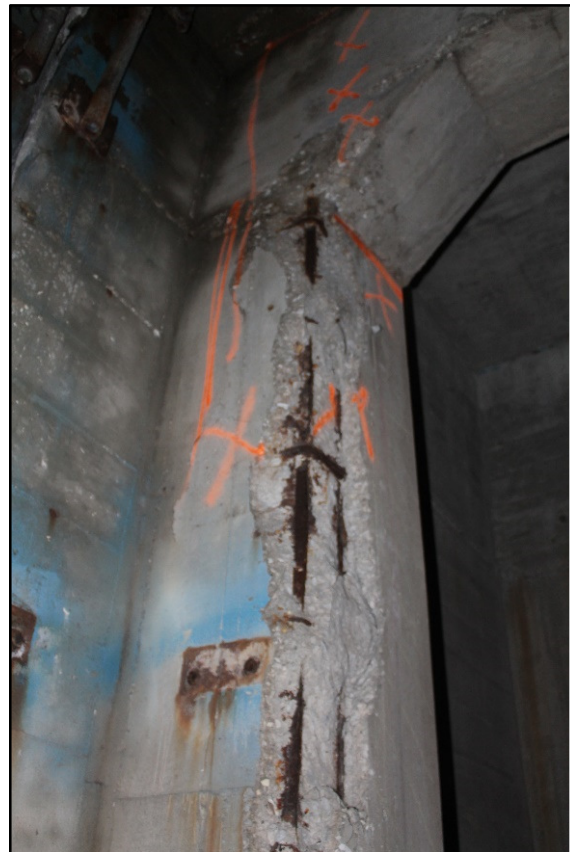
Photo 59 – Spall with Exposed Rebar, Column 1N, Section D.

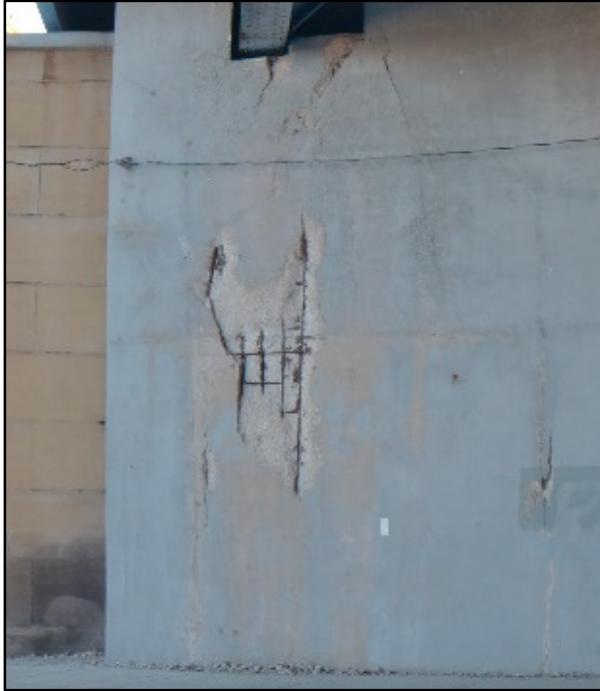
Photo 60 –Typical Mask Wall Deterioration.

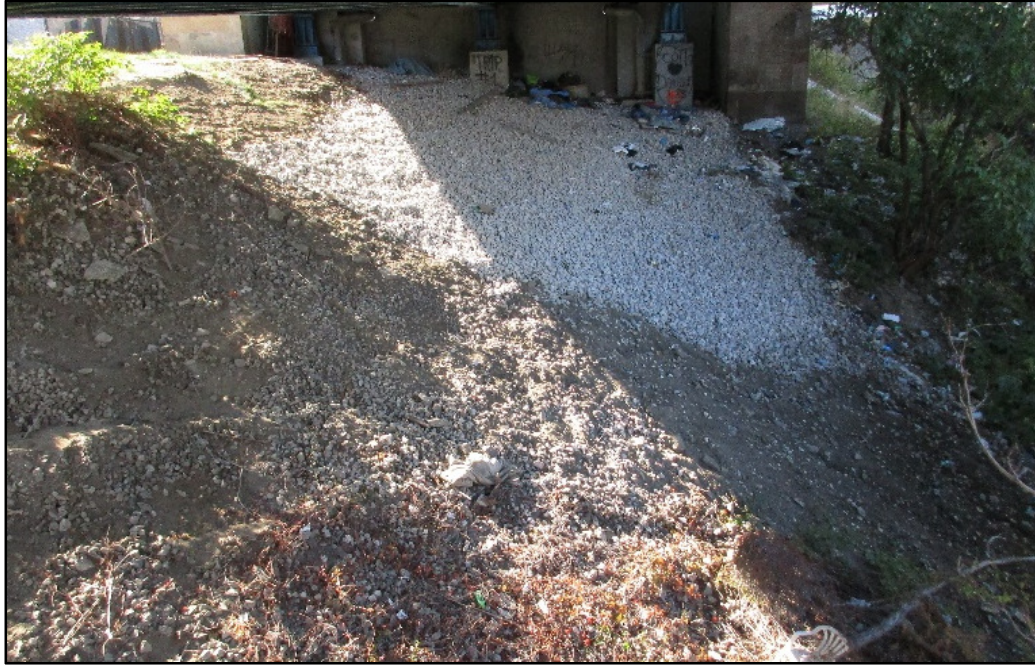
Photo 61 – Slope Protection Repair, East Side of Pier 37.

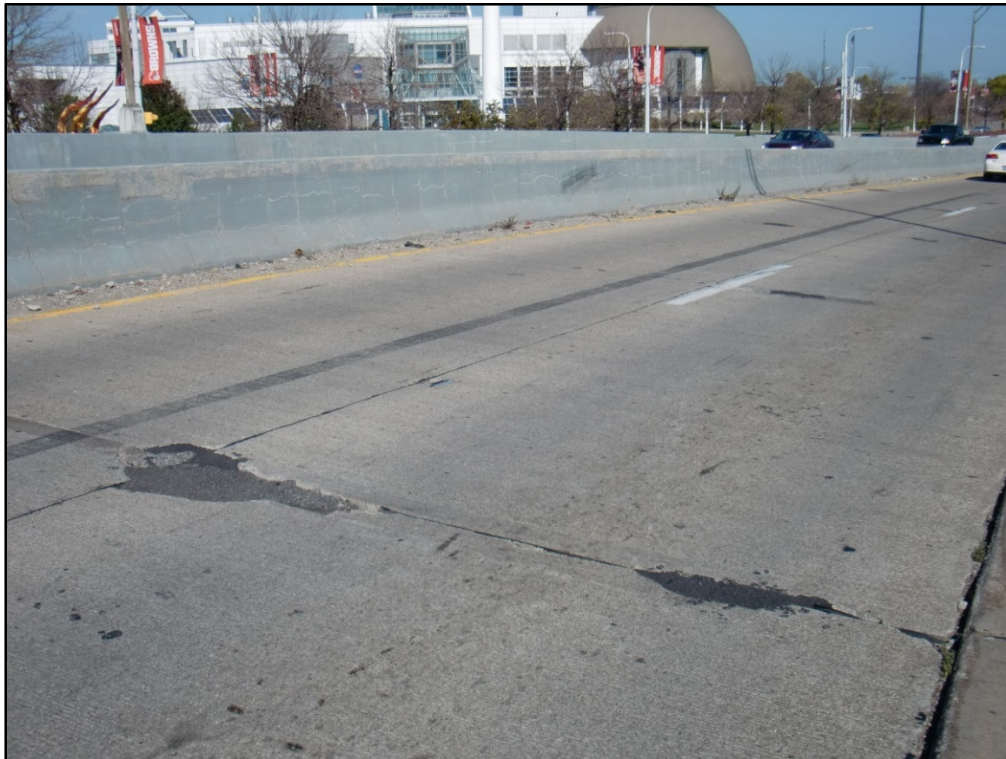
Photo 62 – Patched Spalls in Approach Pavement, East Approach.

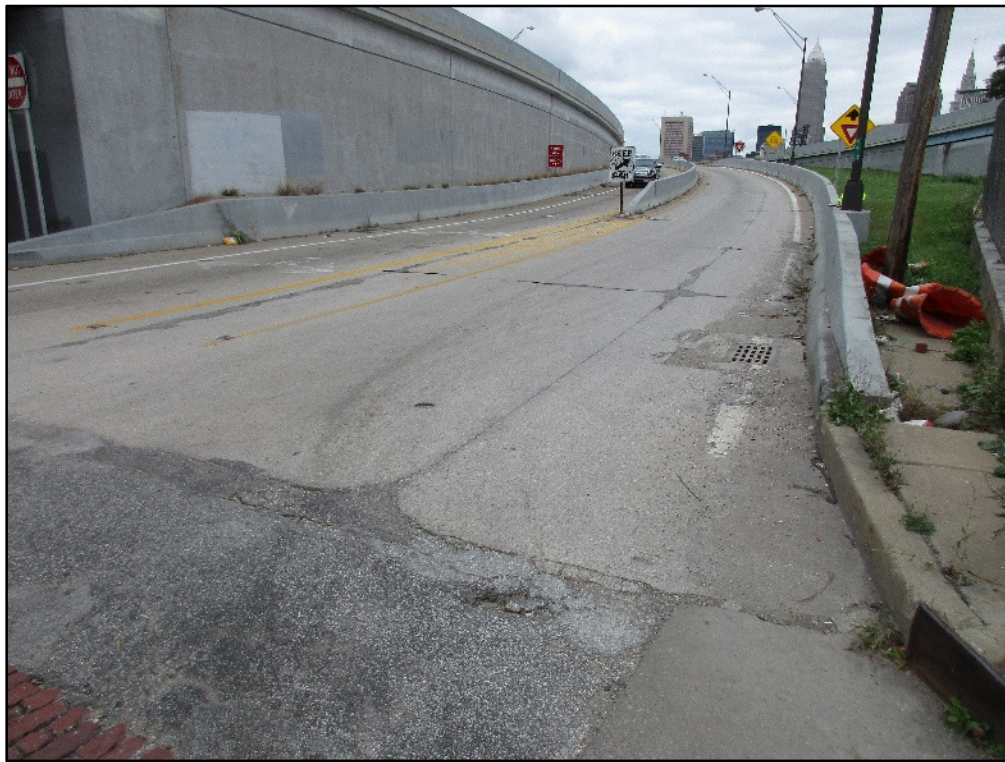
Photo 63 – Typical Approach Slab Condition, W 28th St. Ramp.

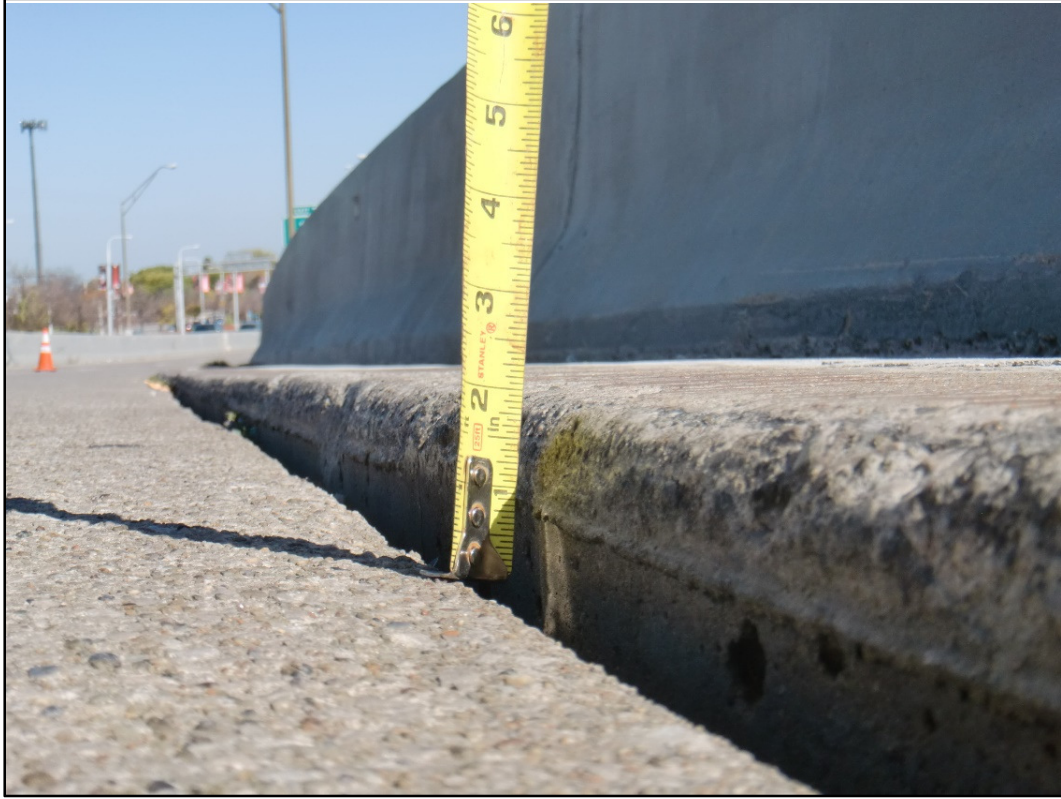
Photo 64 – Typical Condition, W 28th St. Ramp.

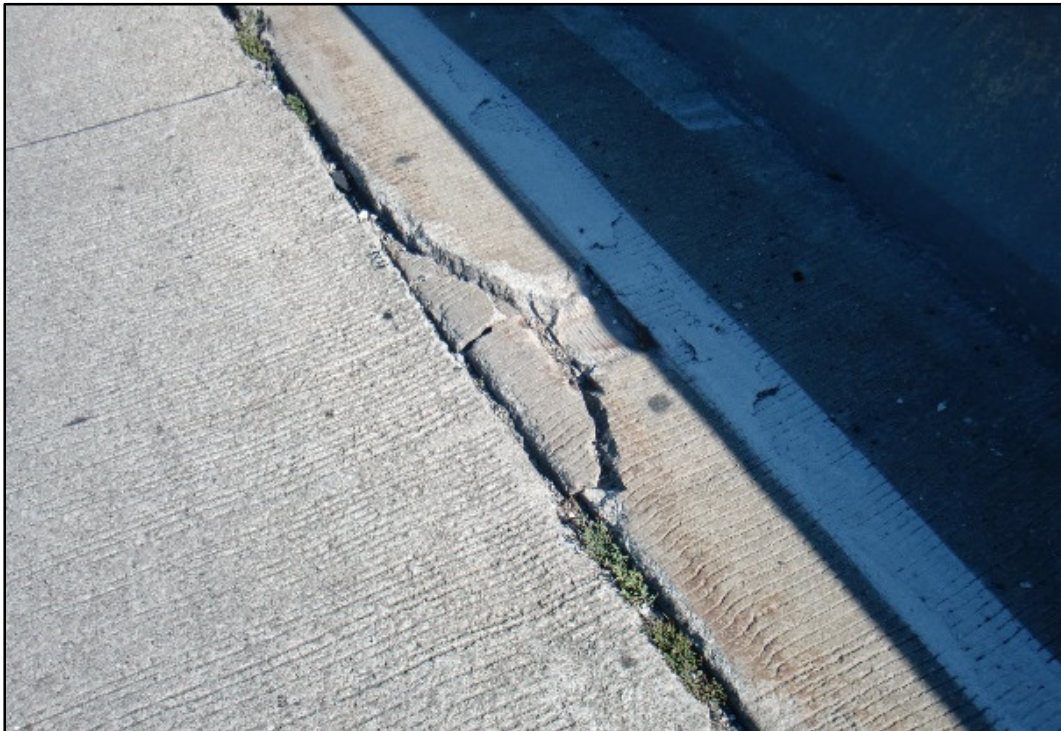
Photo 65 – Approach Slab Settlement, East Approach.

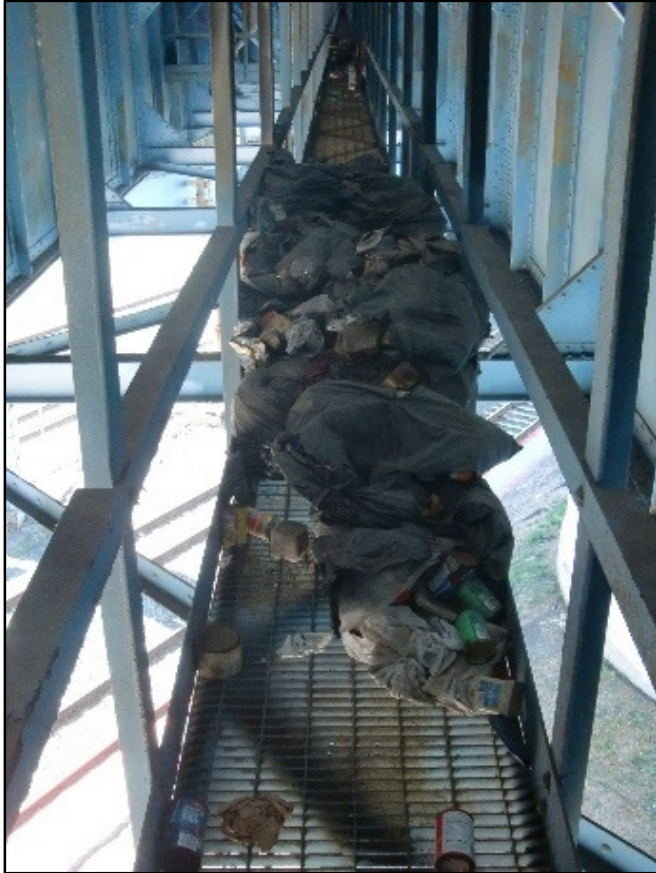
Photo 66 – Debris from Vagrants,
Lakefront Ramp Catwalk.

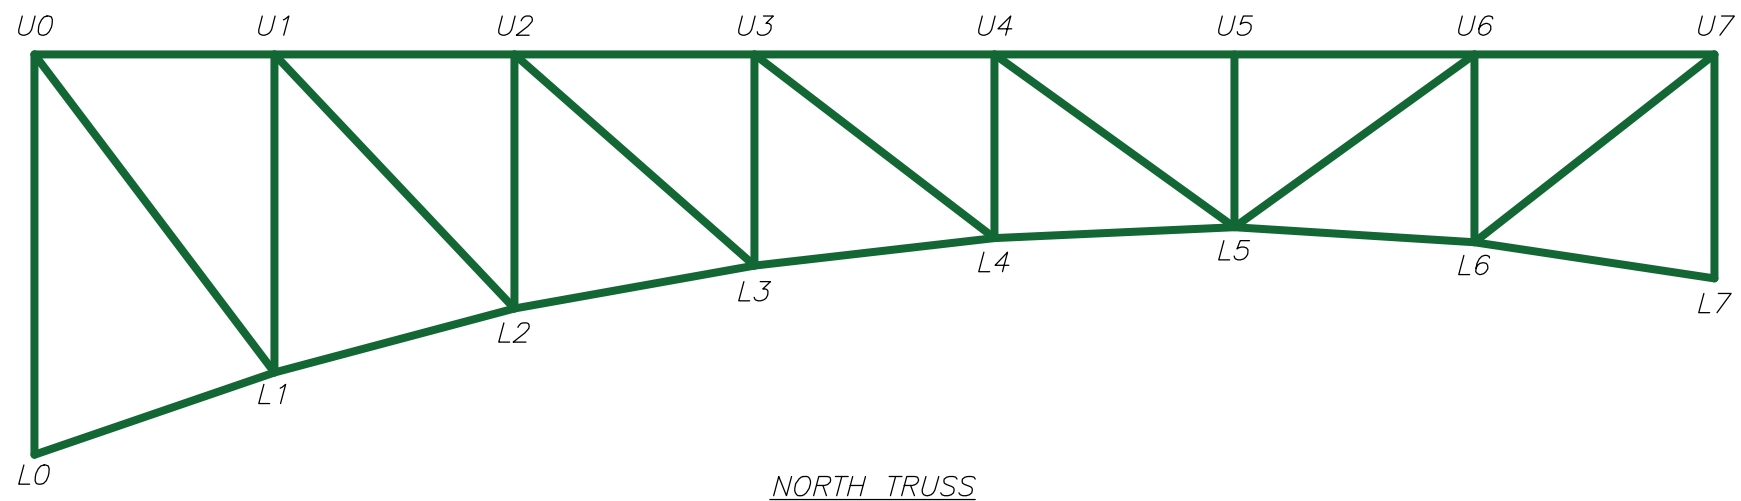
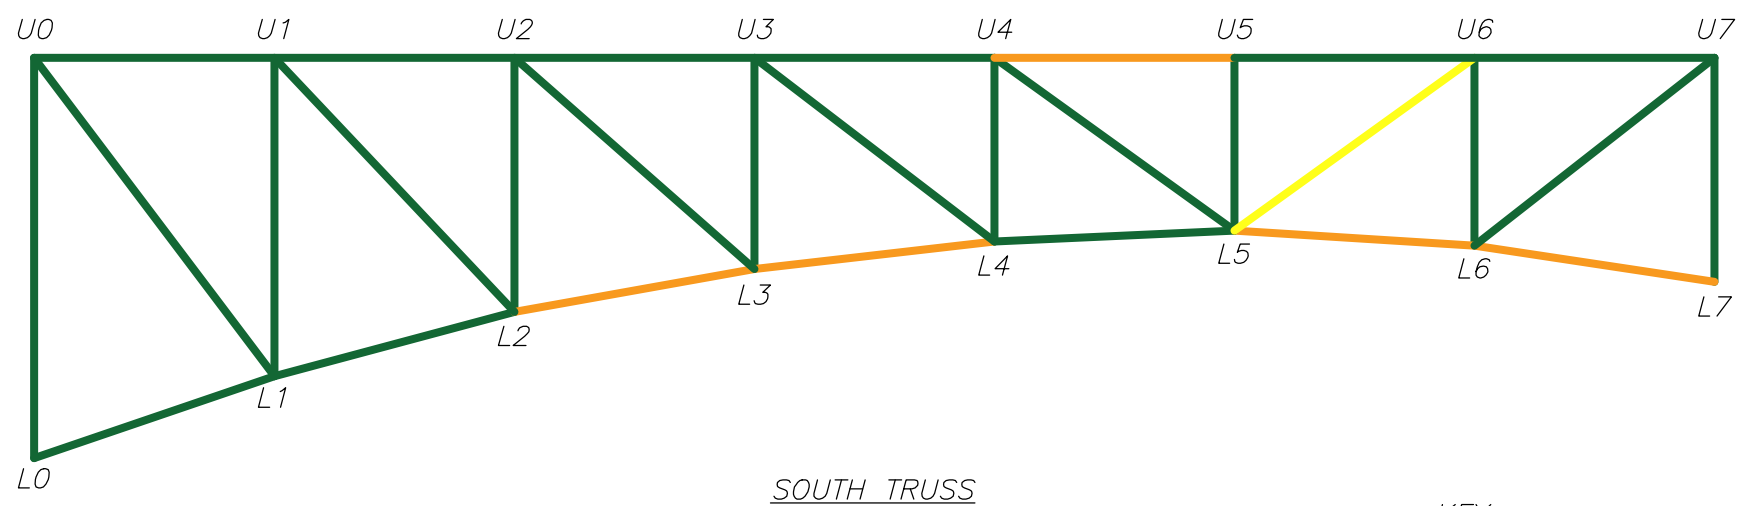
- KEY
- CS1
 - CS2
 - CS3
 - CS4
