CUY-2-1441

PHYSICAL CONDITION REPORT ROUTINE AND FRACTURE CRITICAL INSPECTION OF MAIN AVENUE BRIDGE OVER THE CUYAHOGA RIVER SFN: 1800035

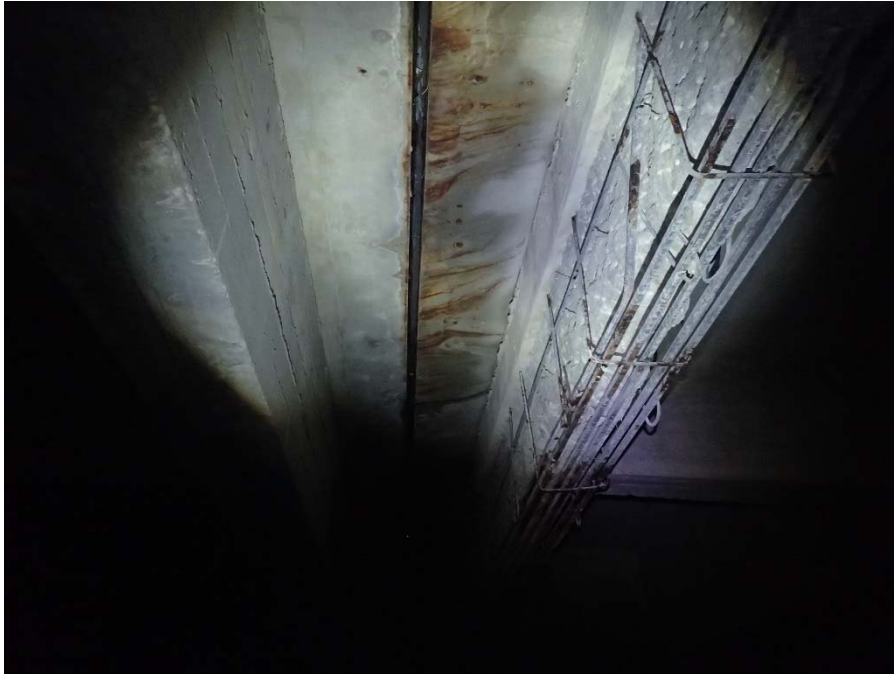
Photo 1 – Unit I, Joint T1; Leaking joint resulting in corrosion staining and efflorescence

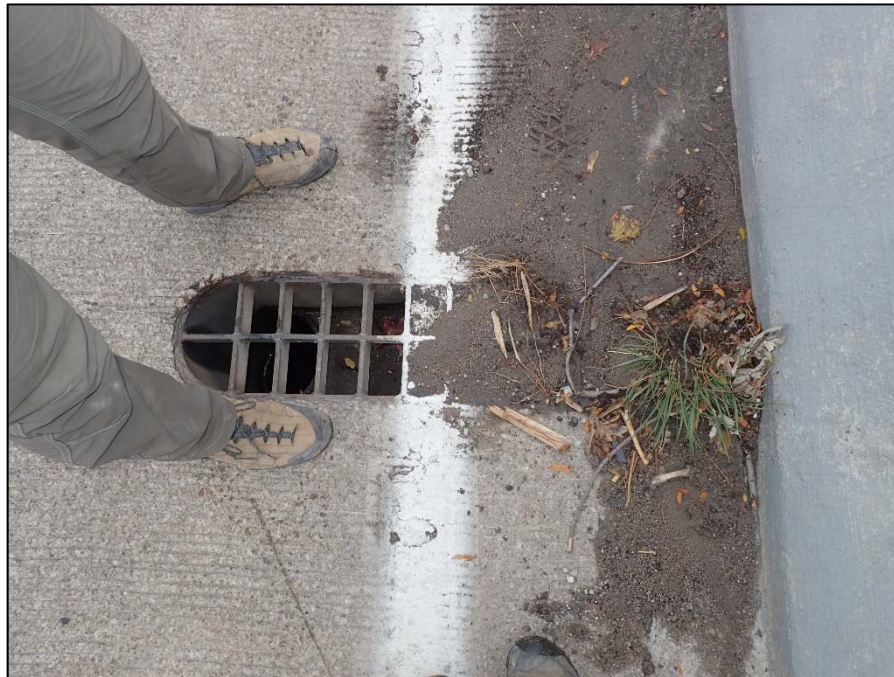
Photo 2 – Unit II, Joint L1; 3/4 blocked curb drain

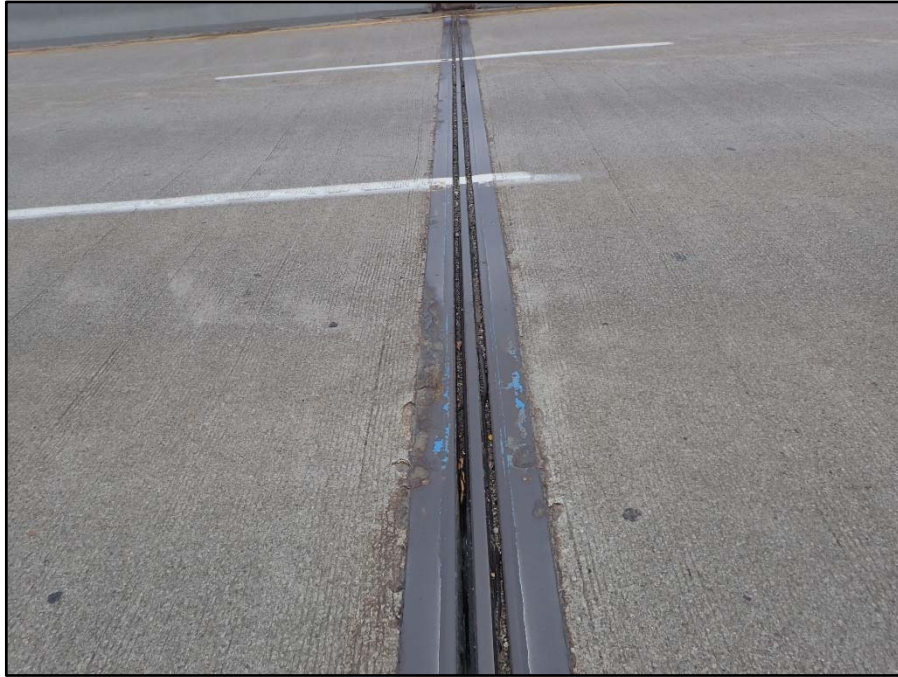
Photo 3 – Unit II, Joint L; Failed joint seal

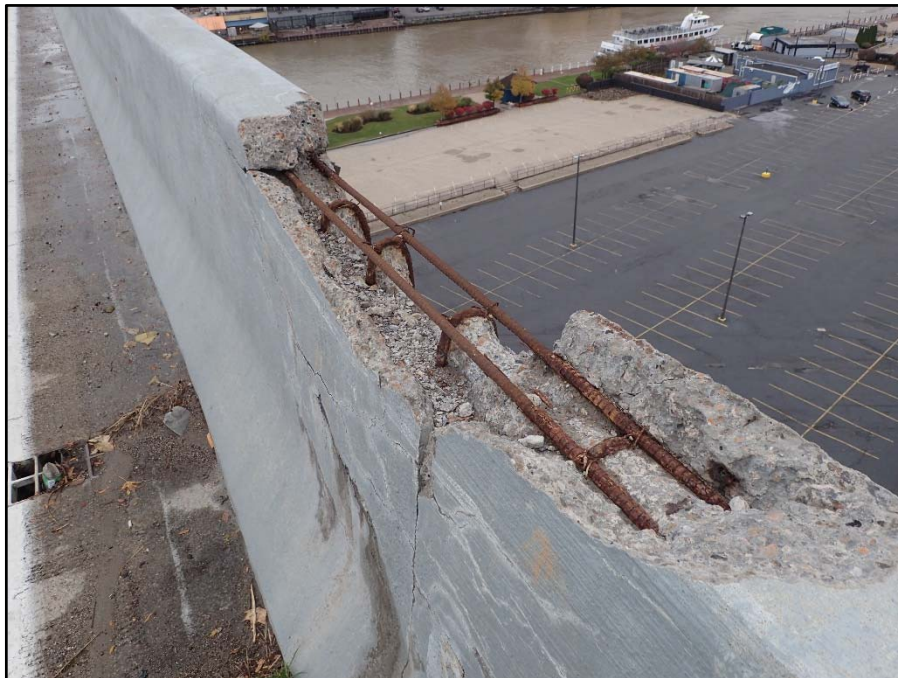
Photo 4 – Unit II, Joint K, bridge parapet; 6' L x Full Width x 18" H spall

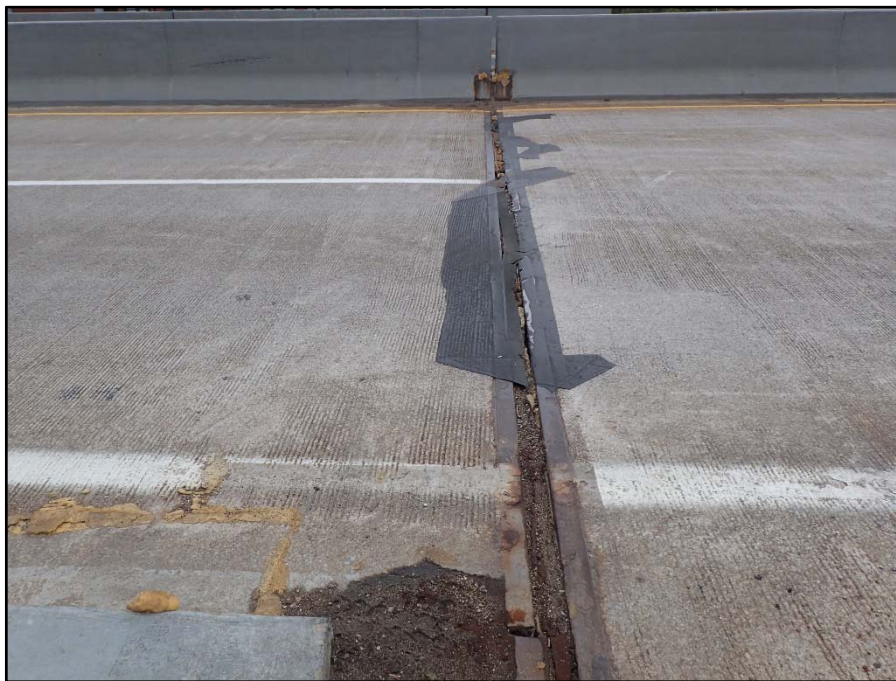
Photo 6 – Unit IV; Entrance Ramp, Westbound lanes; Failed joint

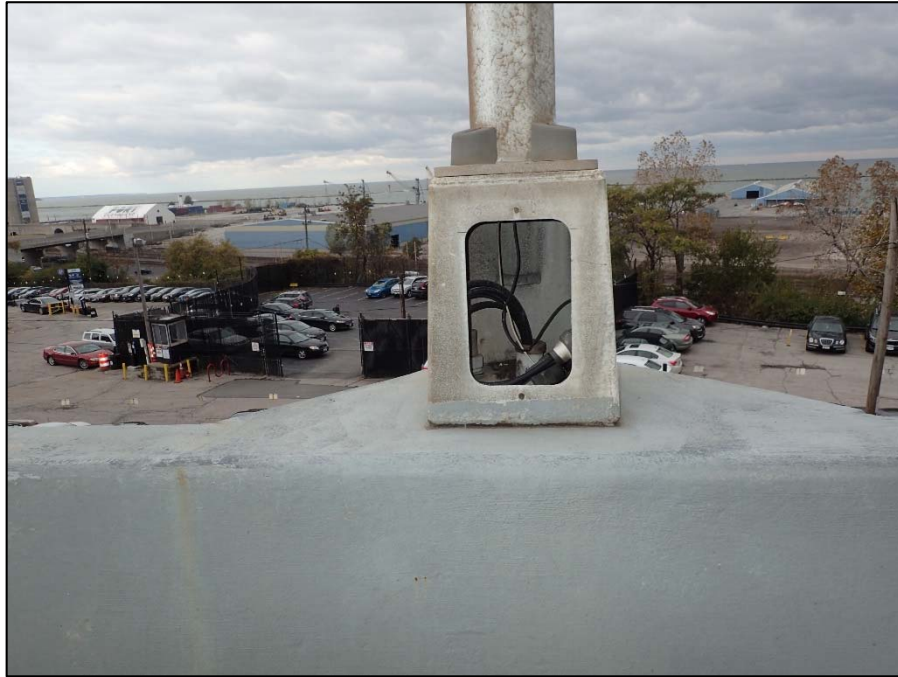
Photo 7 – Unit IV, Section E, North parapet; Missing light base cover

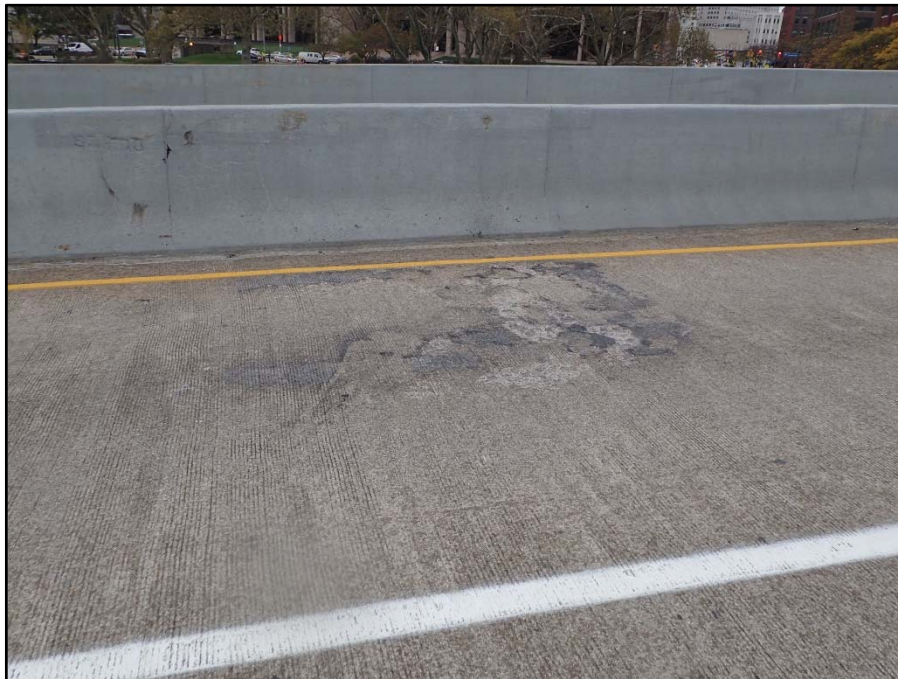
Photo 8 – Unit IV; Westbound lanes, South Lane; 8' L x 8' W area of 1" D spalling with staining

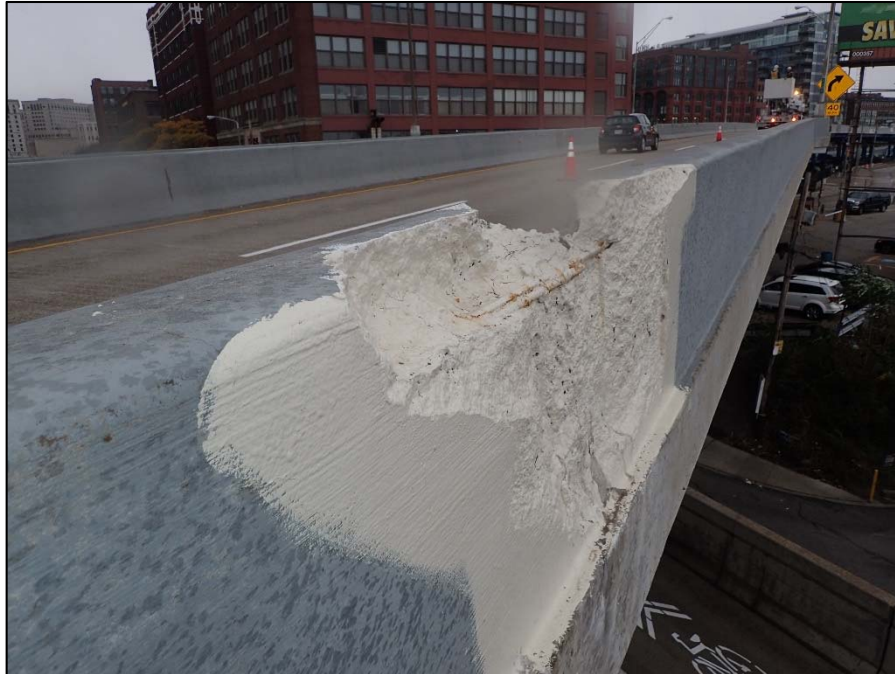
Photo 9 – Unit IV, Section H, Westbound lane; 6' L x Full Width x 6" D spall with exposed reinforcement

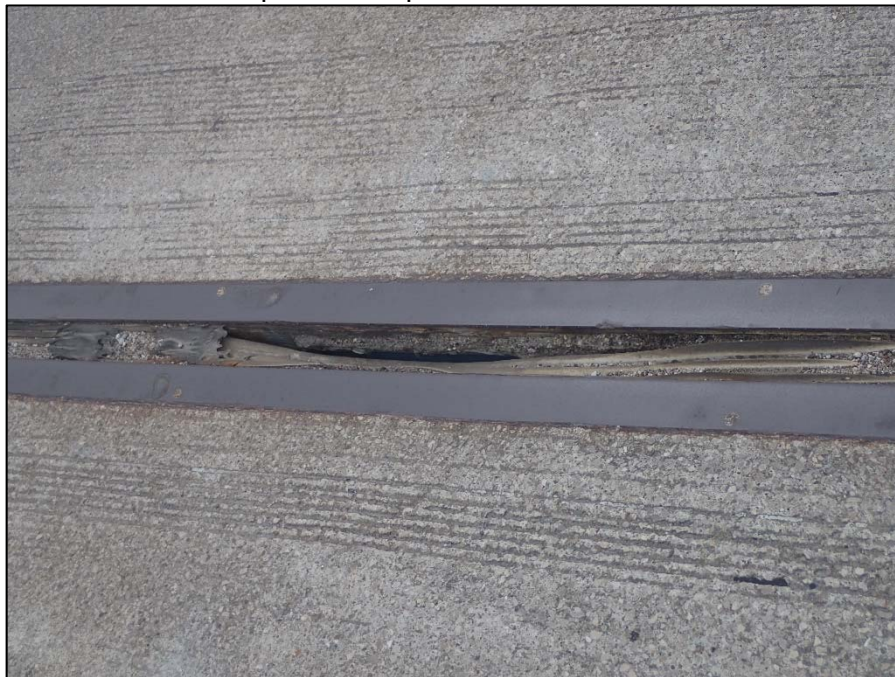
Photo 10 – Unit IV, Joint A; 4' L section of joint has failed along middle

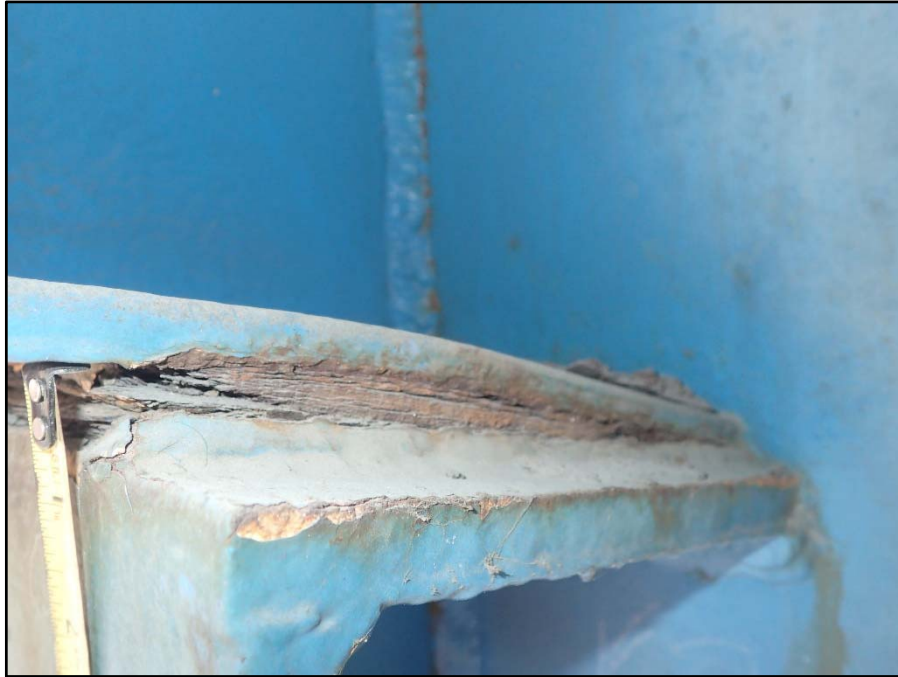
Photo 12 – Unit I, Section K, Floorbeam 2; 6" Long horizontal crack

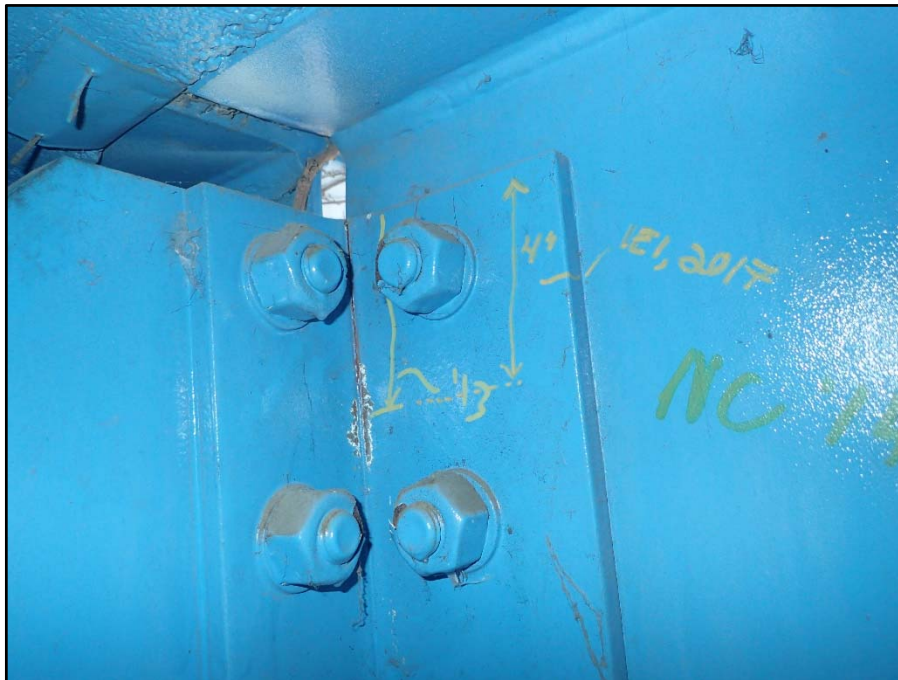
Photo 13 – Unit I, Section M, Floorbeam 2; 4" L vertical crack in south exterior stringer to floorbeam cantilever connection angle

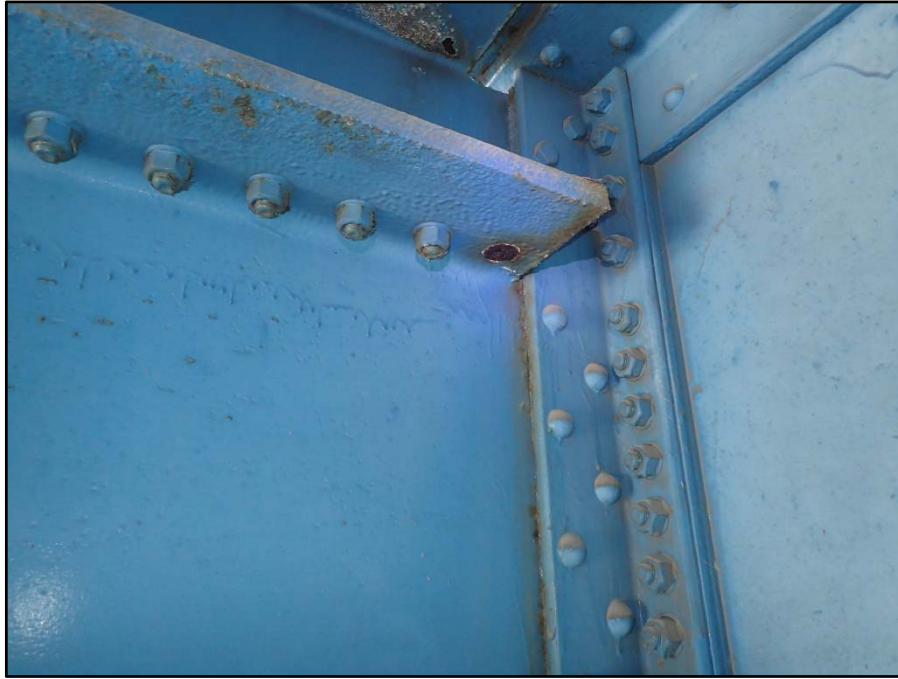
Photo 14 – Unit I, Section N; Popped rivet at end of top flange due to pack rust

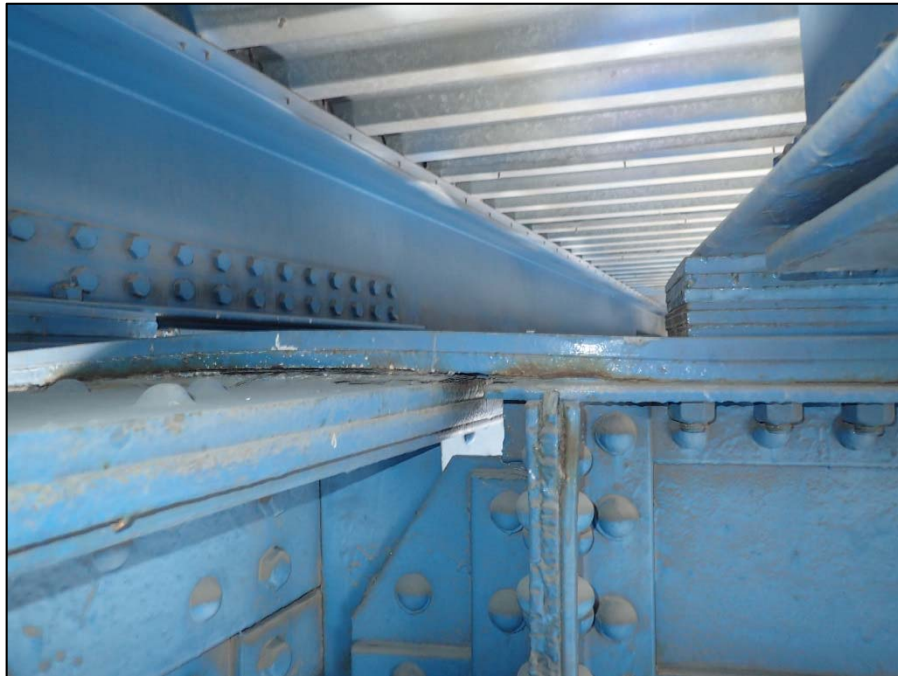
Photo 15 – Unit I, Section N Girder 5; 1/2" T pack rust between girder top flange and cantilever support tie plate

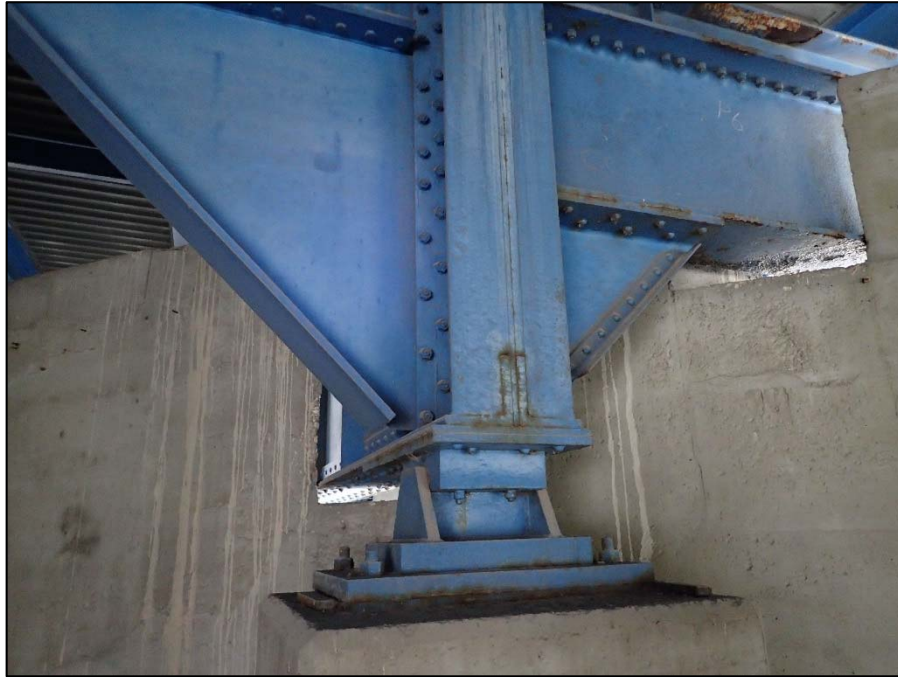
Photo 16 – Unit I, Section N, Floorbeam 7, center bearing; Typical bearing paint condition

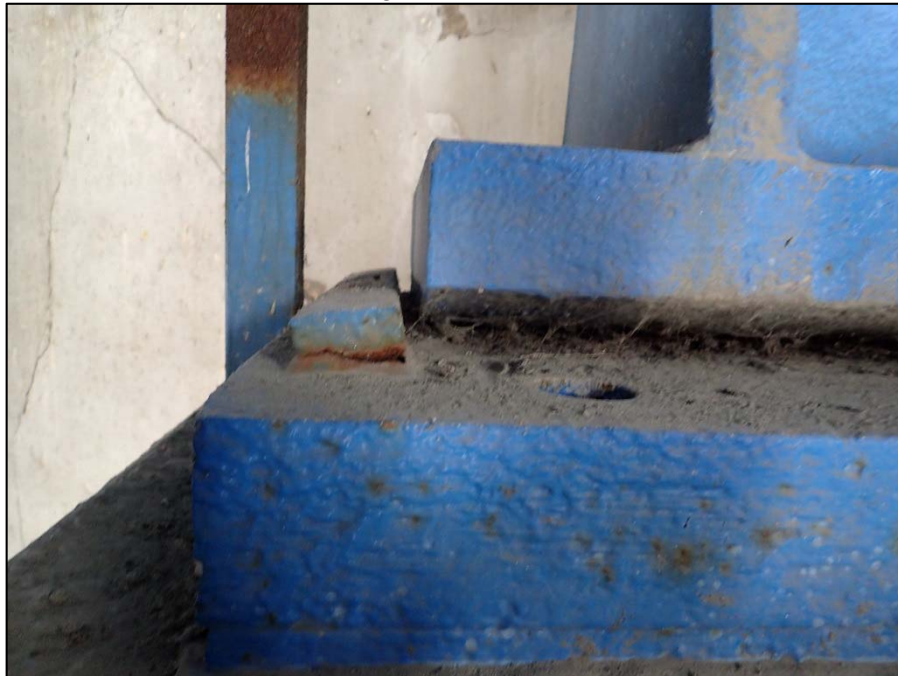
Photo 17 – Unit I, Section N at Floorbeam 8, North girder; South guide bar welds are cracked

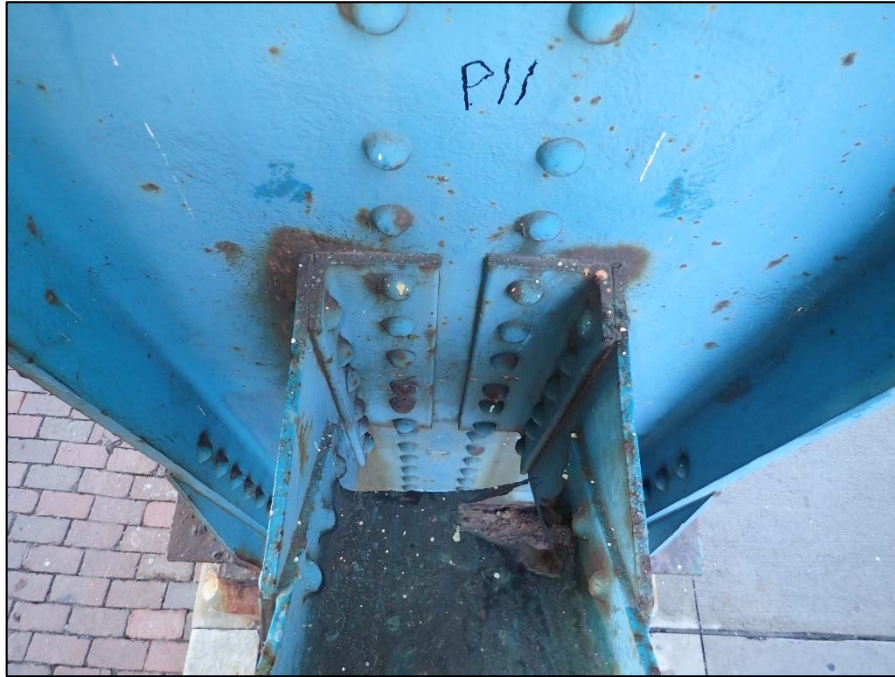
Photo 18 – Unit III, Span 11, North column; 1/4" T pack rust at connection and 4" Diameter corrosion hole through web of brace

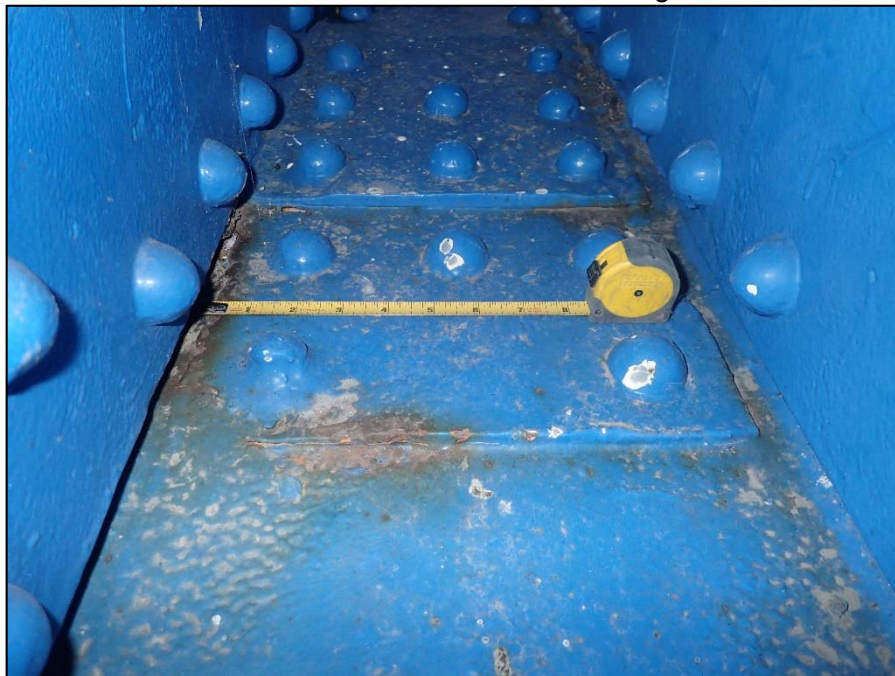
Photo 19 – Unit III, Span 11, Panel Point L2, north truss; Painted over section loss with up to 1/2" T pack rust

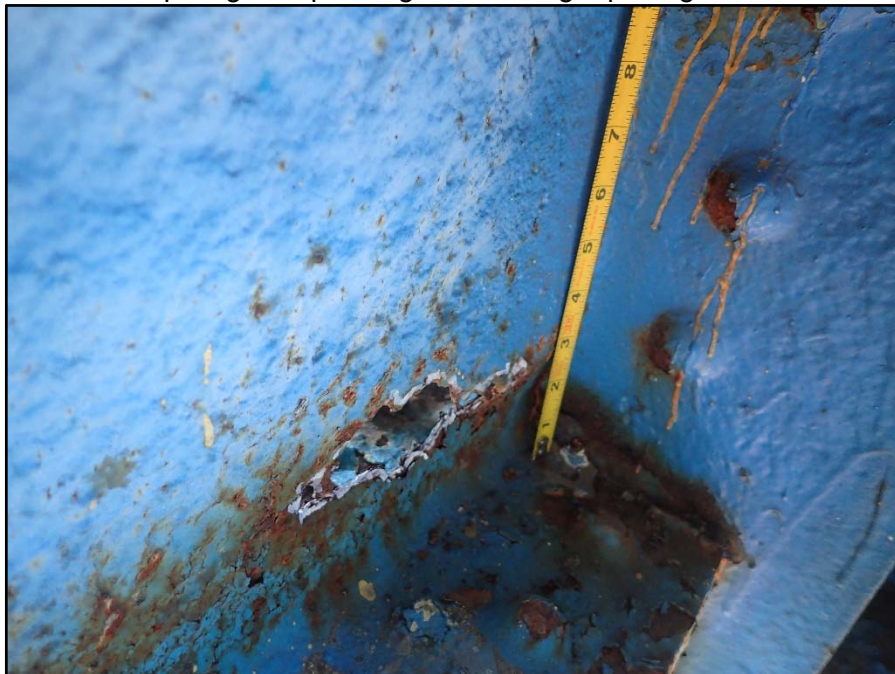
Photo 21 – Unit III, Bent 4, North column; 5-1/2" W x 1/2" H corrosion hole above bearing plate

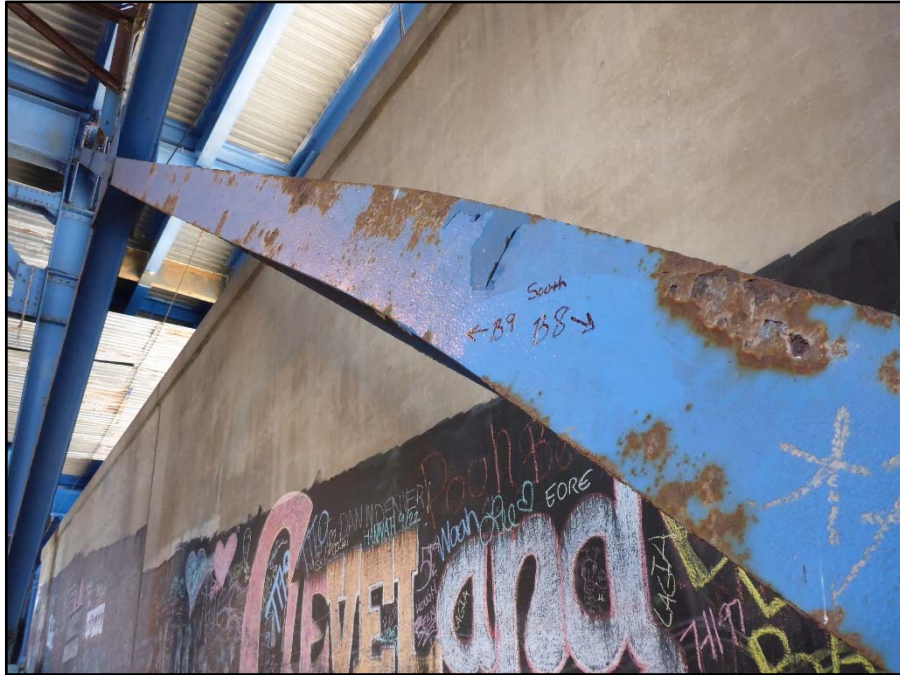
Photo 22 – Unit III, Bent 8-9, South column; Diagonal from Bent 8 to Bent 9 is bent upward and to the South due to collision damage

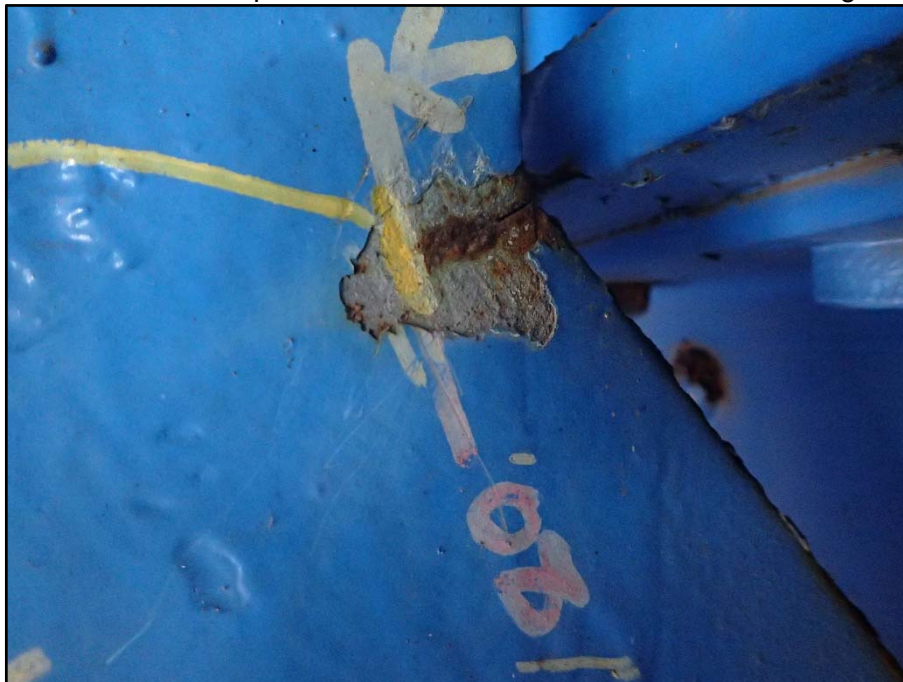
Photo 23 – Unit III, Bent 9, North column; 3/4" L crack in gusset coping from upper cross bracing to column

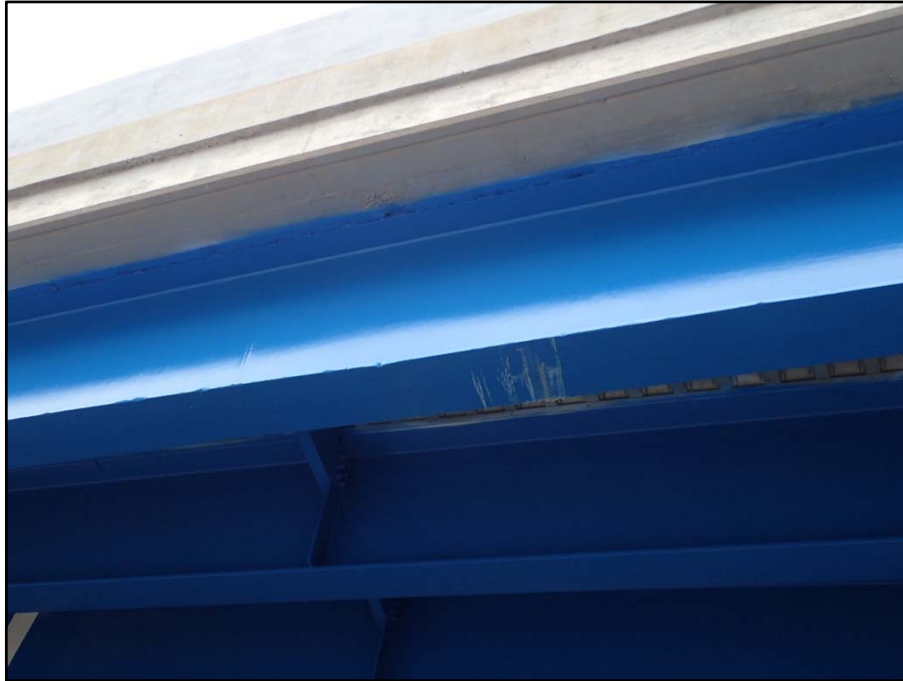
Photo 24 – Unit III, Bent 11 – 12; Over height vehicle collision damage to bottom flange of Stringer 1

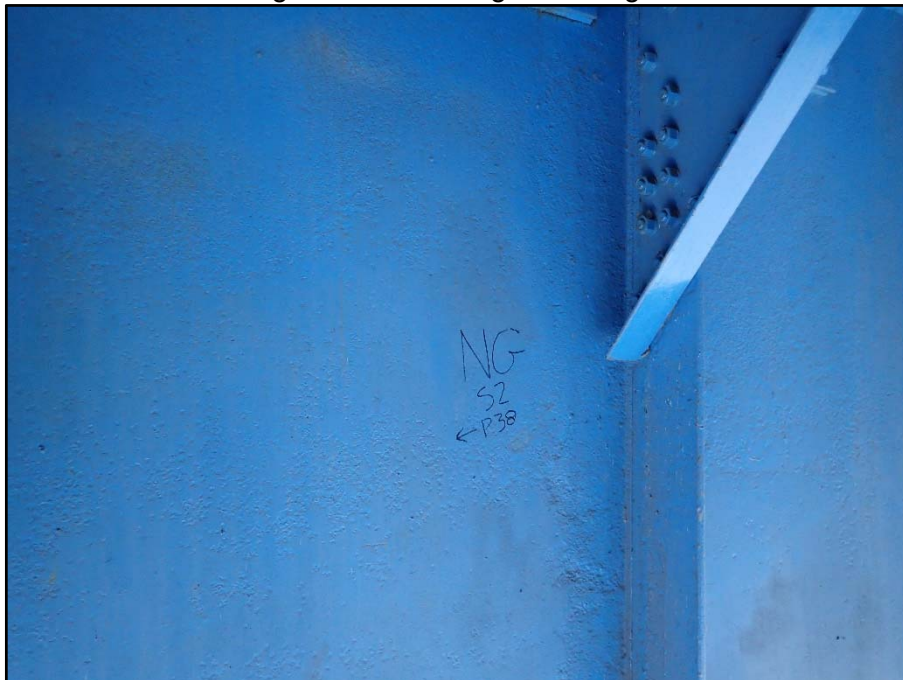
Photo 25 – Unit V, Typical girder; Up to 1/16" D painted over pitting

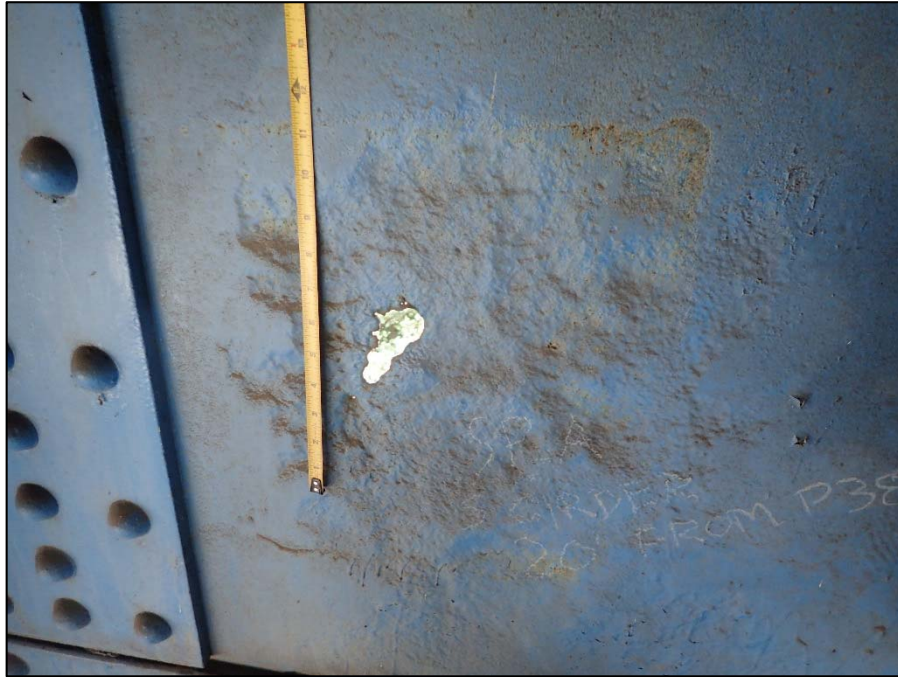
Photo 26 – Unit V, Span 38, South girder, north face; 3" H x 1" L corrosion hole 2' above bottom flange

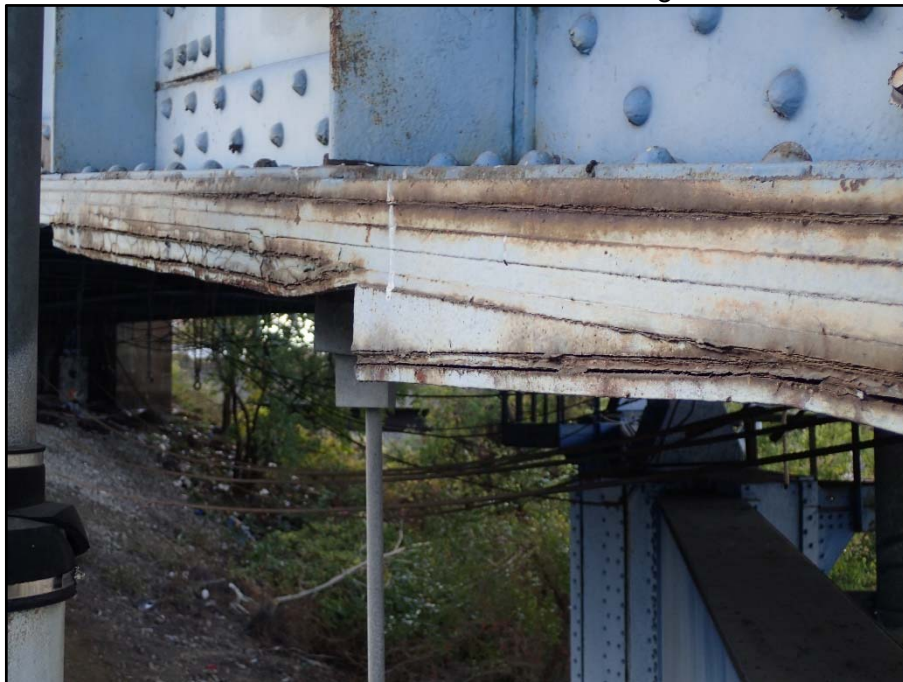
Photo 27 – Unit V, Spans 38 – 39, South Girder; Up to 1-1/4" T pack rust between bottom flange plates

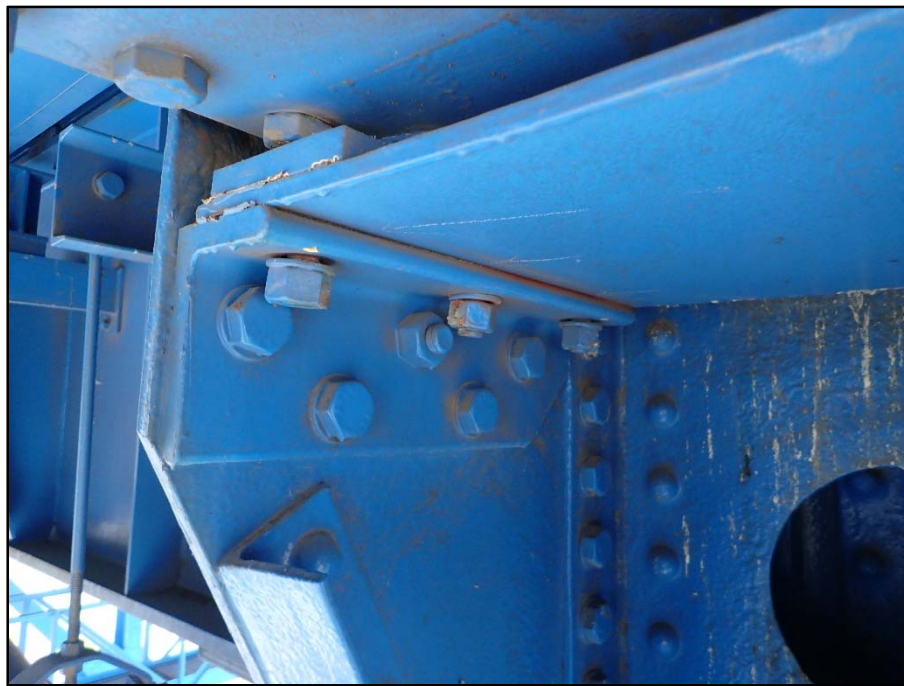
Photo 30 – Span 4, Floorbeam 0; Loose bolts on the inboard sliding plate for the north truss at U0

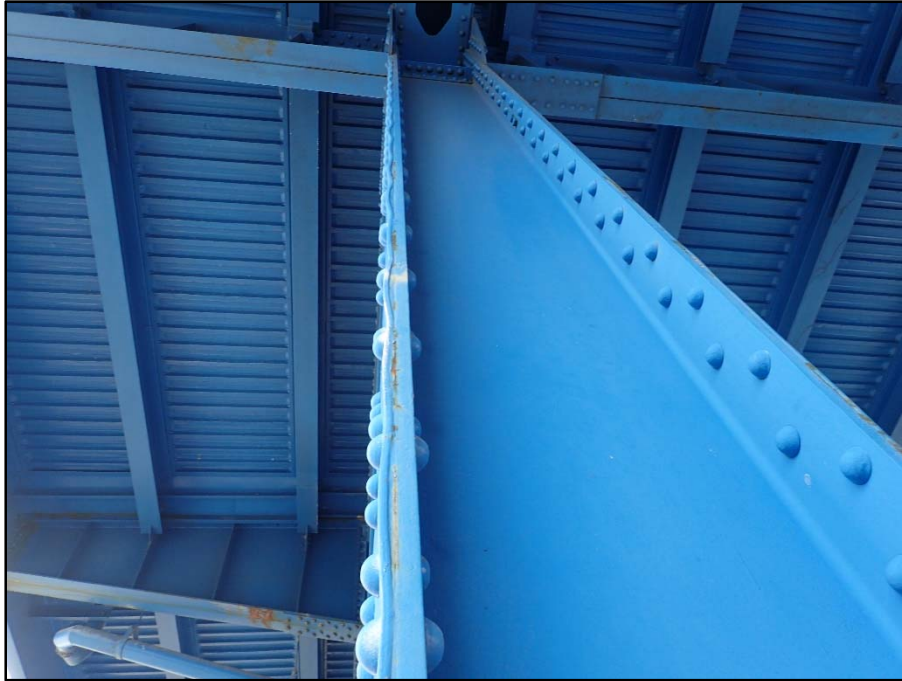
Photo 31 – Span 2, North Truss, L15U15; 3/4" T reactivating pack
rust and scalloping of edges

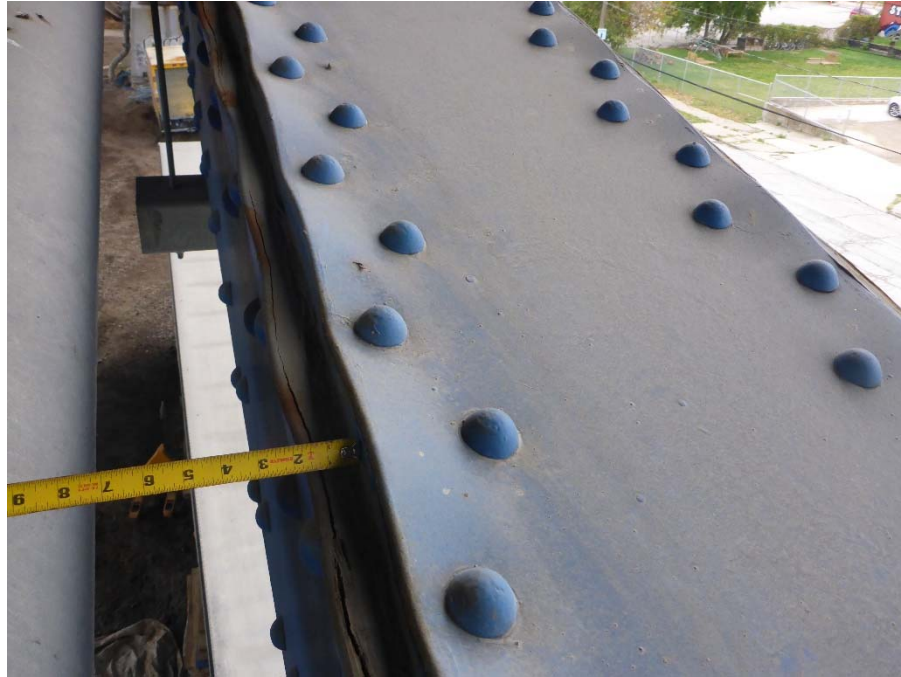
Photo 32 – Span 1, South truss, L2L3; 1" T pack rust distorting top flange plate and web plates

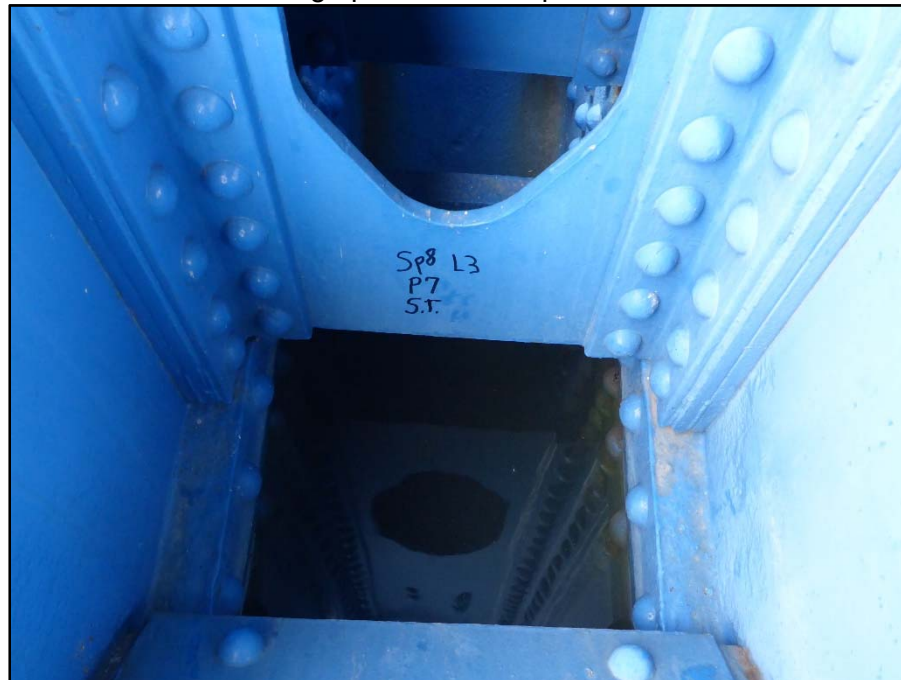
Photo 33 – Span 2, South truss, L2L3; Panel point L3 is full of water

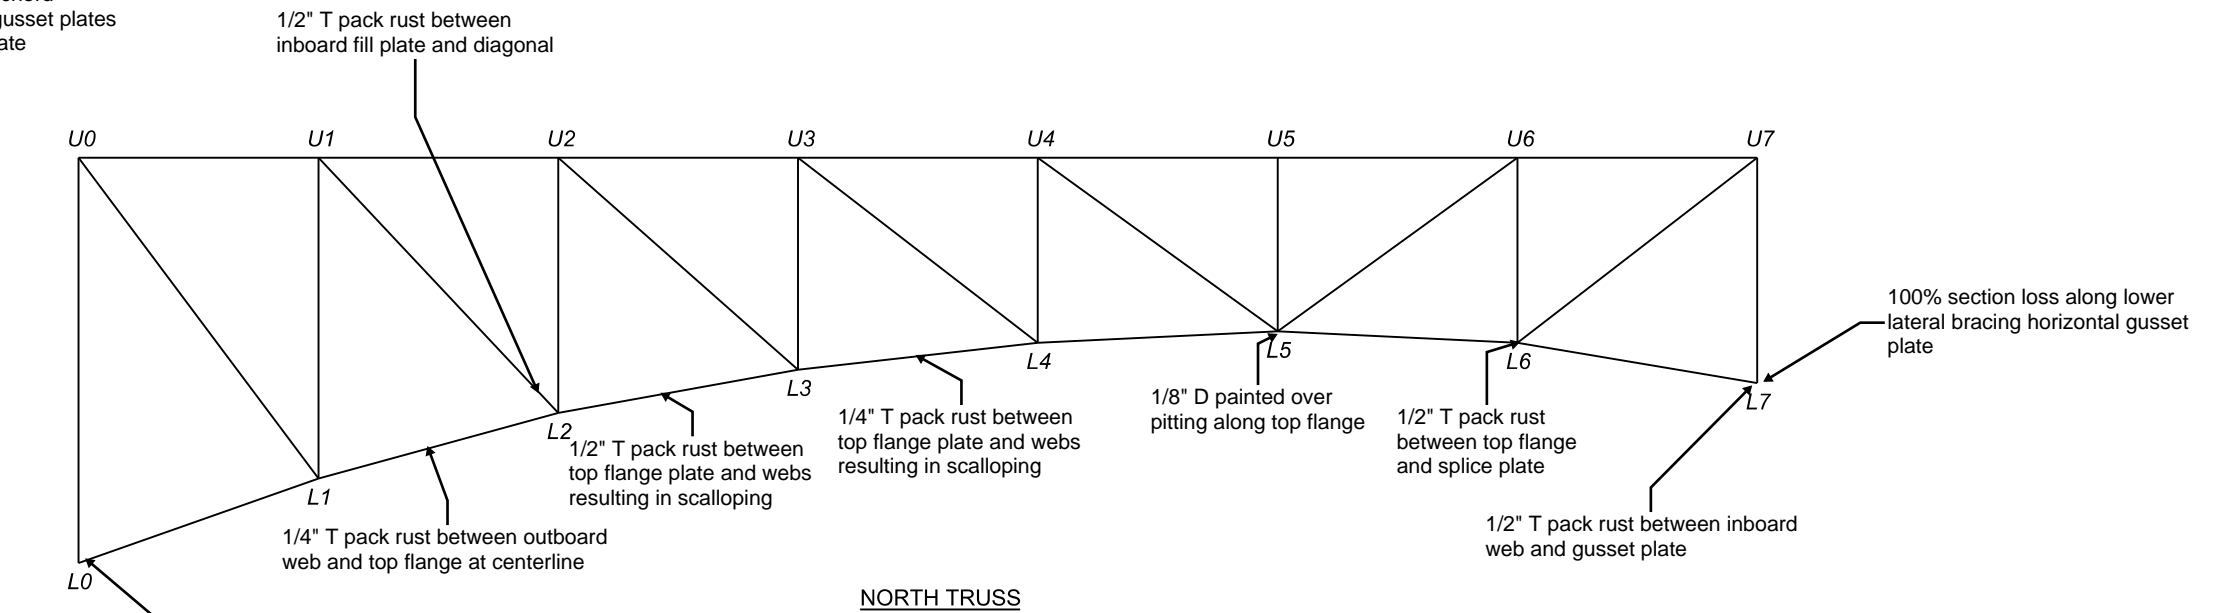
1/8" pack rust between outboard web plate and top flange

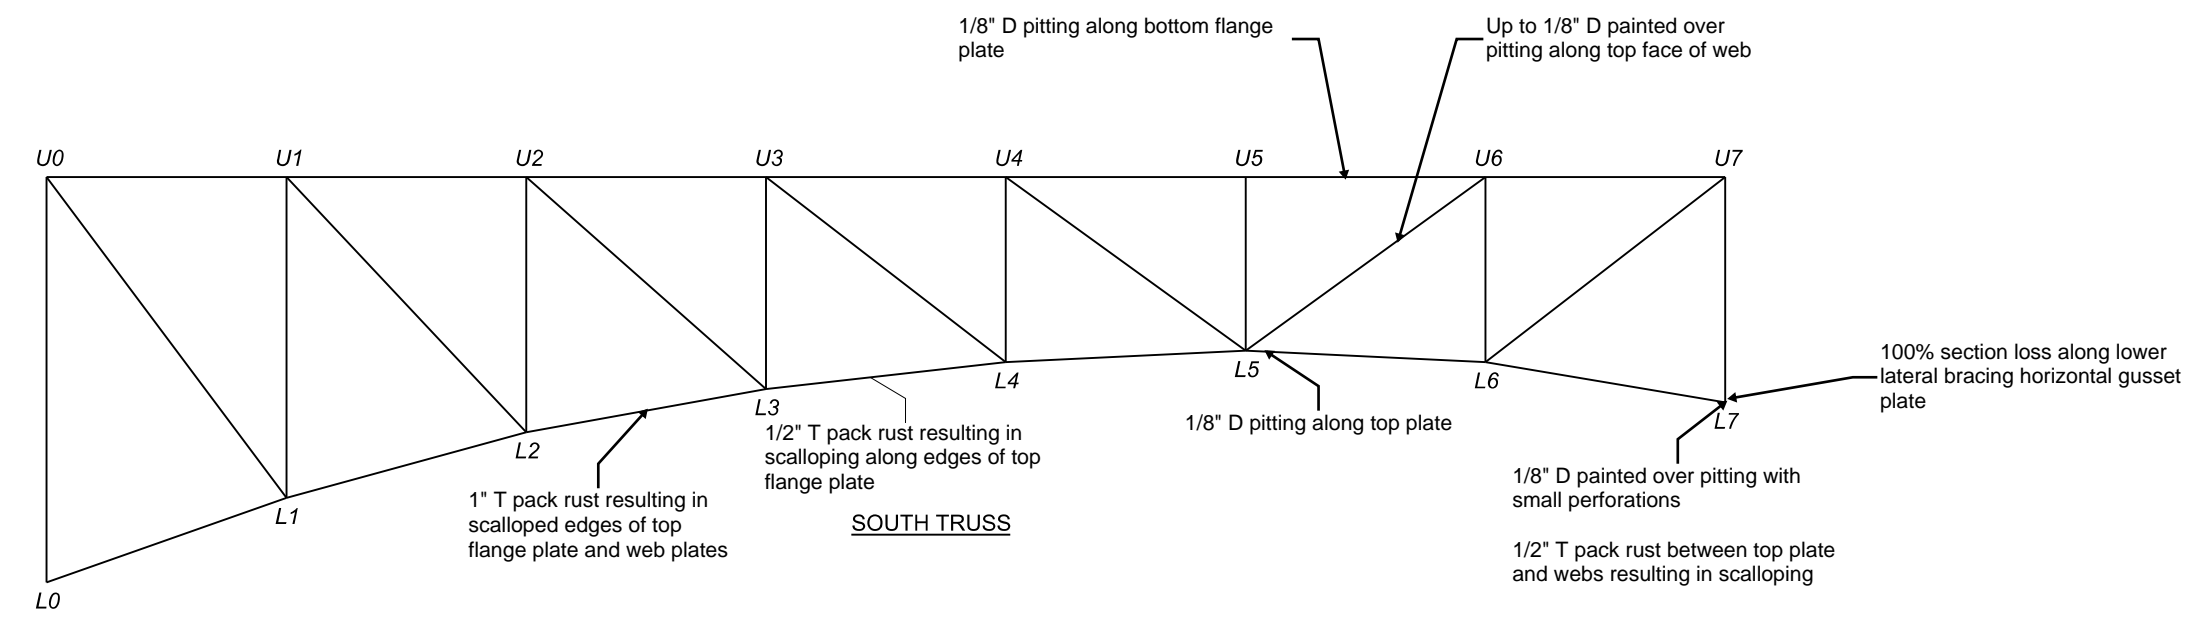
GRAPHIC SCALE MEASURED IN FEET	DATE	200 East Campus View Blvd. Suite 200 Columbus, OH 43235 PH.: 614.310.3048	MAIN AVENUE OVER CUYAHOGA RIVER BRIDGE NO. CUY-2-1441		PAGE
NOT TO SCALE	DEC, 2017	INFRASTRUCTURE ENGINEERS, INC.	TRUSS ELEVATION - SPAN 1		A-1

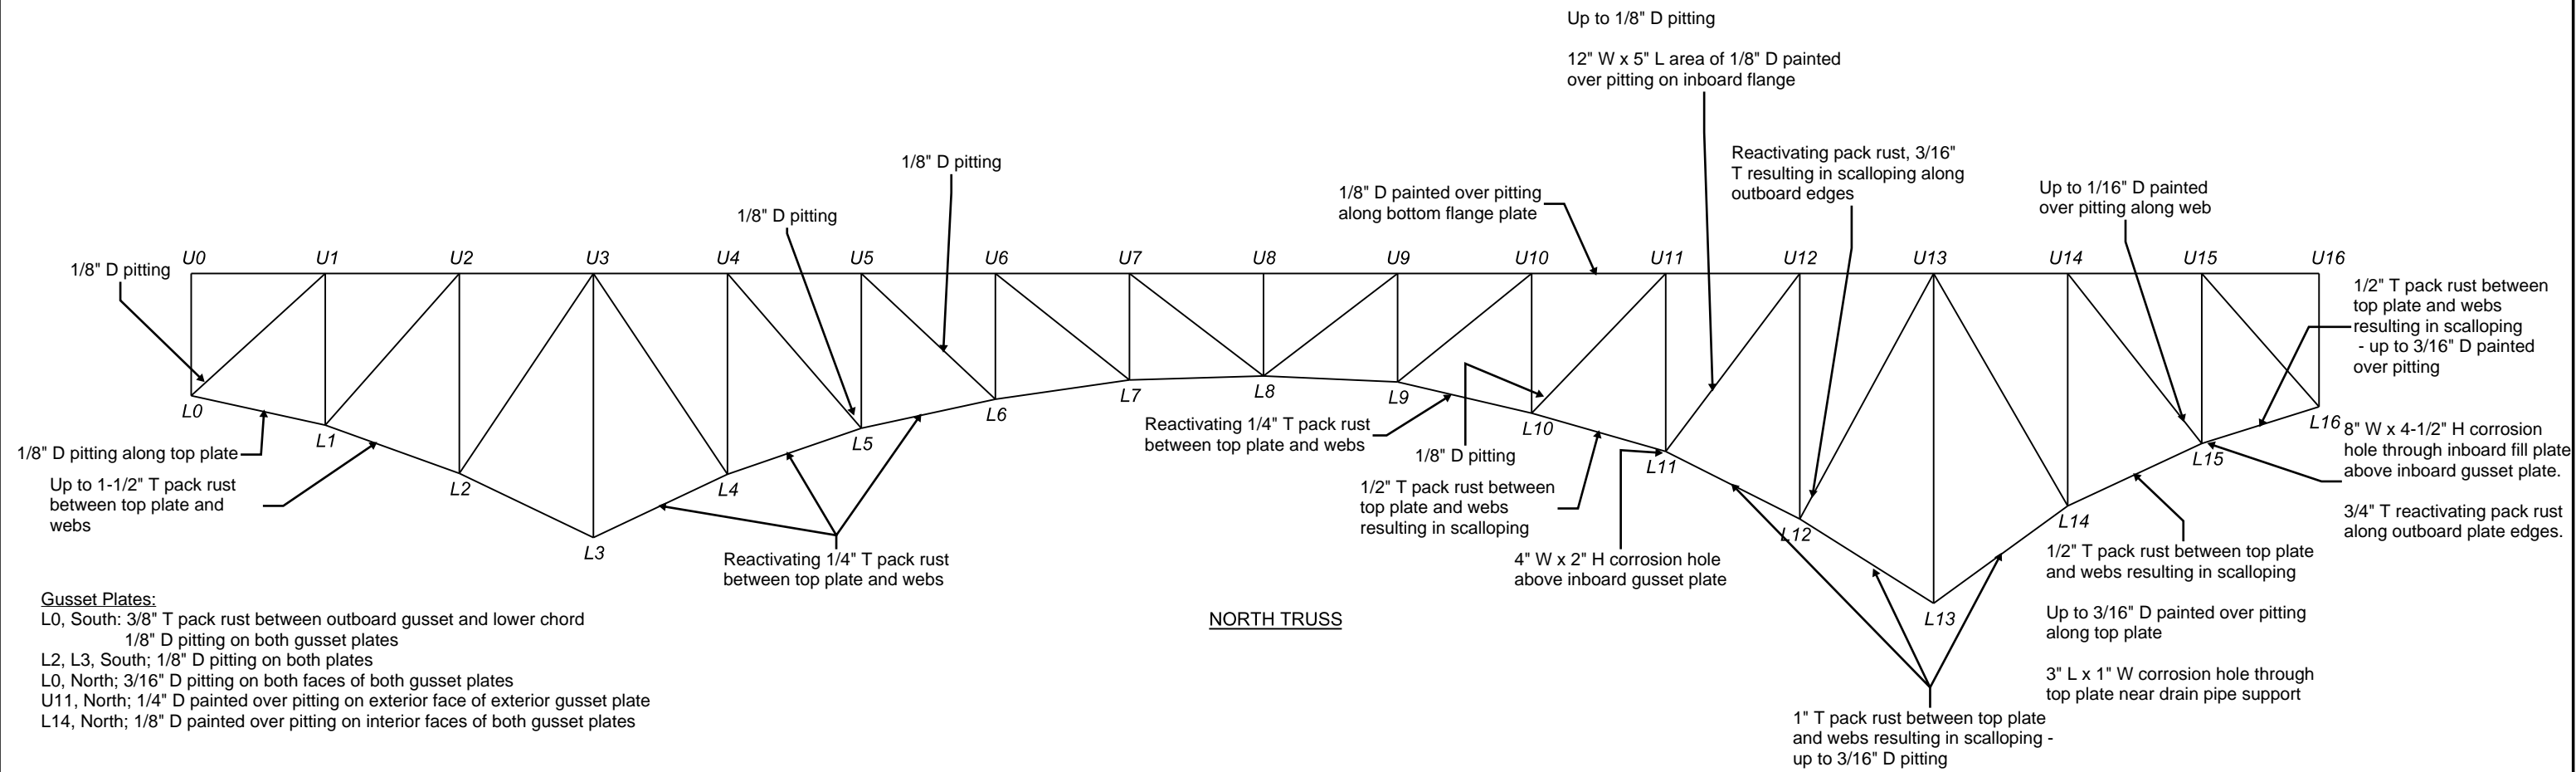
Gusset Plates:
 L0, South: 3/8" T pack rust between outboard gusset and lower chord
 1/8" D pitting on both gusset plates
 L2, L3, South; 1/8" D pitting on both plates
 L0, North; 3/16" D pitting on both faces of both gusset plates
 U11, North; 1/4" D painted over pitting on exterior face of exterior gusset plate
 L14, North; 1/8" D painted over pitting on interior faces of both gusset plates
