CUY-2-1441

PHYSICAL CONDITION REPORT ROUTINE AND FRACTURE CRITICAL INSPECTION OF MAIN AVENUE BRIDGE OVER THE CUYAHOGA RIVER SFN: 1800035

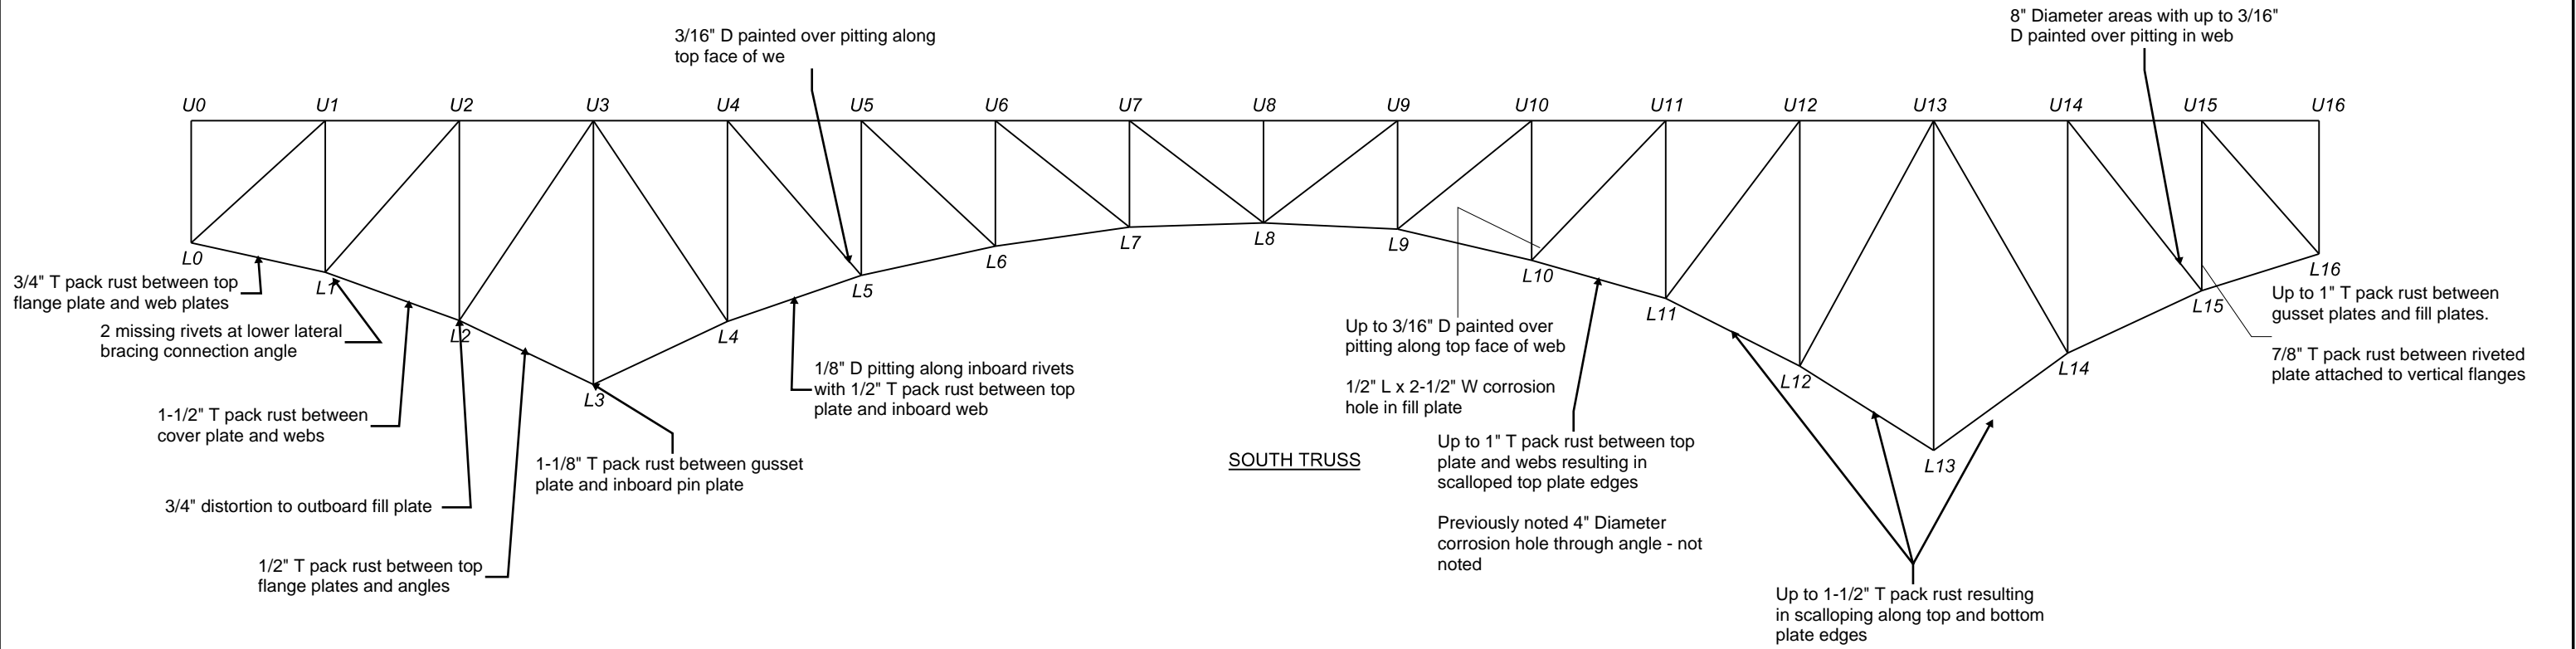
GRAPHIC SCALE MEASURED IN FEET	DATE	200 East Campus View Blvd. Suite 200 Columbus, OH 43235 PH.: 614.310.3048	MAIN AVENUE OVER CUYAHOGA RIVER BRIDGE NO. CUY-2-1441
NOT TO SCALE	DEC, 2017	INFRASTRUCTURE ENGINEERS, INC.	TRUSS ELEVATION - SPAN 2
			PAGE A-3

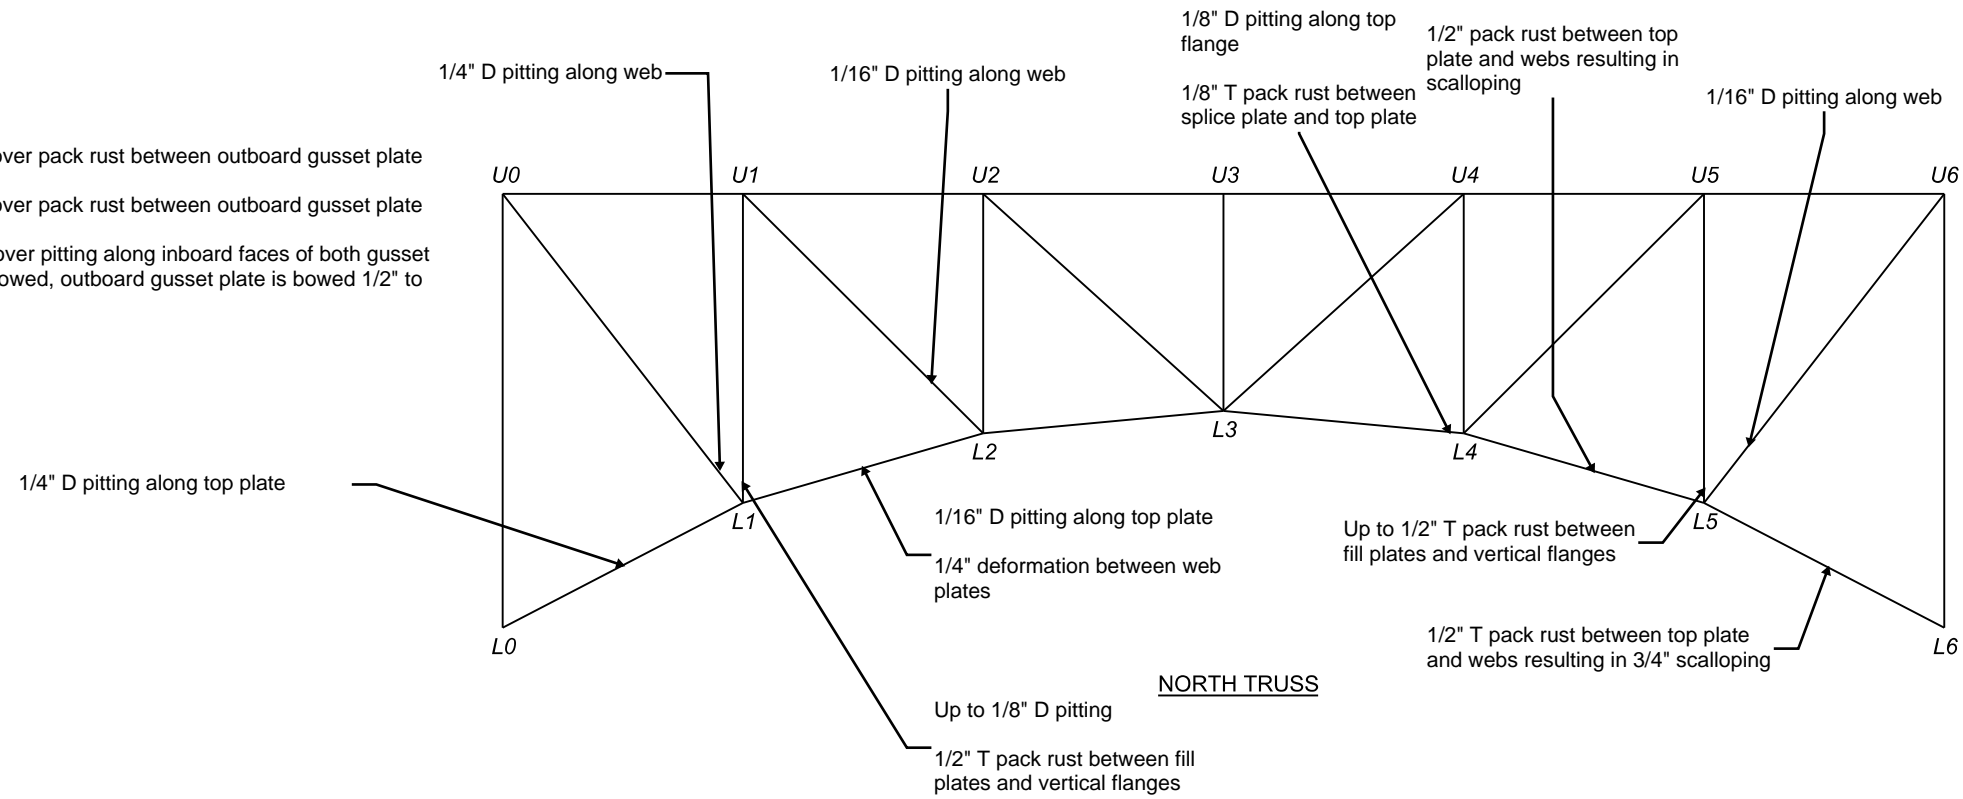
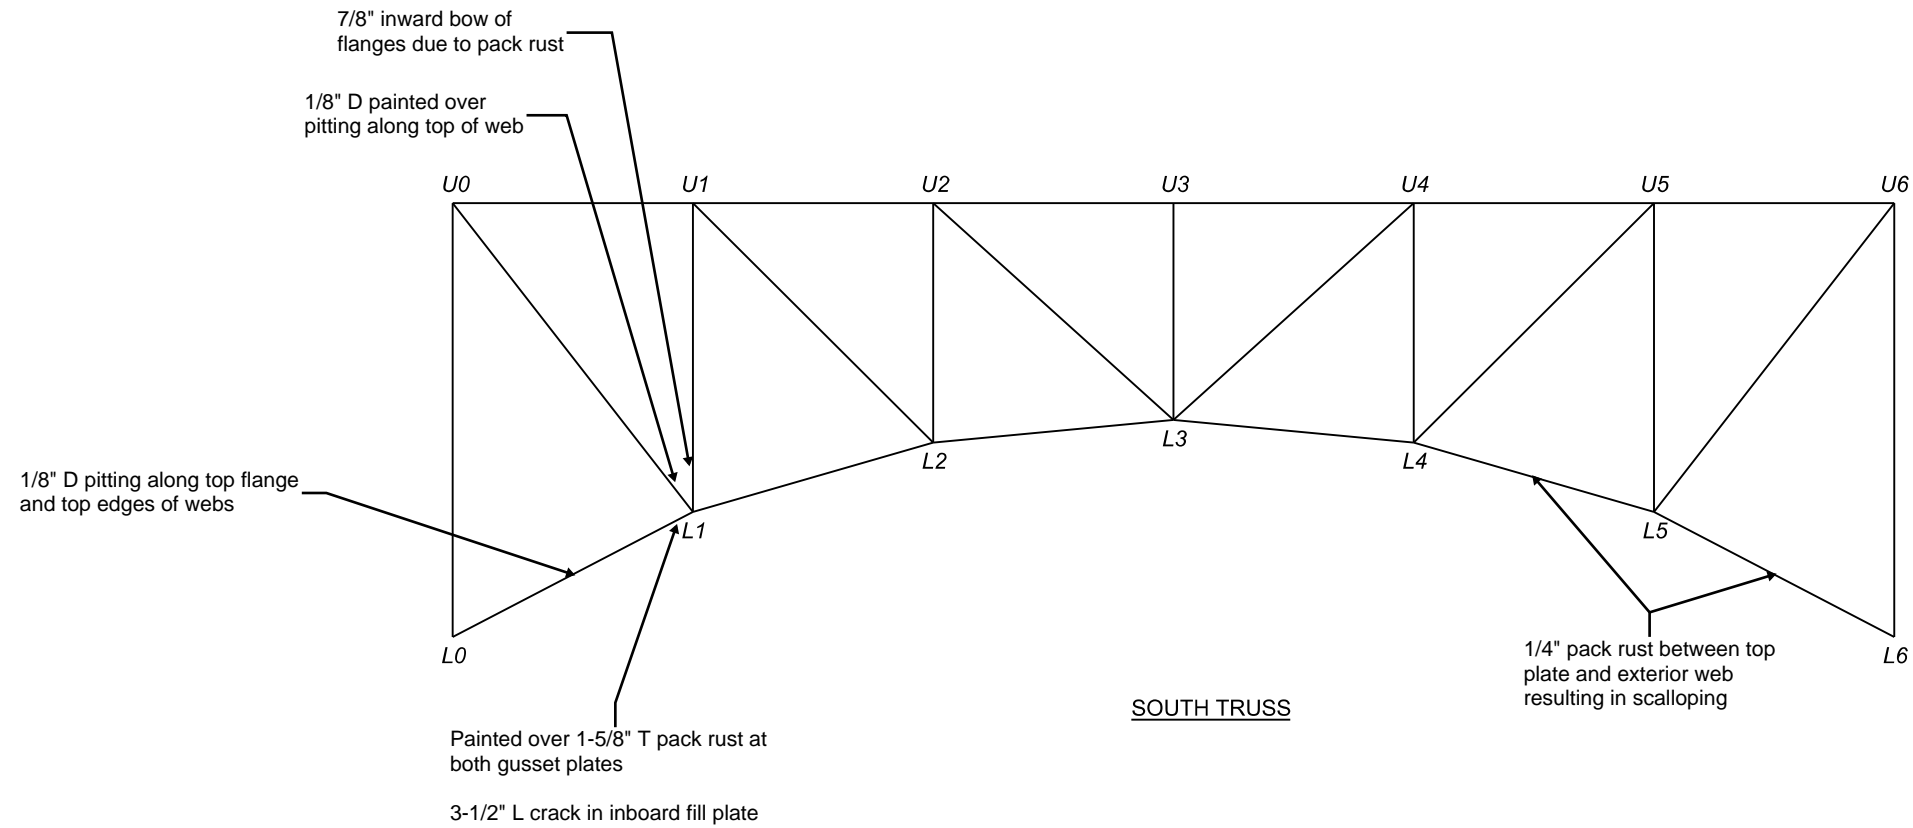
GRAPHIC SCALE MEASURED IN FEET	DATE

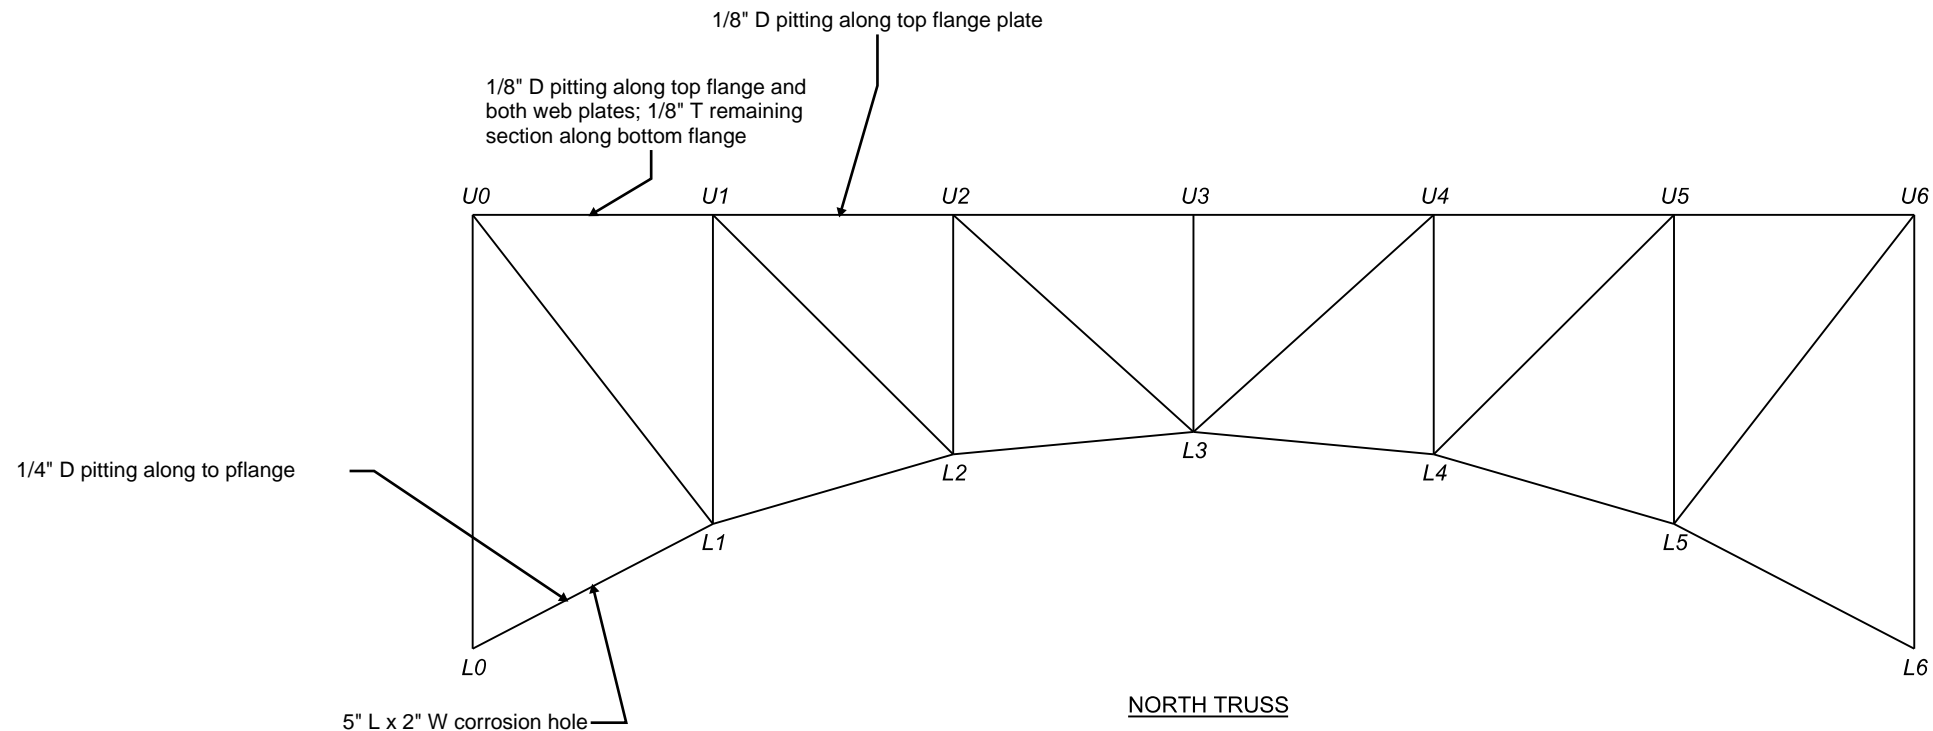
Gusset Plates:
 L3, South; 1/8" D pitting along outboard plate
 L0, North; 3/8" T pack rust distorting outboard gusset plate
 U1, North; 1/2" T pack rust distorting outboard gusset plate

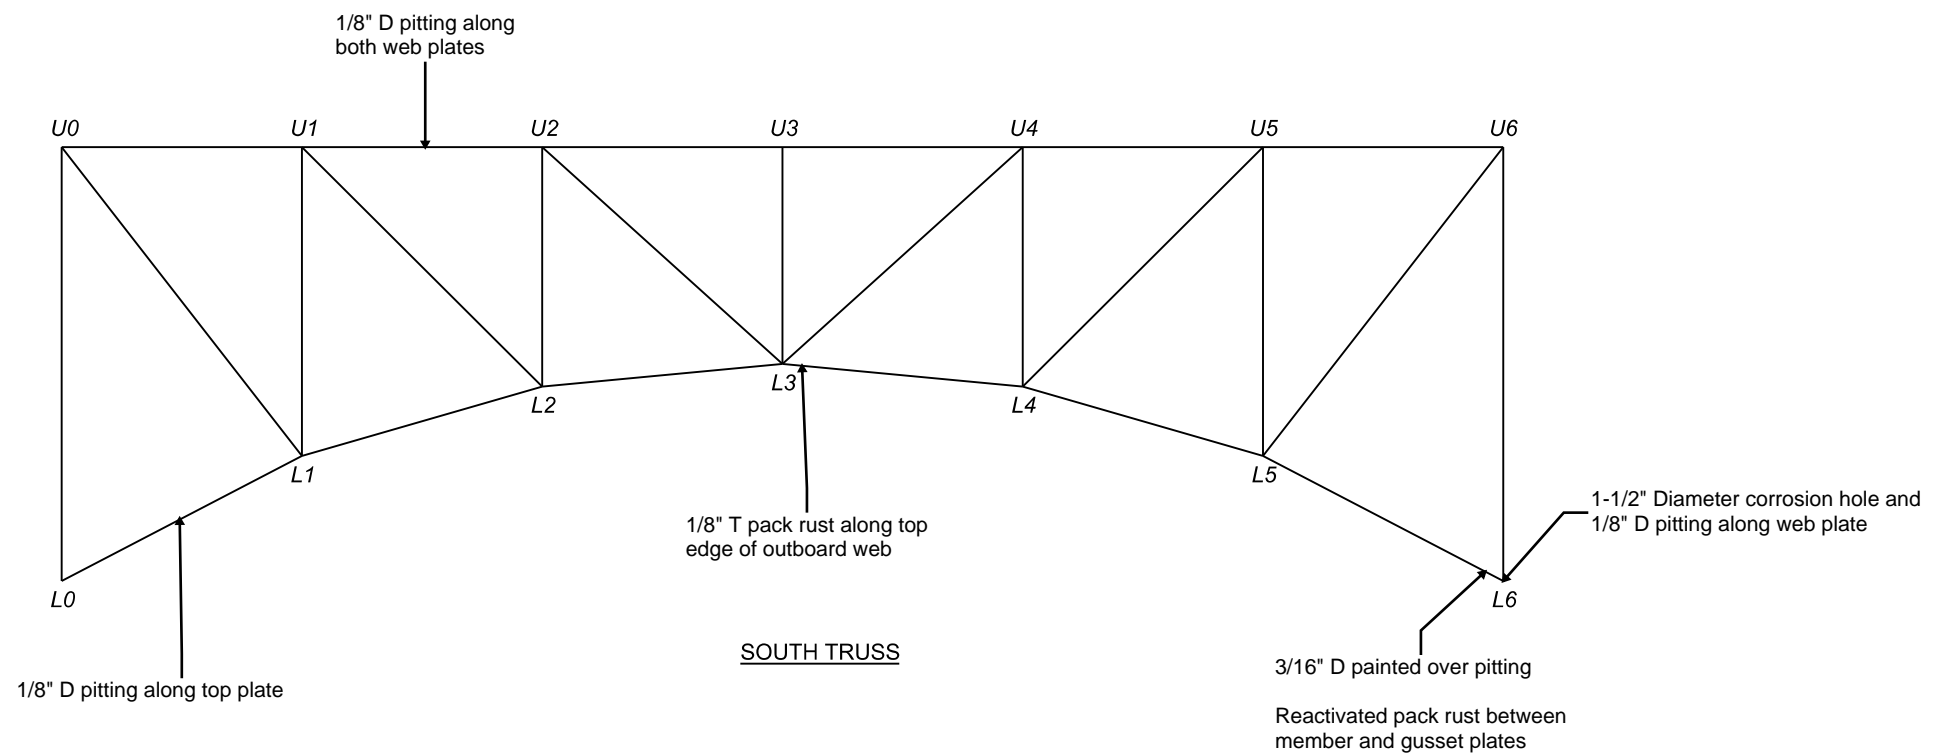
GRAPHIC SCALE MEASURED IN FEET	DATE

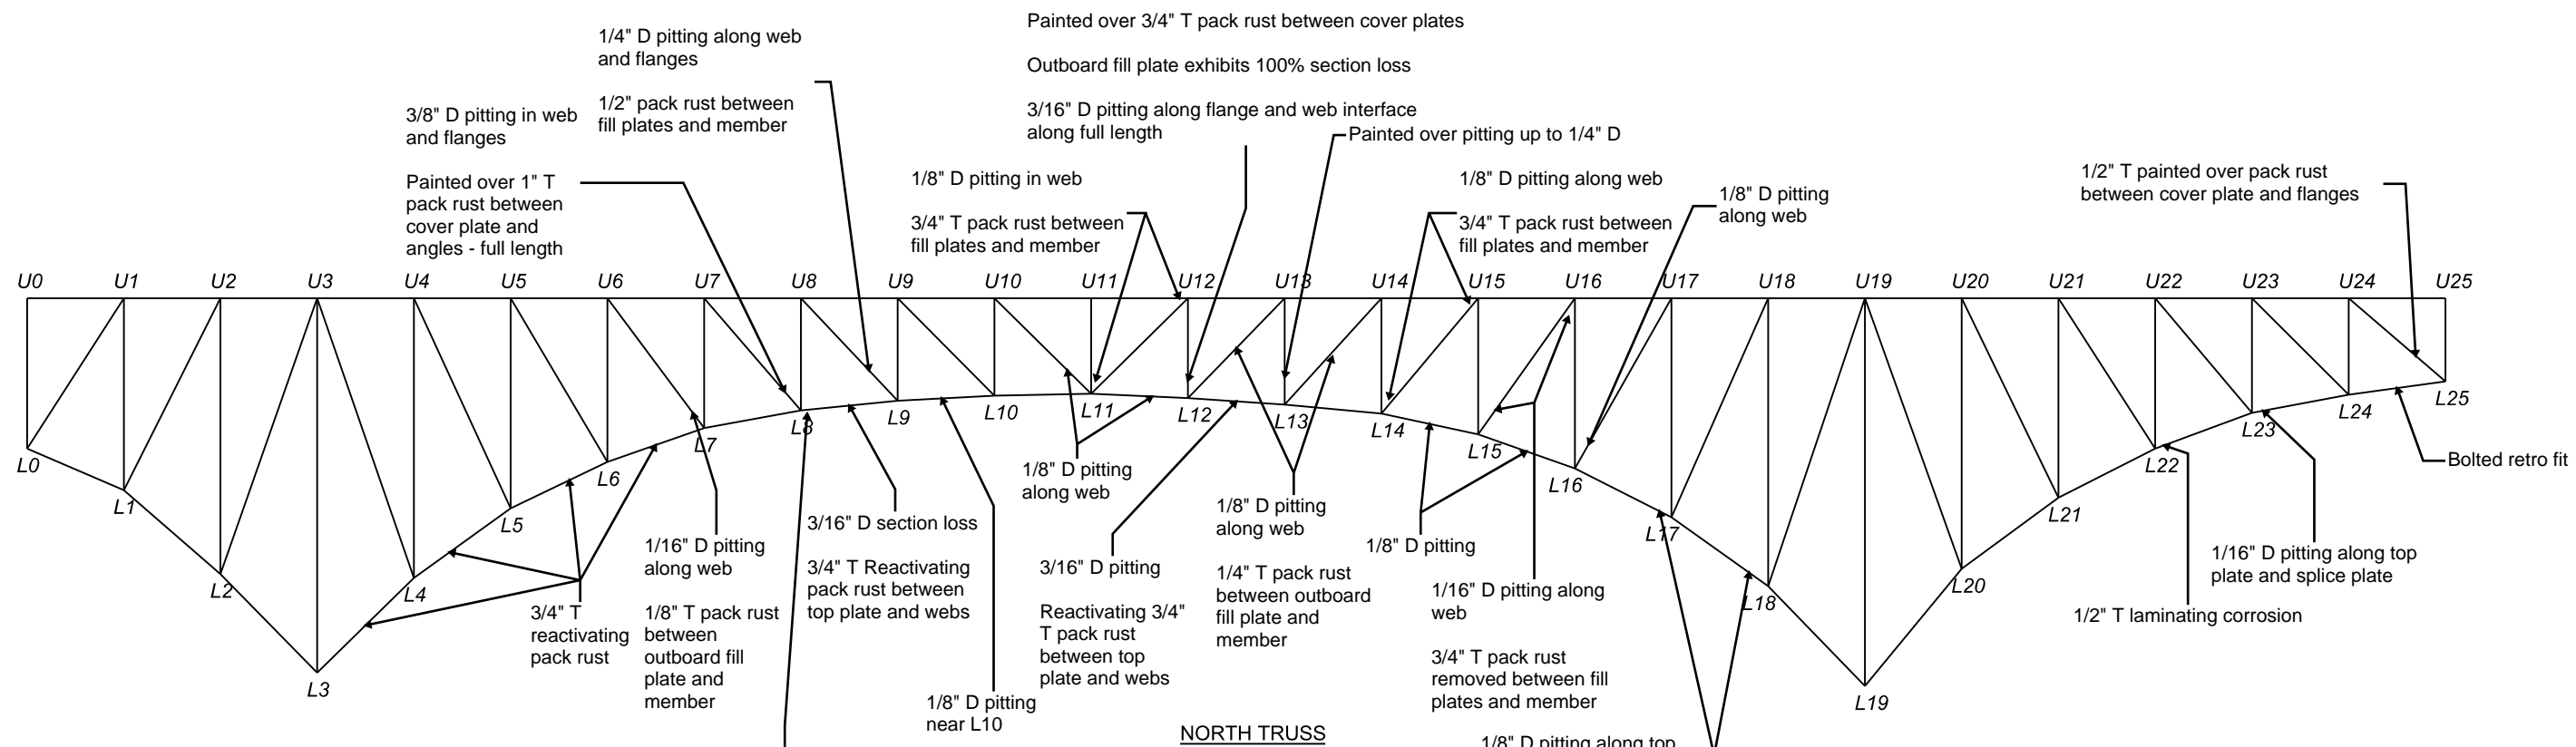
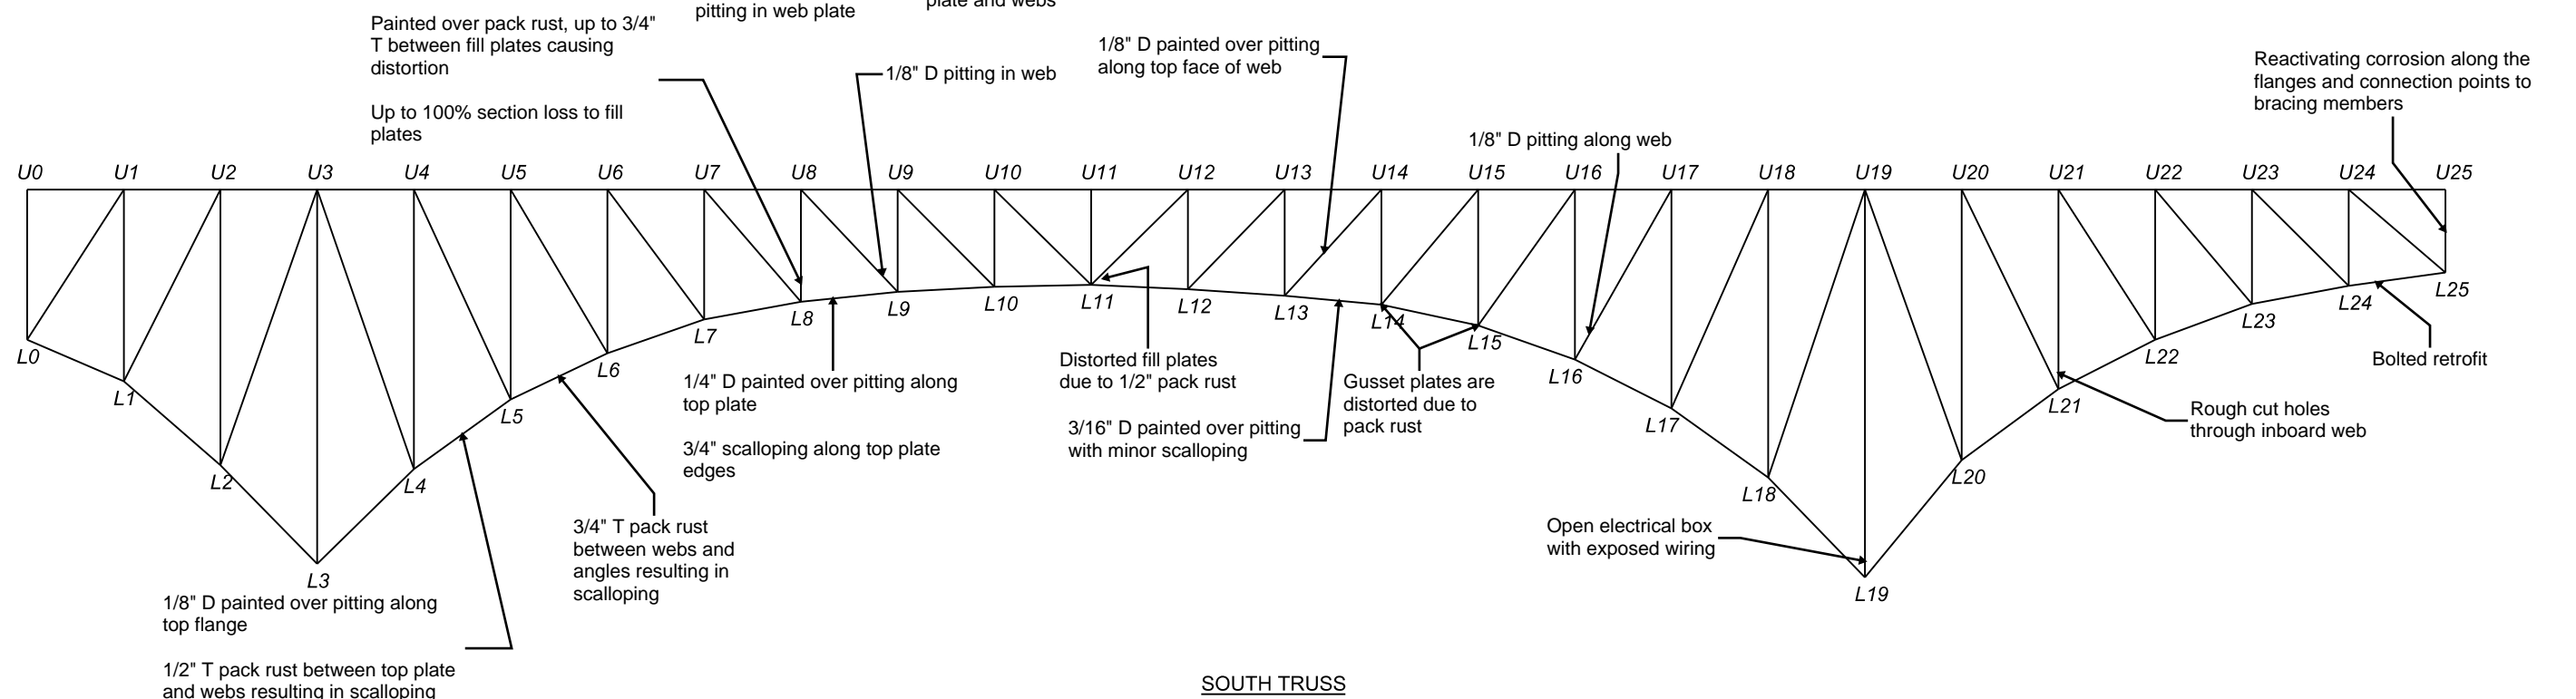
Gusset Plates:
 L4, L5, L6, South; 1/2" T pack rust between outboard gusset and lower chord
 L8, L9, South; 1/8" D painted over pitting on inboard gusset plate
 U16, South; 3/16" D painted over pitting on outboard gusset plate
 L16, South; 1/8" D painted over pitting on inboard gusset plate, inboard face
 L25, South; 1-1/4" T reactivated pack rust between gusset plates and vertical
 L8, North; 1/8" T pack rust along top of gusset plates
 U10, North; Rolling defect on outboard gusset plate
 L13, North; 1/8" D pitting in both gusset plates
 L16, North; 1/8" D pitting in both gusset plates
 L25, North; 1/8" D pitting in both gusset plates

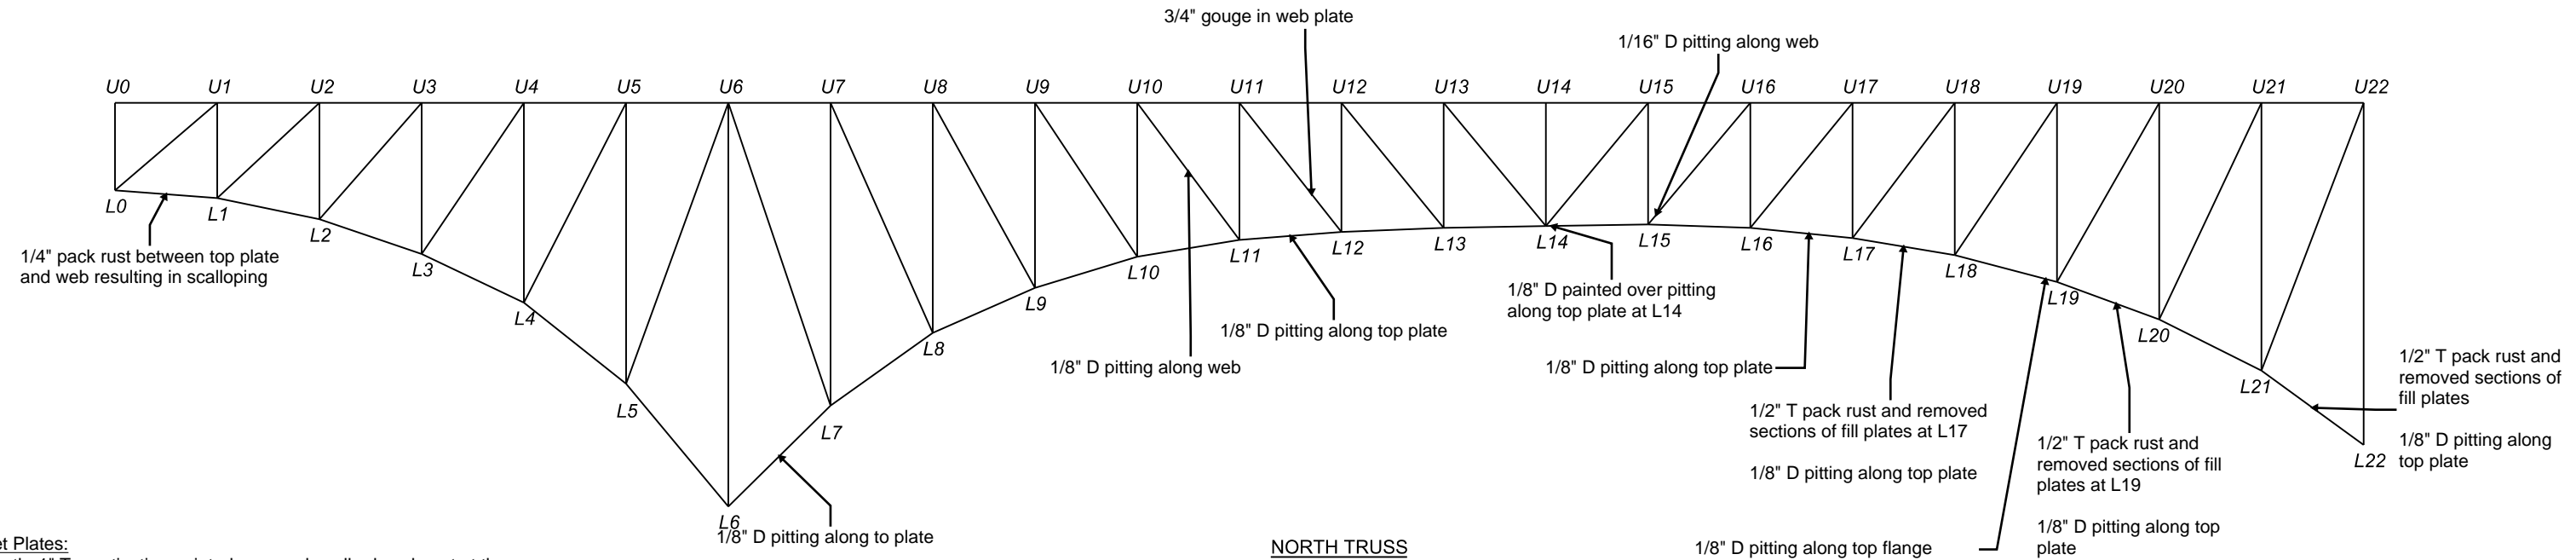
200 East Campus View Blvd. Suite 200 Columbus, OH 43235 PH.: 614.310.3048	MAIN AVENUE OVER CUYAHOGA RIVER BRIDGE NO. CUY-2-1441	
NOT TO SCALE	DEC, 2017		INFRASTRUCTURE ENGINEERS, INC.	TRUSS ELEVATION - SPAN 9

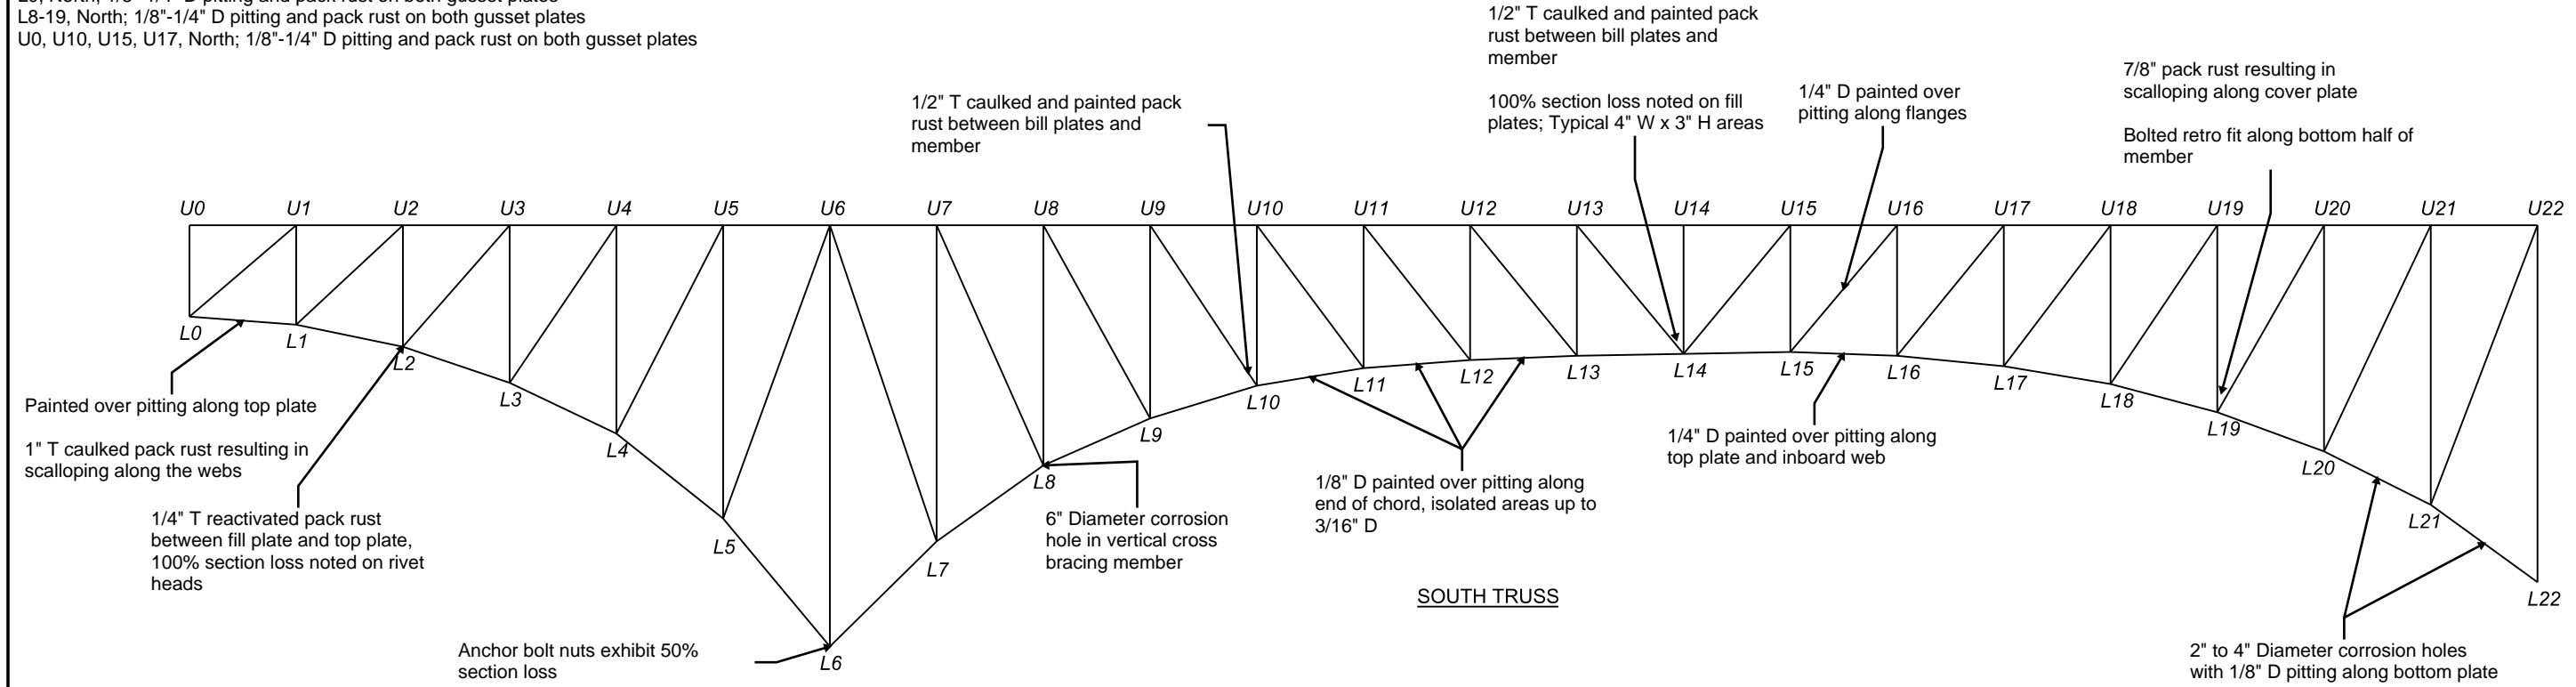
- Gusset Plates:
 L0, South; 1" T reactivating painted over and caulked pack rust at the corners
 1/4" T pack rust between both gusset plates and vertical, 1/8" D painted over pitting
 L1, South; 1/8" T painted and caulked pack rust between outboard gusset plate and lower chord
 U15, South; 1/4" D pitting in both gusset plates
 L22, South; 1/4" D painted over pitting on both gusset plates
 L0, North; 1/8"-1/4" D pitting and pack rust on both gusset plates
 L8-19, North; 1/8"-1/4" D pitting and pack rust on both gusset plates
 U0, U10, U15, U17, North; 1/8"-1/4" D pitting and pack rust on both gusset plates

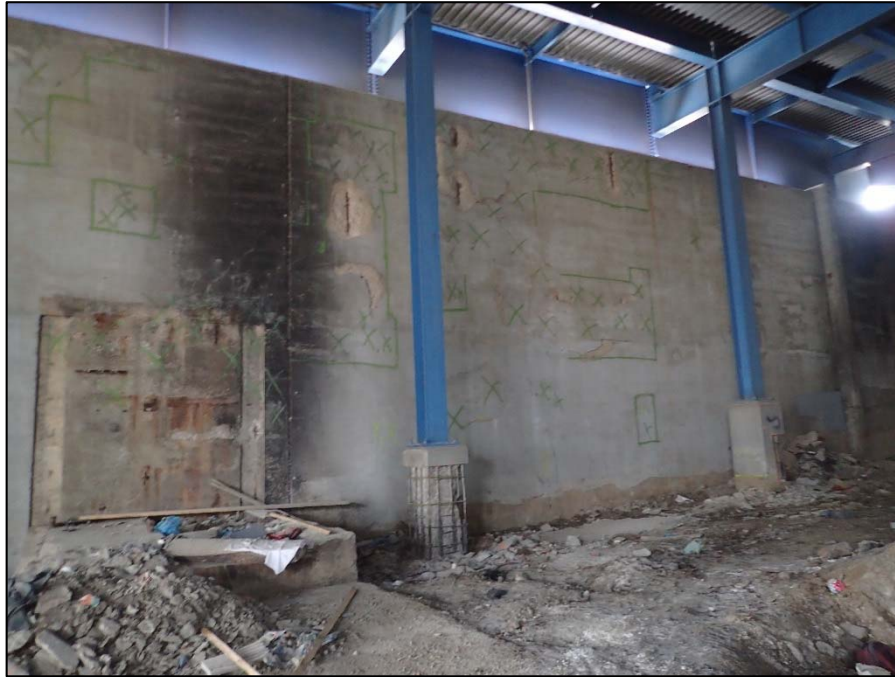
Photo 37 – Unit I, Section N; Southeast curtainwall is mapped out with areas of delaminations and spall to be repaired

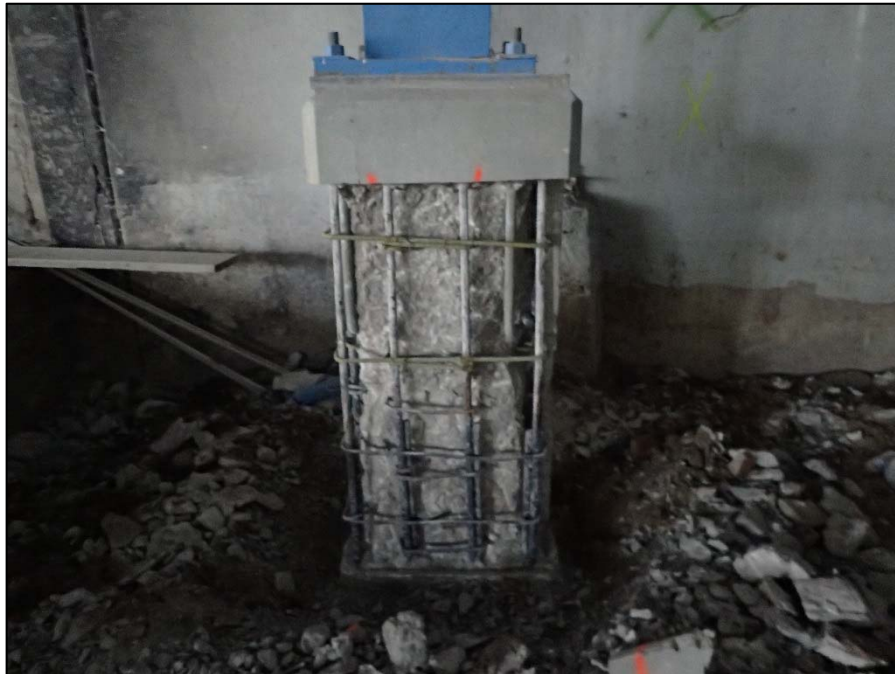
Photo 38 – Unit I, Section N, Frame 8; Active rehabilitation of frame base

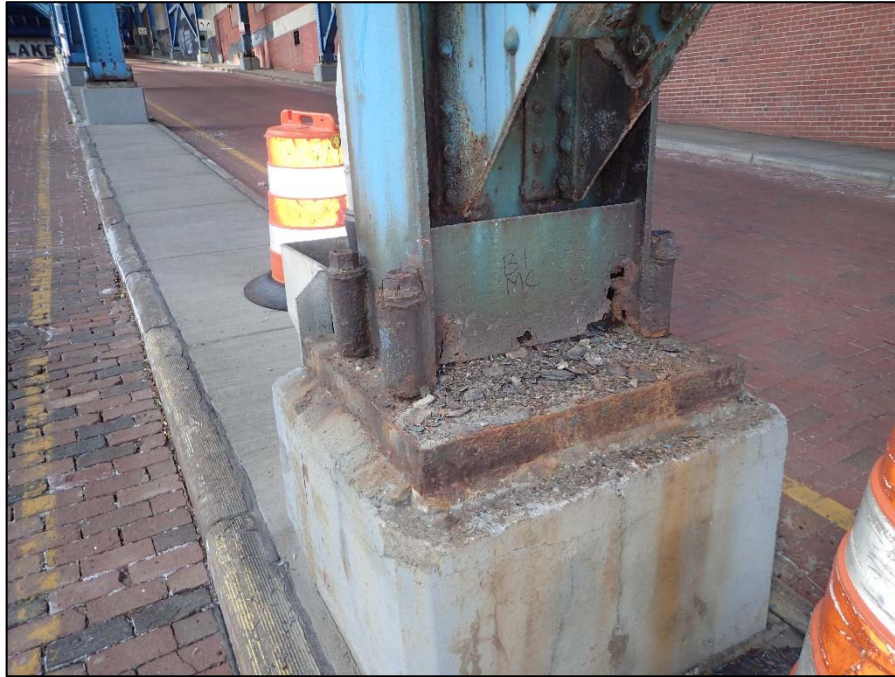
Photo 41 – Unit III, Framed and Braced Column; Bent 1, middle column; 8" H x 6" W corrosion hole in the stay plates

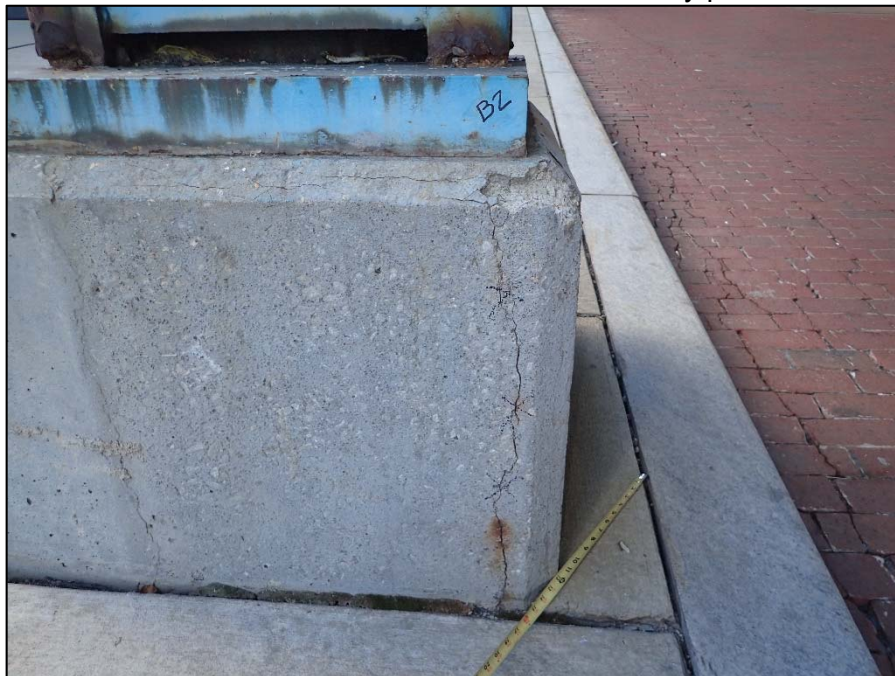
Photo 42 – Unit III, Framed and Braced Column; Bent 2, north column; Full Height x 1/16" W vertical crack on the southwest corner

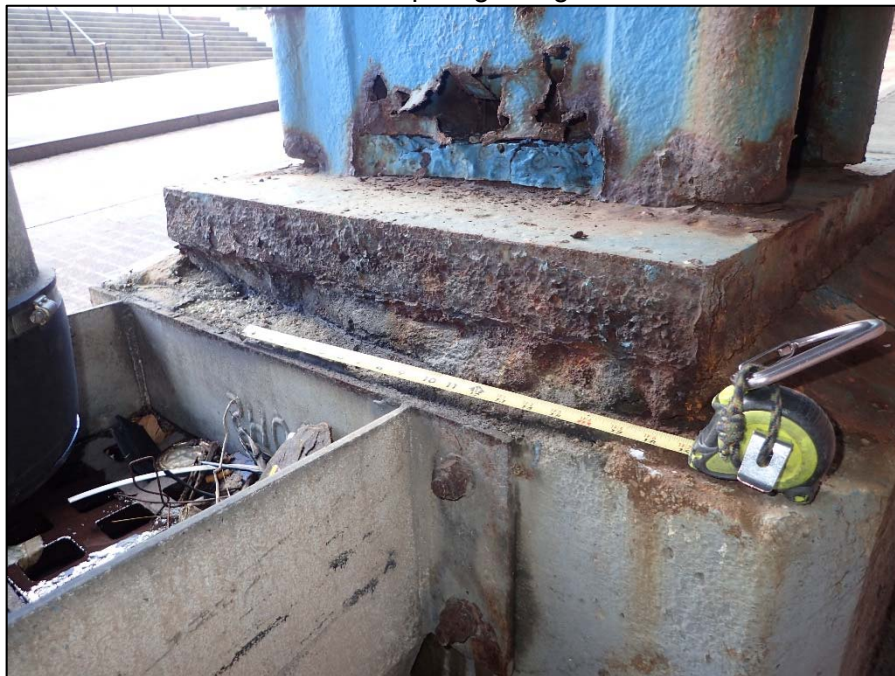
Photo 44 – Unit III, Frame and Braced Column, Bent 4; North column has a Full Length x 3" H x up to 1" D spall with 1/2" D undermining

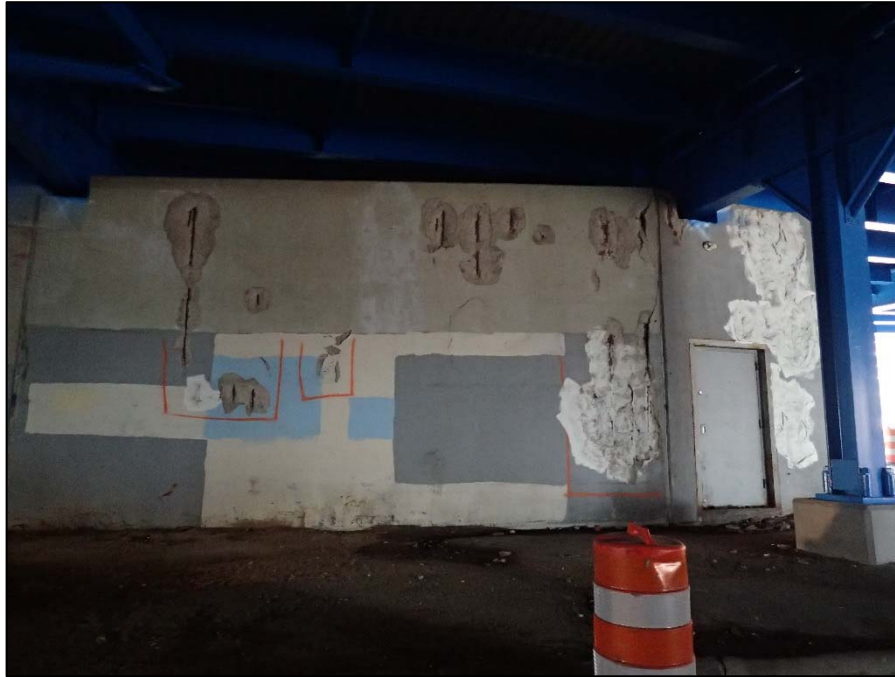
Photo 45 – Unit IV; West Lakeside entrance ramp; West face of south wall exhibits multiple spalls with exposed reinforcement

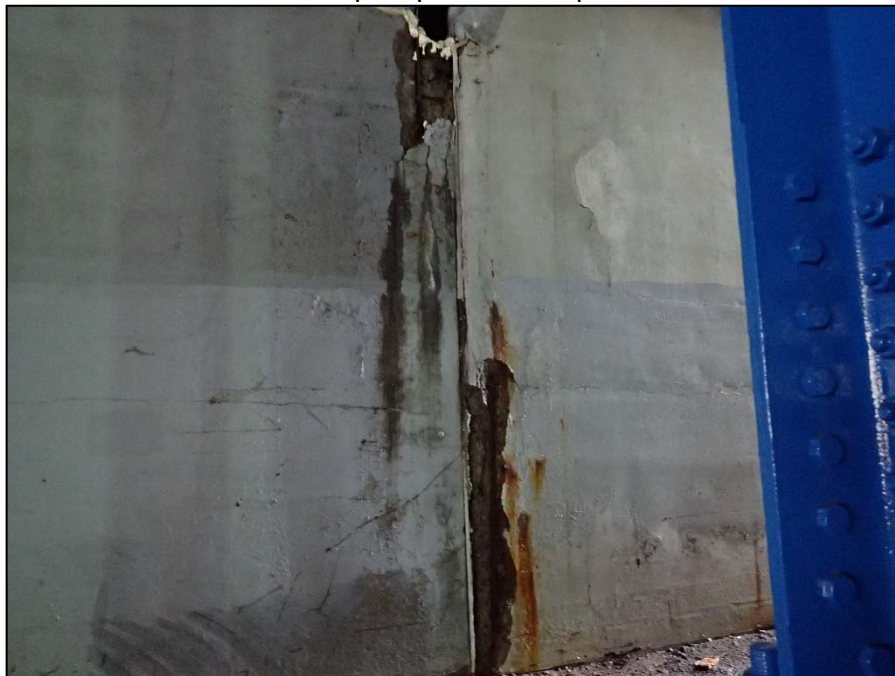
Photo 46 – Unit IV, West Lakeside exit ramp; South wall exhibits spalling with exposed reinforcement and delaminations

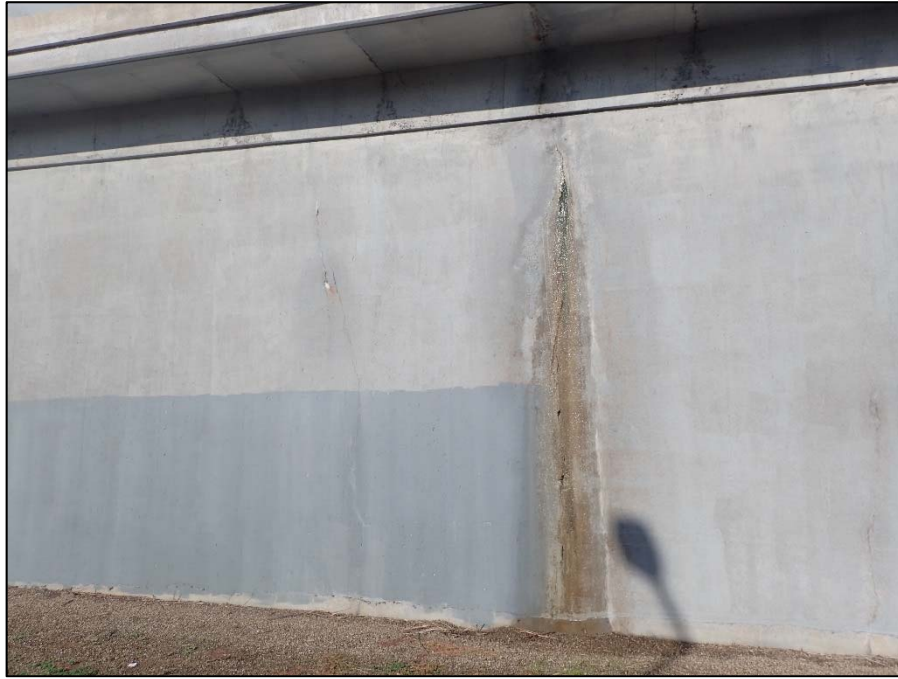
Photo 47 – Unit V, East abutment, South wingwall; Full Height vertical cracking with moisture staining and efflorescence spaced 10'-15' apart
