CUY-2-1441

PHYSICAL CONDITION REPORT ROUTINE INSPECTION OF MAIN AVENUE BRIDGE OVER THE CUYAHOGA RIVER SFN: 1800035

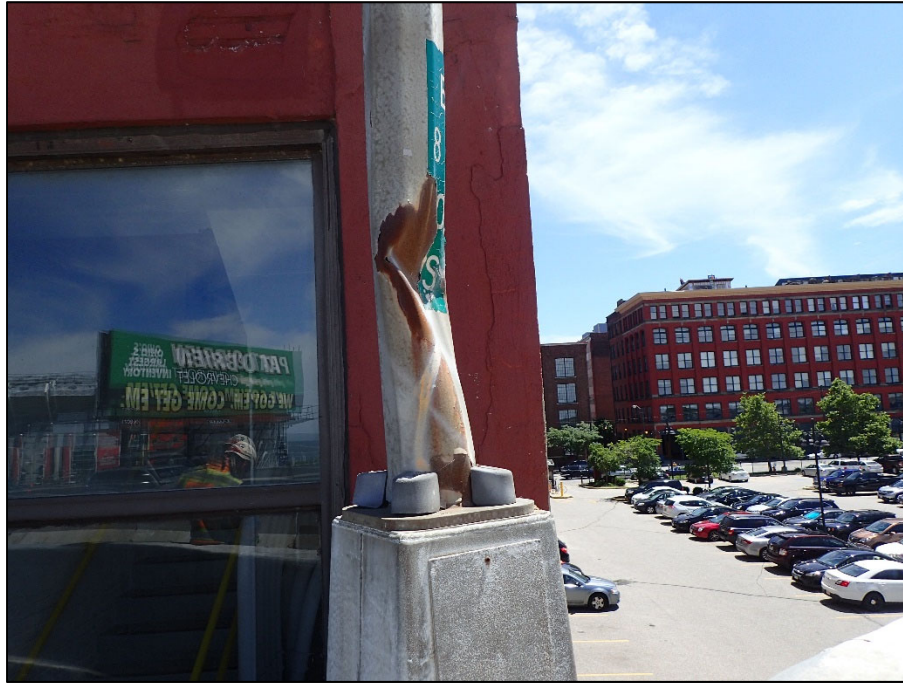
Photo 1 – Joint B2, East parapet; damaged light post

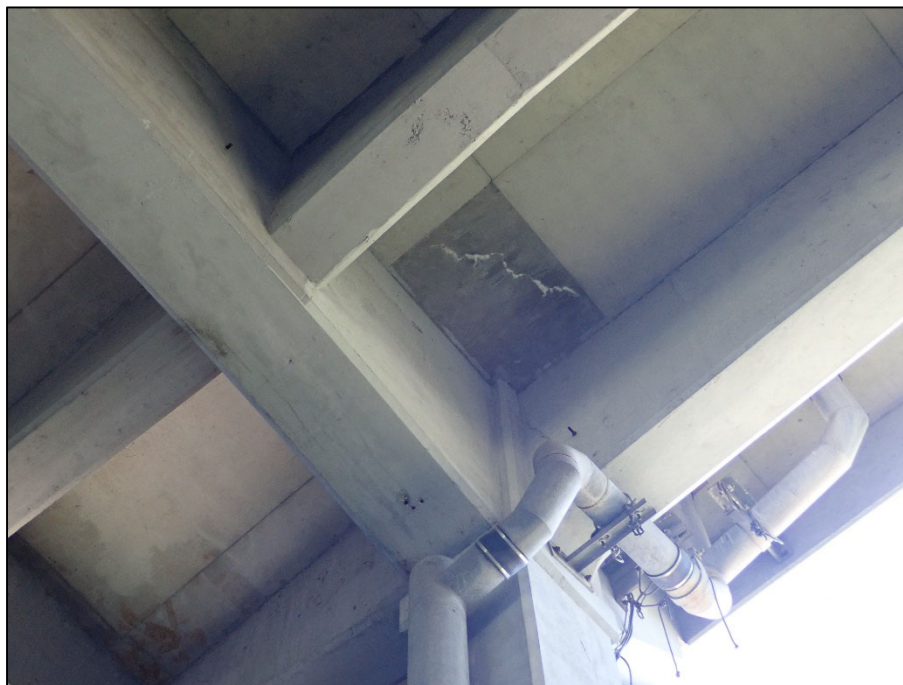
Photo 2 – Unit I, Section P; Transverse cracking with efflorescence

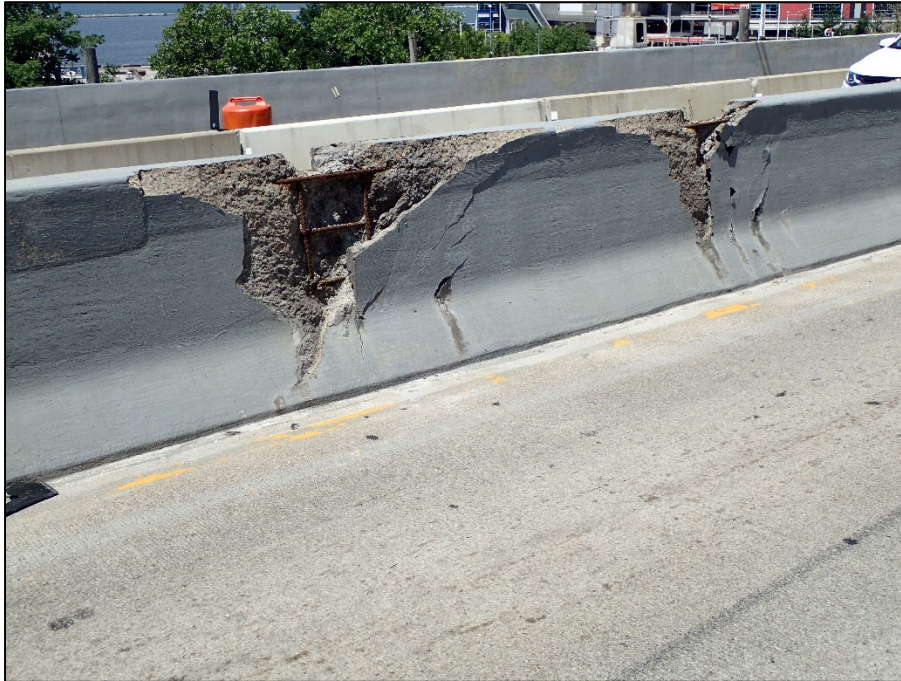
Photo 3 – Unit IV, Section E; Spalling along full height of median, South face

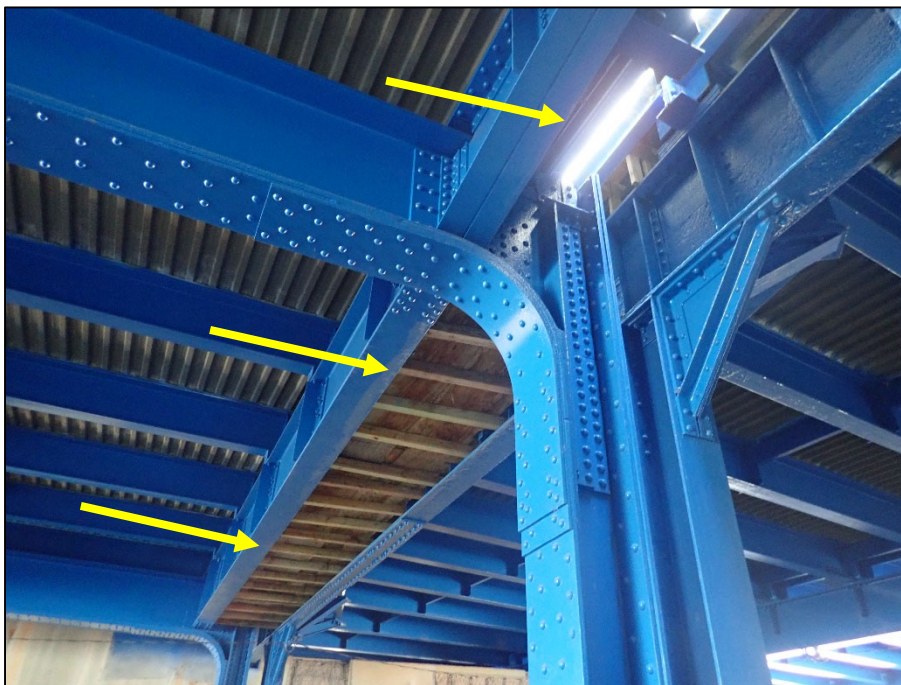
Photo 4 – Section IV, Joint C; Joint being replaced

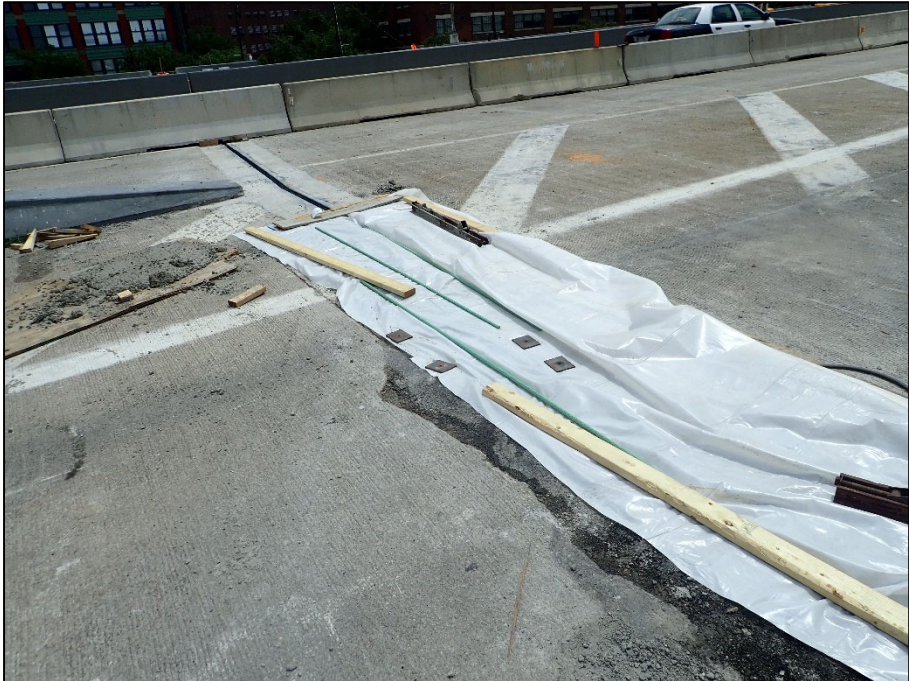
Photo 5 - Section IV, Joint C; Joint being replaced

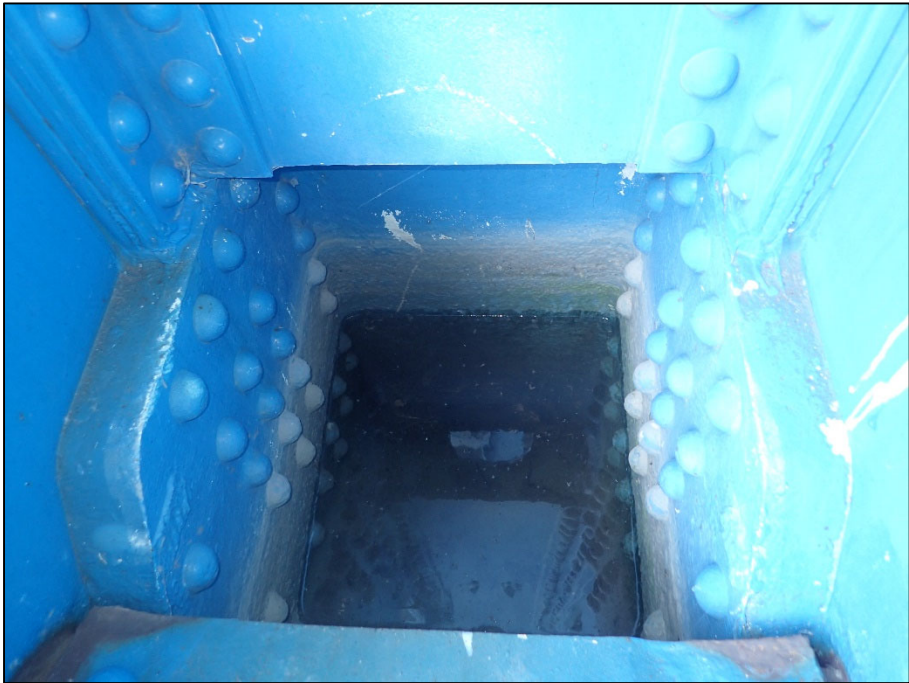
Photo 6 – Unit II, Span 4, L2 bearing; full of water

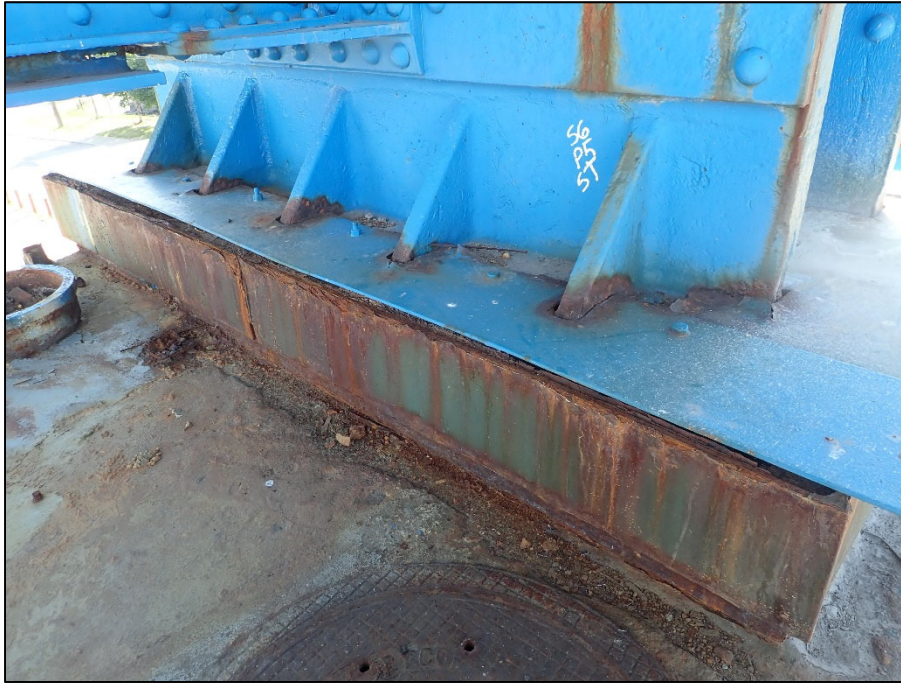
Photo 7 – Unit II, Pier 5, South bearing; moderate surface corrosion along vertical steel box sides

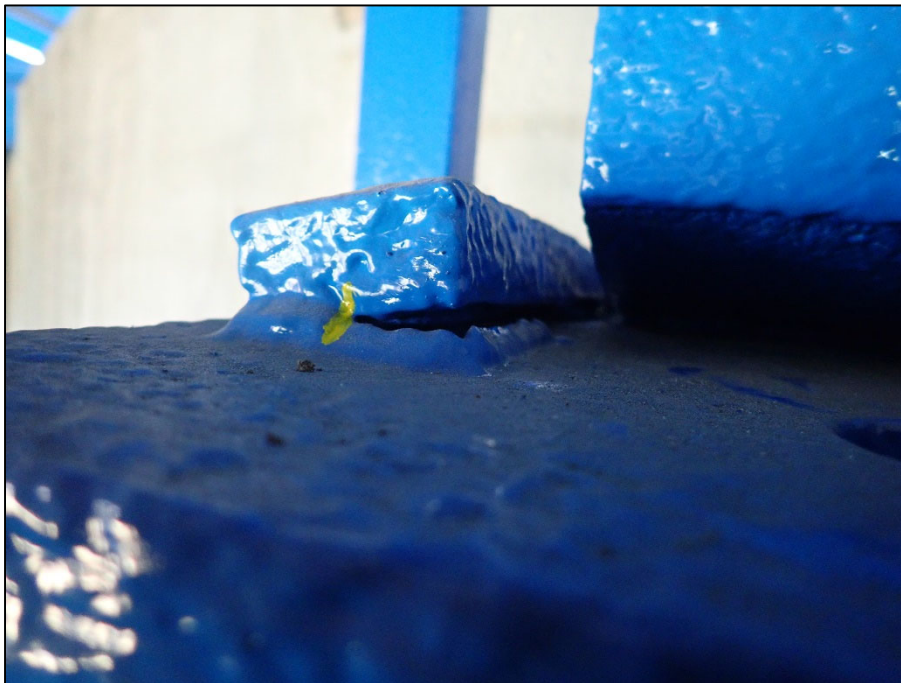
Photo 8 – Unit I, Section N, Floorbeam 8; south guide bar of north bearing is cracked

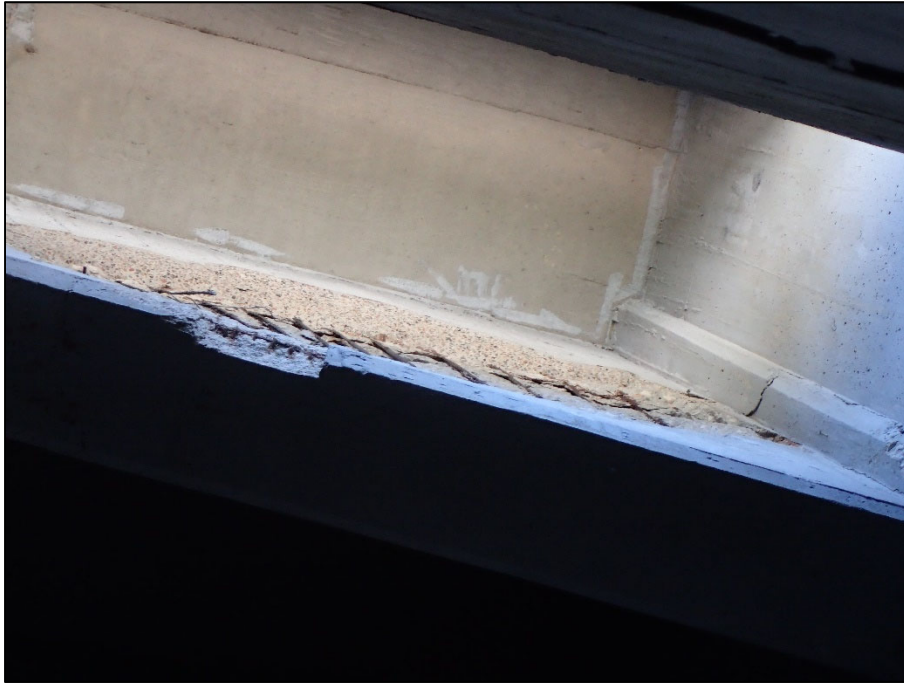
Photo 9 – Unit I, Section P, Frame 1, Floorbeam 2; Full Height x Full Width x 2" D spall with exposed rebar along south end

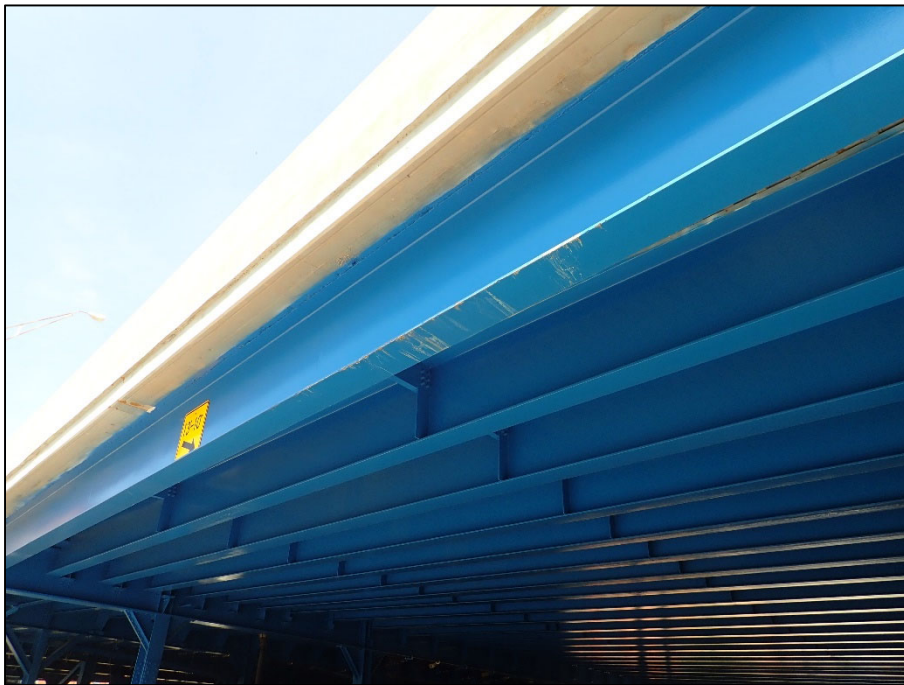
Photo 10 – Unit III, Bent 11/12; Stringer 1 with chipped paint on bottom flange over 9th Street

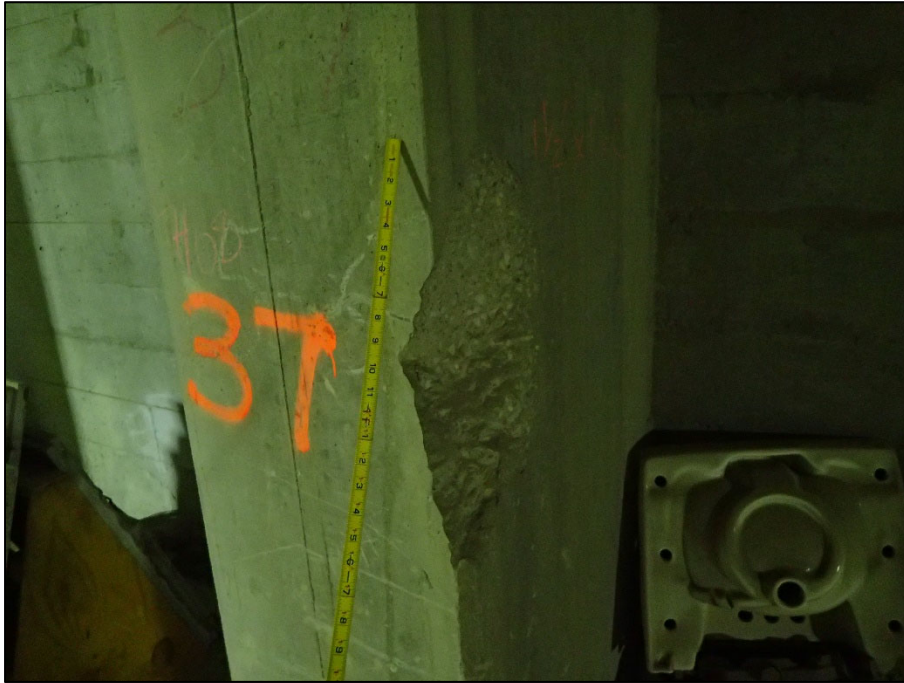
Photo 11 – Unit I, Section D, Frame 37; North column with 1'-10" H x 1' W x 3" D spall

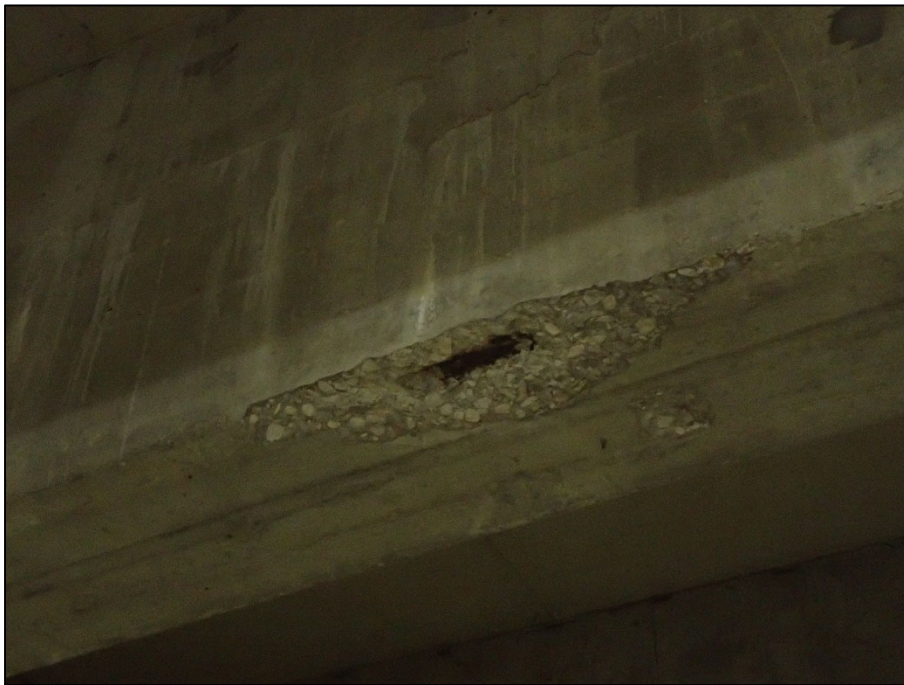
Photo 12 – Unit I, Section M, Frame 12; 2' L x 6" W x 3" D spall

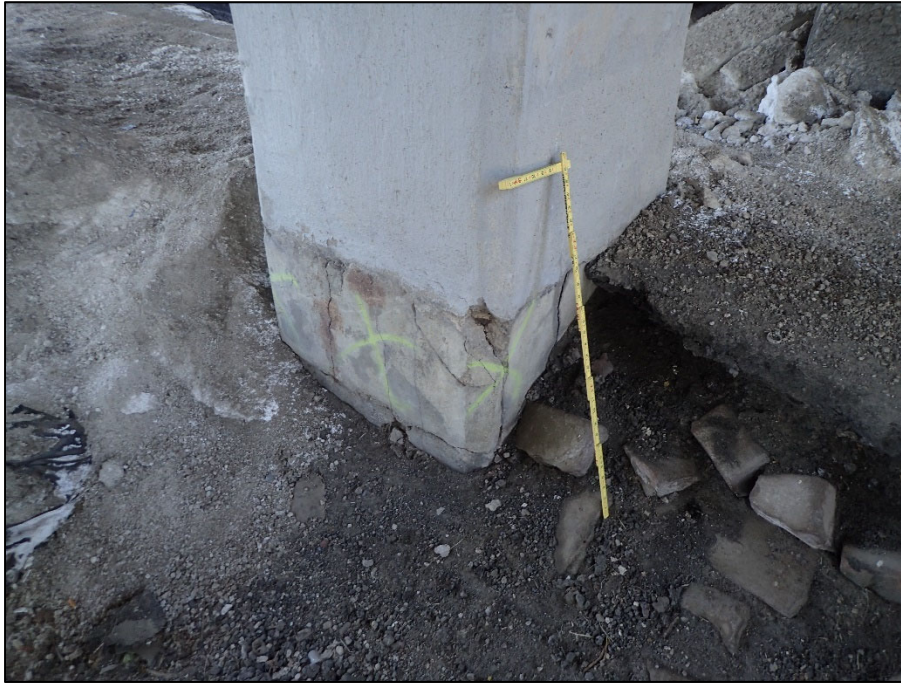
Photo 13 – Unit I, Section P, Pier 2; base of column marked for repair

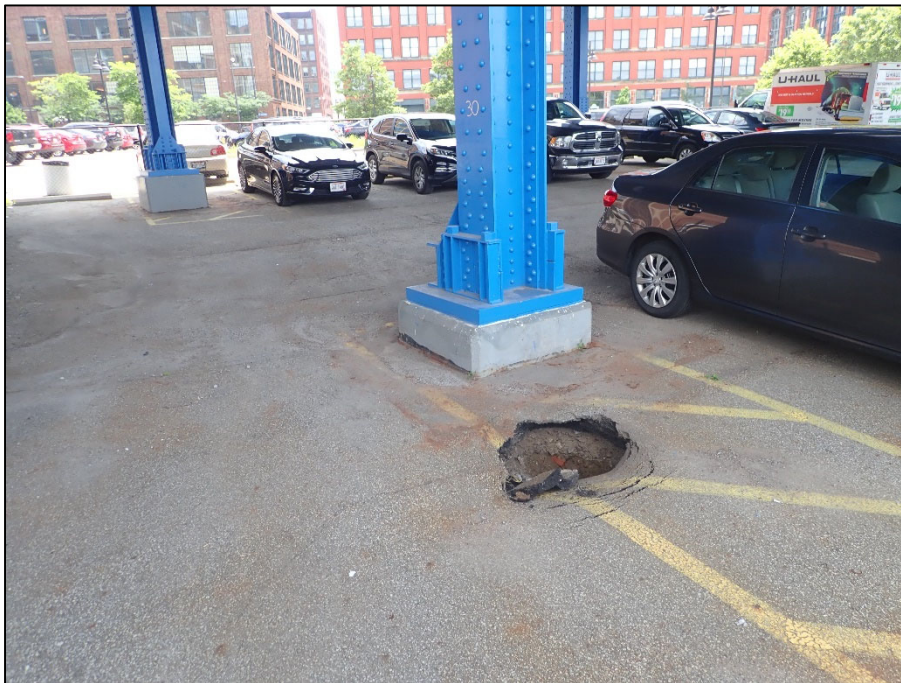
Photo 14 – Unit IV, Bent 30; 3' Diameter x 3' D sink hole near North column

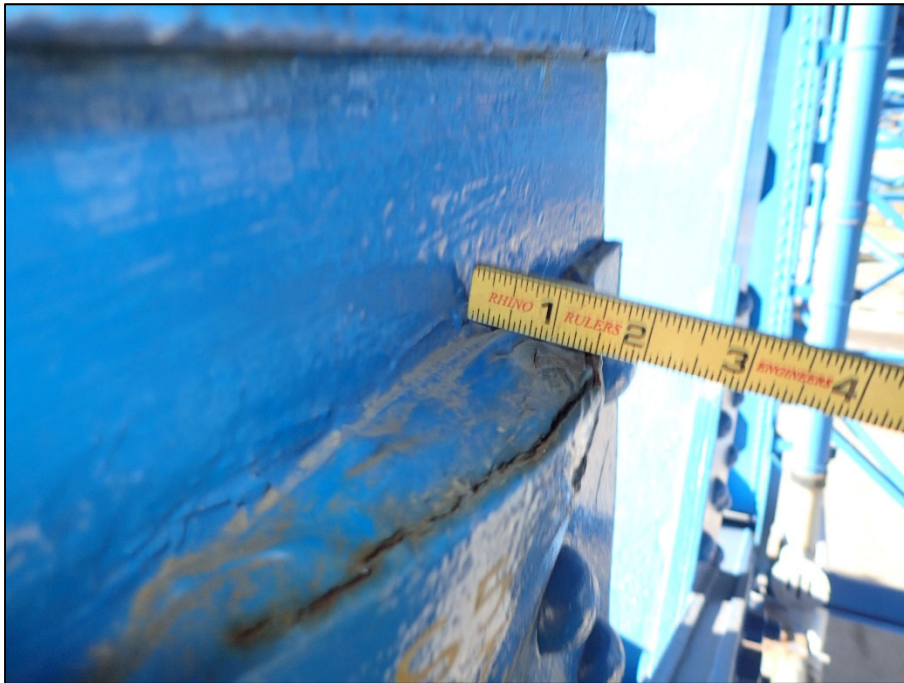
Photo 15 – Unit II, Span 5, South truss at L1; 1-5/8" T painted over pack rust on inboard fill plate

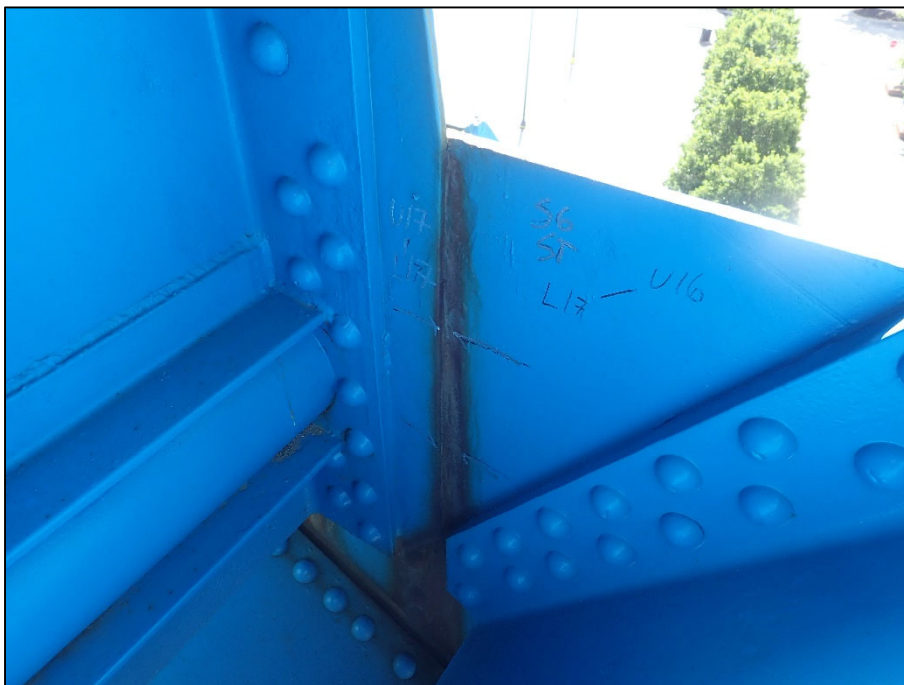
Photo 16 – Unit II, Span 6, South truss at L17; 3/8" T pack rust between outboard gusset and vertical

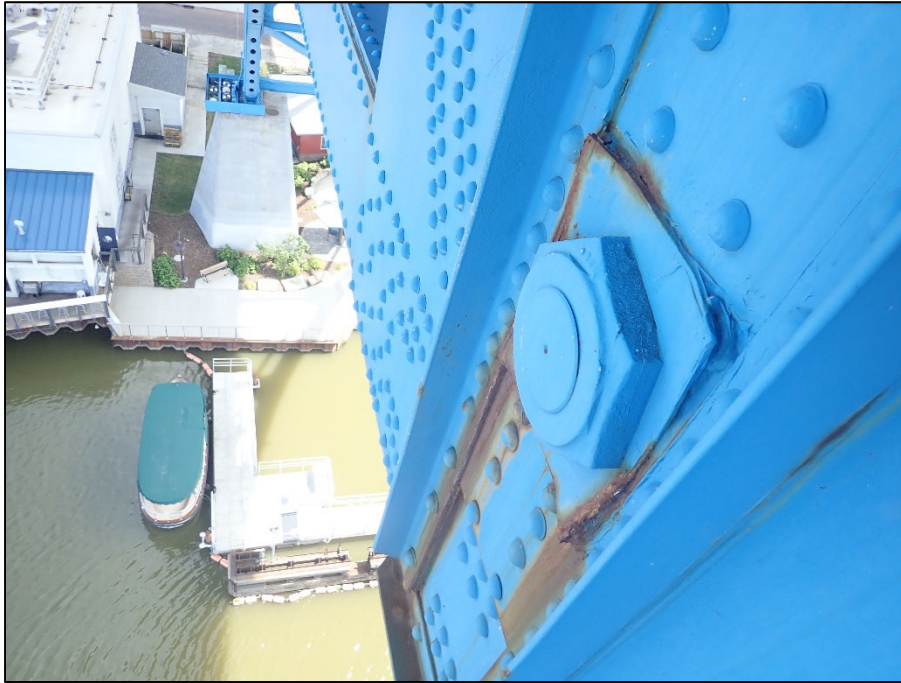
Photo 17 – Unit II, Span 9, North truss at L8; 1" T pack rust between outboard pin plate and vertical

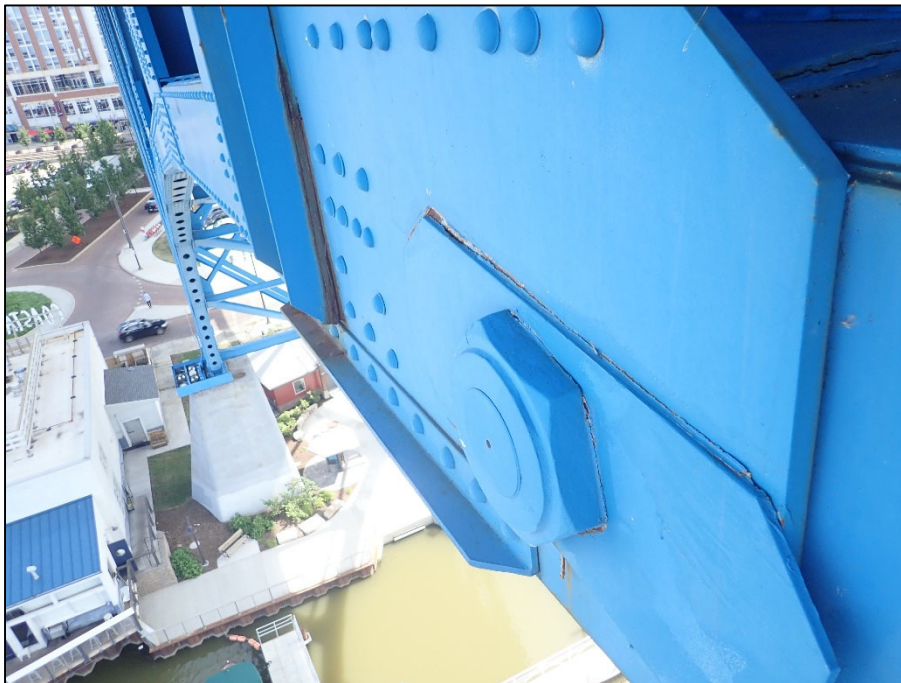
Photo 18 – Unit II, Span 6, South truss at L5; deteriorated caulk along outboard face

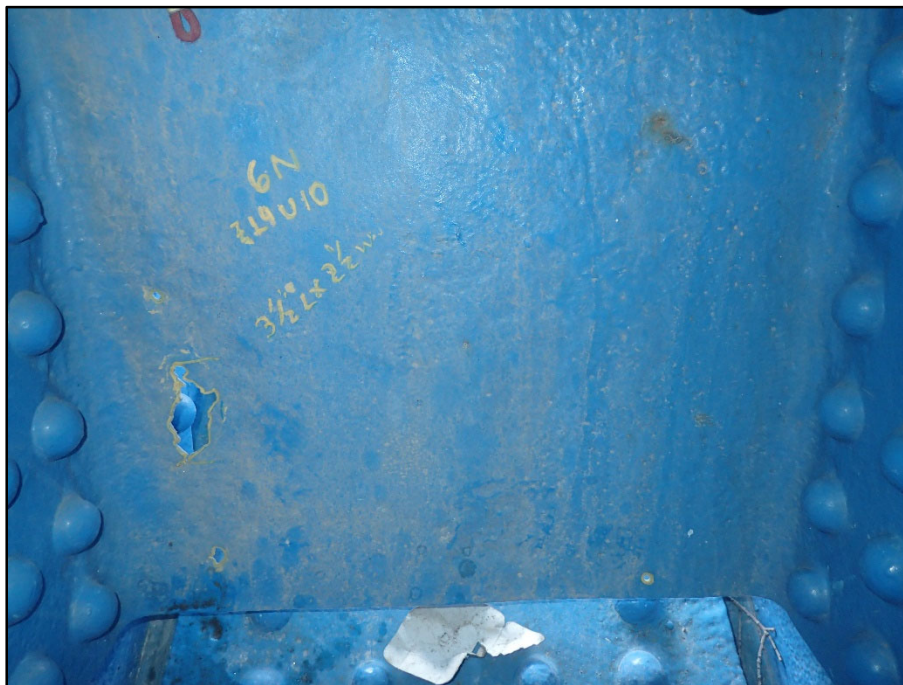
Photo 20 – Unit II, Span 6, North truss at L9; 3-1/2" L x 2-1/2" W corrosion hole with adjacent 1/2" Diameter holes

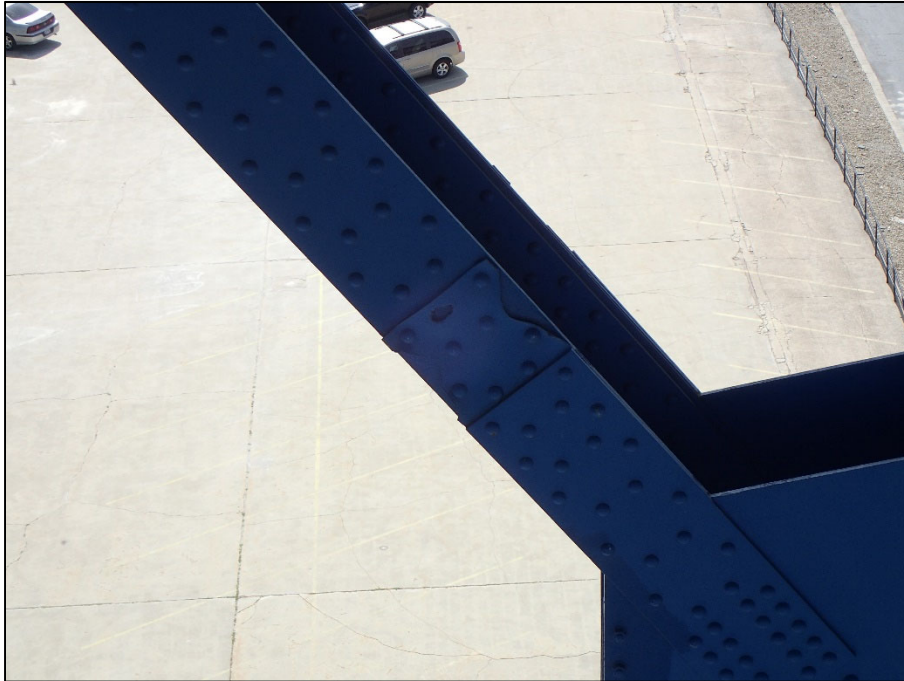
Photo 21 – Unit II, Span 8, South truss near L14; inboard fill plates with painted over corrosion holes

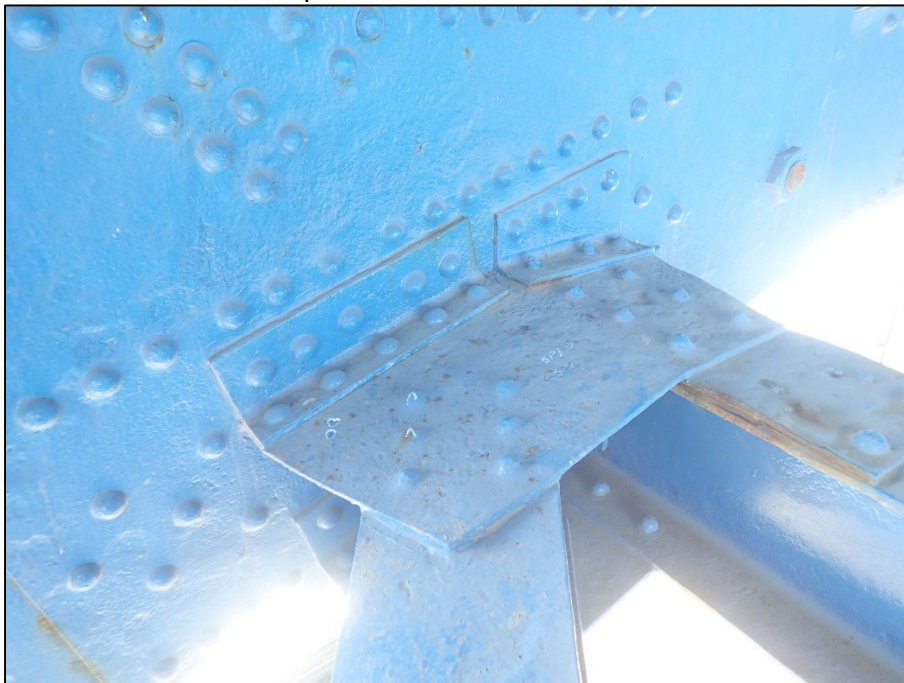
Photo 22 – Unit II, Span 1 South truss at L7; Up to 100% section loss to lower lateral bracing gusset plates

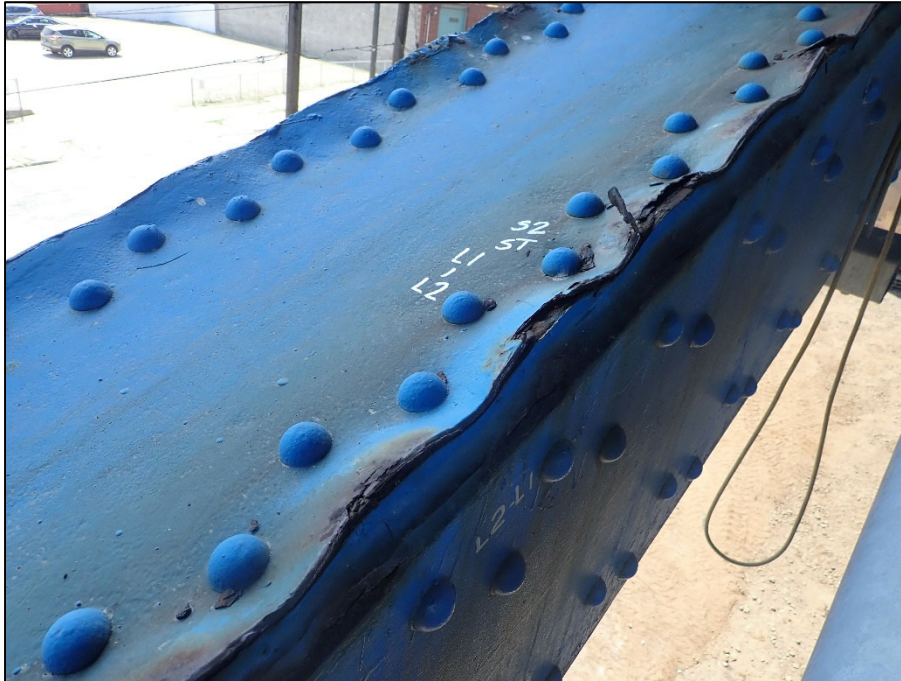
Photo 23 – Unit II, Span 2, South truss, L1L2; up to 2” distortion along inboard and outboard edges of top plate due to reactivated pack rust

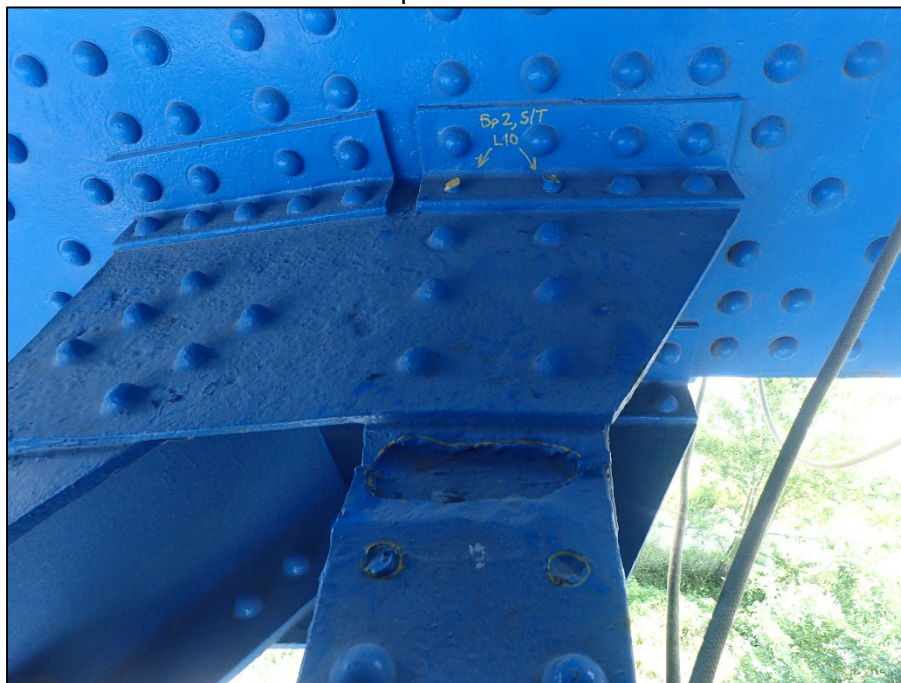
Photo 24 – Unit II, Span 2, South truss, L10; Multiple corrosion holes in lower lateral bracing

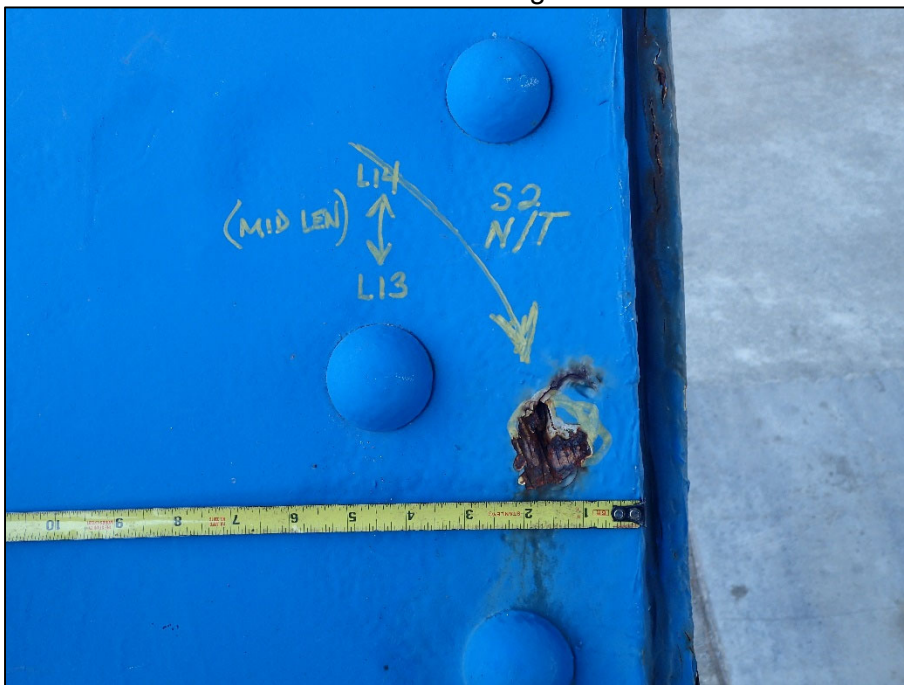
Photo 26 – Unit II, Span 2, North truss, L13L14; 1" Diameter corrosion hole in top plate

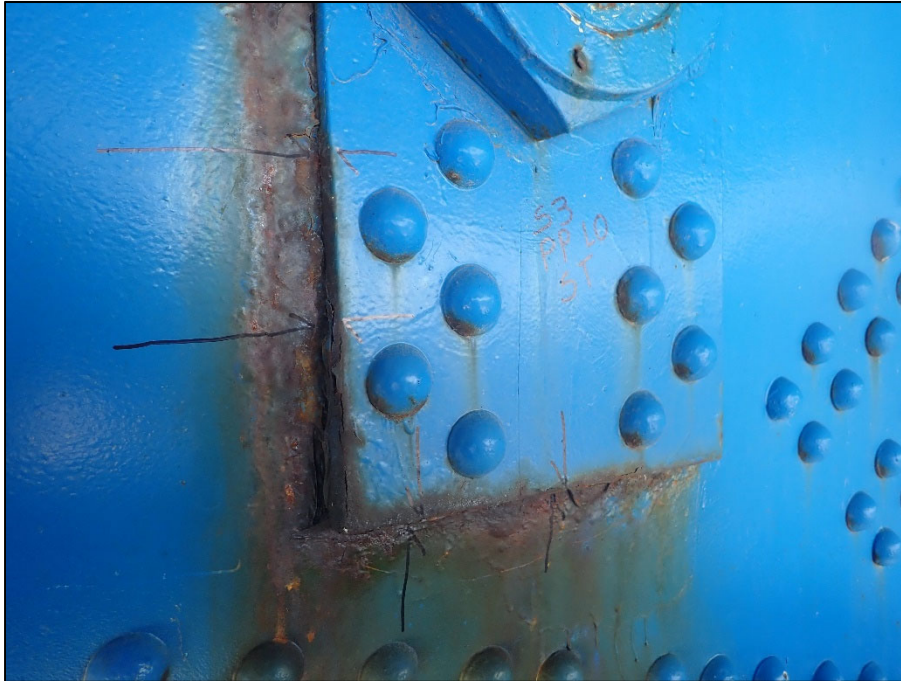
Photo 27 – Unit II, Span 3, South truss at L0; 1/2" T reactivated pack rust between bottom of pin plate and inboard gusset plate

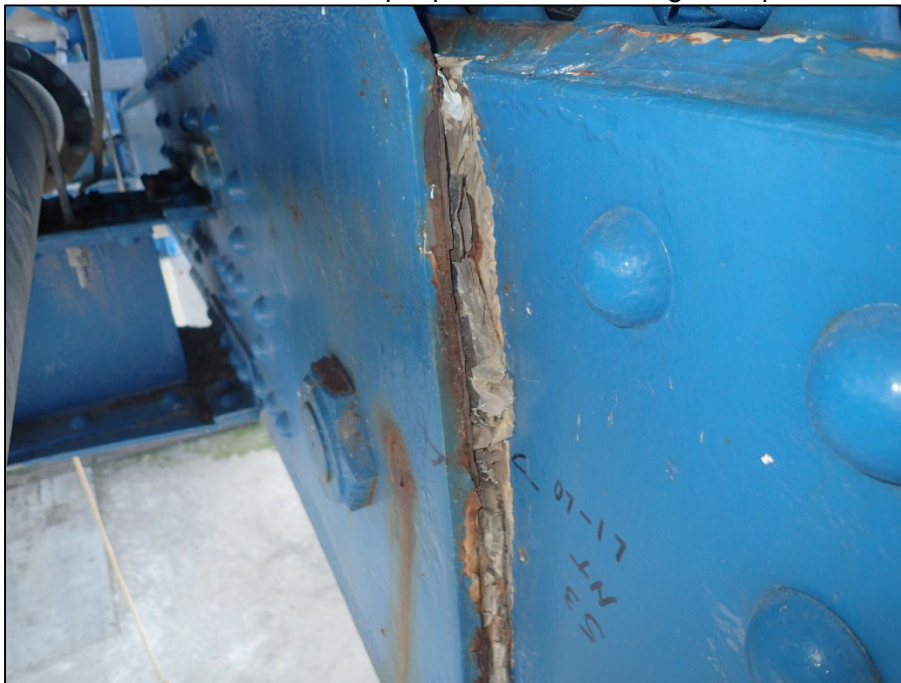
Photo 28 – Unit II, Span 3, North truss at L0; 1" T pack rust between lower chord and interior gusset plate

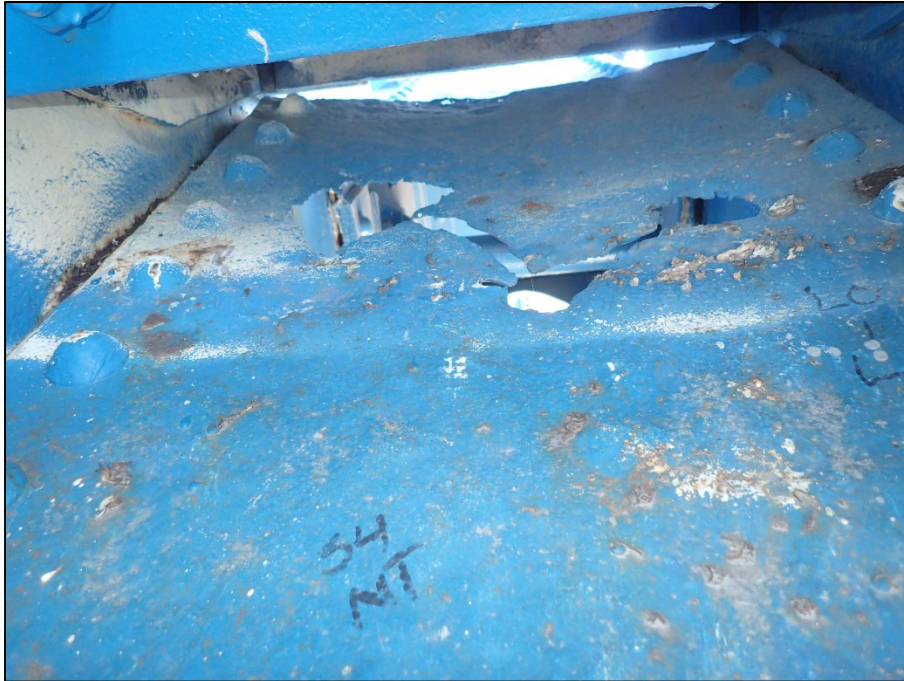
Photo 29 – Unit II, Span 4, North truss at L0; end 16" L with sever painted over dee pitting and 12" W x 16" L corrosion hole

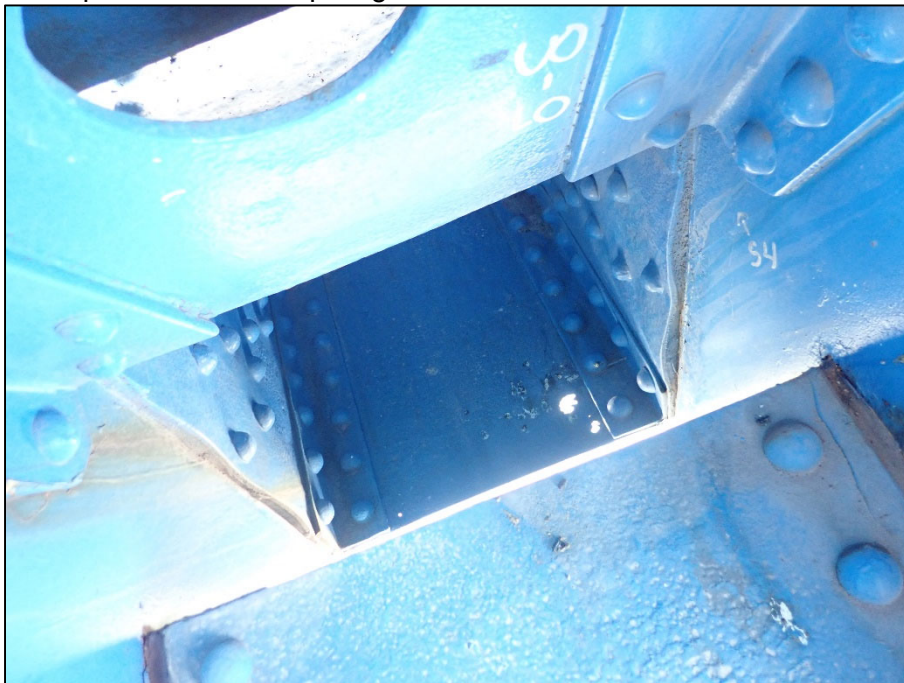
Photo 30 – Unit II, Span 4, South truss at L0; two (2) 1-1/2" Dia corrosion holes in bottom plate

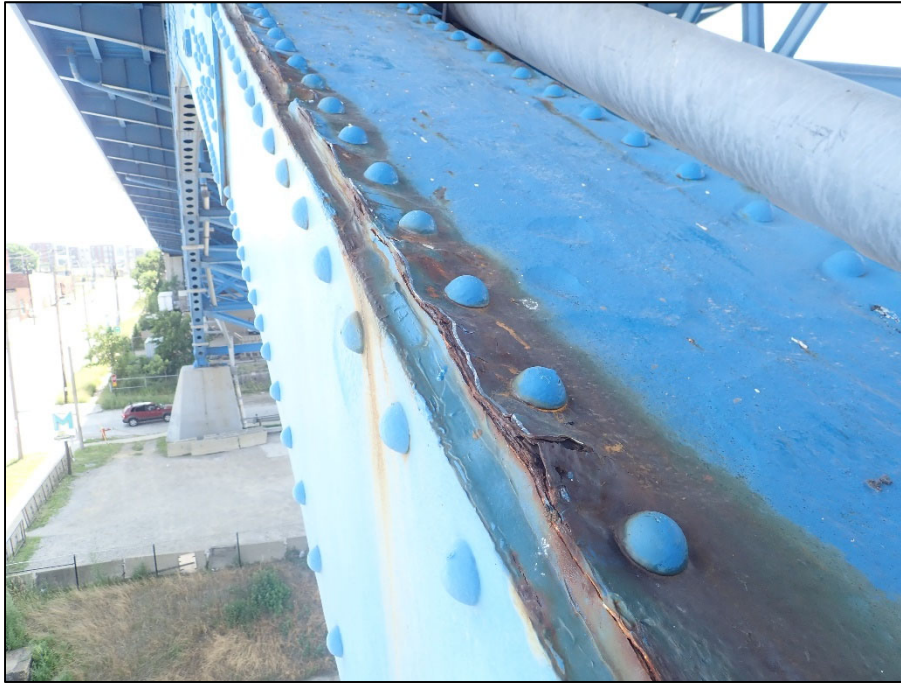
Photo 31 – Unit II, Span 4, South truss at L0L1; 1" T caulked over pack rust along outboard edge of top plate

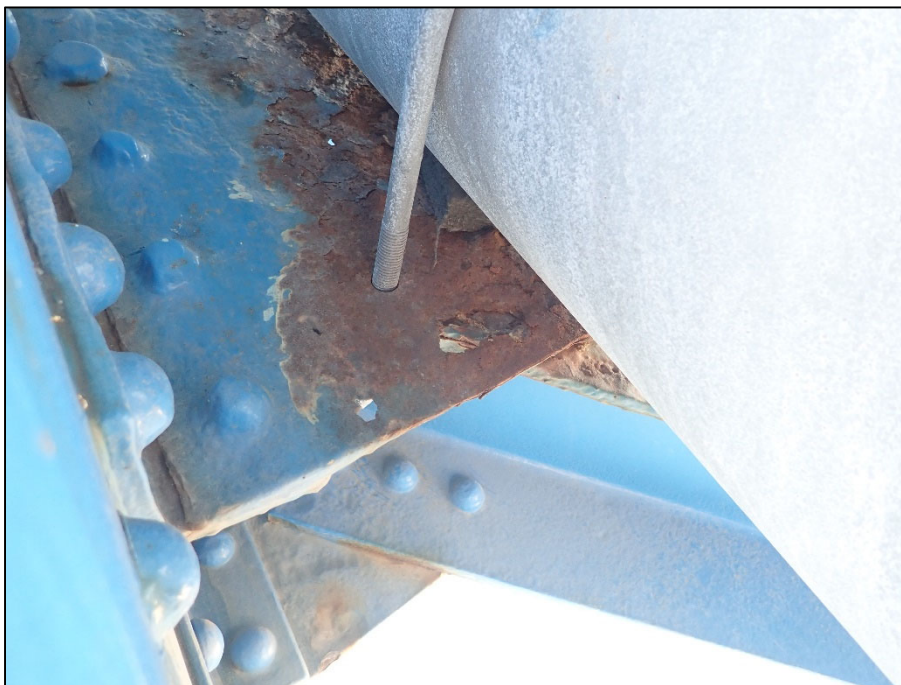
Photo 32 – Unit II, Span 4, South truss; Corrosion holes in lower lateral bracing gusset plate

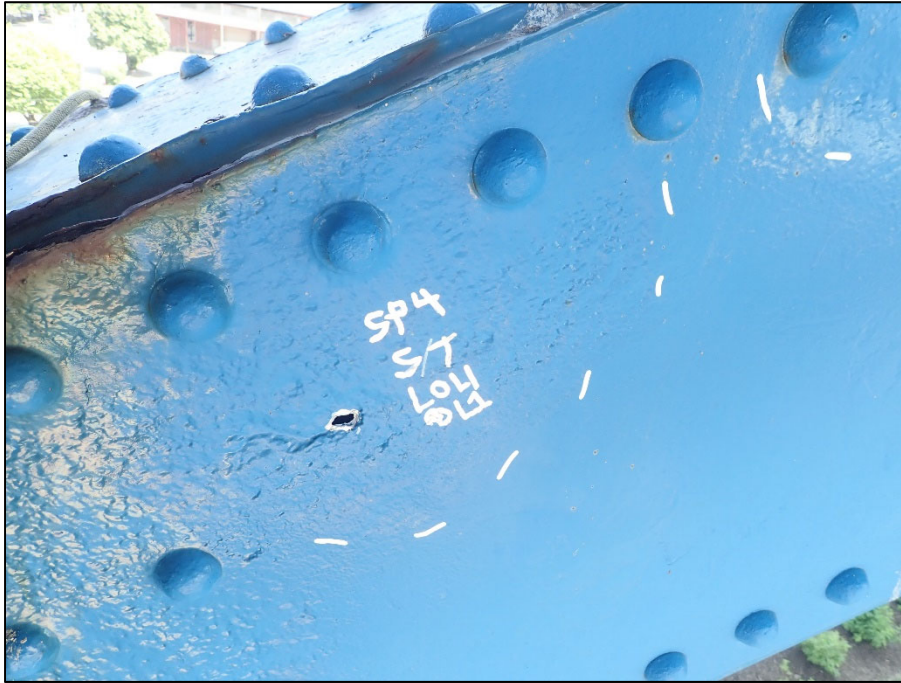
Photo 33 – Unit II, Span 4, South truss near L1; 1" L x 1/2" H painted over corrosion hole in inboard web

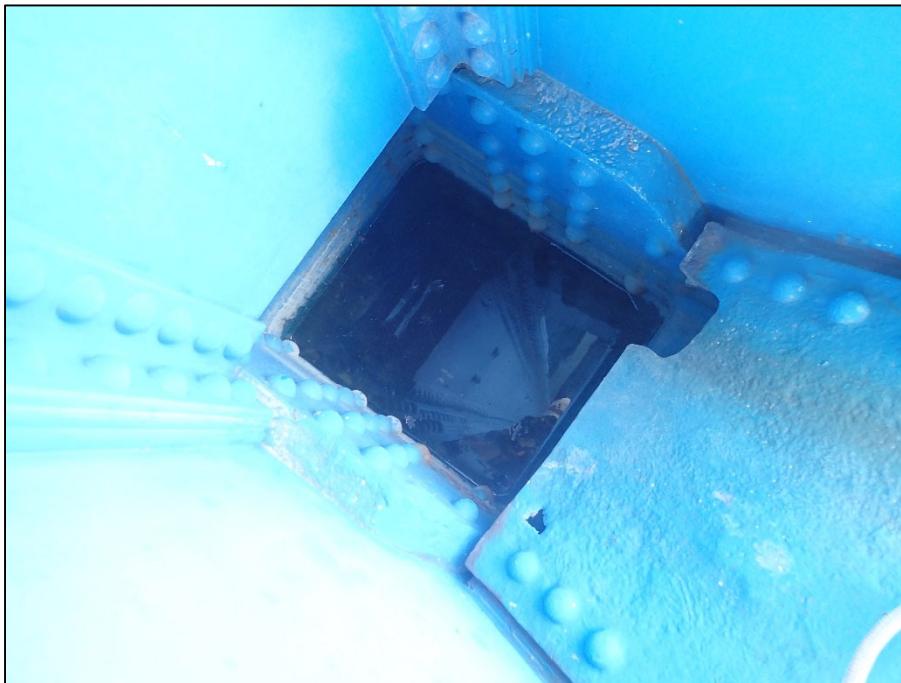
Photo 34 – Unit II, Span 4, South truss at L2; Bearing full of water, 3-1/2" L x 4" W corrosion hole in top plate

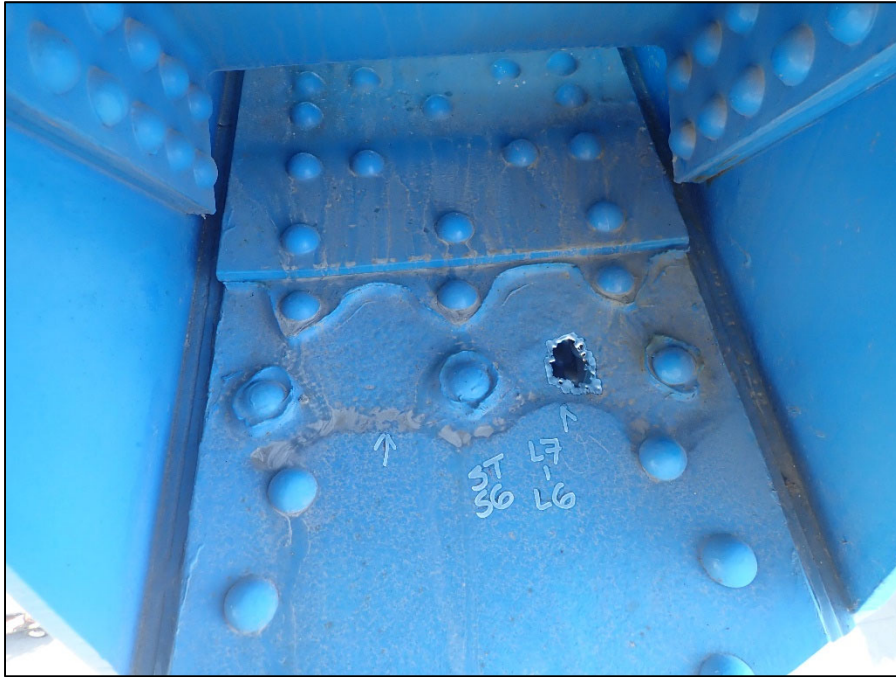
Photo 35 – Unit II, Span 6, South truss at L7; 1/8" T remaining section within 8" L x Full Width with 2" Diameter corrosion hole

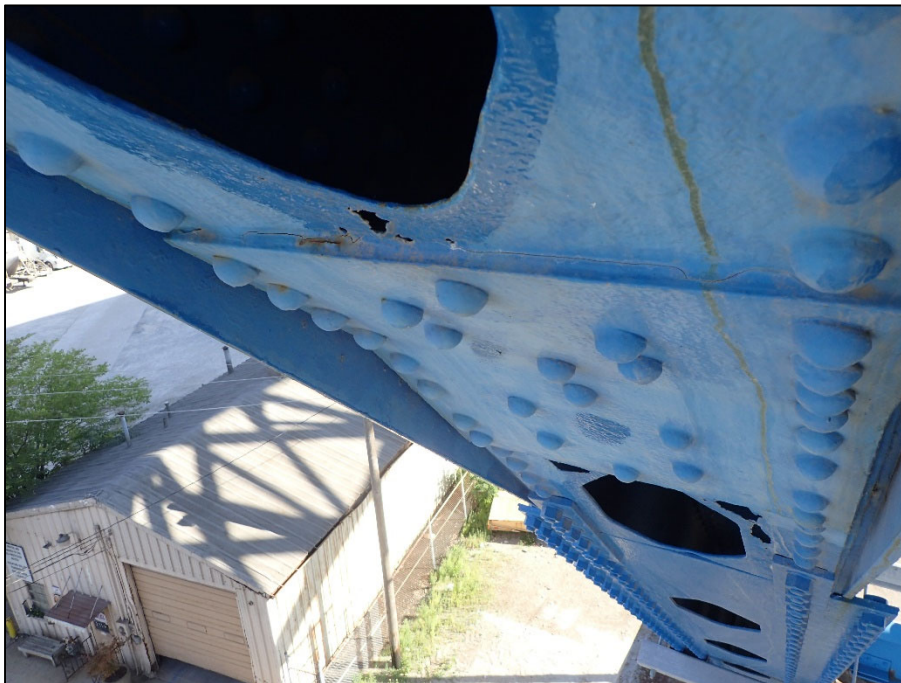
Photo 36 - Unit II, Span 6, North truss at L2; 8" L x 1-1/2" W corrosion hole in bottom flange

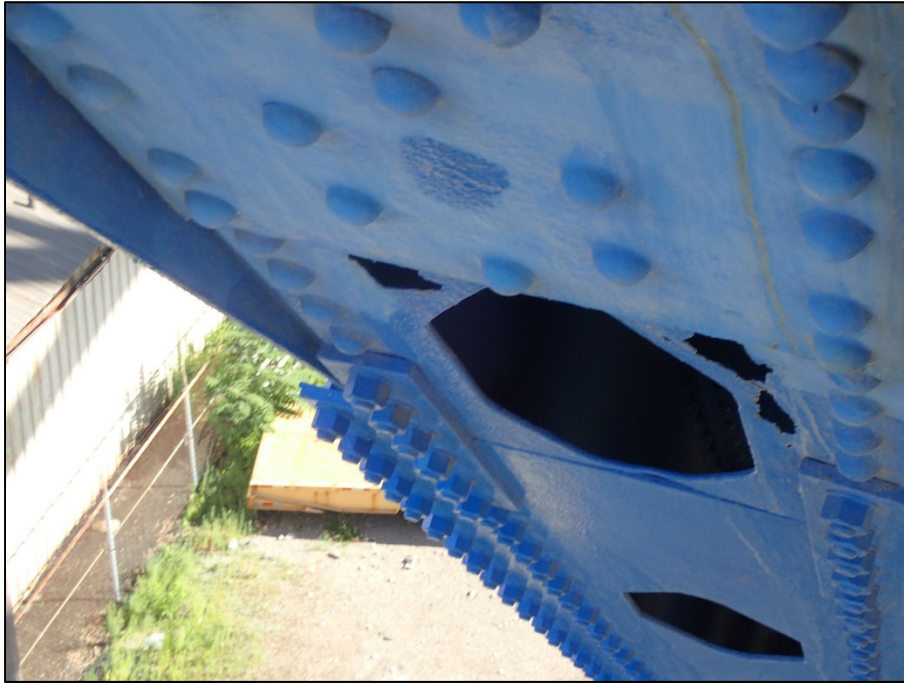
Photo 37 – Unit II, Span 6, North truss under L1; 5" Diameter corrosion hole with 1/4" D pitting

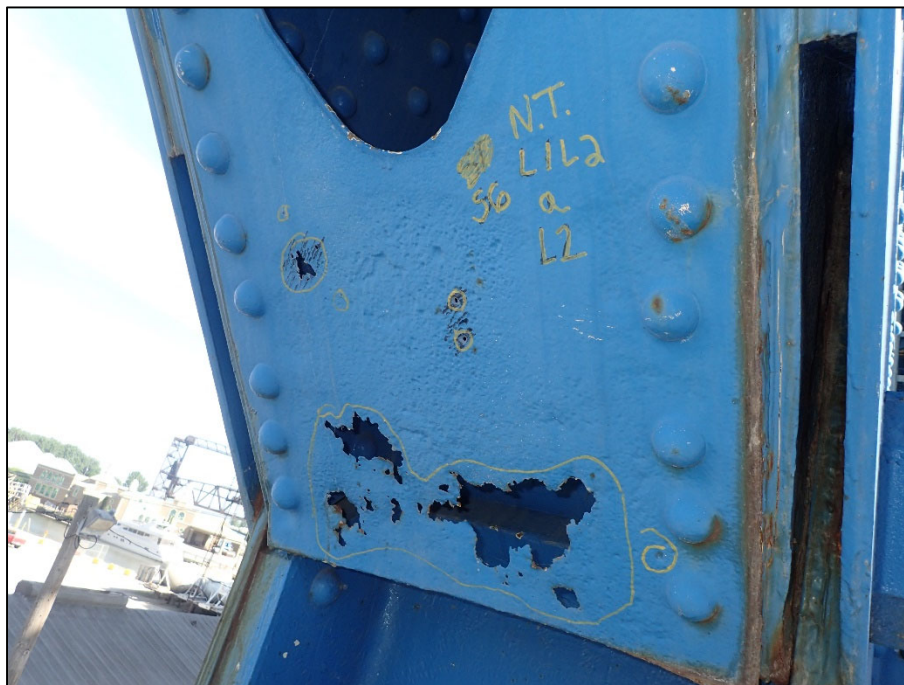
Photo 38 - Unit II, Span 6, North truss at L1; 10" L x 4" W corrosion hole
