CUY-2-1441

PHYSICAL CONDITION REPORT ROUTINE INSPECTION OF MAIN AVENUE BRIDGE OVER THE CUYAHOGA RIVER SFN: 1800035

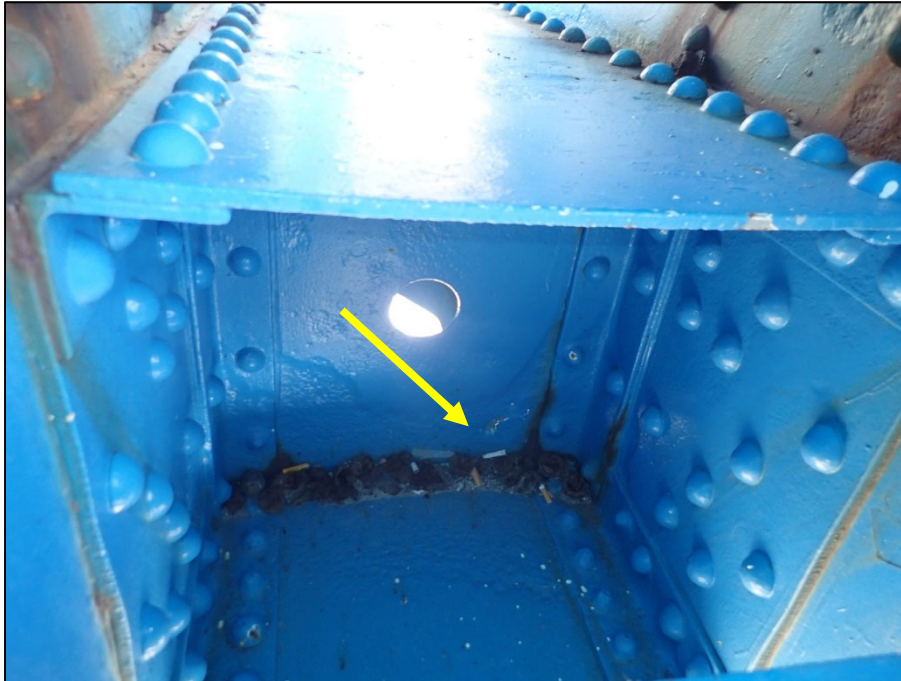
Photo 39 - Unit II, Span 6, North truss at L17; 5" W x 2" H corrosion hole in end plate

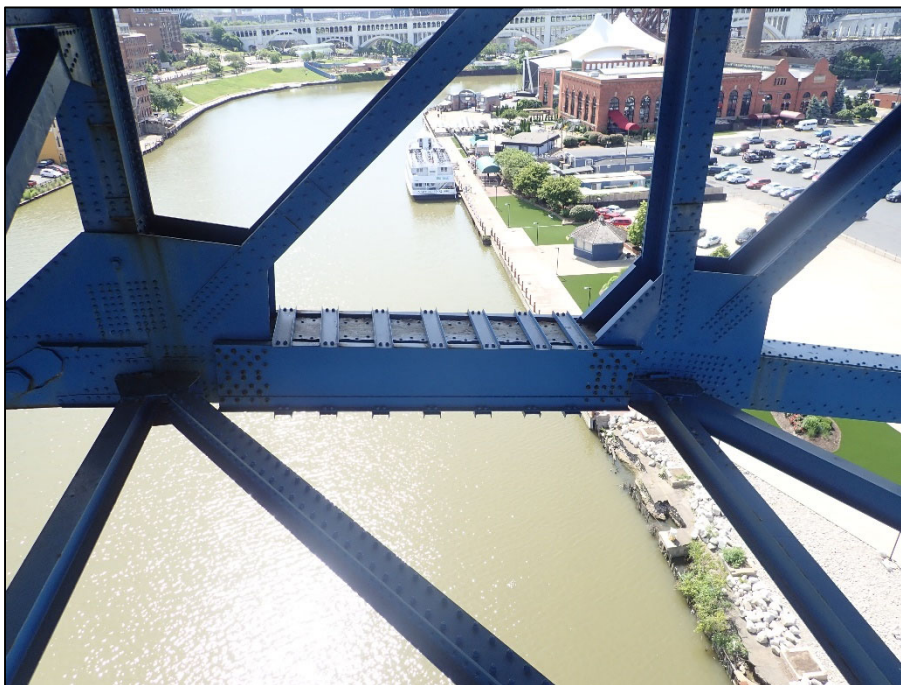
Photo 40 - Unit II, Span 8, South truss, L24L25; lower chord steel channel retrofit

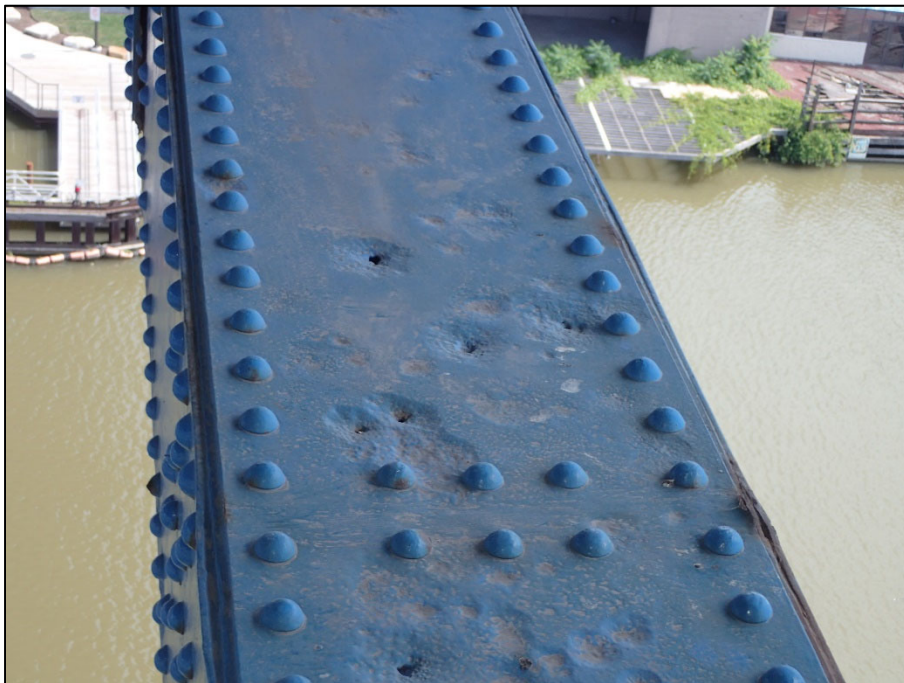
Photo 42 – Unit II, Span 9, South truss along L0L1; Painted over heavy section loss, up to 1/4" D pitting with 1/2" Diameter corrosion holes

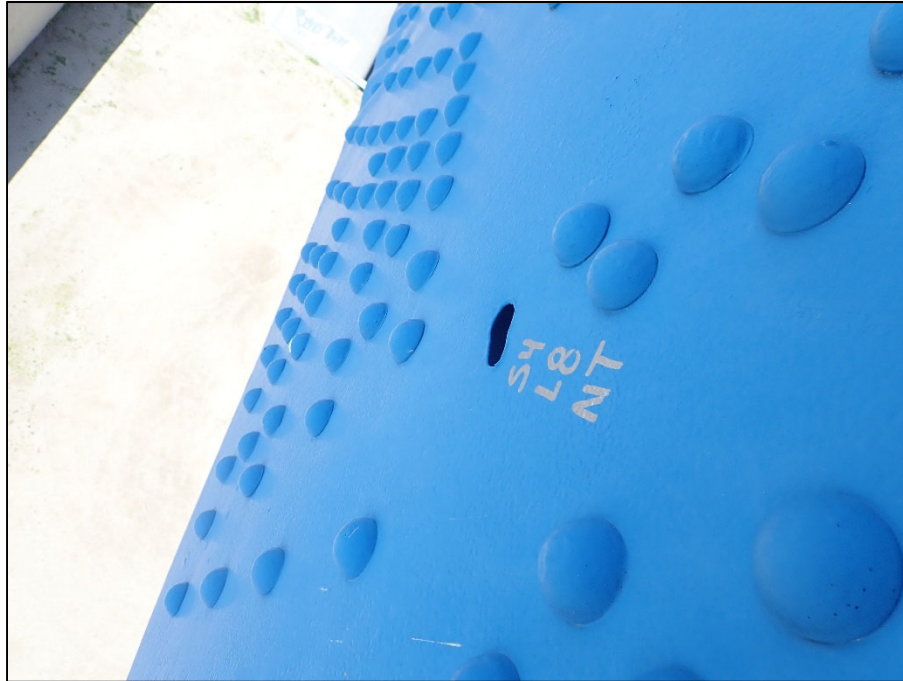
Photo 45 – Unit II, Span 4, North truss at L8; 2" Diameter corrosion hole in outboard gusset plate

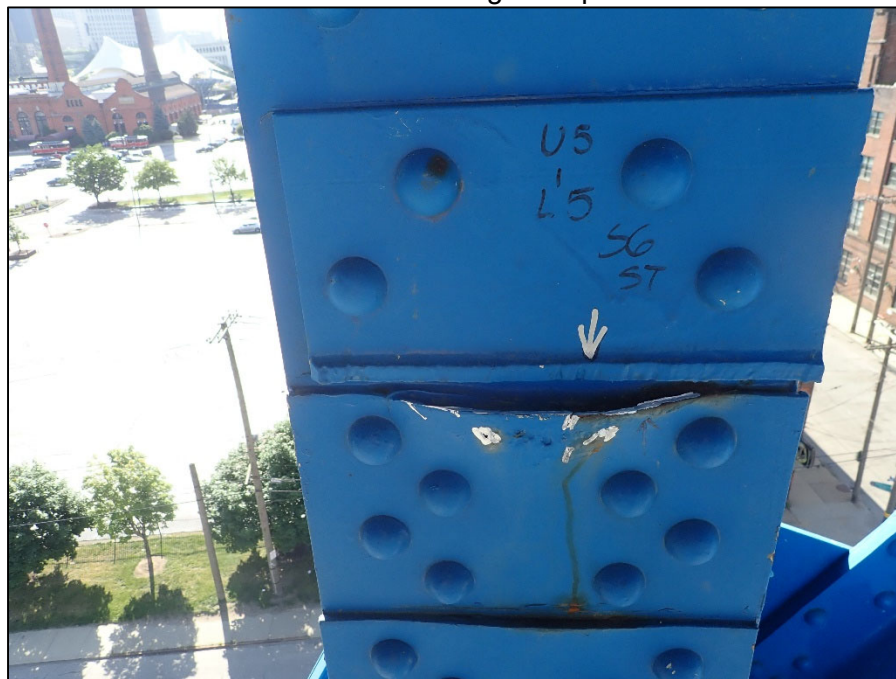
Photo 46 – Unit II, Span 6, South truss at L5; 3" L x 1" H area of section loss with 1 1/8" bow in fill plate

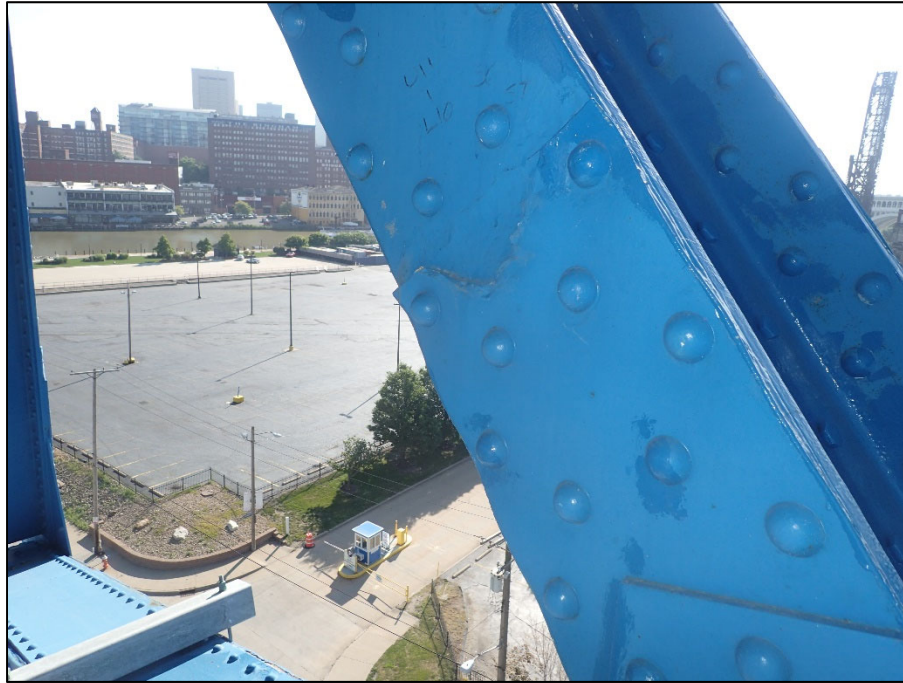
Photo 47 – Unit II, Span 6, South truss at L10; interior fill plate with painted over section loss and corrosion holes in fill plates

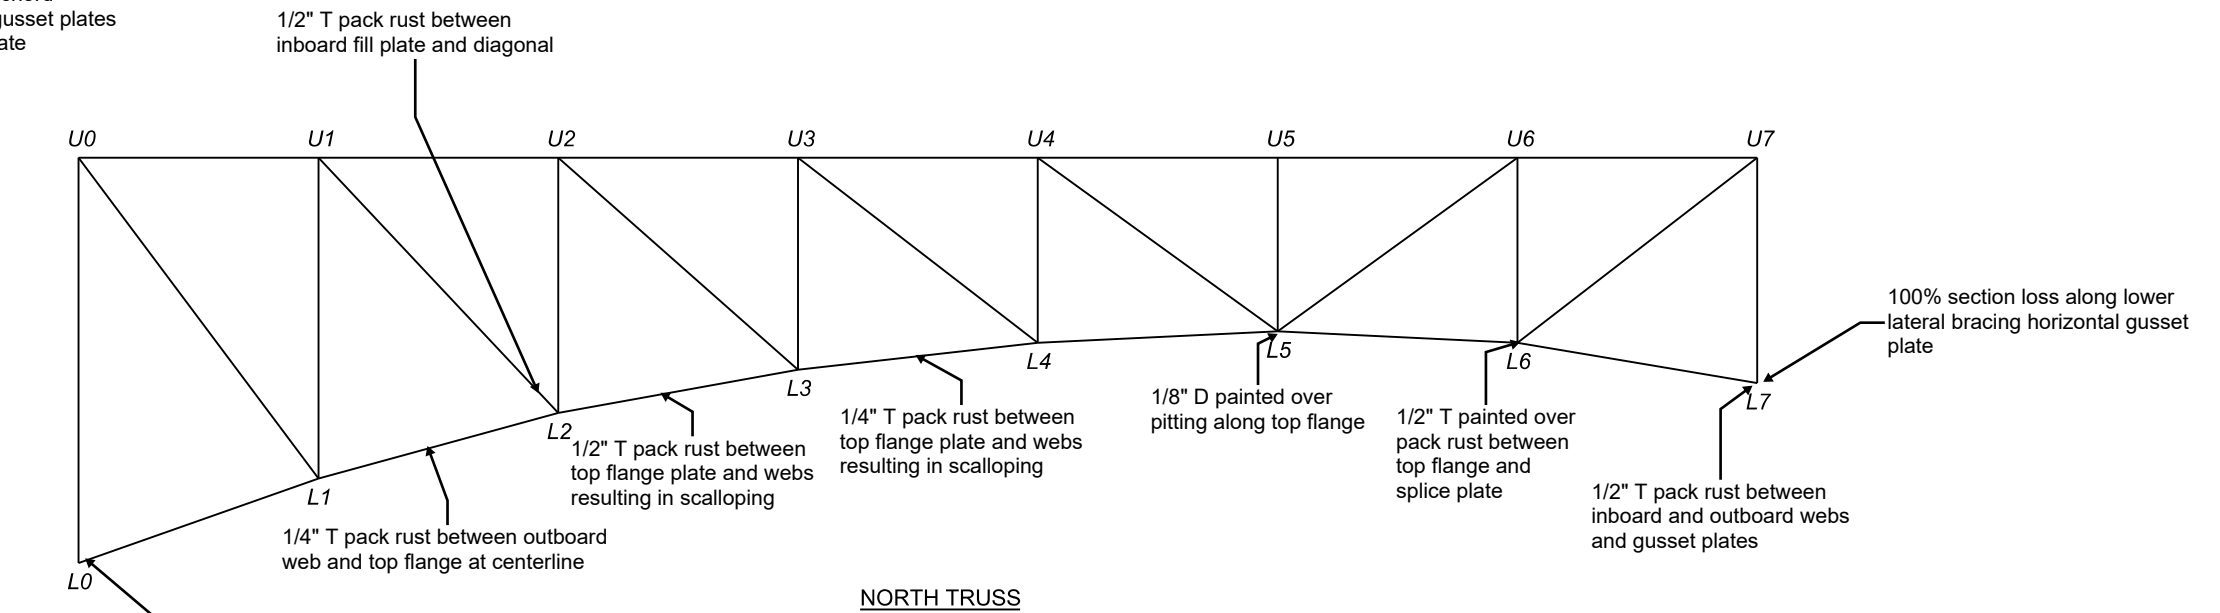
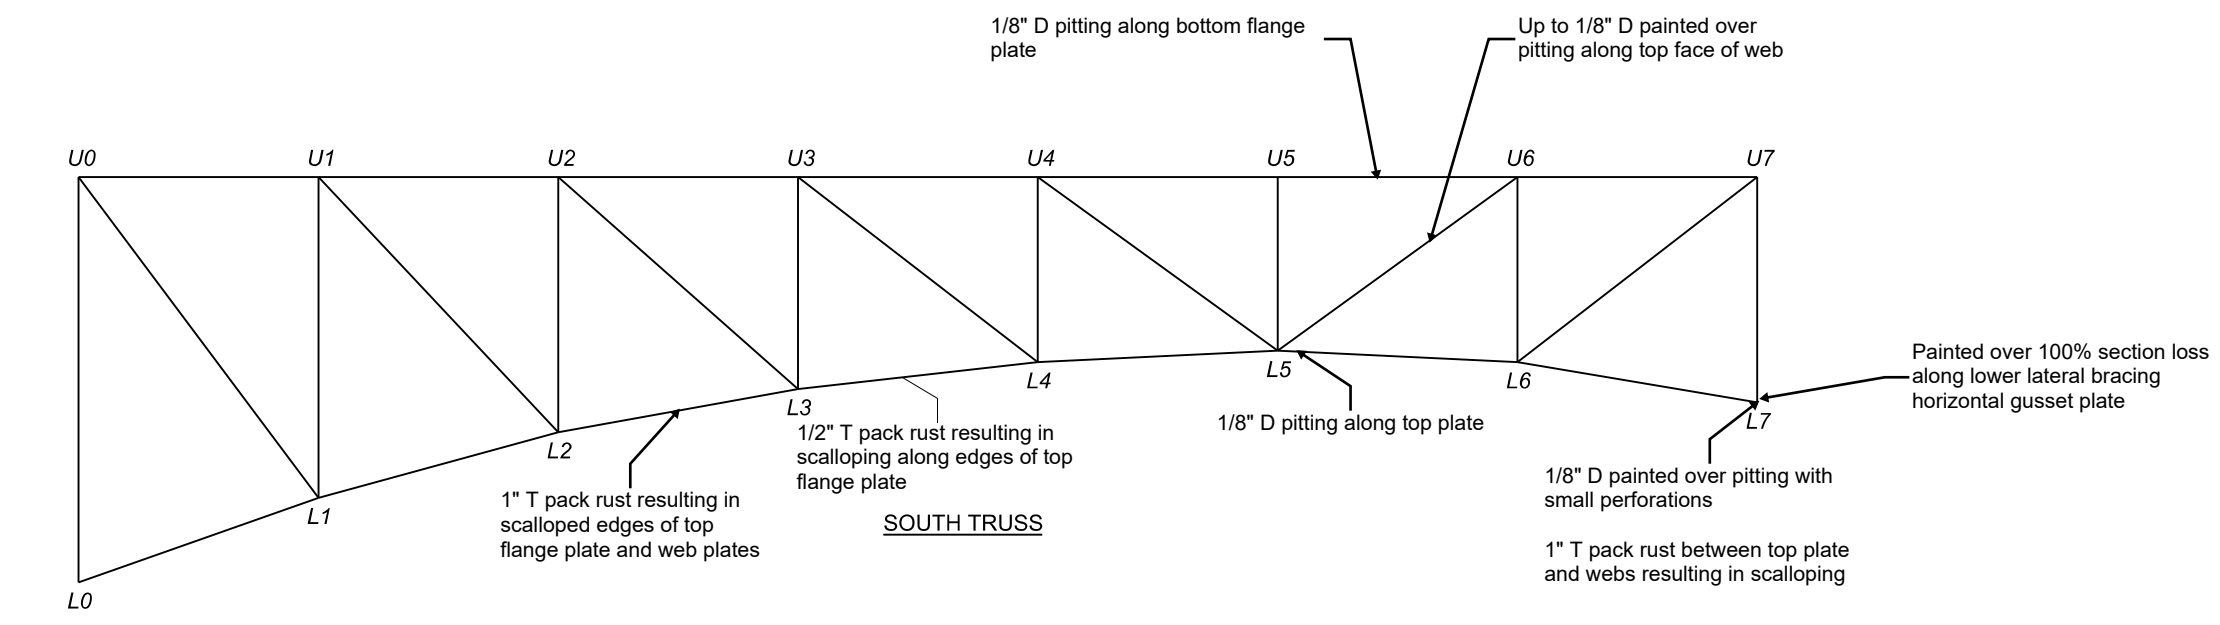
GRAPHIC SCALE MEASURED IN FEET	DATE	 <small>9902 Carver Road Suite 201 Cincinnati, OH 45242 PH: 614-599-5000</small>	MAIN AVENUE OVER CUYAHOGA RIVER BRIDGE NO. CUY-2-1441	PAGE
NOT TO SCALE	JUL, 2018	INFRASTRUCTURE ENGINEERS, LLC	TRUSS ELEVATION - SPAN 1	B-1

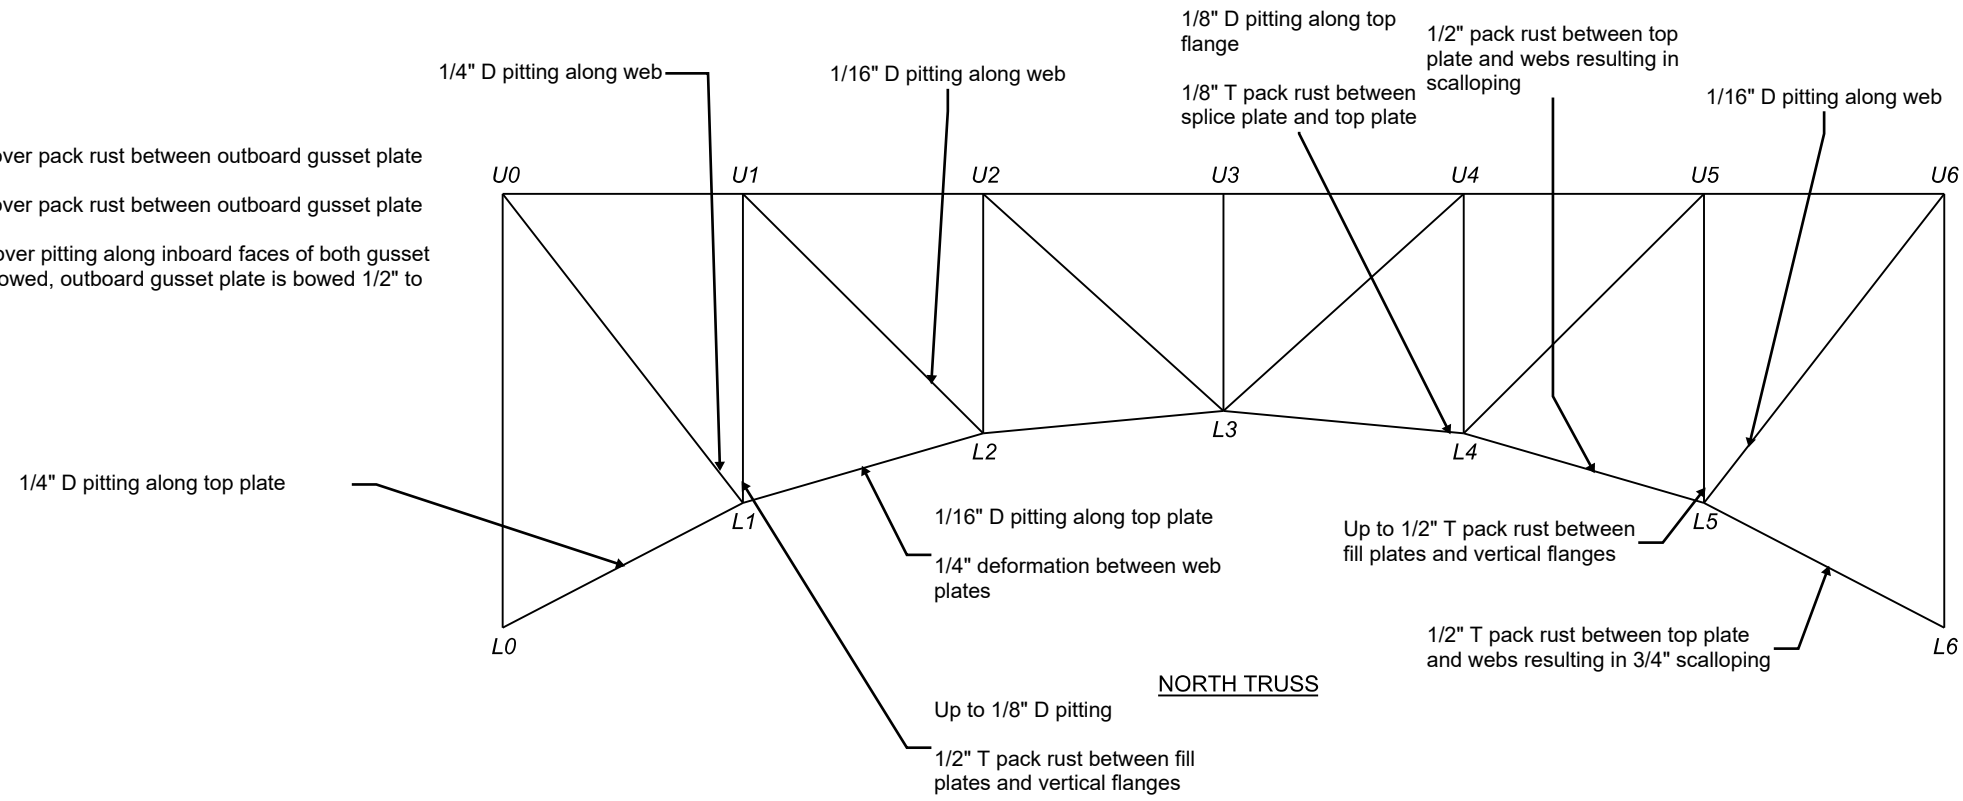
L1, South; 3/4" T painted over pack rust between outboard gusset plate and lower chord
 L2, South; 3/4" T painted over pack rust between outboard gusset plate and lower chord
 L6, South; 1/4" D painted over pitting along inboard faces of both gusset plates, inboard gusset is bowed, outboard gusset plate is bowed 1/2" to the north

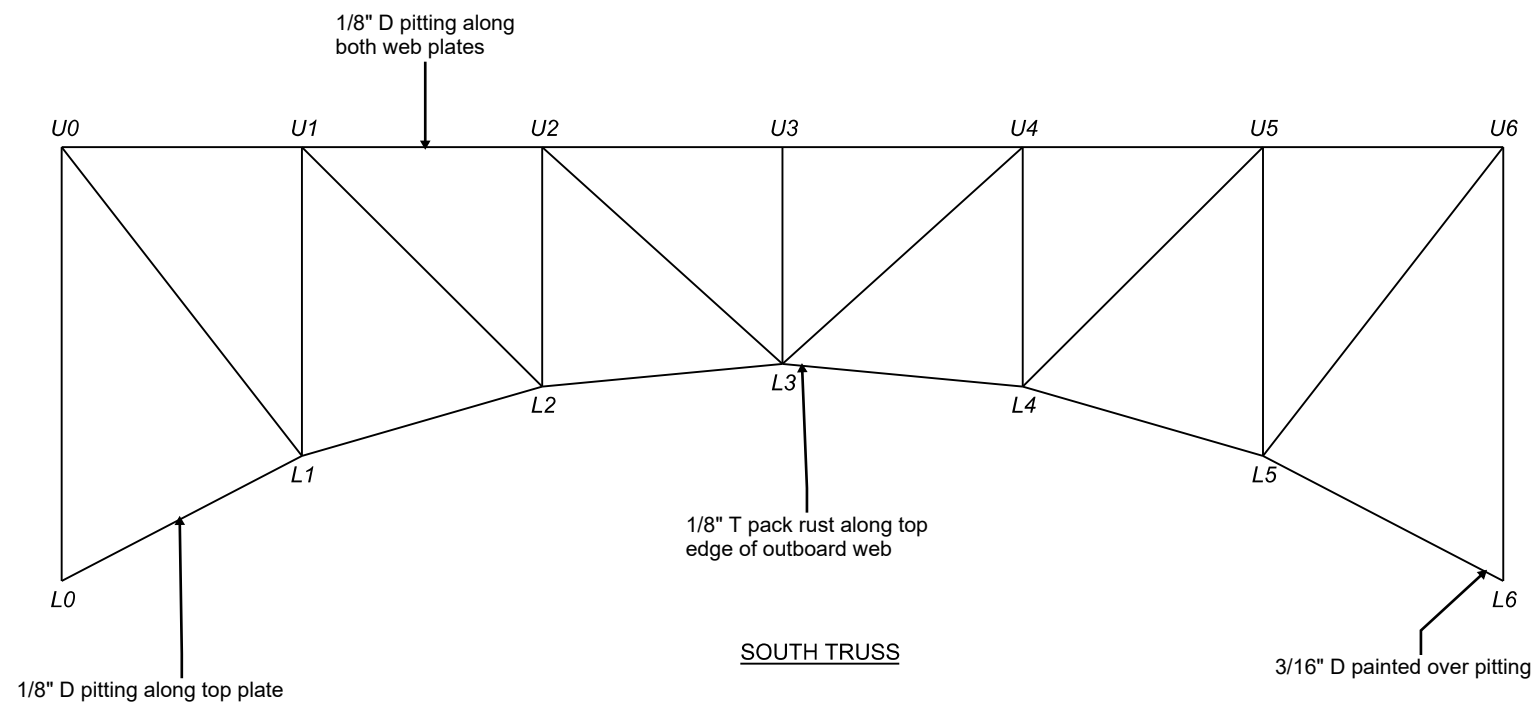
L3, South; 1/8" D pitting along outboard plate
 L0, North; 3/8" T reactivated pack rust distorting both gusset plates
 U1, North; 1/2" T pack rust distorting outboard gusset plate

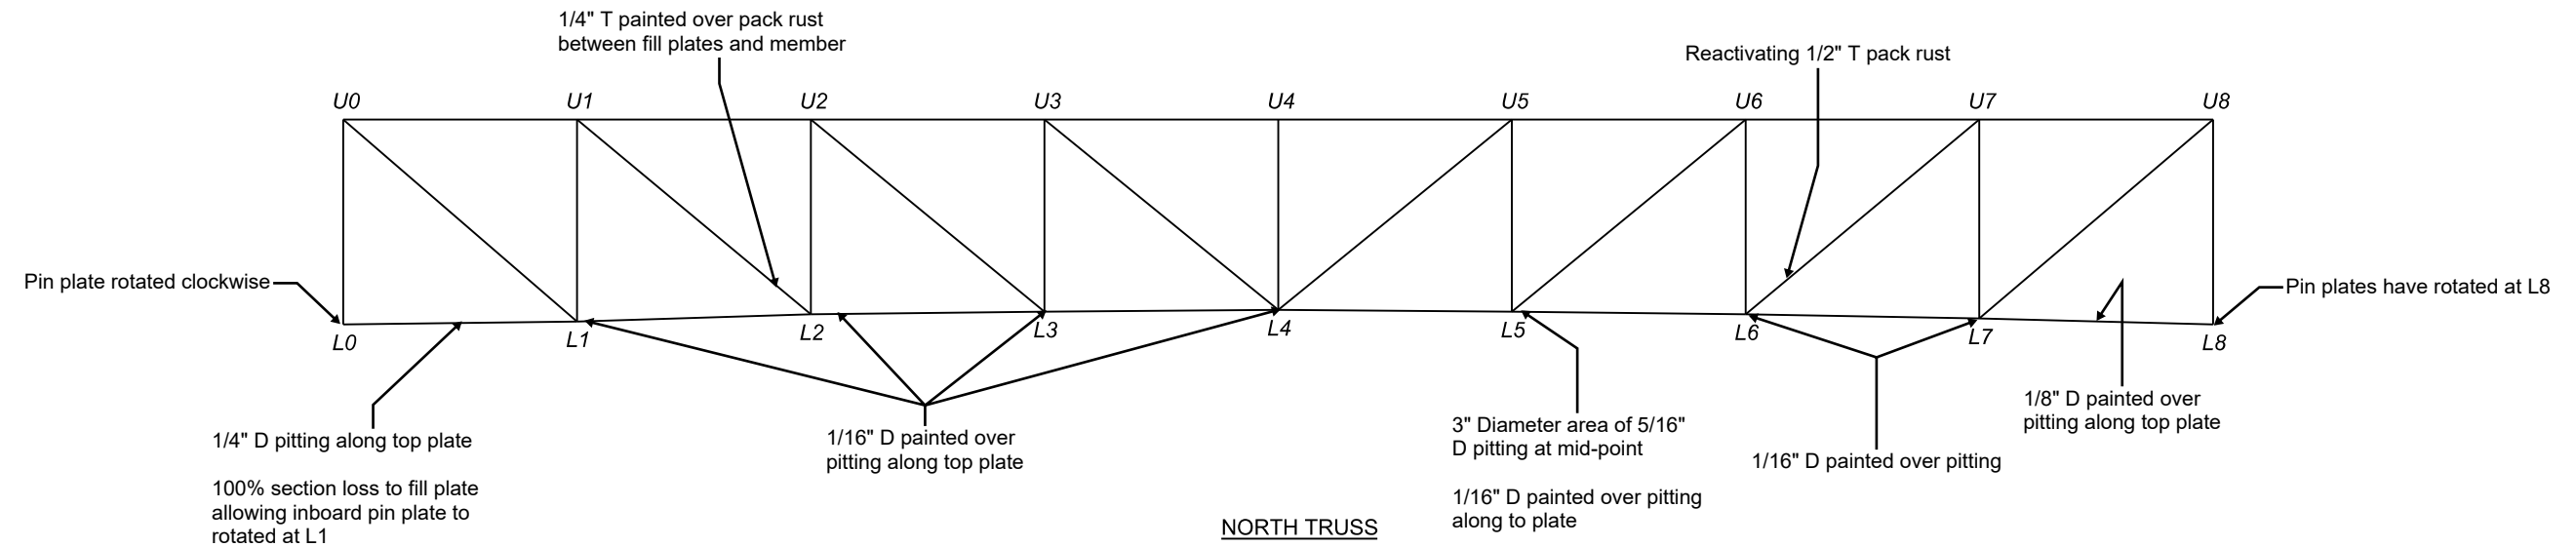
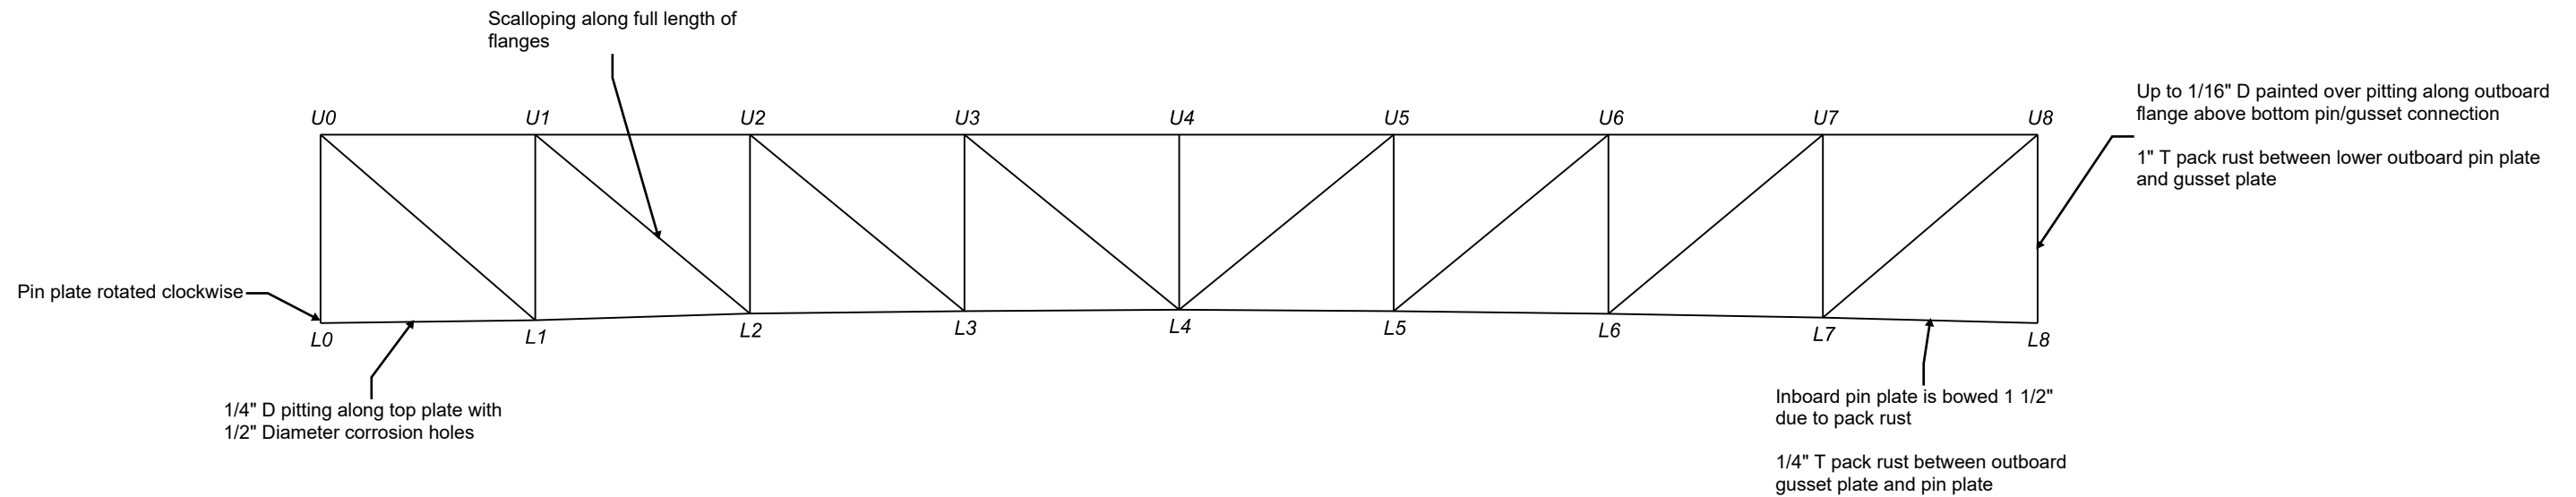
GRAPHIC SCALE MEASURED IN FEET	DATE	  9902 Carver Road Suite 201 Cincinnati, OH 45242 PH: 614-599-5000	MAIN AVENUE OVER CUYAHOGA RIVER BRIDGE NO. CUY-2-1441	
NOT TO SCALE	JUL, 2018		INFRASTRUCTURE ENGINEERS, LLC	TRUSS ELEVATION - SPAN 8

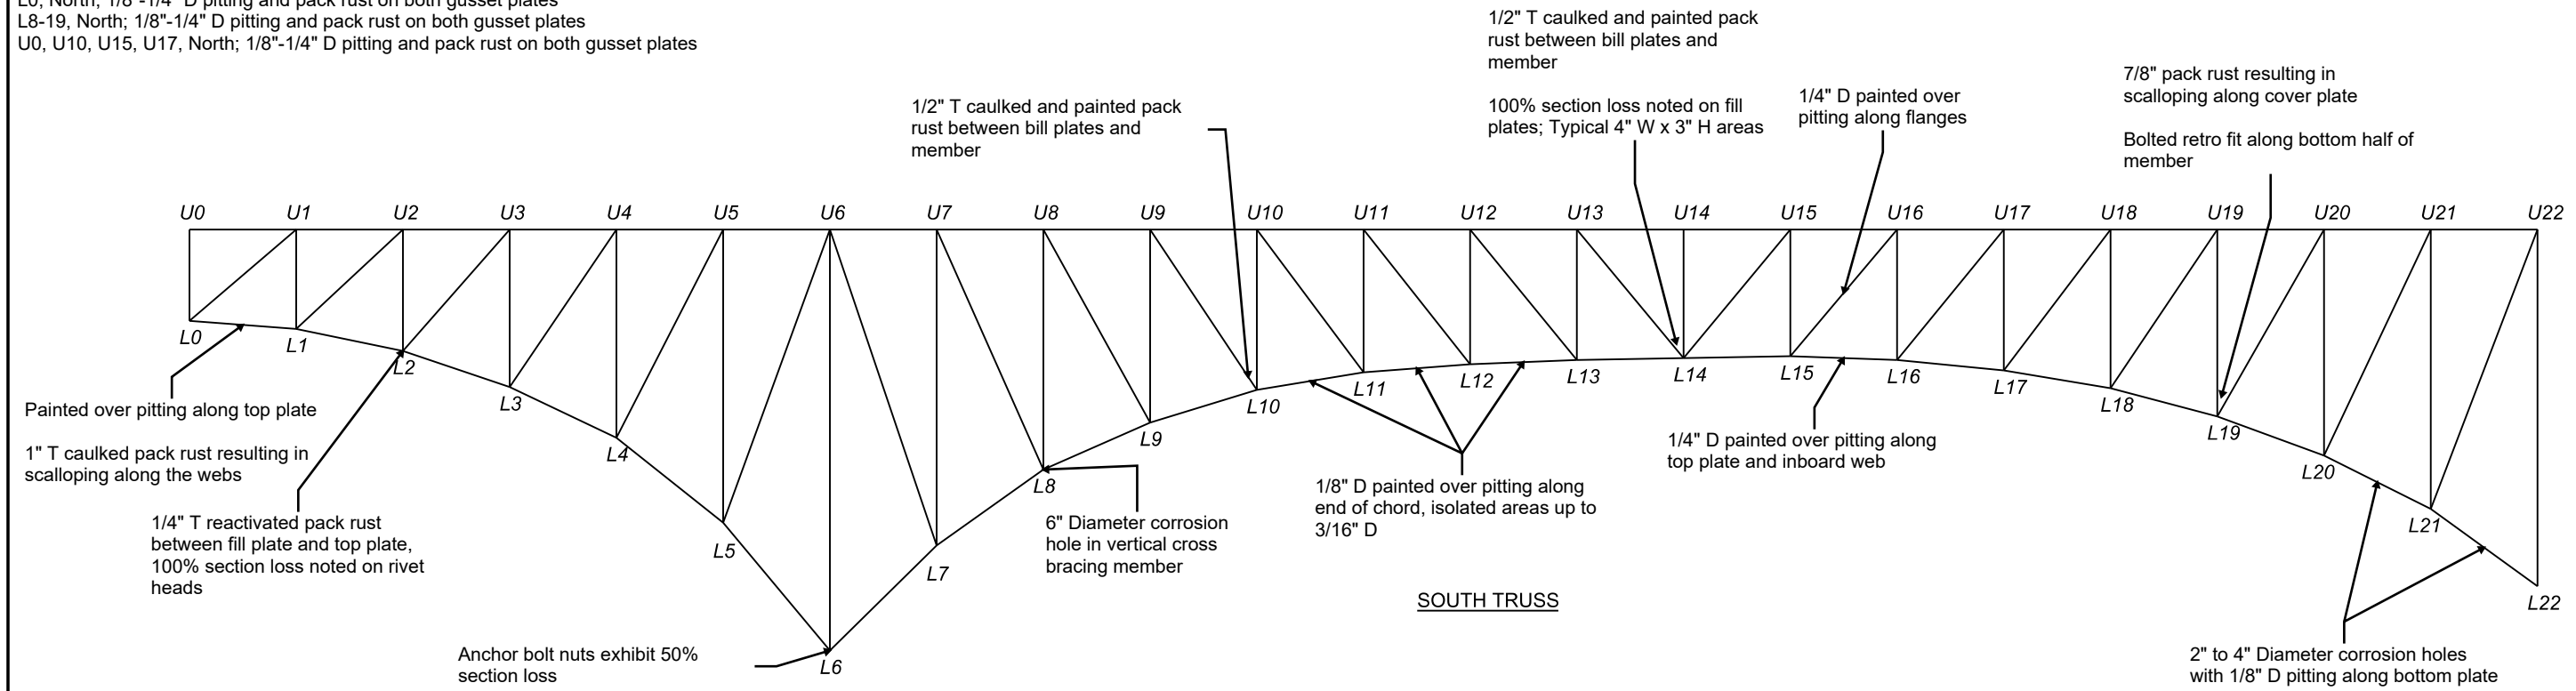
- L0, South; 1" T reactivating painted over and caulked pack rust at the corners
1/4" T pack rust between both gusset plates and vertical, 1/8" D painted over pitting
- L1, South; 1/8" T painted and caulked pack rust between outboard gusset plate and lower chord
- U15, South; 1/4" D pitting in both gusset plates
- L22, South; 1/4" D painted over pitting on both gusset plates
- L0, North; 1/8"-1/4" D pitting and pack rust on both gusset plates
- L8-19, North; 1/8"-1/4" D pitting and pack rust on both gusset plates
- U0, U10, U15, U17, North; 1/8"-1/4" D pitting and pack rust on both gusset plates
