# CUY-6-1456

## PHYSICAL CONDITION REPORT ROUTINE INSPECTION

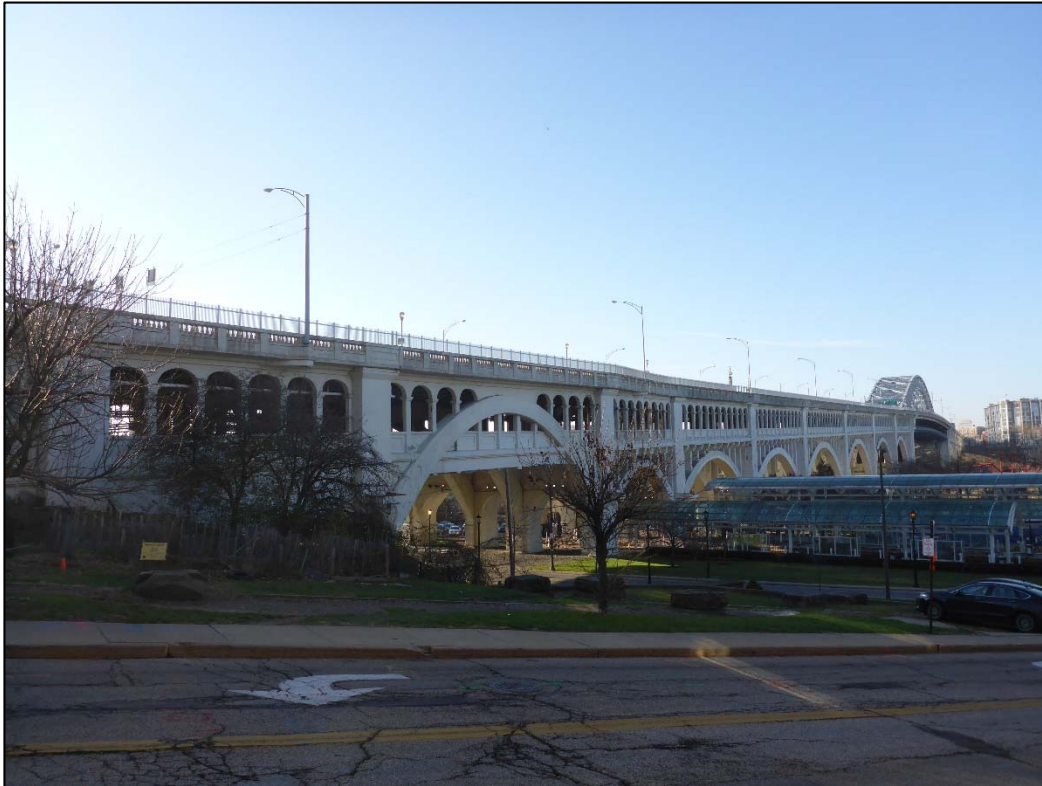
Inspection Date:
November 27-28, 2017

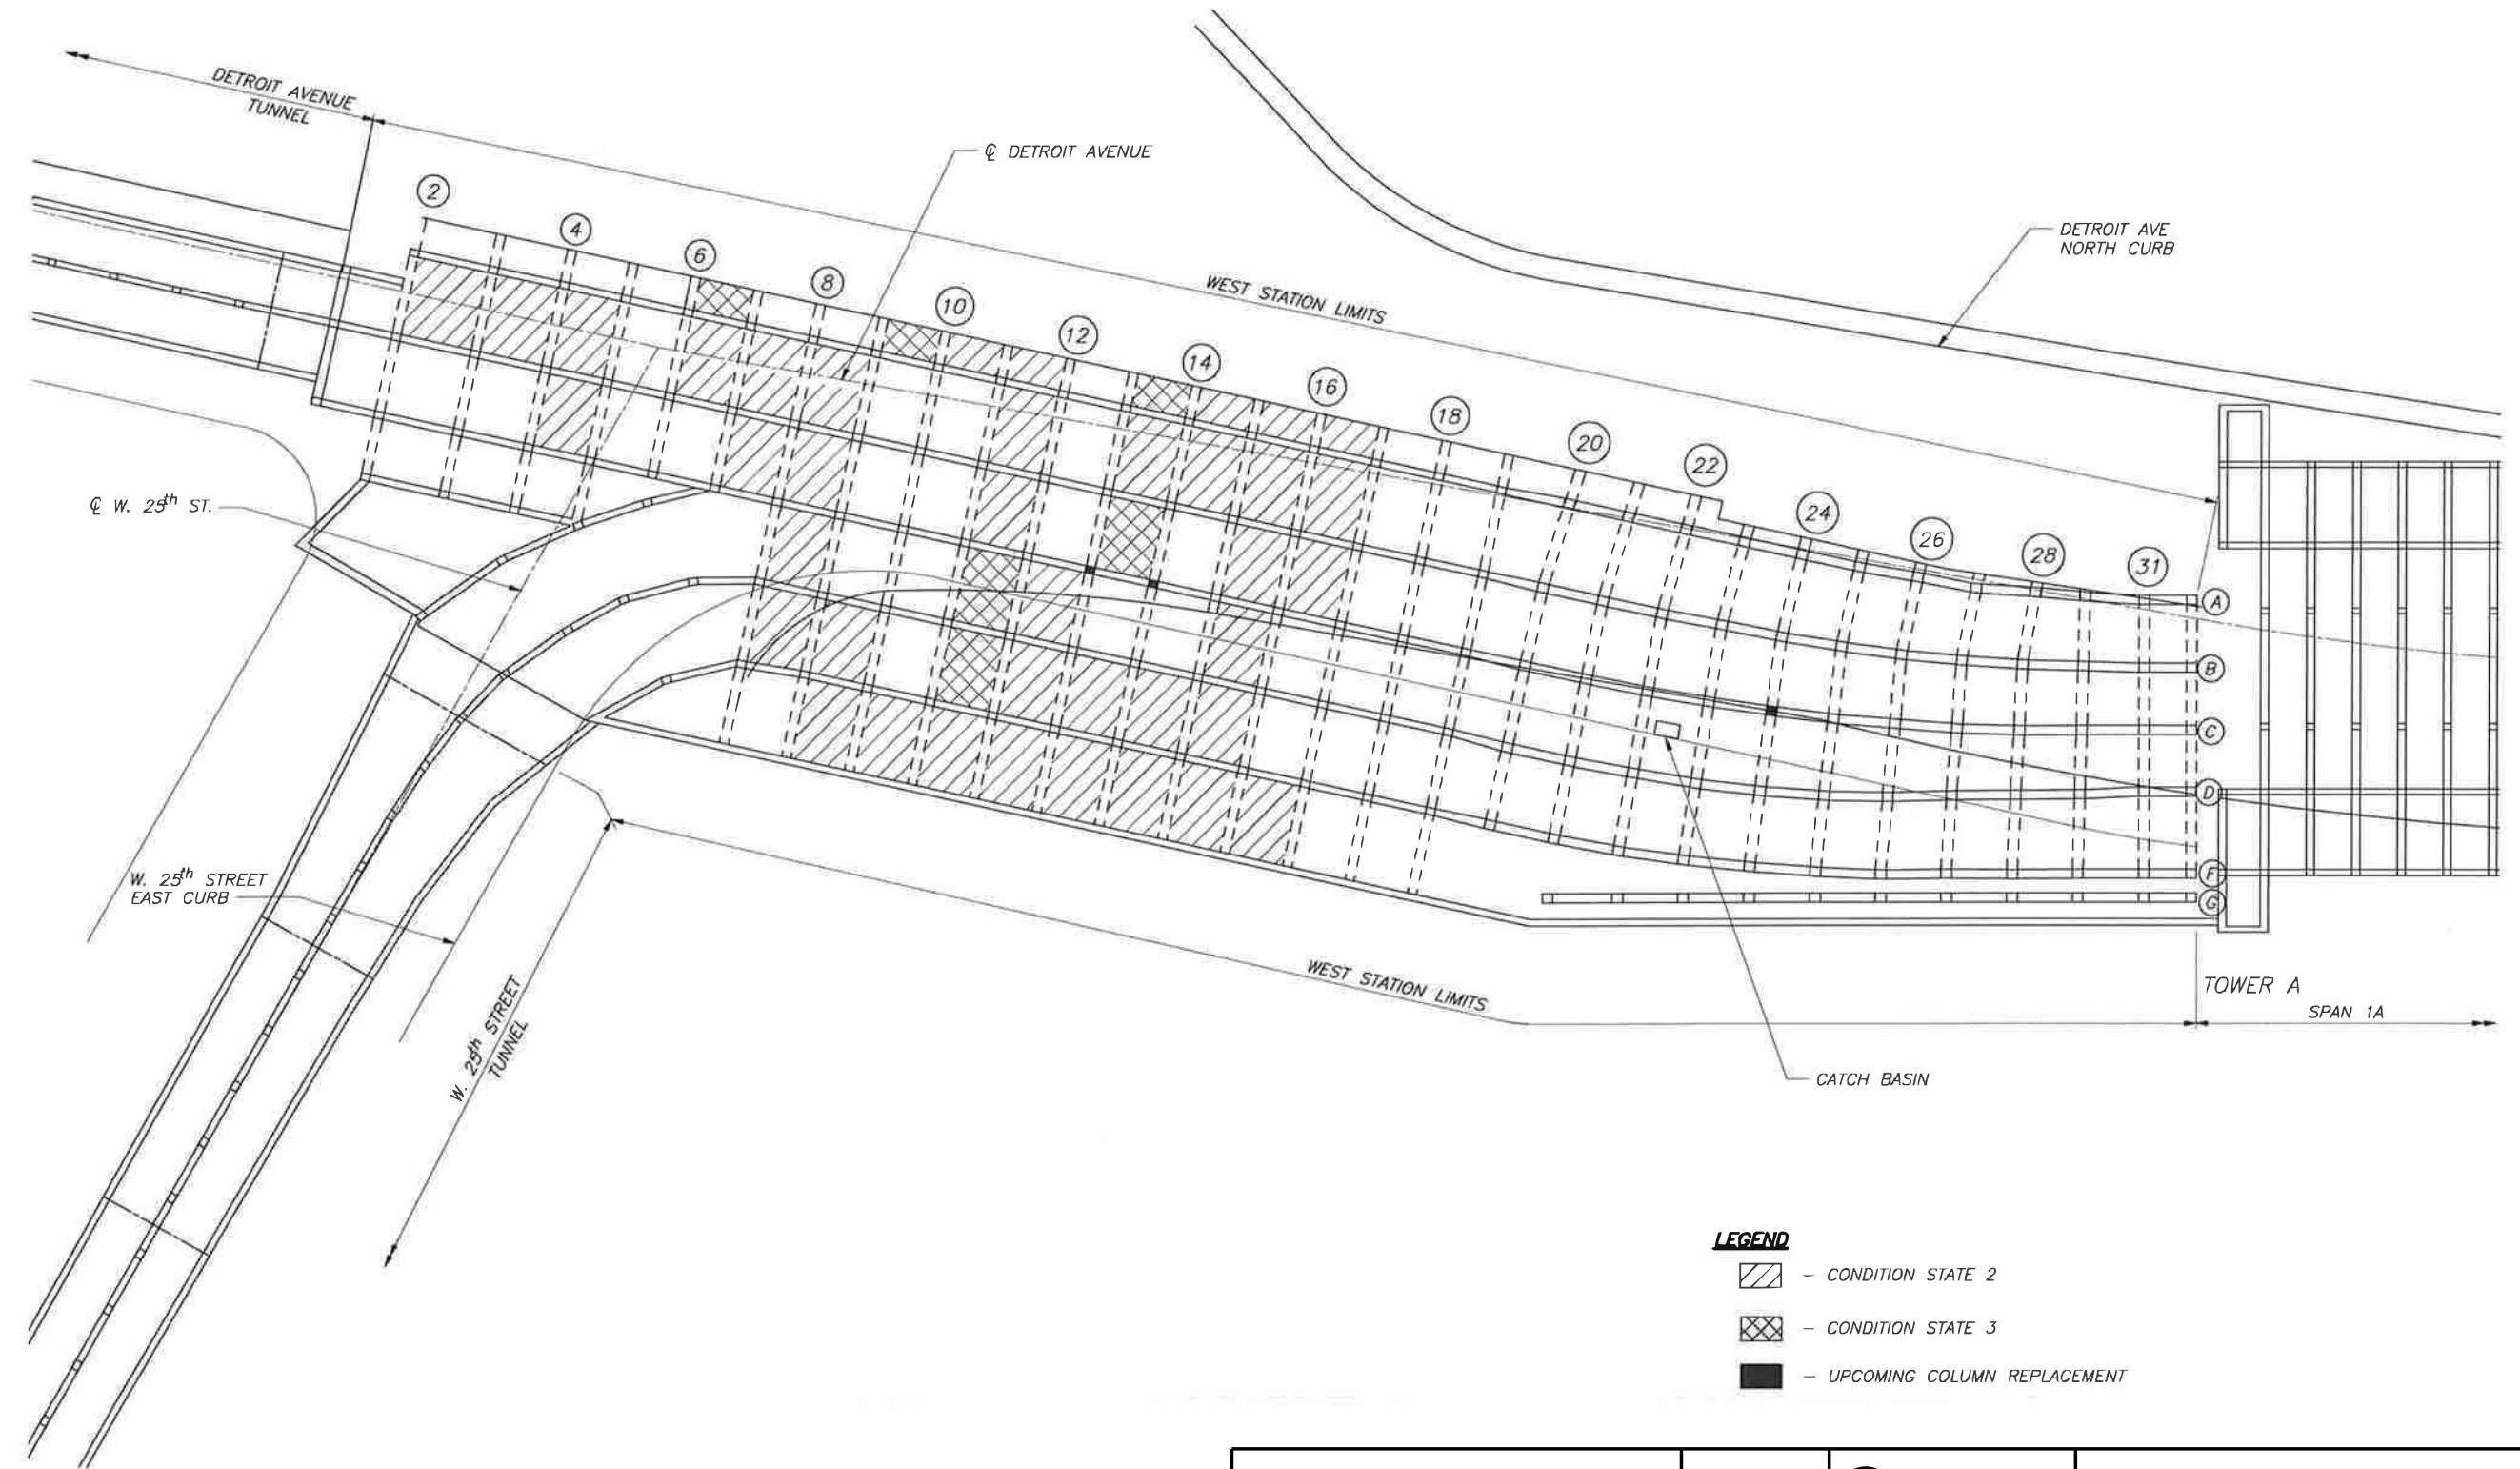
- LEGEND**
- CONDITION STATE 2
  - CONDITION STATE 3
  - UPCOMING COLUMN REPLACEMENT

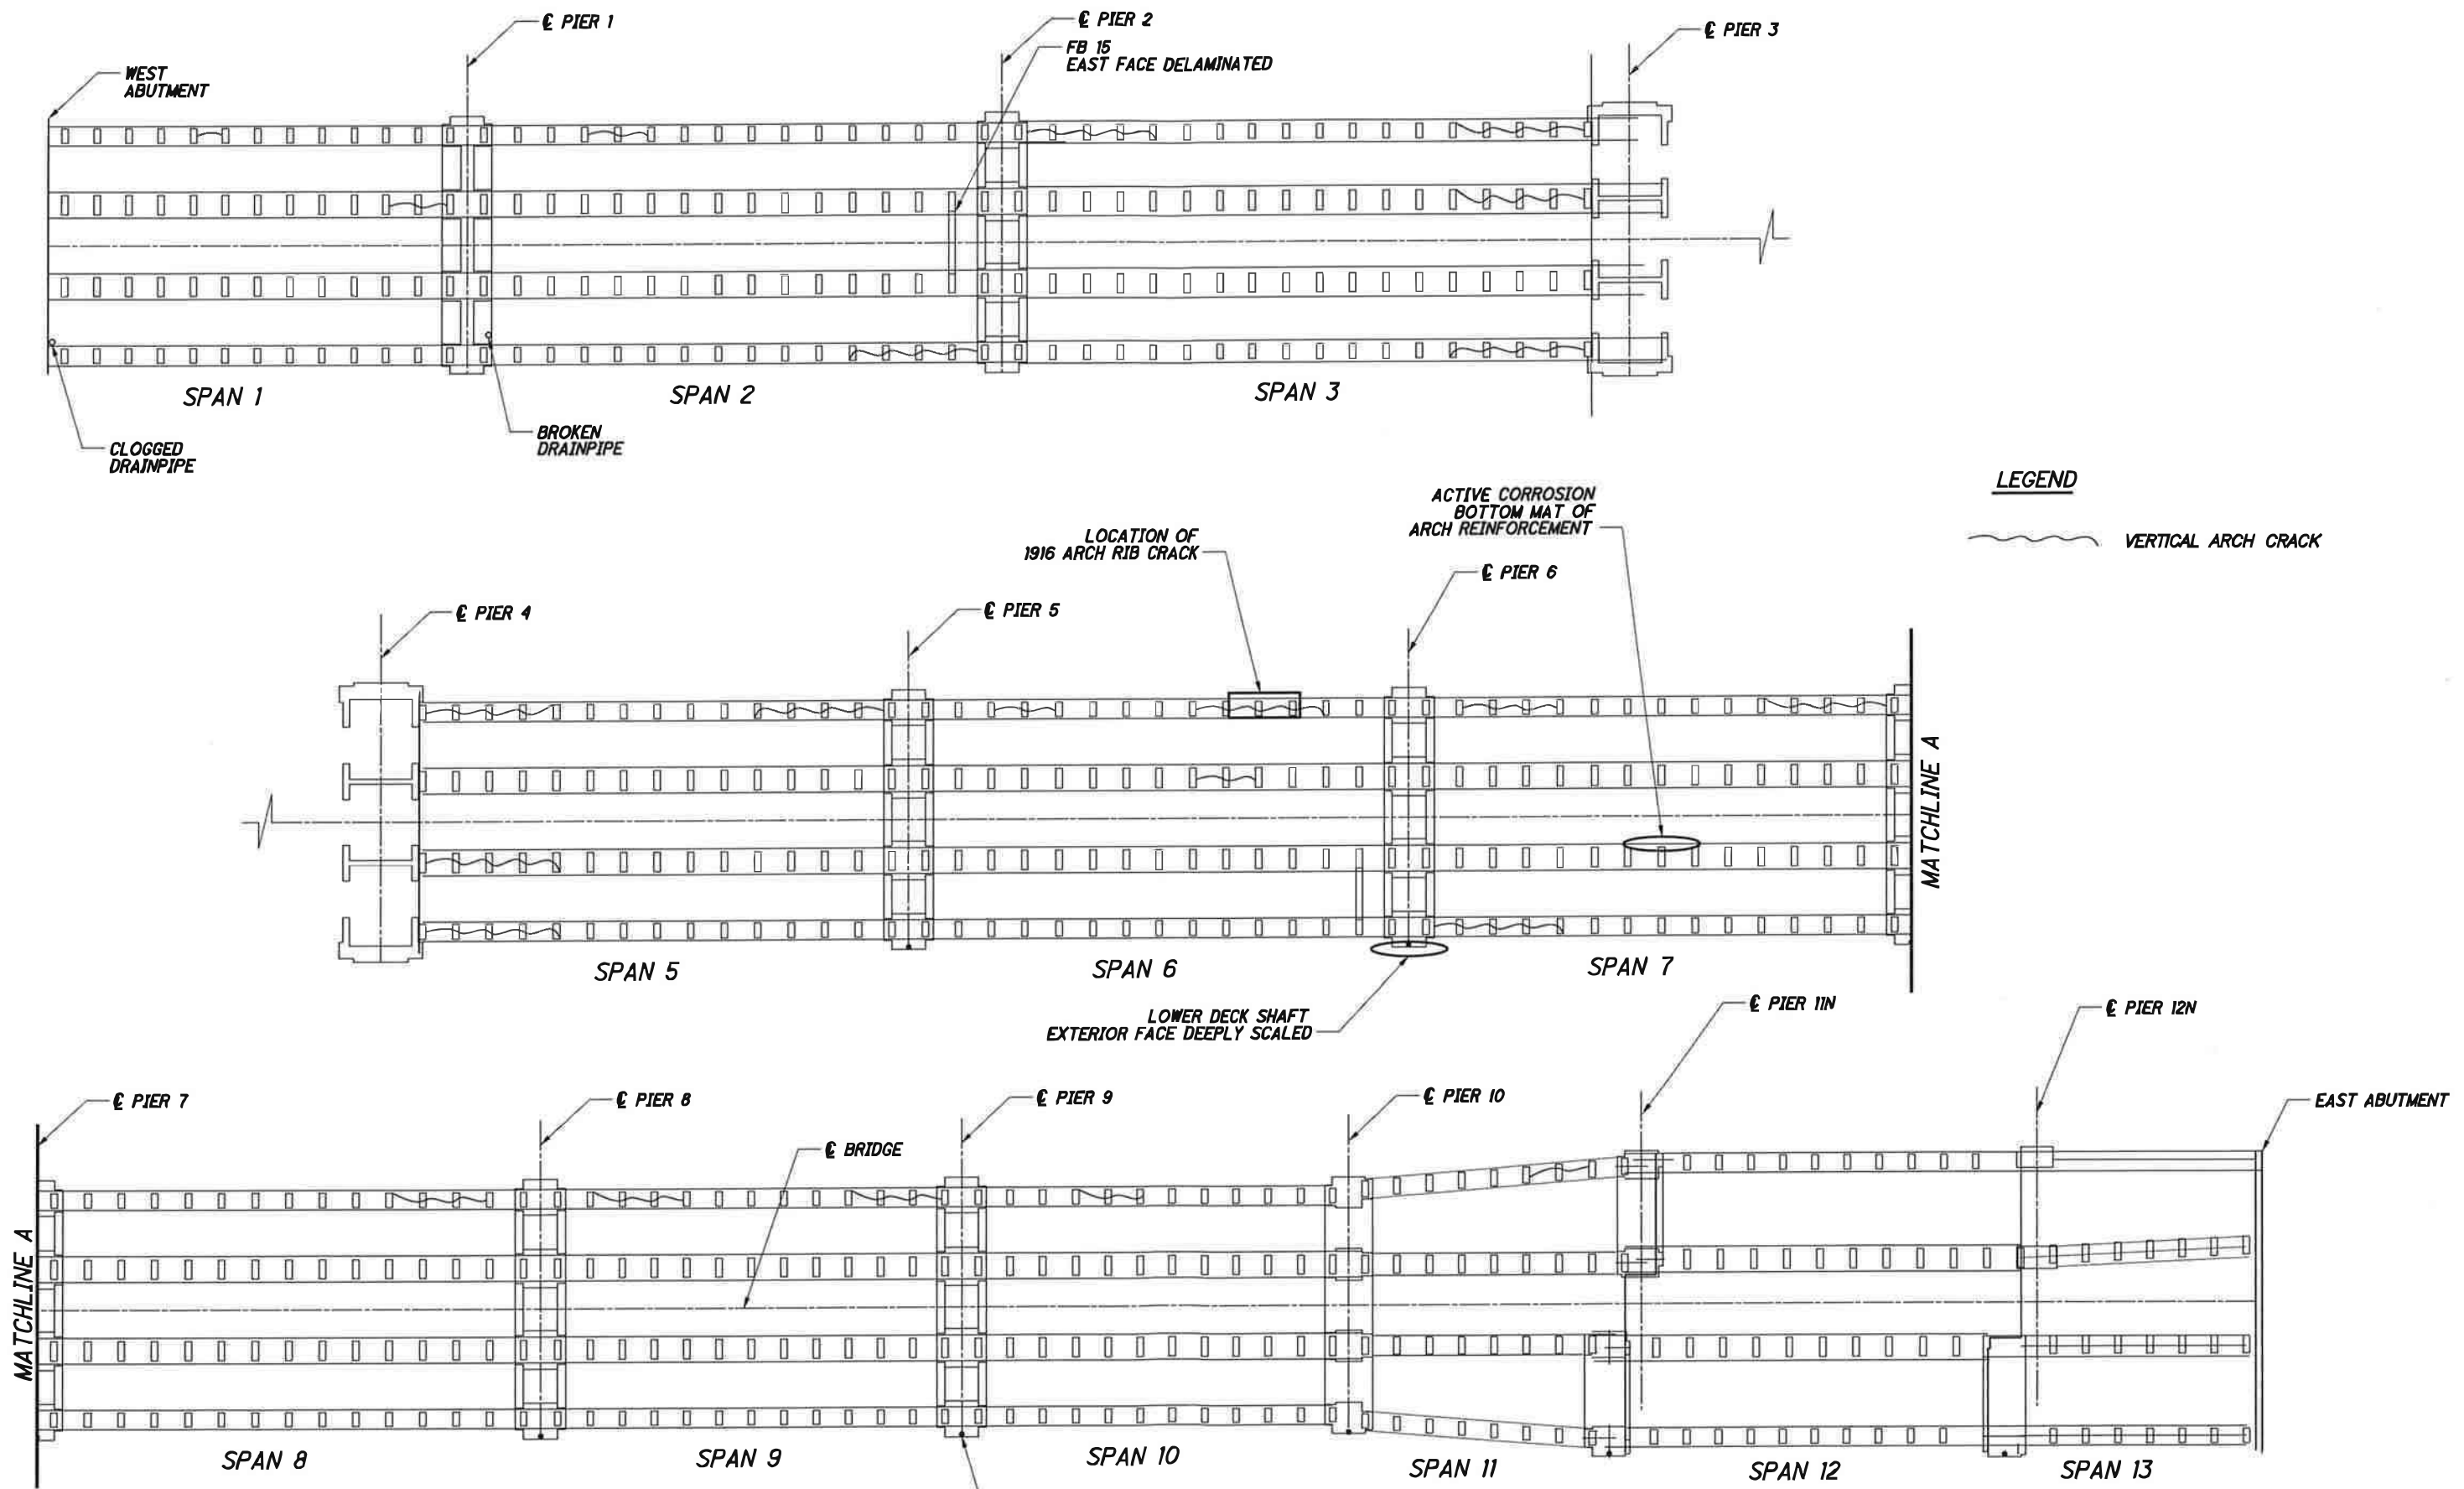
GRAPHIC SCALE MEASURED IN FEET	DATE	  300 East Business Way Suite 200 Cincinnati, OH 45241 PH.: 614.699.5000	DETROIT-SUPERIOR BRIDGE OVER CUYAHOGA RIVER BRIDGE NO. CUY-6-1456	
	NOV, 2017		INFRASTRUCTURE ENGINEERS, INC.	SUPERSTRUCTURE PLAN
NOT TO SCALE

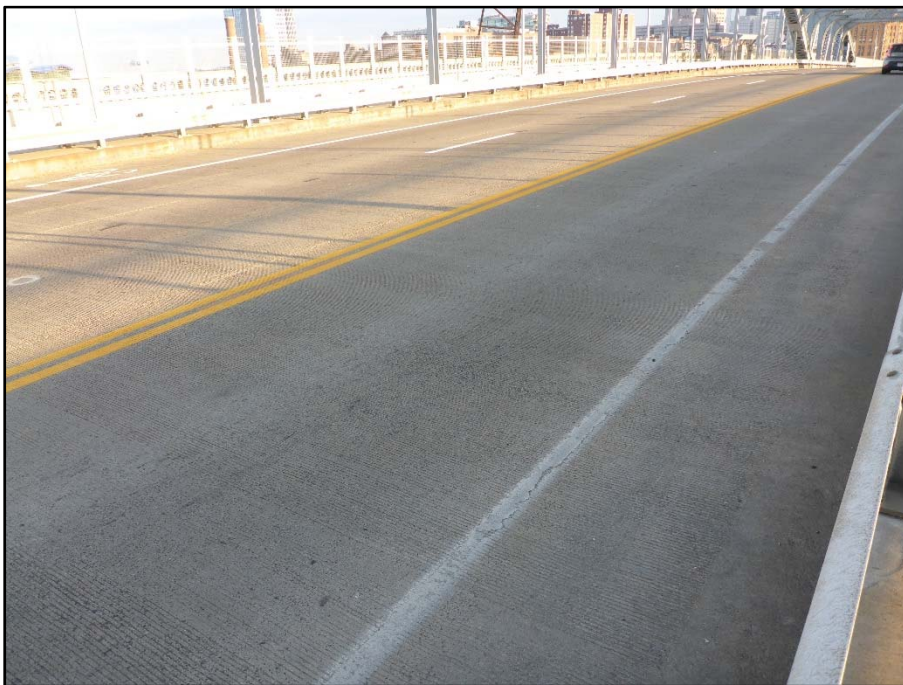
Photo 4 – Typical upper deck wearing surface condition

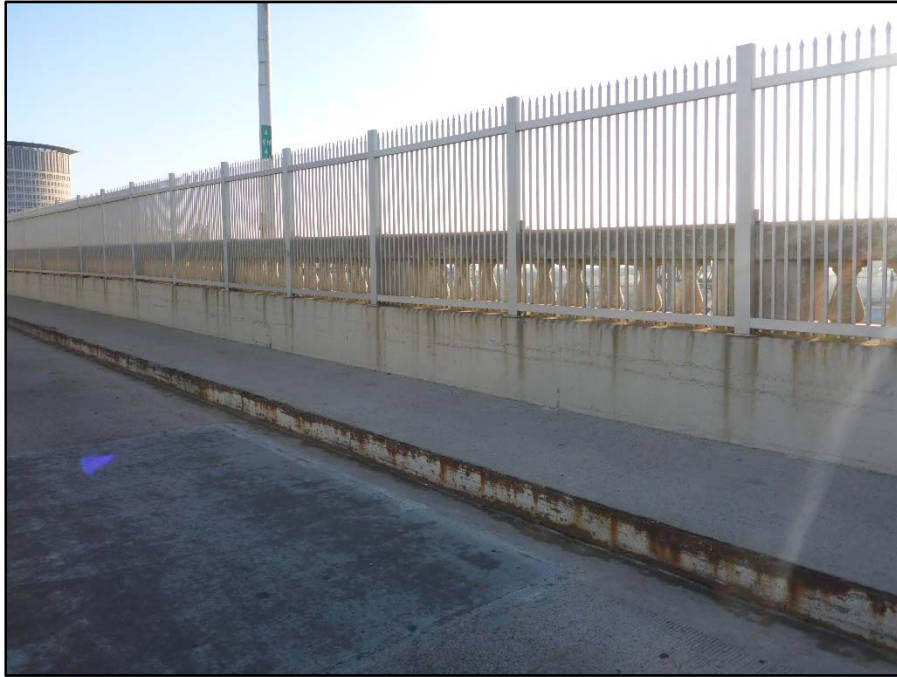
Photo 5 – Typical bridge rail condition

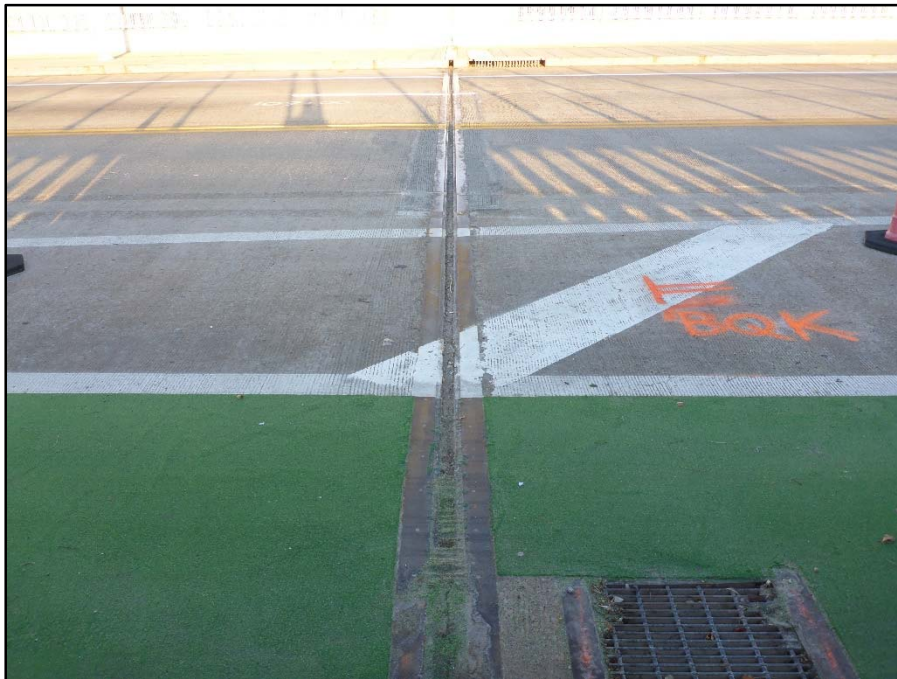
Photo 6 – Typical expansion joint condition

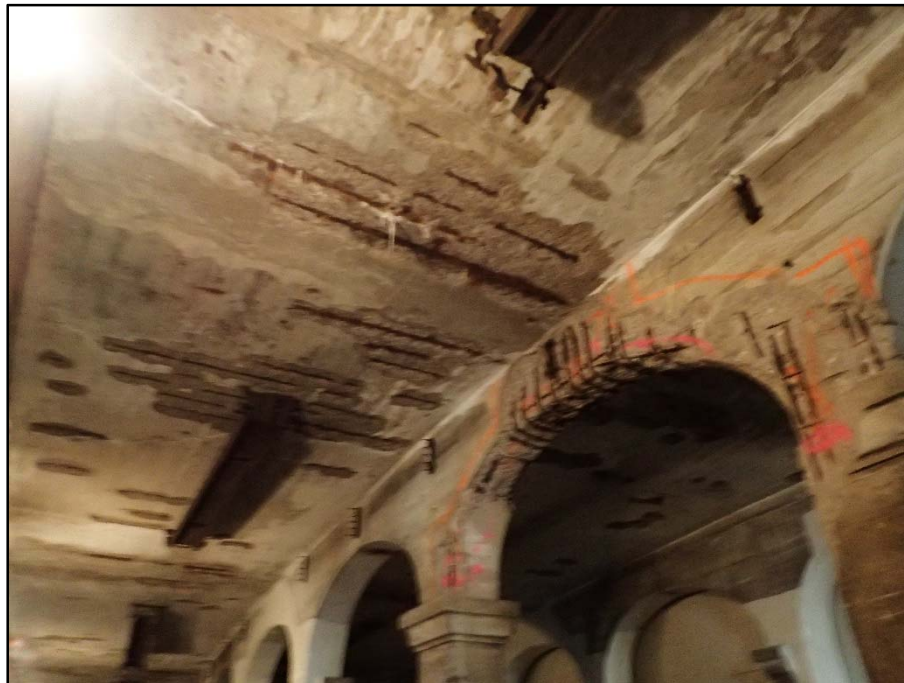
Photo 8 – West tunnels upper deck with heavy efflorescence, cracking, delaminations, and spalls with corroded reinforcing steel

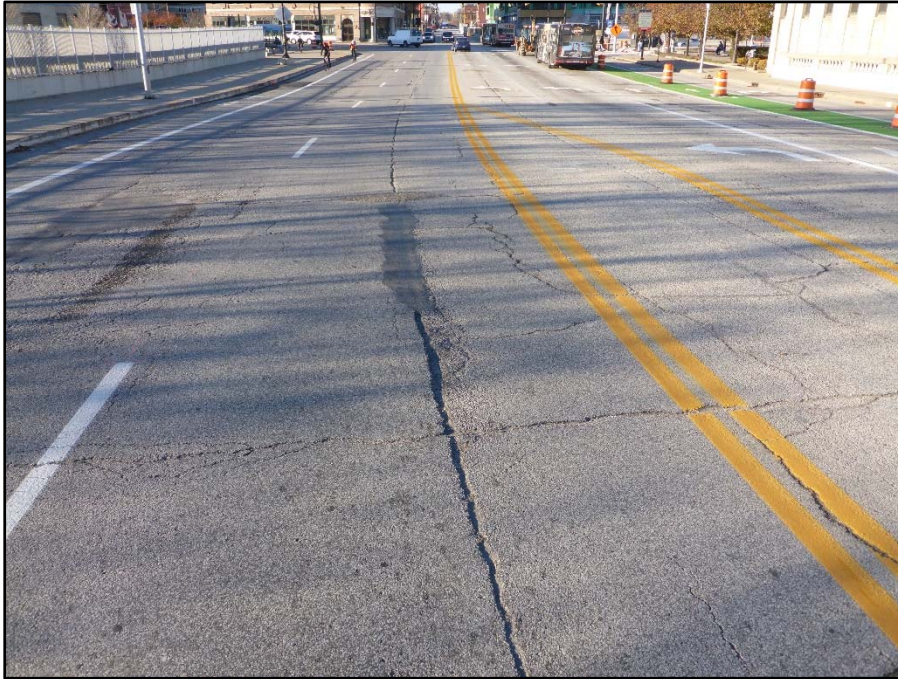
Photo 9 – West Station wearing surface; heavy map cracking and patching throughout

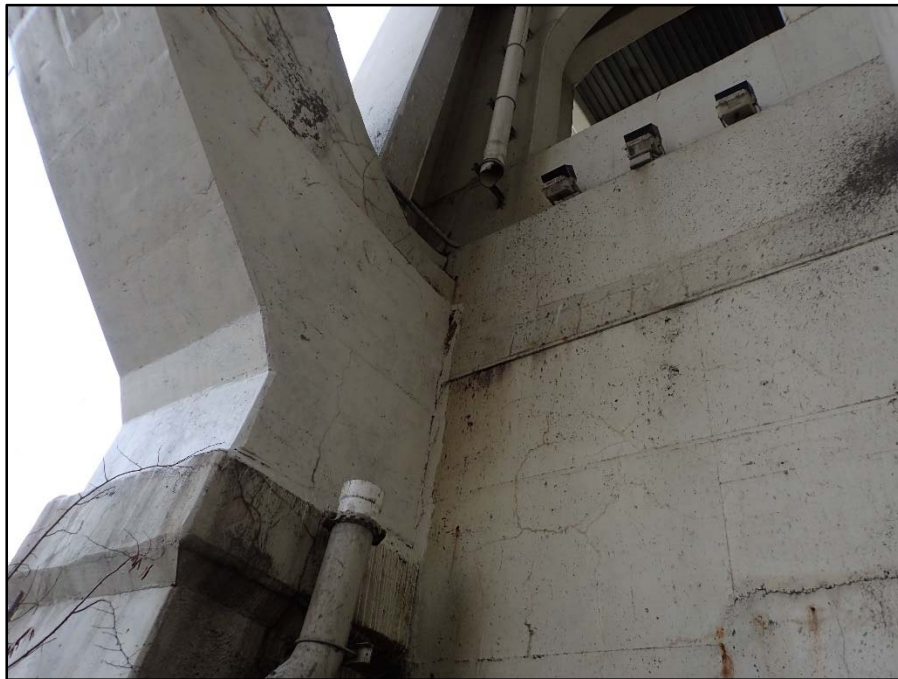
Photo 10 – Pier 1 south downspout; missing 15' section of PVC pipe

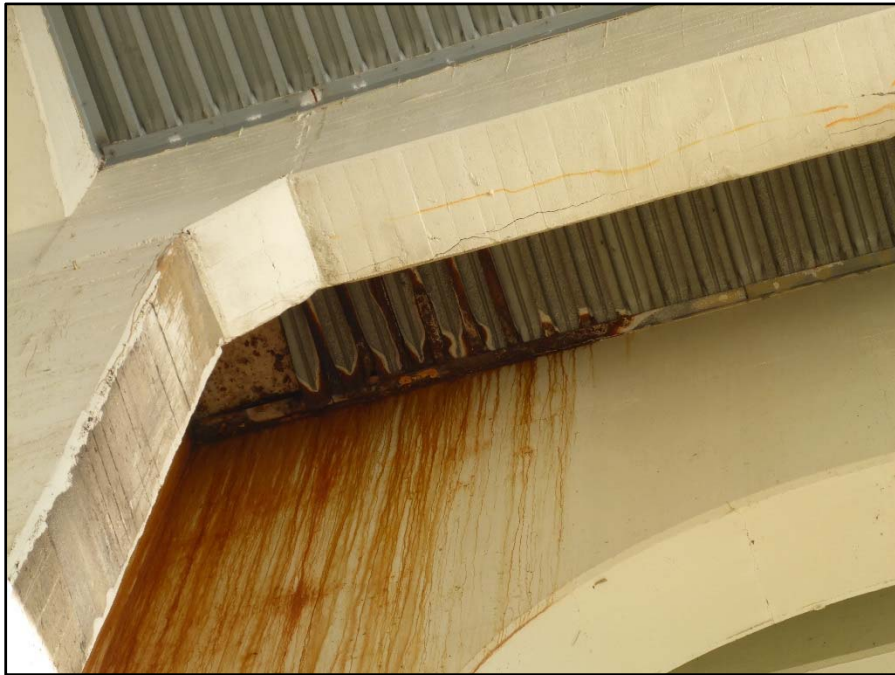
Photo 11 – Span 2, Panel 15 center bay; SIP forms exhibit severe corrosion that is staining the west face of Pier 2

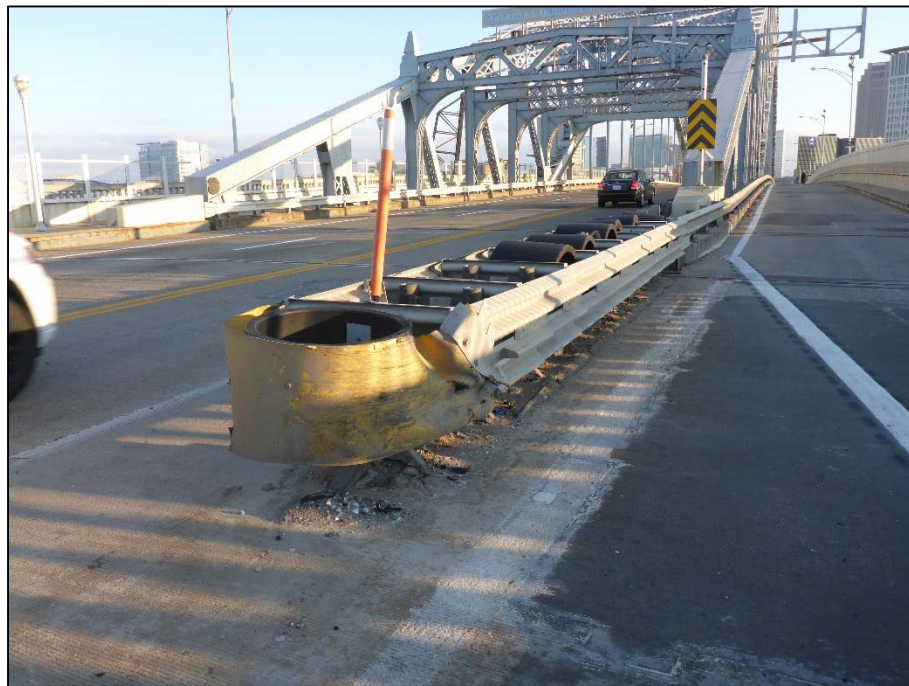
Photo 12 – Span 3 south attenuator; minor impact damage

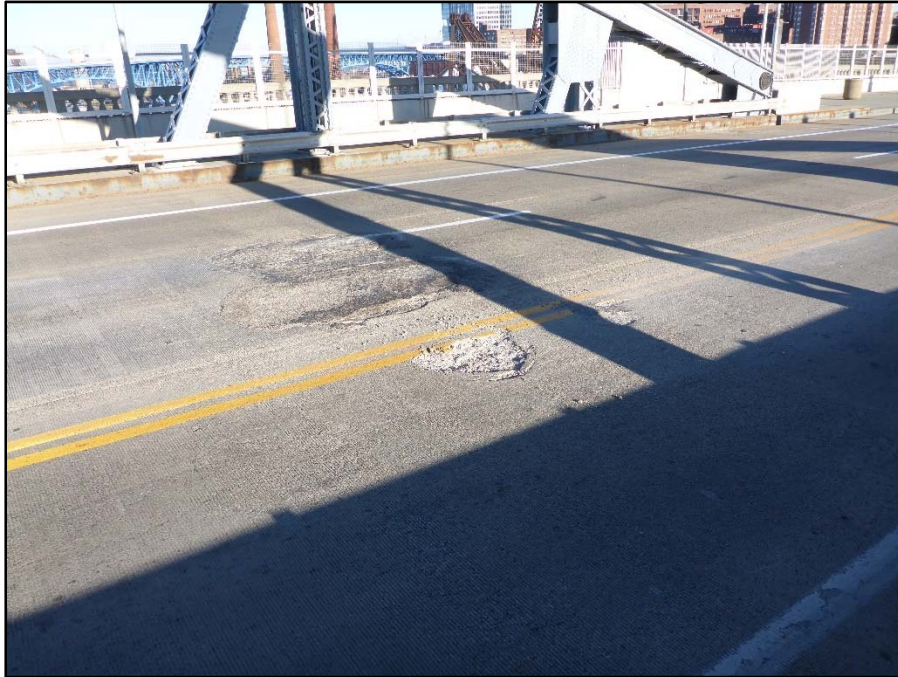
Photo 13 – East end of Span 4; deteriorating 6' Diameter patch with adjacent 2' Diameter x 1-1/2" D pothole

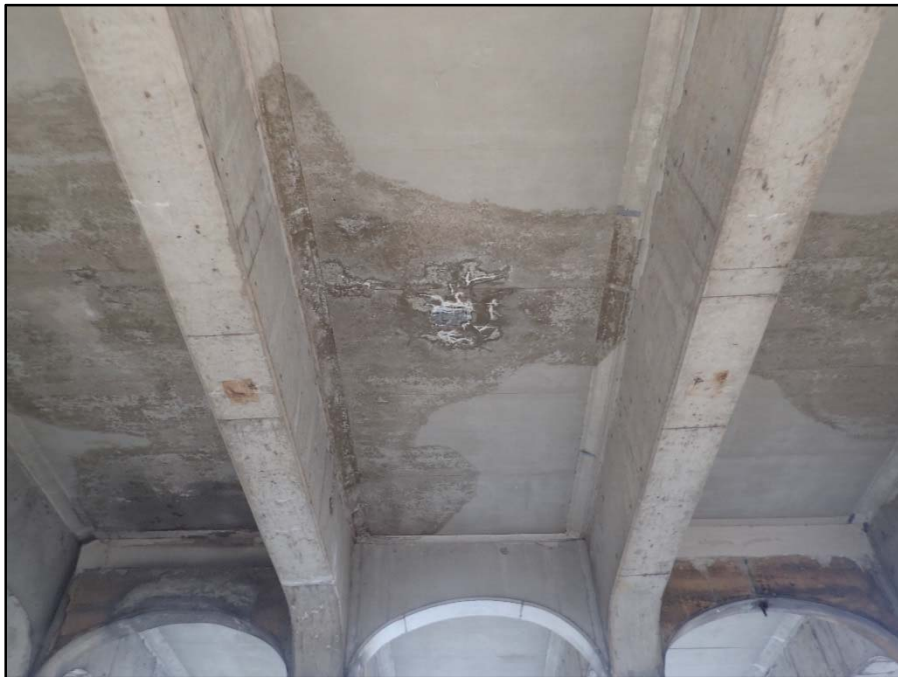
Photo 14 – Upper Deck, Span 7, Panel 4 center bay; local area of efflorescence

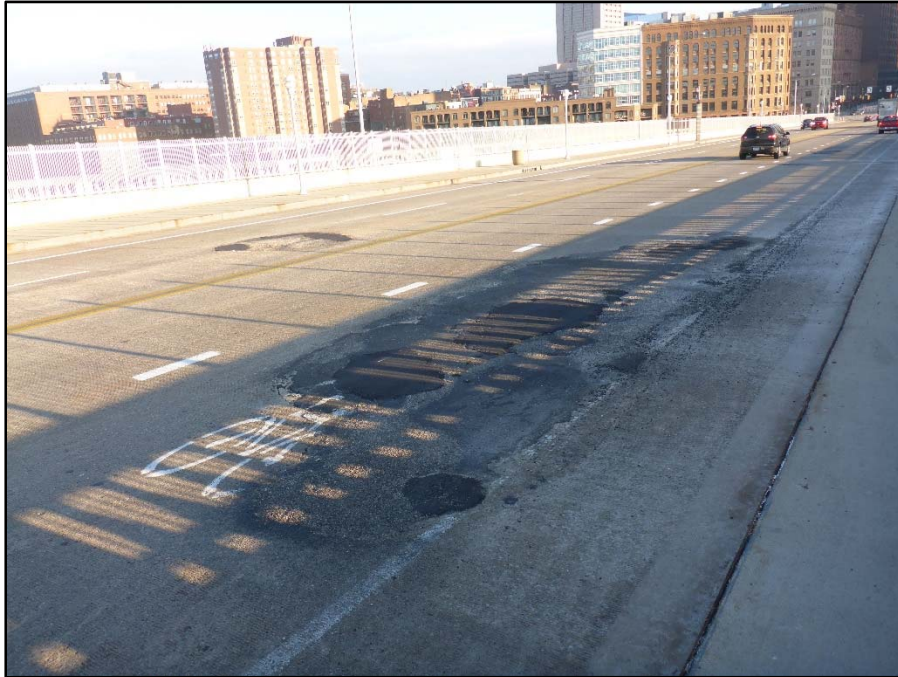
Photo 15 – Span 8 eastbound lane; 36' L deteriorating asphalt patch

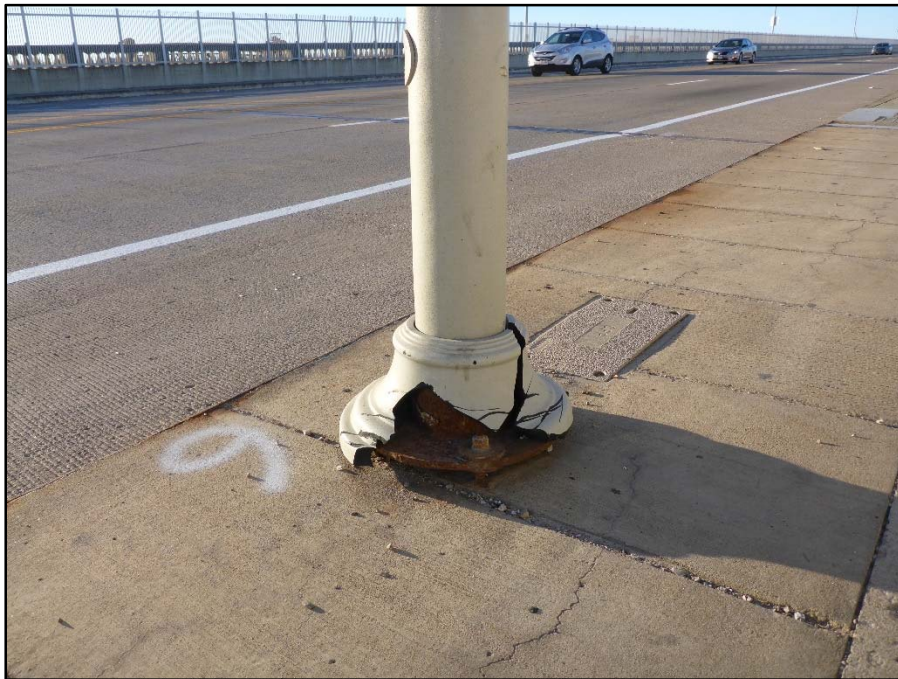
Photo 16 – Span 11, North sidewalk; broken light pole base

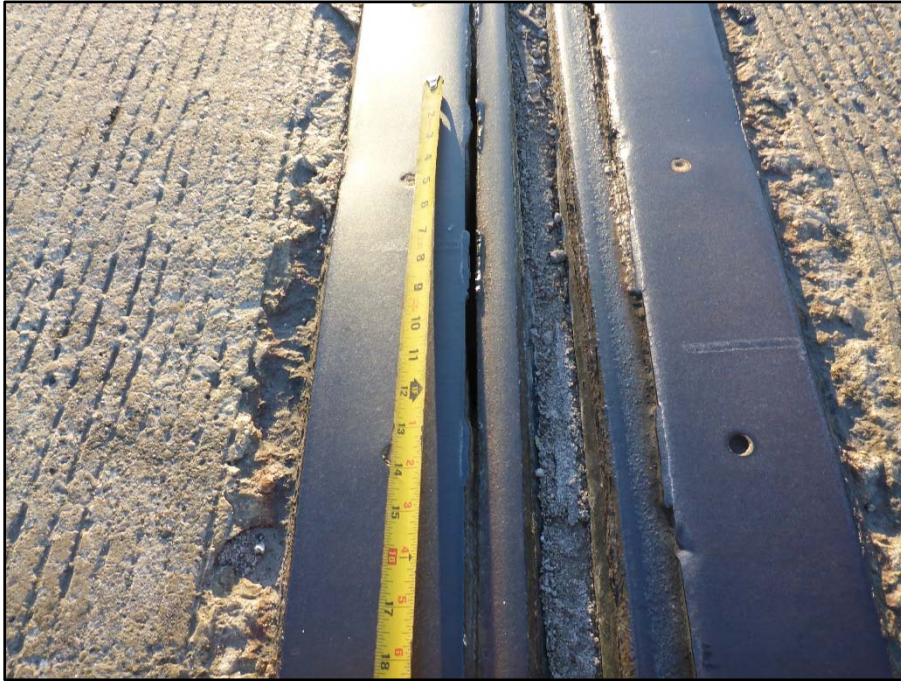
Photo 17 – Tower B expansion joint, left westbound lane; Pack rust has broken fillet welds. Snow plow damage is present.

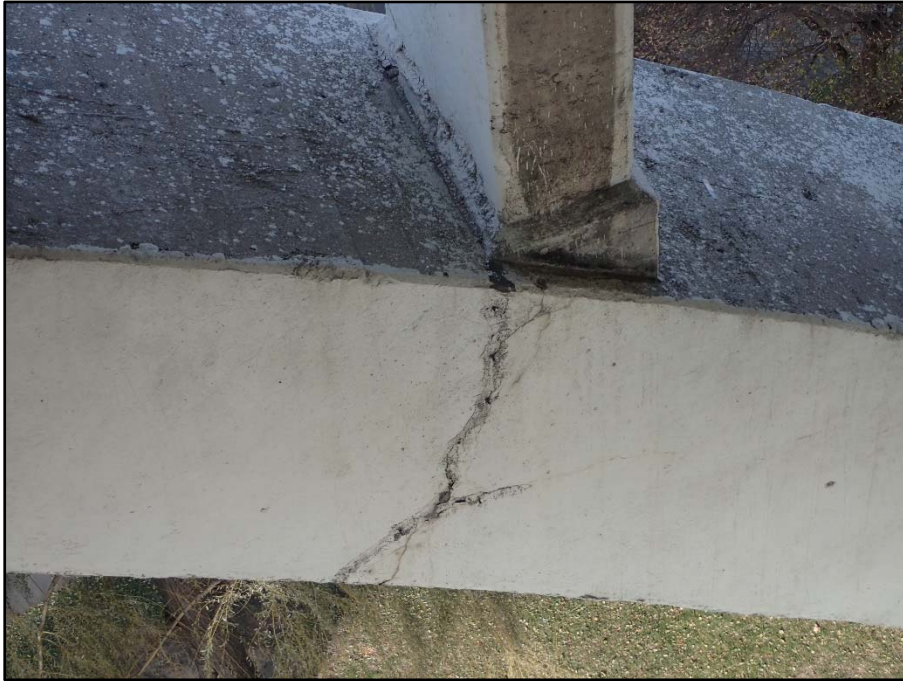
Photo 18 – Span 5 North Exterior Arch Rib, Panel 14; longitudinal through crack that has propagated into several spandrel columns

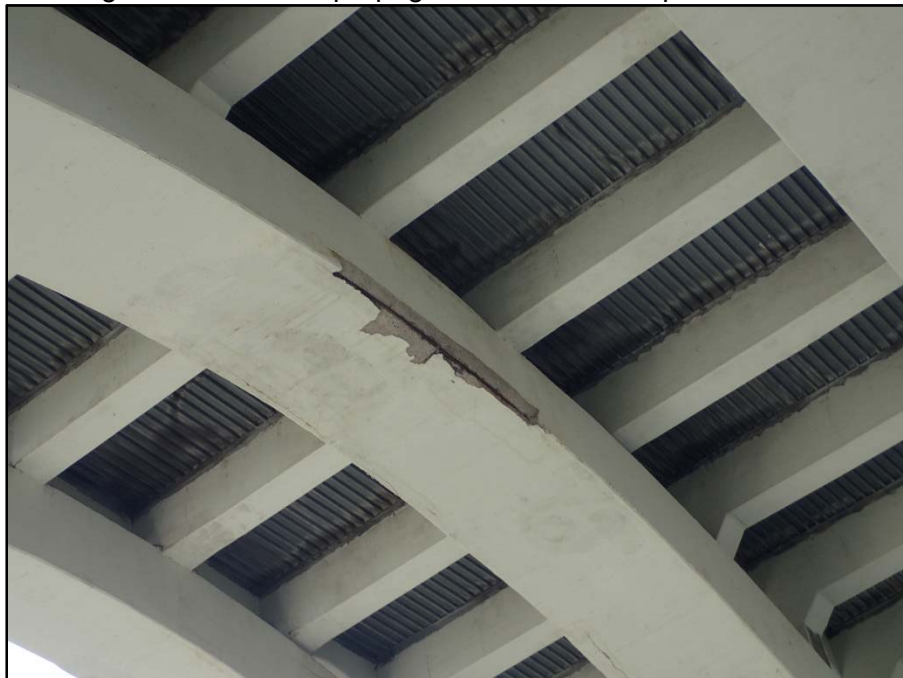
Photo 19 – Span 7 South Interior Arch Rib; lower north corner near apex has an unrepaired spall with exposed reinforcing

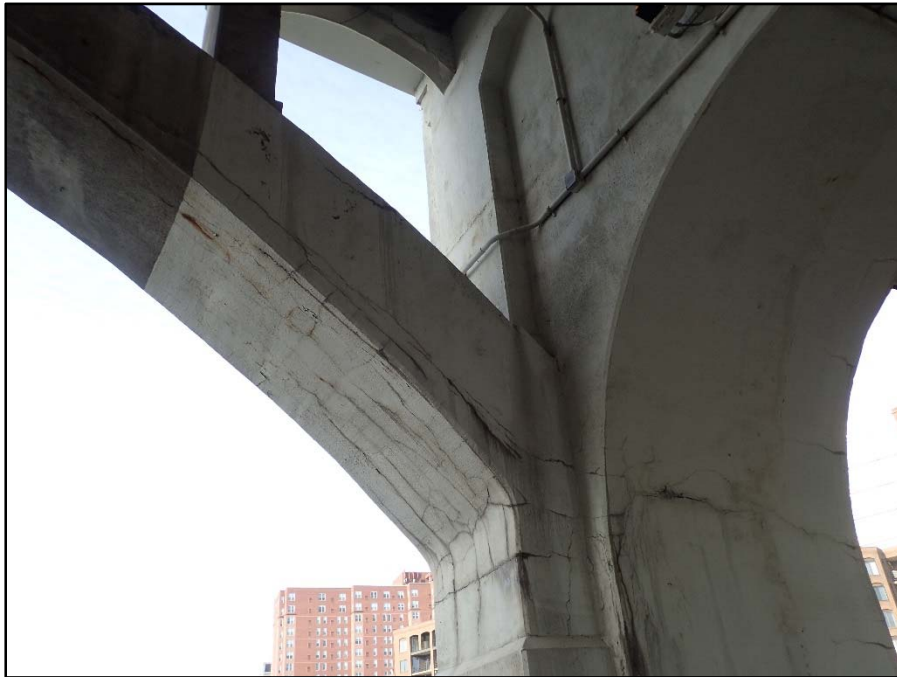
Photo 20 – Span 11 North Exterior Arch, south face; crack extending from Pier 11 up 1/4 length of the arch

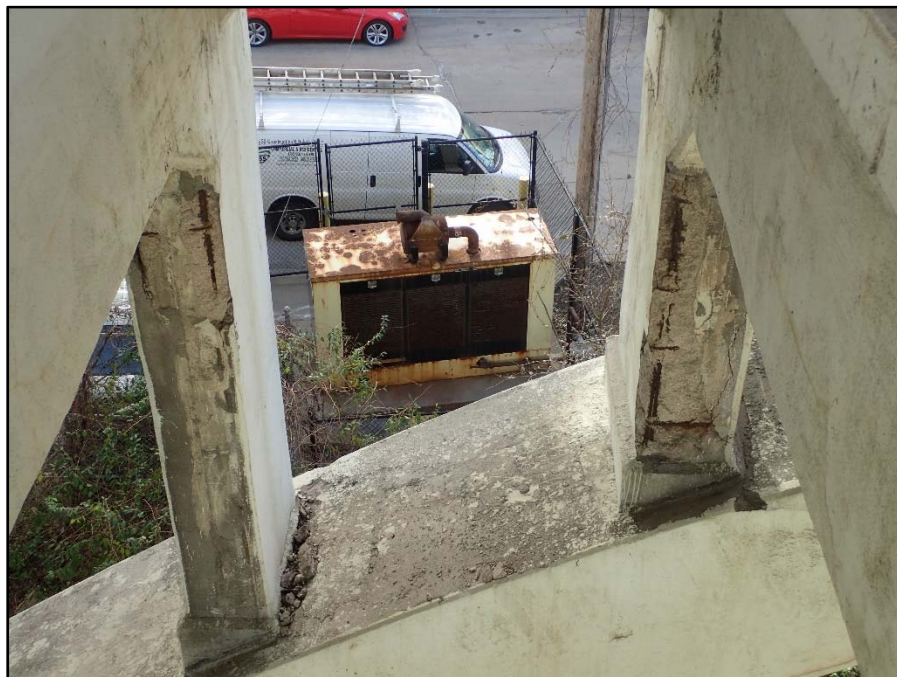
Photo 21 – Span 2 North Exterior lower columns 3 and 4; south faces have up to full height spalling with corroded reinforcing

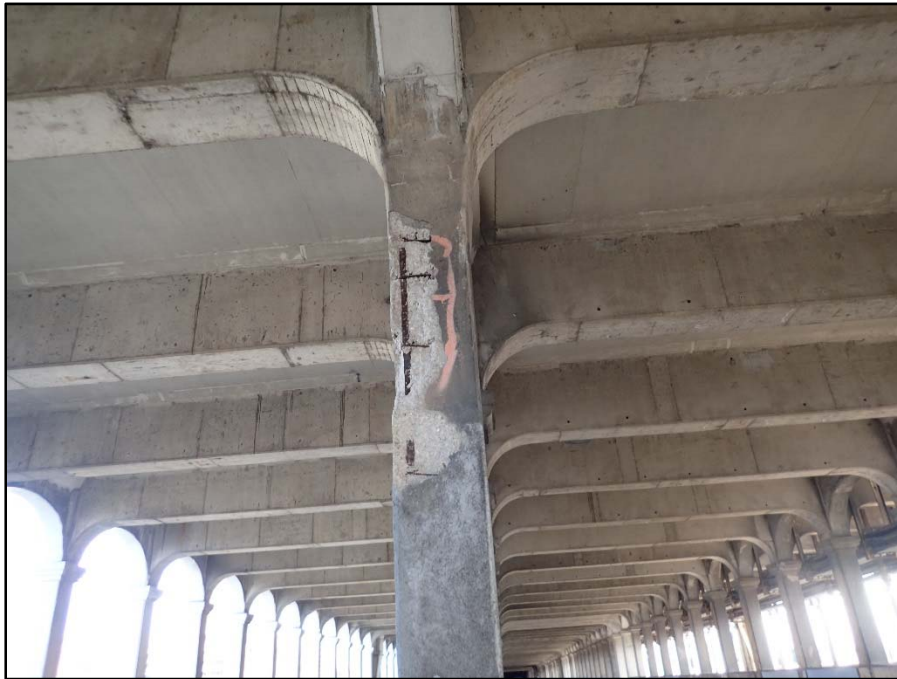
Photo 22 – Span 8 North Interior Upper Column 2; 4' H x 4" D corner spall on the northeast corner of the column with exposed reinforcing

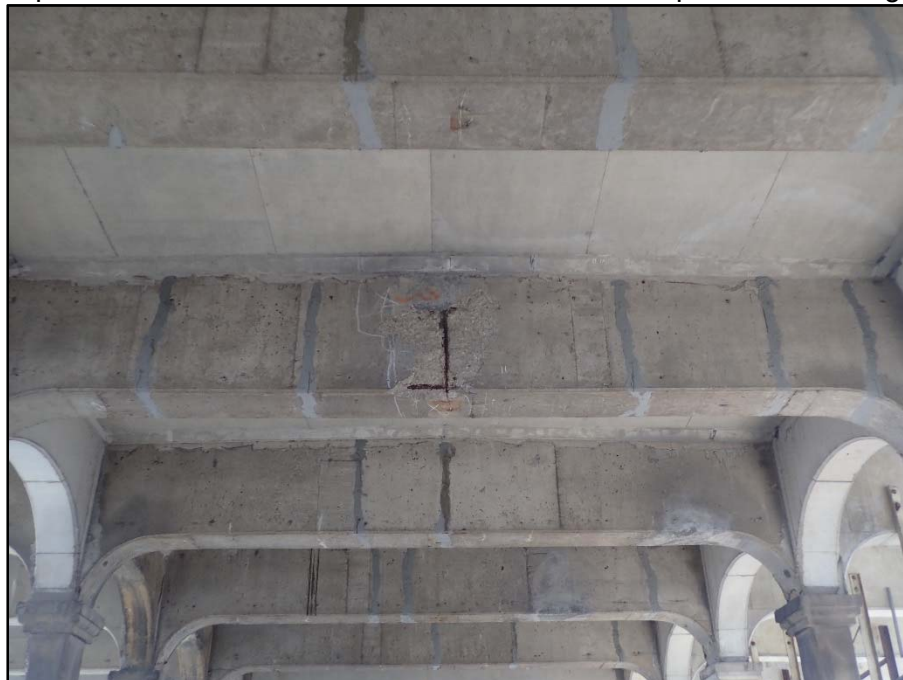
Photo 23 – Span 5 Upper Deck Floorbeam 11 west face between interior arches; Full height x 3' W x 4" D spall with exposed rebar

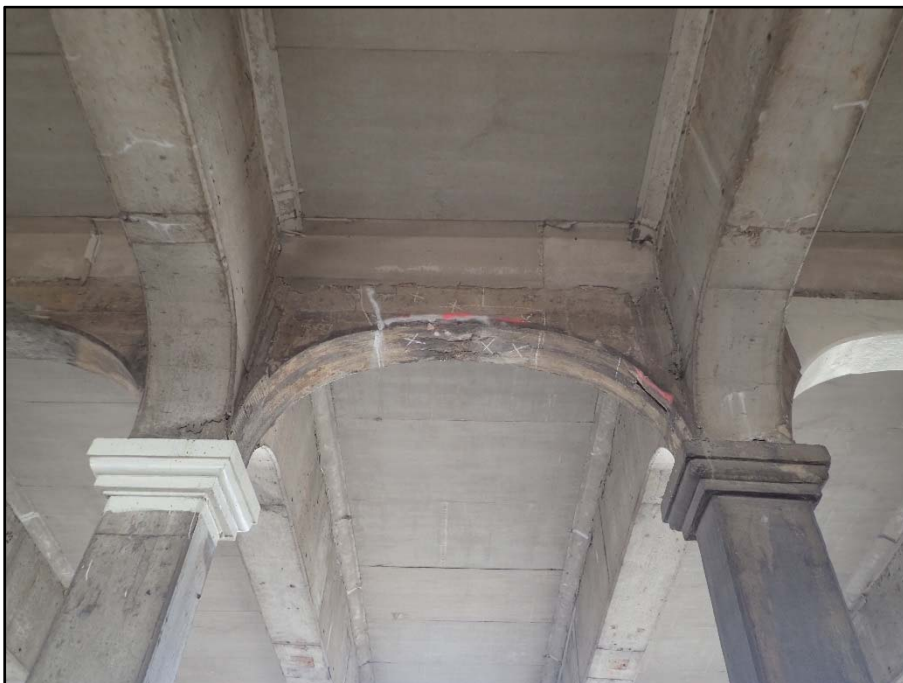
Photo 25 – Span 3 North Interior Arch between upper deck Columns 10 & 11; arch is cracked and delaminated with efflorescence

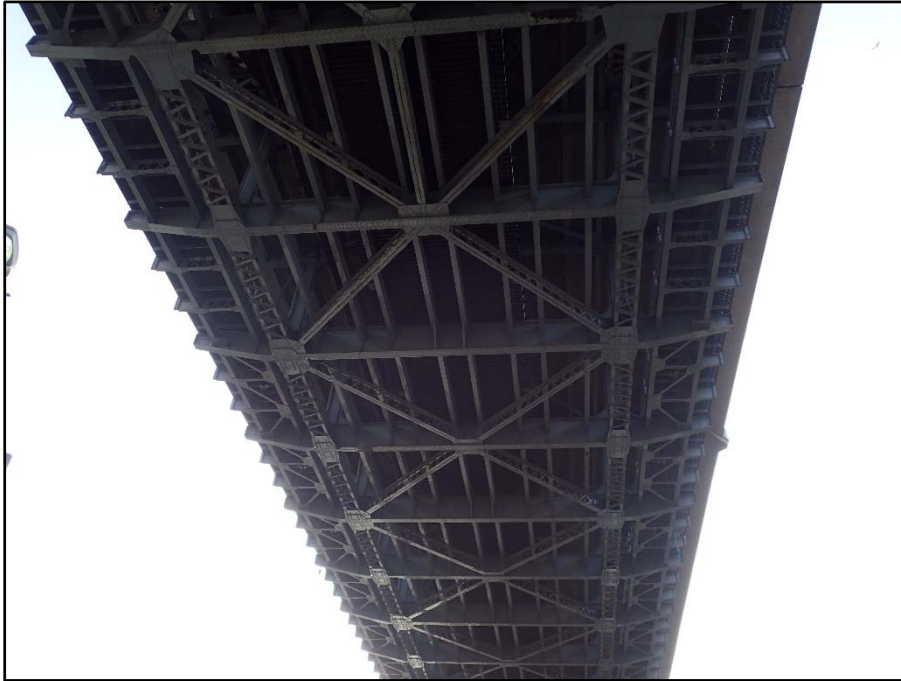
Photo 26 – Typical superstructure condition

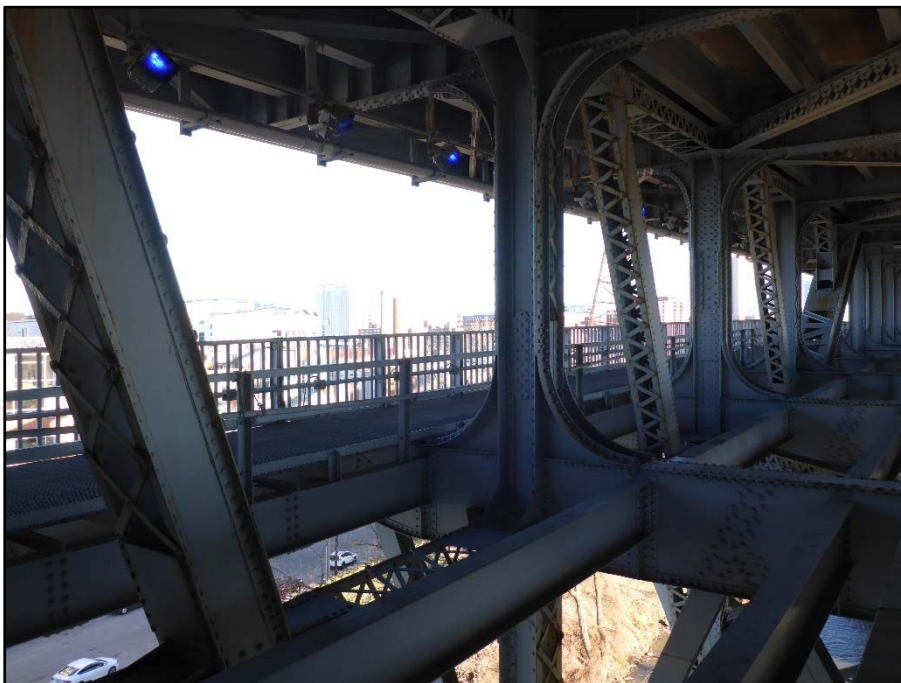
Photo 27 – Typical truss condition

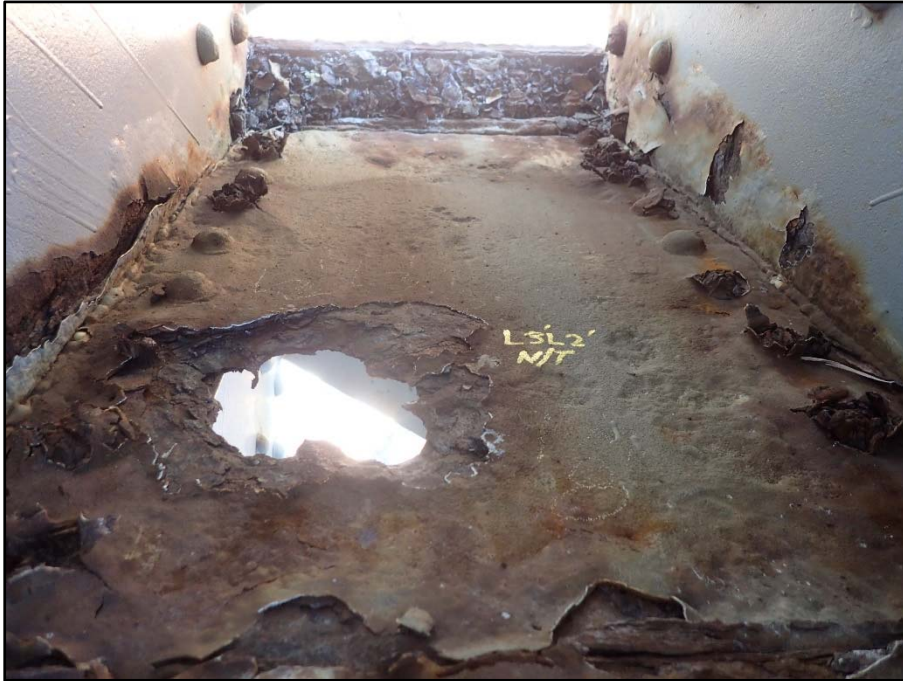
Photo 30 – Span 4 North Truss L3'L2' diaphragm; corrosion hole
