# CUY-6-1456

## PHYSICAL CONDITION REPORT ROUTINE INSPECTION

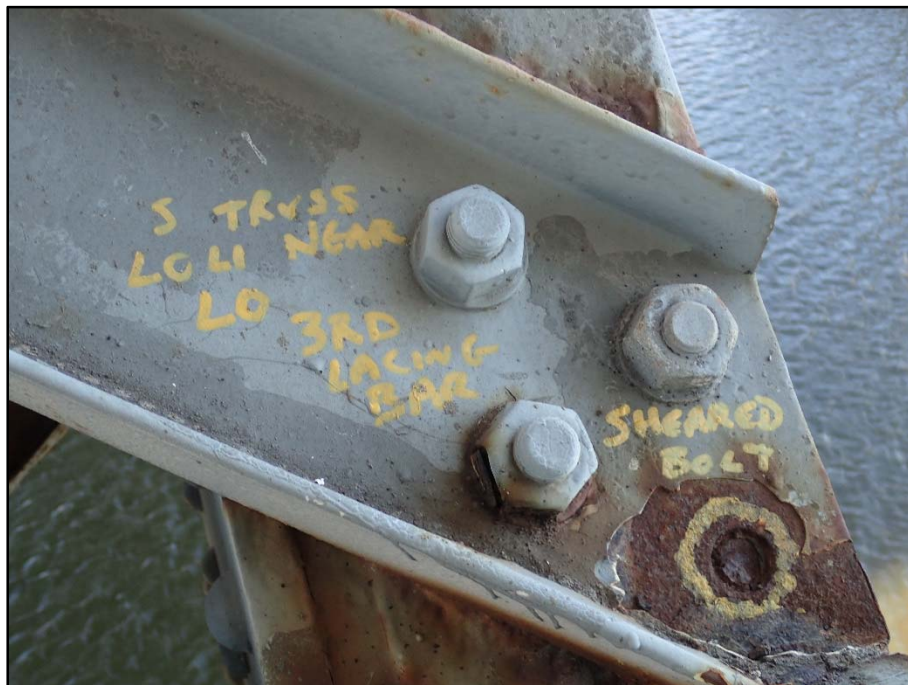
Photo 31 – Span 4 South Truss L0L1 near L0; fractured bolt on top lacing channel connection along top flange

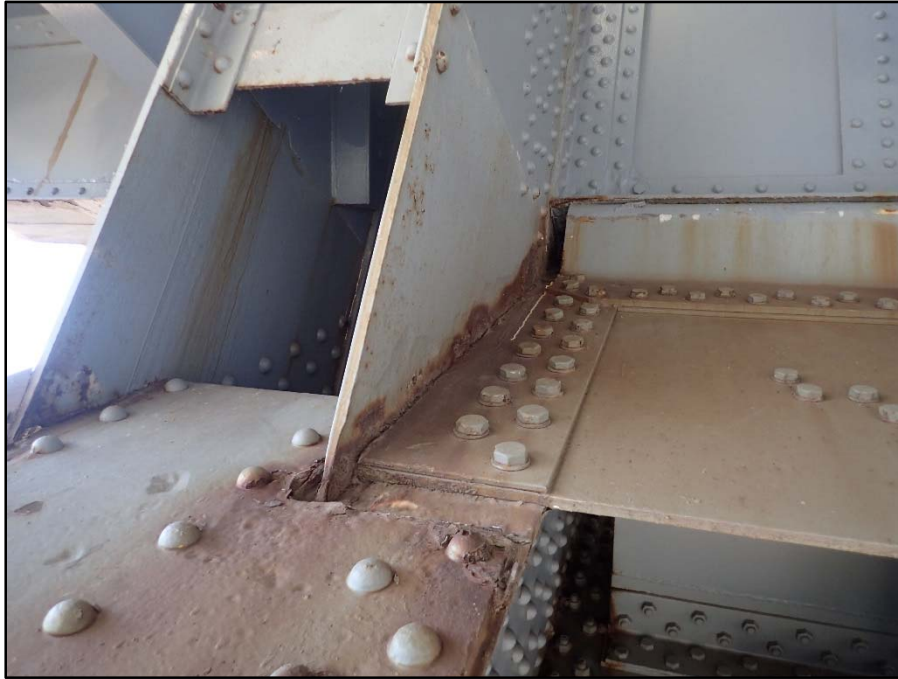
Photo 32 – Span 4 North Truss L3 south gusset above L2L3; Active laminar corrosion and pitting up to 3/16" D

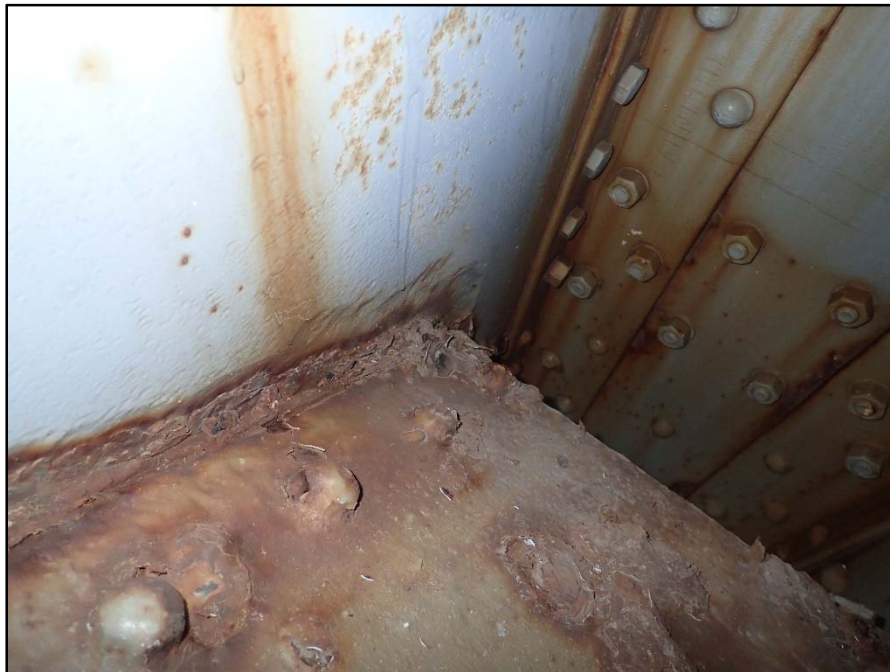
Photo 33 – Span 4 North Truss L2 South Gusset, North Face; 2' L x up to 3' H x up to 1/4" D pitting with reactivating laminar corrosion

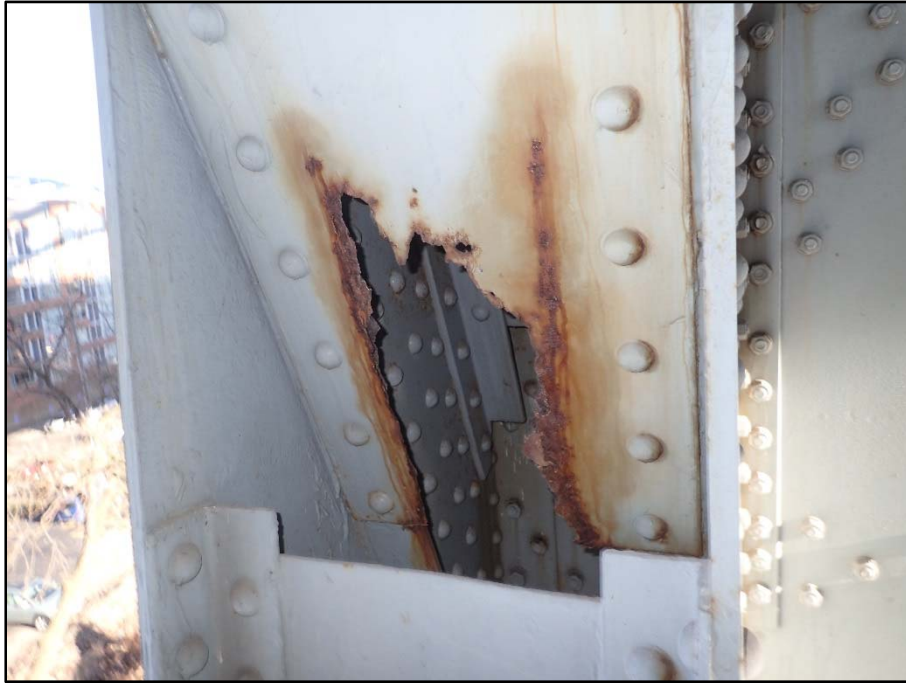
Photo 34 – Span 4 North Truss L2 lower batten plate; 20" L x 8" W corrosion hole

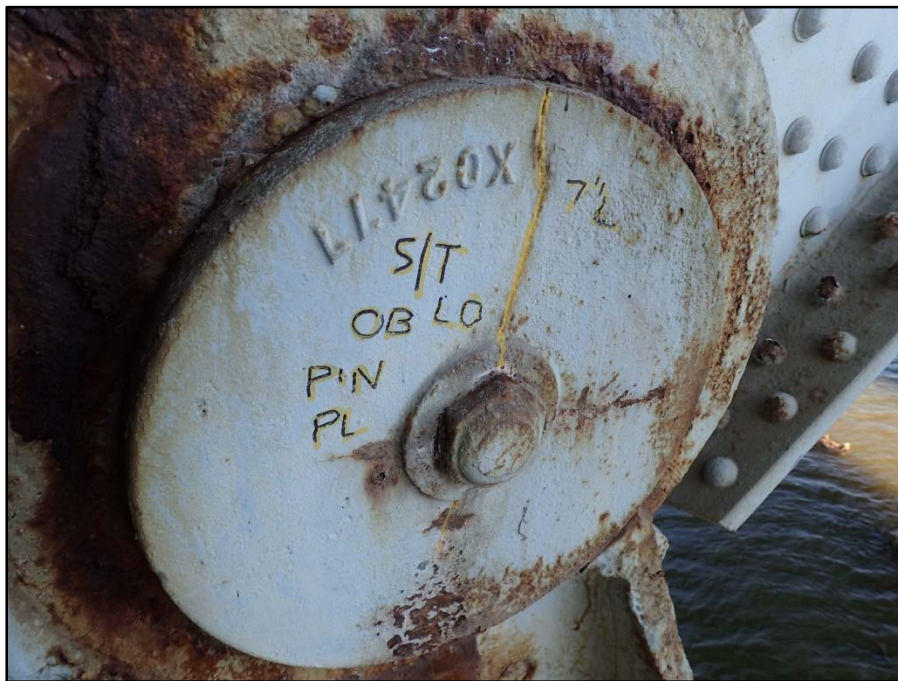
Photo 35 – Span 4 South Truss L0 Outboard Pin Cover Plate; non-structural plate with 7" L crack

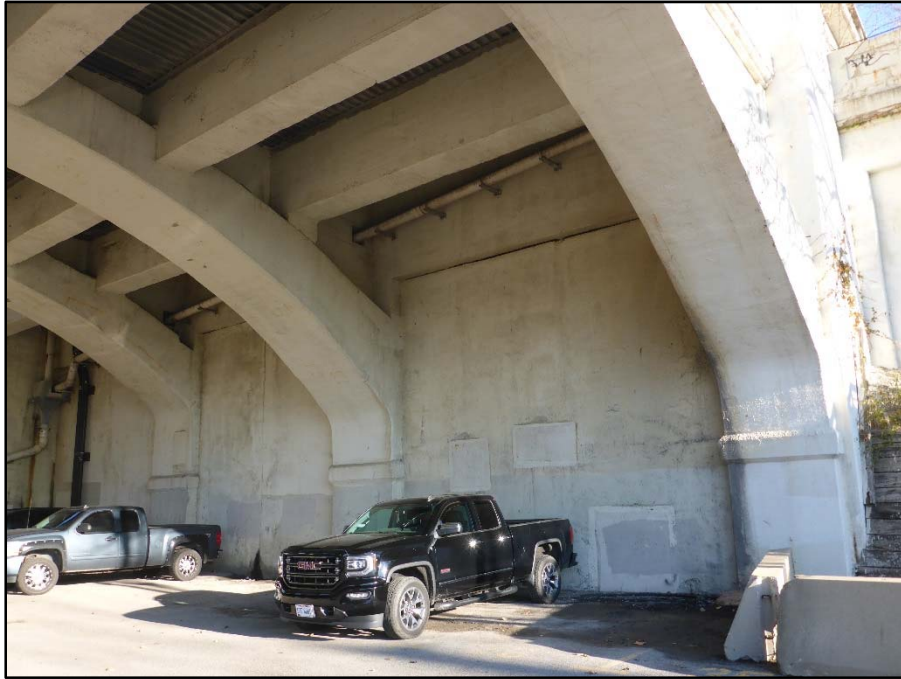
Photo 36 – East Abutment typical condition

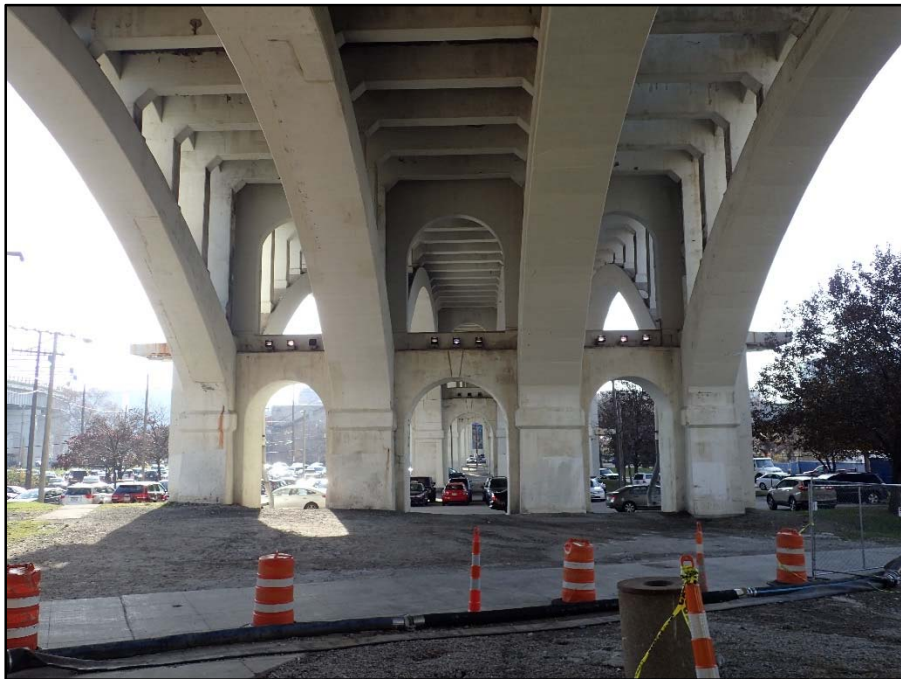
Photo 37 – Pier typical condition

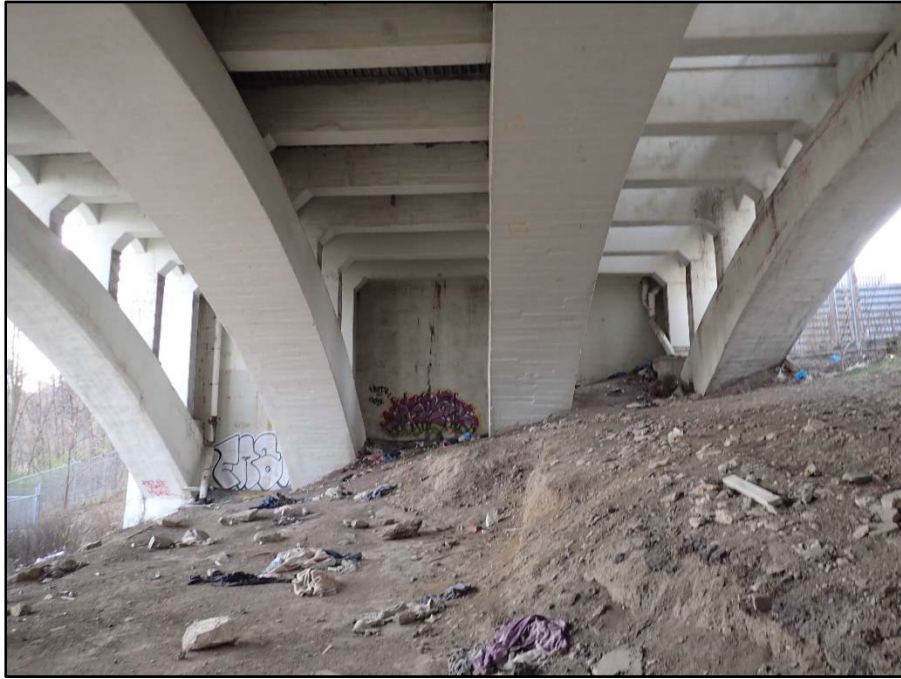
Photo 38 – West Abutment typical condition

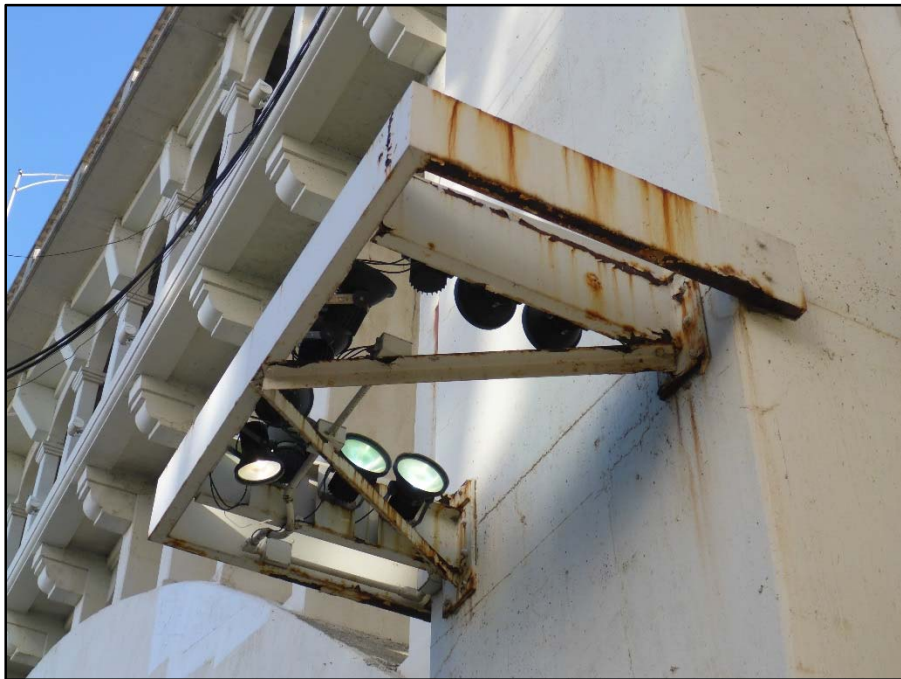
Photo 39 – Pier 2 North Face; architectural lighting brackets are corroding

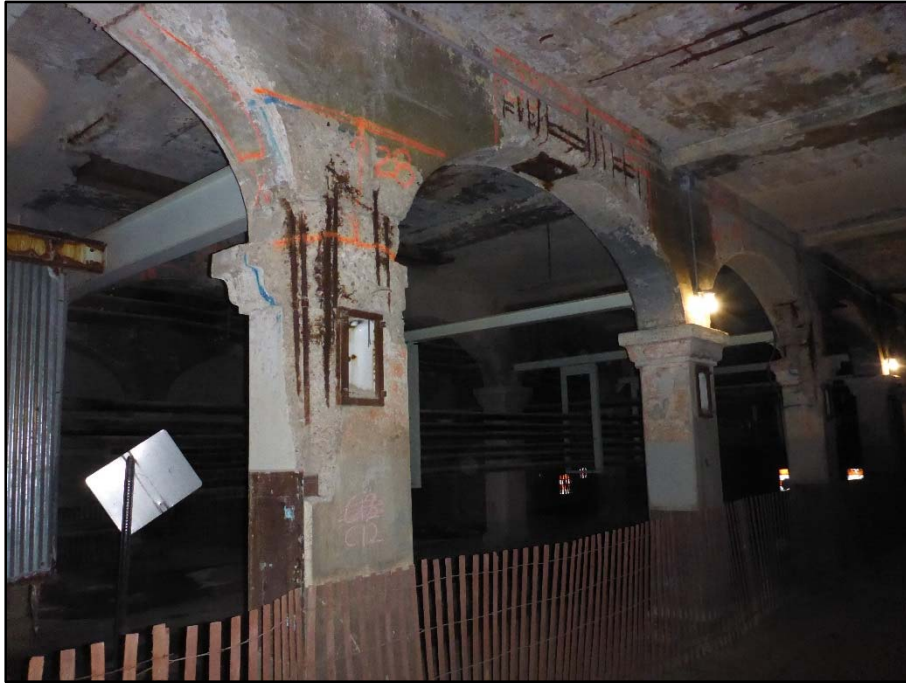
Photo 40 – West Station Columns and Arches; heavily deteriorated with exposed reinforcing and efflorescence

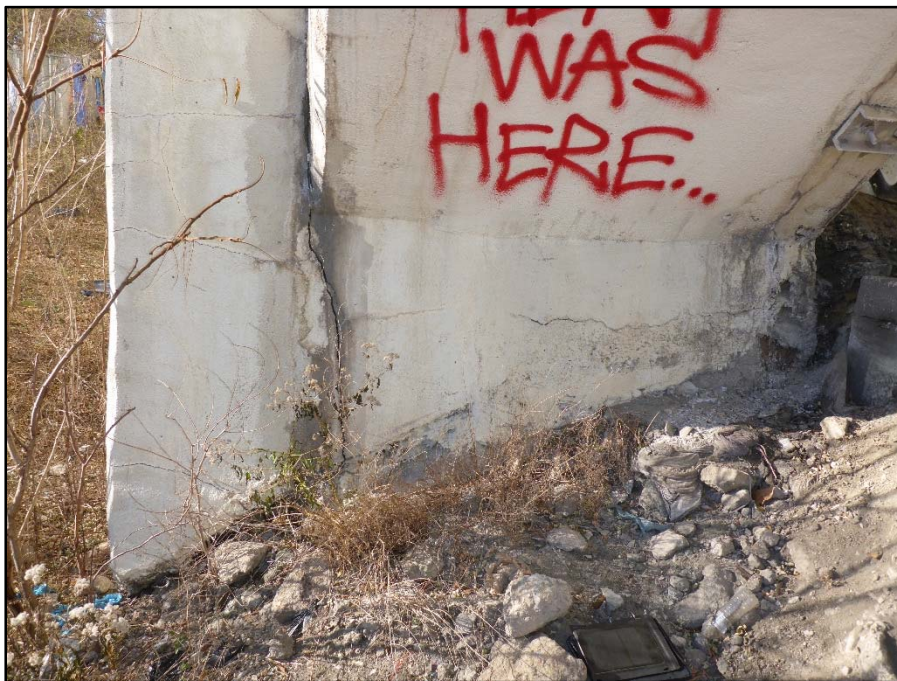
Photo 41 – West Abutment Below South Exterior Arch; 1/4" W vertical crack

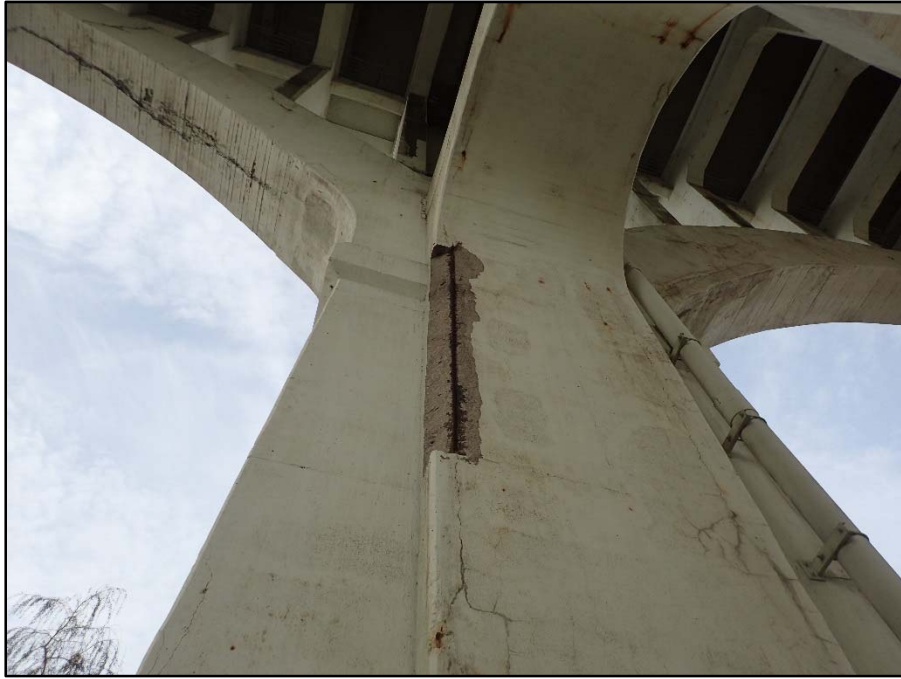
Photo 42 – Pier 5 North Exterior Column; 10' H x 6" D corner spall with exposed reinforcing

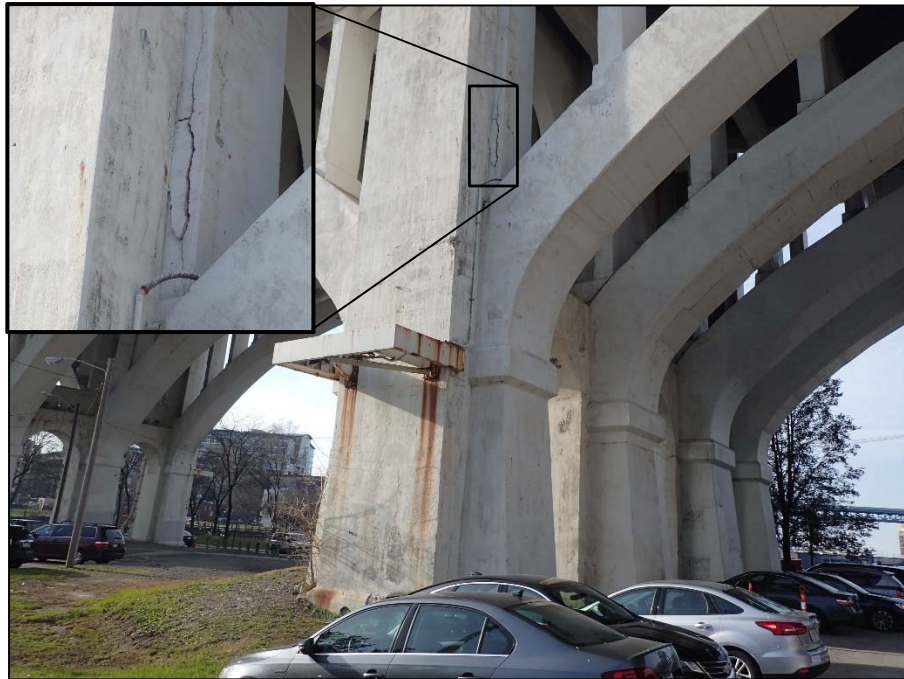
Photo 43 – Pier 8 South Exterior Column, East Face; 6' H x 3'W delamination above parked cars

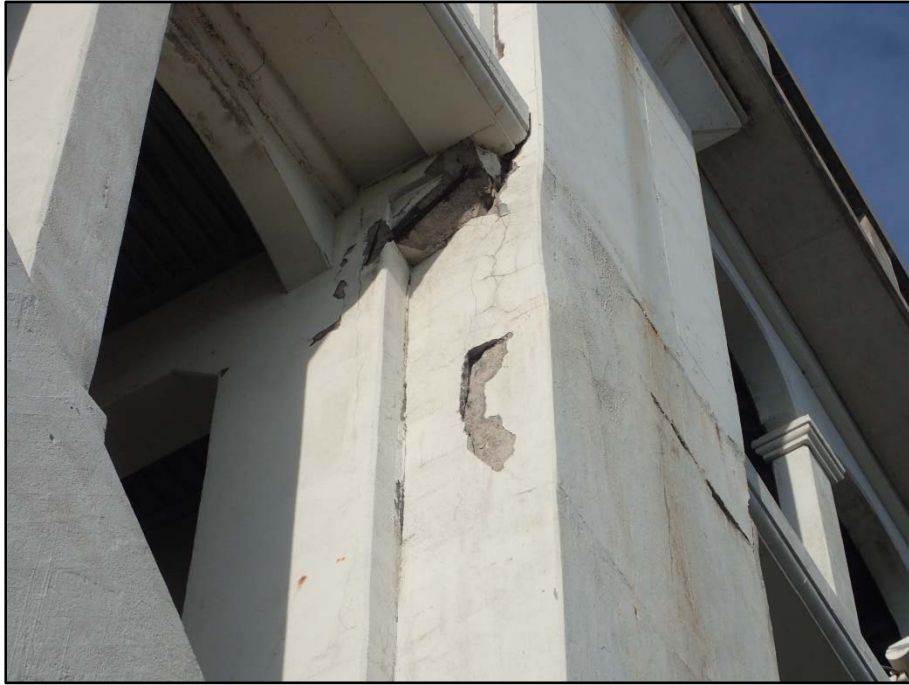
Photo 44 – Pier 8 South Exterior Column, West Face; 4' H x 4' W x 10" D spall

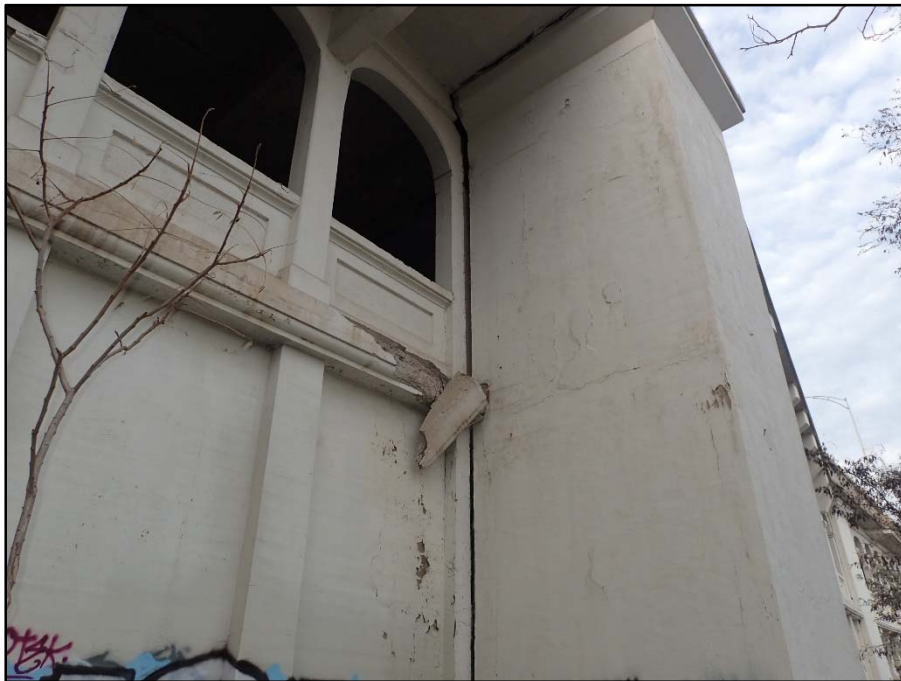
Photo 45 – Tower B South side; rotated outwards and fractured at the interface with the upper deck

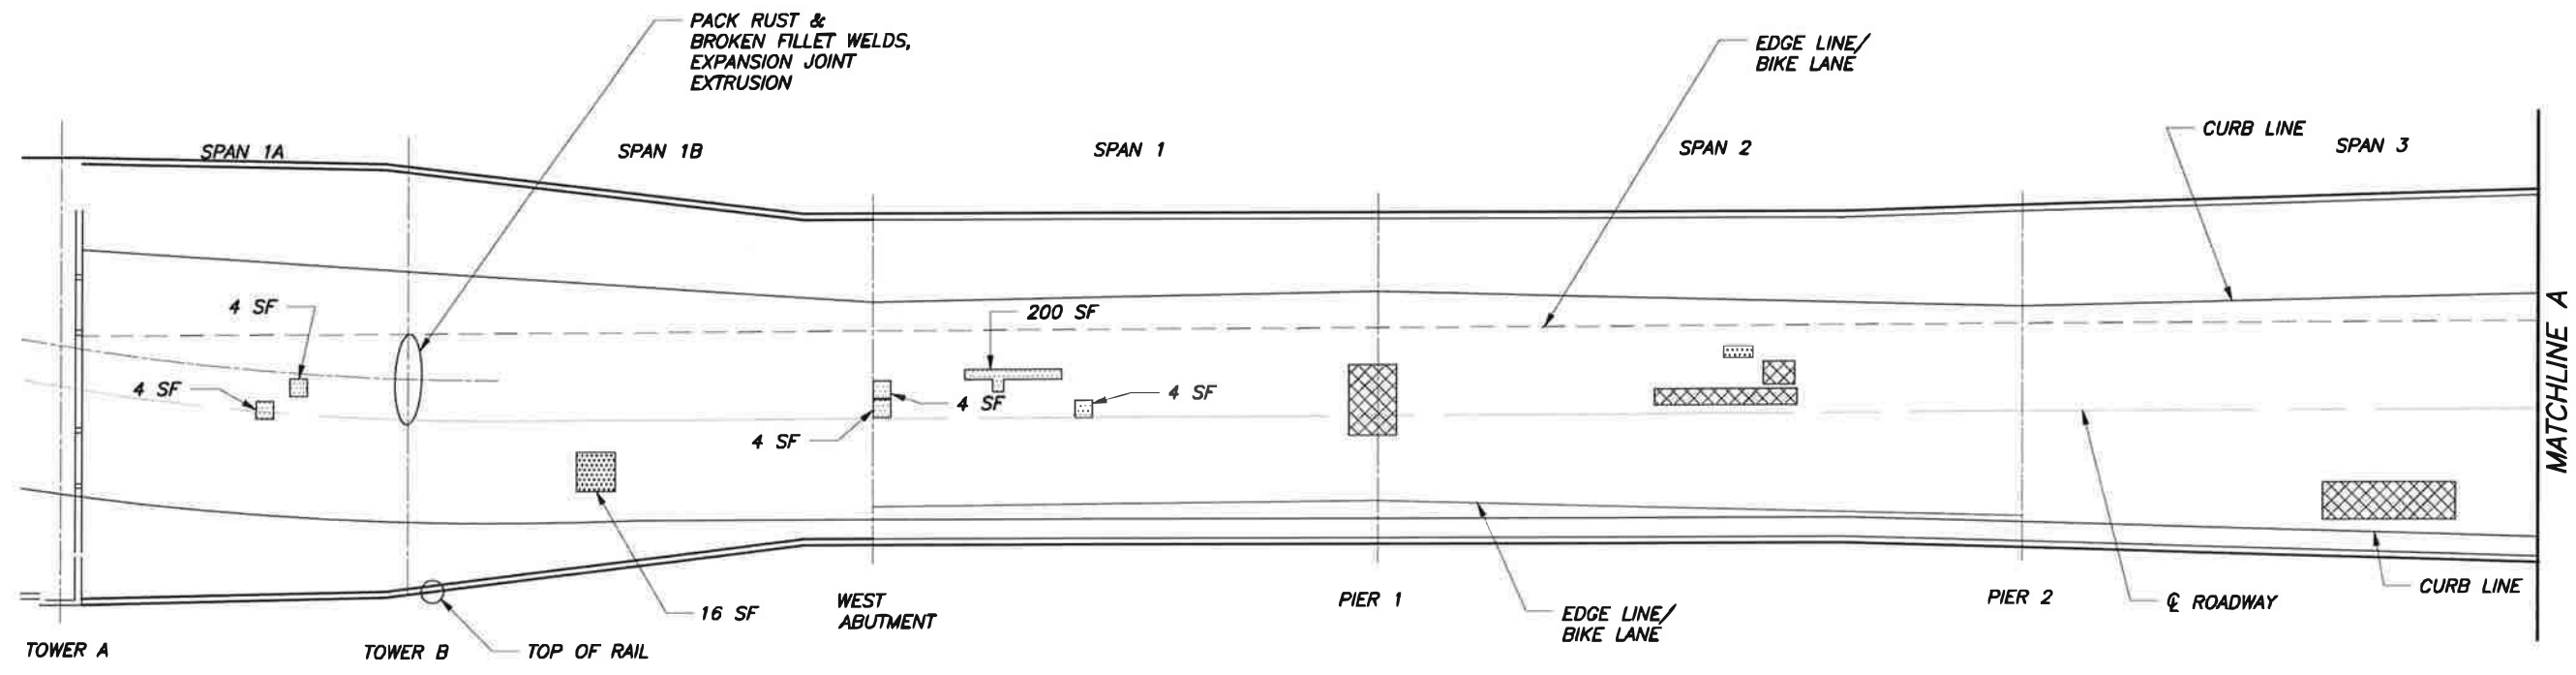
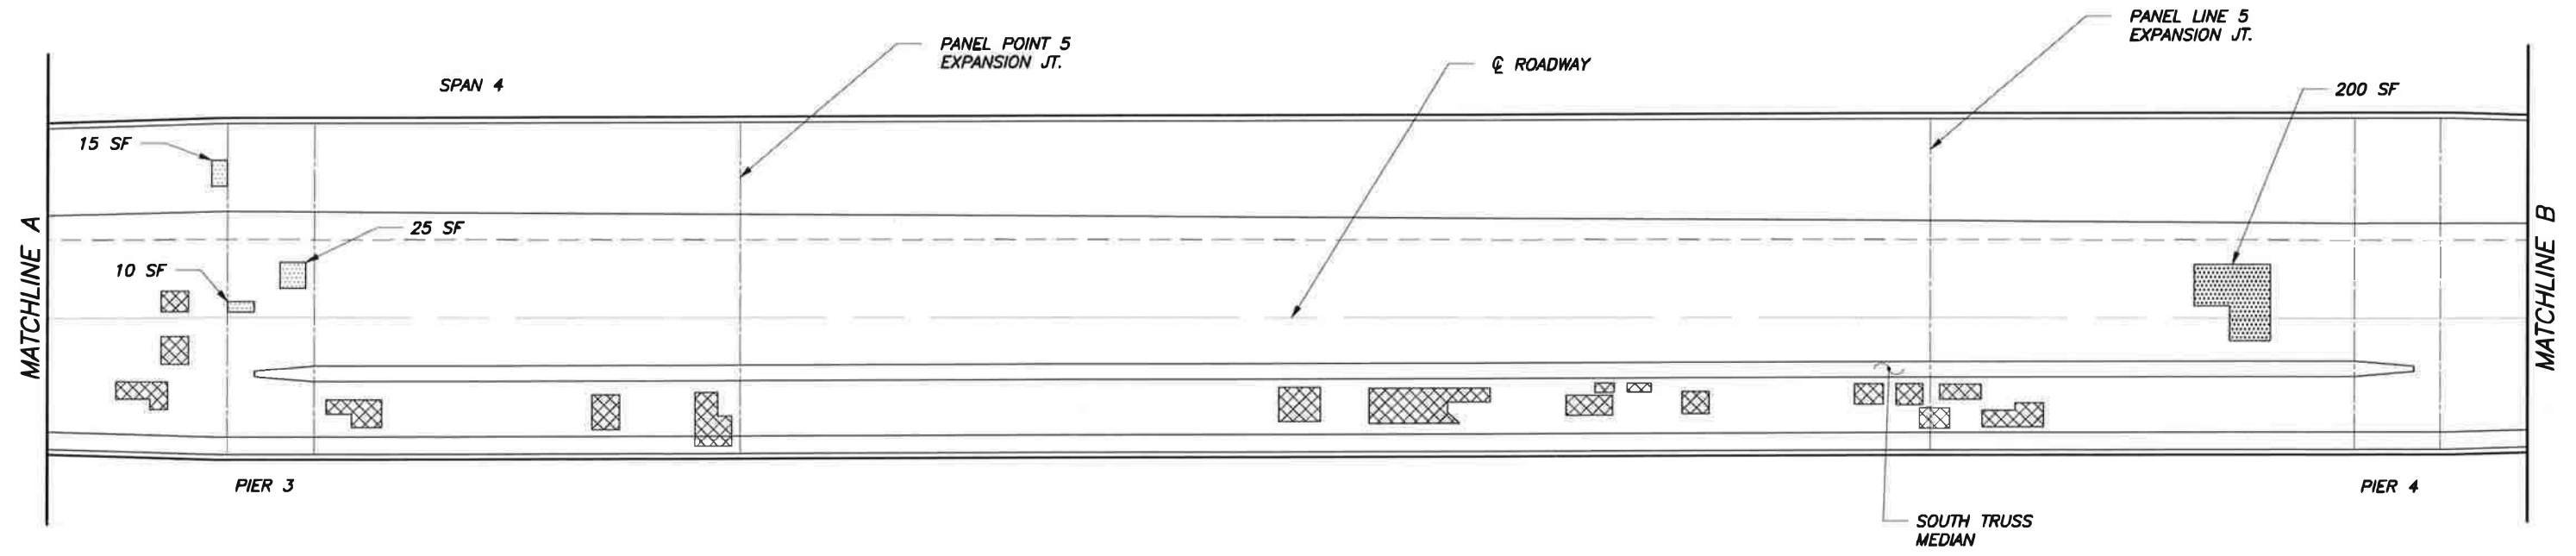
[www.infrastructureengineers.com](http://www.infrastructureengineers.com)

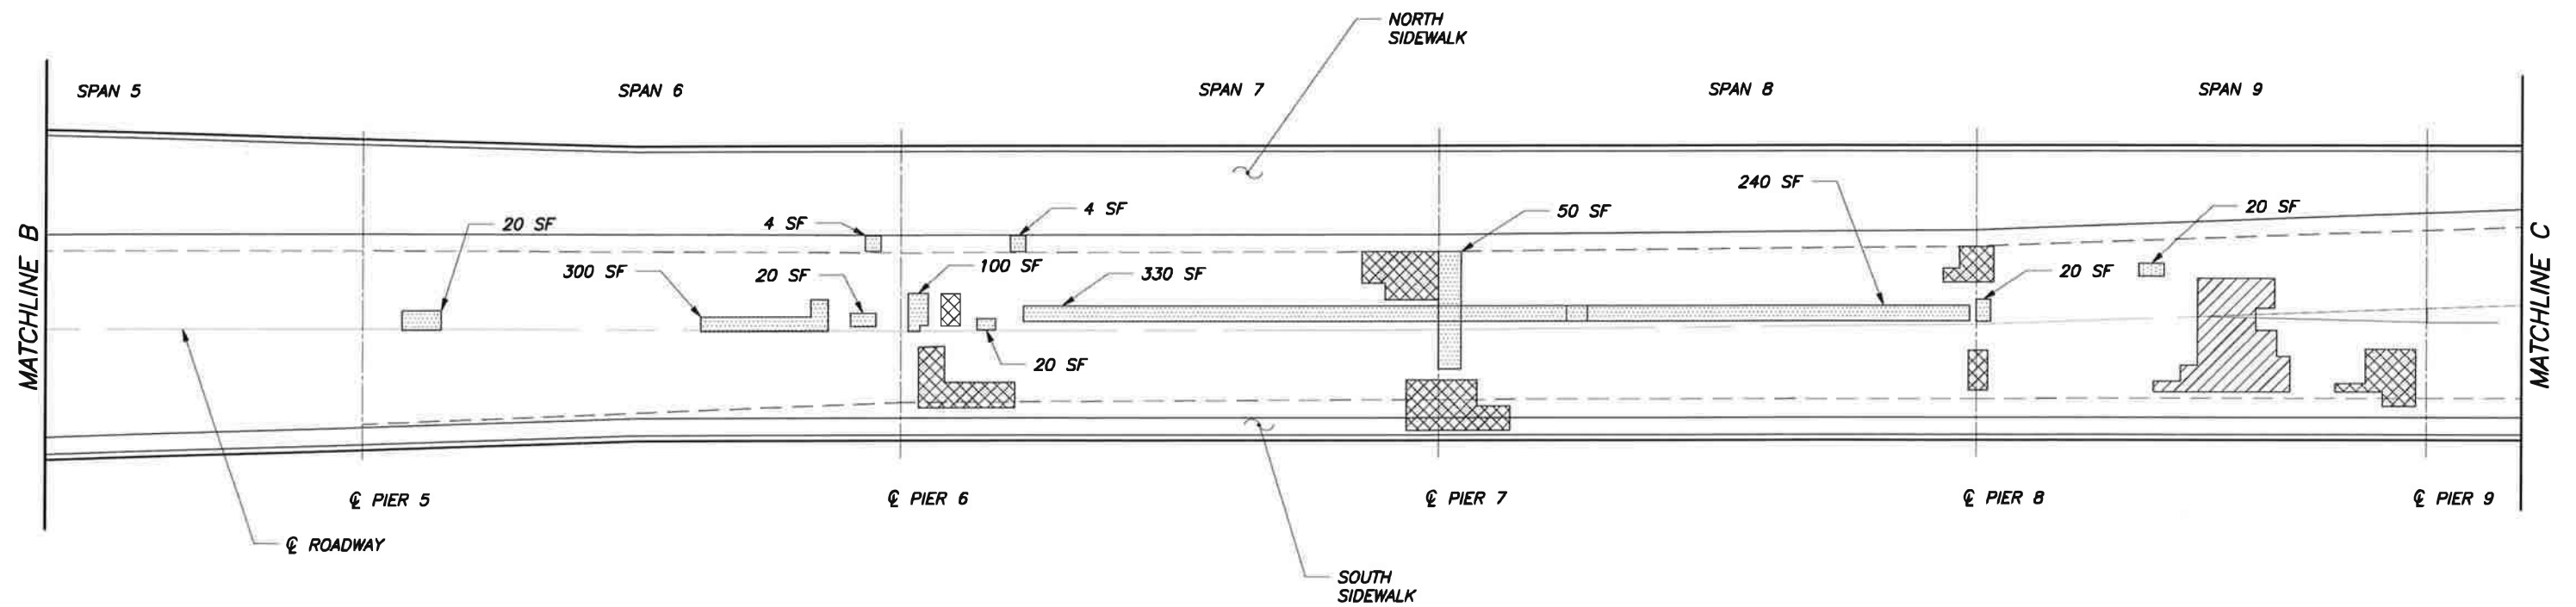
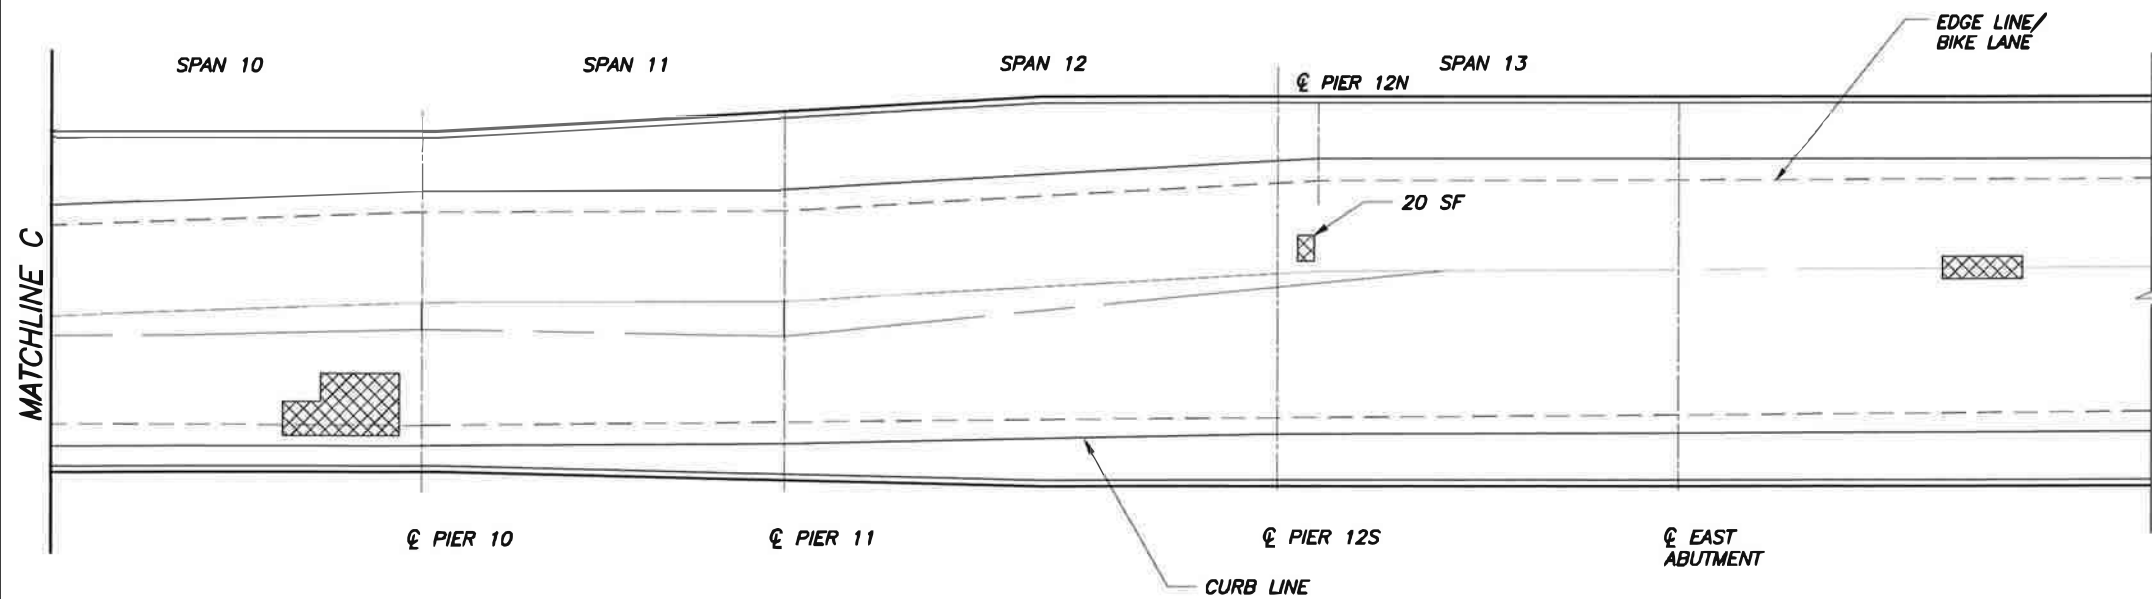
GRAPHIC SCALE MEASURED IN FEET	DATE	300 East Business Way Suite 200 Cincinnati, OH 45241 PH.: 614.699.5000	DETROIT-SUPERIOR BRIDGE OVER CUYAHOGA RIVER	
	NOV, 2017		BRIDGE NO. CUY-6-1456	
NOT TO SCALE	INFRASTRUCTURE ENGINEERS, INC.		DECK PLAN - SPAN 1A TO SPAN 5	PAGE A-1

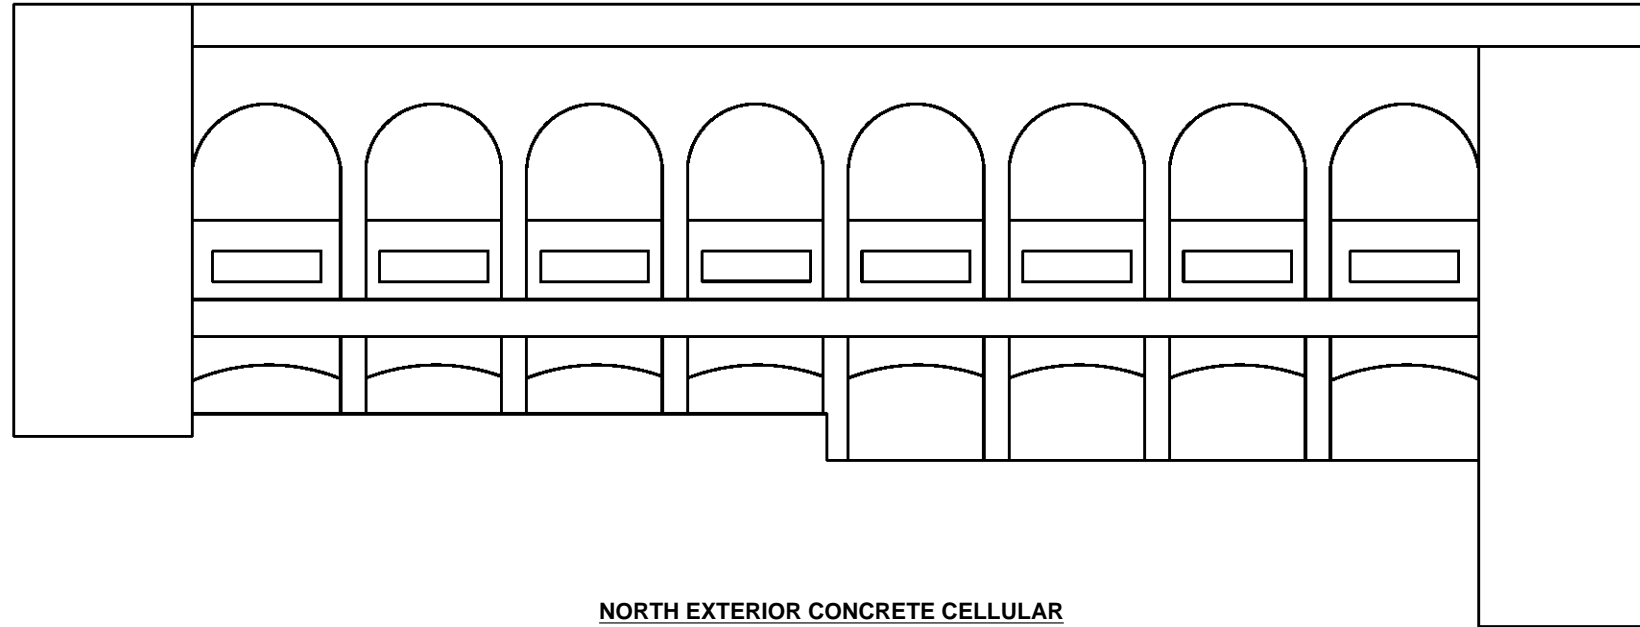
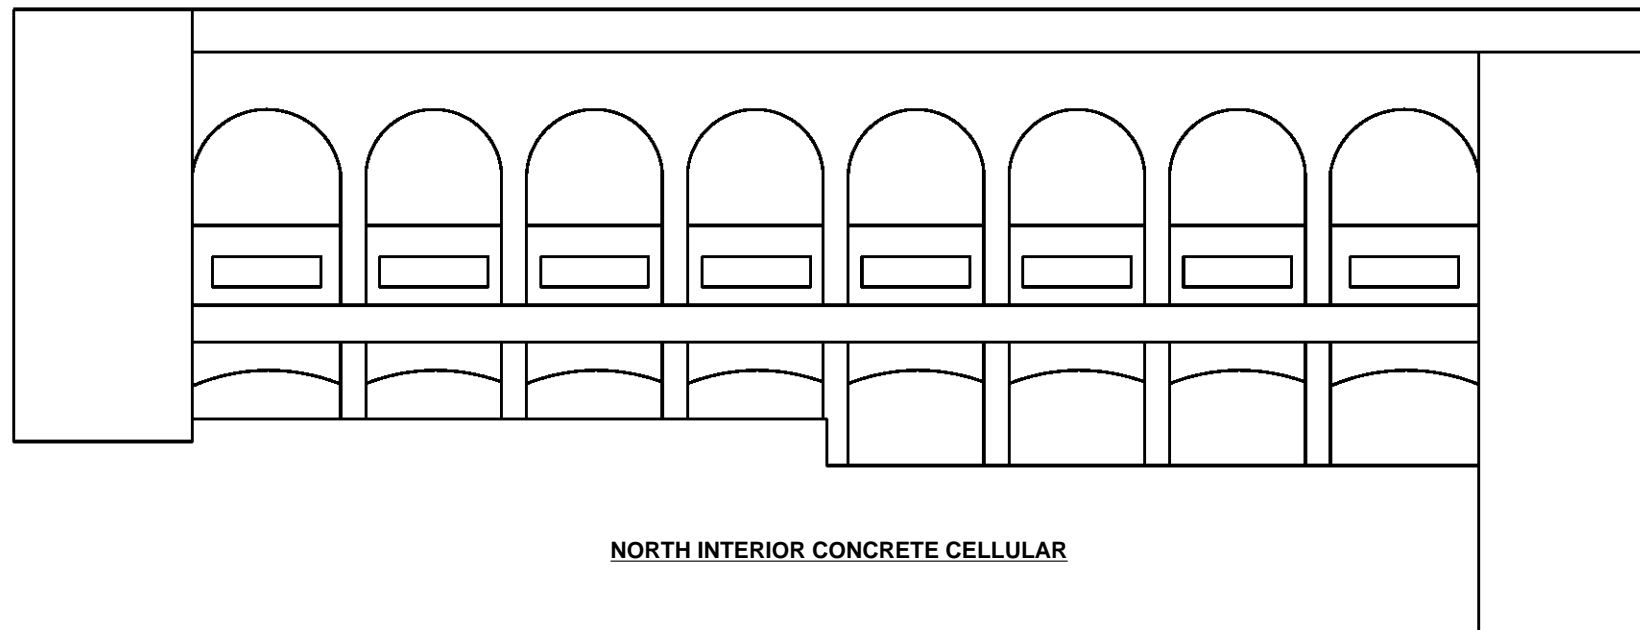
GRAPHIC SCALE MEASURED IN FEET	DATE	  300 East Business Way Suite 200 Cincinnati, OH 45241 PH.: 614.699.5000	DETROIT-SUPERIOR BRIDGE OVER CUYAHOGA RIVER BRIDGE NO. CUY-6-1456
NOT TO SCALE	NOV, 2017

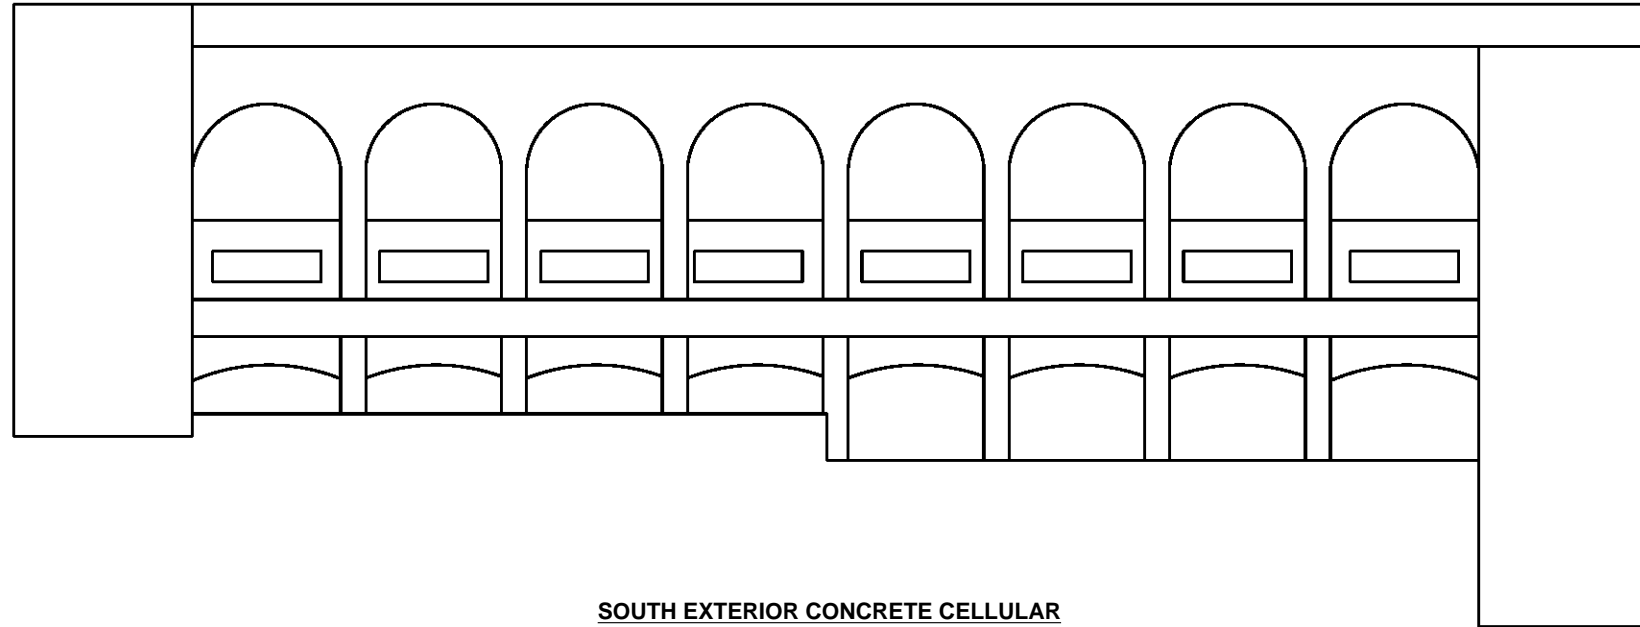
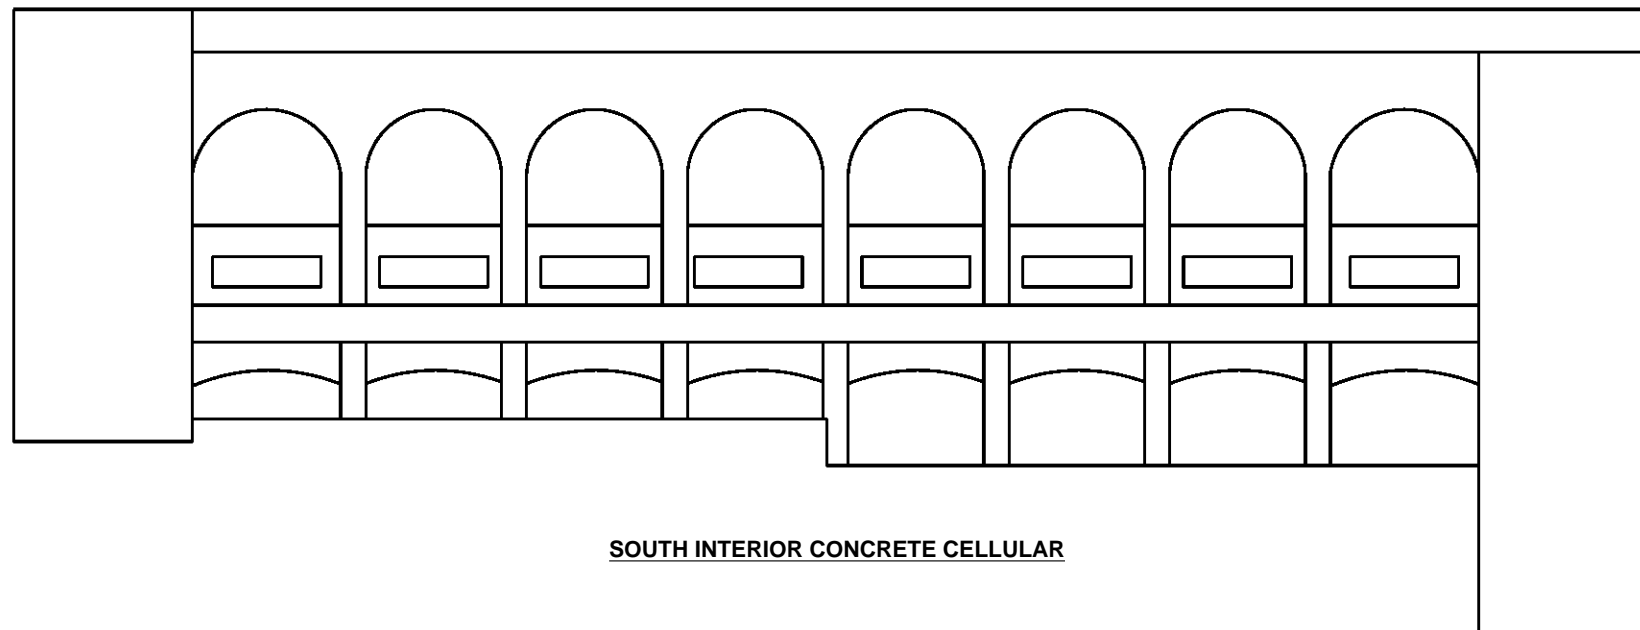
<p>GRAPHIC SCALE MEASURED IN FEET</p>	<p>DATE</p>	<p>300 East Business Way Suite 200 Cincinnati, OH 45241 PH.: 614.699.5000</p>	<p>DETROIT-SUPERIOR BRIDGE OVER CUYAHOGA RIVER BRIDGE NO. CUY-6-1465</p>
<p>NOT TO SCALE</p>	<p>DEC, 2017</p>	<p><b>INFRASTRUCTURE ENGINEERS, INC.</b></p>	<p>STRUCTURE ELEVATION - SPAN 1A</p>

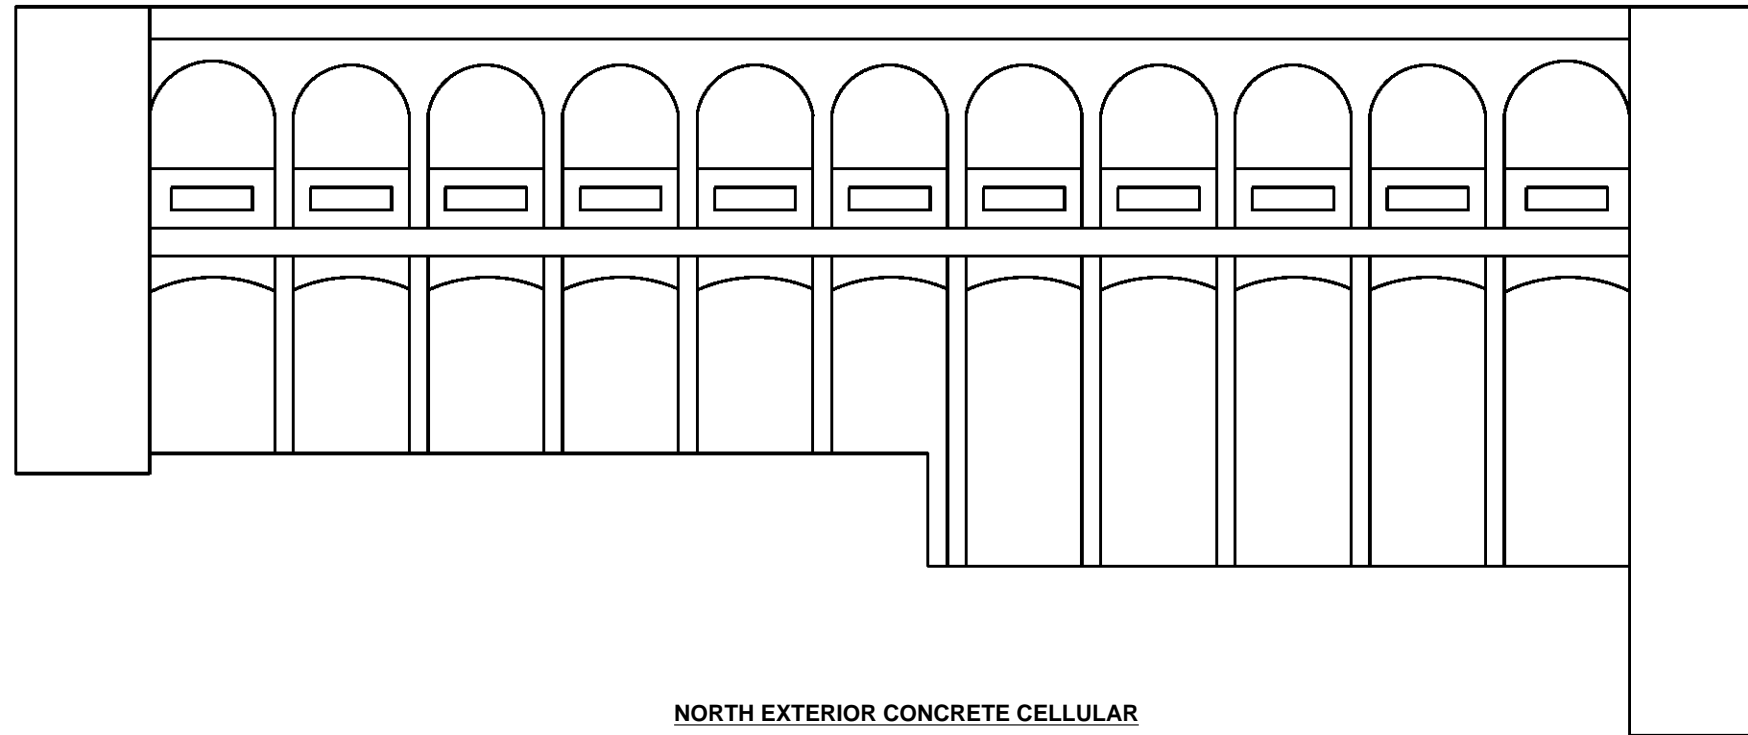
**NORTH EXTERIOR CONCRETE CELLULAR**

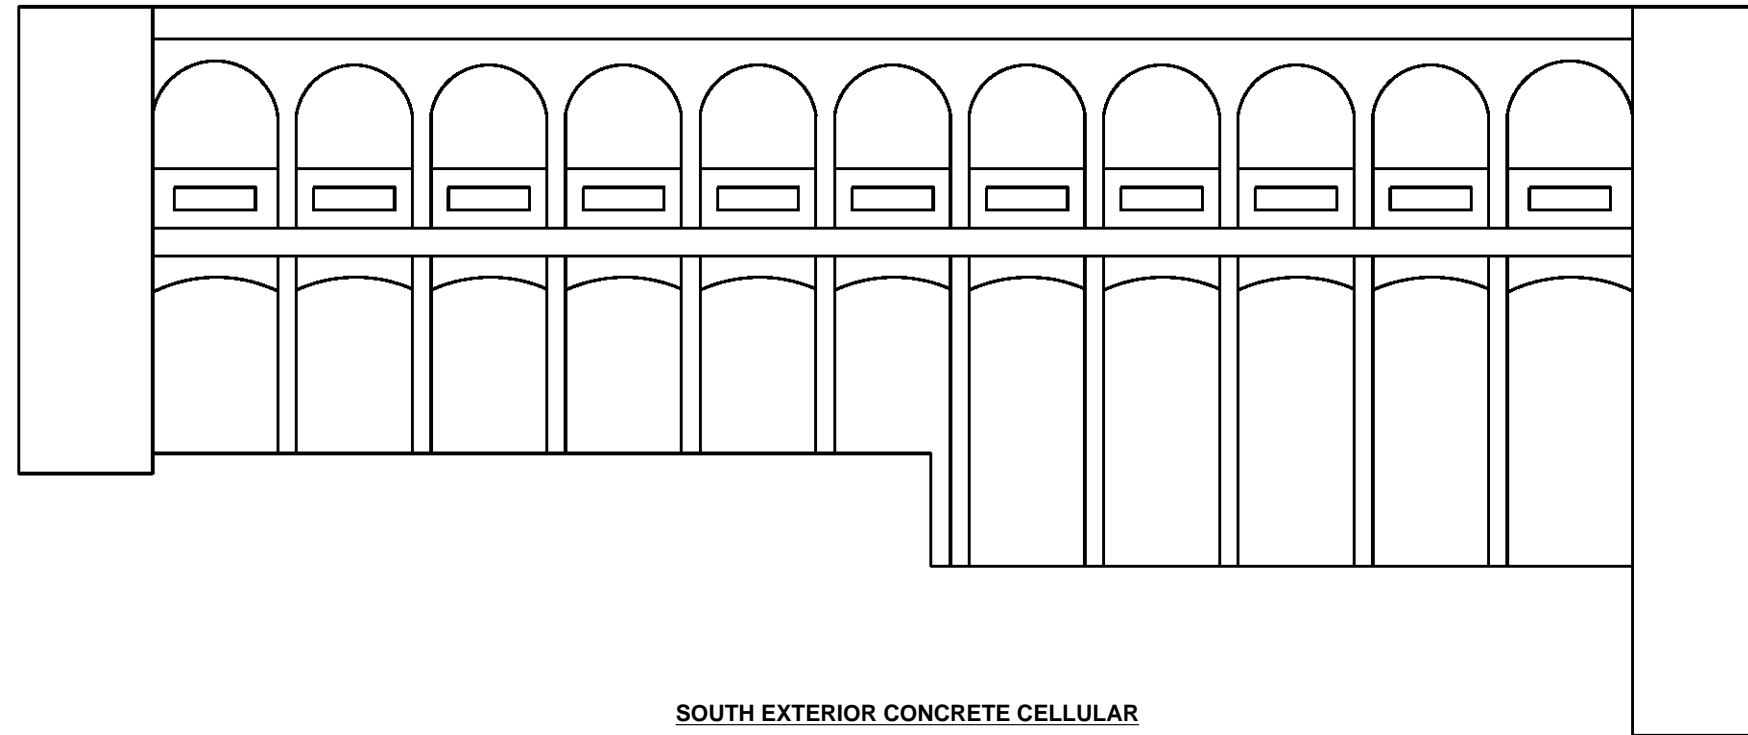
**SOUTH EXTERIOR CONCRETE CELLULAR**
