# CUY-6-1456

## PHYSICAL CONDITION REPORT ROUTINE INSPECTION

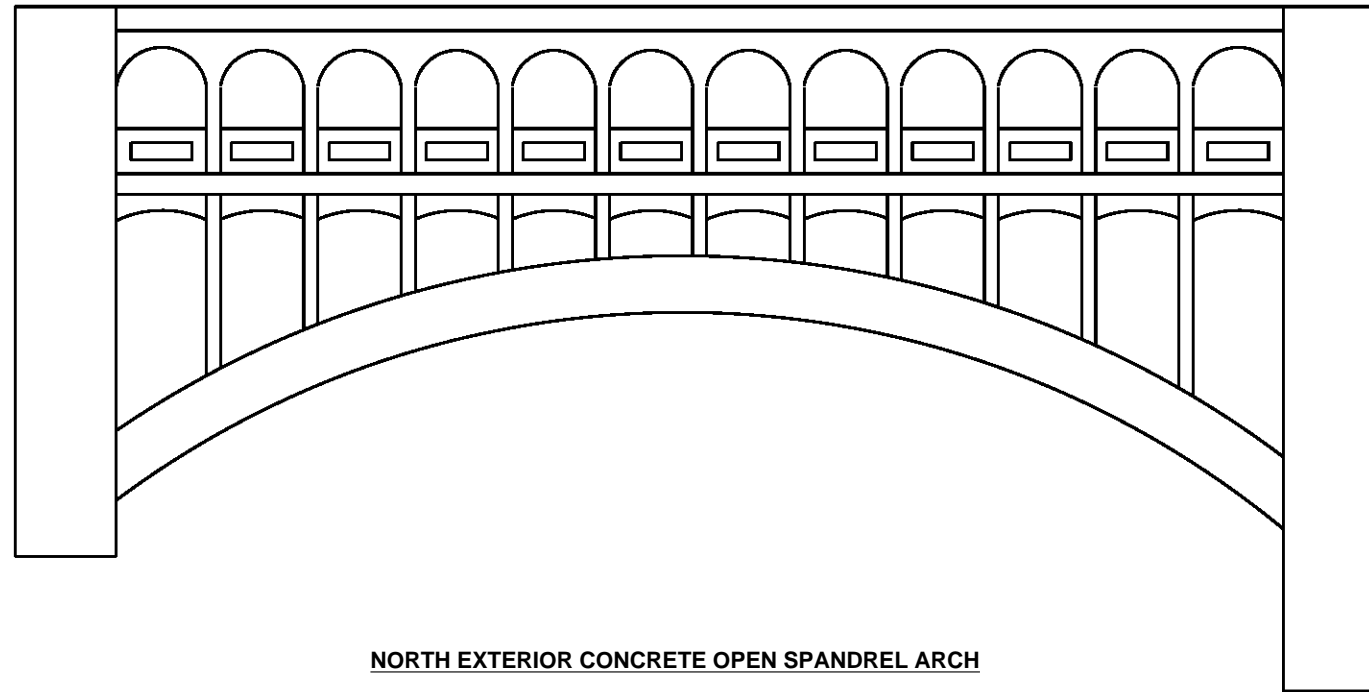
**NORTH EXTERIOR CONCRETE OPEN SPANDREL ARCH**

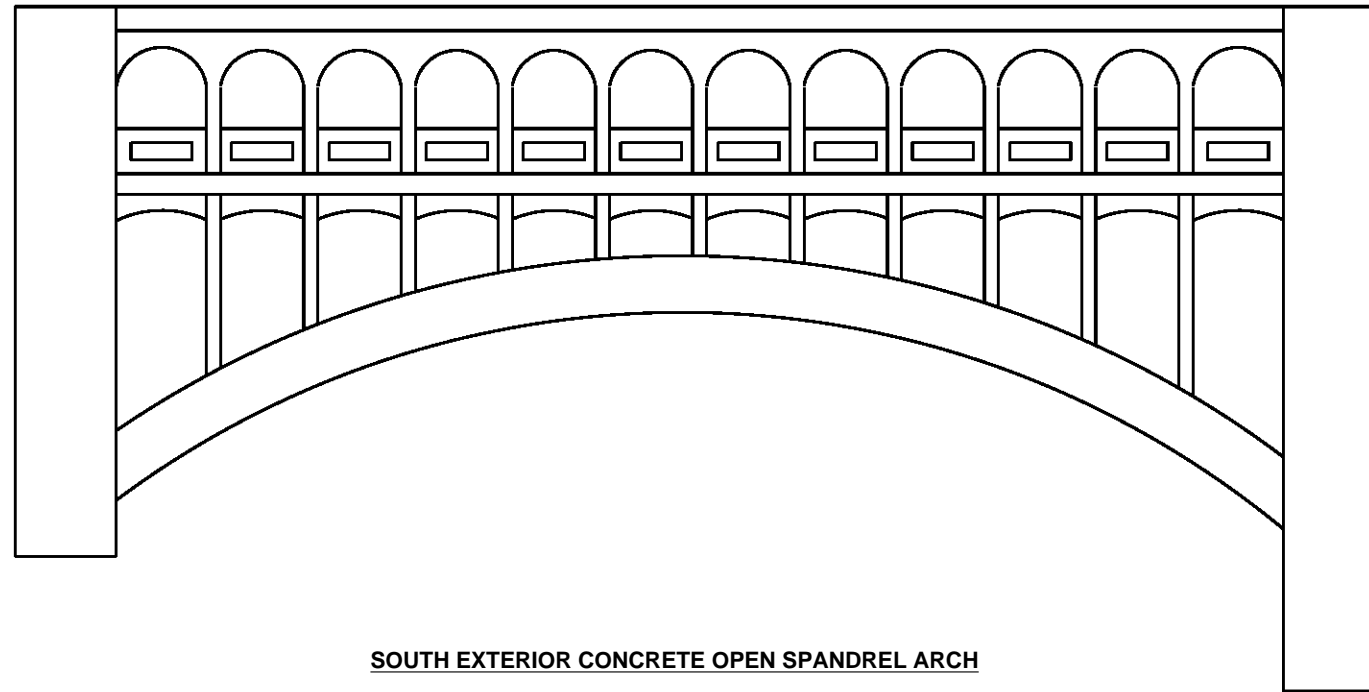
**SOUTH EXTERIOR CONCRETE OPEN SPANDREL ARCH**

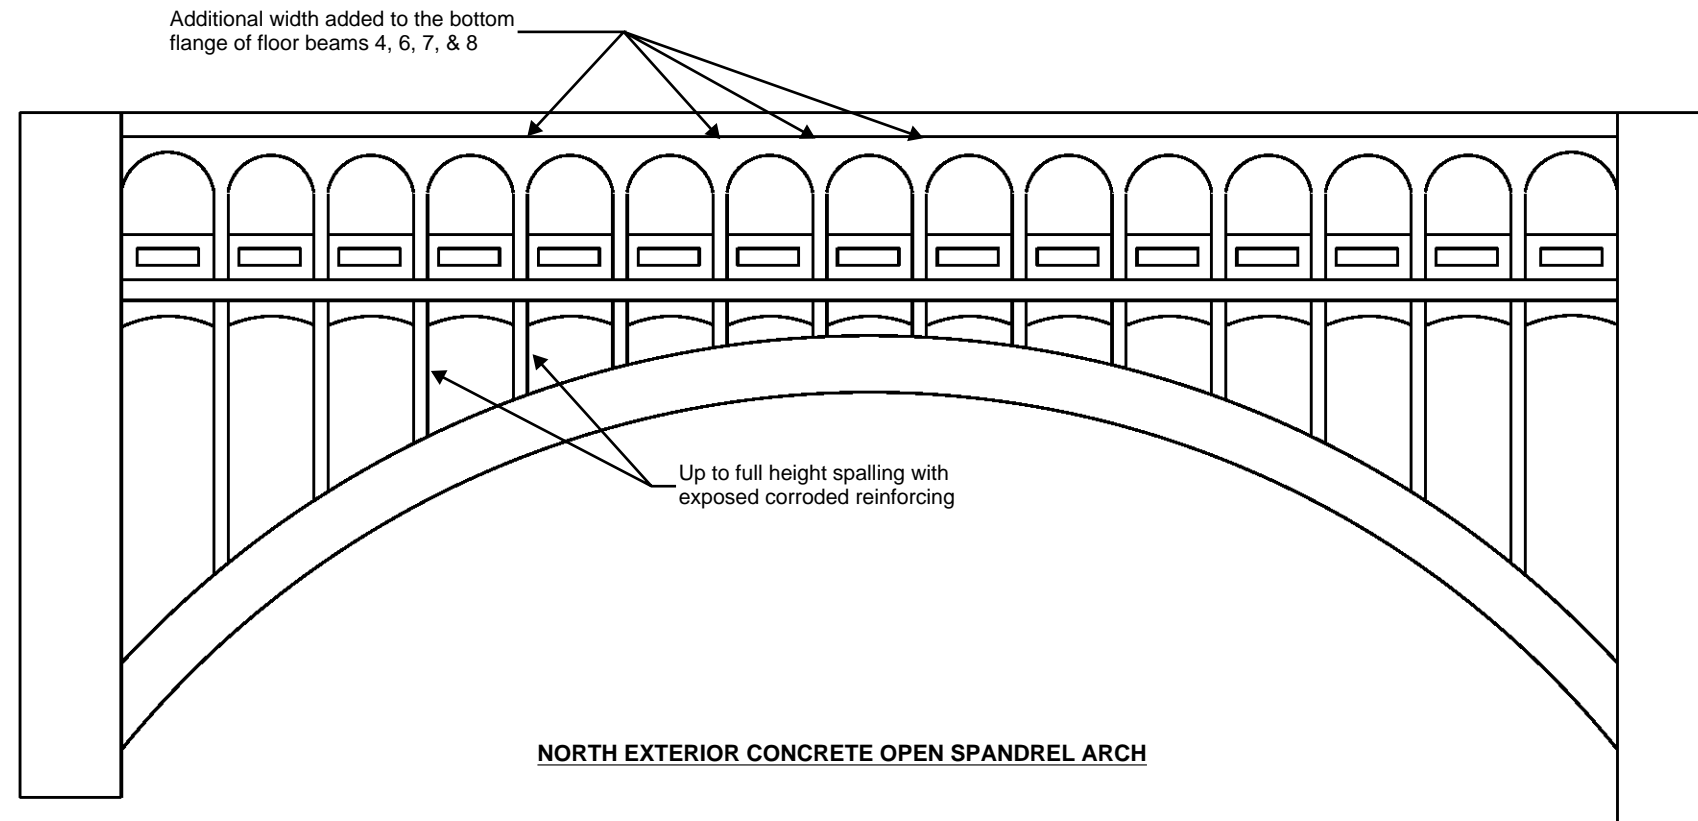
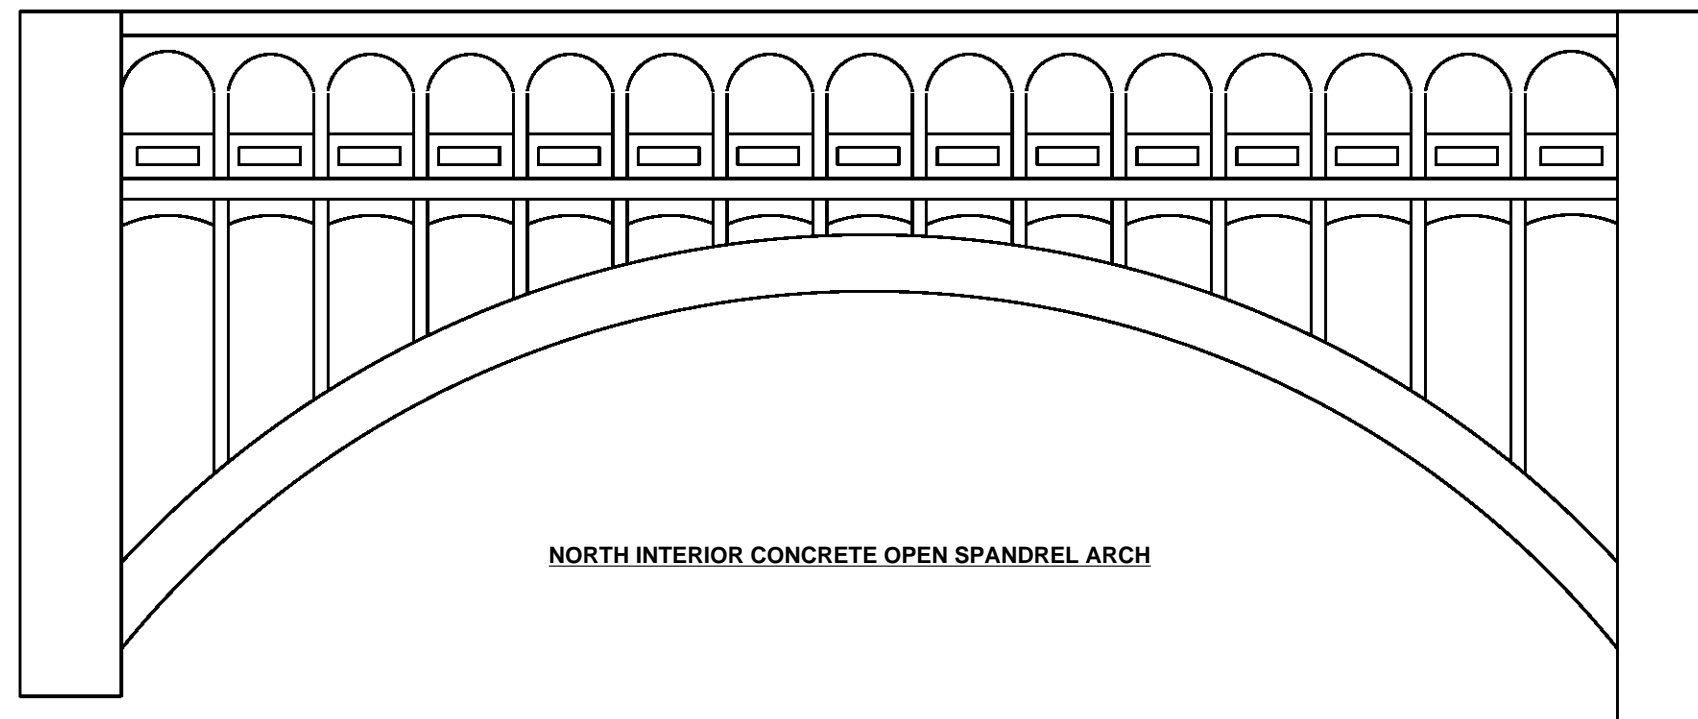
GRAPHIC SCALE MEASURED IN FEET	DATE	  300 East Business Way Suite 200 Cincinnati, OH 45241 PH.: 614.699.5000	<b>DETROIT-SUPERIOR BRIDGE OVER CUYAHOGA RIVER</b> <b>BRIDGE NO. CUY-6-1465</b>
NOT TO SCALE	DEC, 2017

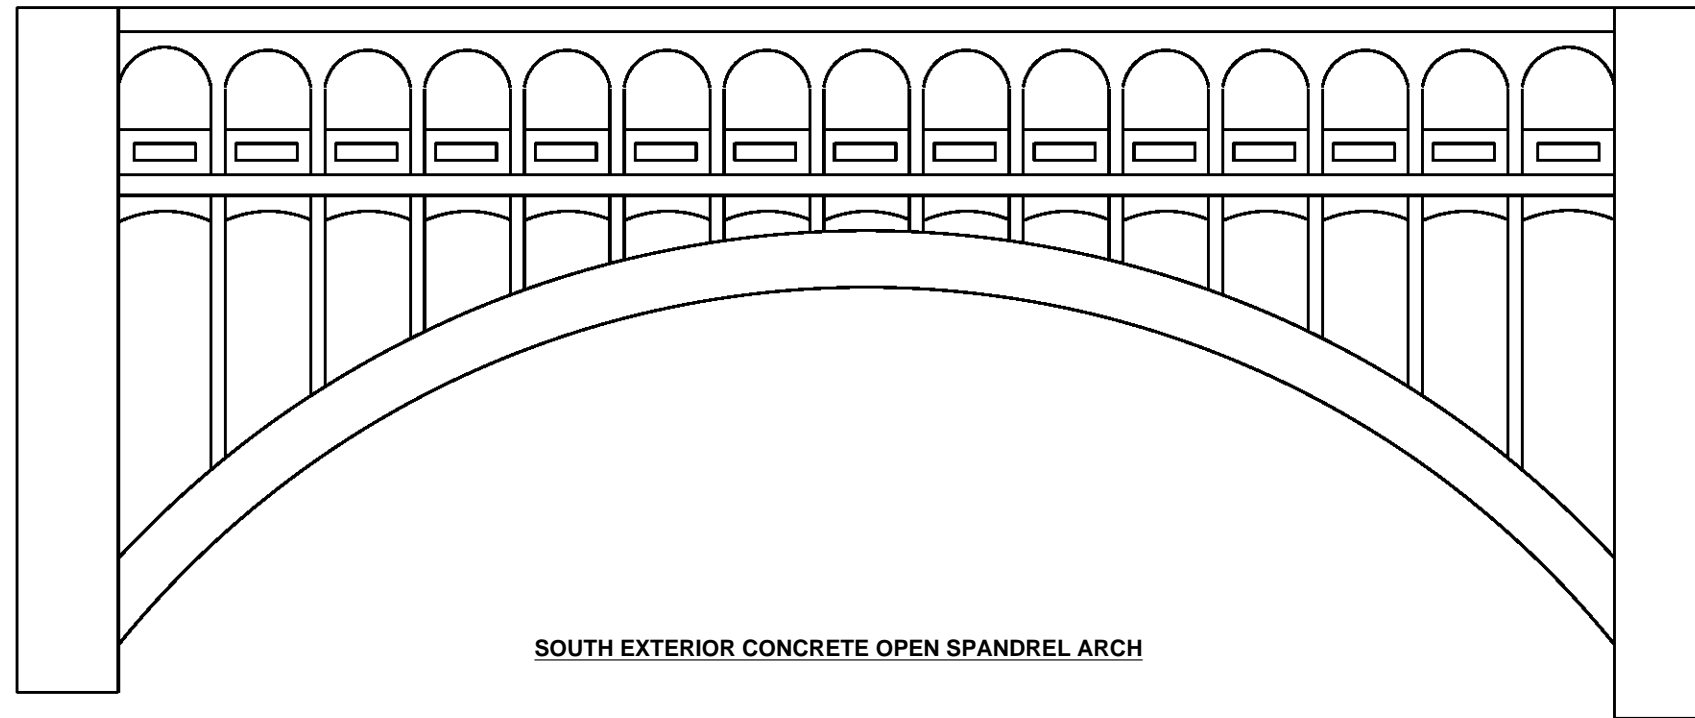
**SOUTH EXTERIOR CONCRETE OPEN SPANDREL ARCH**

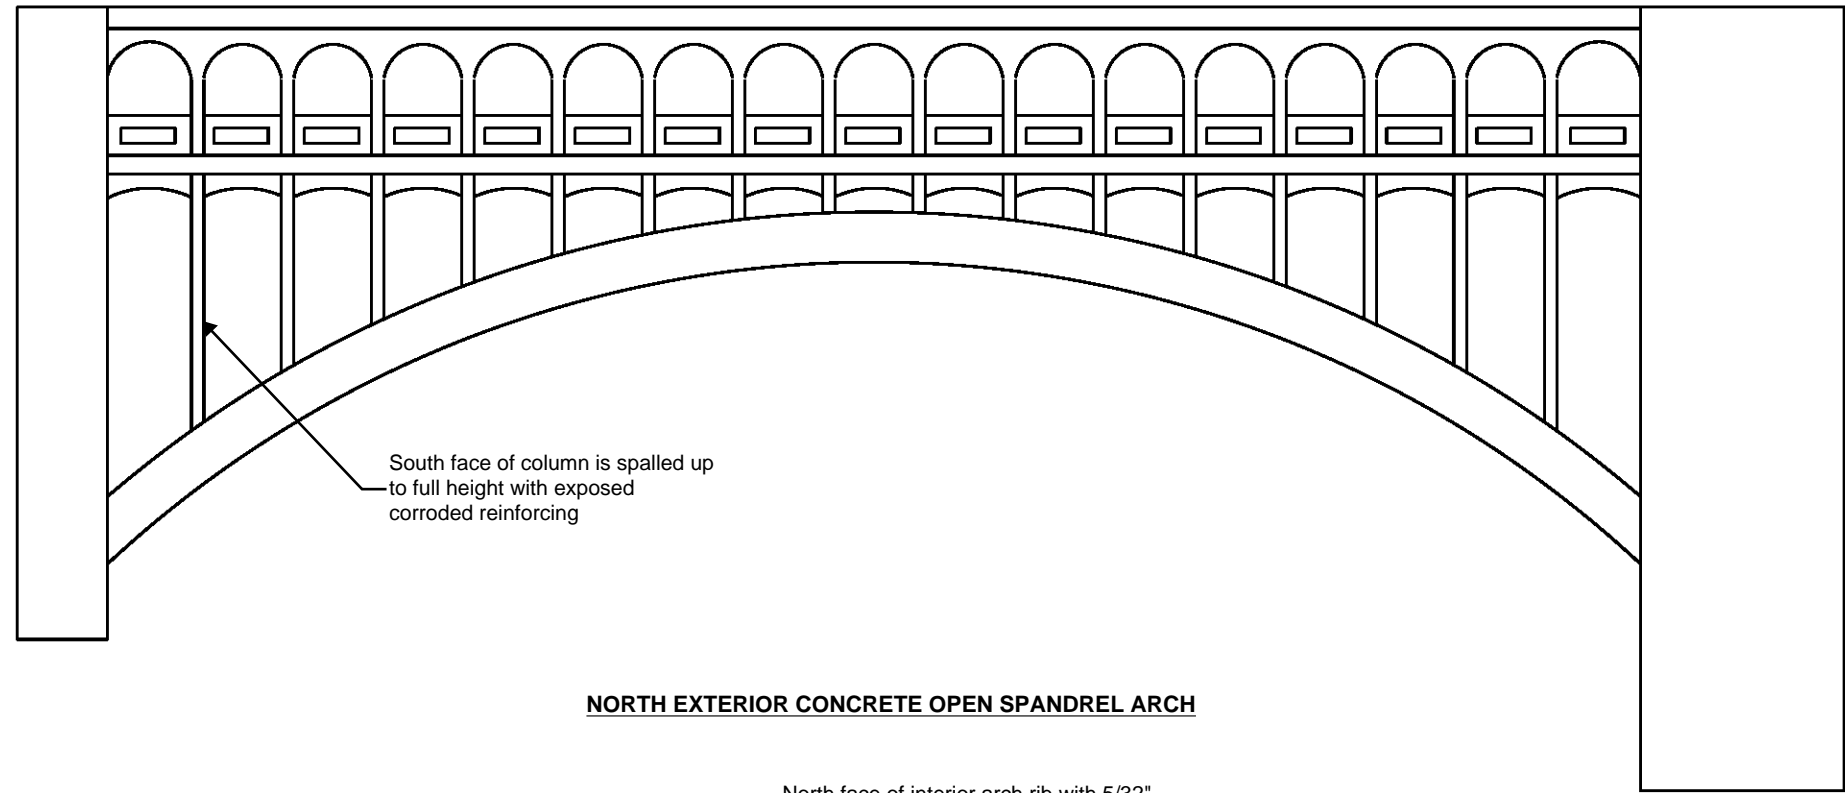
**NORTH EXTERIOR CONCRETE OPEN SPANDREL ARCH**

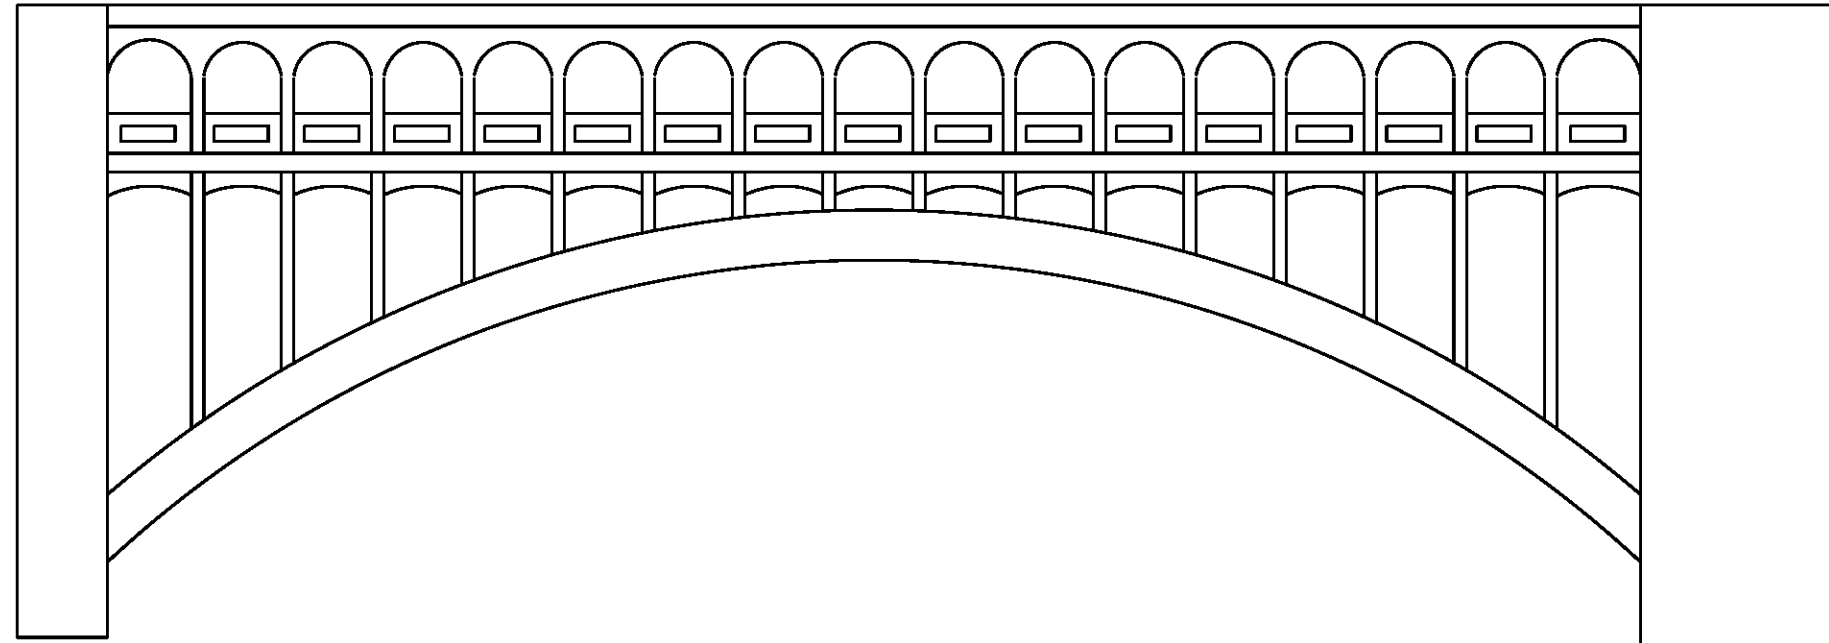
**SOUTH EXTERIOR CONCRETE OPEN SPANDREL ARCH**

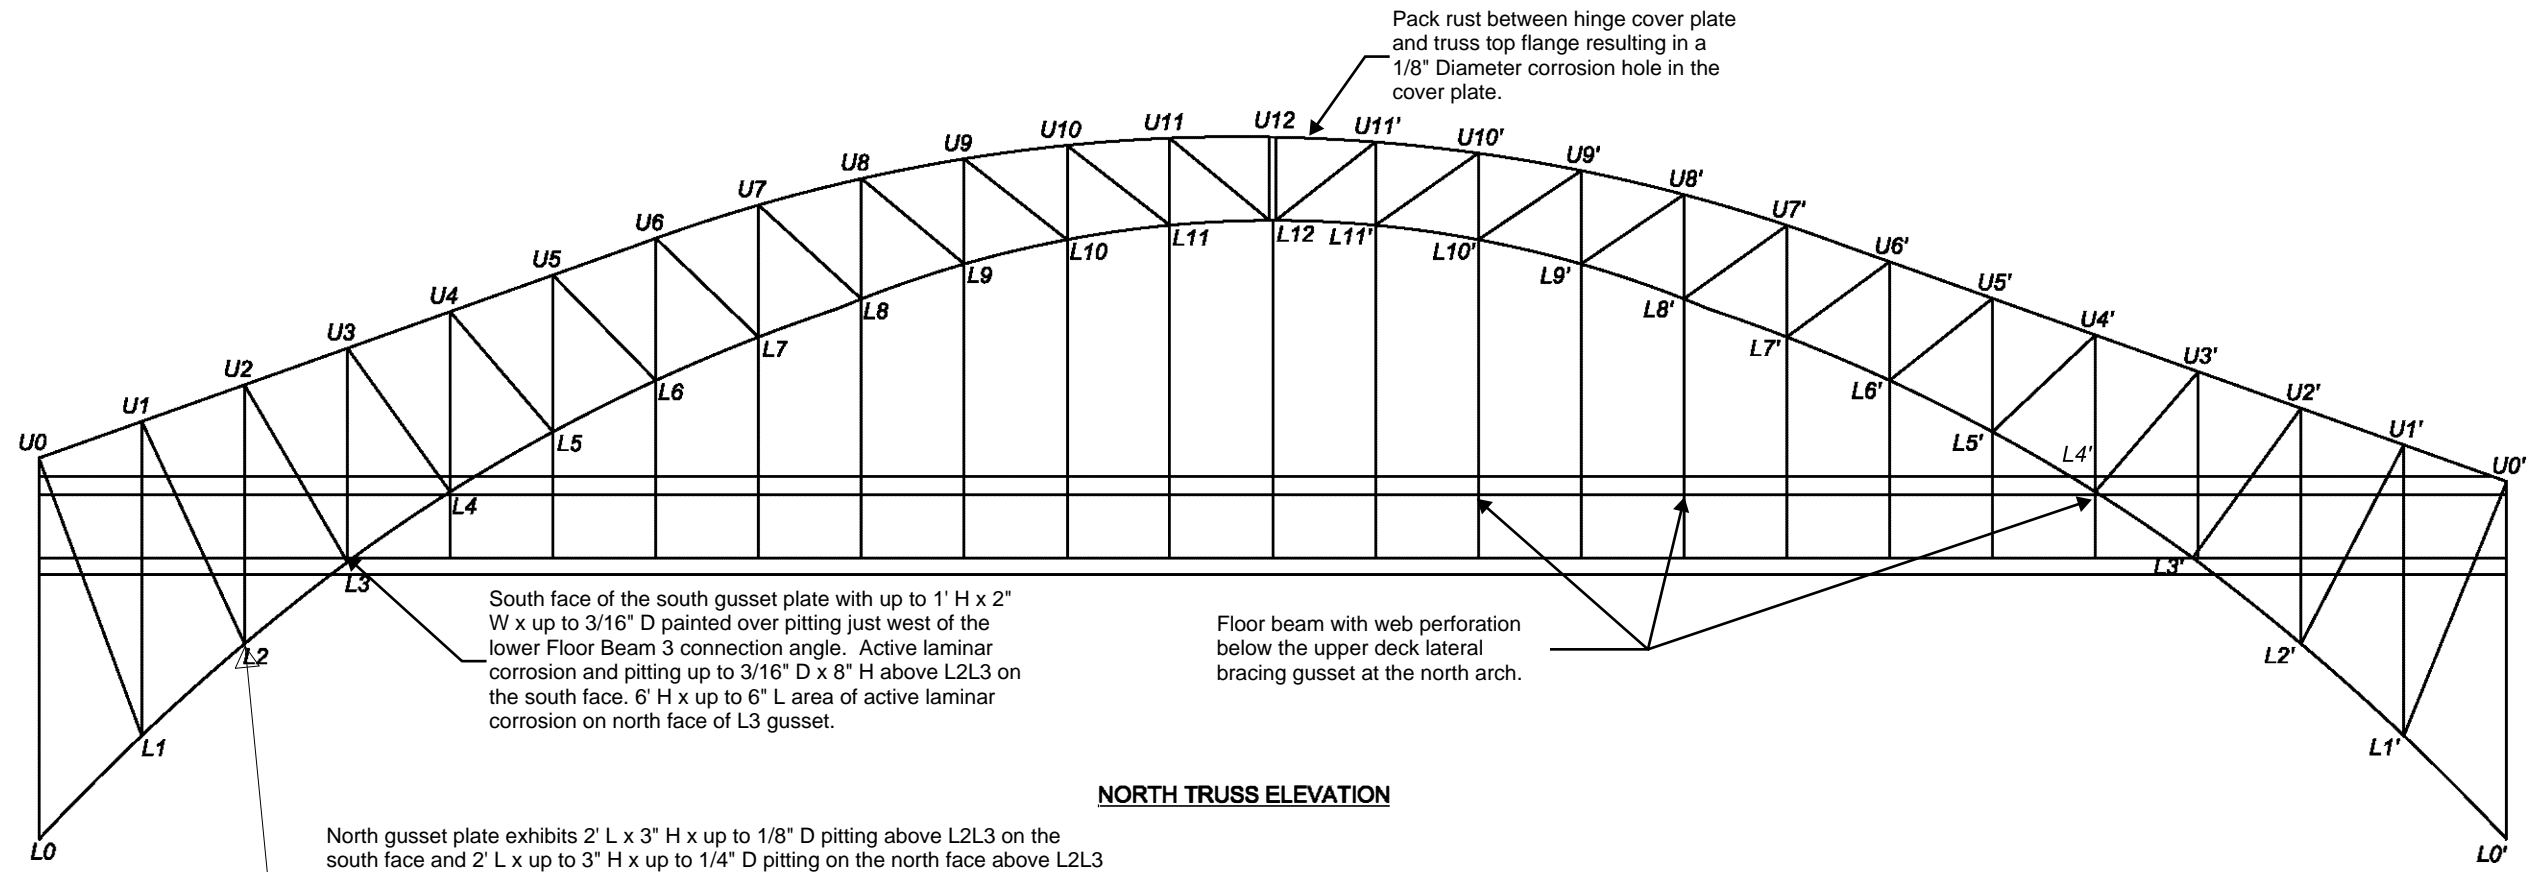
**NORTH TRUSS ELEVATION**

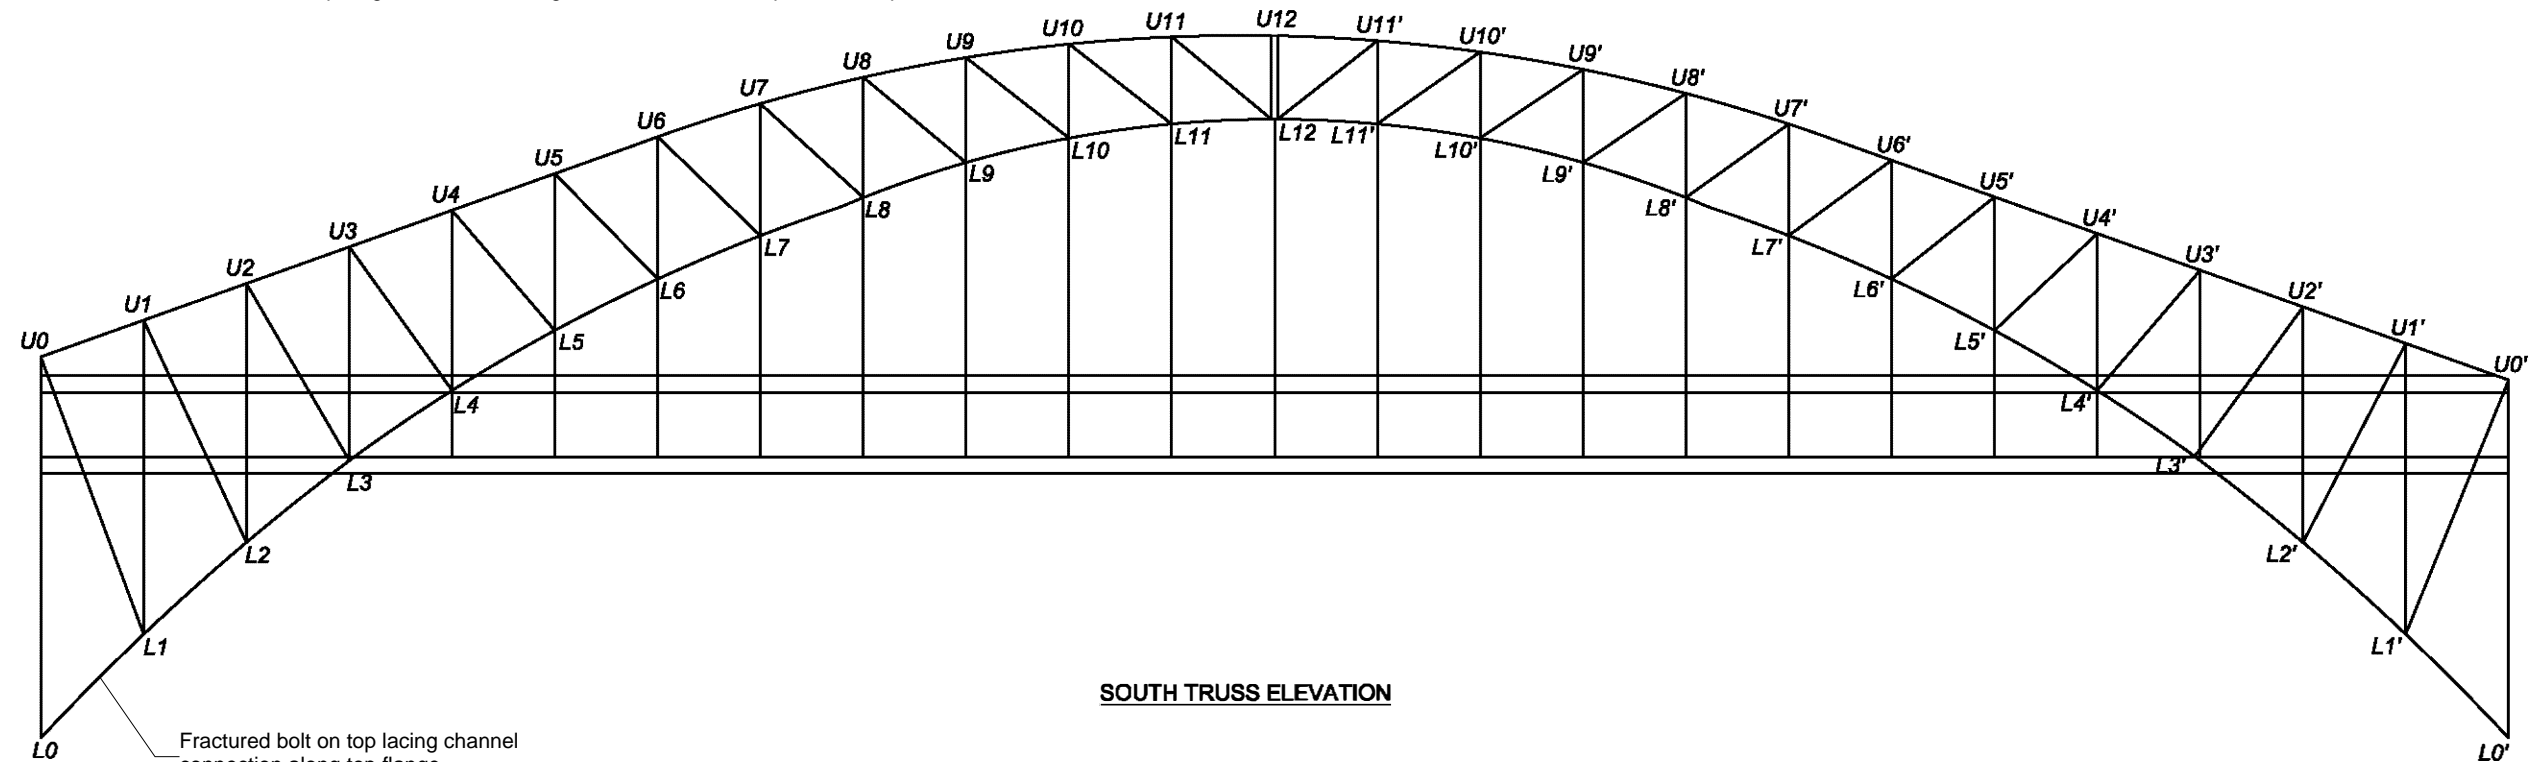
**SOUTH TRUSS ELEVATION**

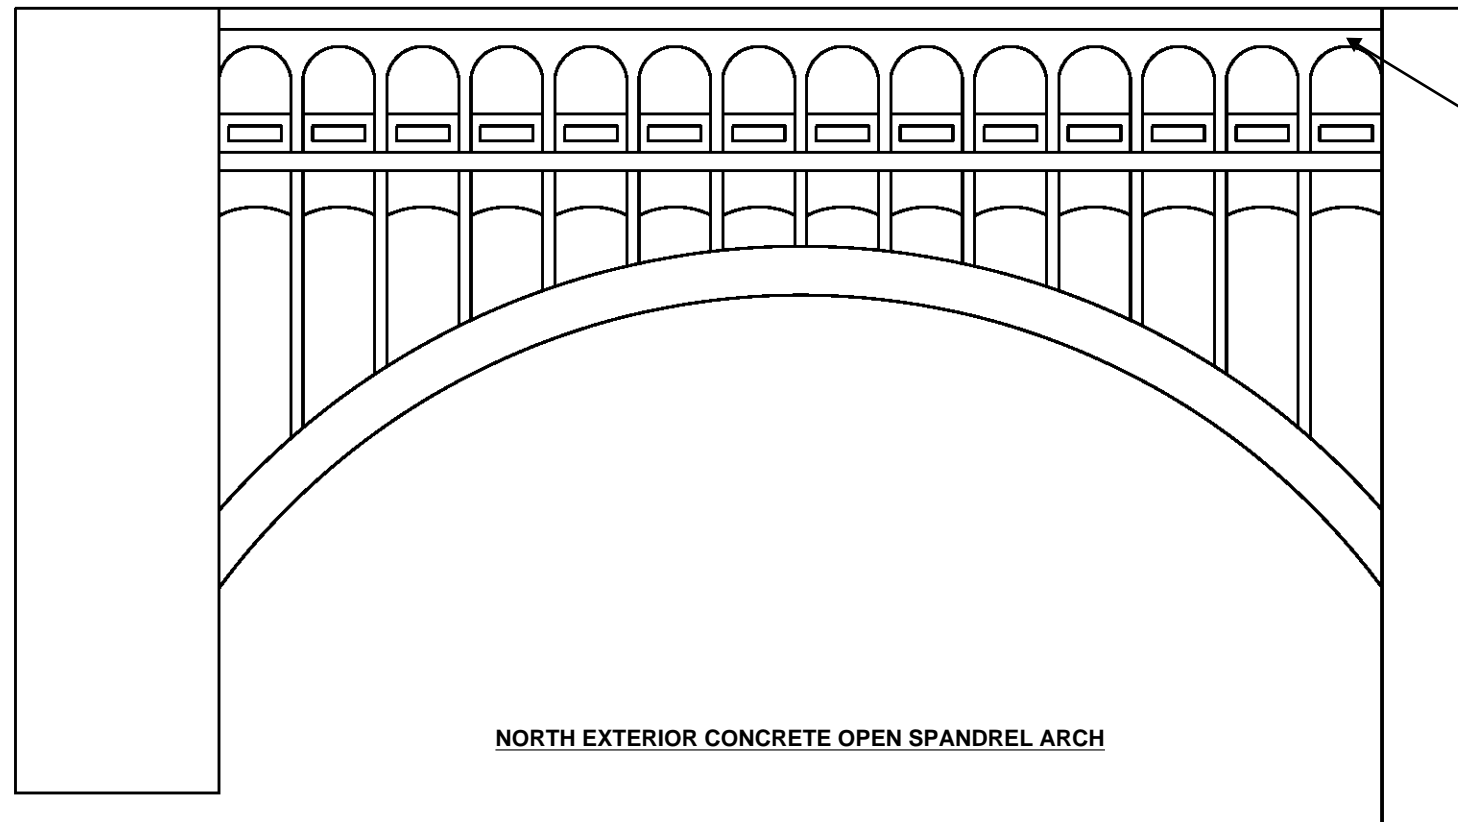
**NORTH EXTERIOR CONCRETE OPEN SPANDREL ARCH**

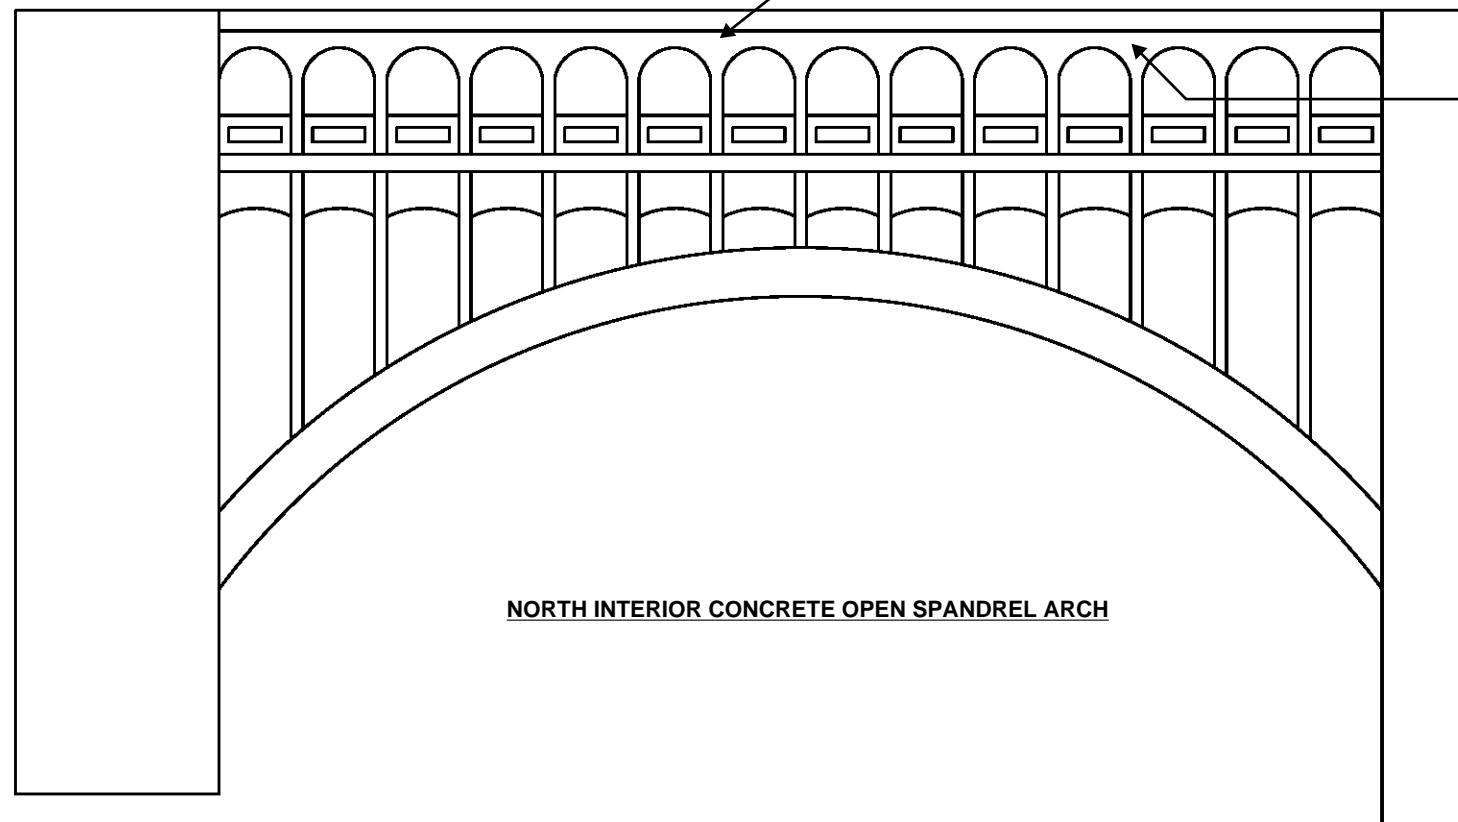
**NORTH INTERIOR CONCRETE OPEN SPANDREL ARCH**

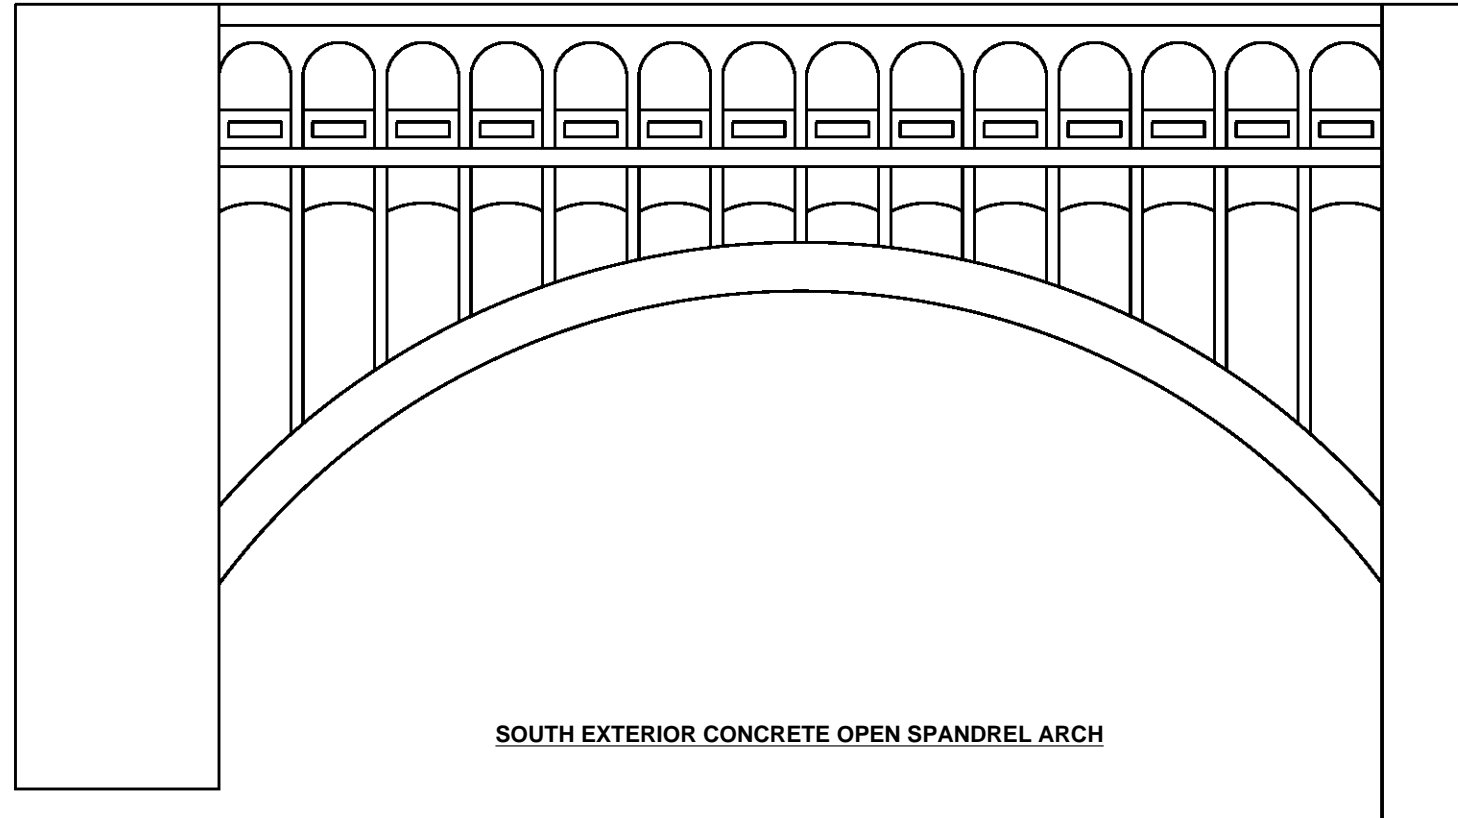
**SOUTH EXTERIOR CONCRETE OPEN SPANDREL ARCH**

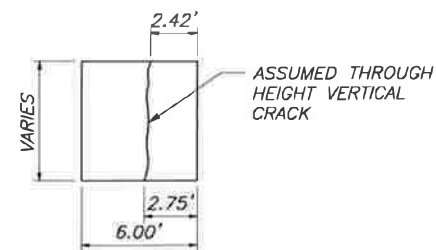
CRACK MEASUREMENTS				
PANEL	INTRADOS		EXTRADOS	
	MEASURED CRACK WIDTH	DIST. FROM SOUTH FACE	MEASURED CRACK WIDTH	DIST. FROM SOUTH FACE
11-12	0.030"	3.50'	<0.030"	2.58' TO 3.75'
12-13	0.156"	2.75'	$\frac{3}{32}$ " & $\frac{5}{8}$ "	2.42'
13-14	0.035" & 0.020"	2.50' & 3.83'	0.040" TO 0.094"	2.75'
14-15	0.012"-0"	2.00'	0.010" TO 0.020"	2.75'

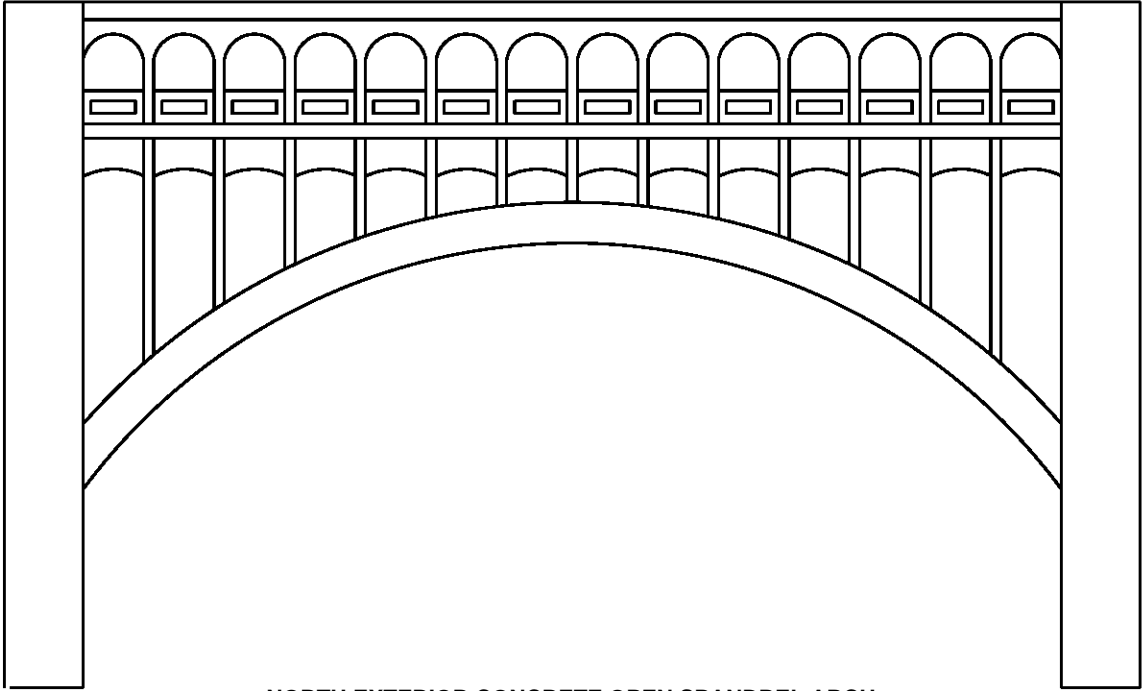
**NORTH EXTERIOR CONCRETE OPEN SPANDREL ARCH**

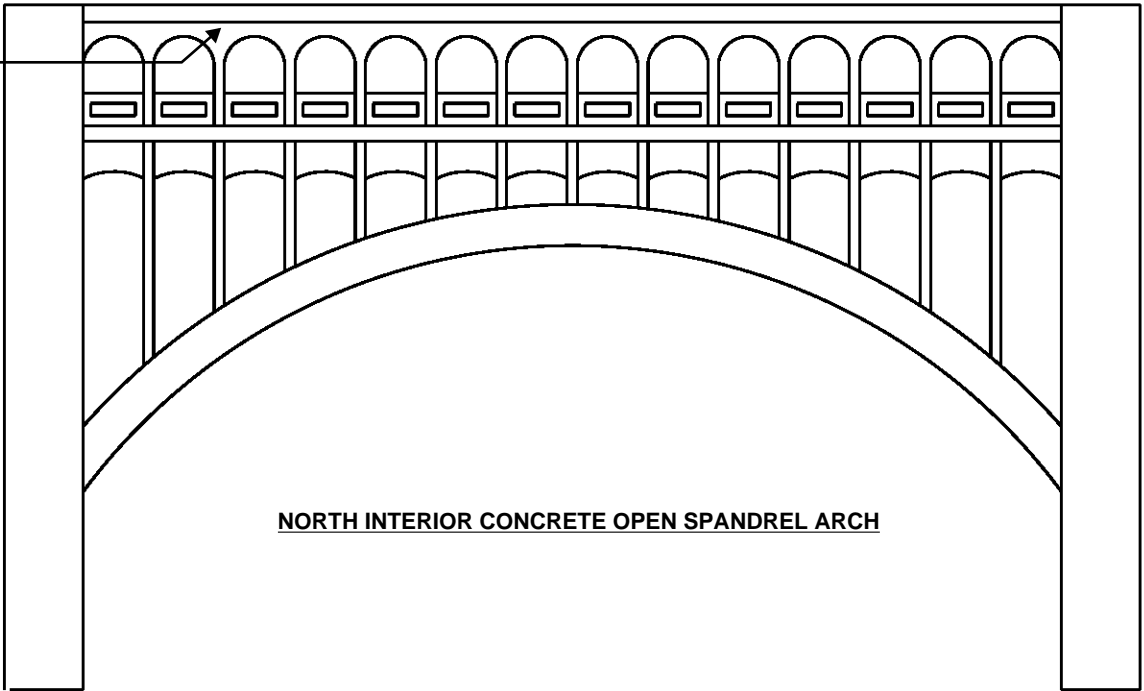
**NORTH INTERIOR CONCRETE OPEN SPANDREL ARCH**

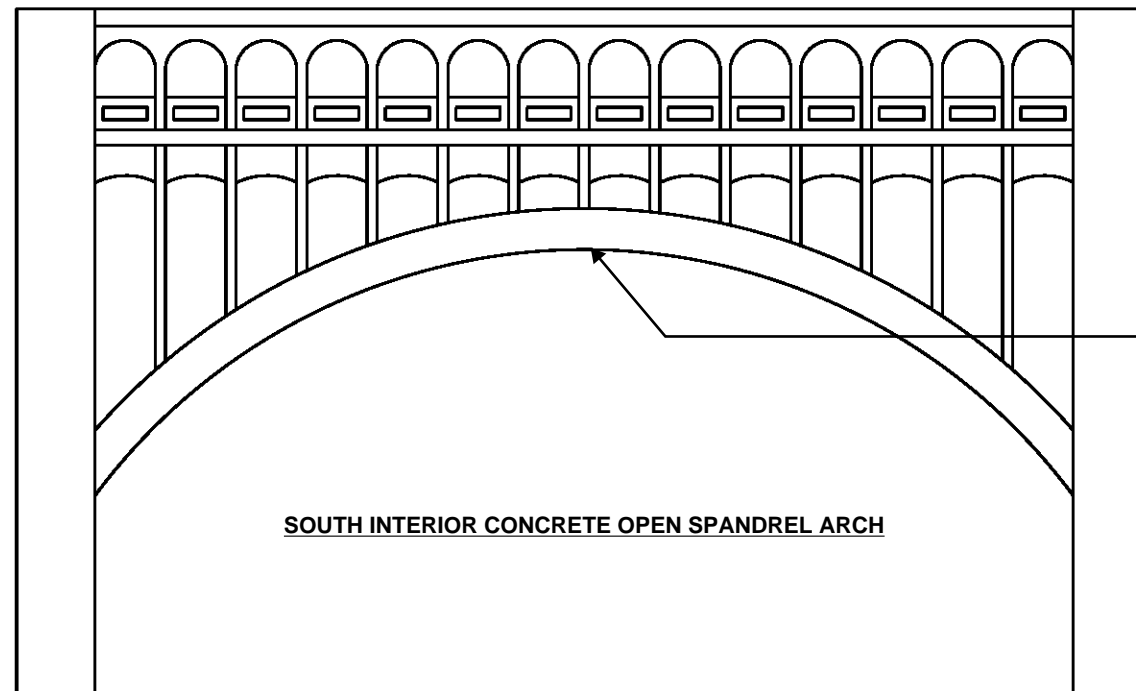
**SOUTH INTERIOR CONCRETE OPEN SPANDREL ARCH**

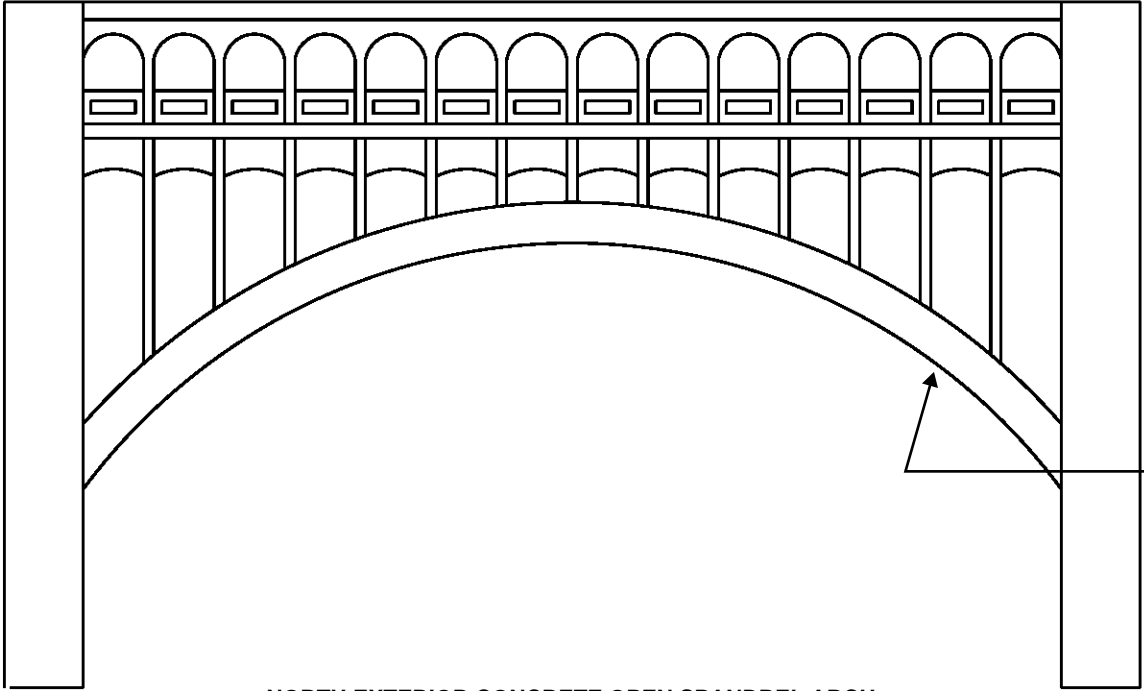
Underside of arch is cracked and delaminated on the east end

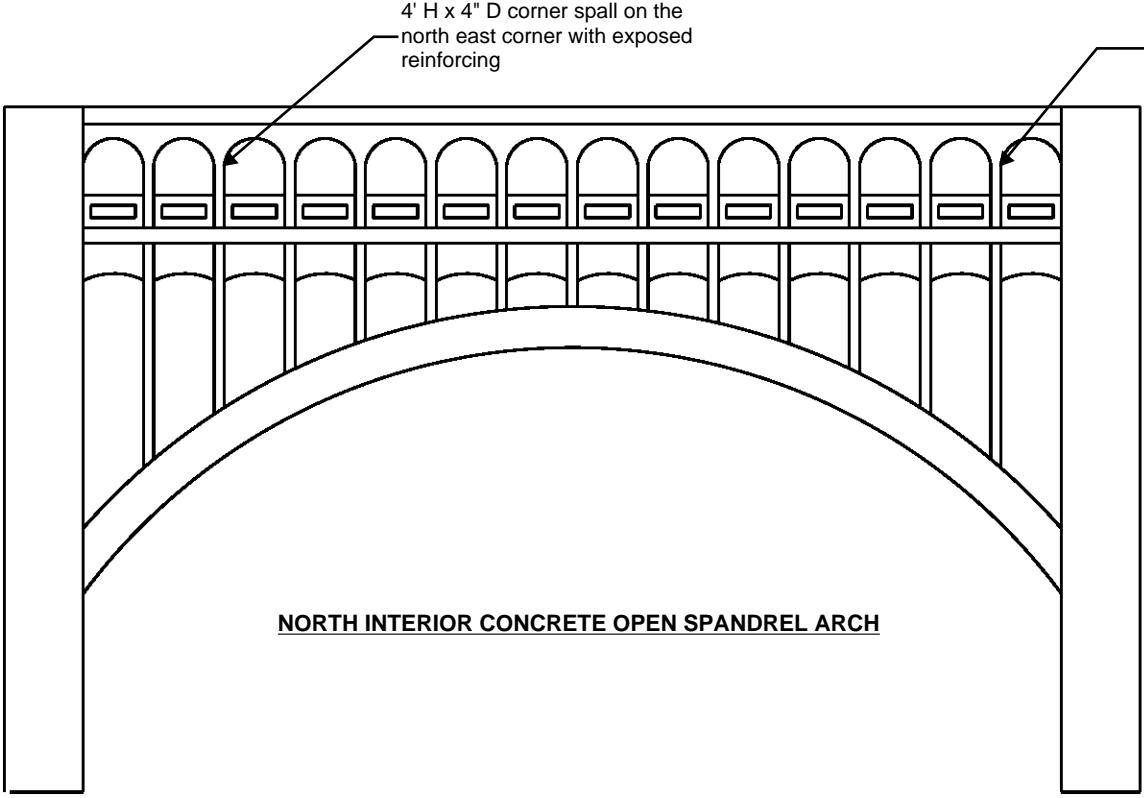
4' H x 4" D corner spall on the north east corner with exposed reinforcing

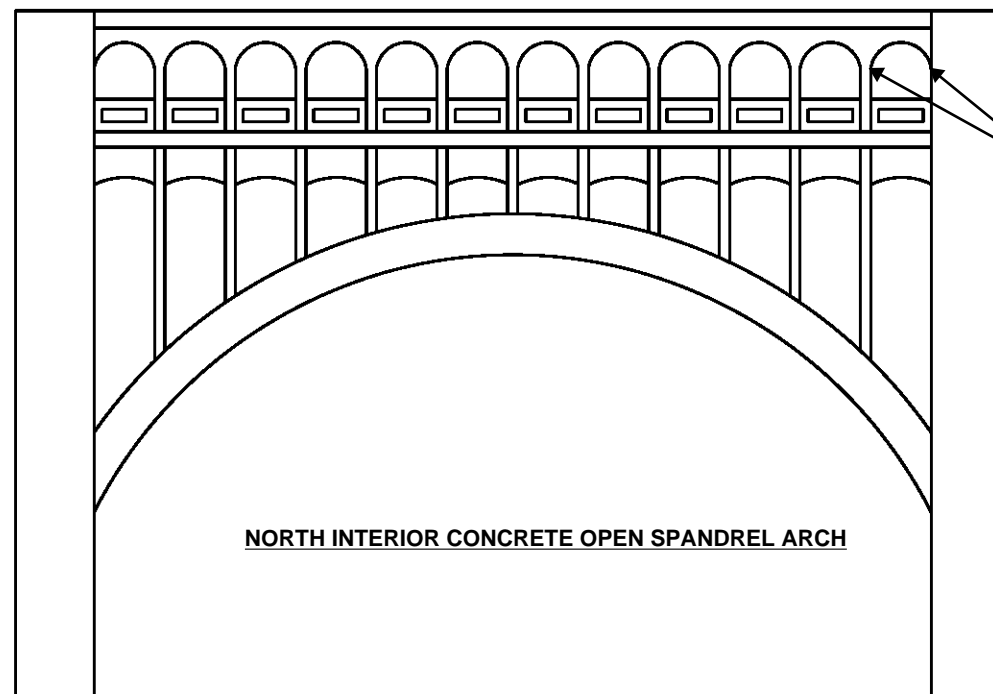
**NORTH INTERIOR CONCRETE OPEN SPANDREL ARCH**

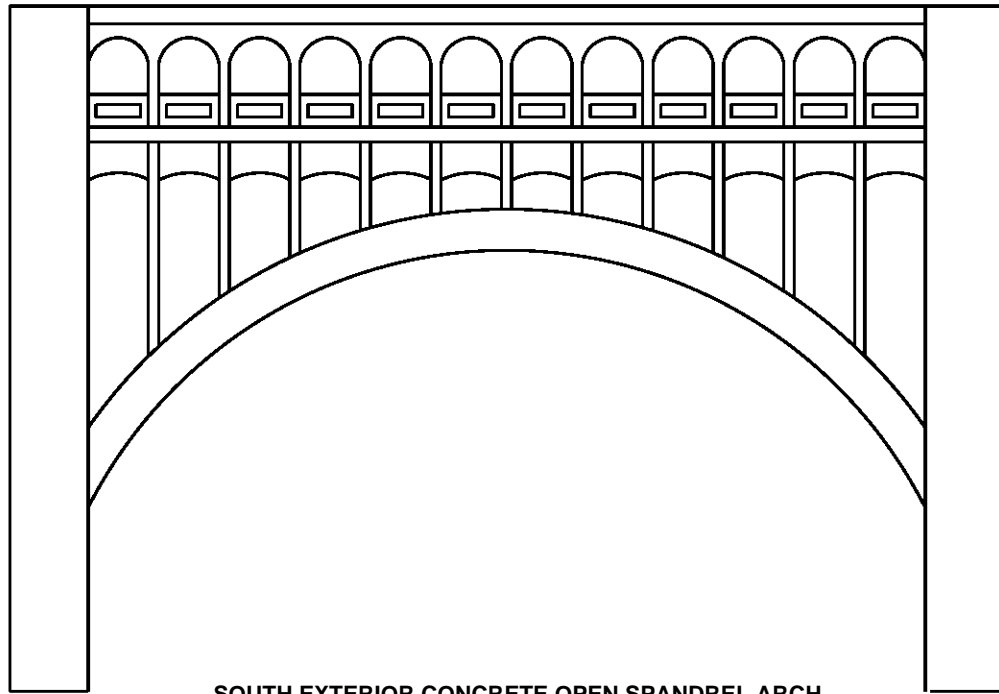
**SOUTH EXTERIOR CONCRETE OPEN SPANDREL ARCH**

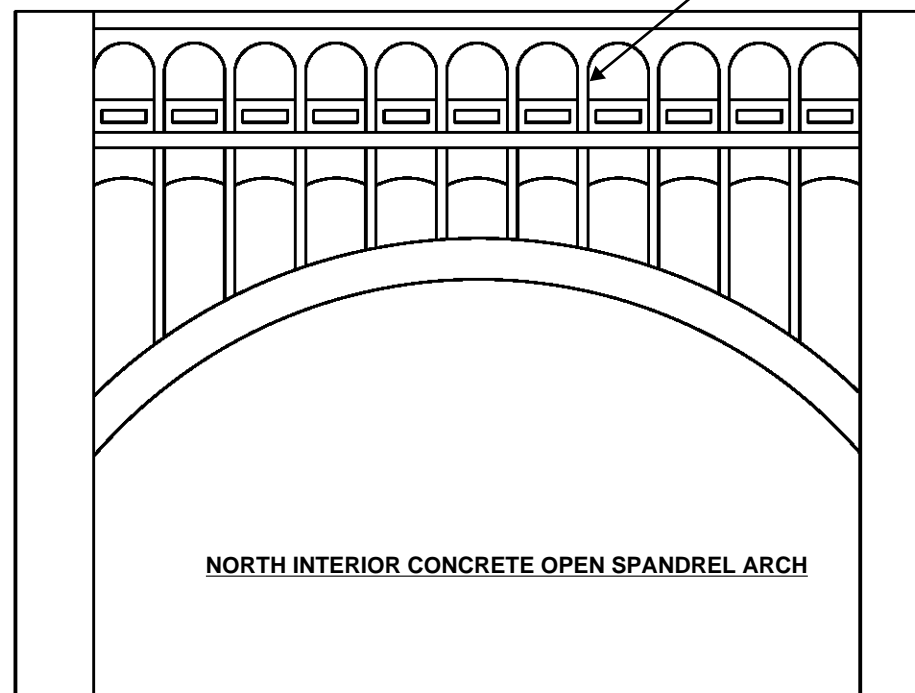
**NORTH INTERIOR CONCRETE OPEN SPANDREL ARCH**

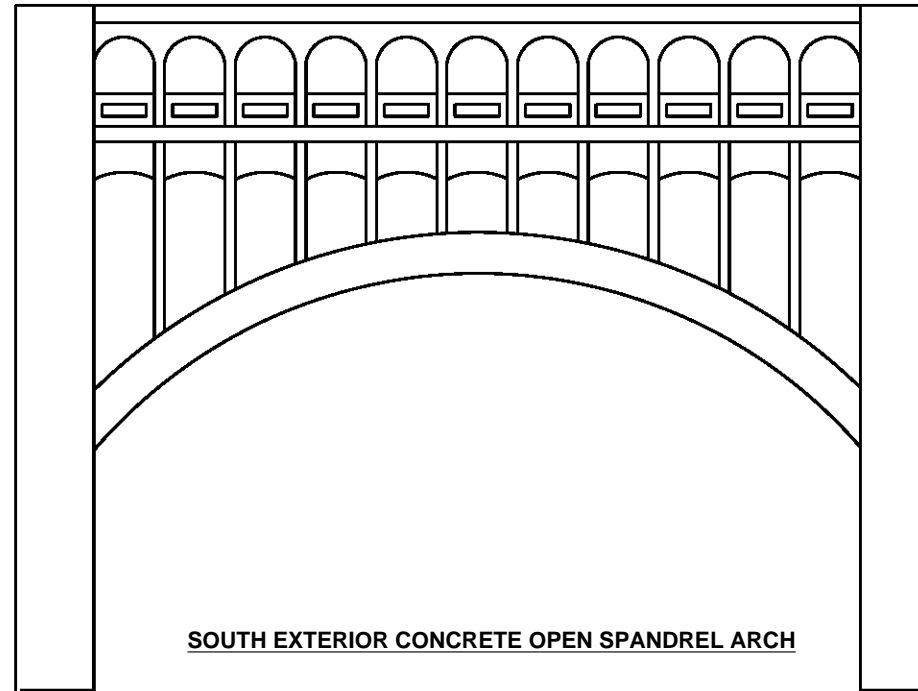
**SOUTH EXTERIOR CONCRETE OPEN SPANDREL ARCH**
