# CUY-6-1456

## PHYSICAL CONDITION REPORT ROUTINE INSPECTION

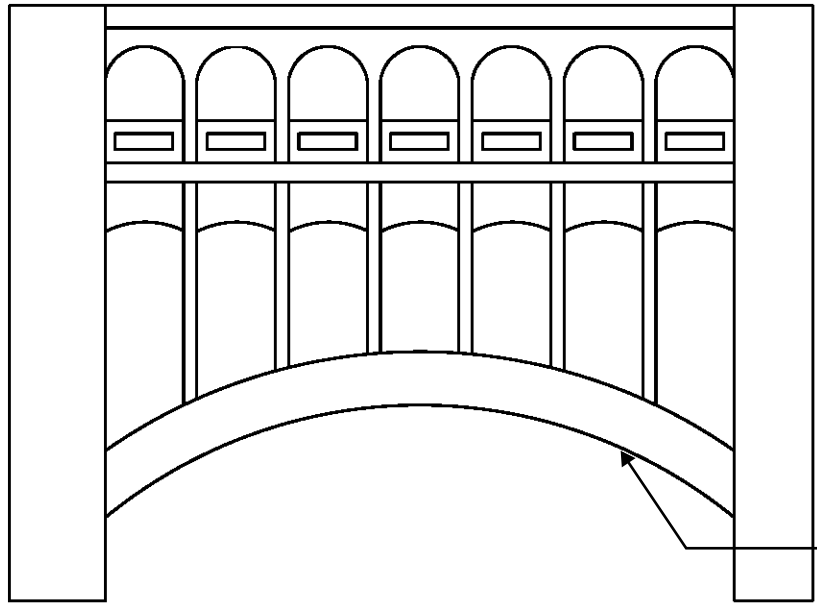
Crack on the south face near the bottom extending from pier 11 to approximately 1/4 the way up the arch

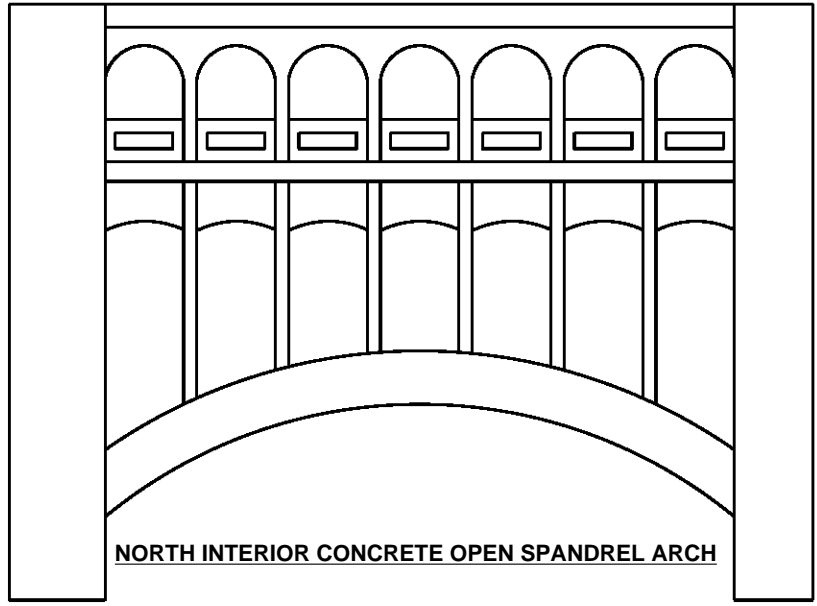
**NORTH INTERIOR CONCRETE OPEN SPANDREL ARCH**

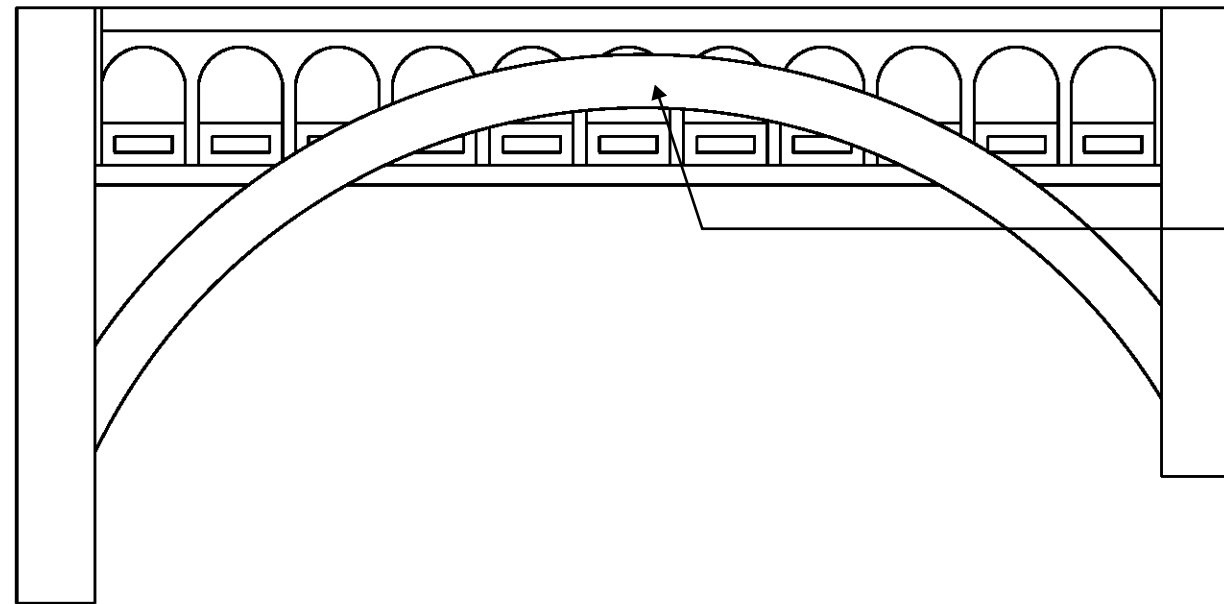
South face of the arch is delaminated with widespread cracking near the bases. 1/2" W crack in the delaminated surface.

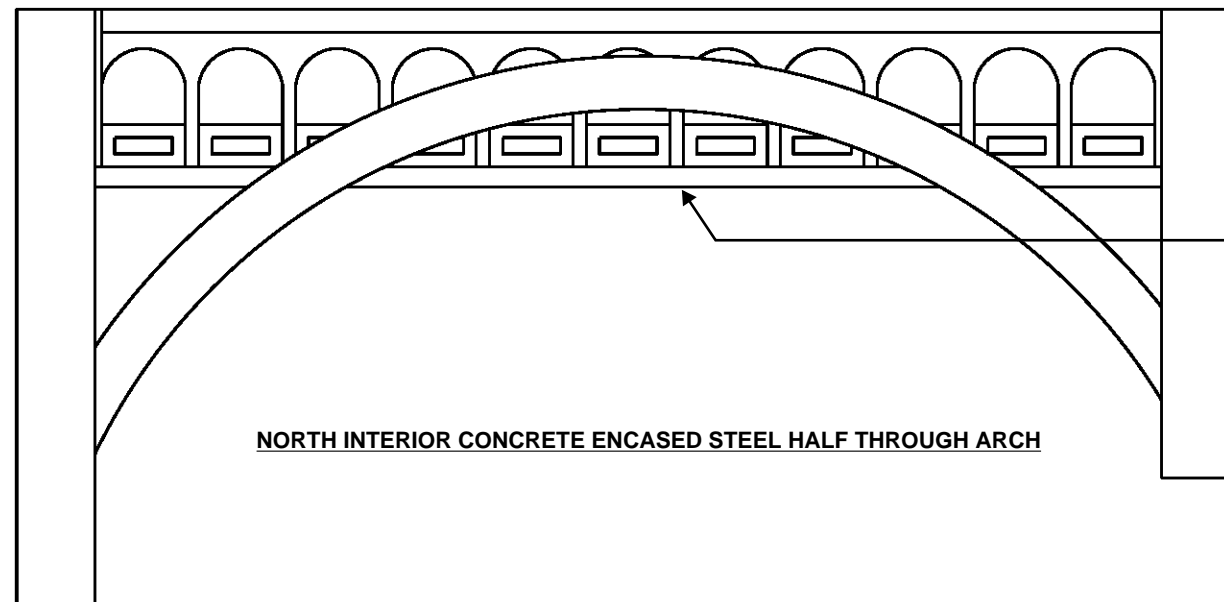
Lower deck floor beam 6 appears to be delaminated along the full length

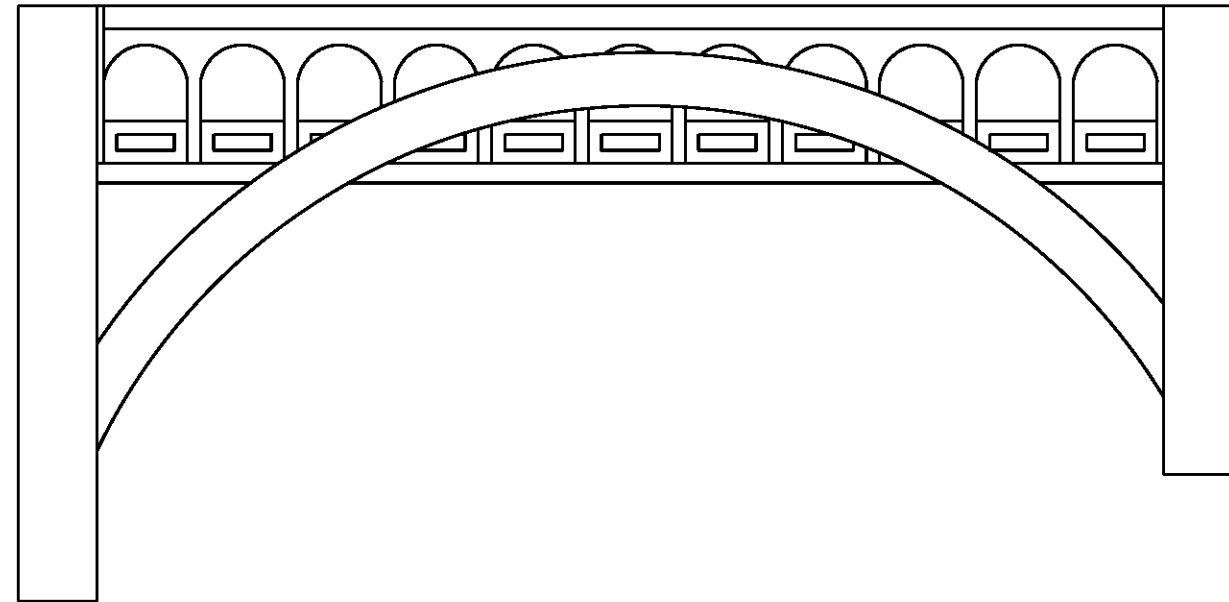
**SOUTH EXTERIOR CONCRETE ENCASED STEEL HALF THROUGH ARCH**

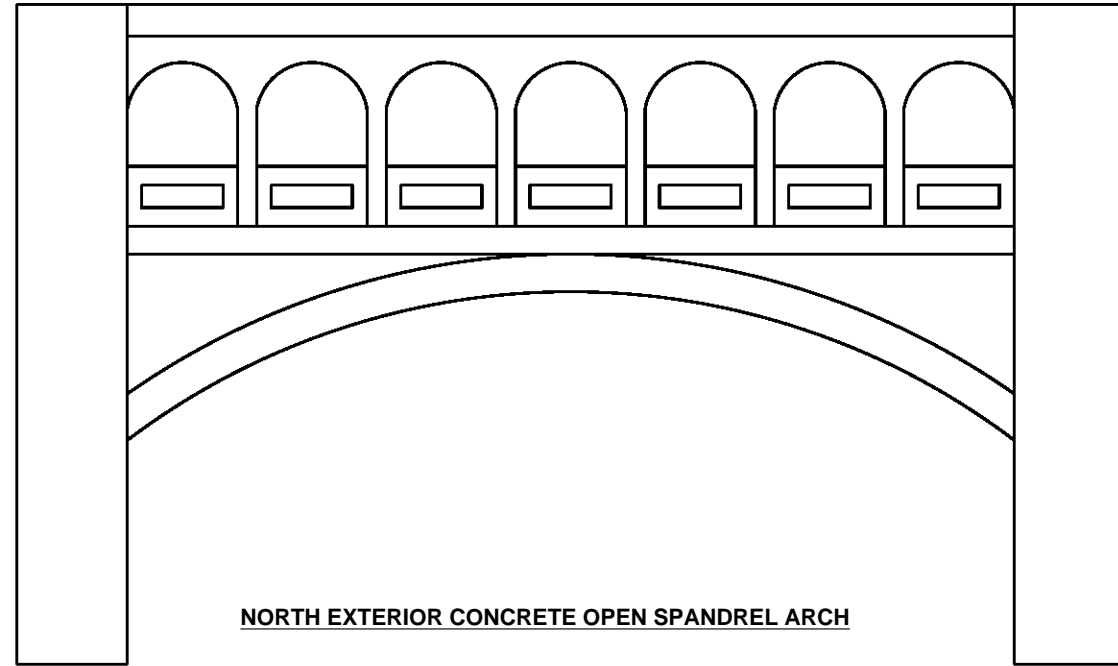
**NORTH EXTERIOR CONCRETE OPEN SPANDREL ARCH**
