CUY-6-1456

PHYSICAL CONDITION REPORT ROUTINE FRACTURE CRITICAL INSPECTION VETERANS MEMORIAL/DETROIT-SUPERIOR BRIDGE OVER THE CUYAHOGA RIVER SFN: 1800930

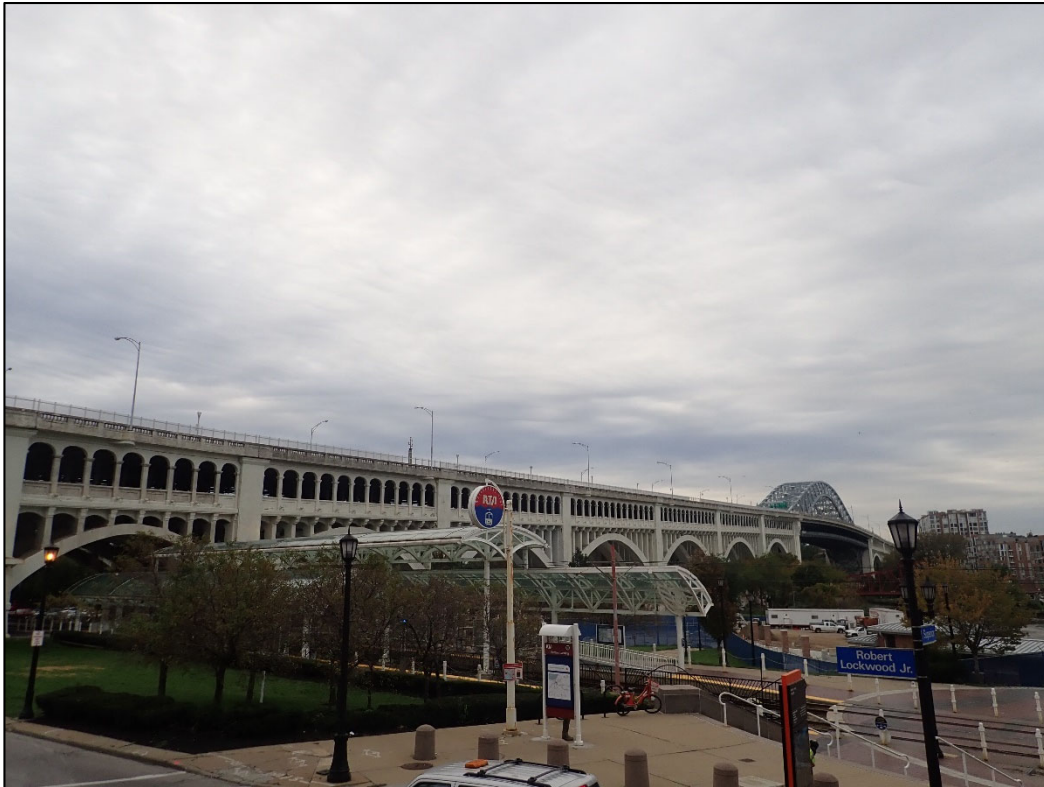
Inspection Date:
October 22-26, 2018
Routine and Fracture Critical Inspection

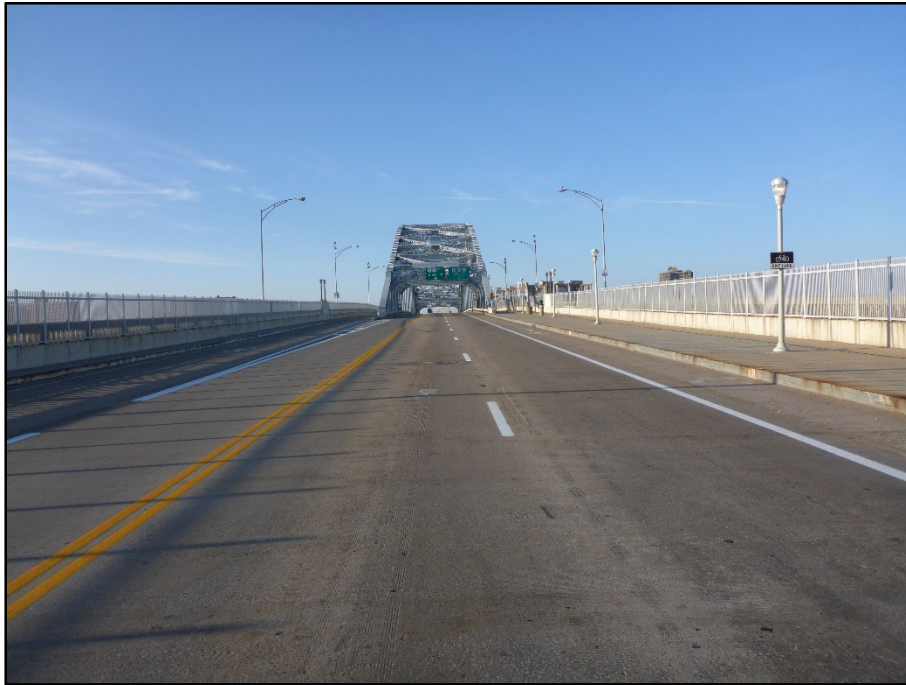
East end view looking west

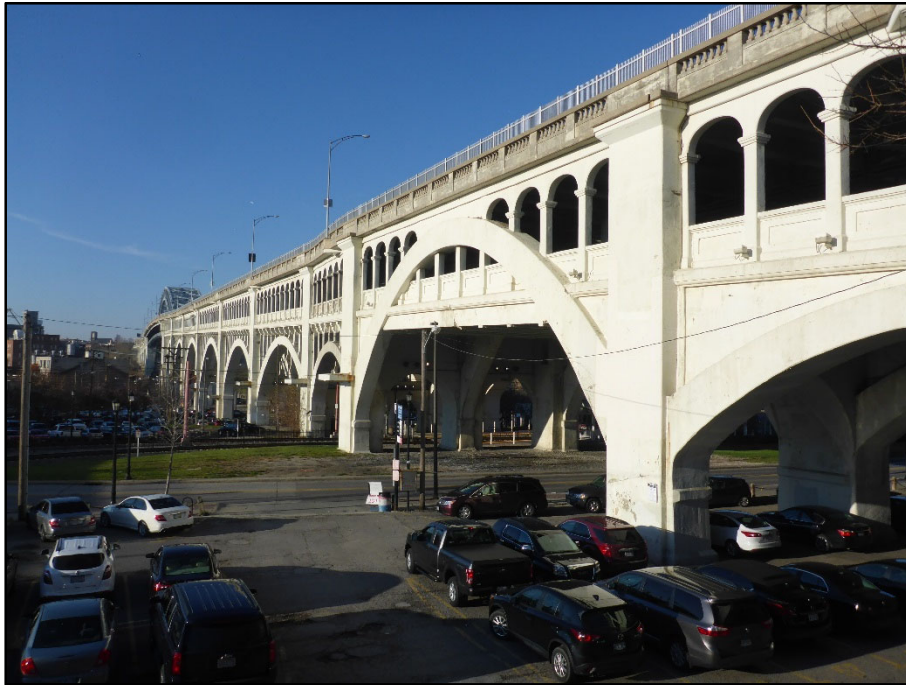
Bridge Number: CUY-6-1456
SFN: 1800930
Inspection Date: October 22-26, 2018

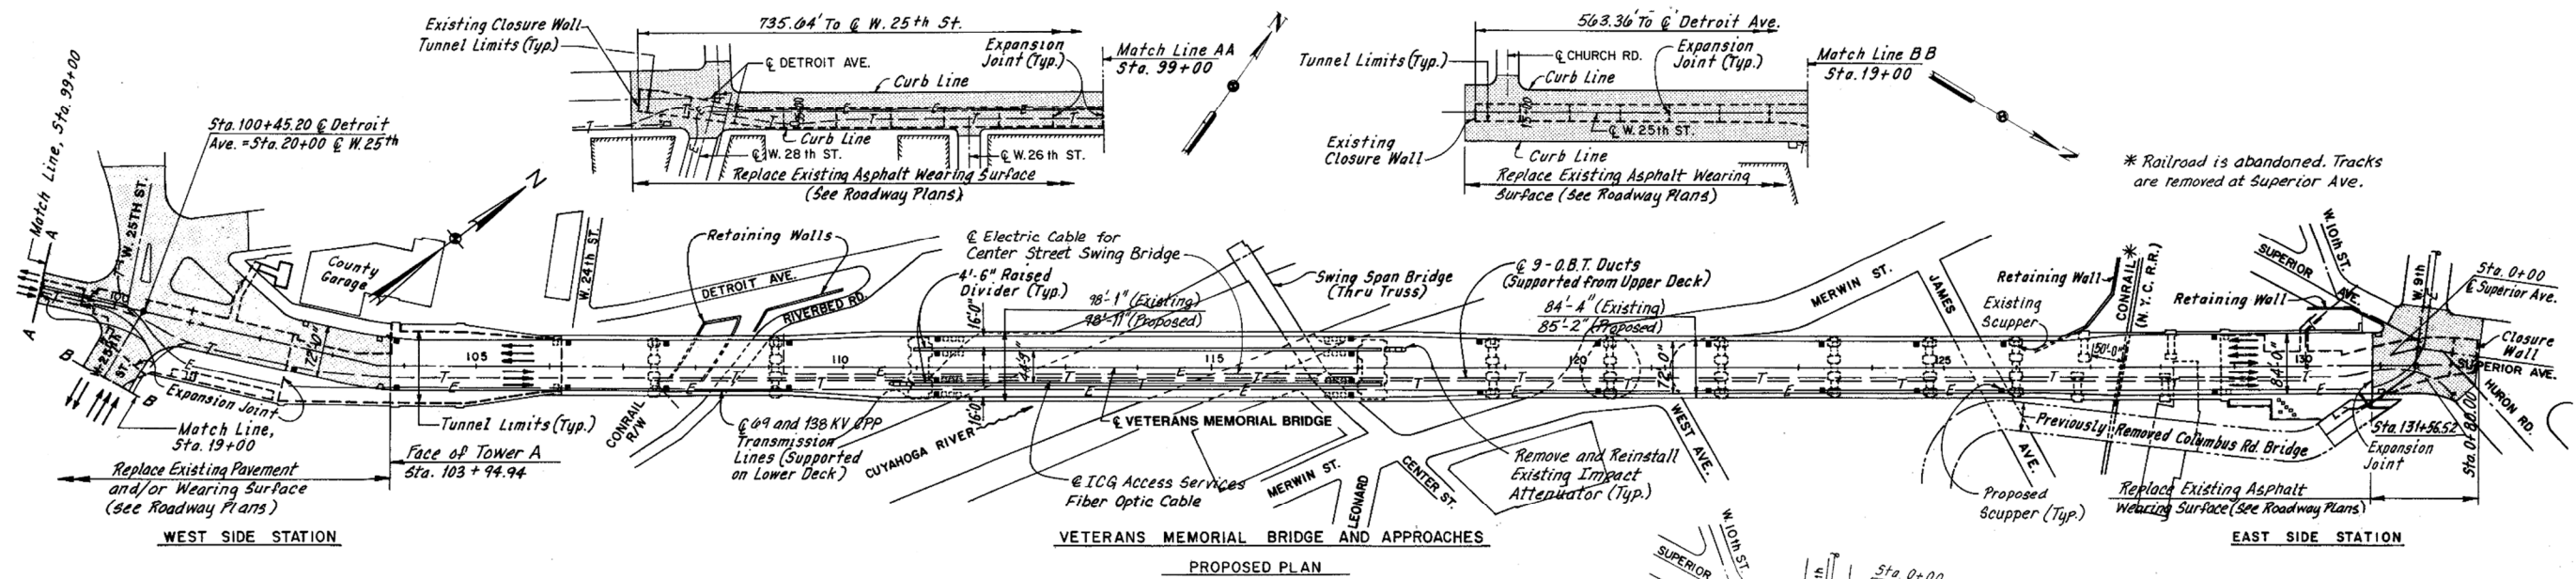
* Railroad is abandoned. Tracks are removed at Superior Ave.

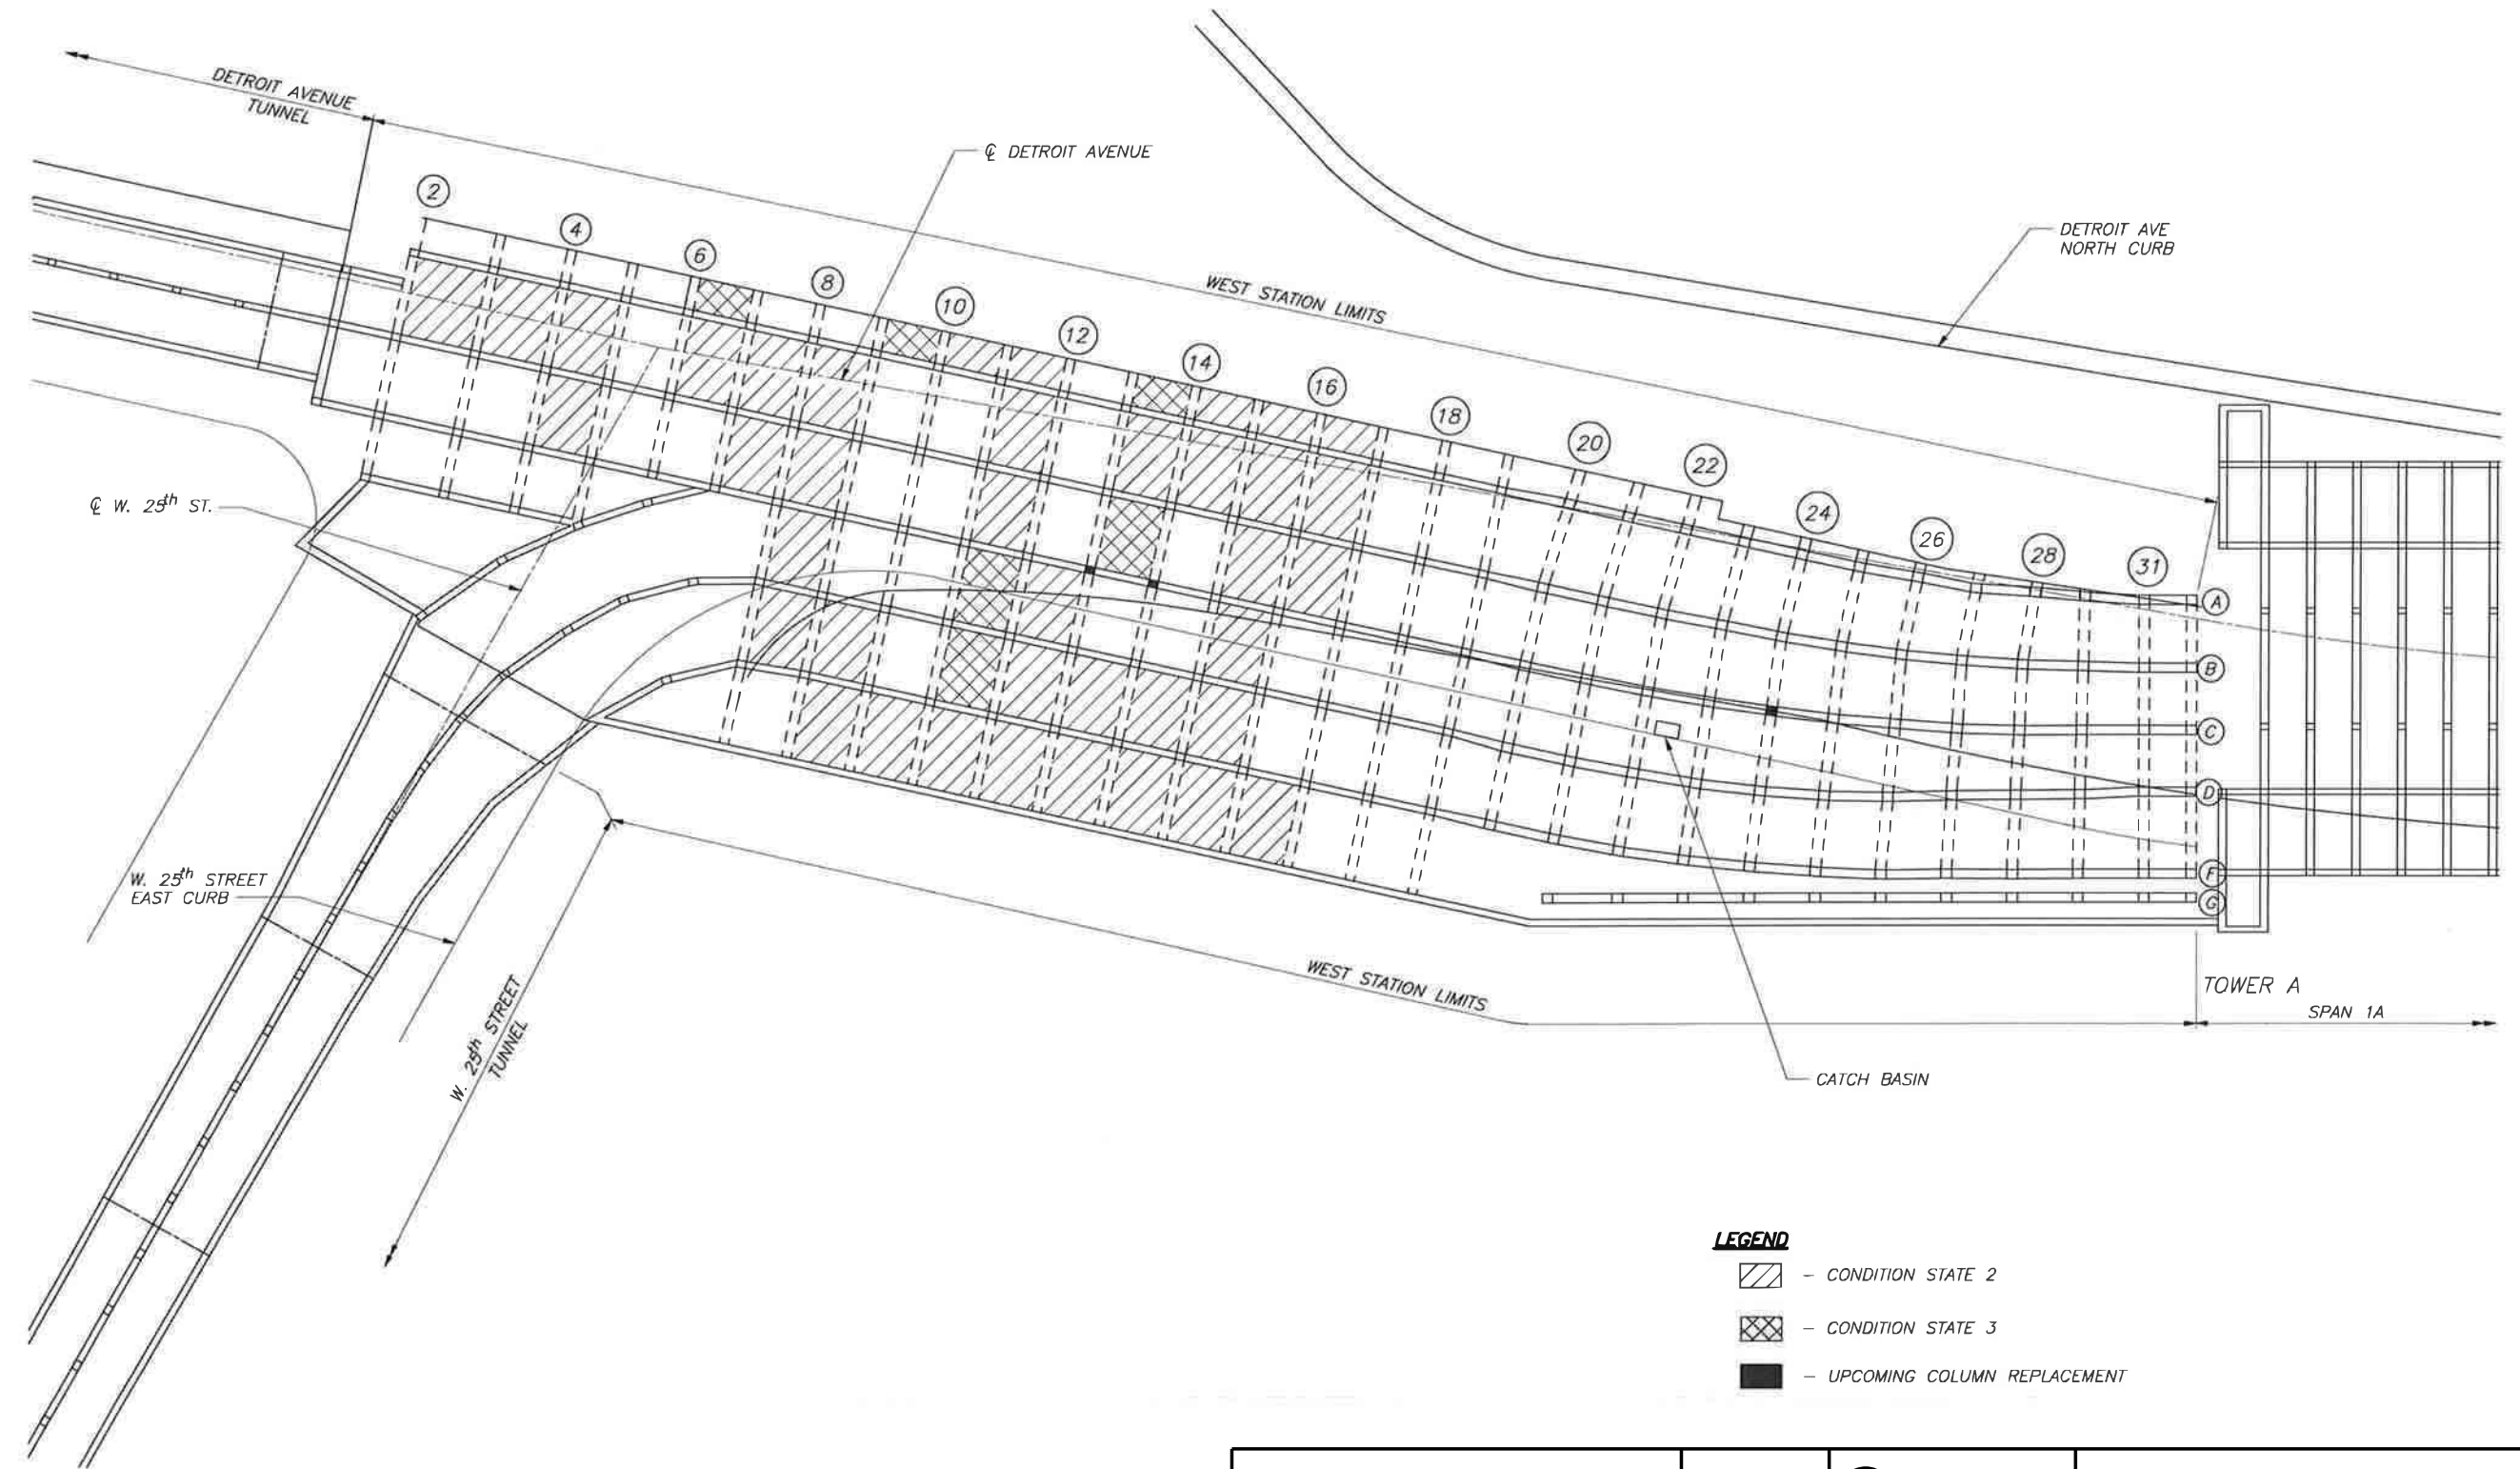
- LEGEND**
- CONDITION STATE 2
 - CONDITION STATE 3
 - UPCOMING COLUMN REPLACEMENT

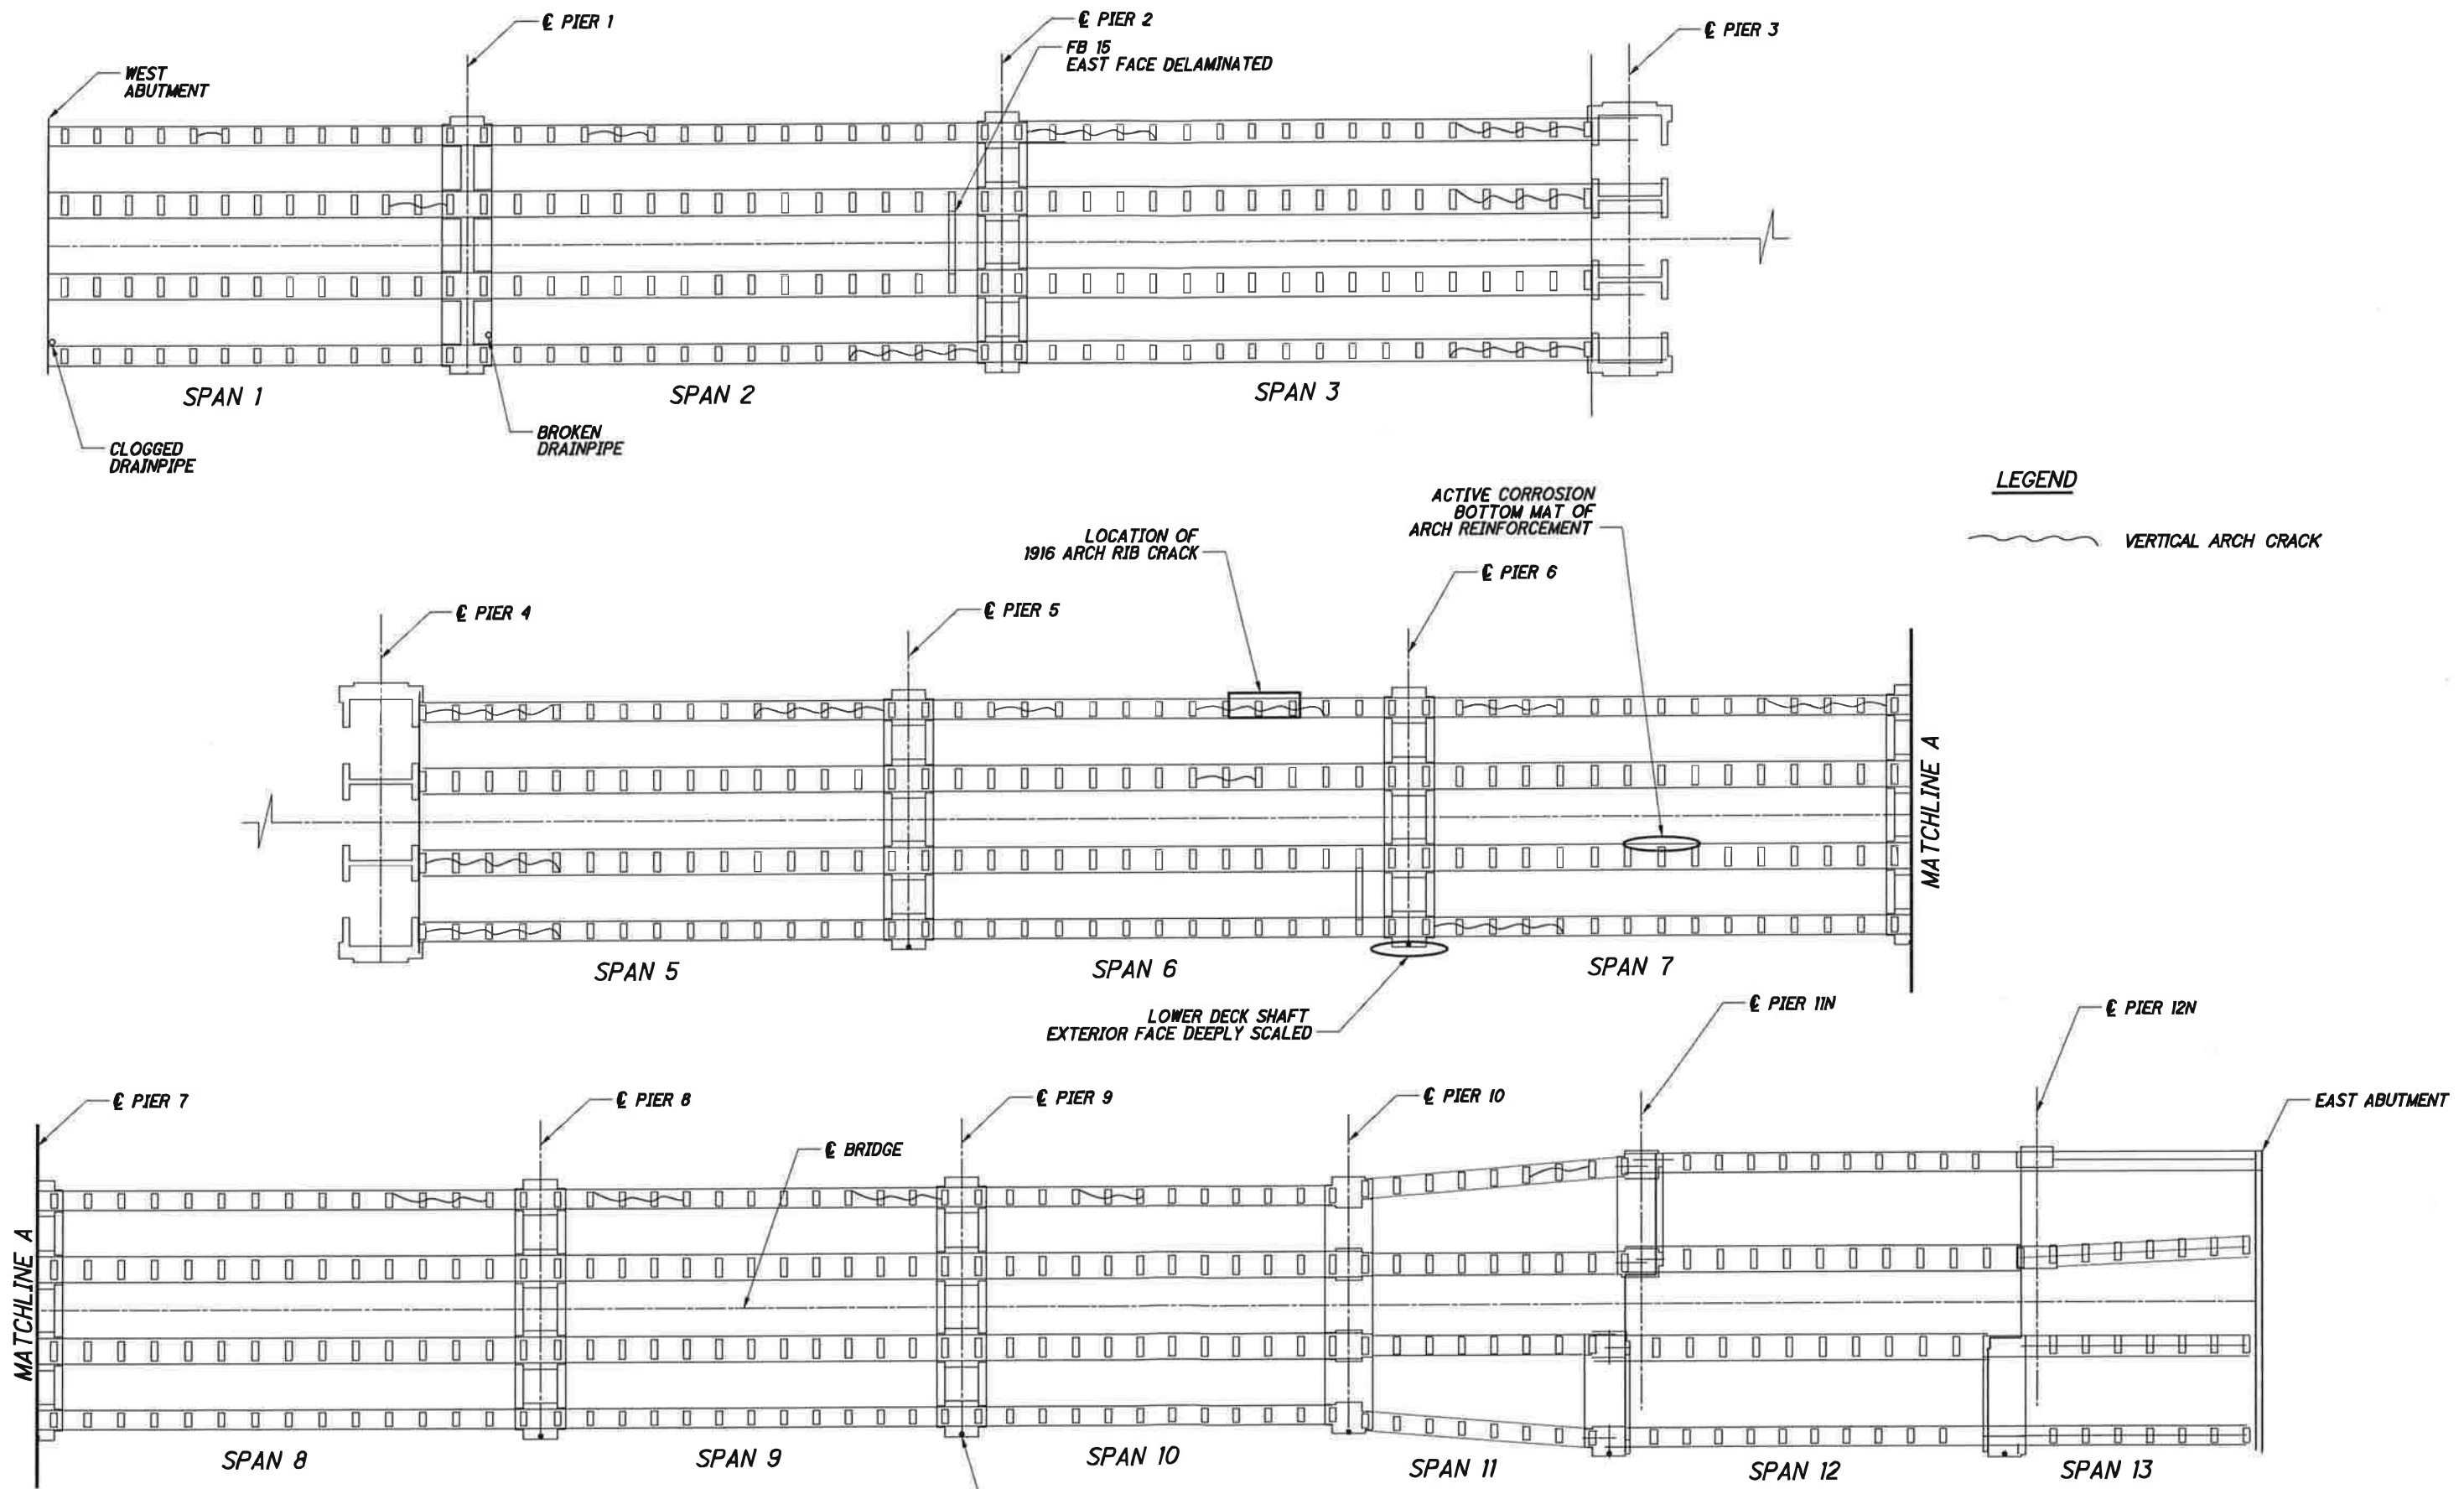
LEGEND
 ~~~~~ VERTICAL ARCH CRACK

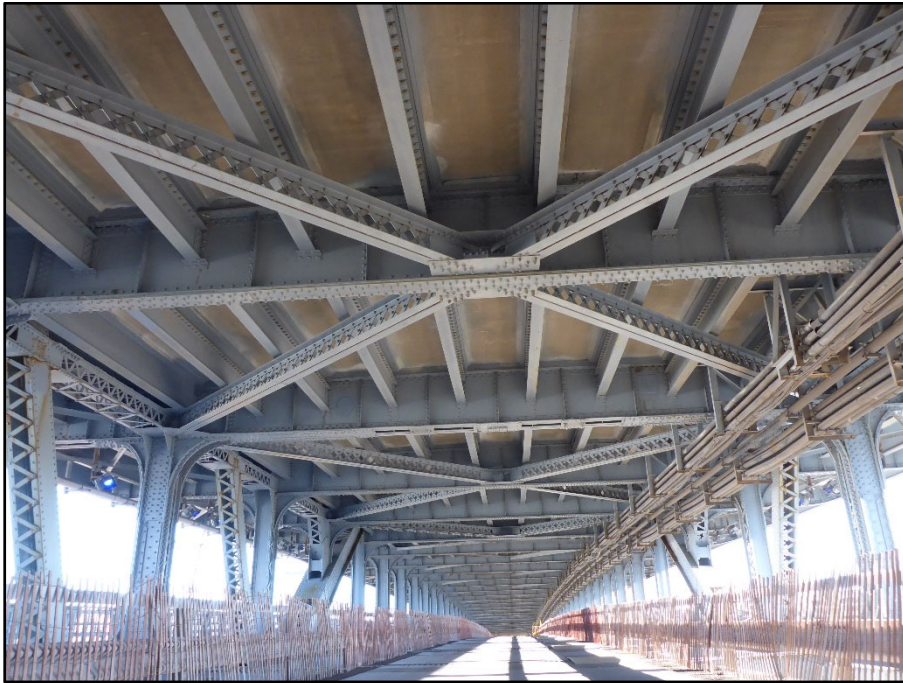
Photo 3 – Typical upper deck soffit Span 4

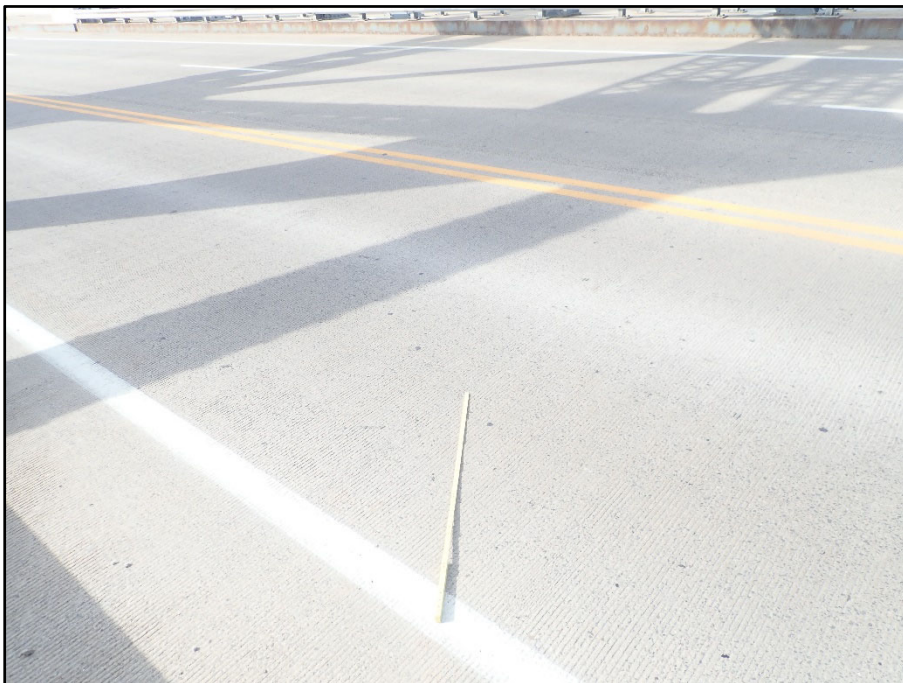
Photo 4 – Typical upper deck wearing surface condition

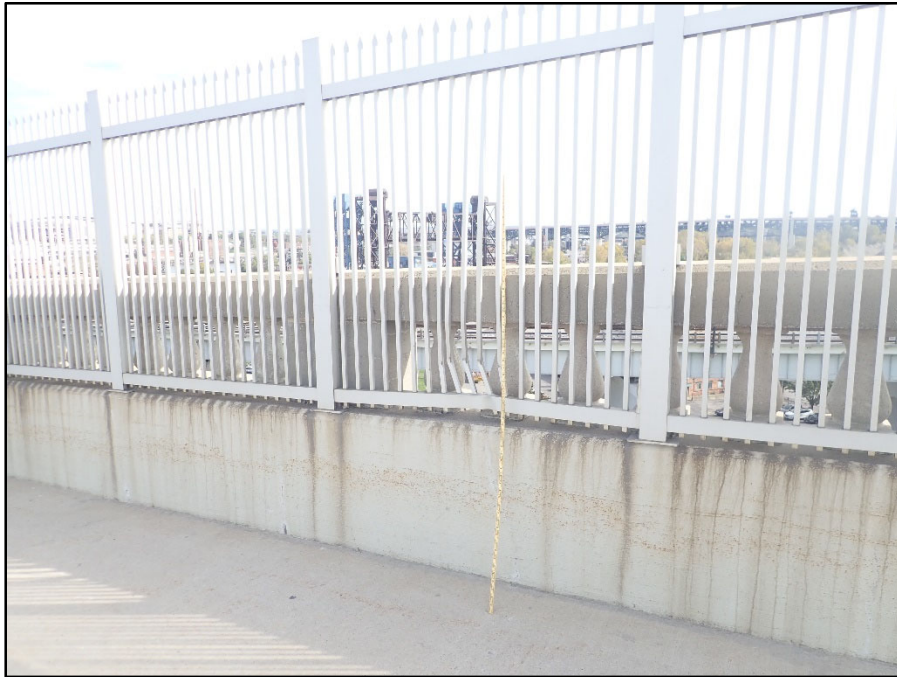
Photo 5 – Typical bridge rail condition

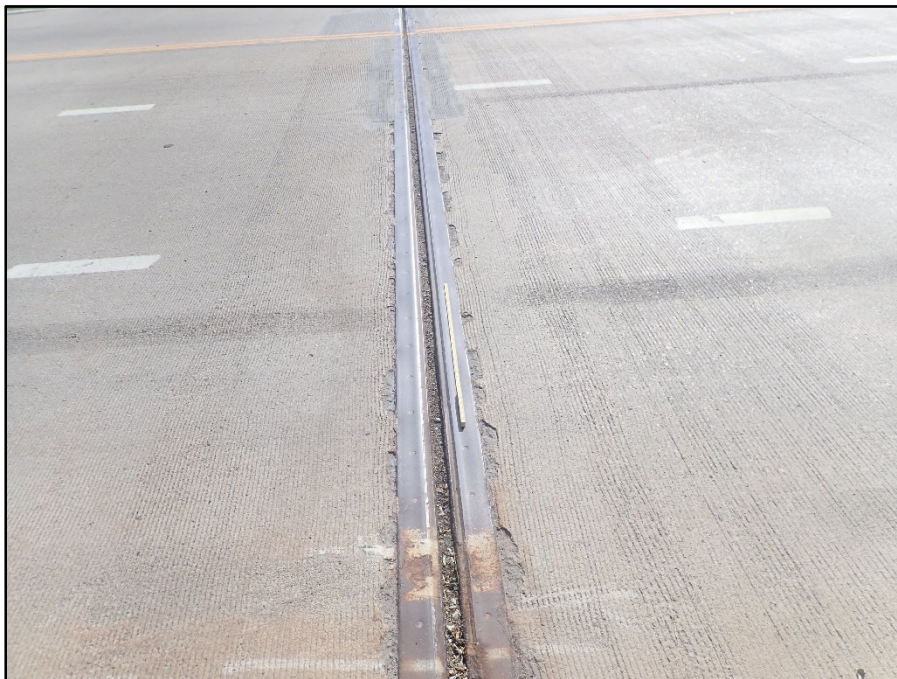
Photo 6 – Typical expansion joint condition

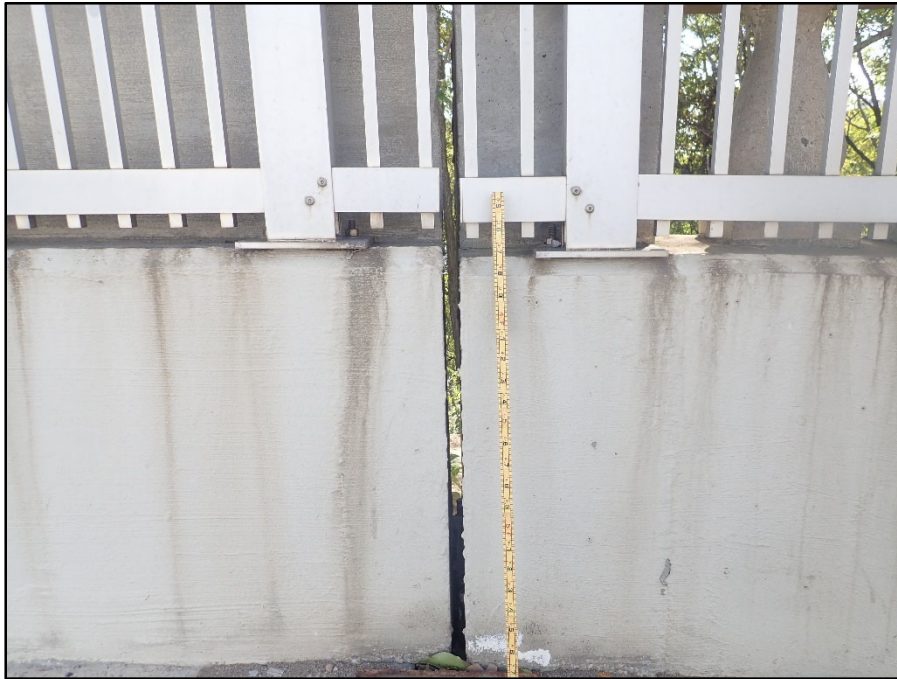
Photo 7 – South top railing at Tower A; vertically misaligned 7/8” at railing joint

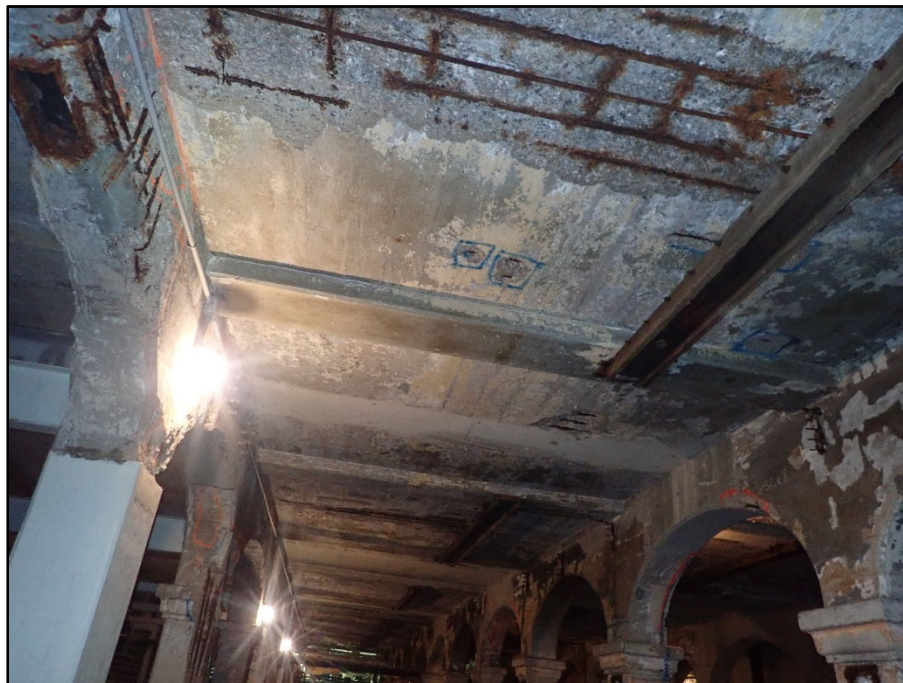
Photo 8 – West tunnels upper deck with heavy efflorescence, cracking, delaminations, and spalls with corroded reinforcing steel

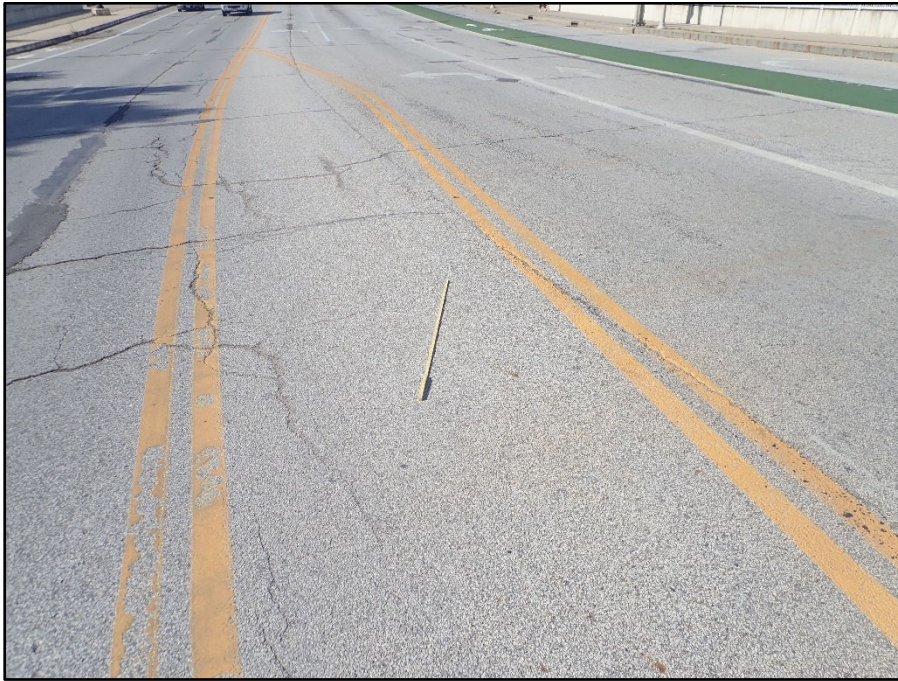
Photo 9 – West Station wearing surface; heavy map cracking and patching throughout

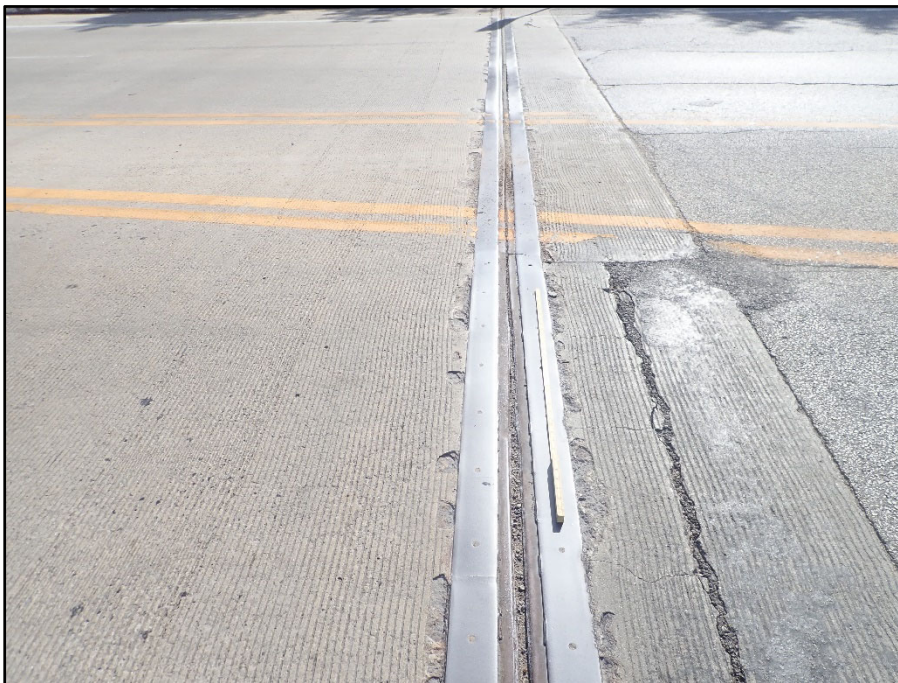
Photo 10 – Tower B expansion joint, left westbound lane; pack rust has broken fillet welds. Snow plow damage is present.

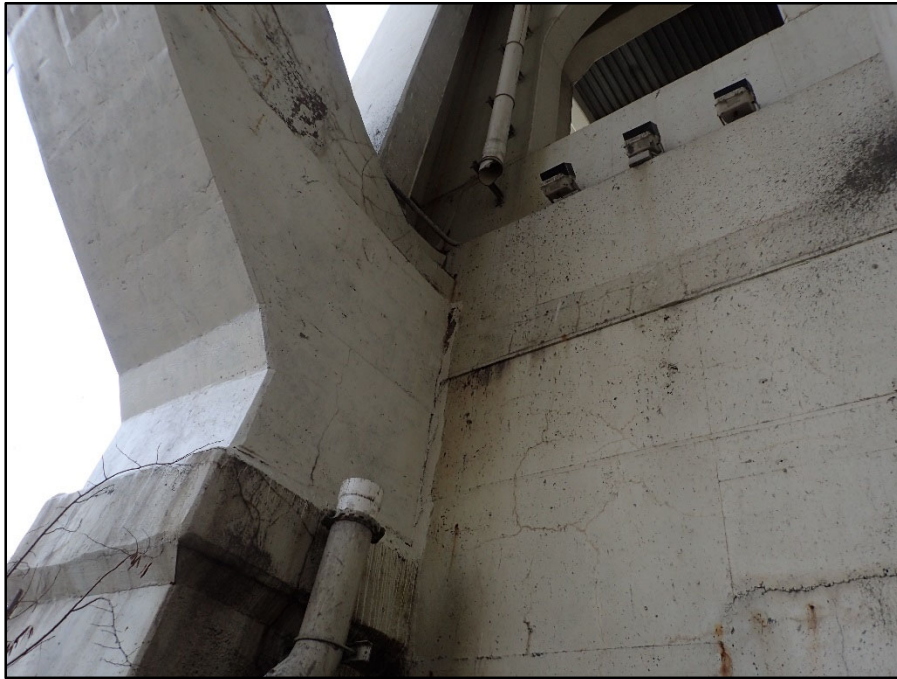
Photo 11 – Pier 1 south downspout; missing 15' section of PVC pipe

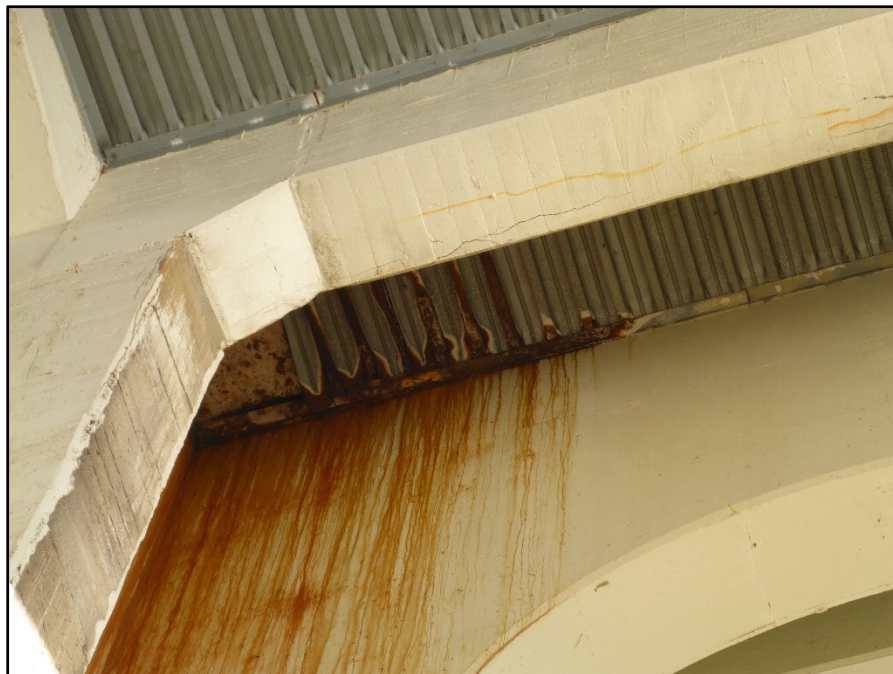
Photo 12 – Span 2, Panel 15 center bay; SIP forms exhibit severe corrosion that is staining the west face of Pier 2

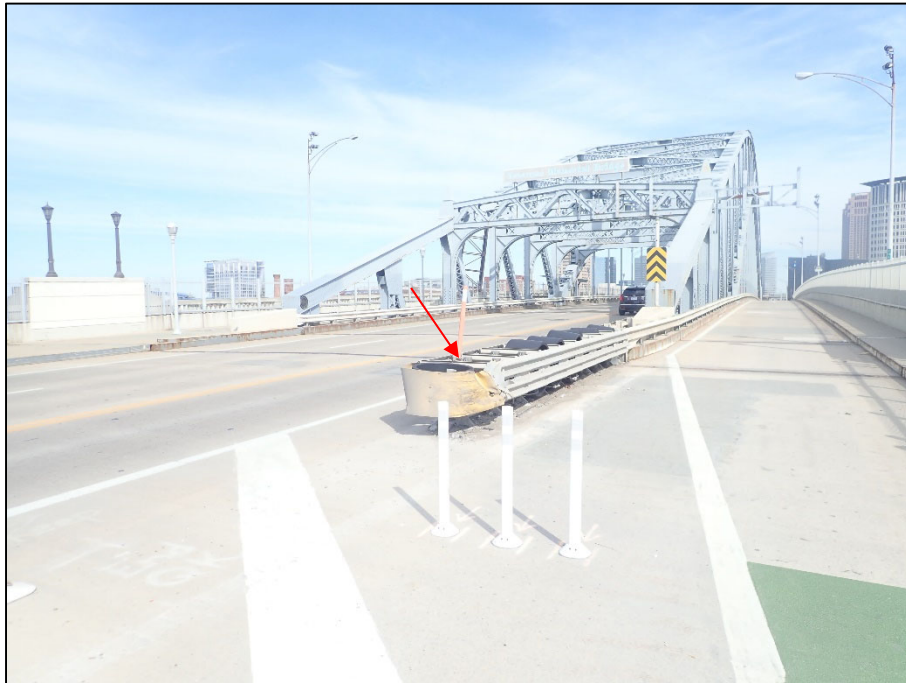
Photo 13 – Span 3 south attenuator; minor impact damage

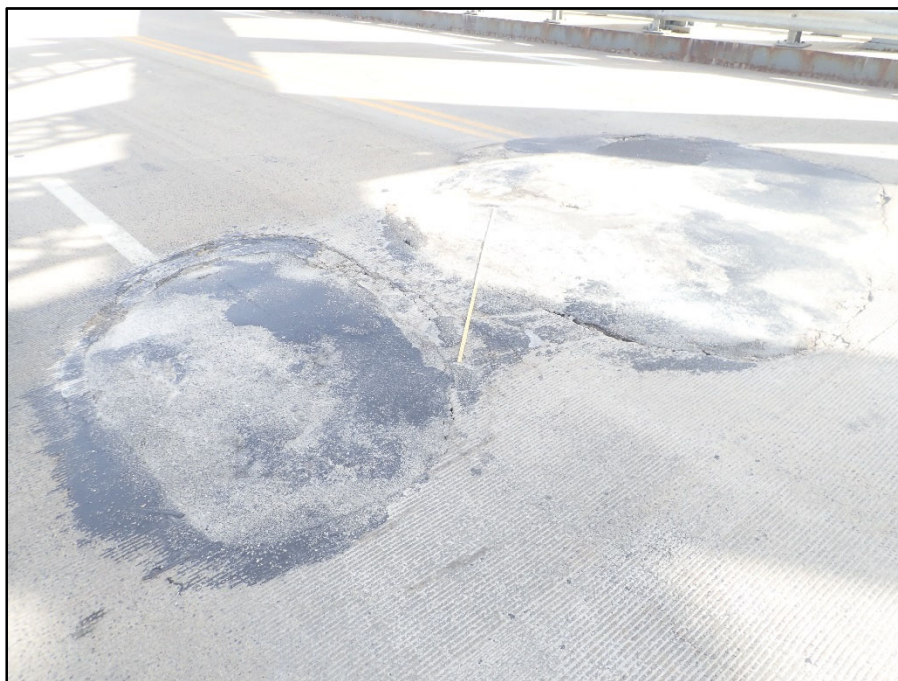
Photo 14 – East end of Span 4; deteriorating 12' L x 18' W x 1" D patch

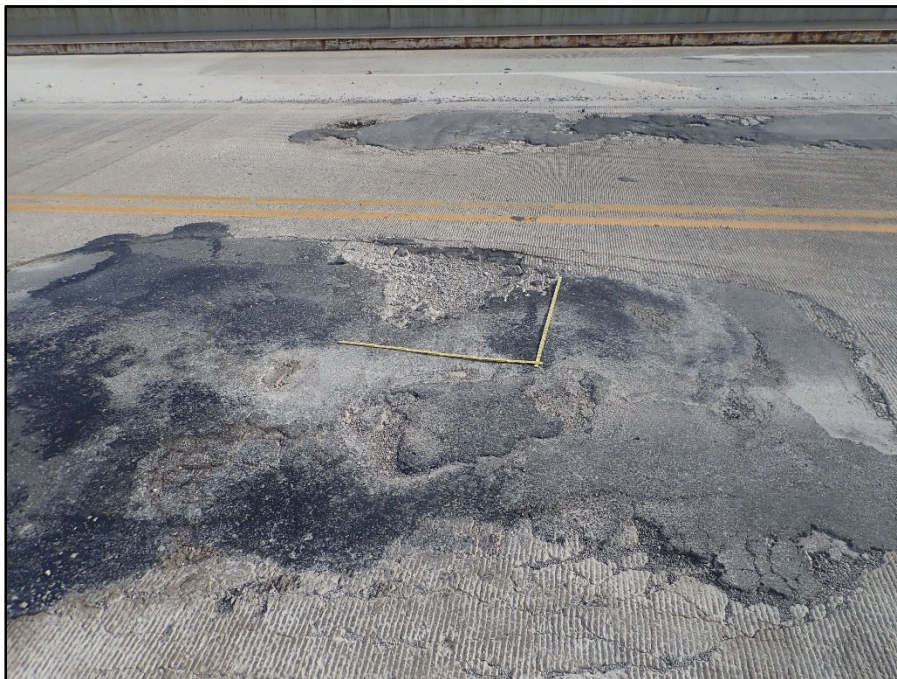
Photo 16 – Span 8 eastbound lane; 25' L x 7' W x up to 3" D spalling patch with exposed reinforcing

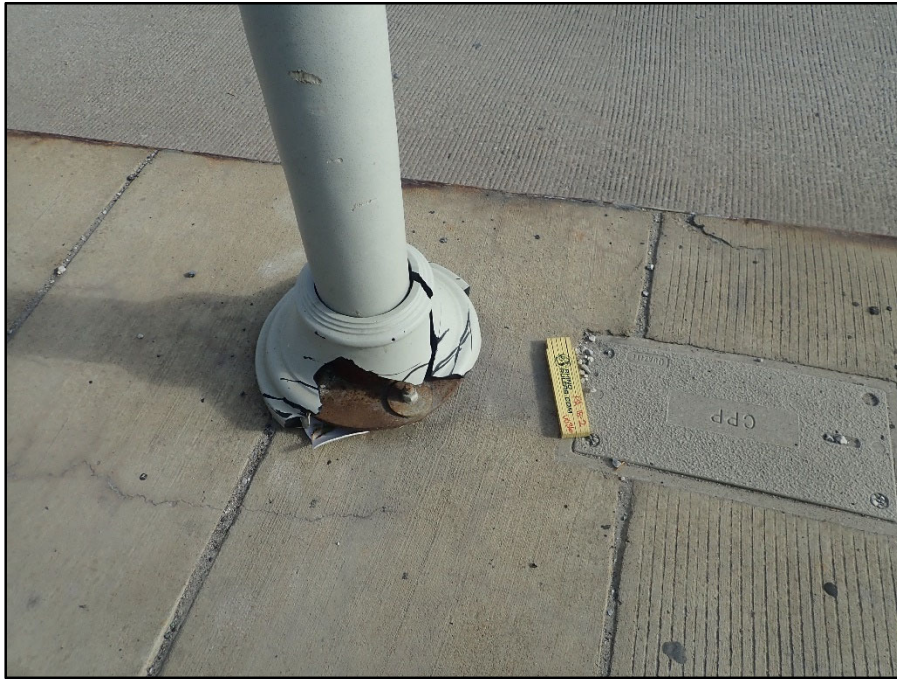
Photo 17 – Span 11, north sidewalk; broken light pole base

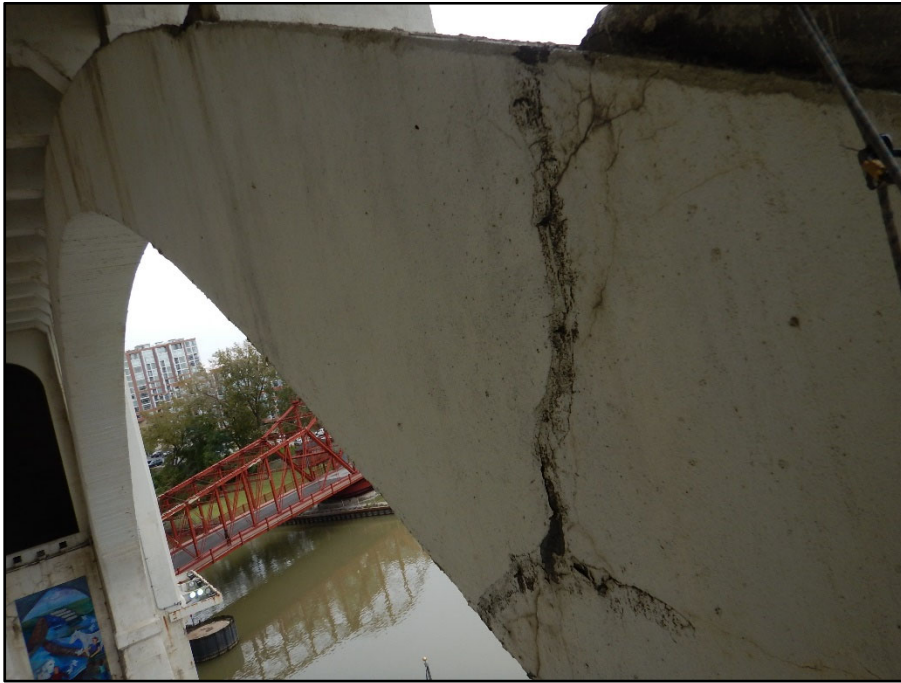
Photo 18 – Span 5 North Exterior Arch Rib, Panel 14; longitudinal through crack that has propagated into several spandrel columns

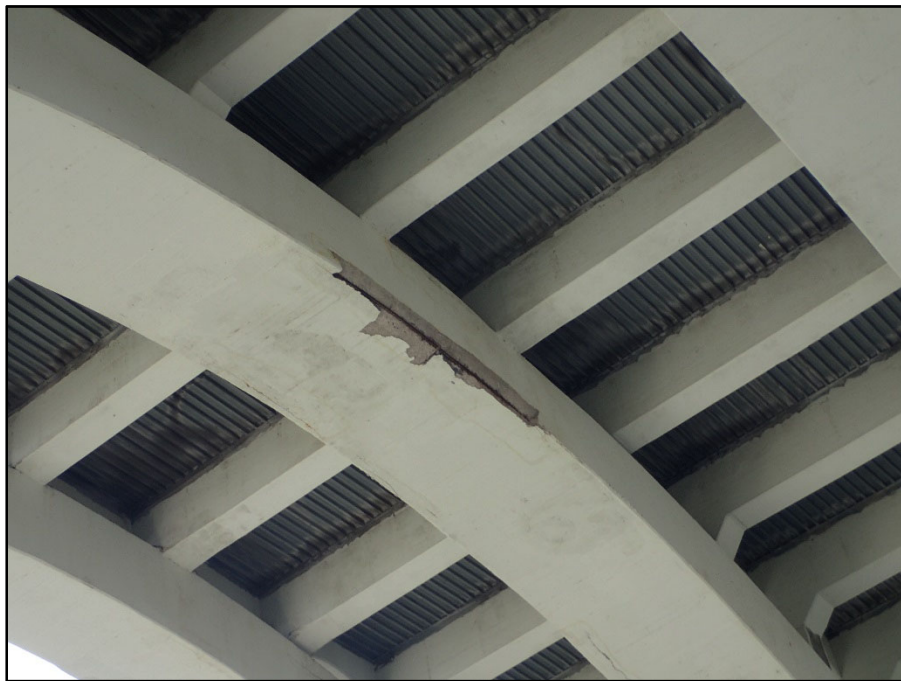
Photo 19 – Span 7 South Interior Arch Rib; lower north corner near apex has an unrepaired spall with exposed reinforcing

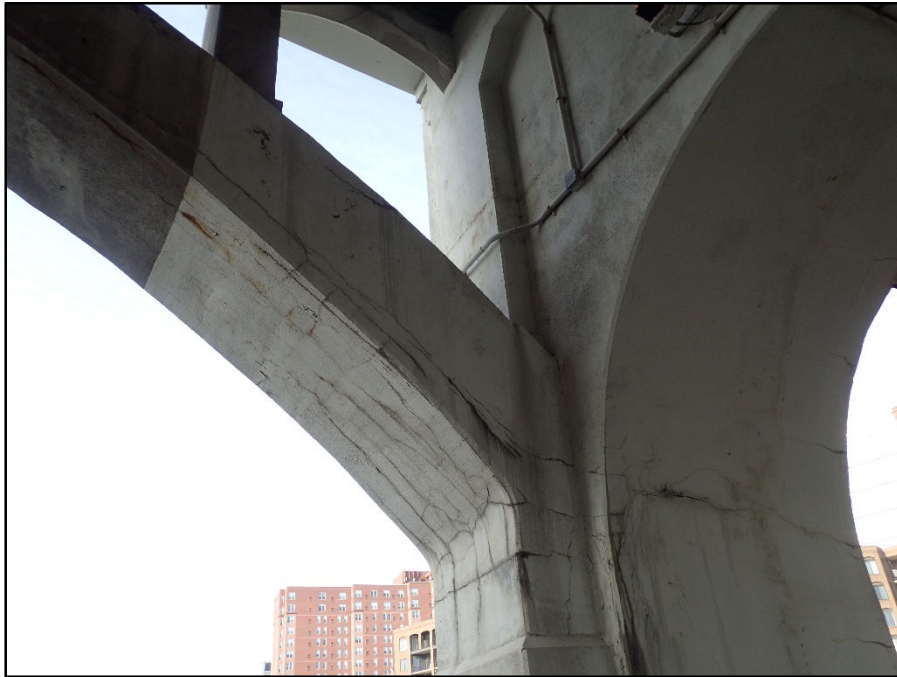
Photo 20 – Span 11 North Exterior Arch, south face; crack extending from Pier 11 up 1/4 length of the arch

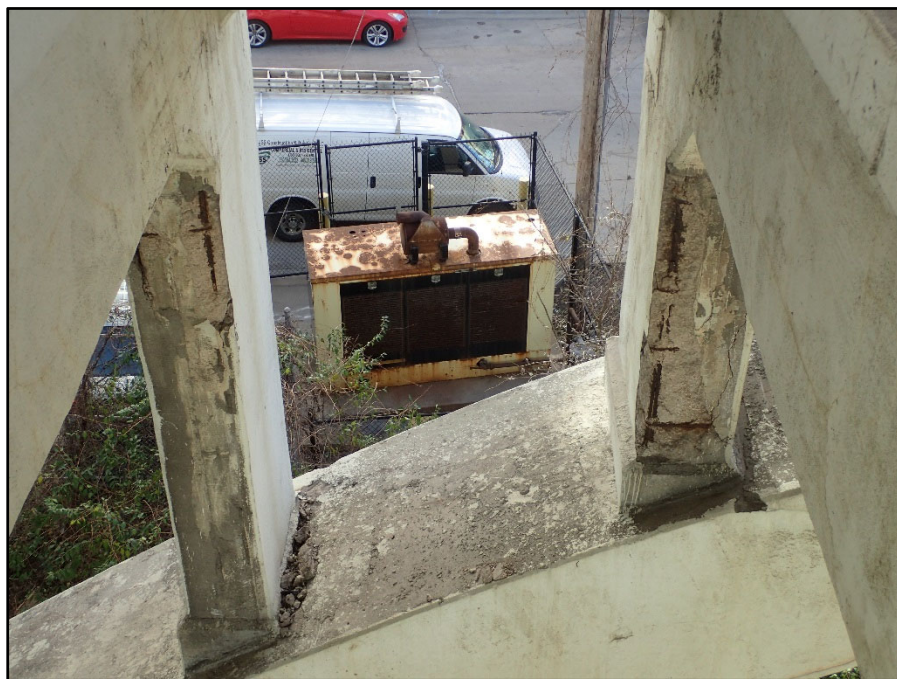
Photo 21 – Span 2 North Exterior lower columns 3 and 4; south faces have up to full height spalling with corroded reinforcing

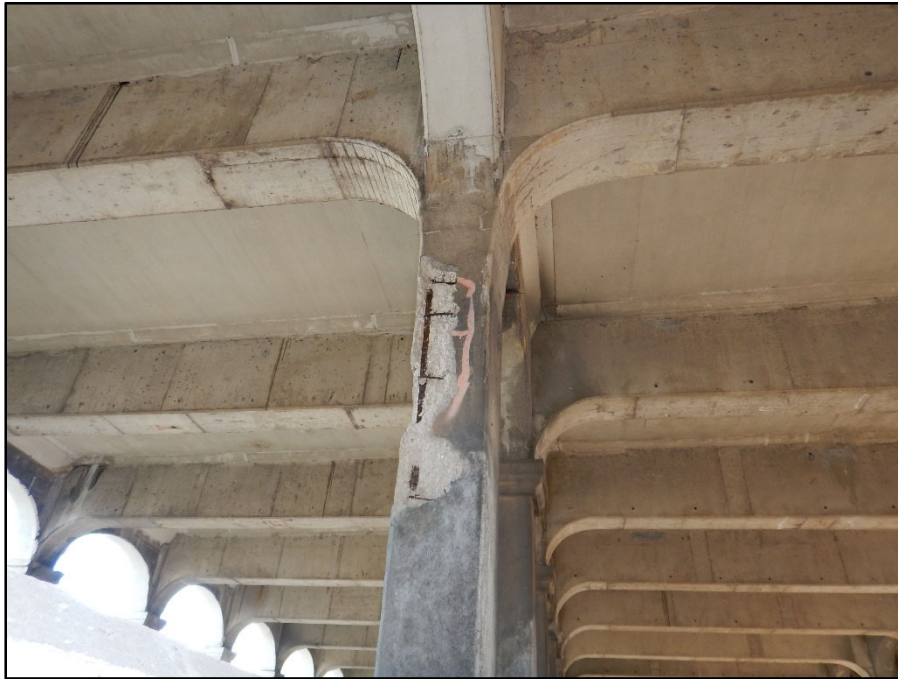
Photo 22 – Span 8 North Interior Upper Column 2; 4' H x 4" D corner spall on the northeast corner of the column with exposed reinforcing
