CUY-6-1456

PHYSICAL CONDITION REPORT ROUTINE FRACTURE CRITICAL INSPECTION VETERANS MEMORIAL/DETROIT-SUPERIOR BRIDGE OVER THE CUYAHOGA RIVER SFN: 1800930

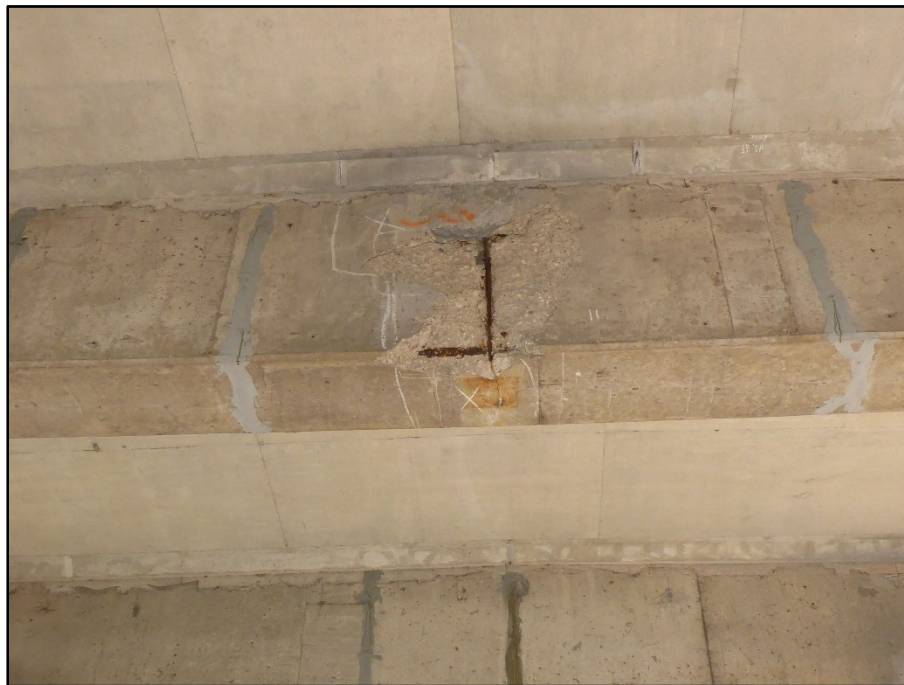
Photo 23 – Span 5 Upper Deck Floorbeam 11 west face between interior arches; Full Height x 3' W x 4" D spall with exposed rebar

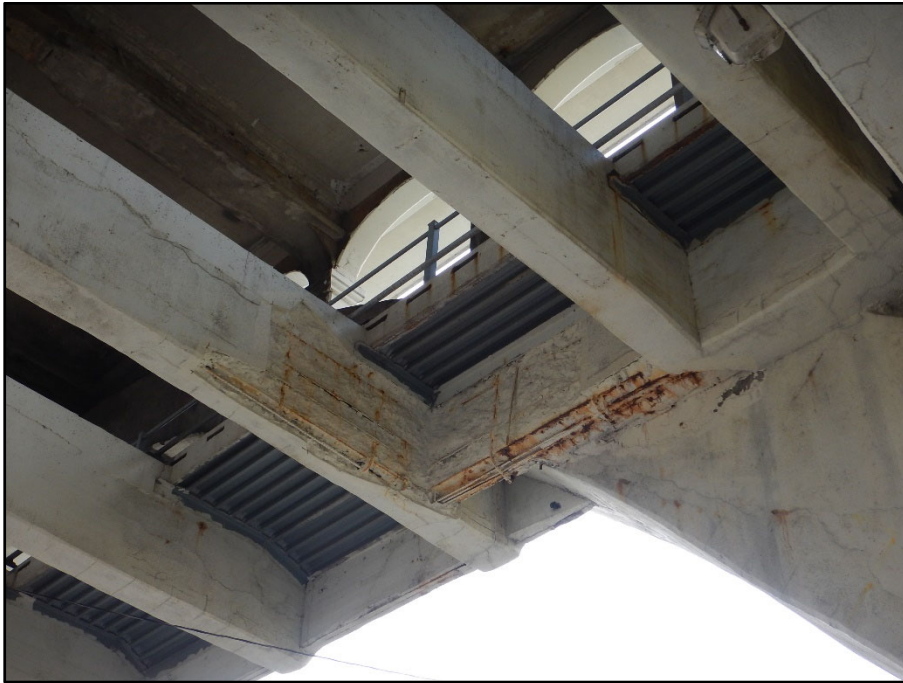
Photo 24 – Span 12, lower deck floorbeams; multiple floorbeams have spalled concrete with exposed, painted over reinforcing

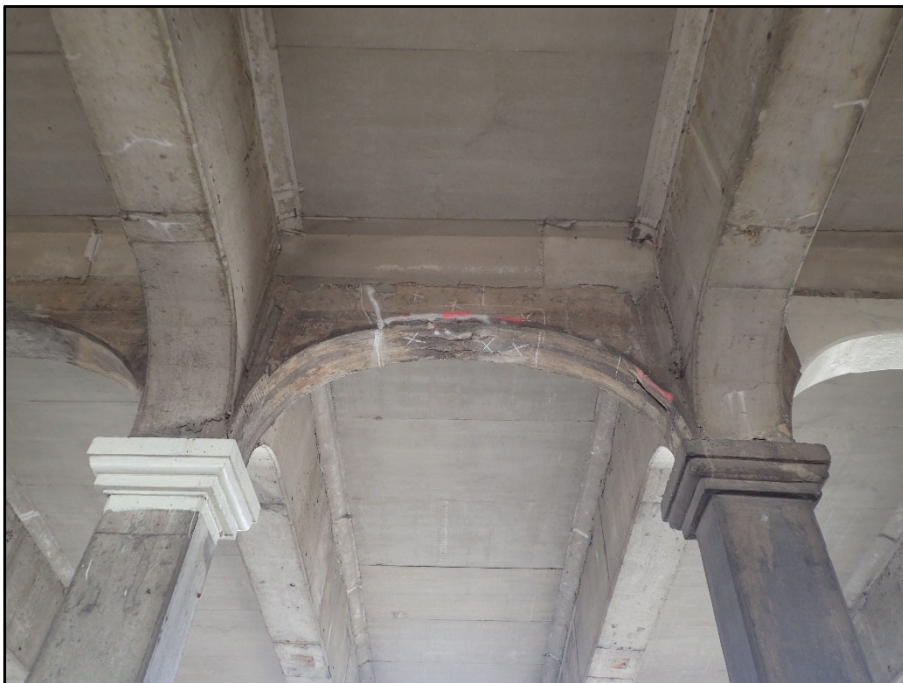
Photo 25 – Span 3 North Interior Arch between upper deck Columns 10 & 11; arch is cracked and delaminated with efflorescence

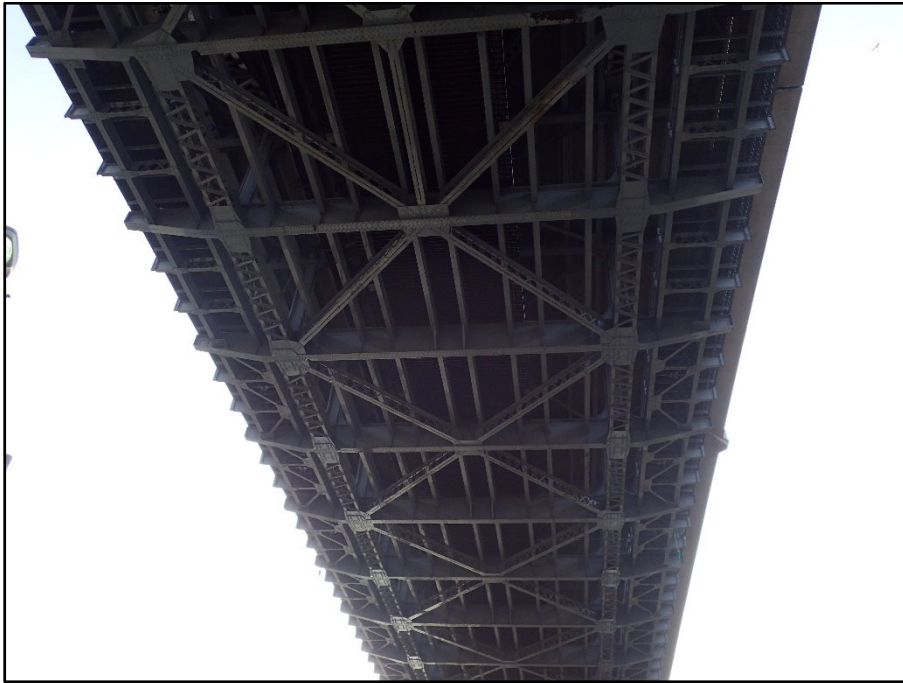
Photo 26 – Typical superstructure condition

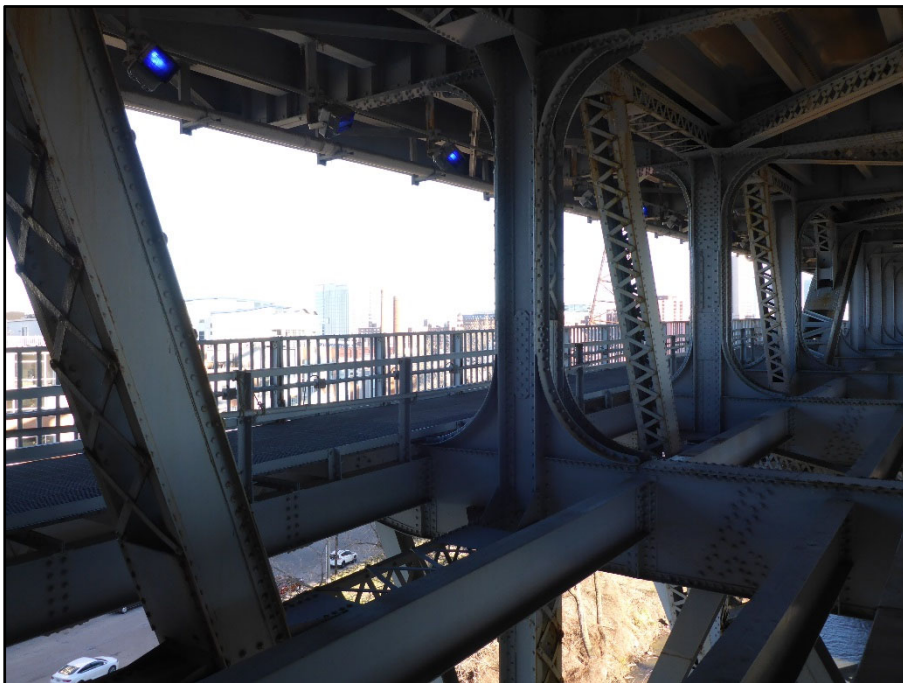
Photo 27 – Typical truss condition

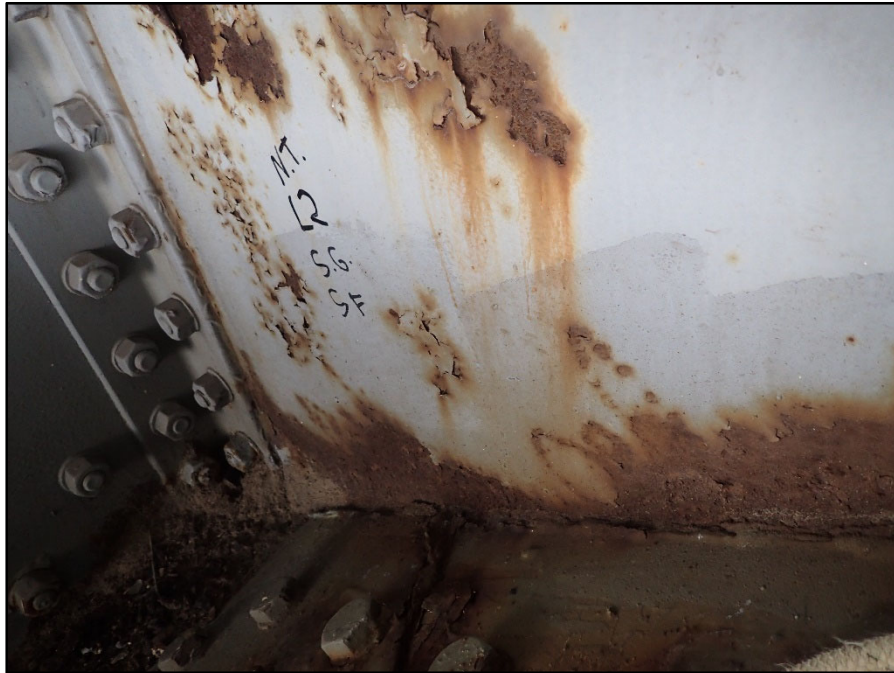
Photo 28 – Span 4 North Truss L2 South Gusset, North Face; 2' L x up to 3" H x up to 1/4" D pitting with reactivating laminar corrosion

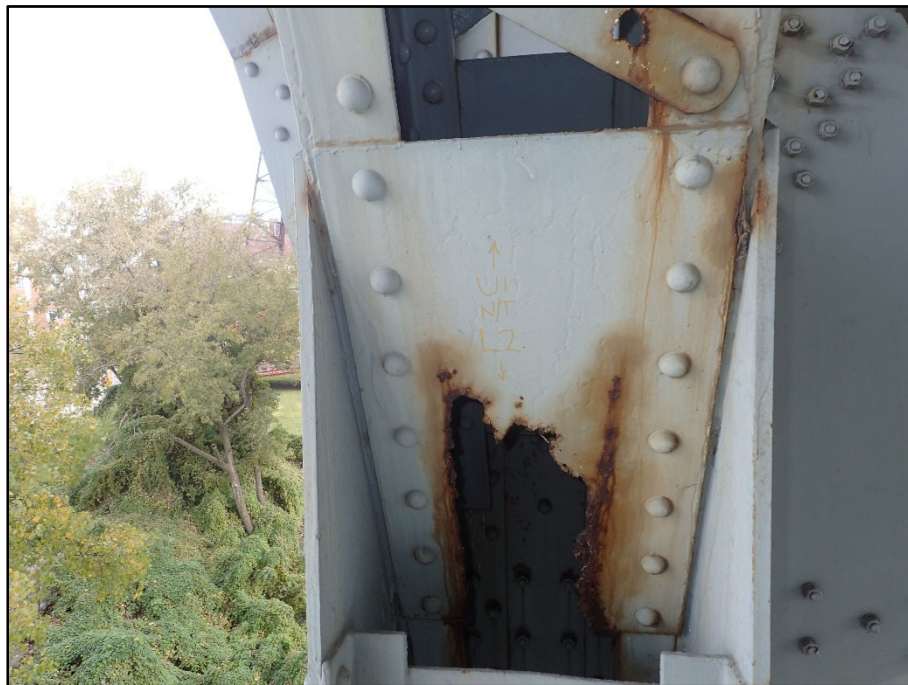
Photo 29 – Span 4 North Truss L2 lower batten plate; 20" L x Full Width corrosion hole

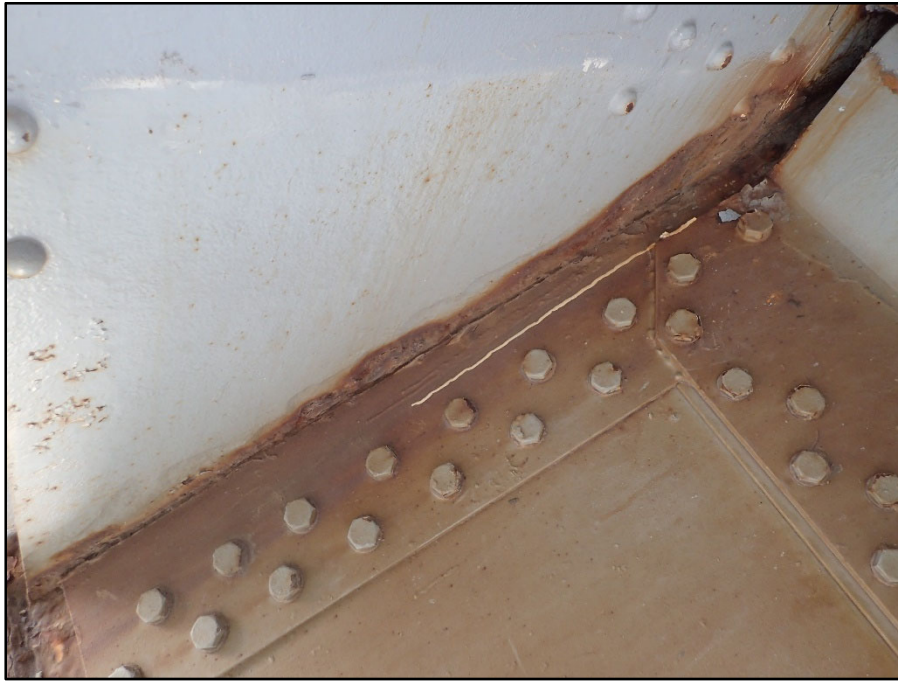
Photo 30 – Span 4 North Truss L3 south gusset above L2L3; Active laminar corrosion and pitting up to 3/16" D

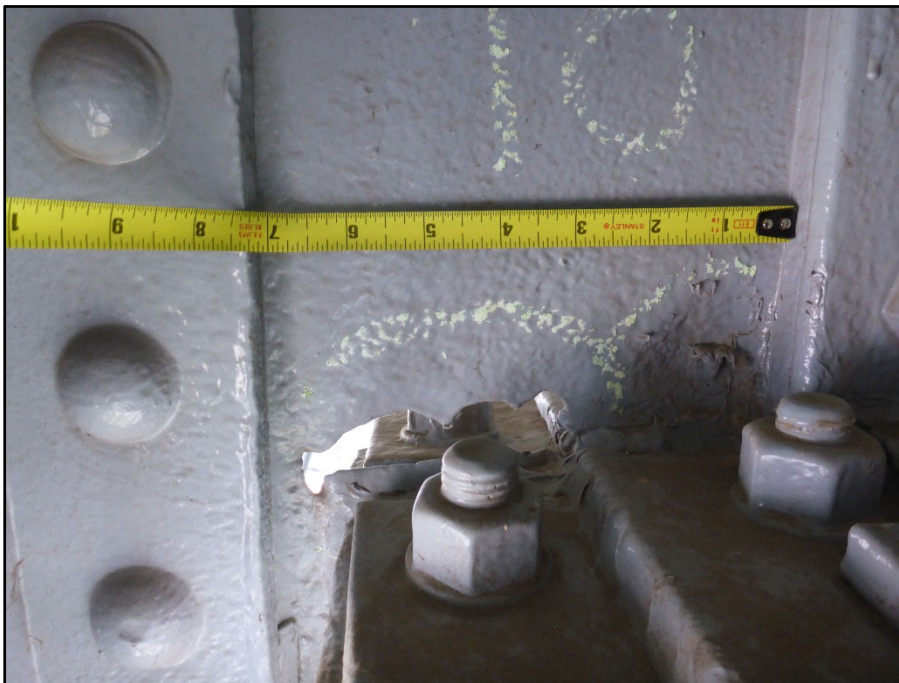
Photo 31 – Span 4 Upper Deck Floorbeam 10'; web corrosion hole north of the first interior stringer from the panel point

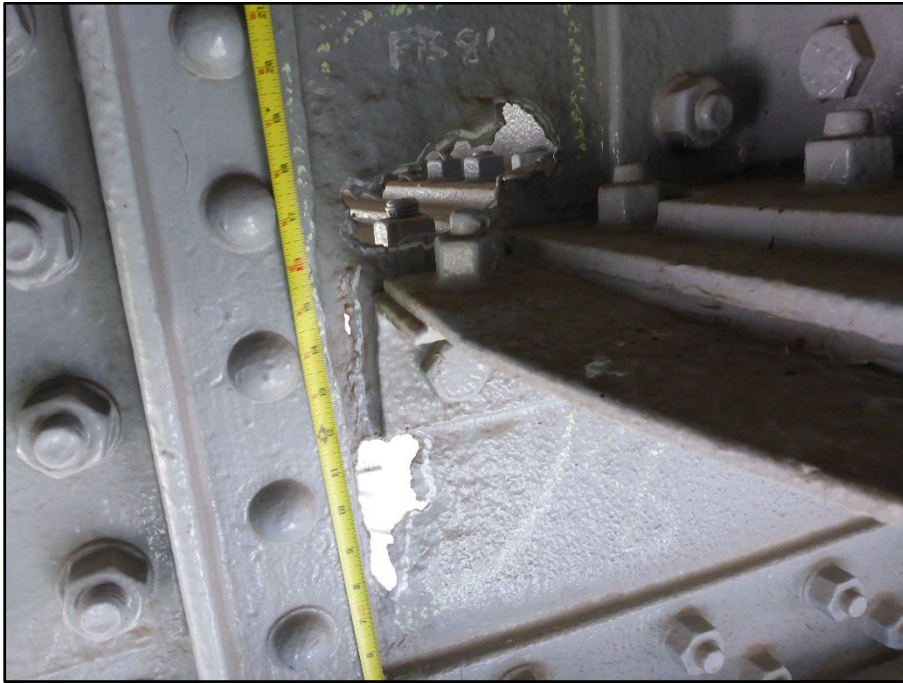
Photo 32 – Span 4 Upper Deck Floorbeam 8'; corrosion hole below the upper deck lateral bracing gusset plate on the north arch

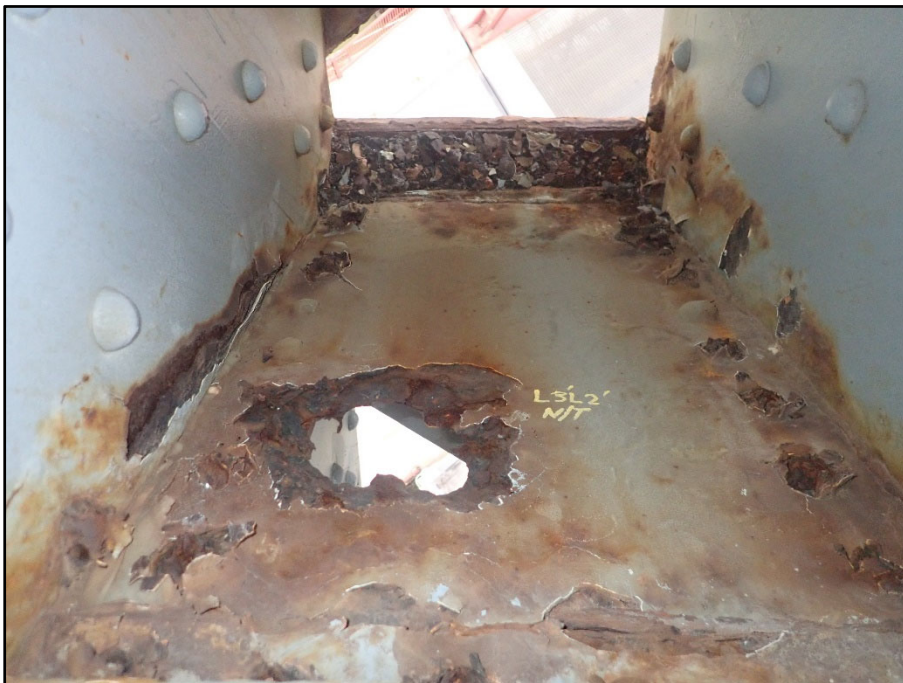
Photo 33 – Span 4 North Truss L3'L2' diaphragm; corrosion hole

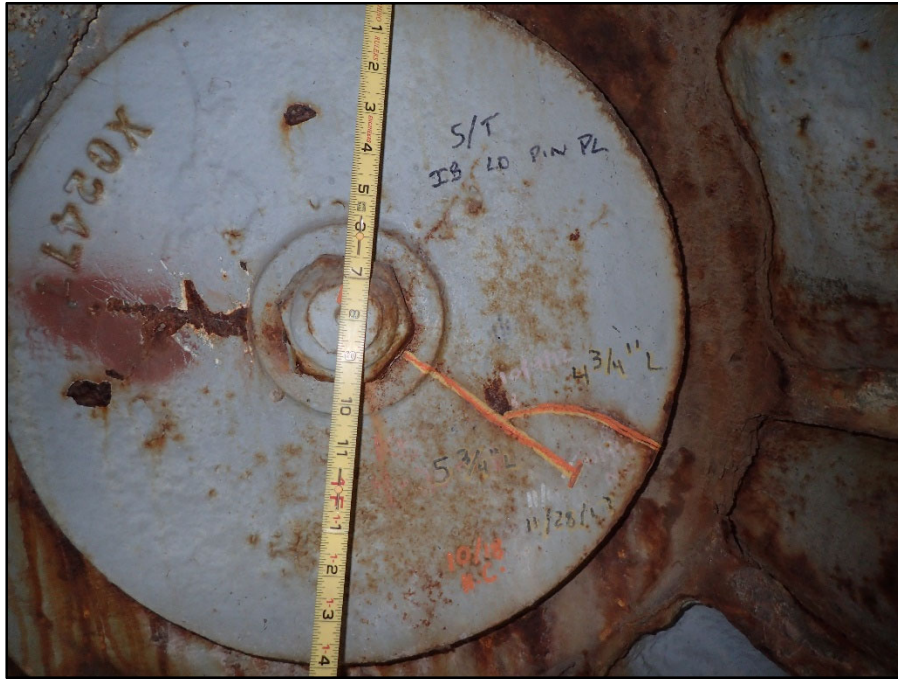
Photo 34 – Span 4 South Truss L0 Inboard Pin Cover Plate; non-structural plate with two cracks

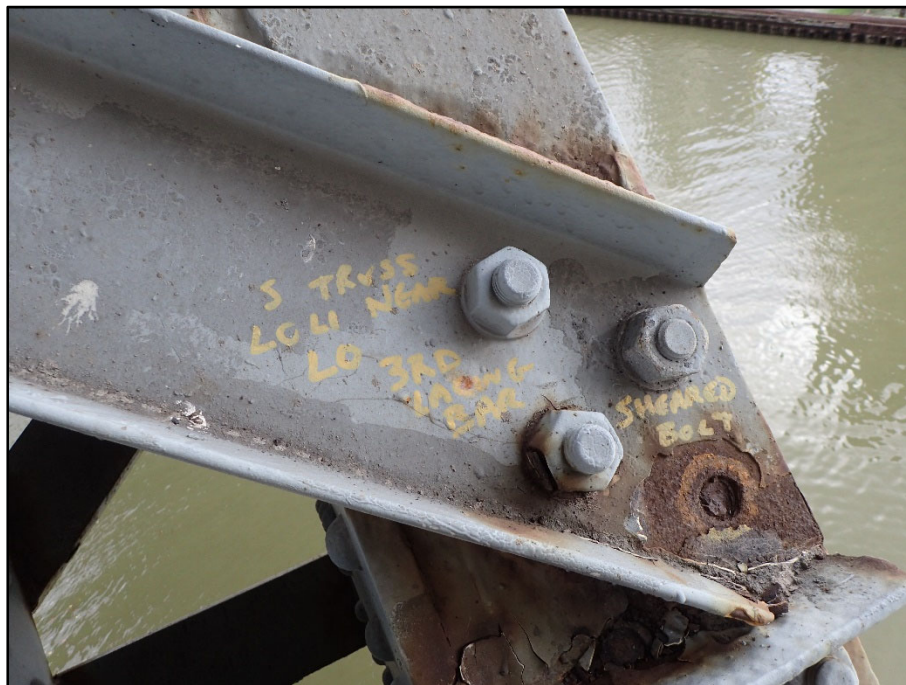
Photo 35 – Span 4 South Truss L0L1 near L0; fractured bolt on top lacing channel connection along top flange

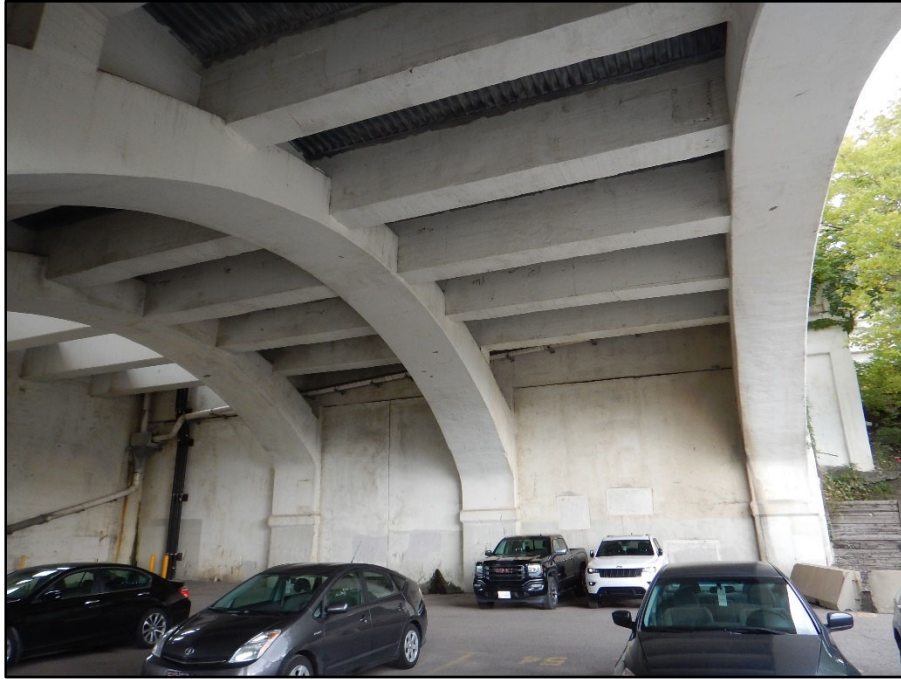
Photo 36 – East Abutment typical condition

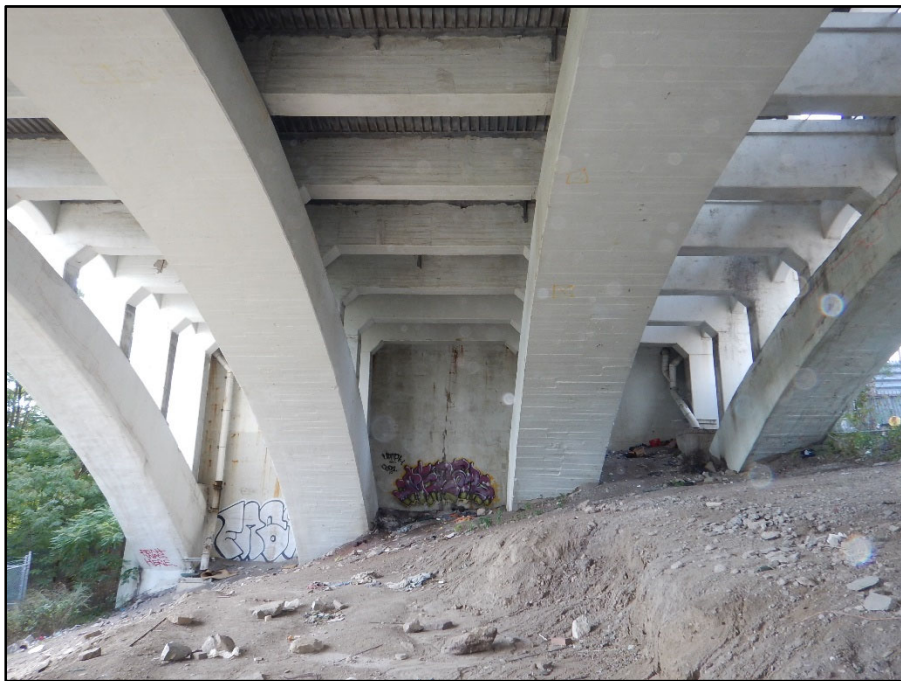
Photo 37 – West Abutment typical condition

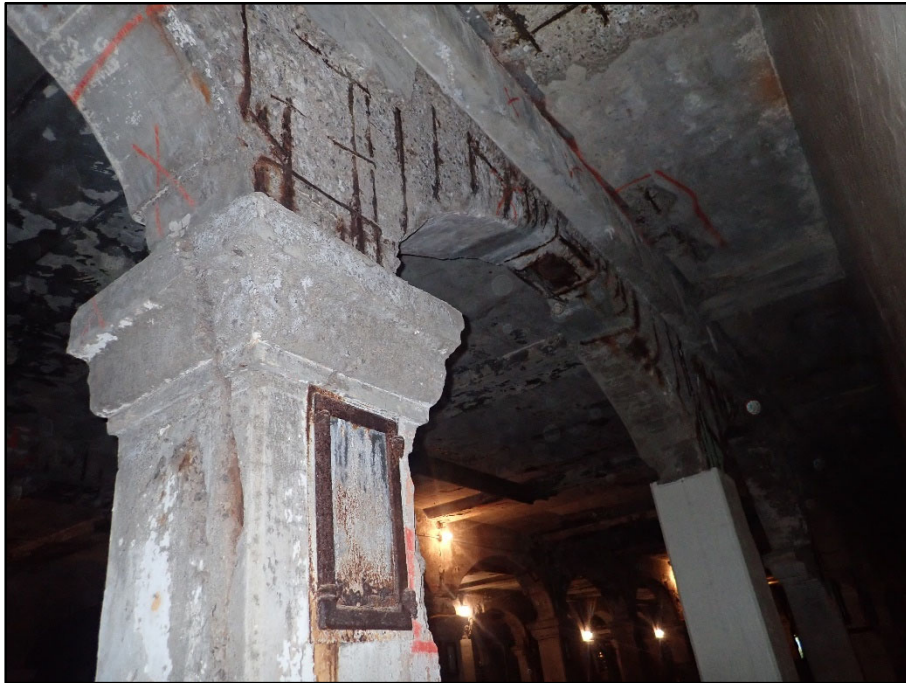
Photo 38 – West 25<sup>th</sup> Street Columns and Arches; heavily deteriorated with exposed reinforcing and efflorescence

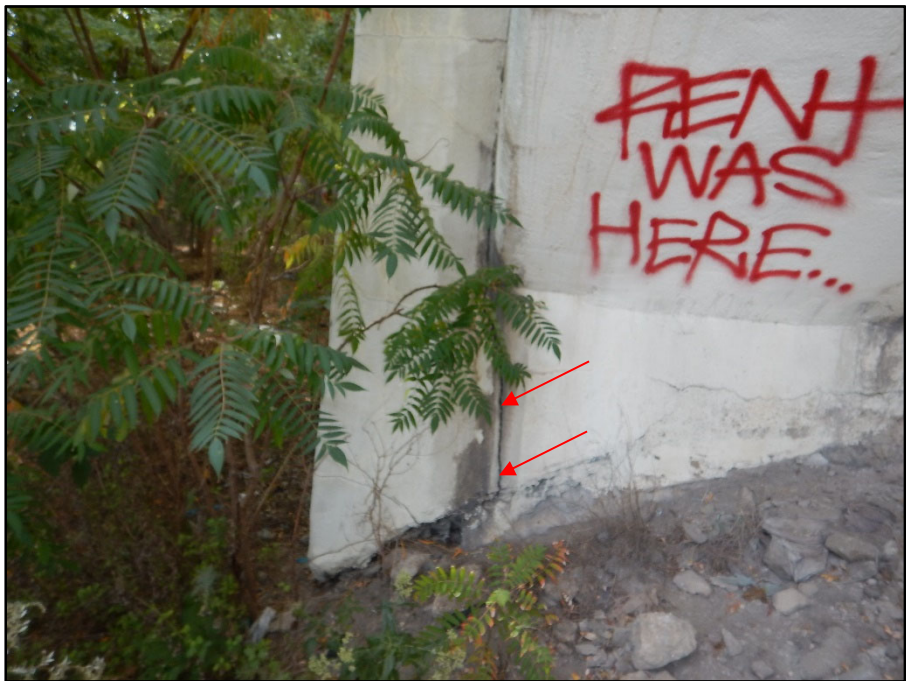
Photo 39 – West Abutment Below South Exterior Arch; 1/4" W vertical crack

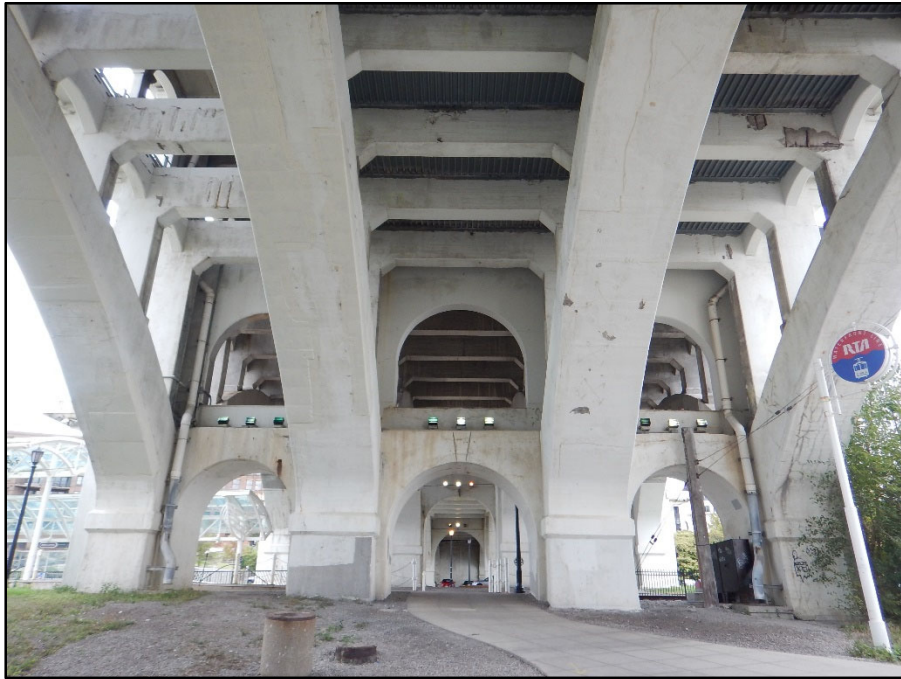
Photo 40 – Pier, typical condition

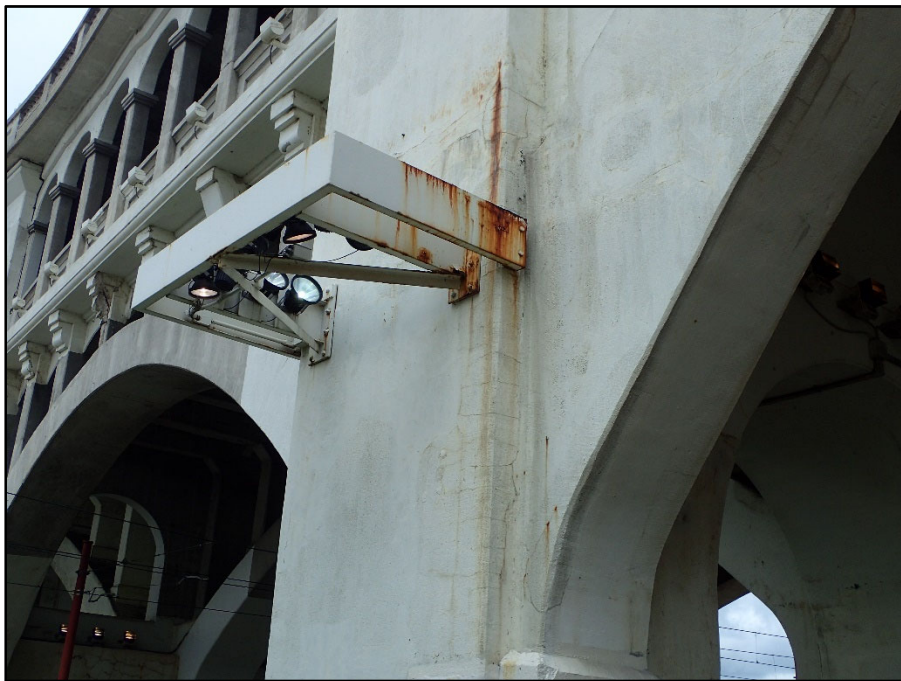
Photo 41 –Typical architectural lighting brackets on pier are corroding

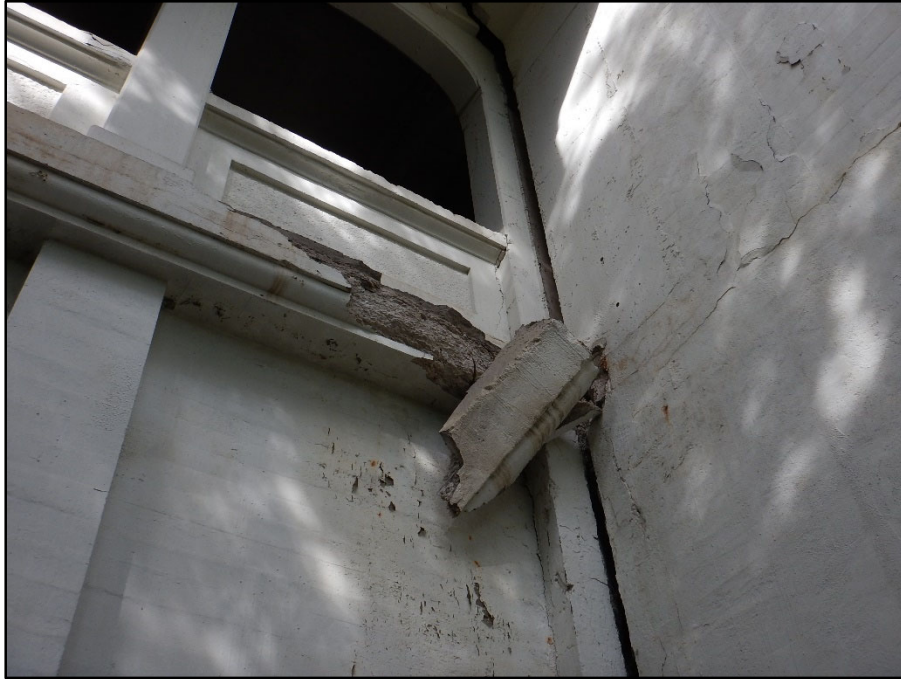
Photo 42 – Tower B South side; rotated outwards and fractured at the interface with the upper deck

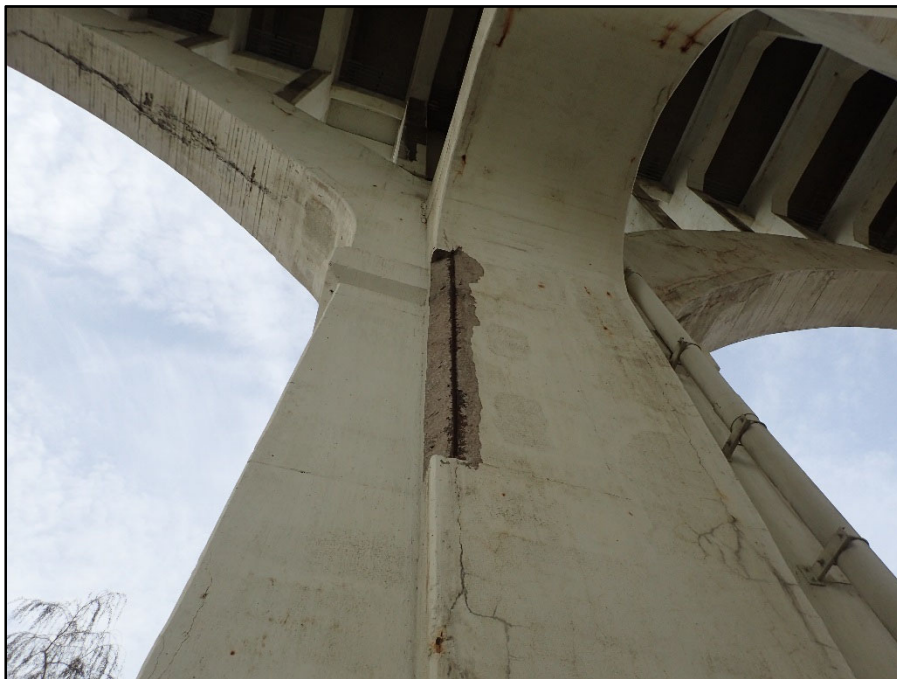
Photo 43 – Pier 5 North Exterior Column; 10' H x 6" D corner spall with exposed reinforcing

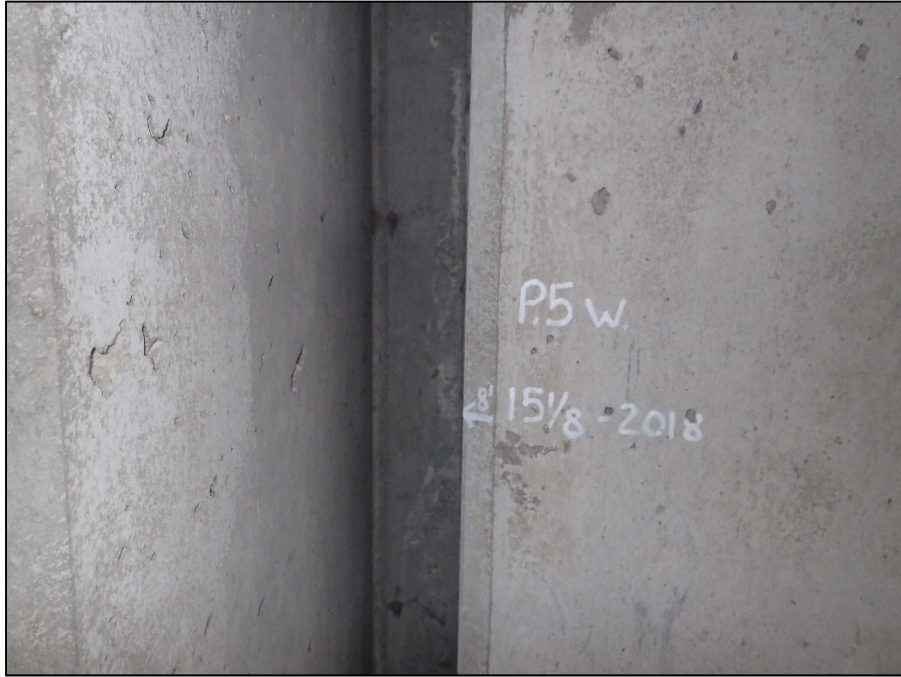
Photo 44 – Pier 5, west side of south wall; 15-2/16” measurement of tower rotation

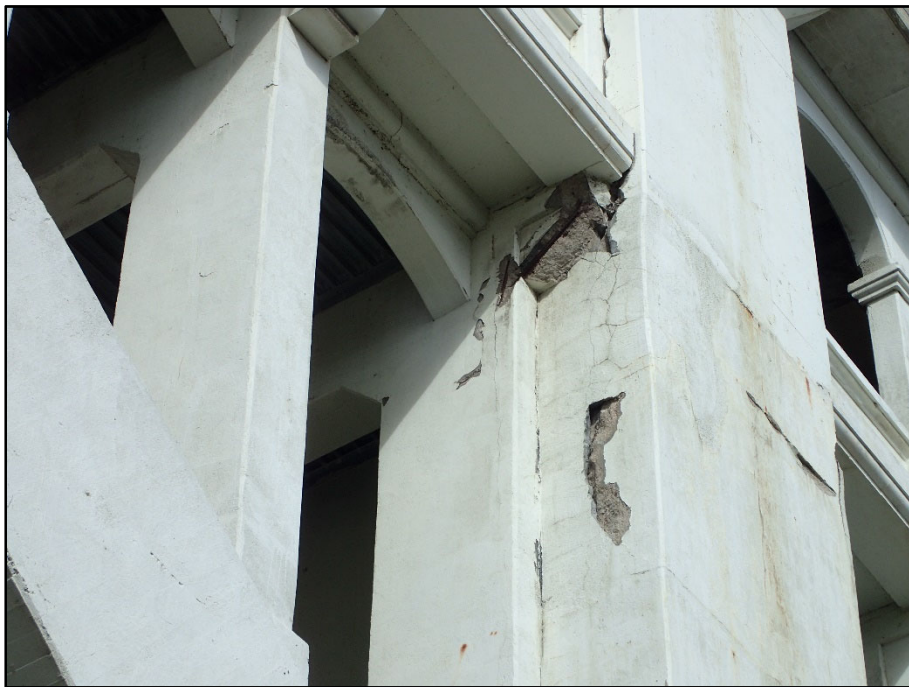
Photo 45 – Pier 8 South Exterior Column, west Face; 4' H x 4' W x 10" D spall

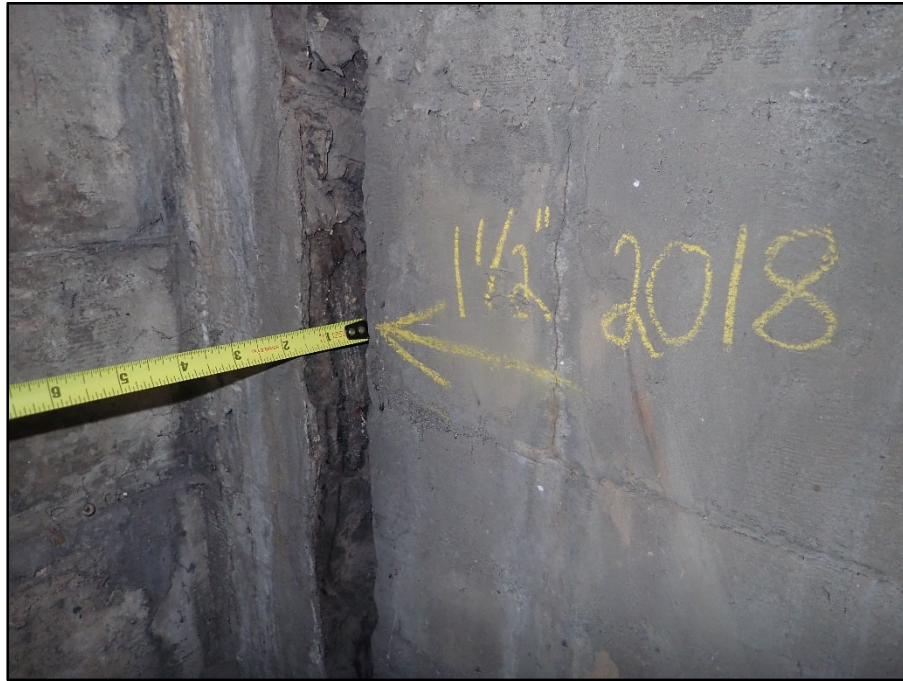
Photo 46 – West Abutment, Chamber 9S, south wall; 1-1/2” rotation towards the south

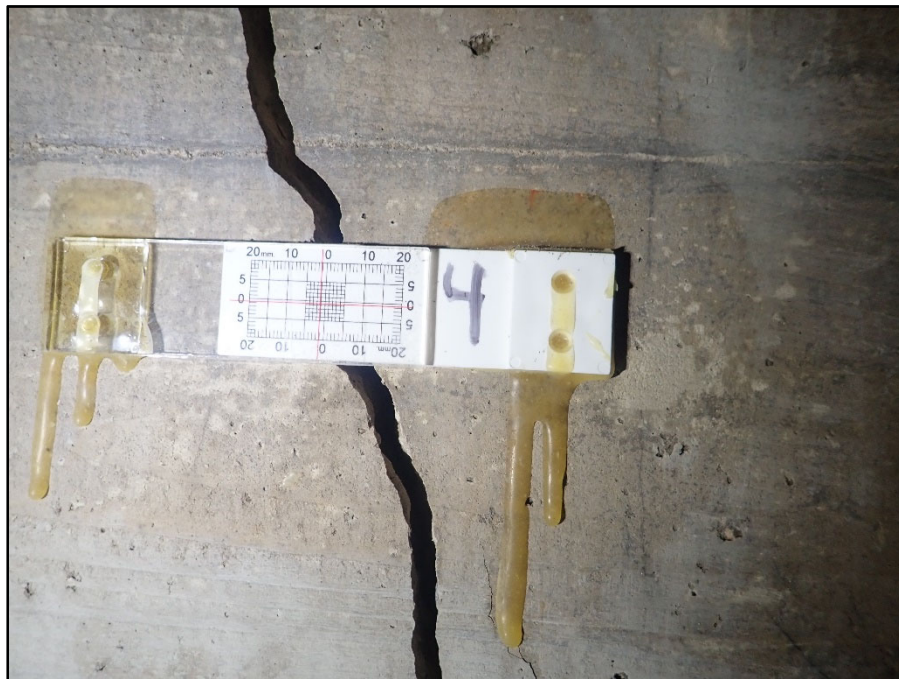
Photo 47 – West Abutment, Chamber 6S, west wall; crack gauge

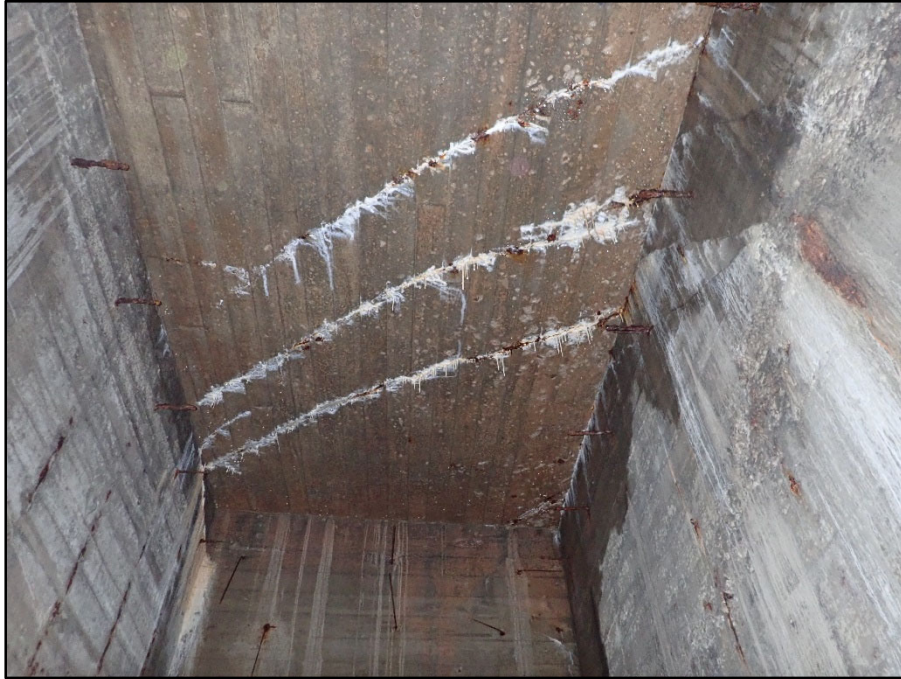
Photo 48 – West Abutment, Chamber 1S, ceiling; typical cracks with efflorescence and moisture

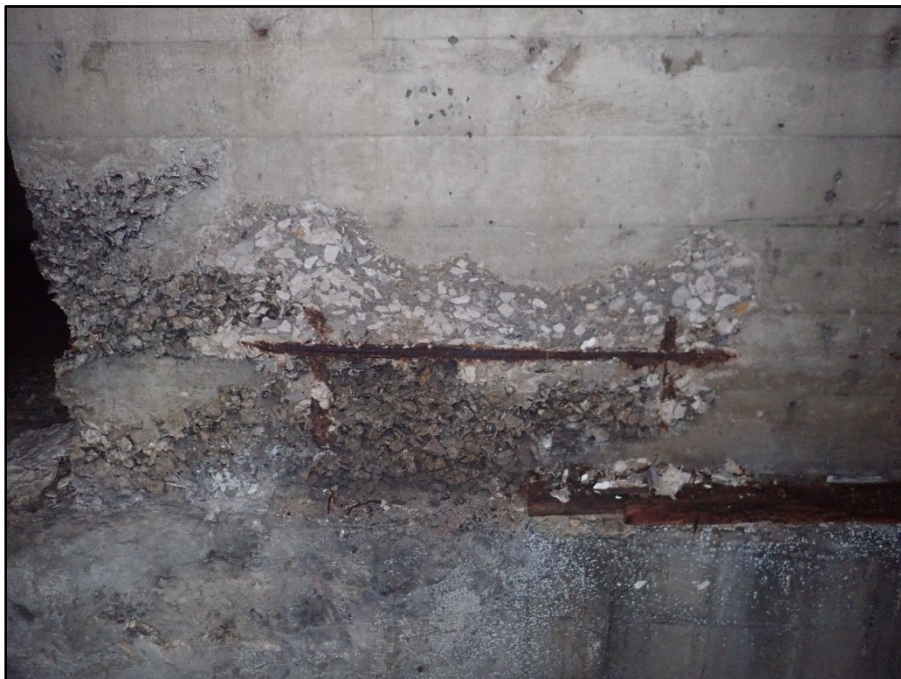
Photo 49 – West Abutment, Chamber 7, west wall; 4' L x 20" H x 1" D spall with exposed reinforcing

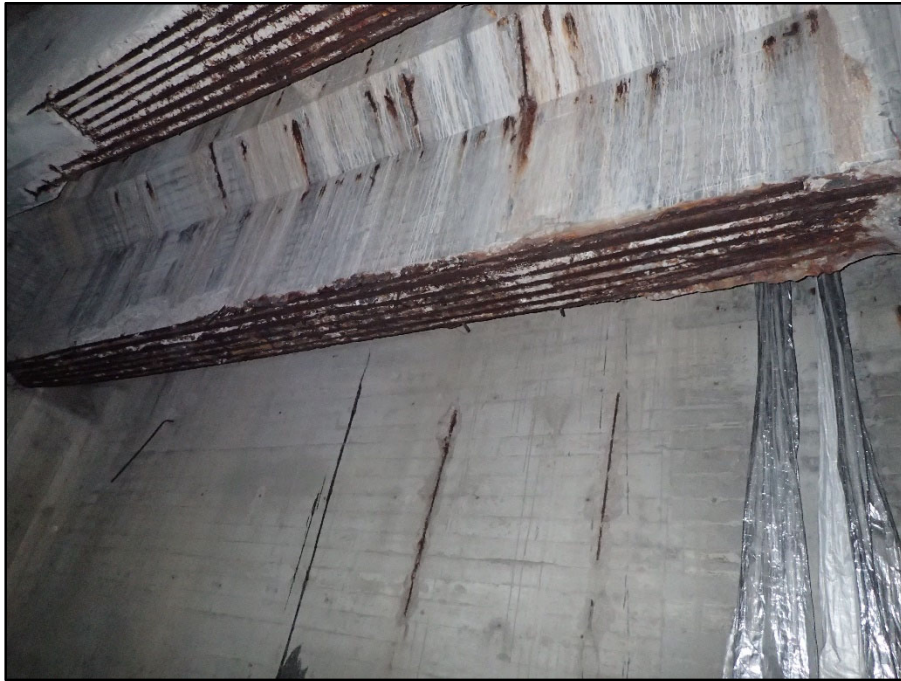
Photo 50 – East Abutment, North Chamber ceiling; bottom of floor beam spalled full length with exposed reinforcing

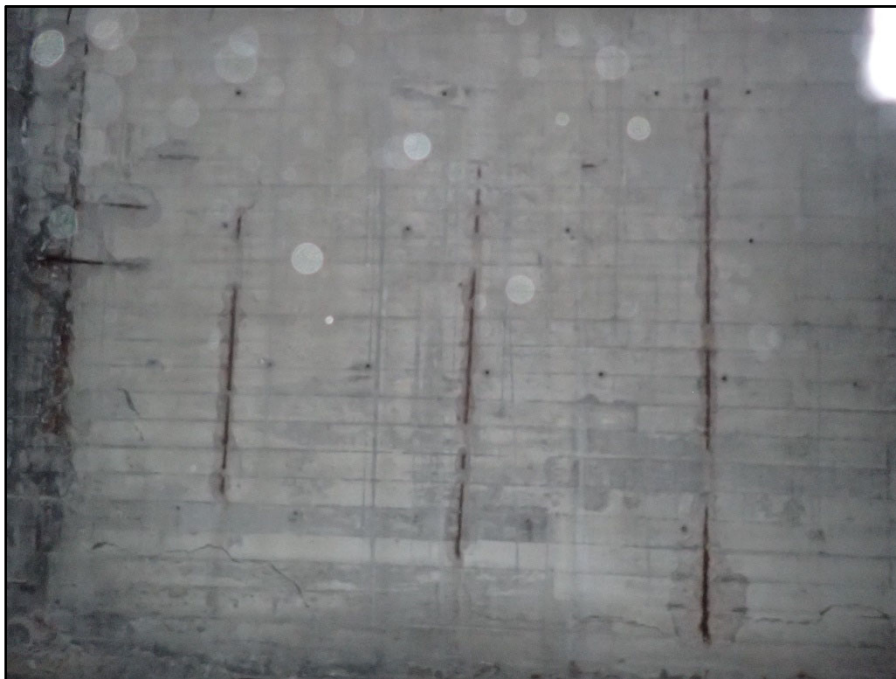
Photo 51 – East Abutment, South Chamber, west wall; vertical spalls with exposed reinforcing

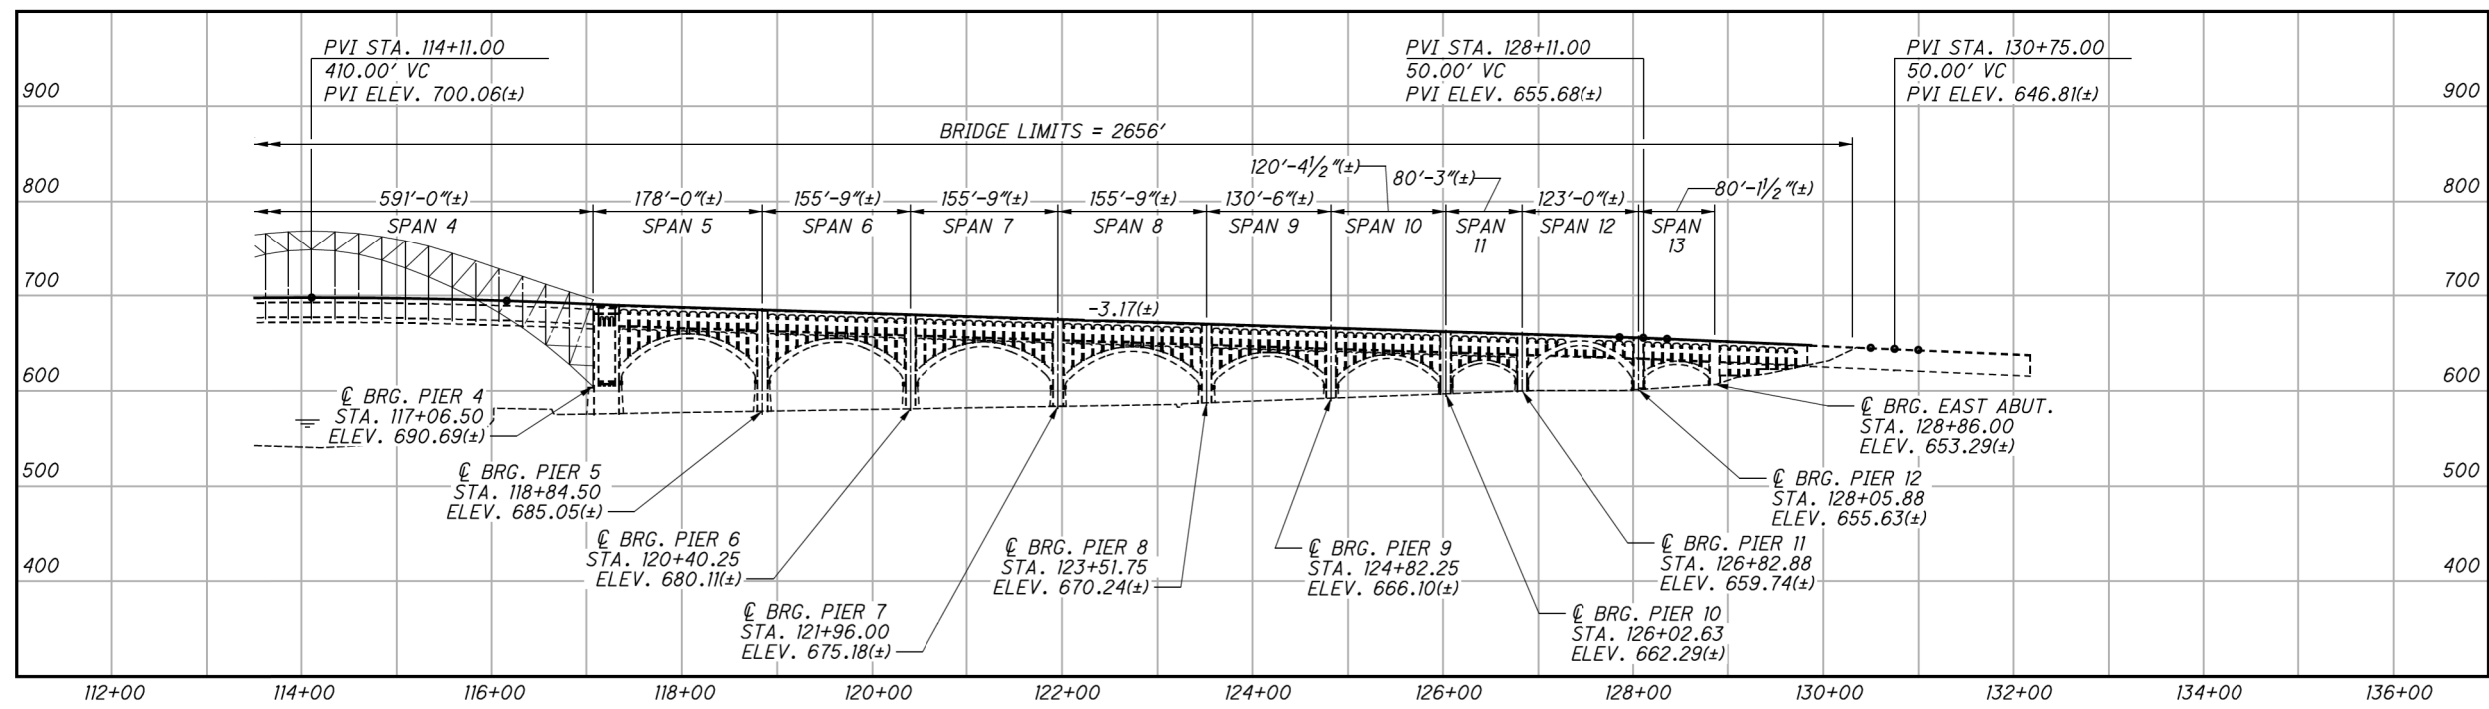
PROFILE ALONG C R/W U.S. 6

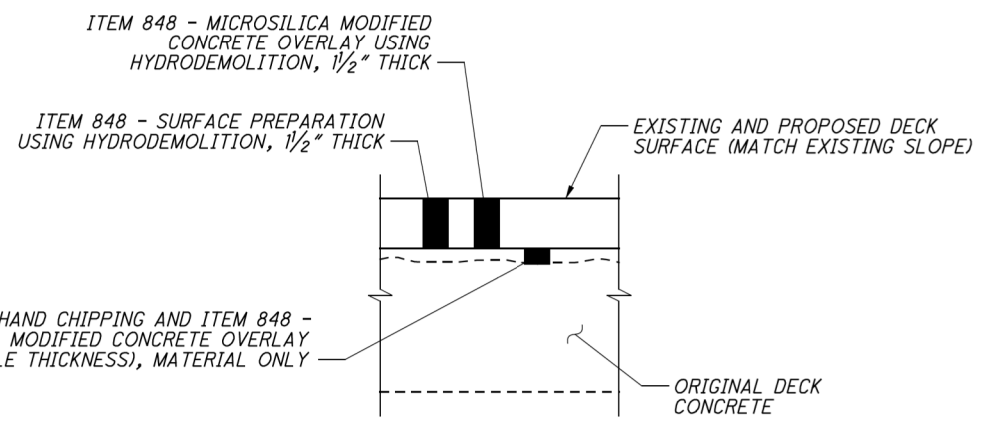
**BRIDGE DECK WEARING SURFACE REPLACEMENT DETAIL**

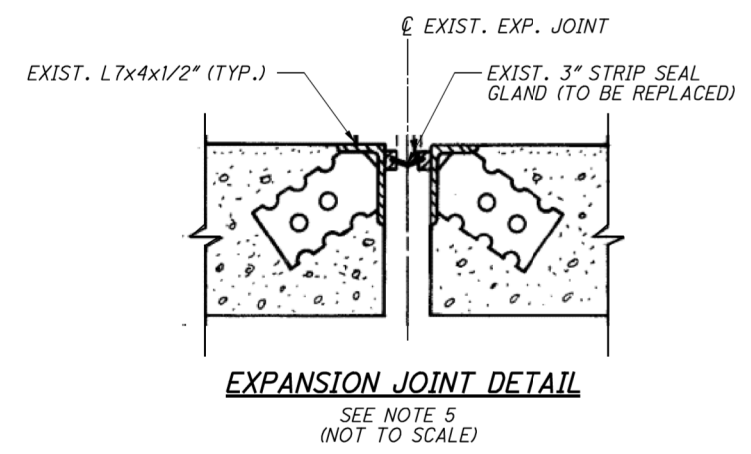
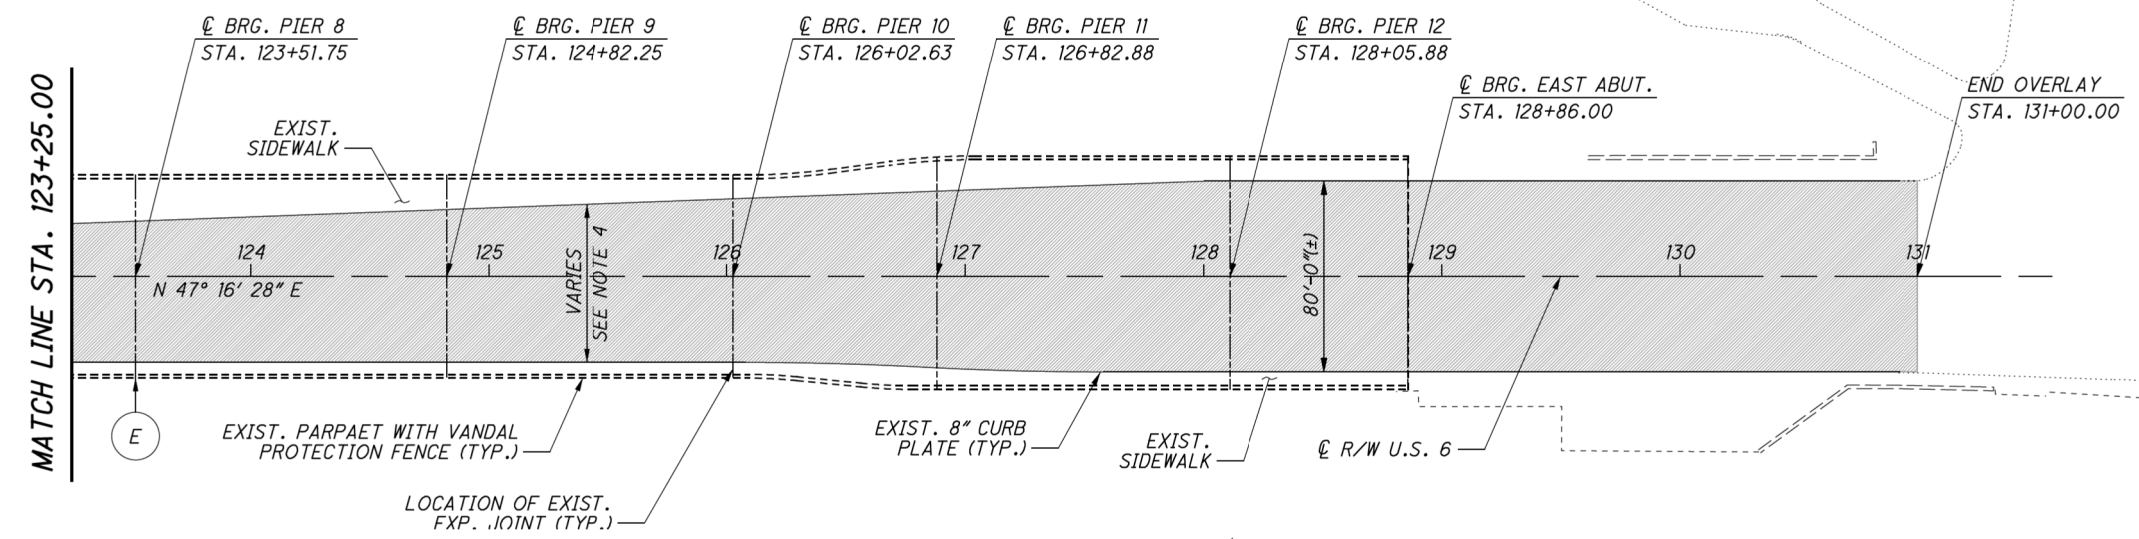
- AREAS OF THE DECK TO HAVE EXISTING OVERLAY REMOVED AND REPLACED. FOR OVERLAY REMOVAL SEE NOTE 2. FOR MICRO SILICA MODIFIED CONCRETE OVERLAY SEE NOTE 3.
- REPLACE STRIP SEAL GLAND IN EXPANSION JOINT, SEE DETAIL ON THIS SHEET
