CUY-6-1456

PHYSICAL CONDITION REPORT ROUTINE FRACTURE CRITICAL INSPECTION VETERANS MEMORIAL/DETROIT-SUPERIOR BRIDGE OVER THE CUYAHOGA RIVER SFN: 1800930

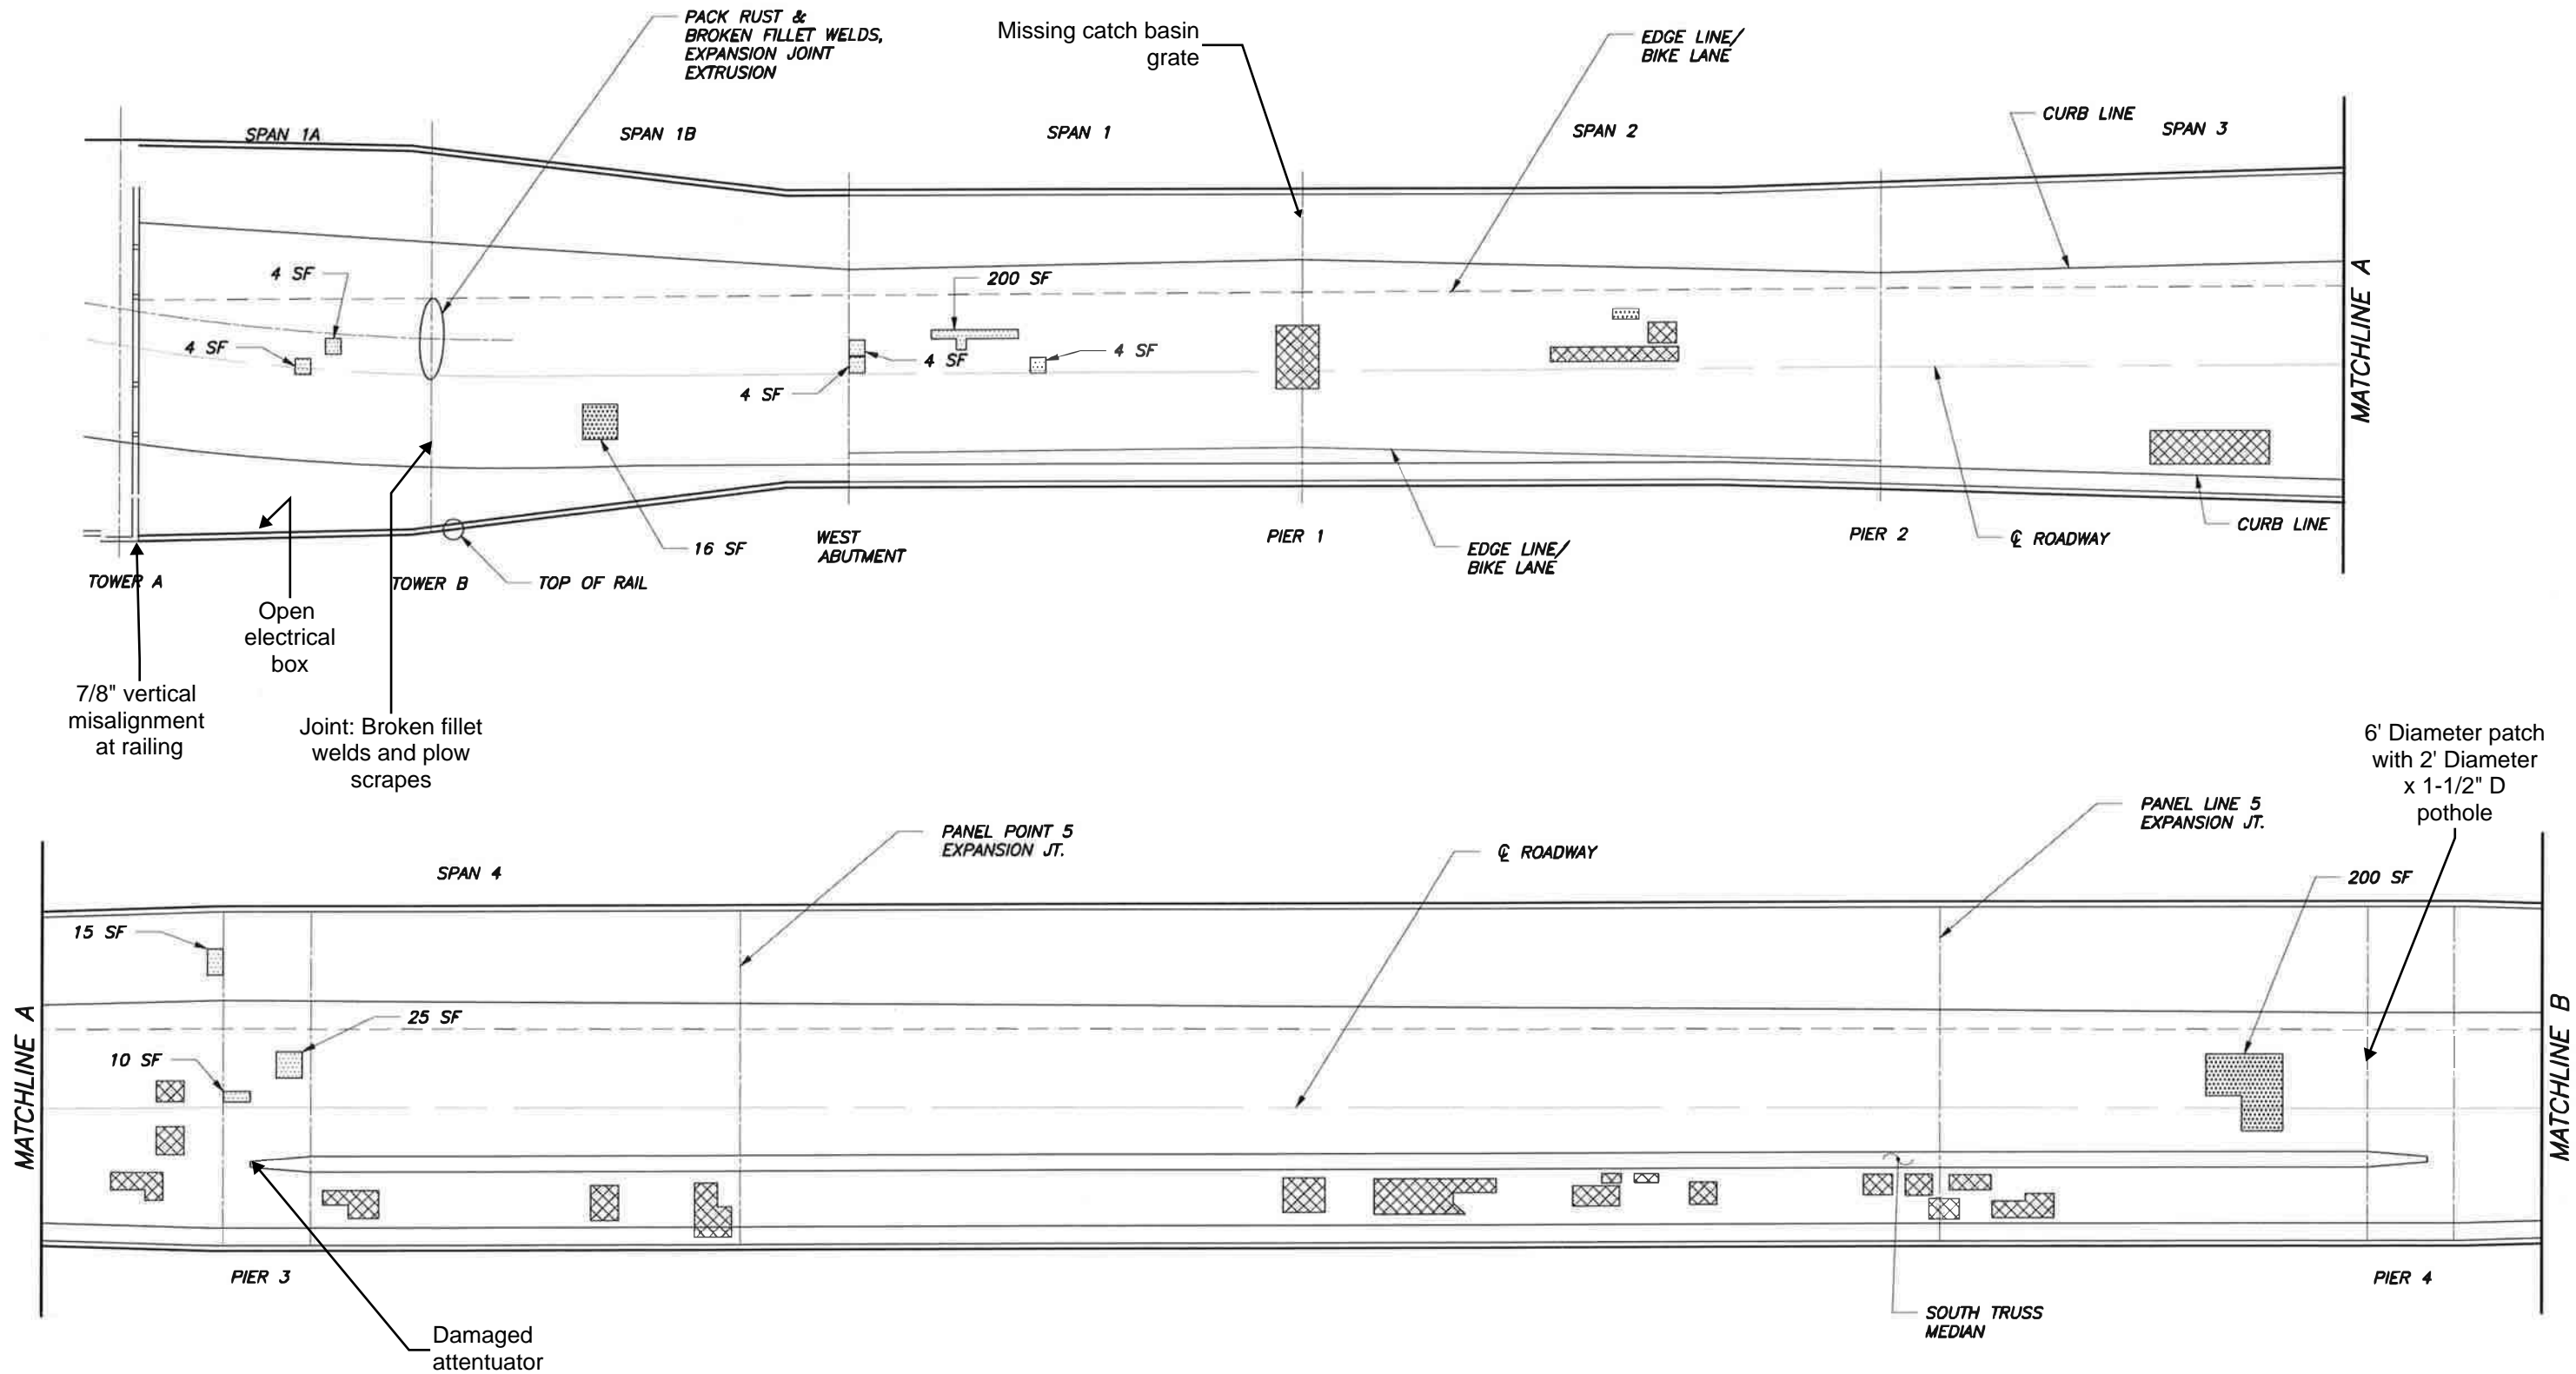
| NOT TO SCALE | NOV, 2018 | INFRASTRUCTURE ENGINEERS, INC. | | UPPER DECK PLAN - 2 | |

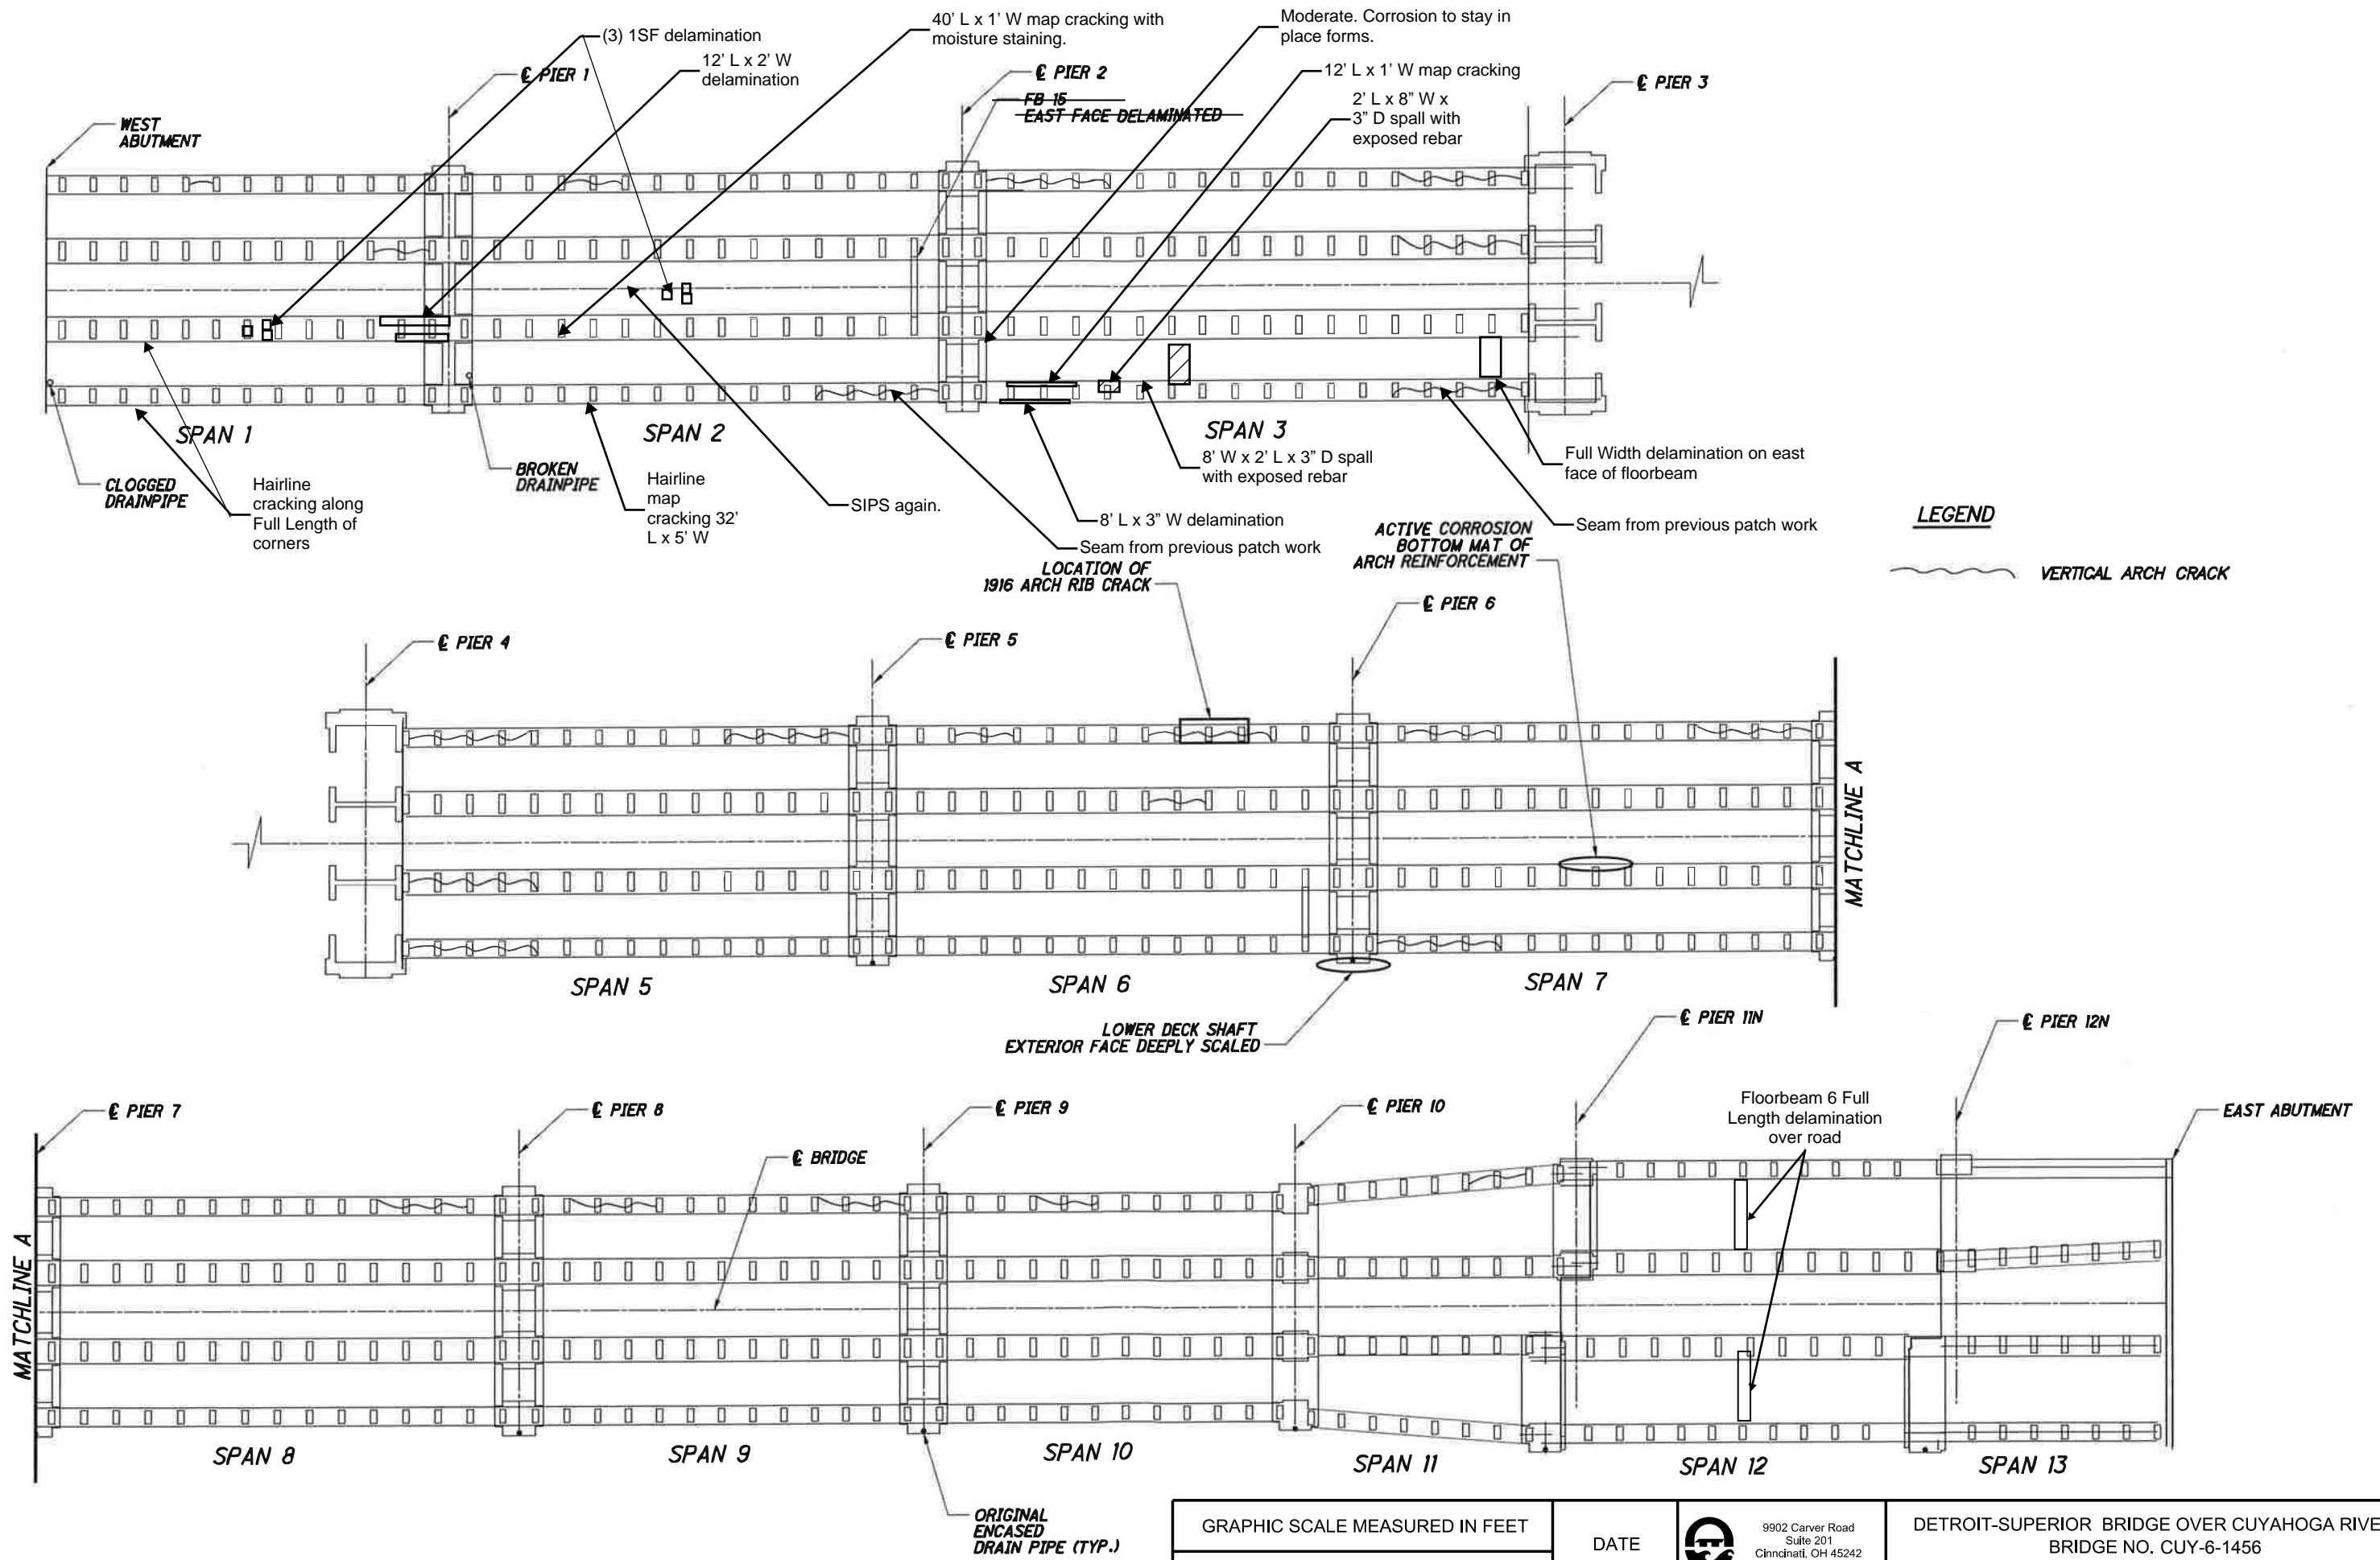
| NOT TO SCALE | | | | |

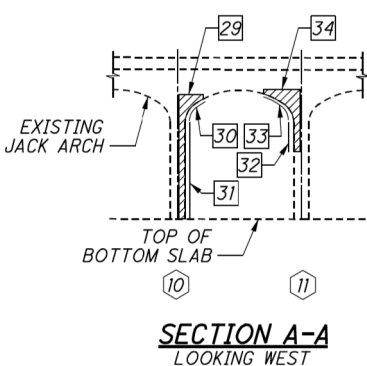
**SECTION A-A
LOOKING WEST**

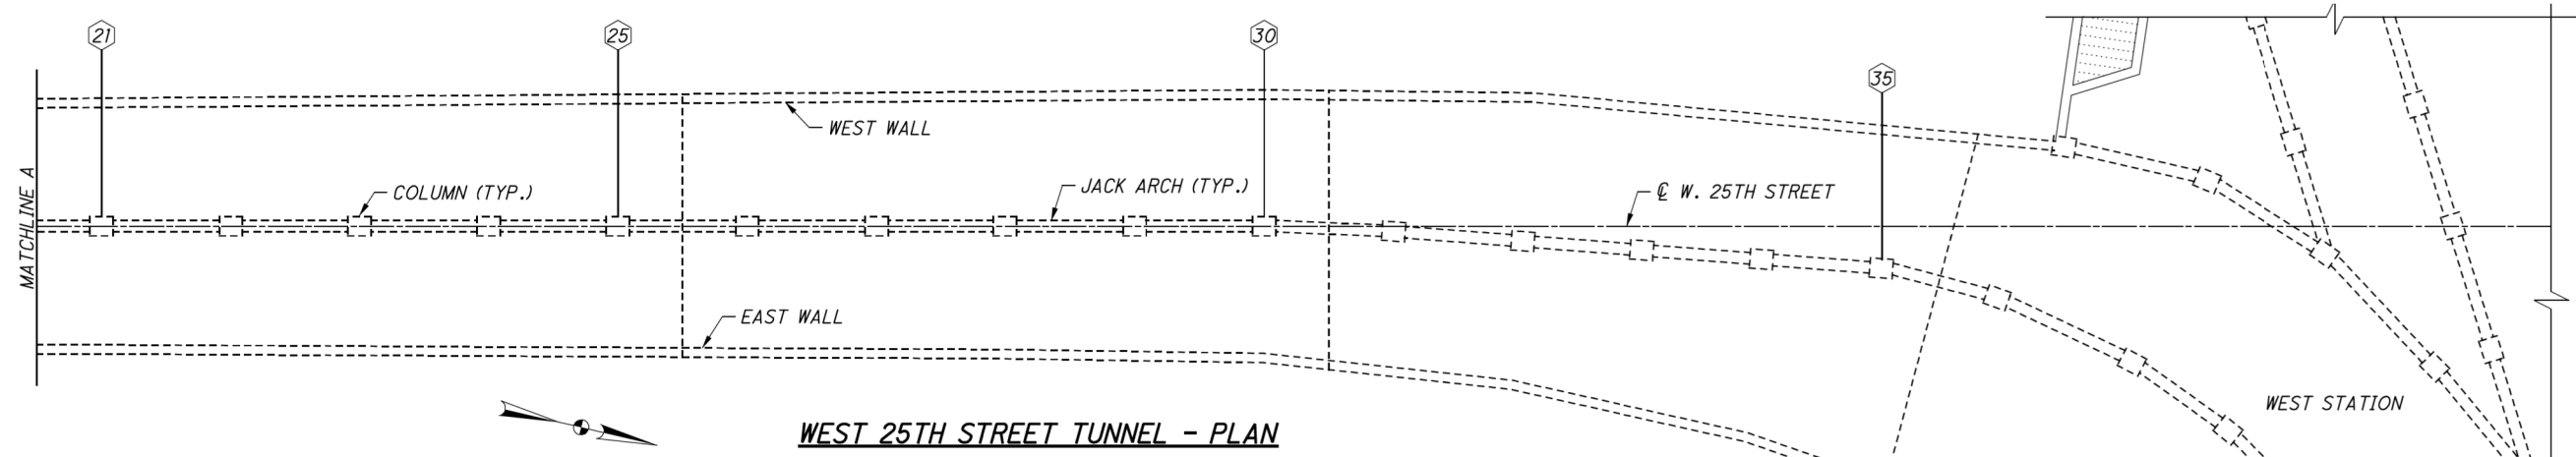
WEST 25TH STREET TUNNEL - PLAN

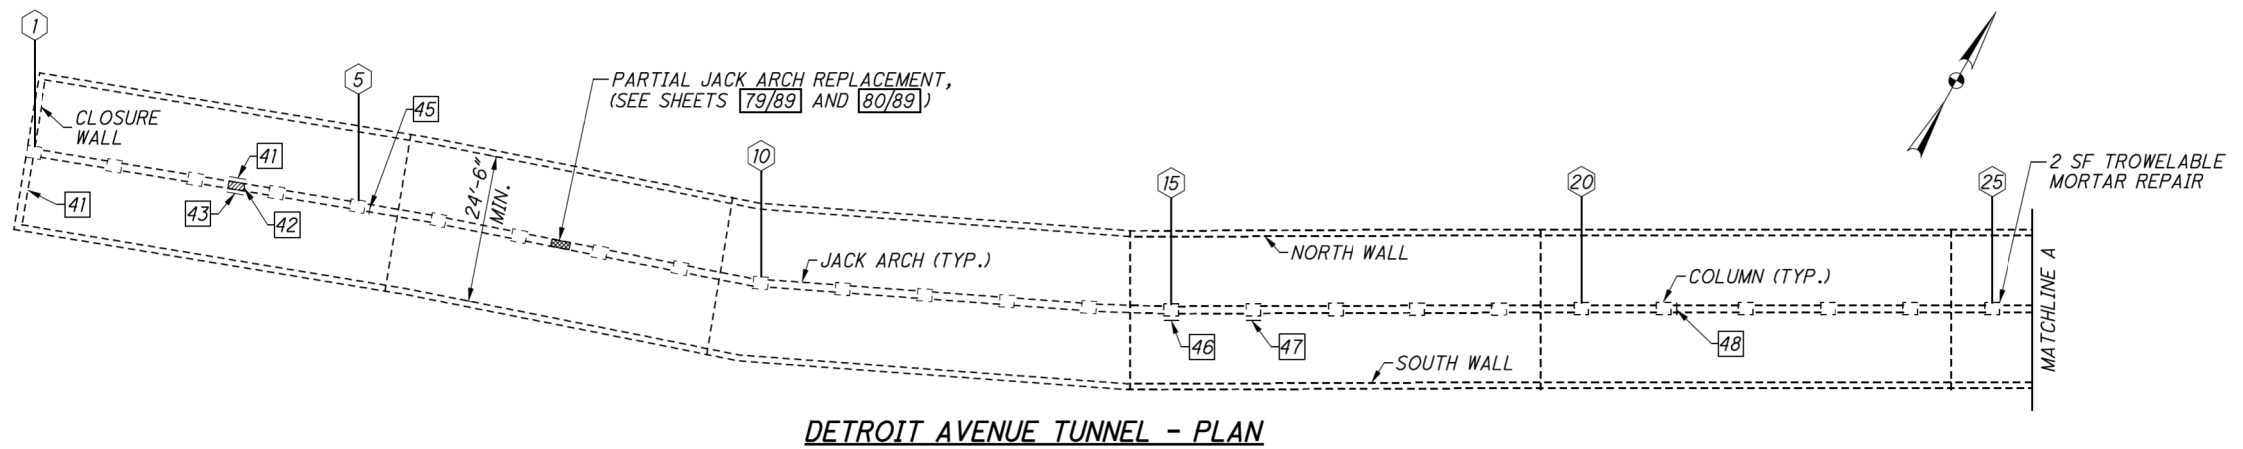
DETROIT AVENUE TUNNEL - PLAN

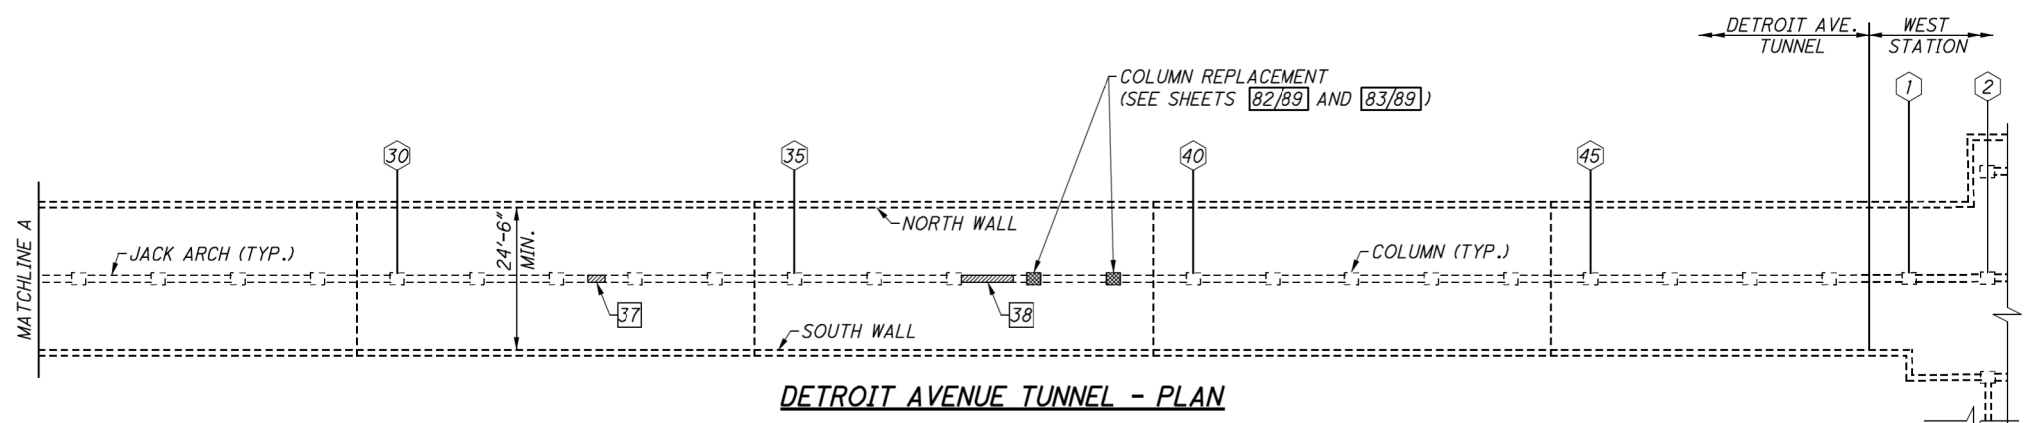
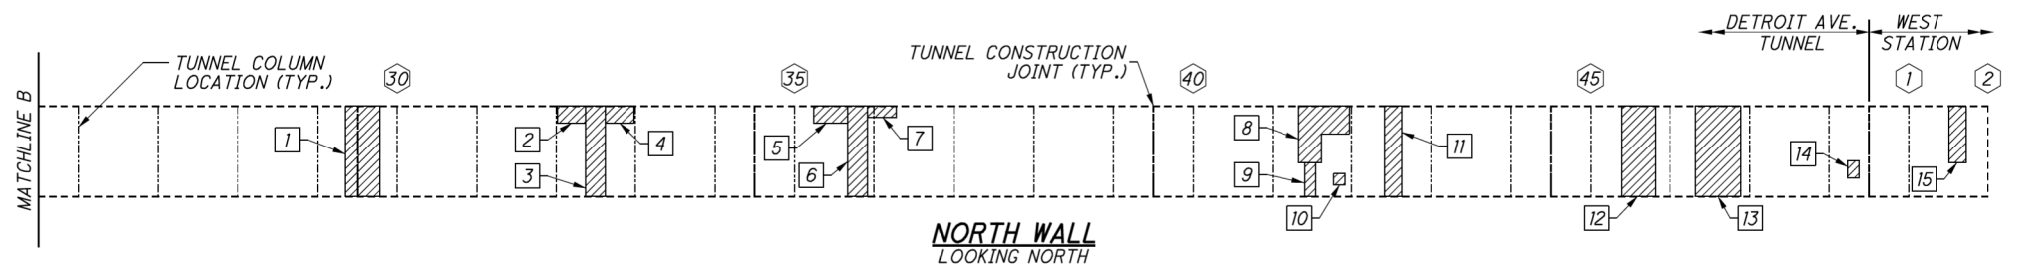
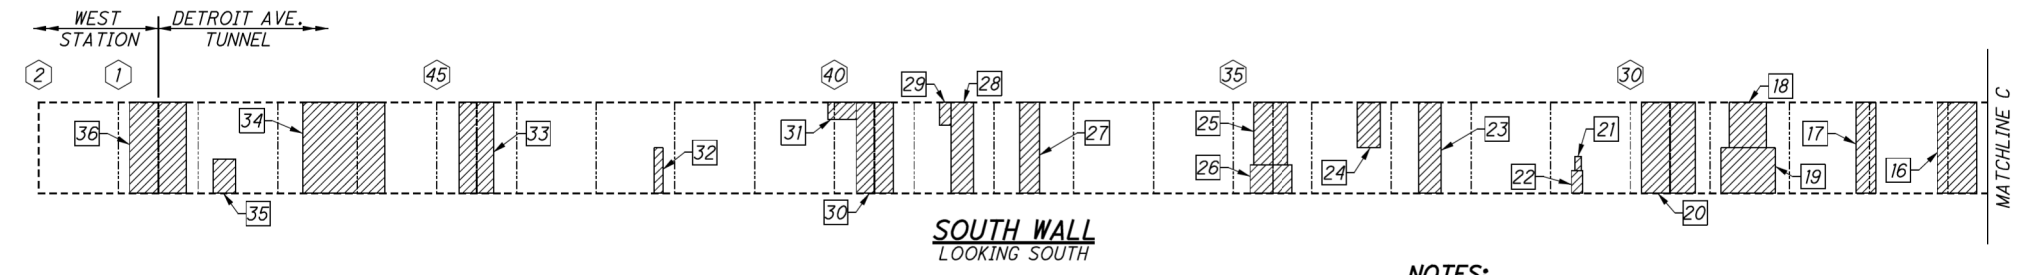
| ESTIMATED PATCHING QUANTITIES | | | |

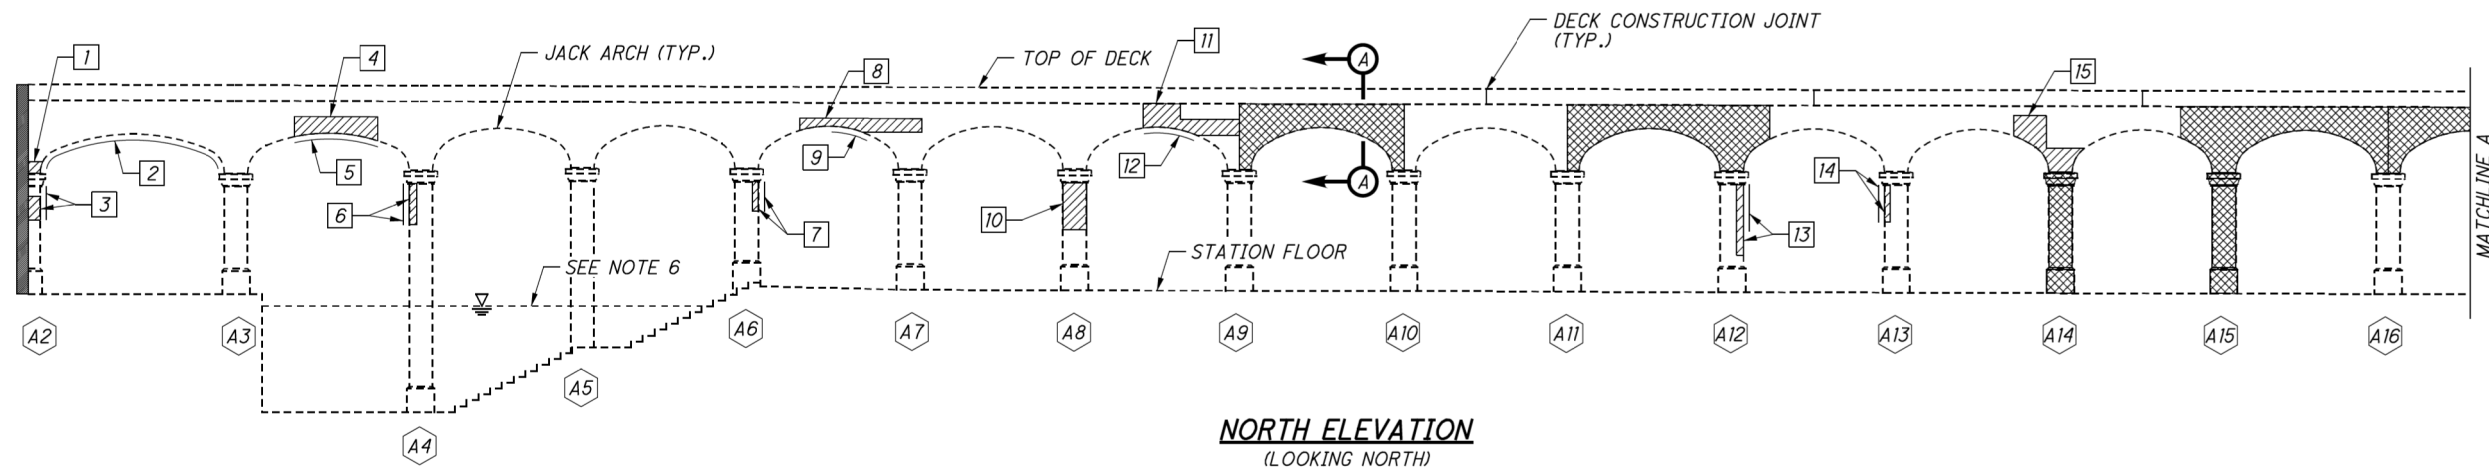
NORTH ELEVATION
(LOOKING NORTH)

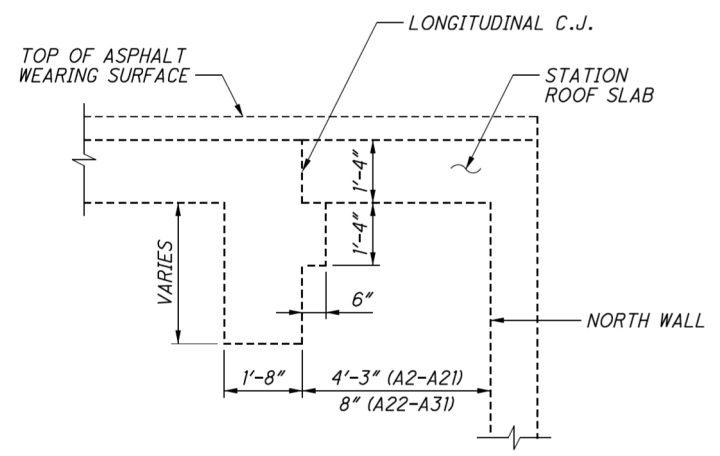
| SHEET QUANTITY SUMMARY | | |
|---|---|---|
| TYPE 2 REPAIR | SF | 28 |

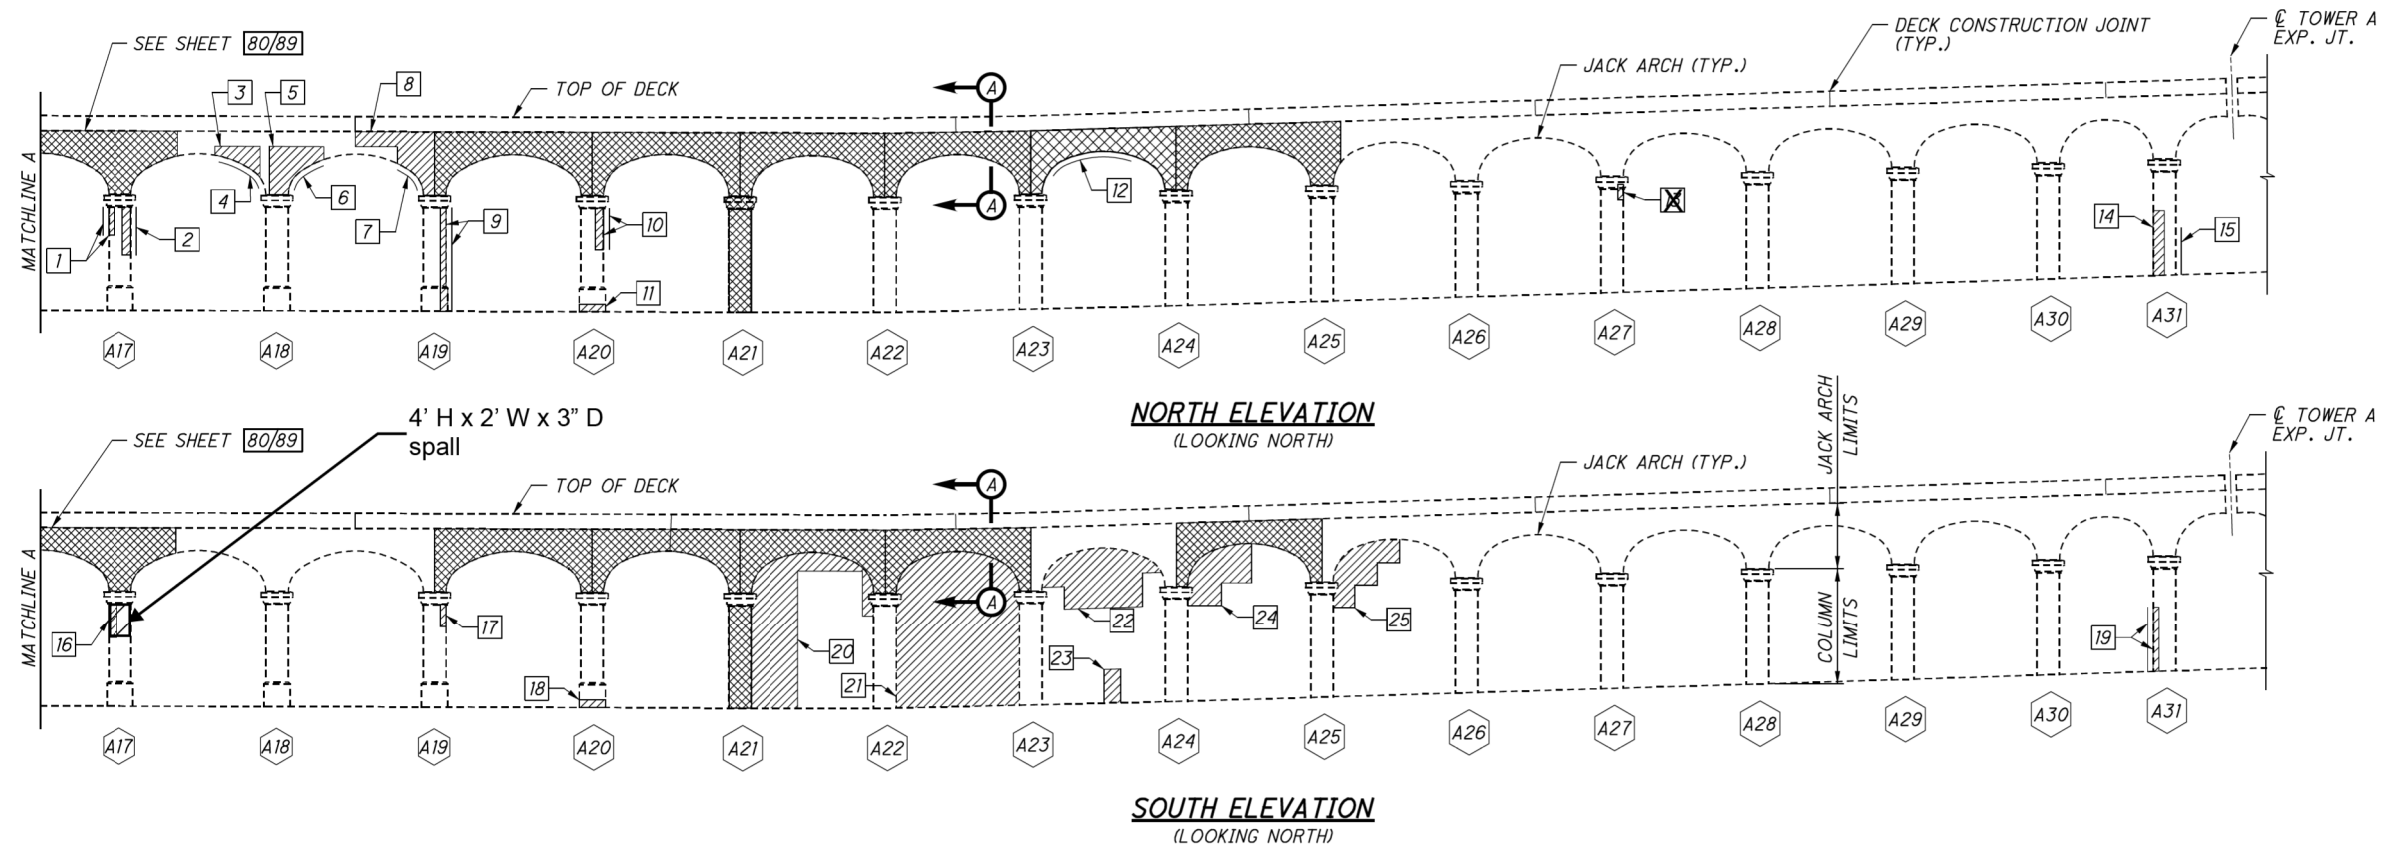
| ESTIMATED PATCHING QUANTITIES | | | |

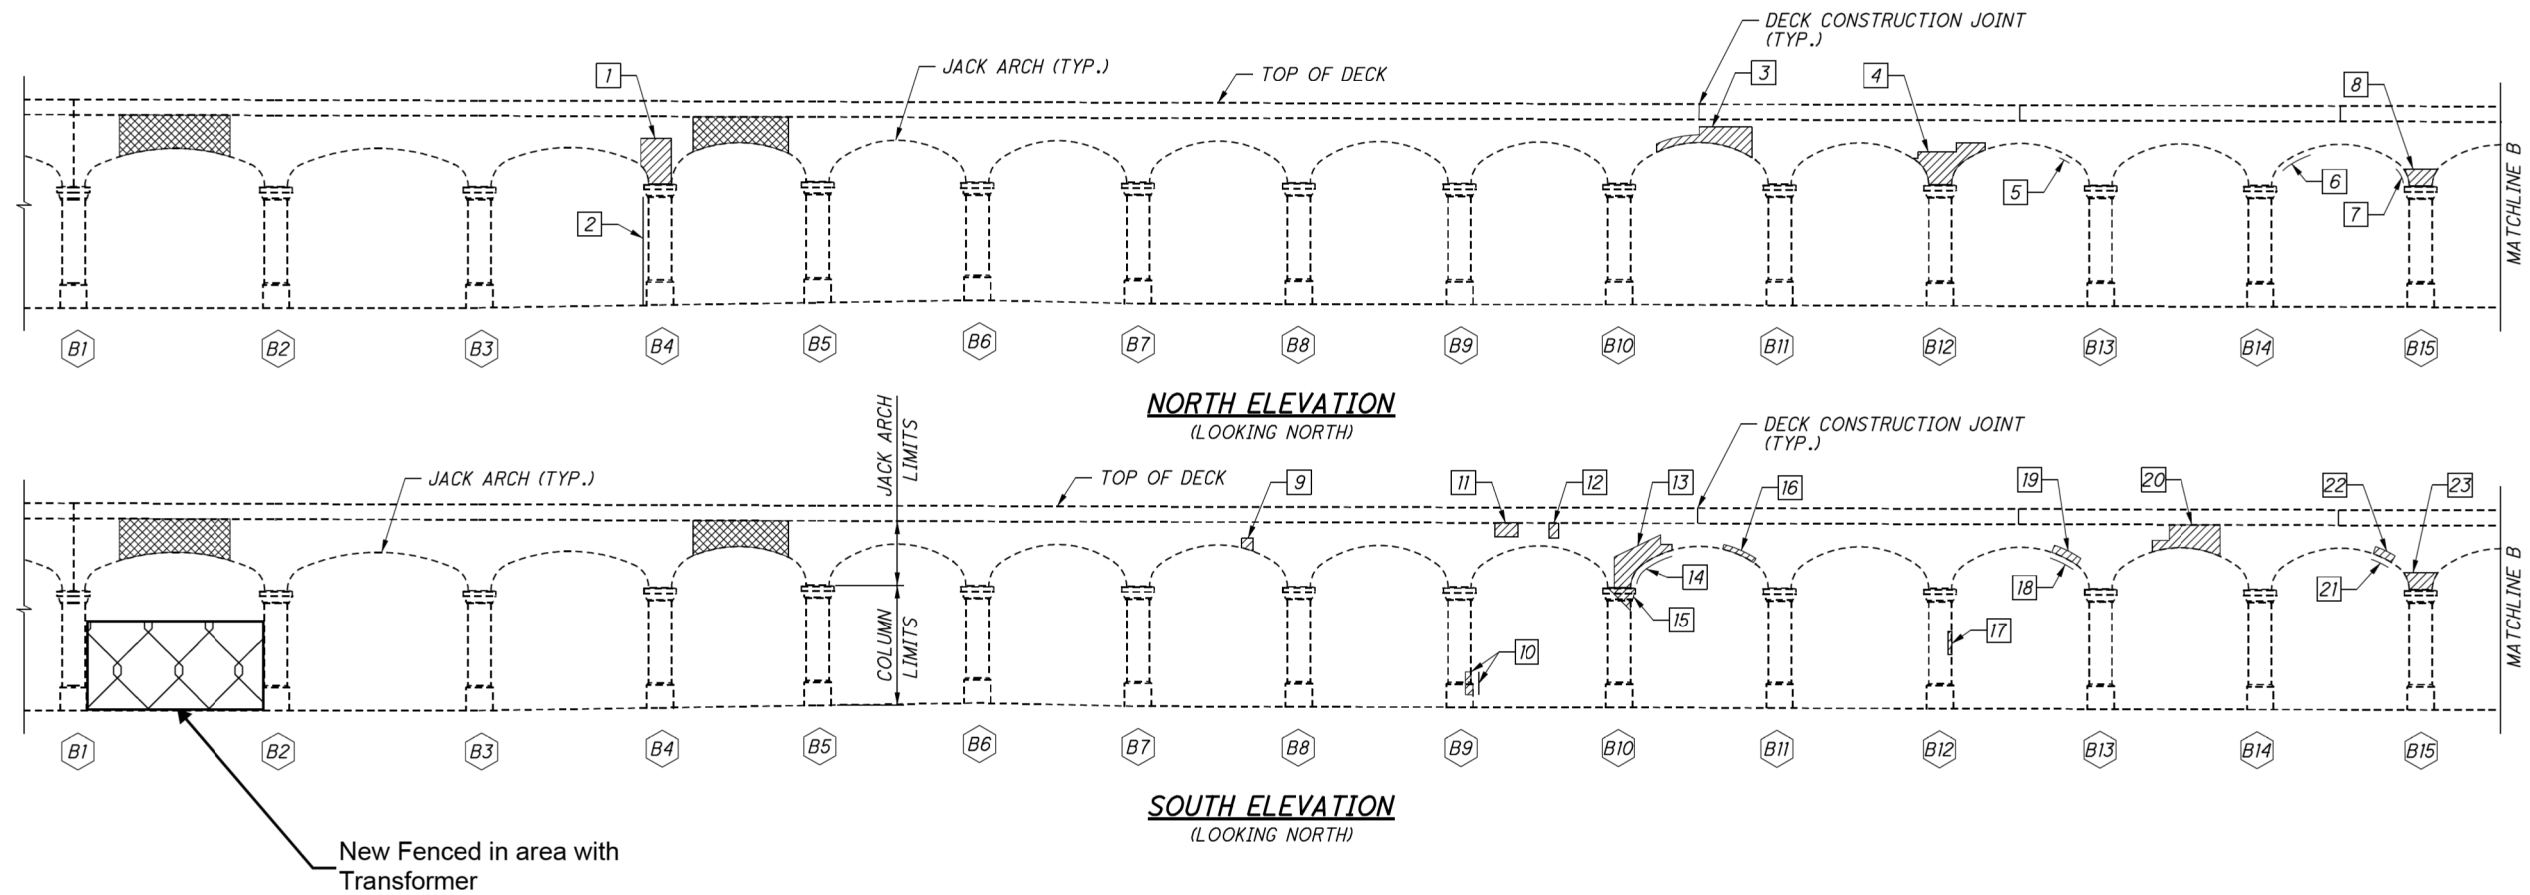
| ESTIMATED PATCHING QUANTITIES | | | |

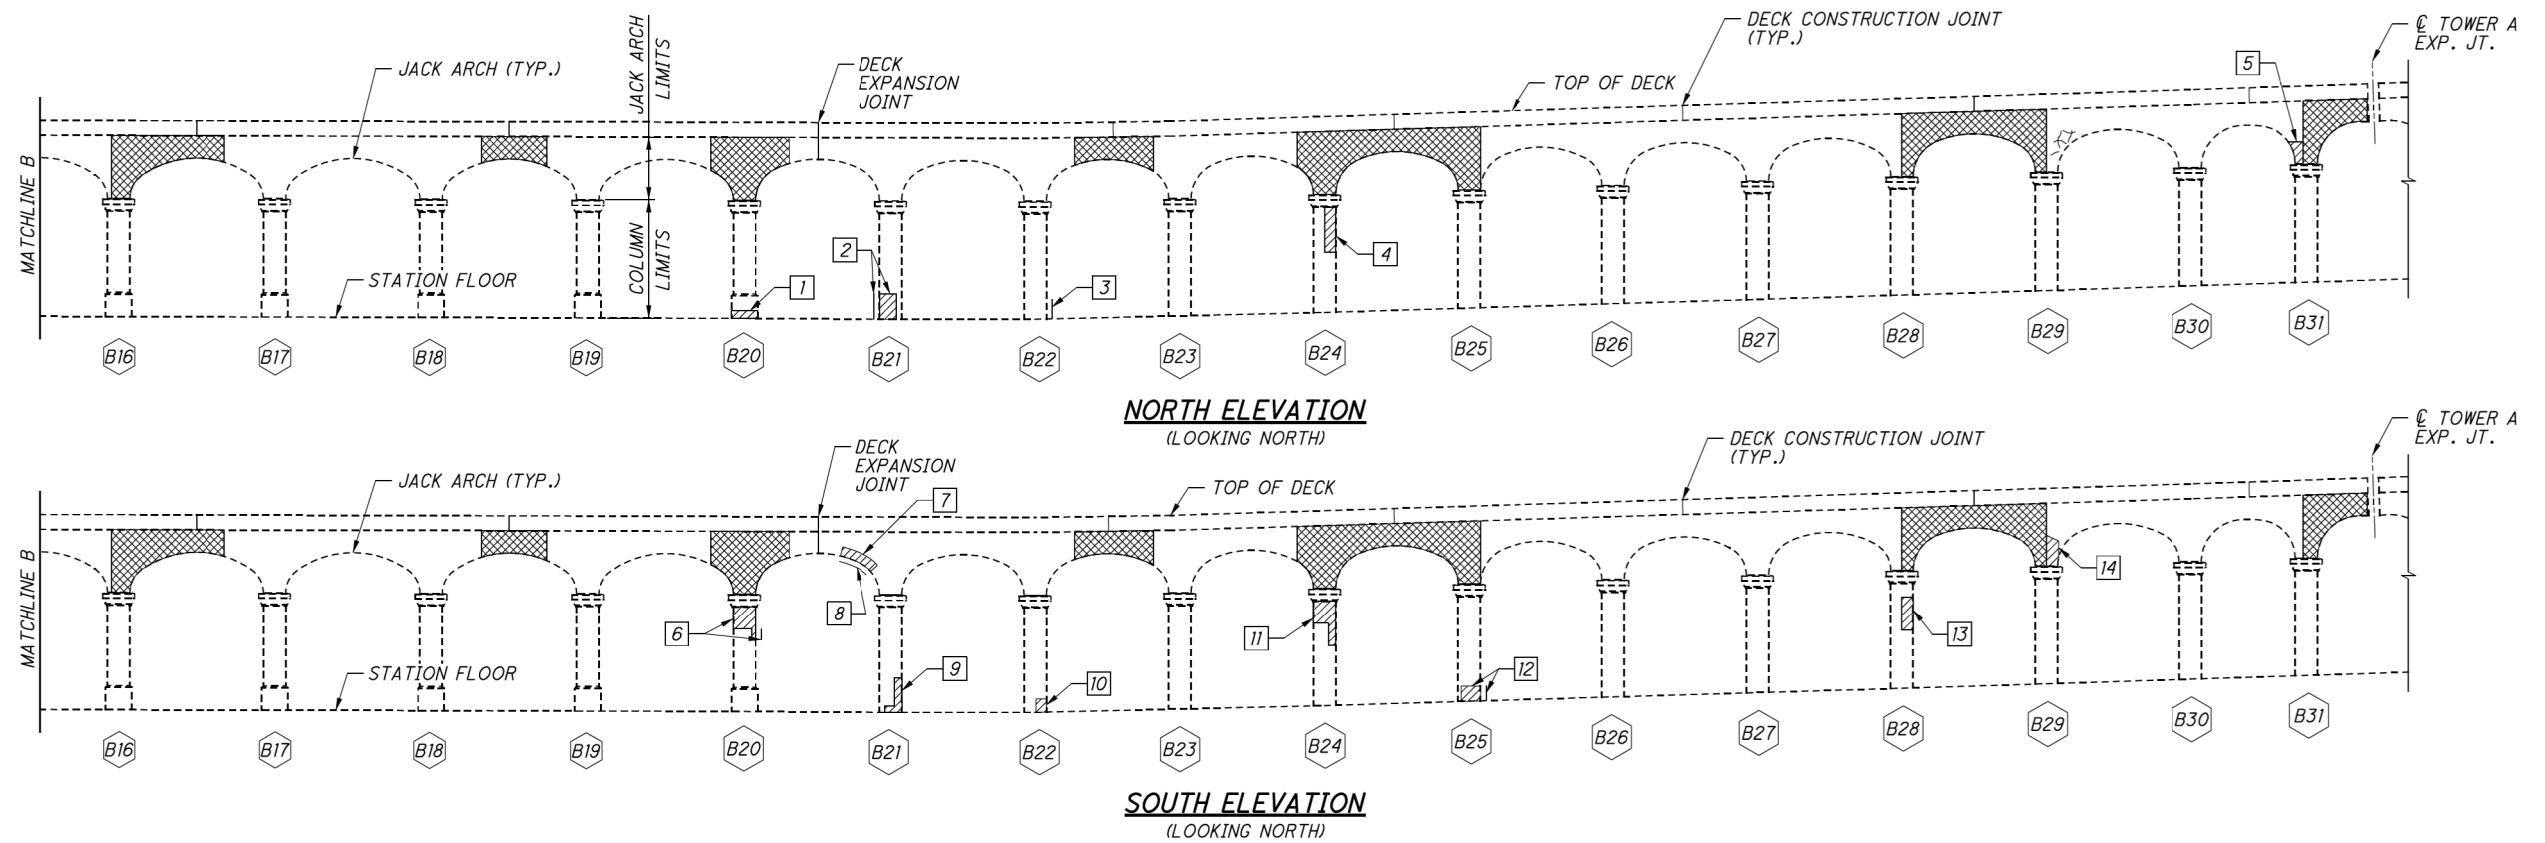
| ESTIMATED PATCHING QUANTITIES | | | |

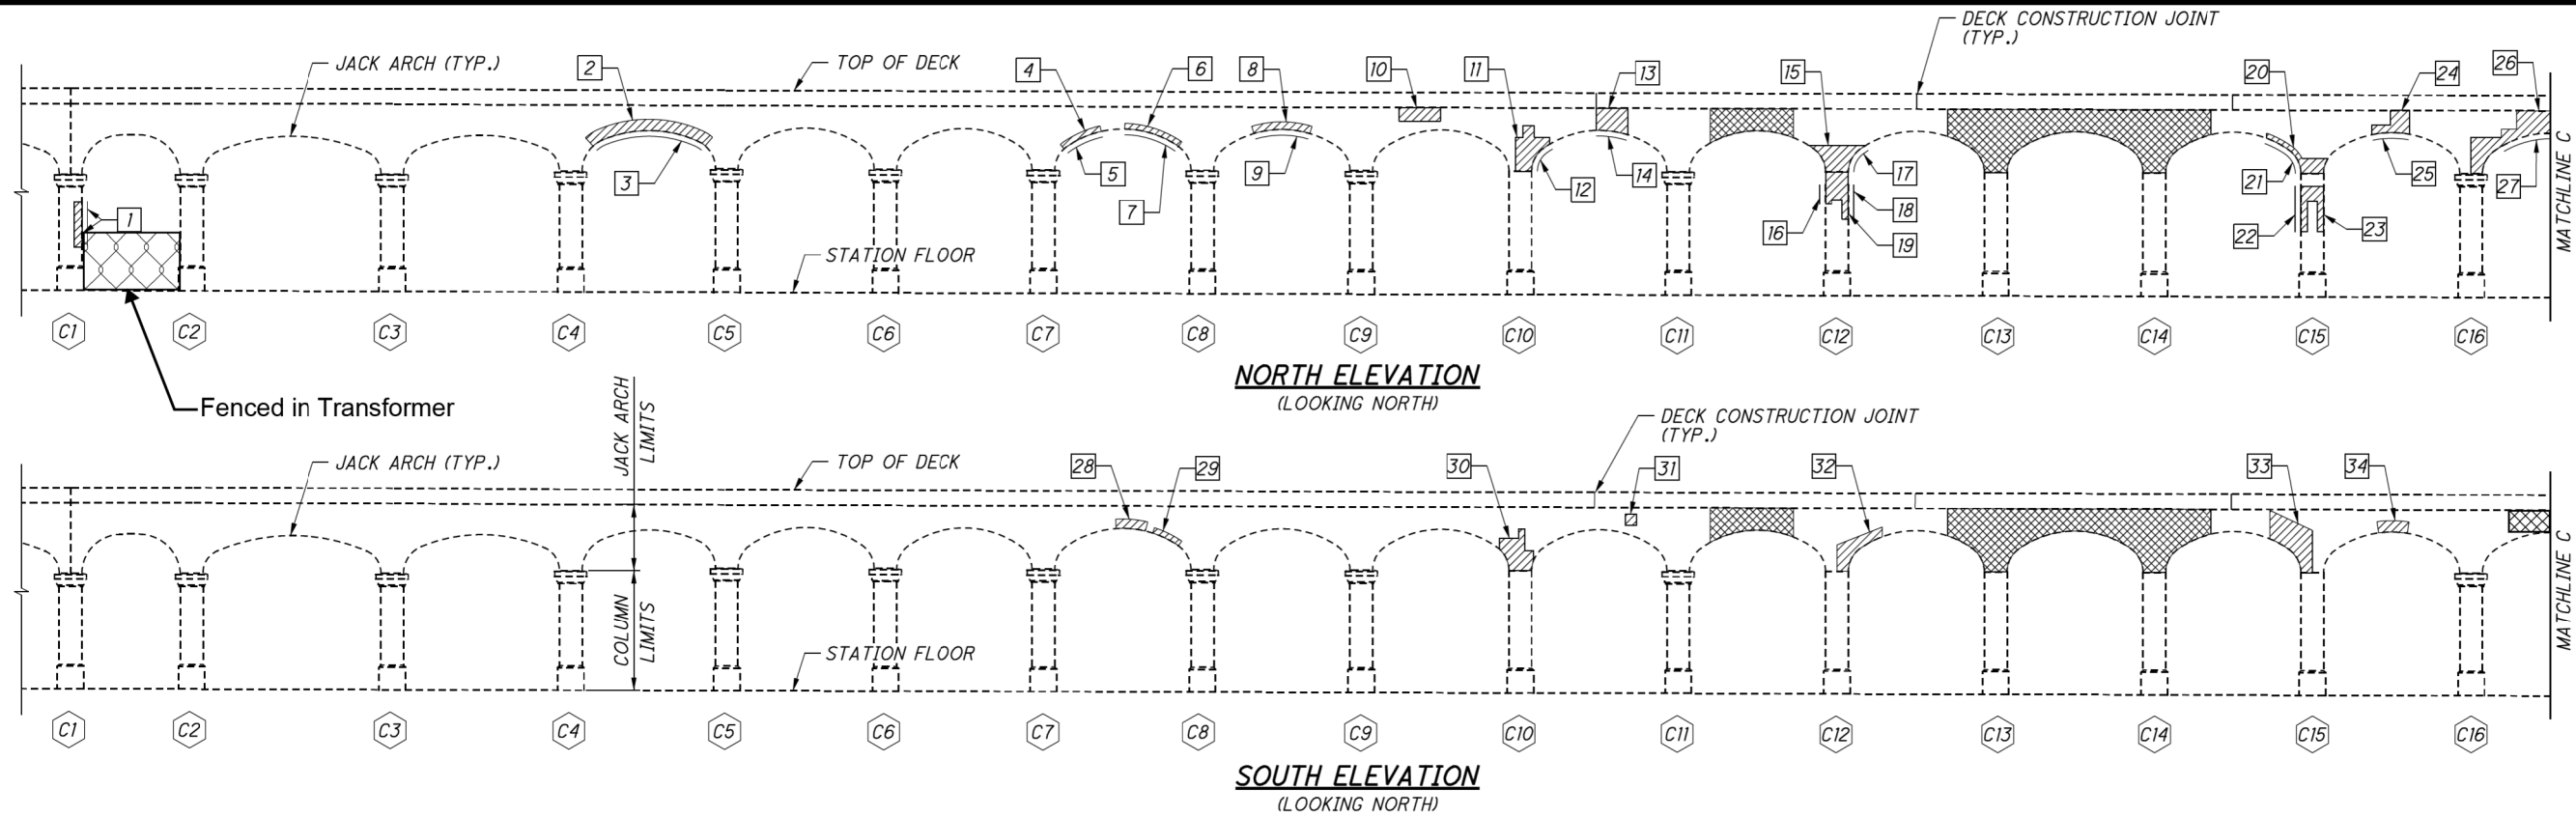
| ESTIMATED PATCHING QUANTITIES | | | |
