CUY-6-1456

PHYSICAL CONDITION REPORT ROUTINE FRACTURE CRITICAL INSPECTION VETERANS MEMORIAL/DETROIT-SUPERIOR BRIDGE OVER THE CUYAHOGA RIVER SFN: 1800930

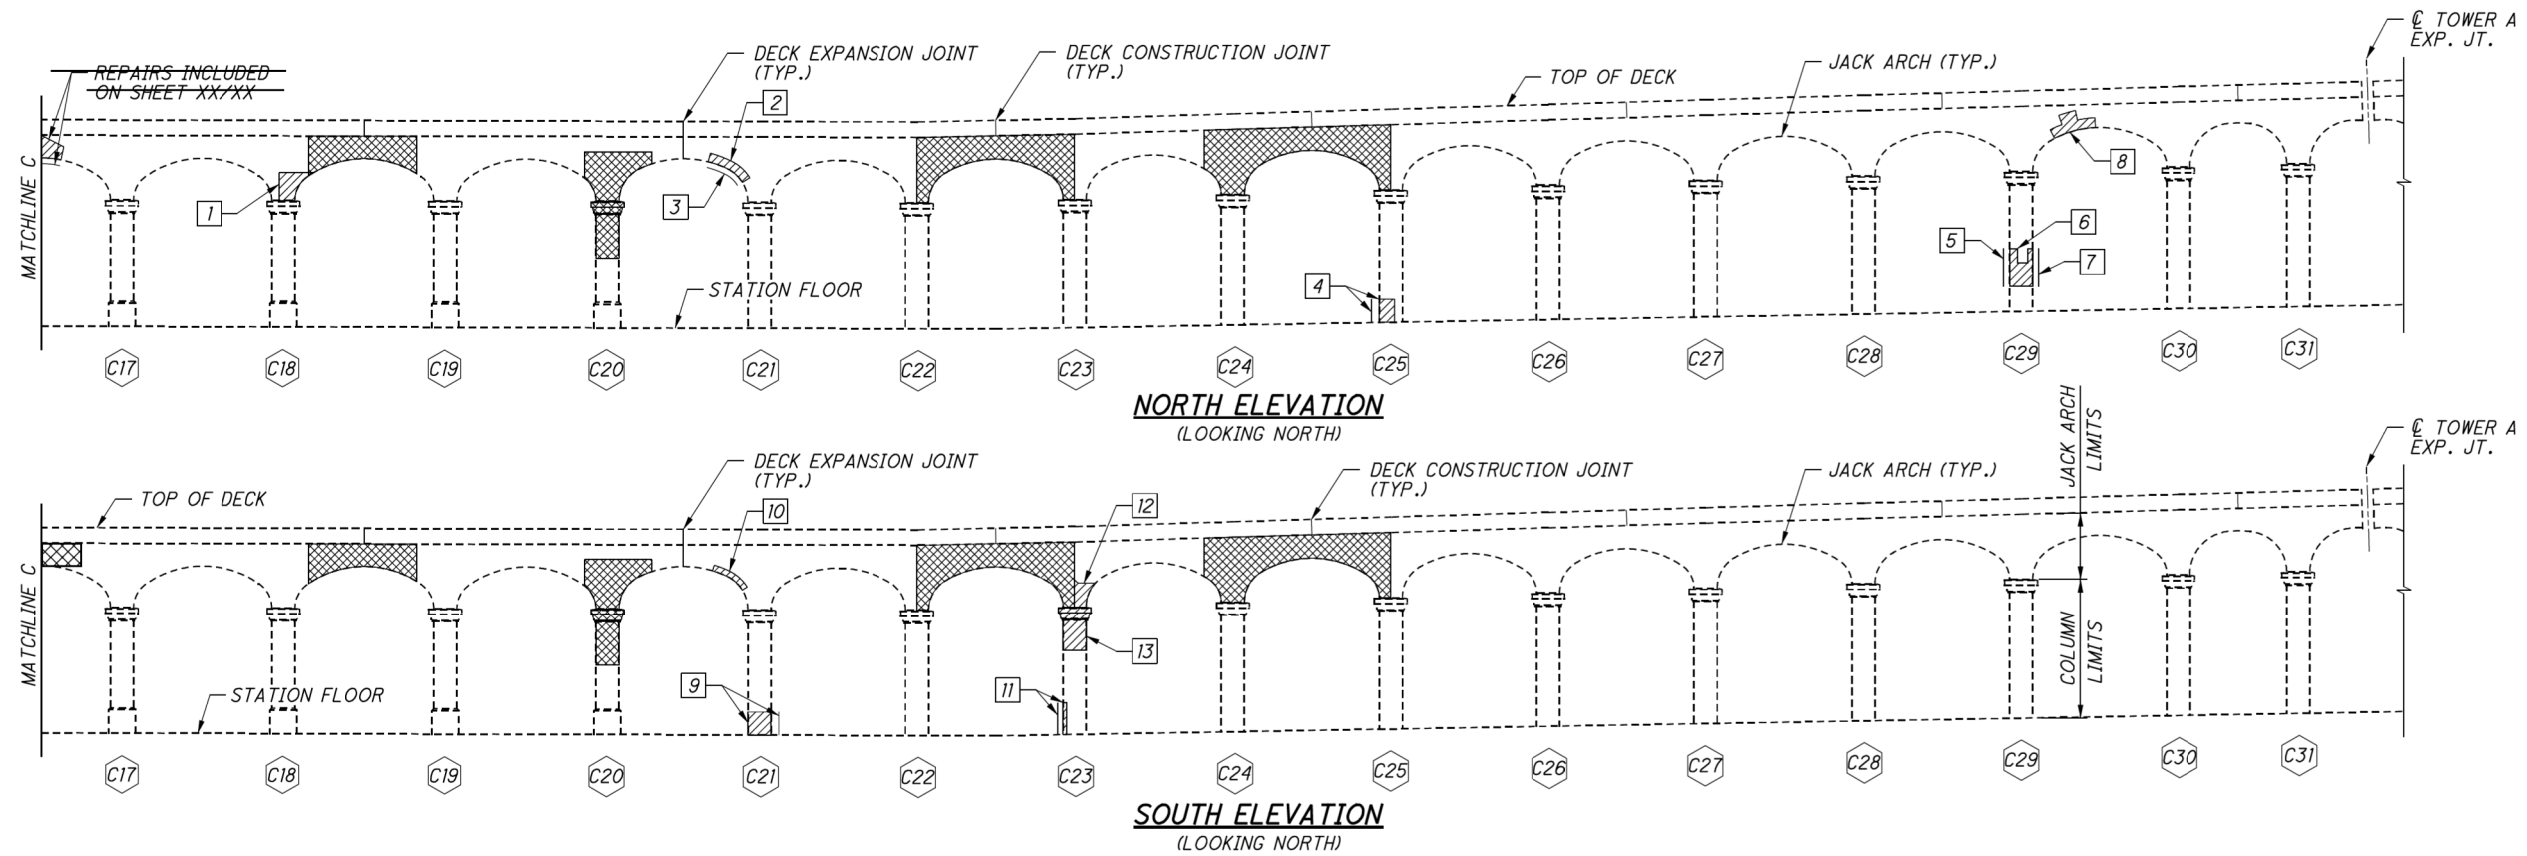
| ESTIMATED PATCHING QUANTITIES | | | |

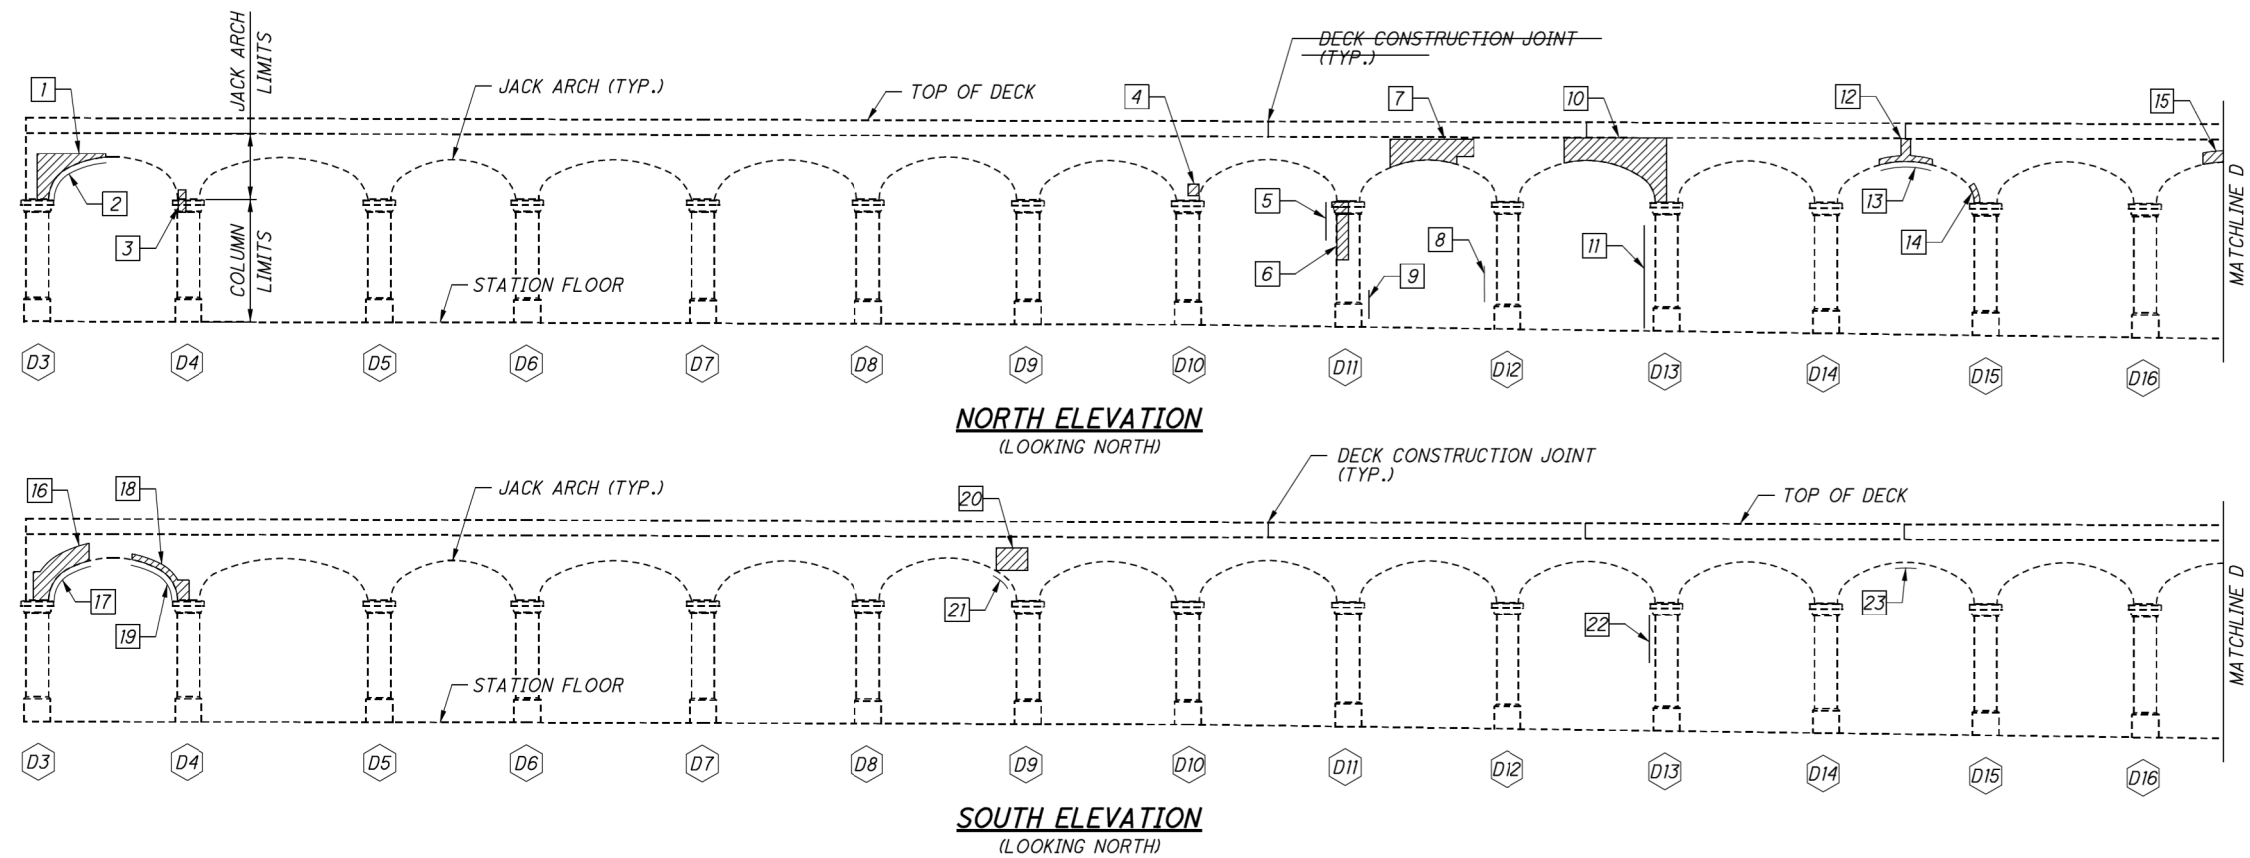
| ESTIMATED PATCHING QUANTITIES | | | |

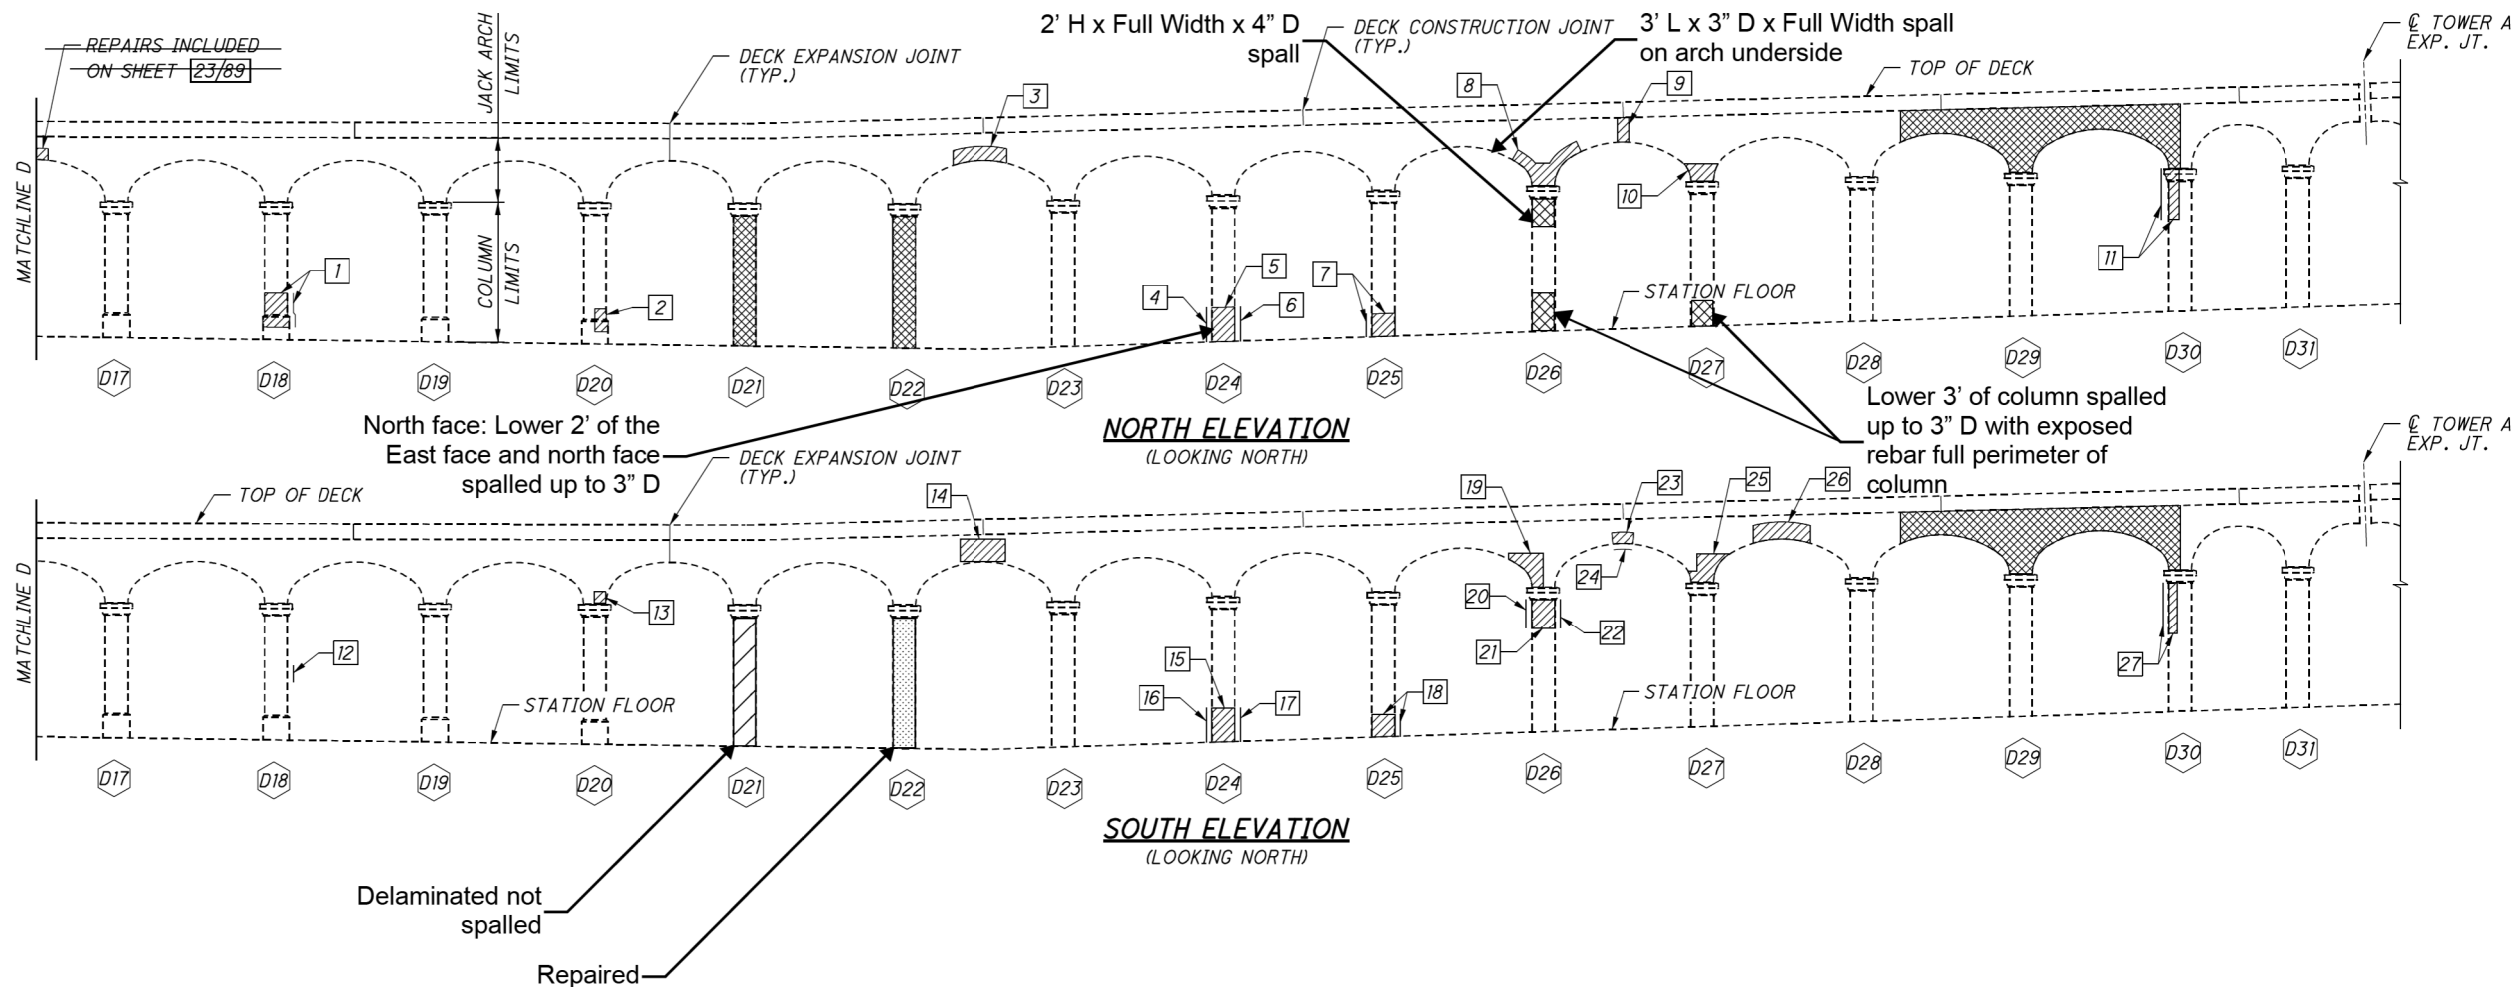
| ESTIMATED PATCHING QUANTITIES | | | |

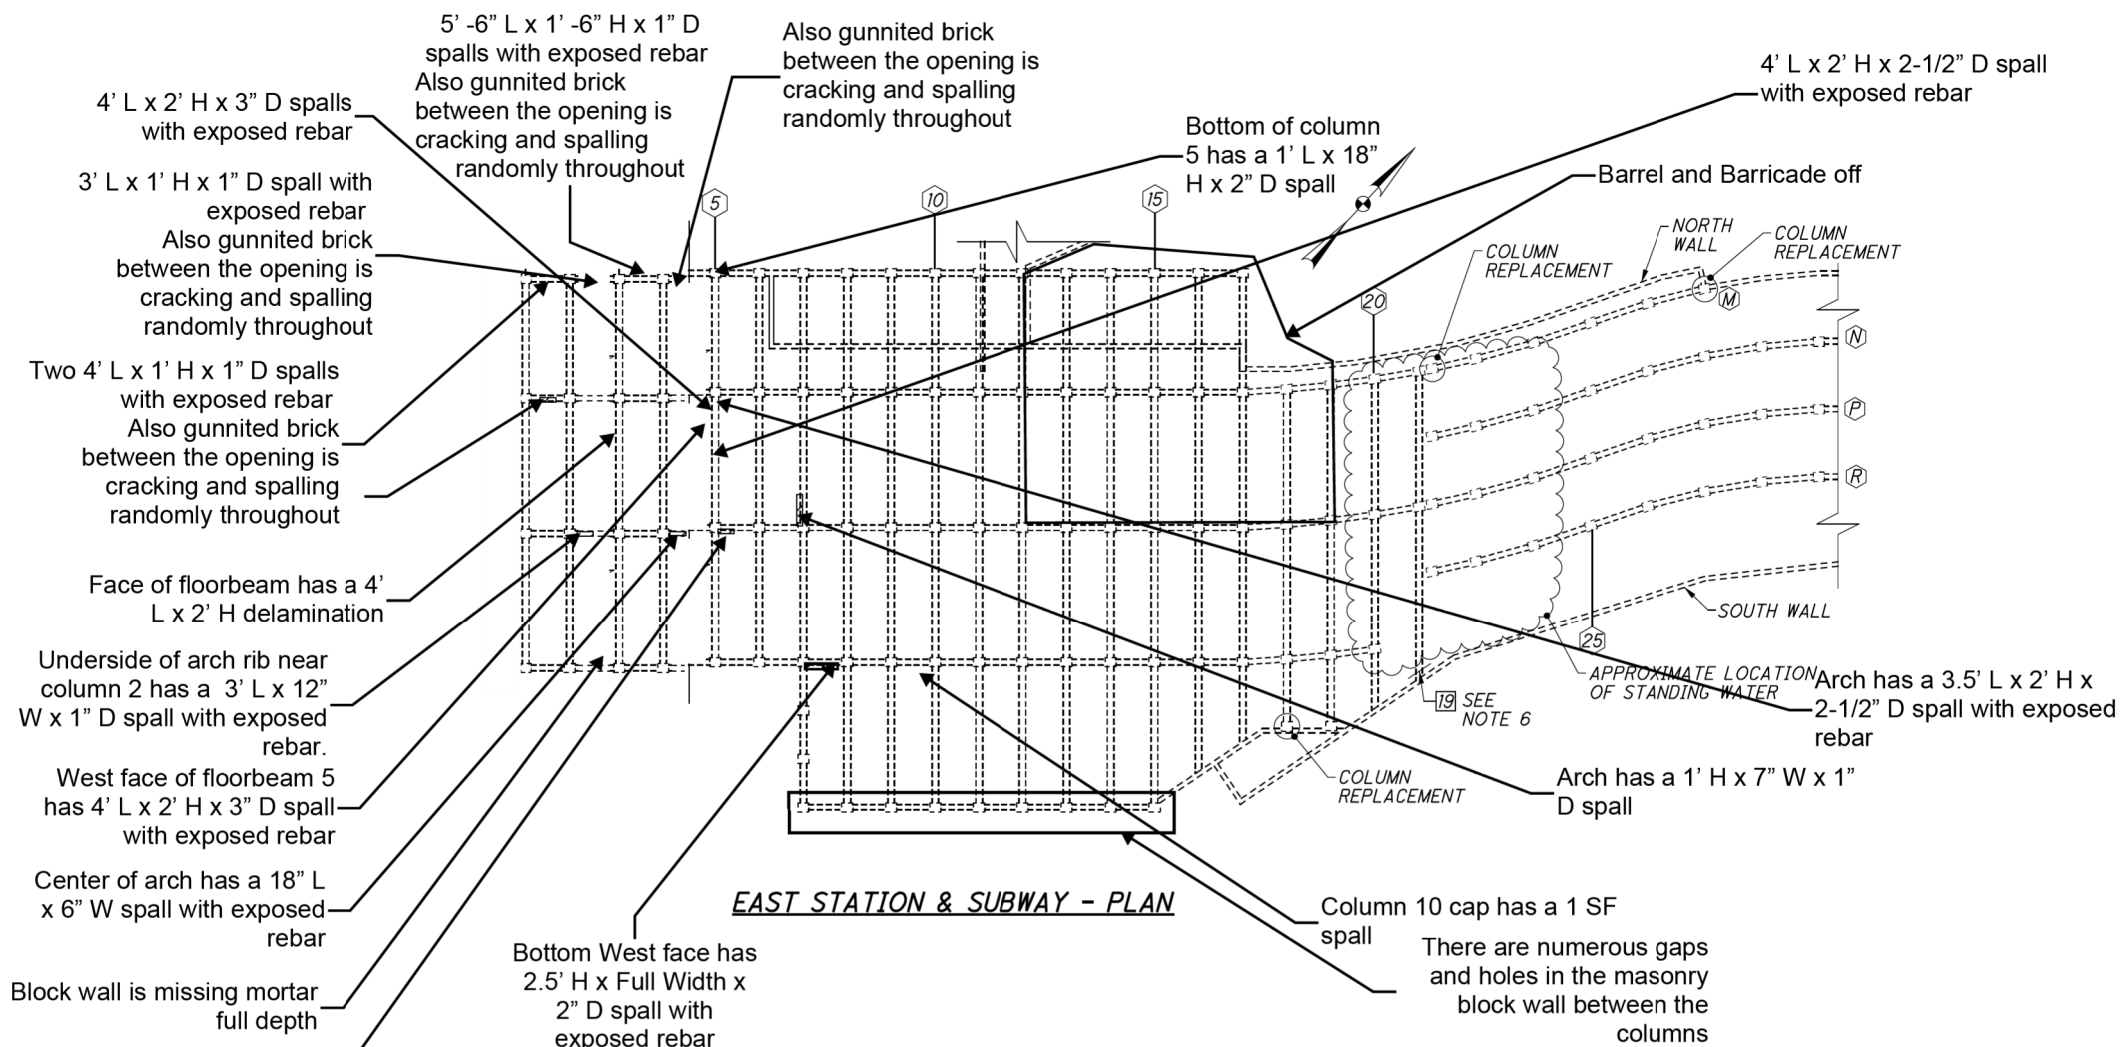
| ESTIMATED PATCHING QUANTITIES | | | |

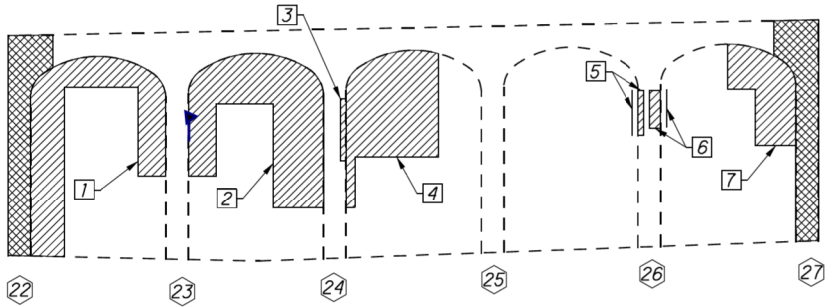
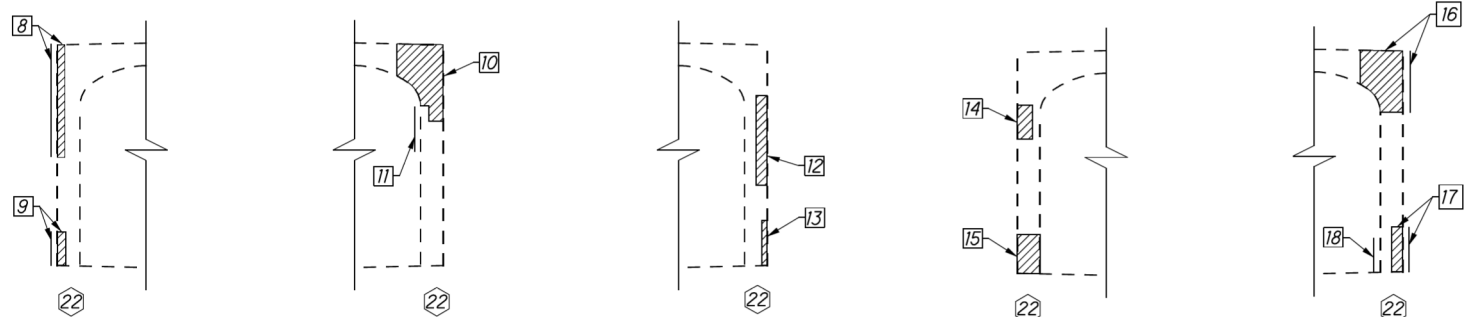
- LEGEND:**
- ⊕ STATION COLUMN NUMBER
 - # REPAIR NUMBER
 - [Hatched Box] LOCATION OF DEFICIENT CONCRETE TO BE REPAIRED IN ACCORDANCE WITH ITEM SPECIAL - PATCHING CONCRETE STRUCTURES, TYPE 1 REPAIR
 - [Dashed Line] LOCATION OF DEFICIENT CONCRETE ON PERPENDICULAR FACE (NOT VISIBLE IN ELEVATION VIEW) TO BE REPAIRED IN ACCORDANCE WITH ITEM SPECIAL PATCHING CONCRETE STRUCTURES, TYPE 1 REPAIR
 - [Cross-hatched Box] LOCATION OF DEFICIENT COLUMN OR JACK ARCH TO BE REPLACED.

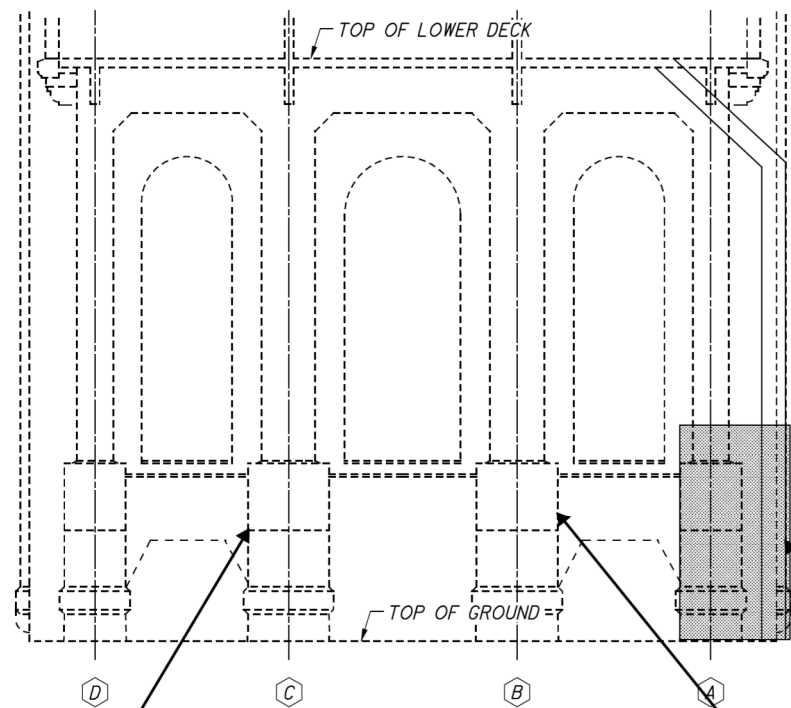
PIER 3 - EAST ELEVATION

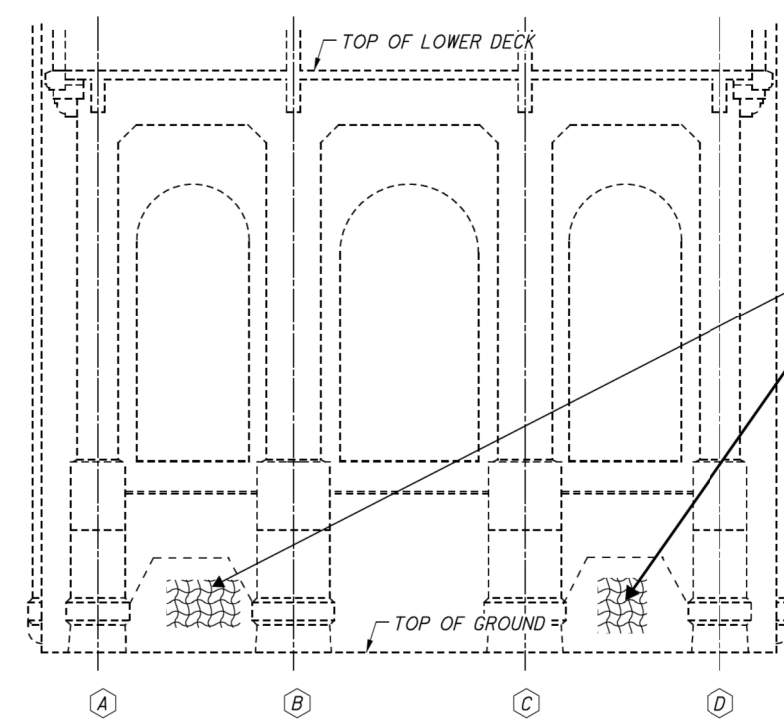
PIER 4 - WEST ELEVATION

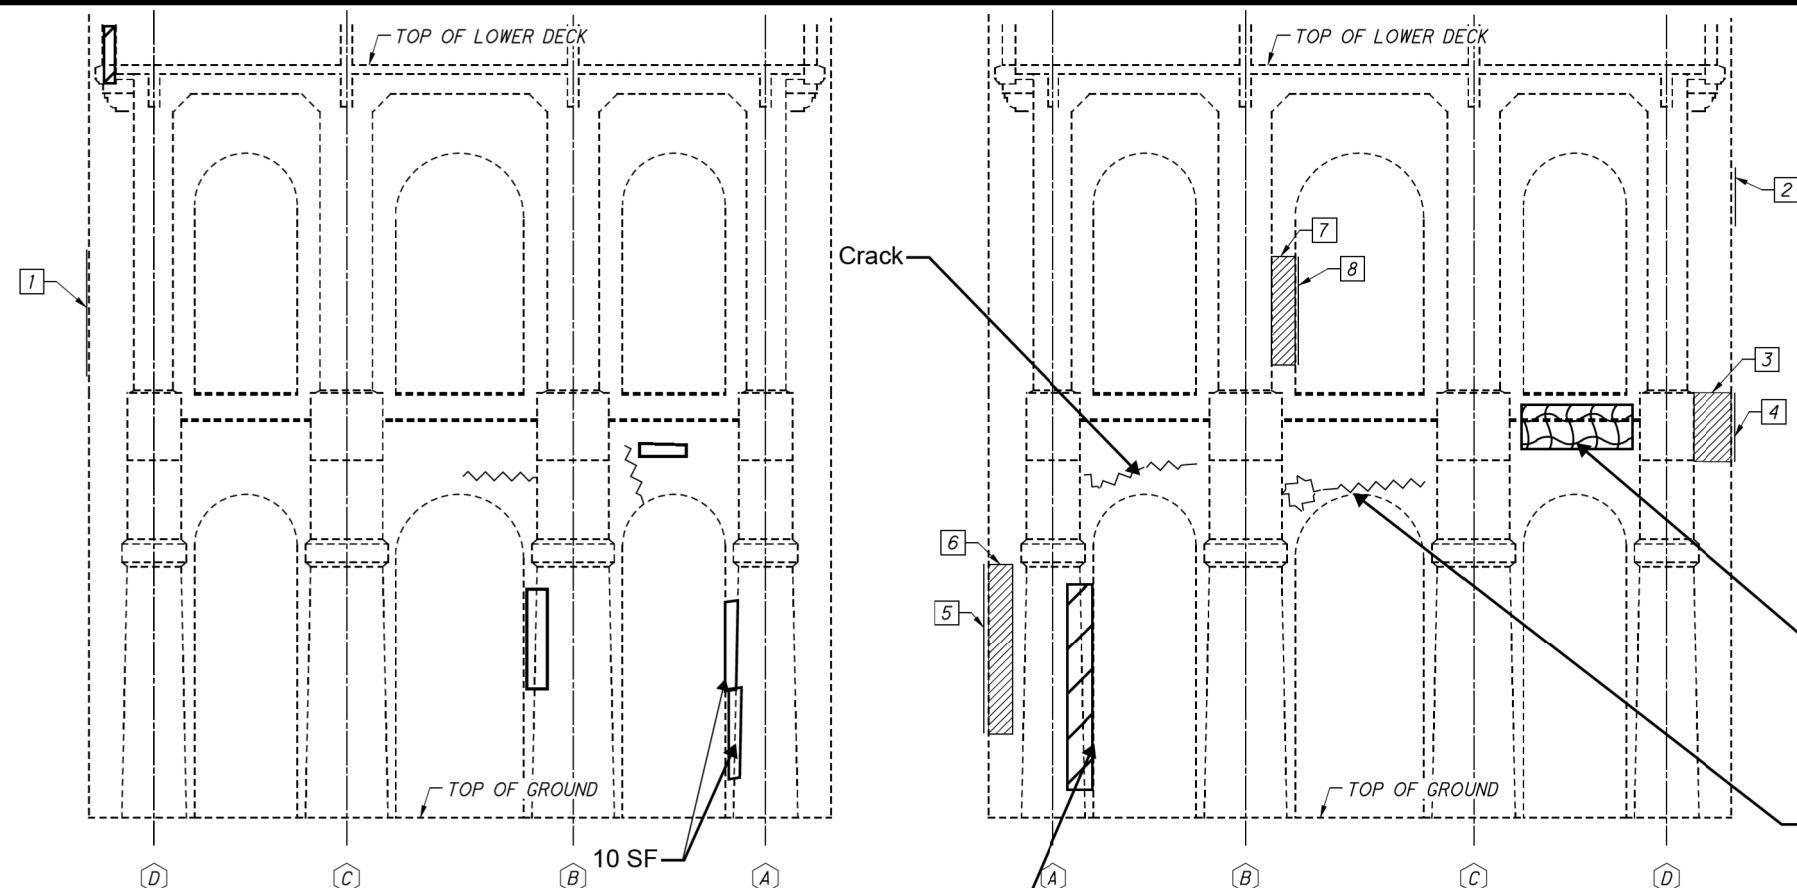
| ESTIMATED PATCHING QUANTITIES | | | |

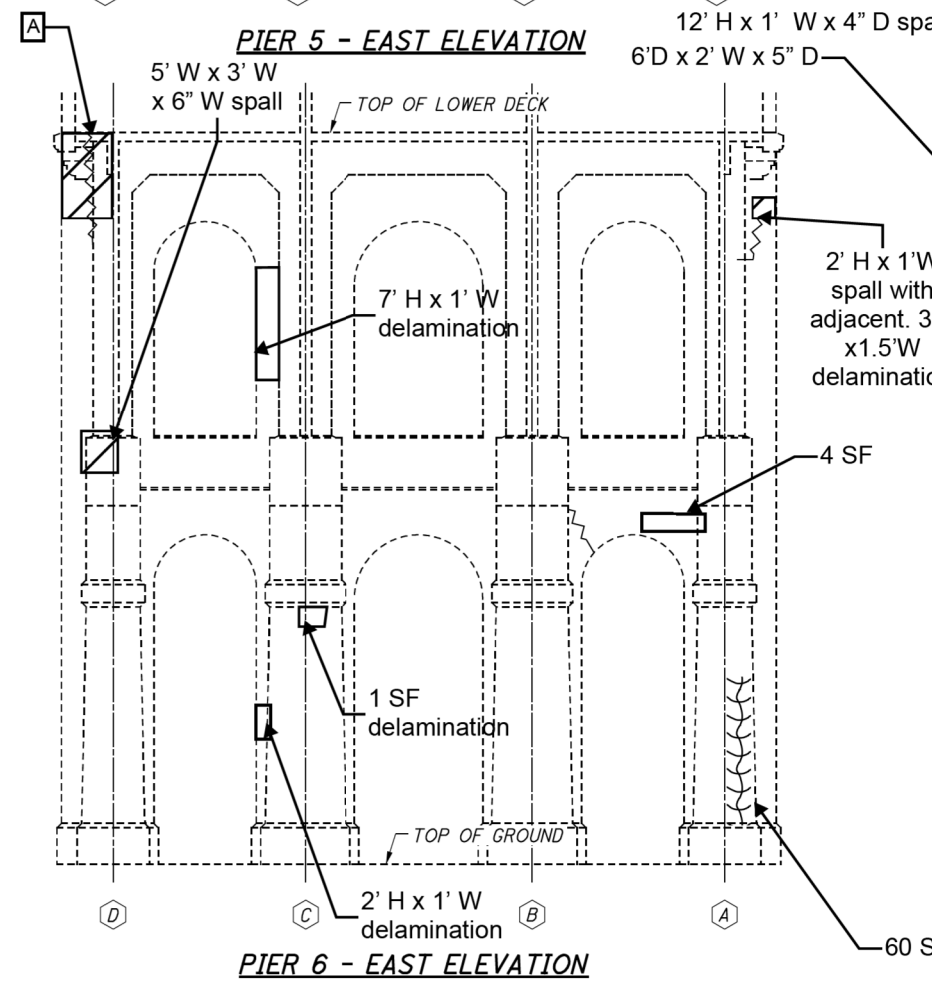
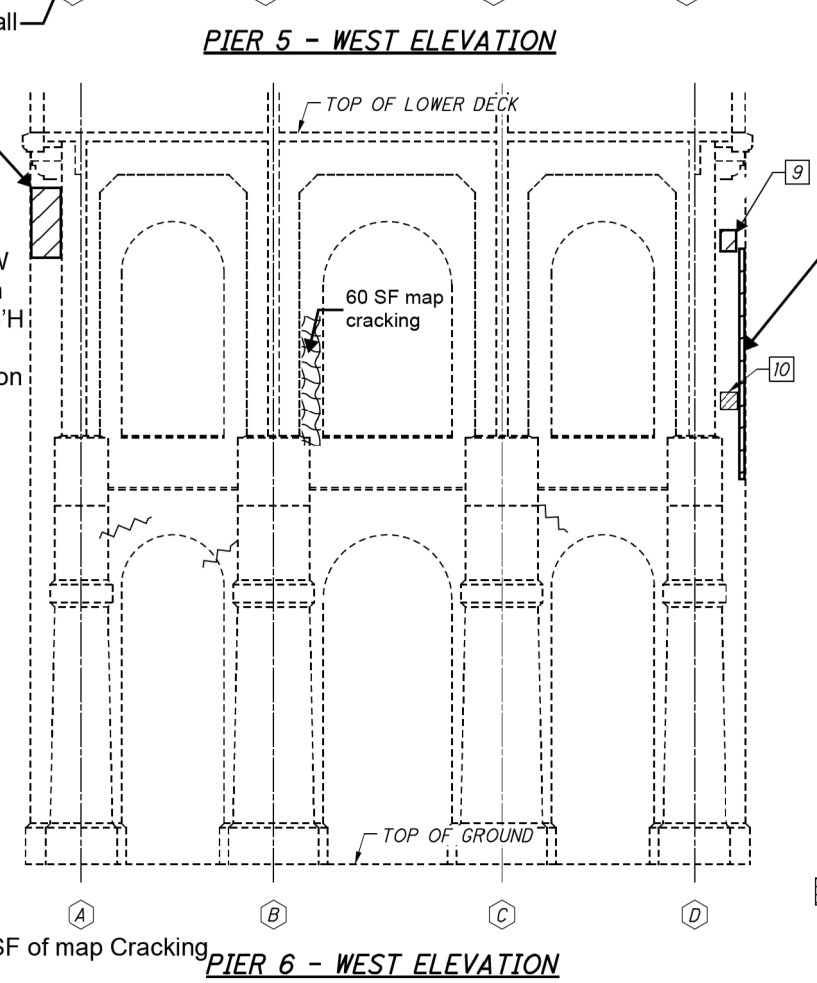
30' H x 7' W area of spalls and associated delaminations.

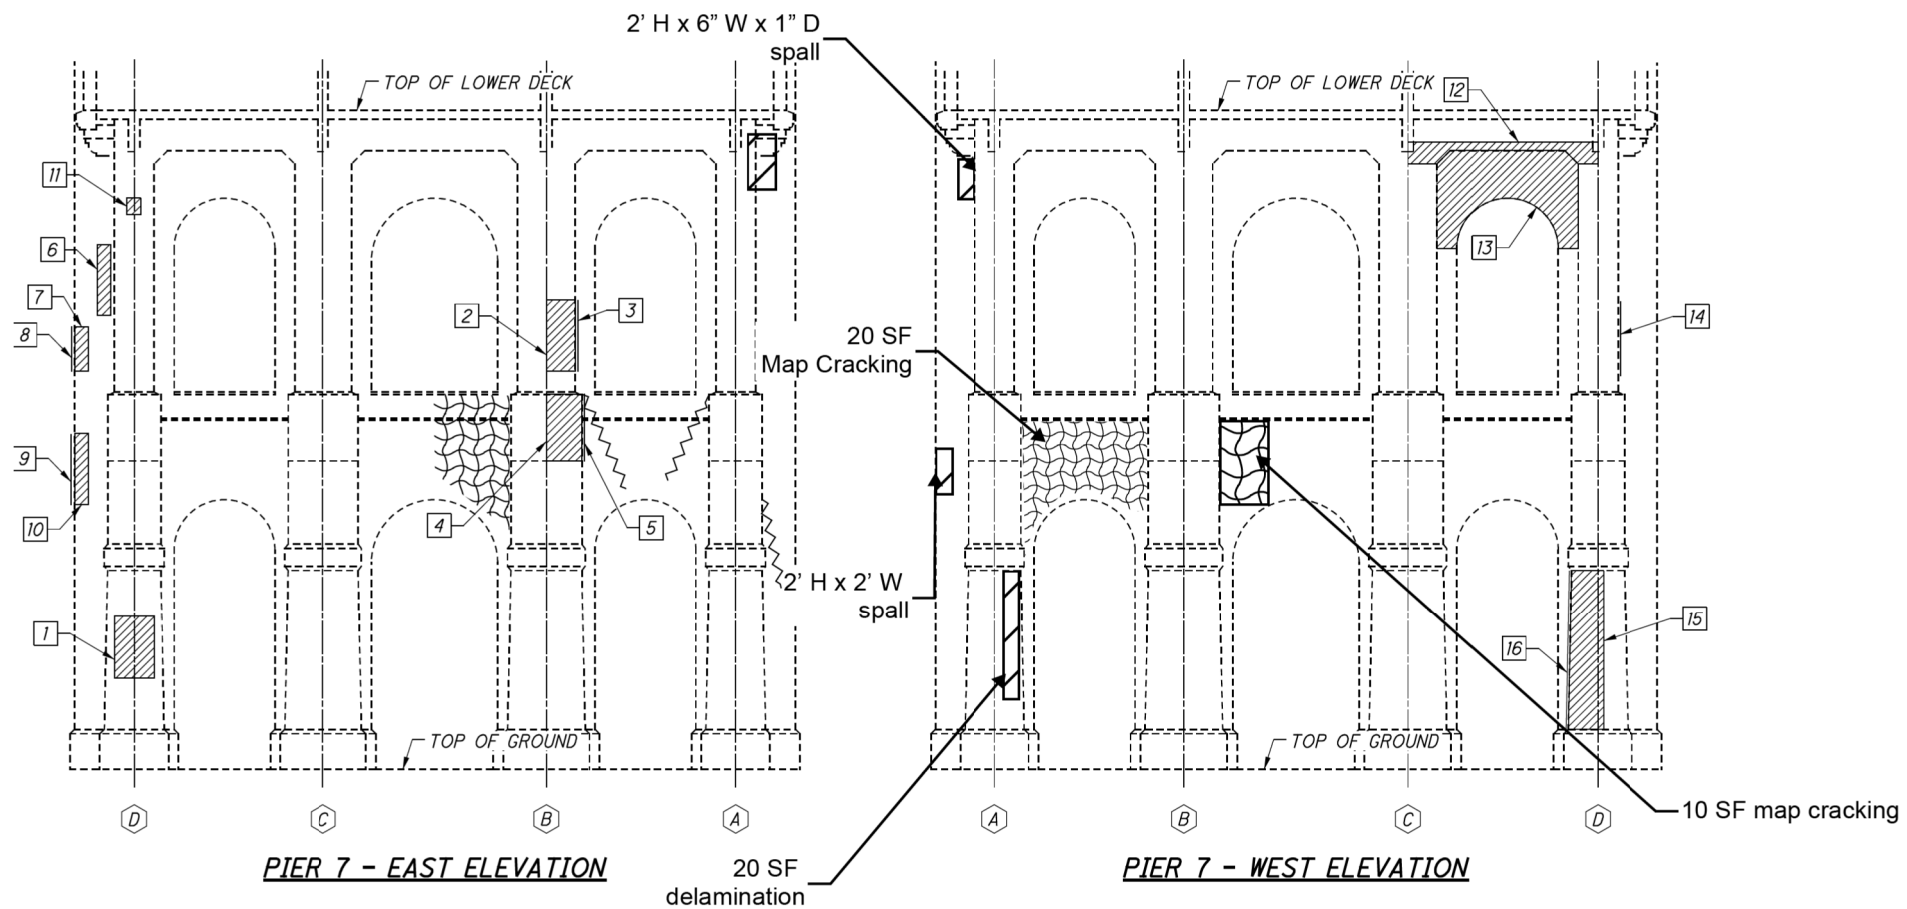
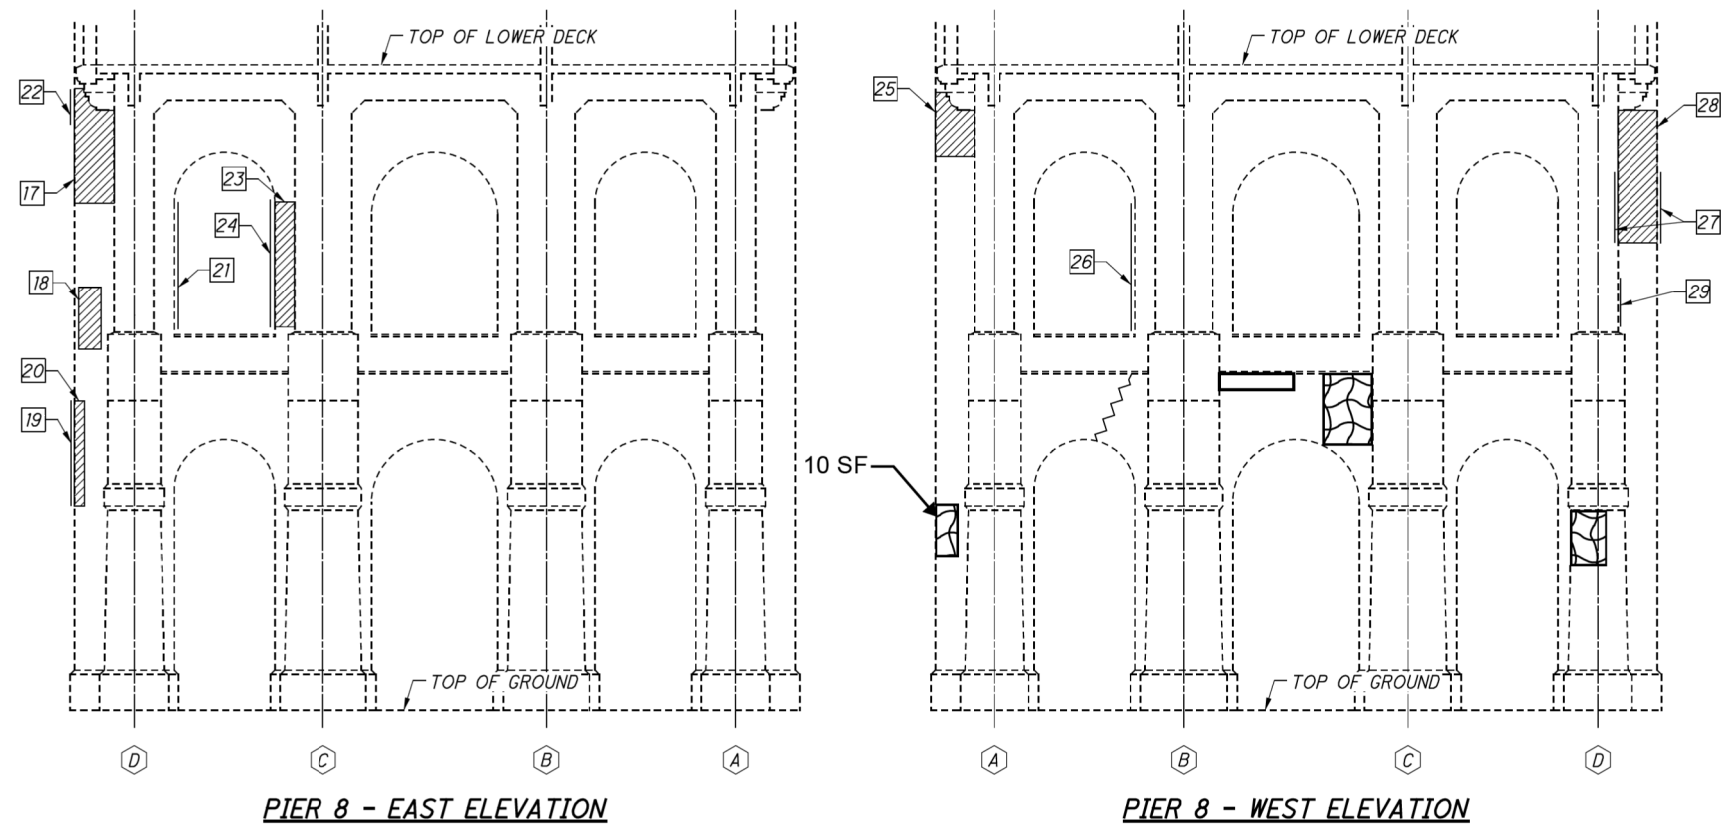
| ESTIMATED PATCHING QUANTITIES | | | |

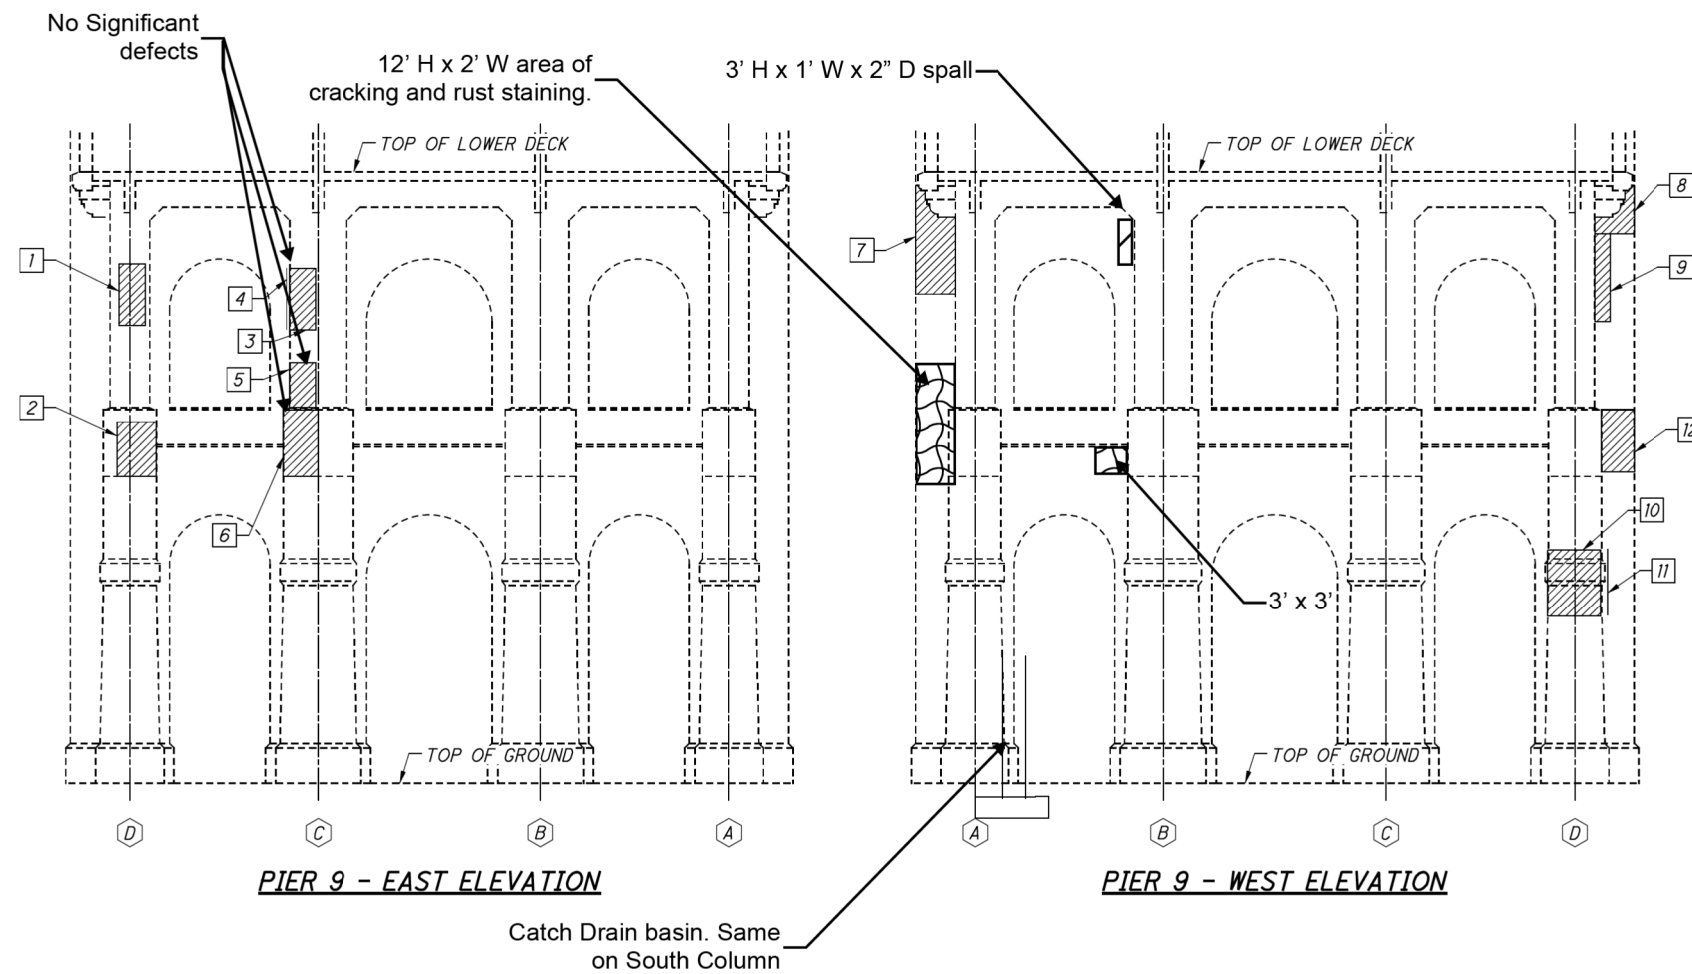
| ESTIMATED PATCHING QUANTITIES | | | |

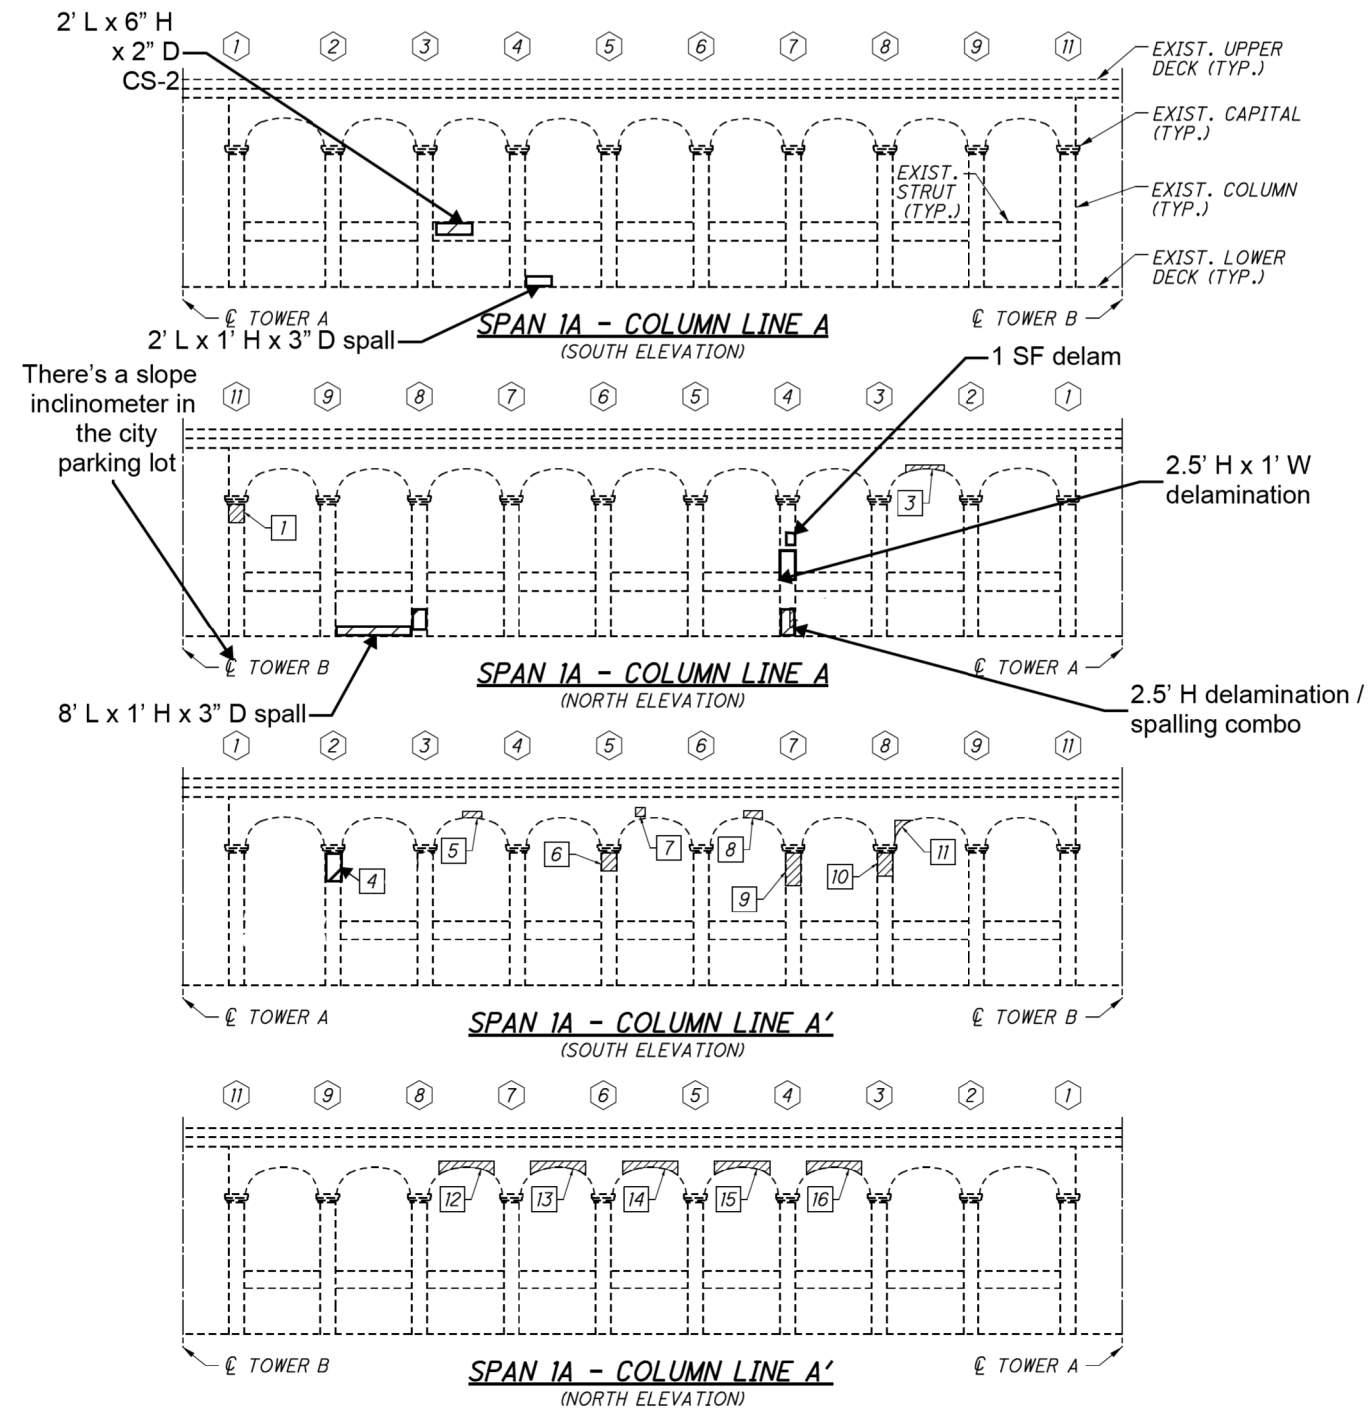
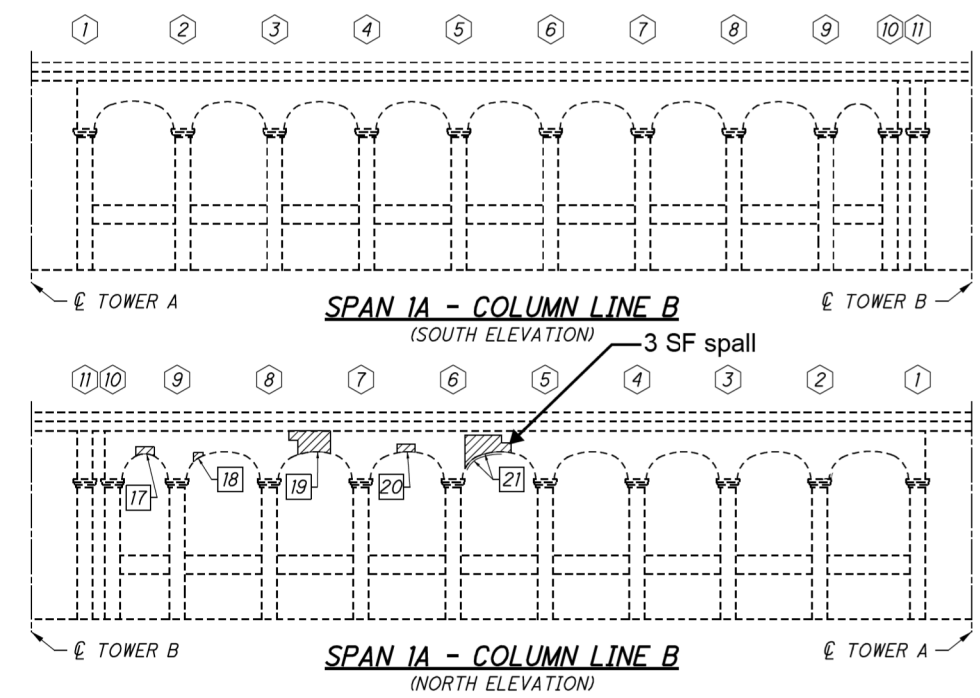
| ESTIMATED PATCHING QUANTITIES | | | |

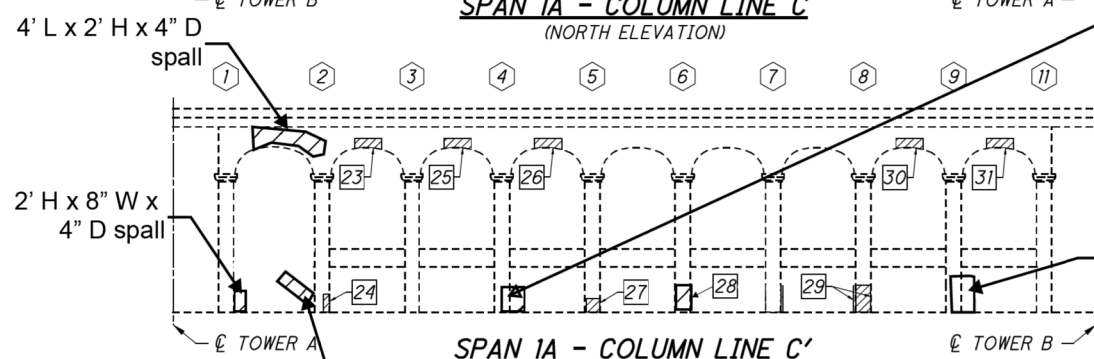
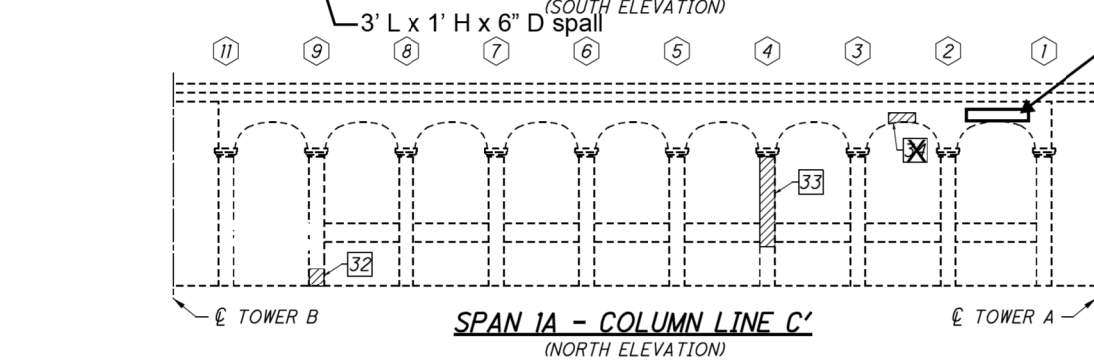
| ESTIMATED PATCHING QUANTITIES | | | |
