CUY-6-1456

PHYSICAL CONDITION REPORT ROUTINE FRACTURE CRITICAL INSPECTION VETERANS MEMORIAL/DETROIT-SUPERIOR BRIDGE OVER THE CUYAHOGA RIVER SFN: 1800930

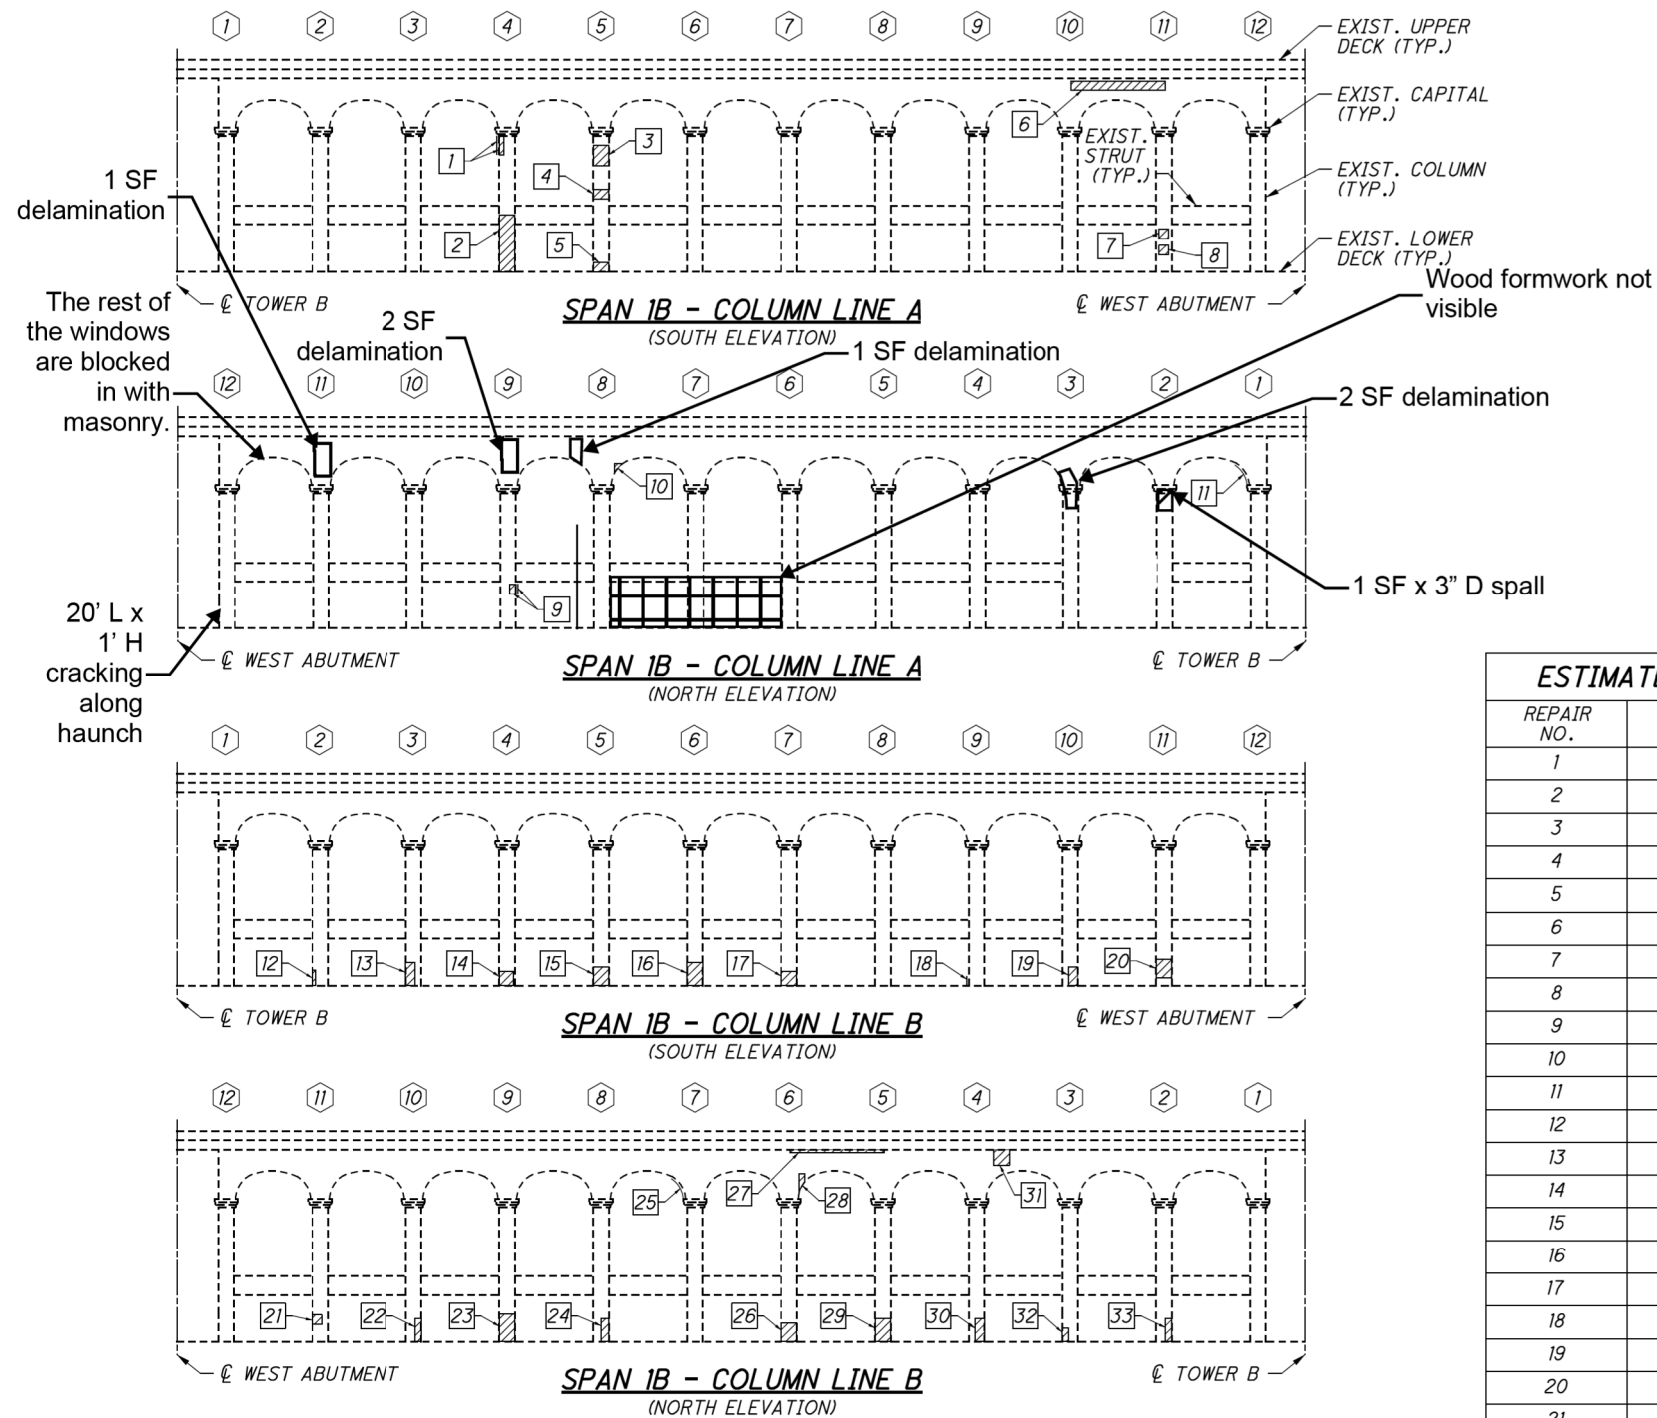
| ESTIMATED PATCHING QUANTITIES | | | |

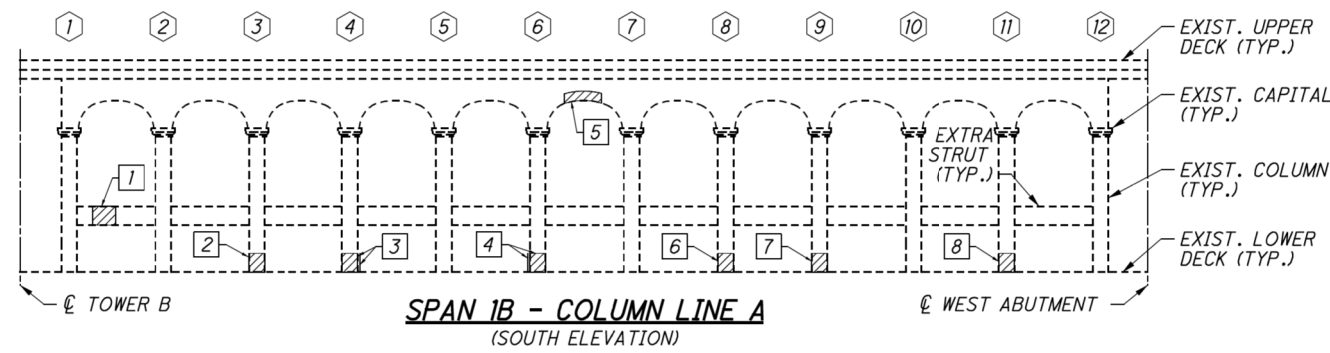
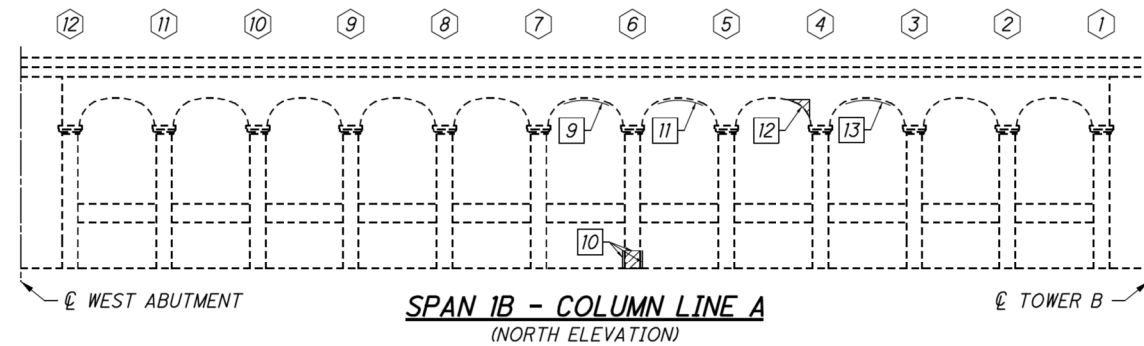
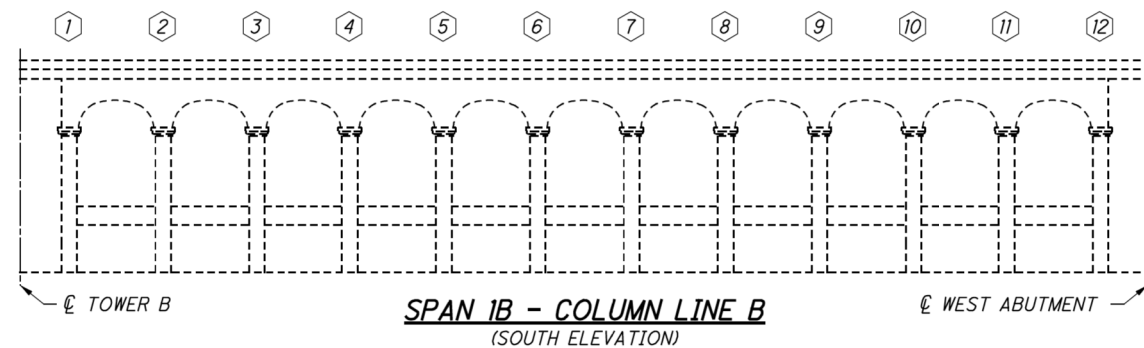
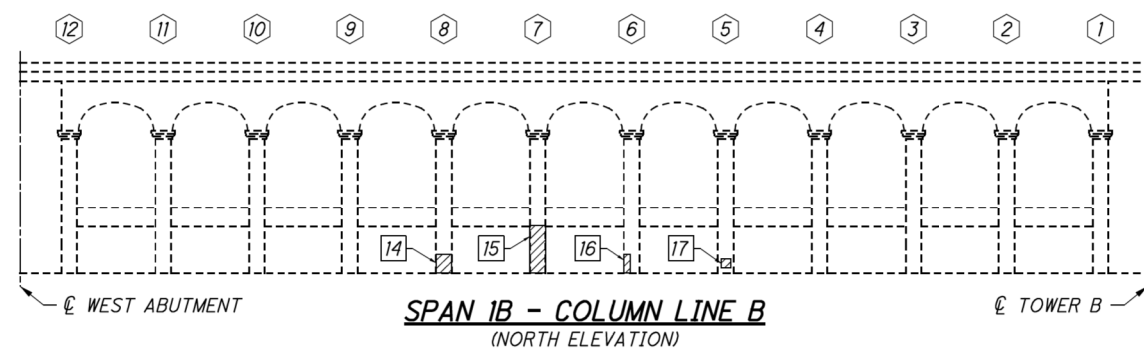
| ESTIMATED PATCHING QUANTITIES | | | |

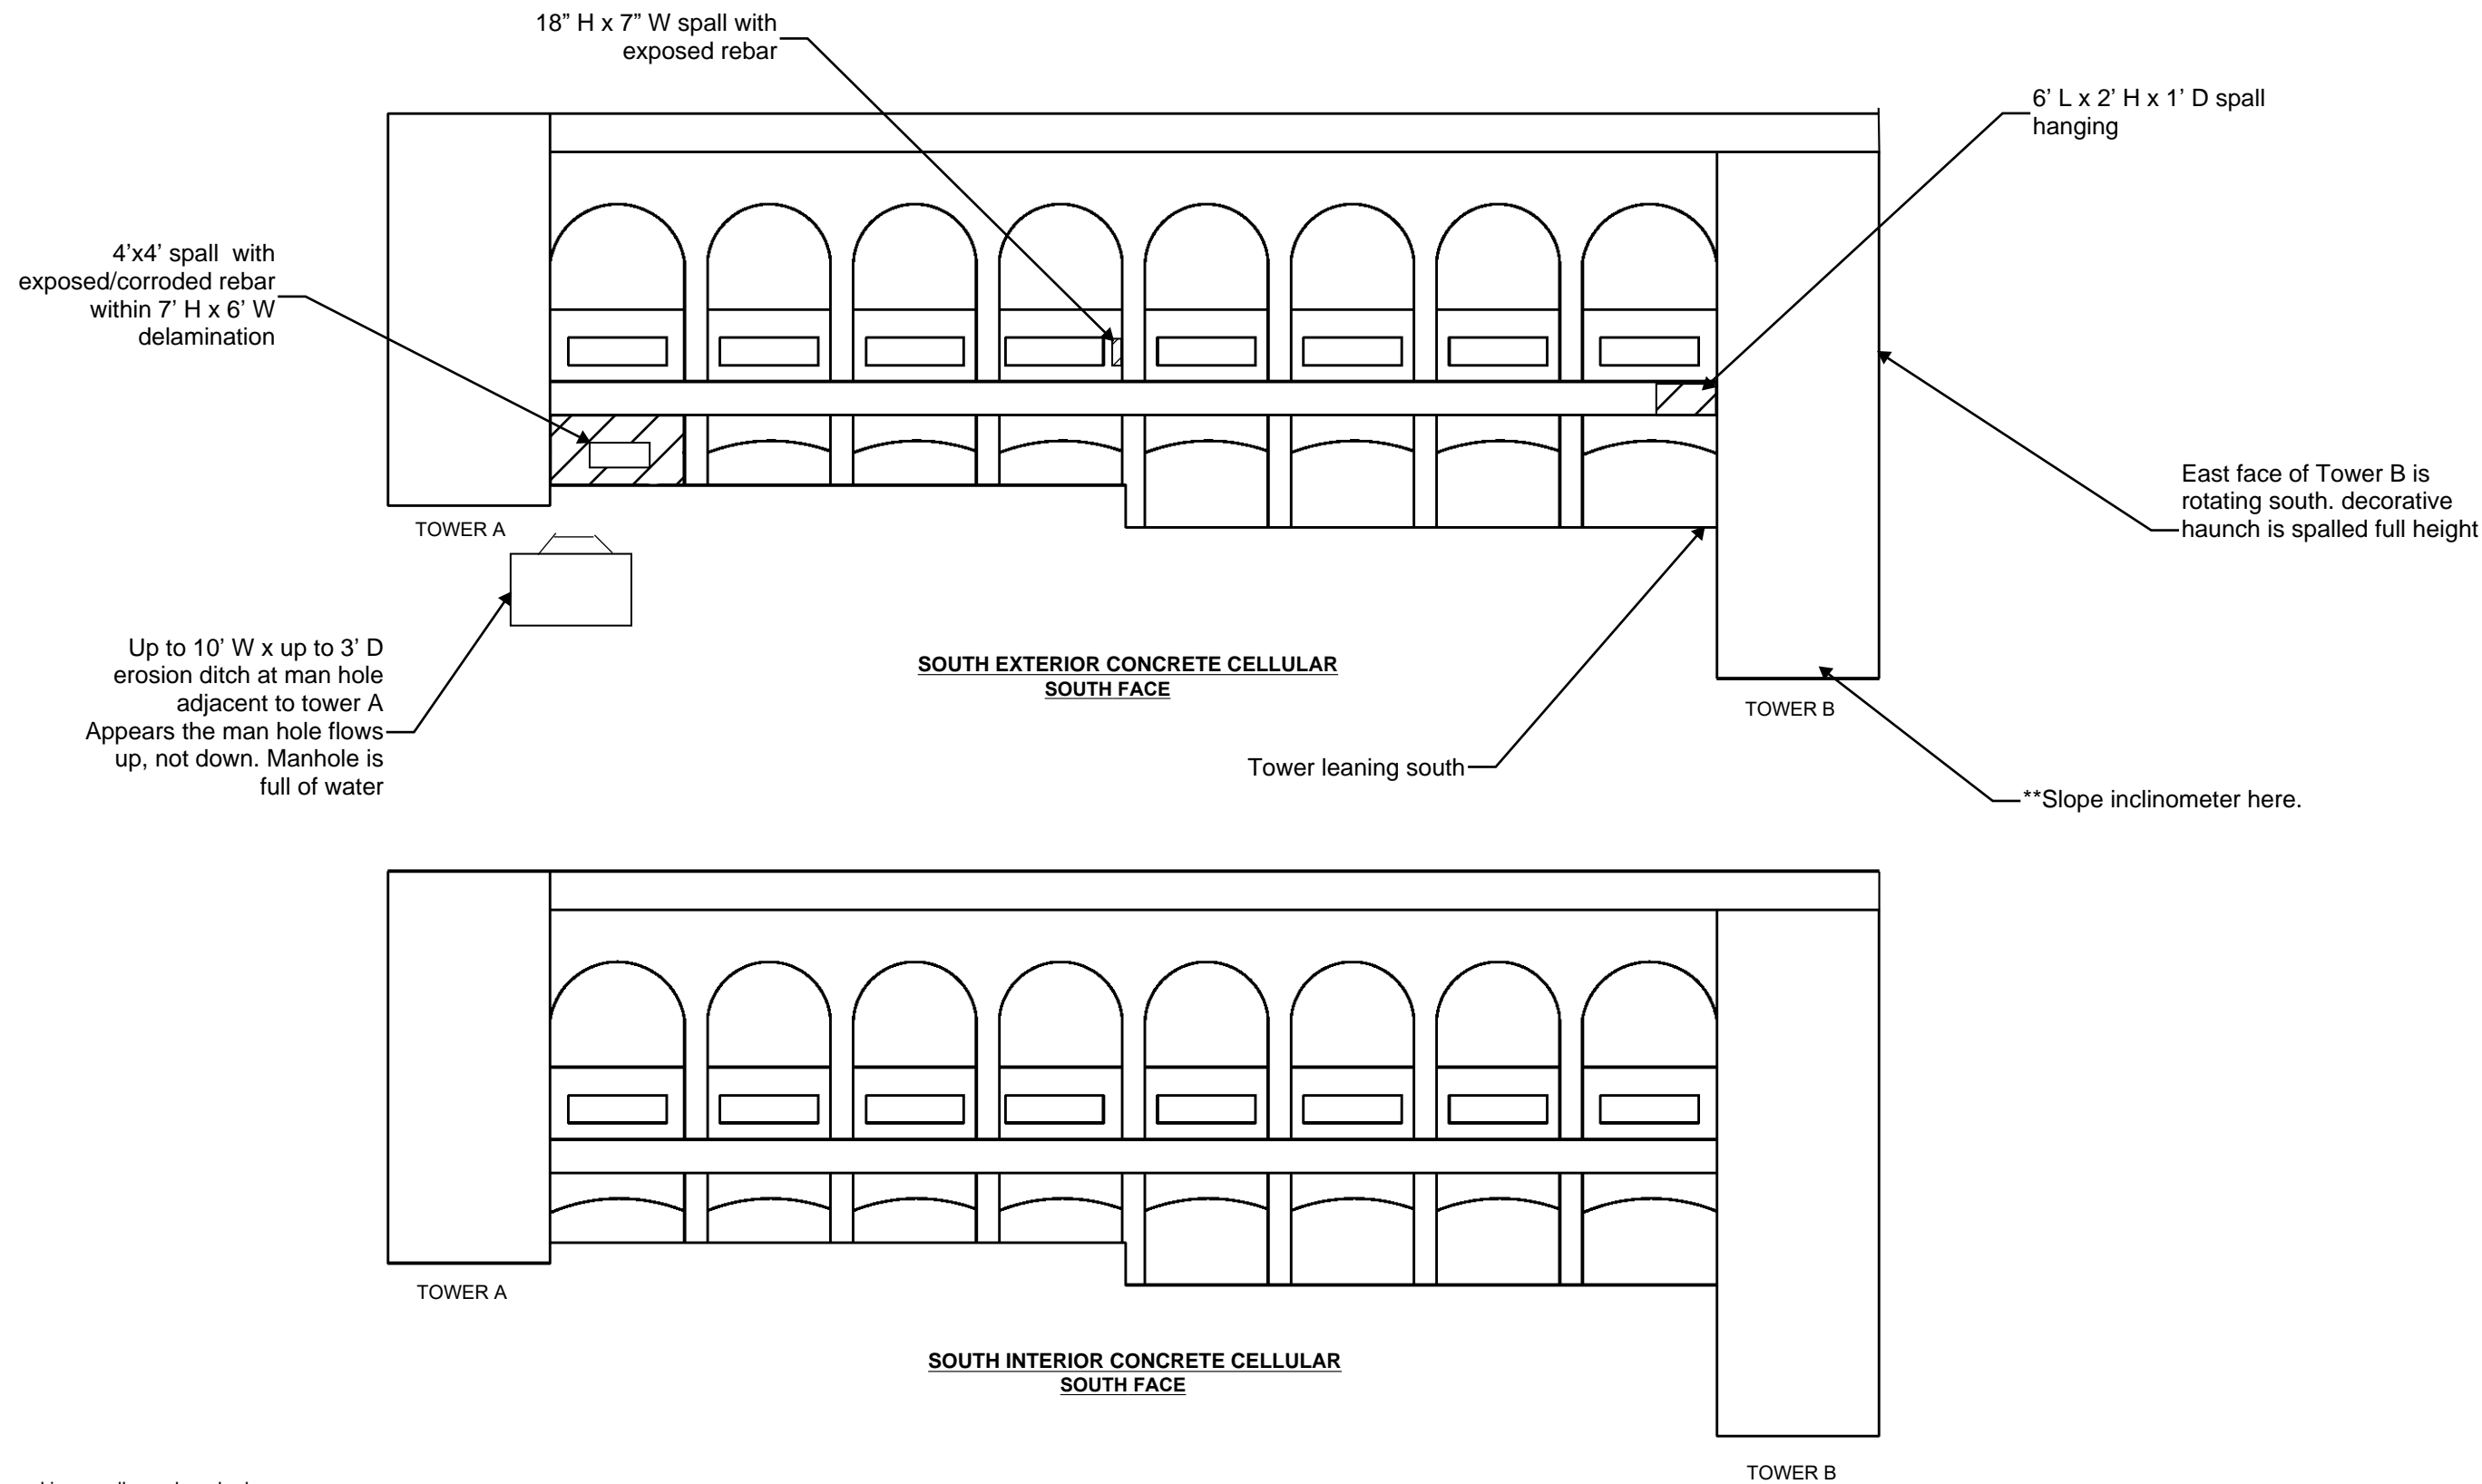
| | | | | PAGE A-32 |

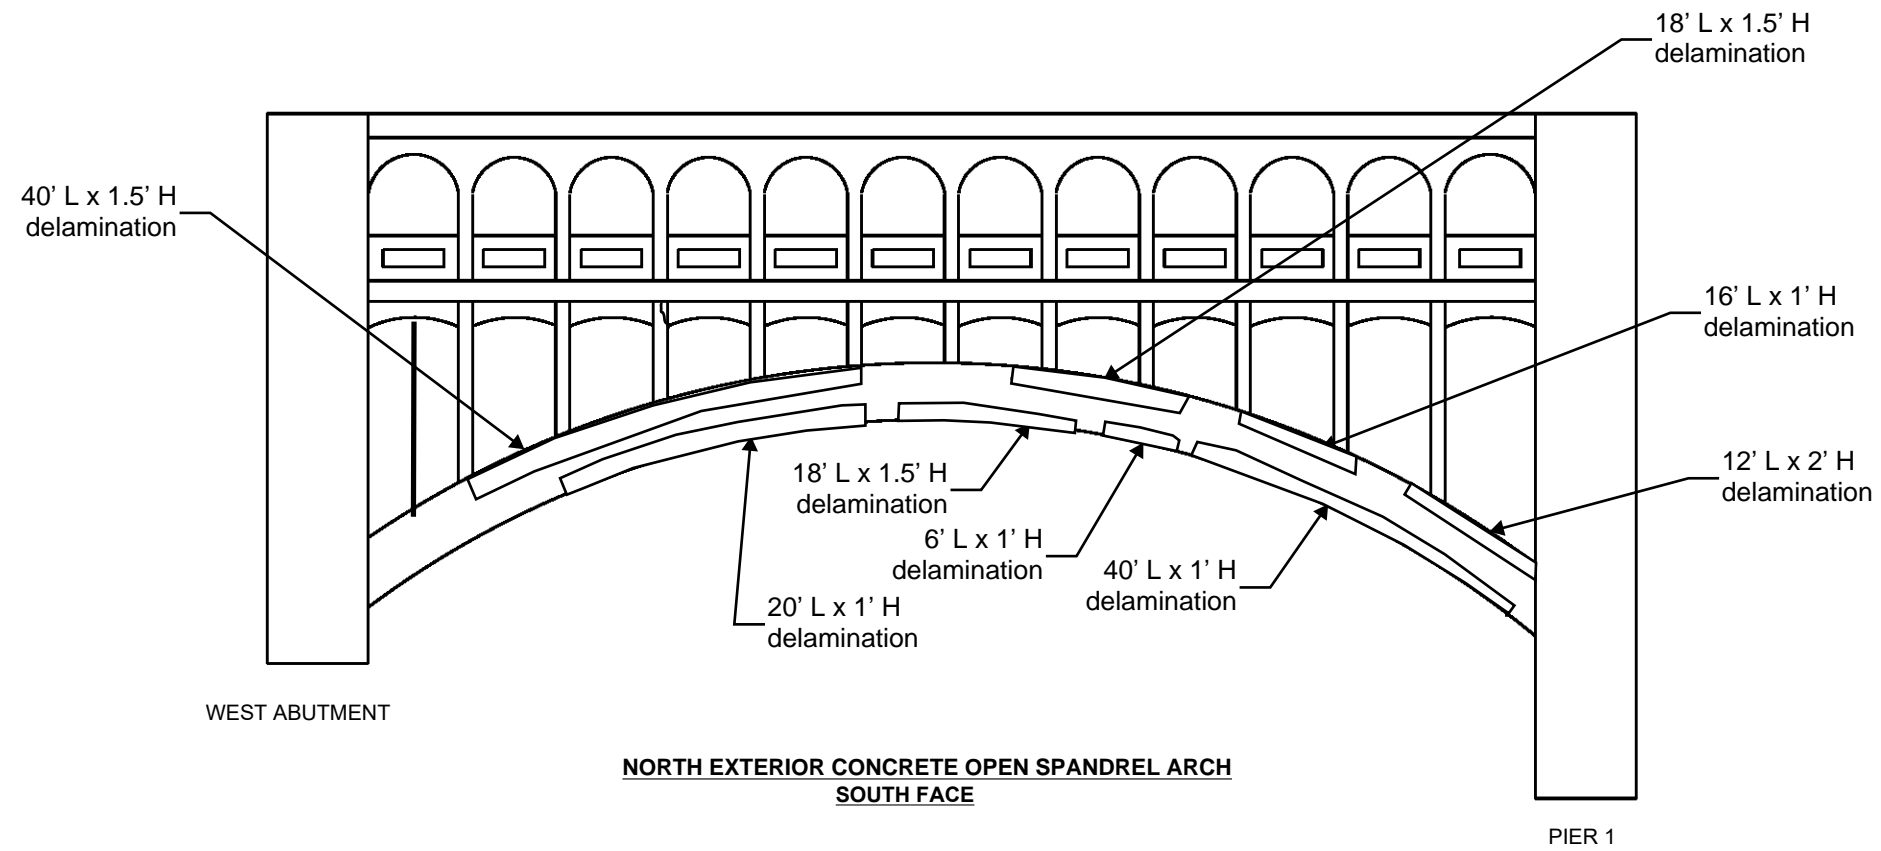
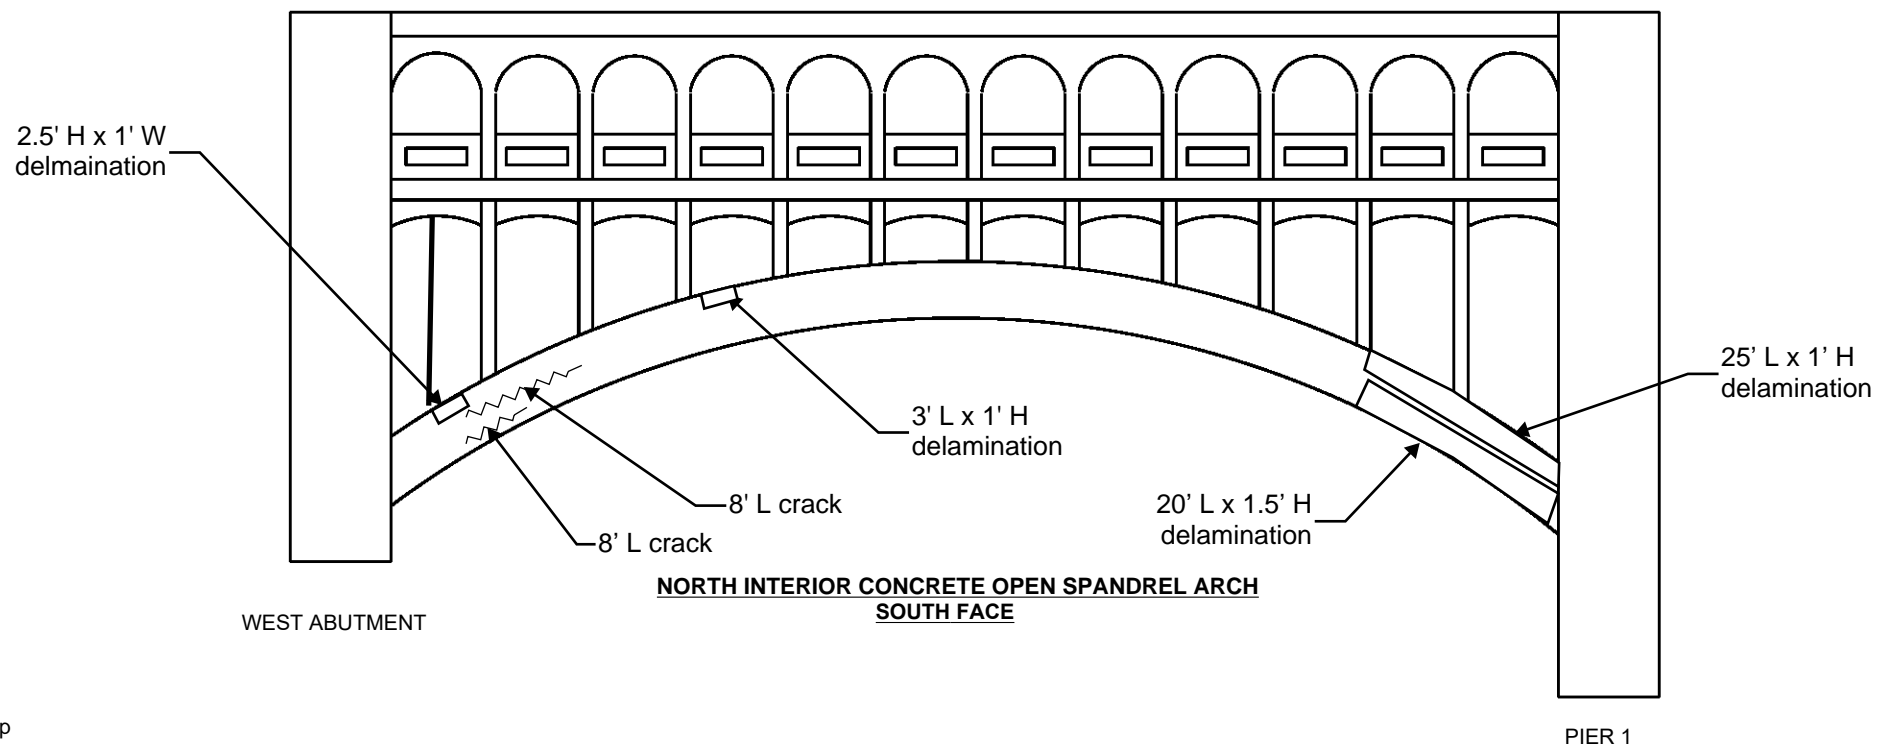
| NOT TO SCALE | NOV, 2018 | | INFRASTRUCTURE ENGINEERS, INC. | SPAN 1 CONCRETE REPAIR DETAILS |

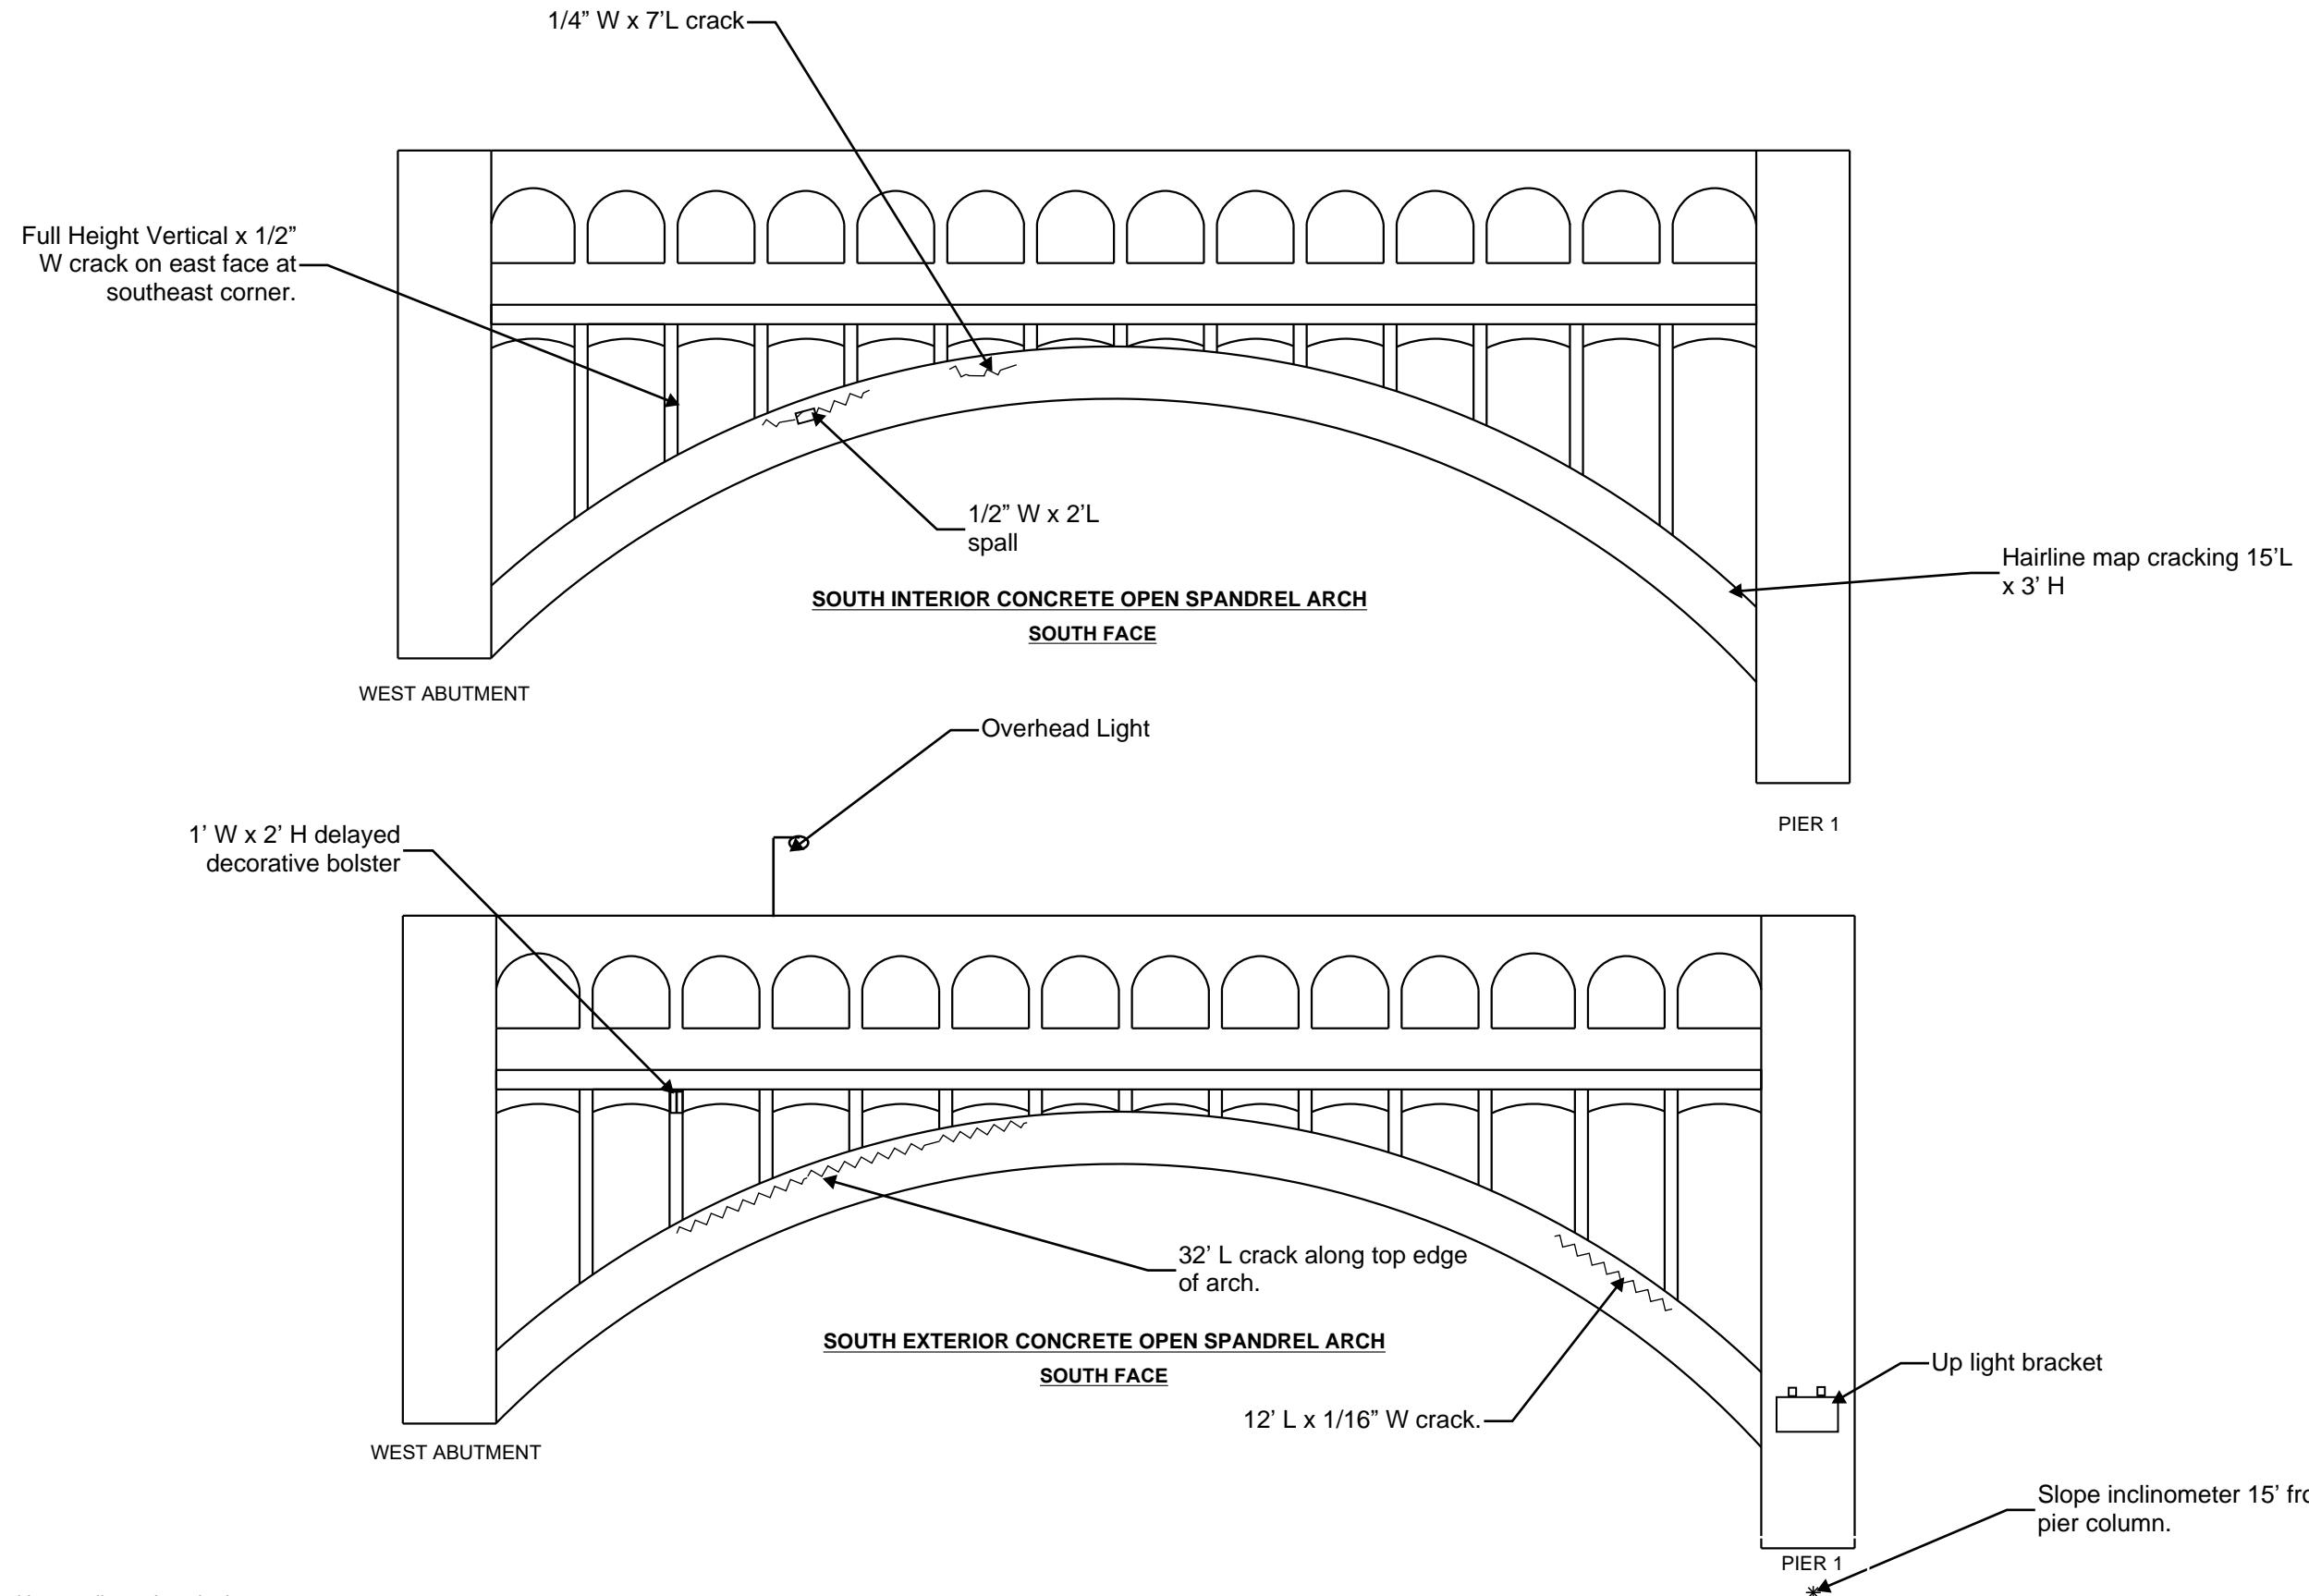
| | | | PAGE | A-36 |

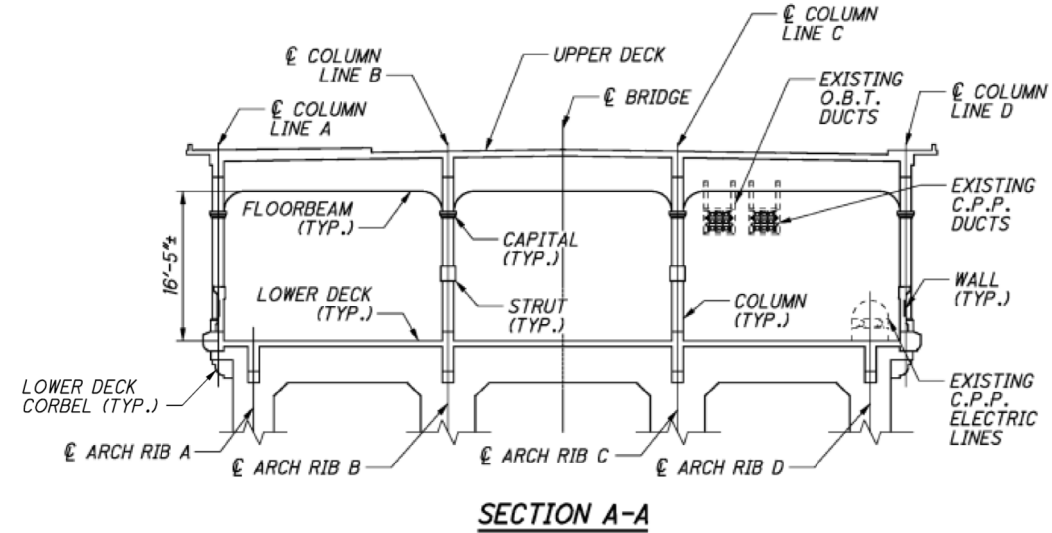
| SHEET QUANTITY SUMMARY | | |
|---|---|---|
| FRP WRAP | SF | 3524 |

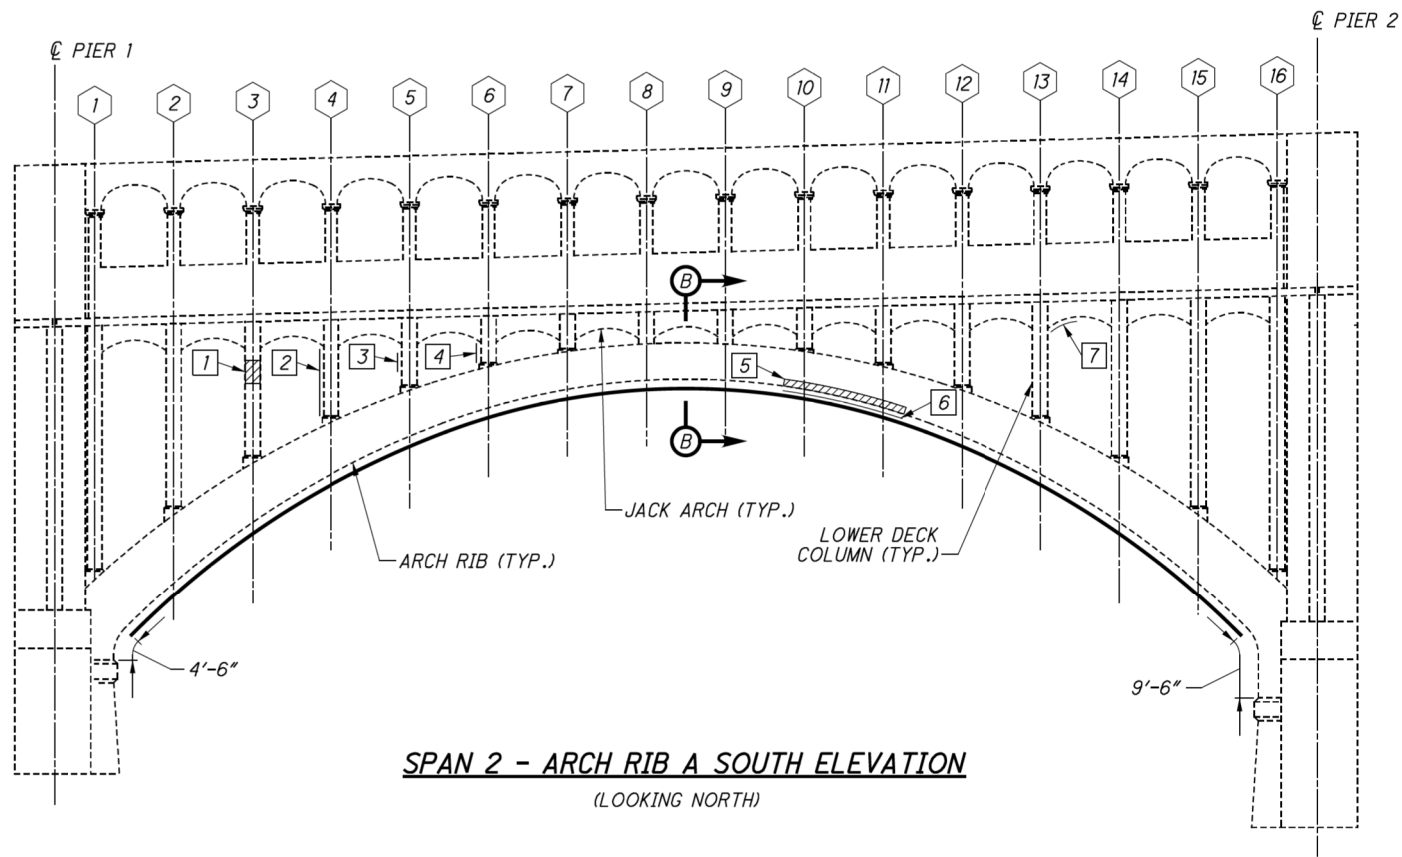
SPAN 2 - ARCH RIB A SOUTH ELEVATION
(LOOKING NORTH)

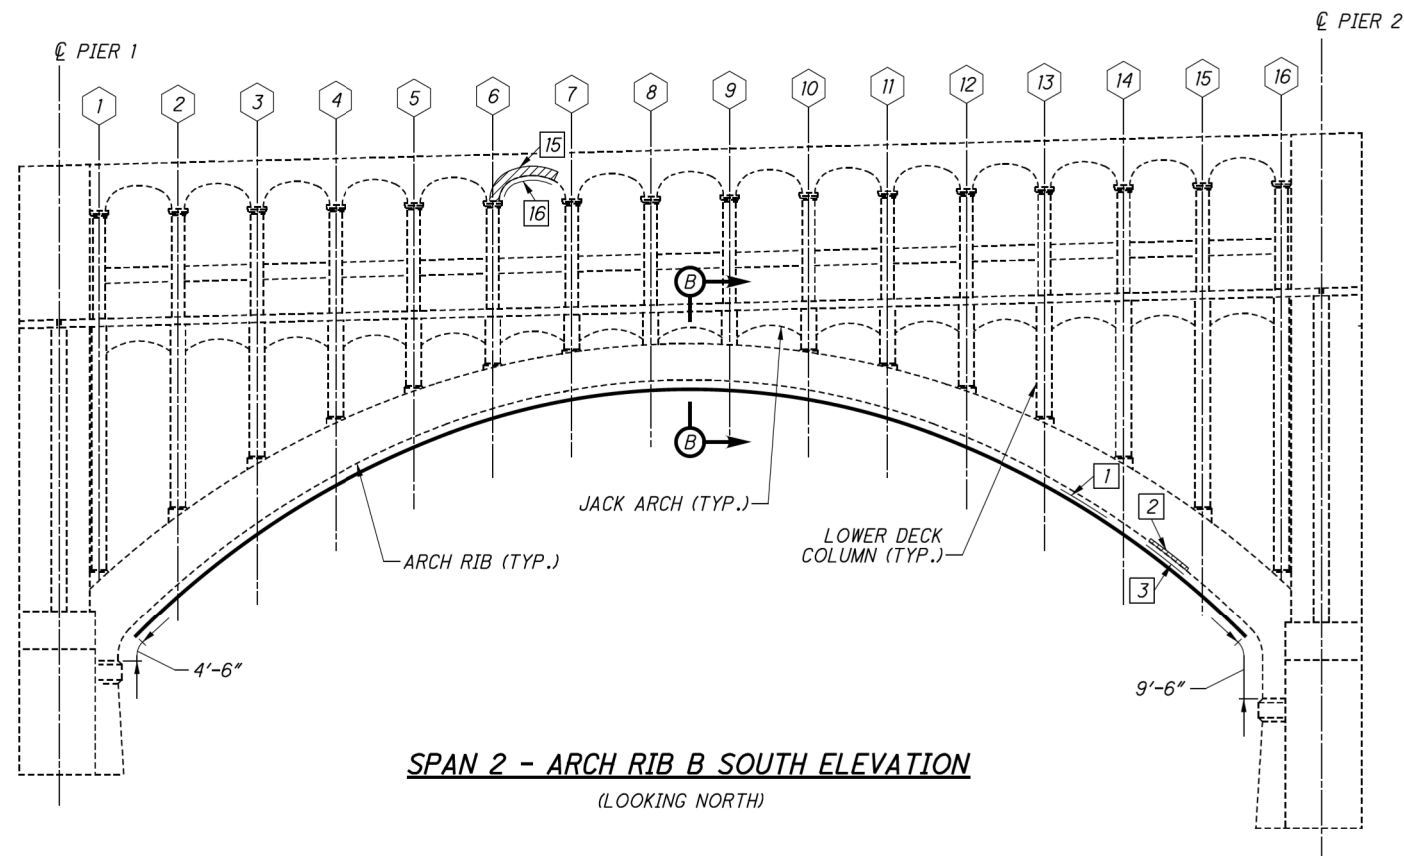
SPAN 2 - ARCH RIB B SOUTH ELEVATION
(LOOKING NORTH)

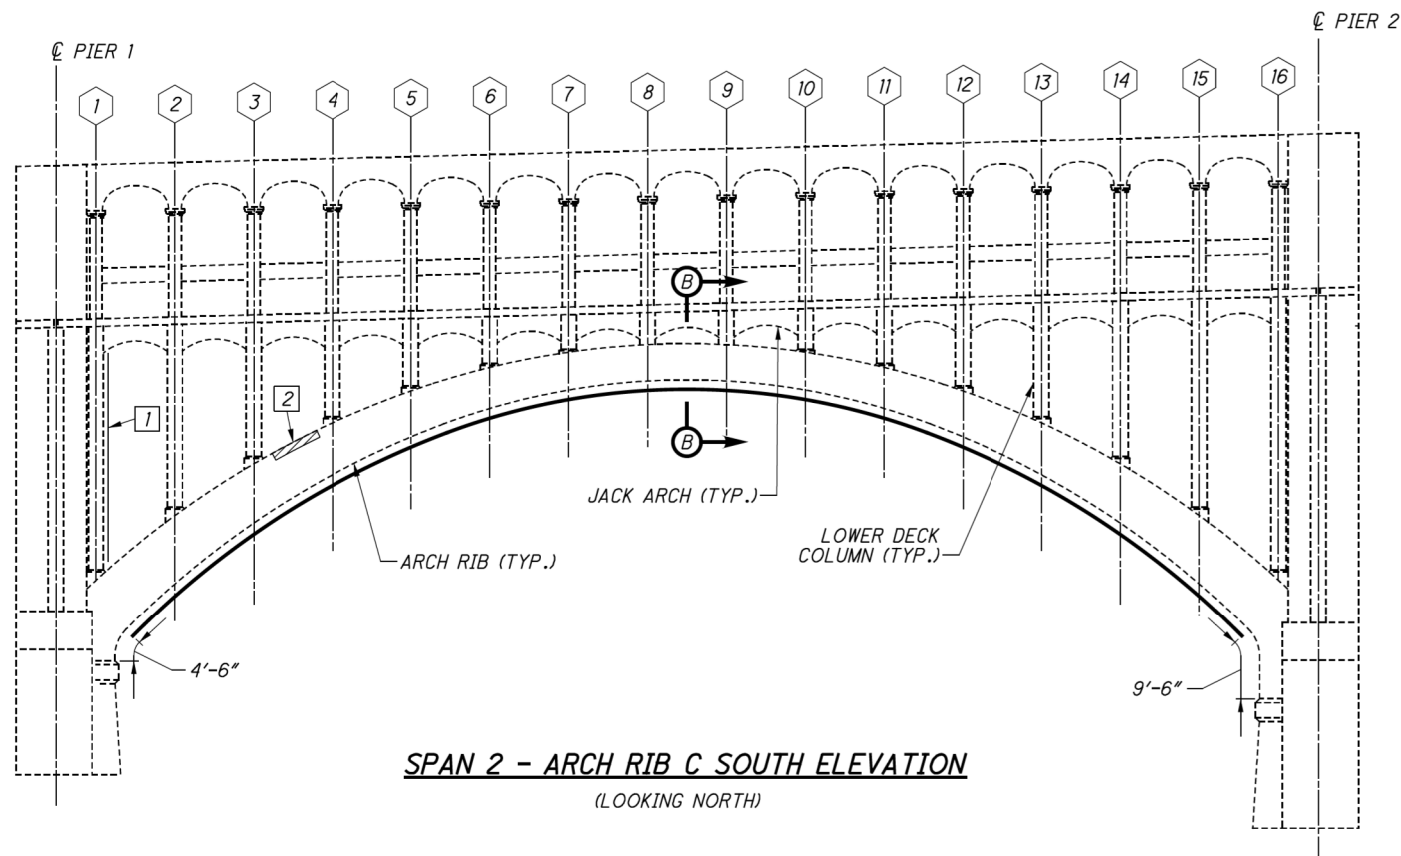
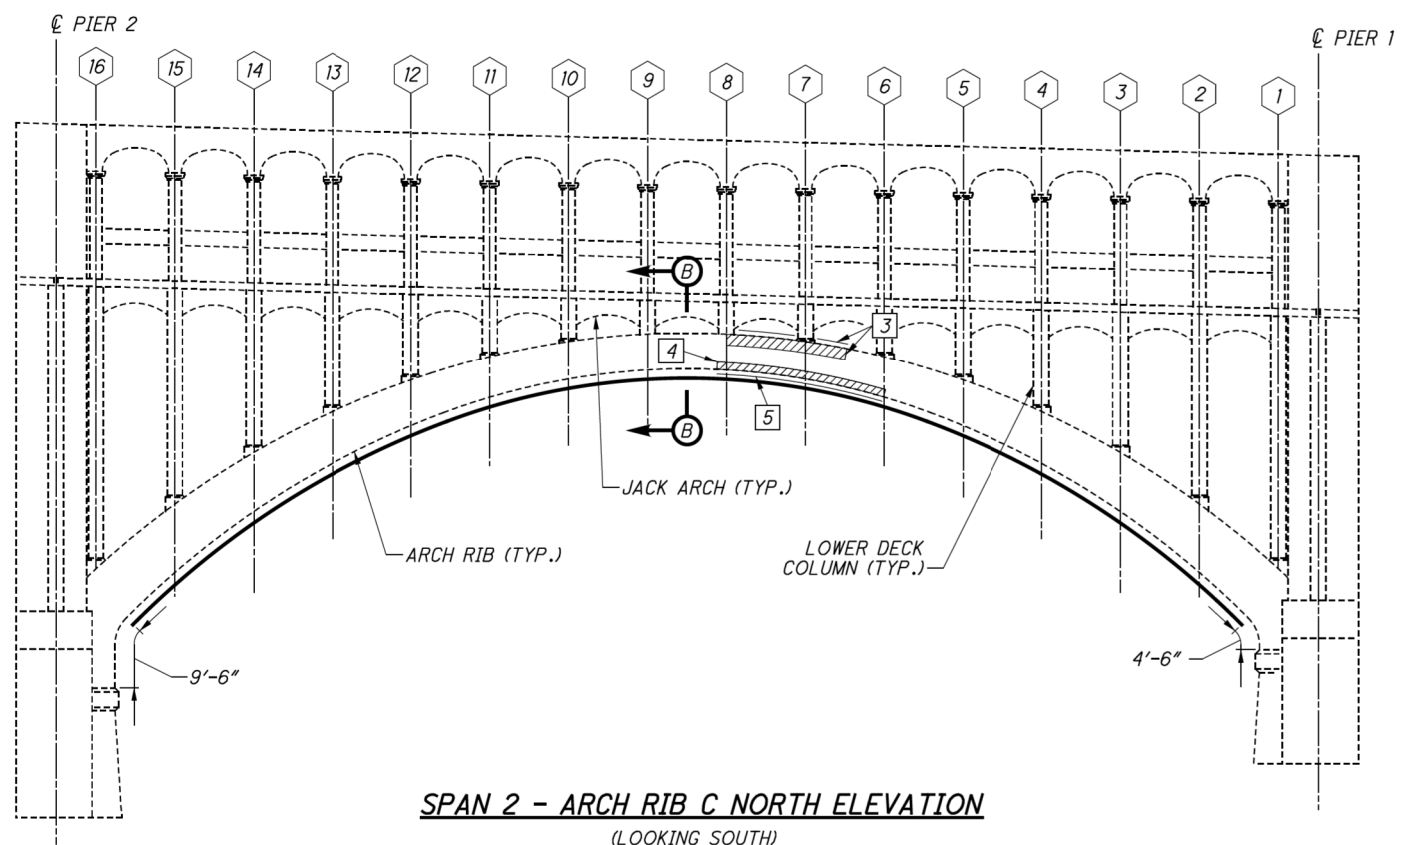
| ESTIMATED PATCHING QUANTITIES | | | |

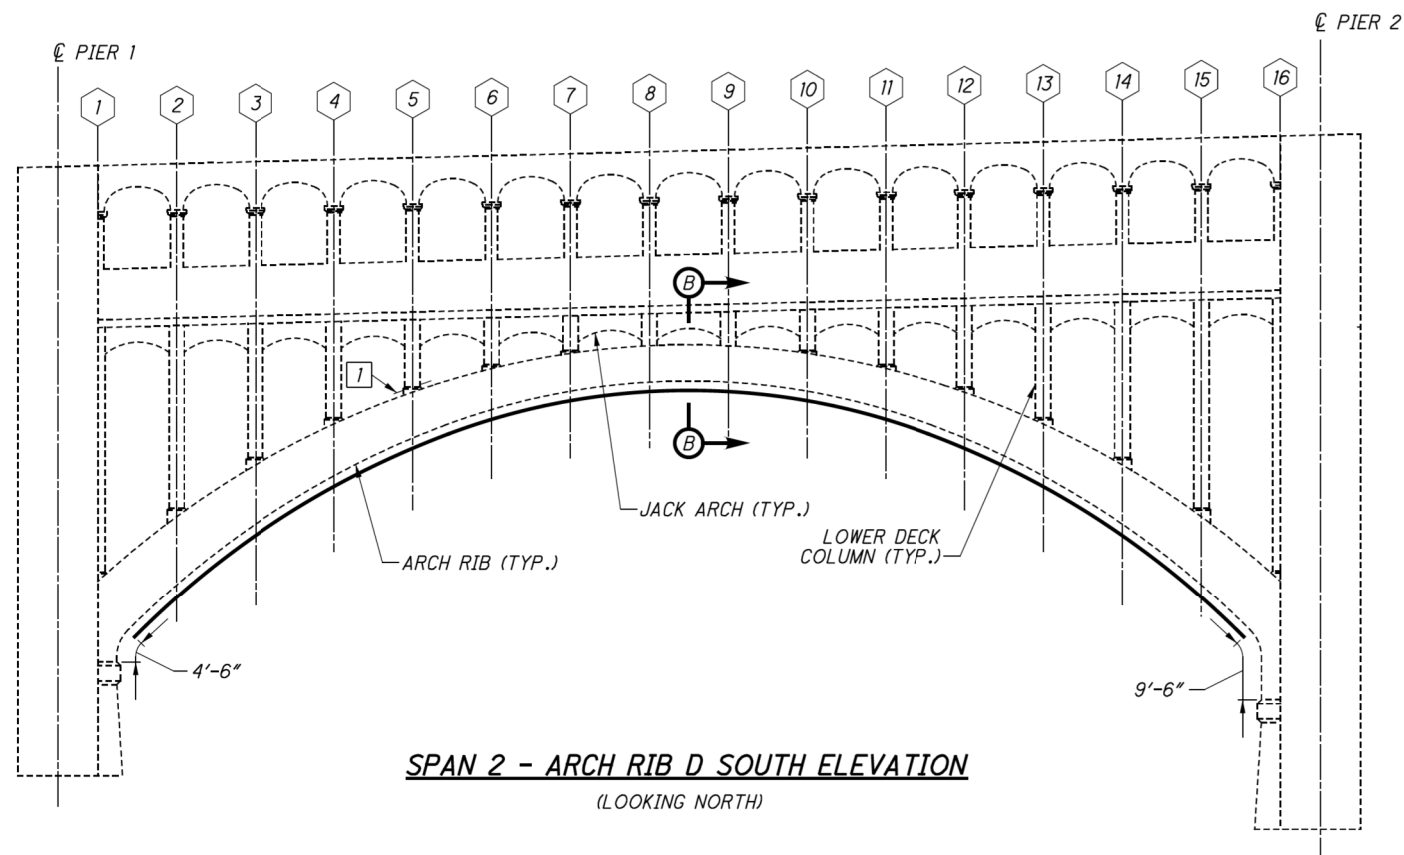
SPAN 2 - ARCH RIB D SOUTH ELEVATION
(LOOKING NORTH)

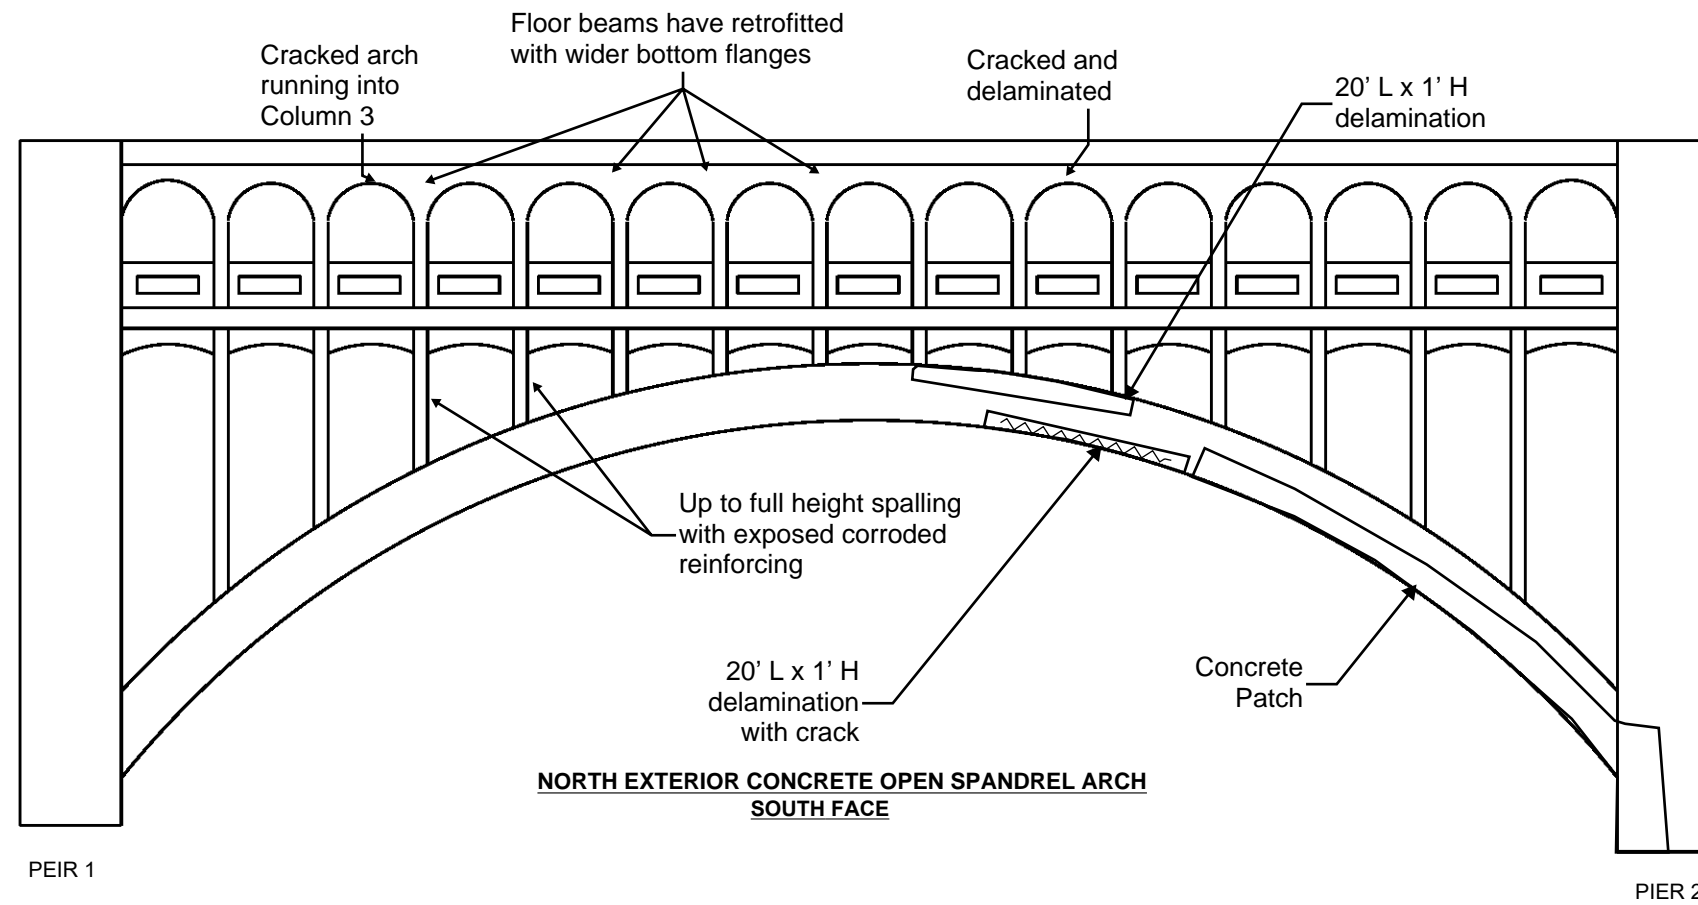
| NOT TO SCALE | NOV, 2018 | | INFRASTRUCTURE ENGINEERS, INC. | SPAN 2 CONCRETE REPAIR DETAILS |
