CUY-6-1456

PHYSICAL CONDITION REPORT ROUTINE FRACTURE CRITICAL INSPECTION VETERANS MEMORIAL/DETROIT-SUPERIOR BRIDGE OVER THE CUYAHOGA RIVER SFN: 1800930

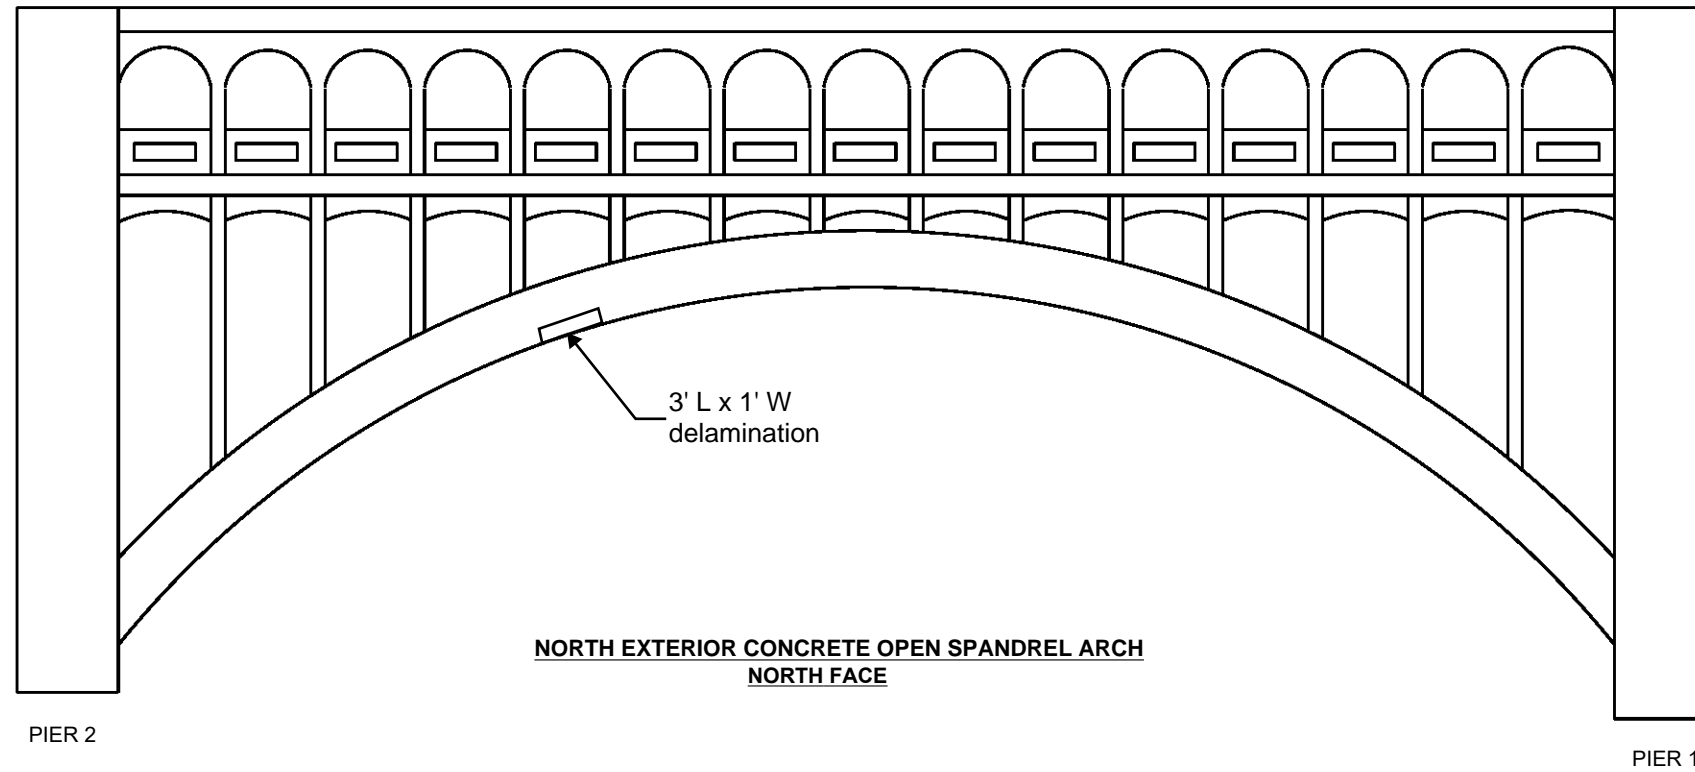
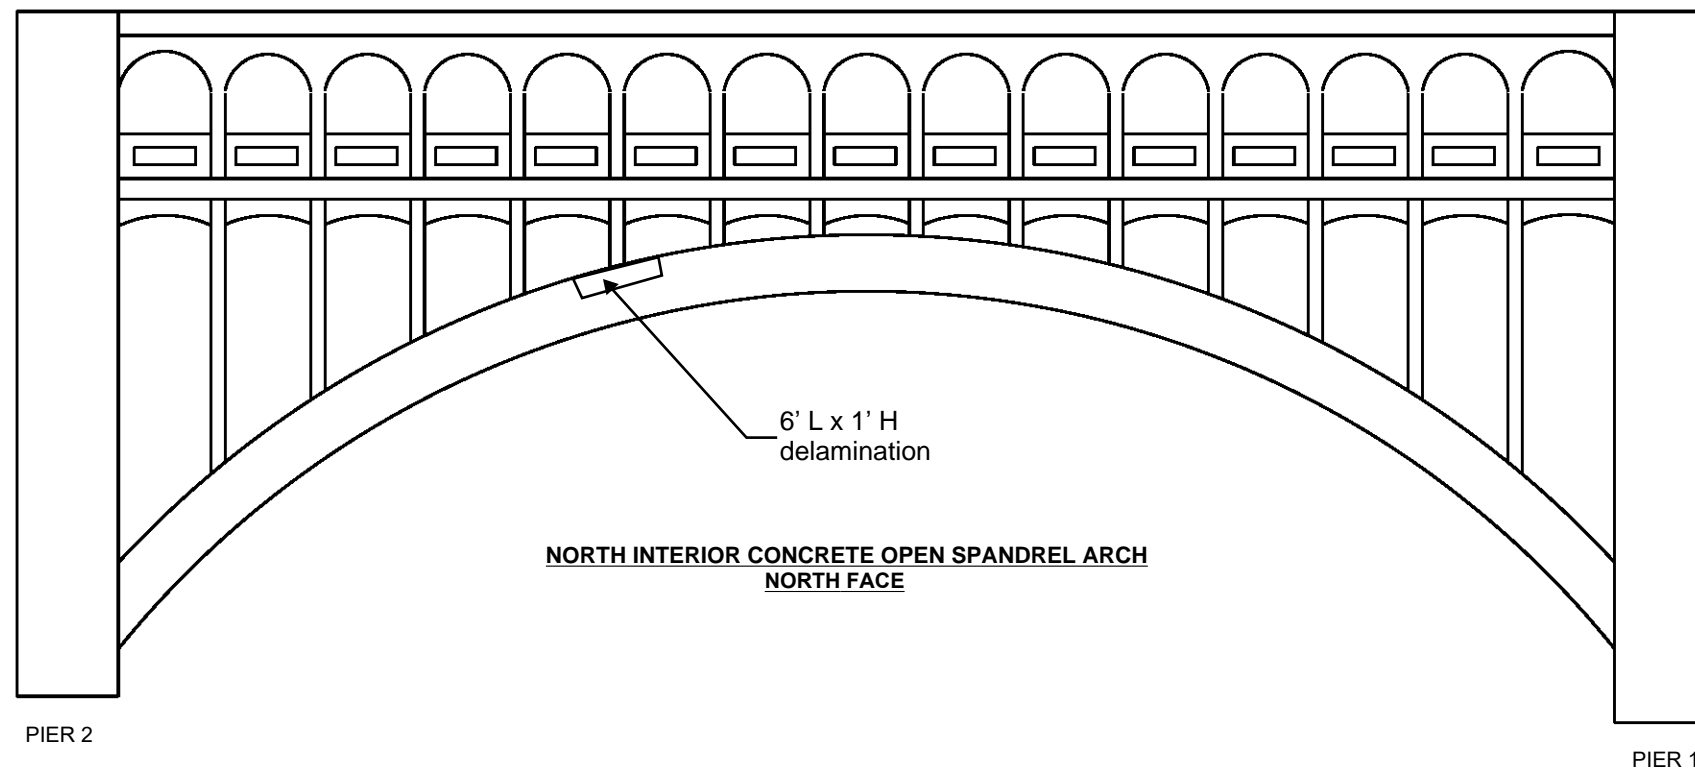
| | | | | |
|---|---|--|--|---|
| GRAPHIC SCALE MEASURED IN FEET | DATE | 9902 Carver Road
Suite 201
Cincinnati, OH 45242
PH.: 614.699.5000 | DETROIT-SUPERIOR BRIDGE OVER CUYAHOGA RIVER
BRIDGE NO. CUY-6-1465 | |
| NOT TO SCALE | NOV, 2018 | | | STRUCTURE ELEVATION - SPAN 2 <table border="1" style="float: right; margin-left: 10px;"> <tr> <td>PAGE</td> </tr> <tr> <td>A-44</td> </tr> </table> |
| PAGE | | | | |
| A-44 | | | | |

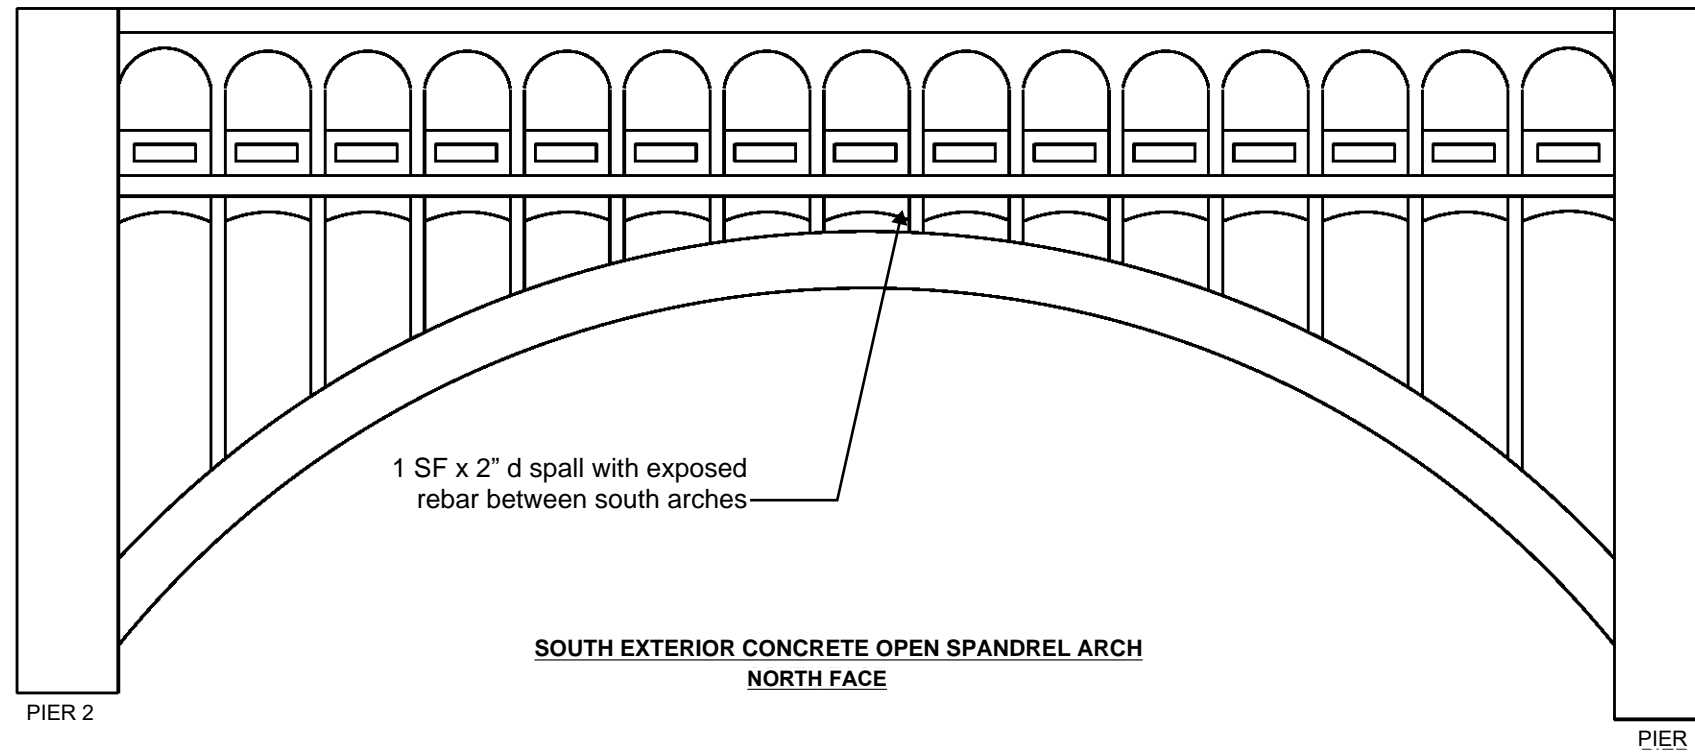
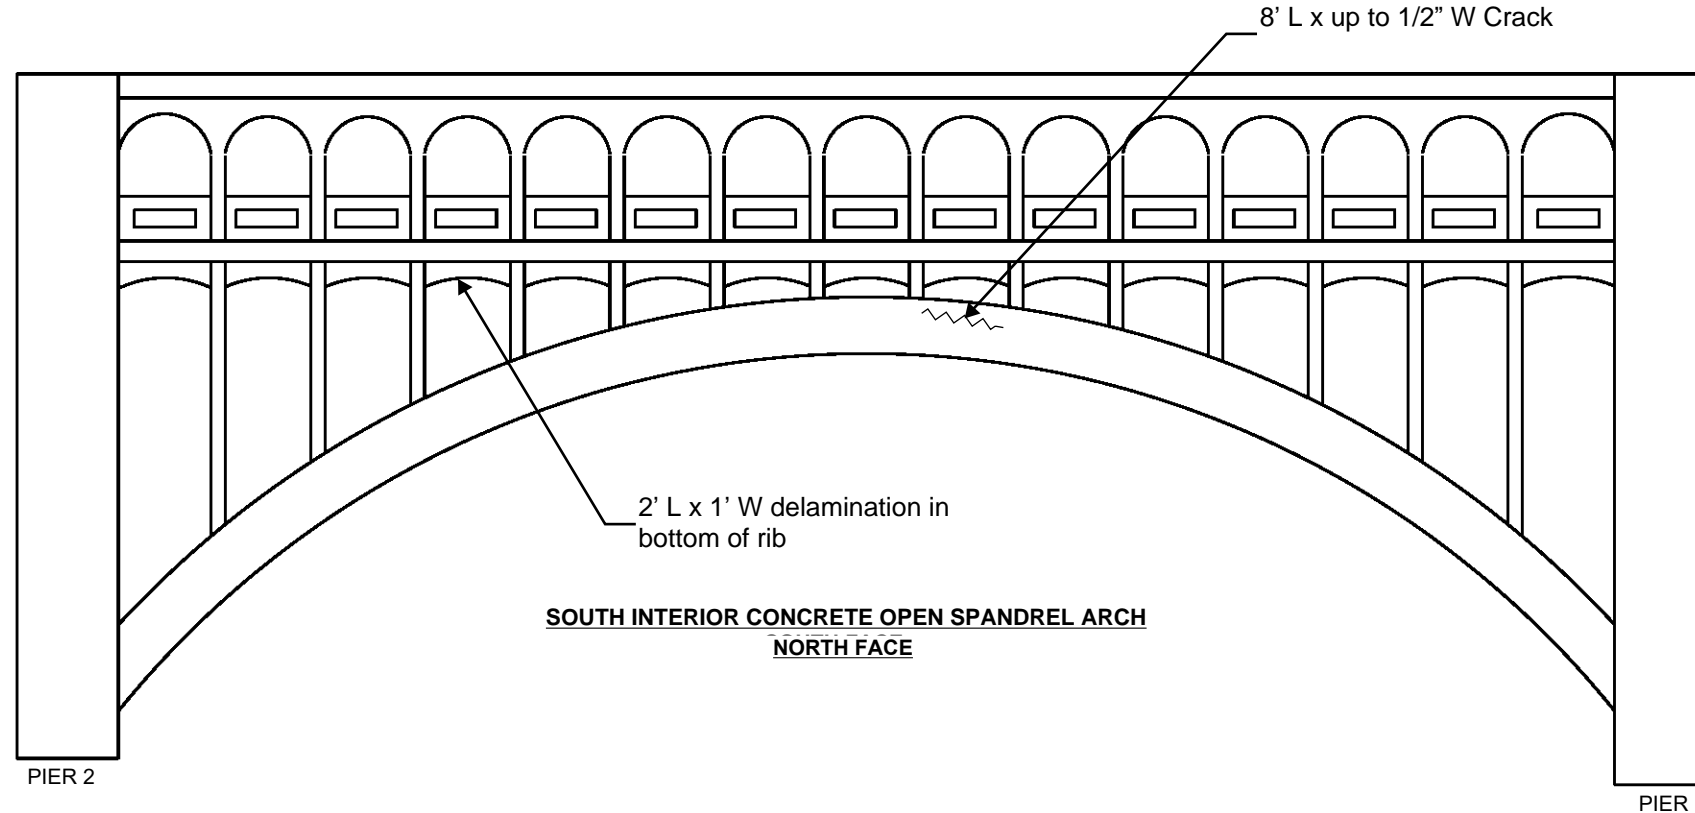
| NOT TO SCALE | NOV, 2018 | | INFRASTRUCTURE ENGINEERS, INC. | STRUCTURE ELEVATION - SPAN 2 |

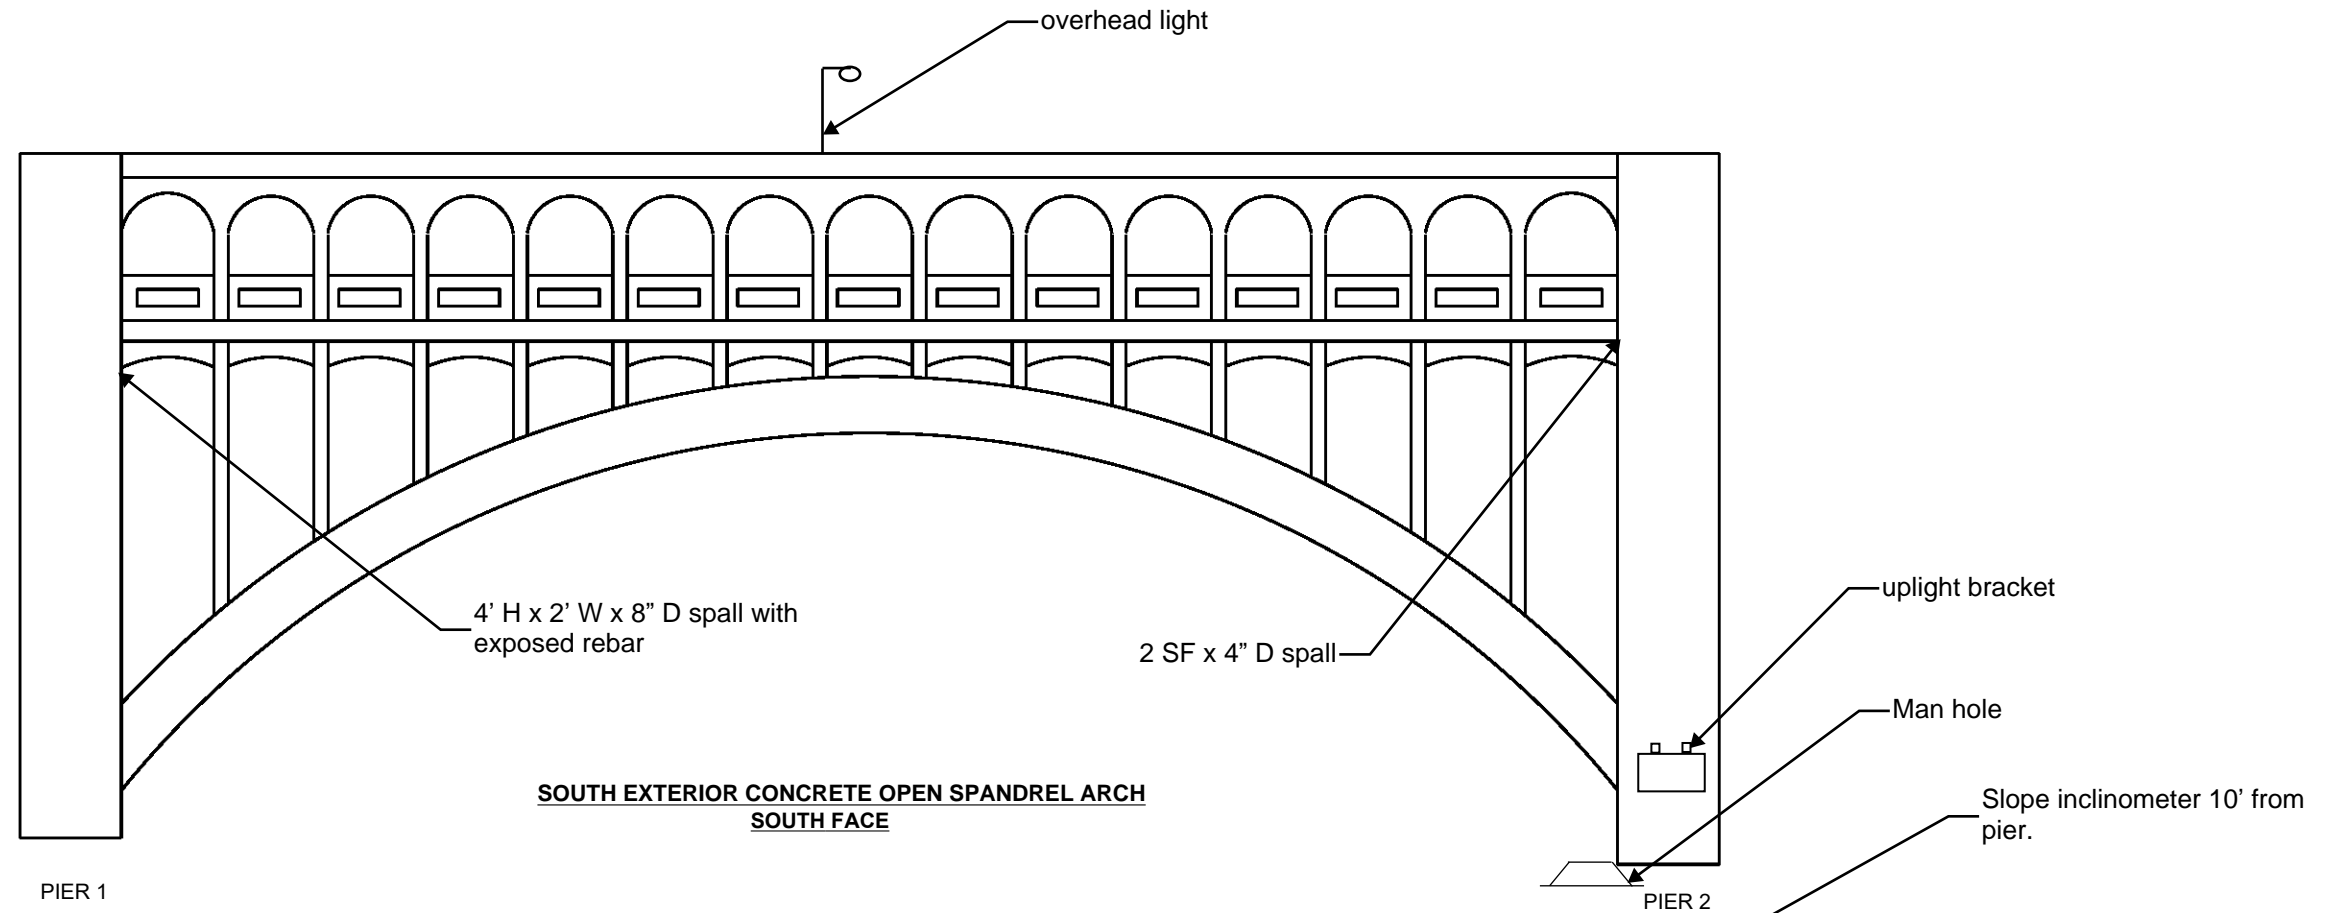
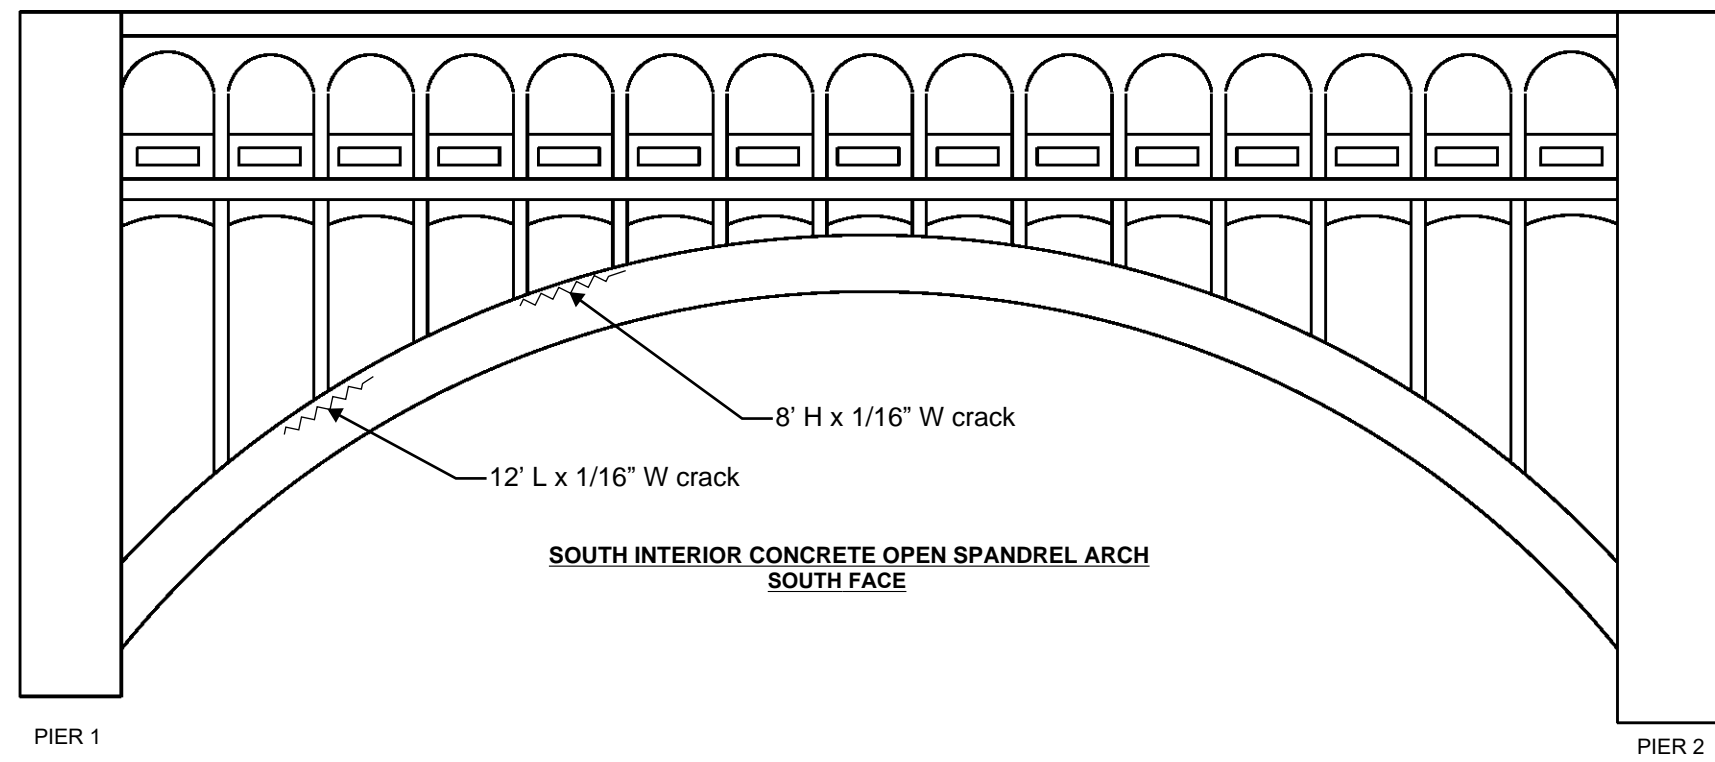
ENGINEERS, INC. | STRUCTURE ELEVATION - SPAN 2 |

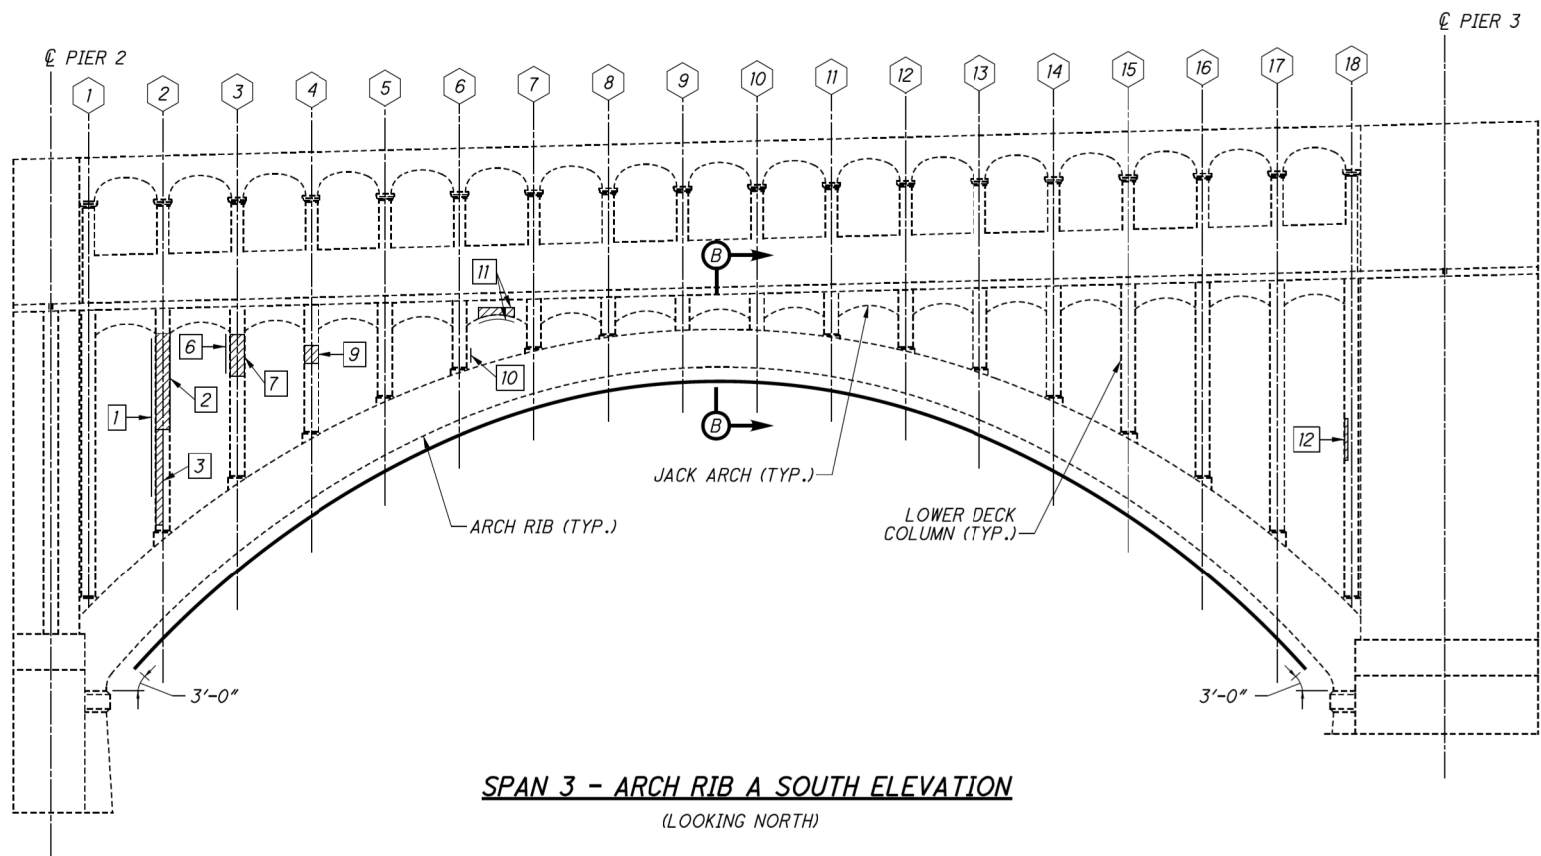
SPAN 3 - ARCH RIB A SOUTH ELEVATION
(LOOKING NORTH)

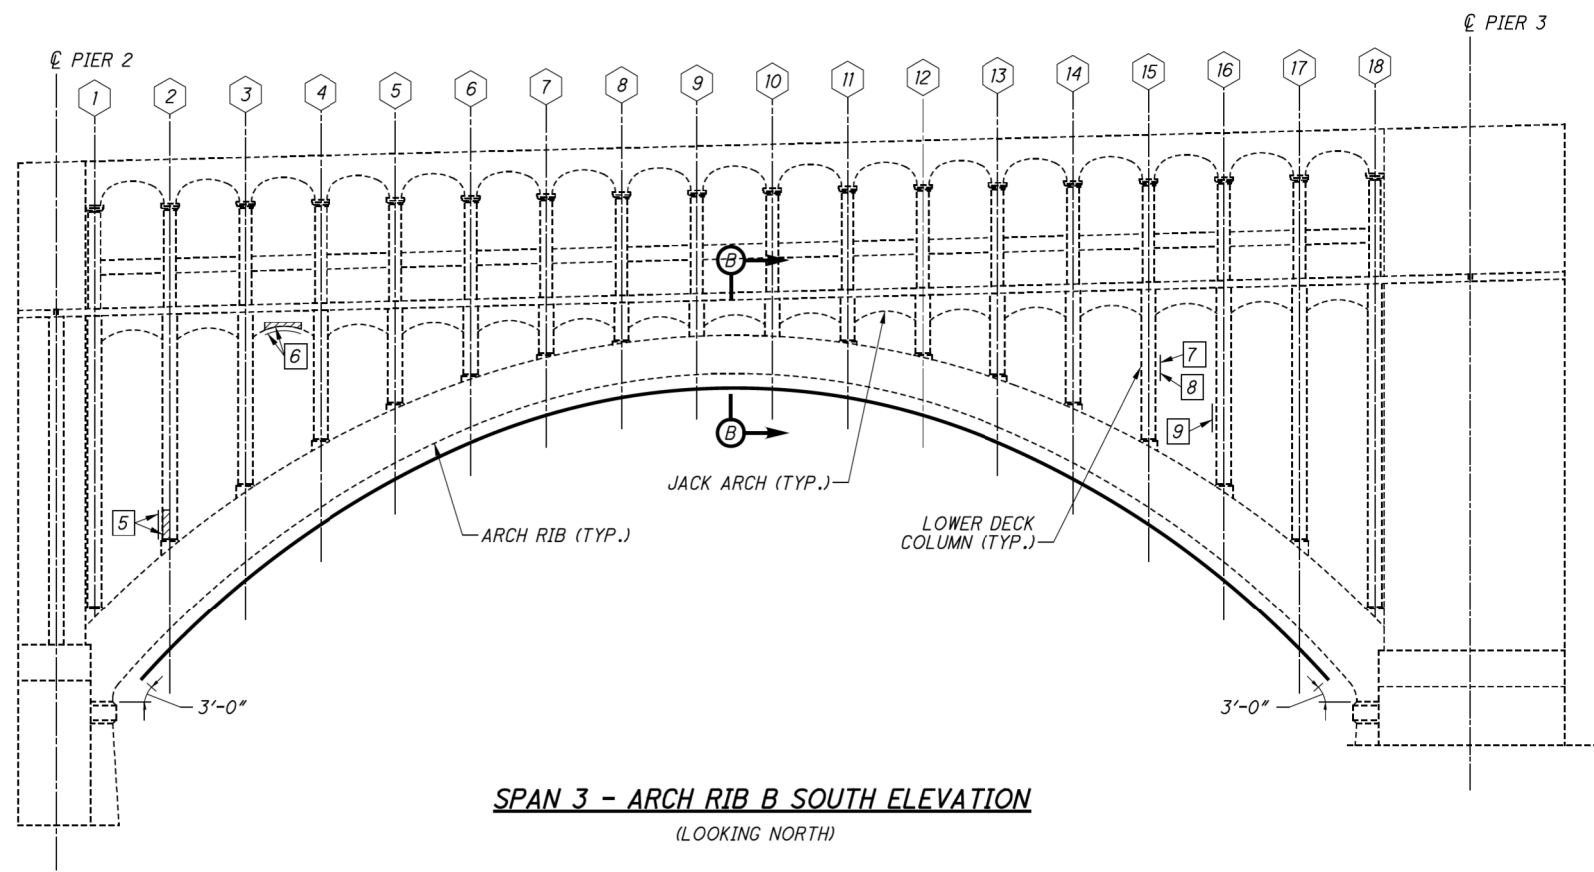
SPAN 3 - ARCH RIB B SOUTH ELEVATION
(LOOKING NORTH)

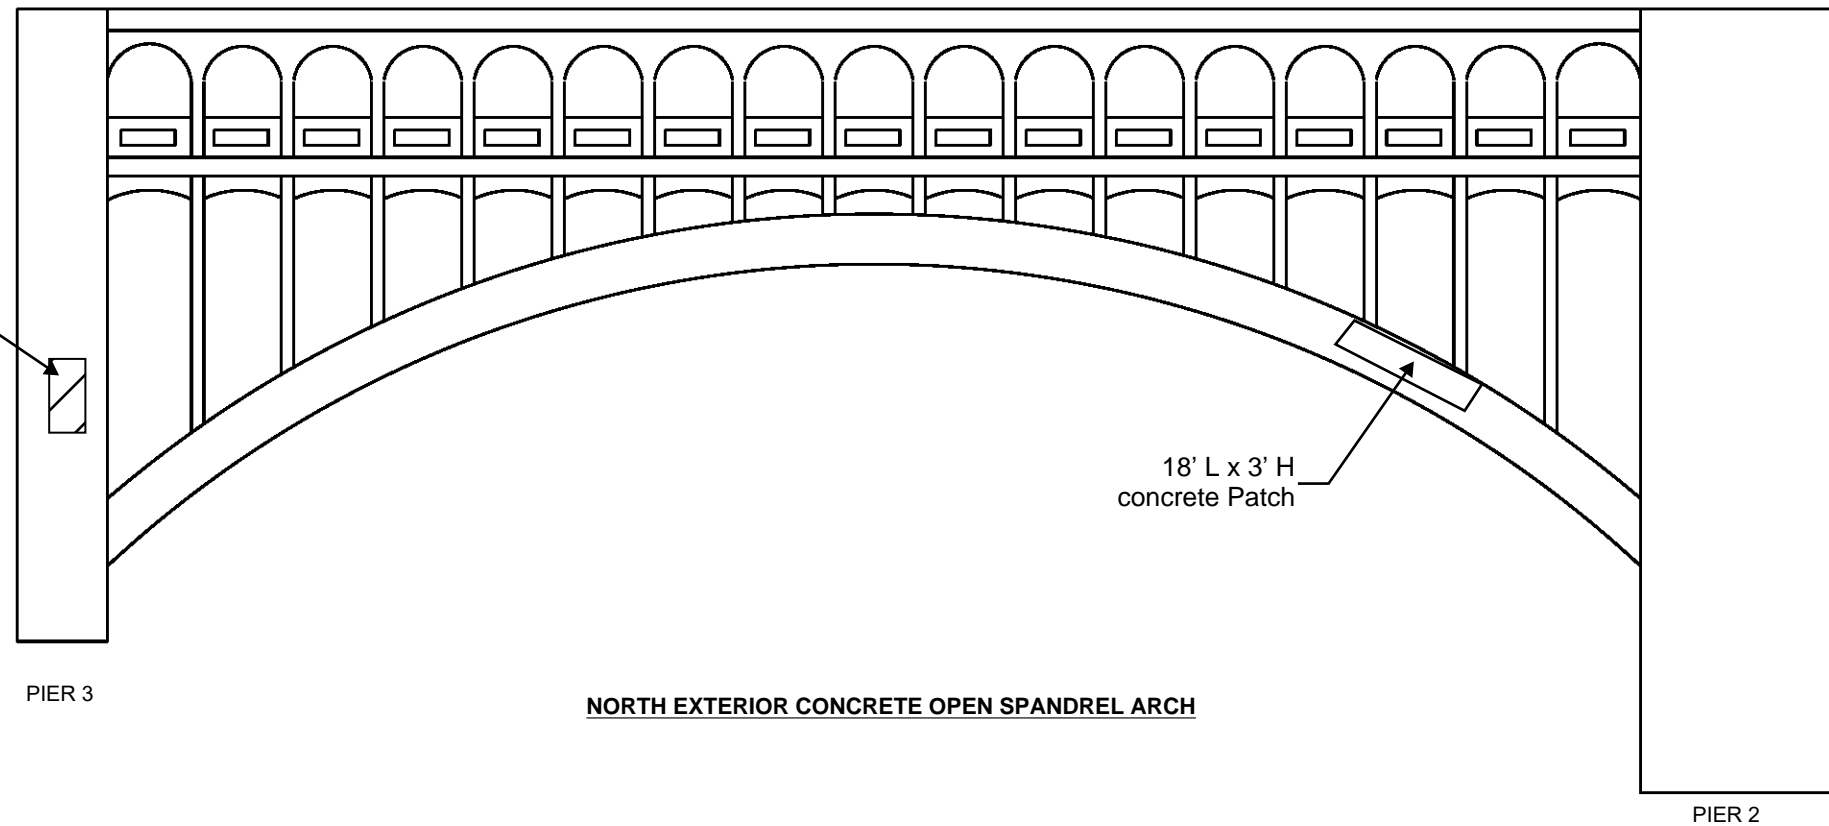
NORTH EXTERIOR CONCRETE OPEN SPANDREL ARCH

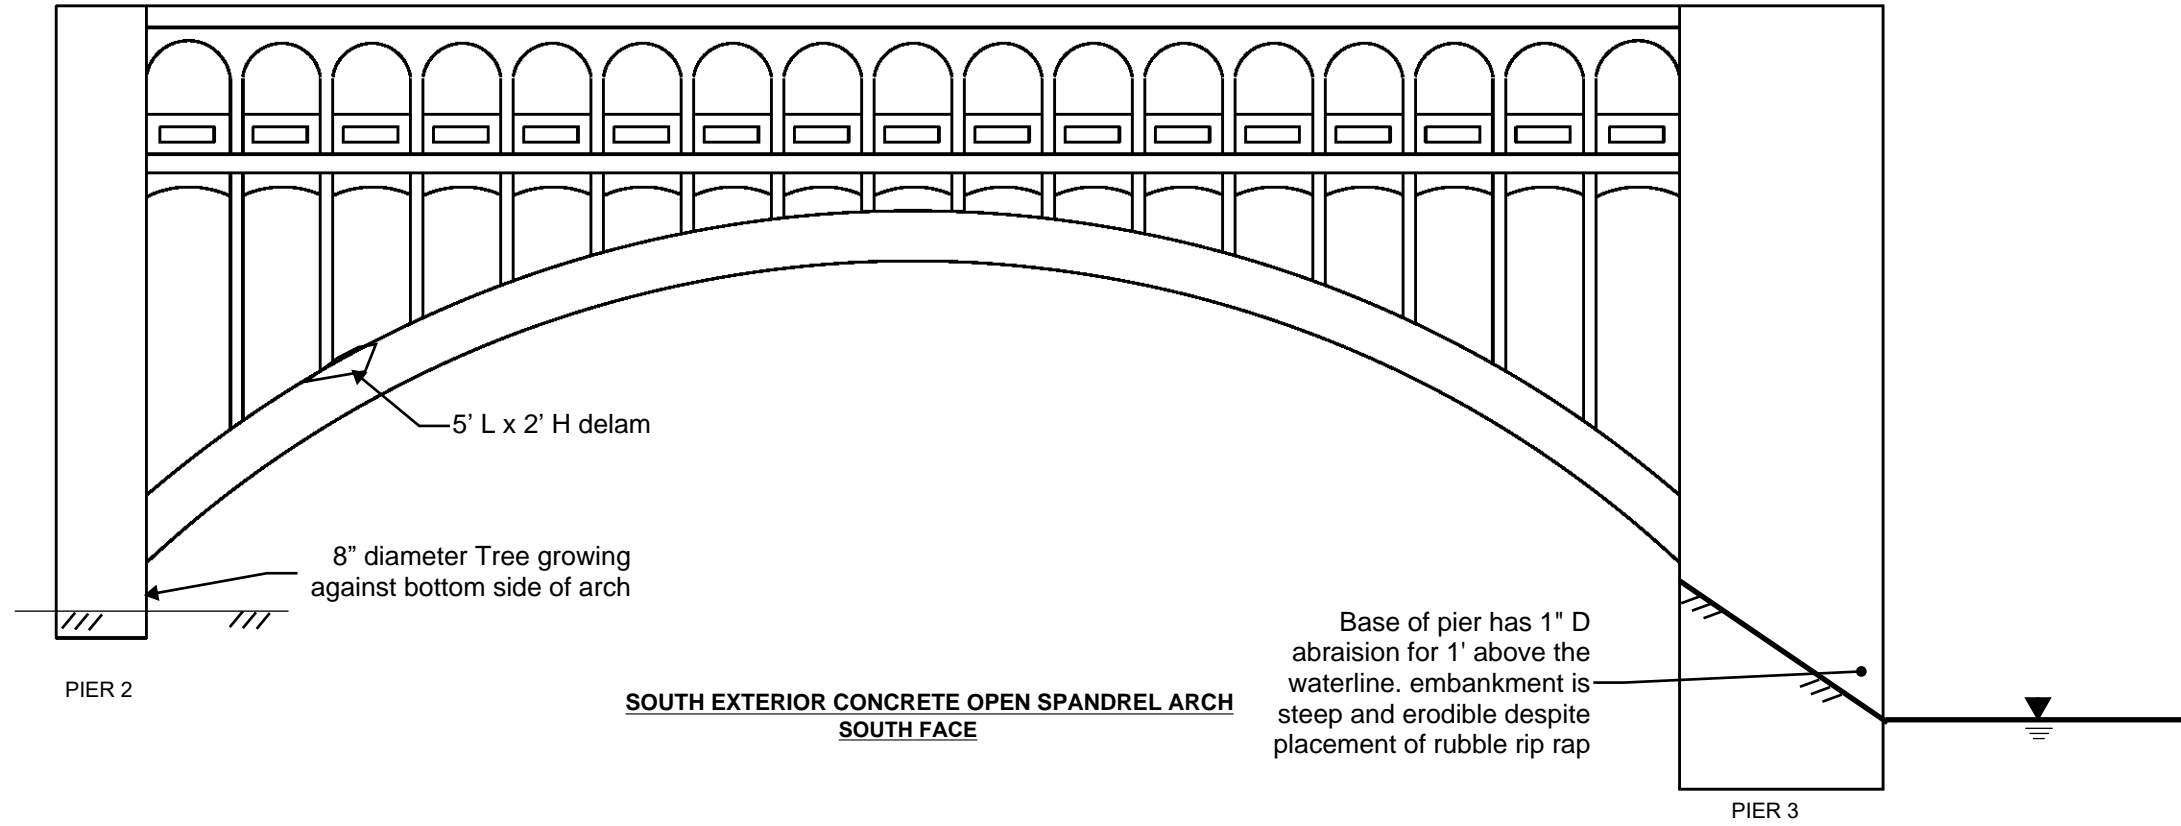
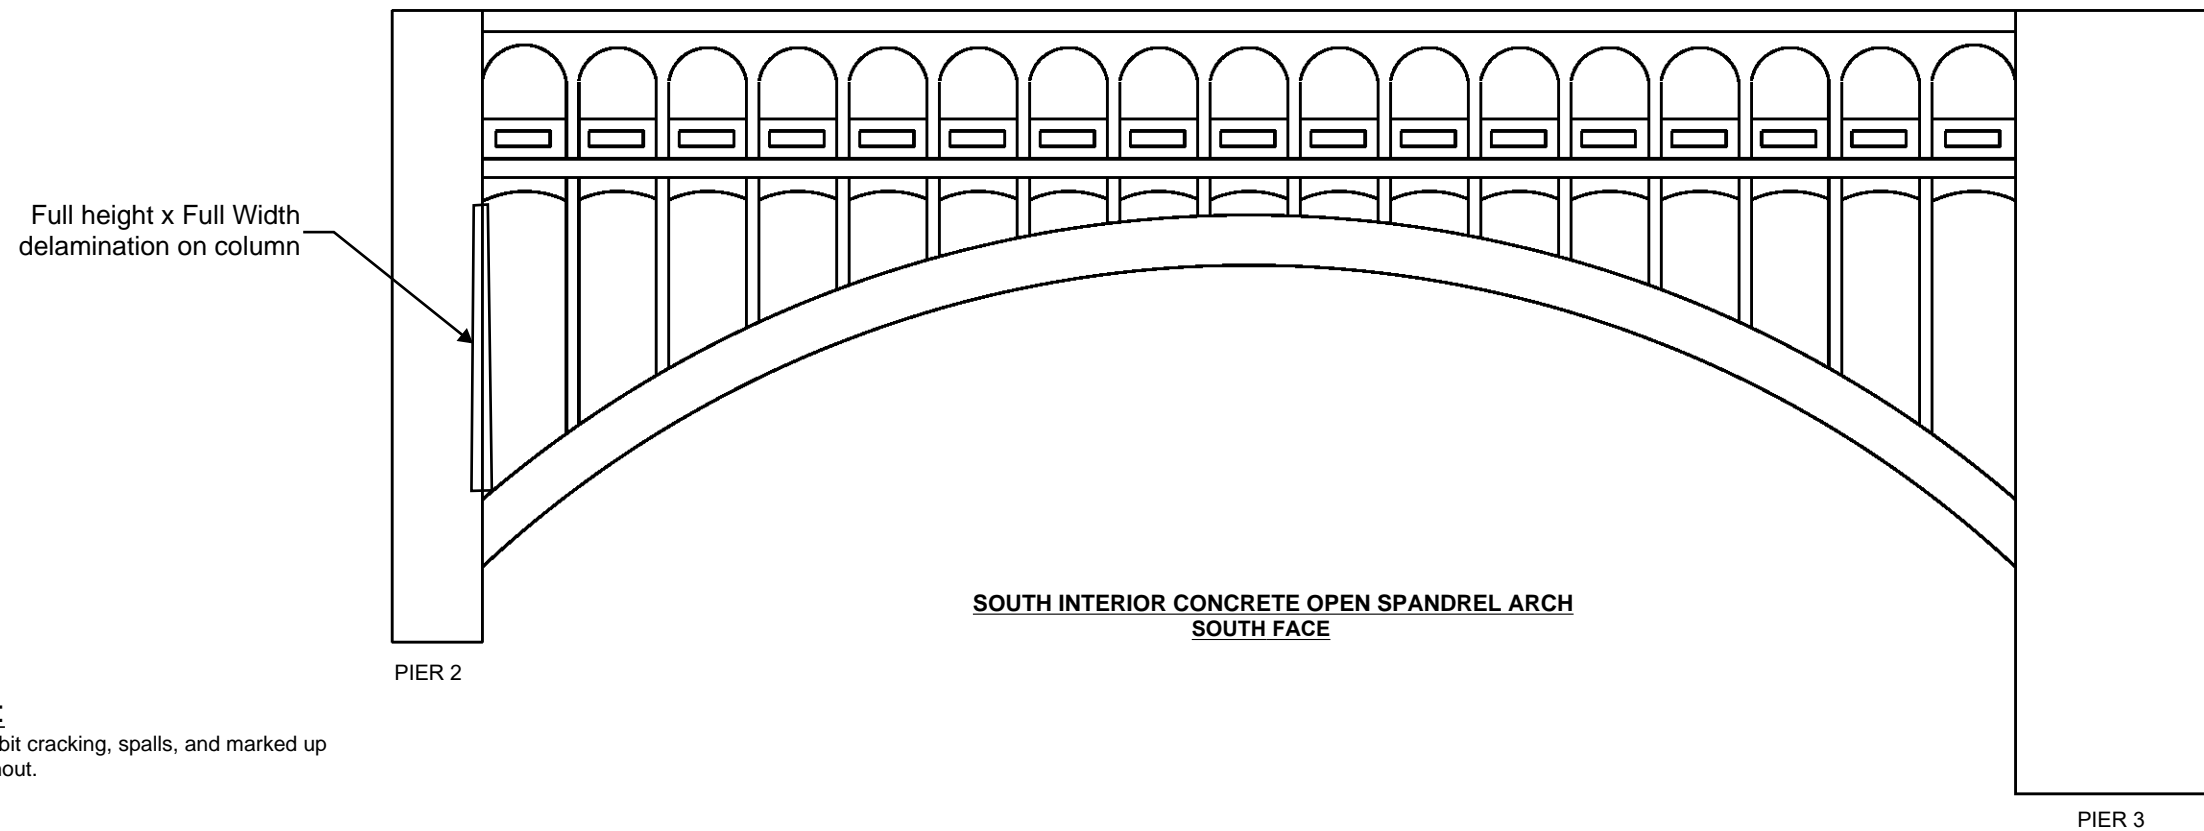
| | | | | | |
|---|---|--|---|---|---|
| GRAPHIC SCALE MEASURED IN FEET | DATE | 9902 Carver Road
Suite 201
Cincinnati, OH 45242
PH.: 614.699.5000 | DETROIT-SUPERIOR BRIDGE OVER CUYAHOGA RIVER
BRIDGE NO. CUY-6-1465 | | |
| NOT TO SCALE | NOV, 2018 | INFRASTRUCTURE ENGINEERS, INC. | STRUCTURE ELEVATION - SPAN 3 <table border="1" style="float: right; width: 50px;"> <tr> <td>PAGE</td> </tr> <tr> <td>A-53</td> </tr> </table> | PAGE | A-53 |
| PAGE | | | | | |
| A-53 | | | | | |

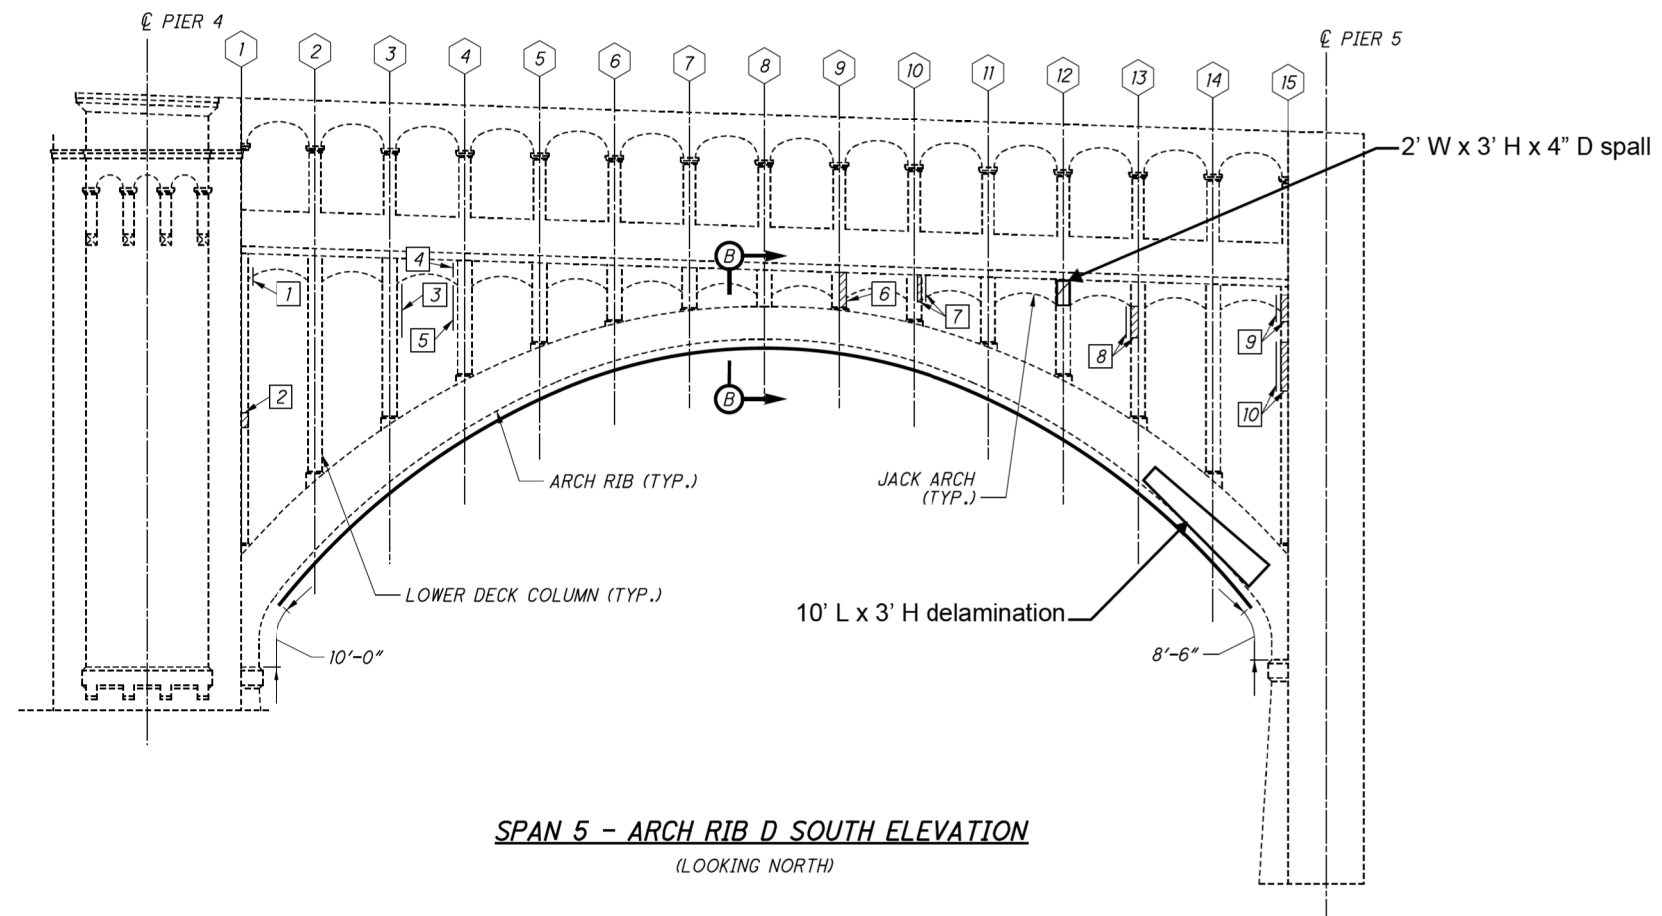
SPAN 5 - ARCH RIB D SOUTH ELEVATION
(LOOKING NORTH)

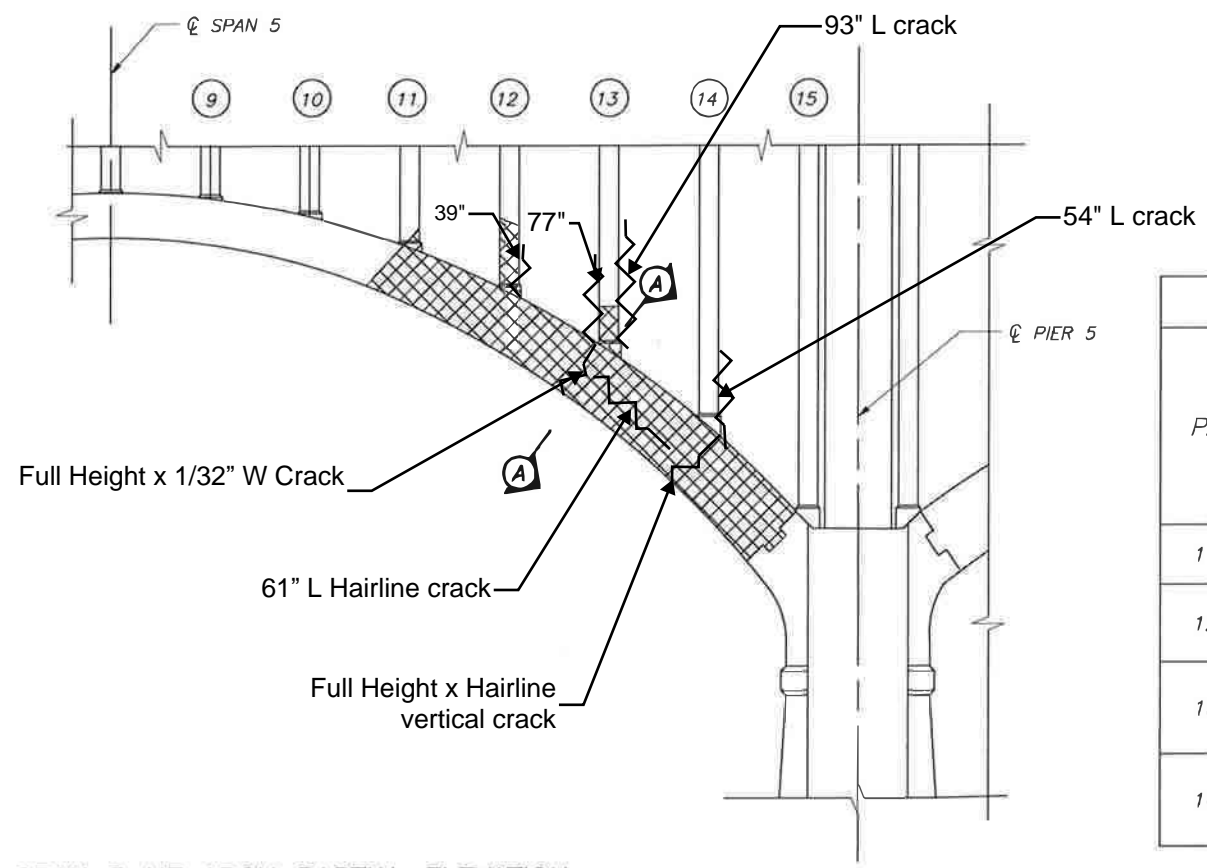
SPAN 5 NE ARCH PARTIAL ELEVATION
LOOKING NORTH

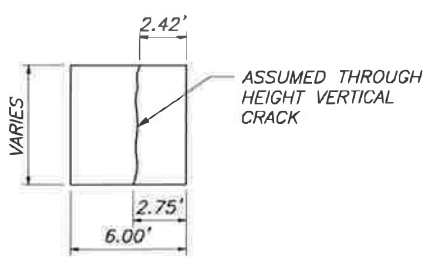
| CRACK MEASUREMENTS | | | | |
|---|---|---|---|---|
| 14-15 | 0.002" | 22.5 | 1/32" | 33" |

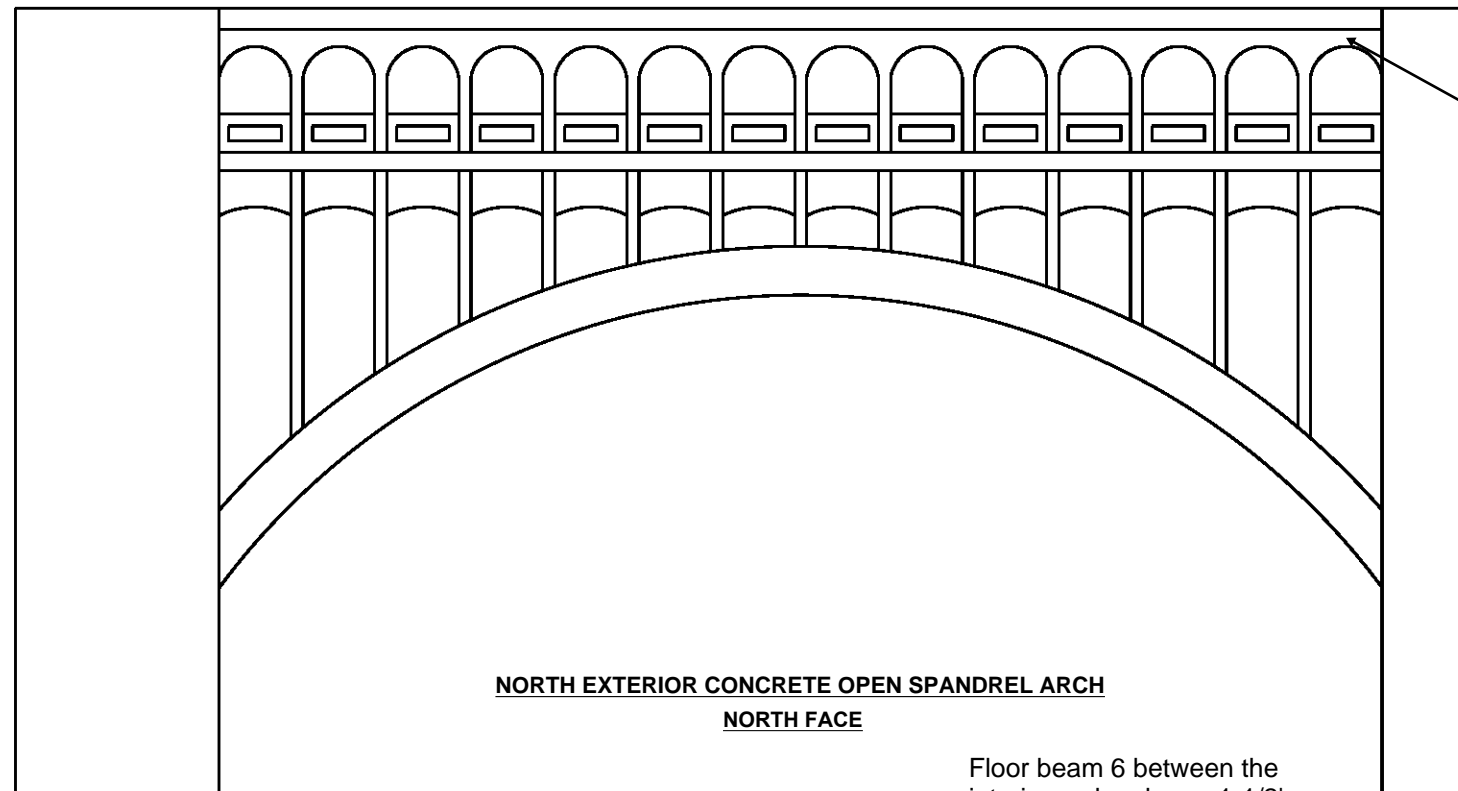
LEGEND
 - VERTICAL CRACK LOCATION

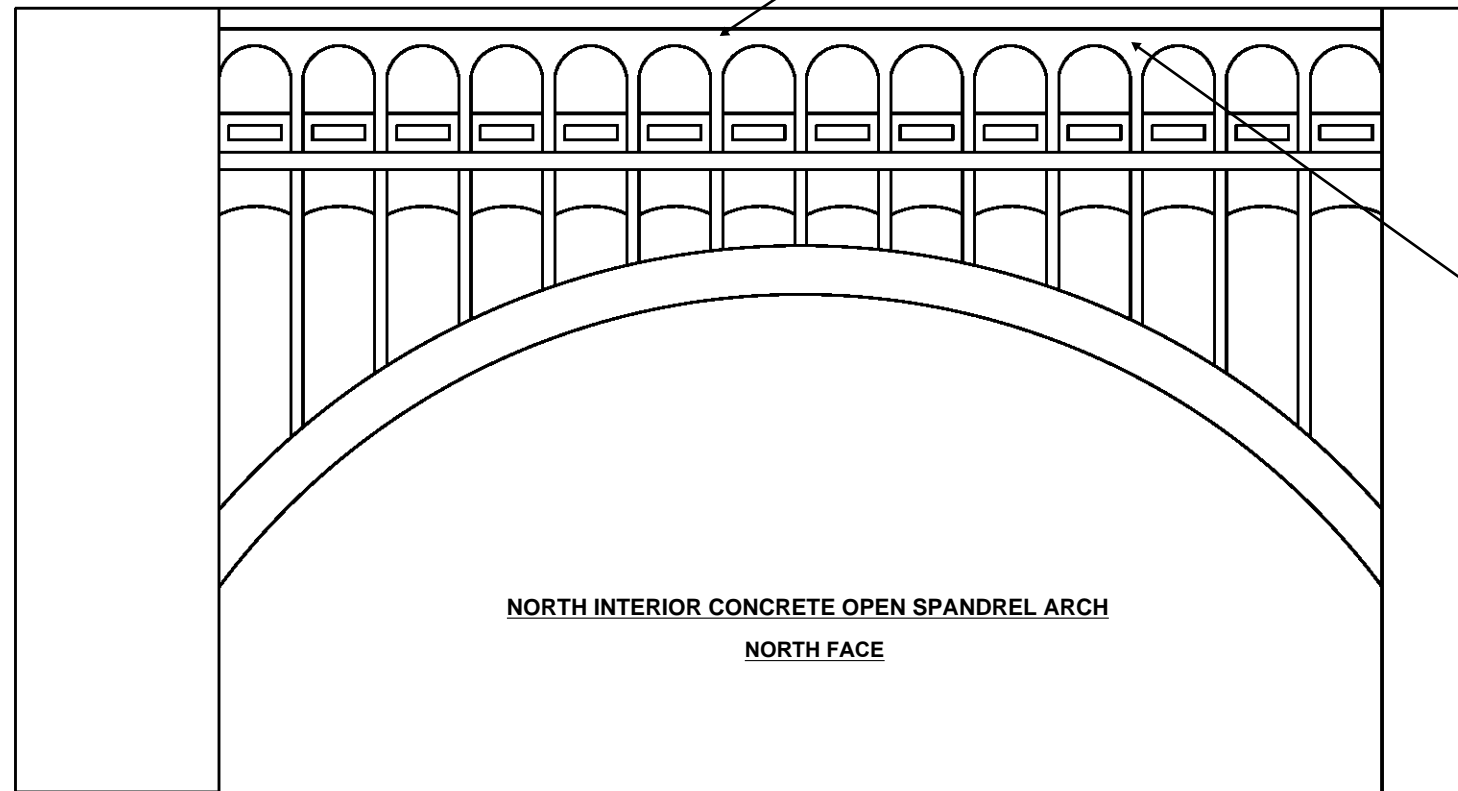
Floor beam 6 between the interior arches has a 1-1/2' Diameter x 2" D spall with exposed reinforcing on the east face

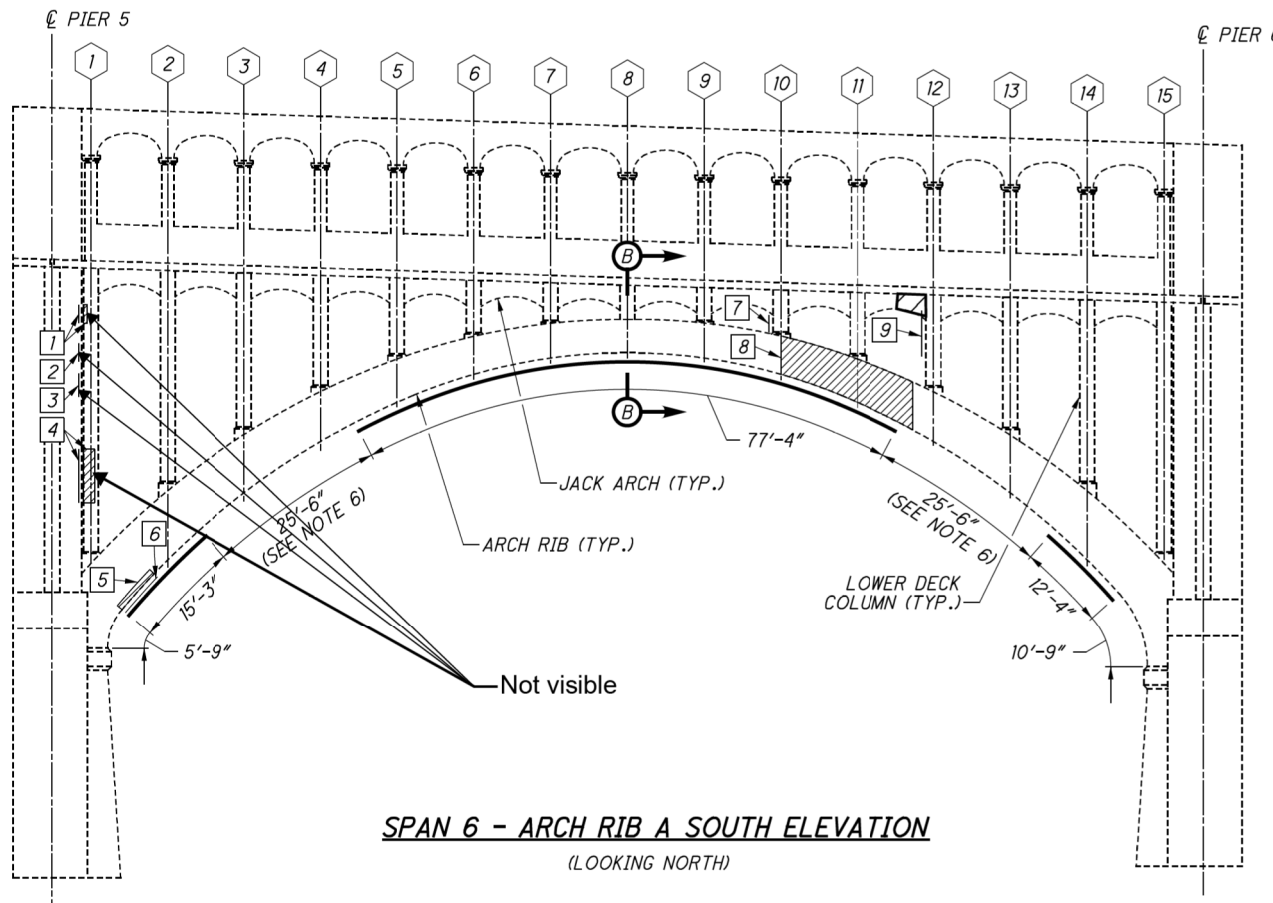
SPAN 6 - ARCH RIB A SOUTH ELEVATION
(LOOKING NORTH)
