CUY-6-1456

PHYSICAL CONDITION REPORT ROUTINE FRACTURE CRITICAL INSPECTION VETERANS MEMORIAL/DETROIT-SUPERIOR BRIDGE OVER THE CUYAHOGA RIVER SFN: 1800930

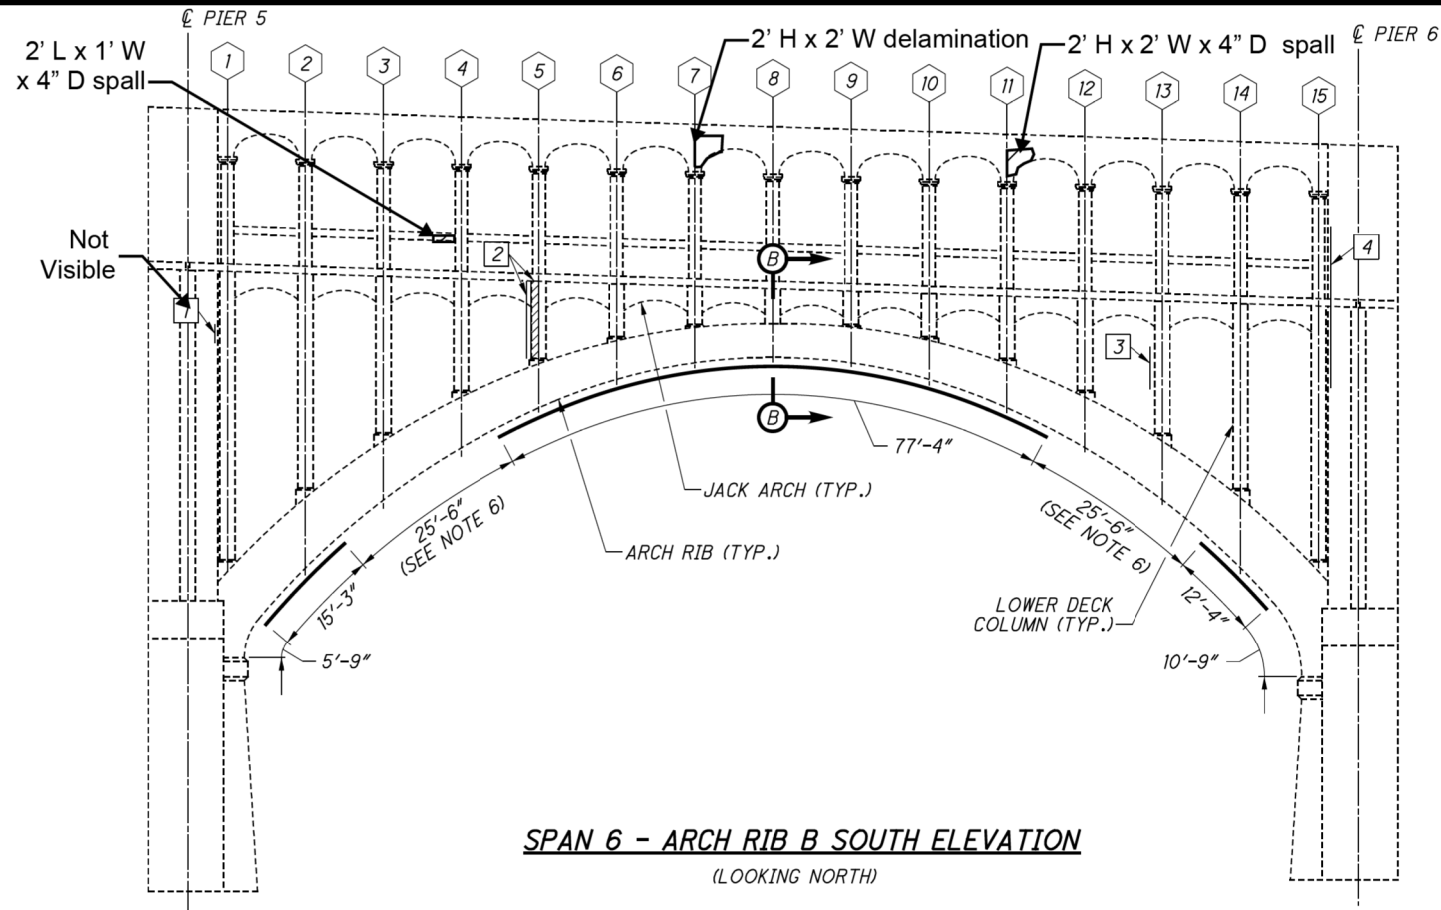
SPAN 6 - ARCH RIB B SOUTH ELEVATION
(LOOKING NORTH)

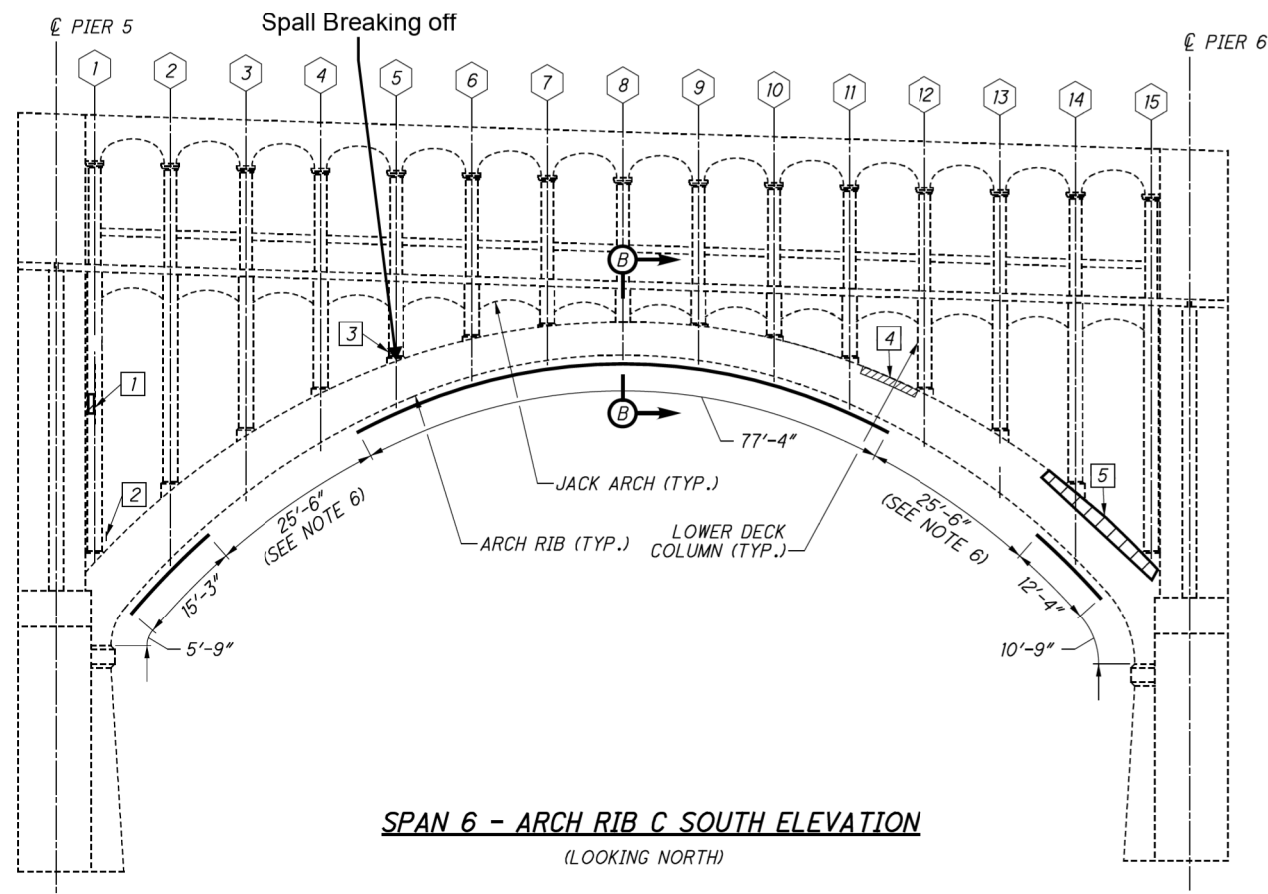
SPAN 6 - ARCH RIB C SOUTH ELEVATION
(LOOKING NORTH)

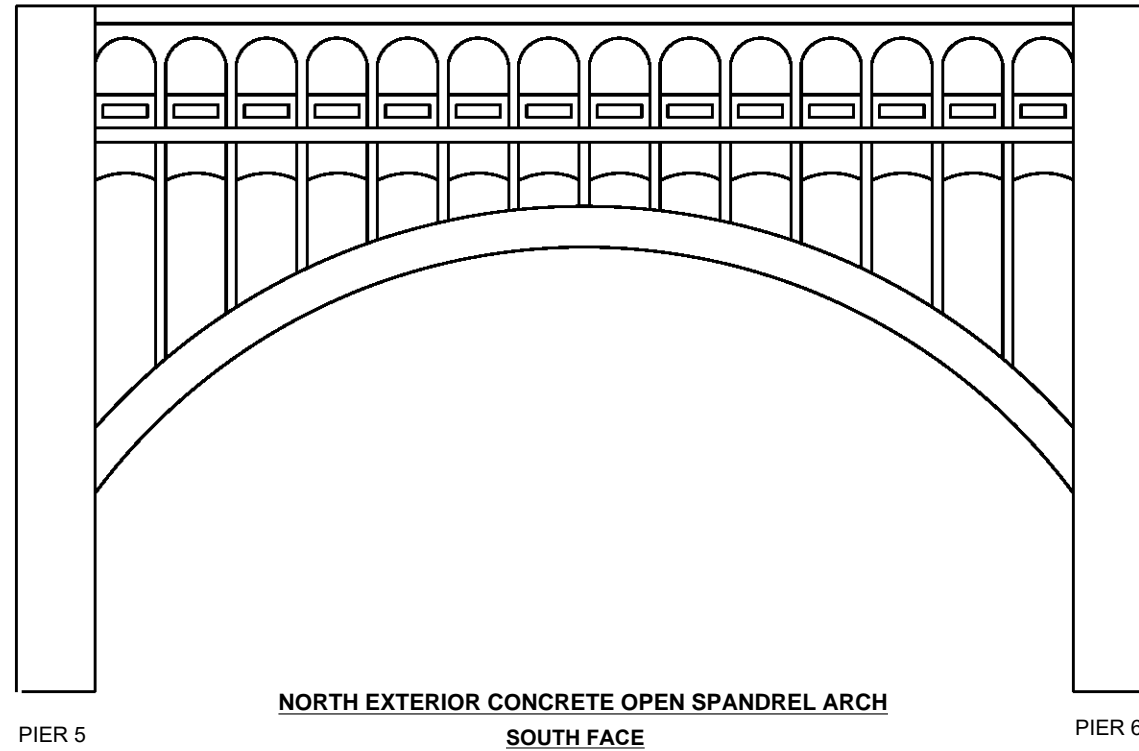
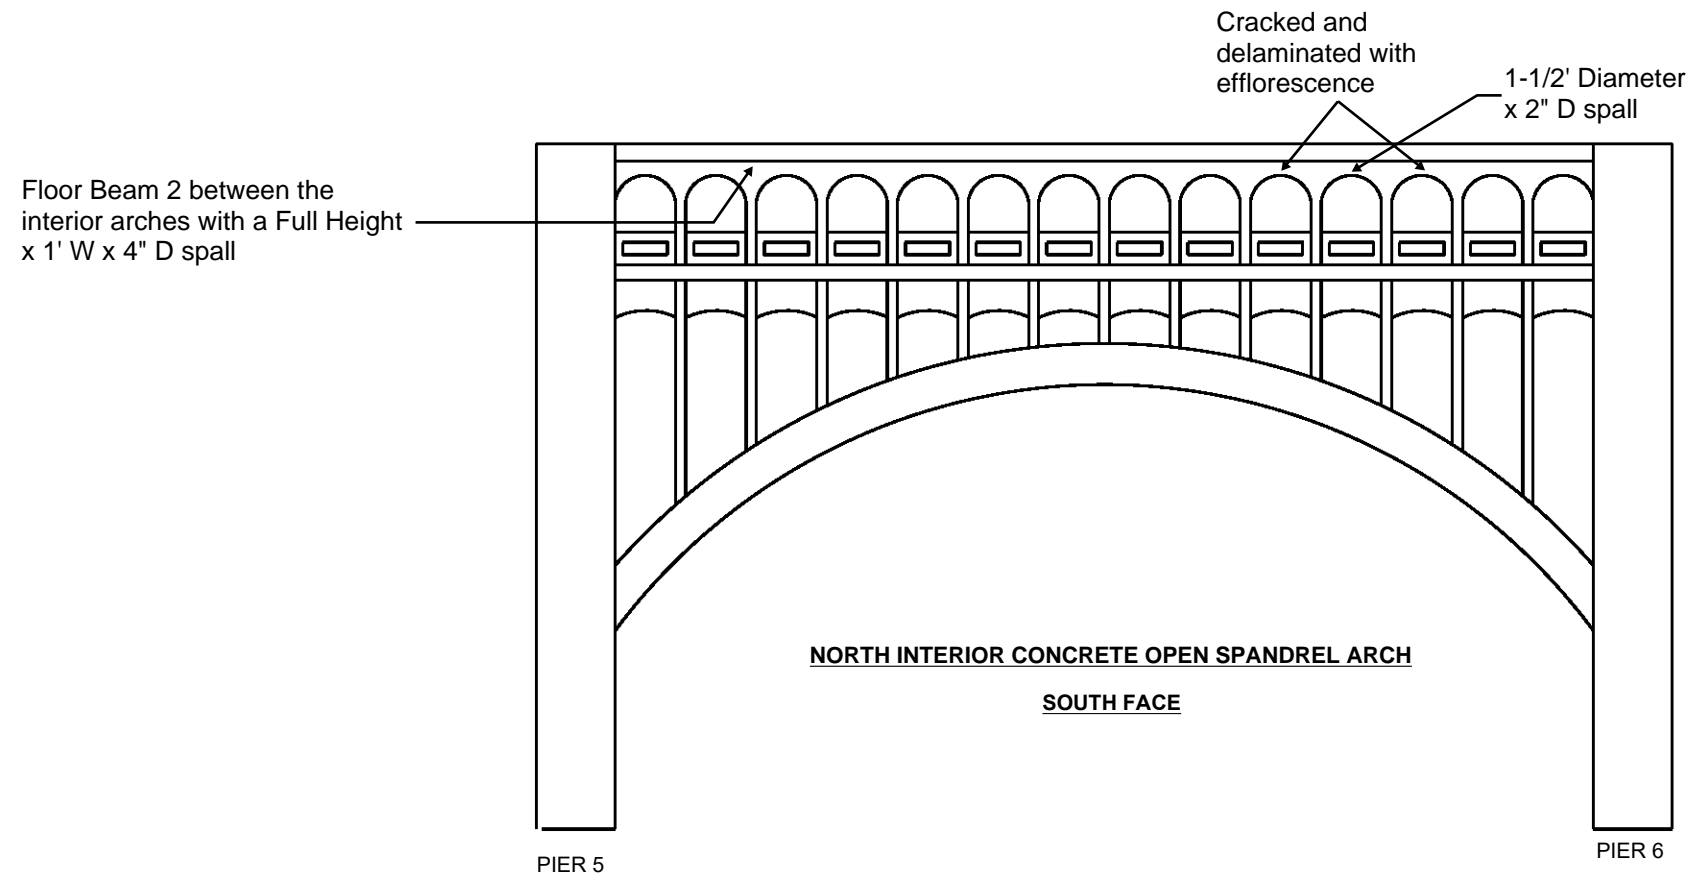
| GRAPHIC SCALE MEASURED IN FEET | DATE | | 9902 Carver Road

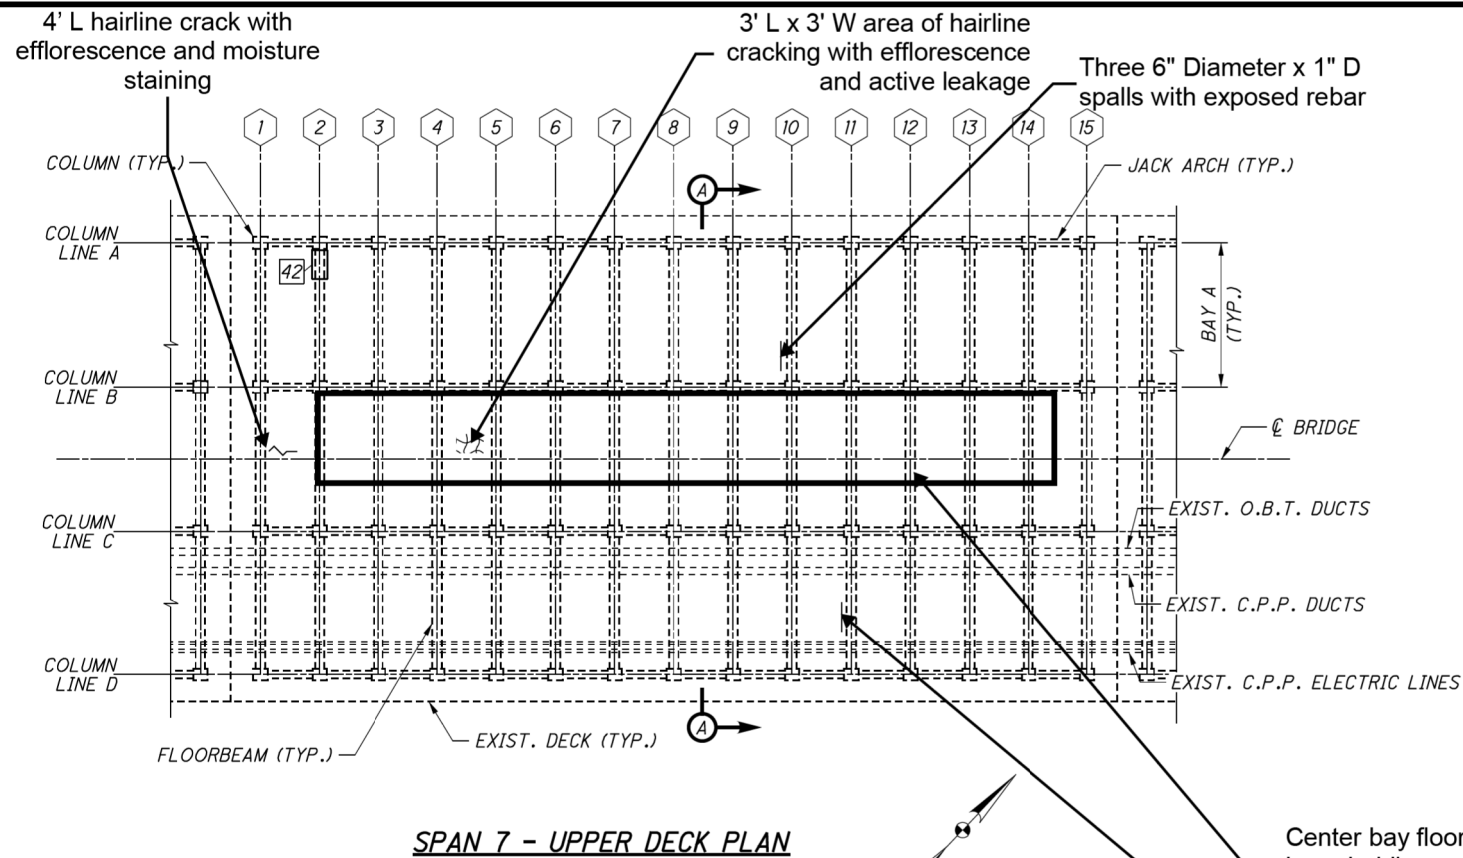
SPAN 7 - UPPER DECK PLAN

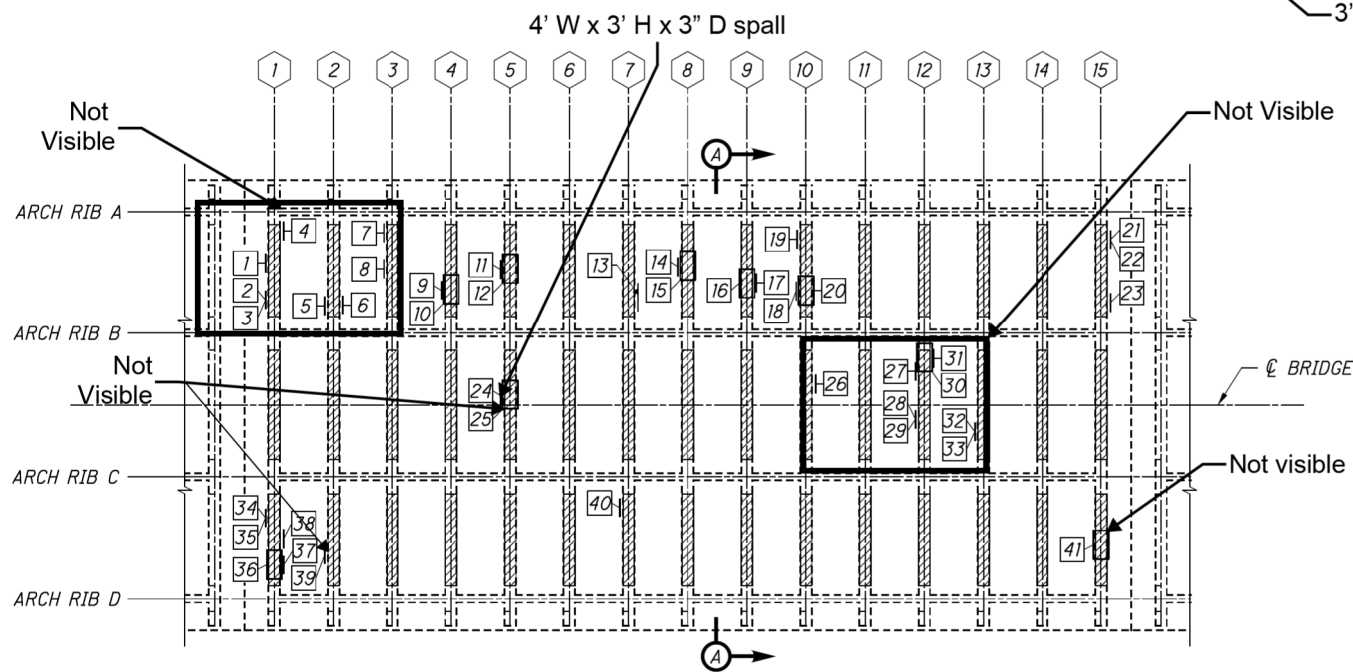
SPAN 7 - LOWER DECK PLAN

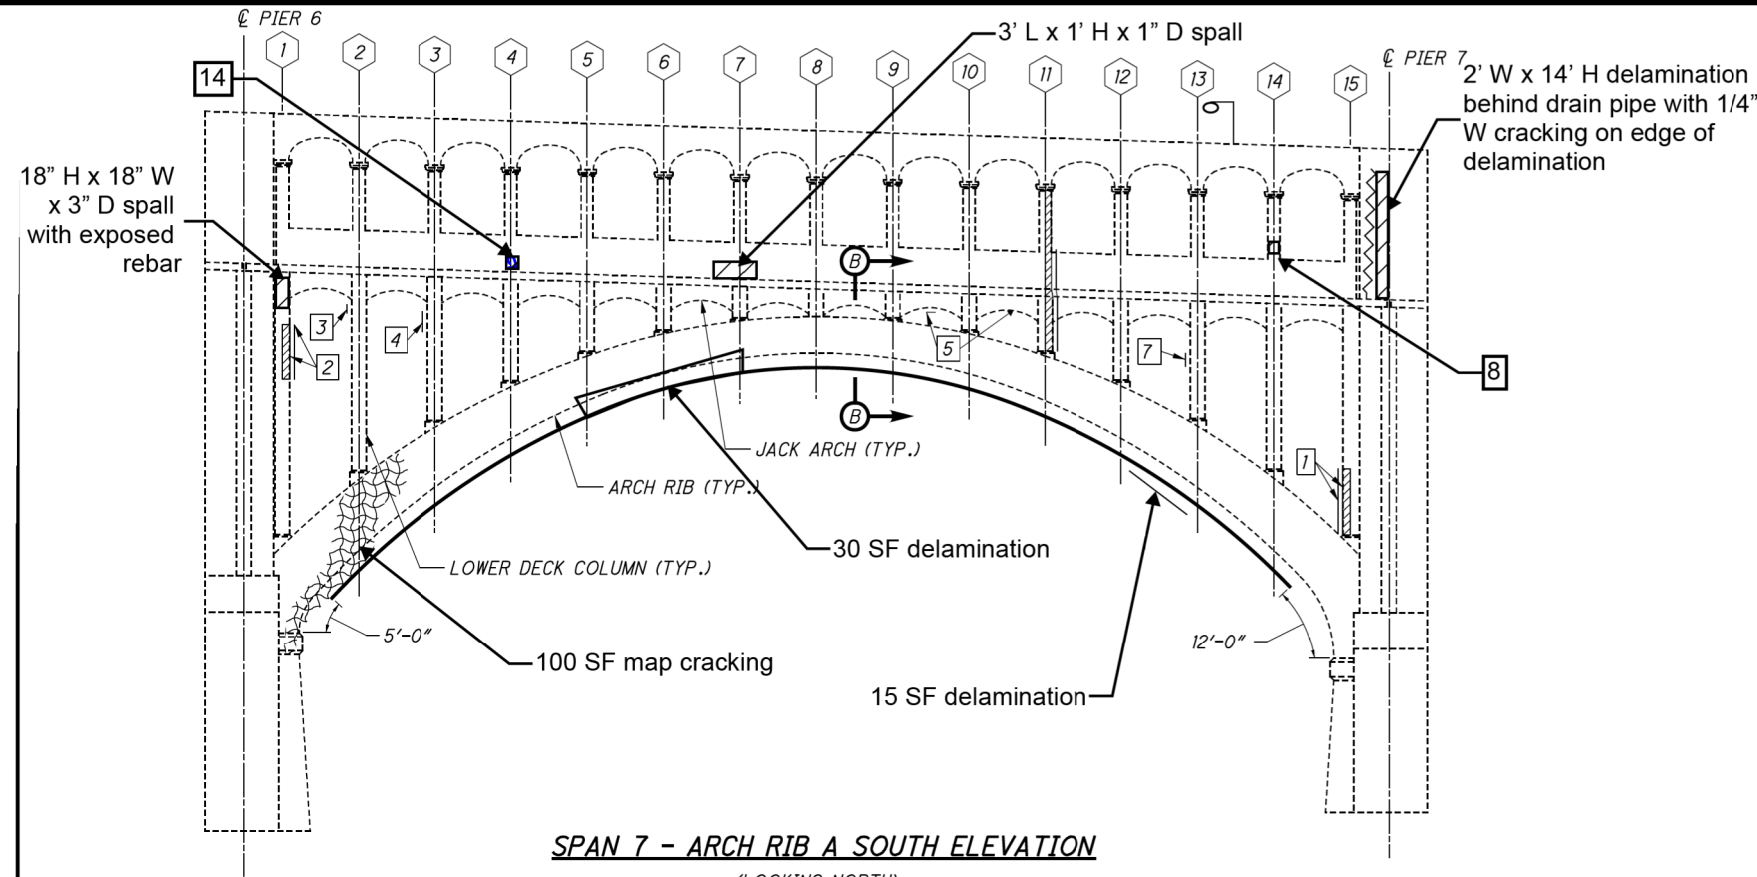
SPAN 7 - ARCH RIB A SOUTH ELEVATION
(LOOKING NORTH)

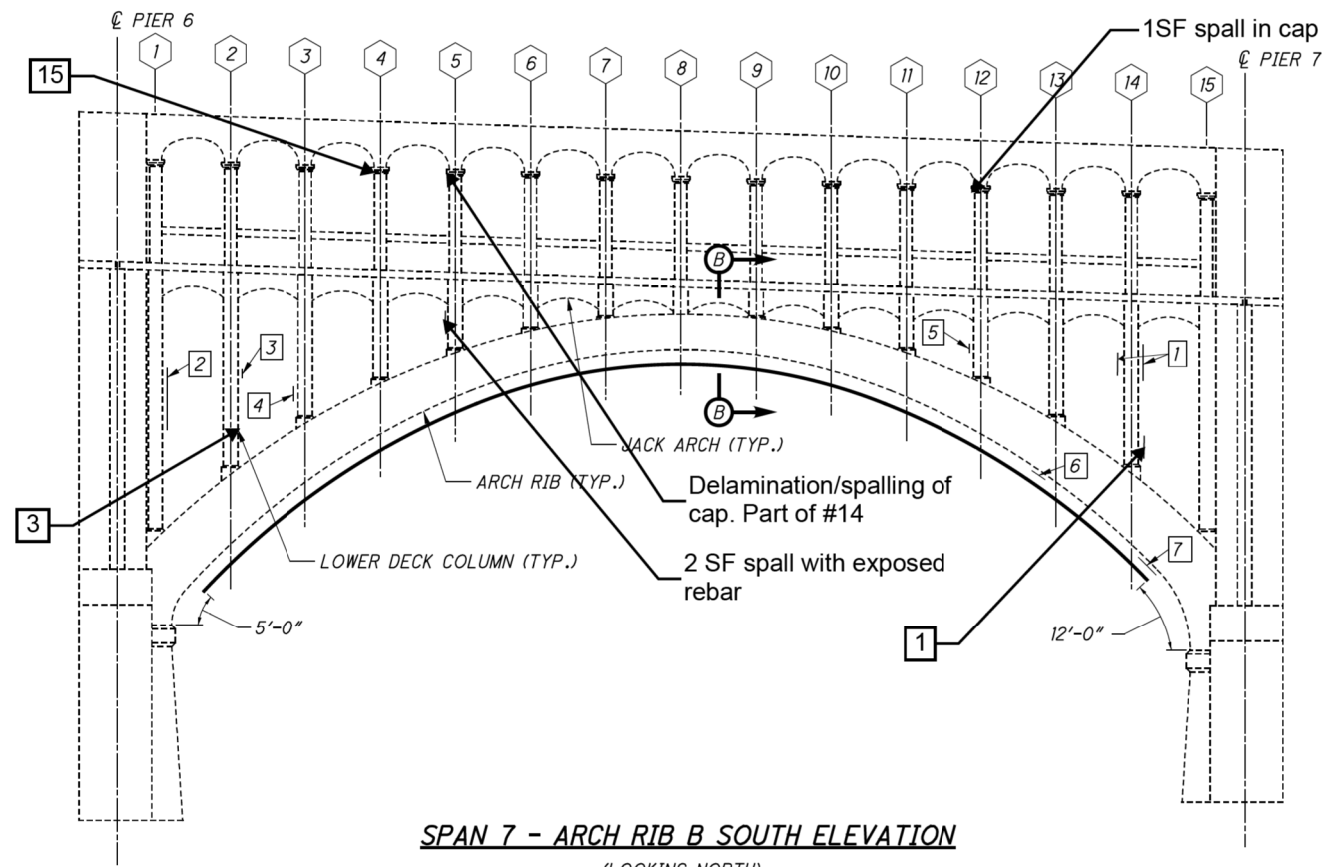
SPAN 7 - ARCH RIB B SOUTH ELEVATION
(LOOKING NORTH)

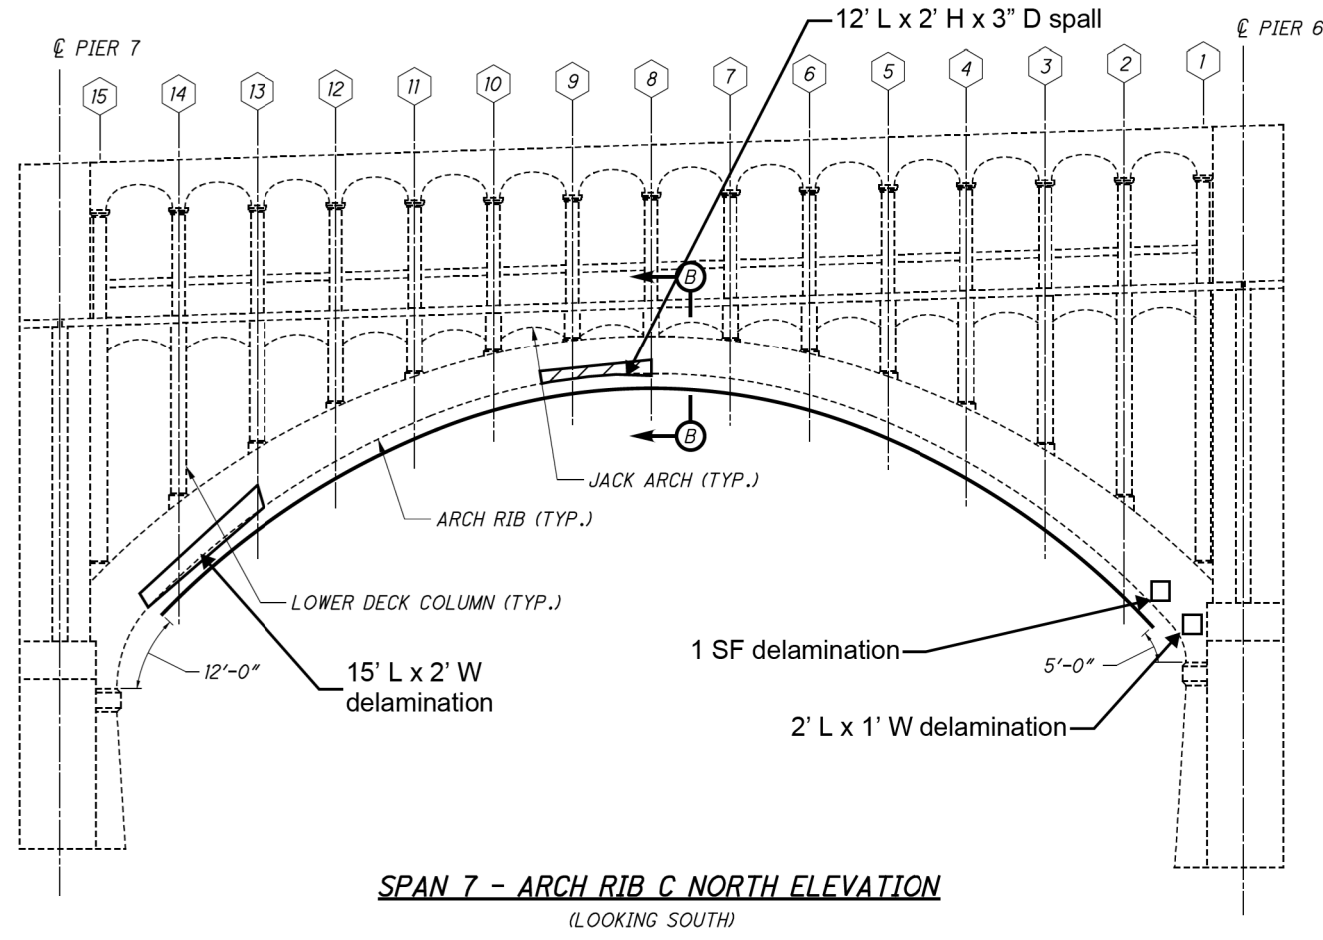
SPAN 7 - ARCH RIB C NORTH ELEVATION
(LOOKING SOUTH)

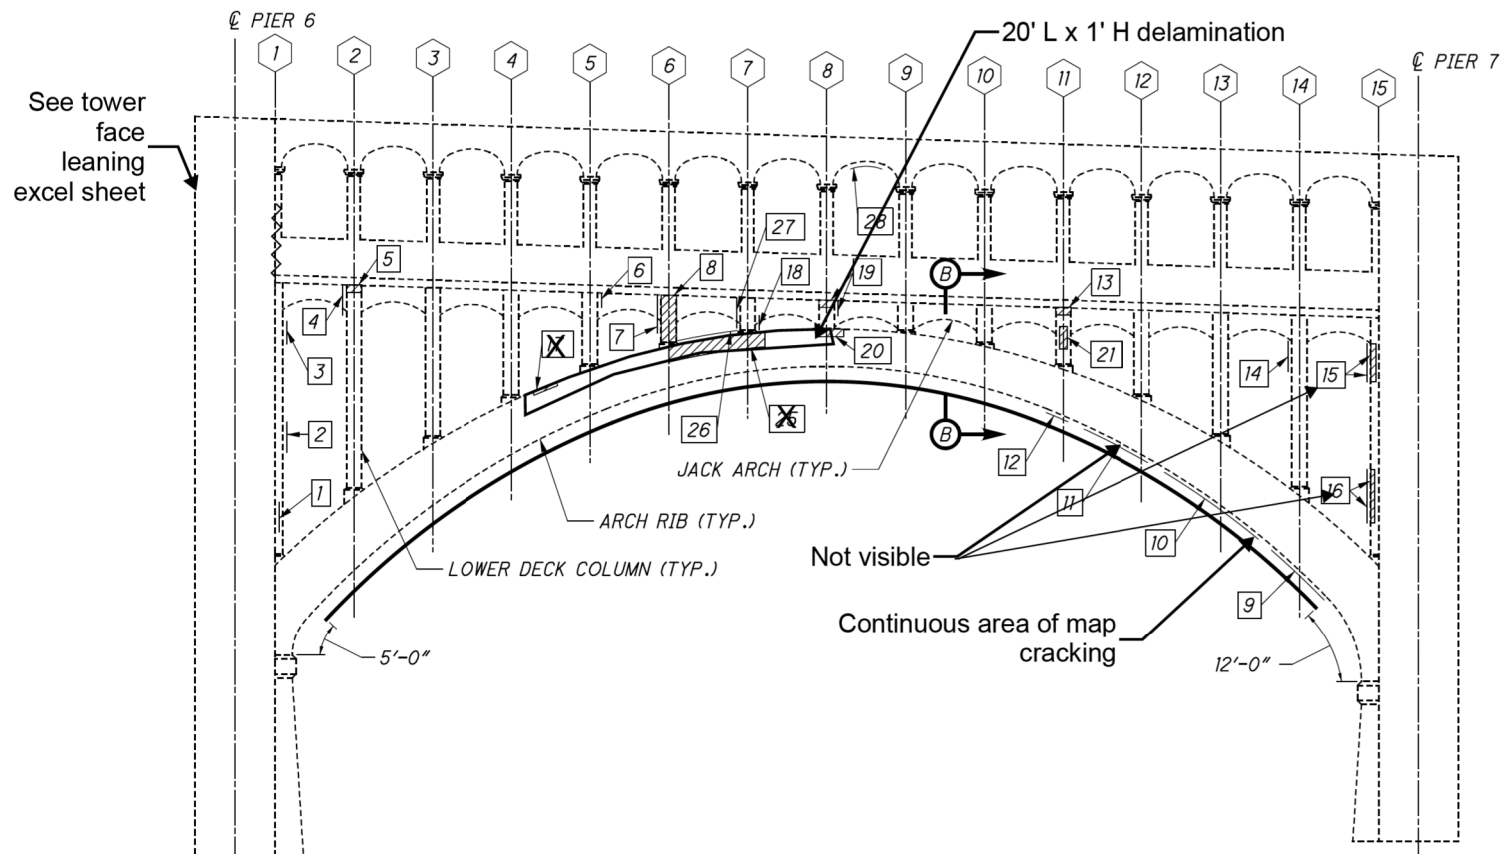
SPAN 7 - ARCH RIB D SOUTH ELEVATION

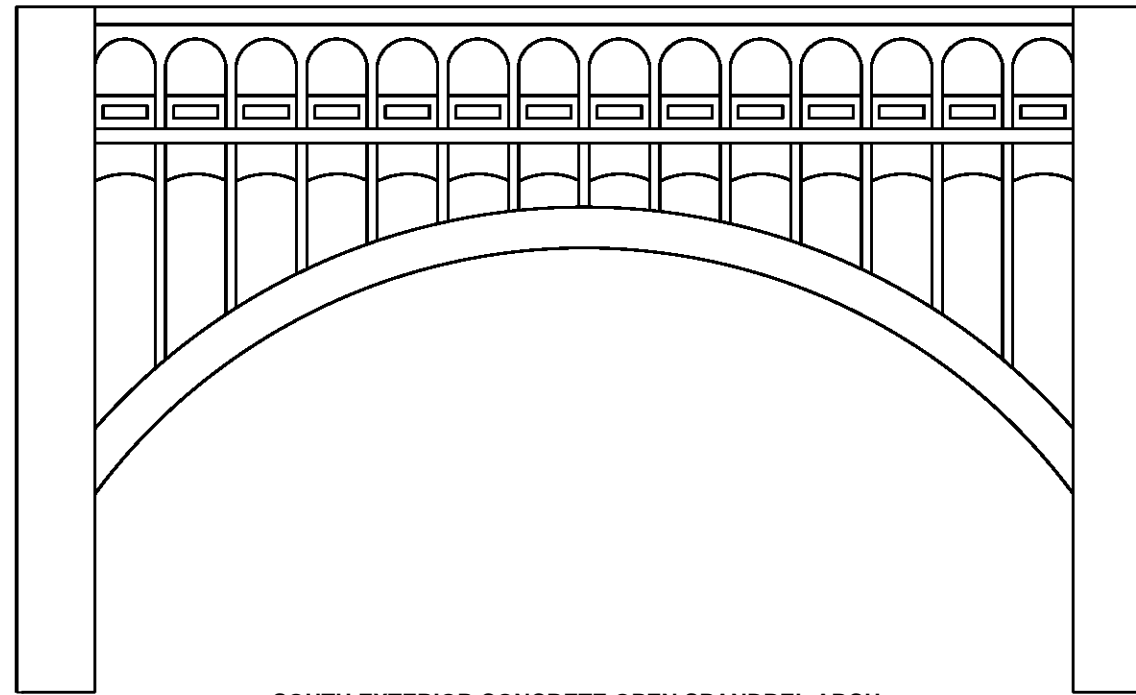
| NOT TO SCALE | NOV, 2018 | | INFRASTRUCTURE ENGINEERS, INC. | SPAN 7 CONCRETE REPAIR DETAILS |

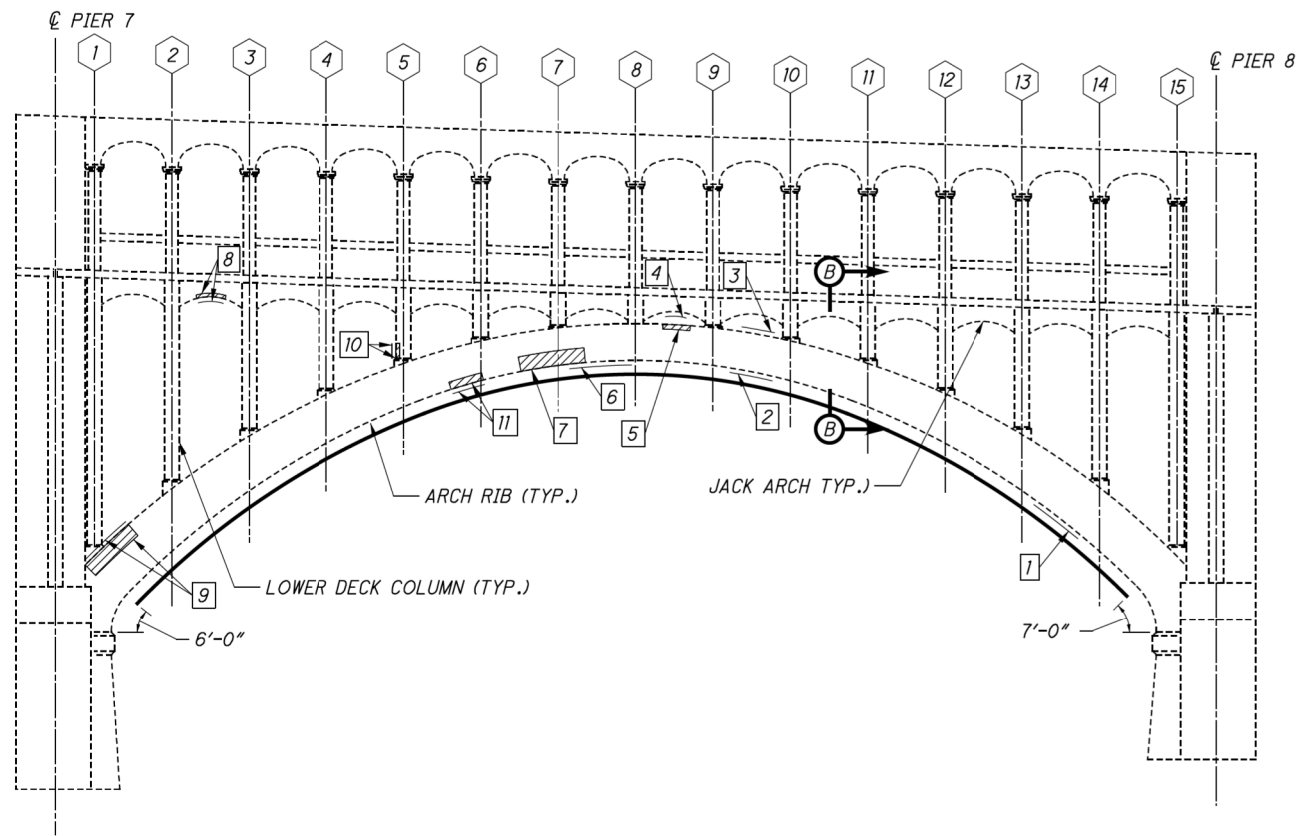
SPAN 8 - ARCH RIB B SOUTH ELEVATION
(LOOKING NORTH)

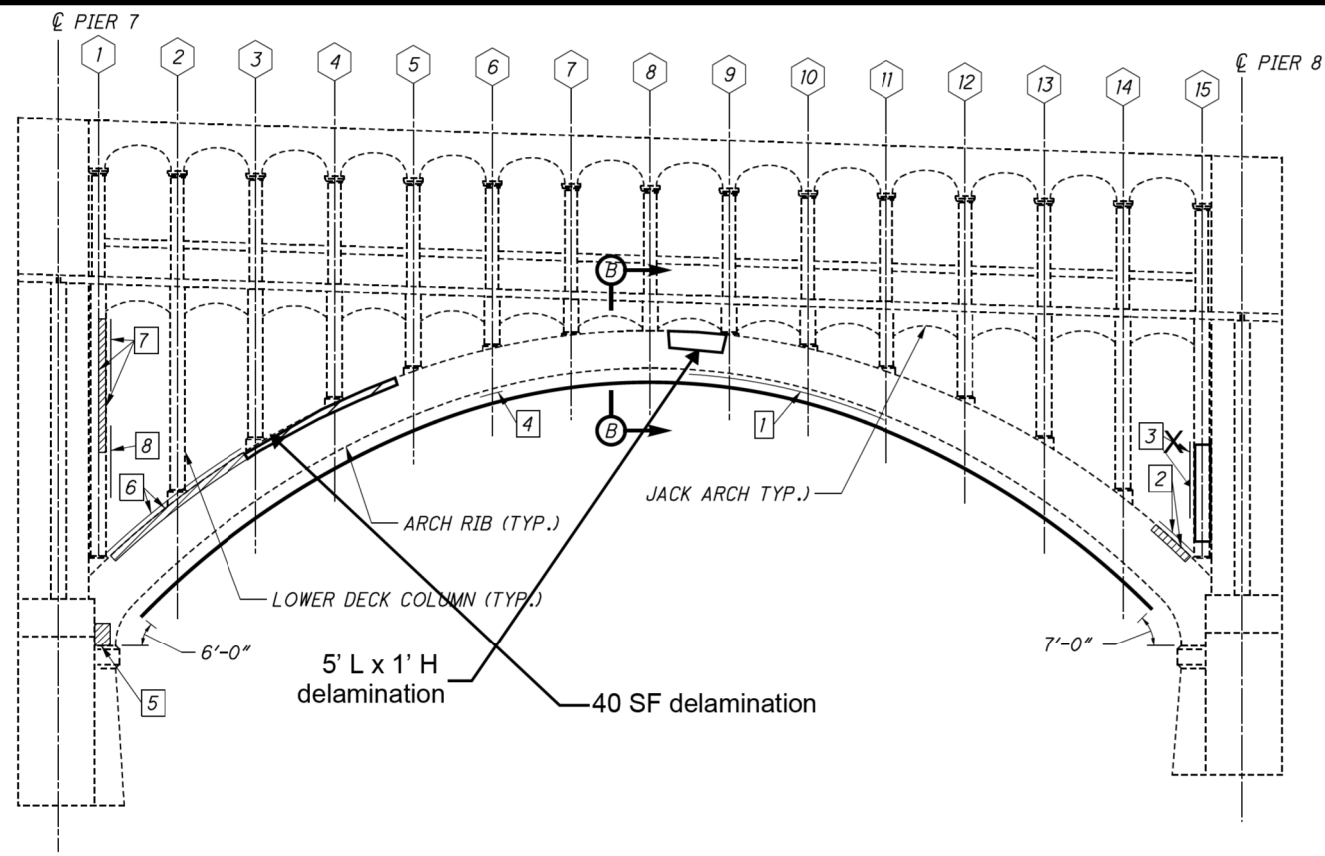
SPAN 8 - ARCH RIB C SOUTH ELEVATION
(LOOKING NORTH)

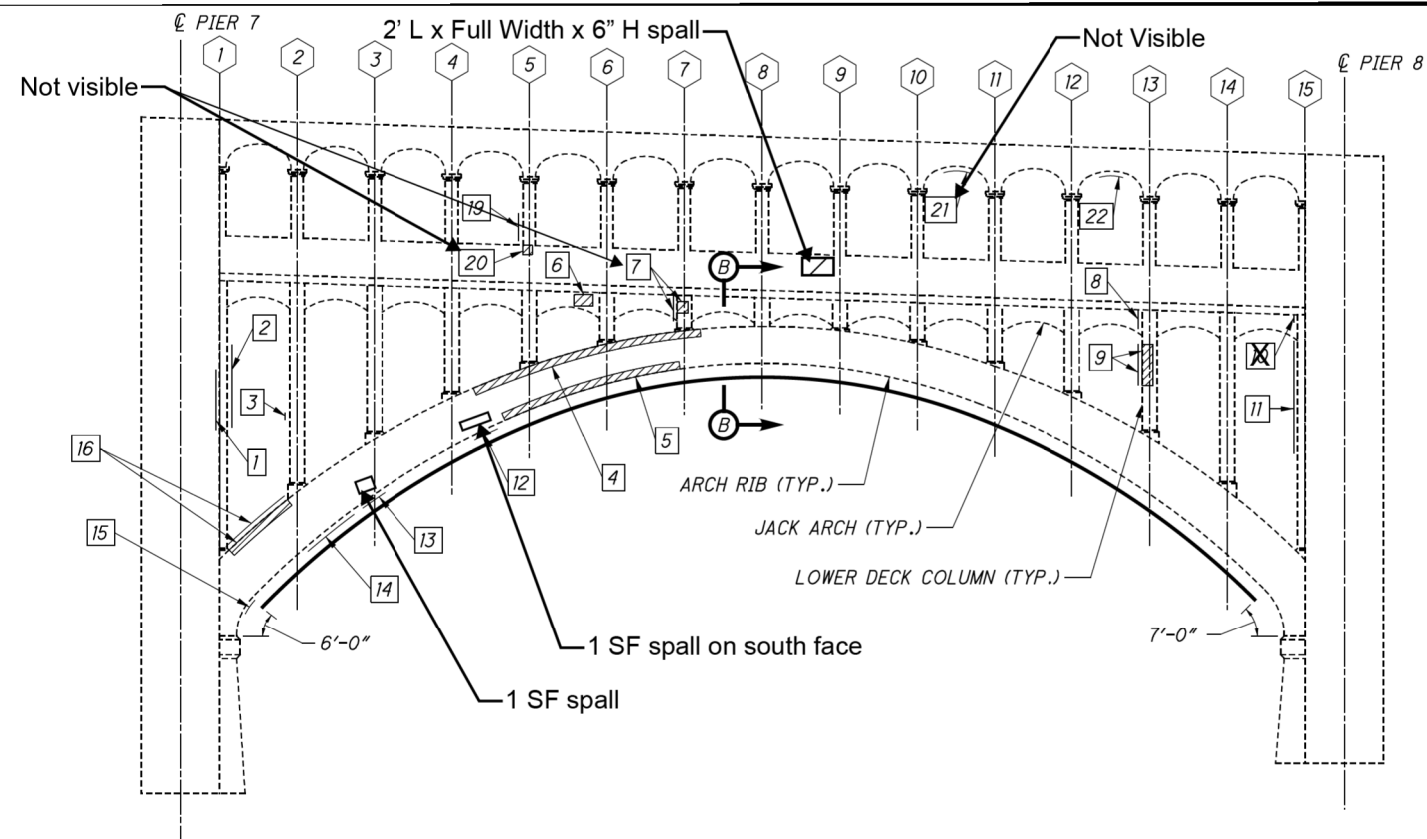
SPAN 8 - ARCH RIB D SOUTH ELEVATION
(LOOKING NORTH)

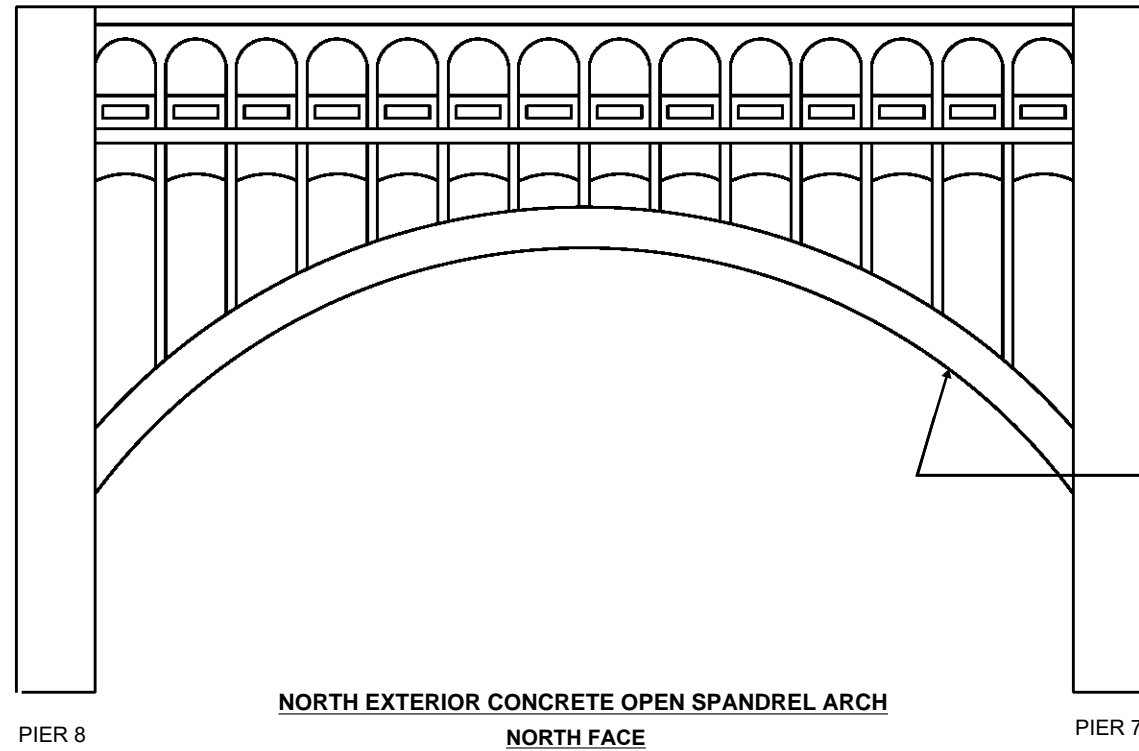
Underside of arch is cracked and delaminated on the east end

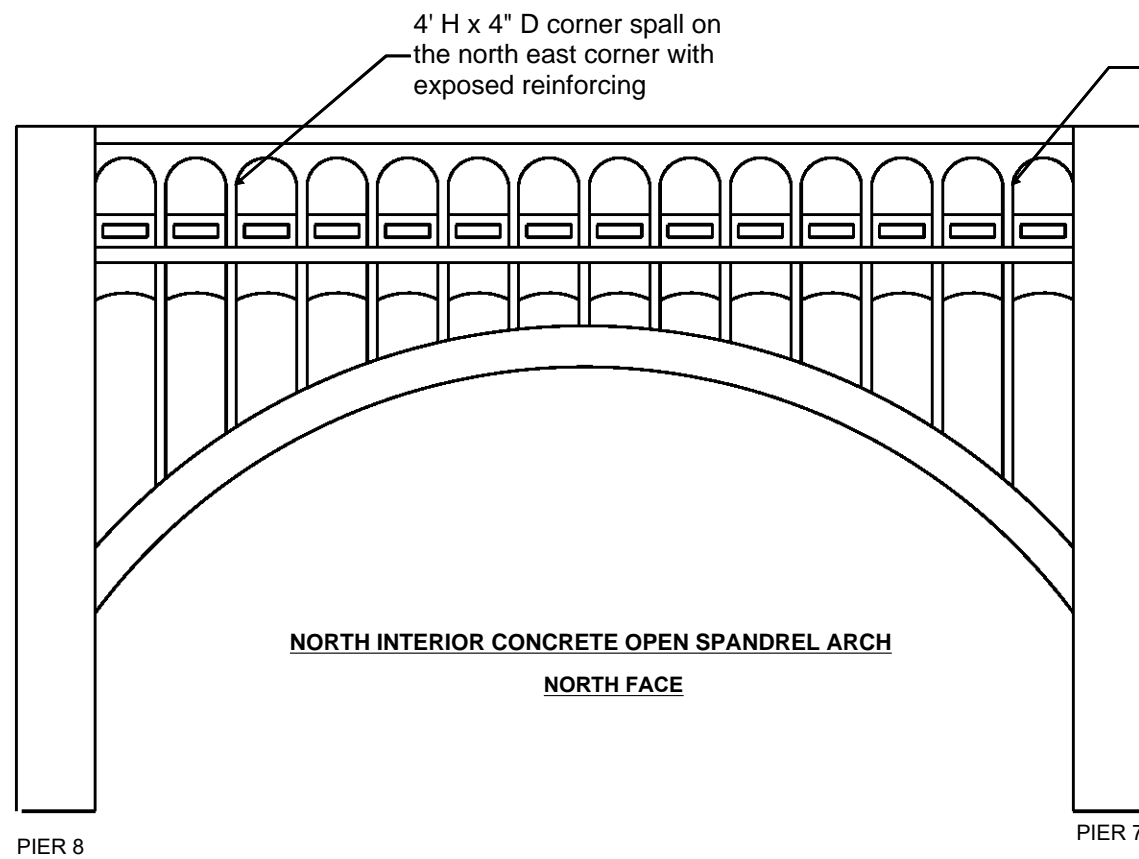
4' H x 4" D corner spall on the north east corner with exposed reinforcing

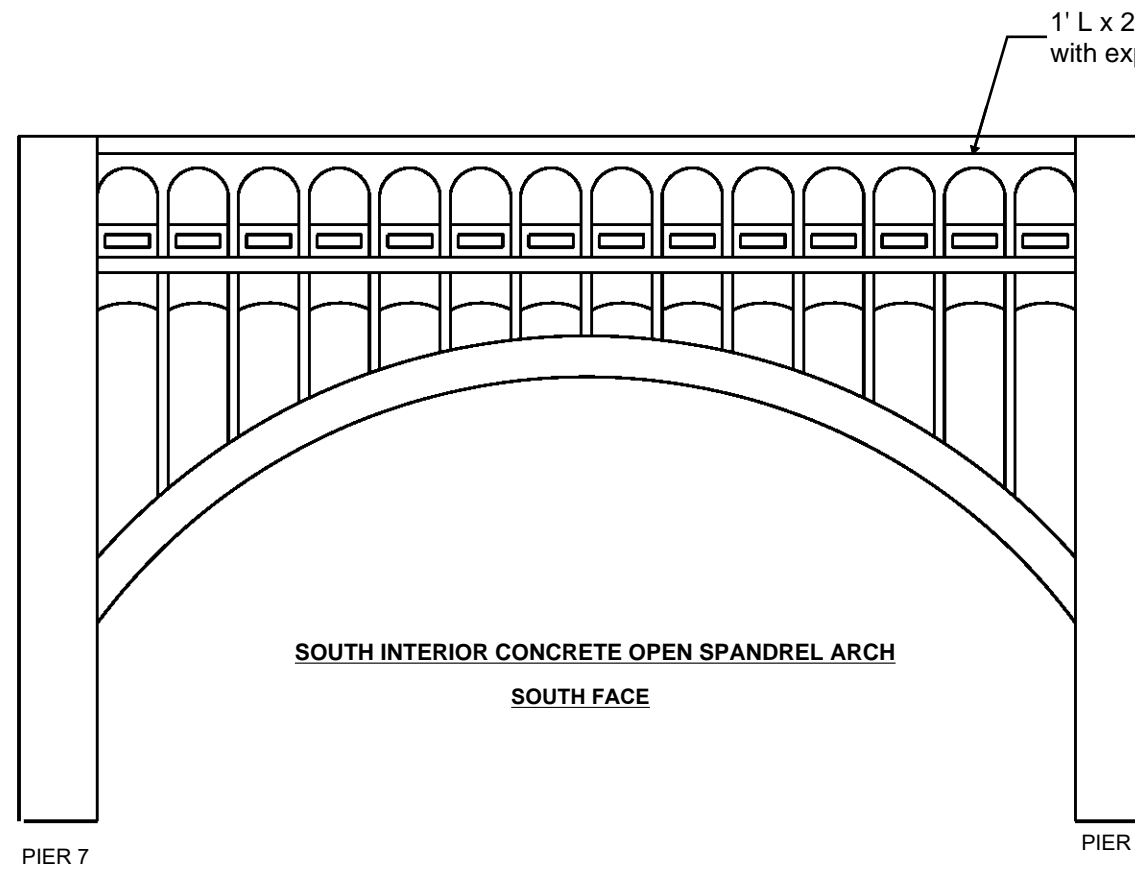
1' L x 2" D spall with exposed rebar

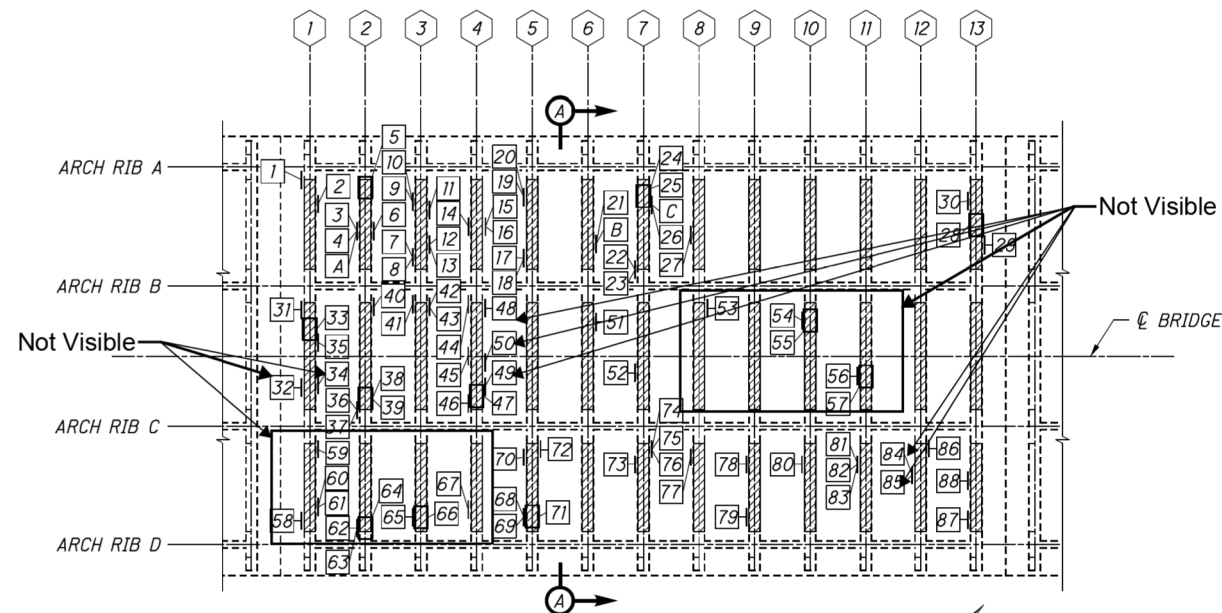
SPAN 9 - LOWER DECK PLAN

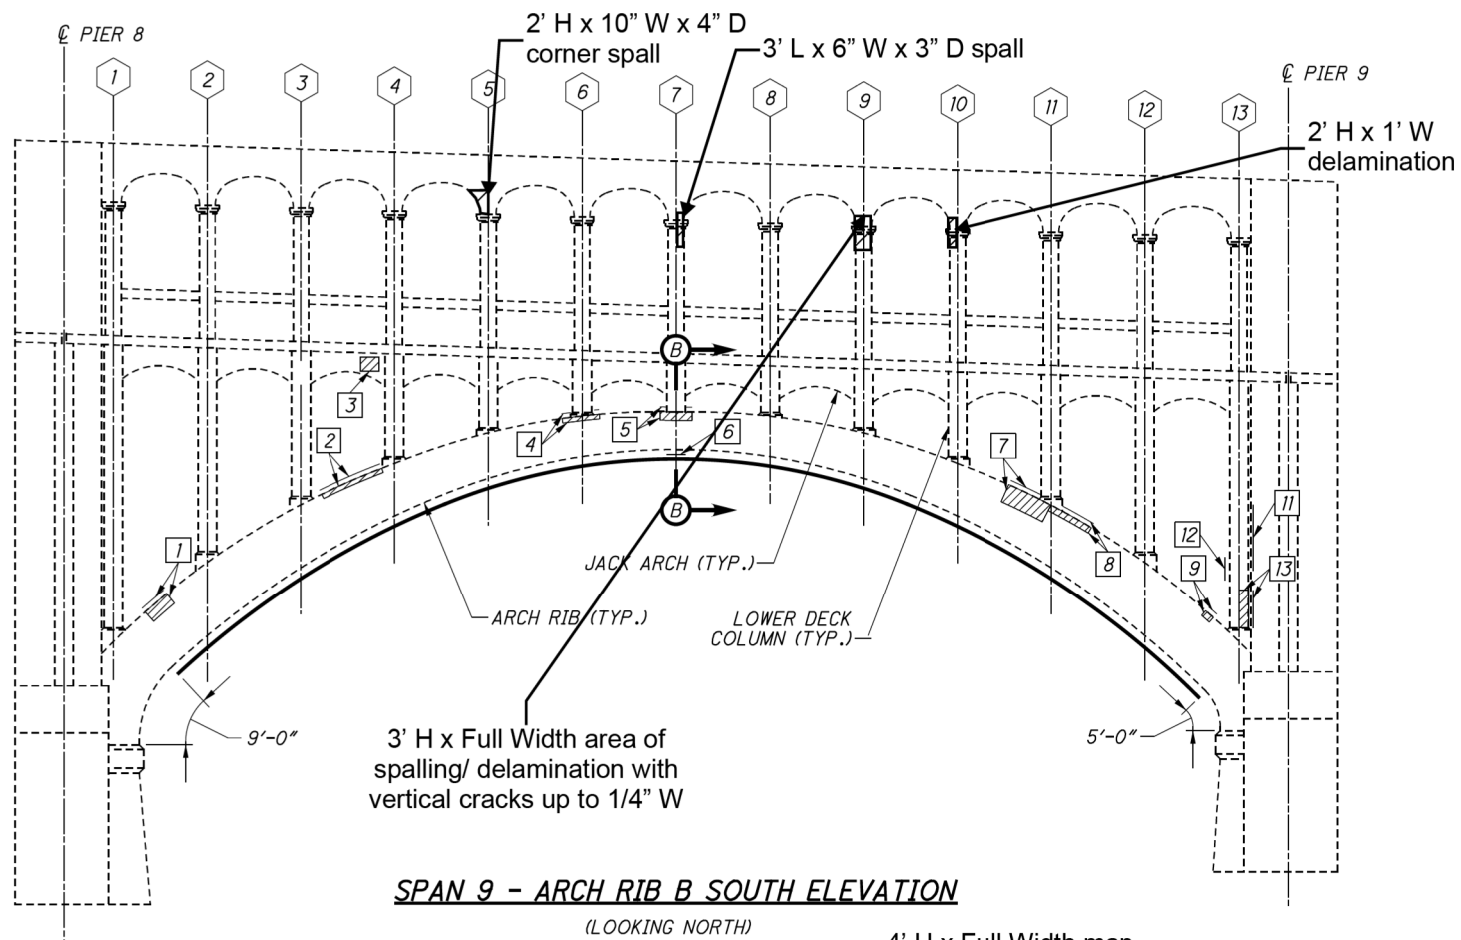
SPAN 9 - ARCH RIB B SOUTH ELEVATION

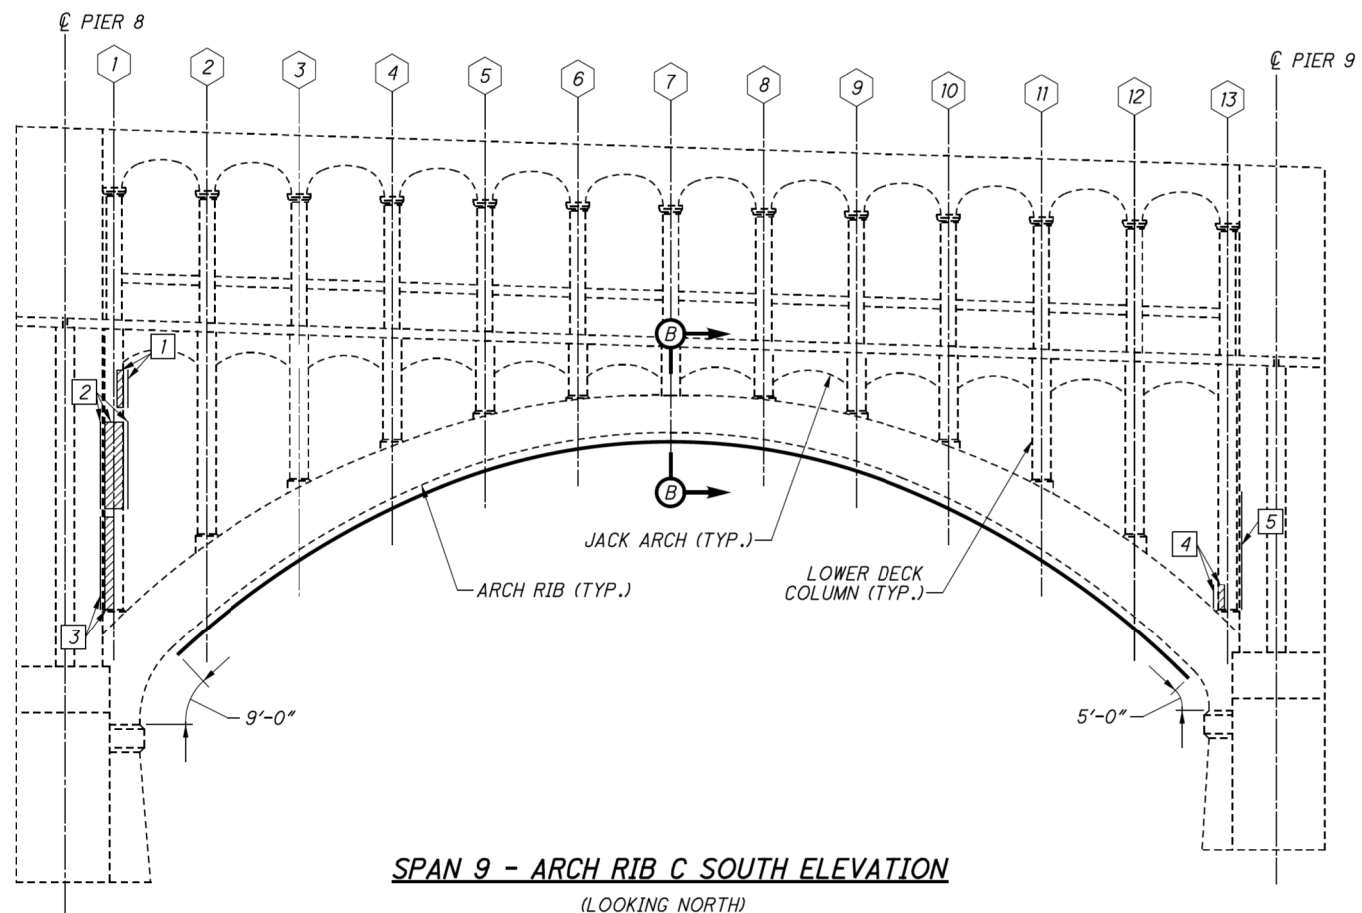
SPAN 9 - ARCH RIB C SOUTH ELEVATION
