CUY-6-1456

PHYSICAL CONDITION REPORT ROUTINE FRACTURE CRITICAL INSPECTION VETERANS MEMORIAL/DETROIT-SUPERIOR BRIDGE OVER THE CUYAHOGA RIVER SFN: 1800930

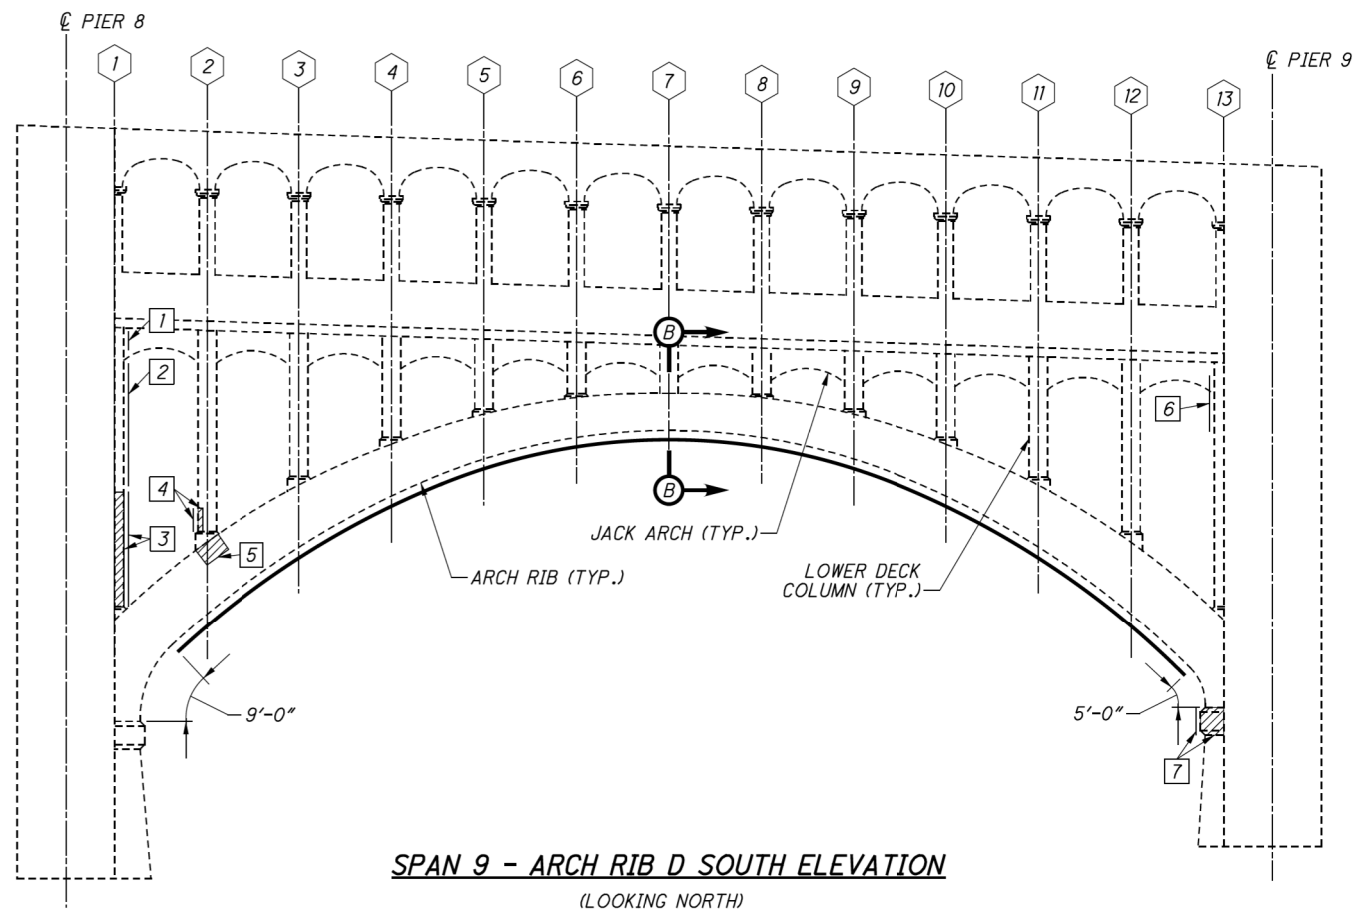
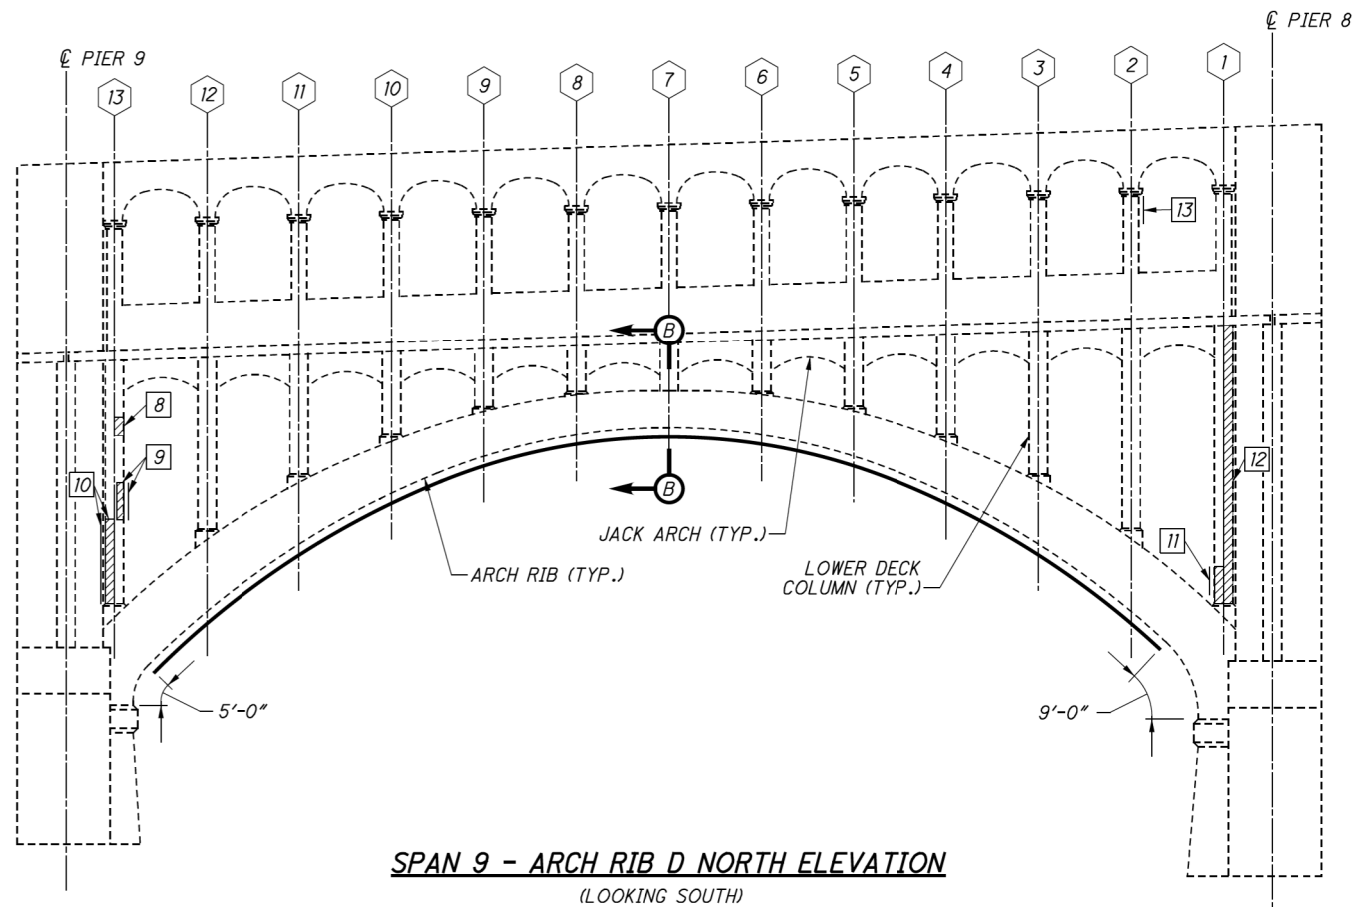
| ESTIMATED PATCHING QUANTITIES | | | |

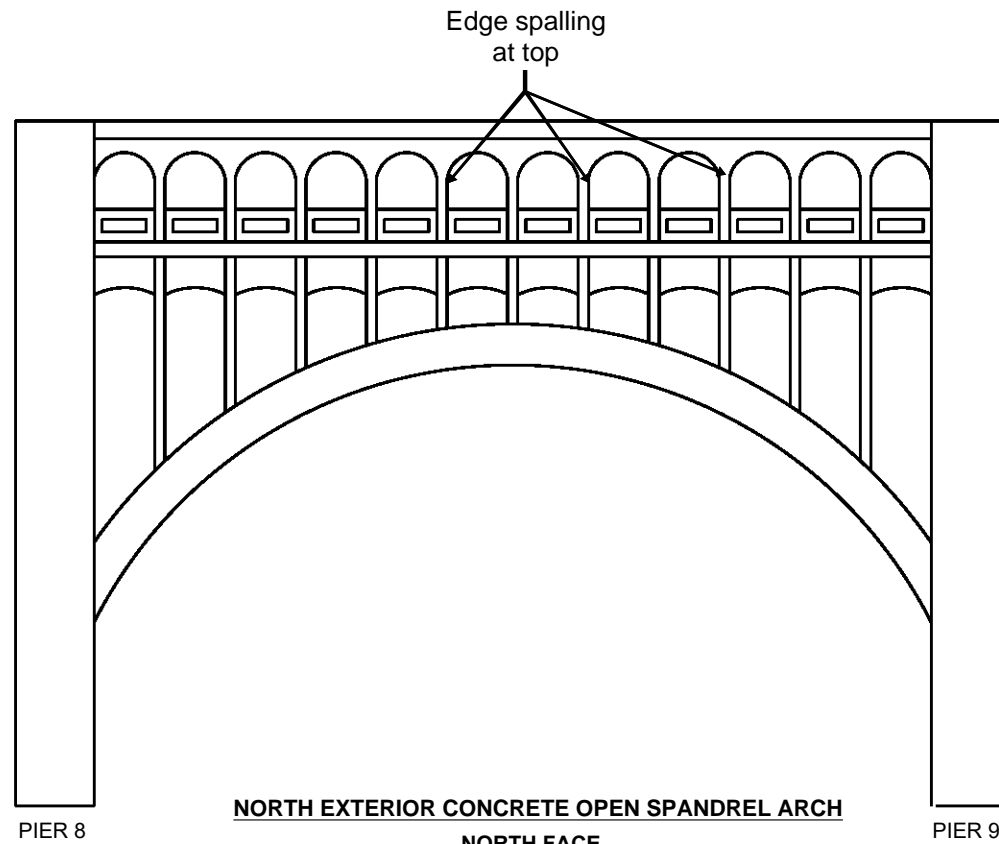
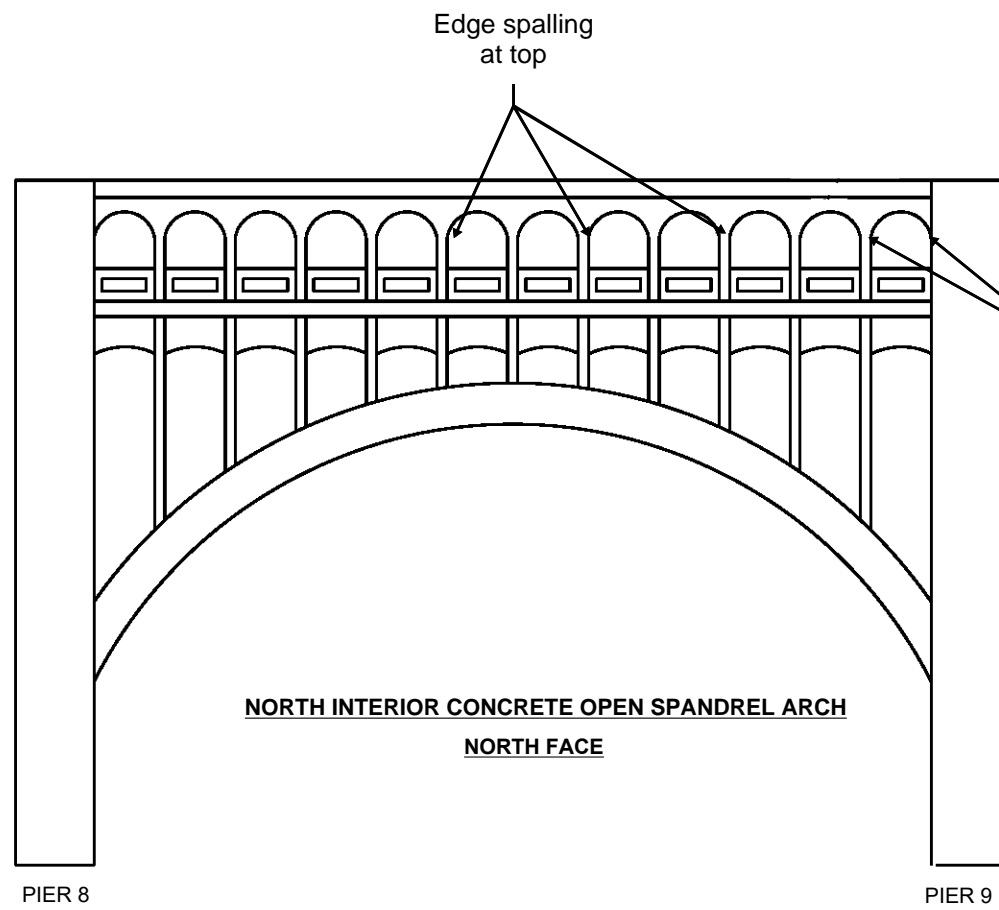
North face of columns have extensive delaminations and spalls along the full height

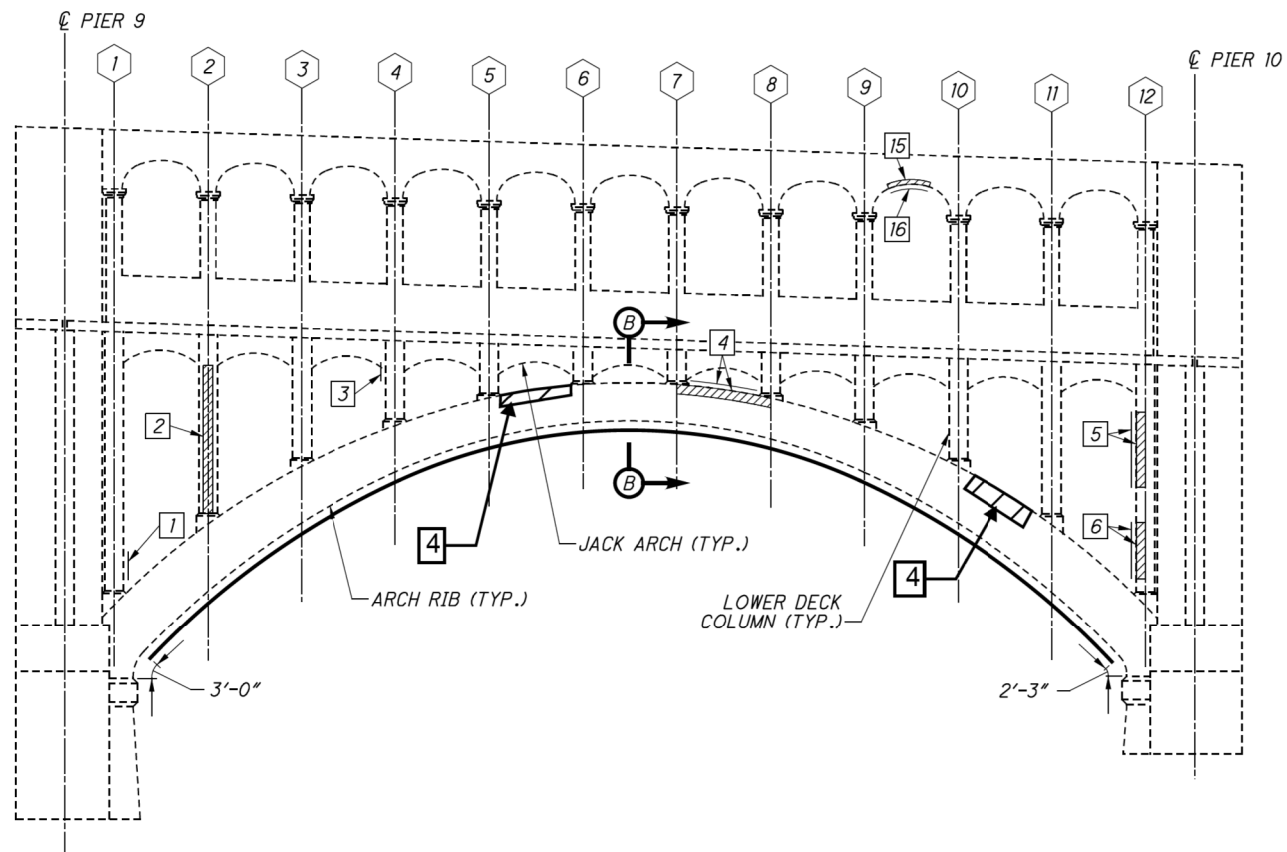
SPAN 10 - ARCH RIB A SOUTH ELEVATION
(LOOKING NORTH)

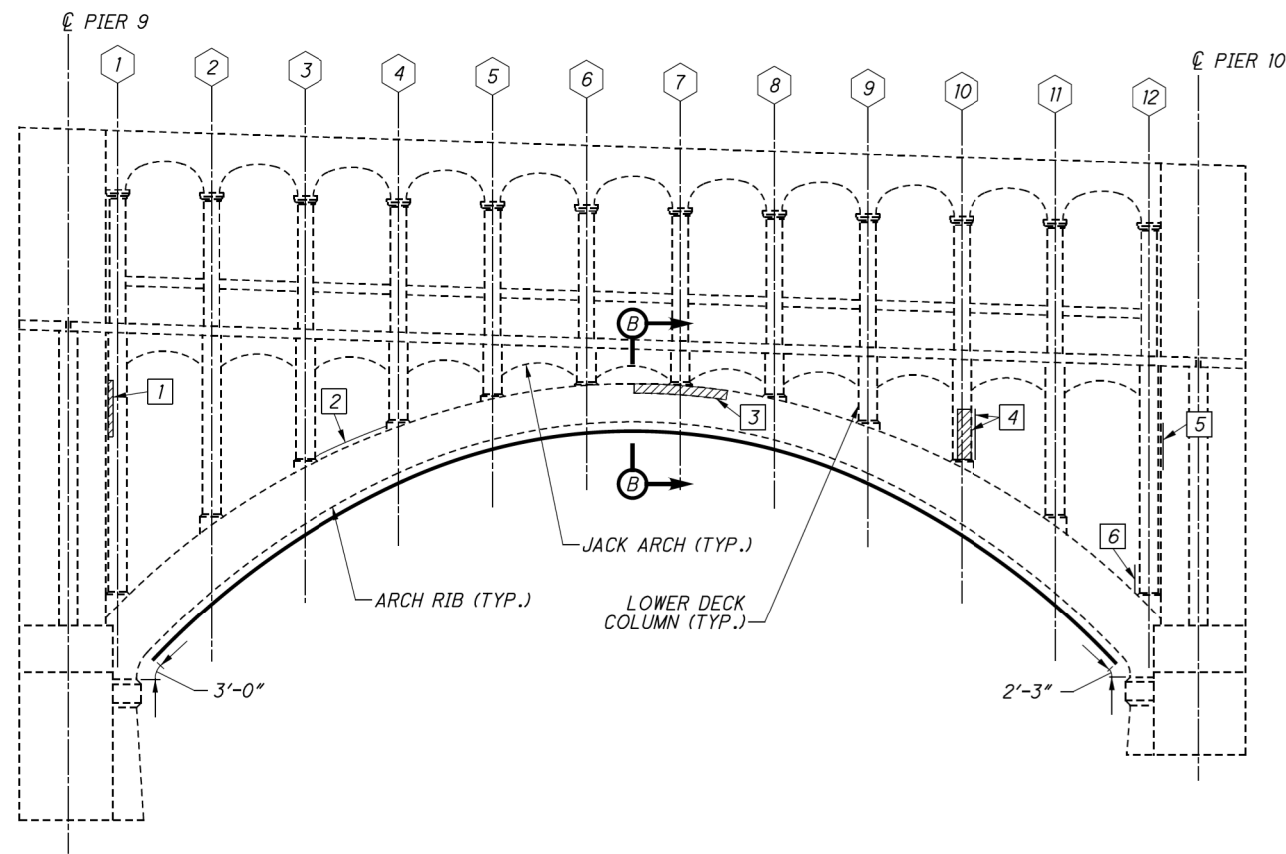
SPAN 10 - ARCH RIB B SOUTH ELEVATION
(LOOKING NORTH)

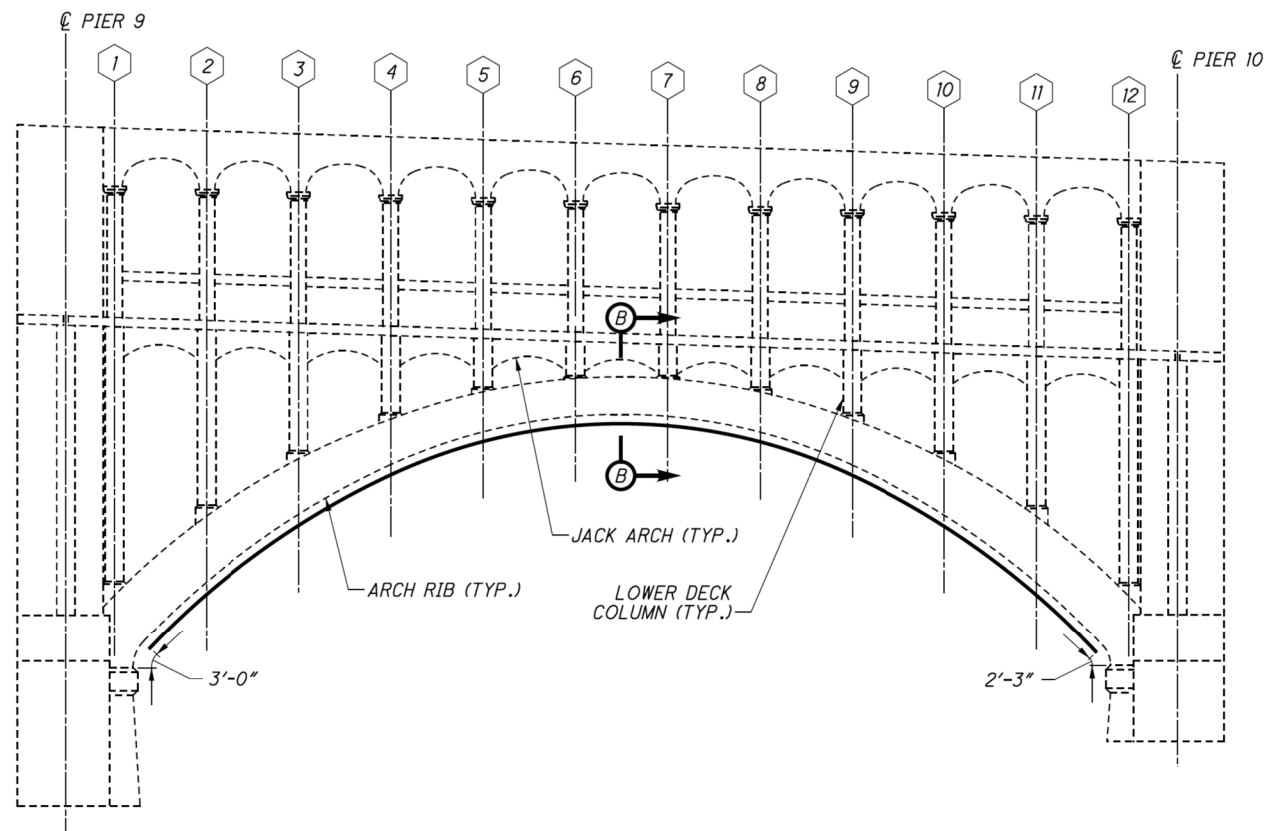
SPAN 10 - ARCH RIB C SOUTH ELEVATION
(LOOKING NORTH)

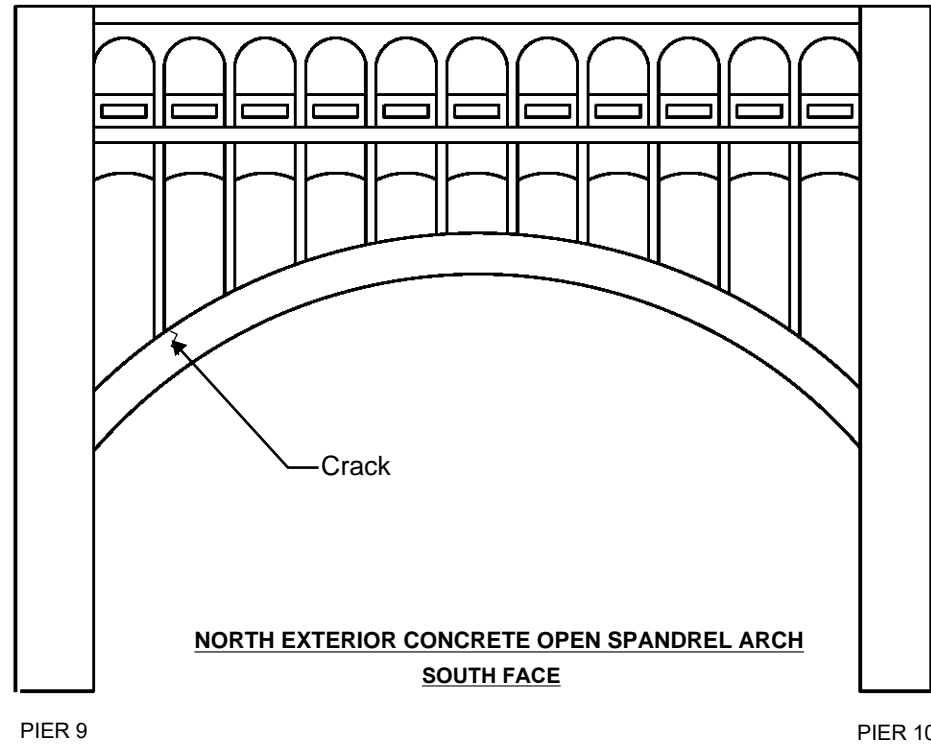
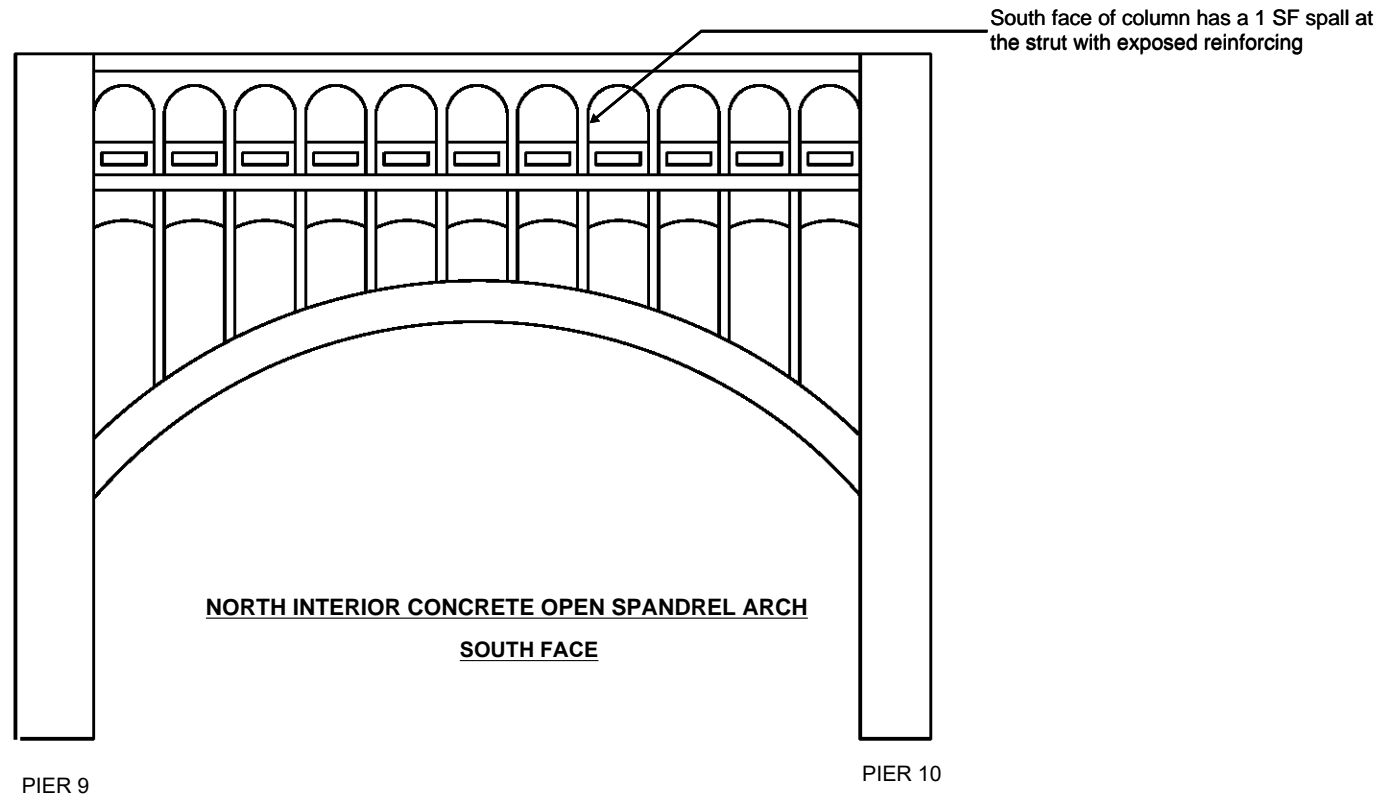
| NOT TO SCALE | NOV, 2018 | | INFRASTRUCTURE ENGINEERS, INC. | SPAN 10 CONCRETE REPAIR DETAILS |

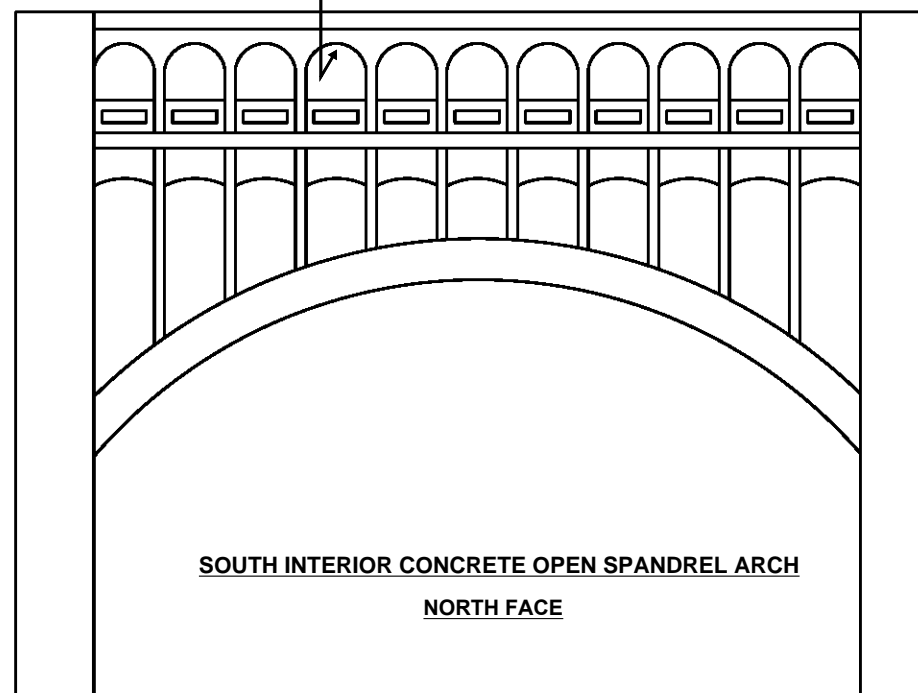
Bottom face: Cracked
and delaminated

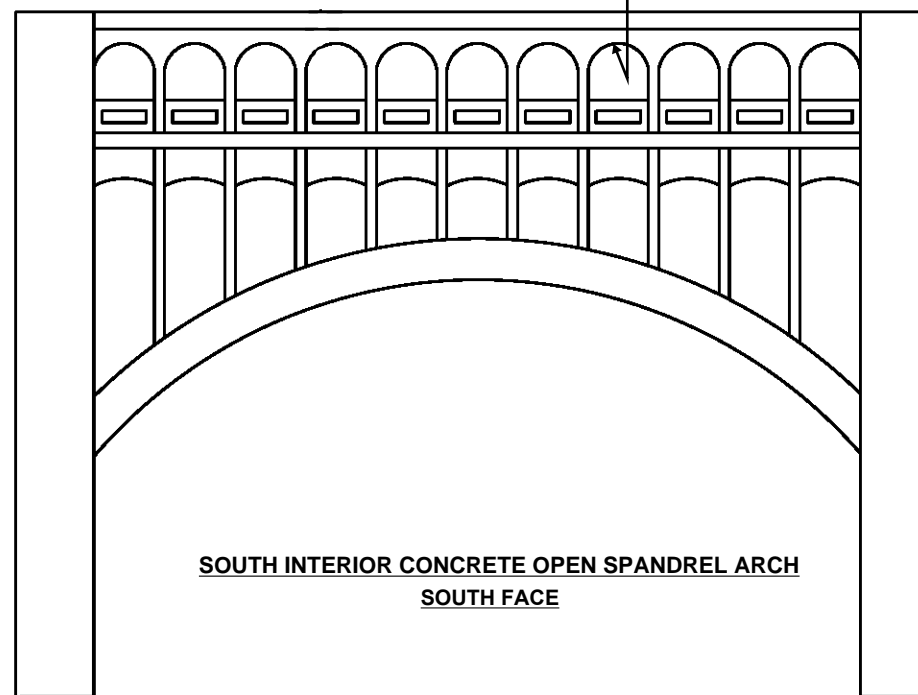
Bottom face: Cracked
and delaminated

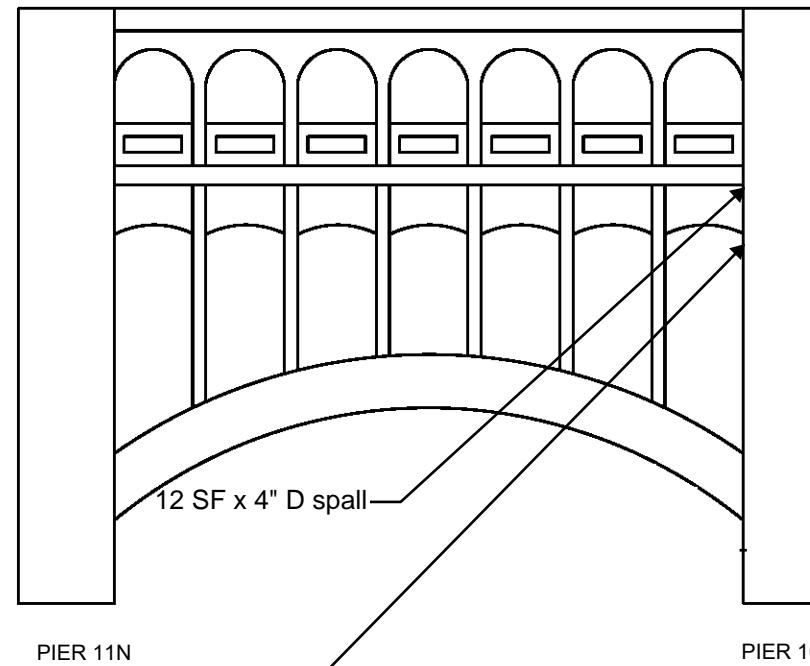
2' horizontal crack with 1'
W x 2" D spall with adjacent
20 SF map cracks

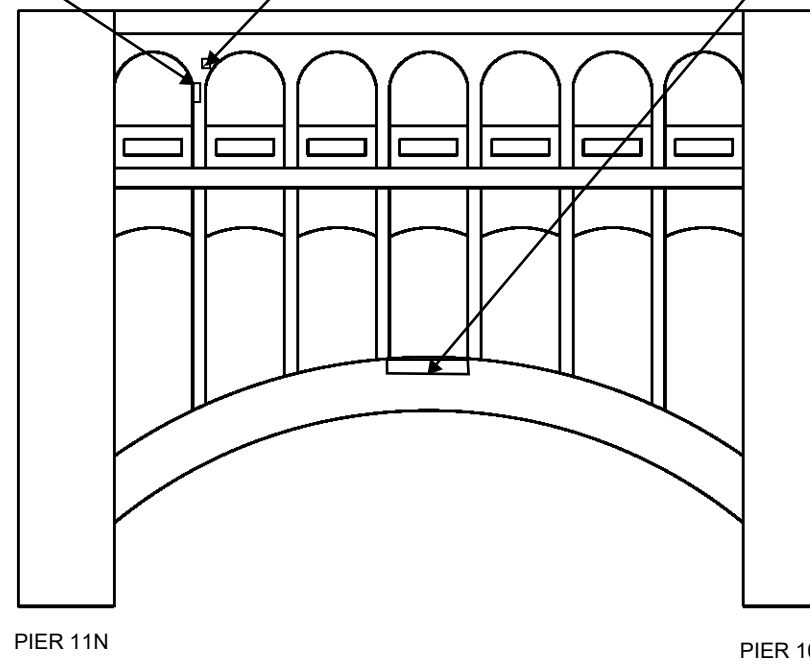
NORTH INTERIOR CONCRETE OPEN SPANDREL ARCH
NORTH FACE

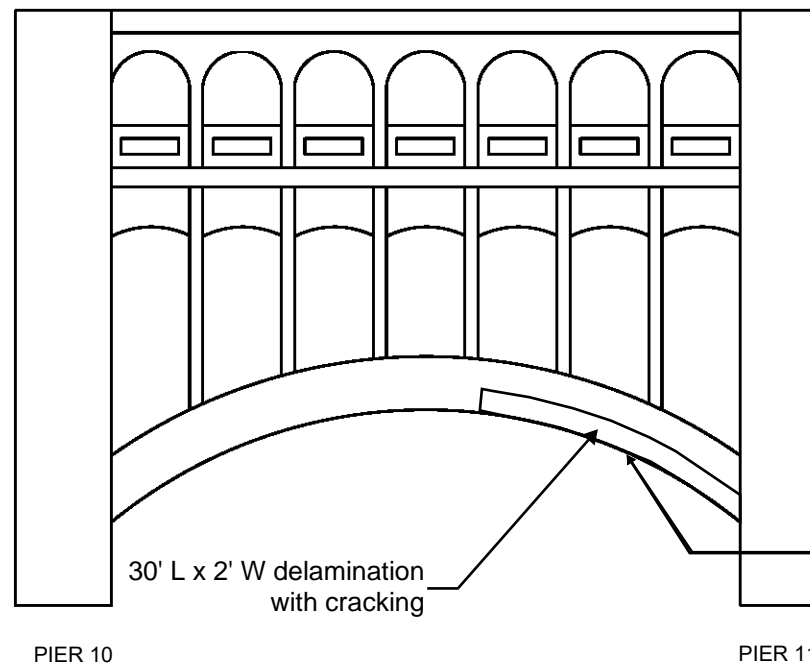
Crack on the south face near the bottom extending from pier 11 to approximately 1/4 the way up the arch

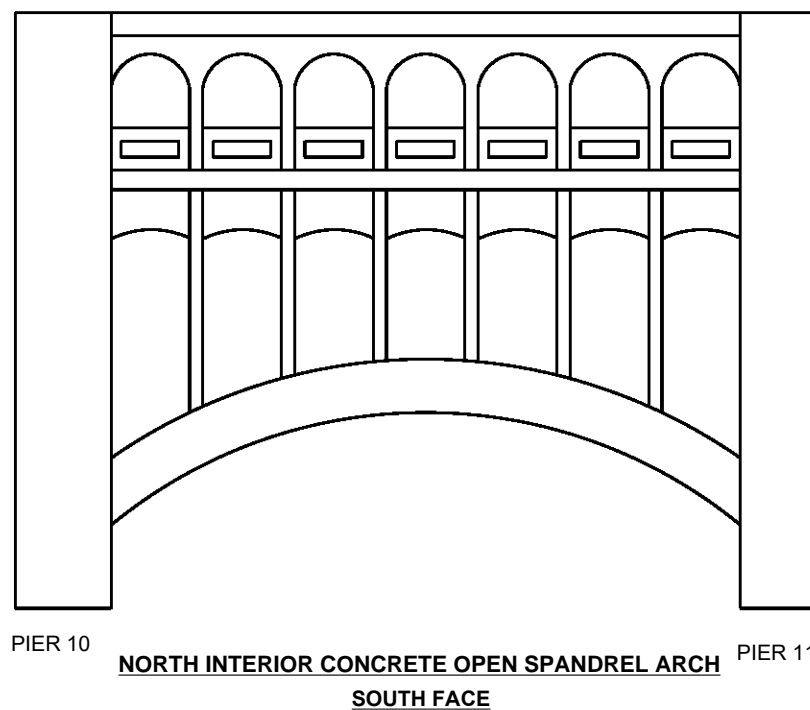
NORTH INTERIOR CONCRETE OPEN SPANDREL ARCH
SOUTH FACE

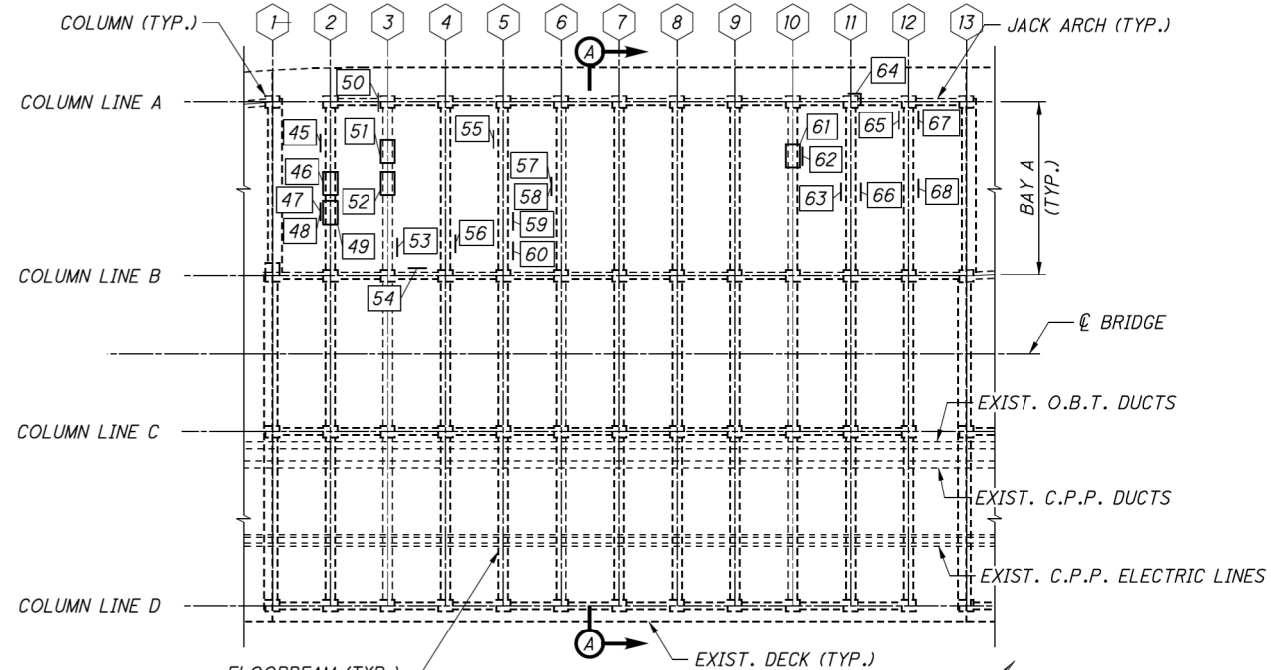
4' L x 2' H x Full Width beam is spalled with exposed steel beam

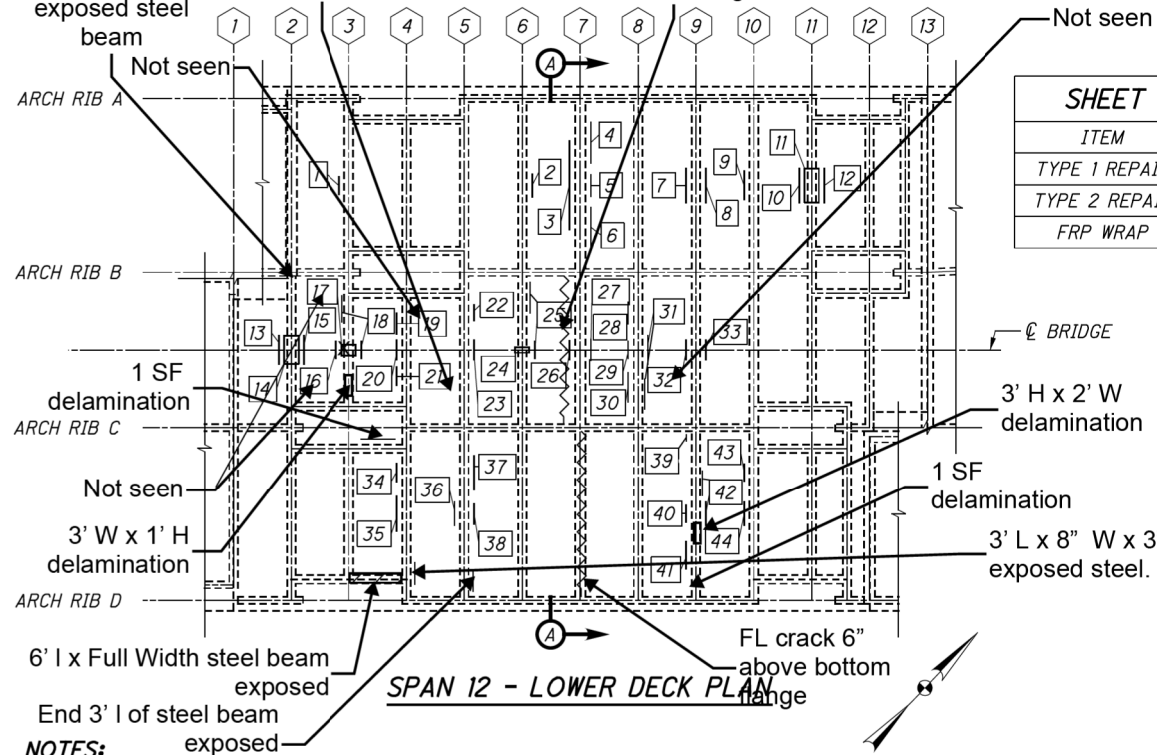
| SHEET QUANTITY SUMMARY | | |

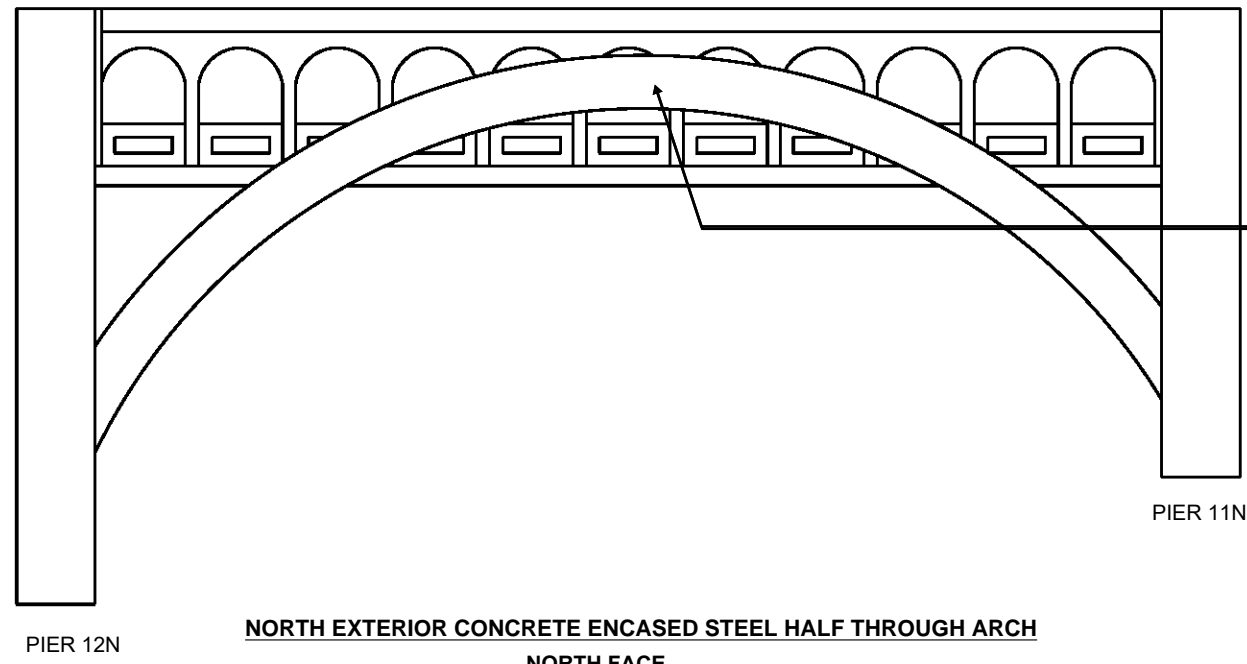
South face of the arch is delaminated with widespread cracking near the bases. 1/2" W crack in the delaminated surface.

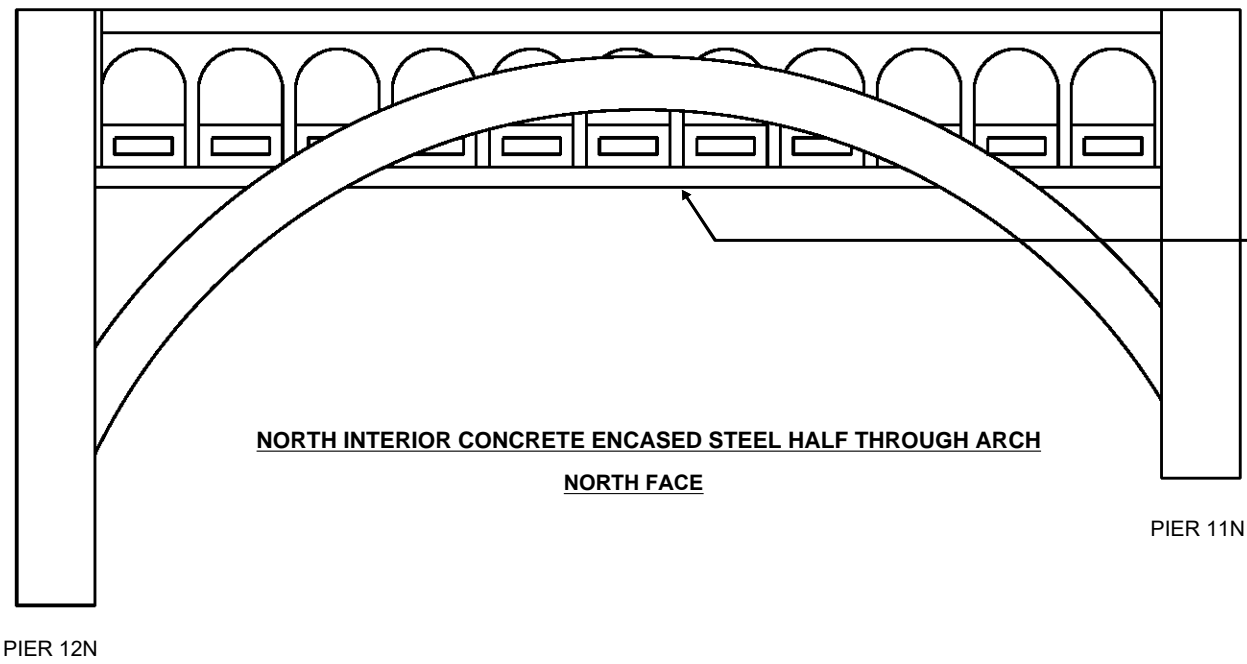
Lower deck floor beam 6 appears to be delaminated along the full length

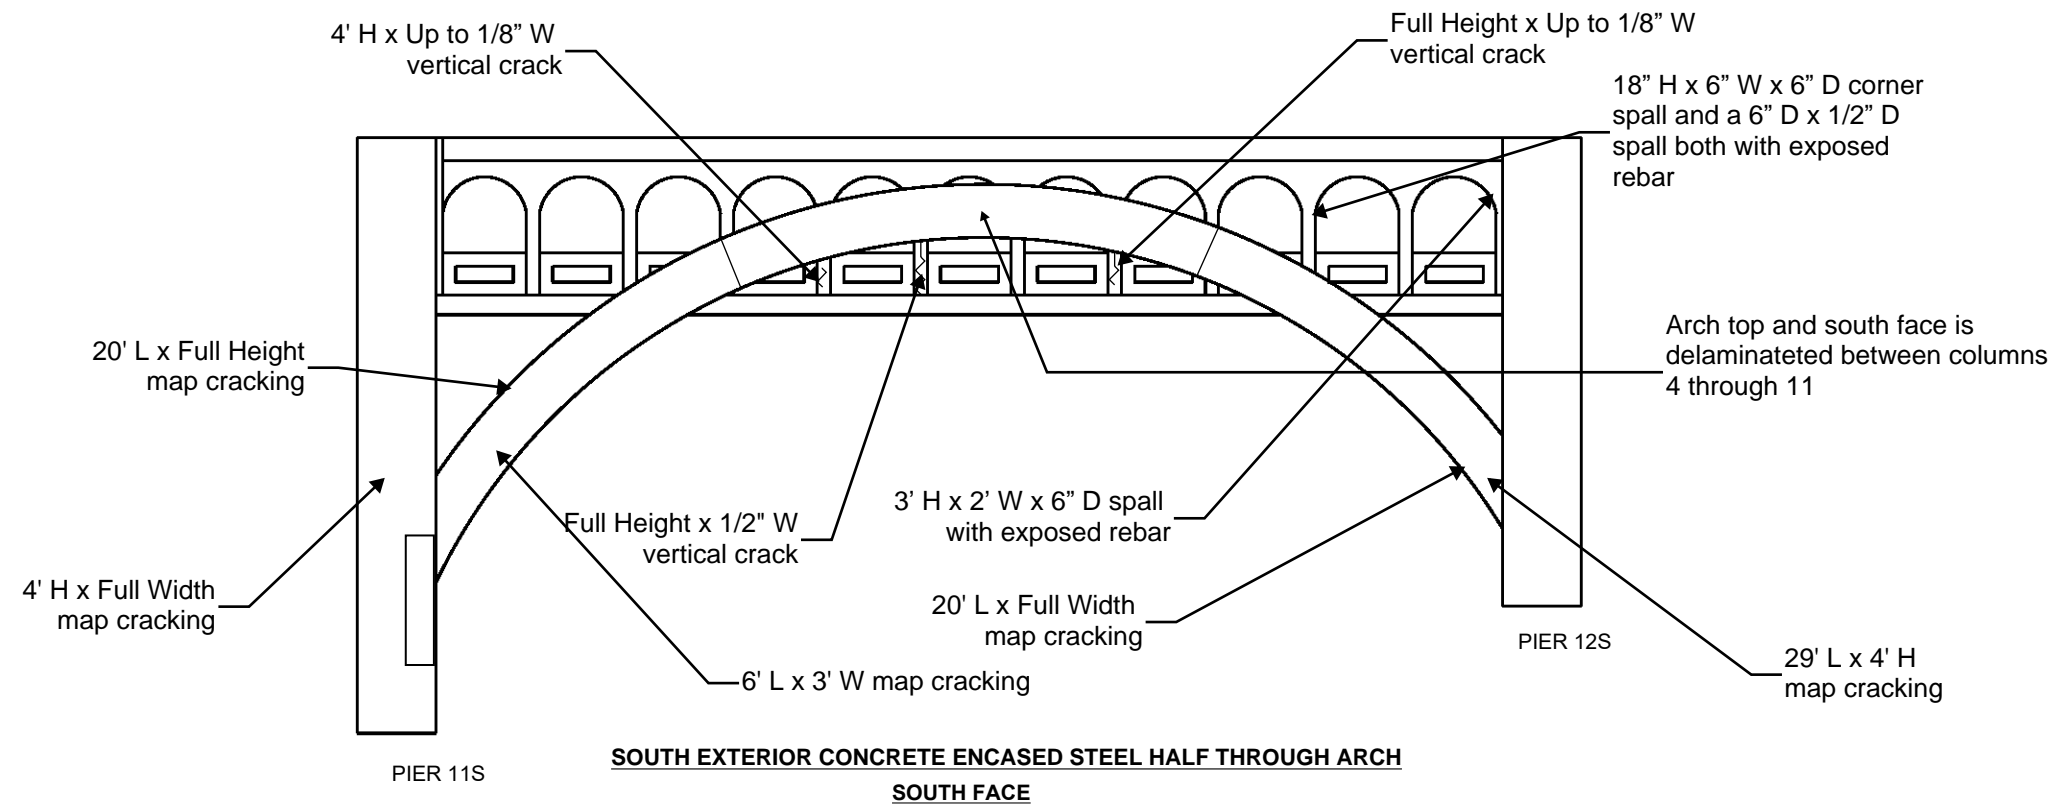
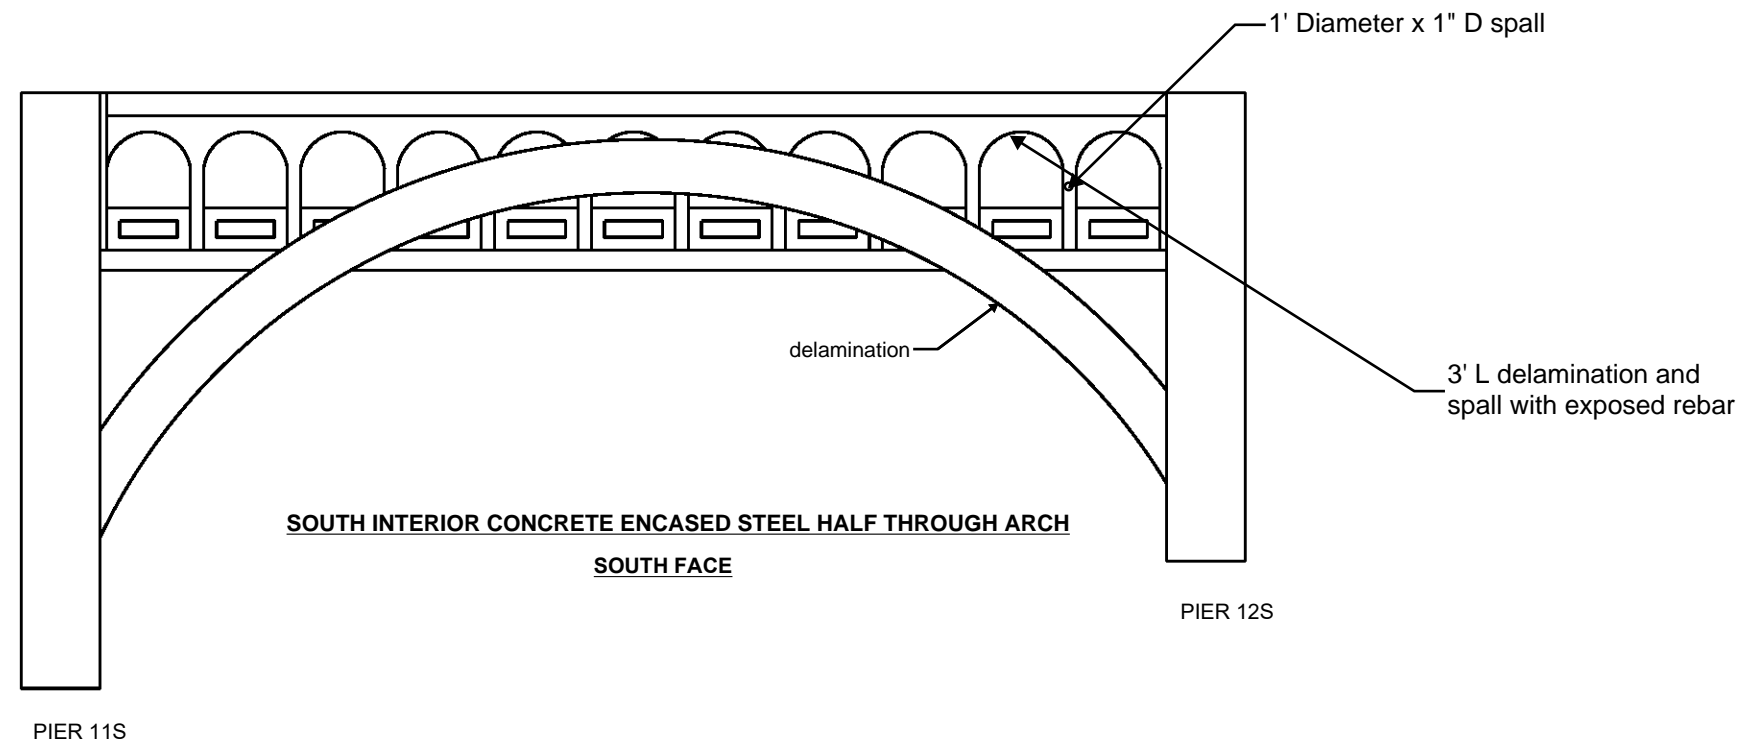
| NOT TO SCALE | NOV, 2018 | | INFRASTRUCTURE ENGINEERS, INC. | STRUCTURE ELEVATION - SPAN 12 |

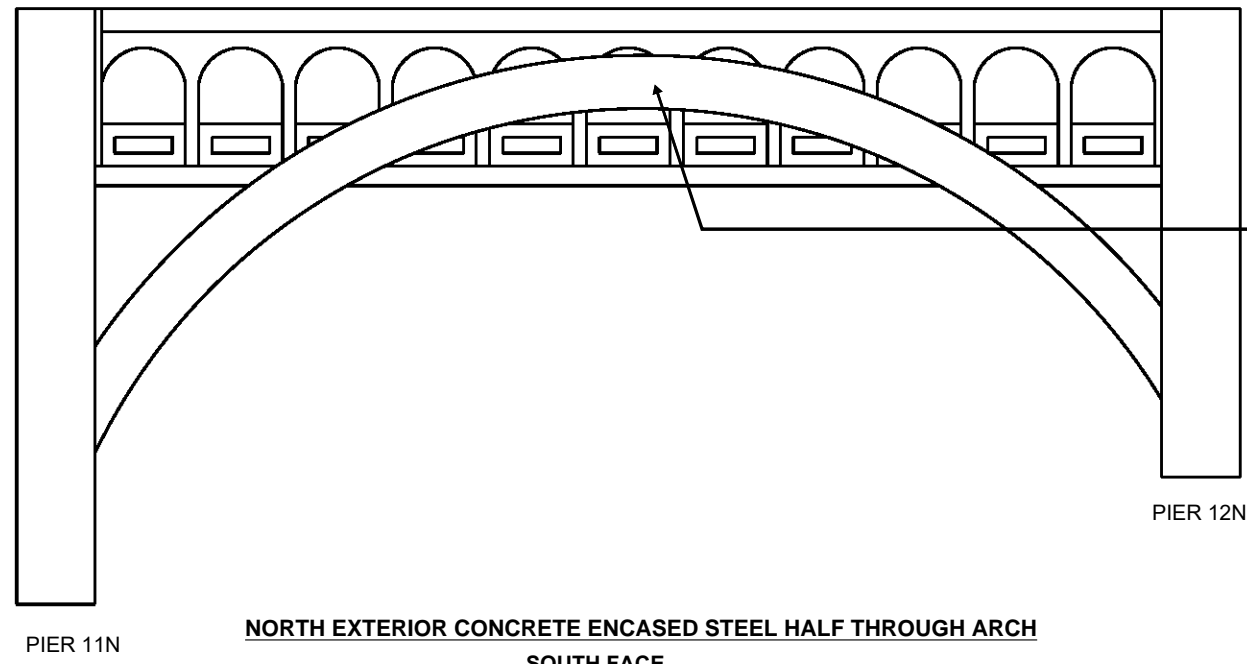
South face of the arch is delaminated with widespread cracking near the bases. 1/2" W crack in the delaminated surface.

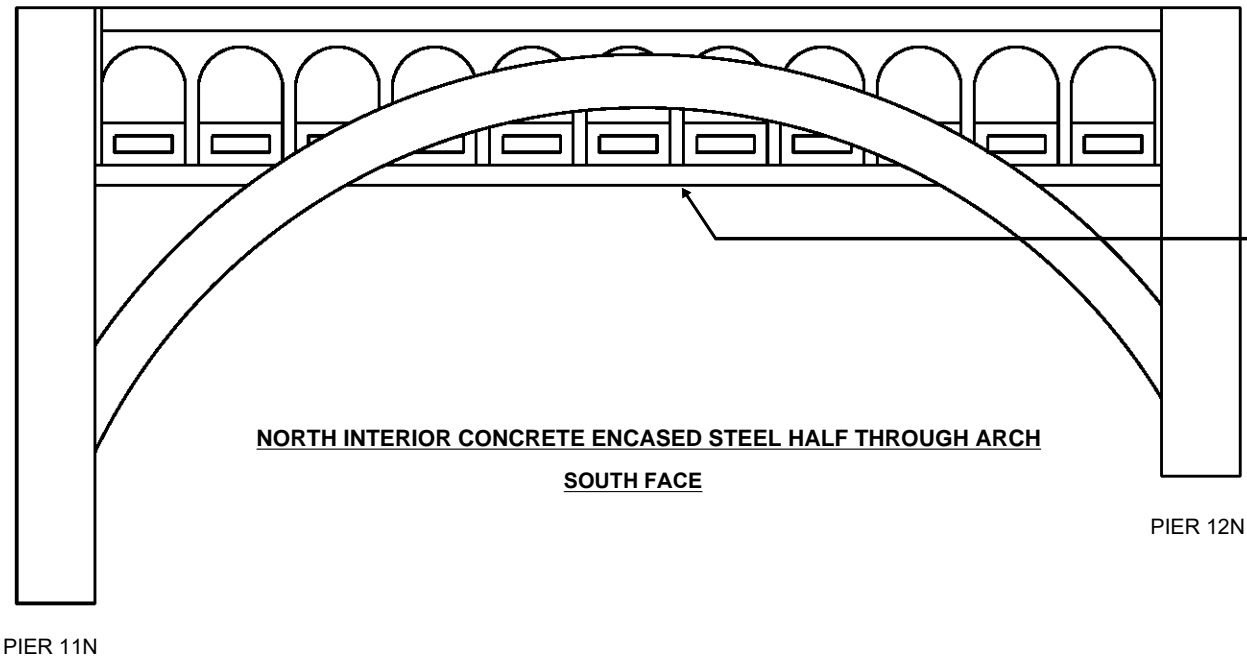
Lower deck floor beam 6 appears to be delaminated along the full length

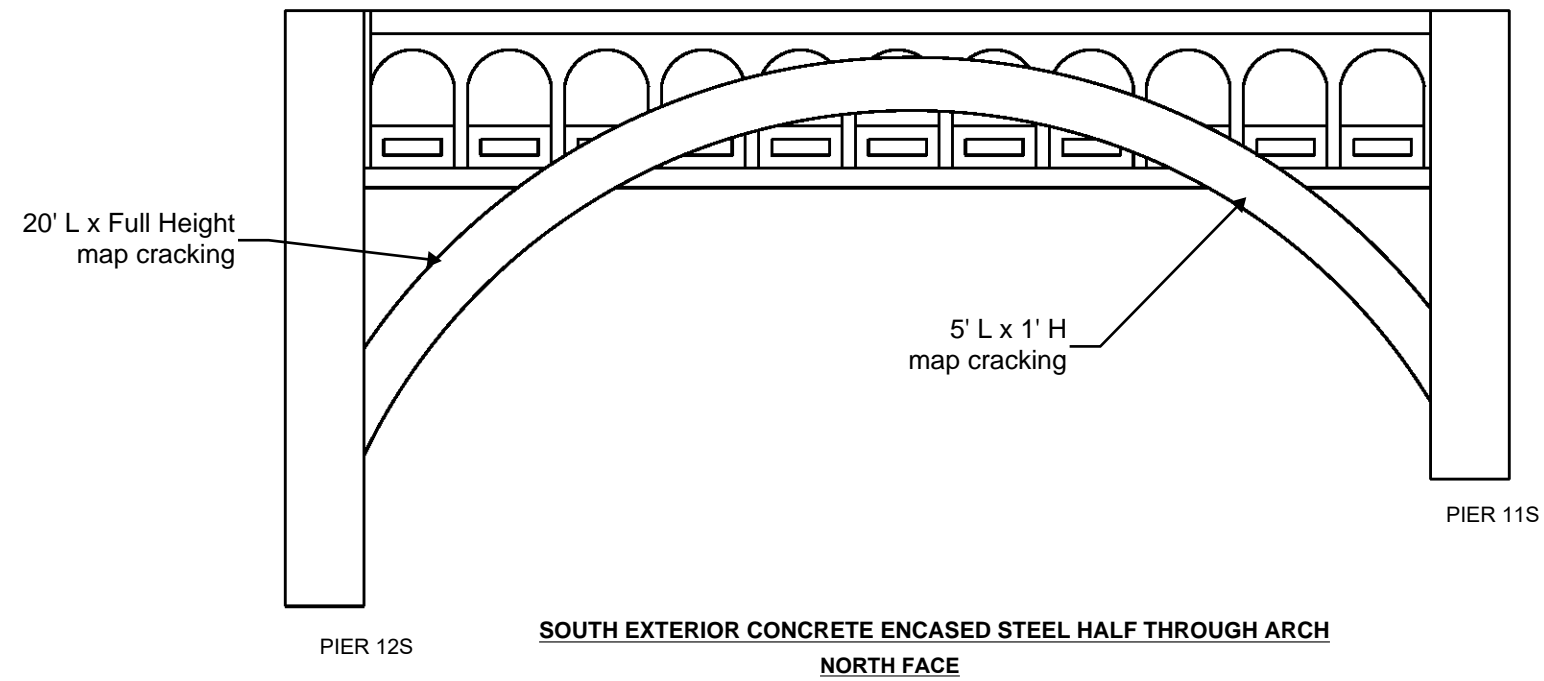
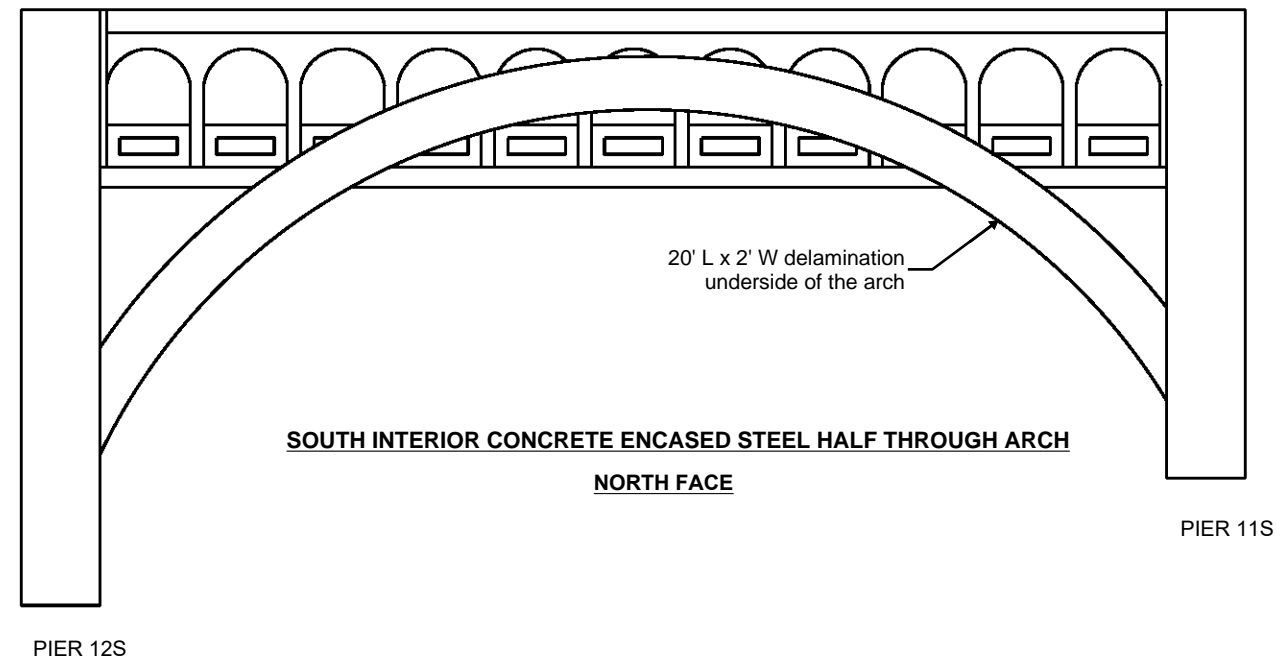
| NOT TO SCALE | NOV, 2018 | | INFRASTRUCTURE ENGINEERS, INC. | STRUCTURE ELEVATION - SPAN 12 |
