CUY-6-1456

PHYSICAL CONDITION REPORT ROUTINE FRACTURE CRITICAL INSPECTION VETERANS MEMORIAL/DETROIT-SUPERIOR BRIDGE OVER THE CUYAHOGA RIVER SFN: 1800930

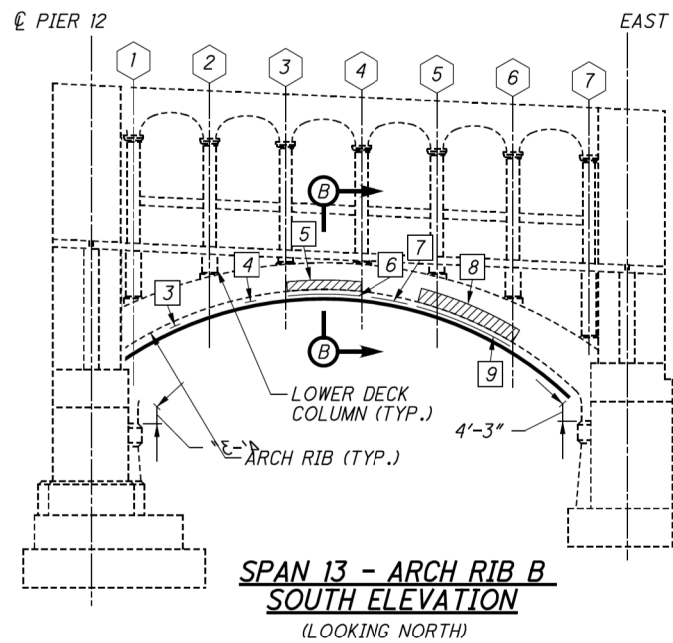
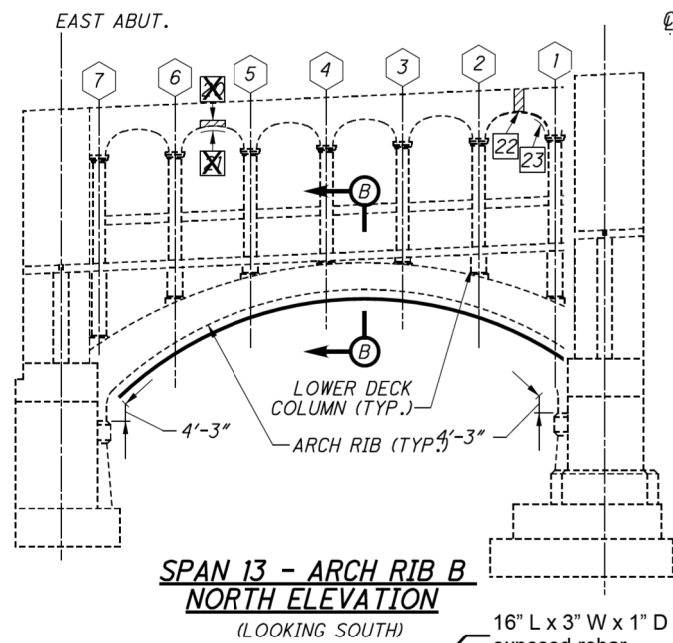
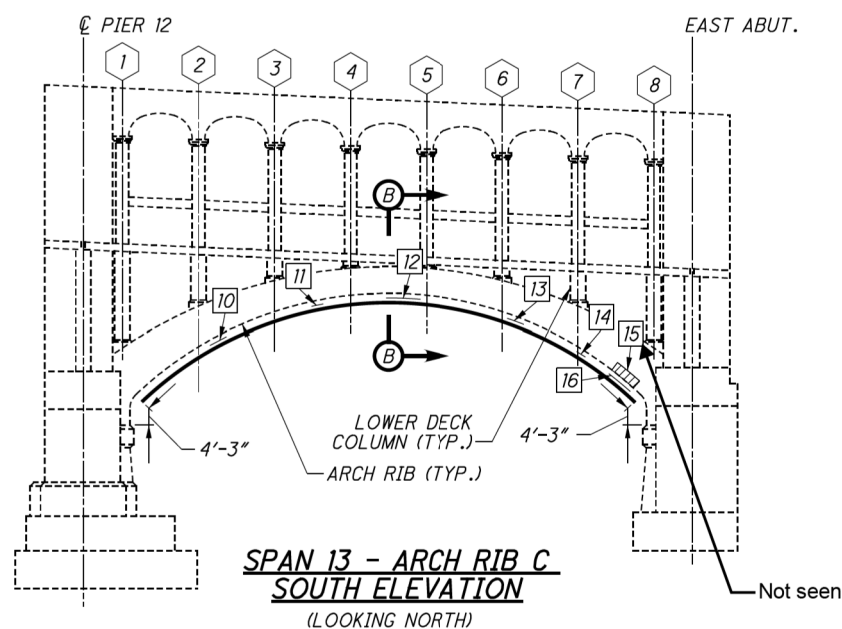
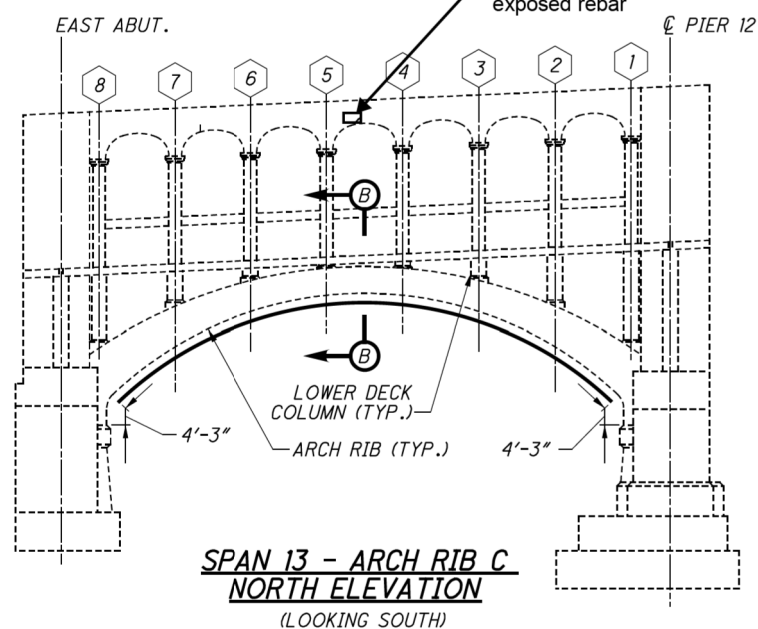
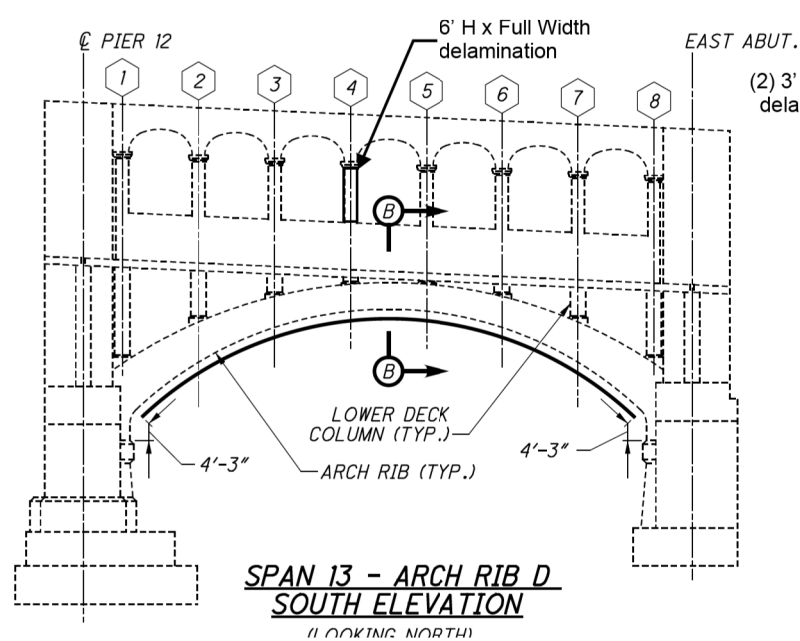
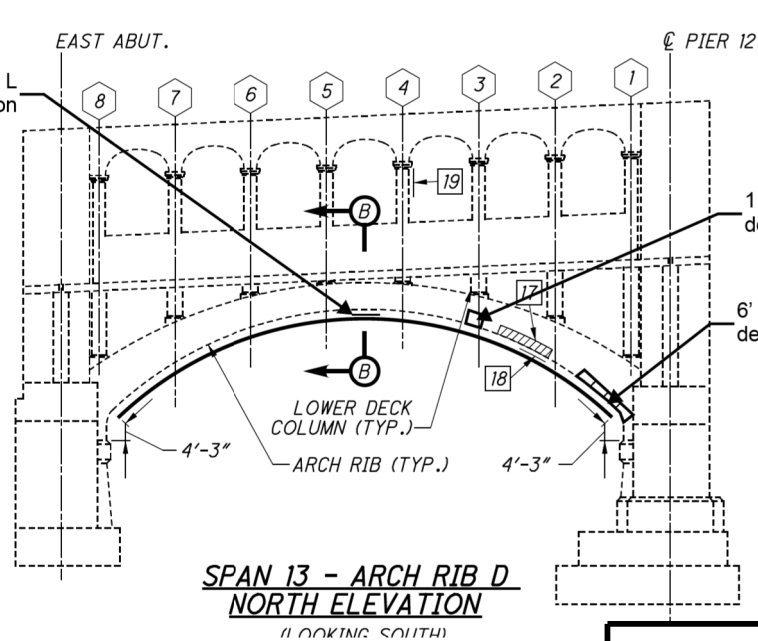
| ESTIMATED PATCHING QUANTITIES | | | |

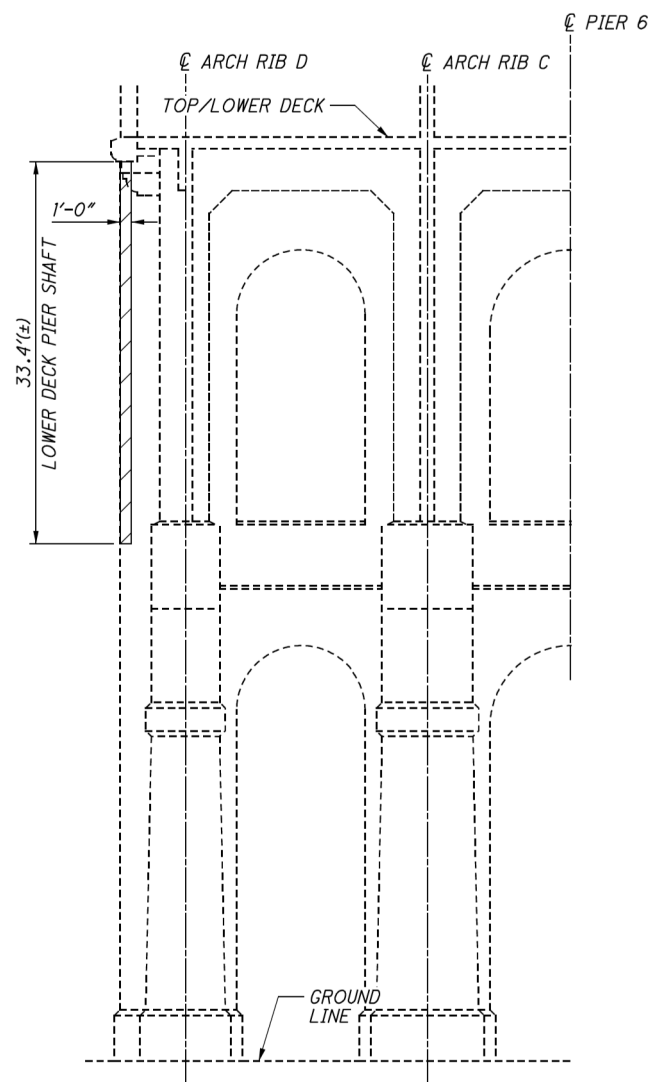
PIER 6 - EAST ELEVATION
SHOWING LIMITS OF REMOVAL

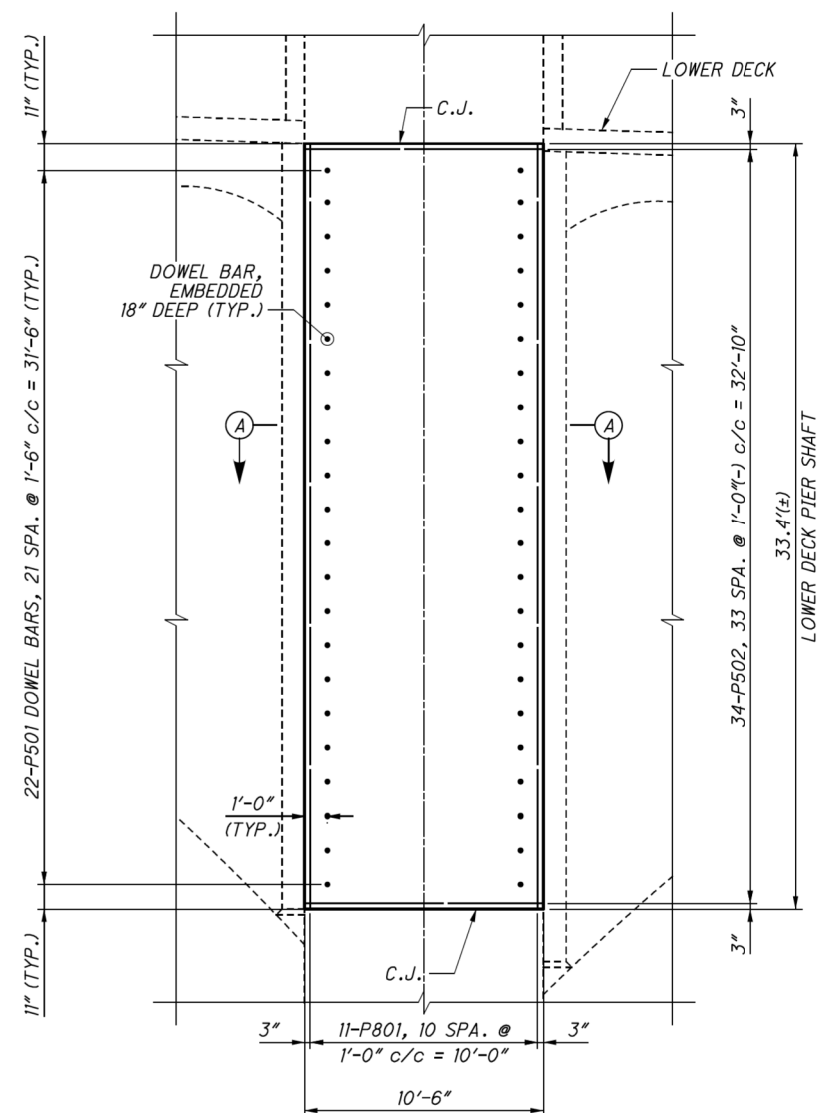
PARTIAL REPLACEMENT
LOWER DECK SHAFT ELEVATION

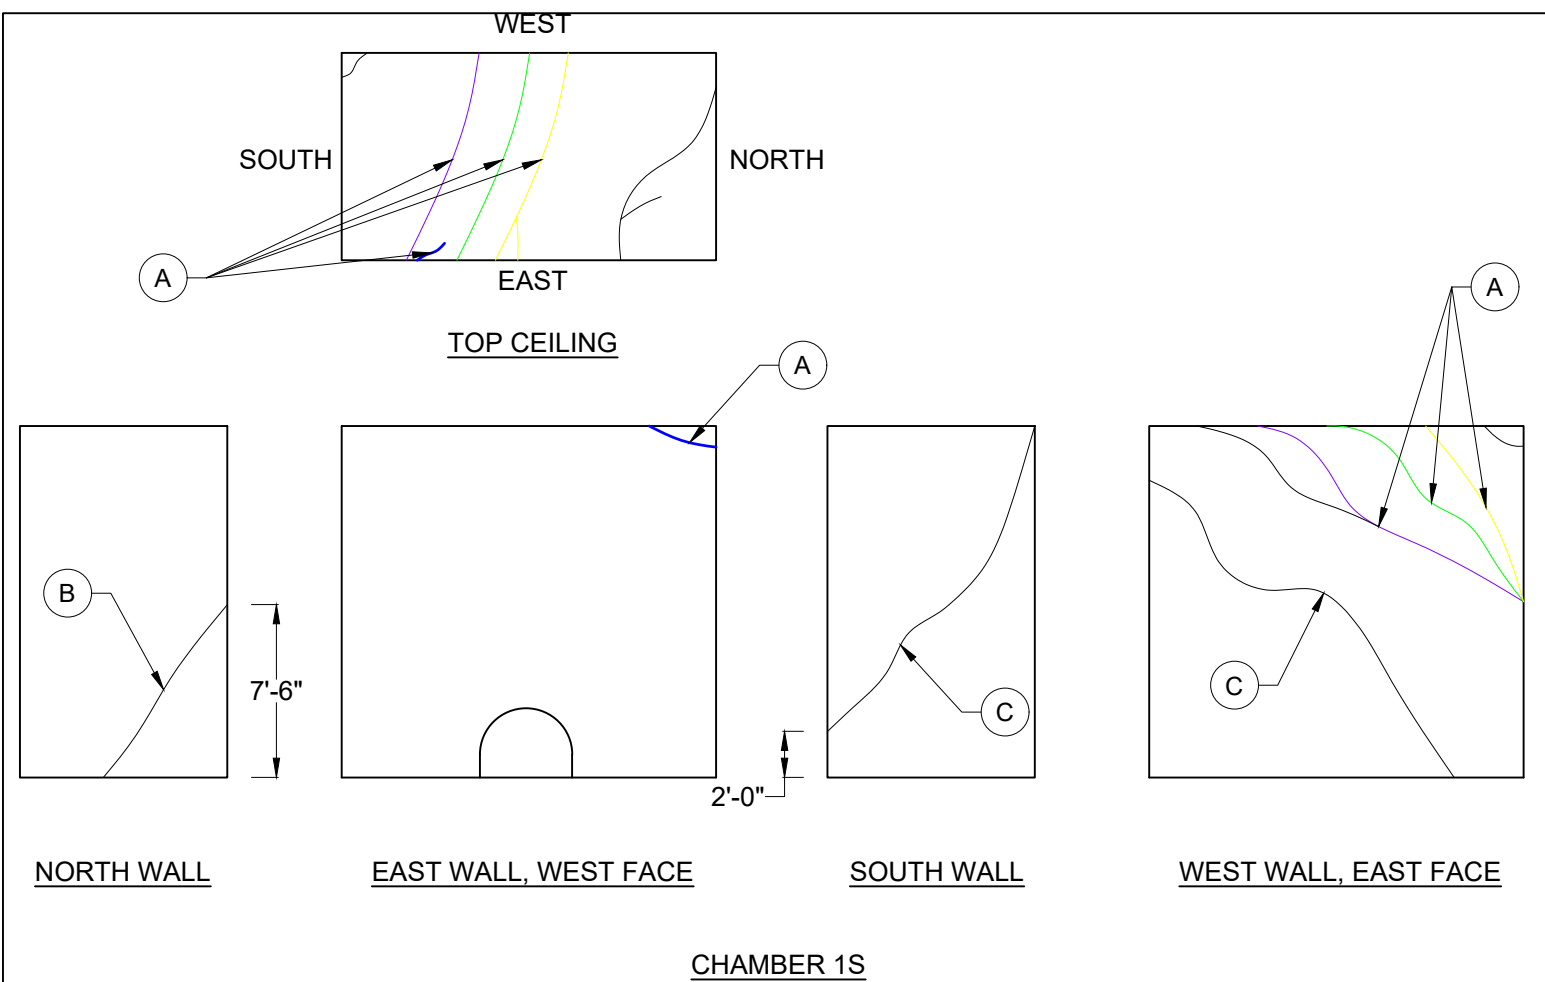
| CHAMBER 1S DEFECT TABLE | | |

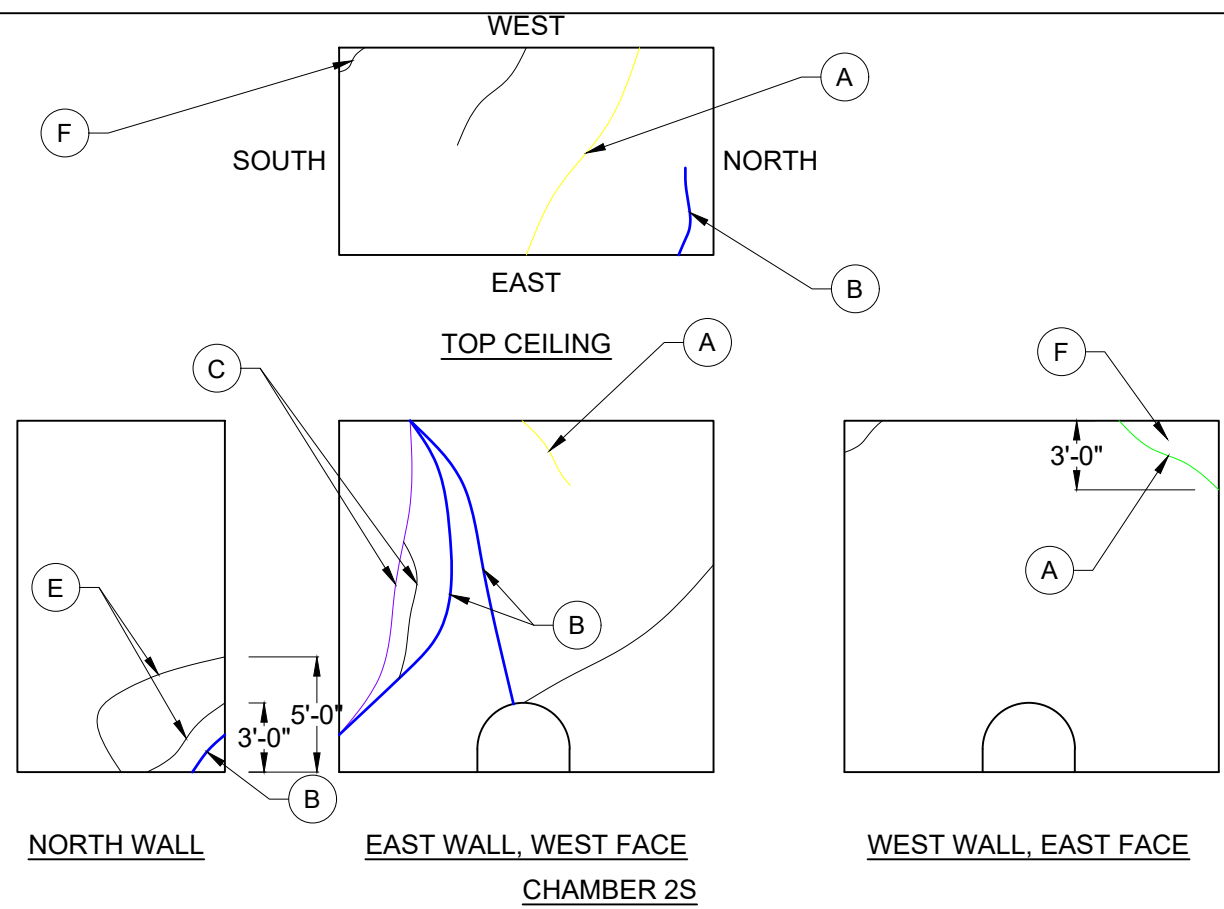
| CHAMBER 2S DEFECT TABLE | | |

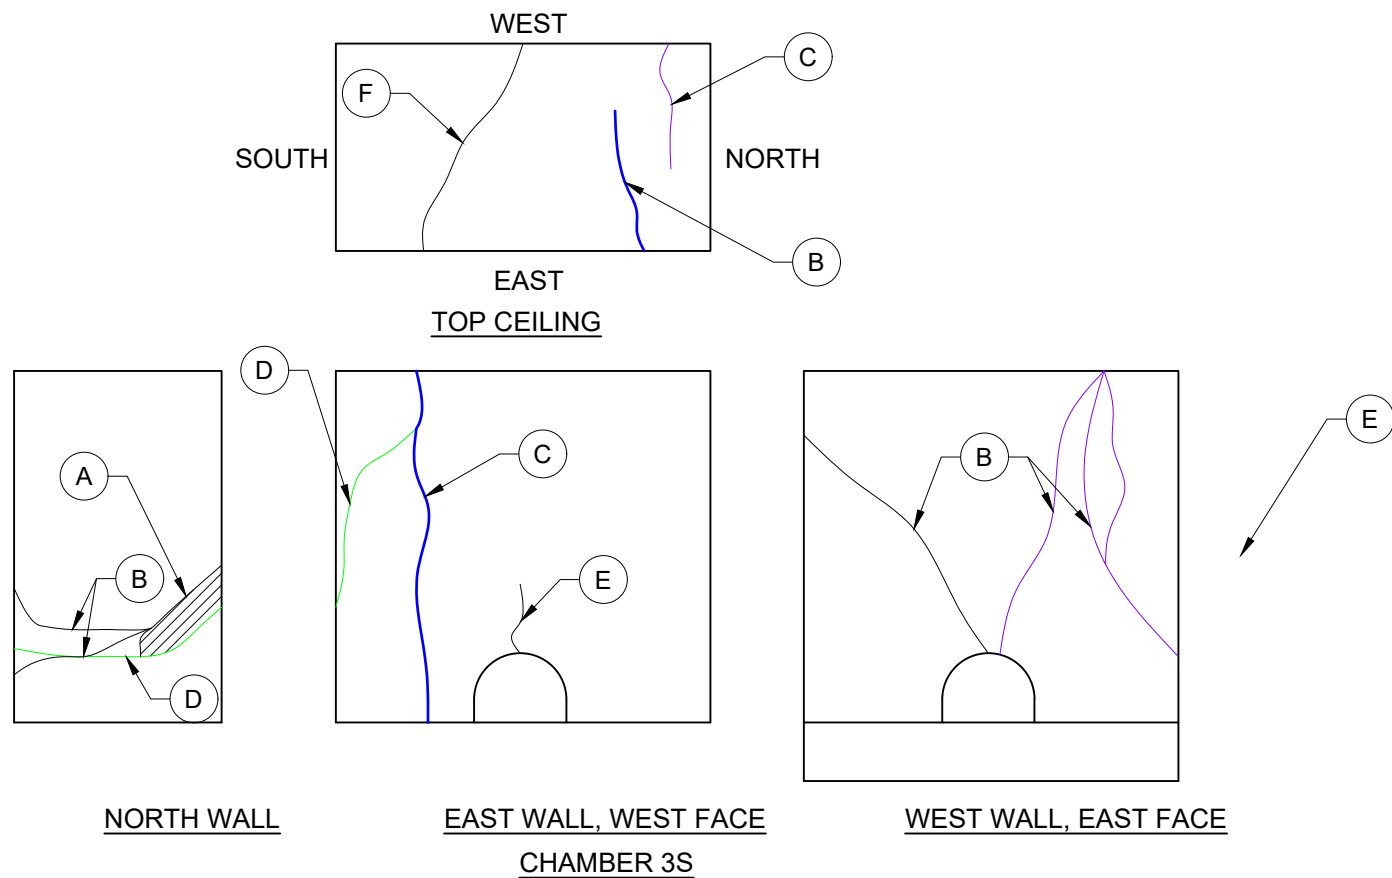
| CALL OUT # | DEFECT DESCRIPTION | PHOTO # |

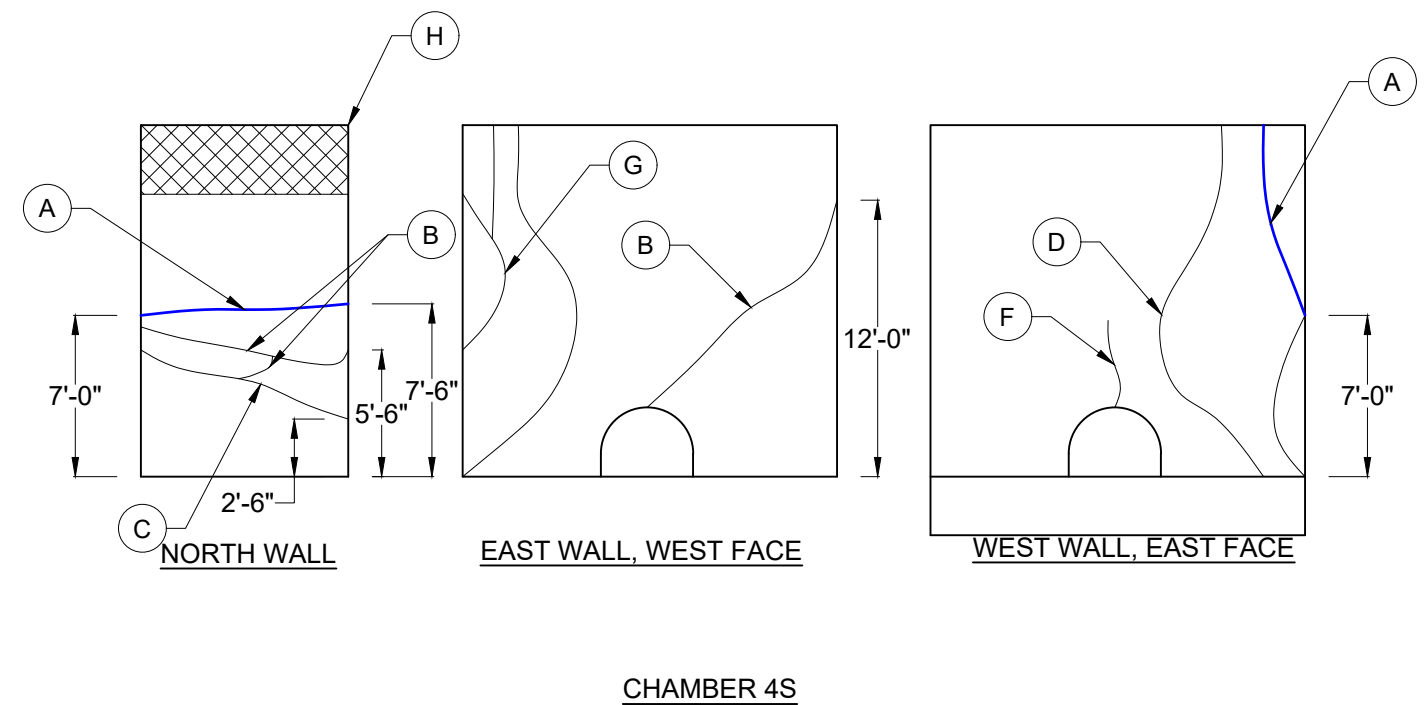
| CALL OUT # | DEFECT DESCRIPTION | PHOTO # |

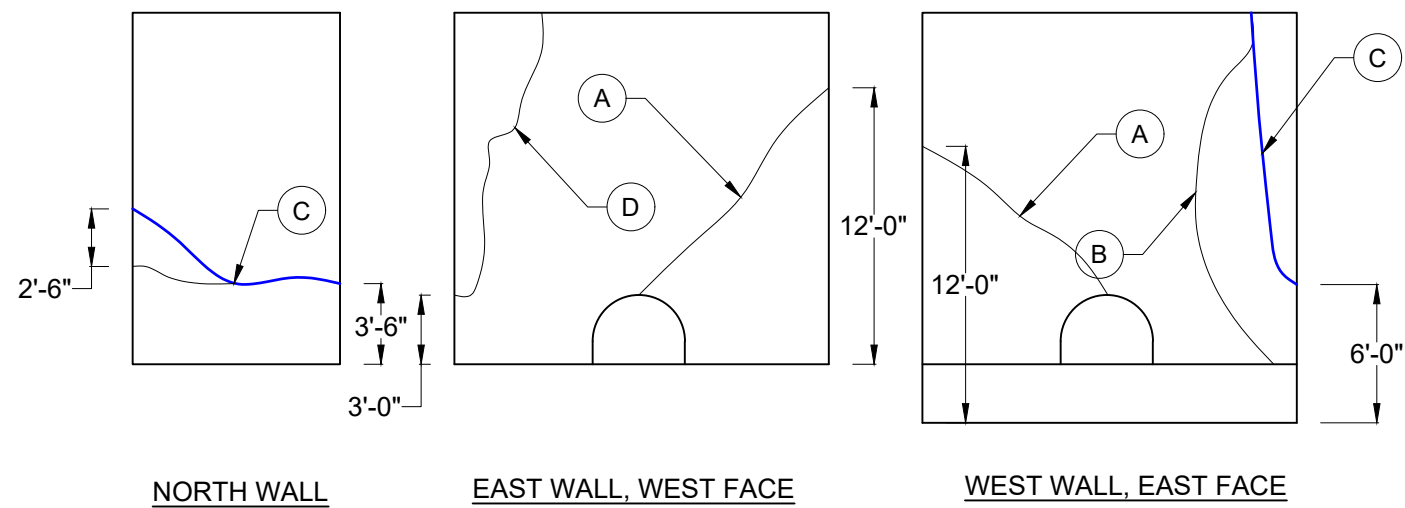
- All Dimensions are Field Measurements.
- Waterline Reference for soundings is the Top of Angled Nose on the Upstream side of Pier 5 (Top of Nose to Waterline = 11.2')
- Stream slope is < 1%.

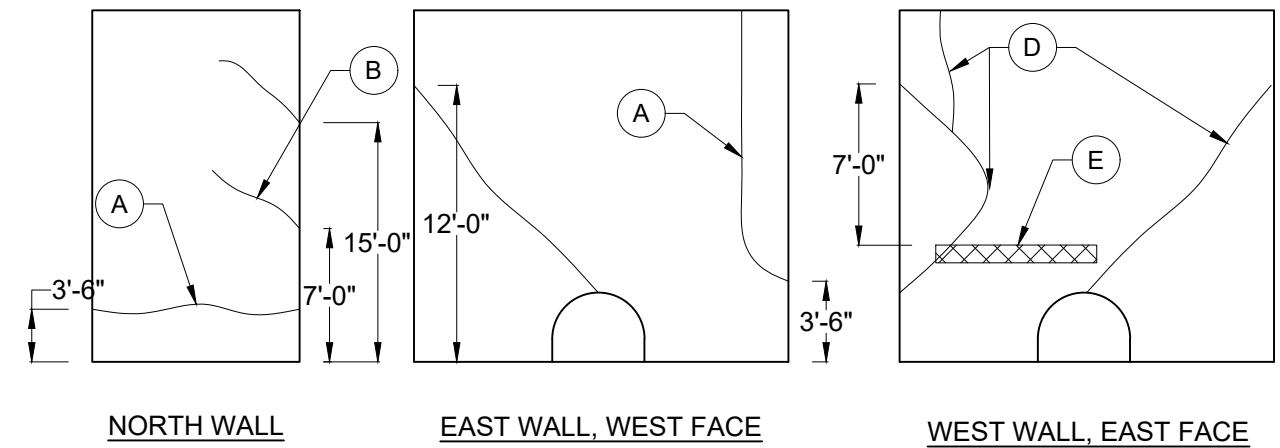
| CHAMBER 5S DEFECT TABLE | | |
|---|--|---|
| D | 3/4" W crack at 7'-6". | DWN059-60 |

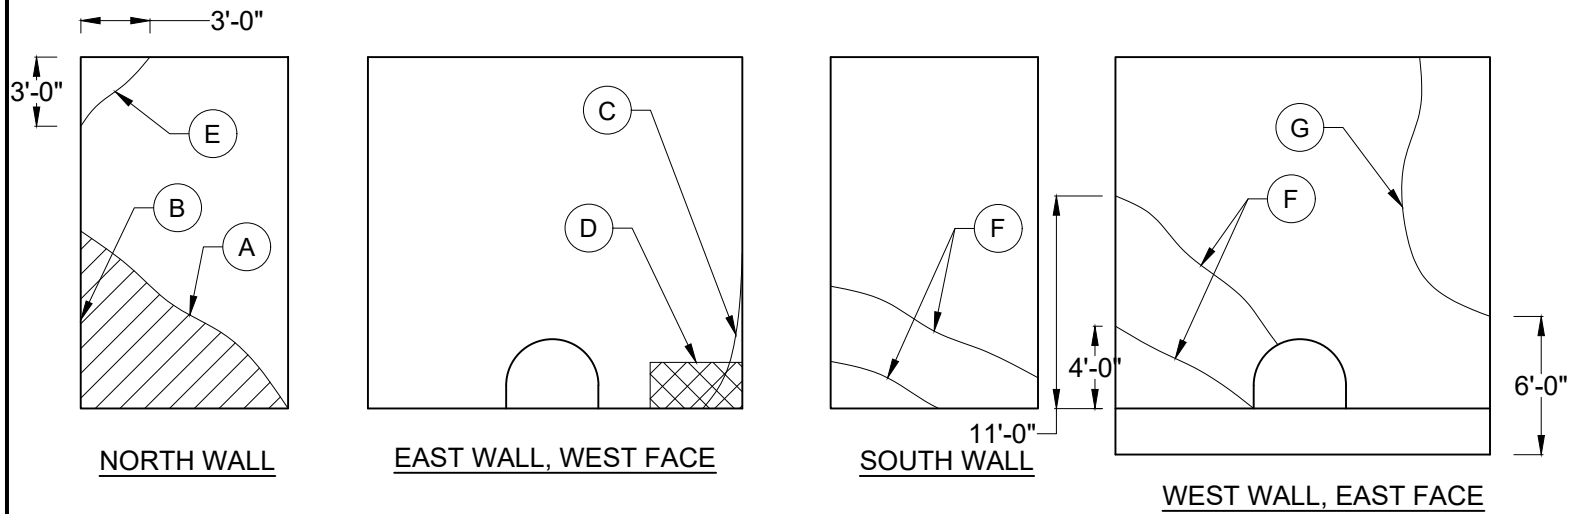
| CHAMBER 7S DEFECT TABLE | | |
|---|--|---|
| F | 1/32" W diagonal crack | |

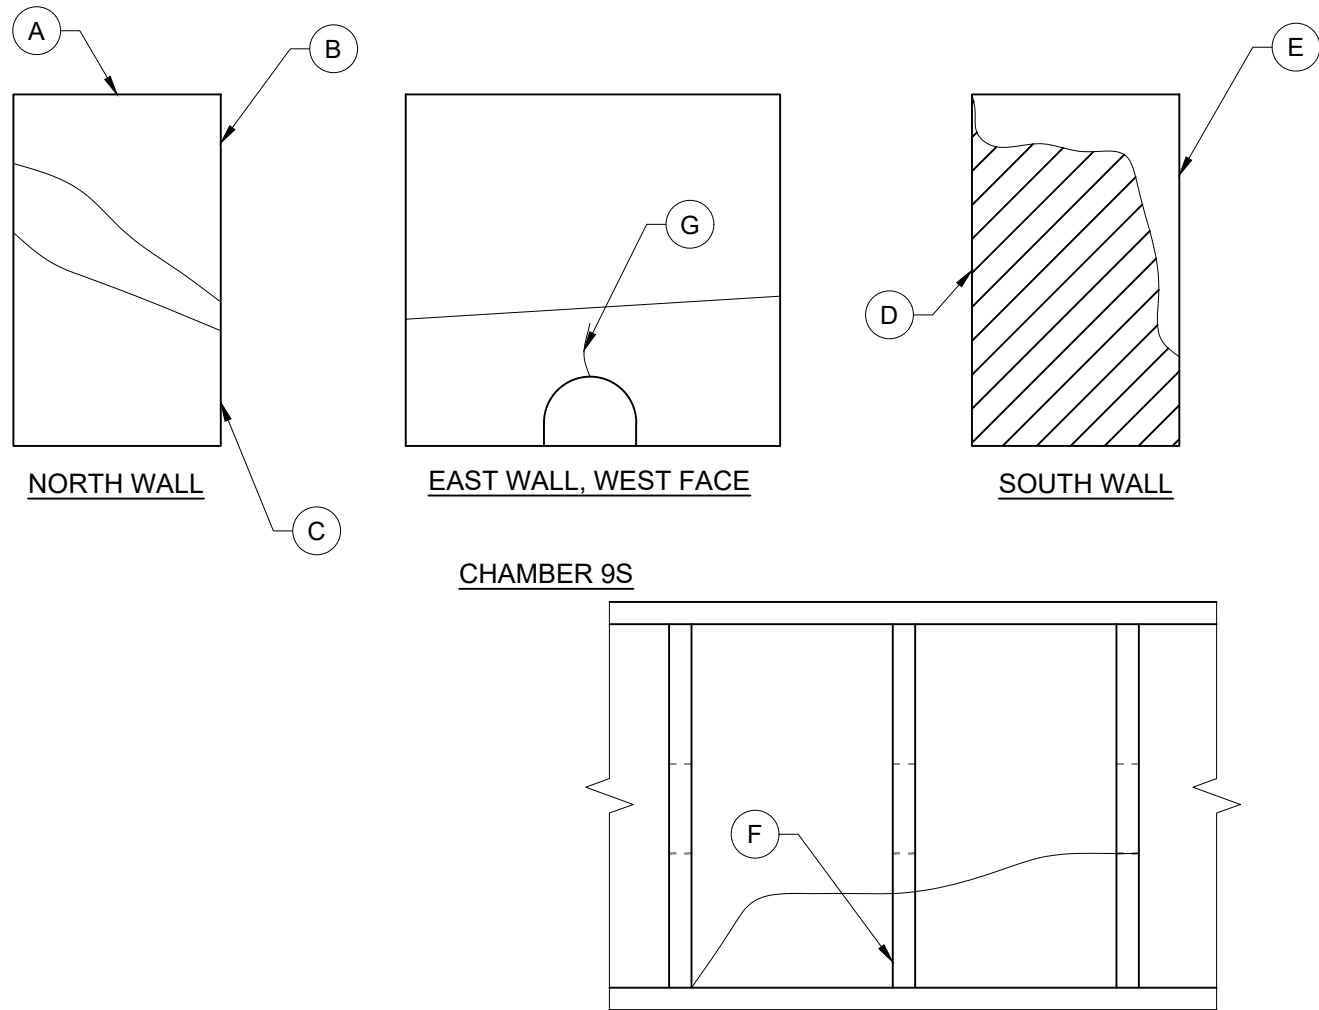
CHAMBER 9S DEFECT TABLE

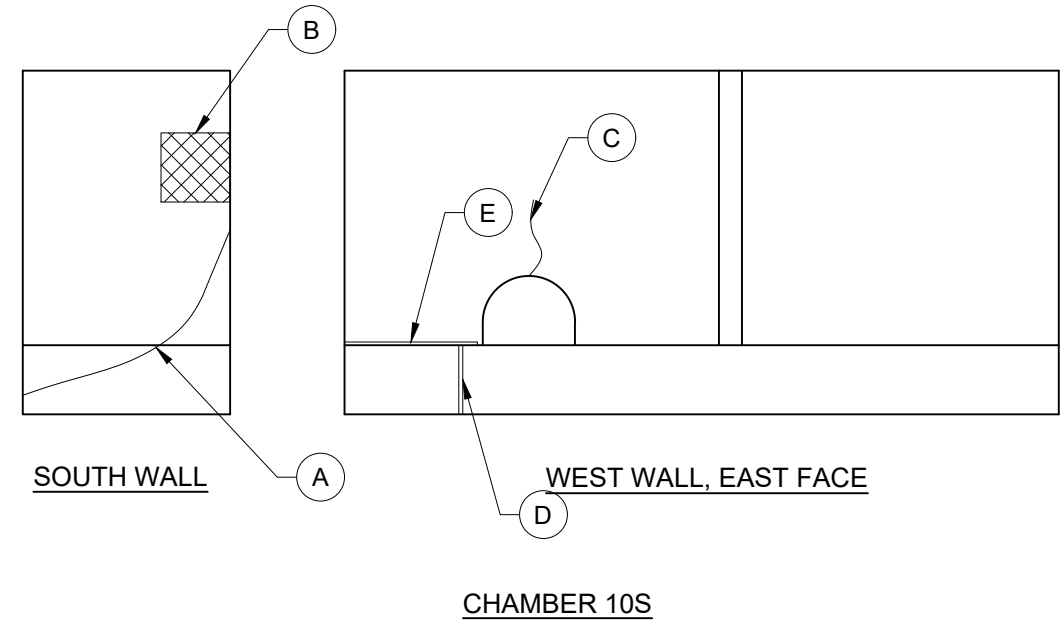
CHAMBER 10S DEFECT TABLE

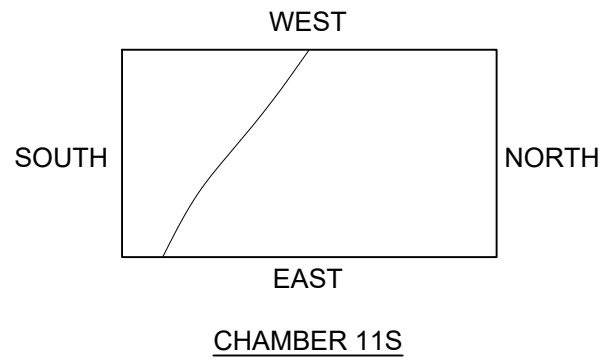
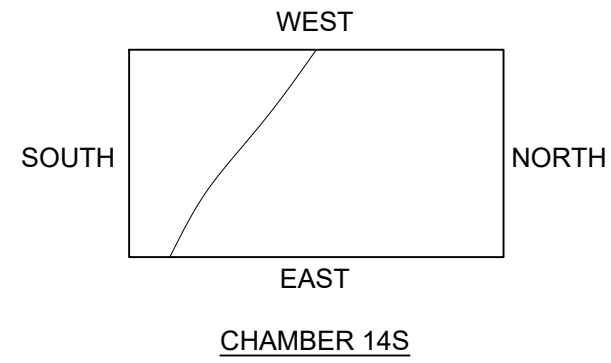
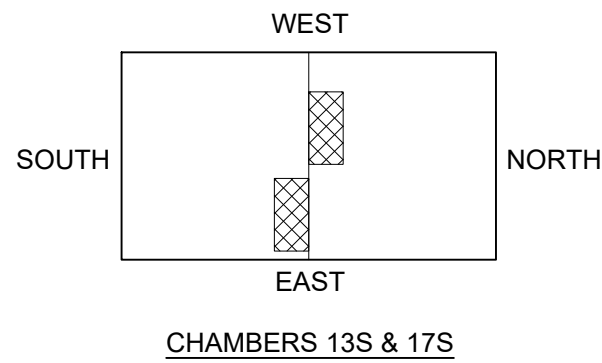
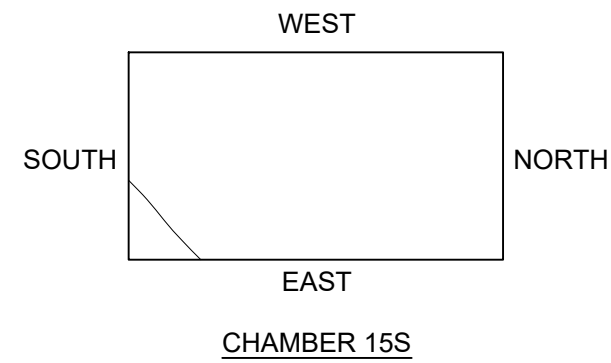
| CHAMBERS 11, 13, 14 & 15S DEFECT TABLE | | |

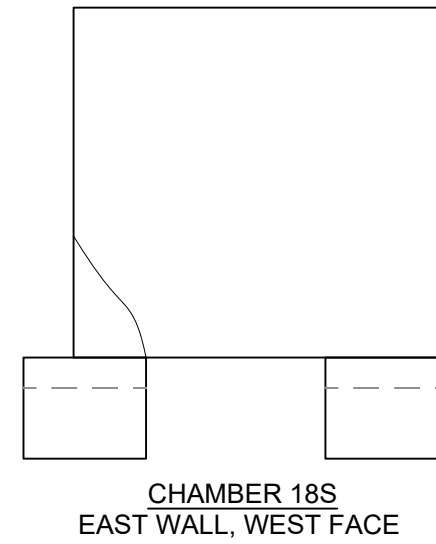
| CHAMBERS 11, 13, 14 & 15S DEFECT TABLE | | |
|--|---|---|
| B | Full width joint in ceiling with typical spalling up to 3'-0" W with exposed reinforcement. | DWN088-089 |

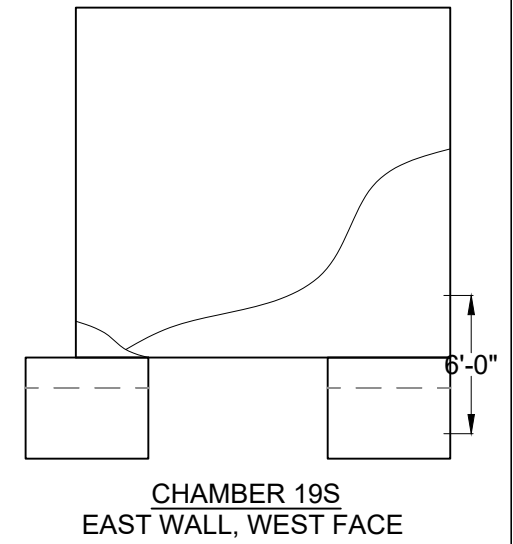
| CHAMBERS 18 & 19s DEFECT TABLE | | |

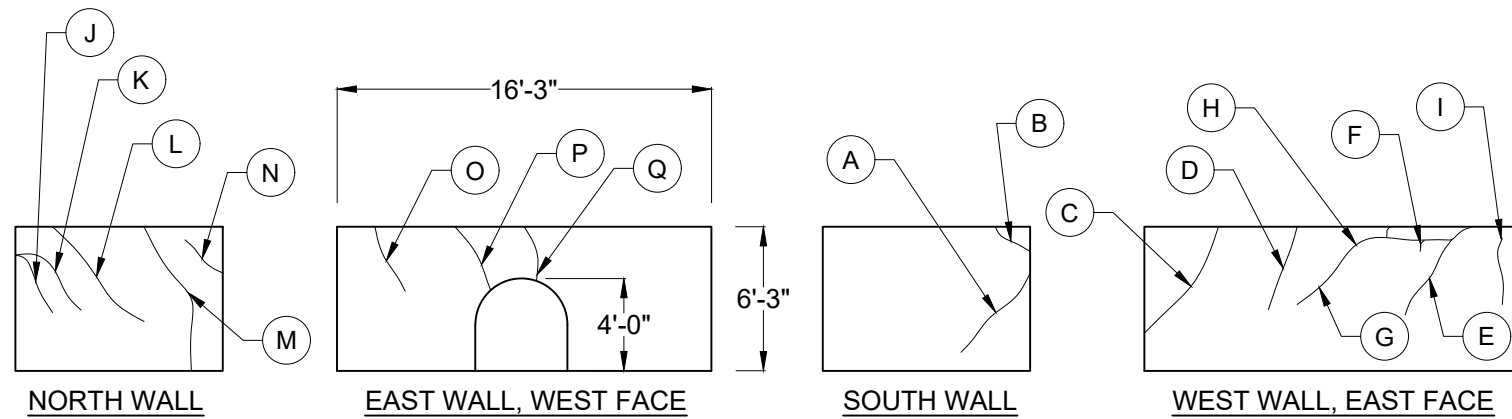
| CHAMBERS 18 & 19s DEFECT TABLE | | |
|---|---|---|
| B | 1/8" W crack is reflective on the east face of wall | DWN096, 098, 099 |

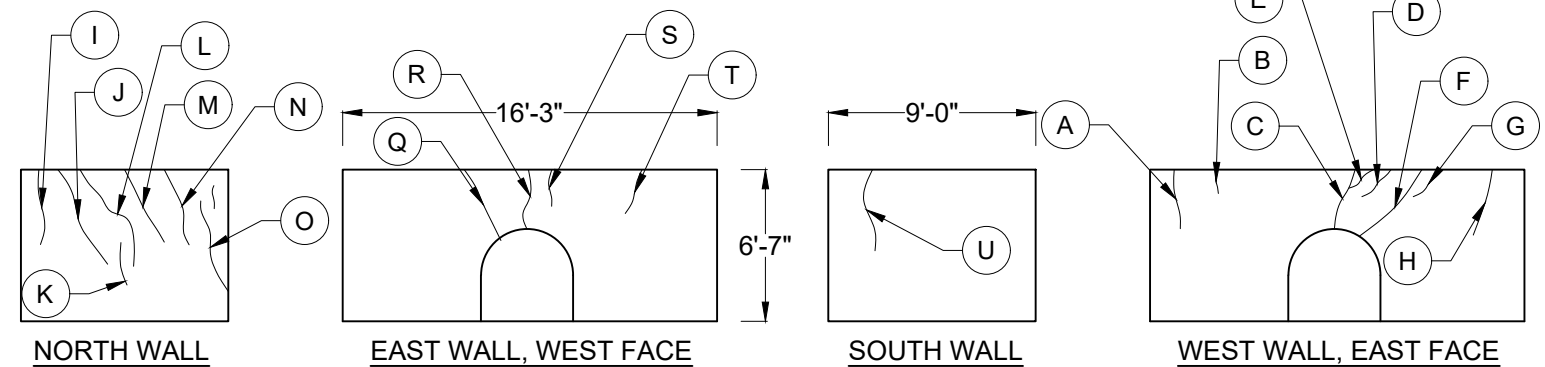
| CHAMBER 1N DEFECT TABLE | | |
|---|---|---|
| R | 2'-5" L x 1/16" W crack with light efflorescence full depth of wall | RSF1688 |

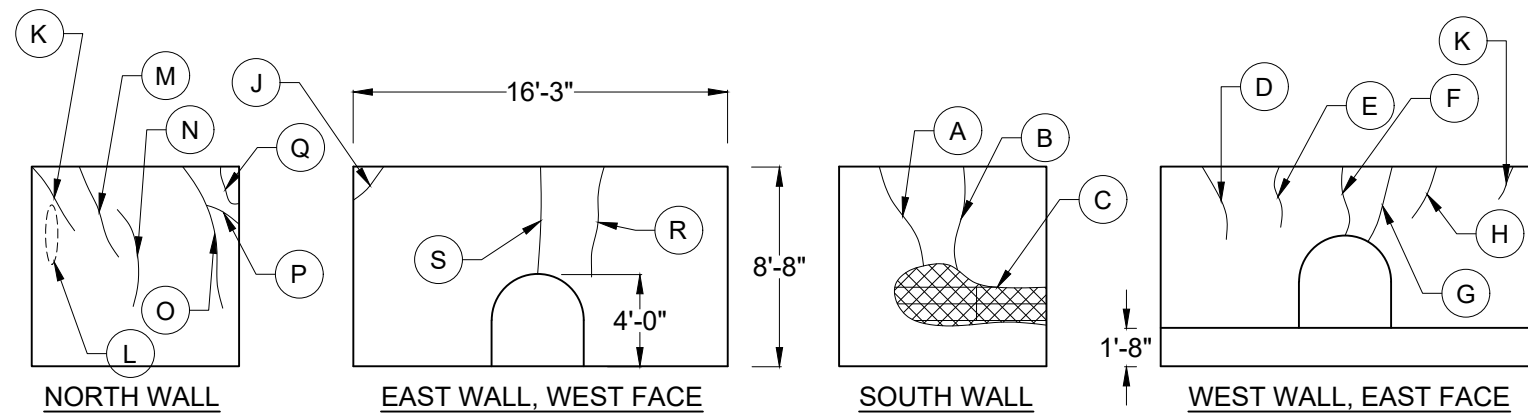
| CHAMBER 2N DEFECT TABLE | | |
|---|--|---|
| U | 3'-6" L x 1/32" W crack with moisture stain. | RSF1703 |

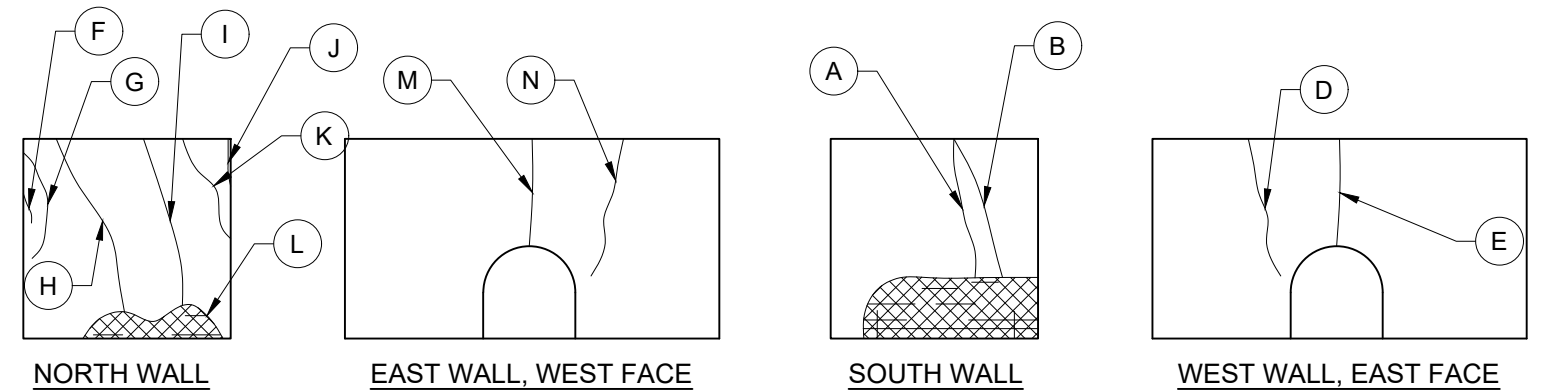
| CALL OUT # | DEFECT DESCRIPTION | PHOTO # |
|---|---|---|
| S | 5'-2" L x 1/32" W crack with light efflorescence. | RSF1719 |

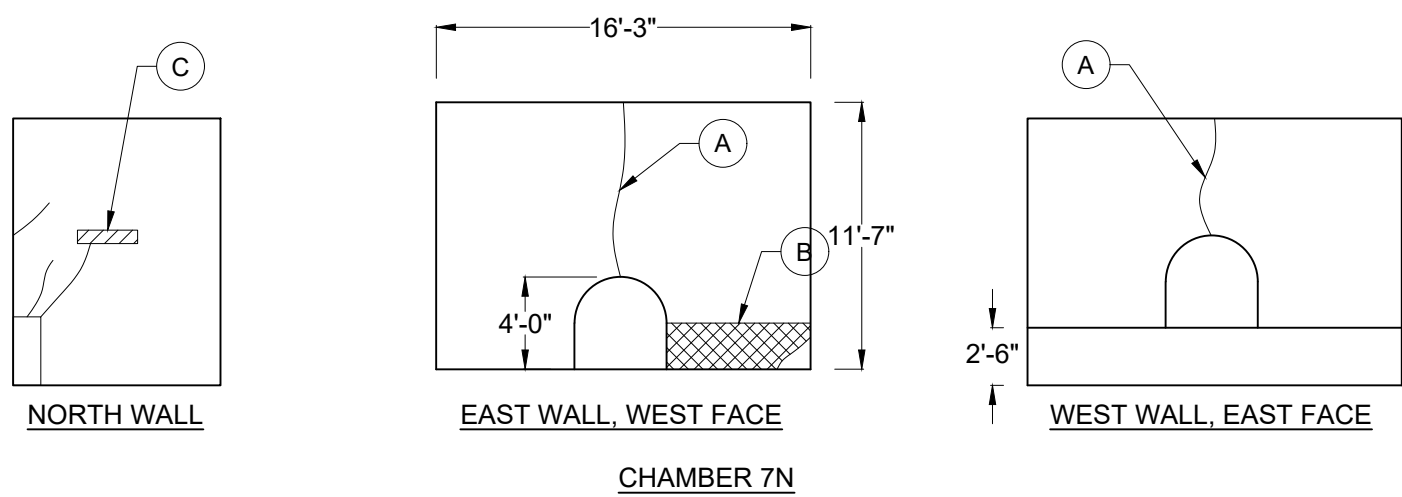
| CHAMBER 7N DEFECT TABLE | | |

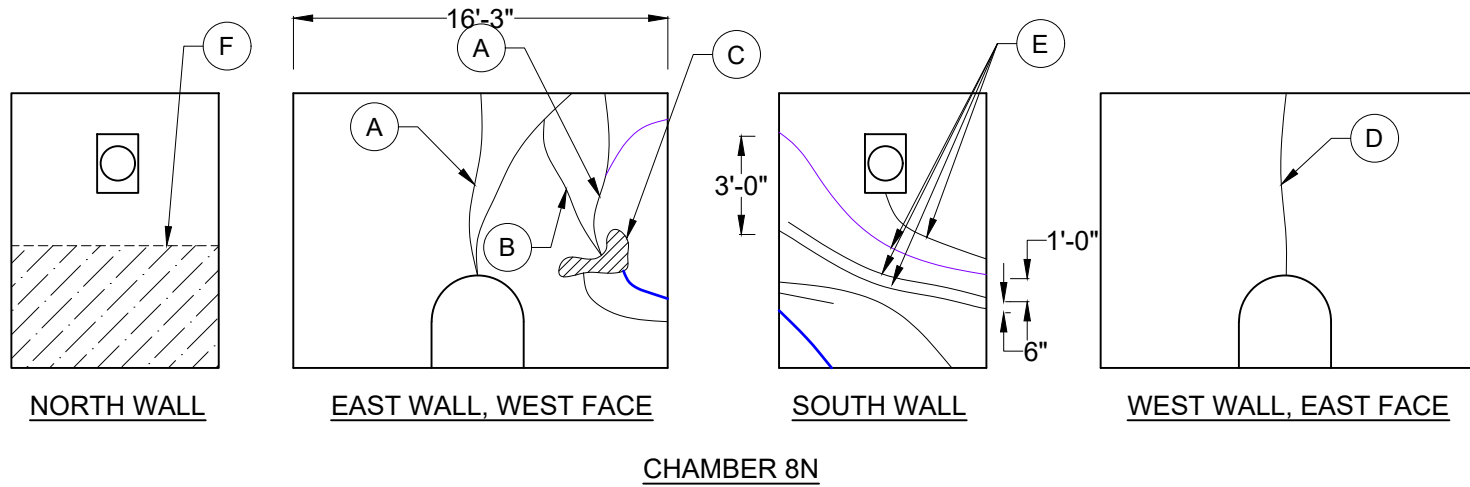
| CHAMBER 8N DEFECT TABLE | | |

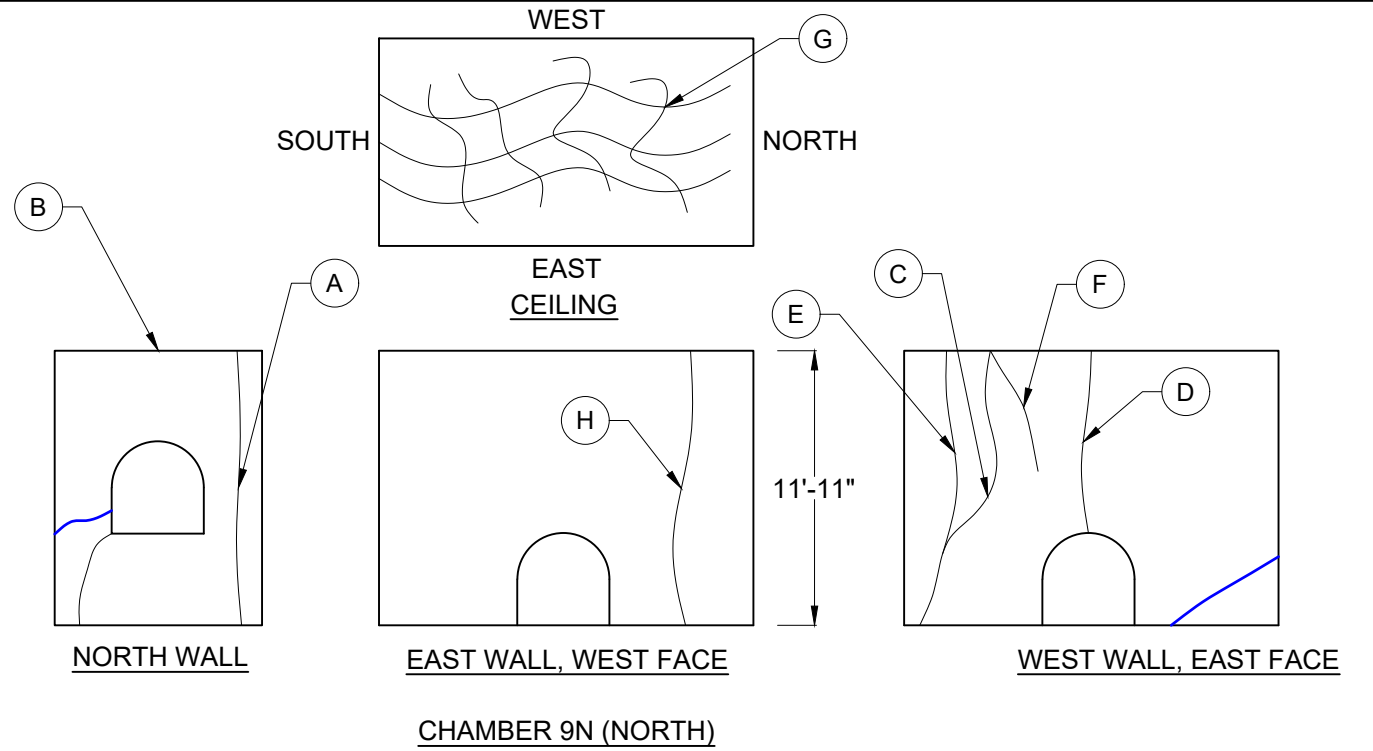
| CHAMBER 9N (NORTH) DEFECT TABLE | | |

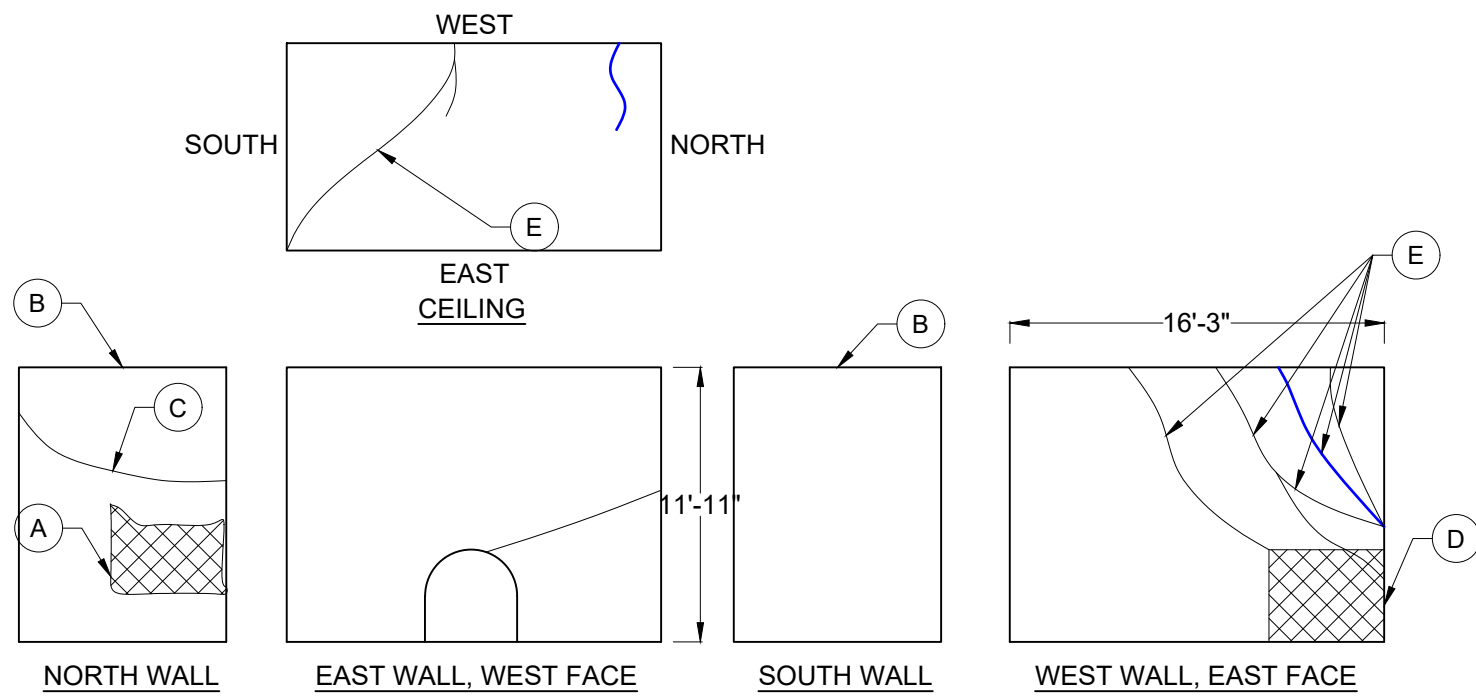
| CHAMBER 9N (NORTH) DEFECT TABLE | | |
|---|---|---|
| H | Full Height x 1/16" W crack | |

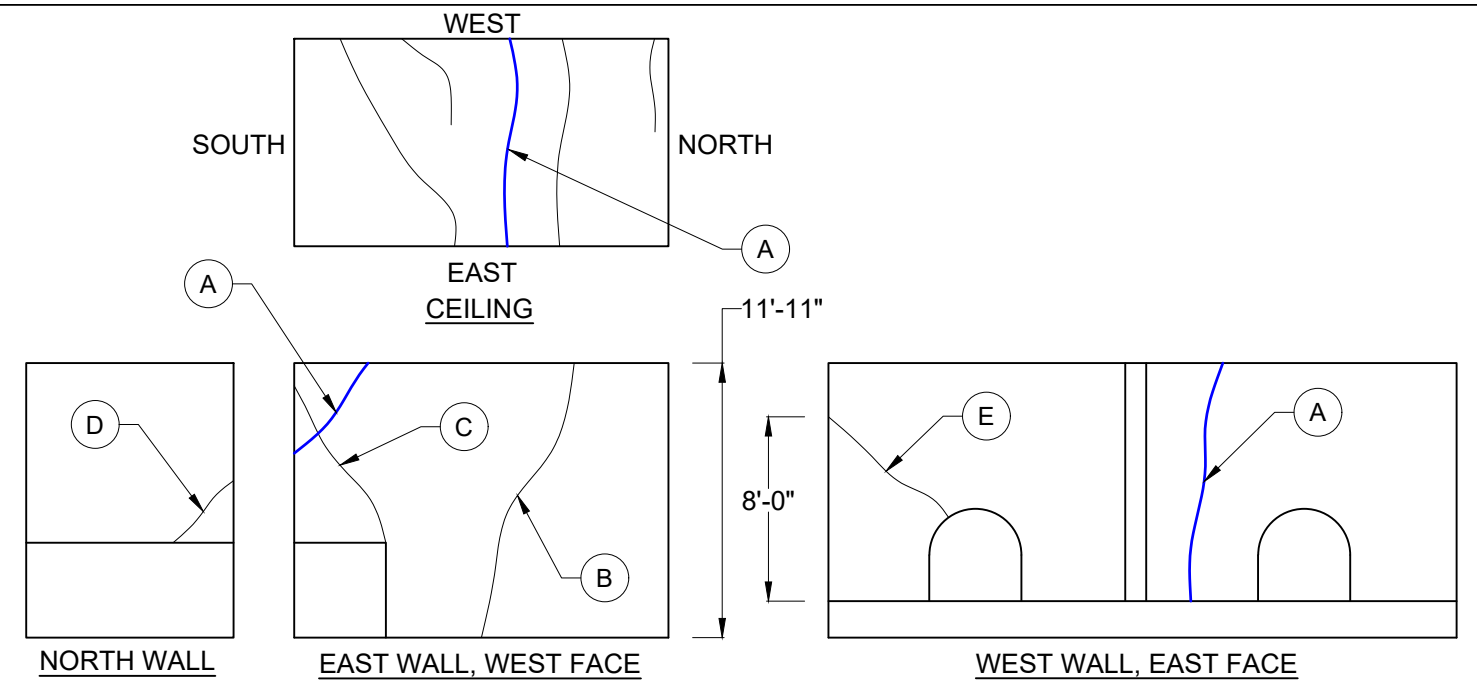
| CHAMBER 9N (SOUTH) DEFECT TABLE | | |
|---|--|---|
| F | 1/16" W crack | DWN123-124 |
