CUY-6-1456

PHYSICAL CONDITION REPORT ROUTINE FRACTURE CRITICAL INSPECTION VETERANS MEMORIAL/DETROIT-SUPERIOR BRIDGE OVER THE CUYAHOGA RIVER SFN: 1800930

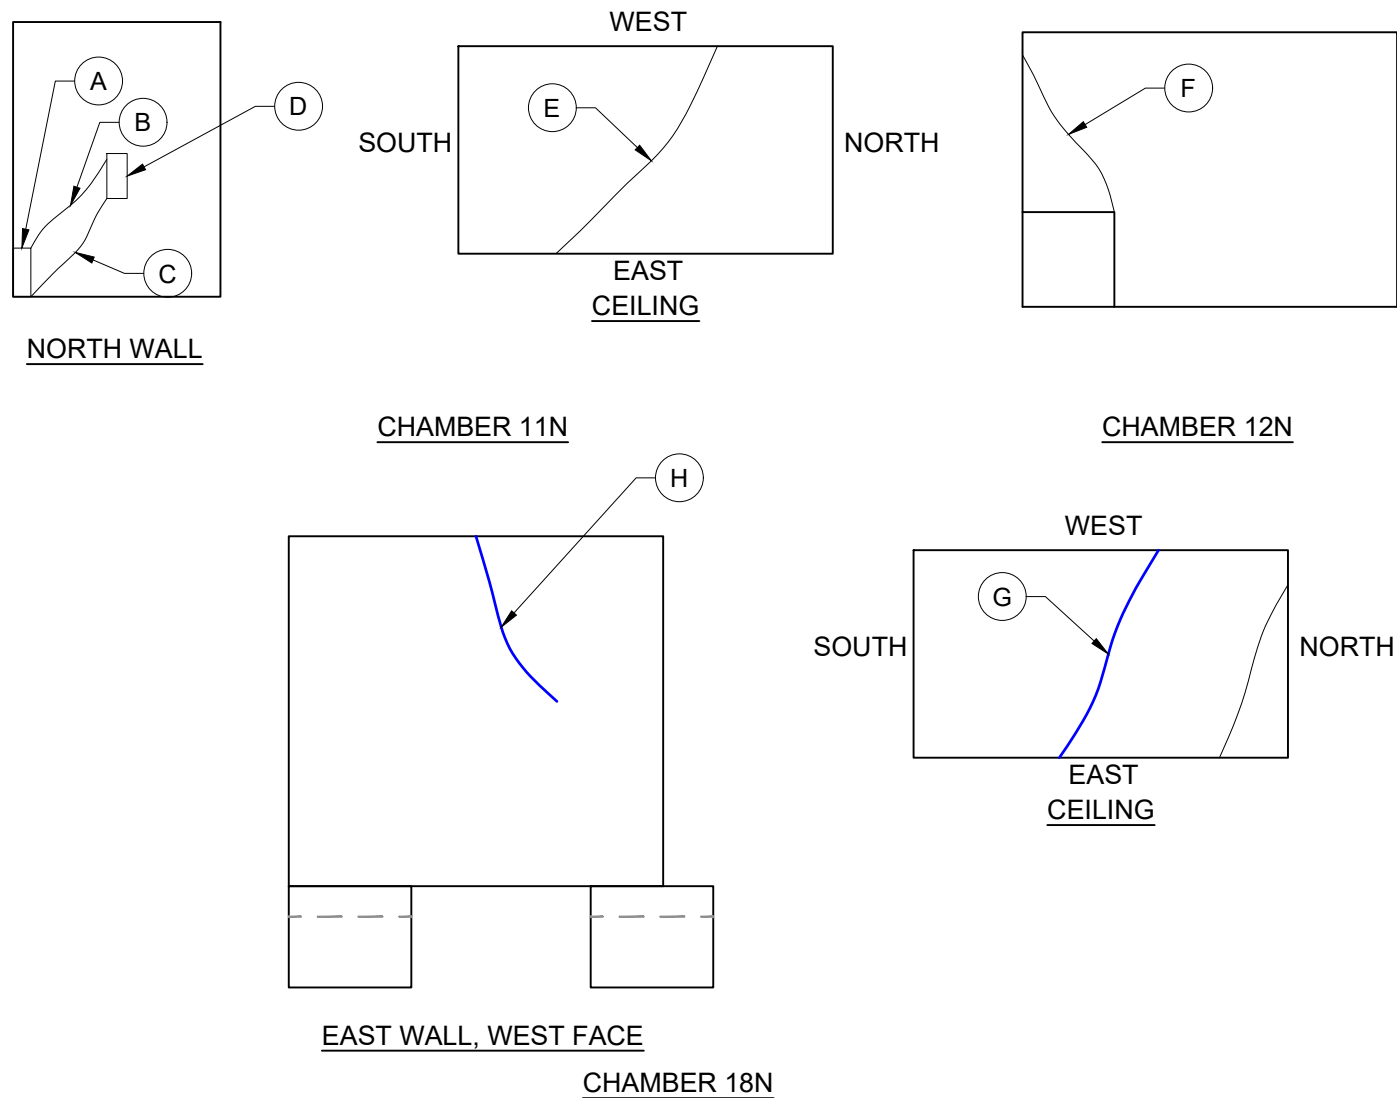
| CALL OUT # | DEFECT DESCRIPTION | PHOTO # |

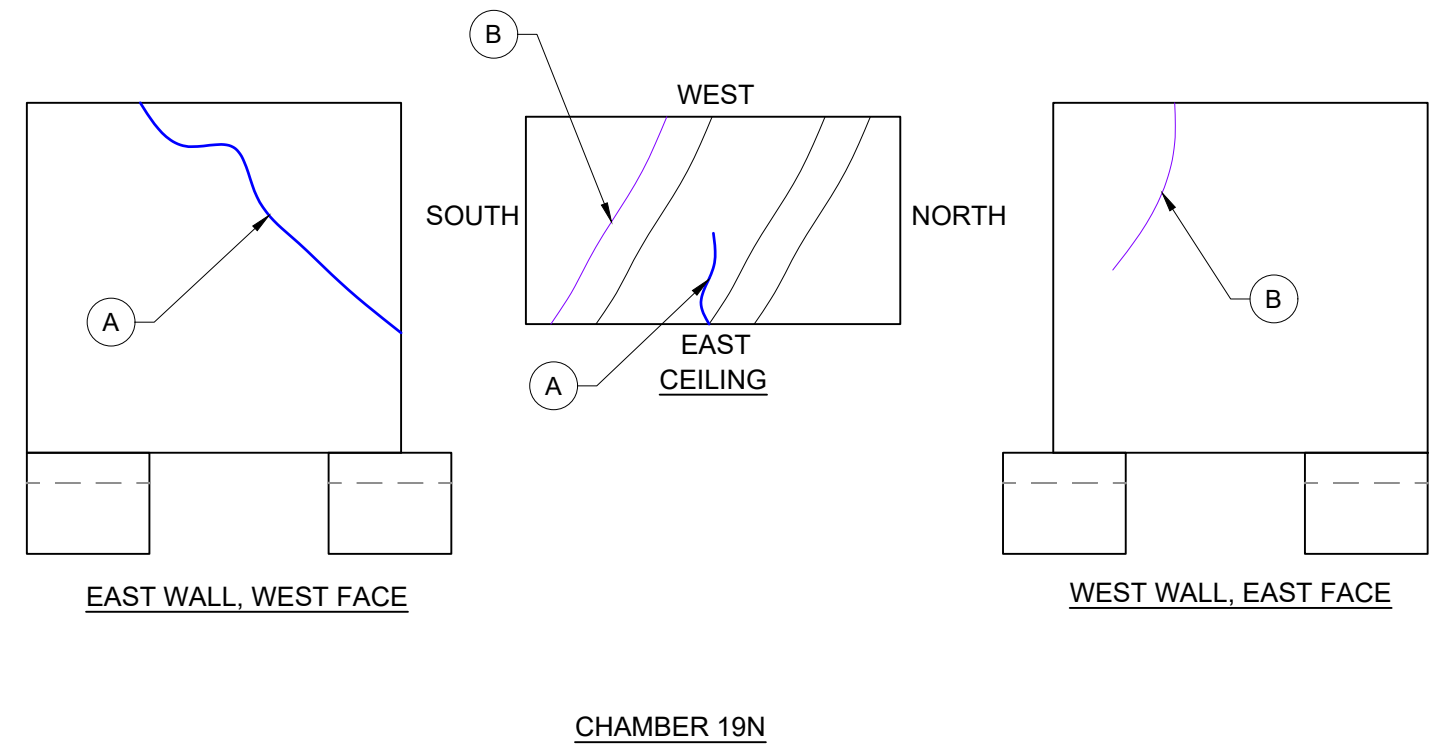
| CALL OUT # | DEFECT DESCRIPTION | PHOTO # |

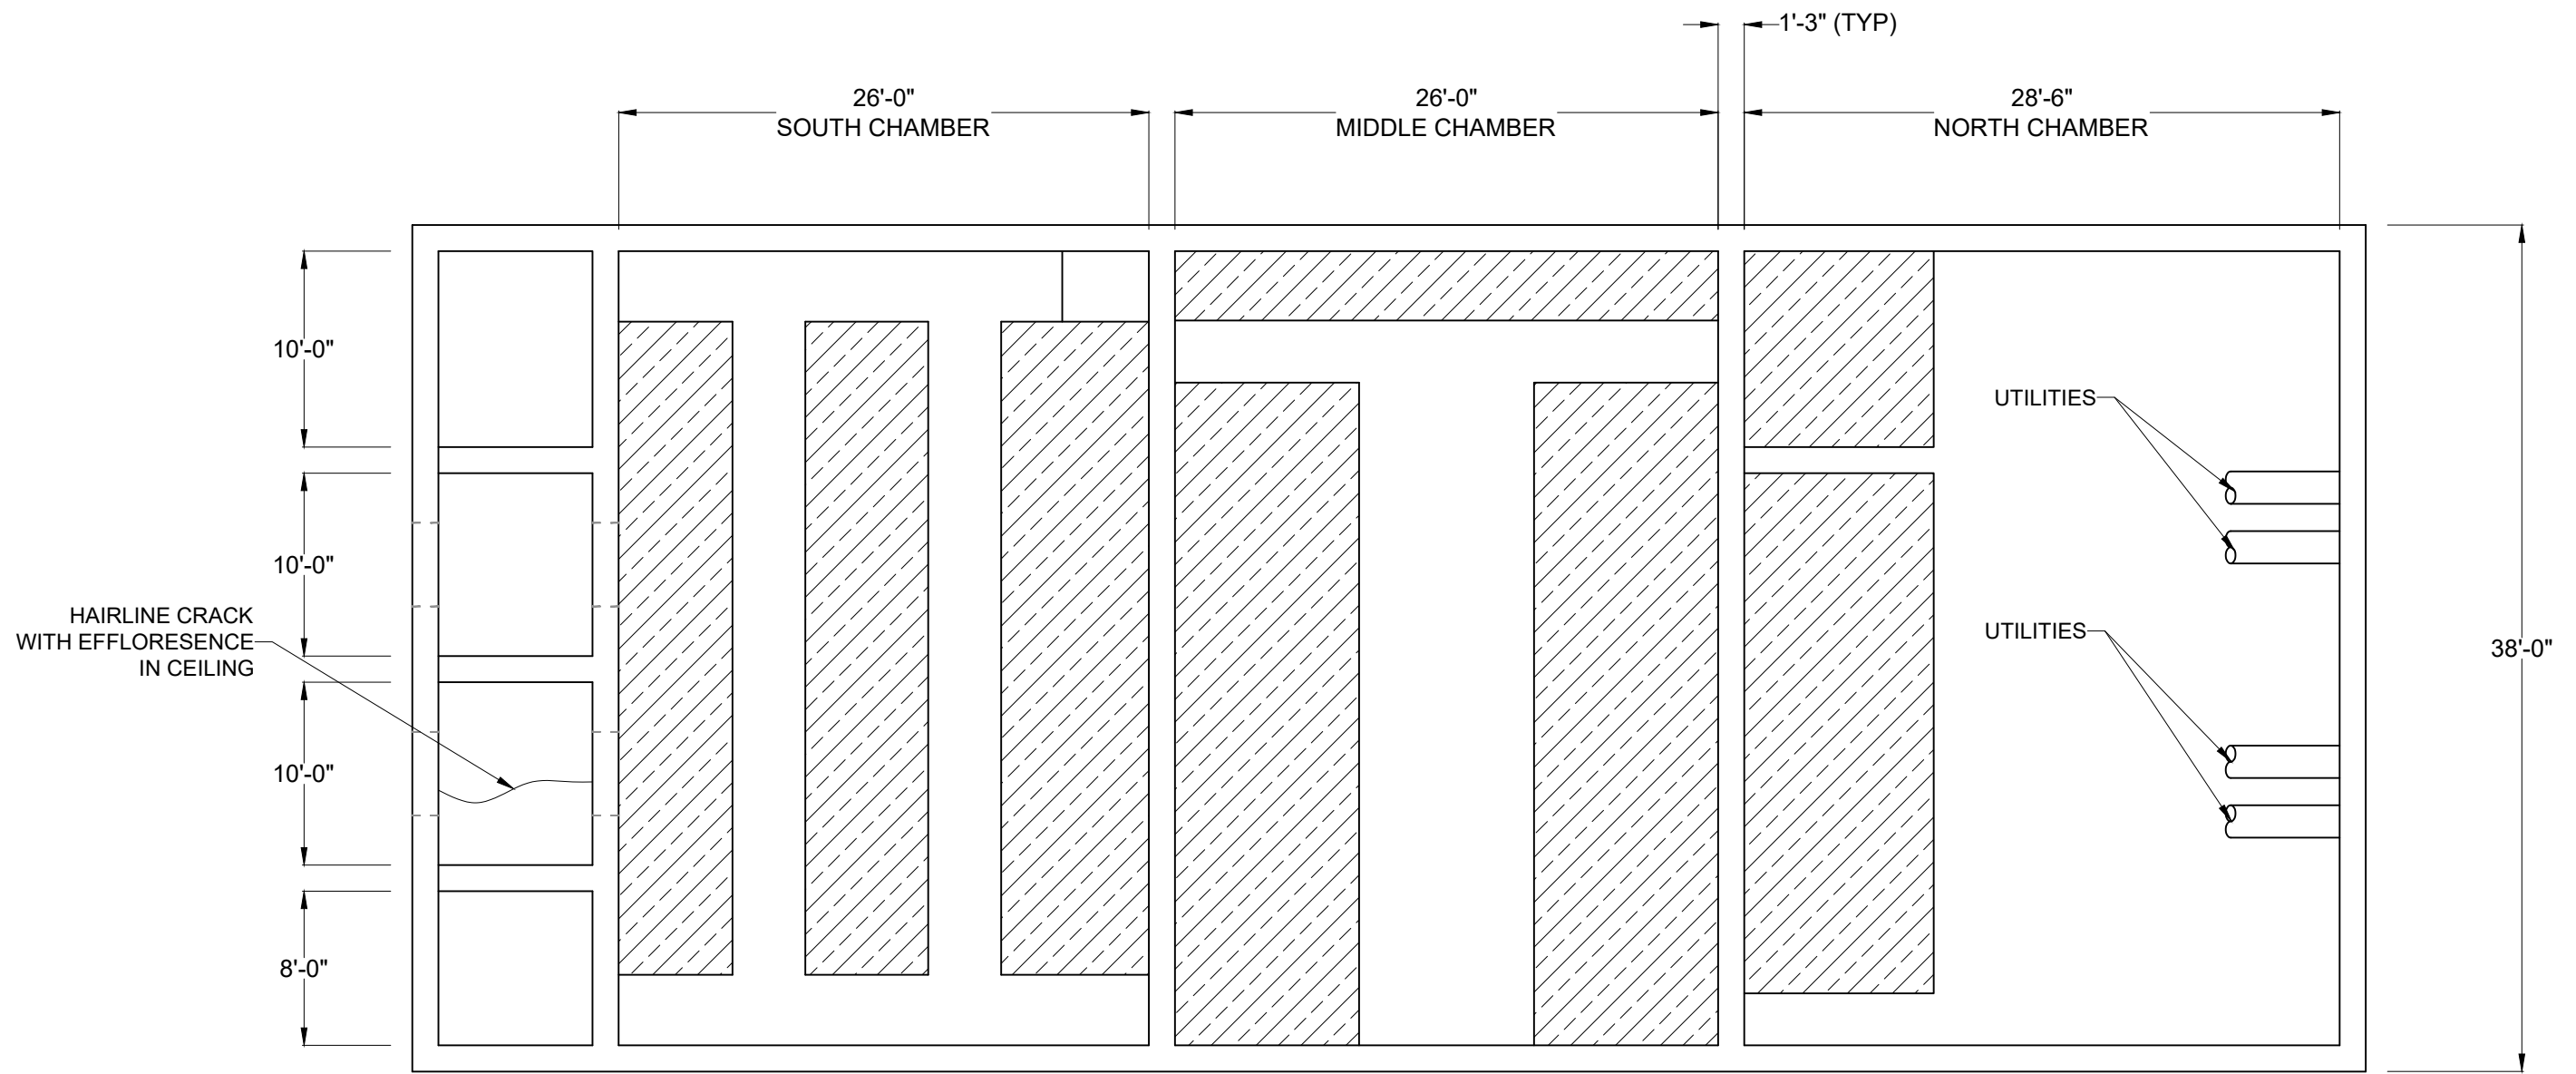
| CALL OUT # | DEFECT DESCRIPTION | PHOTO # |
|---|---|---|
| C | Diagonal cracks full width of ceiling with efflorescence, rust and moisture. | DWN108 |

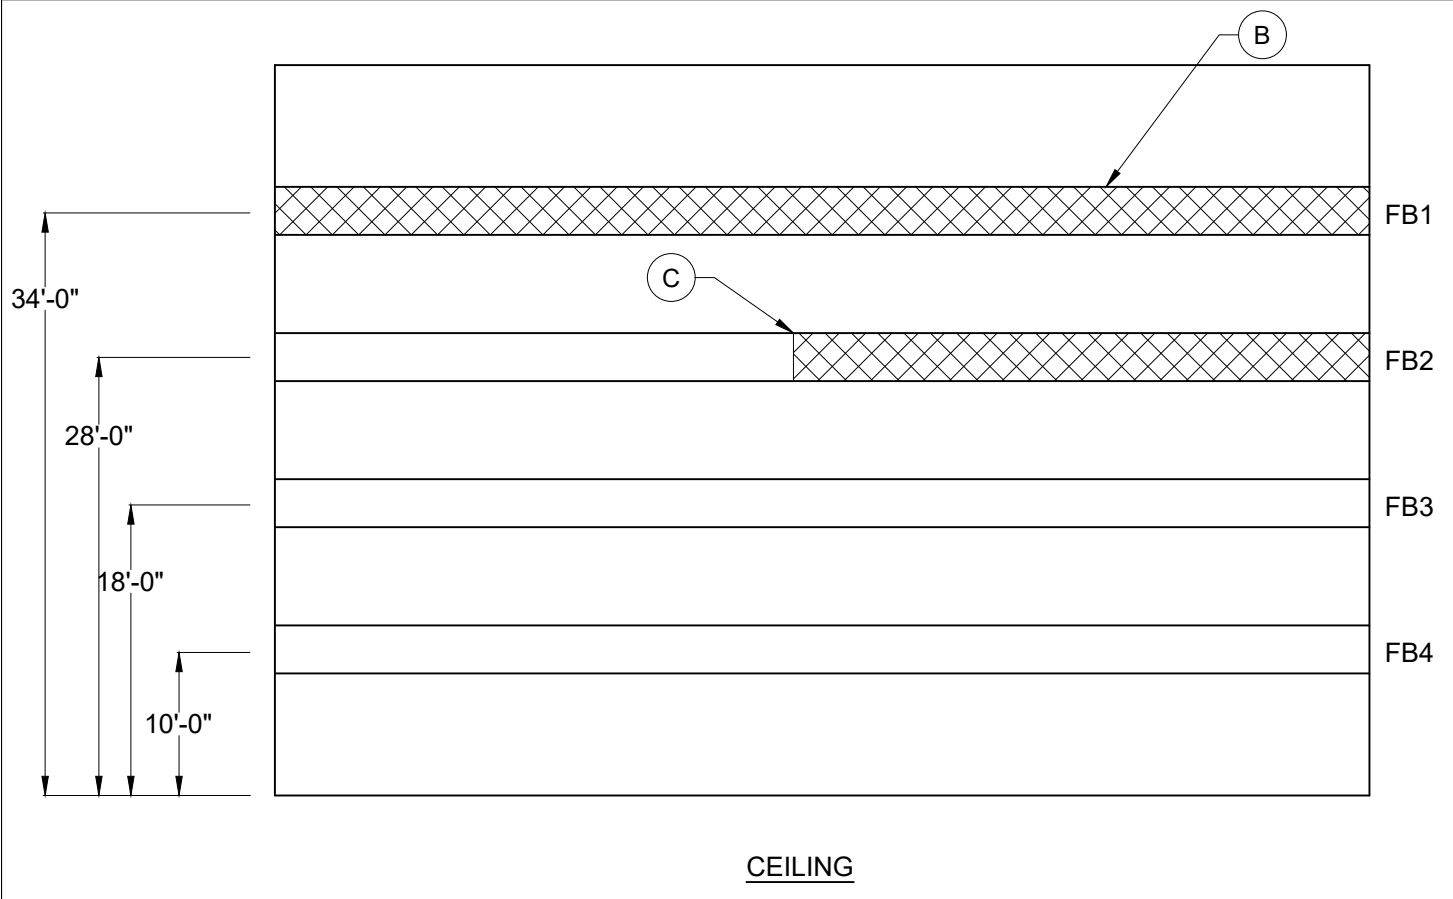
| MIDDLE CHAMBER DEFECT TABLE | | |

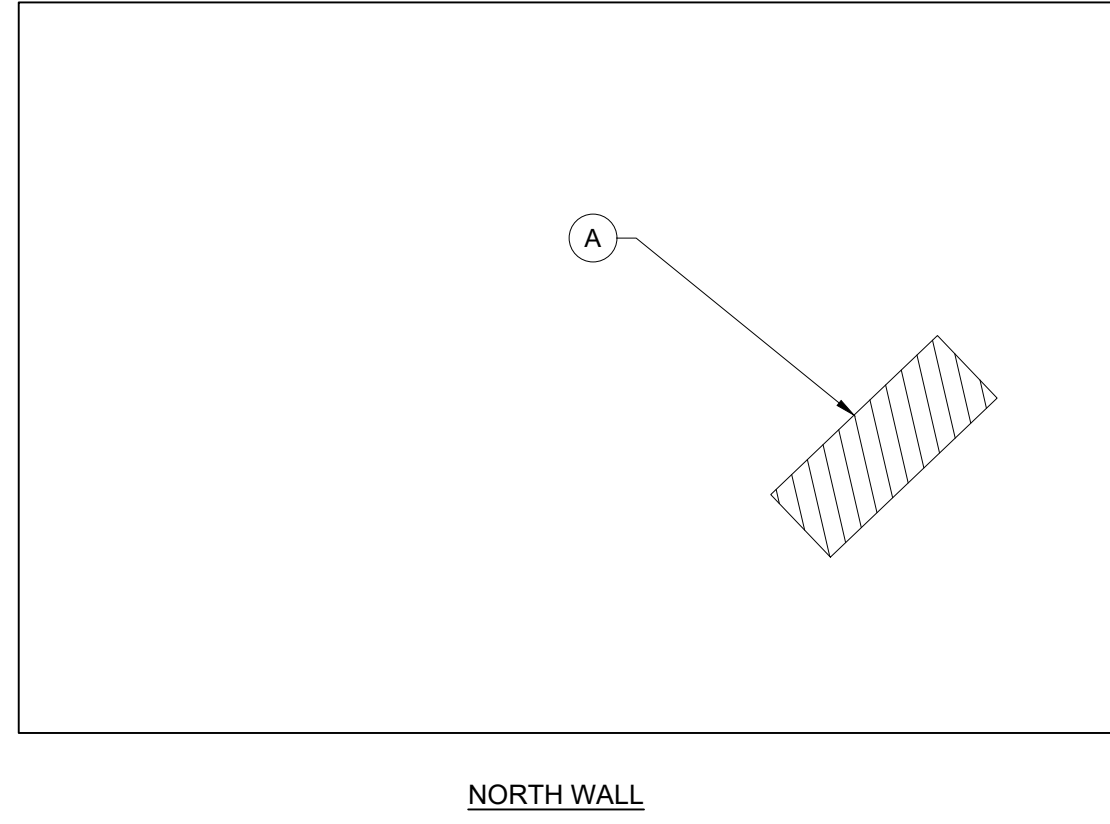
| MIDDLE CHAMBER DEFECT TABLE | | |
|---|---|---|
| C | 20'-0" L x 2'-0" W x 1-1/2" D spall with exposed rebar. | |
