# CUY-10-1613

**PHYSICAL CONDITION REPORT  
ROUTINE INSPECTION  
HOPE MEMORIAL/LORAIN CARNEGIE BRIDGE OVER THE CUYAHOGA RIVER  
SFN: 1801503**

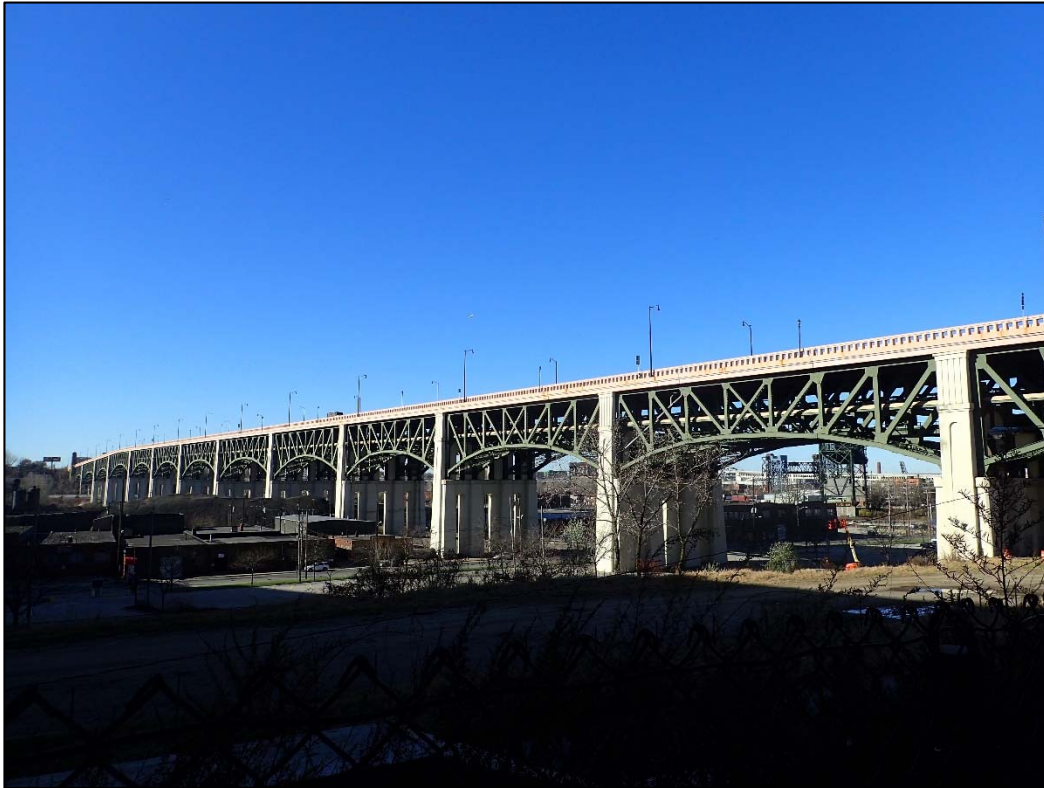
<b>Inspection Date:</b>
<b>November 28-29, 2017</b>

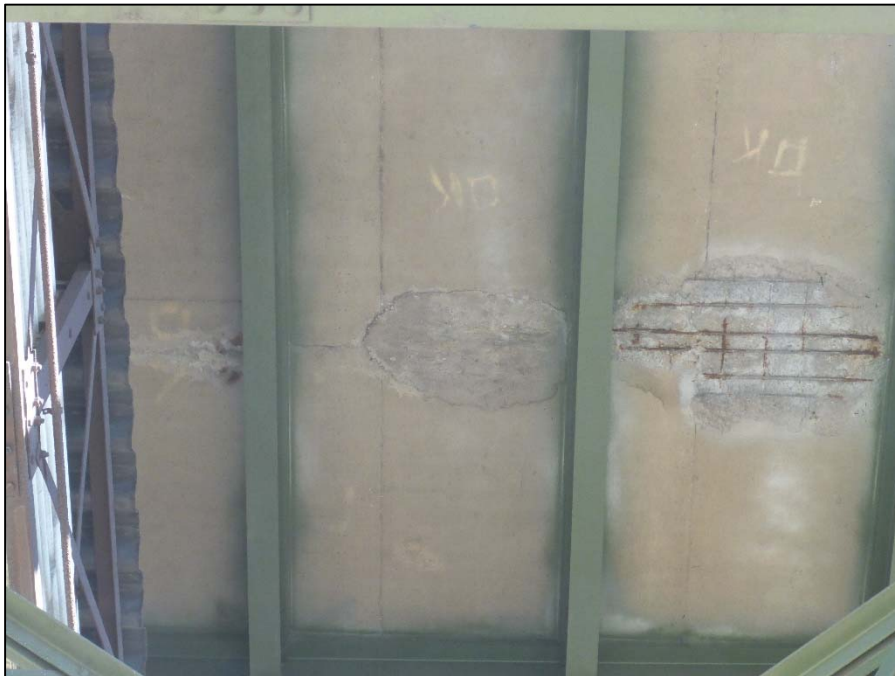
Photo 2 - Typical underside of deck spalling with exposed rebar and delaminations

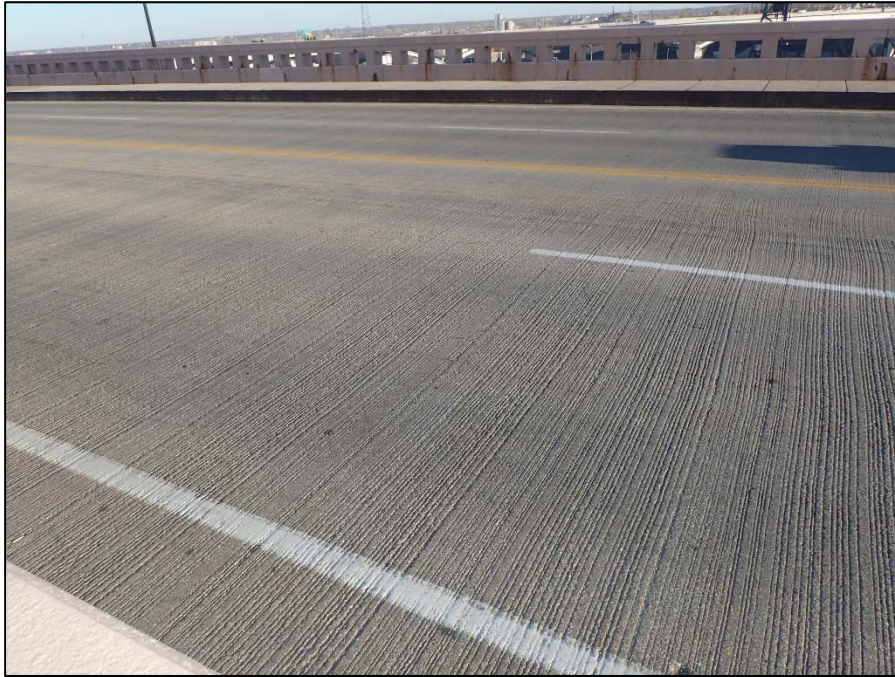
Photo 3 – Typical wearing surface condition

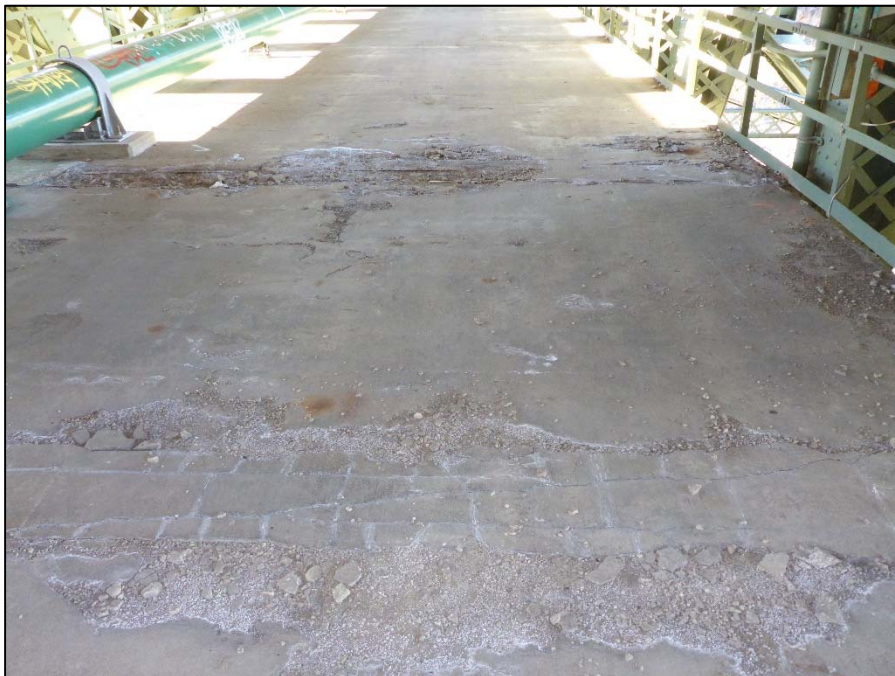
Photo 4 – Typical lower deck wearing surface; Cracking and delaminations with isolated spalling

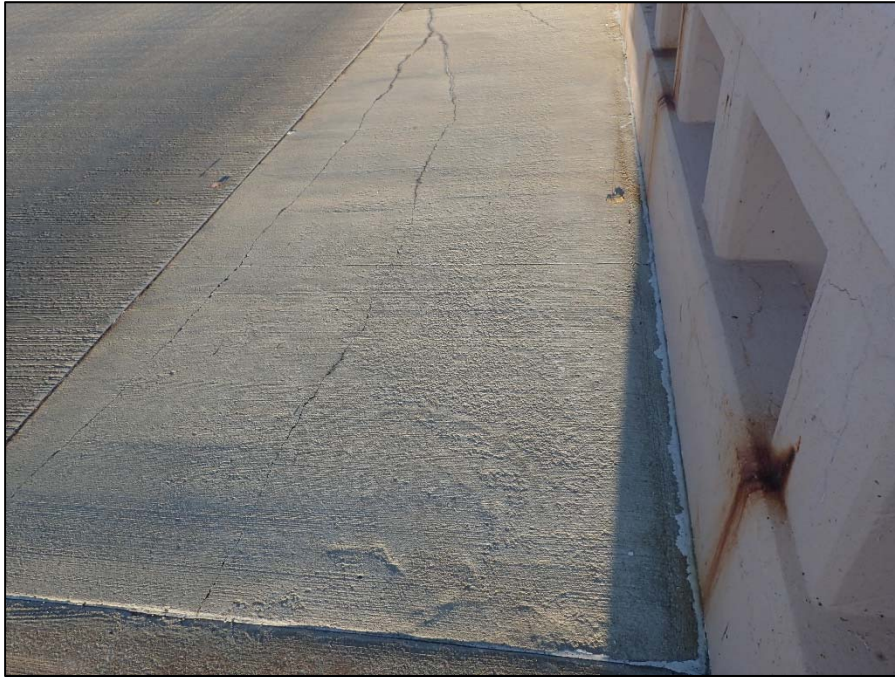
Photo 5 - South sidewalk; 18' L x up to 1/4" W longitudinal crack with associated minor edge spalling

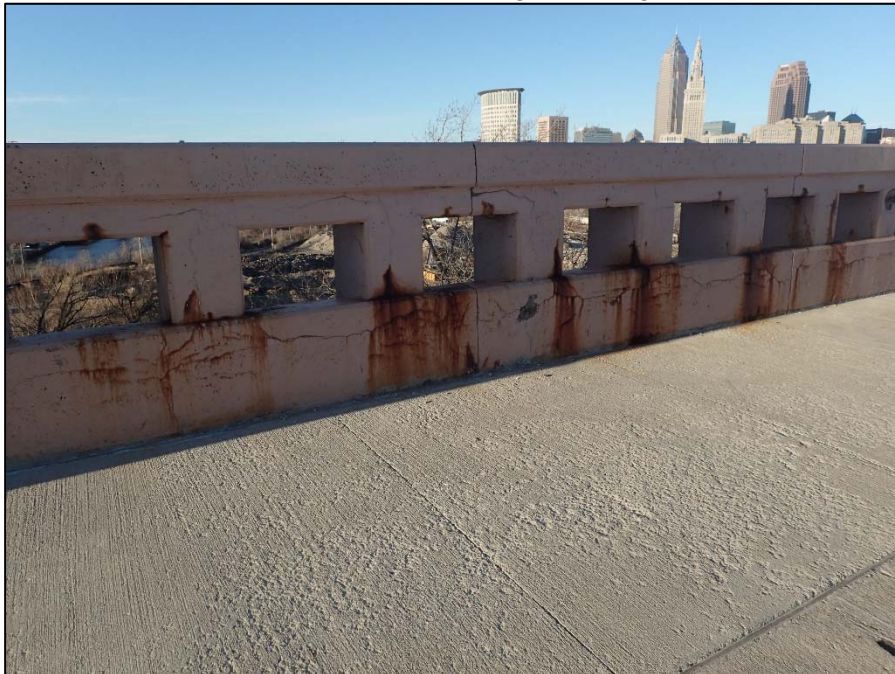
Photo 6 – Typical bridge rail condition

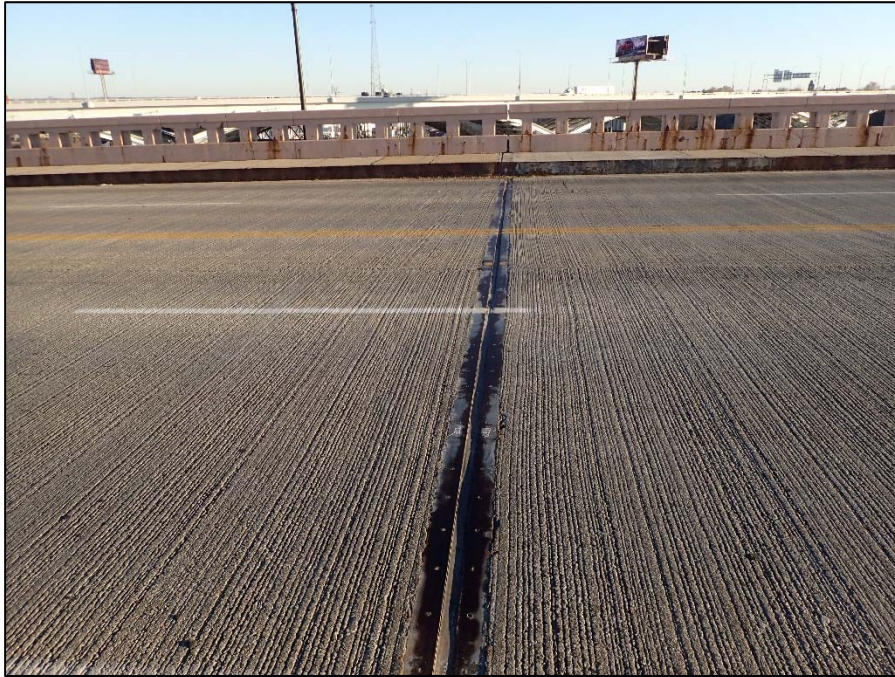
Photo 7 – Typical expansion joint condition

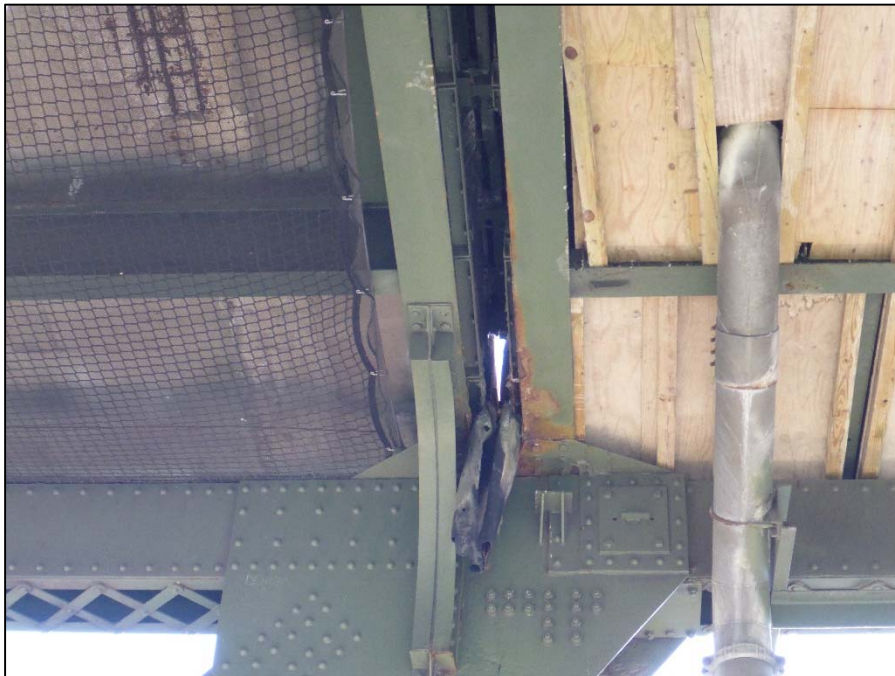
Photo 8 – Span 3 at panel point 13, South end of the joint;  
damaged/deboned with hanging material

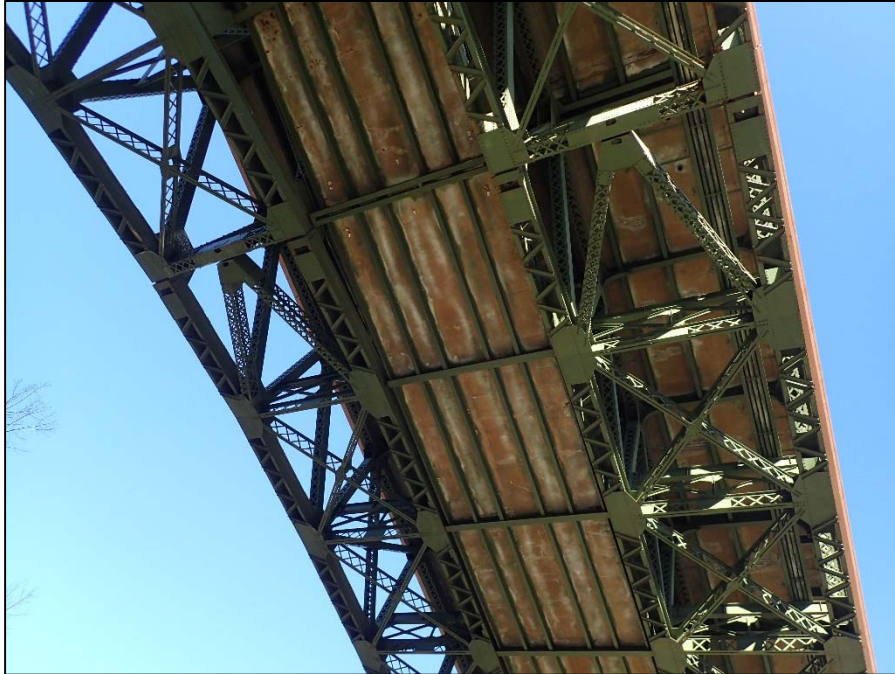
Photo 9 – Typical superstructure condition

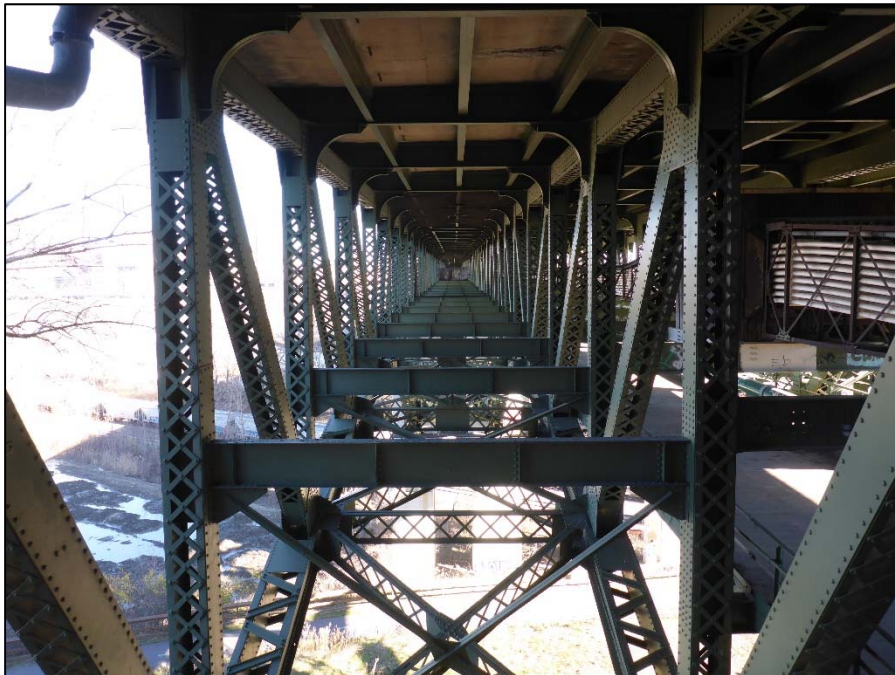
Photo 10 – Typical truss condition

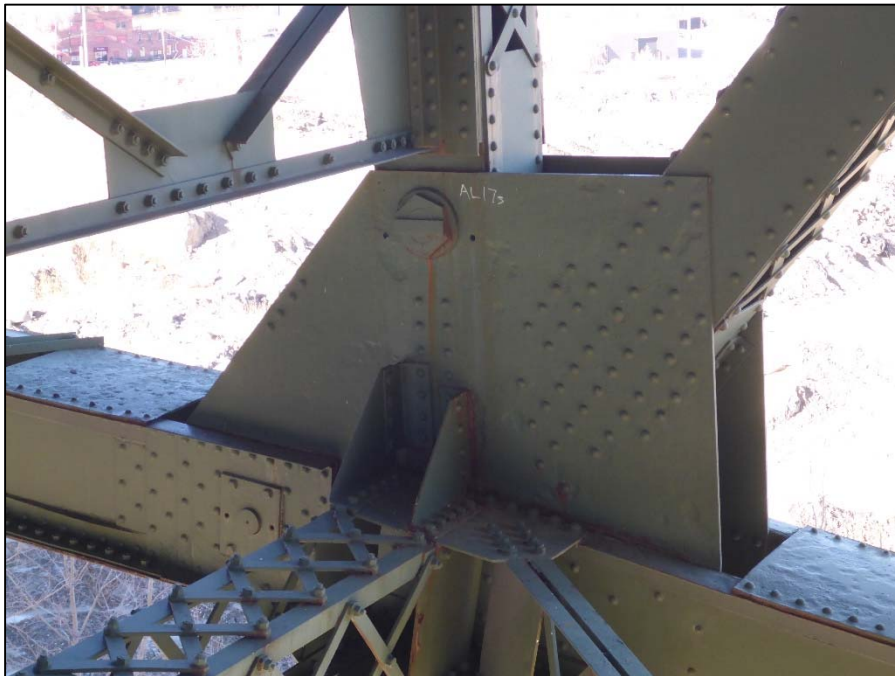
Photo 12 – Typical paint condition at panel points

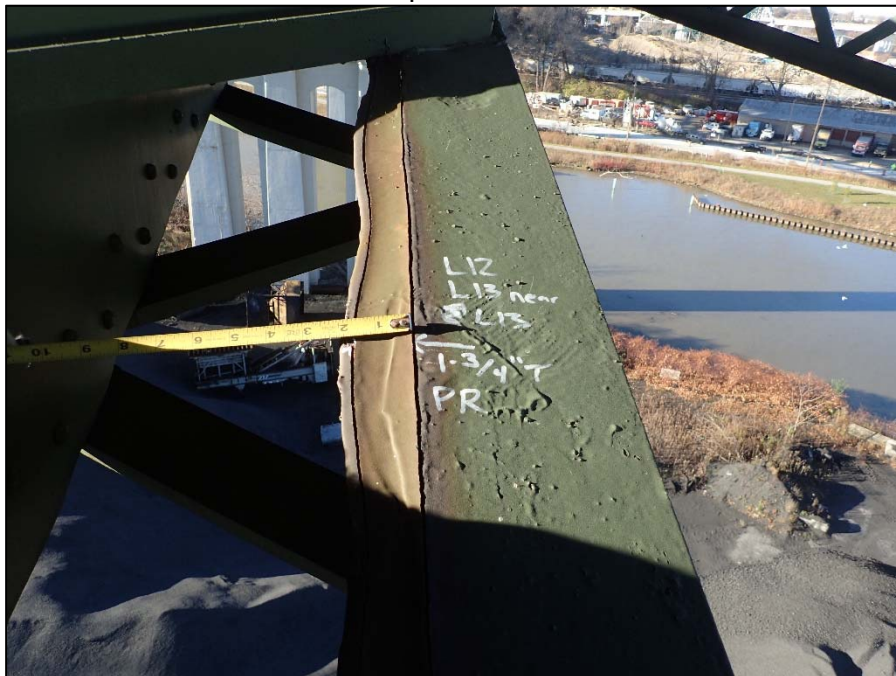
Photo 14 - Span 9 Interior lower chords; Up to 2" T pack rust between the upper flange angles

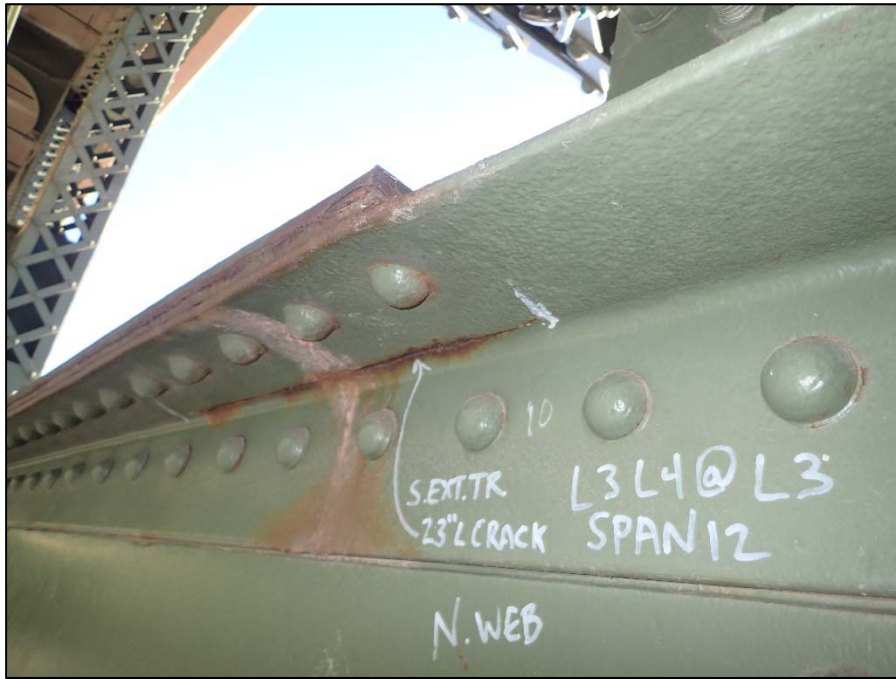
Photo 15 - Span 12, South Exterior Truss L3-L4 at L3; 23" L longitudinal crack in the top North flange angle

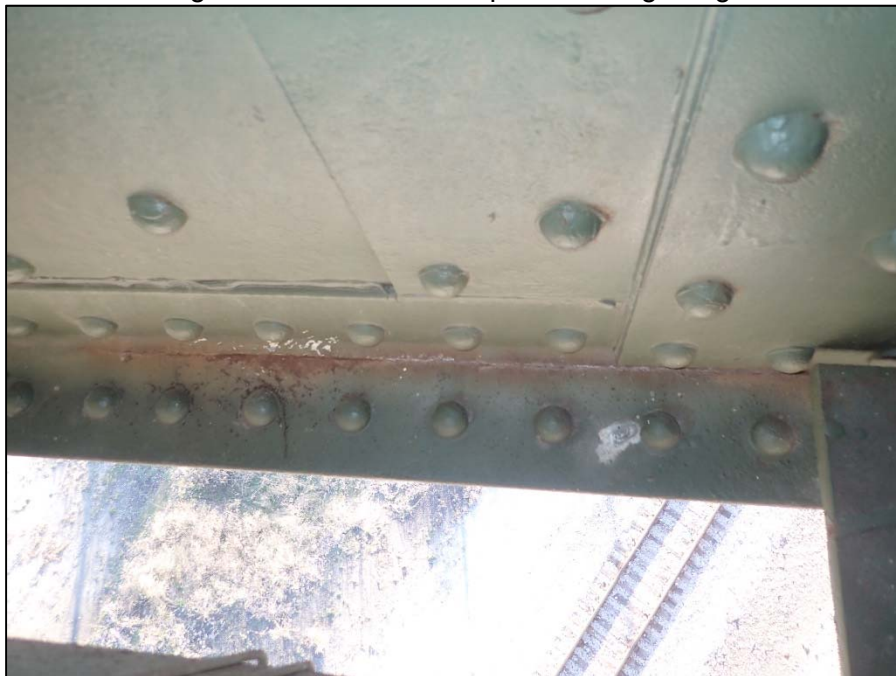
Photo 16 - Span 12, South Interior Truss at L3; Possible 35" L crack in the bottom North flange angle

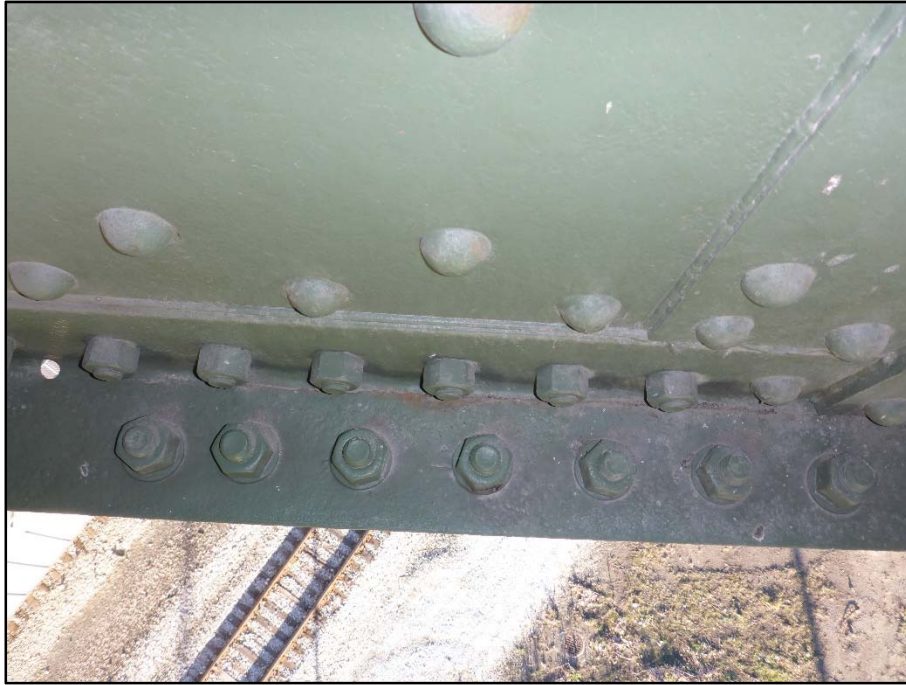
Photo 17 – Span 12, North Interior Truss at L4; Approximately 30" L crack with an arrestor hole drilled at the West end in the bottom South flange angle.

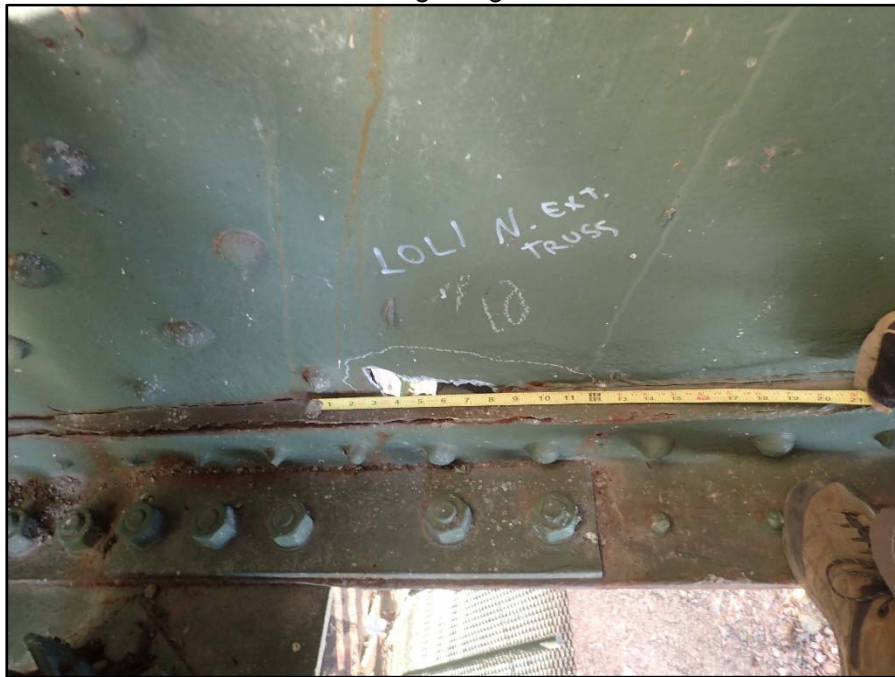
Photo 18 – Span 13; Typical lower chord section loss with perforations

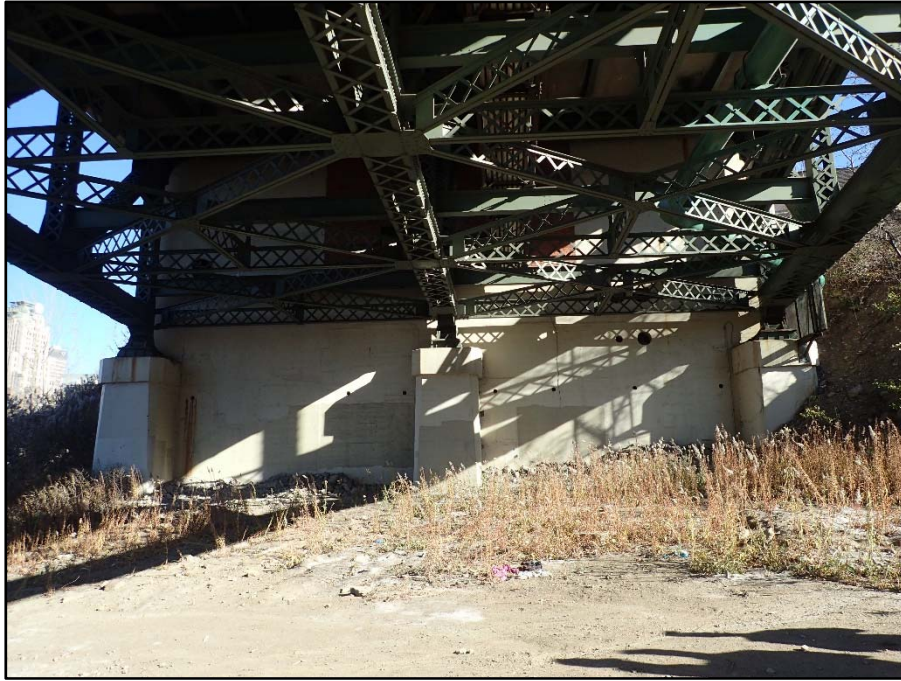
Photo 19 – East Abutment typical condition

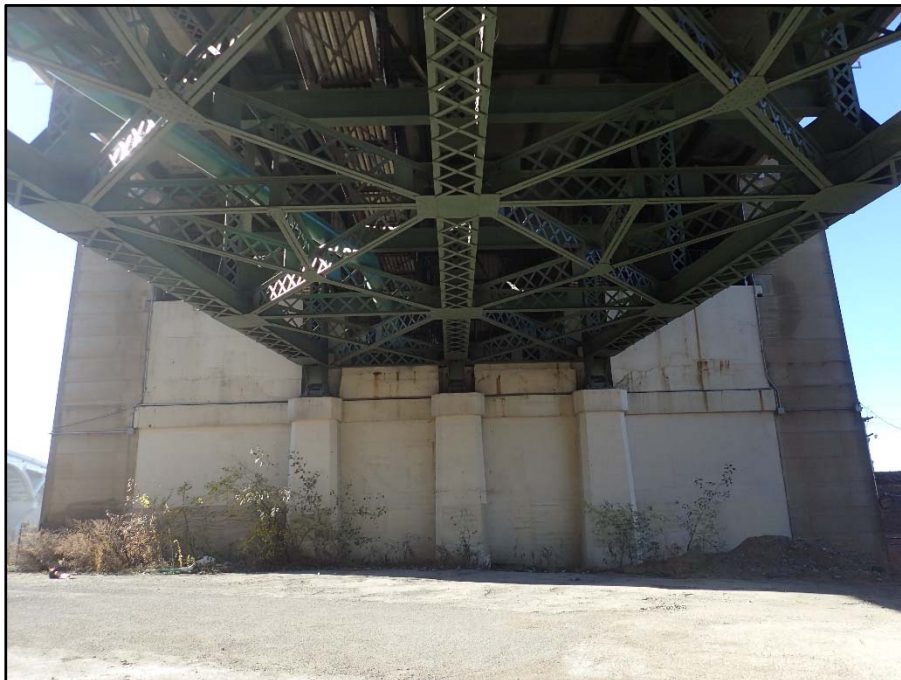
Photo 20 – East Pylon, East face; Typical condition

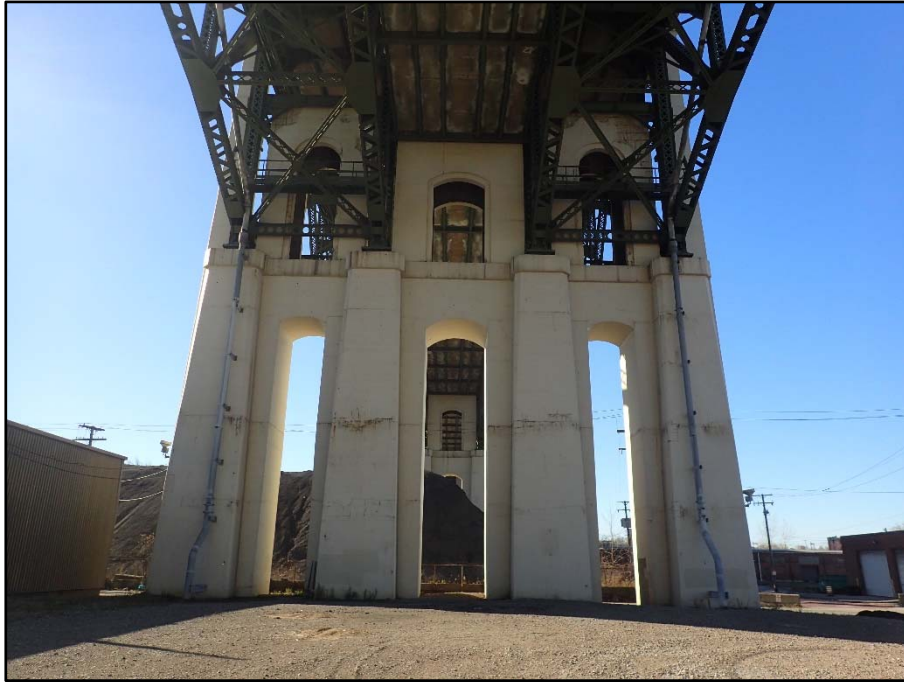
Photo 21 – Pier typical condition

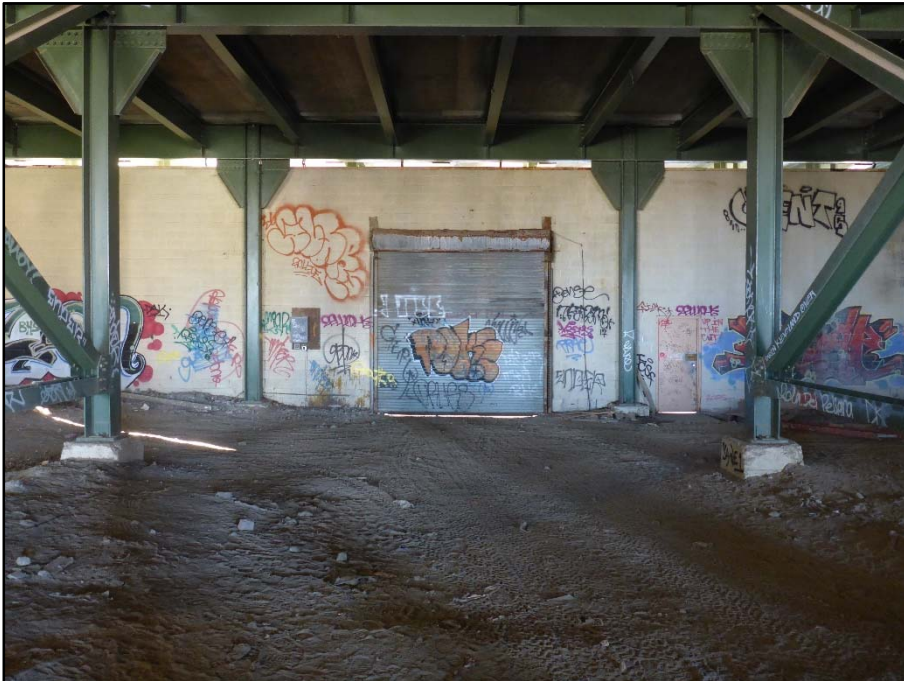
Photo 22 – West Abutment typical condition

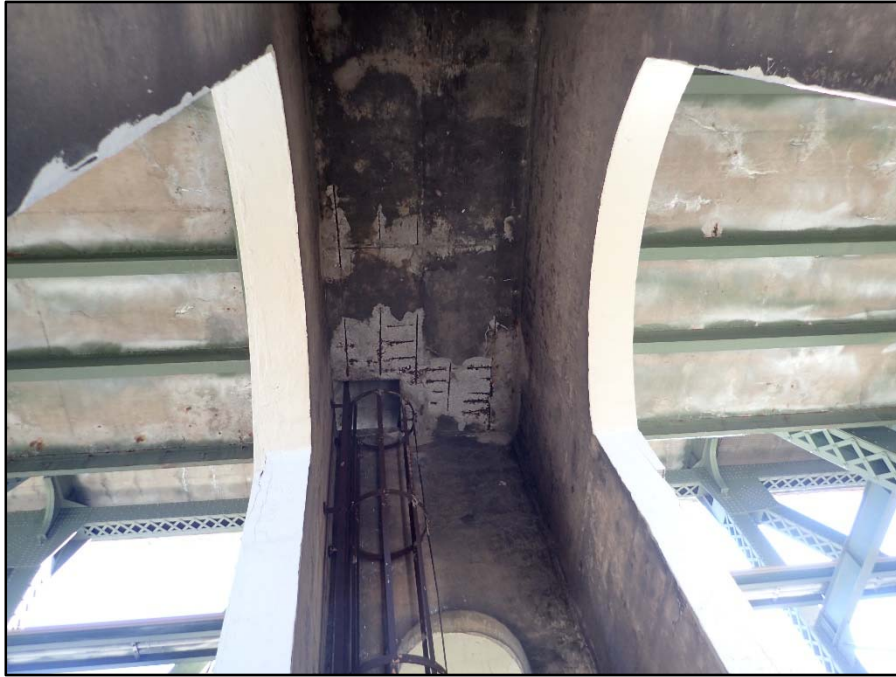
Photo 23 – Underside of Pier 12 cap, Typical condition

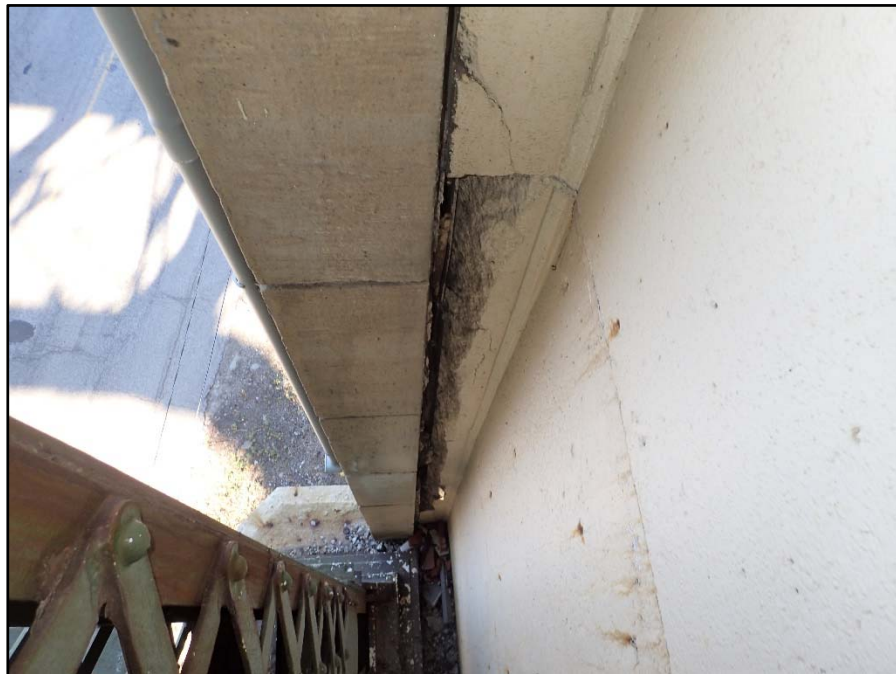
Photo 24 – East pylon backwall has a 12' H x up to 12" W spall/delamination behind the North Exterior Truss

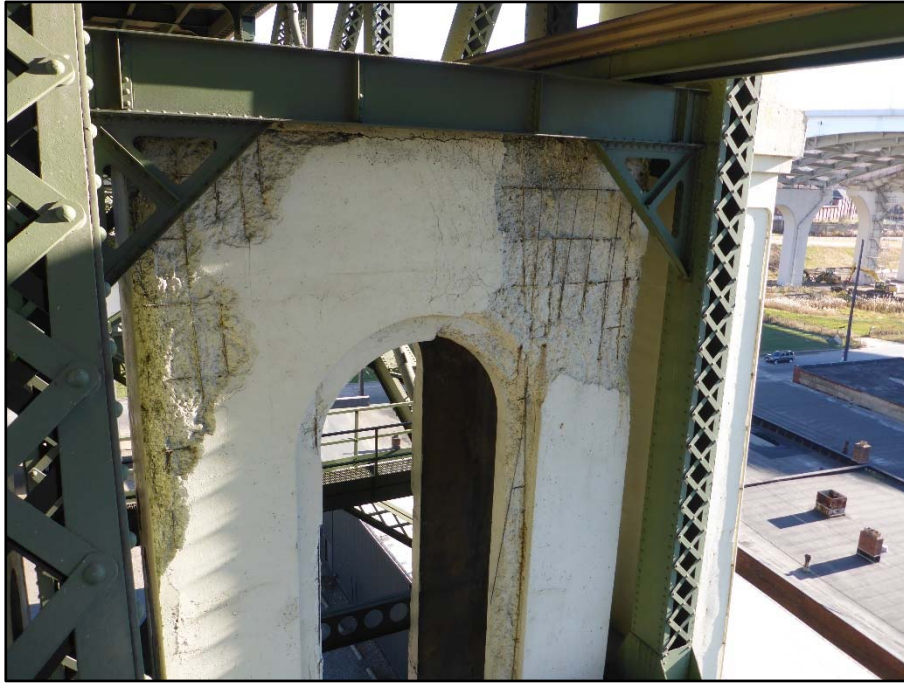
Photo 25 – West faces of Pier 4 have large painted over spalls with exposed reinforcing along the top behind the South truss line

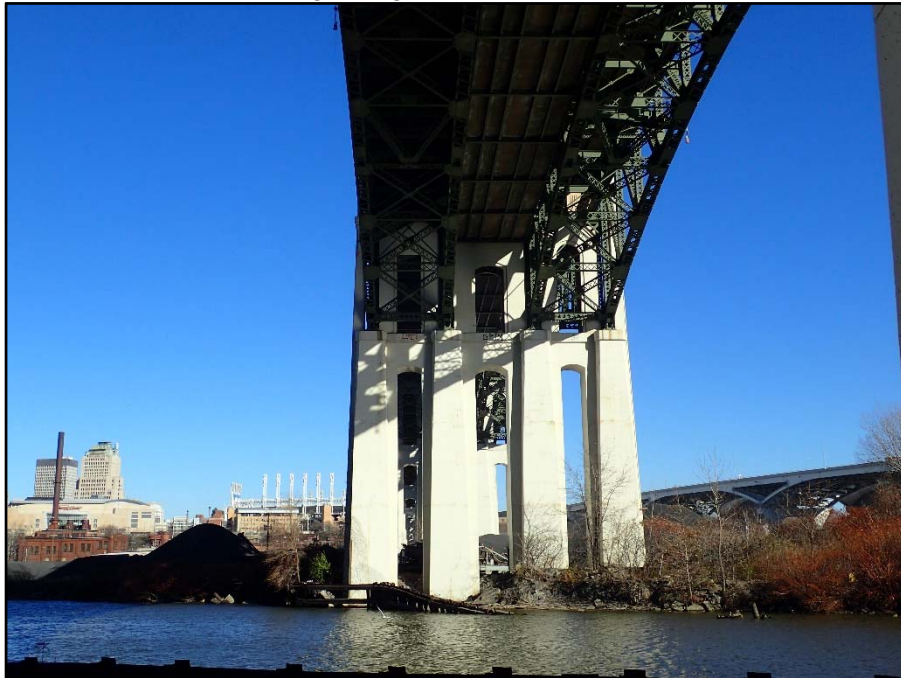
Photo 26 – Pier 9 bulkhead has failed along the East bank

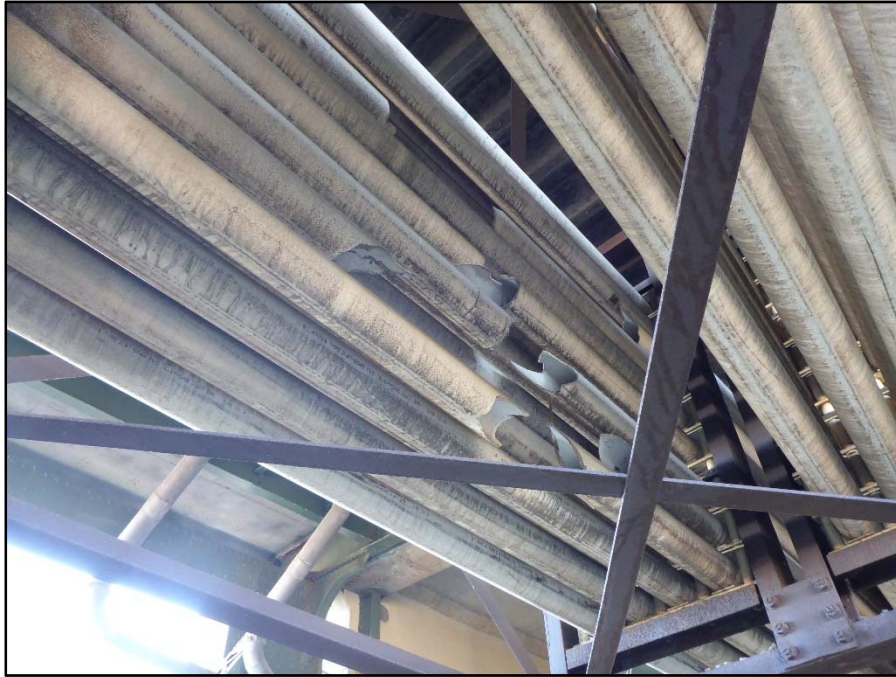
Photo 29 – Span 13, damaged area of conduit

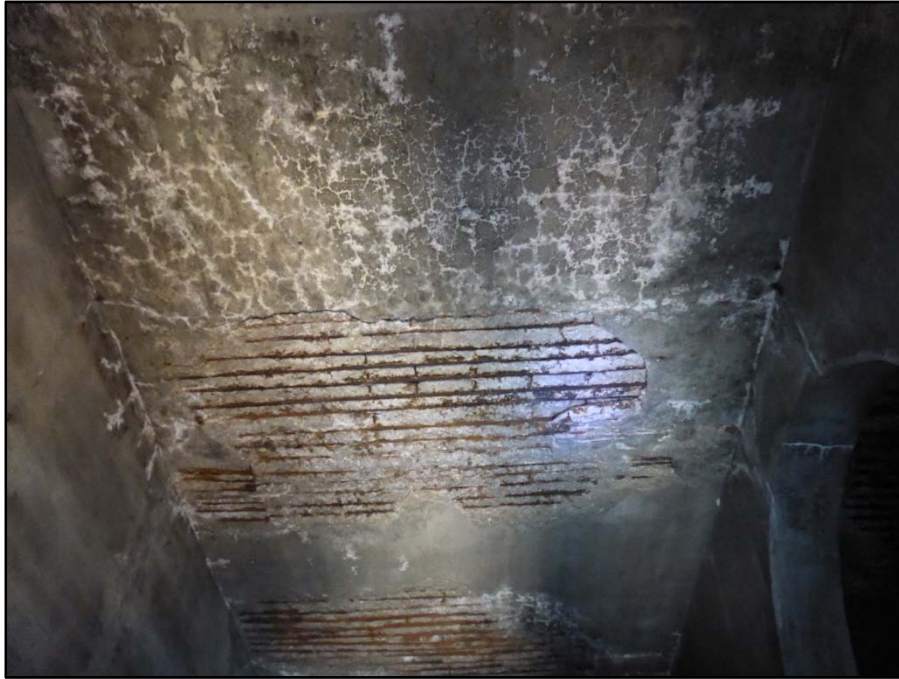
Photo 30 – East approach tunnel has large spalled areas with exposed rebar in all bays

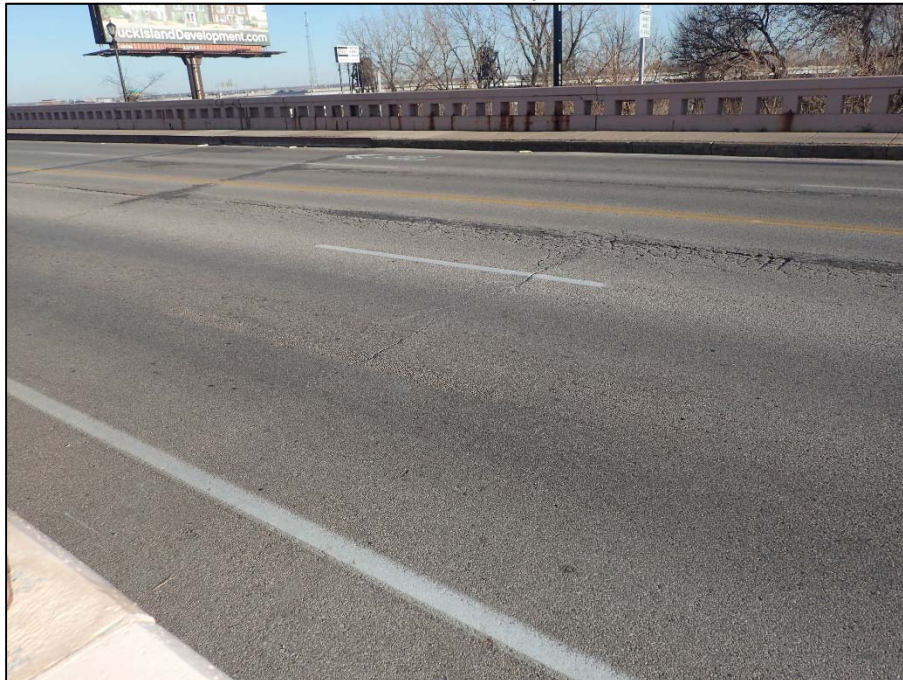
Photo 31 – West approach pavement has spalling, cracking and bituminous patching over 20% of the pavement

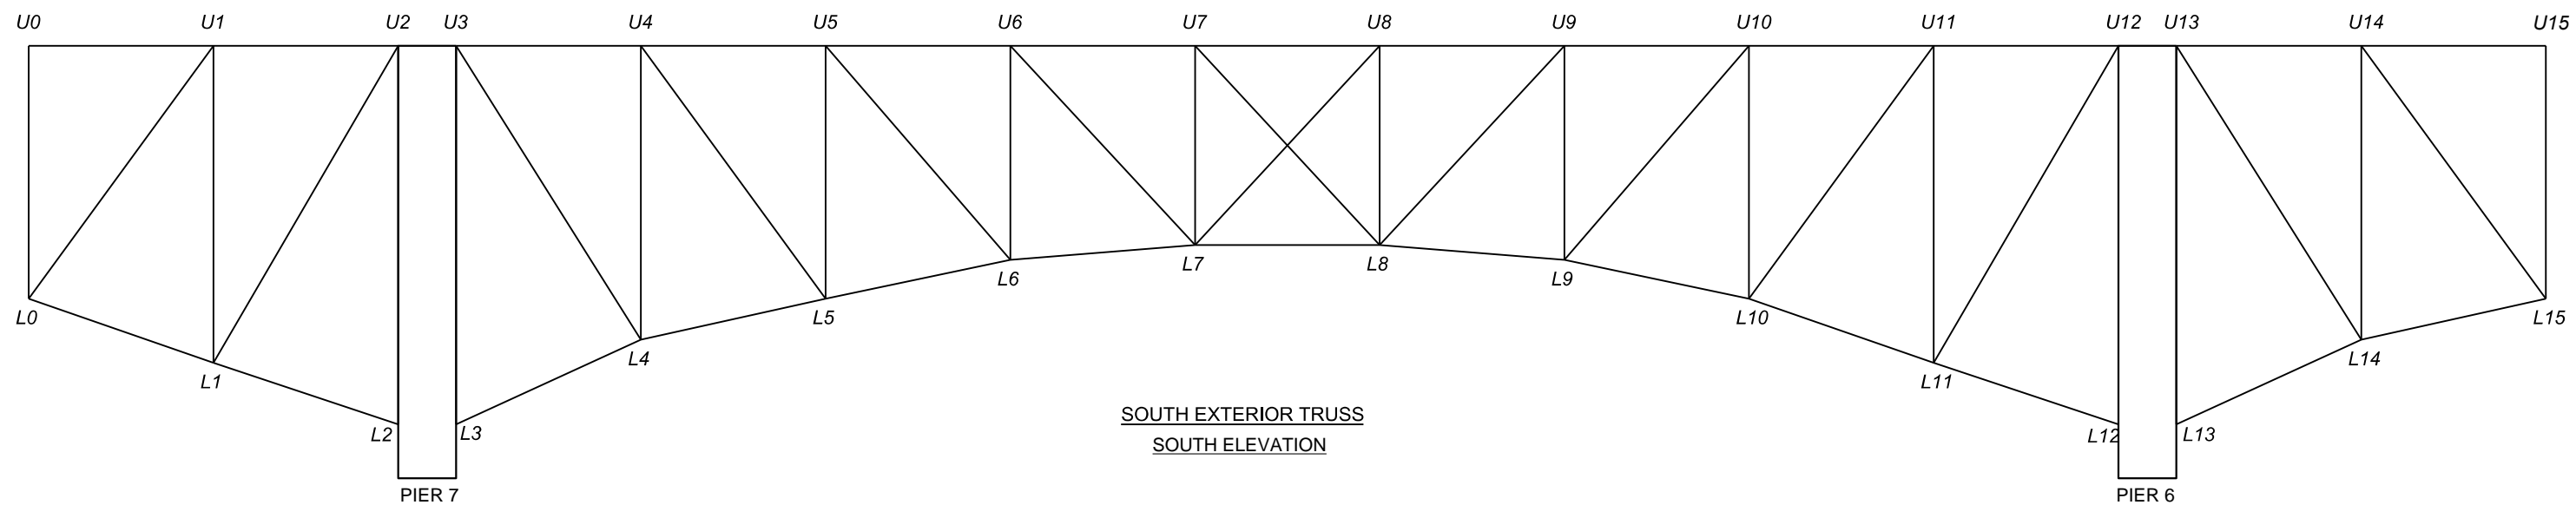
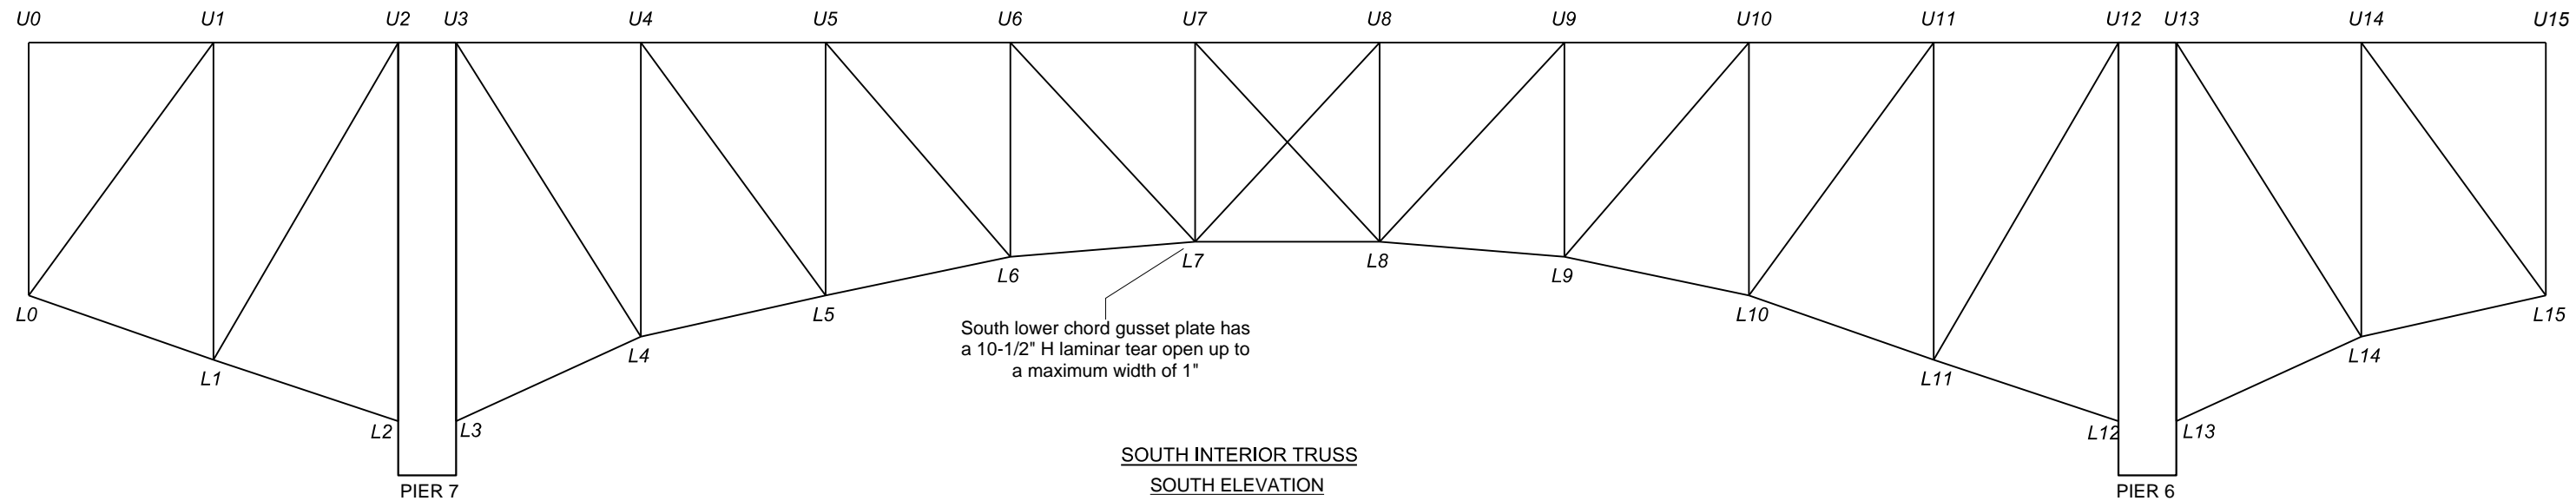
GRAPHIC SCALE MEASURED IN FEET	DATE DEC, 2017	  300 East Business Way Suite 200 Cincinnati, OH 45241 PH: 614.699.5000	HOPE MEMORIAL BRIDGE OVER CUYAHOGA RIVER BRIDGE NO. CUY-10-1613
NOT TO SCALE			INFRASTRUCTURE ENGINEERS, INC.
			PAGE A - 17

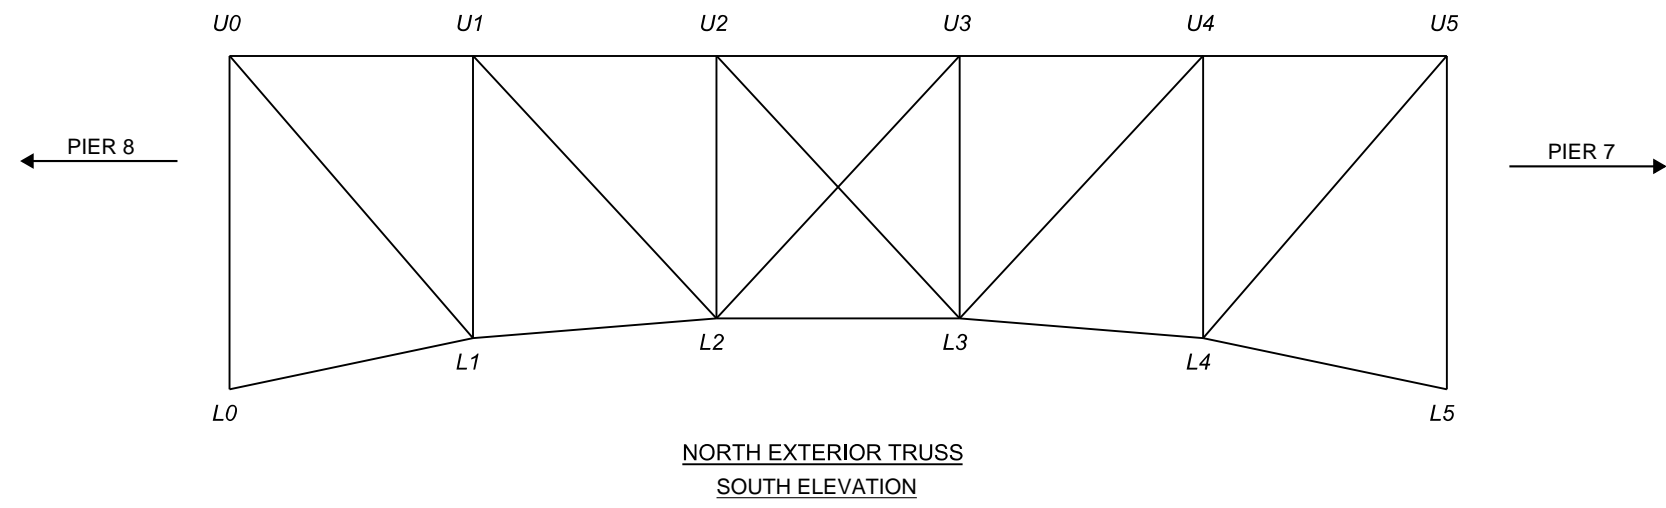
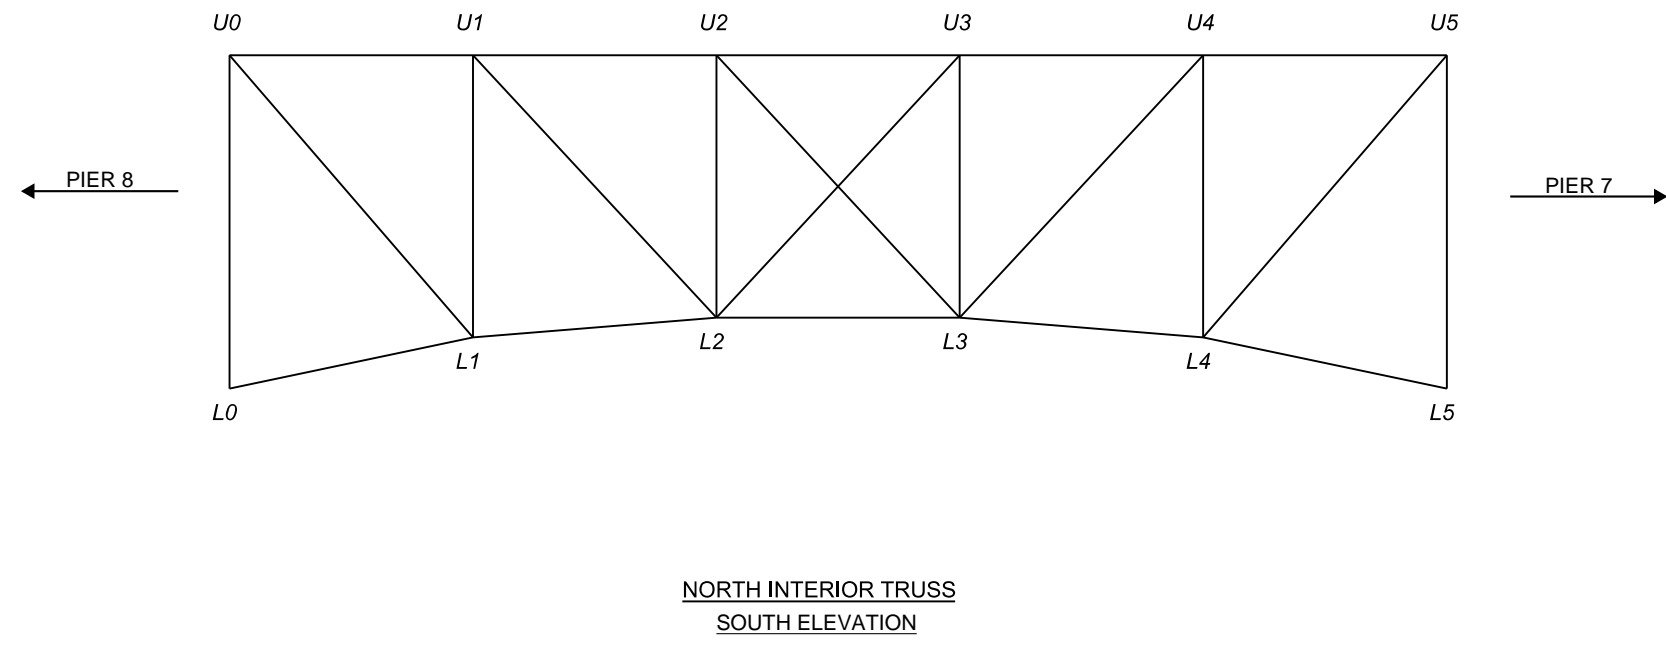
GRAPHIC SCALE MEASURED IN FEET	DATE	  300 East Business Way Suite 200 Cincinnati, OH 45241 PH: 614.699.5000	HOPE MEMORIAL BRIDGE OVER CUYAHOGA RIVER BRIDGE NO. CUY-10-1613	
NOT TO SCALE	DEC, 2017		INFRASTRUCTURE ENGINEERS, INC.	TRUSS ELEVATION - SPAN 8

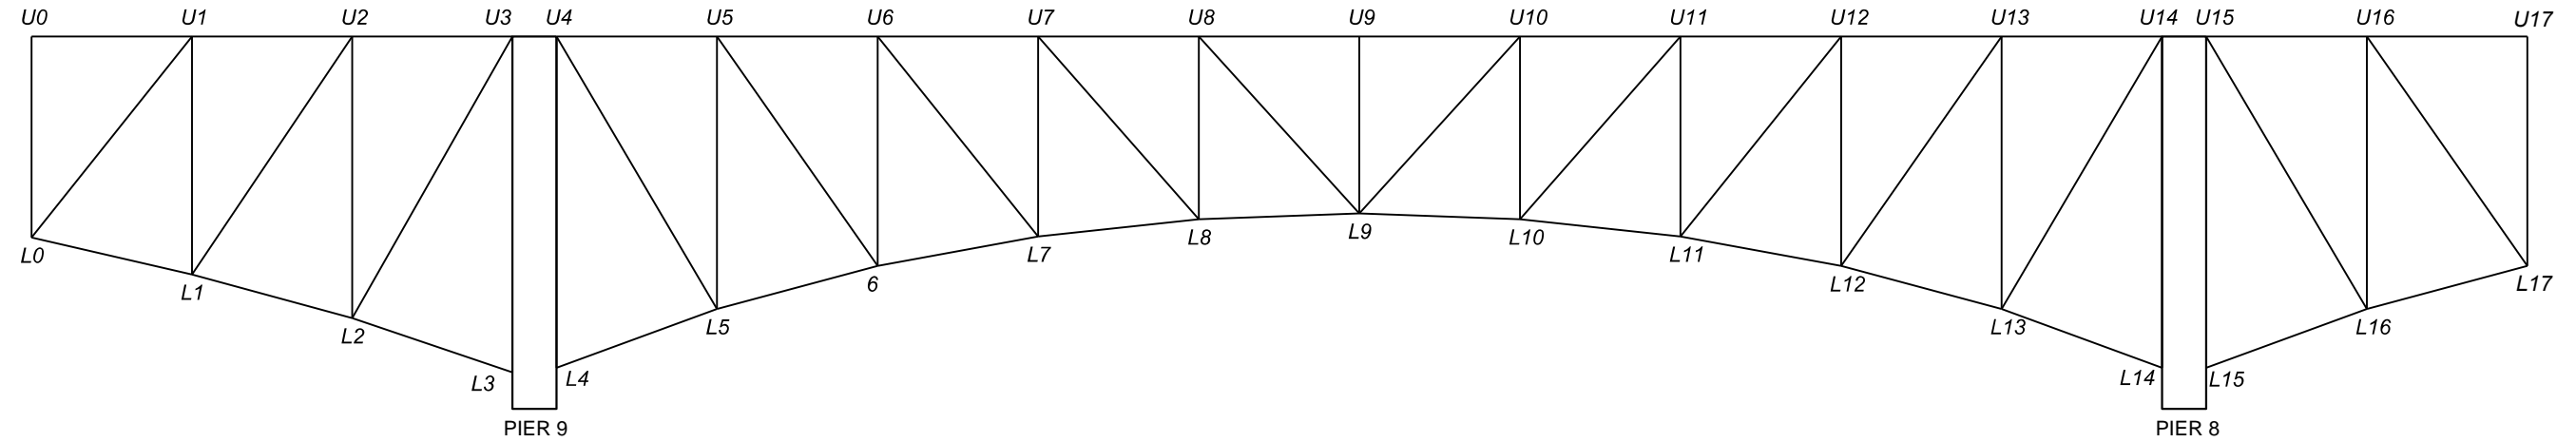
SOUTH EXTERIOR TRUSS  
SOUTH ELEVATION
