# CUY-10-1613

**PHYSICAL CONDITION REPORT  
ROUTINE INSPECTION  
HOPE MEMORIAL/LORAIN CARNEGIE BRIDGE OVER THE CUYAHOGA RIVER  
SFN: 1801503**

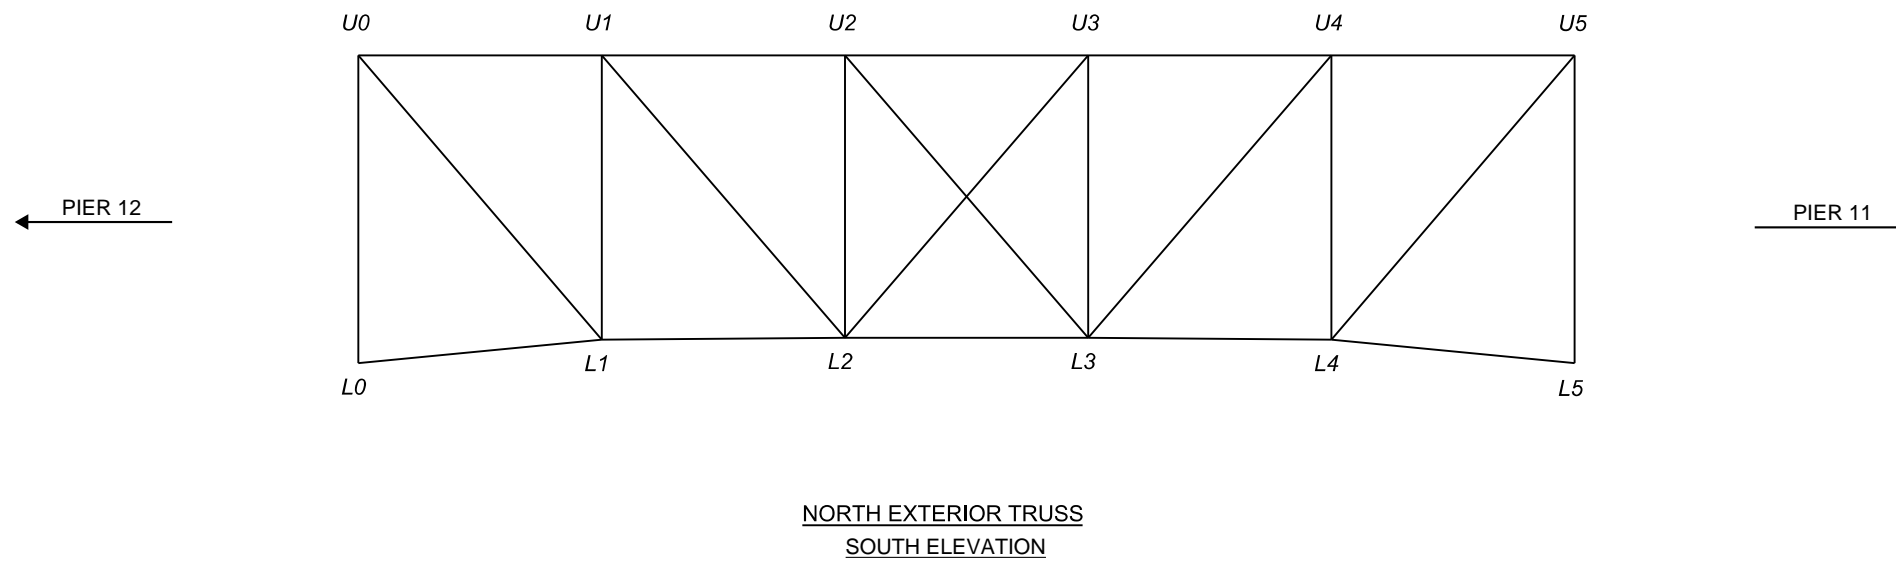
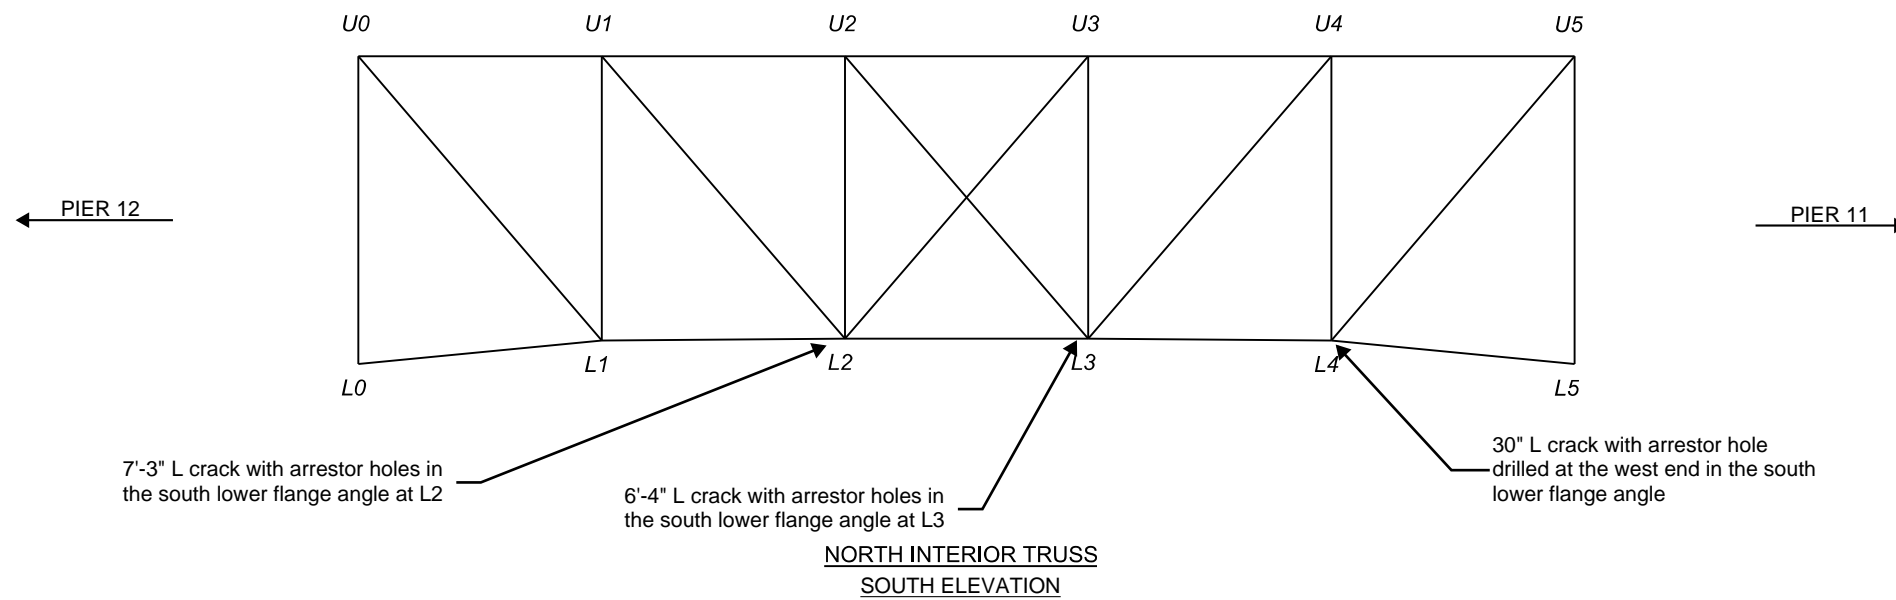
GRAPHIC SCALE MEASURED IN FEET	DATE	  300 East Business Way Suite 200 Cincinnati, OH 45241 PH.: 614.699.5000	HOPE MEMORIAL BRIDGE OVER CUYAHOGA RIVER BRIDGE NO. CUY-10-1613	
NOT TO SCALE	DEC, 2017		<b>INFRASTRUCTURE</b> <b>ENGINEERS, INC.</b>	TRUSS ELEVATION - SPAN 12

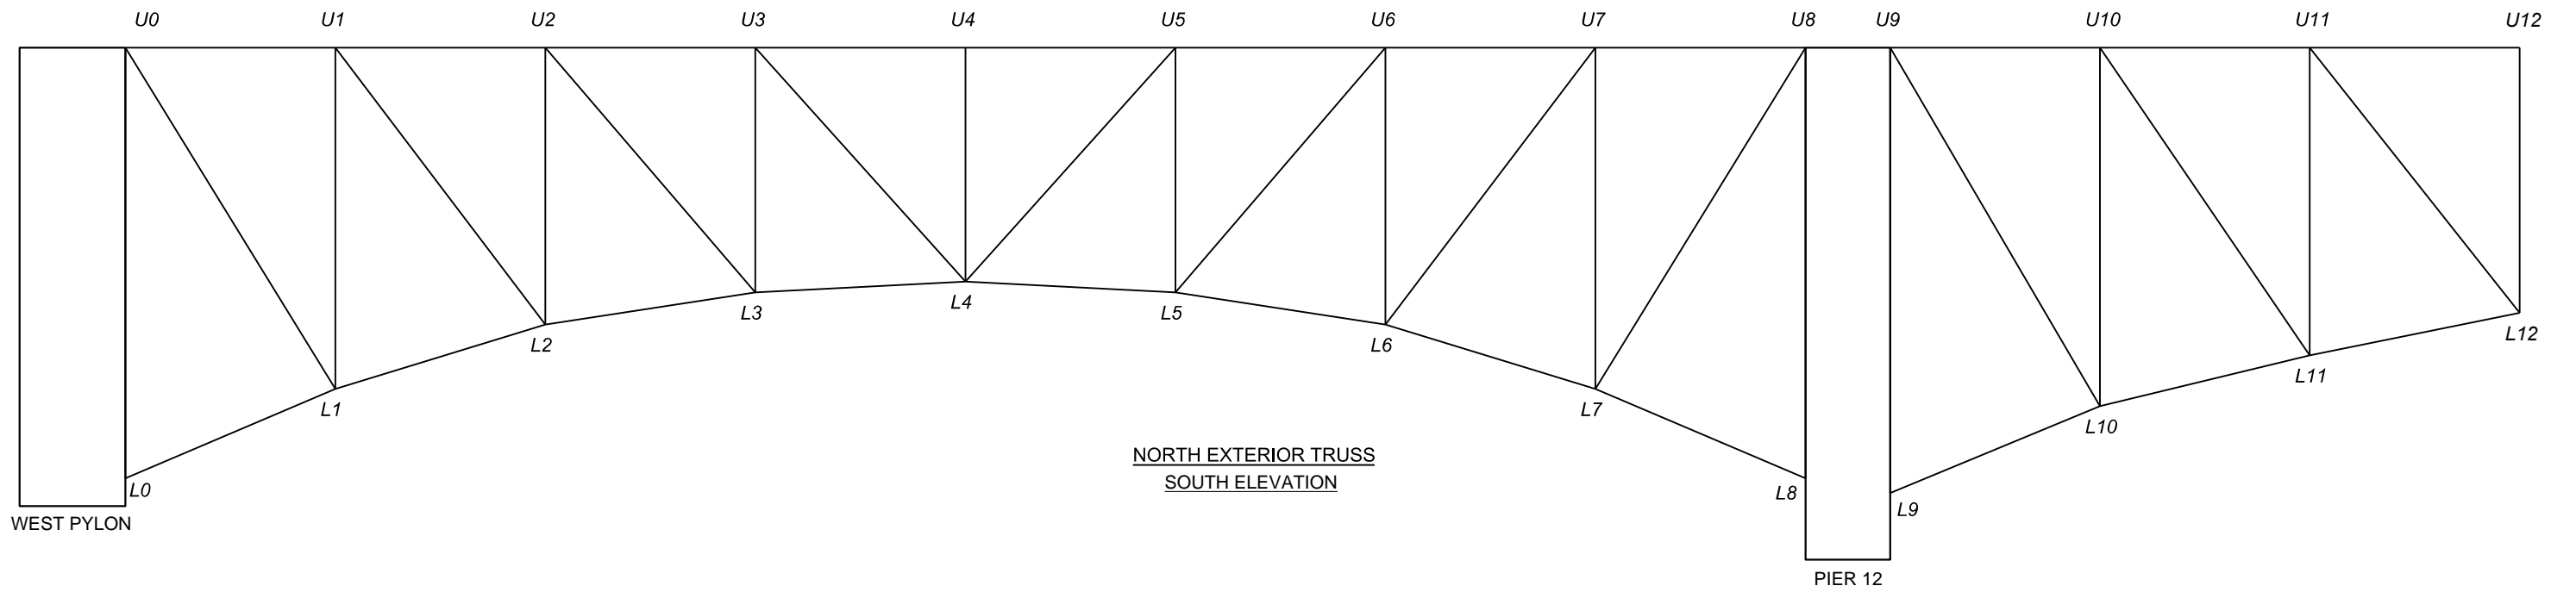
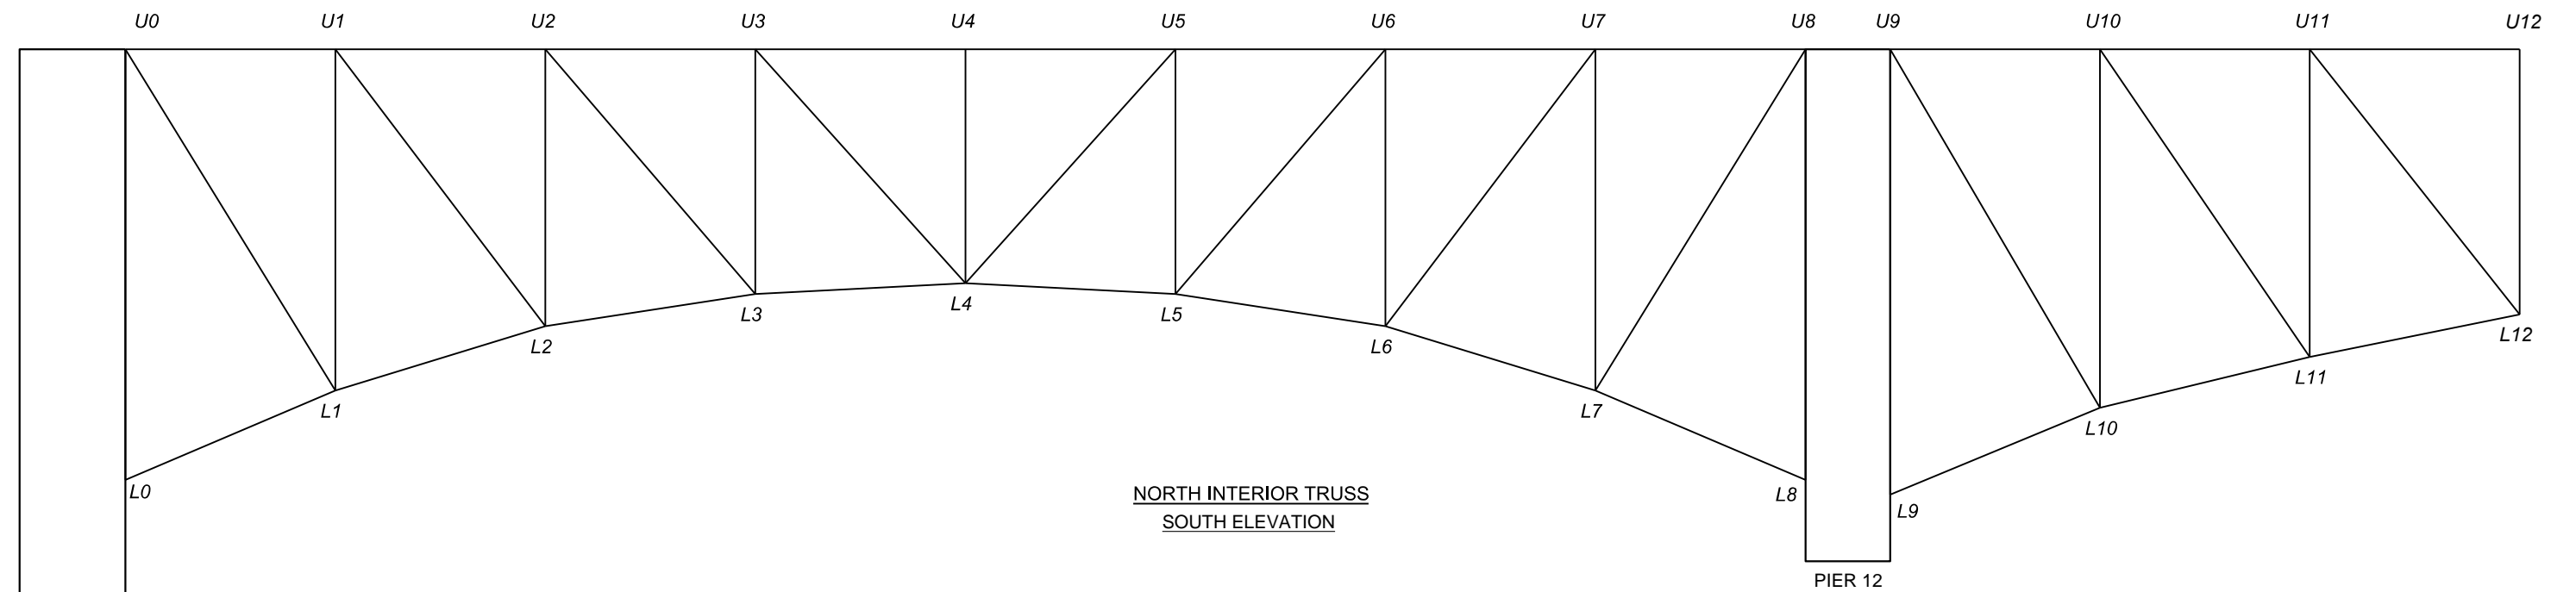
GRAPHIC SCALE MEASURED IN FEET	DATE	  300 East Business Way Suite 200 Cincinnati, OH 45241 PH: 614.699.5000	HOPE MEMORIAL BRIDGE OVER CUYAHOGA RIVER BRIDGE NO. CUY-10-1613	
	DEC, 2017		INFRASTRUCTURE ENGINEERS, INC.	TRUSS ELEVATION - SPAN 12
NOT TO SCALE
