CUY-10-1613

PHYSICAL CONDITION REPORT ROUTINE FRACTURE CRITICAL INSPECTION HOPE MEMORIAL/LORAIN CARNEGIE BRIDGE OVER THE CUYAHOGA RIVER SFN: 1801503

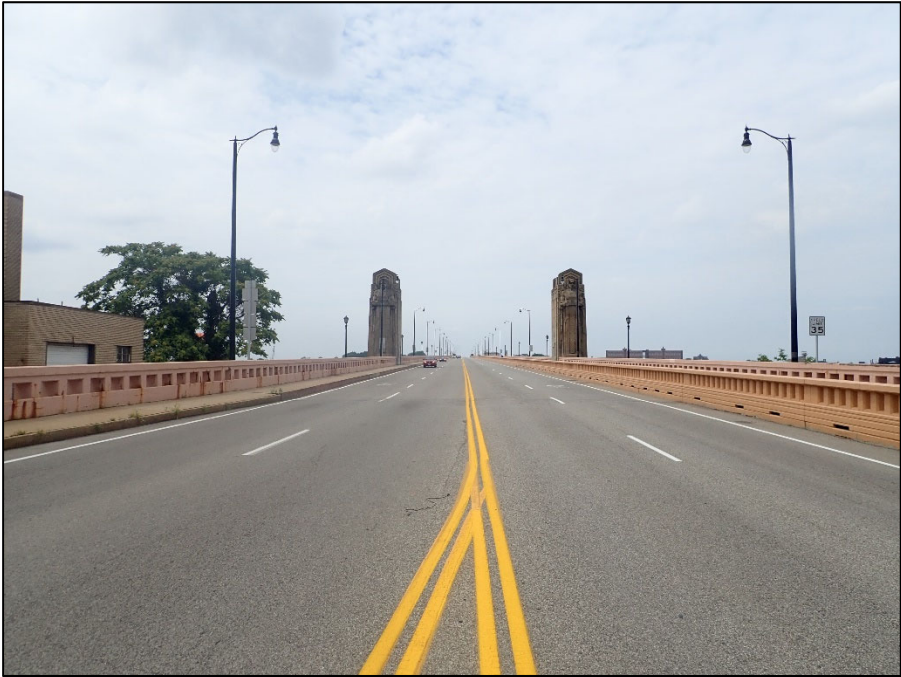
East end view looking West

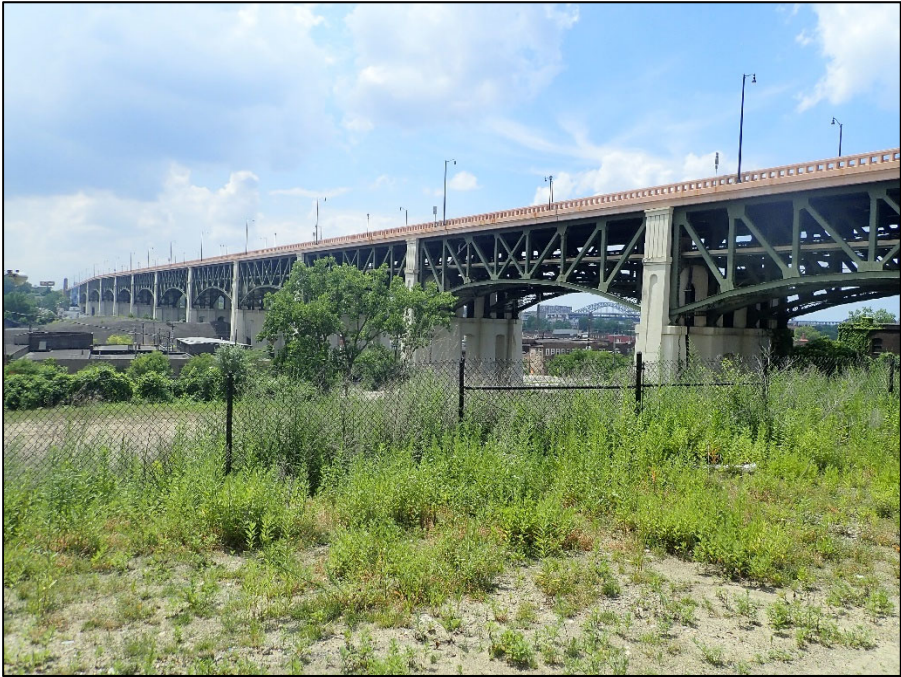
Bridge Number: CUY-10-1613
SFN: 1801503
Inspection Date: July 16-20, 2018

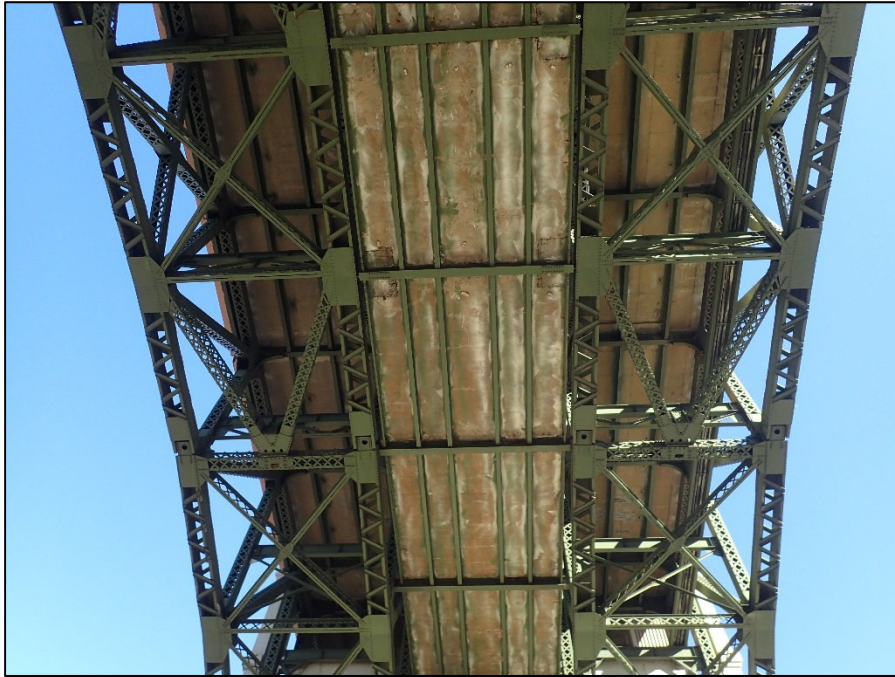
Photo 1 - Typical upper and lower deck soffits

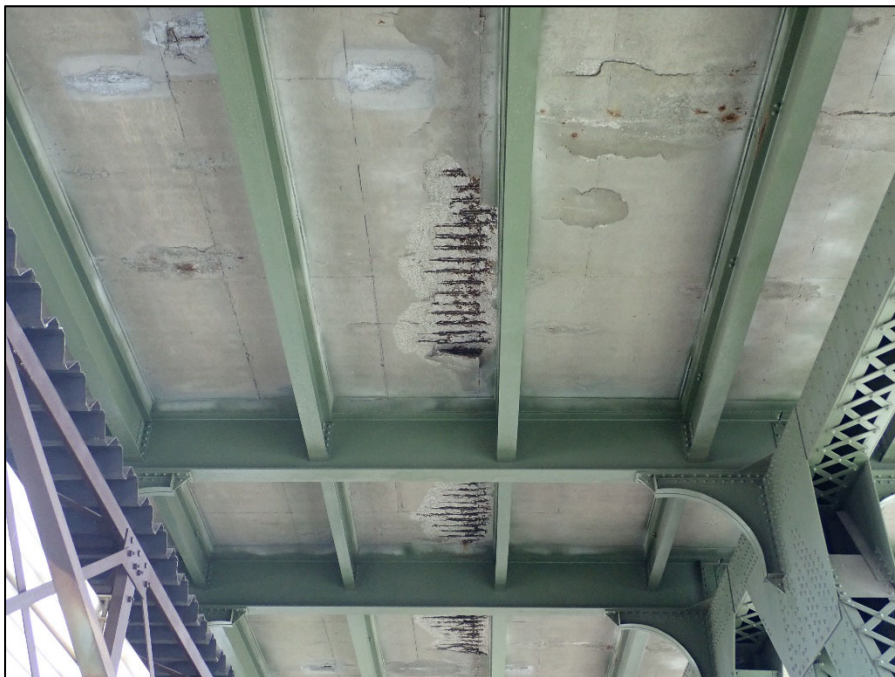
Photo 2 - Typical underside of deck spalling with exposed rebar and delaminations

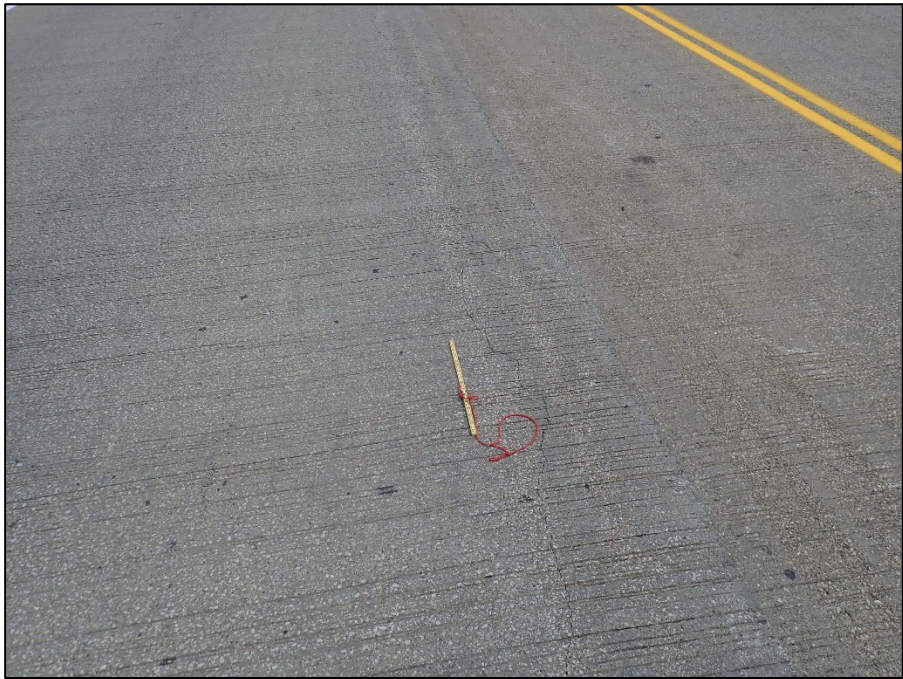
Photo 3 – Typical wearing surface condition

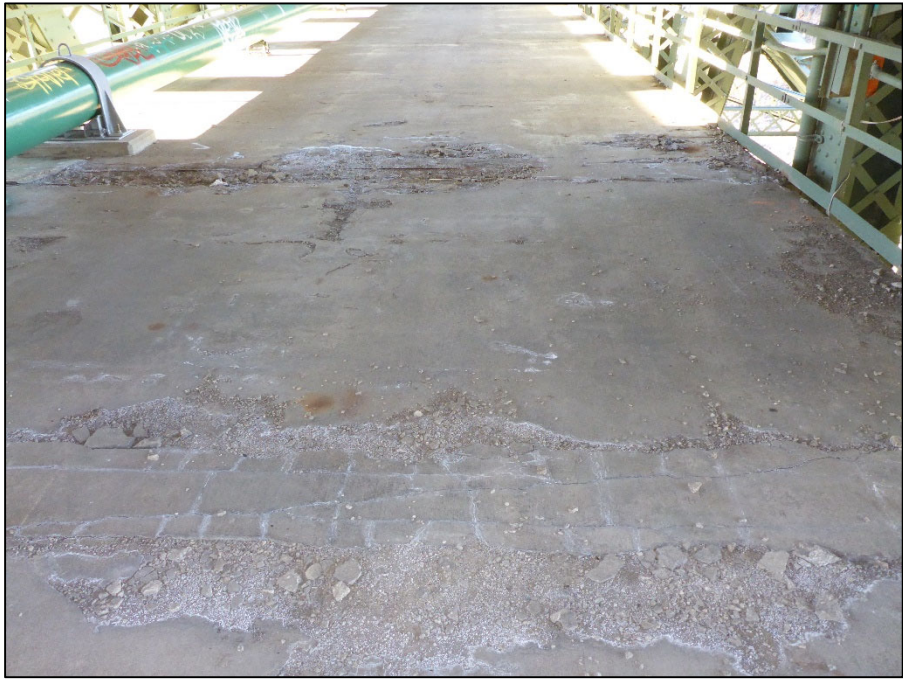
Photo 4 – Typical lower deck wearing surface; Cracking and delaminations with isolated spalling

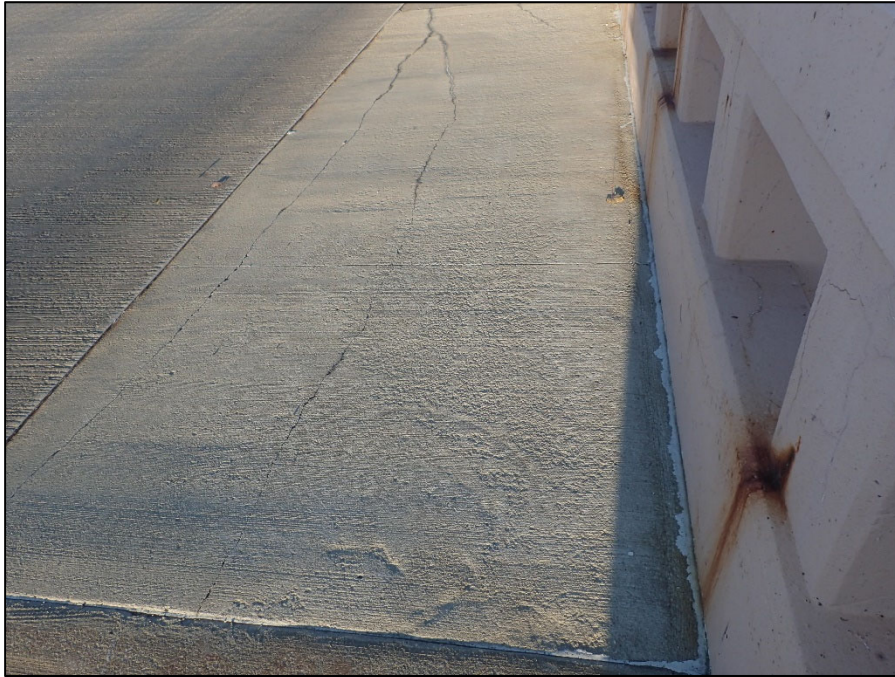
Photo 5 - South sidewalk; 18' L x up to 1/4" W longitudinal crack with associated minor edge spalling

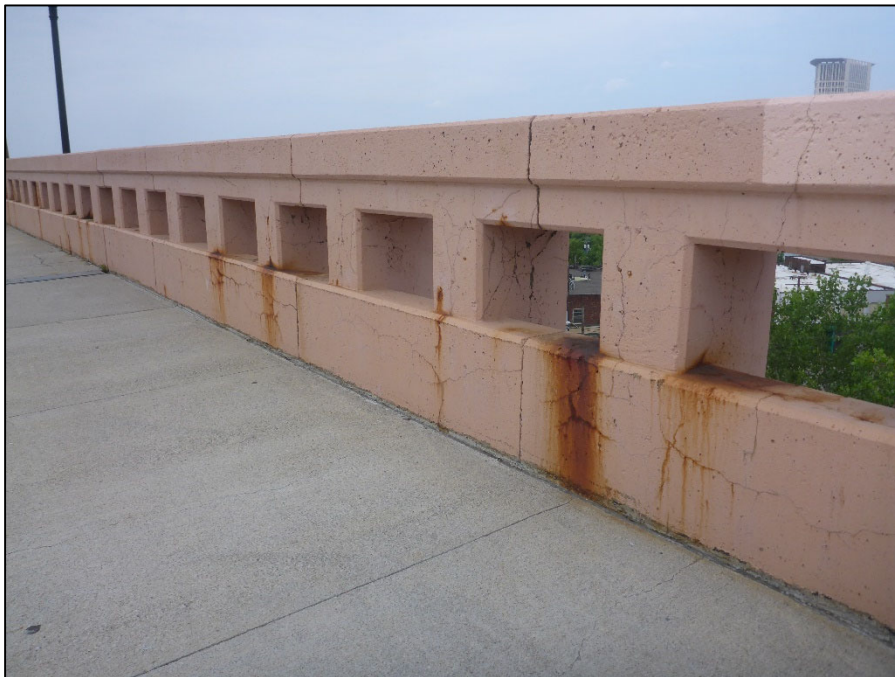
Photo 6 – Typical bridge rail condition

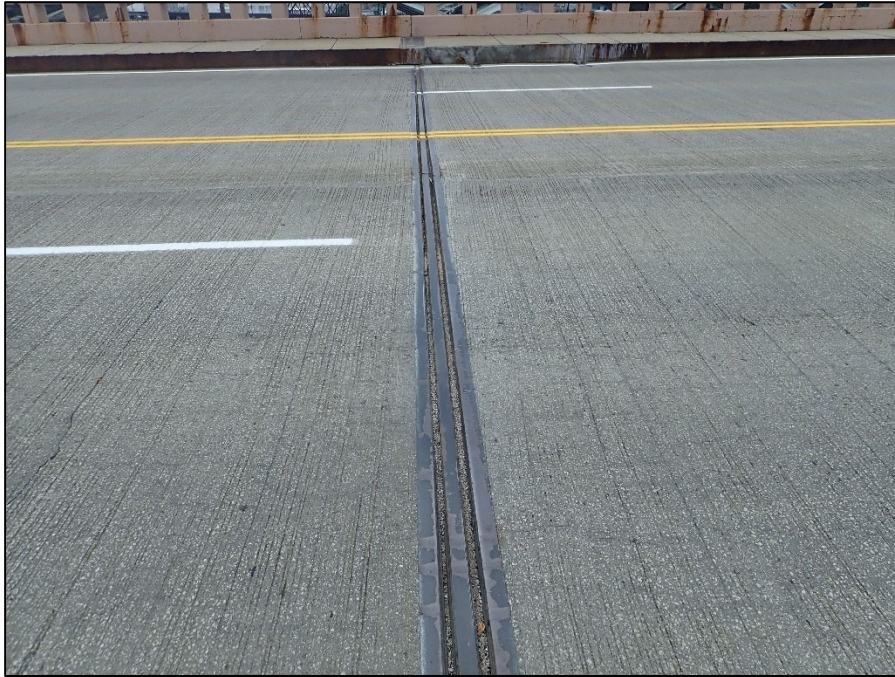
Photo 7 – Typical expansion joint condition

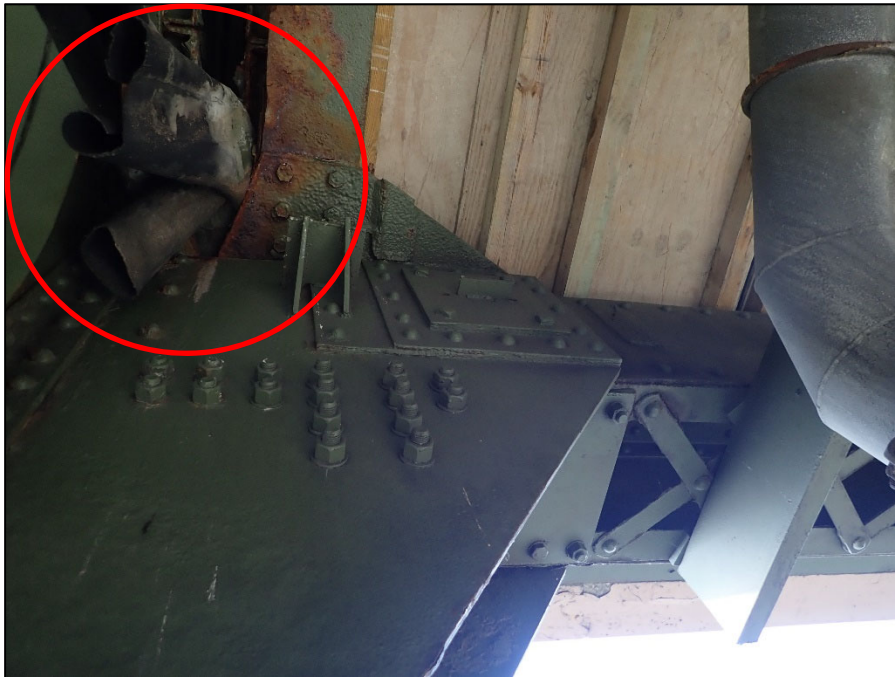
Photo 8 – Span 3 at panel point 13, South end of the joint;
damaged/de-bonded with hanging material

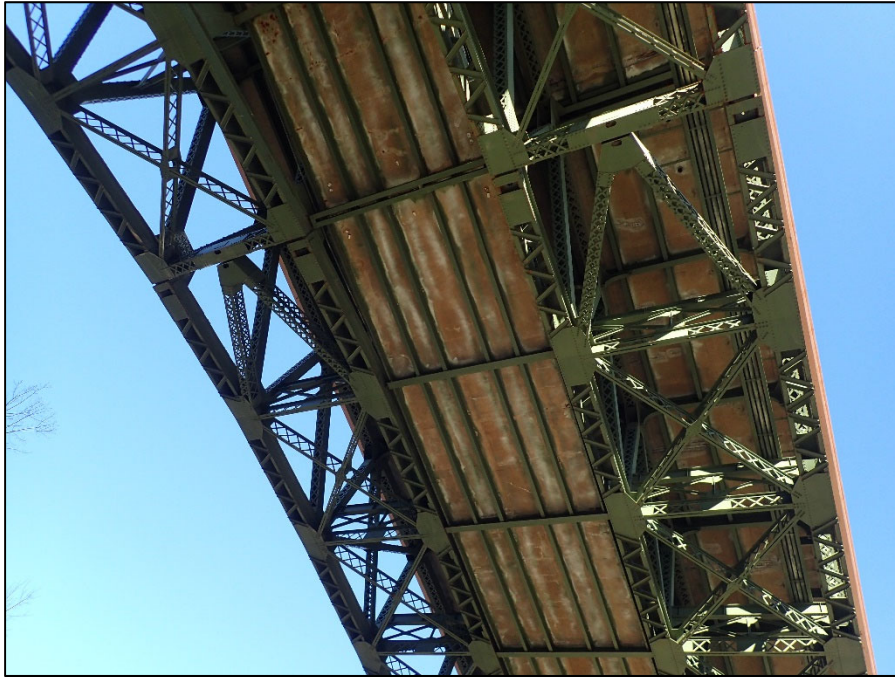
Photo 9 – Typical superstructure condition

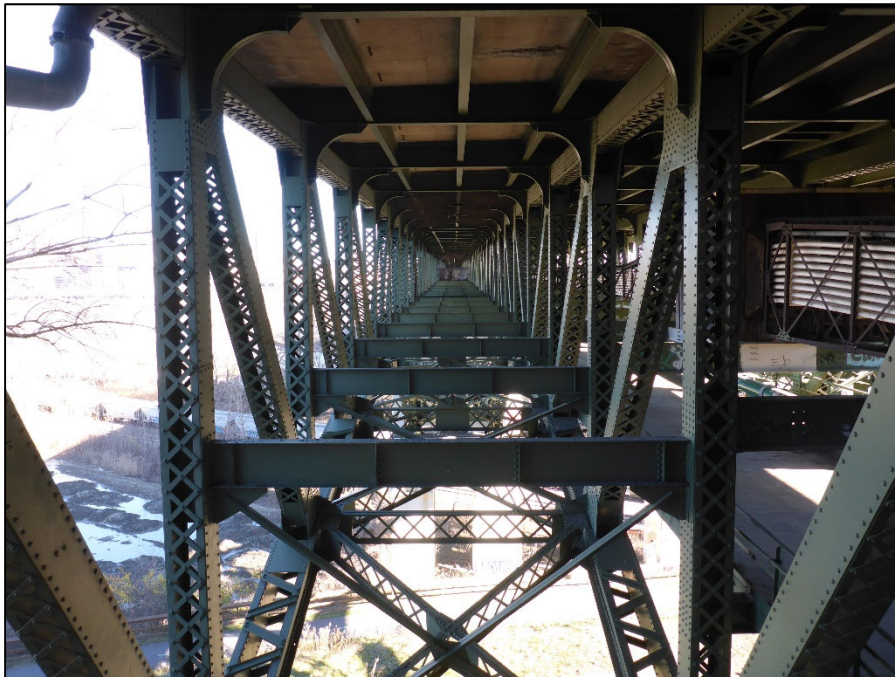
Photo 10 – Typical truss condition

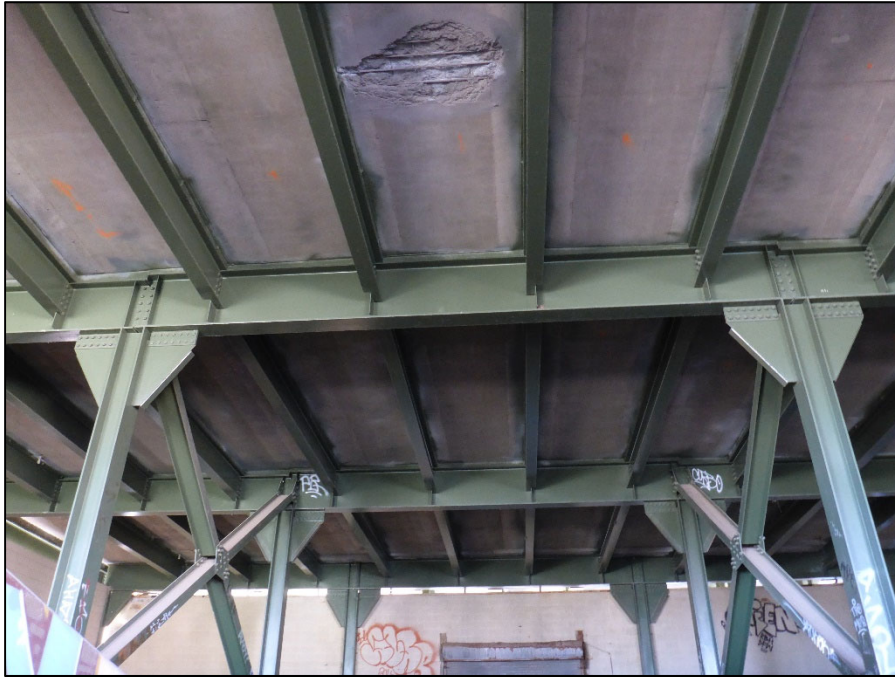
Photo 11 – Typical West approach superstructure

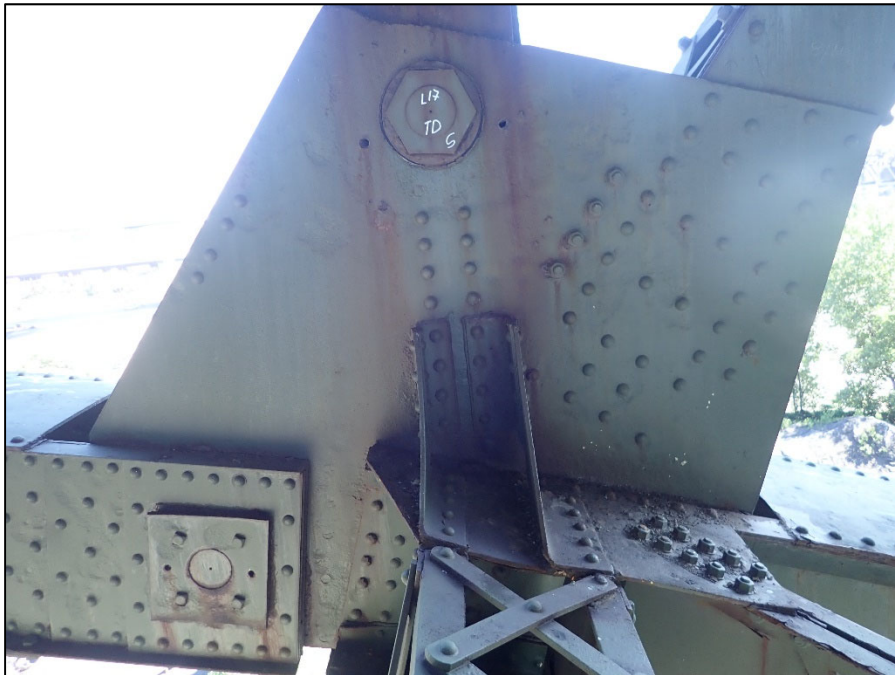
Photo 12 – Typical paint condition at panel points

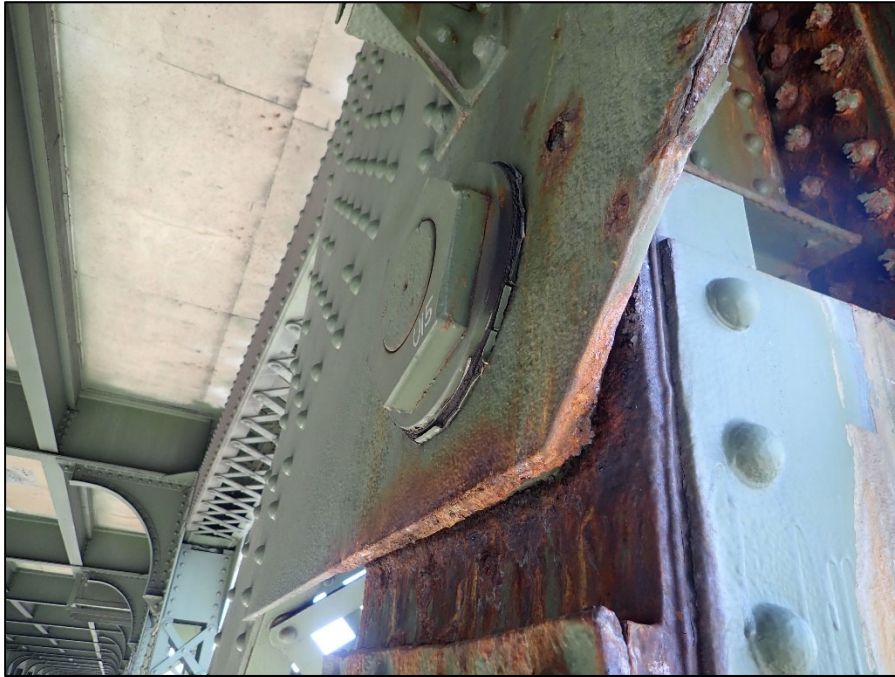
Photo 13 - South Interior Truss, Span 7, L15U15 at U15; Vertical below deck joint with active corrosion and pack rust

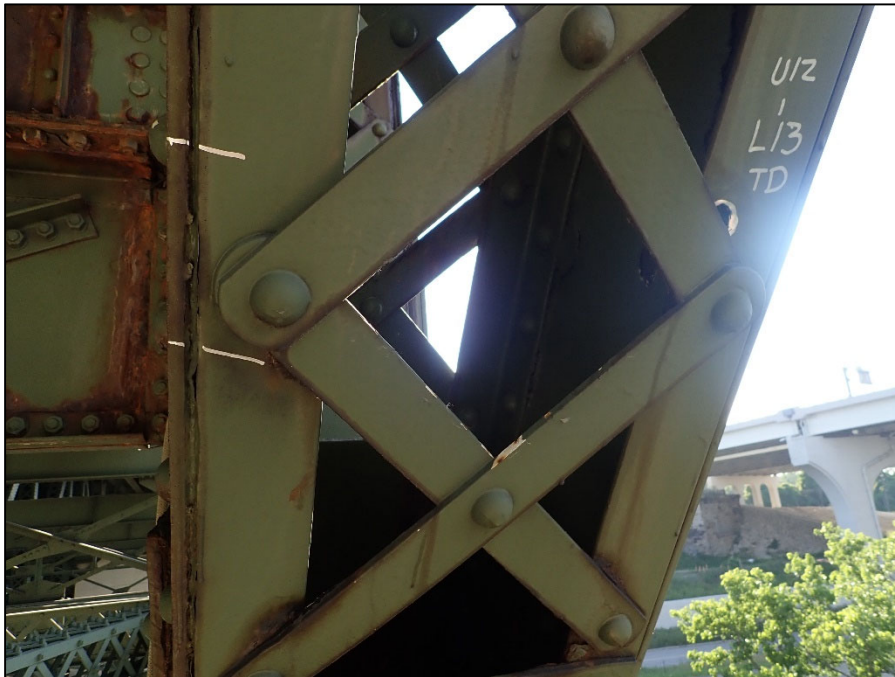
Photo 14 - South Exterior Truss, Span 3, U12L13; pack rust and corrosion holes

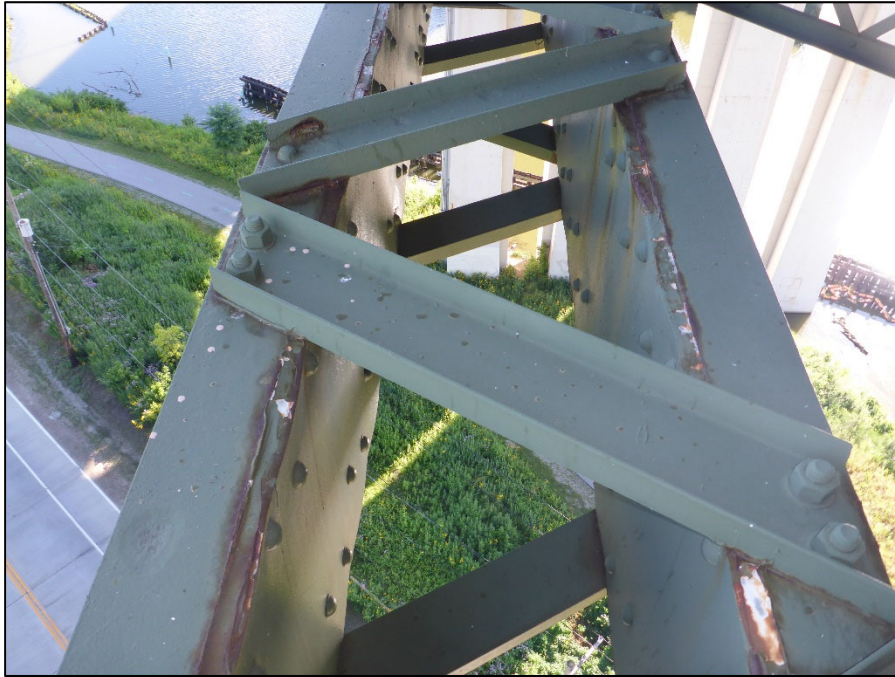
Photo 15 – North Exterior Truss, Span 11, L8L9; typical pack rust between lower chord built up members

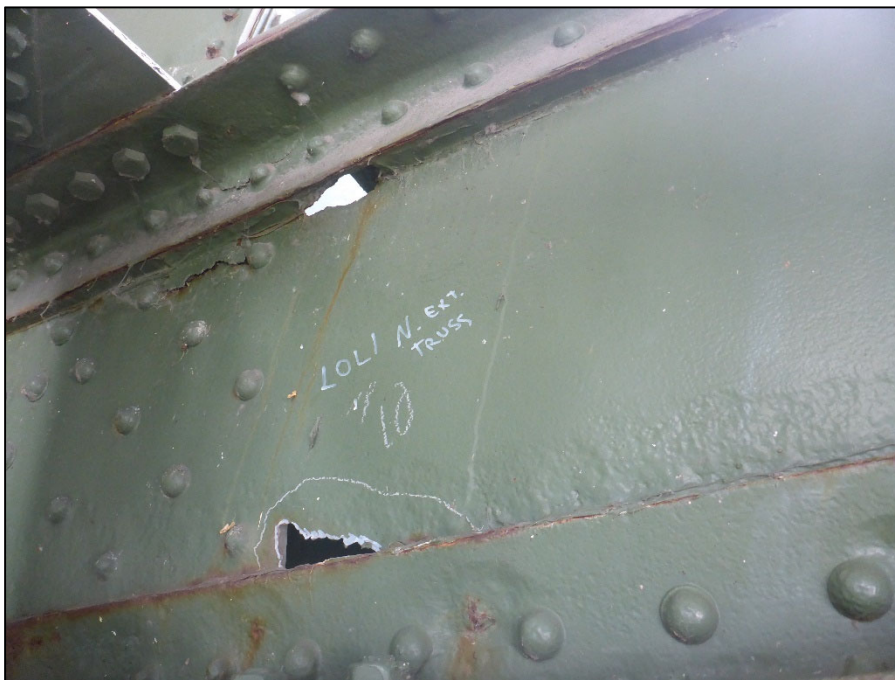
Photo 16 – North Exterior Truss, Span 13, L0L1; corrosion holes in lower chord web

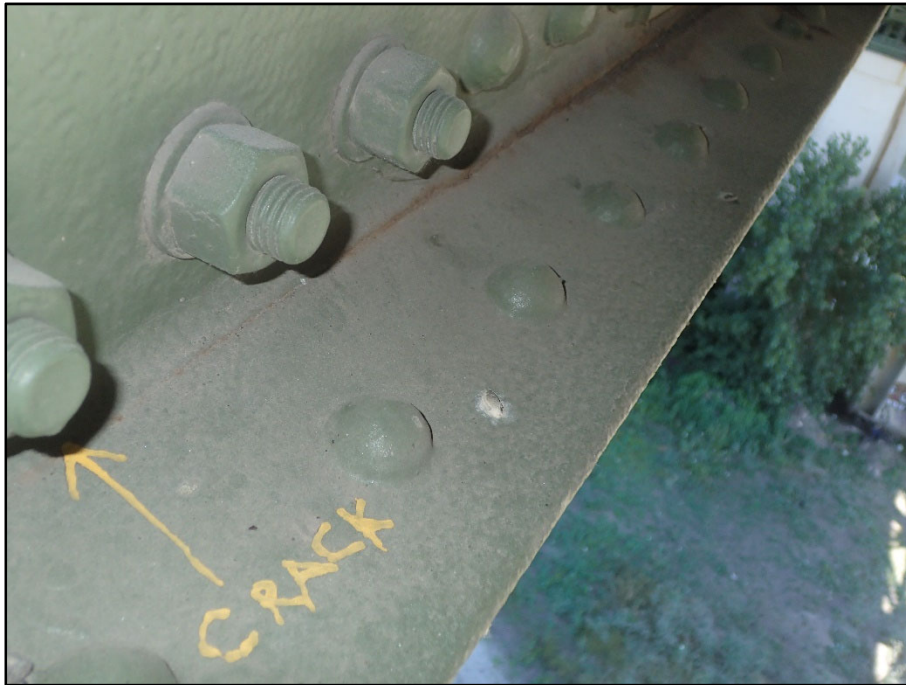
Photo 17 – North Interior Truss, Span 12, L1L2; 6'-4" L crack with an arrestor hole at the east end of crack

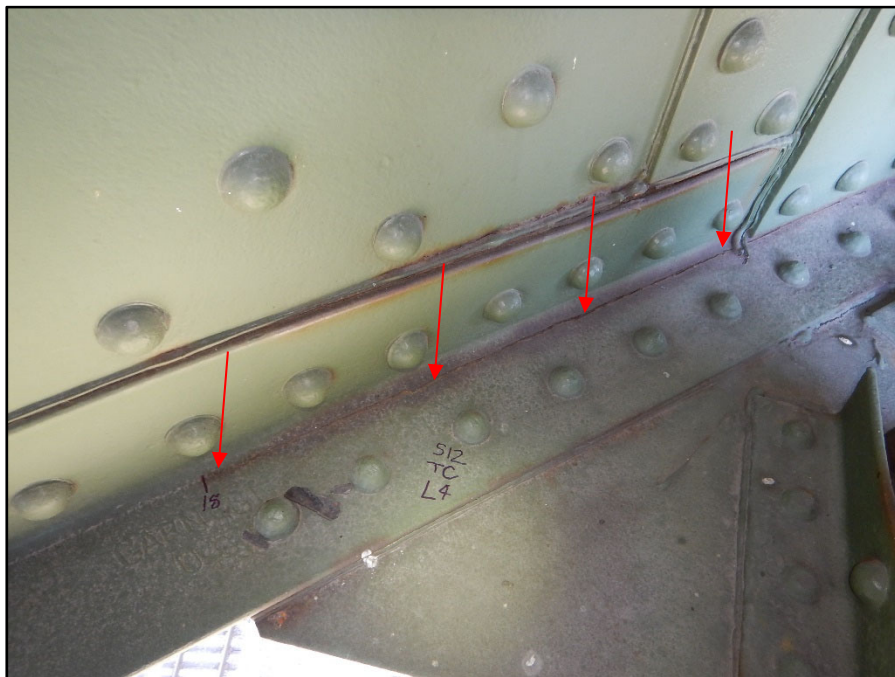
Photo 18 – South Interior truss, Span 12, L3L4; south lower angle at L4 with a 38-1/4" L crack

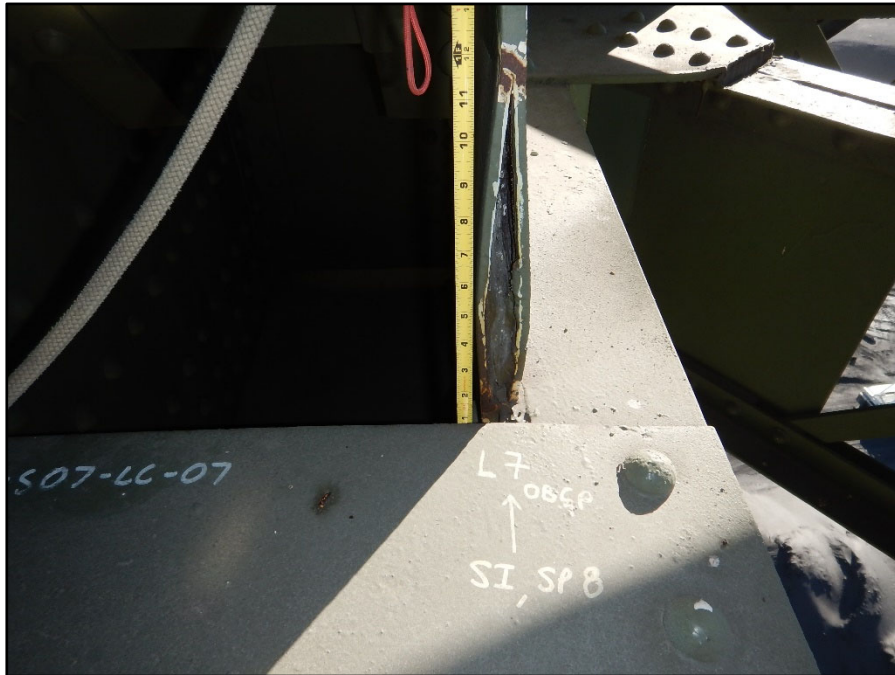
Photo 19 – South Interior truss, Span 7, L7; Laminar rolling defect opening gusset plate 1" W

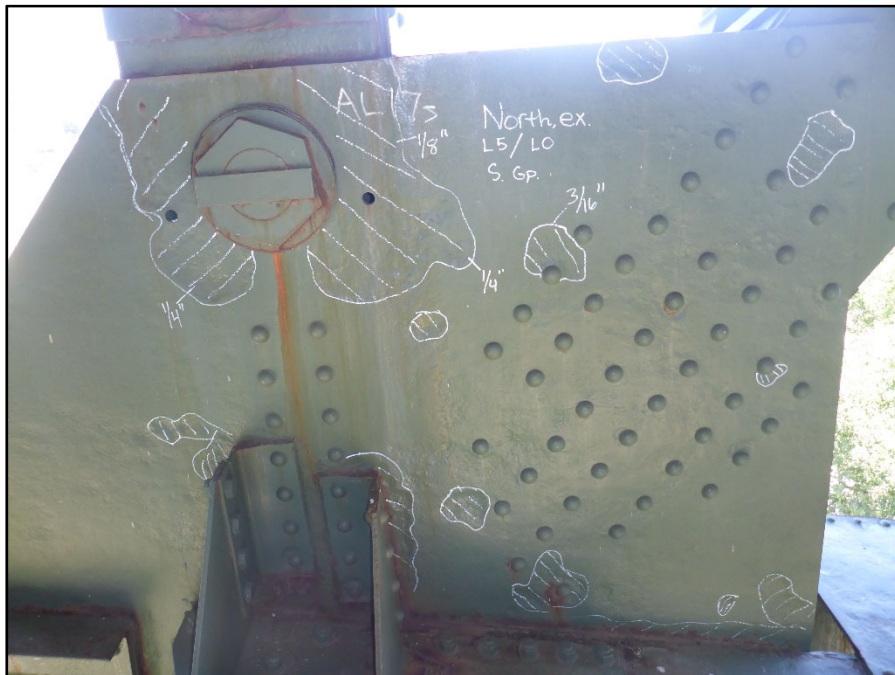
Photo 20 – North Exterior Truss, Span 11, L0 south Gusset Plate; Typical painted over pitting up to 1/4" D

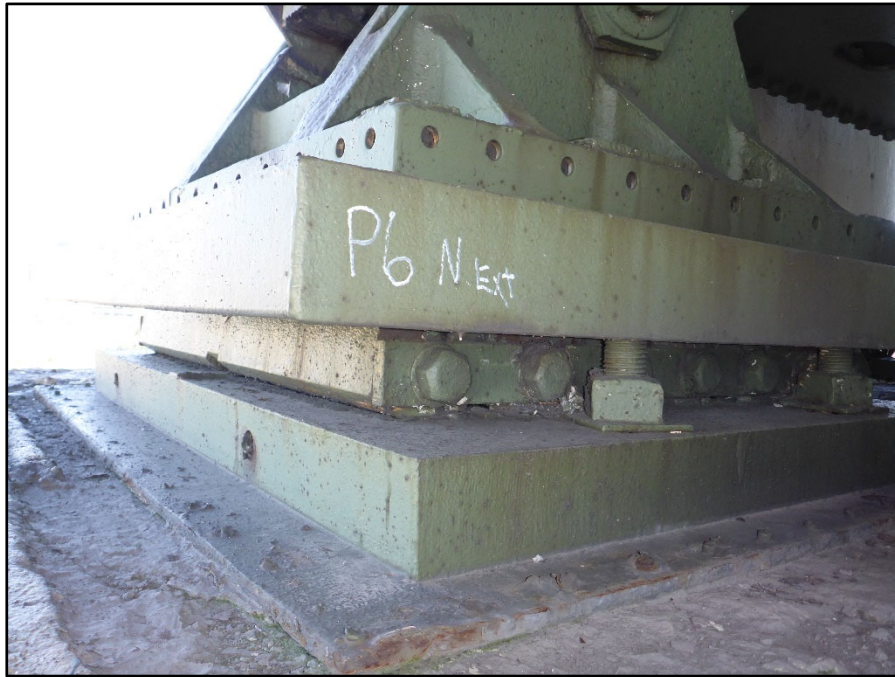
Photo 21 – North Exterior Truss, Pier 6; Typical nested rocker bearing

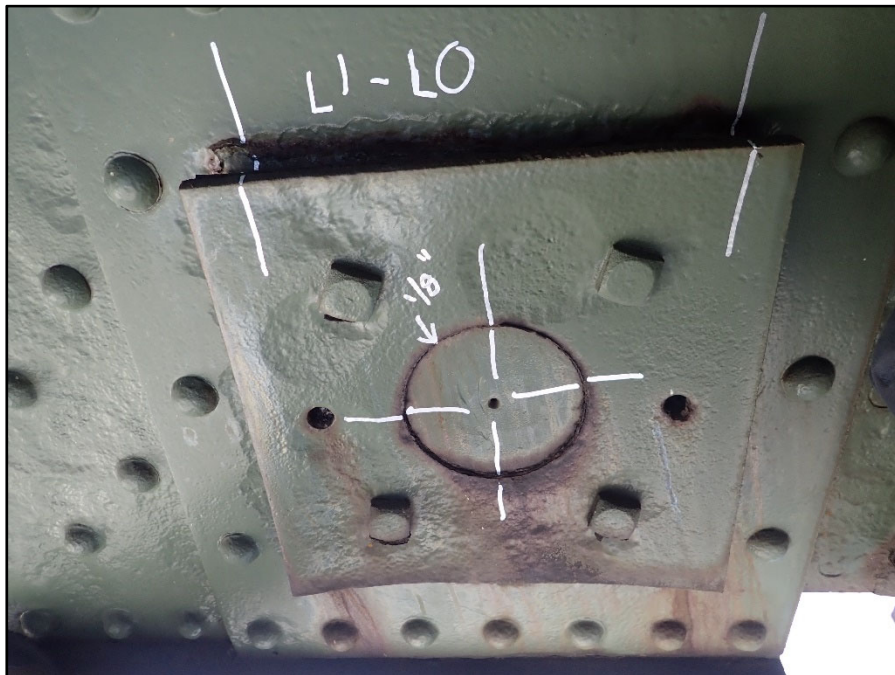
Photo 22 – South Exterior Truss, Span 8, L0; Typical corrosion and pack rust around pin and plate

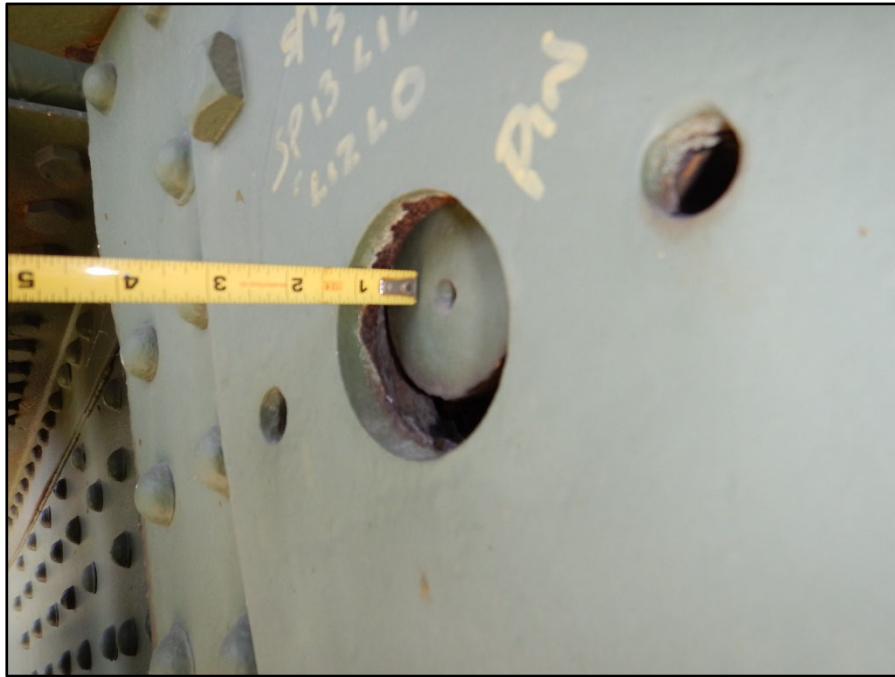
Photo 23 – South Interior Truss, Span 12, L0; dislodged pin

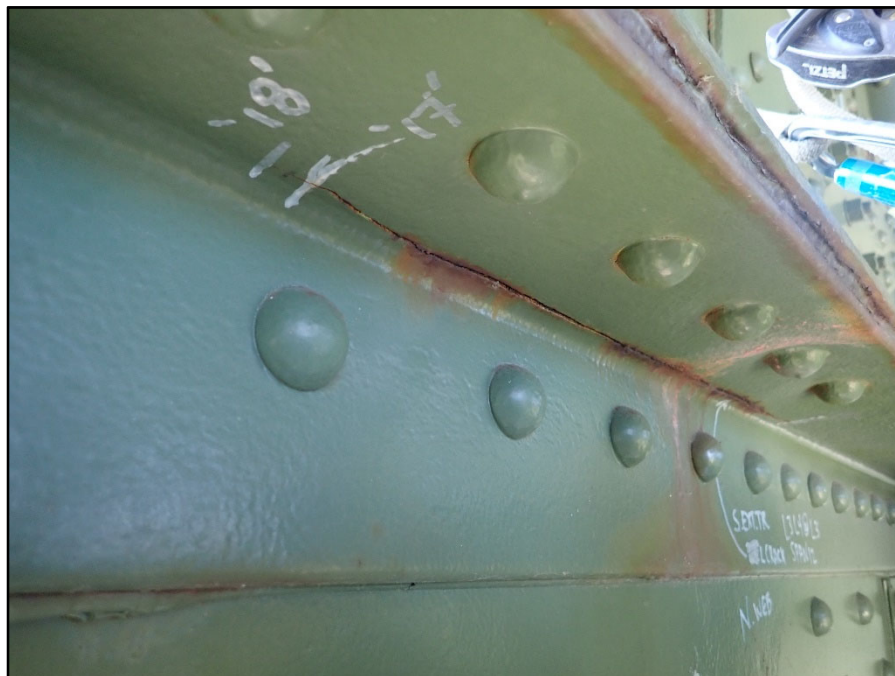
Photo 24 –South Exterior truss Span 12, L3; 23-3/4" L longitudinal crack in inboard top north flange angle (3/4" growth since previous inspection)

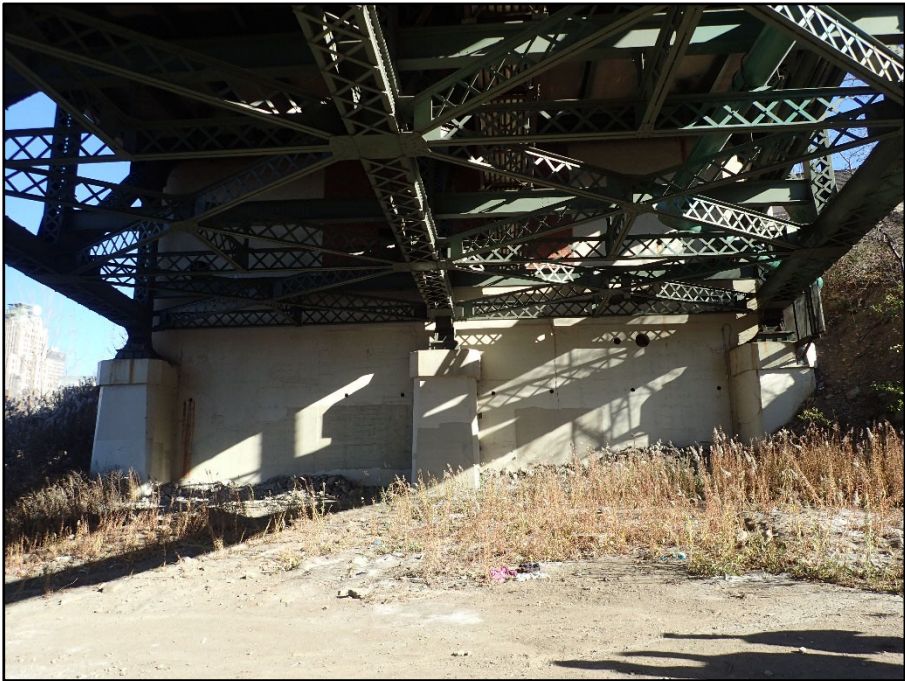
Photo 25 – East Abutment typical condition

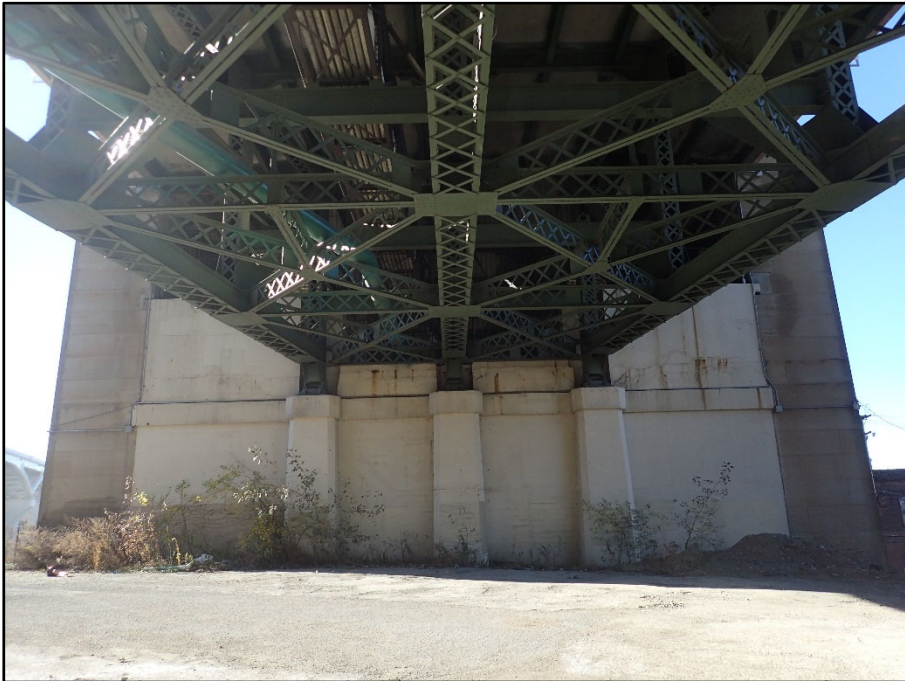
Photo 26 – East Pylon, East face; Typical condition

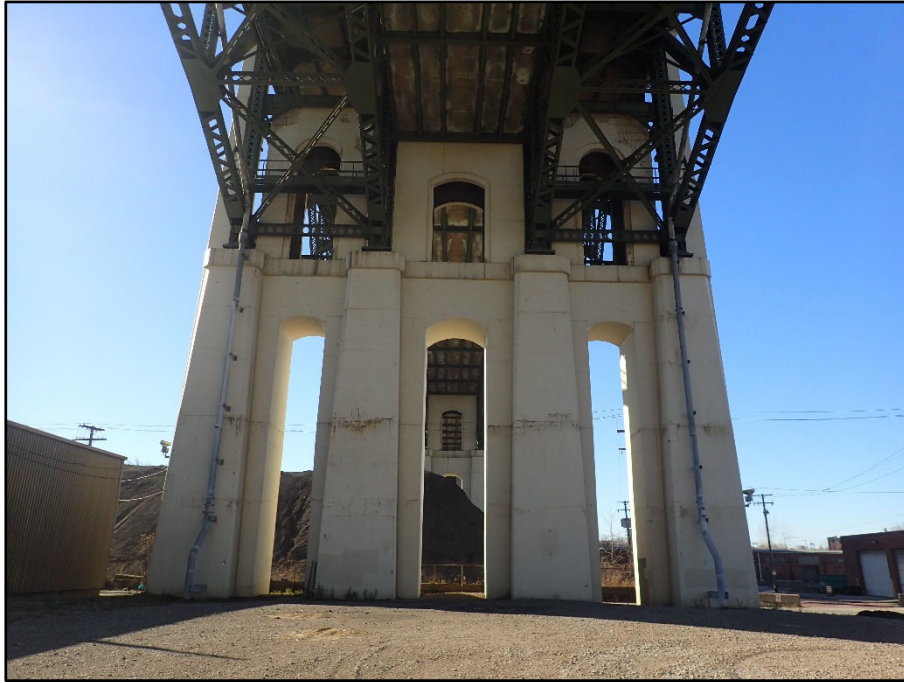
Photo 27 – Pier typical condition

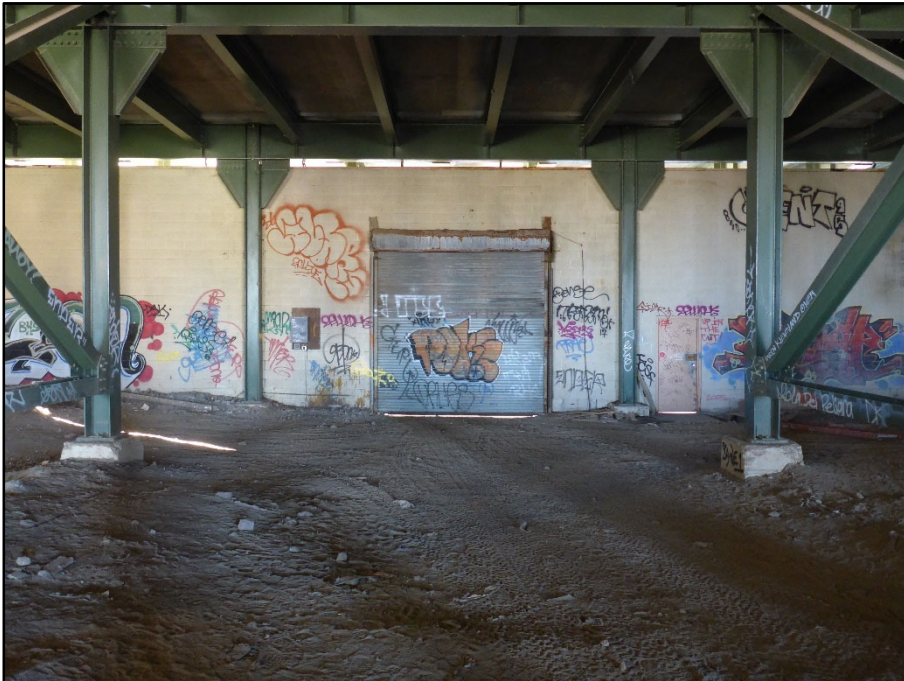
Photo 28 – West Abutment typical condition

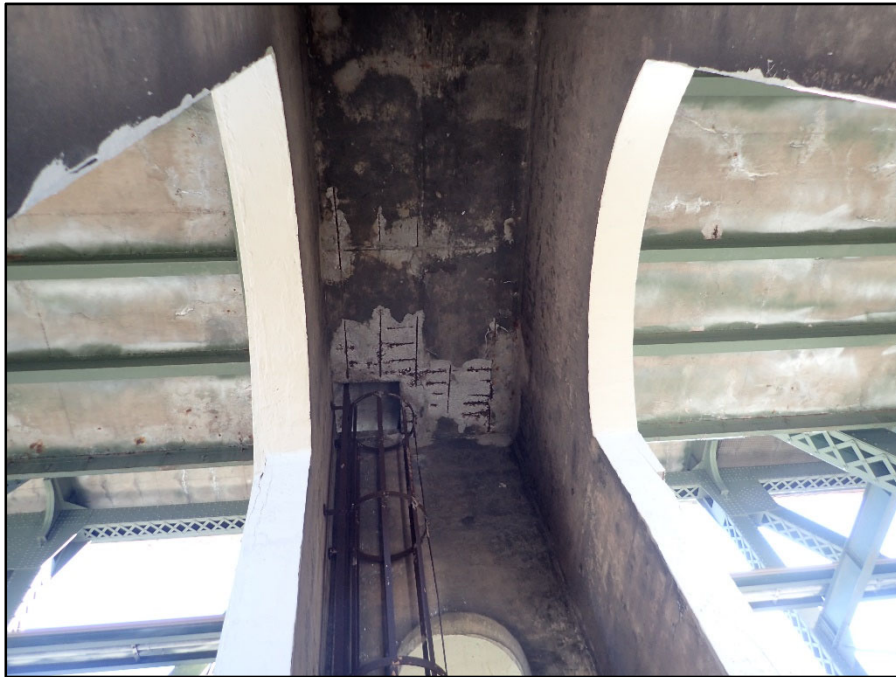
Photo 29 – Underside of Pier 12 cap, Typical condition

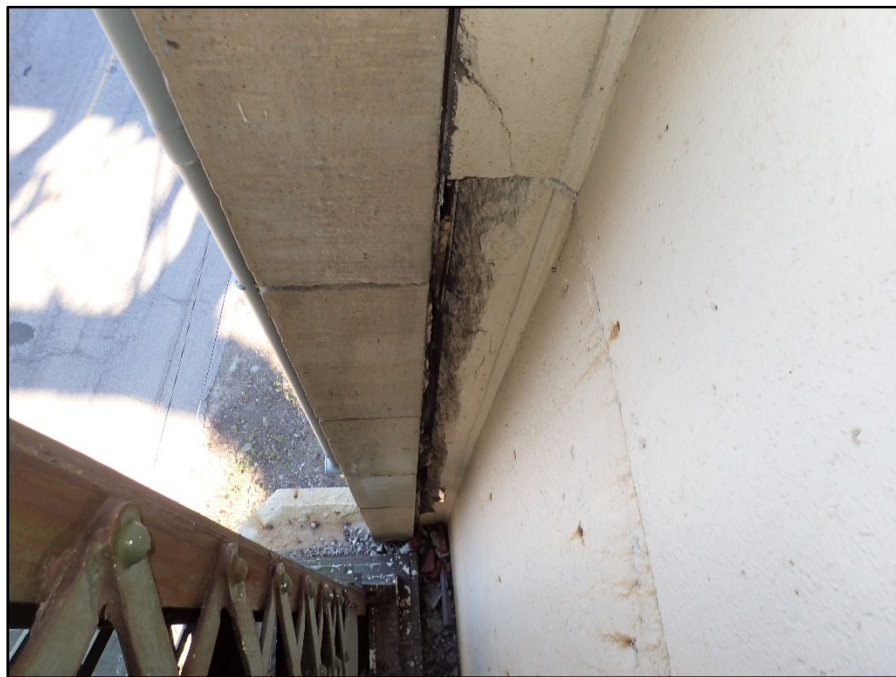
Photo 30 – East pylon backwall has a 12' H x up to 12" W spall/delamination behind the North Exterior Truss

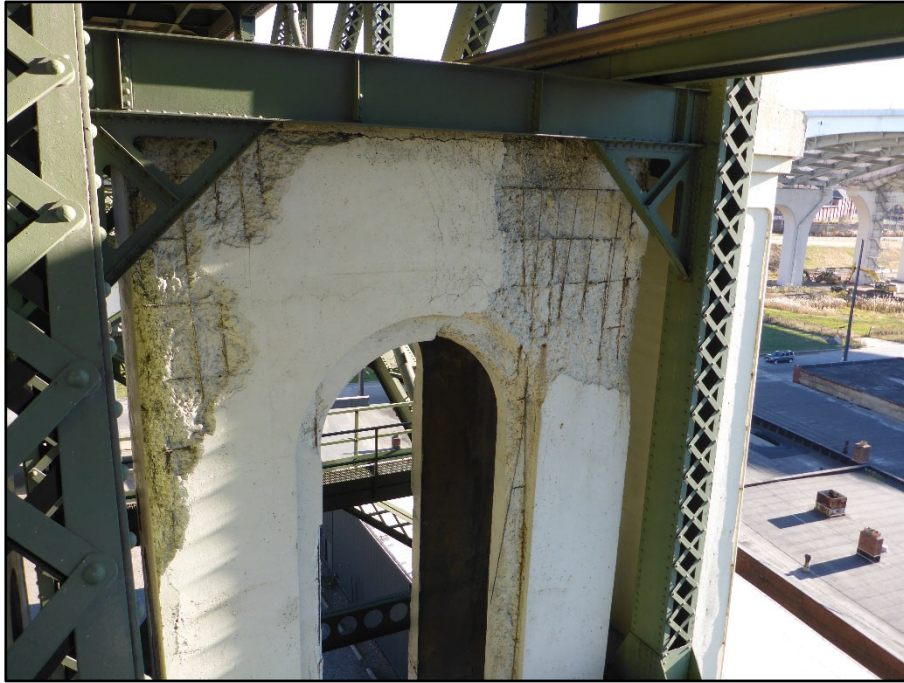
Photo 31 – West faces of Pier 4 have large painted over spalls with exposed reinforcing along the top behind the South truss line

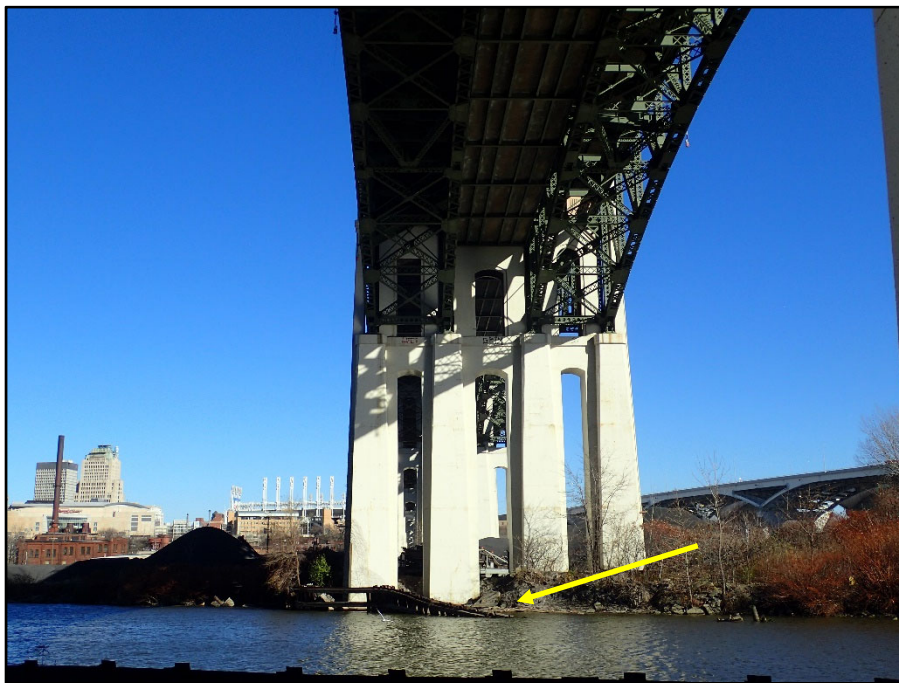
Photo 32 – Pier 9 bulkhead has failed along the East bank

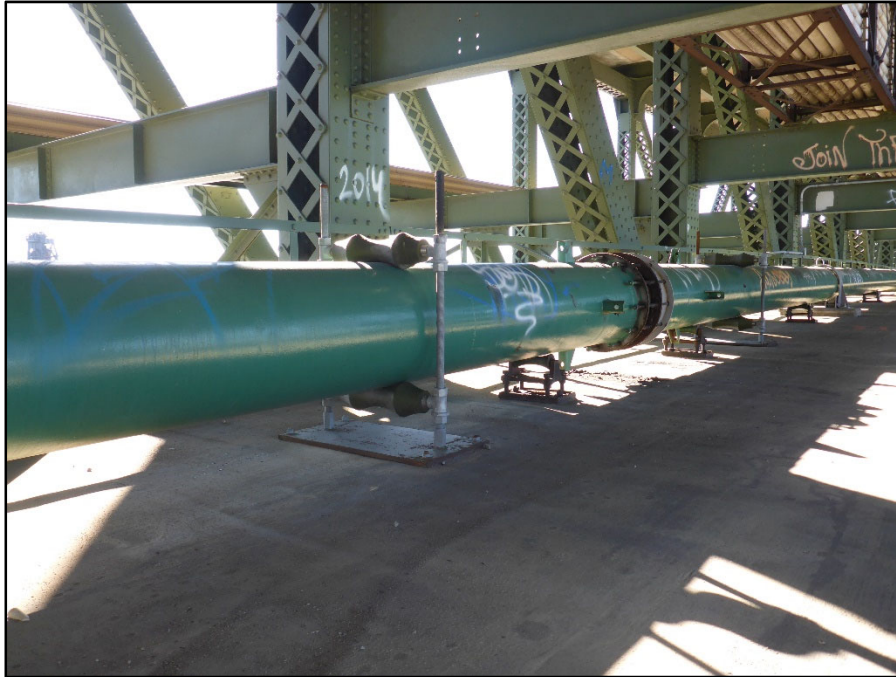
Photo 33 – Typical gas line on lower deck

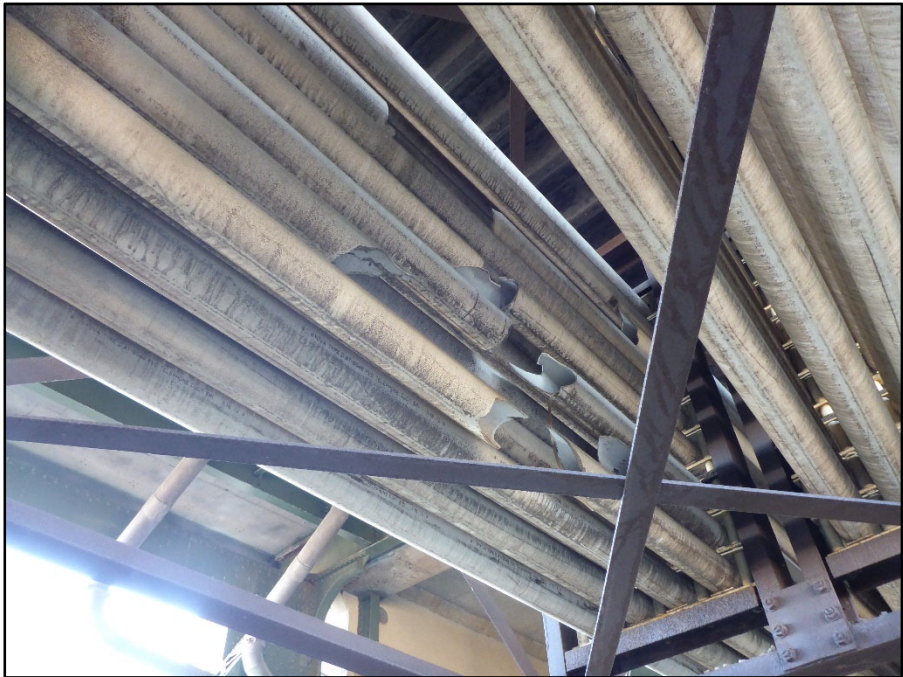
Photo 35 – Span 13, damaged area of conduit

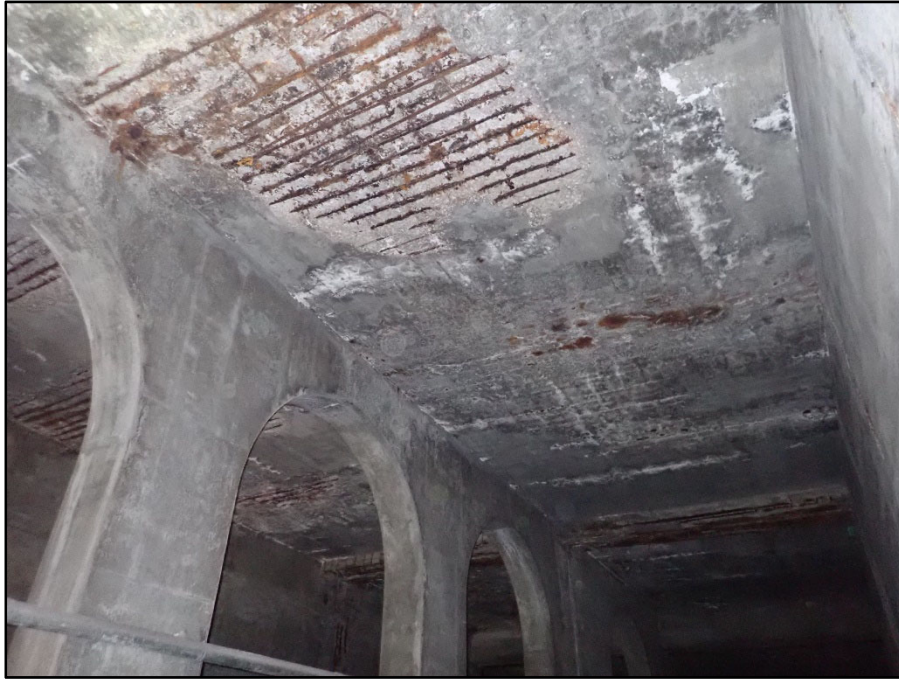
Photo 36 – East approach tunnel has large spalled areas with exposed rebar in all bays
