CUY-10-1613

PHYSICAL CONDITION REPORT ROUTINE FRACTURE CRITICAL INSPECTION HOPE MEMORIAL/LORAIN CARNEGIE BRIDGE OVER THE CUYAHOGA RIVER SFN: 1801503

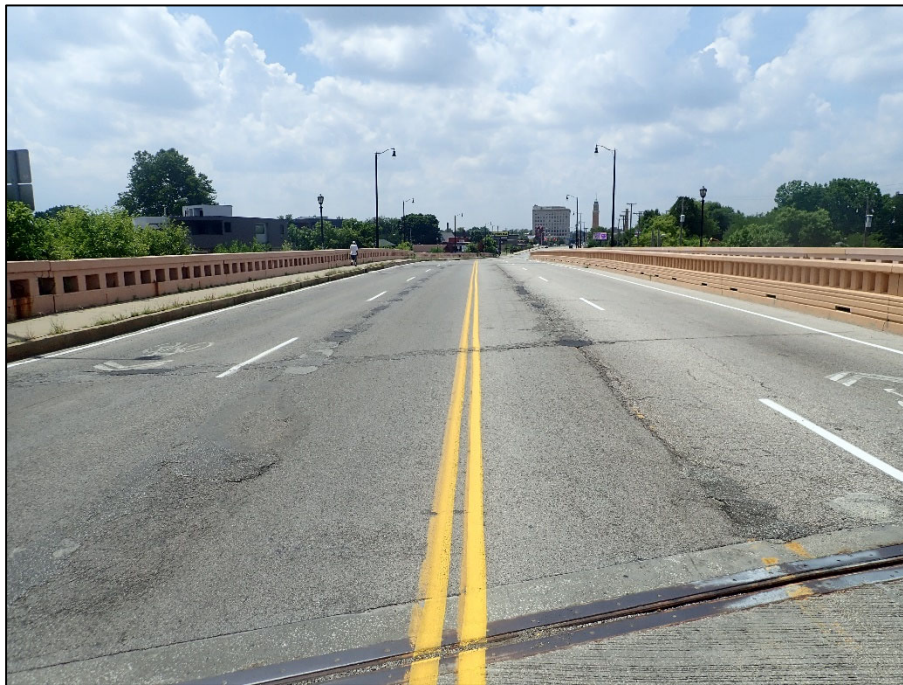
Photo 37 – West approach pavement has spalling, cracking, and bituminous patching over 20% of the pavement

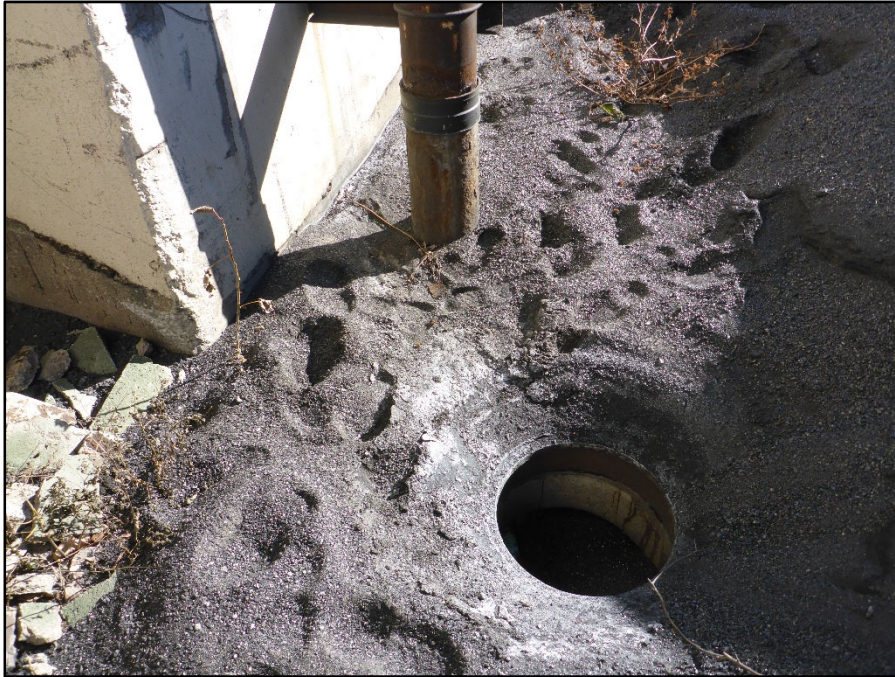
Photo 38 – Embankment on West face of Pier 6 has an open manhole

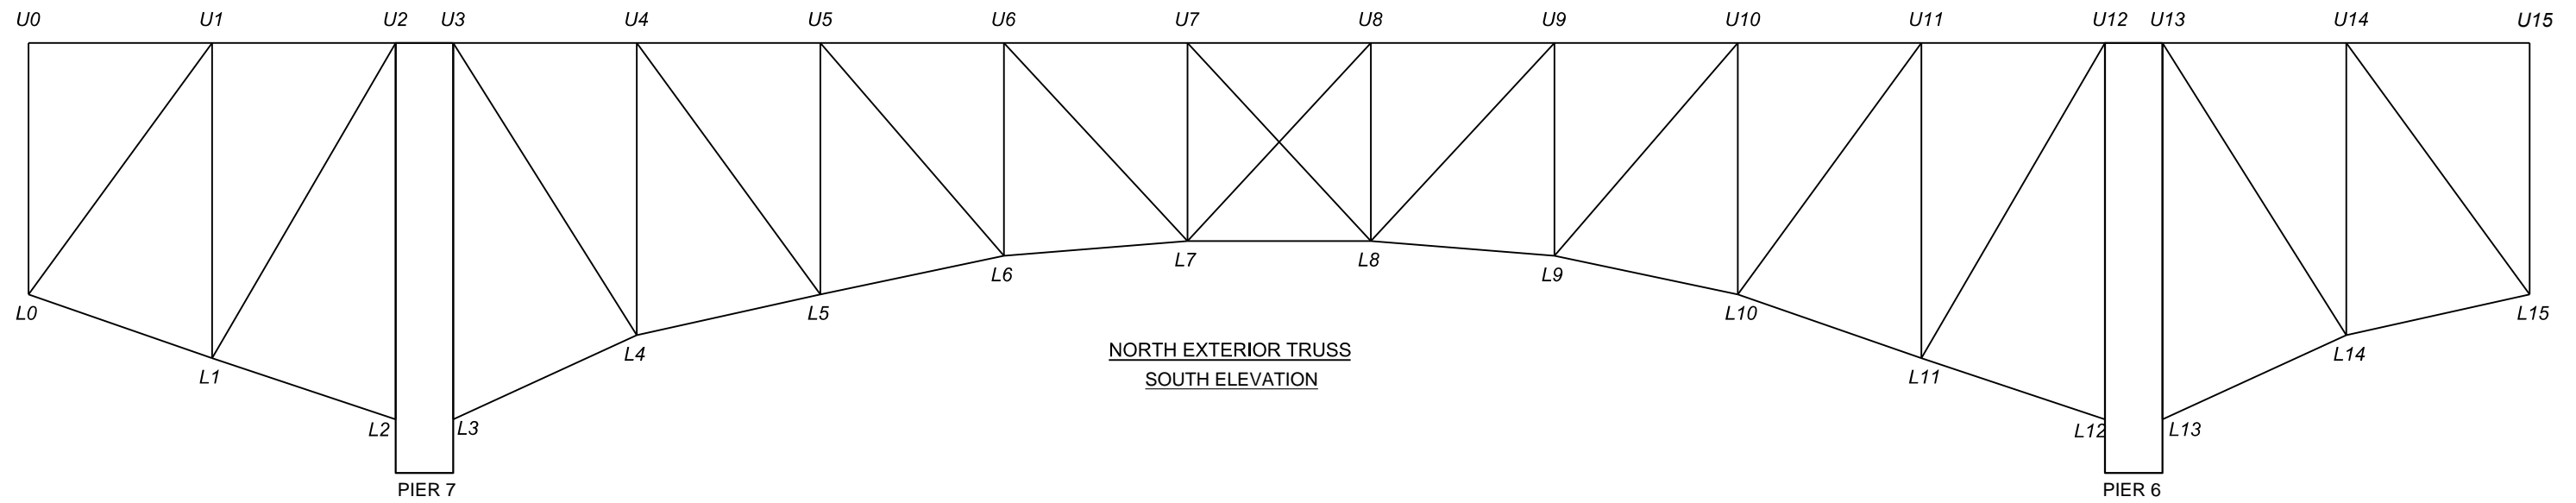
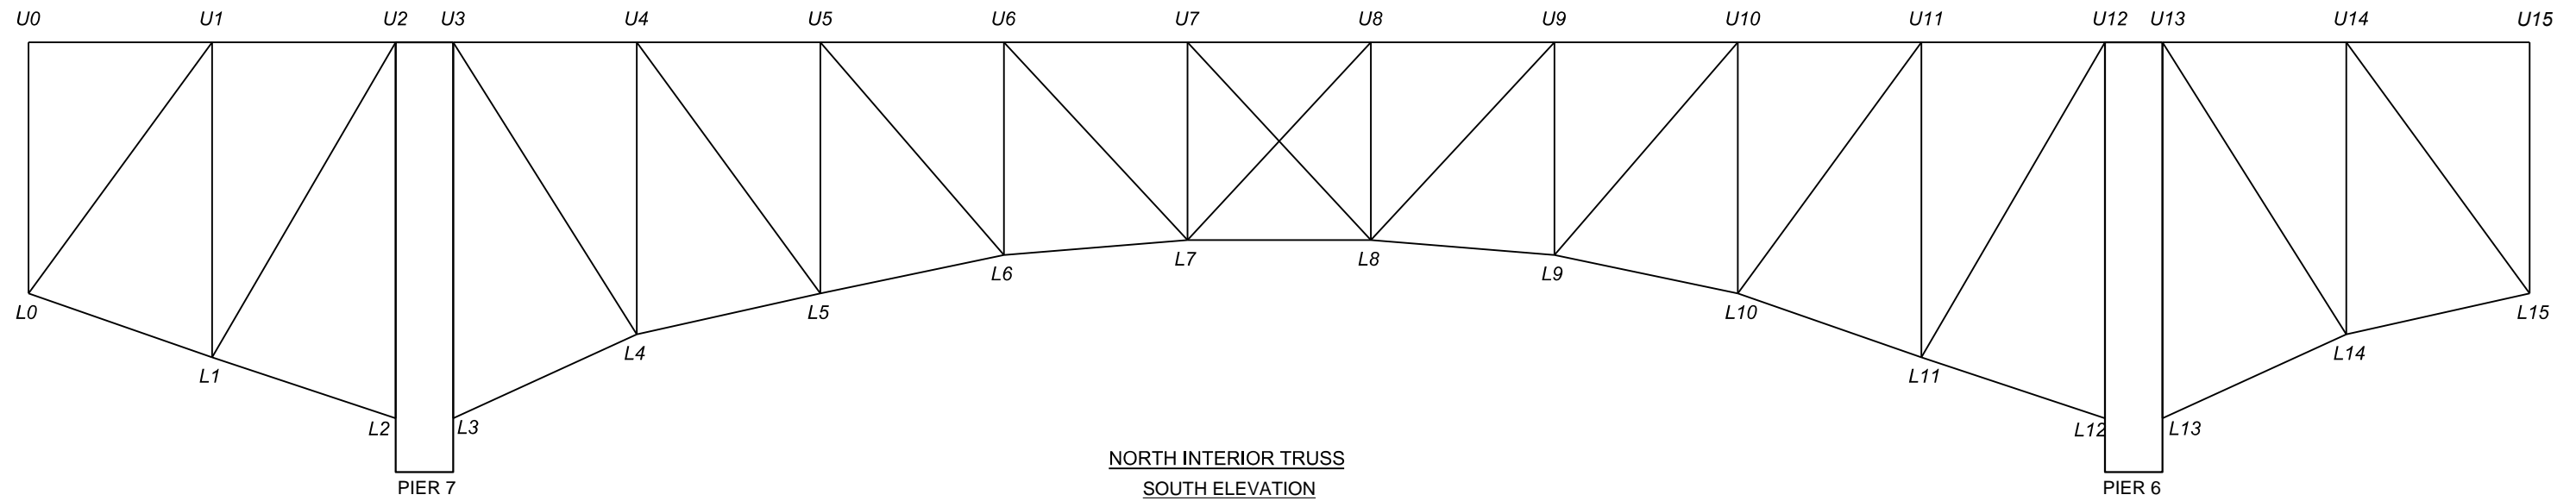
GRAPHIC SCALE MEASURED IN FEET	DATE	  9902 Carver Road Suite 201 Cincinnati, OH 45242 PH: 614-699-5000	HOPE MEMORIAL BRIDGE OVER CUYAHOGA RIVER BRIDGE NO. CUY-10-1613	
NOT TO SCALE	JUL, 2018		INFRASTRUCTURE ENGINEERS, LLC.	TRUSS ELEVATION - SPAN 6

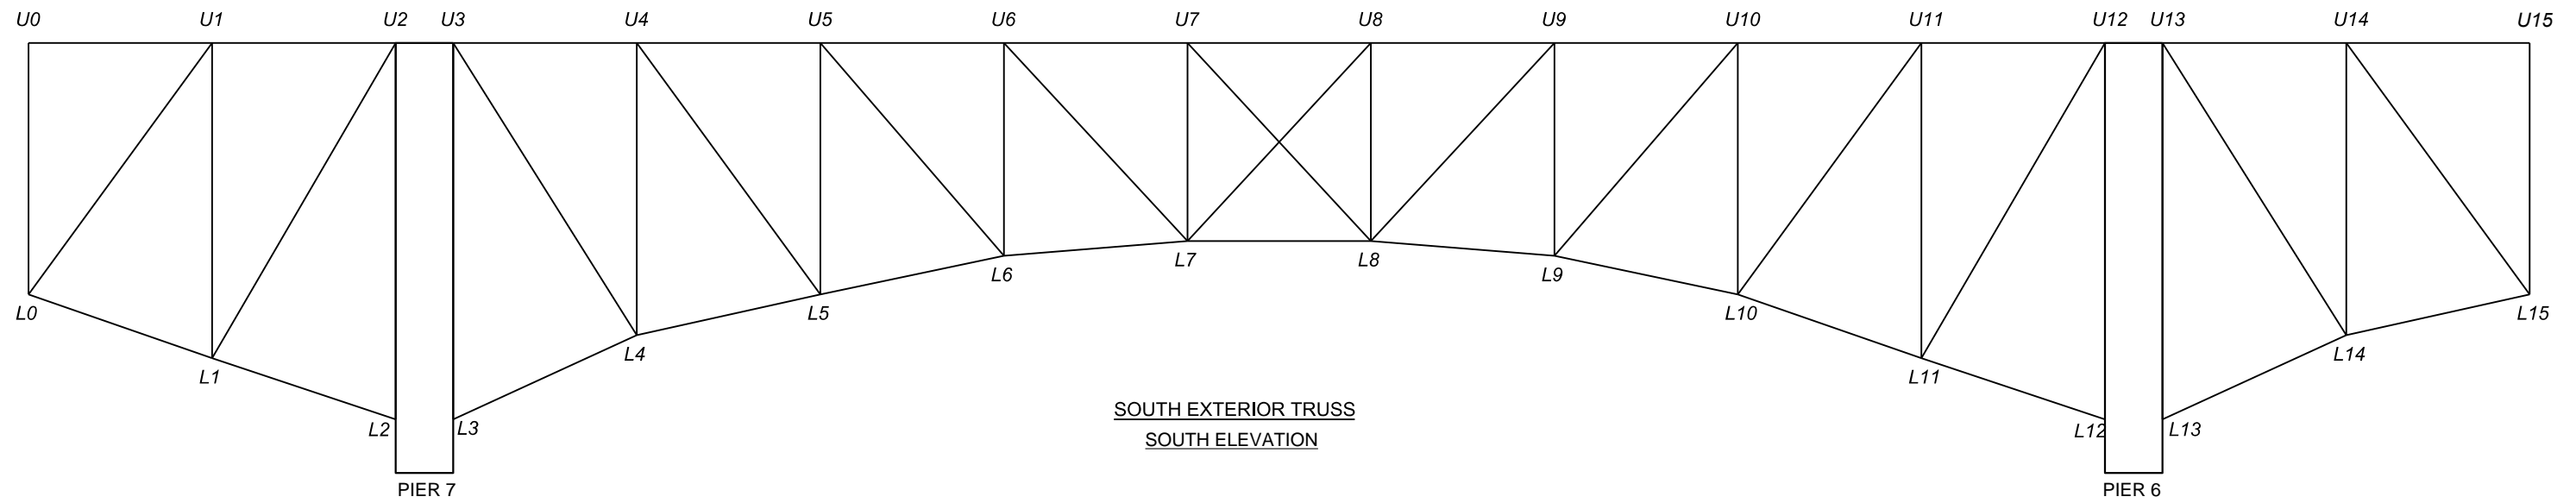
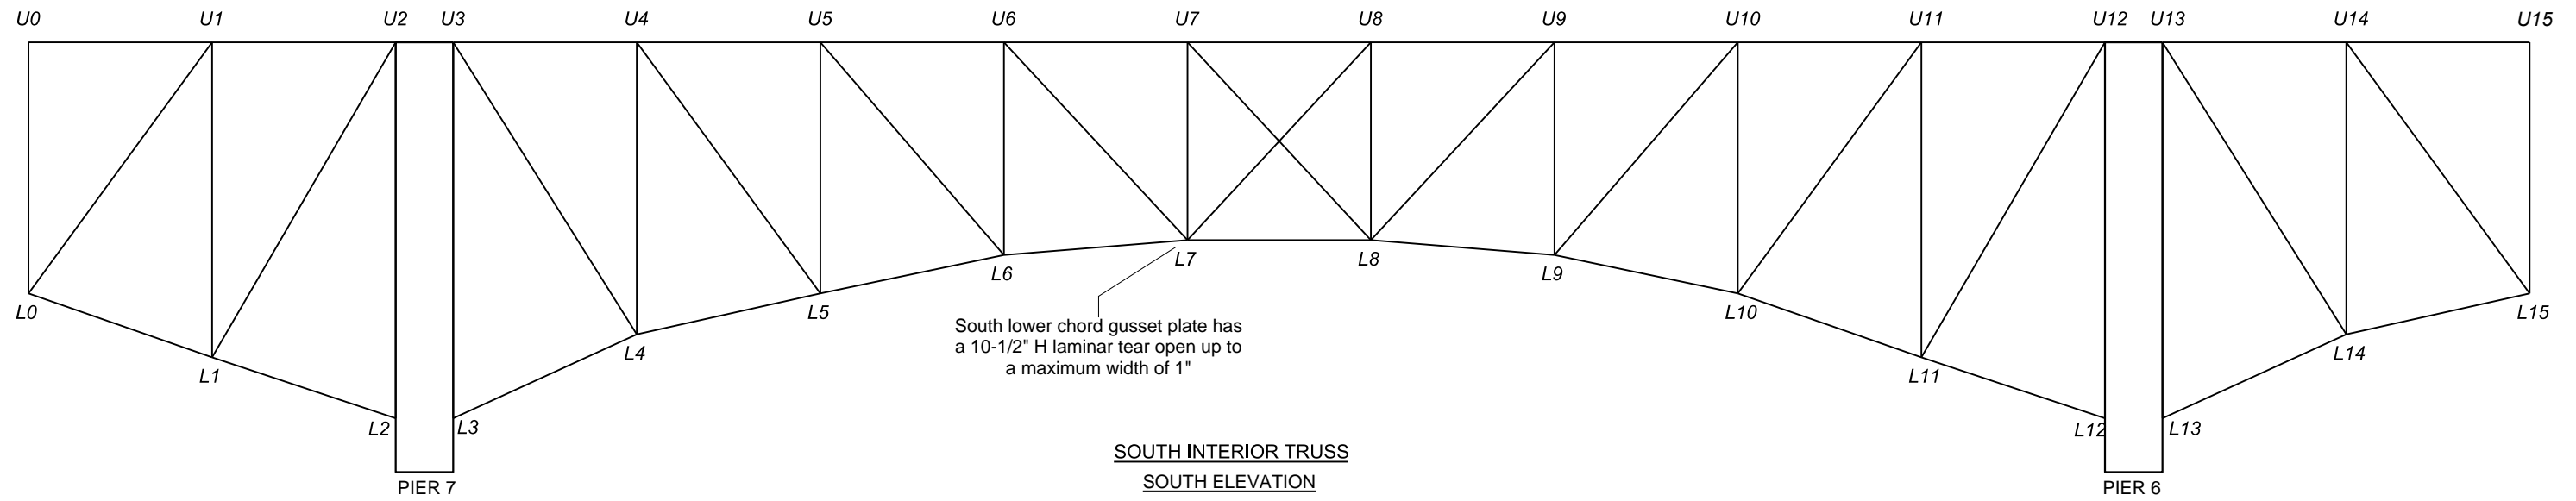
GRAPHIC SCALE MEASURED IN FEET	DATE	  9902 Carver Road Suite 201 Cincinnati, OH 45242 PH: 614-599-5000	HOPE MEMORIAL BRIDGE OVER CUYAHOGA RIVER BRIDGE NO. CUY-10-1613
NOT TO SCALE	JUL, 2018	INFRASTRUCTURE ENGINEERS, LLC.	TRUSS ELEVATION - SPAN 7
			PAGE A - 17

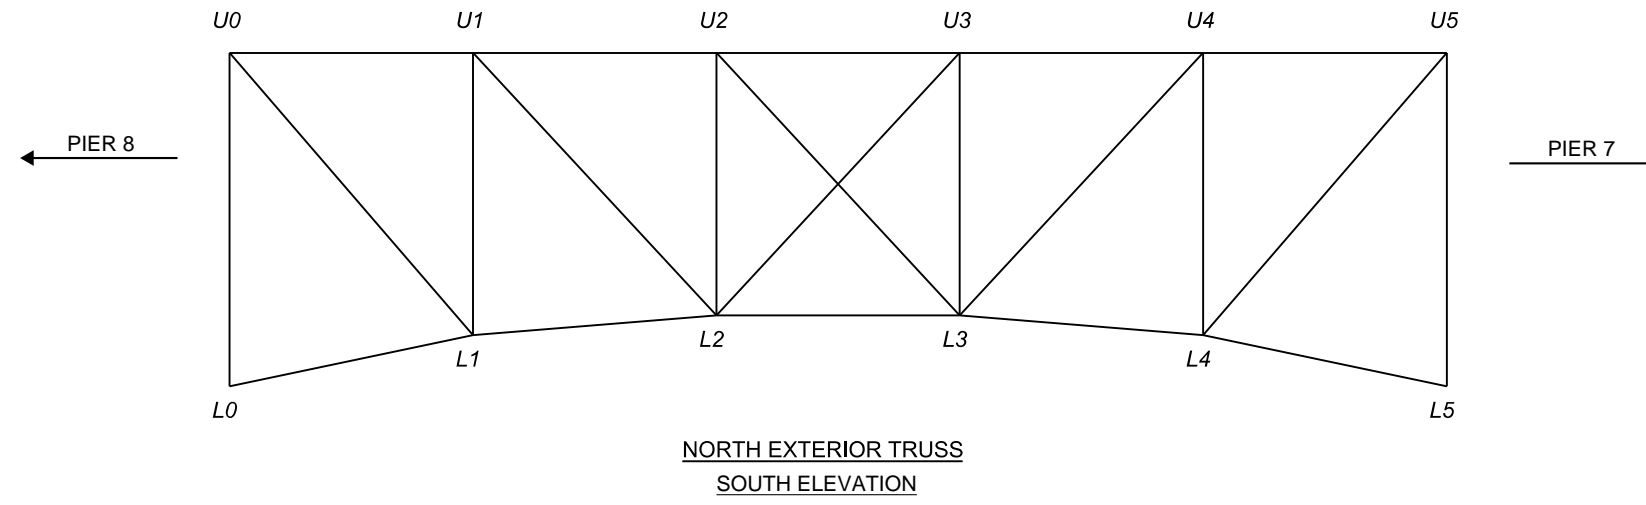
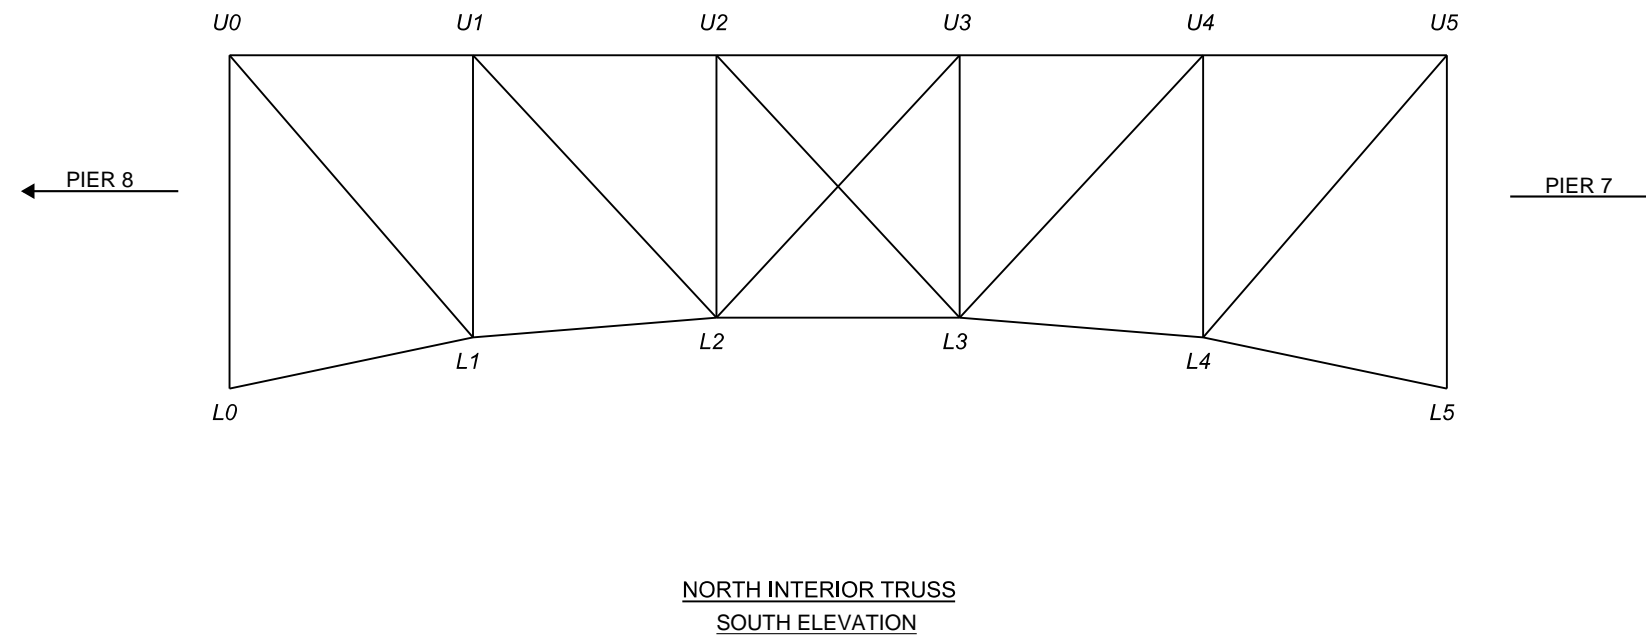
GRAPHIC SCALE MEASURED IN FEET	DATE	  <small>9902 Carver Road Suite 201 Cincinnati, OH 45242 PH: 614-699-5000</small>	HOPE MEMORIAL BRIDGE OVER CUYAHOGA RIVER BRIDGE NO. CUY-10-1613	PAGE
NOT TO SCALE	JUL, 2018	INFRASTRUCTURE ENGINEERS, LLC.	TRUSS ELEVATION - SPAN 8	A - 19

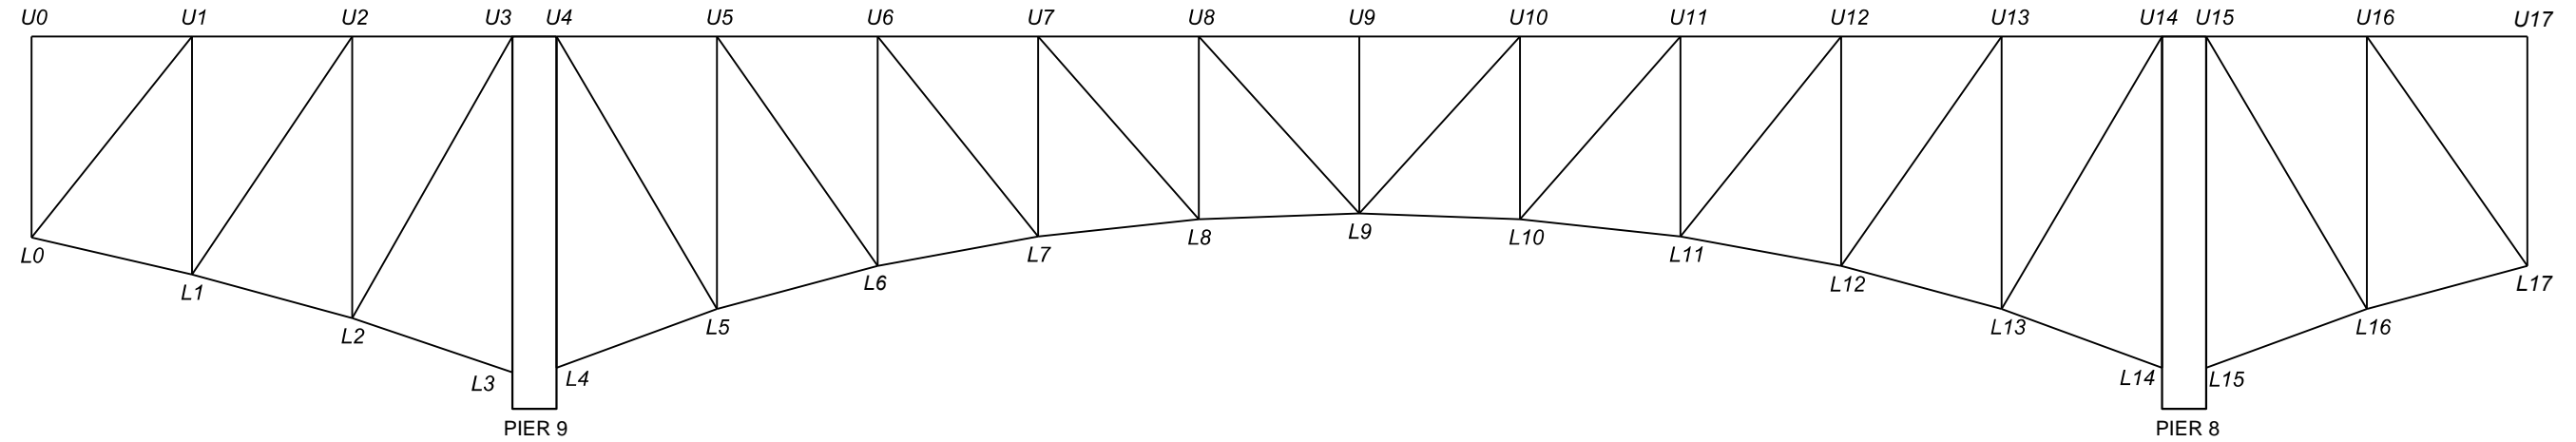
SOUTH EXTERIOR TRUSS
SOUTH ELEVATION

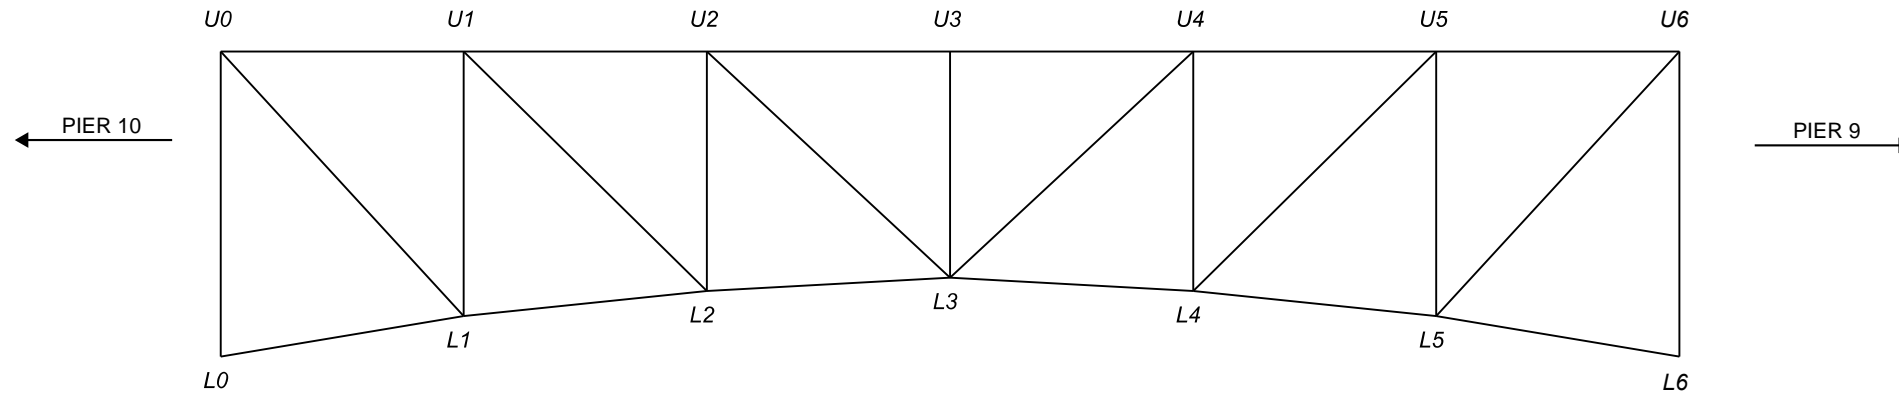
NORTH EXTERIOR TRUSS
SOUTH ELEVATION

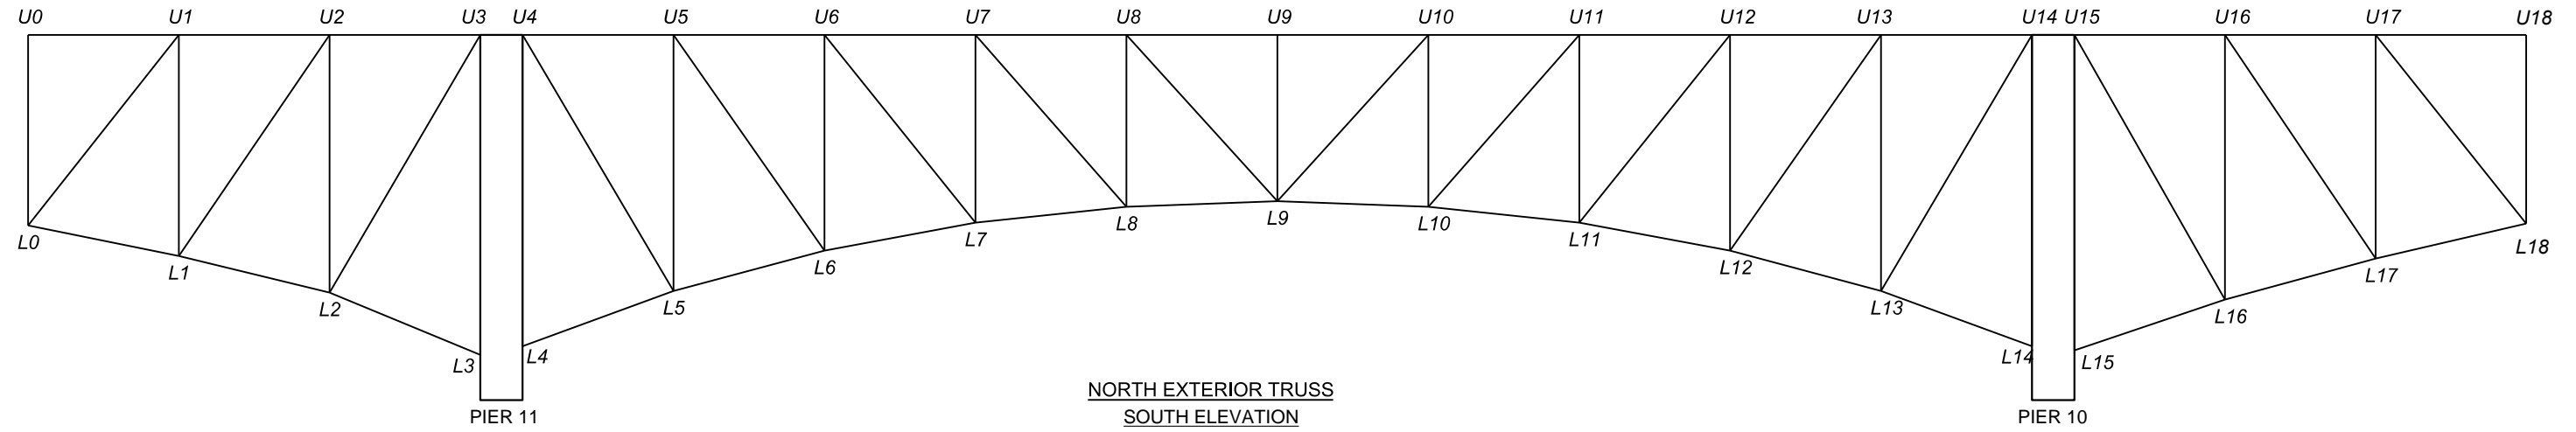
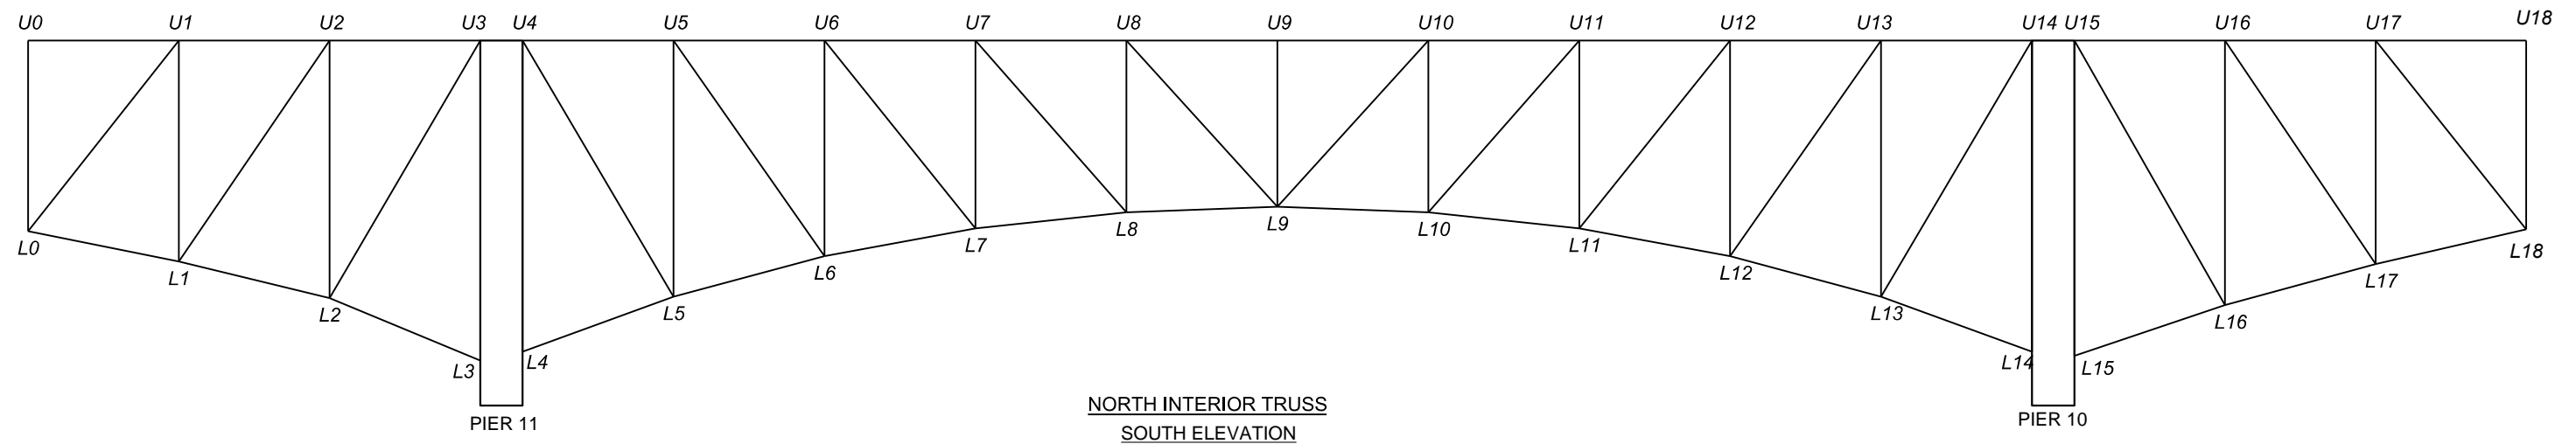
GRAPHIC SCALE MEASURED IN FEET	DATE	  9902 Carver Road Suite 201 Cincinnati, OH 45242 PH: 614-699-5000	HOPE MEMORIAL BRIDGE OVER CUYAHOGA RIVER BRIDGE NO. CUY-10-1613	
NOT TO SCALE	JUL, 2018		INFRASTRUCTURE ENGINEERS, LLC.	TRUSS ELEVATION - SPAN 10

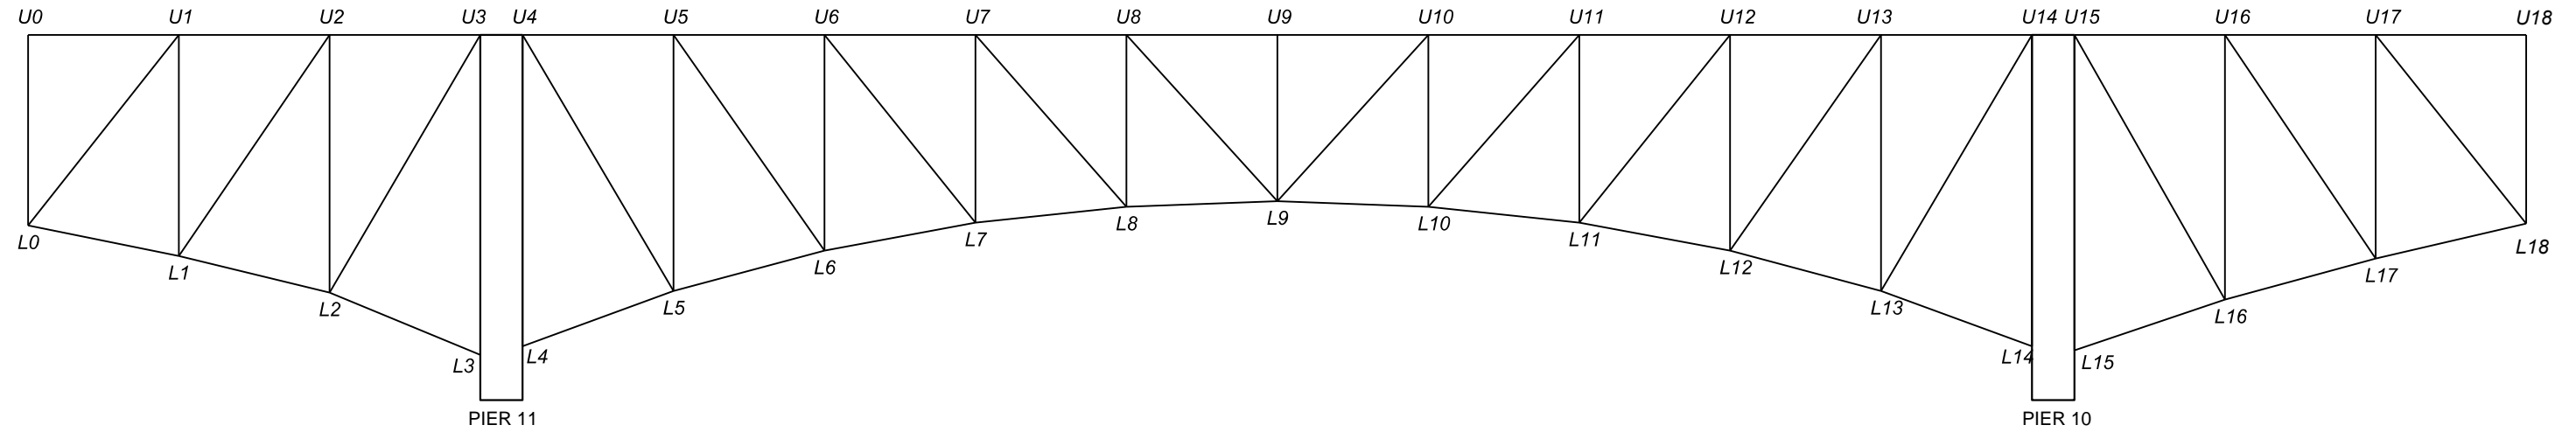
SOUTH EXTERIOR TRUSS
SOUTH ELEVATION

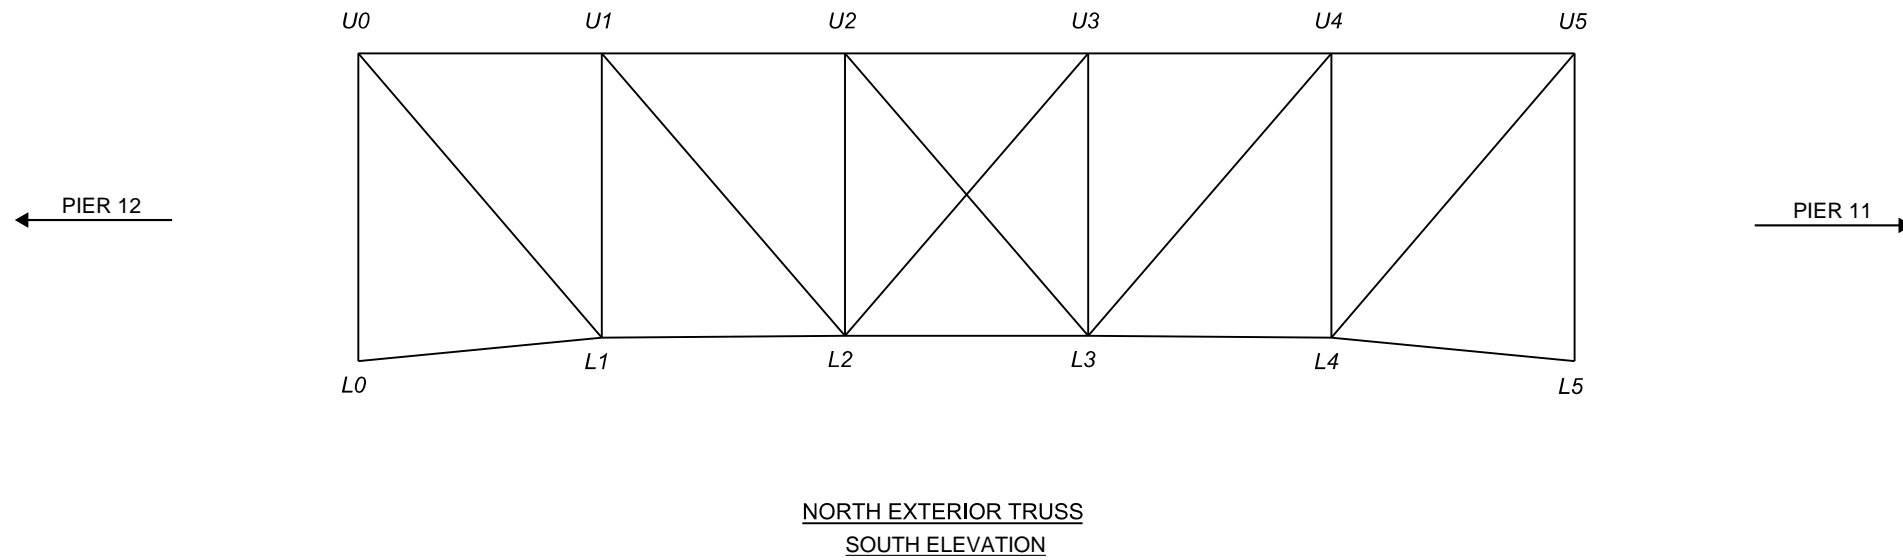
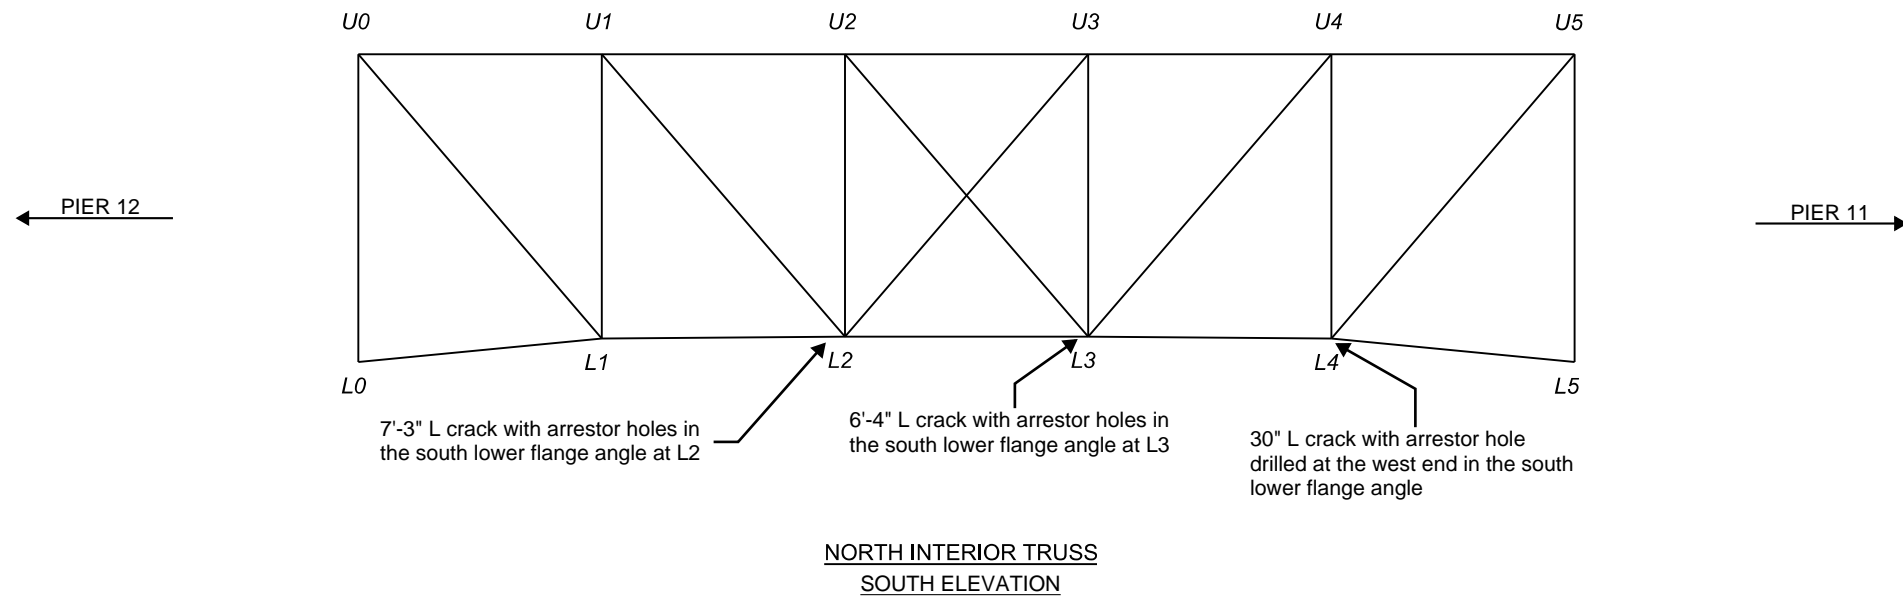
GRAPHIC SCALE MEASURED IN FEET	DATE	  9902 Carver Road Suite 201 Cincinnati, OH 45242 PH: 614-699-5000	HOPE MEMORIAL BRIDGE OVER CUYAHOGA RIVER BRIDGE NO. CUY-10-1613	
			NOT TO SCALE	JUL, 2018

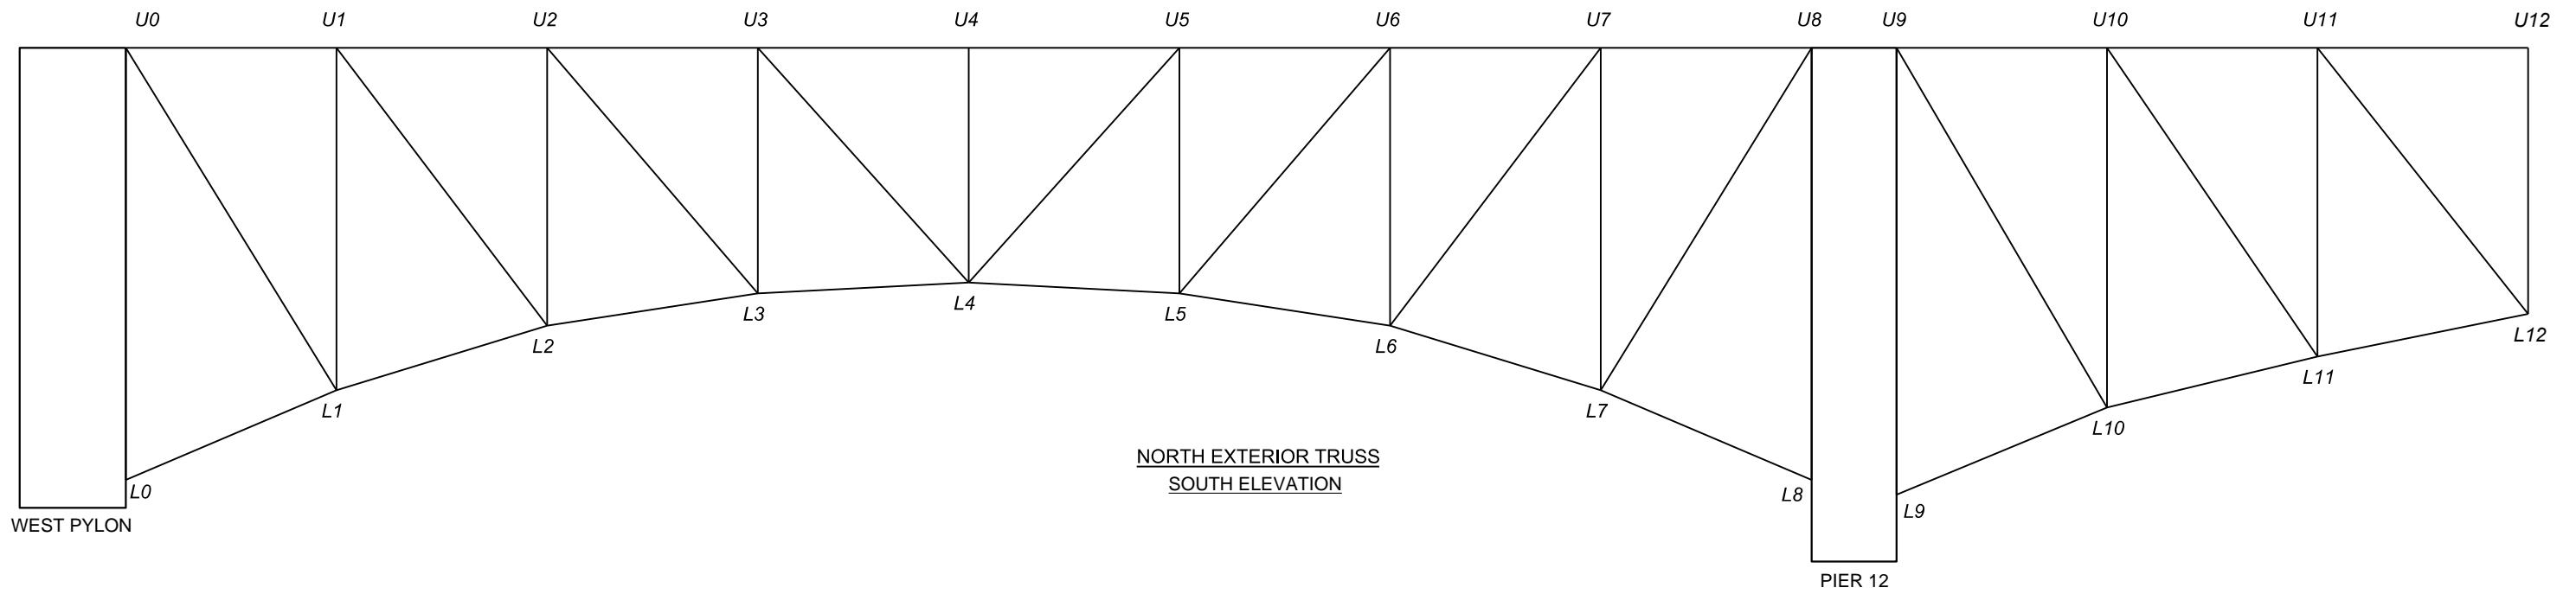
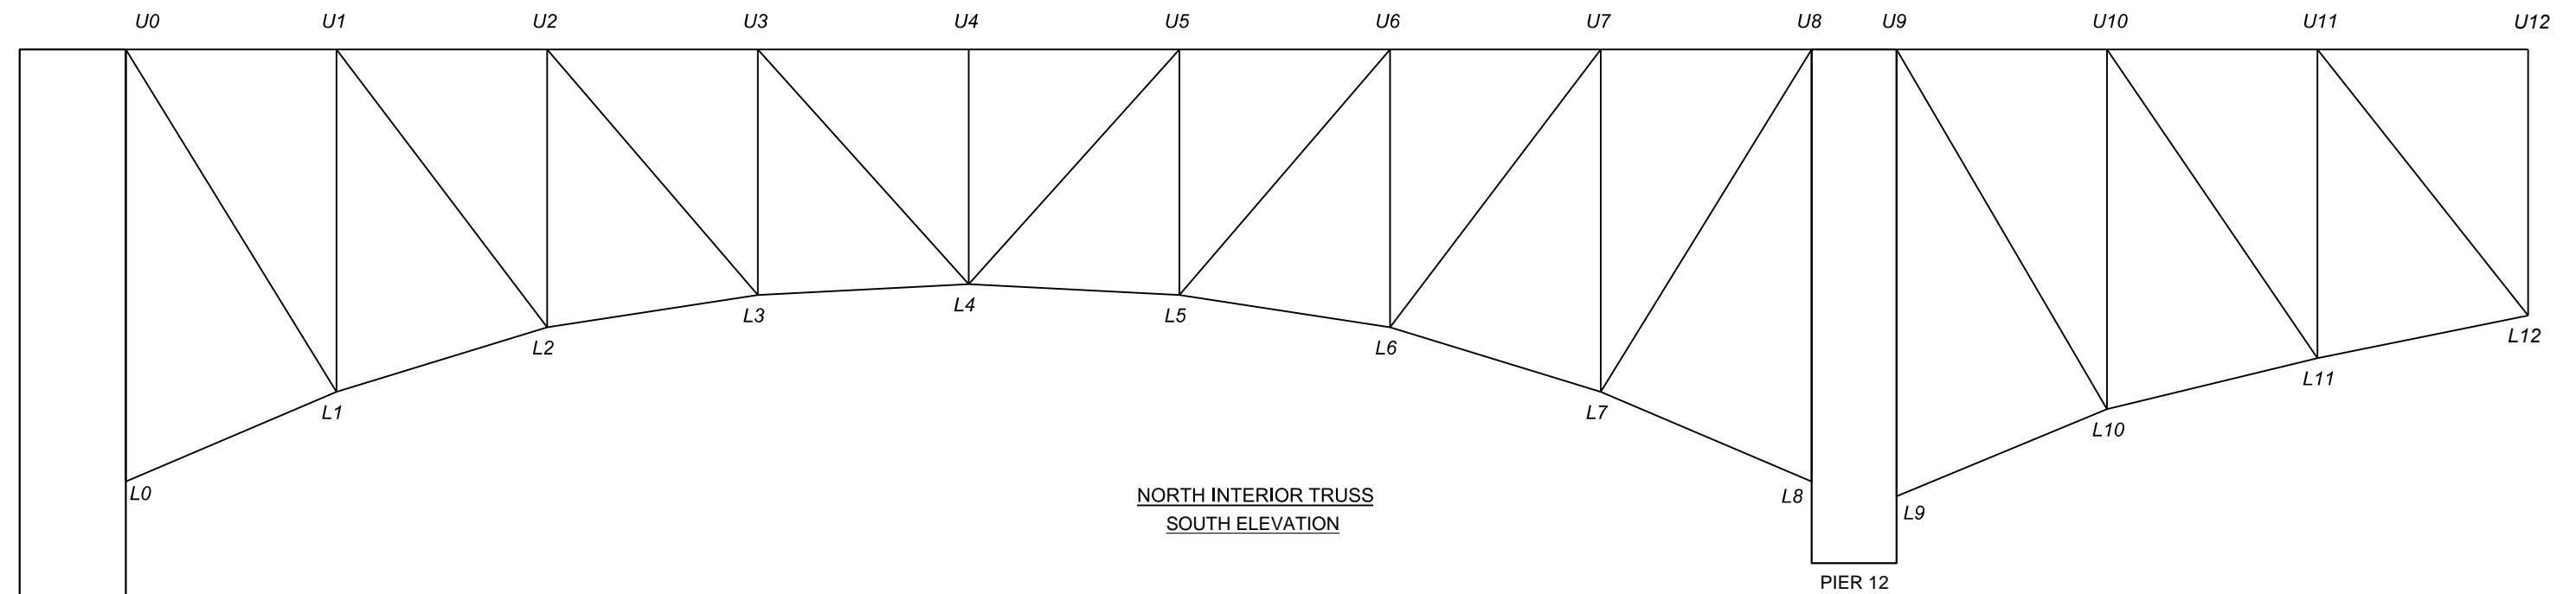
GRAPHIC SCALE MEASURED IN FEET	DATE	  9902 Carver Road Suite 201 Cincinnati, OH 45242 PH: 614-699-5000	HOPE MEMORIAL BRIDGE OVER CUYAHOGA RIVER BRIDGE NO. CUY-10-1613	
			NOT TO SCALE	JUL, 2018
			PAGE A - 28

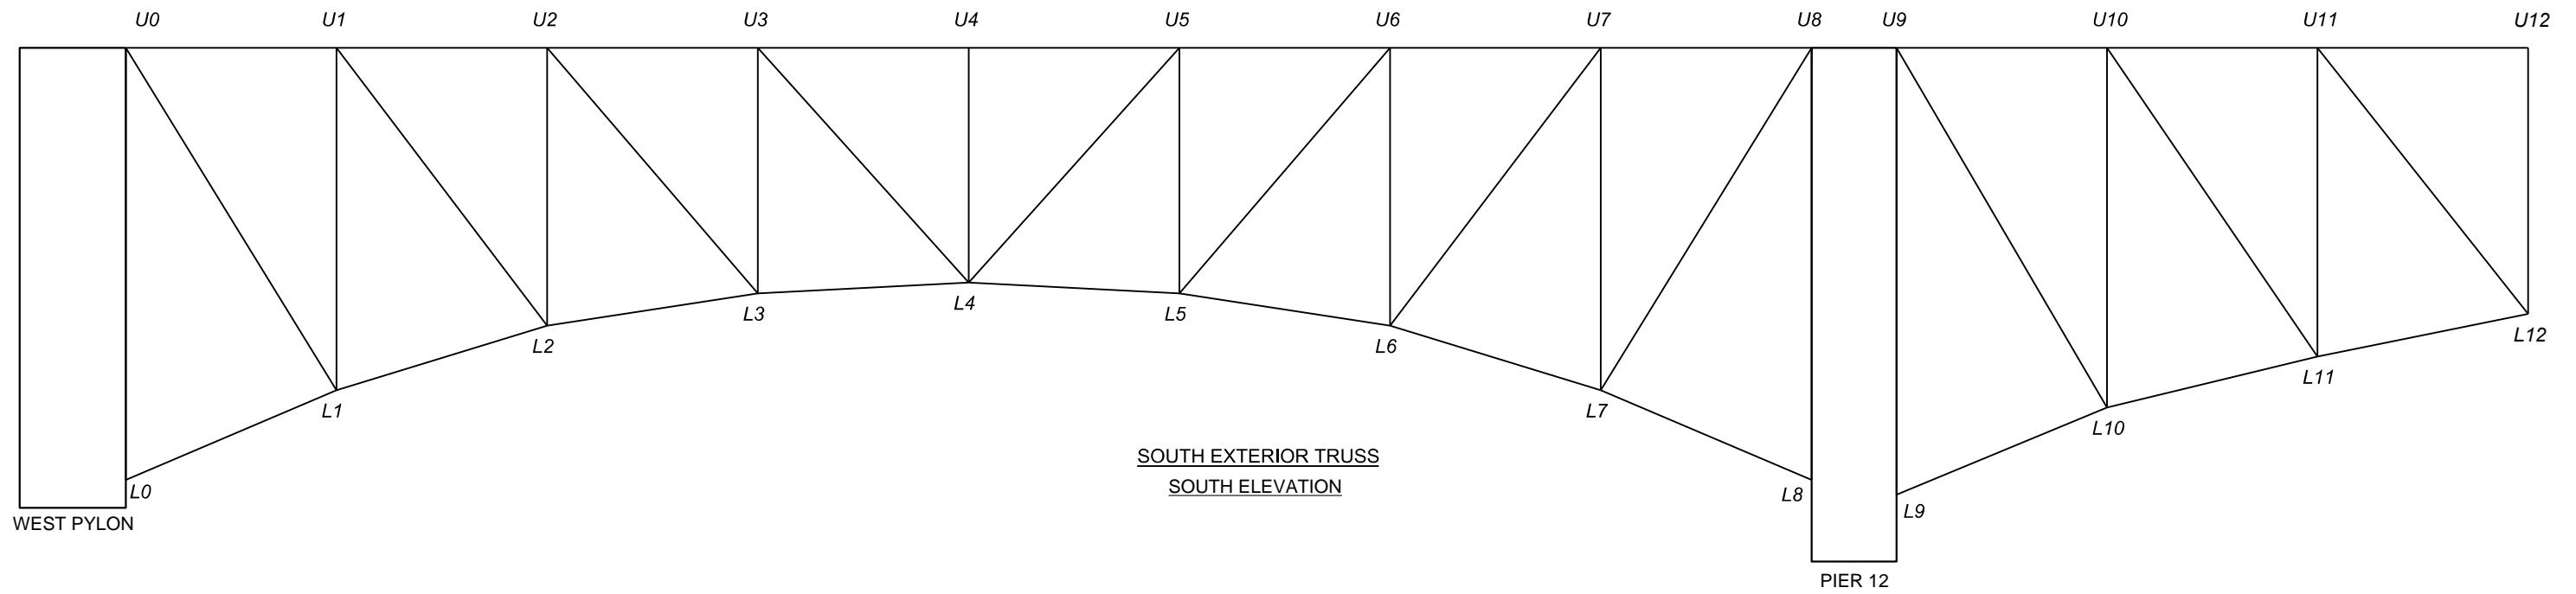
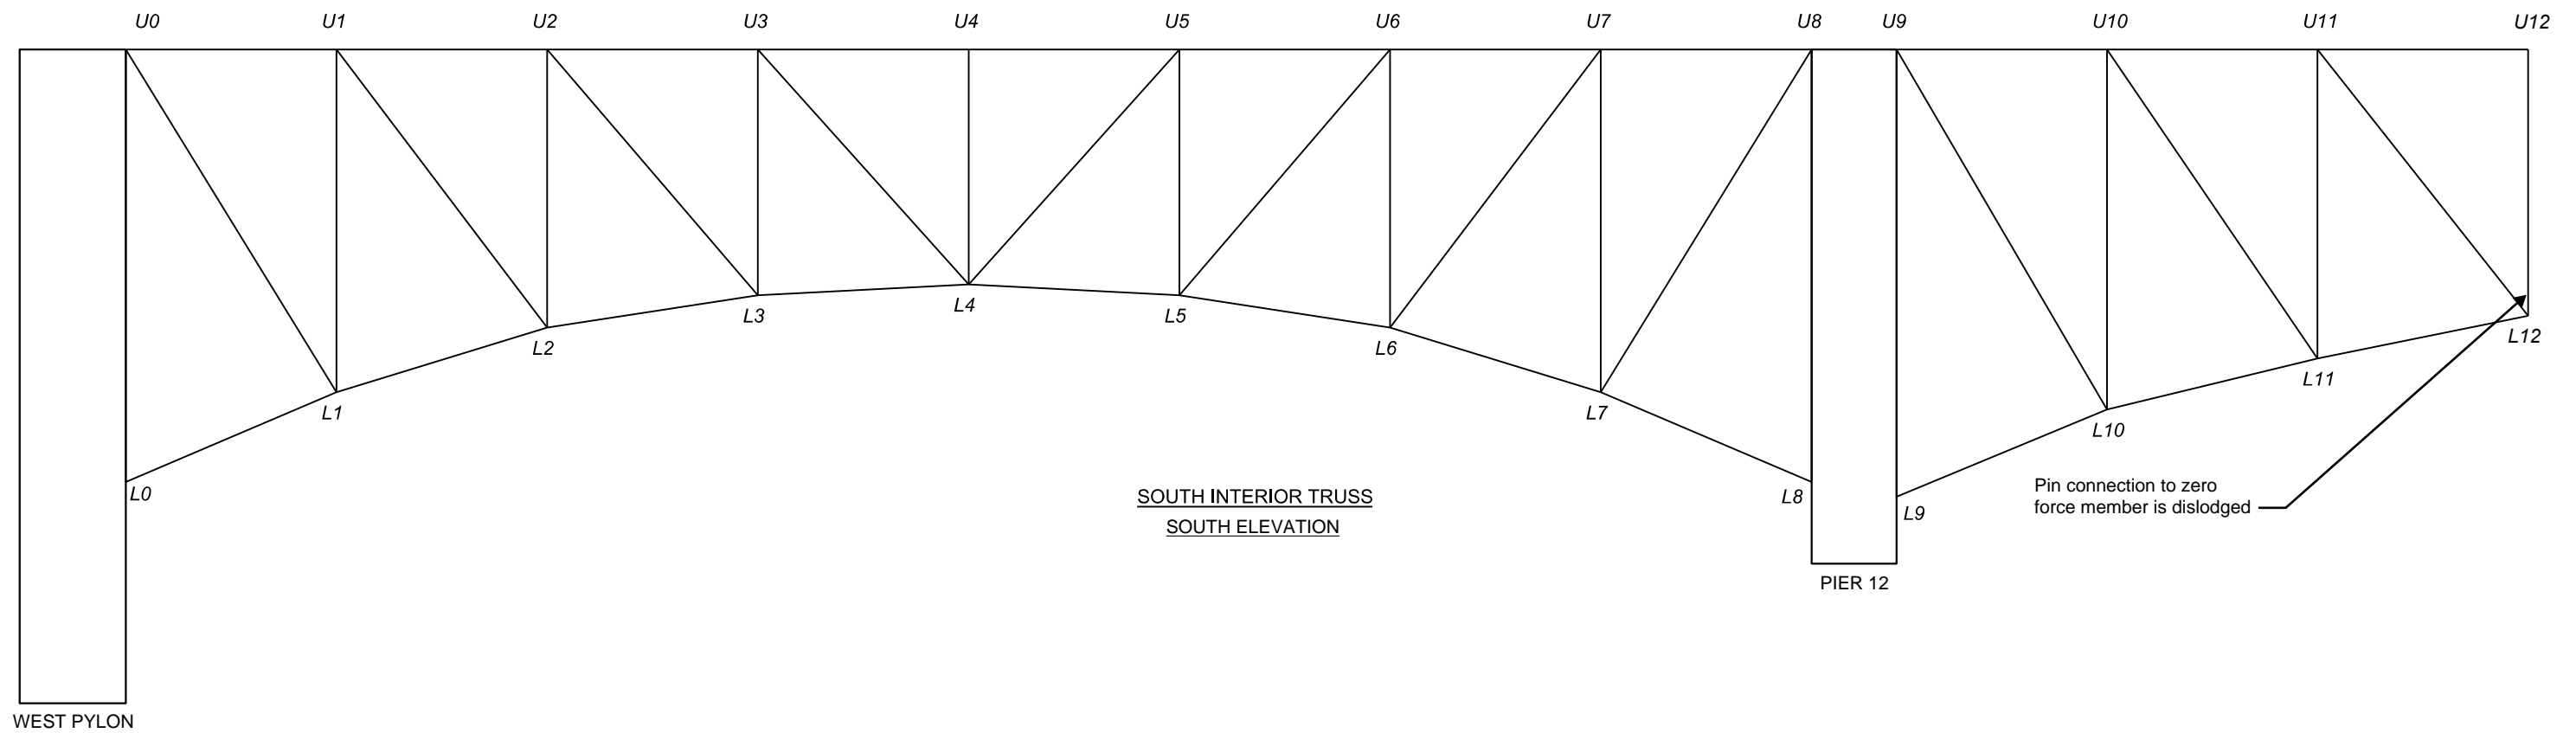
GRAPHIC SCALE MEASURED IN FEET	DATE	  9902 Carver Road Suite 201 Cincinnati, OH 45242 PH: 614-699-5000 INFRASTRUCTURE ENGINEERS, LLC.	HOPE MEMORIAL BRIDGE OVER CUYAHOGA RIVER BRIDGE NO. CUY-10-1613	PAGE A - 29
NOT TO SCALE	JUL, 2018		TRUSS ELEVATION - SPAN 13
