Pier #5 - North Tower		
Level	Deficiency	Status
1	Blade-thin horizontal stiffeners with 2"+ perforations	N.G.
2	Thinning horizontal stiffeners with width loss	OK
3	Thinning horizontal stiffeners with width loss	OK
4	Thinning horizontal stiffeners with width loss	OK
5	Thinning horizontal stiffeners with width loss	OK
6	Thinning horizontal stiffeners with width loss	OK
7	Thinning horizontal stiffeners with width loss	OK
8	Surface rust on all horizontals and diagonals	OK
9	Surface rust on all horizontals and diagonals	OK
10	Surface rust on all horizontals and diagonals	OK
11	Surface rust on all horizontals and diagonals	OK
12	Surface rust on all horizontals and diagonals	OK
13	Surface rust on all horizontals and diagonals	OK
14	Surface rust on all horizontals and diagonals	OK
15	Surface rust on all horizontals and diagonals	OK
16	Surface rust on all horizontals and diagonals	OK
17	Surface rust on all horizontals and diagonals	OK

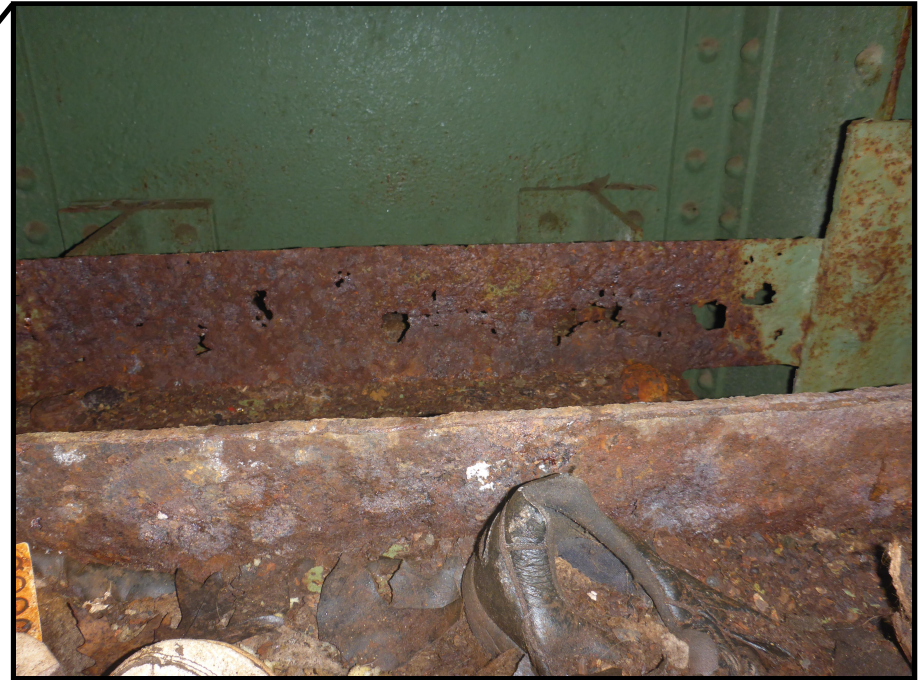
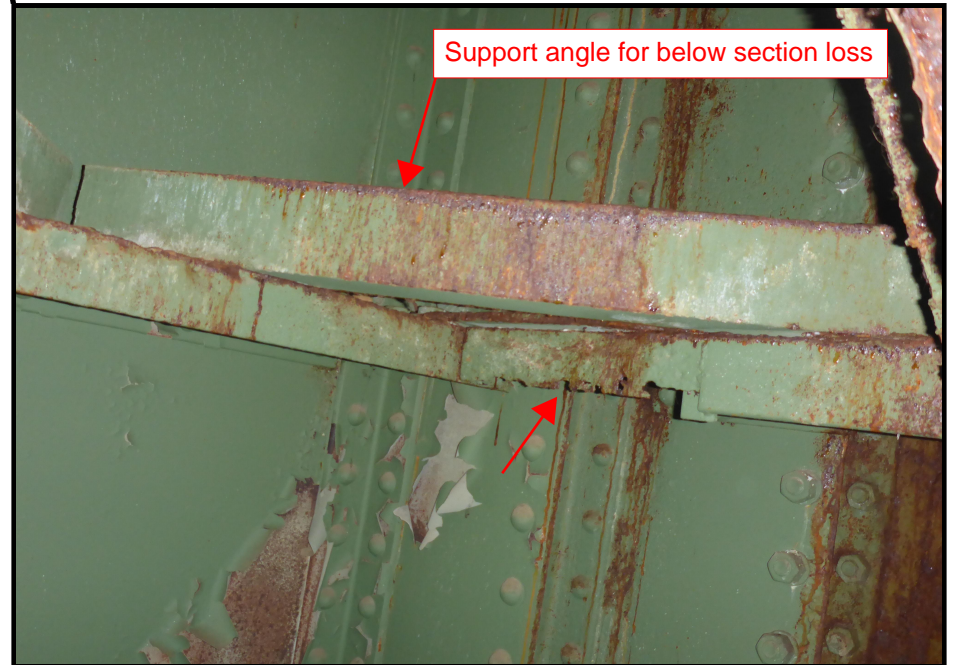
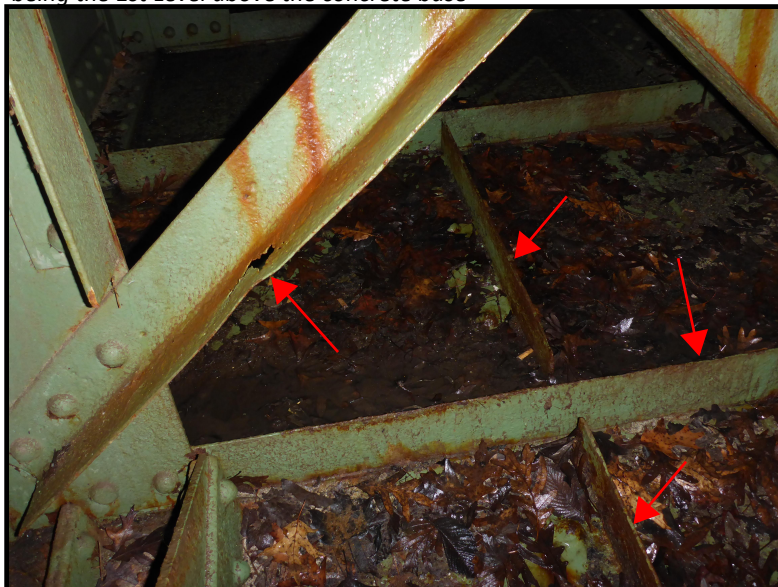
Cap	Blade-thin angle stiffeners	N.G.
Cap	Leaking expansion joint	N.G.

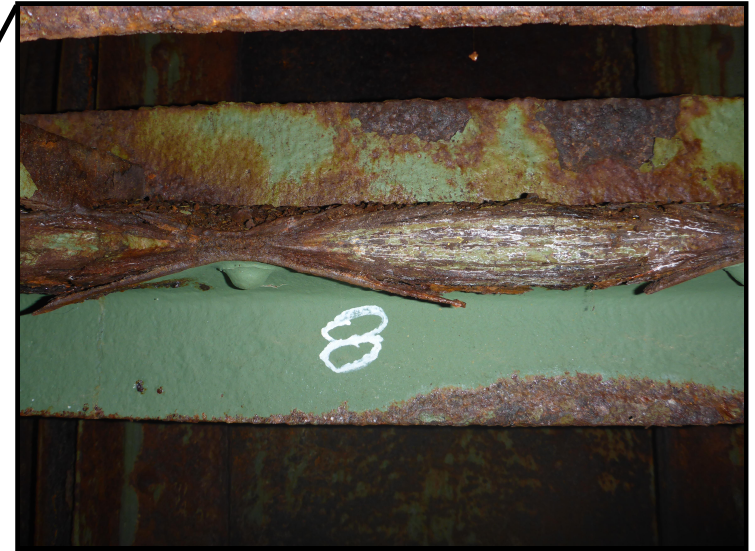
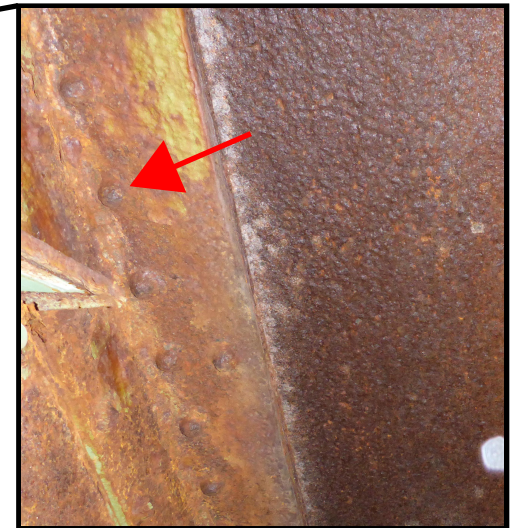
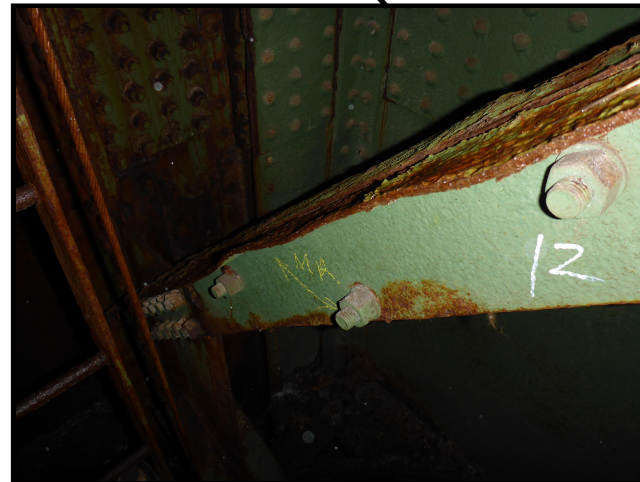
Pier #5 - South Tower		
Level	Deficiency	Status
1	Ponding water; surface rust on all horizontals and diagonals	OK
2	Surface rust on all horizontals and diagonals	OK
3	Surface rust, minor perforation on horizontal angle	OK
4	Surface rust on all horizontals and diagonals	OK
5	Surface rust on all horizontals and diagonals	OK
6	Surface rust on all horizontals and diagonals; 2 missing bolts on South face plate	OK
7	Surface rust on all horizontals and diagonals	OK
8	Pack rust forcing built up horizontal and diagonal members 1" apart	N.G.
9	Pack rust forcing built up horizontal and diagonal members 1" apart	N.G.
10	Pack rust forcing built up vertical stiffeners 1" apart	N.G.
11	South face plate severely corroded rivet heads	N.G.
12	Section loss on diagonal angle leg, thin and bent	N.G.
13	Surface rust on all horizontals and diagonals	OK
14	Surface rust on all horizontals and diagonals	OK
15	Surface rust on all horizontals and diagonals	OK

16	Surface rust on all horizontals and diagonals	OK
17	Surface rust on all horizontals and diagonals	OK
Cap	Blade-thin angle stiffeners with 2"+ perforations	N.G.
Cap	Leaking expansion joint	N.G.

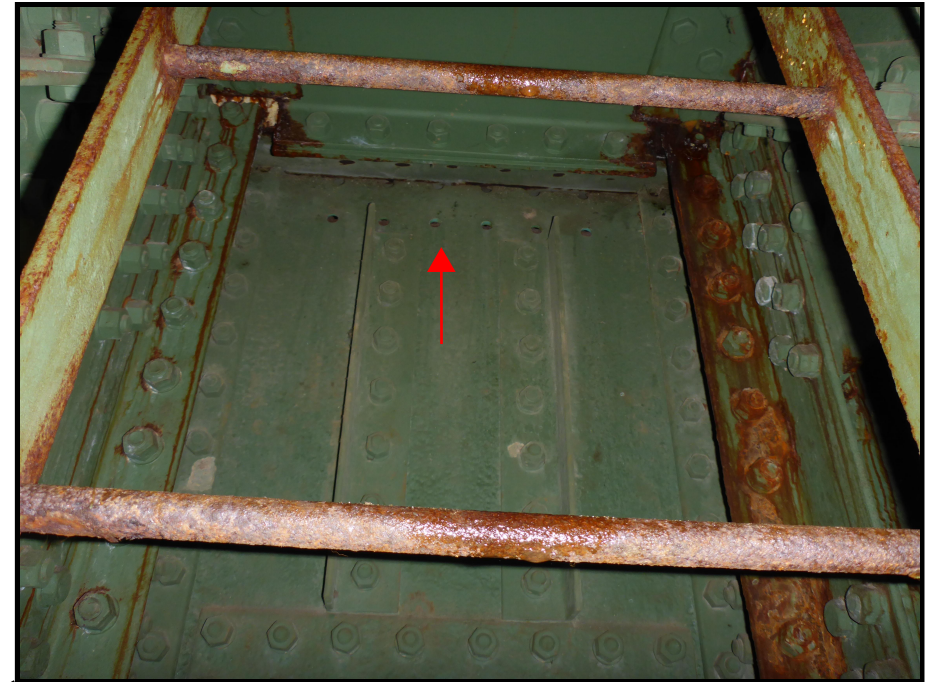
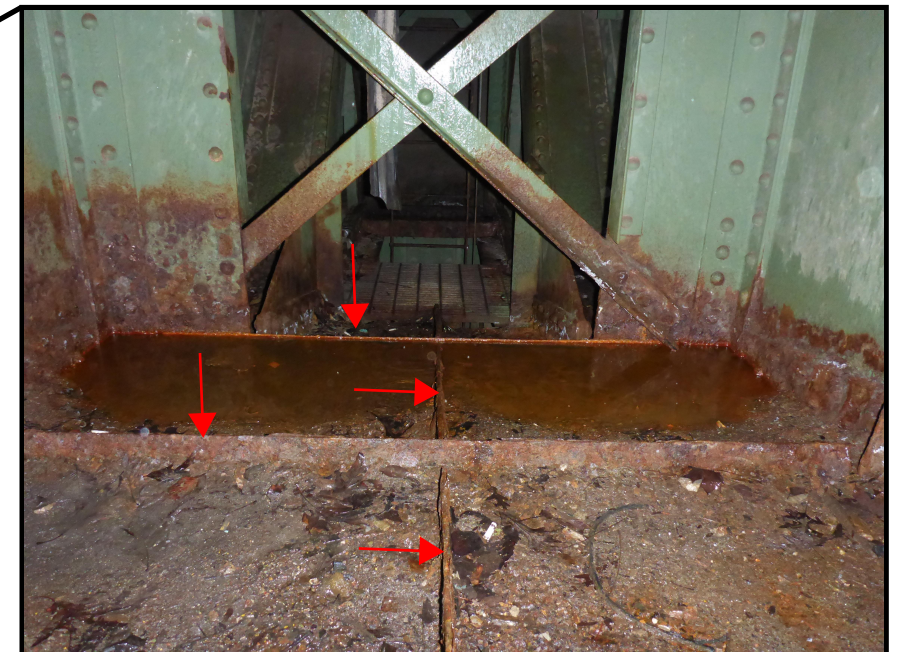
Pier #6 - North Tower		
Level	Deficiency	Status
1	Misdrilled holes on connection plates; minor section loss	OK
2	Thinning horizontal stiffeners with width loss	OK
3	Thinning horizontal stiffeners with width loss	OK
4	Thinning horizontal stiffeners with width loss	OK
5	Thinning horizontal stiffeners with width loss	OK
6	North face plate thinning with pin holes and missing bolts; Thinning horizontal stiffeners with width loss	OK
7	North face plate thinning with pin holes	OK
8	Surface rust on all horizontals and diagonals	OK
9	Surface rust on all horizontals and diagonals	OK
10	Surface rust on all horizontals and diagonals	OK
11	Surface rust on all horizontals and diagonals	OK
12	Thinning south vertical stiffener	OK
13	Surface rust on all horizontals and diagonals	OK
14	Surface rust on all horizontals and diagonals	OK
15	Surface rust on all horizontals and diagonals	OK
16	Surface rust on all horizontals and diagonals	OK

17	Surface rust on all horizontals and diagonals	OK
18	6 holes missing rivets	N.G.
Cap	Ponding water, leaking expansion joint; thinning stiffeners	N.G.
Cap	Leaking expansion joint	N.G.

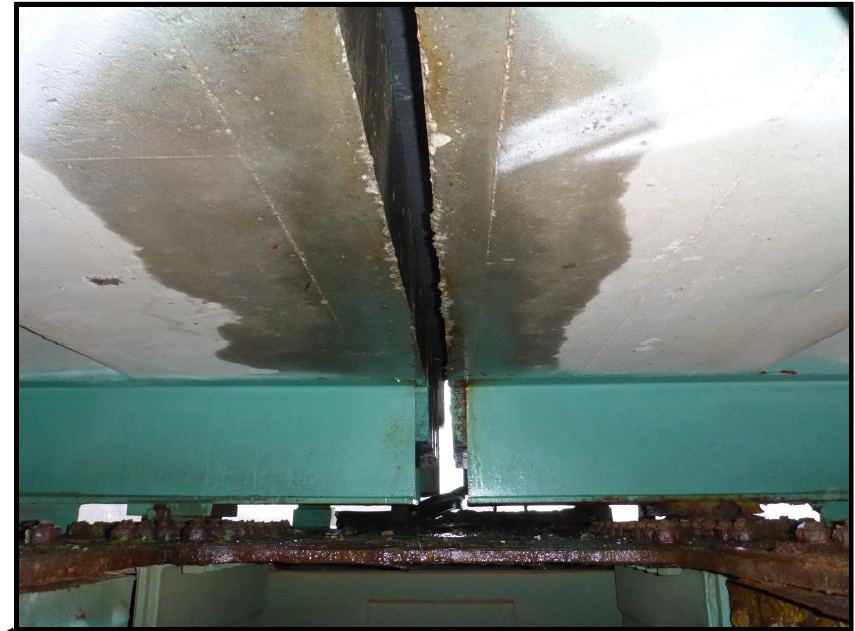
Pier #6 - South Tower		
Level	Deficiency	Status
1	Surface rust on all horizontals and diagonals	OK
2	Surface rust on all horizontals and diagonals	OK
3	Surface rust on all horizontals and diagonals	OK
4	Surface rust on all horizontals and diagonals	OK
5	1/16" section loss of both diagonal braces	OK
6	1/16" section loss of both diagonal braces	OK
7	Surface rust on all horizontals and diagonals	OK
8	Surface rust on all horizontals and diagonals	OK
9	Pinholes on south face plate; laminar rust between built up horizontal members	OK
10	2 x 1" diameter corrosion holes in south face plate; Surface rust on all horizontals and diagonals	OK
11	Surface rust on all horizontals and diagonals	OK
12	1/2" diameter corrosion hole in south face plate; Surface rust on all horizontals and diagonals	OK
13	Surface rust on all horizontals and diagonals	OK
14	Surface rust on all horizontals and diagonals	OK
15	Surface rust on all horizontals and diagonals	OK

16	Surface rust on all horizontals and diagonals	OK
17	Surface rust on all horizontals and diagonals	OK
18	Surface rust on all horizontals and diagonals	OK
Cap	Leaking expansion joint	N.G.

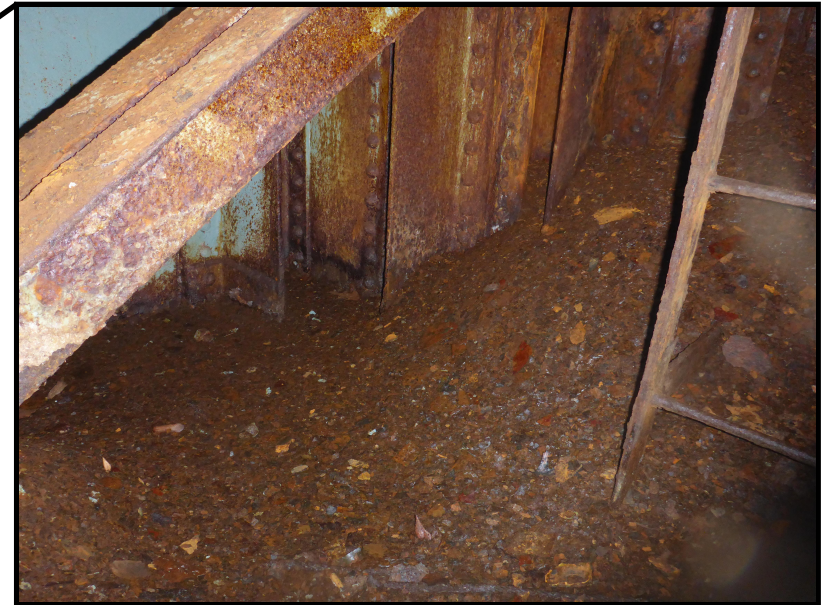
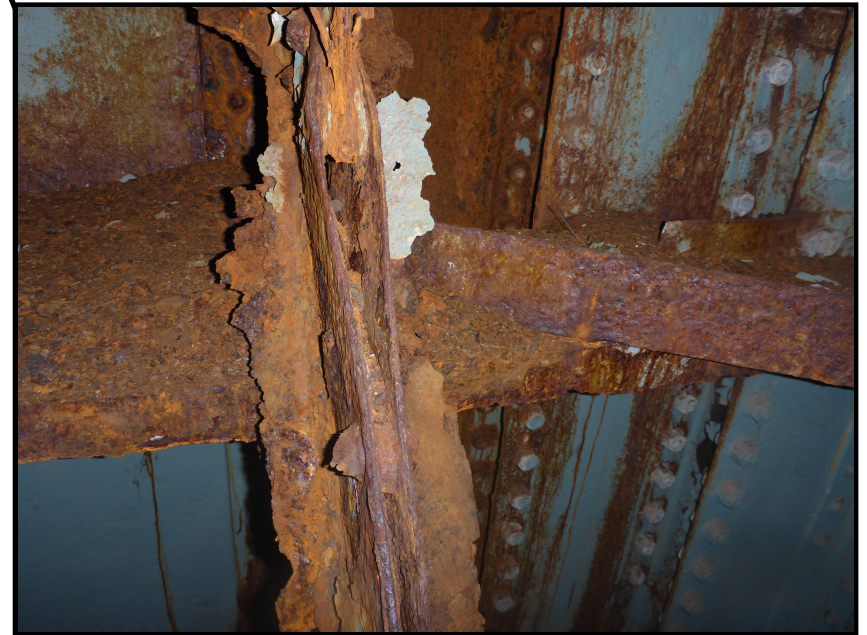
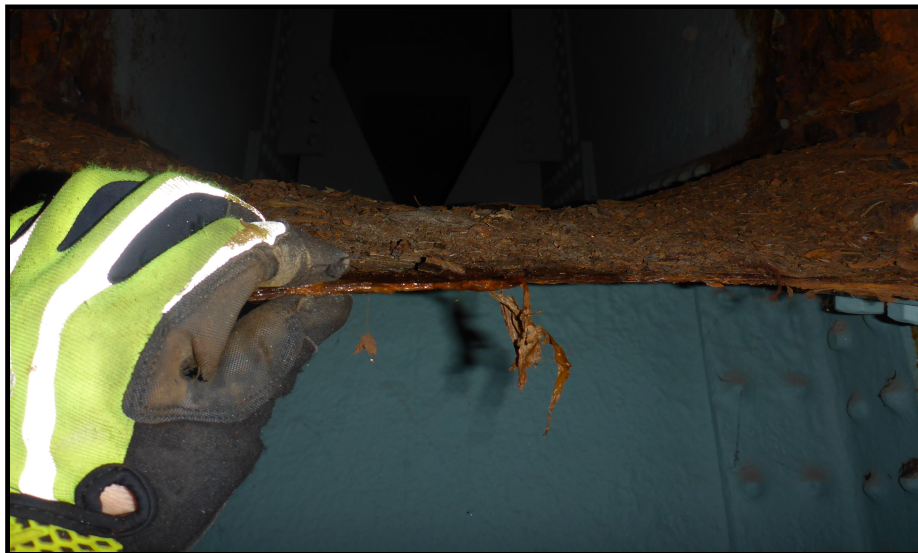
Pier #7 - North Tower		
Level	Deficiency	Status
1	Piles of rust in the base of the tower; severe thinning angles	N.G.
2	Severe thinning and section loss on all braces	N.G.
3	Severe thinning and section loss on all braces	N.G.
4	Severe thinning and section loss on all braces	N.G.
5	Severe thinning and section loss on all braces	N.G.
6	Severe thinning and section loss on all braces	N.G.
7	Severe thinning and section loss on all braces	N.G.
8	Severe thinning diagonal and horizontal braces; mid pier strut floor very thin	N.G.
9	<i>--inspection stopped at level 8 due to deterioration--</i>	
10		
11		
12		
13		
14		
15		
16		
17		
Cap

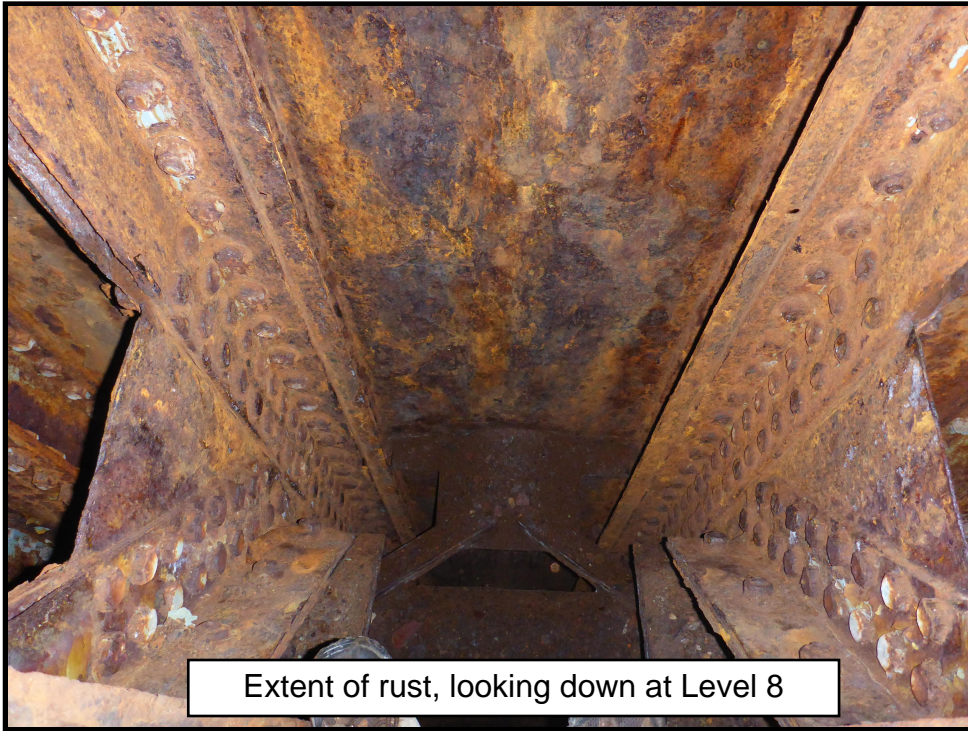
Extent of rust, looking down at Level 8

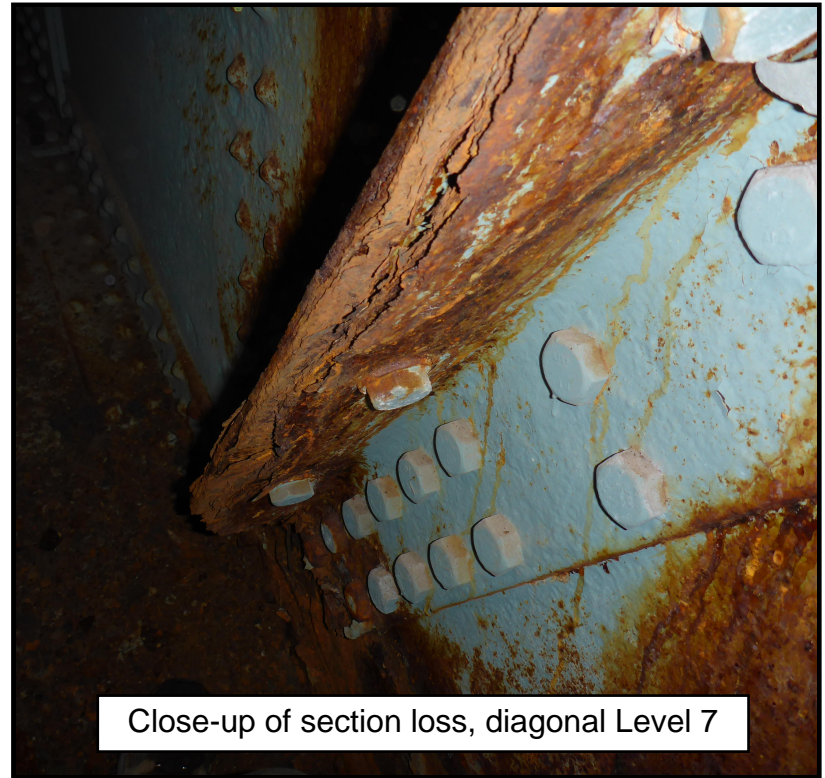
Close-up of section loss, diagonal Level 7

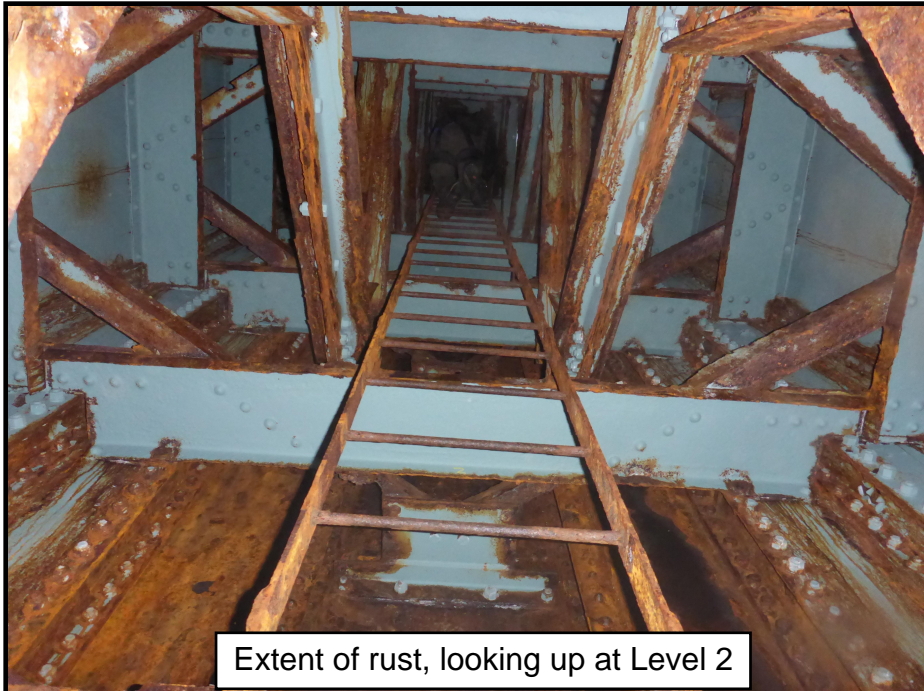
Extent of rust, looking up at Level 2

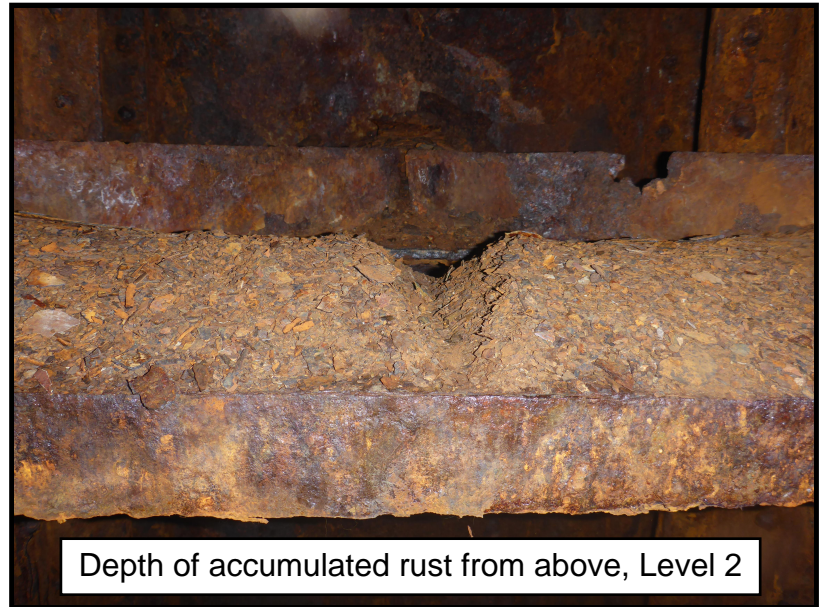
Depth of accumulated rust from above, Level 2

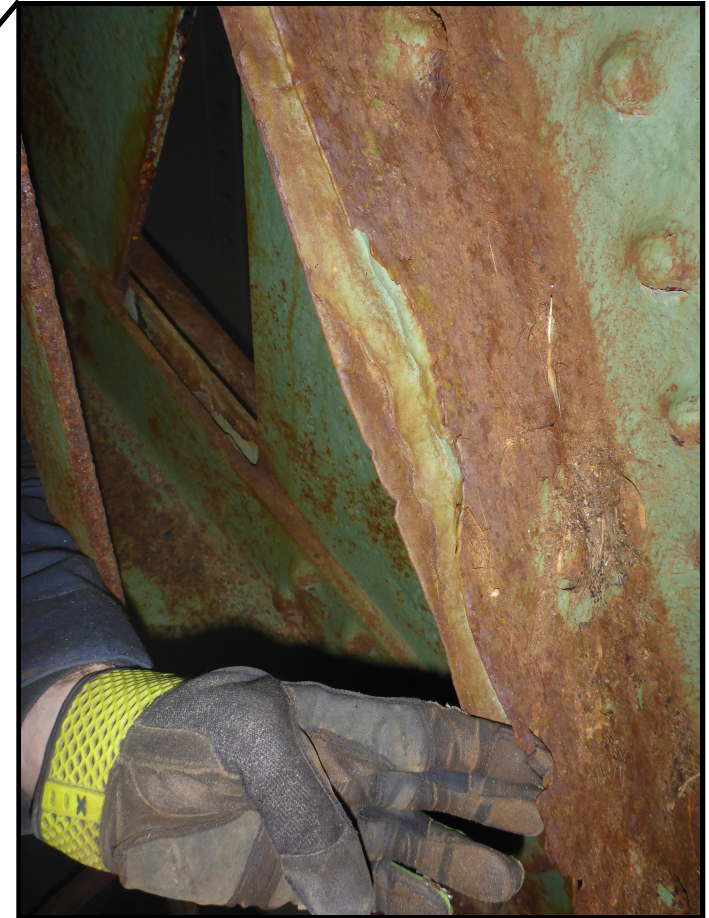
Support angle for below section loss
