**We are a Full  
Service Firm**

Oil & Natural Gas Systems  
Development

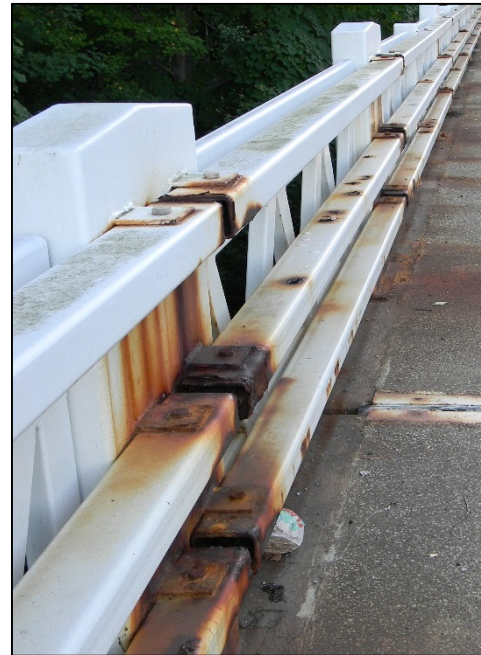
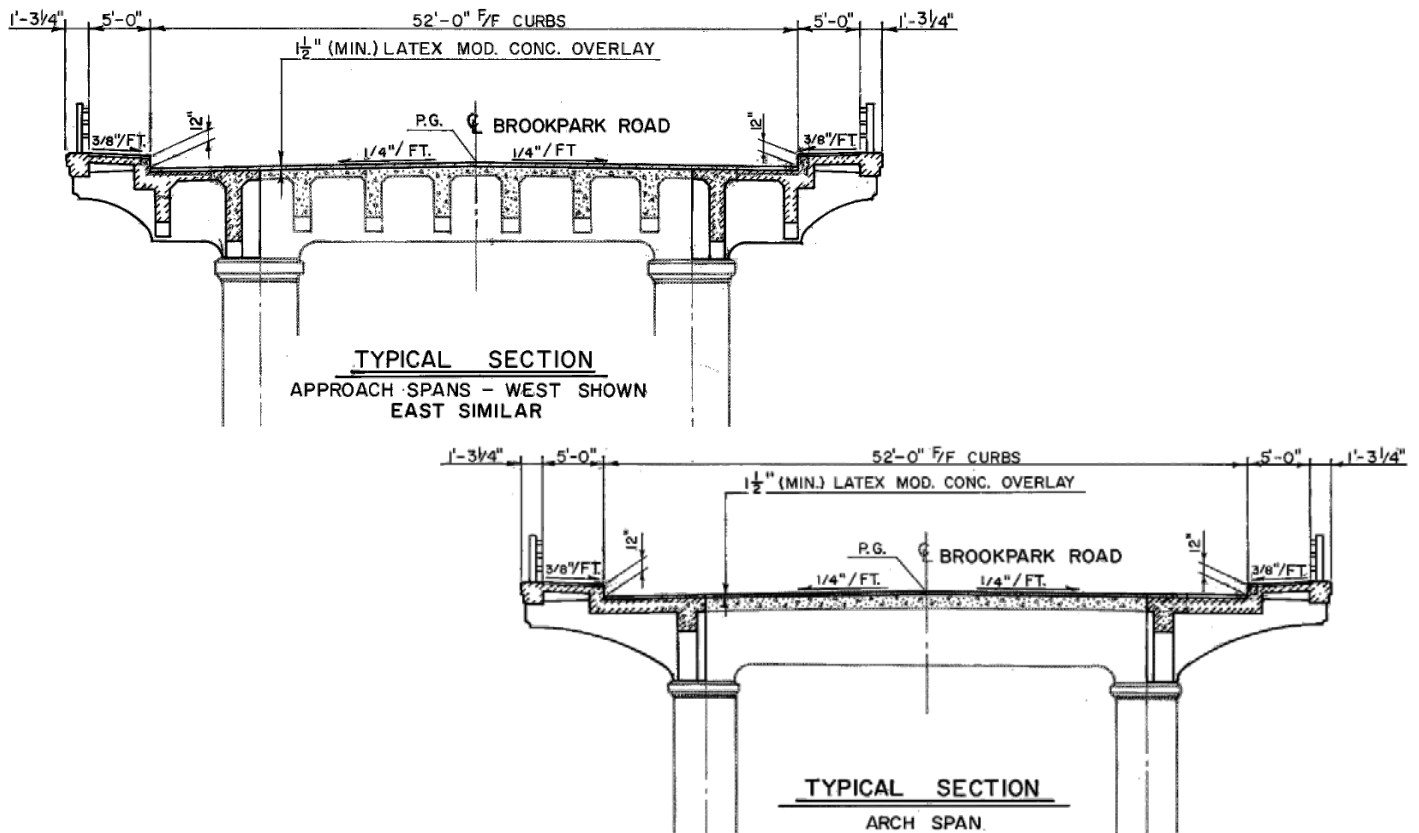
Figure 1 – Typical Approach and Arch sections of the 1989 rehabilitation.

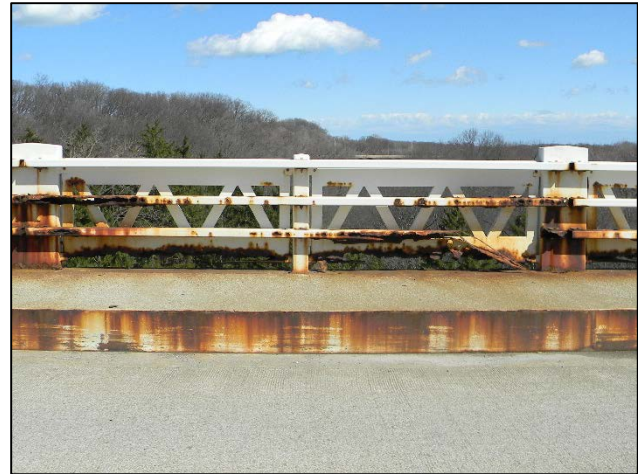
The existing railing is a combined traffic and pedestrian railing and is at the outside of a 5 foot clear sidewalk with a 12" curb. The existing railing is a steel tubular rail with a decorative, steel panel. The average weight of the existing railing is approximately 86 pounds per foot.

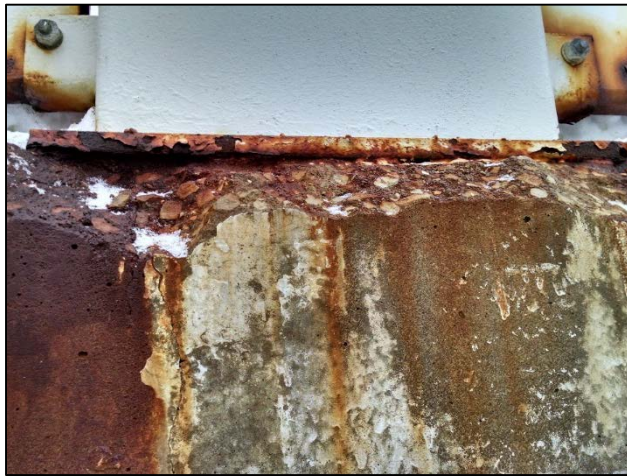
*Photo 1 – Top Corner spall exposing approximately 1/4" of bottom of post base plate. Fourth post of Arch B, South Sidewalk shown.*

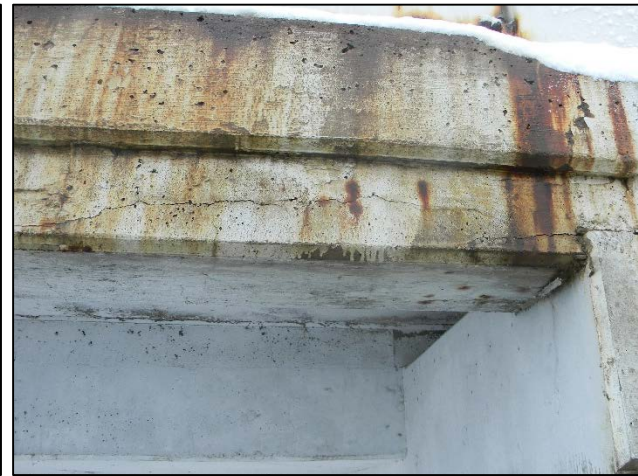
*Photo 2 – Typical longitudinal cracks along the vertical face of the sidewalk fascia beam. North Sidewalk, Arch H Bay 4 Shown.*

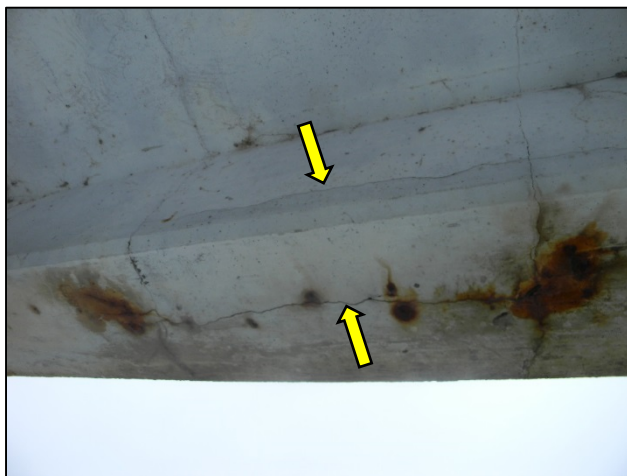
*Photo 3 – Typical corner delamination with side and bottom cracks pointed out. North Sidewalk, Arch E Bay 5 shown.*

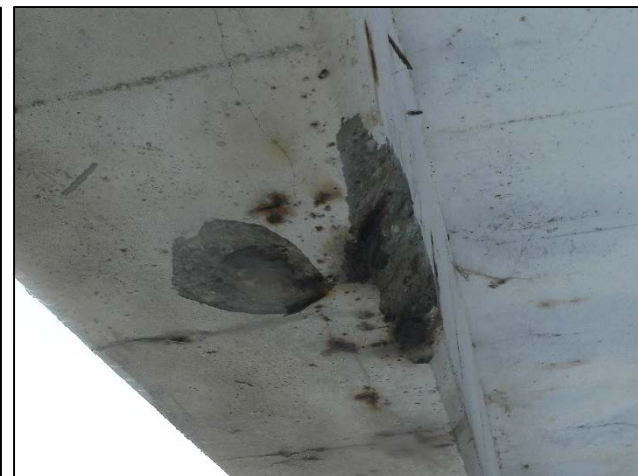
*Photo 4 – Typical corner spalling along the fascia beam bottom. 2"x2"x9" spall and 3" diameter spall shown at North Sidewalk, Arch D Bay 2.*

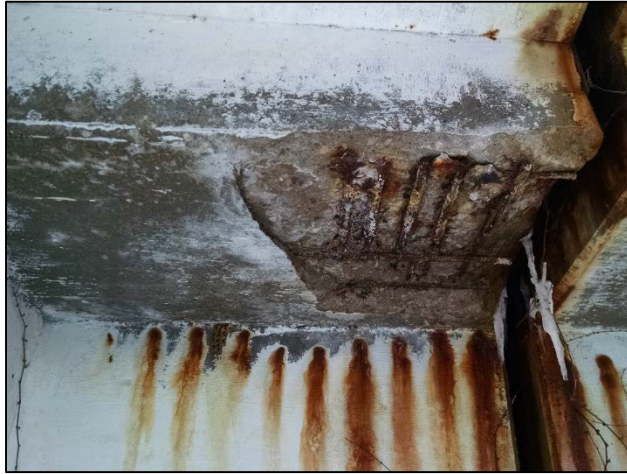
*Photo 5 – Curb beam and deck soffit delaminated and spalled to bottom mat at the West Pylon joint. South Sidewalk shown.*

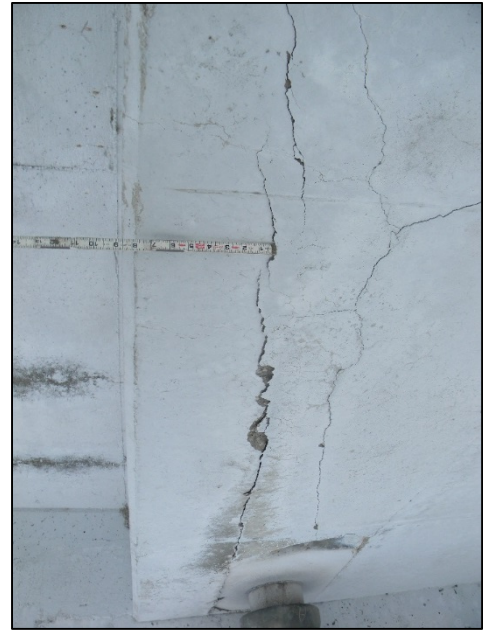
*Photo 6 – Large delaminated area beginning approximately 9" from the back of the curb beam, approximately 12" by 4 feet. North Sidewalk, Arch D Bay 1 shown.*

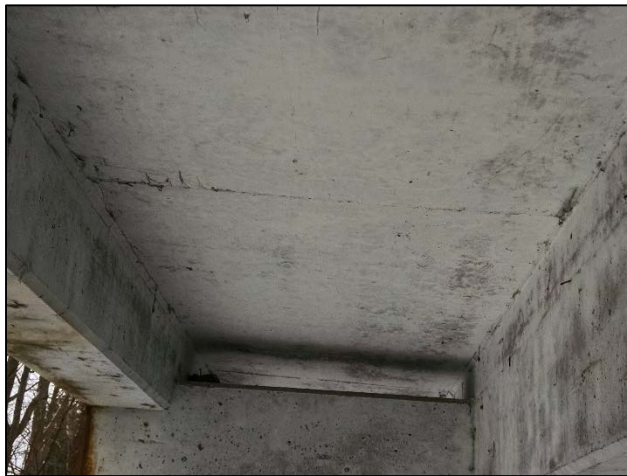
*Photo 7 – Typical good condition of the bottom of the sidewalk slab. West Approach, South sidewalk shown.*

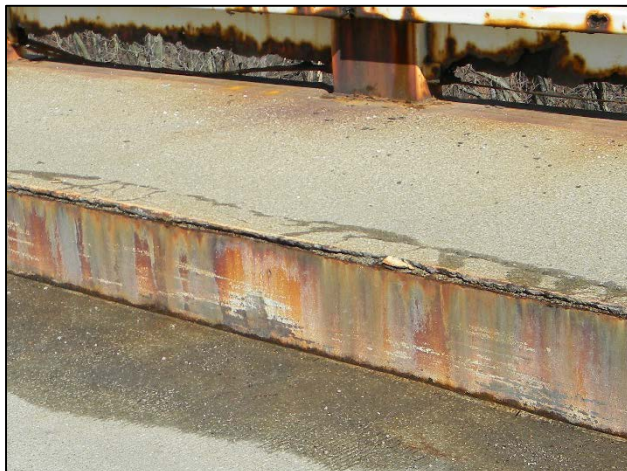
*Photo 8 – Portion of an 11 foot long, 1 foot wide delamination of the Arch B North sidewalk. Water and rust is buckling the delaminated layer of concrete up.*

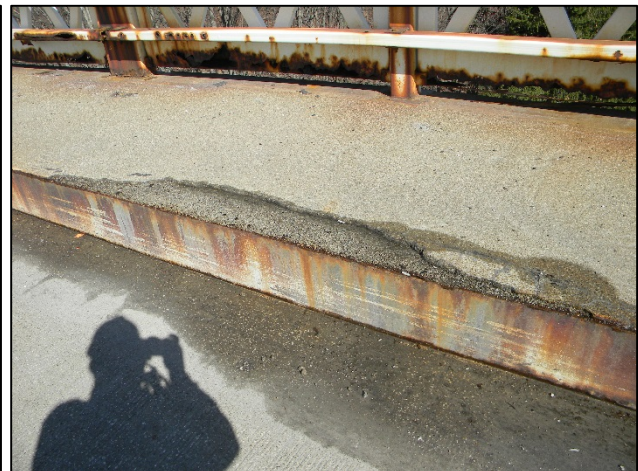
*Photo 9 – Another Arch B North sidewalk location showing asphalt fill in a spalled portion of the sidewalk.*

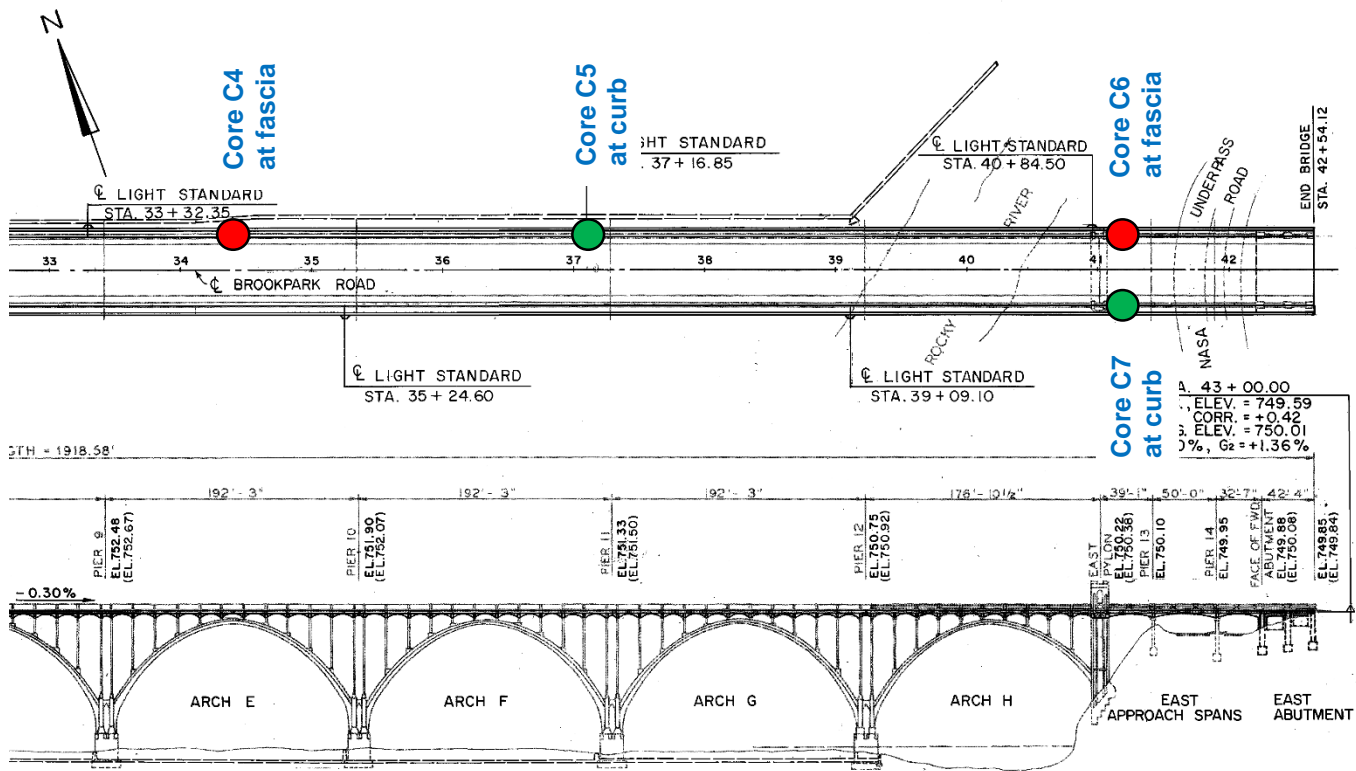
Figure 3 – Existing sidewalk configuration, typical both sides. The red dots are cores taken adjacent to the railings, and the green dots were taken at the curbs.

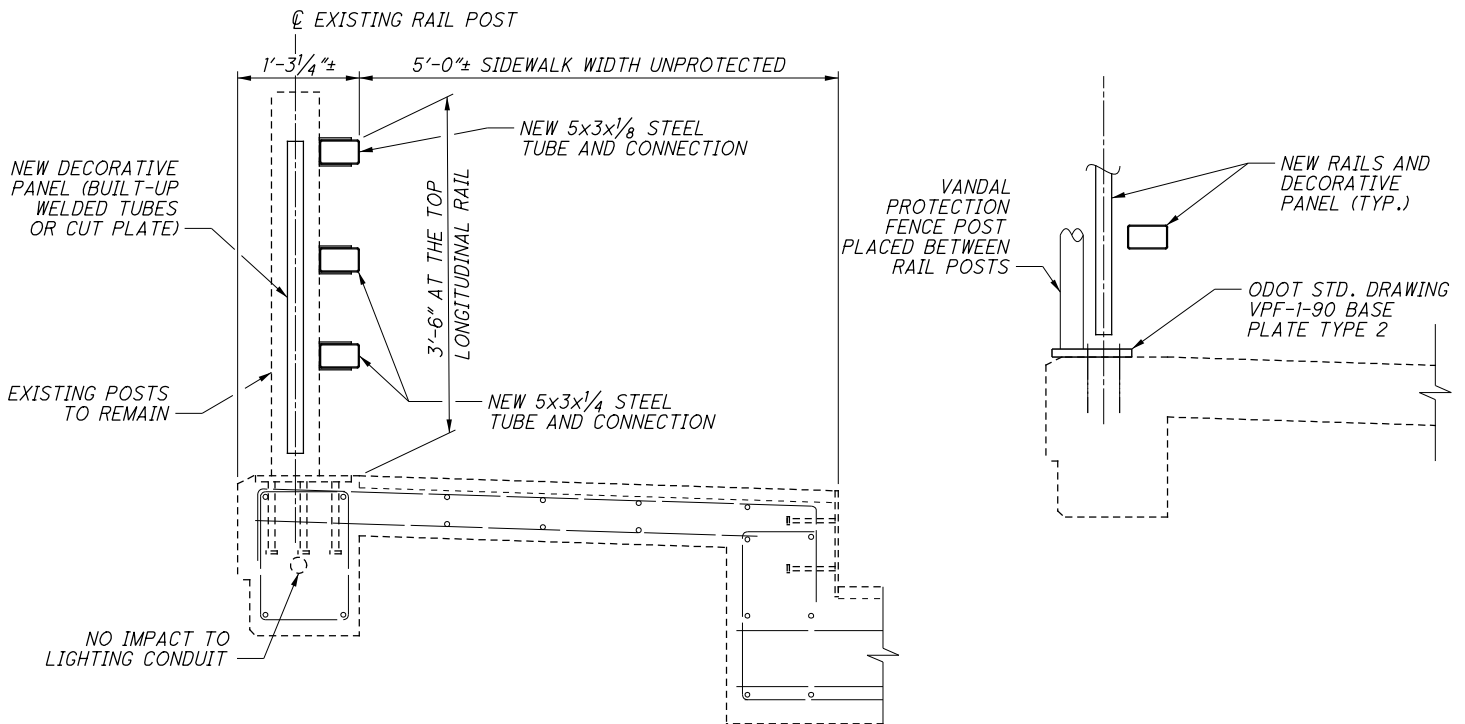
Figure 4 – Alternative 1 will repair the existing railing by replacing the horizontal rails and the decorative panels. Optional vandal protection fence detail shown separately for clarity.

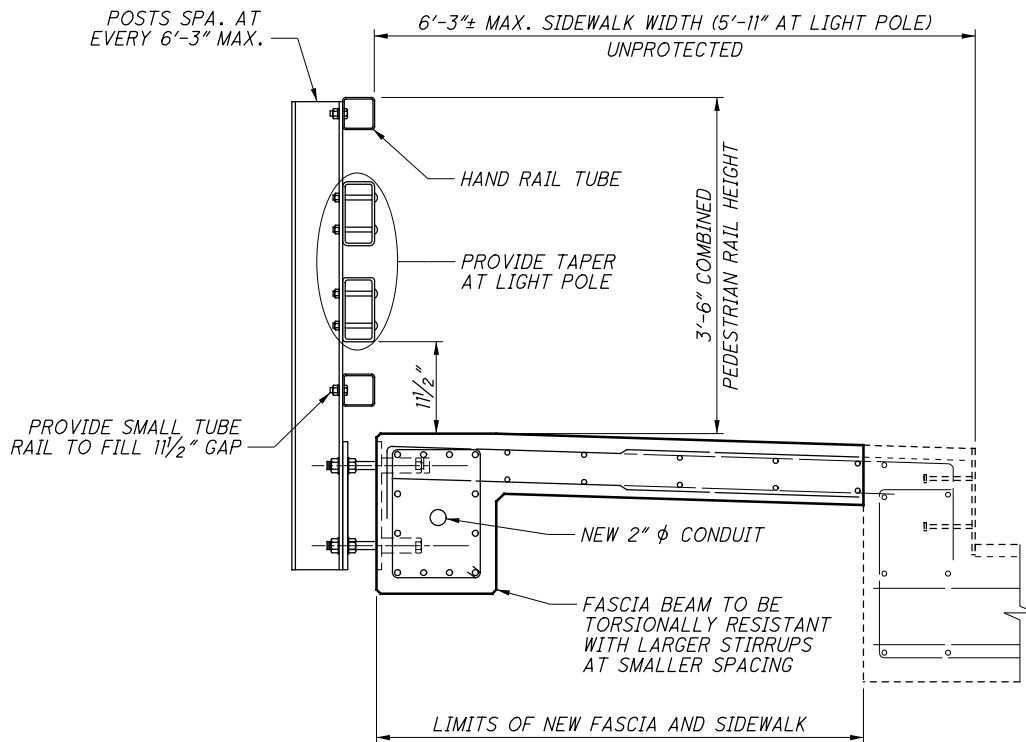
Figure 6 – Alternative 2 without the vandal protection fence requires added height to the TST rail post and additional horizontal tubes but allows the railing to have a see-through aesthetic.

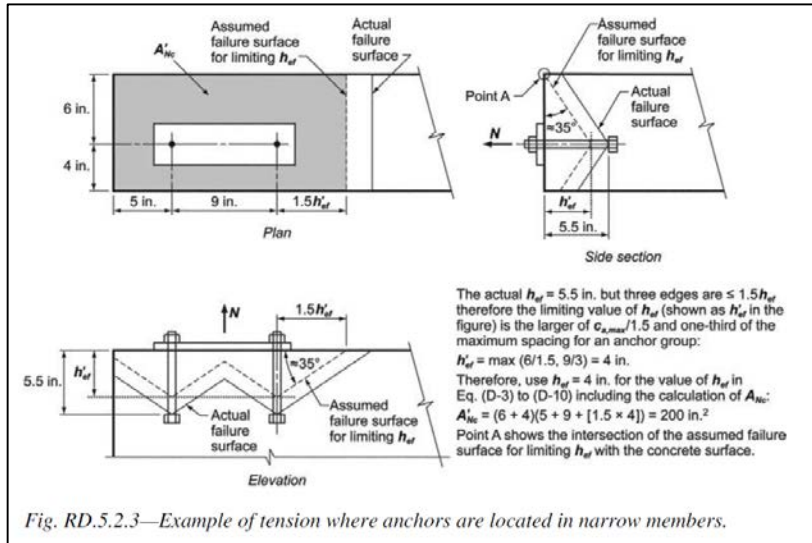
Incidentally, if the top mounted TST railing is placed on the curb beam, the same edge distance breakout strengths affect the anchors. The curb edge beam is also not wide enough.

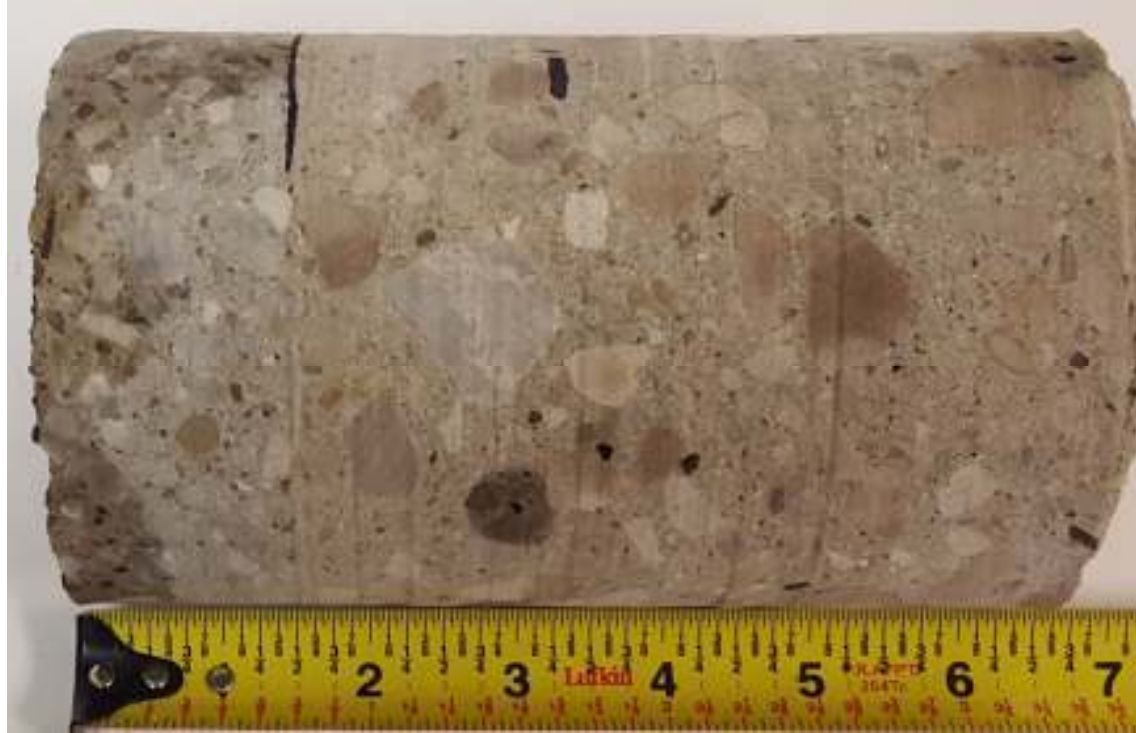
Core Number	Location	Layers	Core Composition		Remarks
			LMC Overlay	Bridge Deck	
C-1	<b>CUY-17-2.83 SIDEWALK (WB)</b> Latitude : 41.4205° Longitude : -81.8611°	A	1 ½"	--	Good Condition
		B	--	4 ¾"	Good Condition

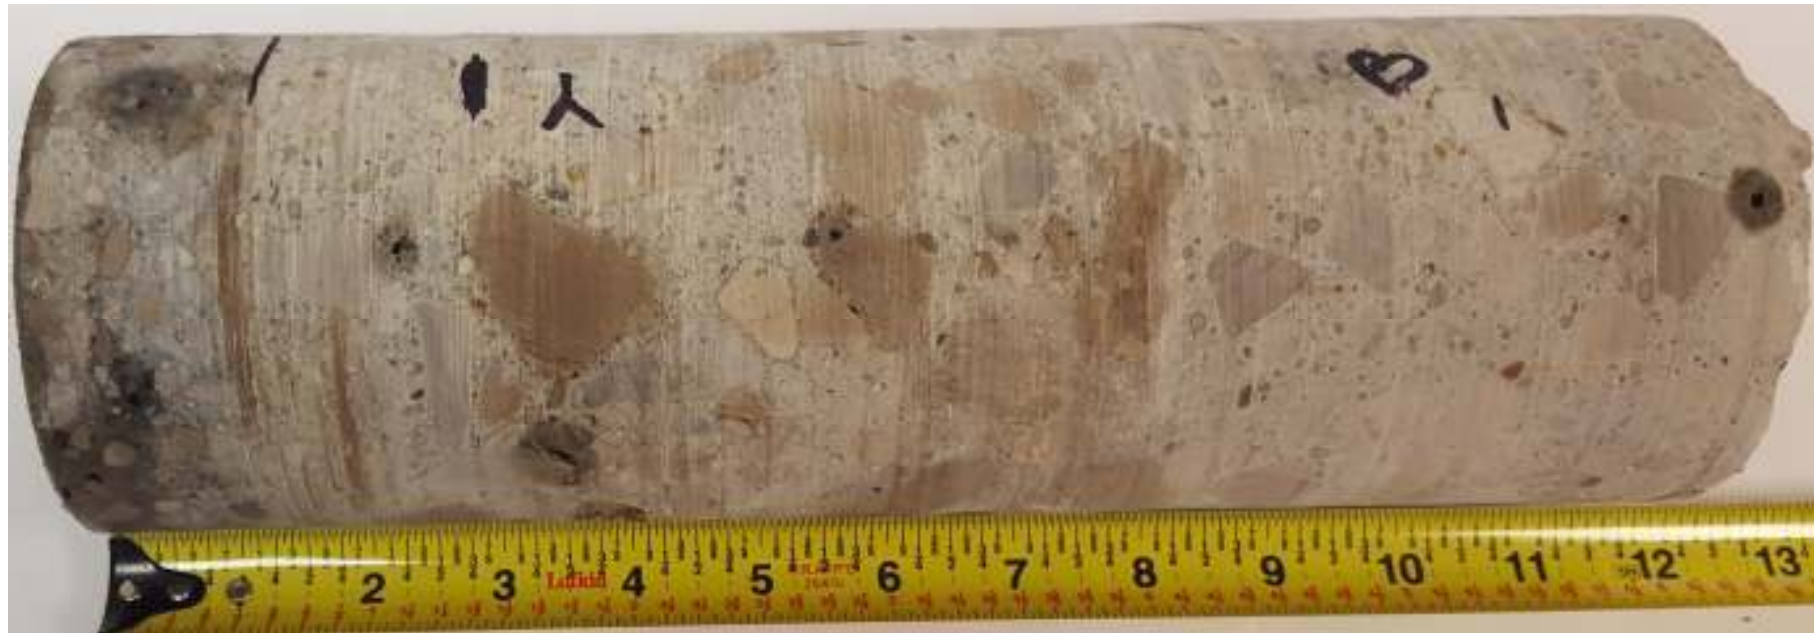
Core Number	Location	Layers	Core Composition		Remarks	
			LMC Overlay	Bridge Deck		
C-2	<b>CUY-17-2.83 SIDEWALK (WB)</b> Latitude : 41.4202° Longitude : -81.8600°	A	1 ½"	--	Good Condition	
		B	--	10 ½"	Good Condition

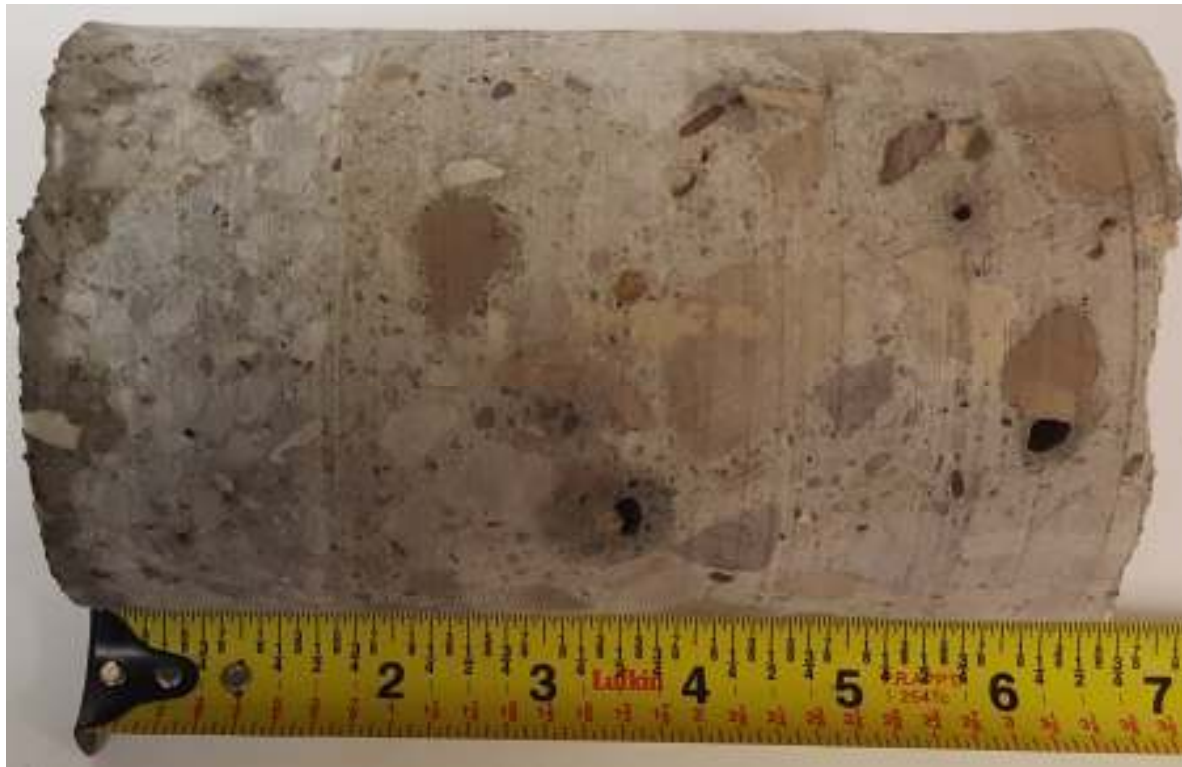
Core Number	Location	Layers	Core Composition		Remarks	
			LMC Overlay	Bridge Deck		
C-3	<b>CUY-17-2.83 SIDEWALK (WB)</b> Latitude : 41.4199° Longitude : -81.8588°	A	1 ¾"	--	Good Condition	
		B	--	4 ¾"	Good Condition

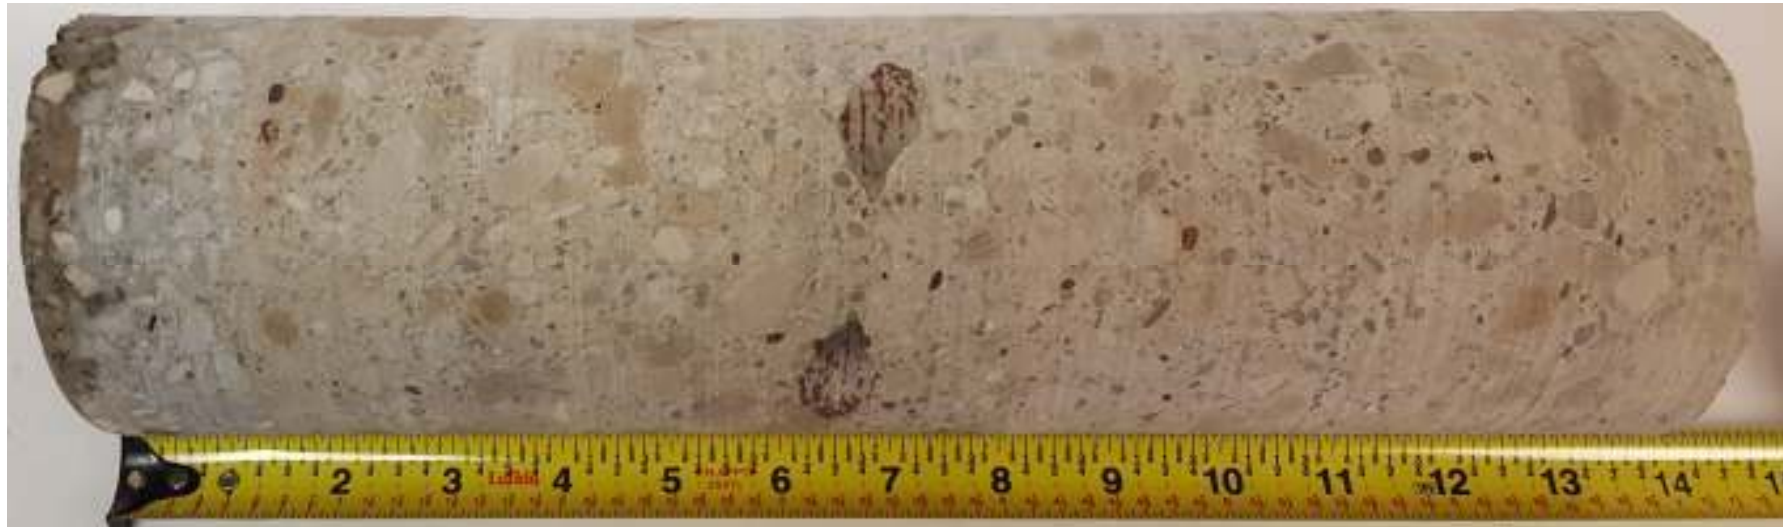
Core Number	Location	Layers	Core Composition		Remarks
			LMC Overlay	Bridge Deck	
C-4	<b>CUY-17-2.83 SIDEWALK (WB)</b> Latitude : 41.4196° Longitude : -81.8577°	A	1 3/4"	--	Good Condition
		B	--	12 1/4"	Good Condition

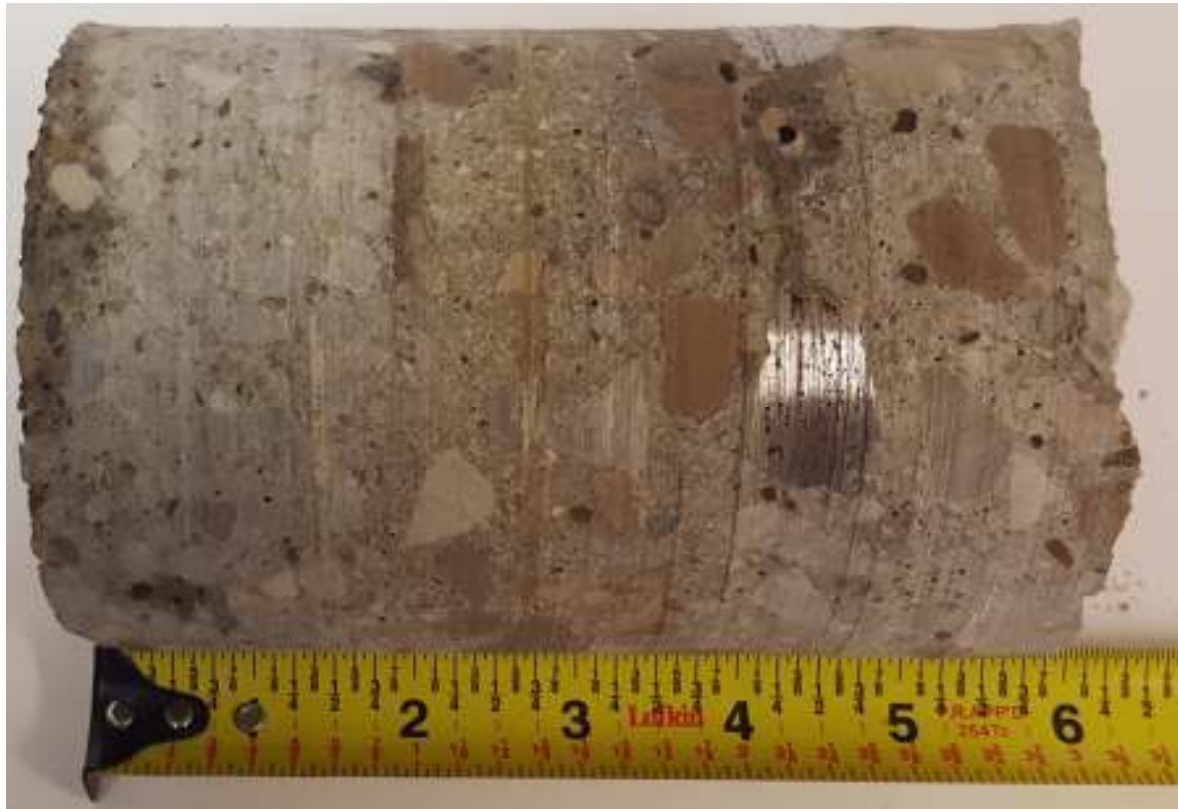
Core Number	Location	Layers	Core Composition		Remarks
			LMC Overlay	Bridge Deck	
C-5	<b>CUY-17-2.83 SIDEWALK (WB)</b> Latitude : 41.4194° Longitude : -81.8568°	A	2"	--	Good Condition
		B	--	3 ¾"	Good Condition

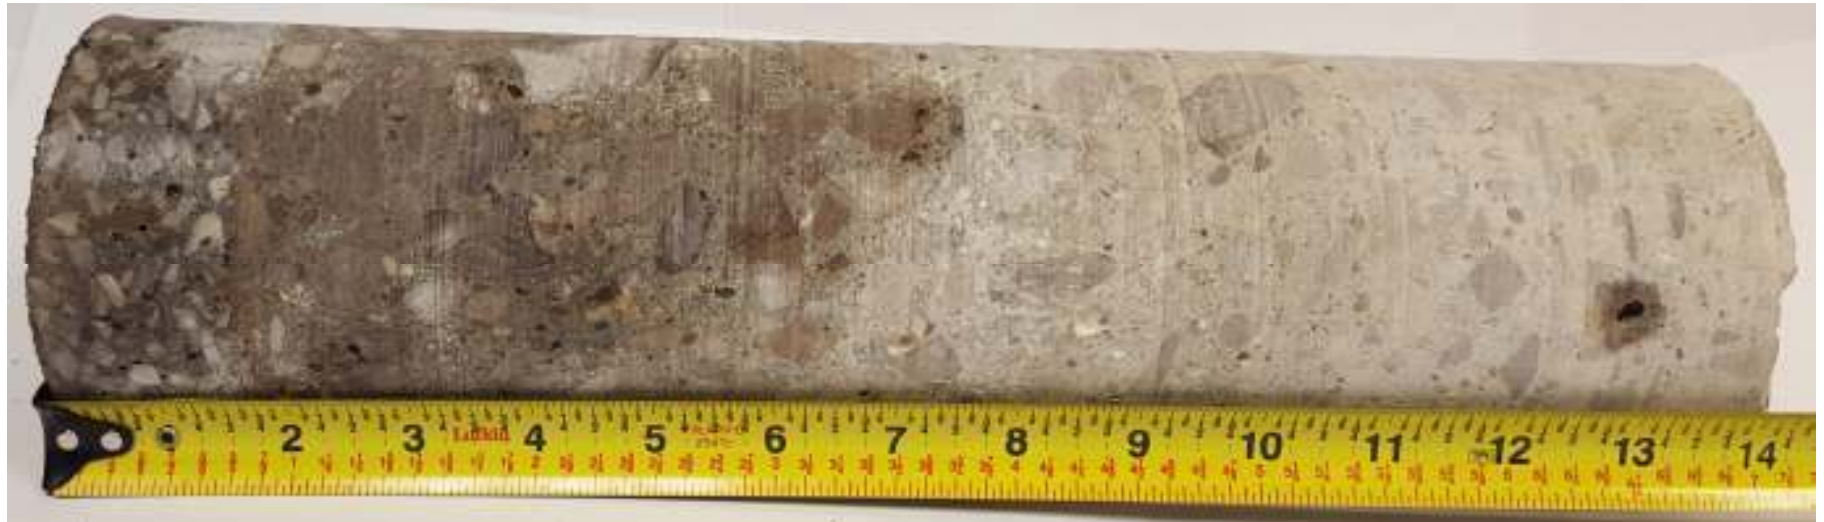
Core Number	Location	Layers	Core Composition		Remarks	
			LMC Overlay	Bridge Deck		
C-6	<b>CUY-17-2.83 SIDEWALK (WB)</b> Latitude : 41.4190° Longitude : -81.8555°	A	1 ½"	--	Good Condition	
		B	--	12 ¾"	Good Condition

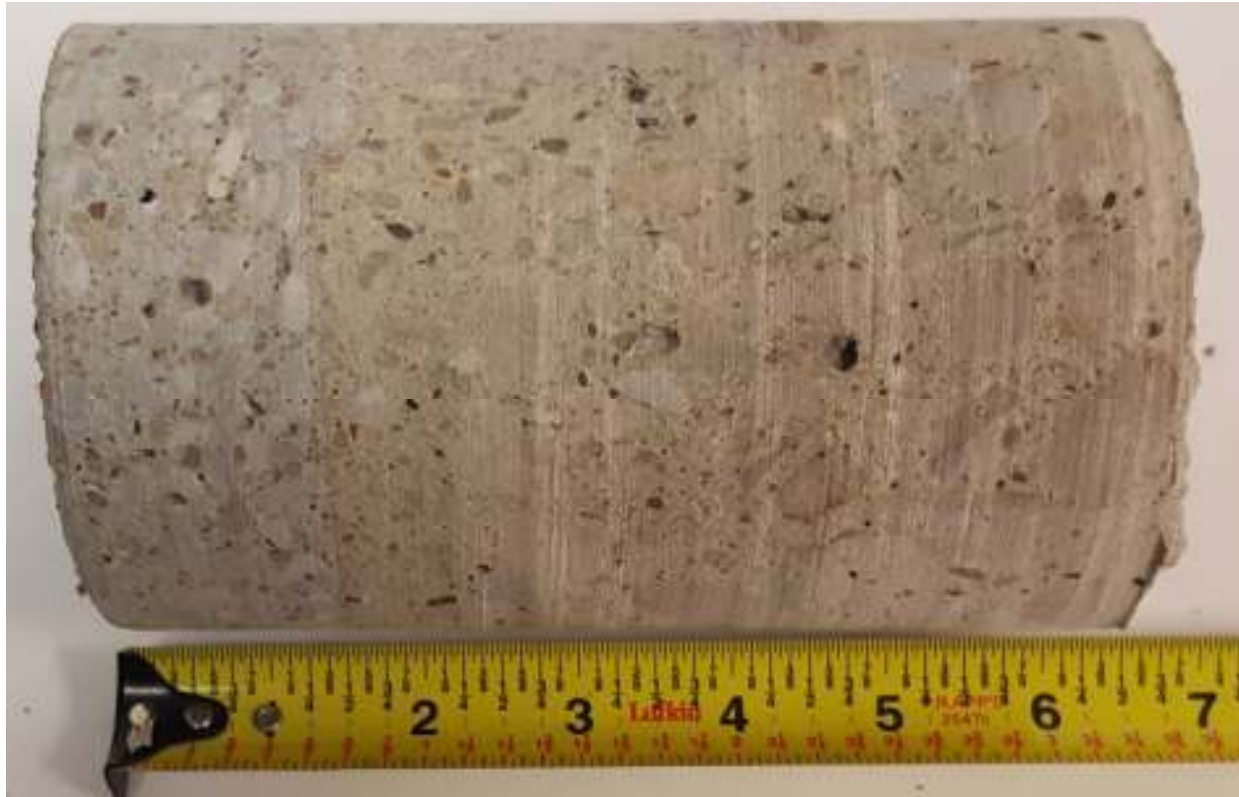
Core Number	Location	Layers	Core Composition		Remarks
			LMC Overlay	Bridge Deck	
C-7	<b>CUY-17-2.83 SIDEWALK (EB)</b> Latitude : 41.4189° Longitude : -81.8556°	A	1 ½"	--	Good Condition
		B	--	4 ¾"	Good Condition

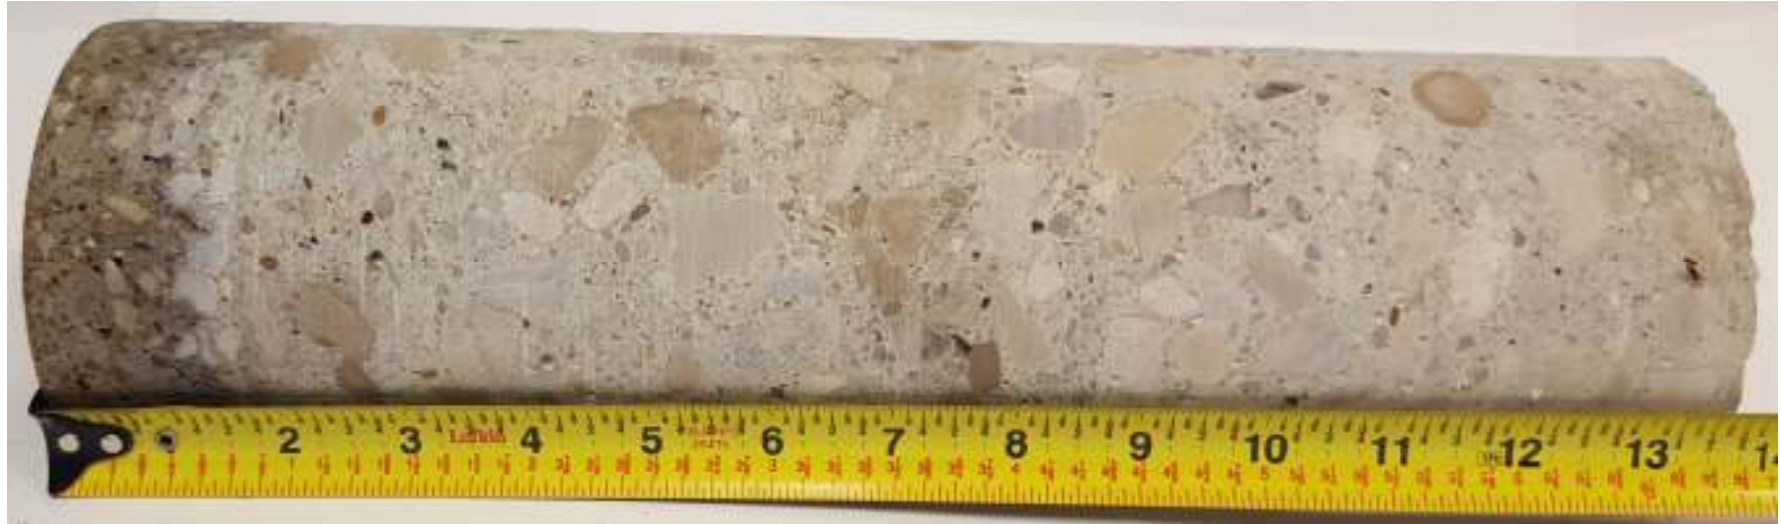
Core Number	Location	Layers	Core Composition		Remarks
			LMC Overlay	Bridge Deck	
C-8	<b>CUY-17-2.83 SIDEWALK (EB)</b> Latitude : 41.4192° Longitude : -81.8569°	A	1 ½"	--	Good Condition
		B	--	12 ¼"	Good Condition

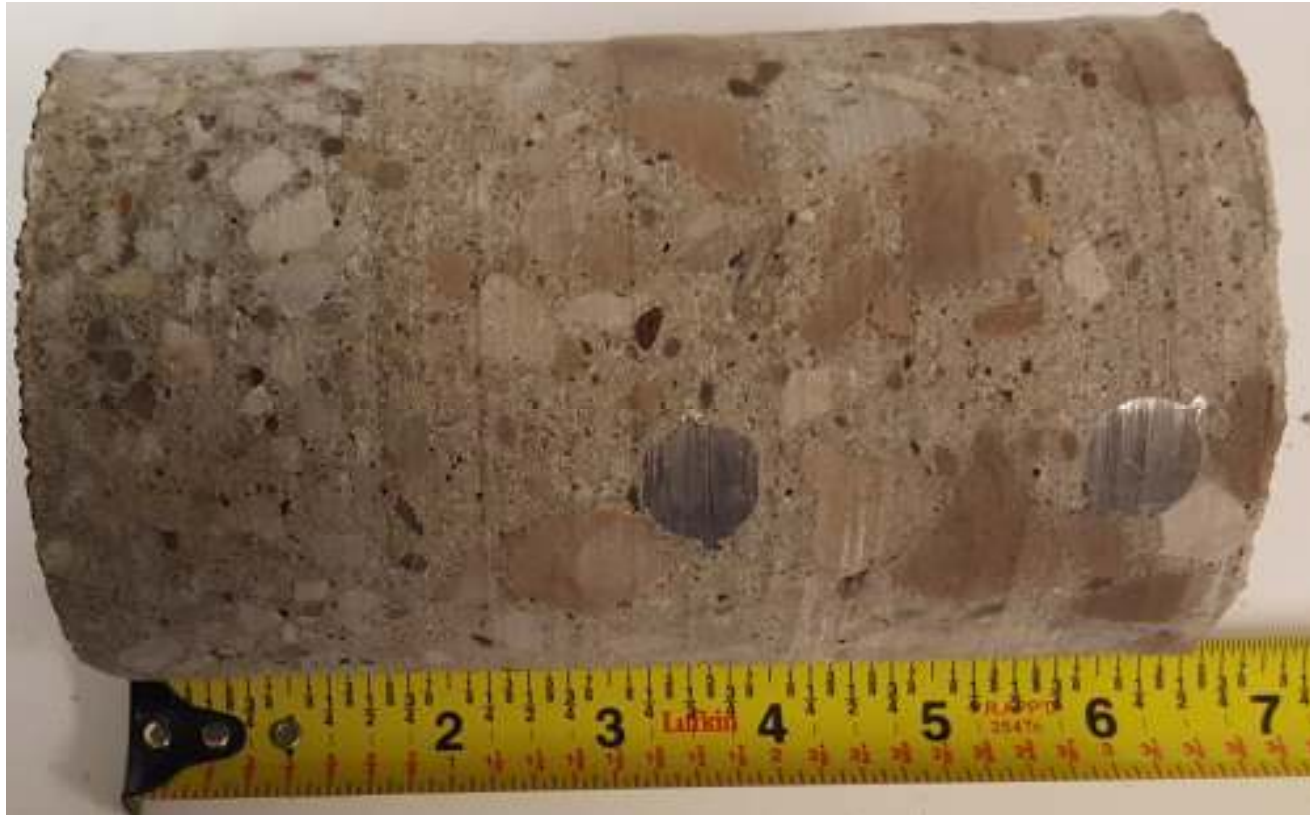
Core Number	Location	Layers	Core Composition		Remarks
			LMC Overlay	Bridge Deck	
C-9	<b>CUY-17-2.83 SIDEWALK (EB)</b> Latitude : 41.4195° Longitude : -81.8578°	A	1 ¾"	--	Good Condition
		B	--	4 ½"	Good Condition

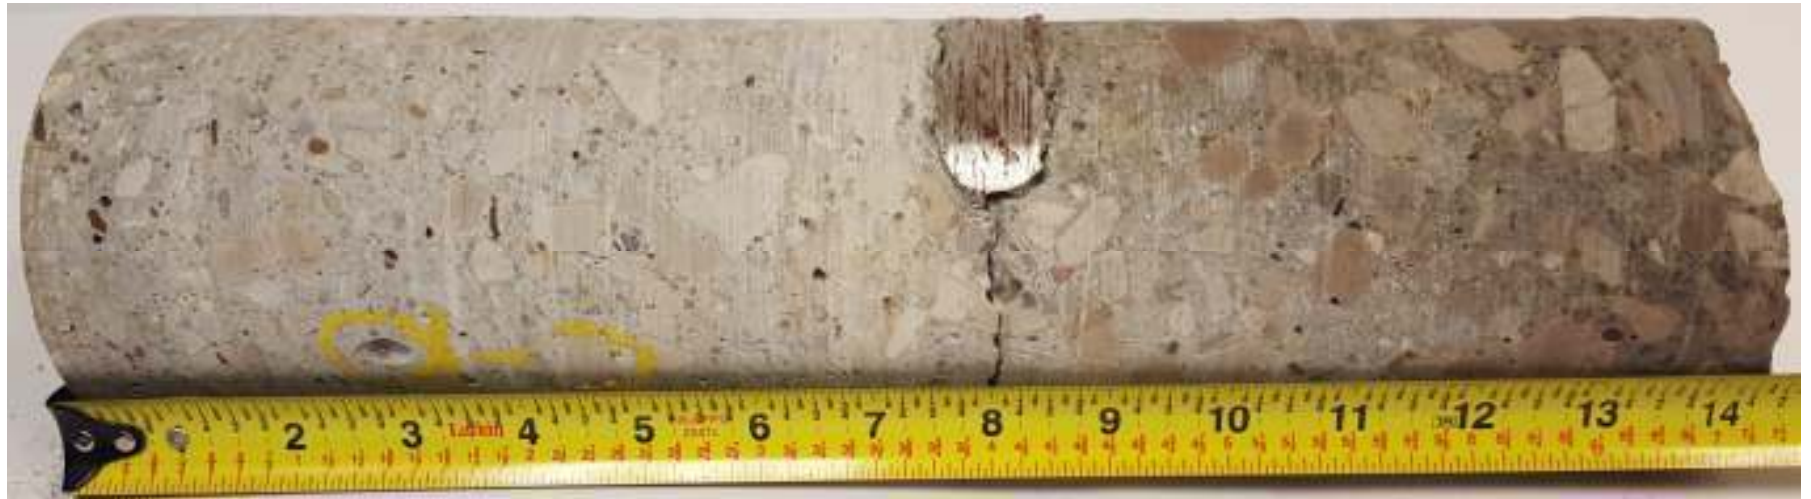
Core Number	Location	Layers	Core Composition		Remarks
			LMC Overlay	Bridge Deck	
C-10	<b>CUY-17-2.83 SIDEWALK (EB)</b> Latitude : 41.4198° Longitude : -81.8598°	A	1 ½"	--	Good Condition
		B	--	12 ¾"	Good Condition, Cracked During Coring

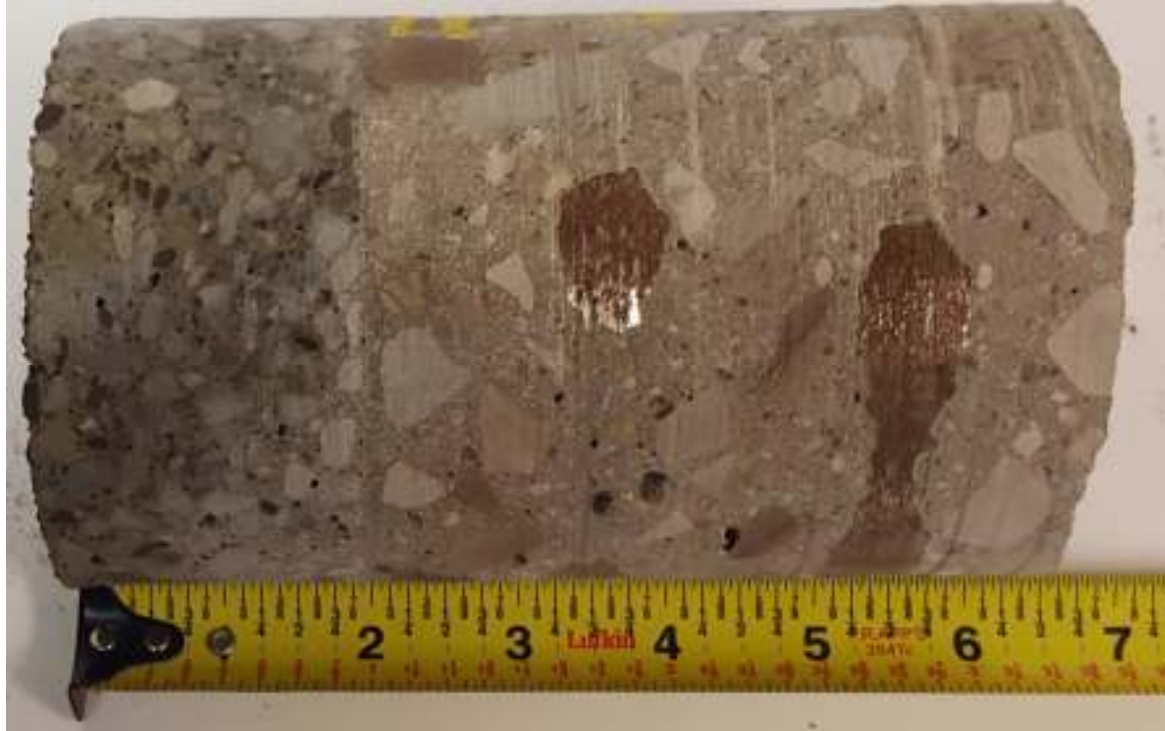
Core Number	Location	Layers	Core Composition		Remarks
			LMC Overlay	Bridge Deck	
C-11	<b>CUY-17-2.83 SIDEWALK (EB)</b> Latitude : 41.4200° Longitude : -81.8600°	A	2"	--	Good Condition
		B	--	4 ¼"	Good Condition

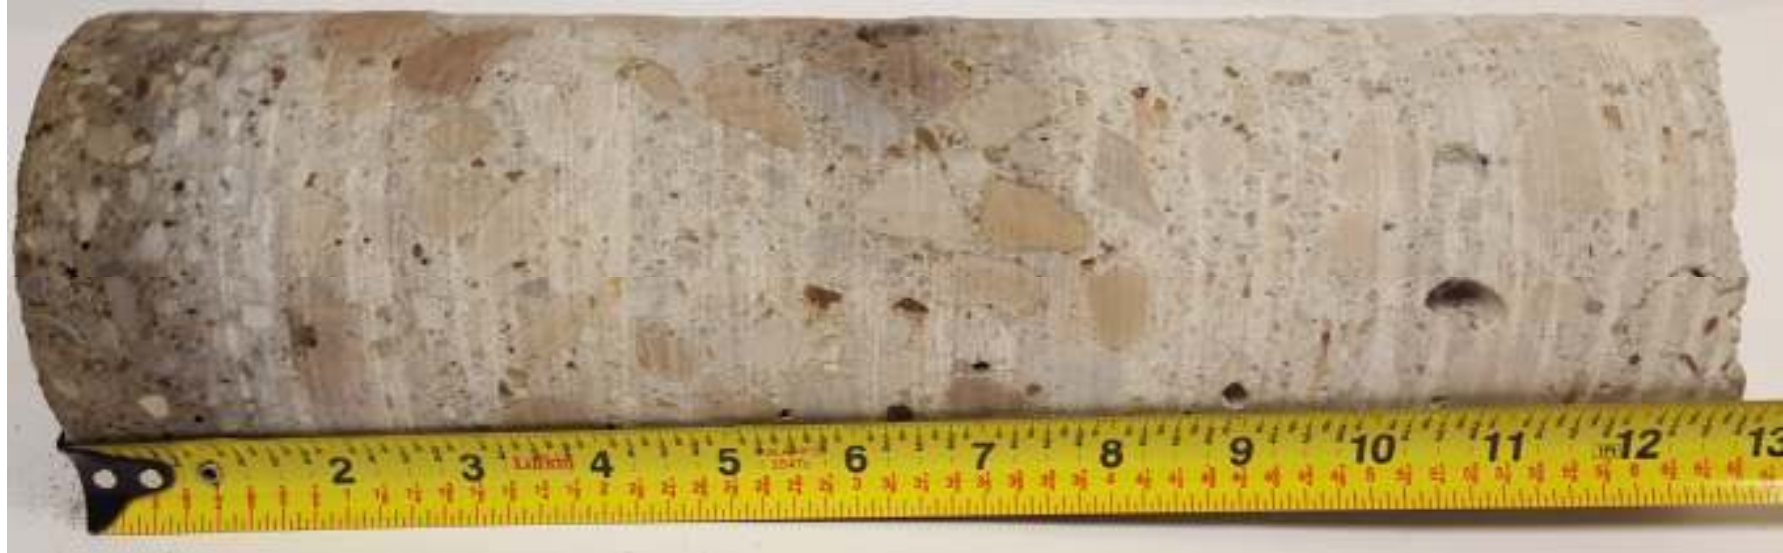
Core Number	Location	Layers	Core Composition		Remarks
			LMC Overlay	Bridge Deck	
C-12	<b>CUY-17-2.83 SIDEWALK (EB)</b> Latitude : 41.4203° Longitude : -81.8611°	A	1 3/4"	--	Good Condition
		B	--	10 3/4"	Good Condition
