**PHYSICAL CONDITION REPORT  
FOR THE 2022 ROUTINE ELEMENT LEVEL INSPECTION**

**BROOKPARK ROAD BRIDGE**  
BRIDGE NO. CUY-17-0283  
SFN: 1802046

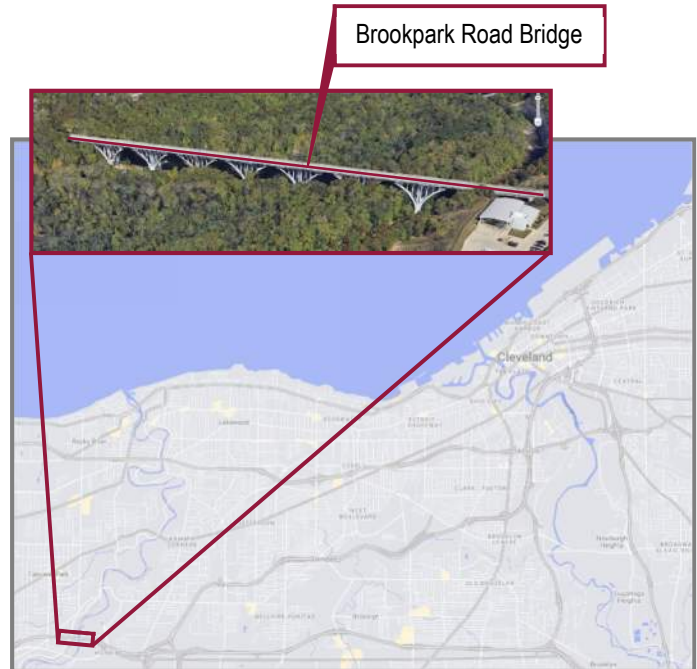
The bridge underwent several minor rehabilitations in 1955, 1966, and 2017. In 1955, portions of the rear abutment, sidewalks, curbs, and roadway joints were rehabilitated, and the expansion joints were replaced in 1966. There was a major rehabilitation in 1989 in order to widen the structure from a 39' roadway to a 52' roadway. During the course of the widening, a new wearing surface was applied, the drainage system was replaced, new elastomeric compression seals were installed, bronze sliding plate expansion bearings were rehabilitated by replacing asbestos sheets with Teflon sheets, and areas of deteriorated concrete were patched with pneumatically-placed mortar. The most recent rehabilitation took place in 2017 and included a

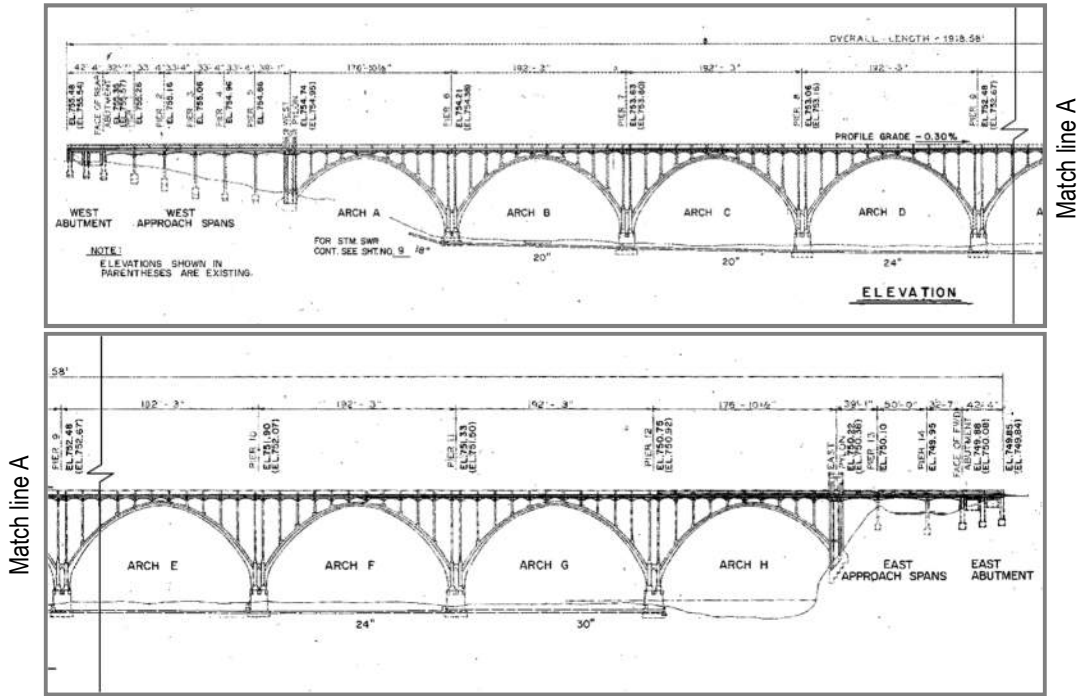
Figure 1 – CUY-17-0283 South Elevation (taken from the major rehabilitation plans).

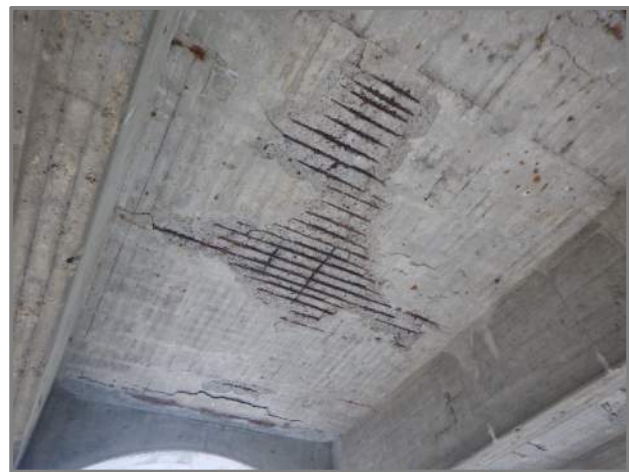
Photo 1 – Typical spalls with exposed and corroded reinforcement, delaminations, and rust staining in the deck underside (looking up and south between Floorbeams H3 and H4).

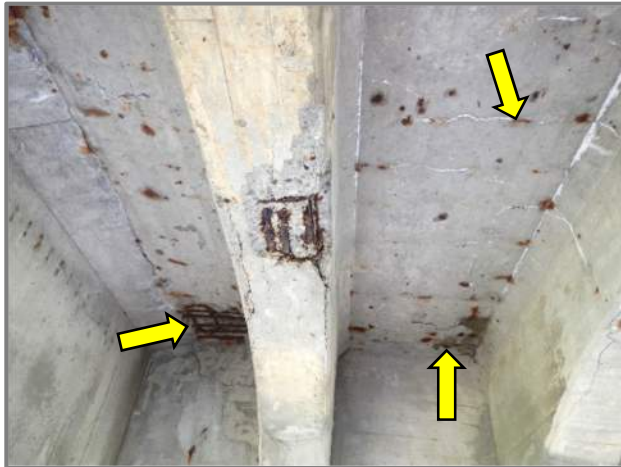
Photo 2 – Typical deck condition at the forward end of the bridge (looking east between Beams 2 to 4 at the left forward end of Span 17). Note the longitudinal construction joint between the original structure and the portion added during the major rehabilitation (typical on both sides of all spans).

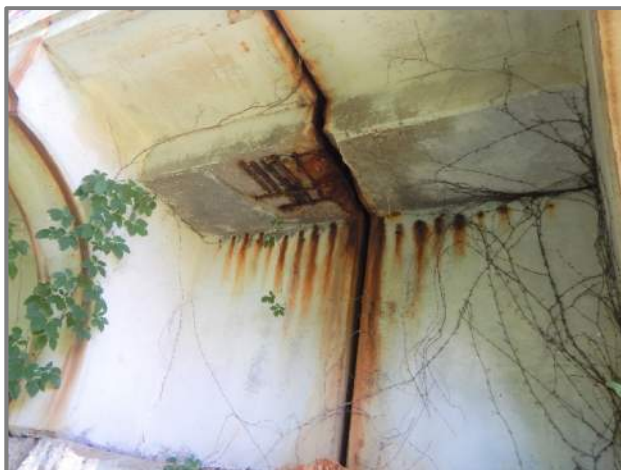
Photo 3 – Spall with three layers of exposed reinforcement at the right side of the deck underside (looking northwest at the West Pylon).

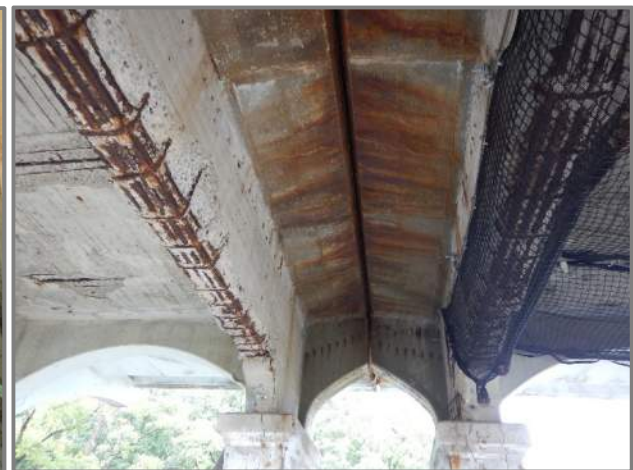
Photo 4 – Typical heavy rust staining in the deck underside below the compression joints (looking south at the Pier 6 joint underside). Note the netting in Span B and extensive floorbeam spalls.

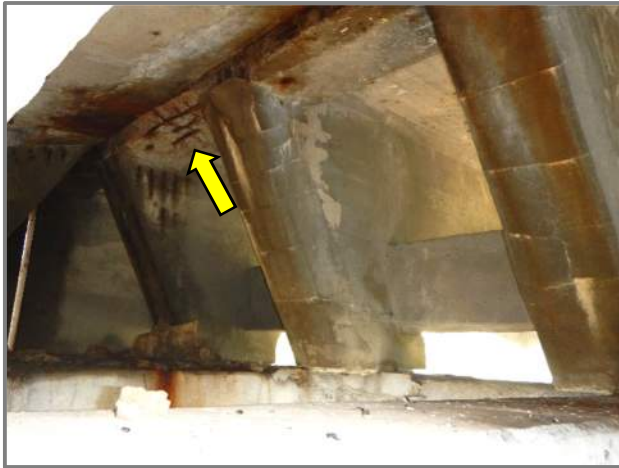
Photo 5 – Deck underside at the East Pylon with a large spall with exposed reinforcement between Beams 2 and 3 in Span 15 (looking northeast).

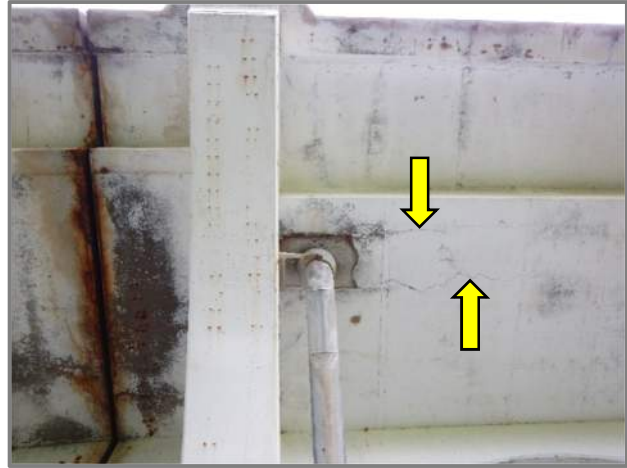
Photo 6 – Wide longitudinal cracks in the deck underside below scuppers (looking up and south in Span F near Pier 11).

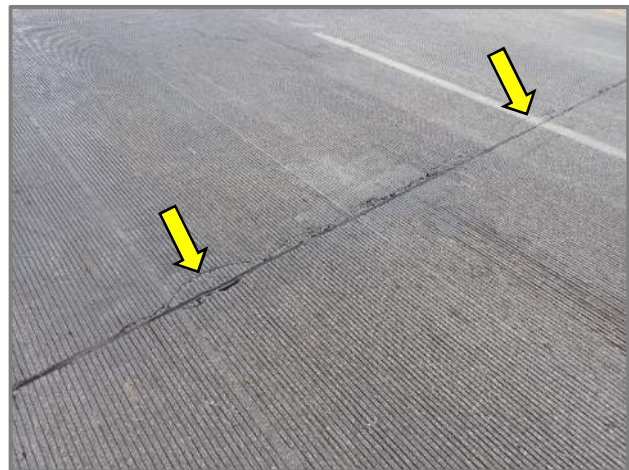
Photo 7 – Transverse cracks at the rear edge of the Rear Abutment slab wearing surface (looking southeast in the westbound lanes).

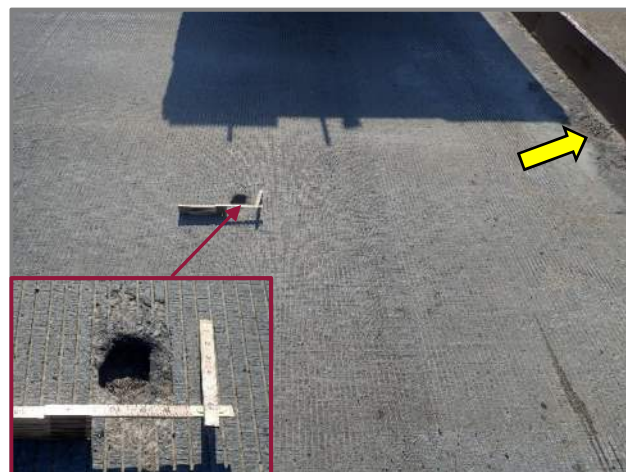
Photo 8 – A spall in the wearing surface located near midspan of Span C (looking east in the eastbound lanes). Note the depression in the wearing surface near the curb.

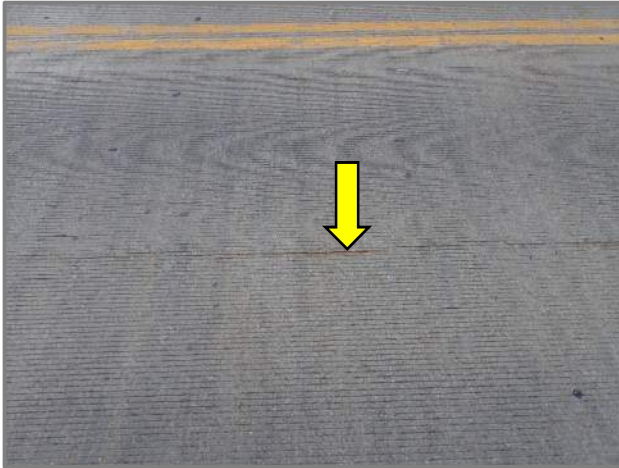
Photo 9 – A location of minor rust staining at a longitudinal crack in the wearing surface (looking south at the westbound lanes near midspan of Span E).

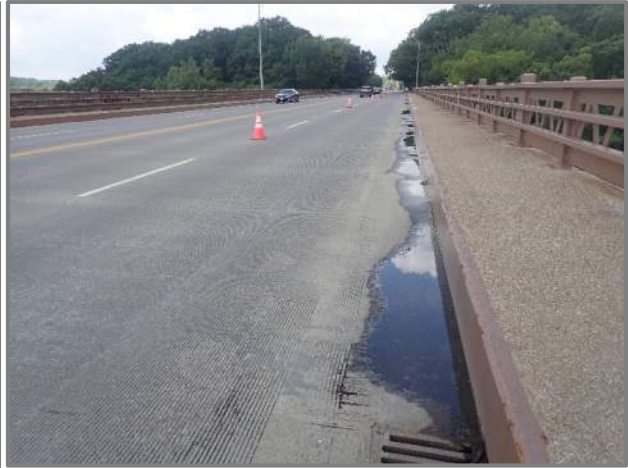
Photo 10 – Water ponding throughout the left edge of the wearing surface (looking west in the westbound lanes from Pier 7).

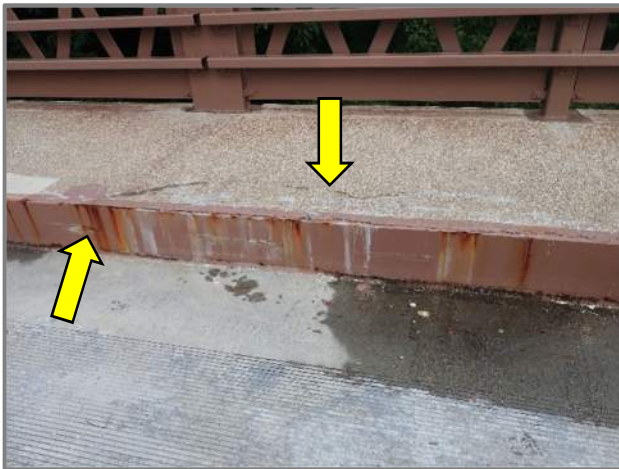
Photo 11 – Delamination at the rear end of the Span A left sidewalk (looking north). Note the typical rust staining on the curb plates at the impact scrapes and areas of failed protective coating.

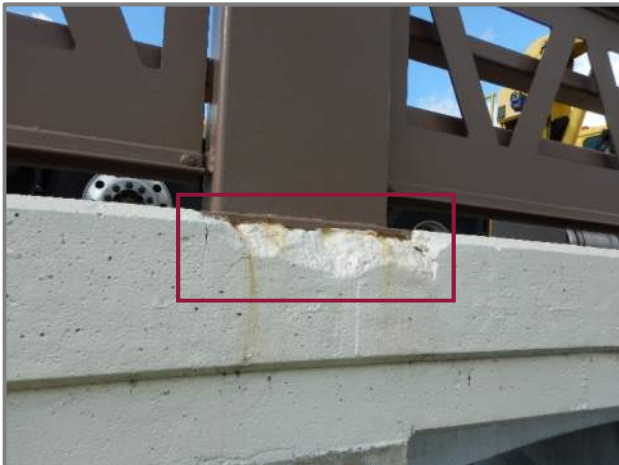
Photo 12 – Typical sealed spall in the exterior face of the concrete portion of the railings (looking southwest at the left railing near Pier 13).

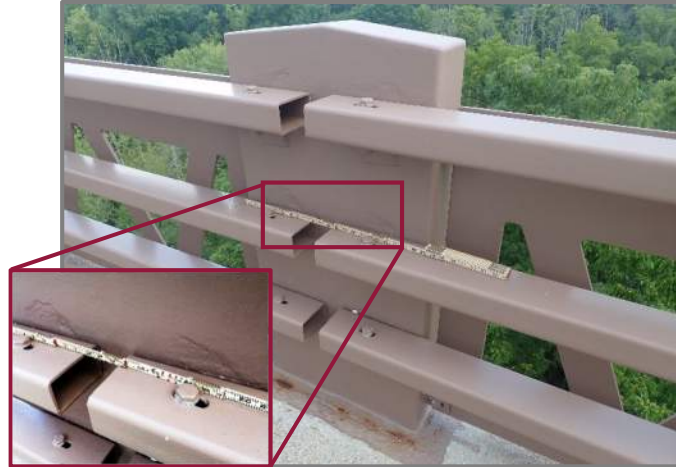
Photo 13 – Painted over pitting in a metal post above the railing (looking north at the left forward end of Span E). Note the minor corrosion at the base plate.

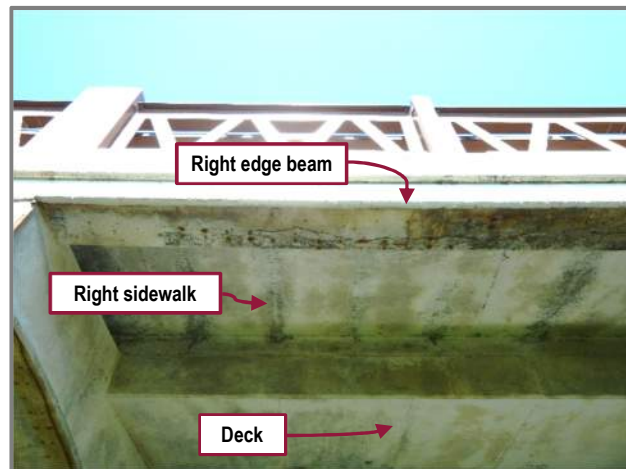
Photo 14 – Right edge beam with typical longitudinal cracks, rust staining, and water staining (looking up and north between Floorbeams 6 and 7 in Span A). Note the transverse hairline cracks in the sidewalk underside.

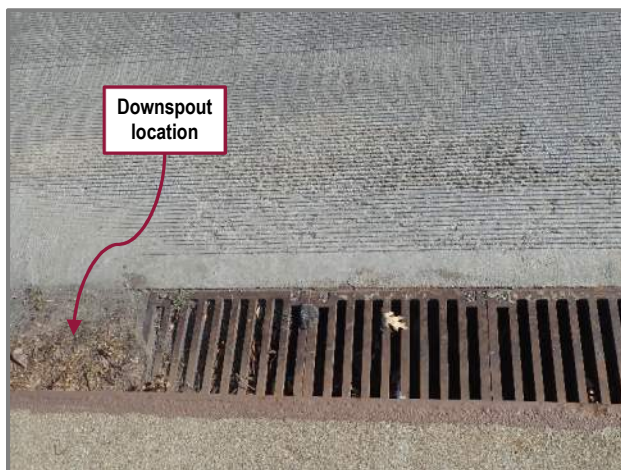
Photo 15 – Scupper at the right forward end of Span A which is 100% clogged above the downspout (looking north). Note the minor wear in the wearing surface.

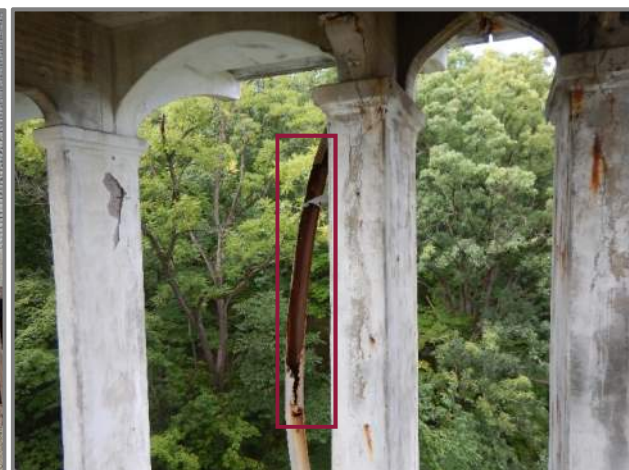
Photo 16 - 100% section loss in the downspout on the west side of Pier 6 (looking northwest).

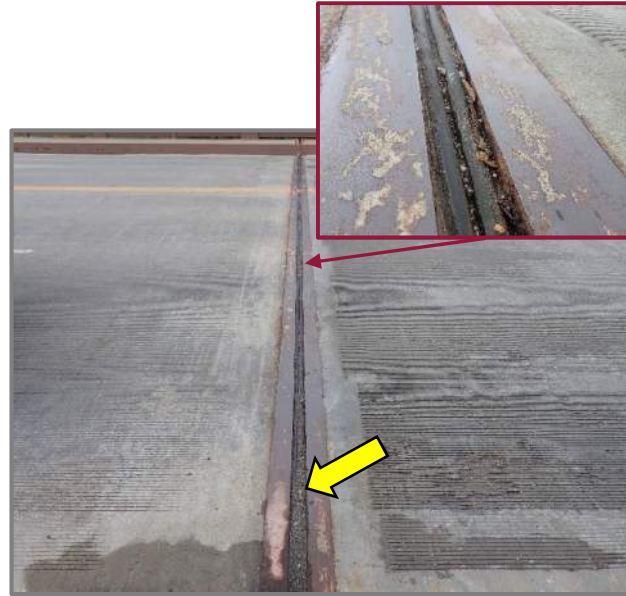
Photo 17 – Typical compression joint seal with moderate to heavy debris in the joint and laminate corrosion on the armor (looking south at the East Pylon joint). Note the heavy debris near the left curb.

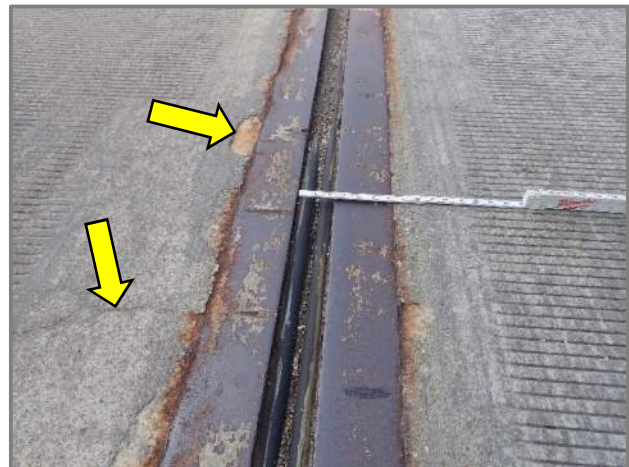
Photo 18 – Typical loss of adhesion of the compression joint seals with bulges and depressions (looking south at the Pier 7 joint in the westbound lanes). Note the minor spalls and longitudinal hairline crack in the joint header.

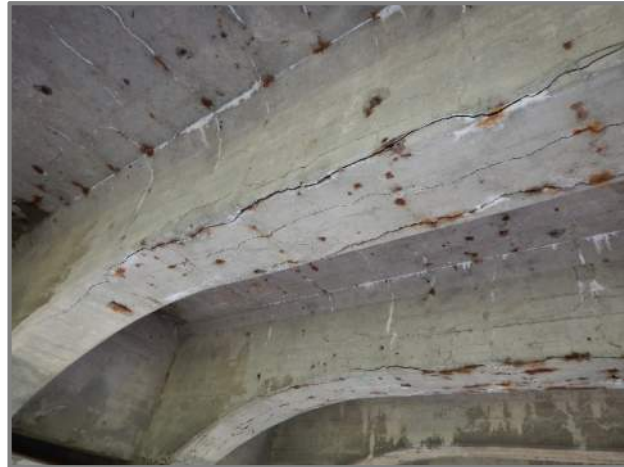
Photo 19 – Delamination with wide cracks in the underside of Beams 4 and 5 at the forward side of Span 17 (looking southeast). Inset: Looking southeast at the underside of Beam 5 closer to midspan.

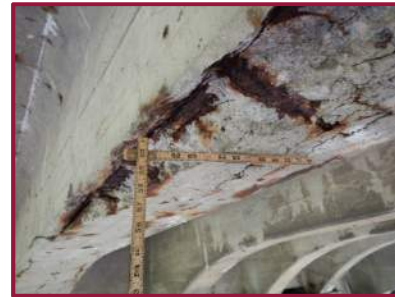
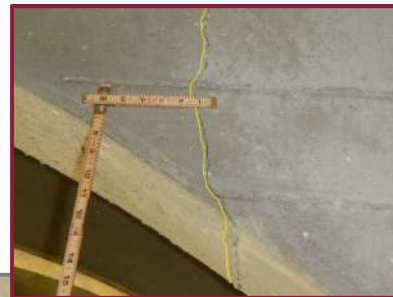
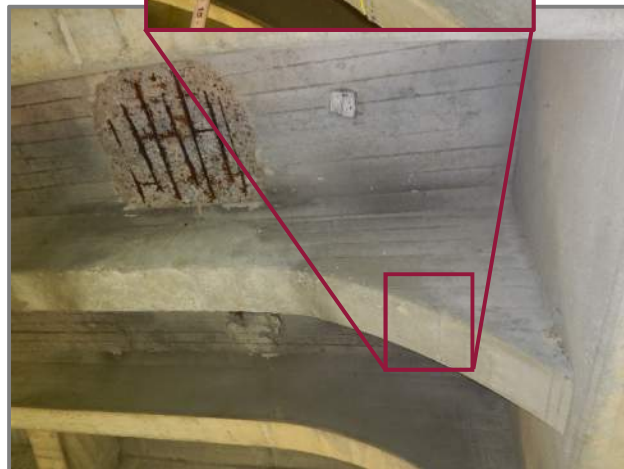
Photo 20 – 1/16" wide crack around the full perimeter of Beam 4 in Span 4 (looking north at the forward end near Pier 5). Crack outlined in yellow.

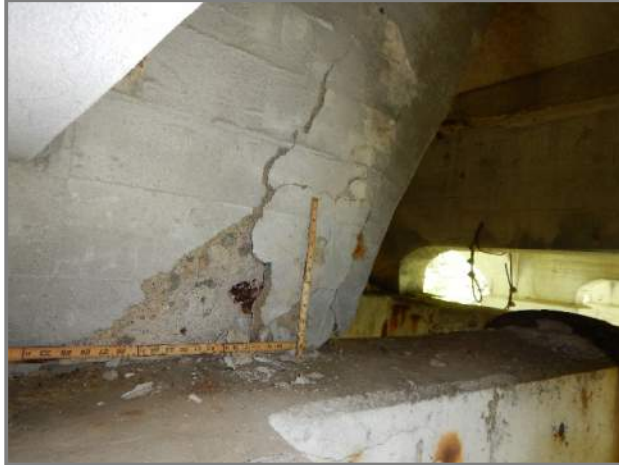
Photo 21 – Spall and delamination in the end of Beam 4 at the West Pylon (looking northeast in Span 6).

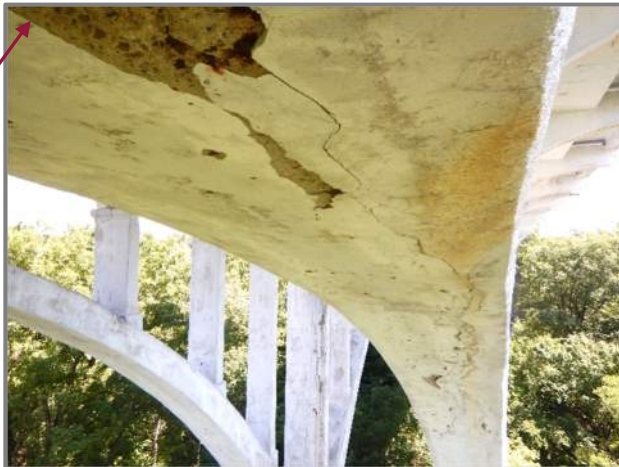
Photo 22 - Typical main arch rib underside exhibiting spalls with exposed reinforcement and delaminations (looking east at the Span E right arch). Inset: Looking south.

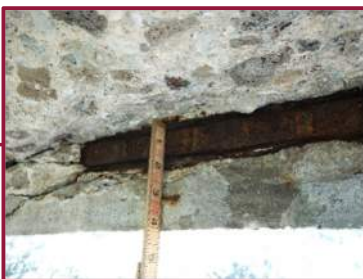
Spalls in the arch spandrel columns are most prevalent at the interior face below the joints with the worst locations being Piers 6 through 9 and 12. The upper 10' of the spandrel columns are typically spalled up to 5" deep (see Photo 24) with the remaining height exhibiting delaminations and wide cracks with rust staining. The remainder of the arch spandrel columns have scattered spalls and delaminations with the most notable being the

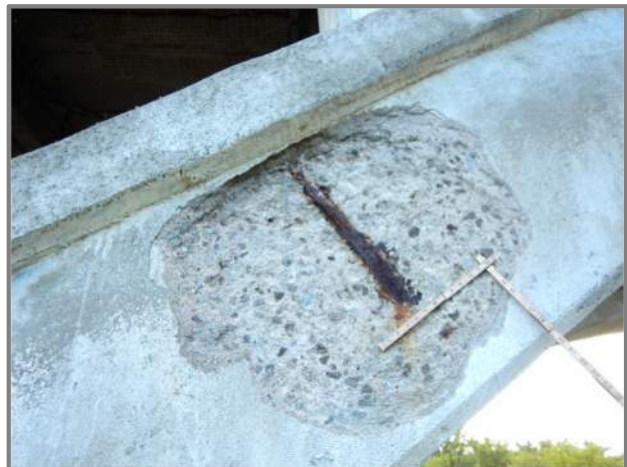
Photo 23 – Spall with exposed reinforcement where a delamination in the Span B left arch was safely removed during the inspection (looking south above the east shoulder of Valley Parkway and below Column 8).

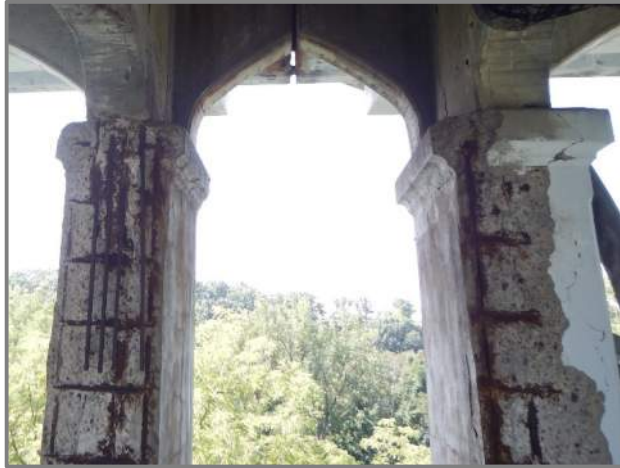
Photo 24 – Typical spalls with exposed reinforcement in the arch spandrel columns below the joints (looking south at right columns near Pier 9).

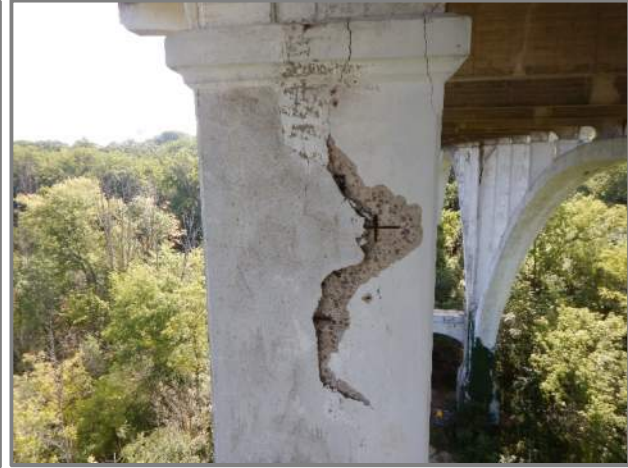
Photo 25 – Spall/delamination 8' high in the rear face of the Span D left arch Spandrel Column 2 (looking east).

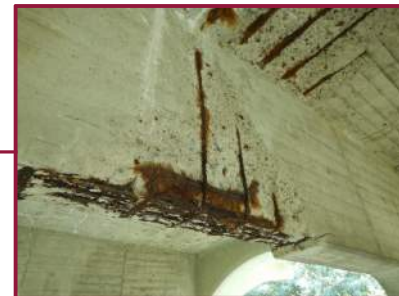
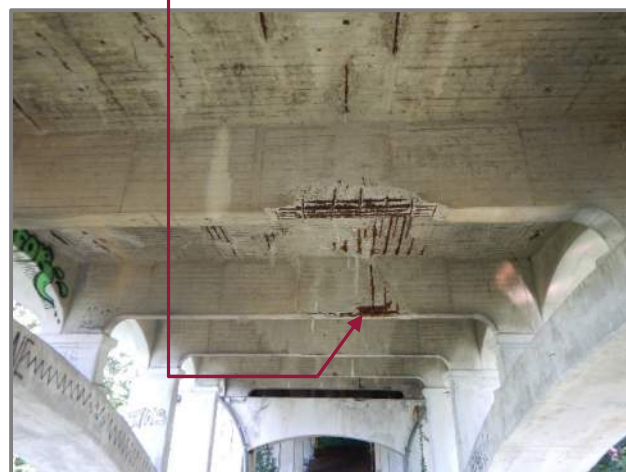
Photo 26 – Spalls with 3 broken stirrups in Floorbeams A3 and A4 (looking west). Inset: Looking northwest at Floorbeam A3 where a 10' long delamination was removed.

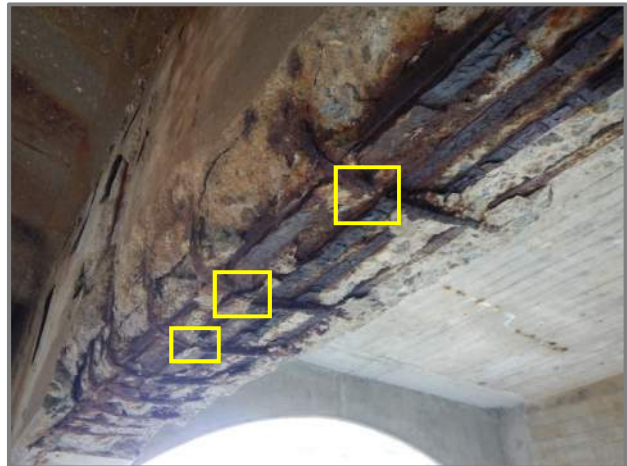
Photo 27 – Floorbeam Pier 12W spall with broken stirrups and spalling up to full height (looking southwest in Span H).

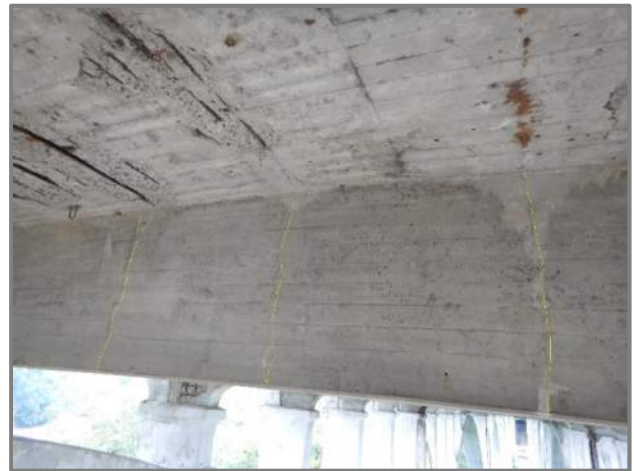
Photo 28 – Full height vertical hairline cracks in Floorbeam H5 (looking west). Cracks outlined in yellow.

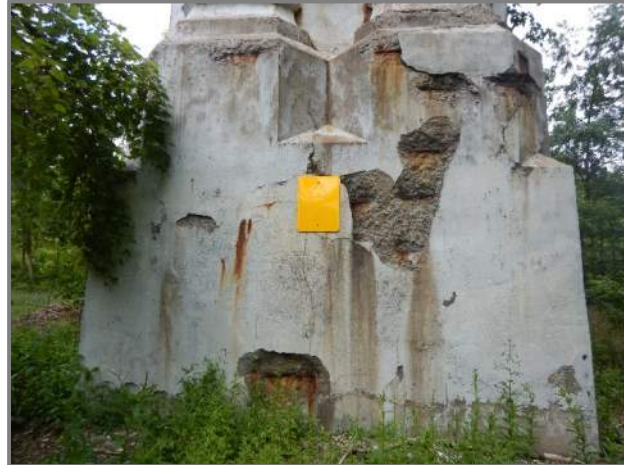
Photo 29 – Spalls with exposed reinforcement throughout the Pier 8 right column exterior face (looking north). Note the nearly fully faded falling concrete warning sign.

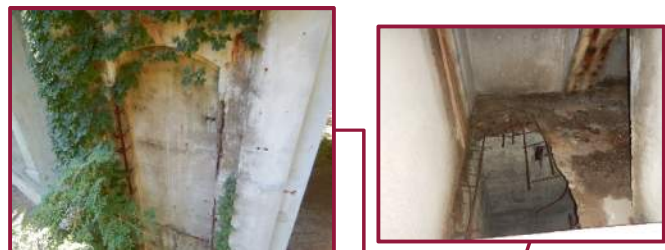
The pylon columns have several spalls with exposed reinforcement and hairline horizontal cracks with minor to moderate rust staining, particularly in the exterior faces below the joint (see Photo 30). The interior faces of the pylon columns exhibit moderate rust staining from corroding reinforcement below the joints which emanates from the openings below the pier caps. At the top of the West Pylon left column, the upper slab has been cut open in an 8' long by 4' wide area, and the exposed reinforcement is deteriorating with scaling in the surrounding concrete.

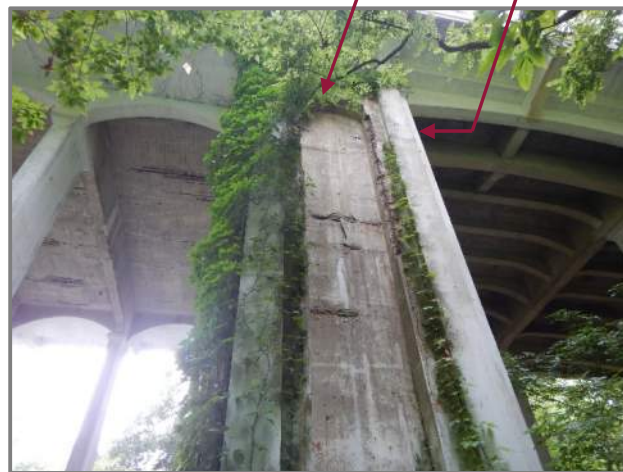
Photo 30 – West Pylon left column exterior face with spalls with exposed reinforcement and vegetation growth (looking south at the left face). Top left inset: Looking south. Top right inset: Looking east at the top of the column on the left side of Beam 1.

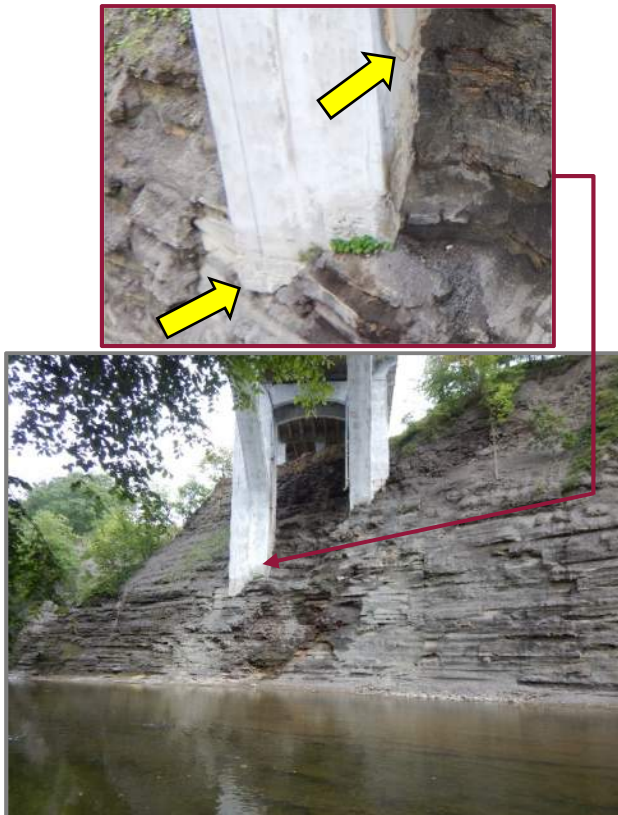
Photo 31 – Drastic elevation change between Pier 15 and the East Pylon with advanced erosion of the shale surrounding the East Pylon columns (looking east from Pier 12). Inset: Looking northeast at the left column undermined left rear corner and nearby downspout.

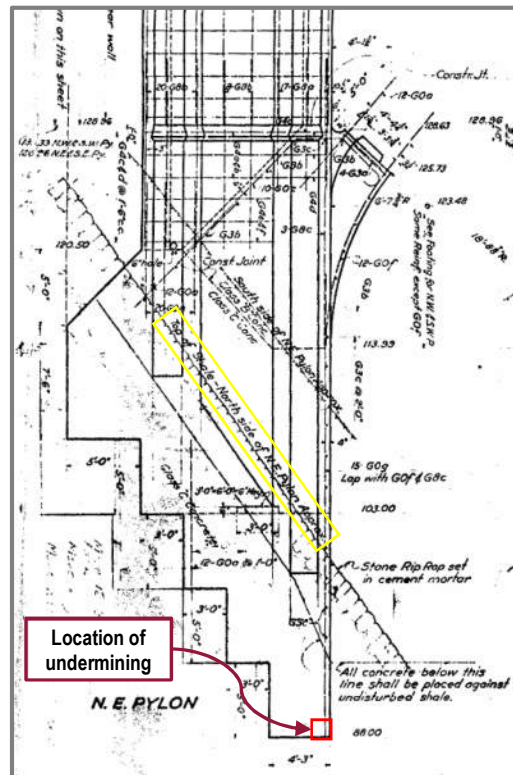
Figure 4 - East Pylon left column footing detail (taken from the original design drawings).

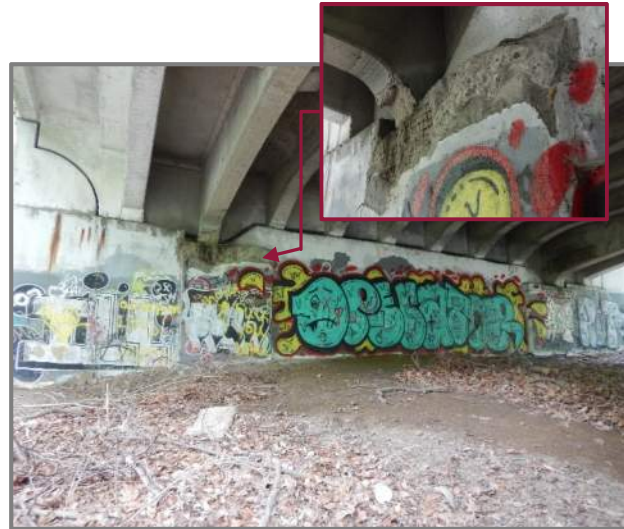
Photo 32 – East elevation of the Rear Abutment (looking west). Inset: Looking southwest at the spall with exposed reinforcement in the right relief.

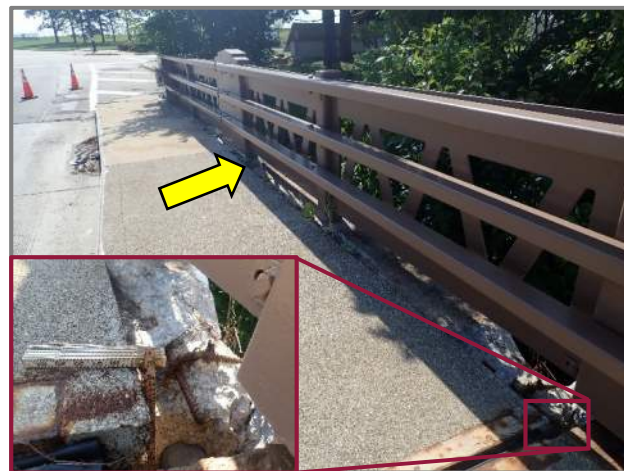
Photo 33 – Spall up to 20" deep at the rear end of the Forward Abutment right wall (looking east). Note the spalls throughout the top of the wall.

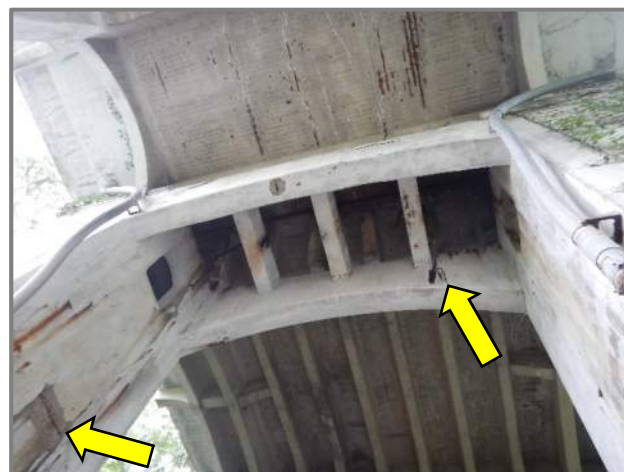
Photo 34 – East elevation of the West Pylon pier caps (looking up and west below the centerline of the bridge). Note the spall and rust staining in the West Pylon right column and the previous compression joint seal discarded on top of the pier cap struts.

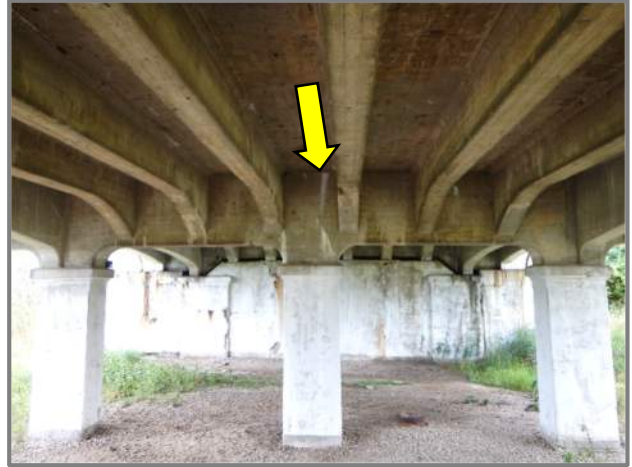
Photo 35 – West elevation of the Pier 14 cap with moderate efflorescence at full height vertical hairline cracks between Beams 5 and 6 (looking east). Note the spalls and rust staining in the Forward Abutment.

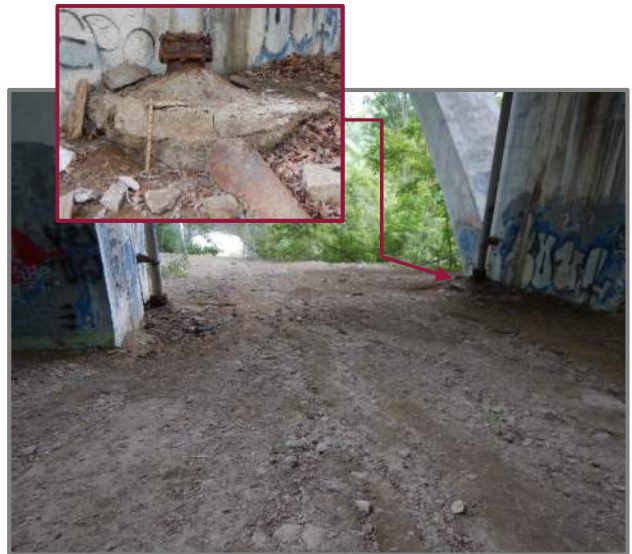
Photo 36 – Typical minor erosion channels at the rear approach spans with up to 18" deep erosion at the West Pylon right downspout (looking east from Span 6). Inset: Looking southwest.

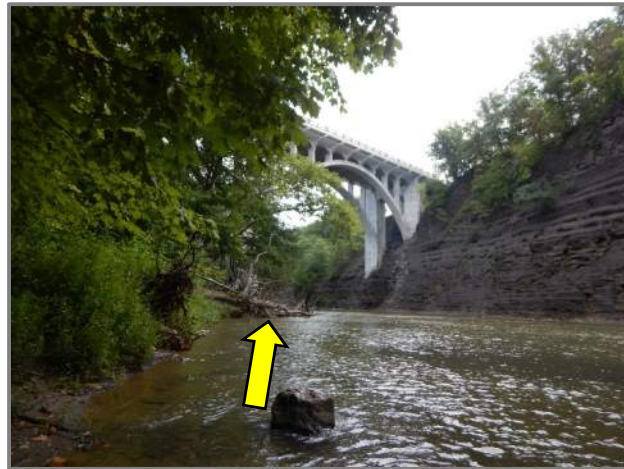
Photo 37 – Looking towards the bridge from upstream (looking north towards Span H). Note the curve in the channel alignment at the bridge and the downed tree.

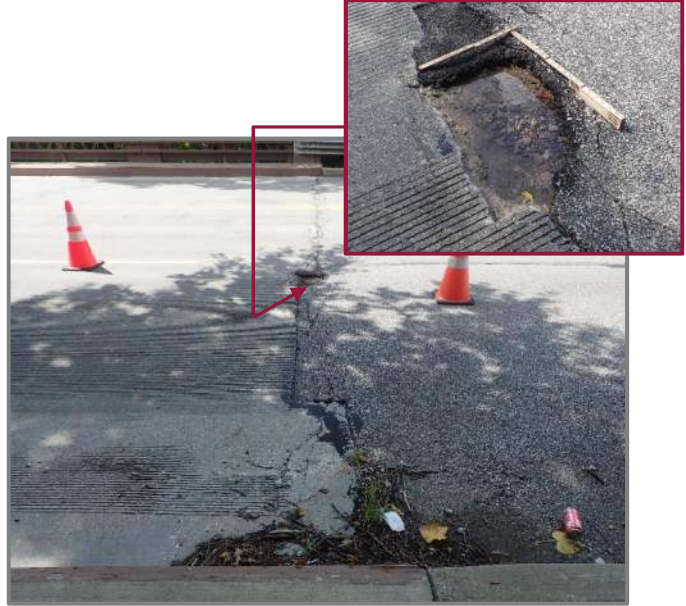
Photo 39 – Rear approach slab with a failed patch/pothole at the rear edge (looking west). Note the cracking along the rear edge of the slab.

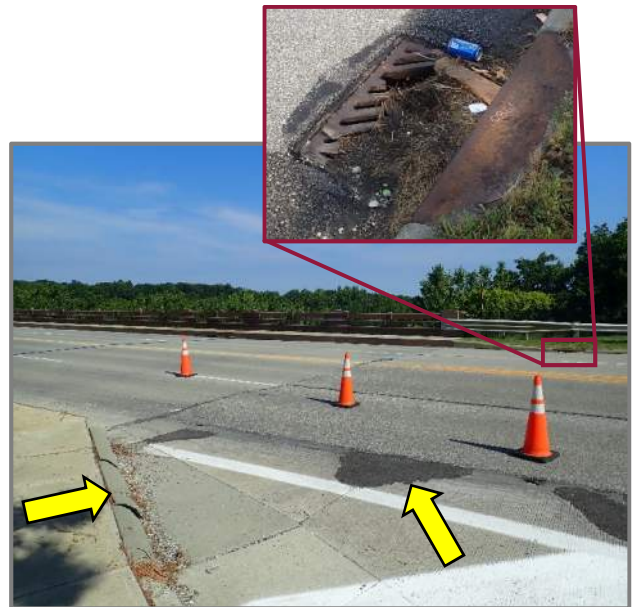
Photo 40 – Typical forward approach (looking north). Note the asphalt patches in the approach wearing surface and spalls in the right curb. Inset: Looking southwest at the cracked left forward curb inlet grate.

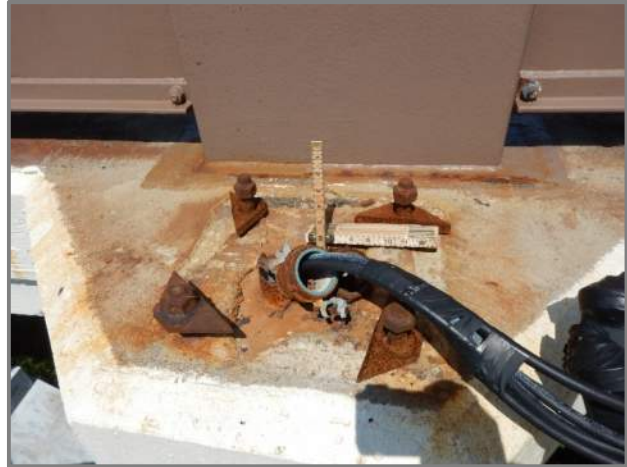
Photo 41 – Missing light post with corrosion on the anchor bolts and nuts and taped electrical wires (looking north at the right forward end of Pier 10 in Span E).

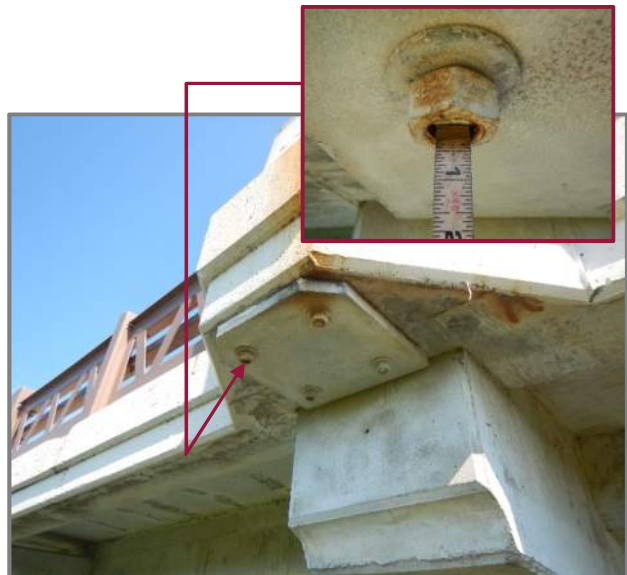
Photo 42 – Light post anchor bolts and nuts with minor corrosion and negative thread count (looking northwest at the right forward end of Span C).

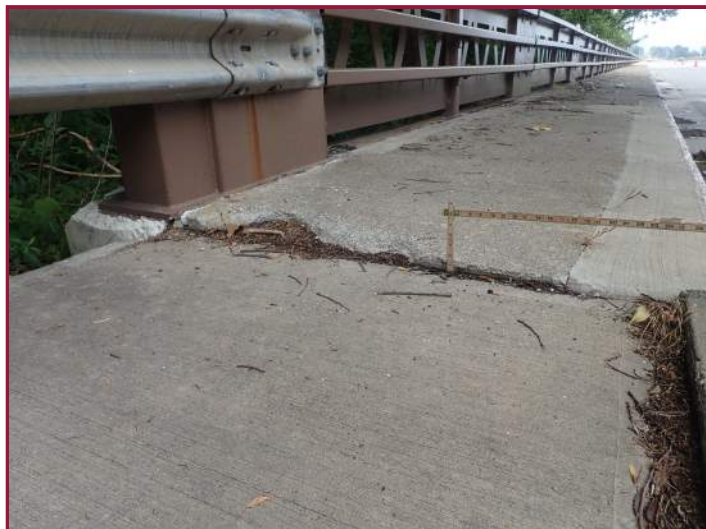
Settlement of the left rear approach sidewalk at the bridge (looking east).

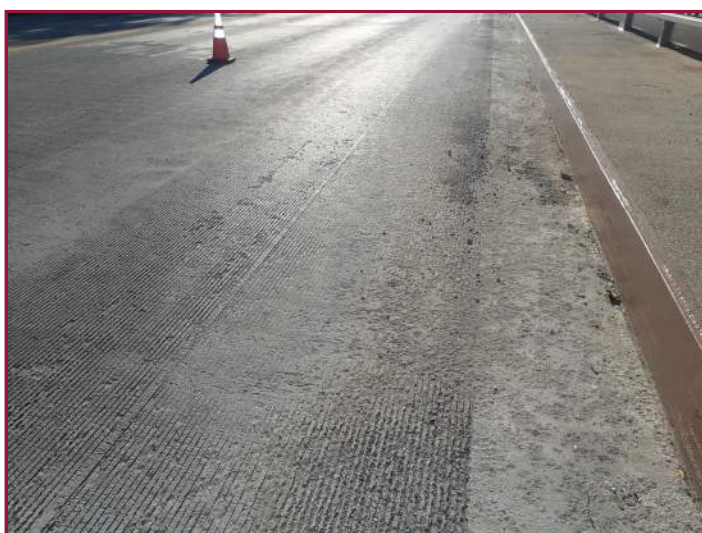
Minor scaling in the right side of the wearing surface (looking east).

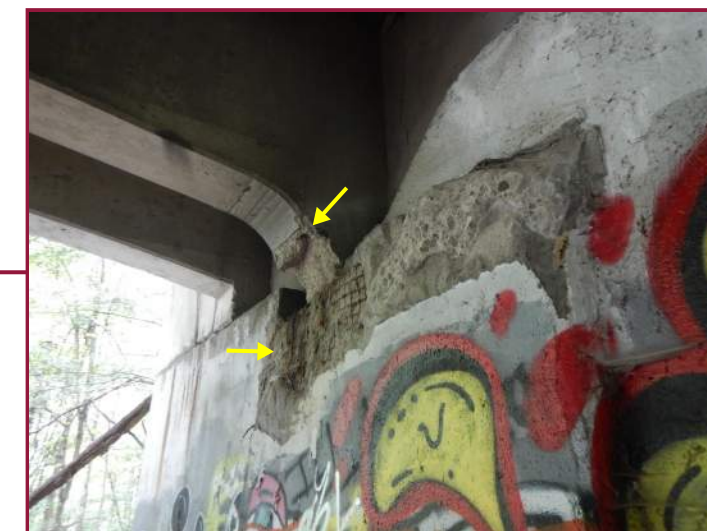
Spalls at the end of Beam 9 and in the top corner of the Rear Abutment beam seat (looking southwest).

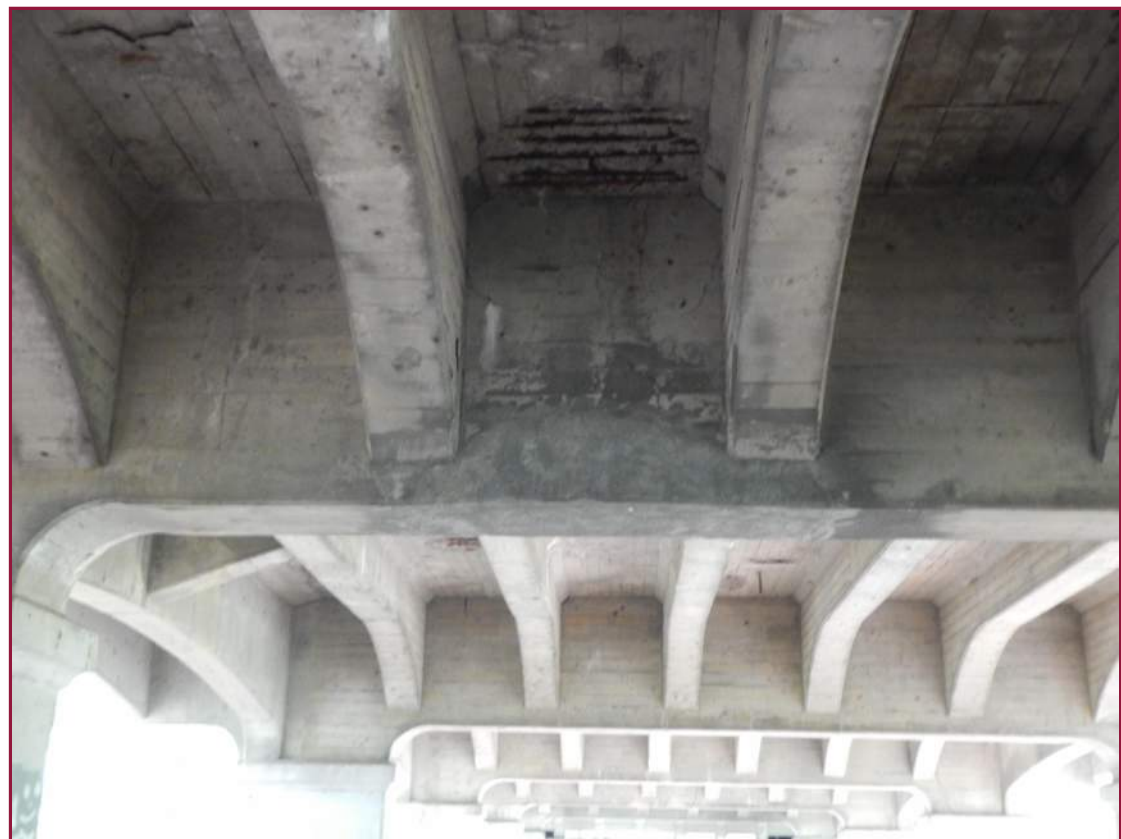
Patch in the Pier 1 cap (looking east).

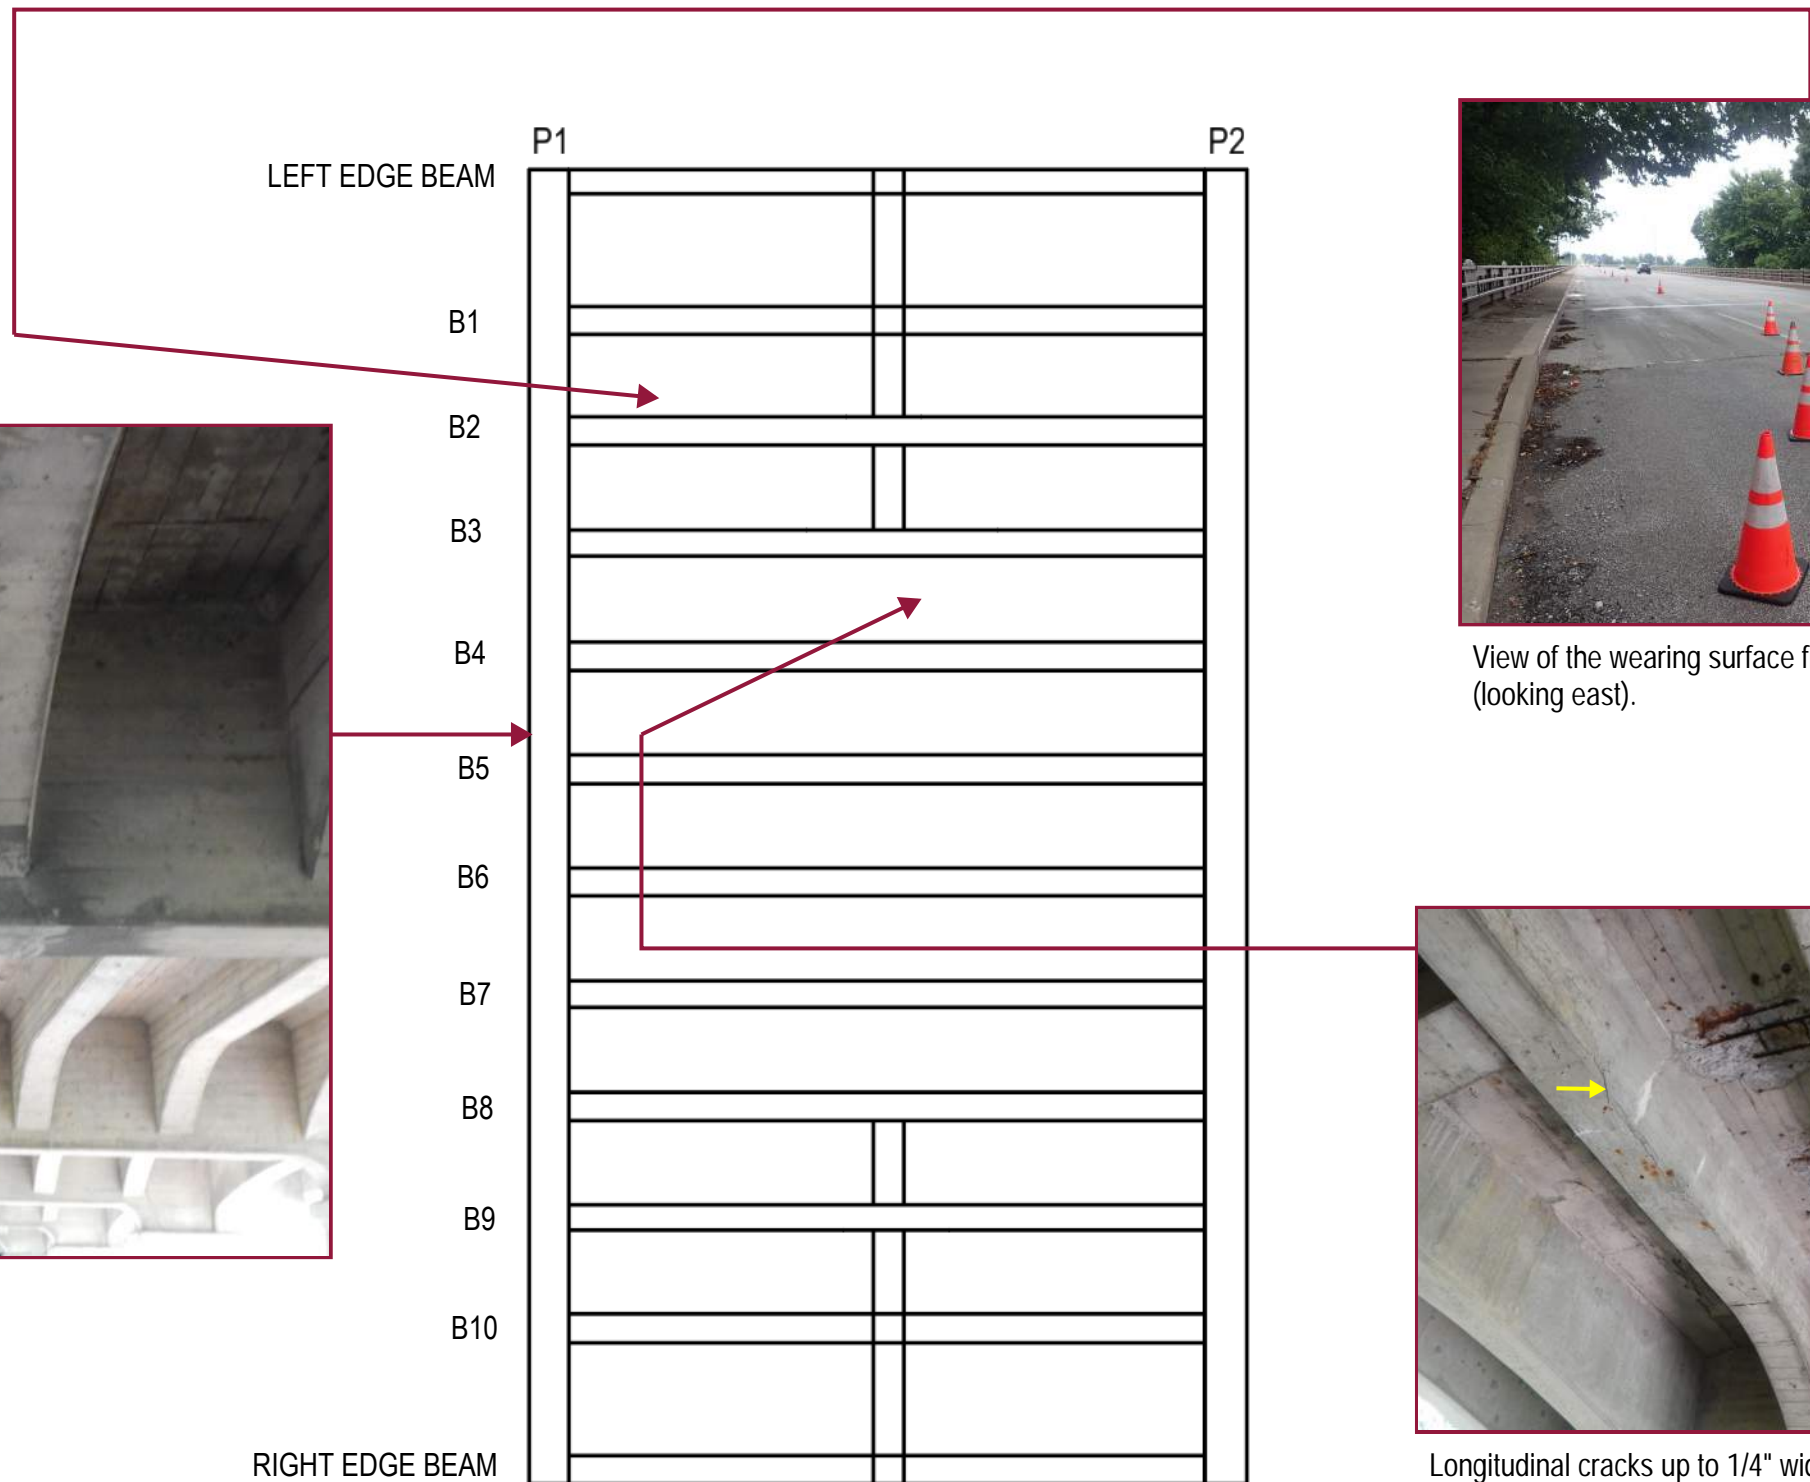
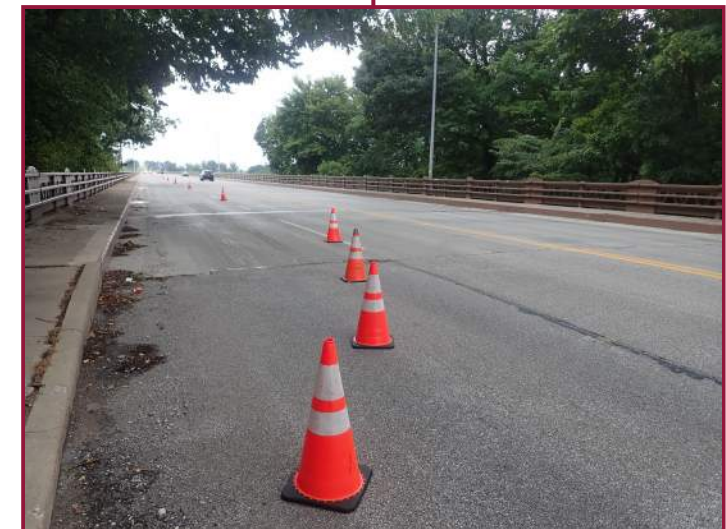
View of the wearing surface from the rear approach (looking east).

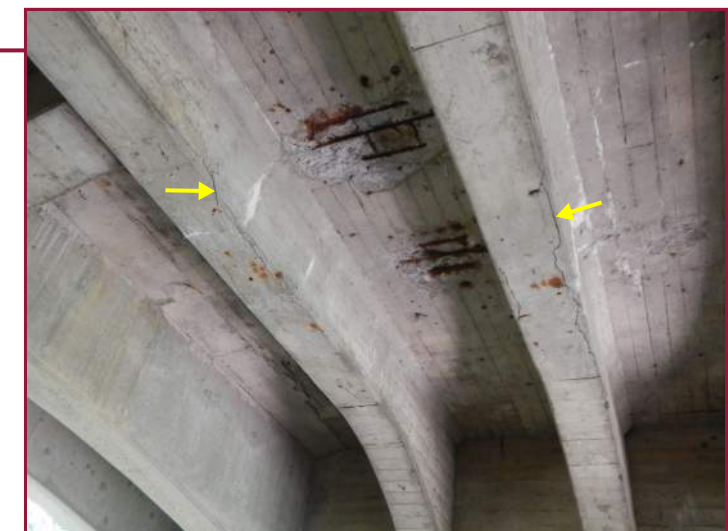
Longitudinal cracks up to 1/4" wide at delaminations in the underside of Beams 3 and 4 (looking east). Note the spalls with exposed reinforcement in the underside of the deck.
