**PHYSICAL CONDITION REPORT  
FOR THE 2022 ROUTINE ELEMENT LEVEL INSPECTION**

**BROOKPARK ROAD BRIDGE**  
BRIDGE NO. CUY-17-0283  
SFN: 1802046

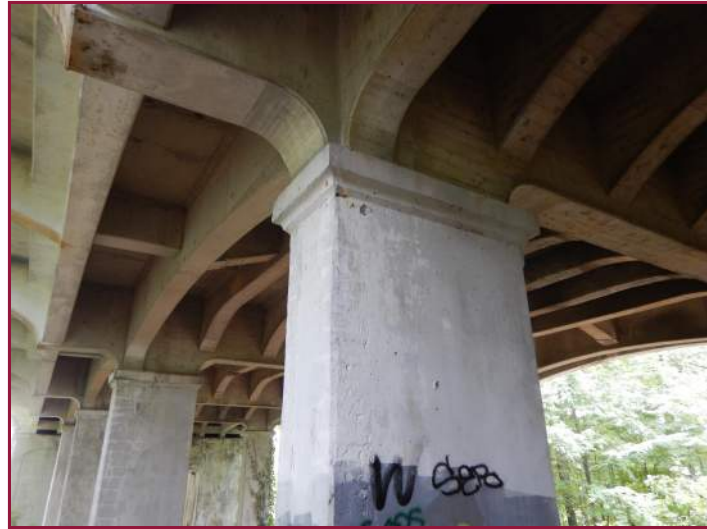
Typical hairline map cracking and minor popouts at patches in the columns (looking southeast).

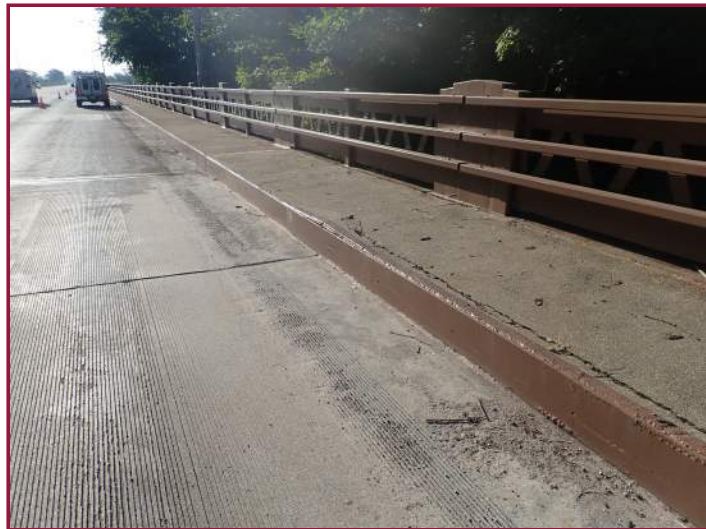
Typical railing and wearing surface (looking southeast from the rear approach).

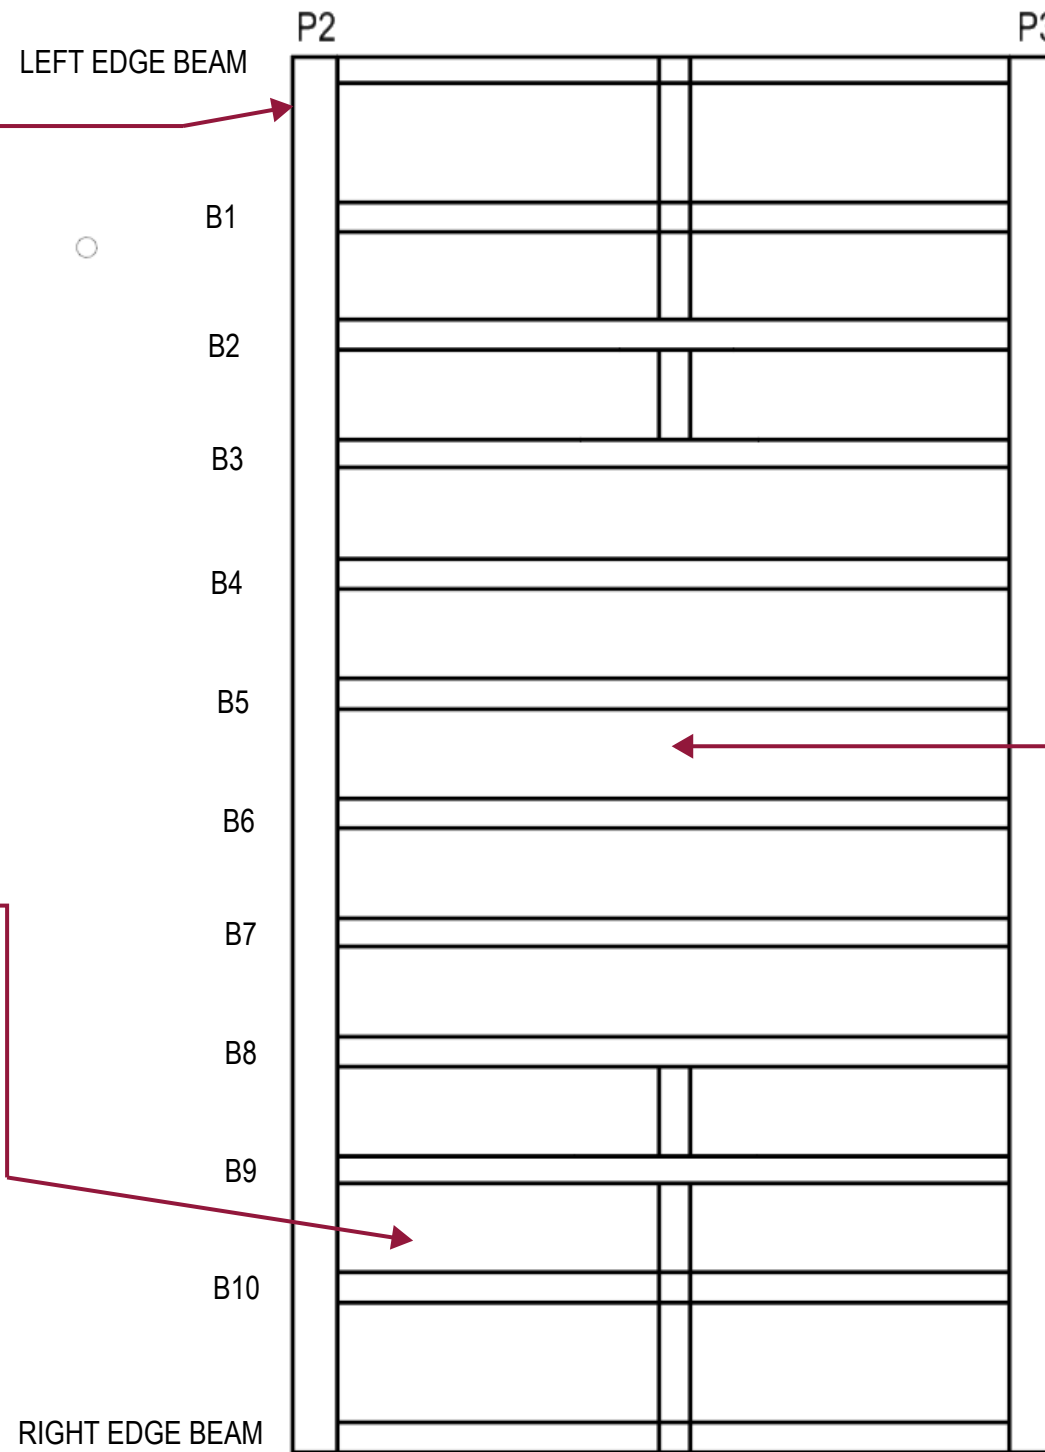
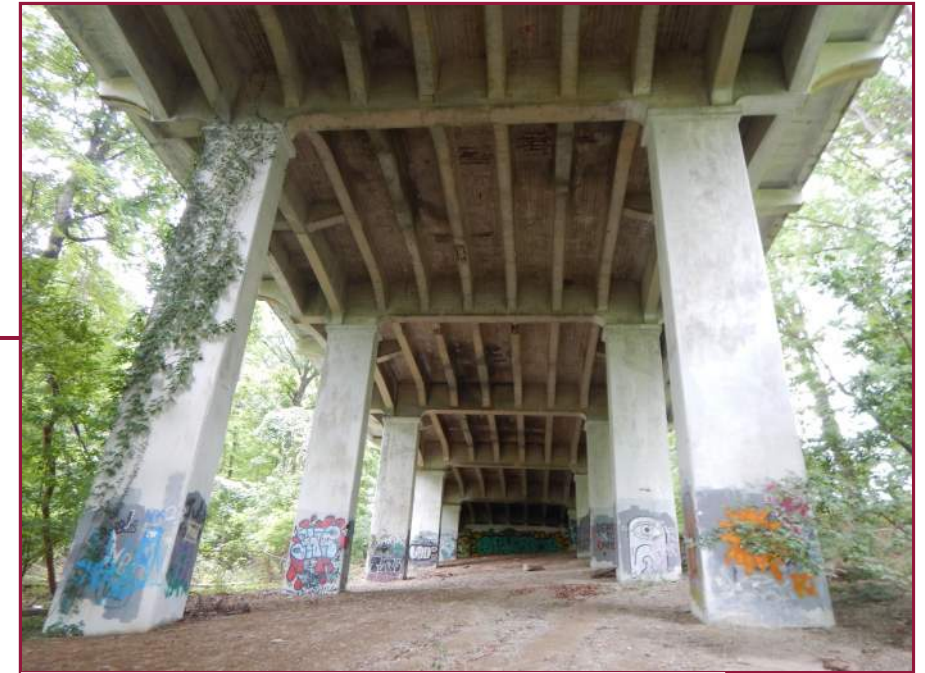
Deck underside overall view (looking west).

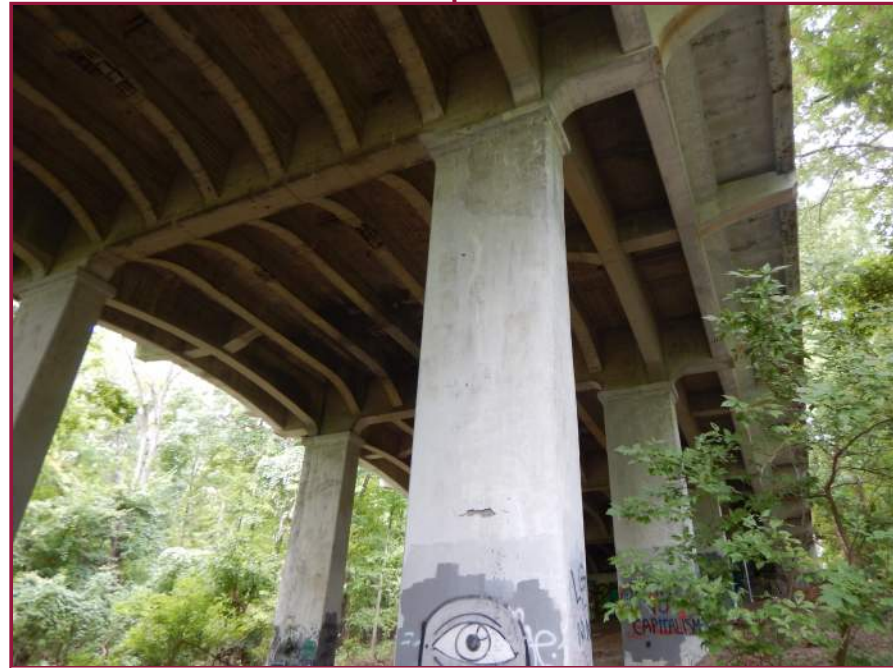
Typical hairline map cracking at patches in the approach columns (looking west).

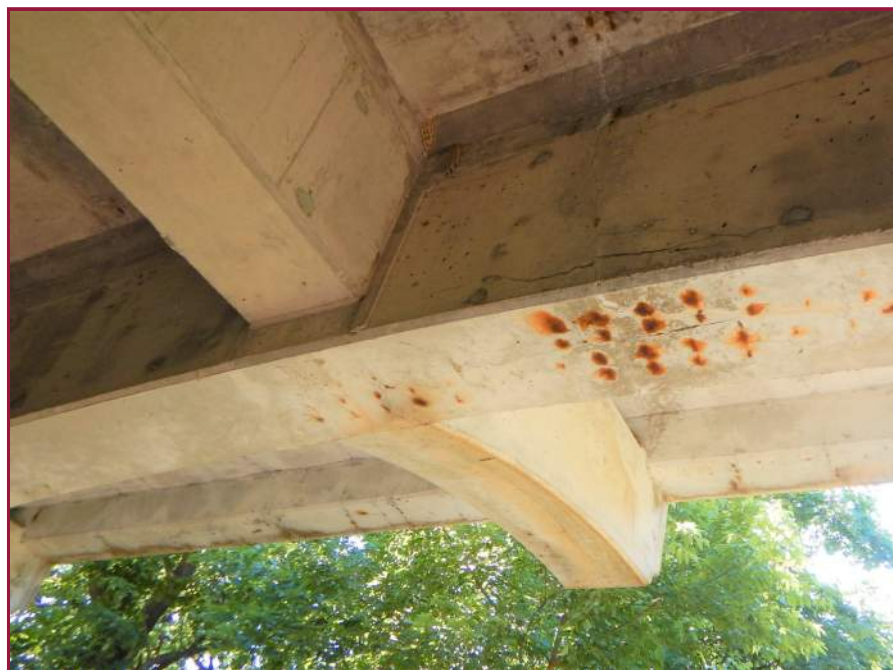
Delamination in the underside of Beam 10 near midspan (looking southeast).

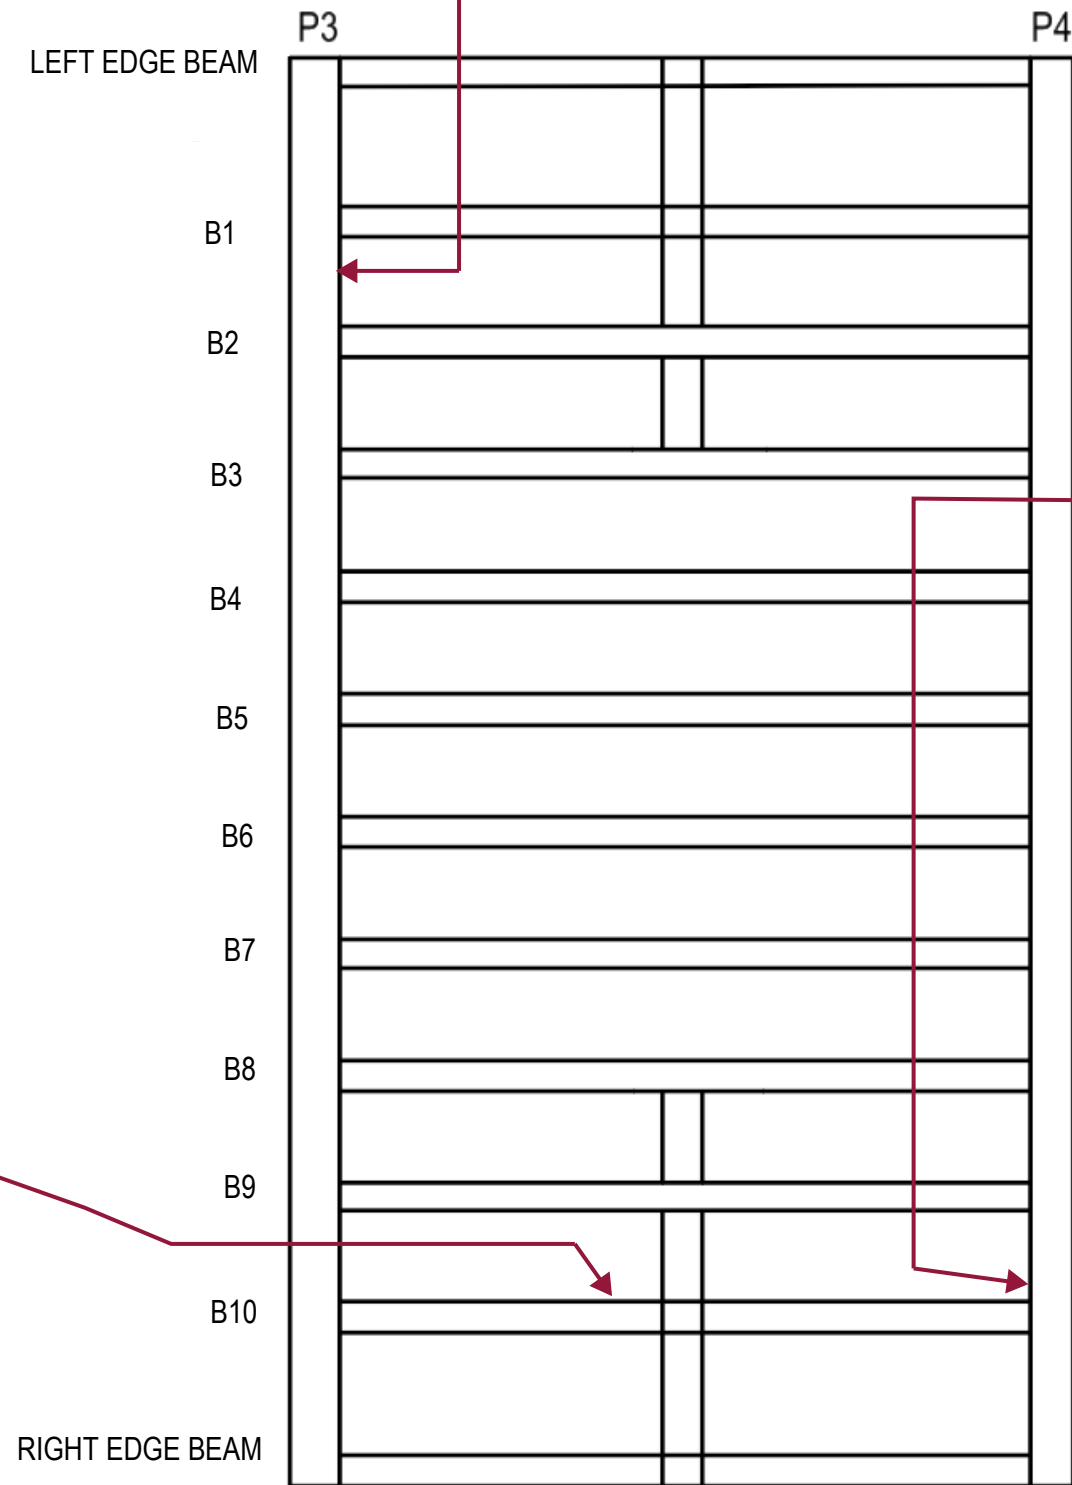
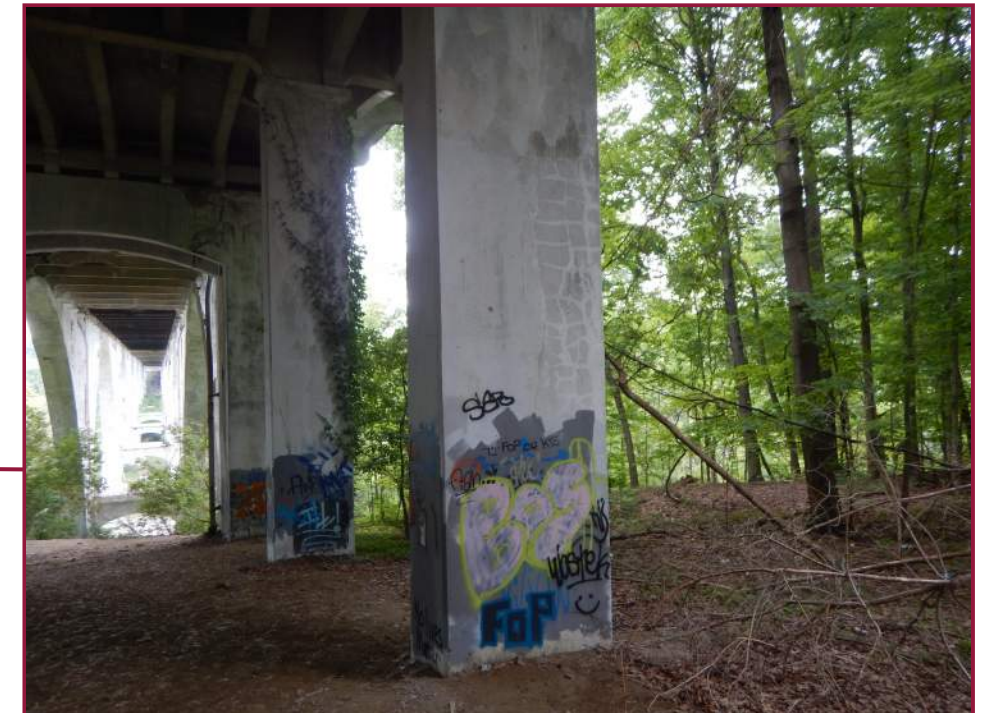
Hairline map cracking at a patch in the Pier 4 right column (looking east).

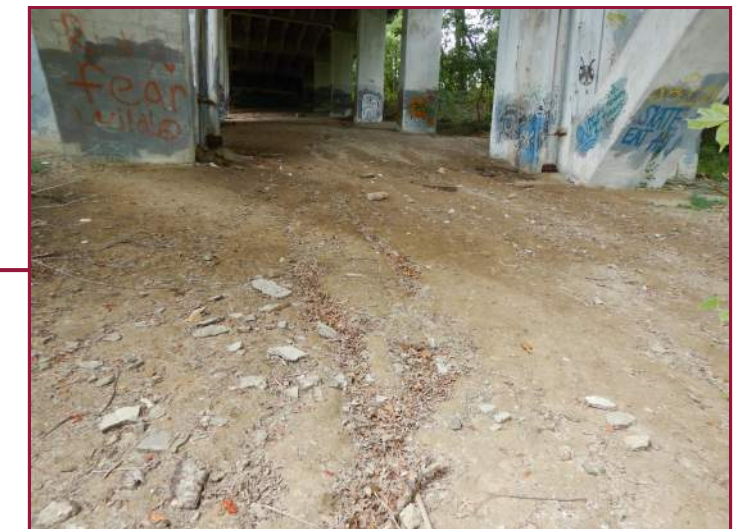
Typical minor erosion channels in the area below the bridge (looking west).

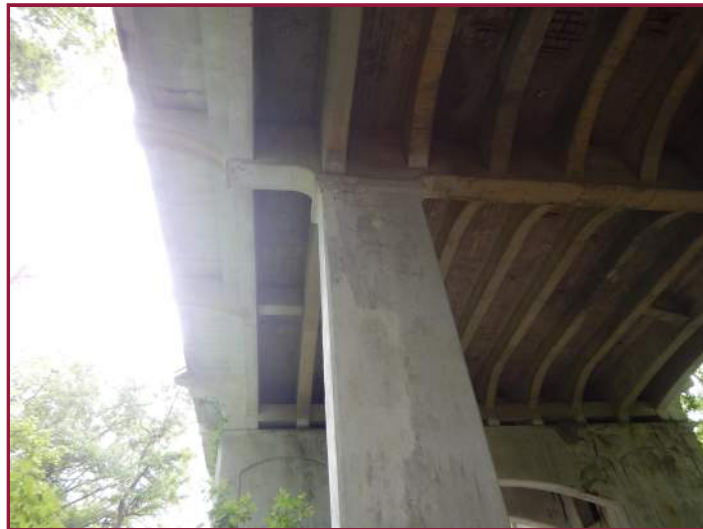
Hairline map cracking at a patch in the approach pier column (looking east).

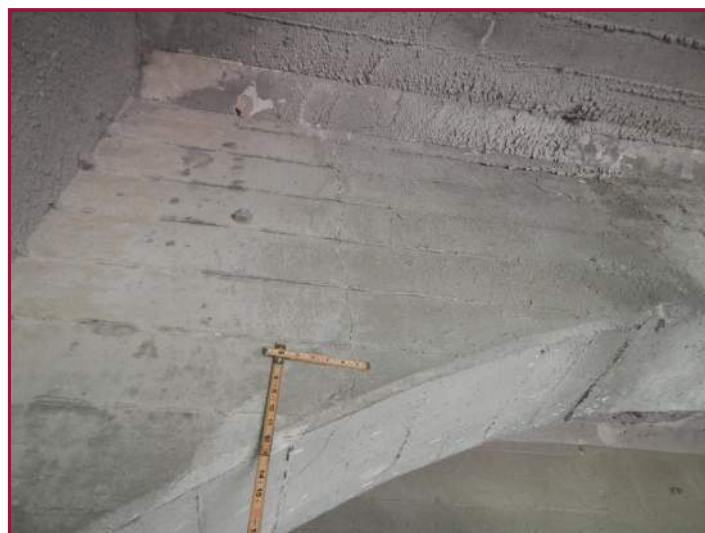
Full height vertical crack up to 1/16" wide at the east end of the Beam 4 north face (looking south).

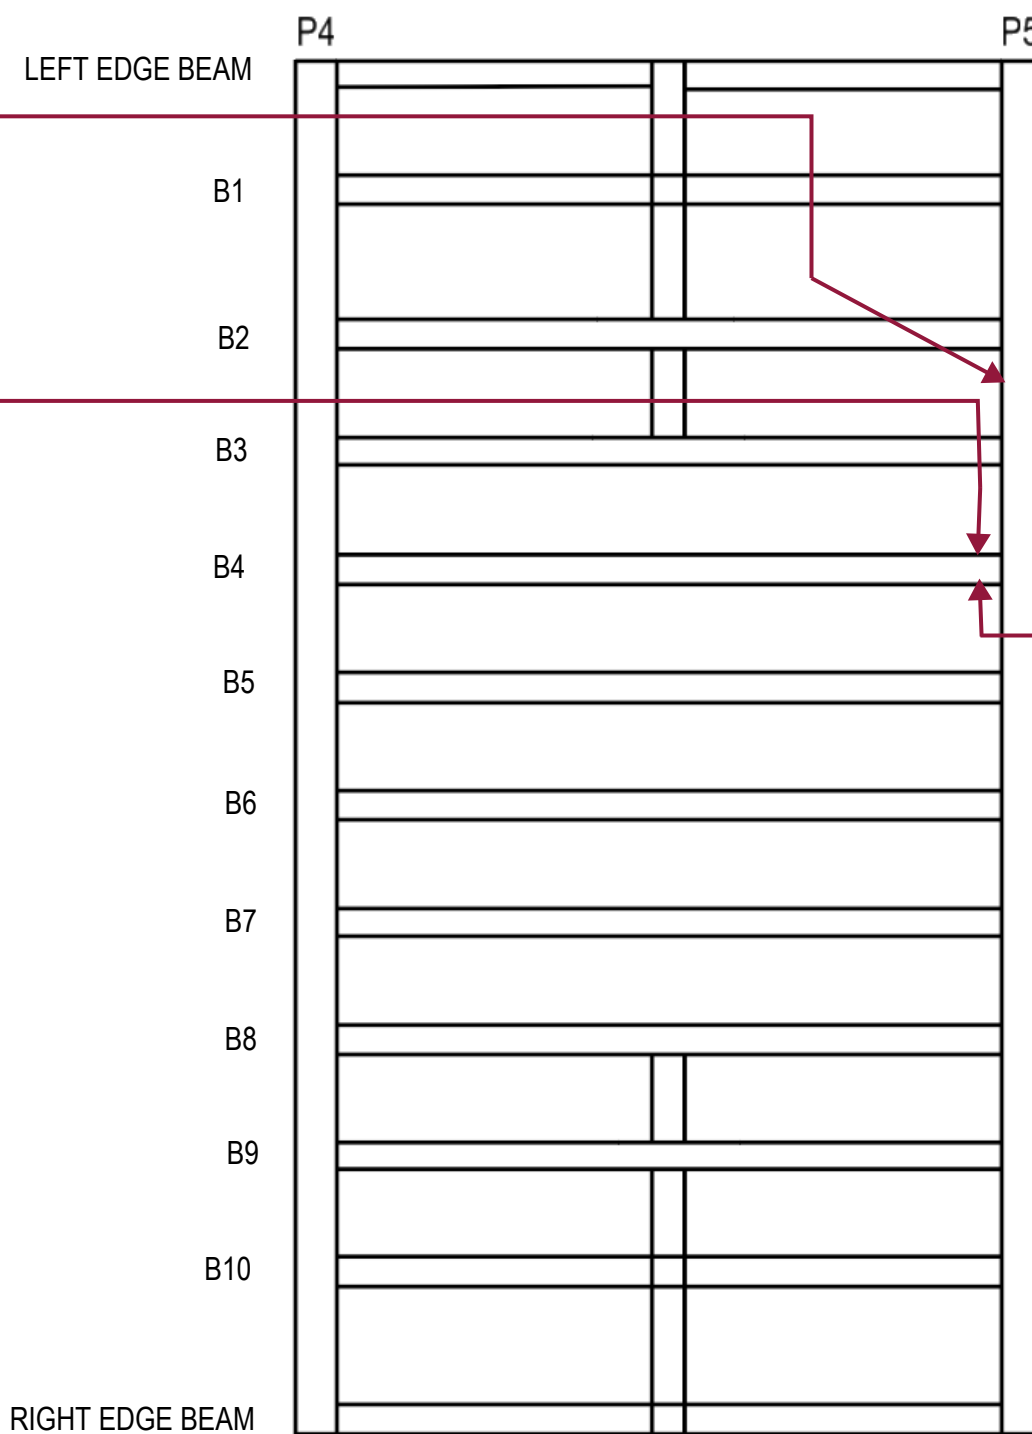
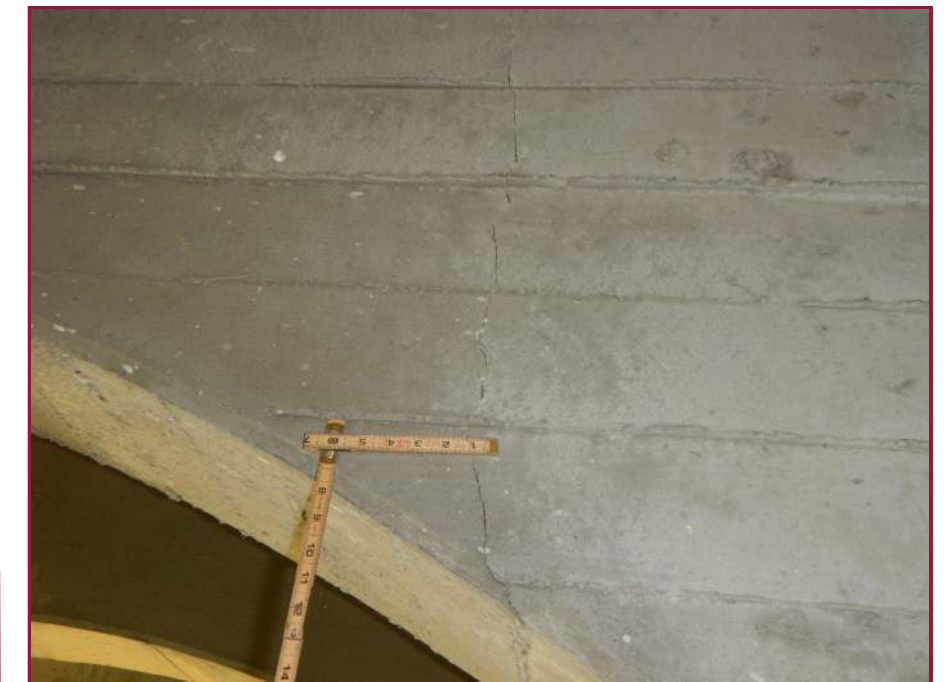
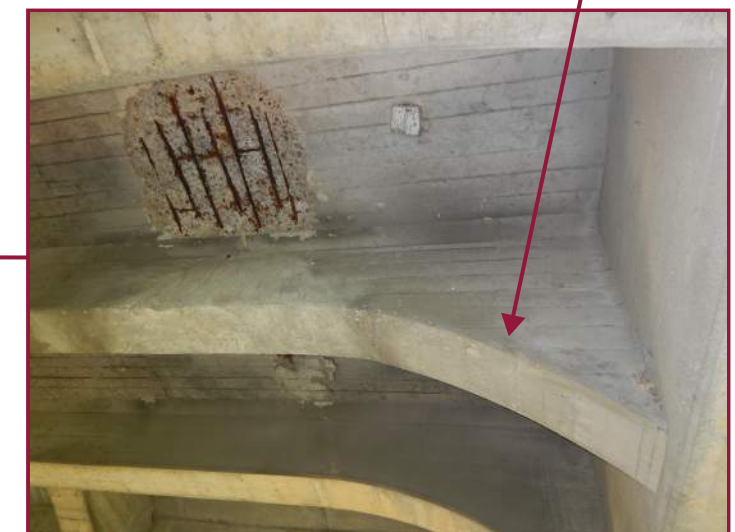
Full height vertical crack up to 1/16" wide at the east end of the Beam 4 south face (looking north).

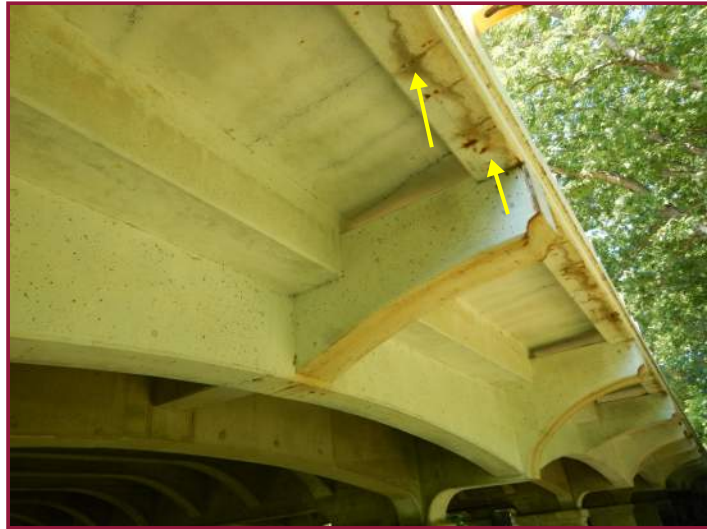
Typical longitudinal hairline cracks with rust staining and isolated spalls up to 2" deep at the north face of the Left Edge Beam near midspan (looking southwest).

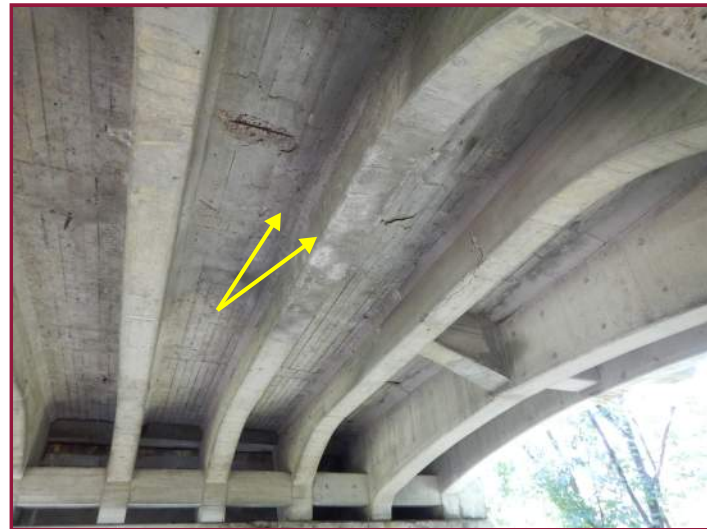
Patch to the deck underside and all faces of Beam 7 near midspan (looking southeast).

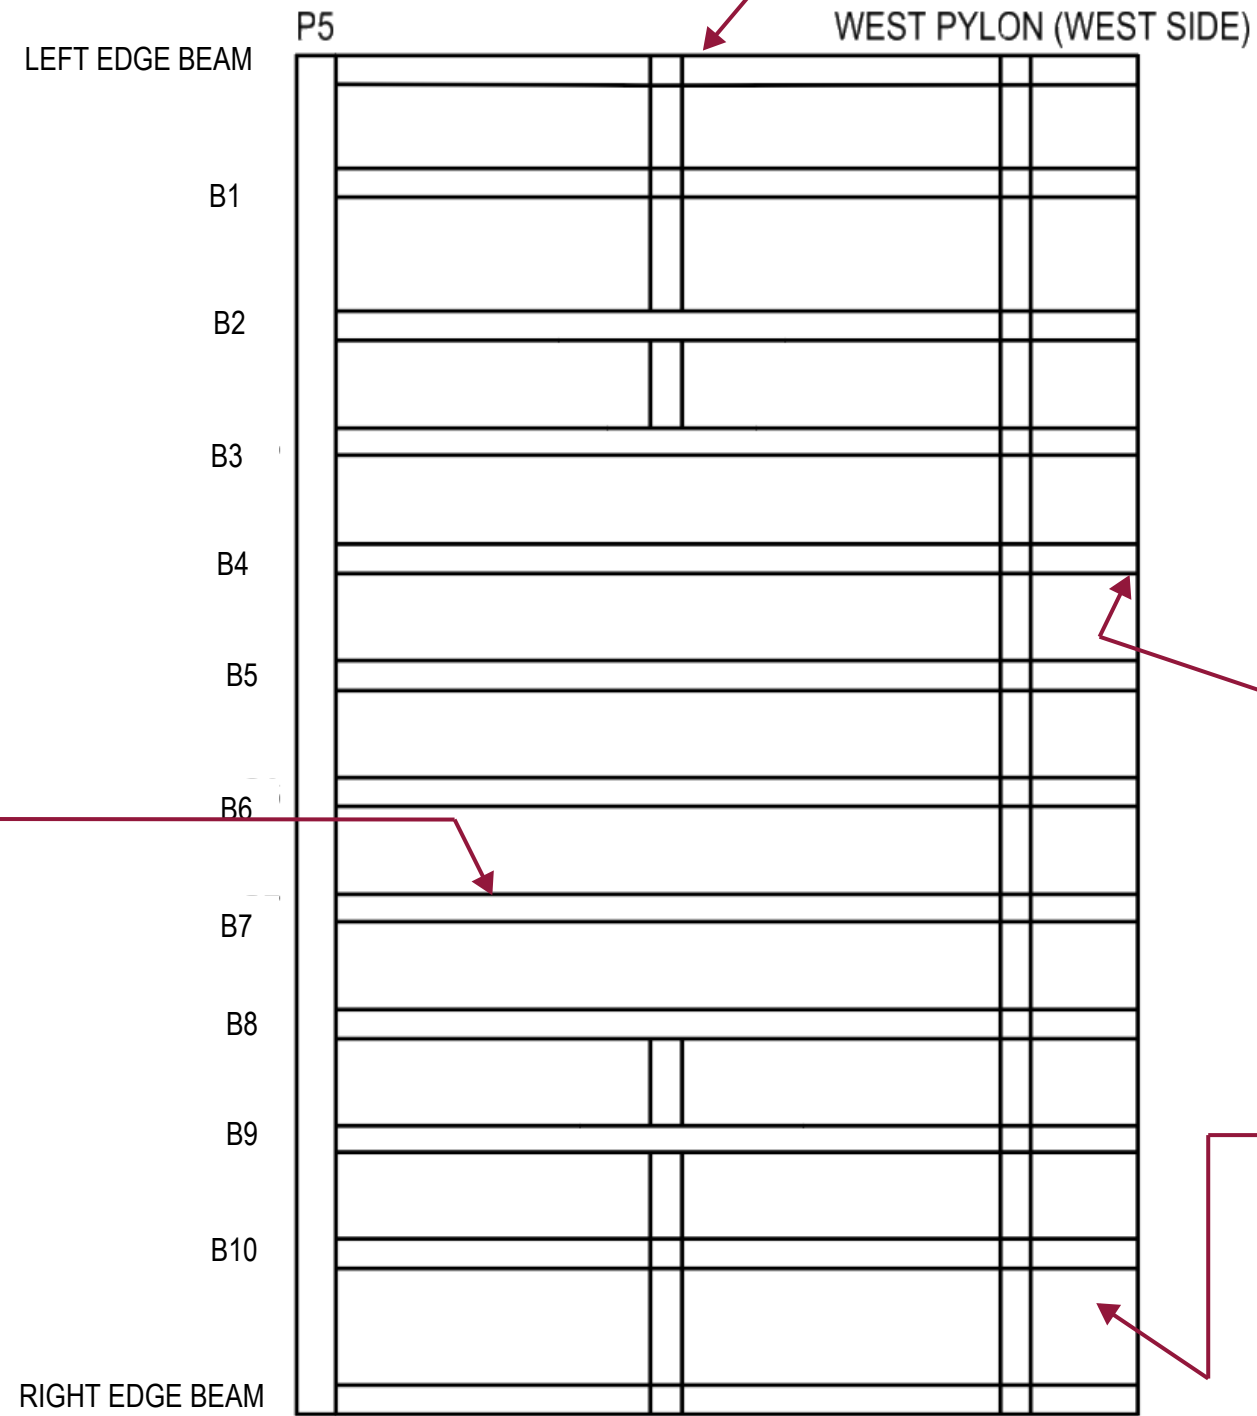
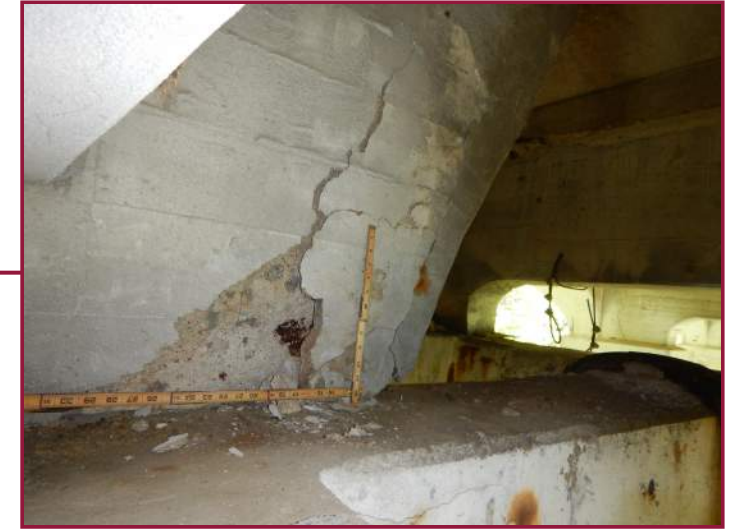
Up to 2' high by 2' long by 3" deep spall/ delamination on the south face of Beam 4 at the east end at the West Pylon (looking northeast).

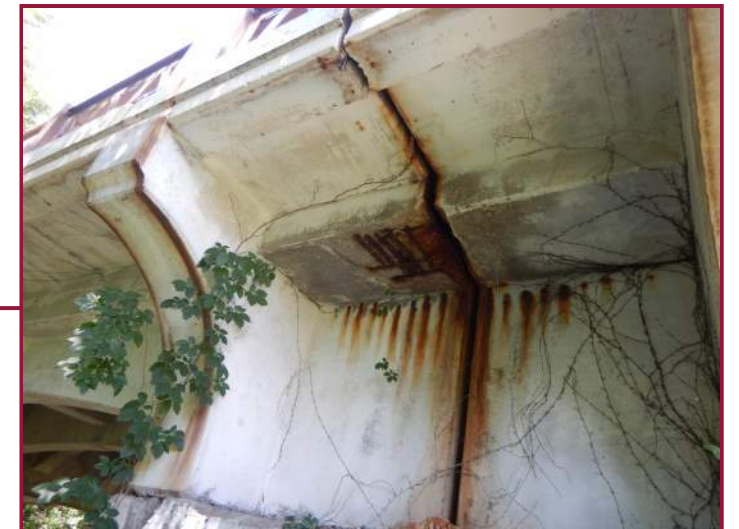
Spall with three layers of exposed reinforcement and moderate rust staining in the underside of the deck at the top of the south face of the West Pylon (looking north).

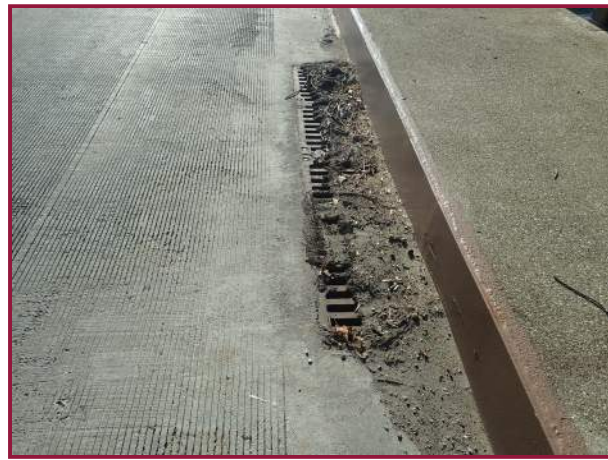
Scupper 75% blocked by debris (looking east near the right curb).

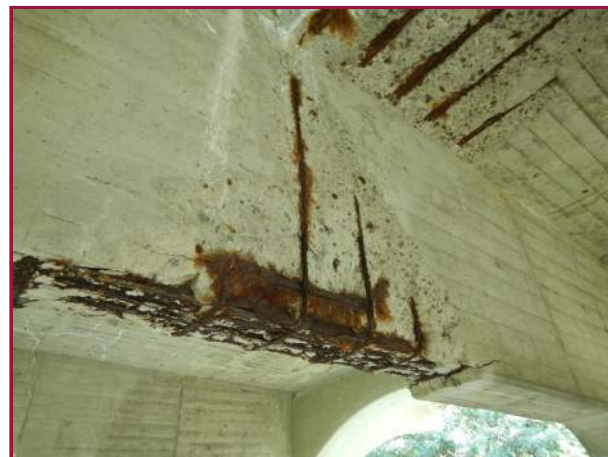
10" long by 4" high by 3" deep spall with exposed and broken reinforcement on the east and bottom face of Floorbeam A3 near midpoint between the Left and Right Jack Arch (looking west).

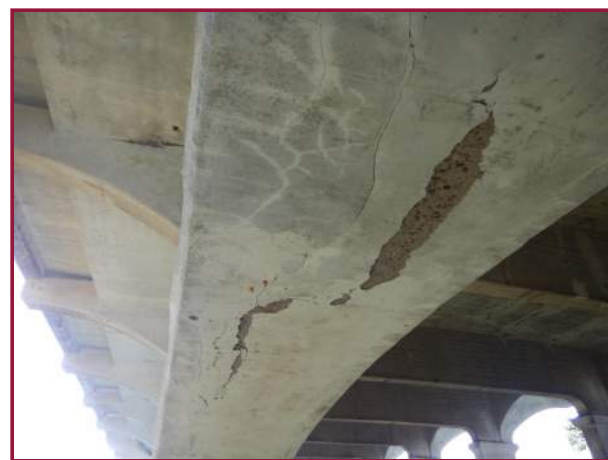
20' long by 4' wide spall/ delamination on the bottom face of the North Arch between Spandrel Columns 4 & 5 (looking east).

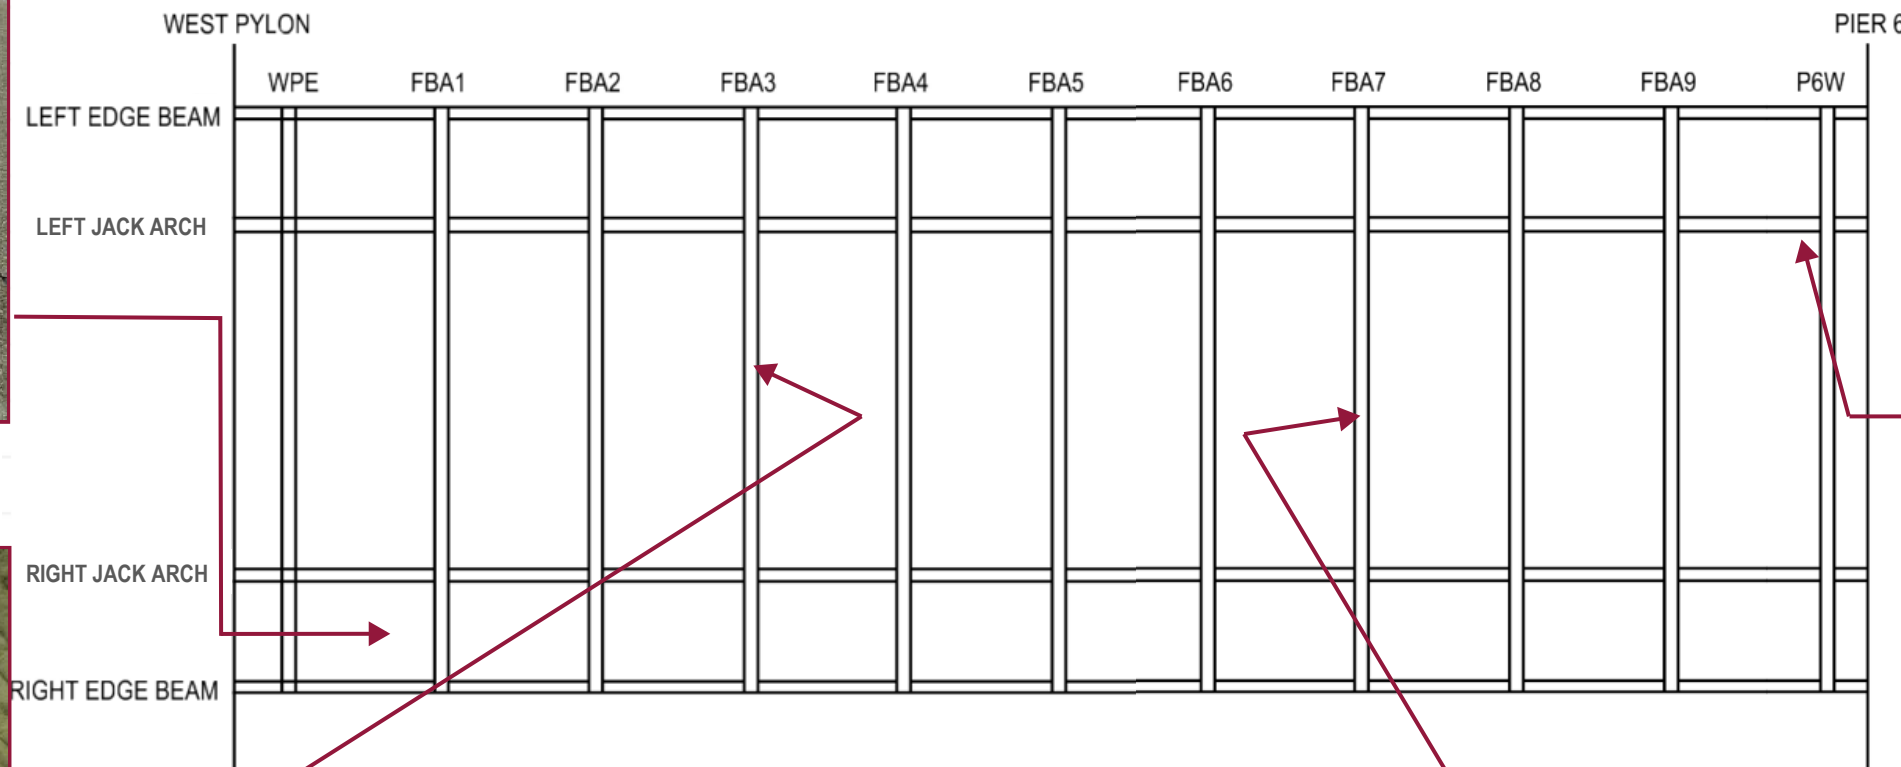
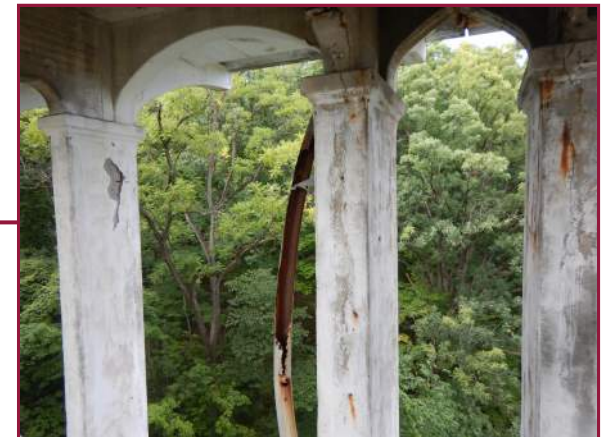
North downspout with 100% section loss throughout the south half at Spandrel Column 6W on the North Arch (looking north).

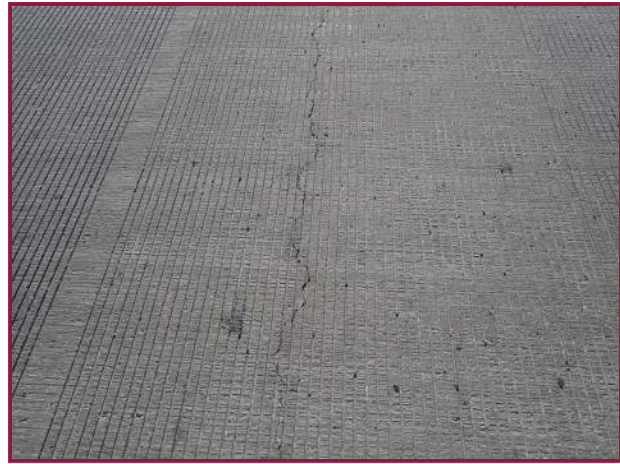
Longitudinal crack up to 1/16" wide in the eastbound lanes (looking east).

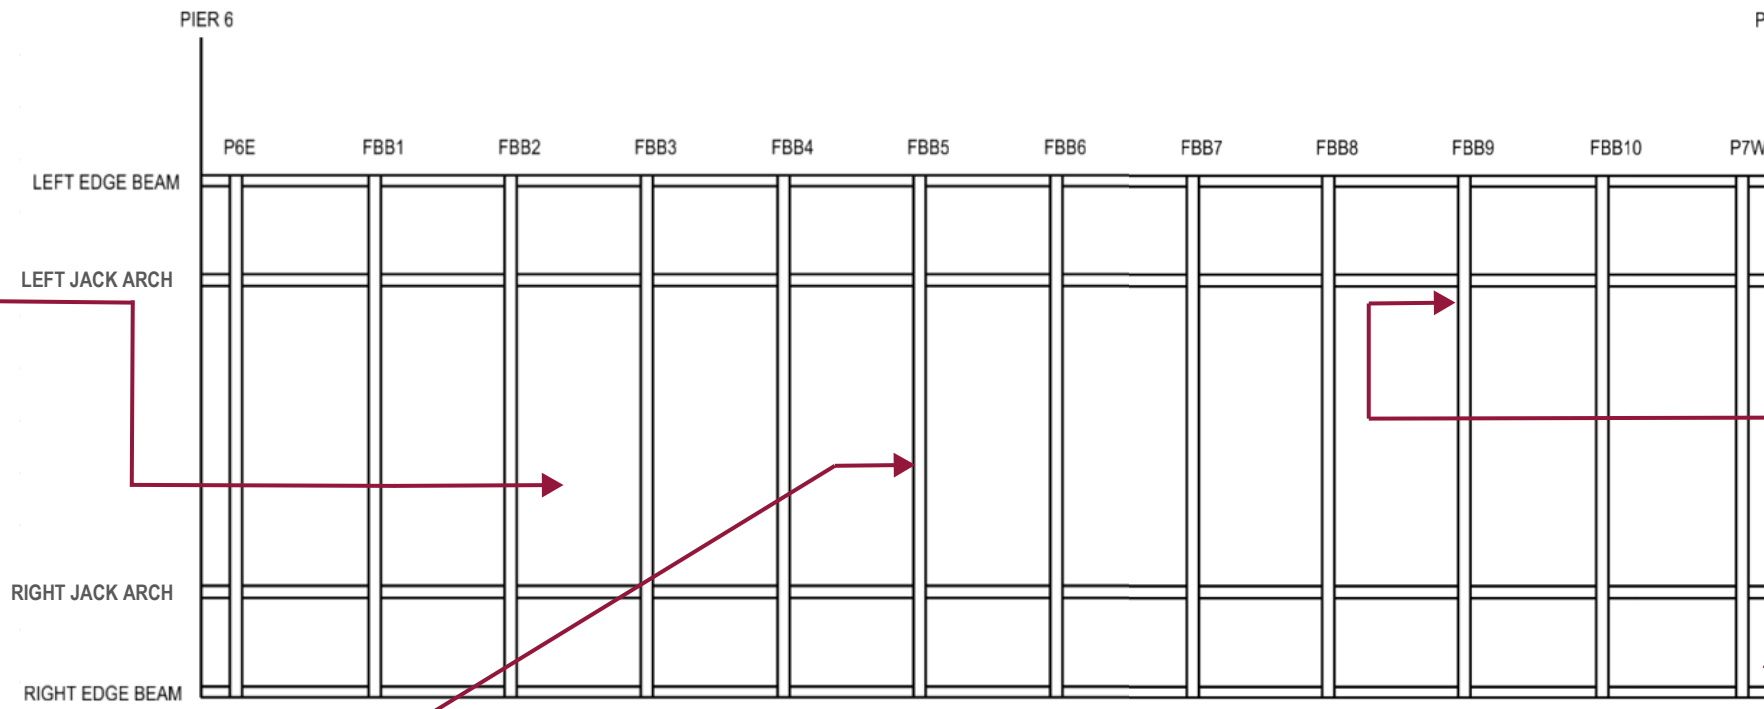
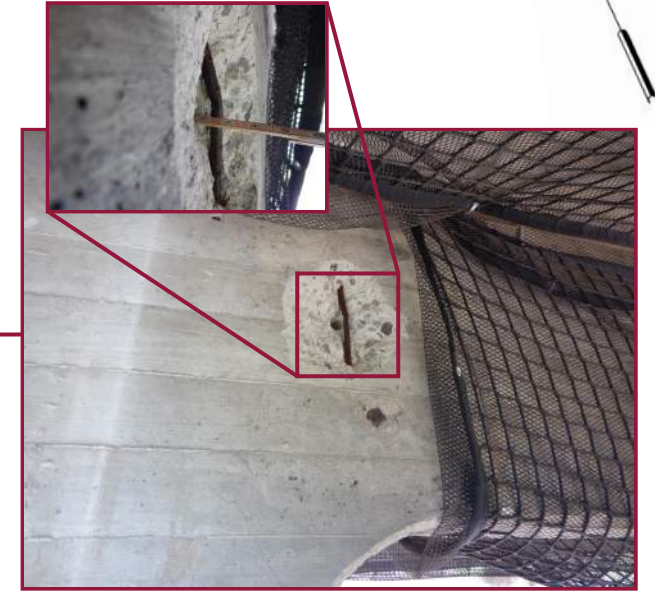
Spall with exposed and bent reinforcement in the north half of the west face of Floorbeam B9 between the Left and Right Jack Arch (looking east).

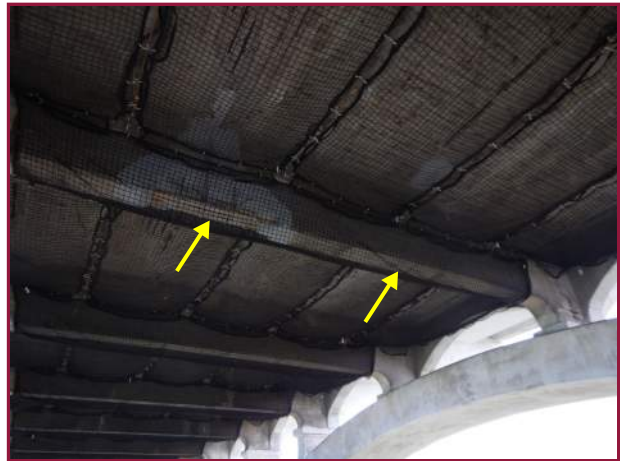
Spall with exposed reinforcement that has been sealed in the north half of the west face of Floorbeam B5 between the Left and Right Jack Arch (looking east).

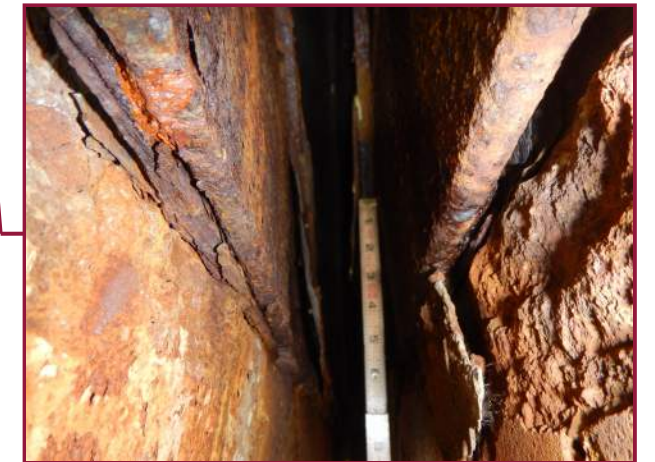
Up to 1/2" thick laminate corrosion throughout the interior face of the joint armor at Pier 7 at the Right Arch (looking north).

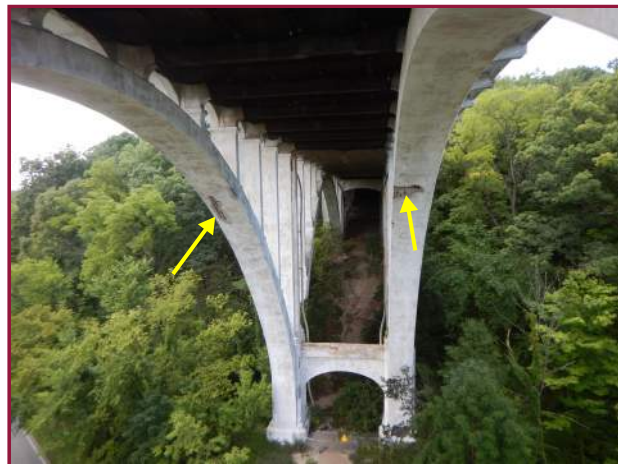
Spalls with exposed reinforcement in the underside of both the North and South Arch between Spandrel Columns 7 & 8 (looking west).

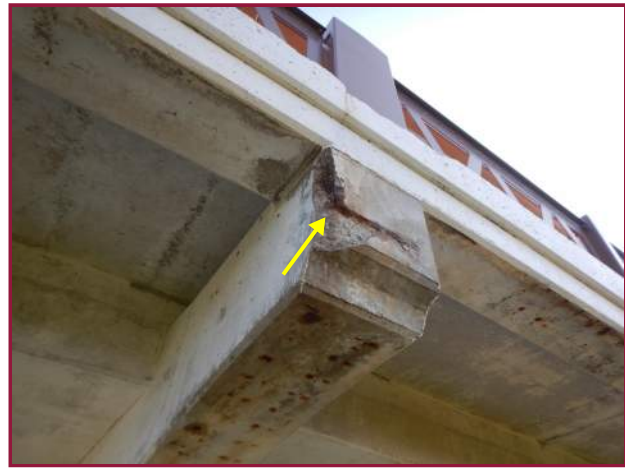
Spall with exposed reinforcement on the south face of Floorbeam C2 (looking northeast).

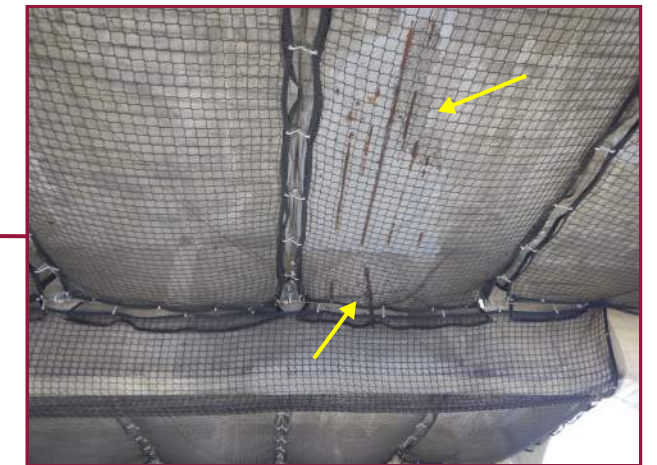
Partially sealed spalls with exposed reinforcement on the east face of Floorbeam C7 and in the underside of the deck at Floorbeam C7 (looking northwest).

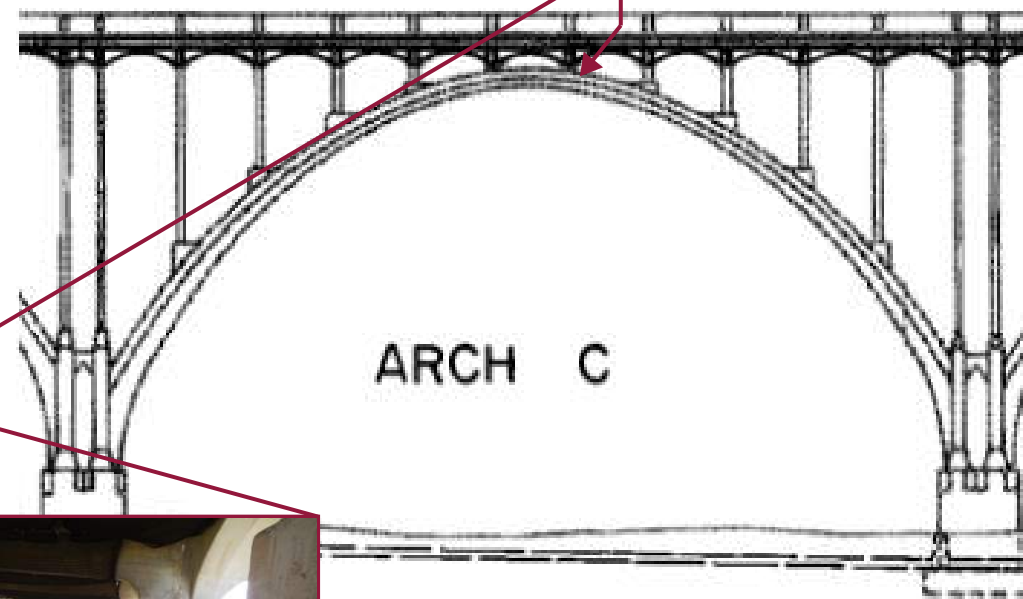
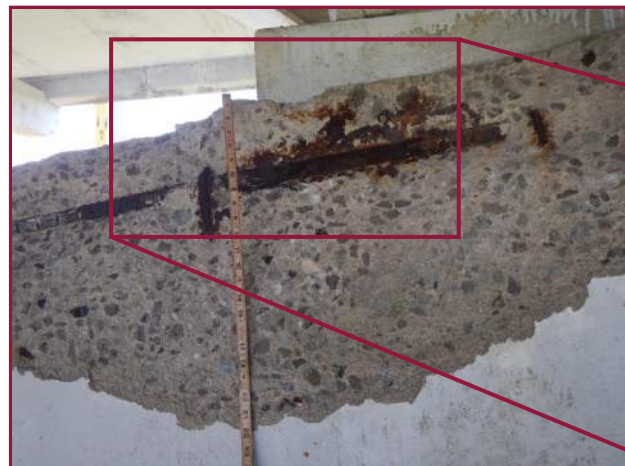
Top edge spall with exposed reinforcement on the north face of the South Arch below Column 6 (looking south).

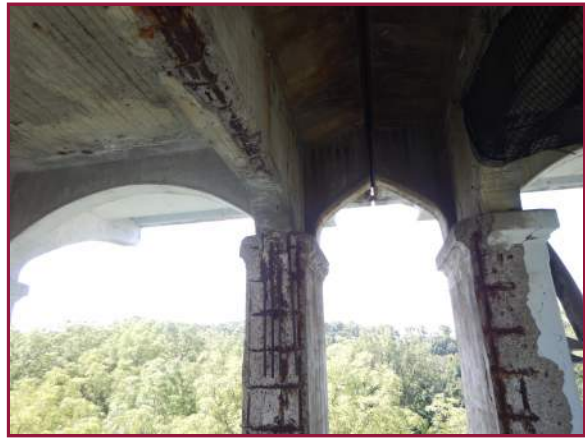
Typical spalls with exposed and deteriorated reinforcement and cracks throughout Spandrel Columns near the Right Jack Arch on the South Truss (looking south).

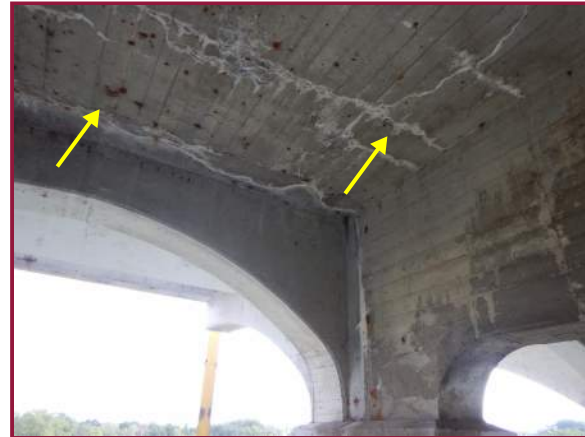
Longitudinal and transverse cracks with minor efflorescence and rust staining throughout the underside of the deck near the Left Jack Arch and west side of Floorbeam D9 (looking east).

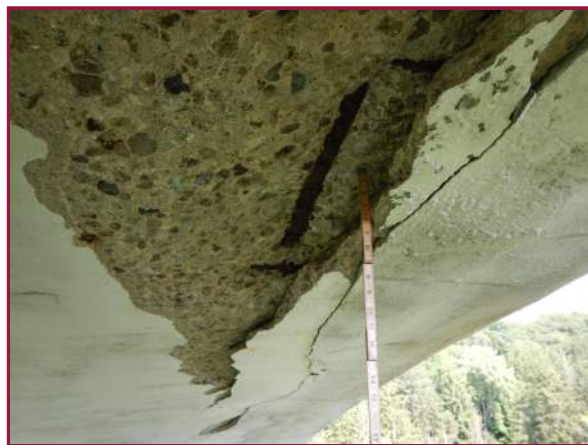
5' long by 2' wide by 4" deep spall on the bottom face of the North Arch between Spandrel Columns 4 & 5 (looking west).
