**PHYSICAL CONDITION REPORT  
FOR THE 2022 ROUTINE ELEMENT LEVEL INSPECTION**

**BROOKPARK ROAD BRIDGE**  
BRIDGE NO. CUY-17-0283  
SFN: 1802046

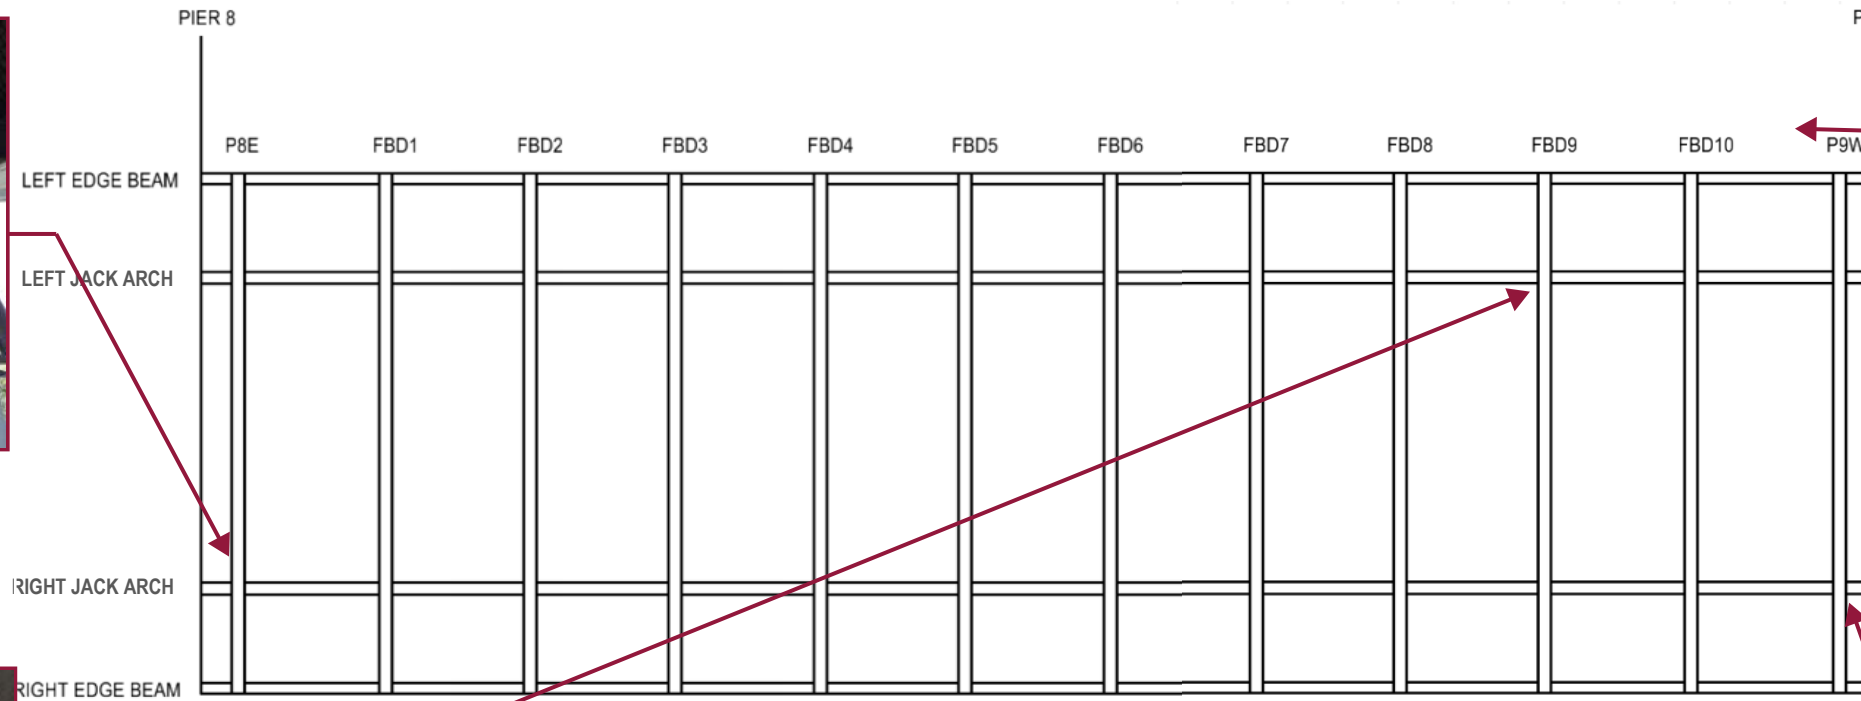
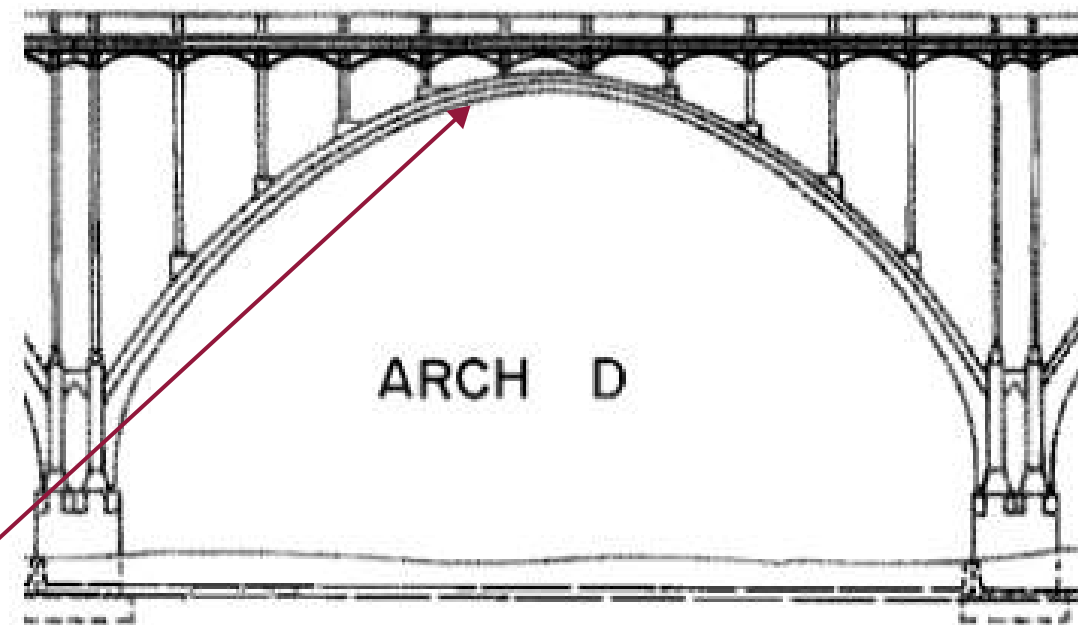
5' long by 2' wide by 4" deep spall on the bottom face of the North Arch between Spandrel Columns 4 & 5 (looking west).

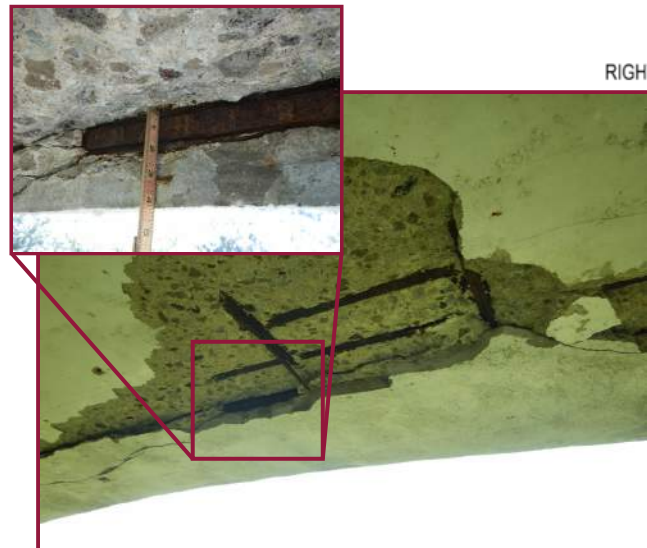
18" wide by 3' long by 3-1/2" deep spall to the underside of the South Arch between Spandrel Columns 5 & 6 (looking south).

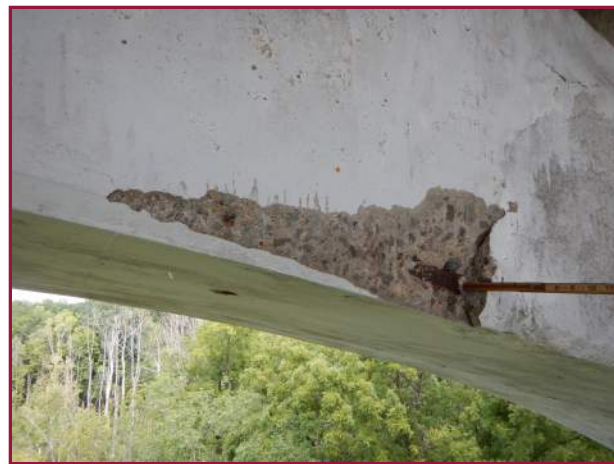
2' wide by 1' high by 2" deep spall on the south face of the North Arch below Spandrel Column 7 (looking north).

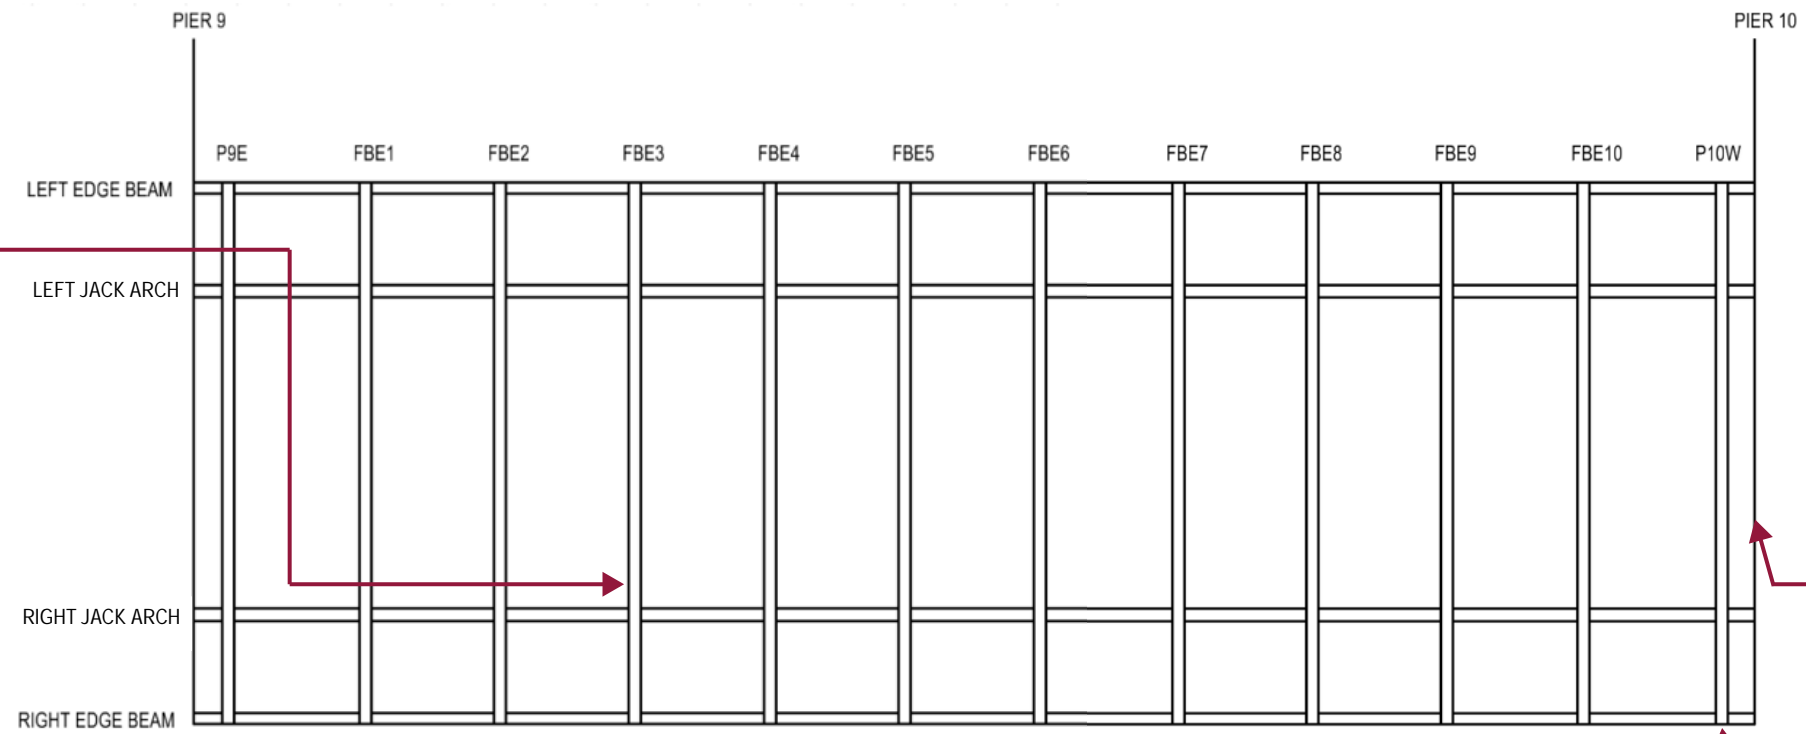
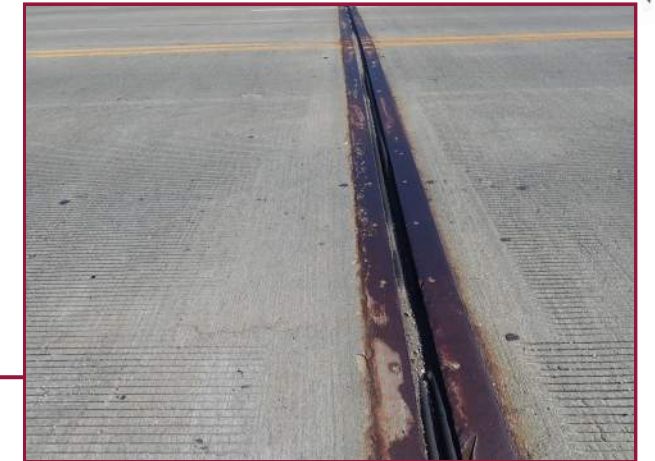
Vertical displacement of the compression seal material up to 1/4" over an 18" length (looking north).

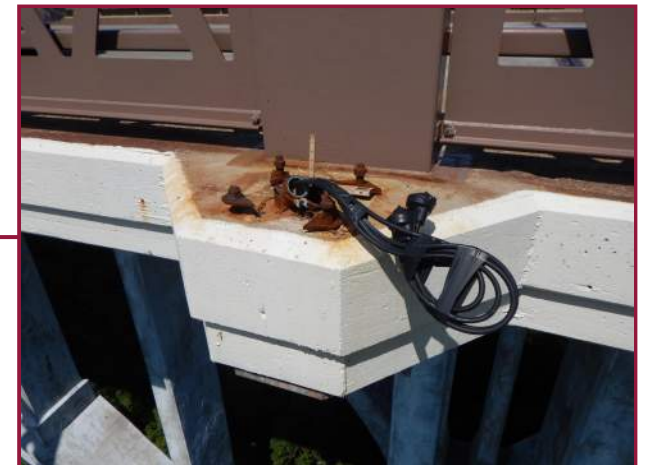
Missing light standard and wires taped off at the south railing and edge of deck at Pier 10 (looking north).

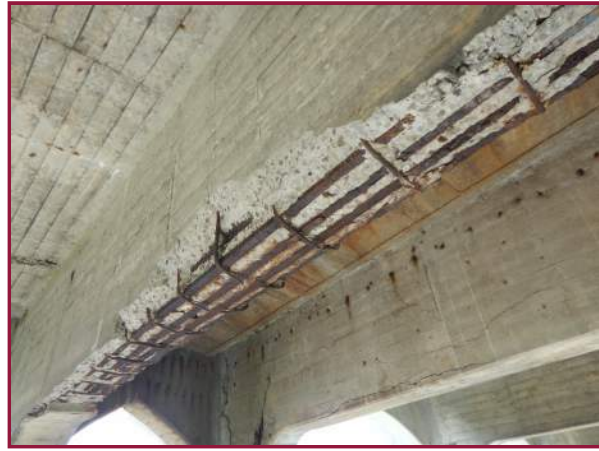
20' long by 18" high by full width spall with exposed reinforcement including 5 broken stirrups on the underside of Pier 10 (looking southwest).

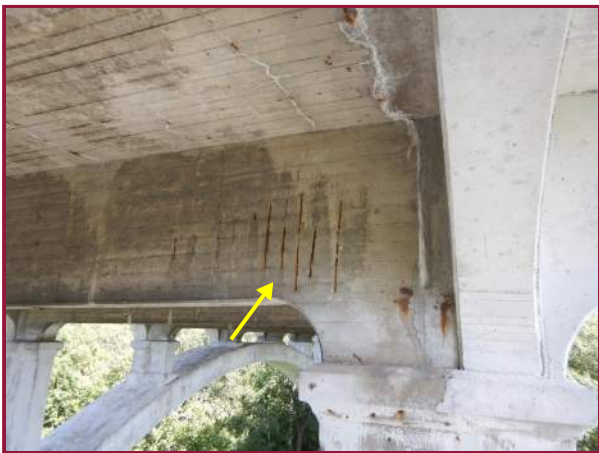
Shallow spall with exposed reinforcement due to lack of cover on the west face of Floorbeam F2 near the Right Jack Arch on the South Arch (looking east).

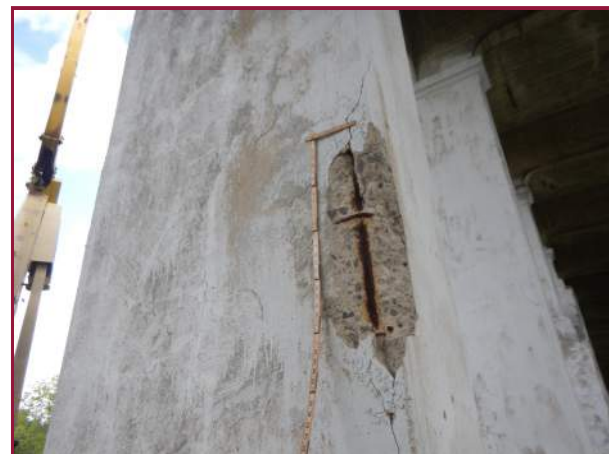
Shallow spall with exposed reinforcement on the west face of Spandrel Column 1 on the North Arch (looking east).

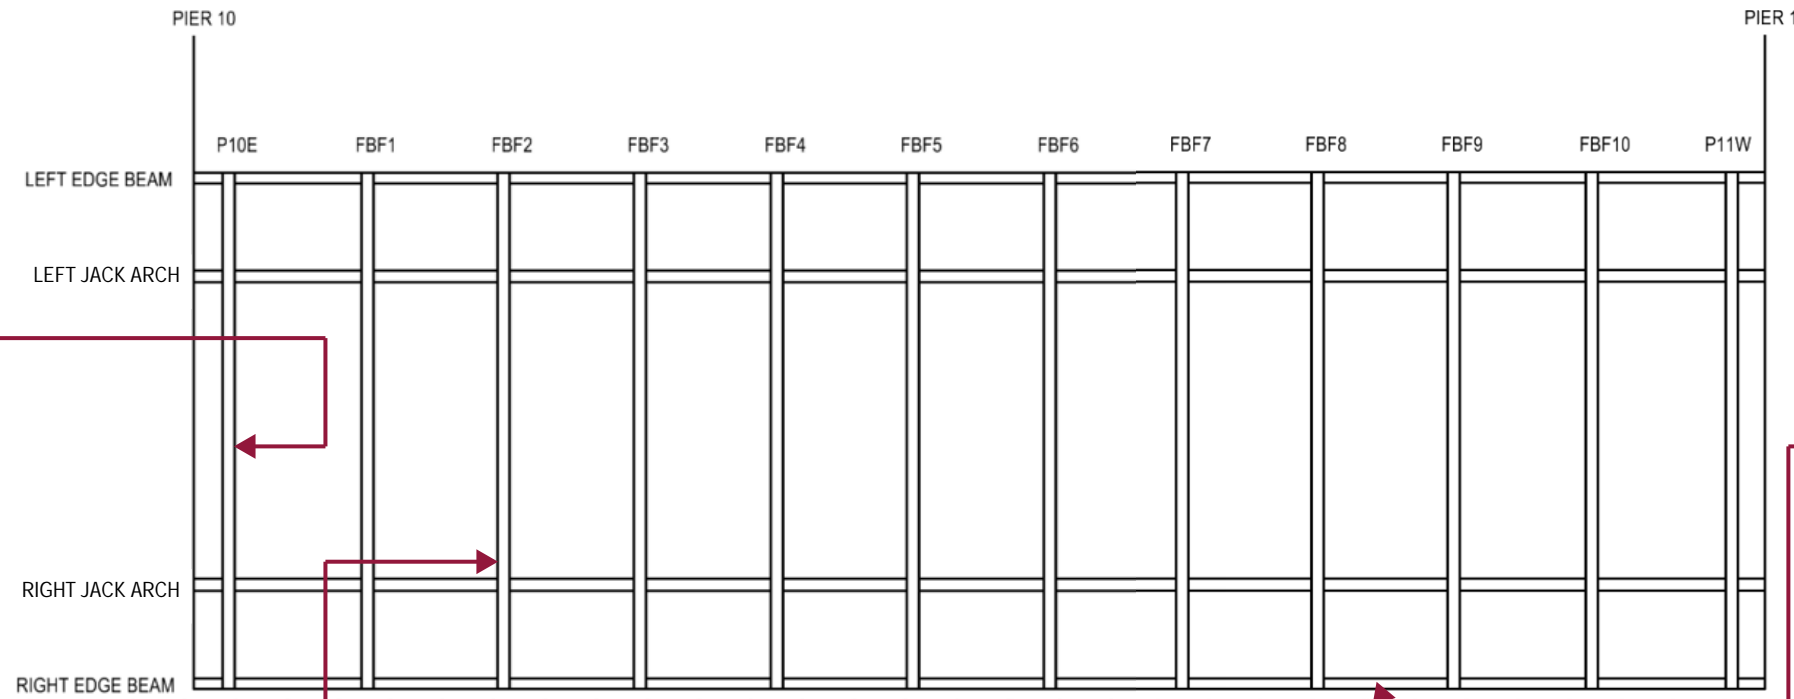
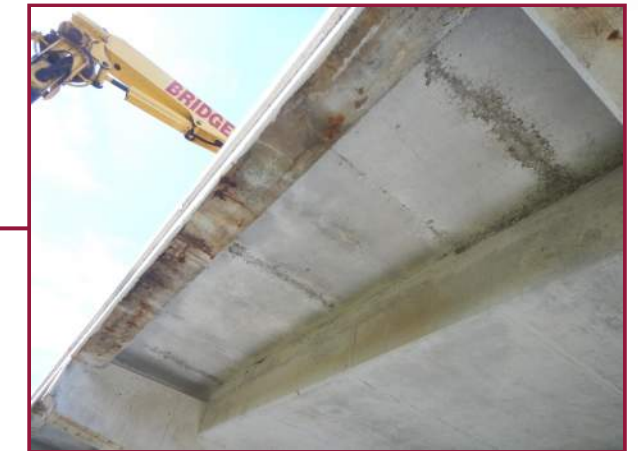
Longitudinal hairline cracks along the underside of the Right Edge Beam between Floorbeams F8 & F9 (looking north).

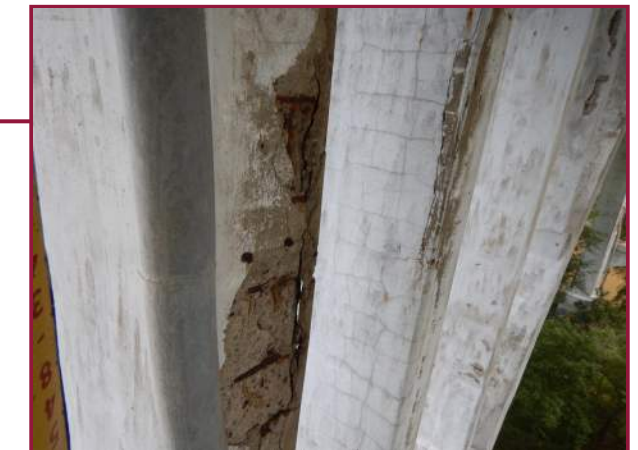
Full width by 6' high edge spall with exposed reinforcement on the south face of the North Spandrel Column at Pier 11 (looking northeast).

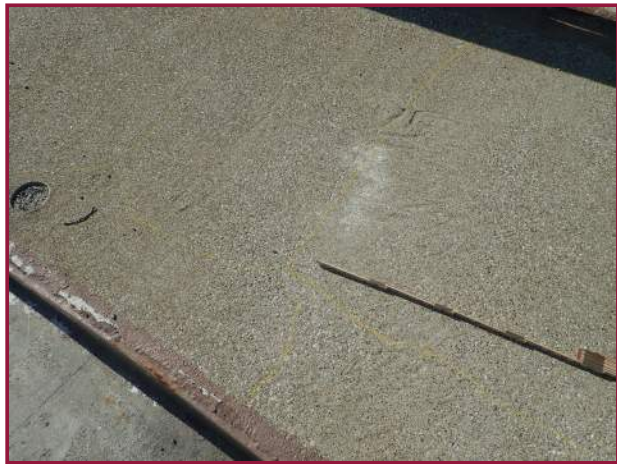
Typical longitudinal and transverse hairline cracks in the sidewalks (looking southeast).

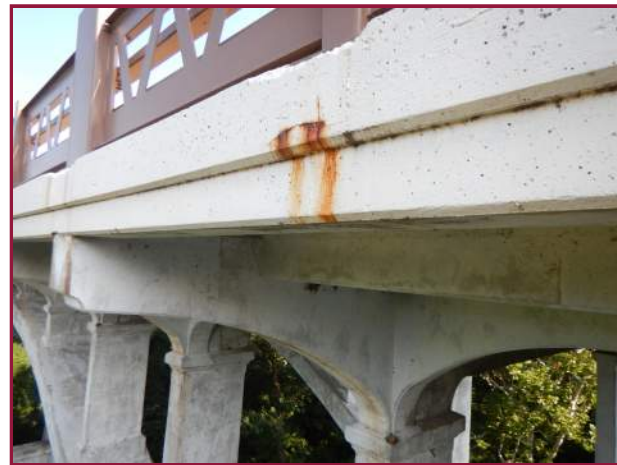
Typical longitudinal and transverse hairline cracks in the sidewalks (looking southeast).

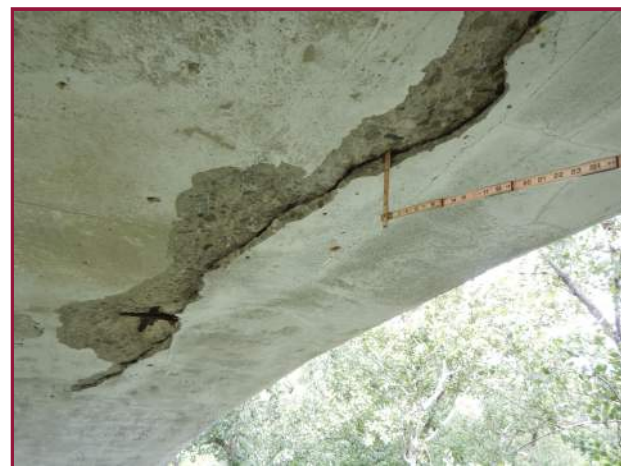
12' long by 2' wide by 2-1/2" deep spall/delamination on the underside of the North Arch between Spandrel Columns 4 & 5 (looking northwest).

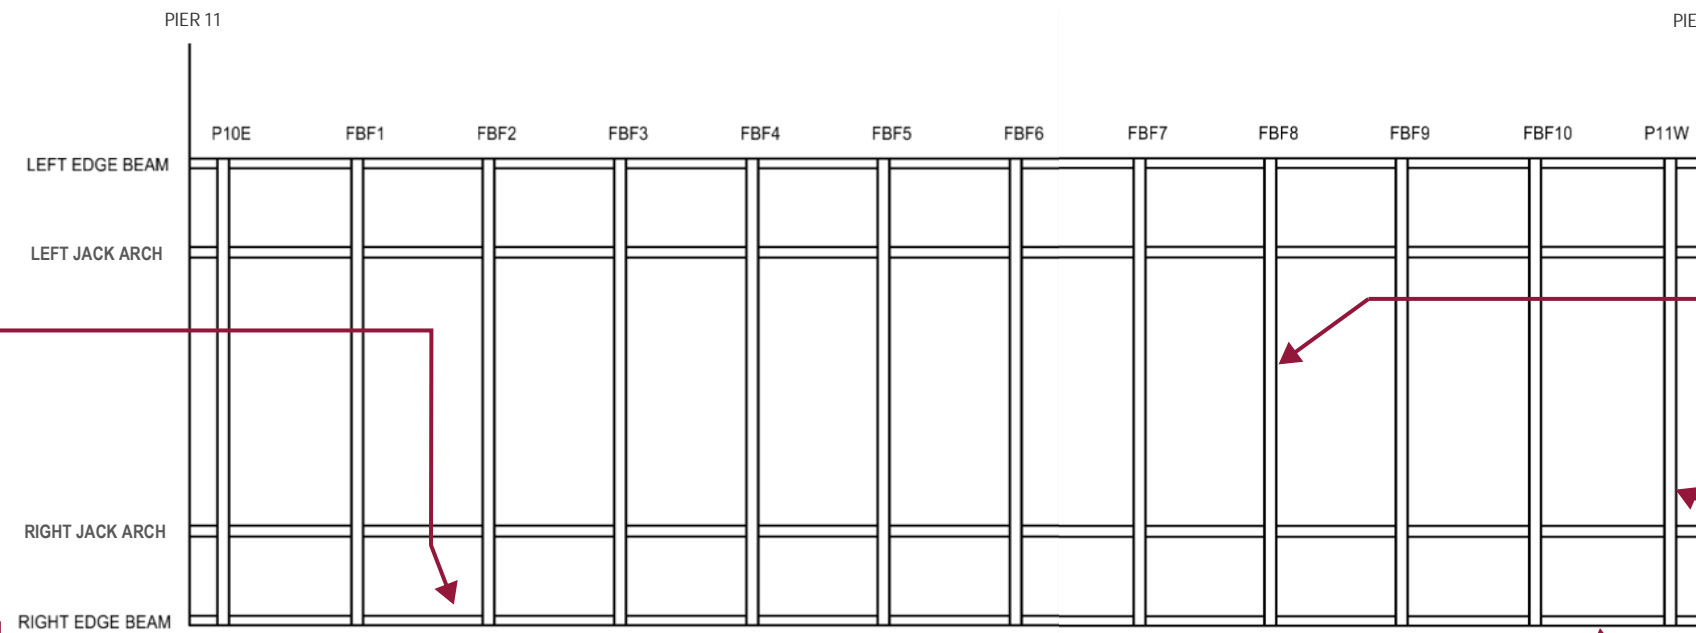
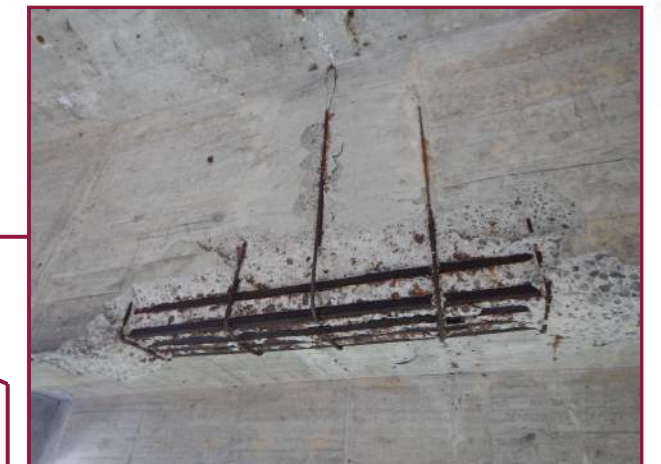
7' long by 18" high spall with exposed reinforcement and 3 broken stirrups on the east face of Floorbeam G8 at the midpoint between the Left and Right Jack Arches (looking west).

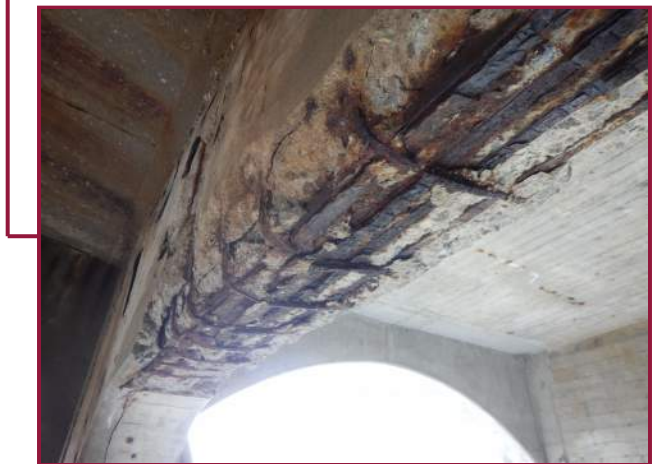
Spall with exposed reinforcement and nine stirrups with 100% section loss on the east face Pier 12 near the Right Jack Arch on the South Arch (looking west).

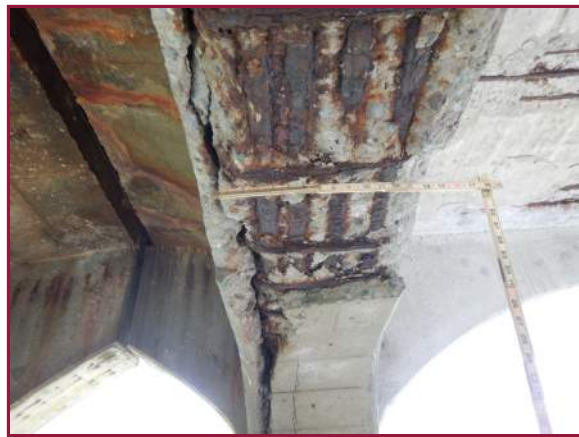
Full width spall with exposed and deteriorated reinforcement on the underside of Pier 12 near the Left Jack Arch (looking north).

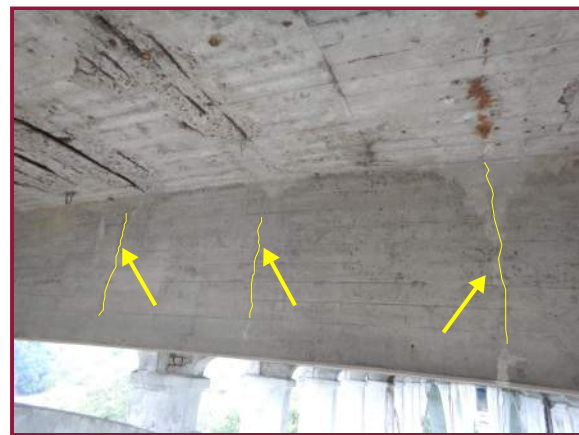
Full height vertical hairline cracks in the web on the east face of Floorbeam H5 near the midpoint (looking west).

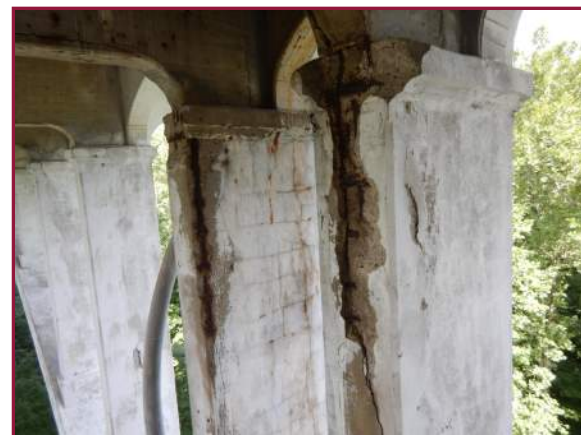
Spalls with exposed reinforcement on both columns at Pier 12 on the North Arch (looking northwest).

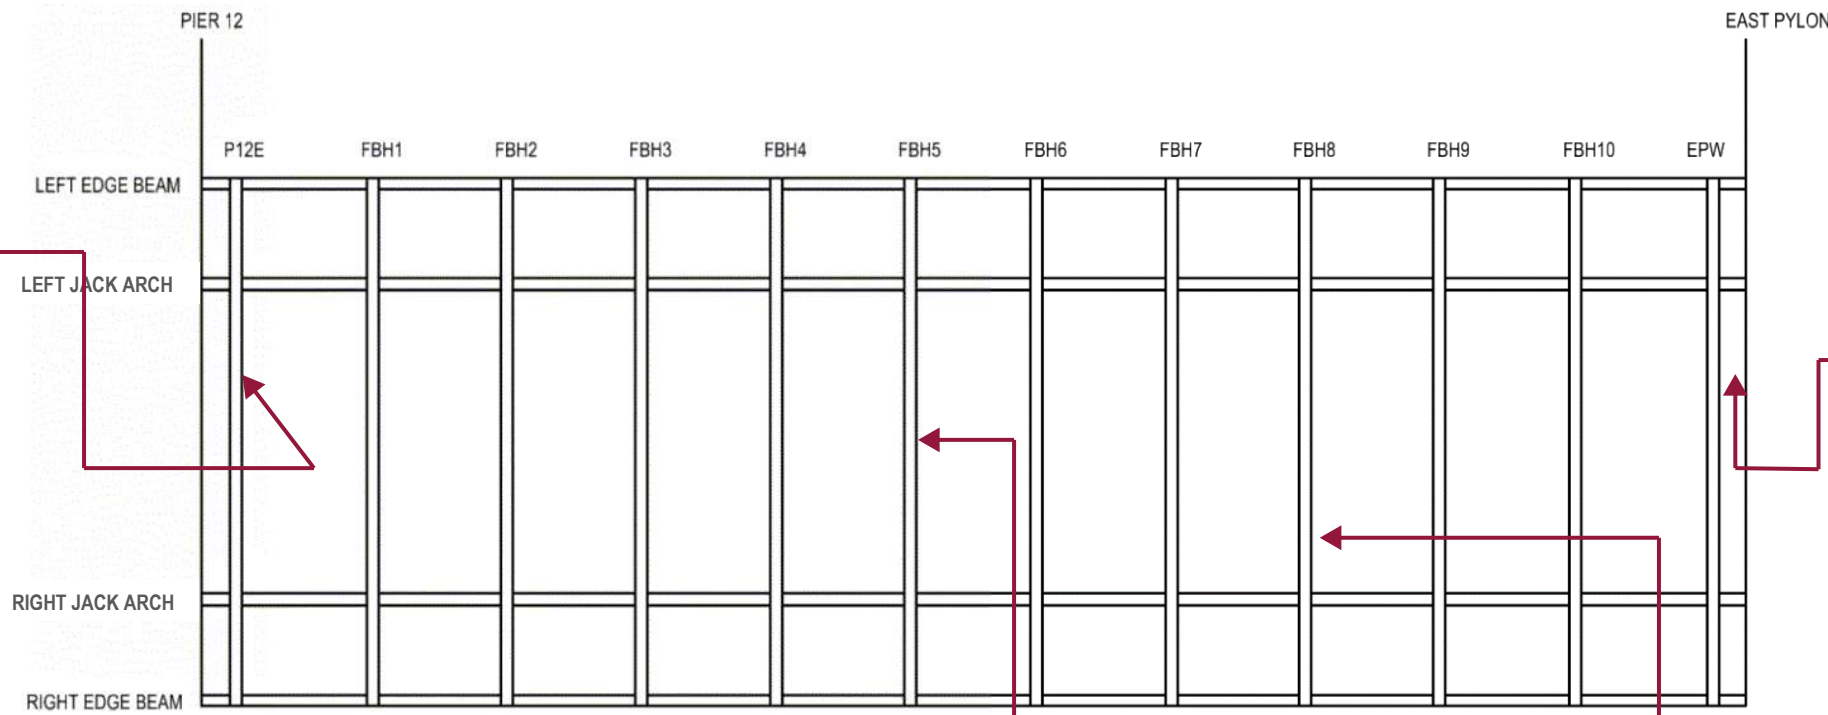
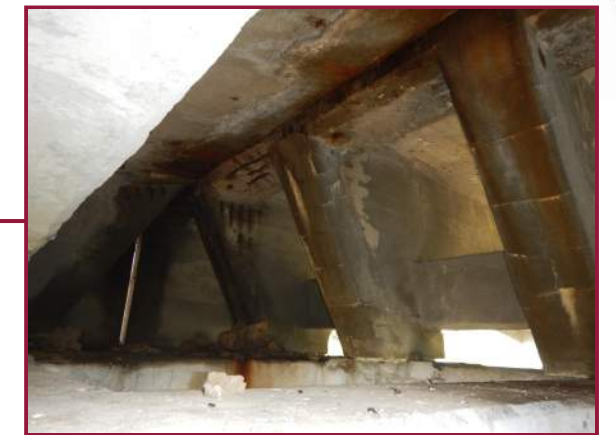
Spalls with exposed reinforcement and hairline cracking with minor efflorescence on the east end of Beams 2 through 4 at the interior of the East Pylon (looking northeast).

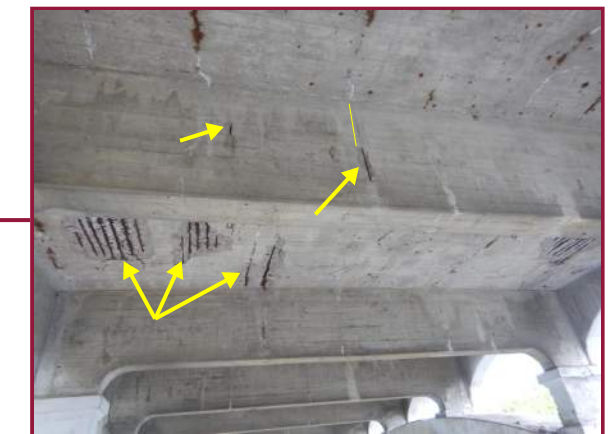
Full height vertical hairline cracks with minor spalls in the web on the east face of Floorbeam H8 near the midpoint (looking west). Note the large spalls with exposed reinforcement on the underside of the deck.

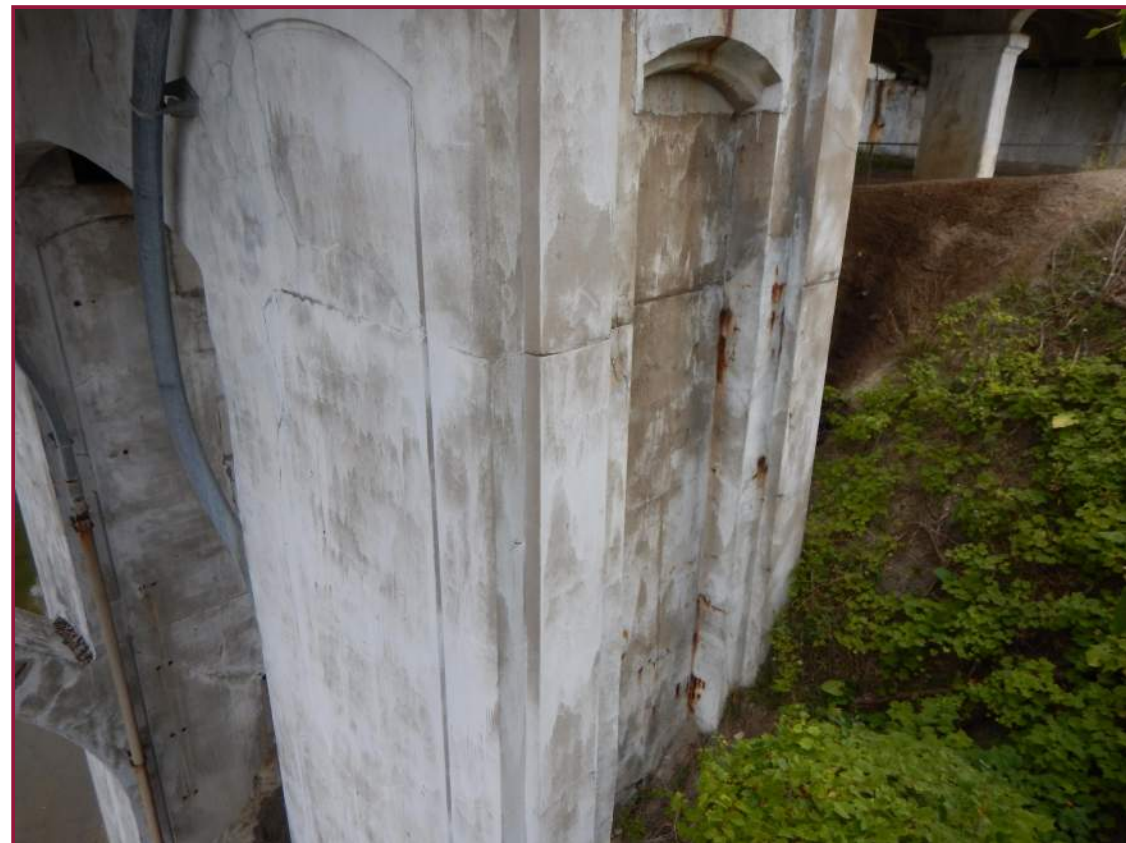
Hairline cracks with map cracking in the south face of the East Pylon right column (looking northeast).

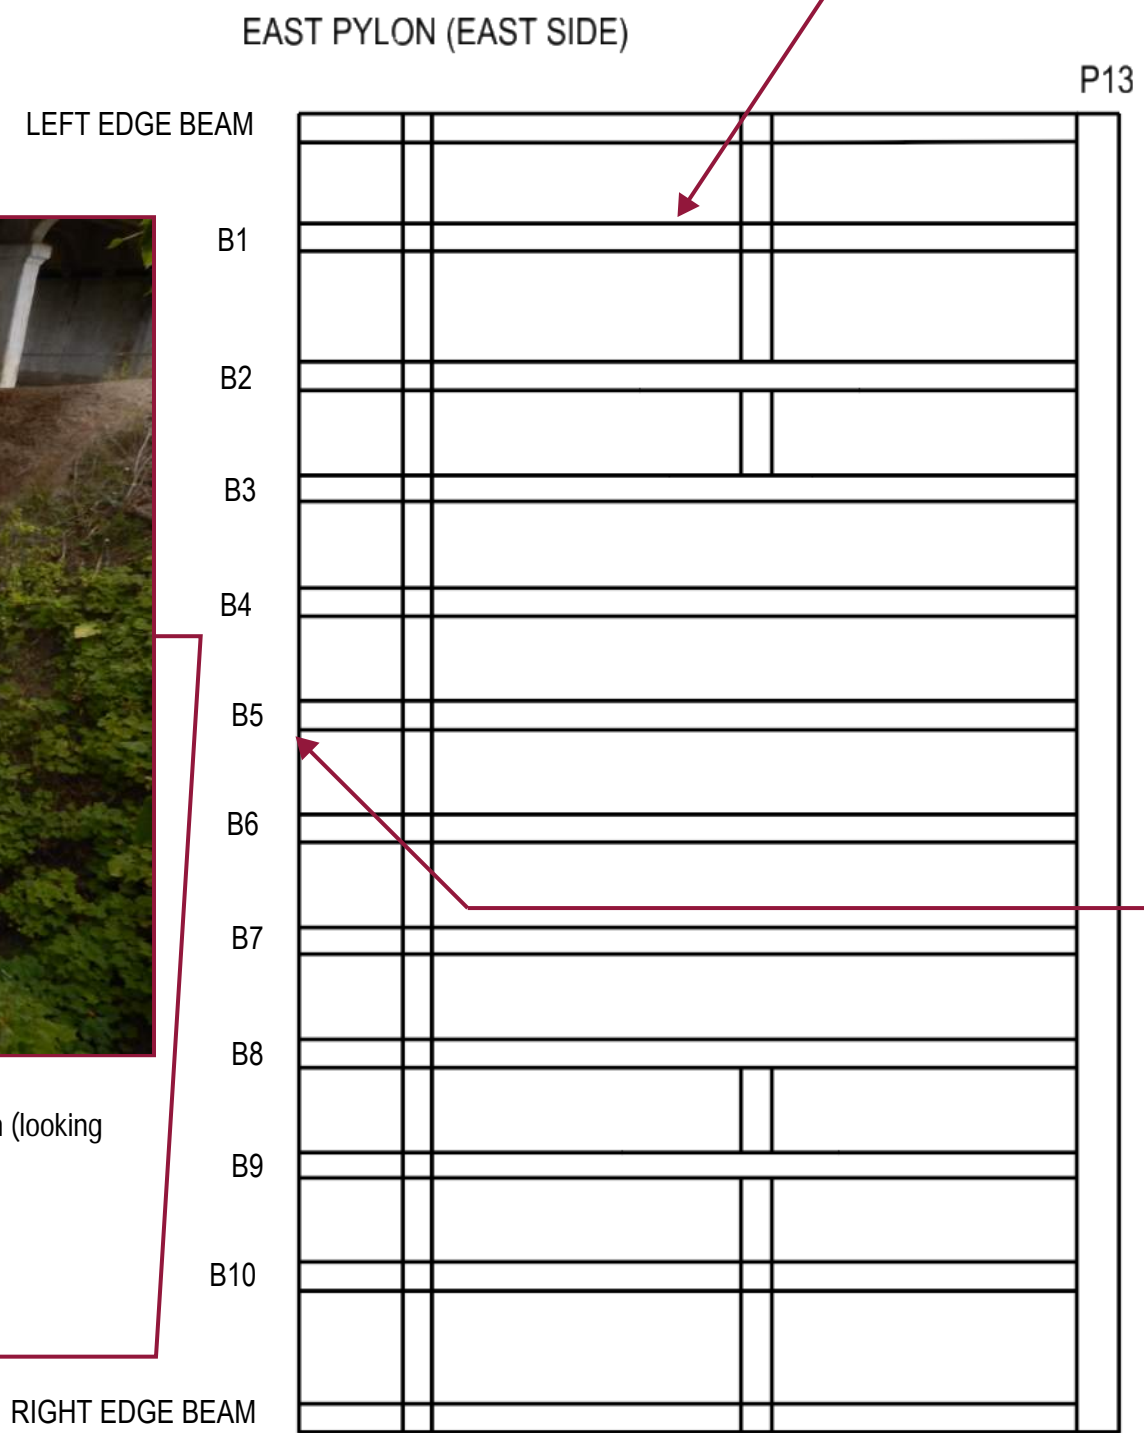
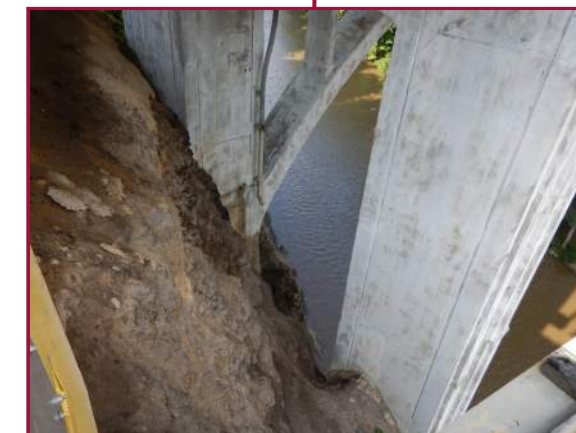
Rapid elevation change of shale slope between Pier 15 and the East Pylon (looking southwest).

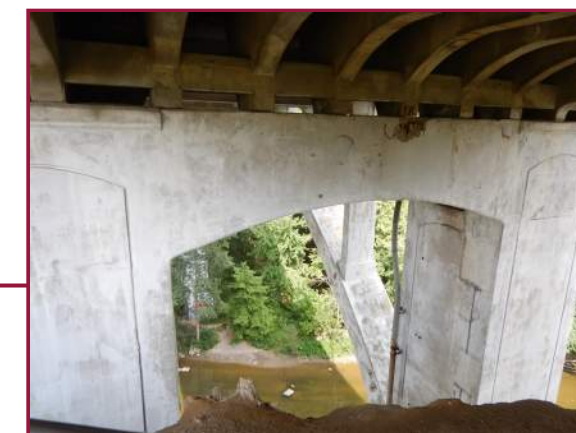
East Pylon east elevation and a spall with exposed reinforcement in the east pier cap below Beam 5 (looking west).

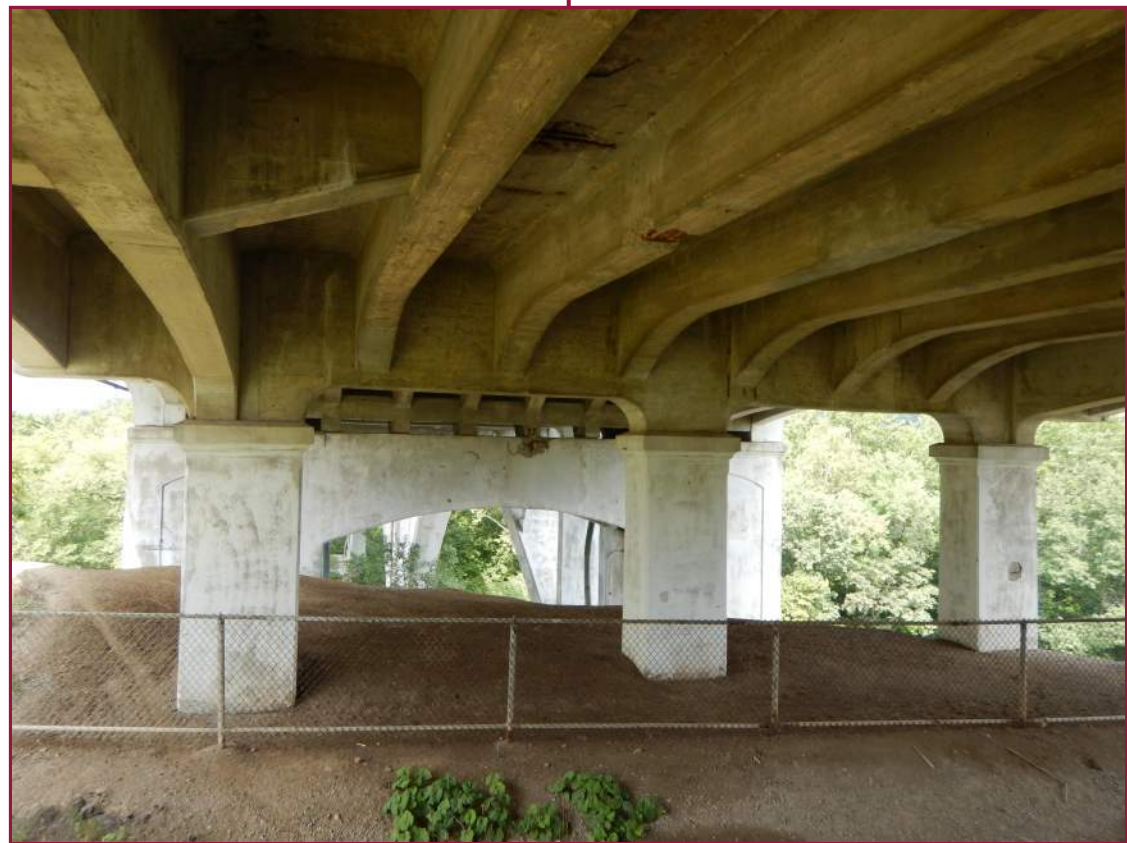
Pier 13 east elevation (looking west).

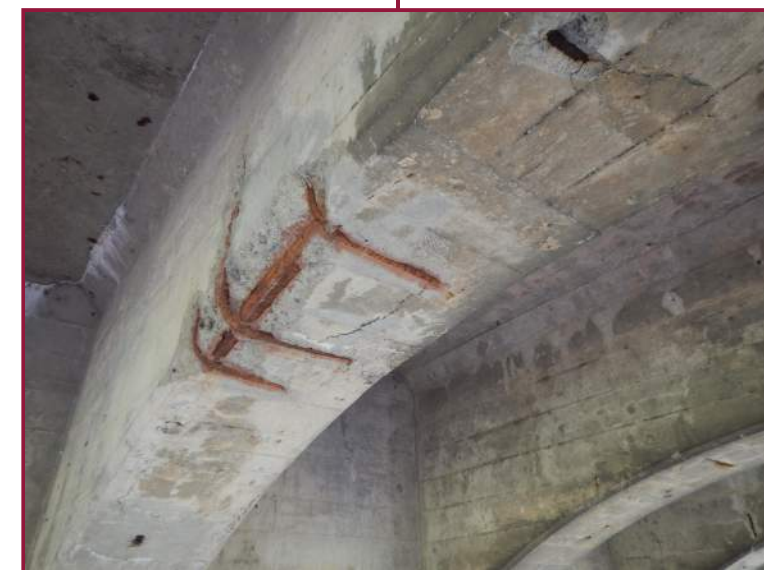
18" long by 12" wide spall with exposed reinforcement on the north face bottom edge of Beam 6 near Pier 14 (looking southeast).

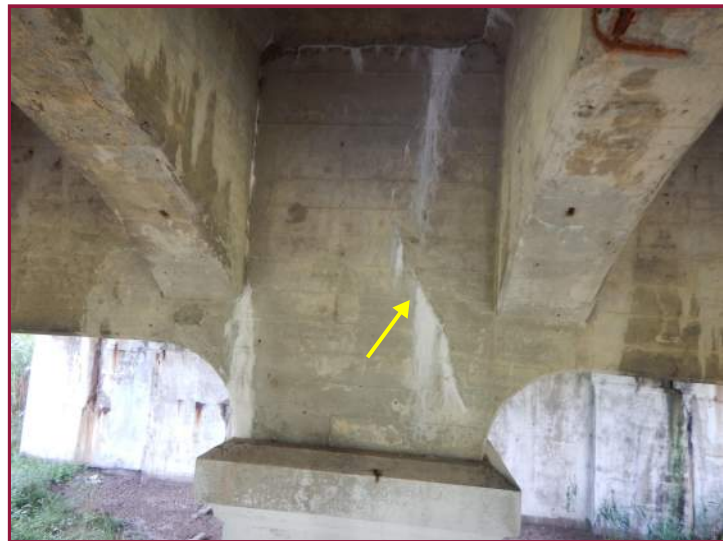
Vertical hairline crack with moderate efflorescence on the west face of the diaphragm between Beams 5 & 6 at Pier 14 (looking east).

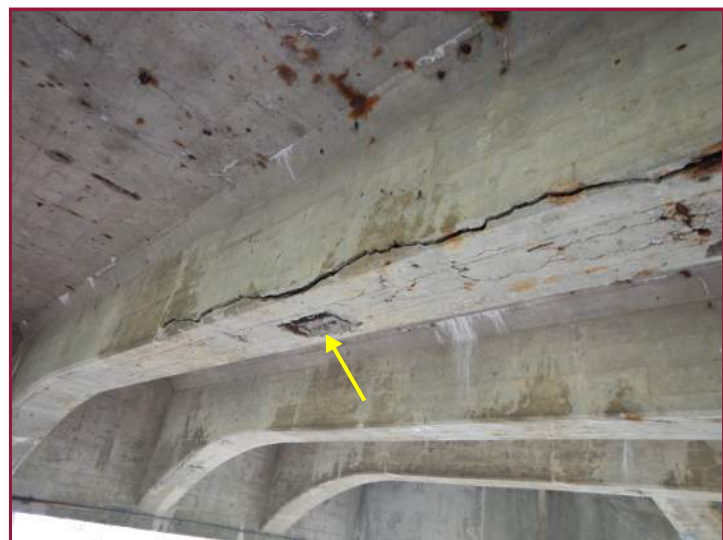
Full width delamination with an isolated spall on the underside of Beam 5 near midspan (looking north).

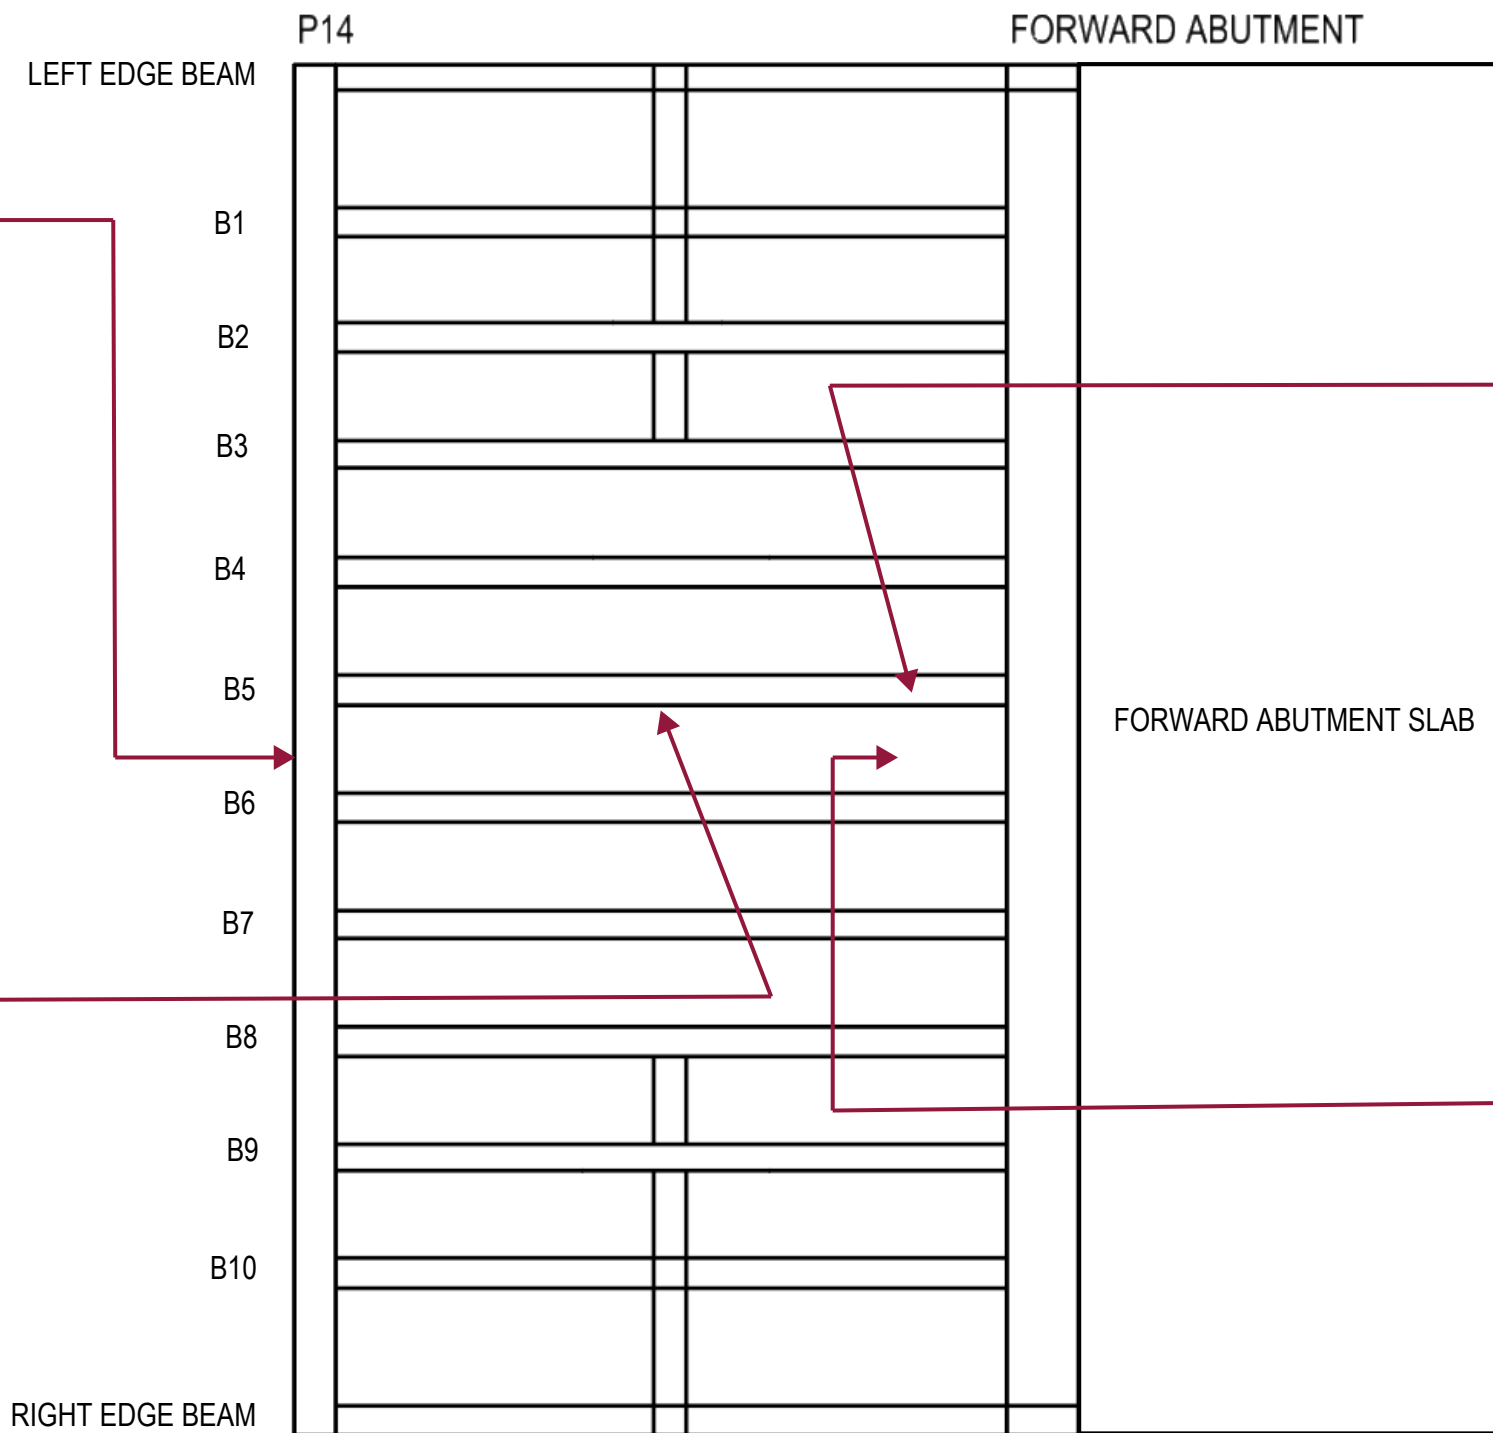
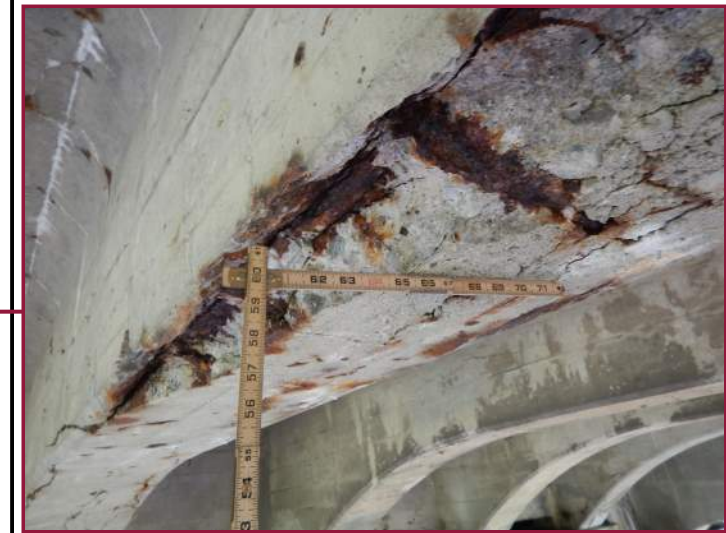
Full width spall with exposed reinforcement on the underside of Beam 5 near the Forward Abutment (looking east).

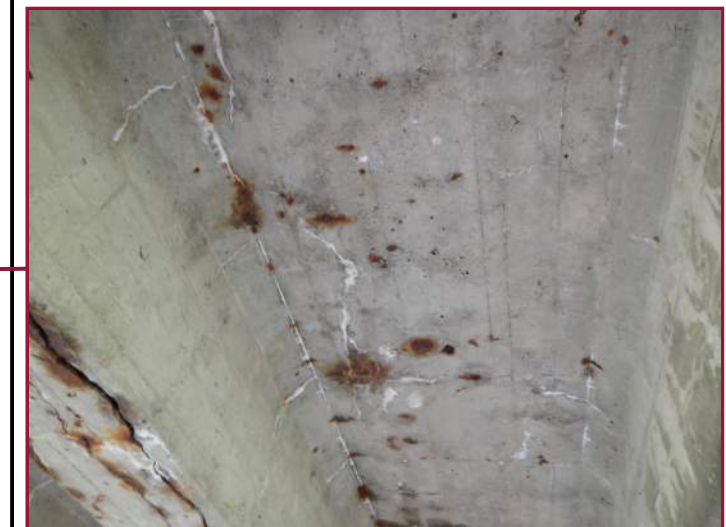
Hairline longitudinal and transverse cracks with minor efflorescence and rust staining throughout the underside of the deck between Beams 5 & 6 near the Forward Abutment (looking east).
