**PHYSICAL CONDITION REPORT  
FOR THE 2022 ROUTINE ELEMENT LEVEL INSPECTION**

**BROOKPARK ROAD BRIDGE**  
BRIDGE NO. CUY-17-0283  
SFN: 1802046

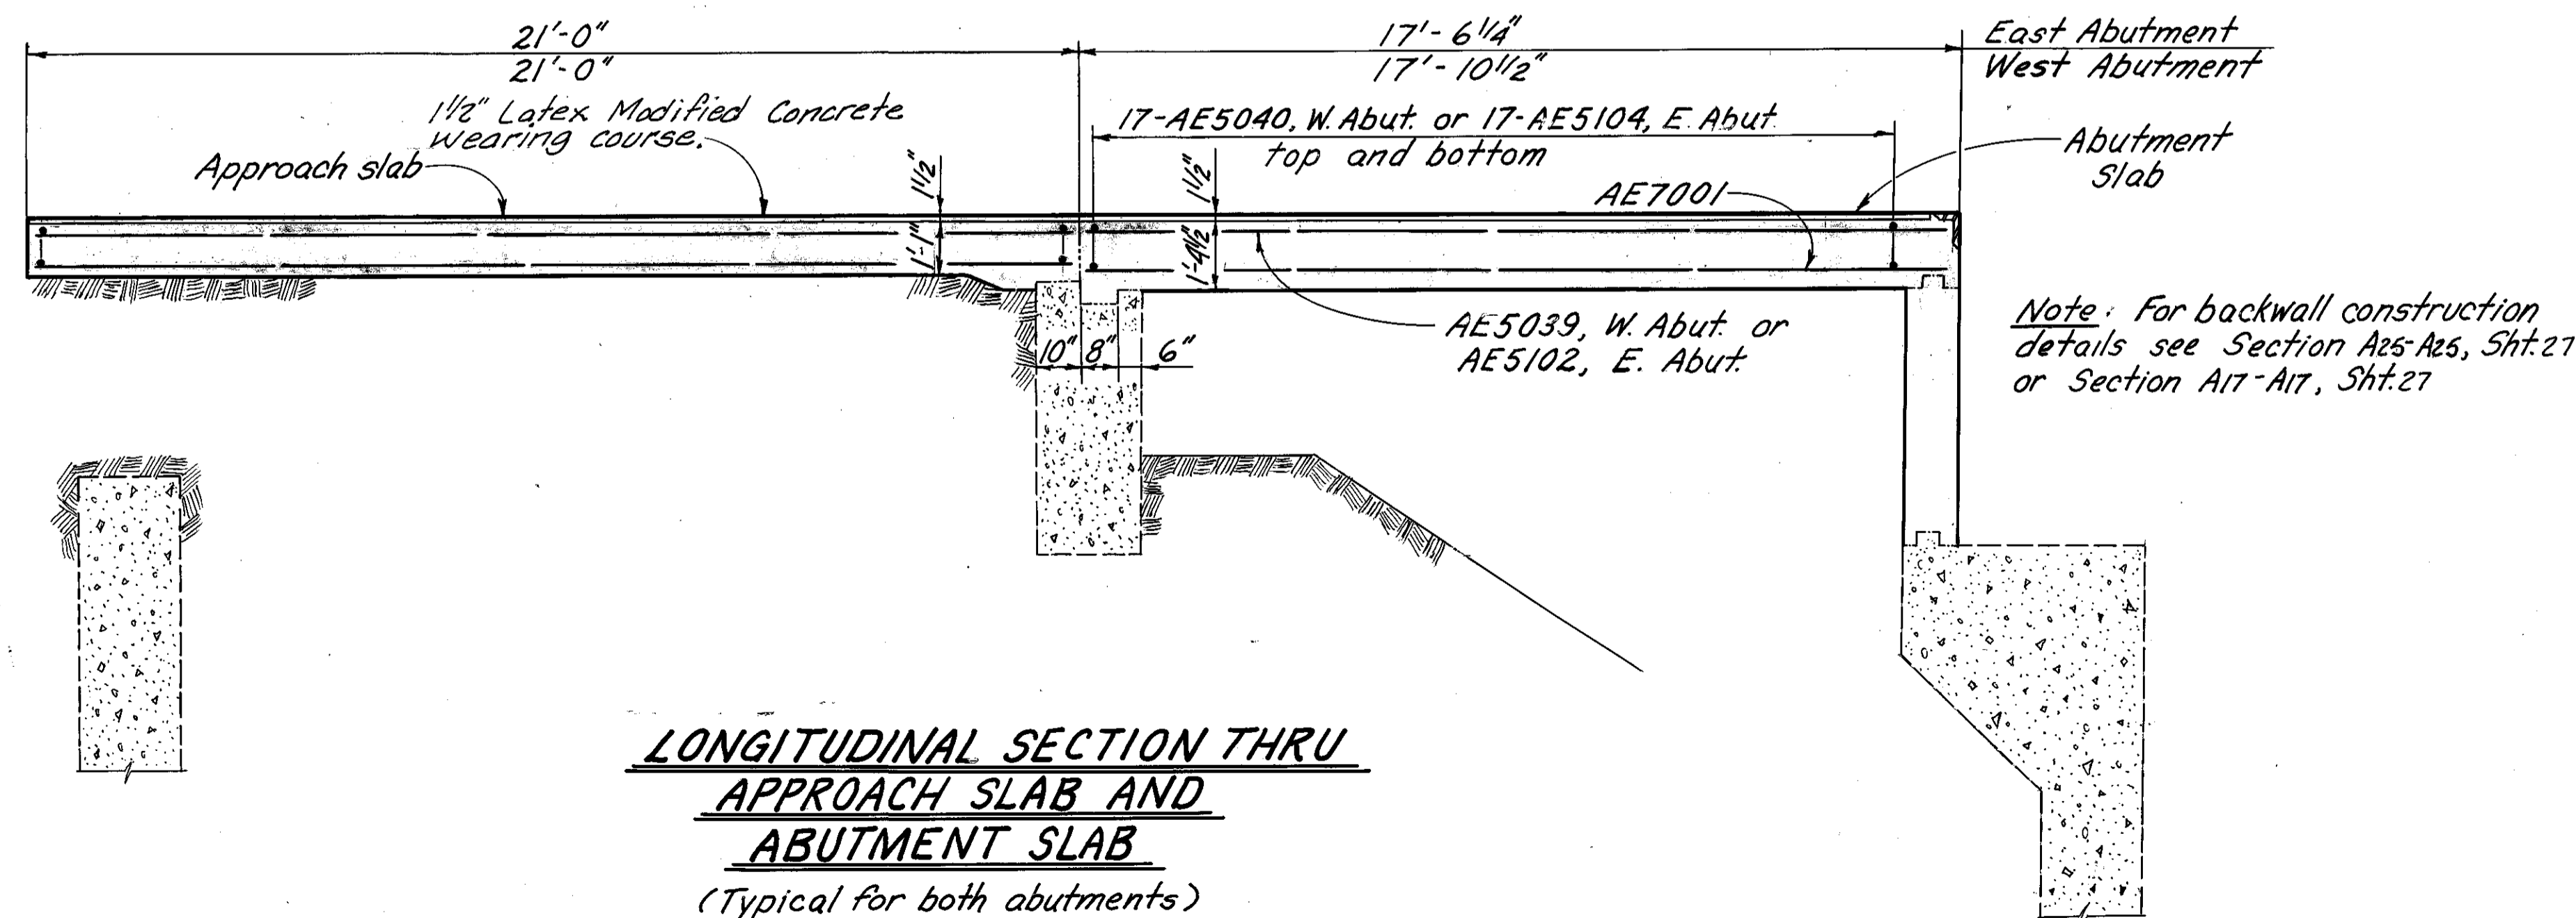
**LONGITUDINAL SECTION THRU  
APPROACH SLAB AND  
ABUTMENT SLAB**

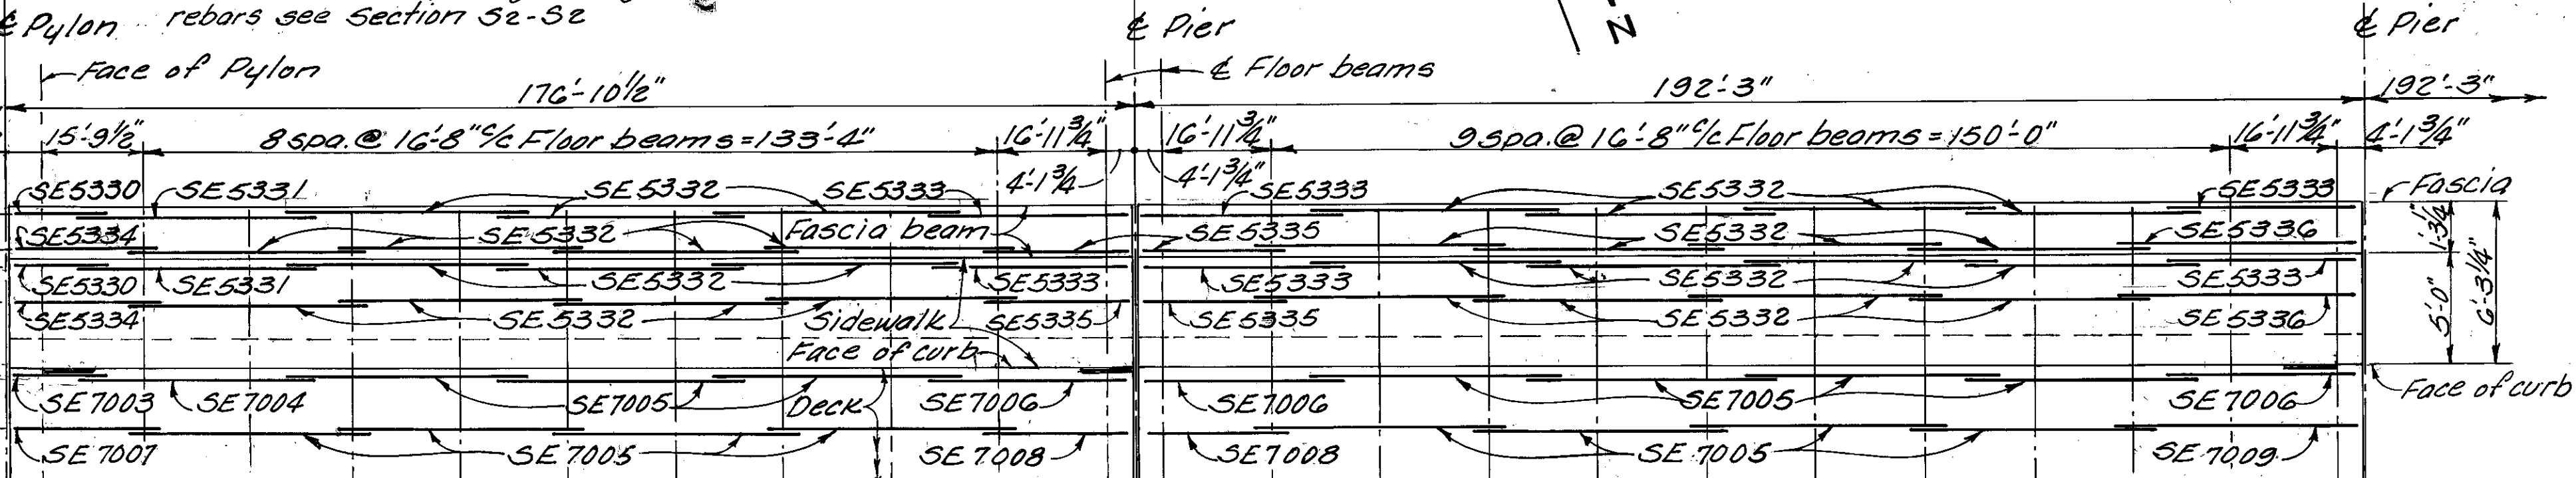
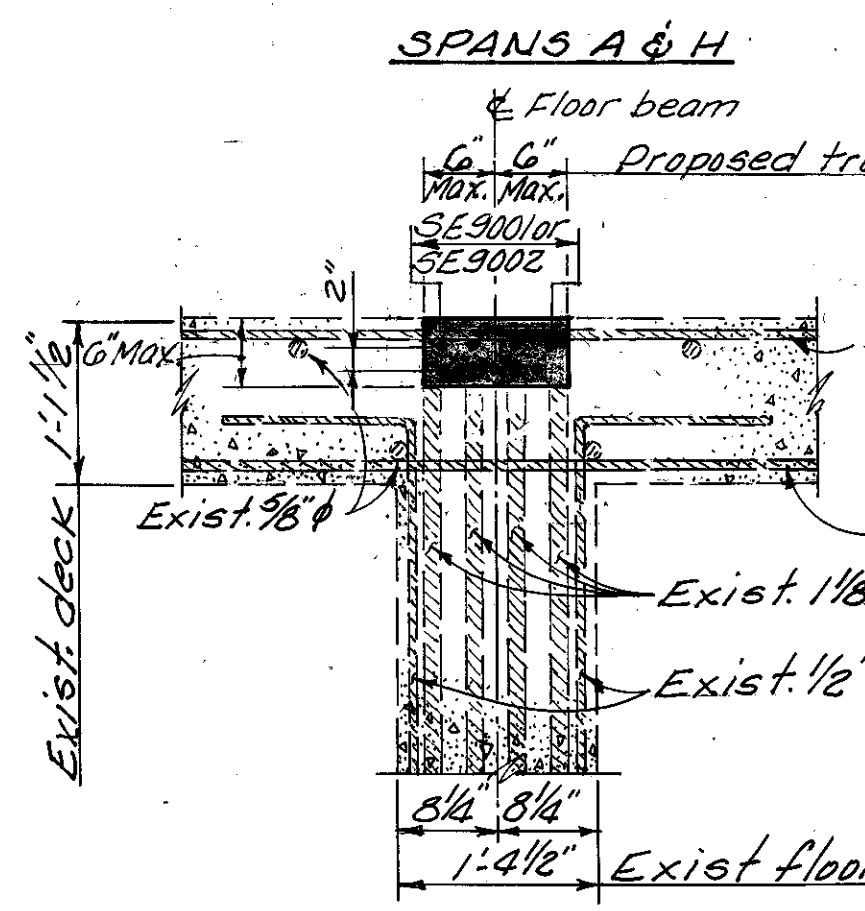
SECTION S21-S21  
Showing trough cut in existing deck to accept SE 9001 or SE 9002 reinforcing bars in cantilevered bracket. Exercise care in concrete removal so as not to damage concrete and rebars which are to remain.
