**PID 101682**

**CUY-17-02.83**  
*Fairview Park, Ohio*

# DRAFT DECK CONDITION SURVEY

**April 2016**

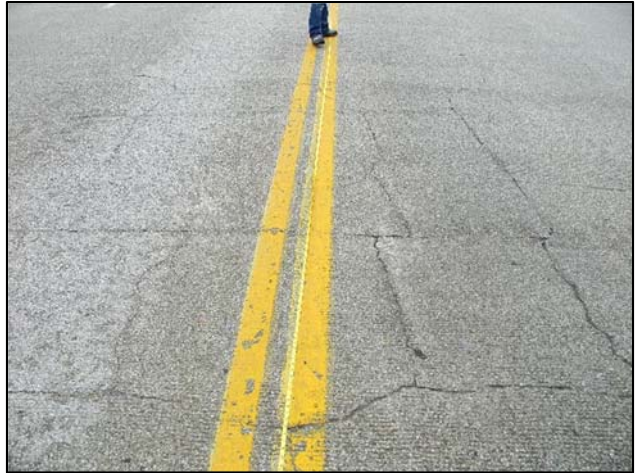
In general, the wearing surface is in Poor Condition, particularly in the areas over the original 1933 deck. Both approach spans exhibit large areas of pattern or map cracking with de-bonded overlay throughout (see *Photos 1 and 2*), and scattered areas of deep delamination and isolated locations of spalls. Please refer to the figures in Appendix A for detailed mapping of deterioration. These areas of deterioration typically begin 7' to 8' from the face of both curbs. The construction joint between the 1989 widening and the original 1933 deck is located at 7'-9" from the face of the both curbs (see *Figure 2*). Near this joint is a 1/16" open crack running longitudinally for the entire East and West Approach spans that stays within 7' to 8' of the face of the curbs. There is minor map cracking in the overlay located over the 1989 widened deck.

*Photo 1 – Large map cracks at least 1/16" wide throughout the East Approach Spans over the original deck area.*

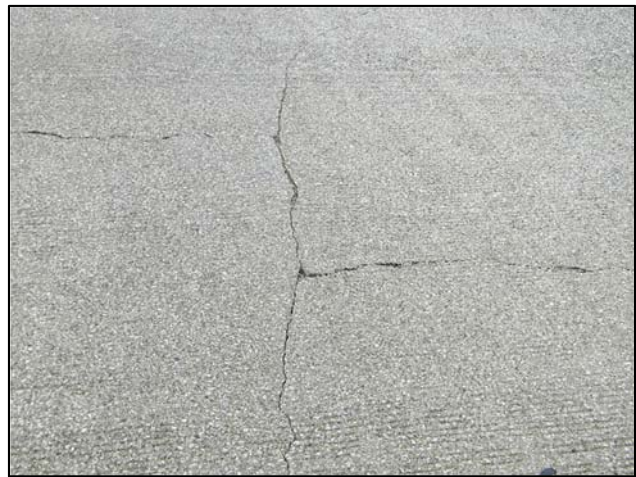
*Photo 2 – Detail of irregular transverse cracks joining longitudinal cracks, typical. The overlay is typically de-bonded throughout both the East and West Approach spans in the original deck area.*

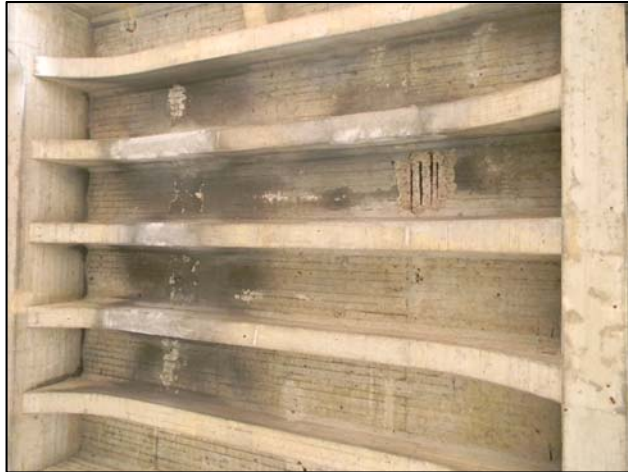
The original 1933 deck undersides for the West Approach Spans (Spans 1 through 6) are in Poor Condition and exhibit typical transverse cracks with water infiltration with delaminations and spalls. Approximately 14% of the slab is deteriorated, mostly following transverse cracks (see *Photos 3 and 4*).

*Photo 3 – Overall view of the original West Approach Span 3 underside exhibiting typical delaminations and spalling.*

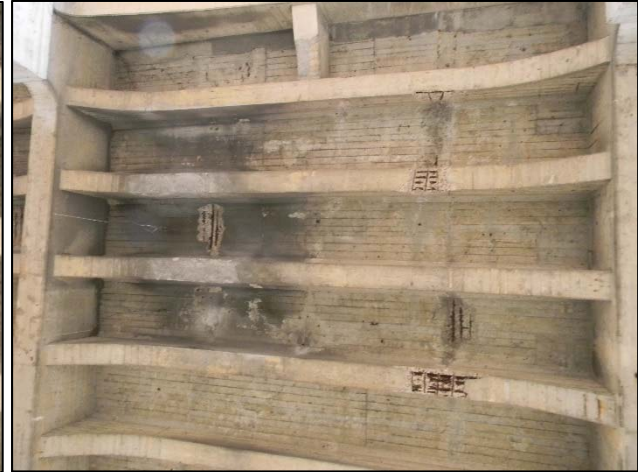
*Photo 4 – Overall view of the original West Approach Span 4 underside exhibiting typical delaminations and spalling. Note extensions of spalls to the stringers.*

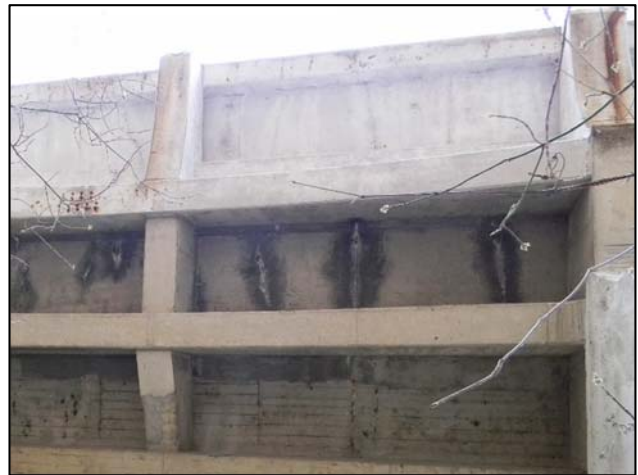
*Photo 6 – Typical transverse cracks with efflorescence at 2-6 foot spacing in widened deck. Span 4, south end shown.*

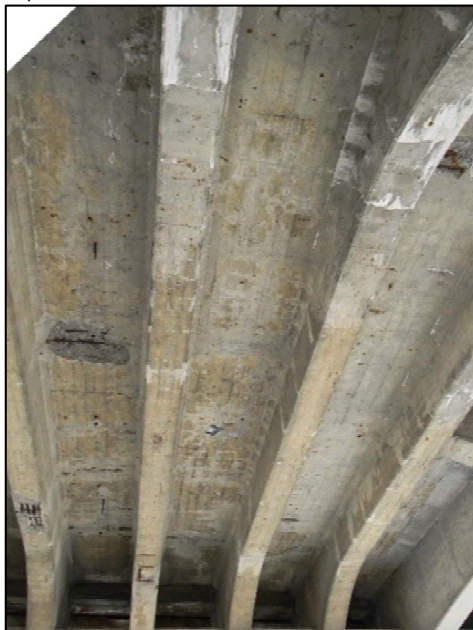
The East Approach Spans (Spans 7 through 9) have similar cracks and spalls; however, they are more randomly located (see *Photo 5*). In both the West and East Approach spans, the 1989 widened portion of the deck exhibits transverse cracks with efflorescence that extend into the sidewalk framing (see *Photo 6*). The sidewalk framing condition is specifically discussed in the Railing Alternative Study as a separate document. The construction joints between the original and widened portions of the deck exhibit heavy efflorescence and seepage in all three East Approach Spans (see *Photo 7*).

*Photo 5 – Original East Approach Span 7 underside exhibiting typical delaminations and spalling. Note heavy efflorescence on stringers.*

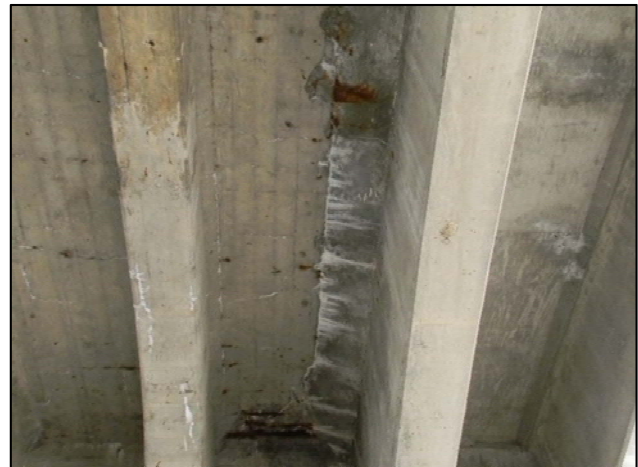
*Photo 7 – Typical heavy efflorescence at construction joint. East Approach Span 9, south joint shown.*

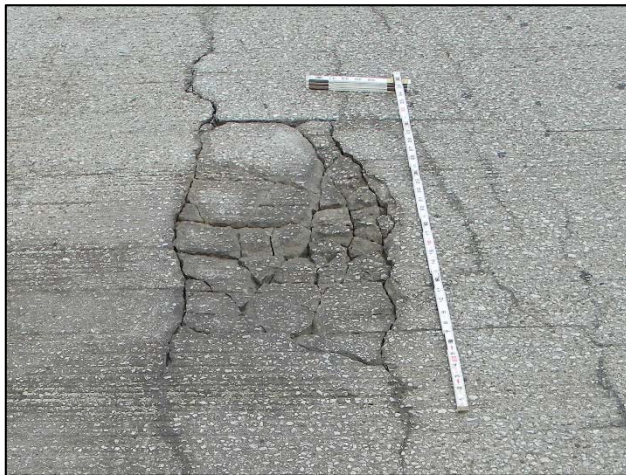
Large areas of delamination and scattered spalls are typical throughout all spans over the original 1933 deck area (see *Photos 9 and 10*). However, the 1989 widened deck overlay exhibits minor map cracking throughout. Please refer to the Figures in Appendix A for detailed mapping of deterioration. These areas of deterioration typically begin 8' to 8.5' from the face of both curbs. The construction joint between the 1989 widening and the original 1933 deck is located at 8'-3" from the face of the both curbs (see *Figure 2* above, and *Photo 11*). The arch spans also exhibit the same reflective minimum 1/16" open longitudinal crack near this joint.

*Photo 9 – Localized area of delamination that has fractured and settled 1". This location is in the East end of Arch F, center EB lane shown.*

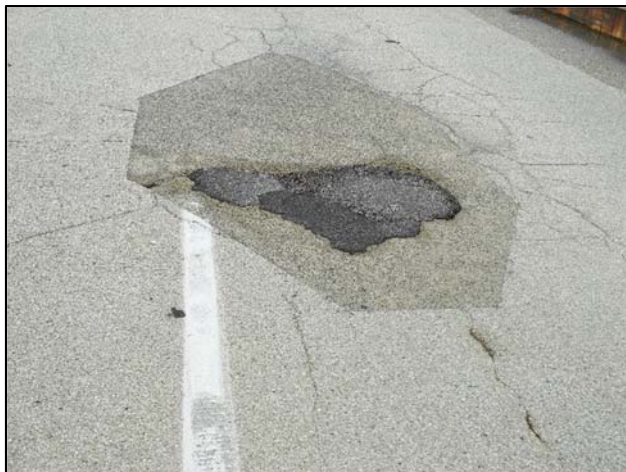
*Photo 10 – Typical spall filled in with asphalt. Arch D, north EB lane shown – the surrounding area is fully delaminated and note the rust staining.*

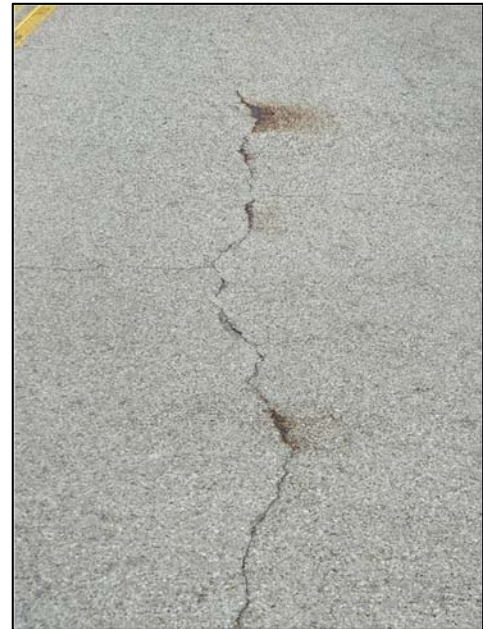
*Photo 8 – Longitudinal crack exhibiting active rust staining from crack. Arch H, center WB lane shown.*

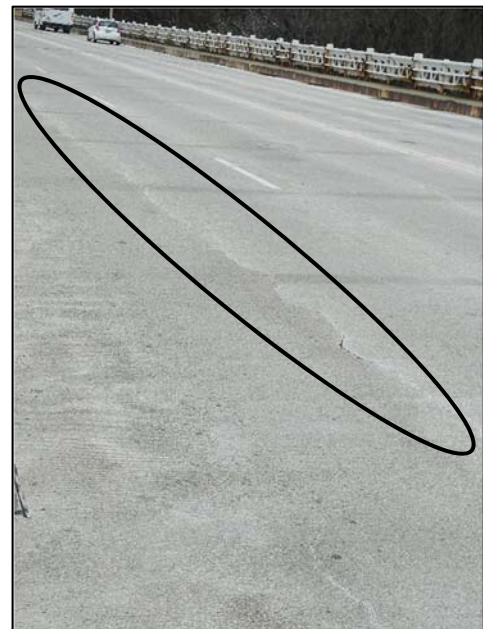
*Photo 11 – Typical 1/16" longitudinal crack, approximately 8.5' from the curb face. Arch B, south EB lane shown.*

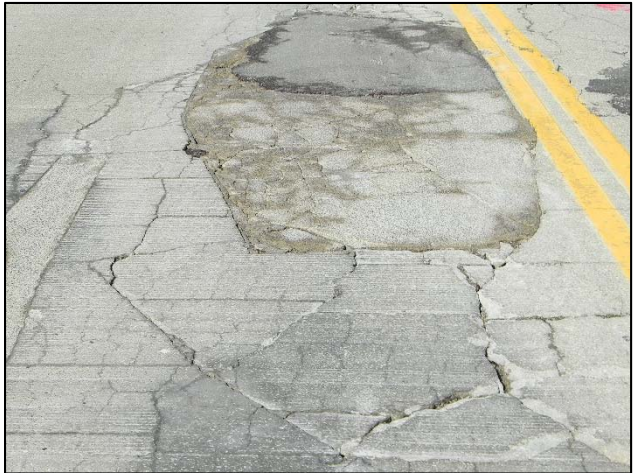
The critical span is the Arch A span due to the approximately 1400 SF of failed wearing surface as a result of the spalling, fracturing, settling and rutting of the surface from 3/4" to little more than an 1", located at the west end of the center lanes (see *Photos 12 through 15*). This area also has at least two distinct, coincident layers of patches that have failed, indicating the deterioration is deep and continuous. In addition, the longitudinal cracks are open up to 1/4". This area should be monitored. Outside of this area, the overlay exhibits the typical cracks and delaminations as the other Arch spans.

*Photo 12 – Fully fractured and settled overlay and patches with a spall filled in with cracking asphalt.*

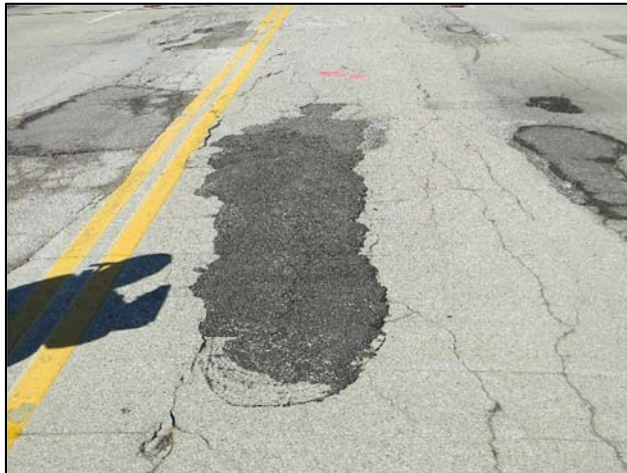
*Photo 13 – The overlay is beginning to fracture and settle at the asphalt-filled spalls. Note the conchoidal breaking of the deck surface at the bottom of the asphalt patch.*

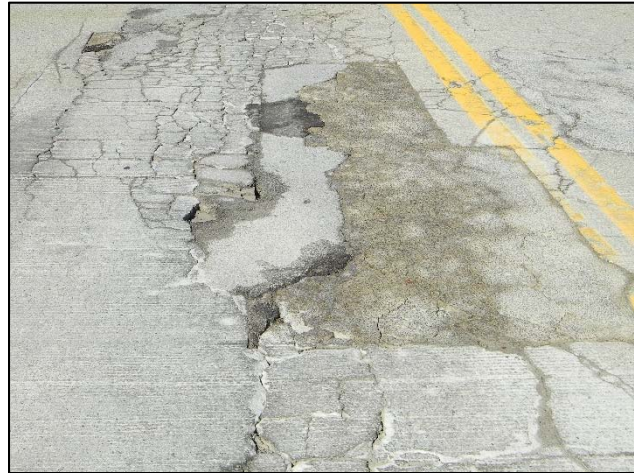
*Photo 14 – Severe "block" cracking of the overlay and patches leading to fractured concrete.*

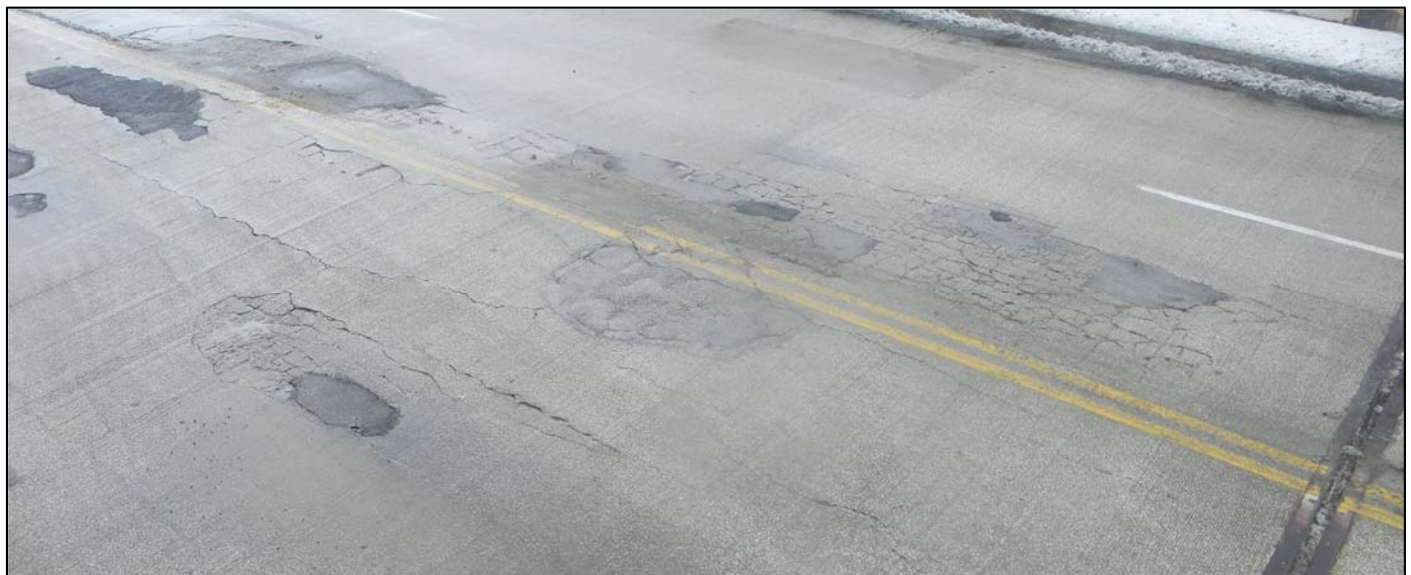
*Photo 15 – Overview of the failed overlay at the west end of Arch A showing various longitudinal cracks splitting and the fracturing of the surface indicating the spalled areas are actively growing. Photo taken during the sidewalk framing inspection atop the UB-40 truck.*

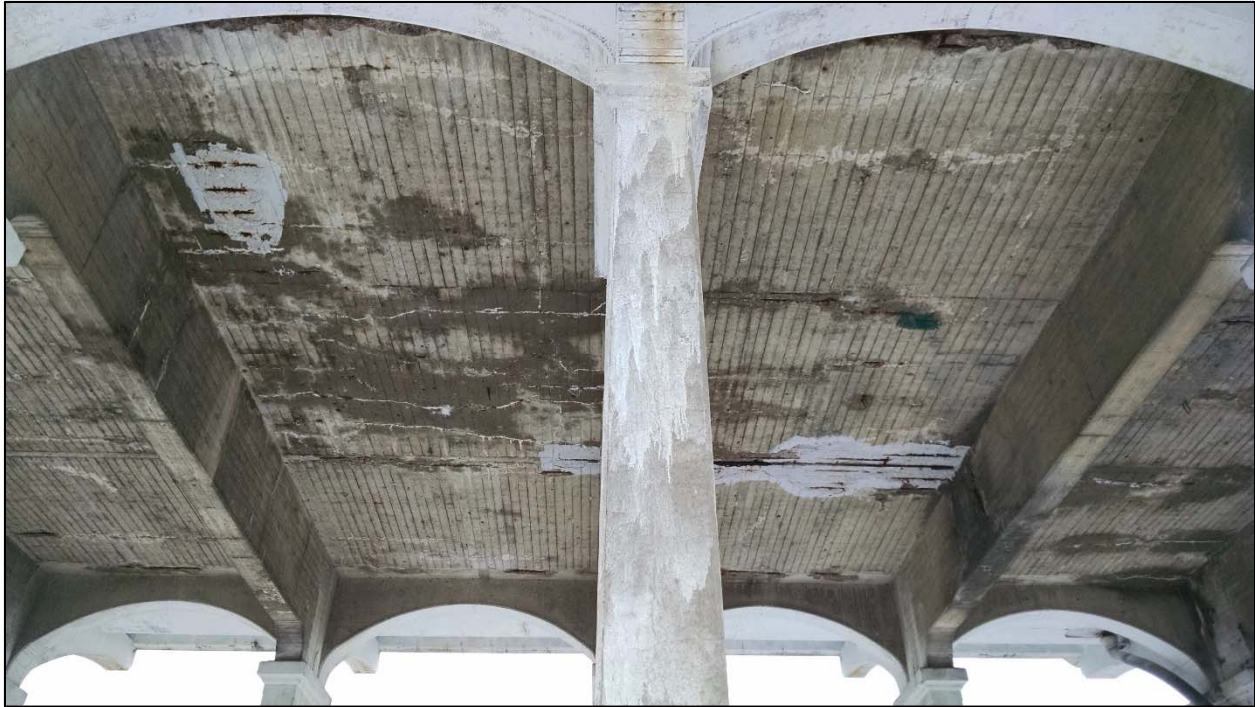
The Arch Span decks are generally in Poor Condition (excluding Arch A) with the original portions of the deck underside exhibiting large areas of water infiltration, cracks, delaminations, spalls with exposed reinforcing throughout all spans (see *Photos 16 through 18*). The exposed reinforcing is actively corroding, water stains the deck underside after rainfall or snow melt. Efflorescence stalactites occasionally form in these areas. Appendix A shows the estimated areas of deterioration (spalls and suspected areas of delamination) per bay. Arch A is discussed on the following page.

*Photo 16 – Overview of Arch B, interior Bays 9 and 10, seen from the south end. Typical water infiltration and efflorescence at the cracks. Note the continuation of spalling at locations where the deck was epoxy sealed.*

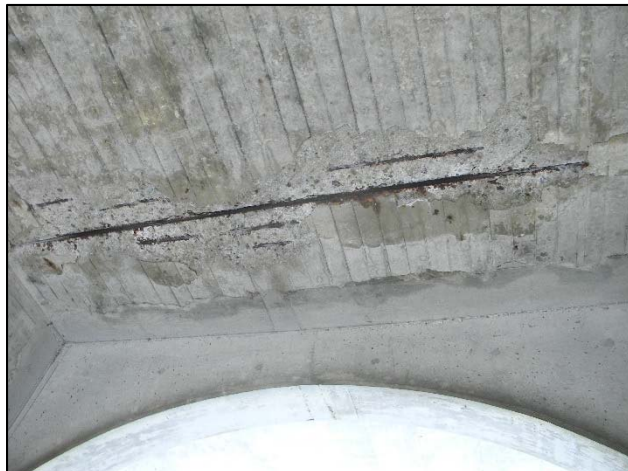
*Photo 17 – Delaminations with a fresh spall near the 1989 widening construction joint. Arch F, north end of interior Bay 7*

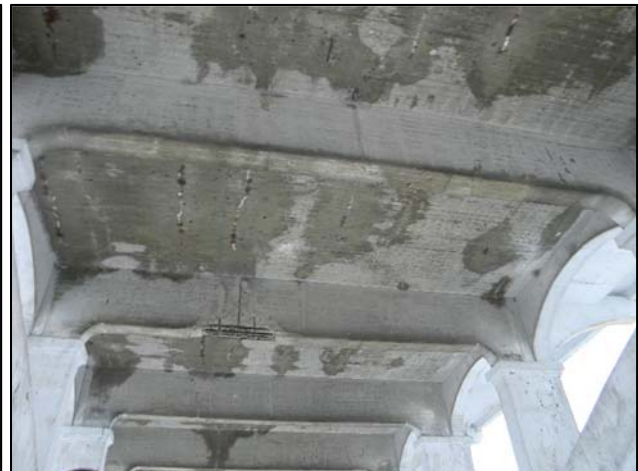
*Photo 18 – General view of the bottom of Arch G deck showing extent of water infiltration.*

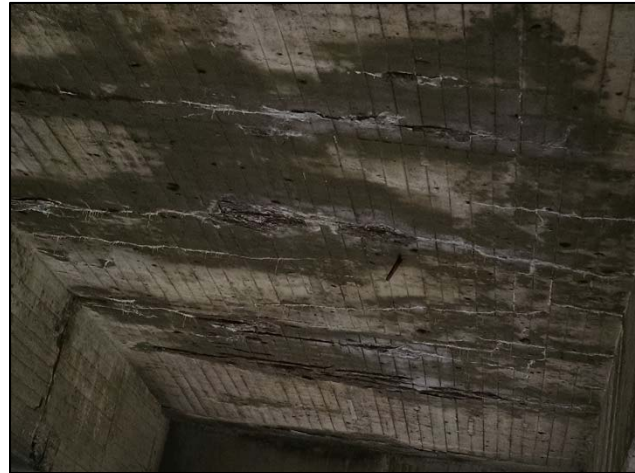
Photo 19 – Interior Bay 1 of Arch A viewed from the south.

The Arch A deck underside is in Serious Condition with large areas of exposed, corroding rebar (see *Photos 19 through 21*). There are various locations in the two west bays where water constantly drips a day after rainfall. This area coincides with the failed and settling patches in the deck surface above. This area should be monitored for a future, potential through-hole.

- For the next inspection cycle, perform an arm's length, in-depth inspection of the slab utilizing testing or other methods to quantify full-depth repair.
- Perform full-depth repairs in conjunction with replacing the overlay with a latex modified concrete to keep water away from the deck for the remaining useful life.
- Remove all loose concrete over the roadway and park trails

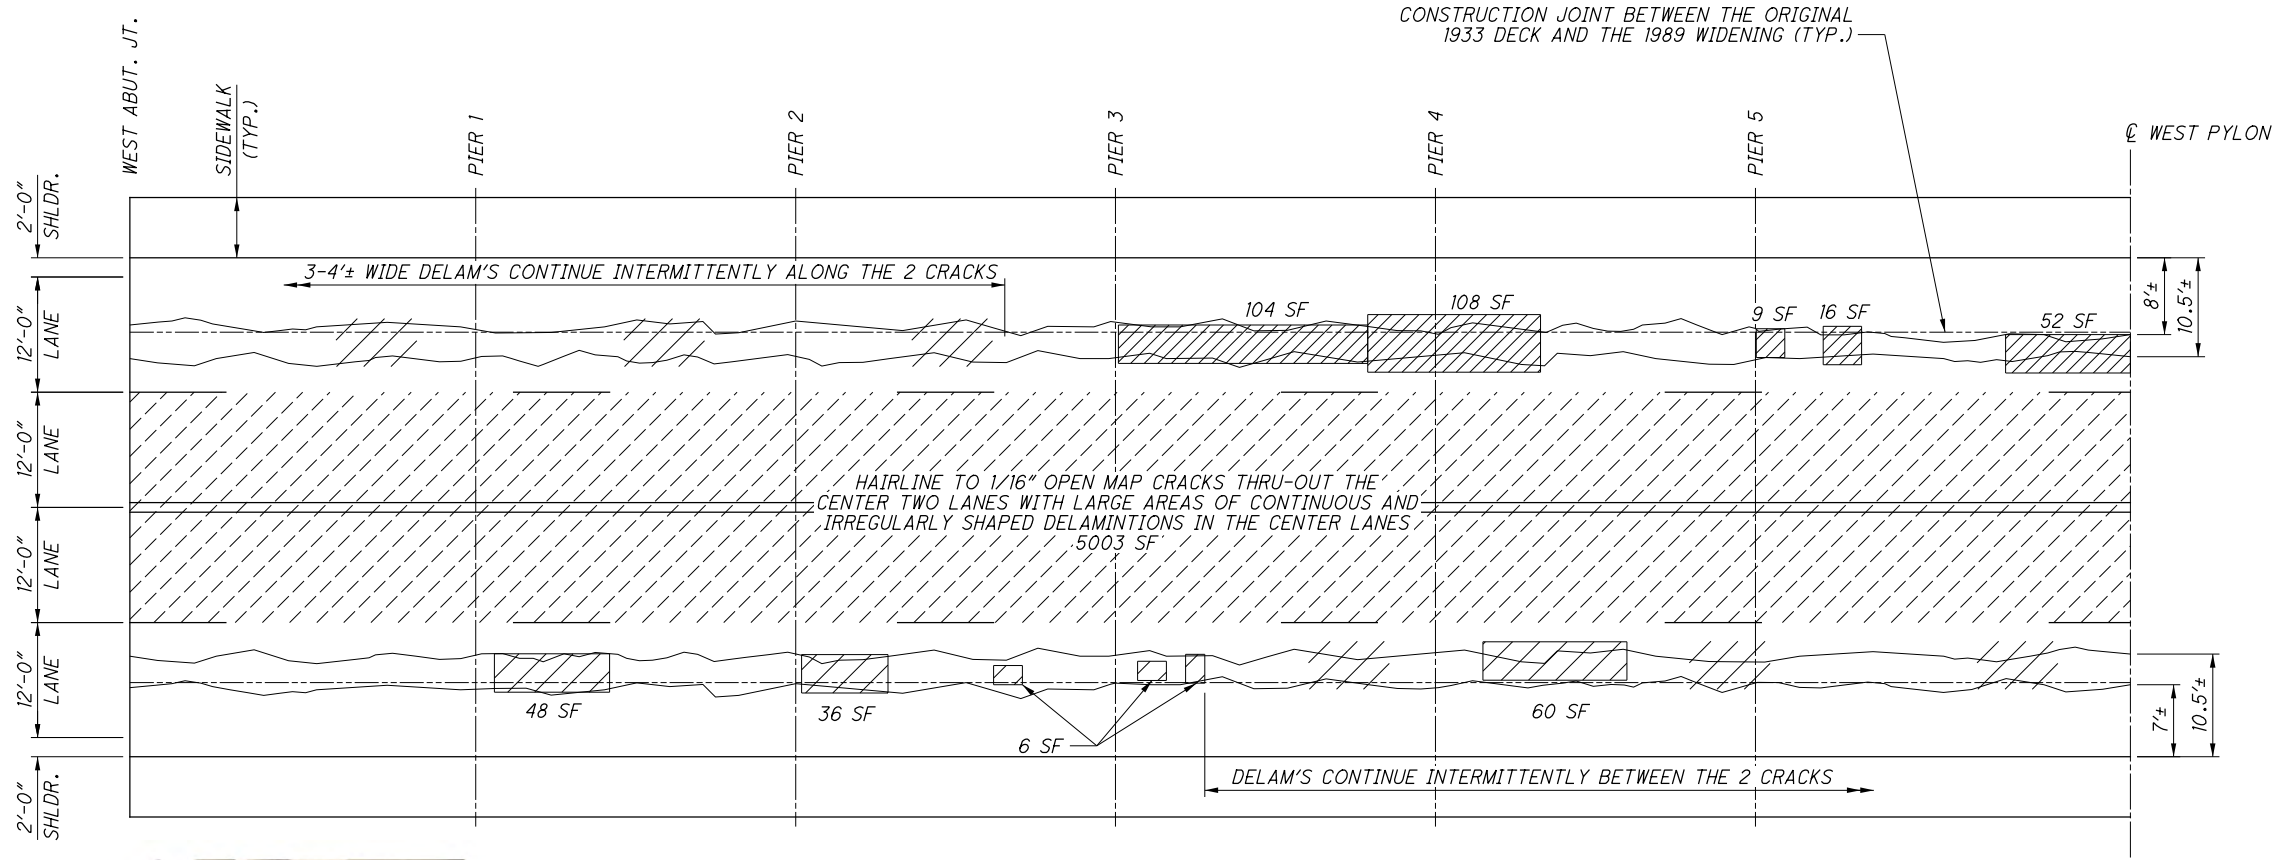
TOTAL AREA OF OVERLAY = 10840 SF  
 TOTAL AREA OF DETERIORATION (SPALLS AND DELAMINATIONS ONLY) = 5614 SF  
 52% DETERIORATION EXCLUDING CRACKS

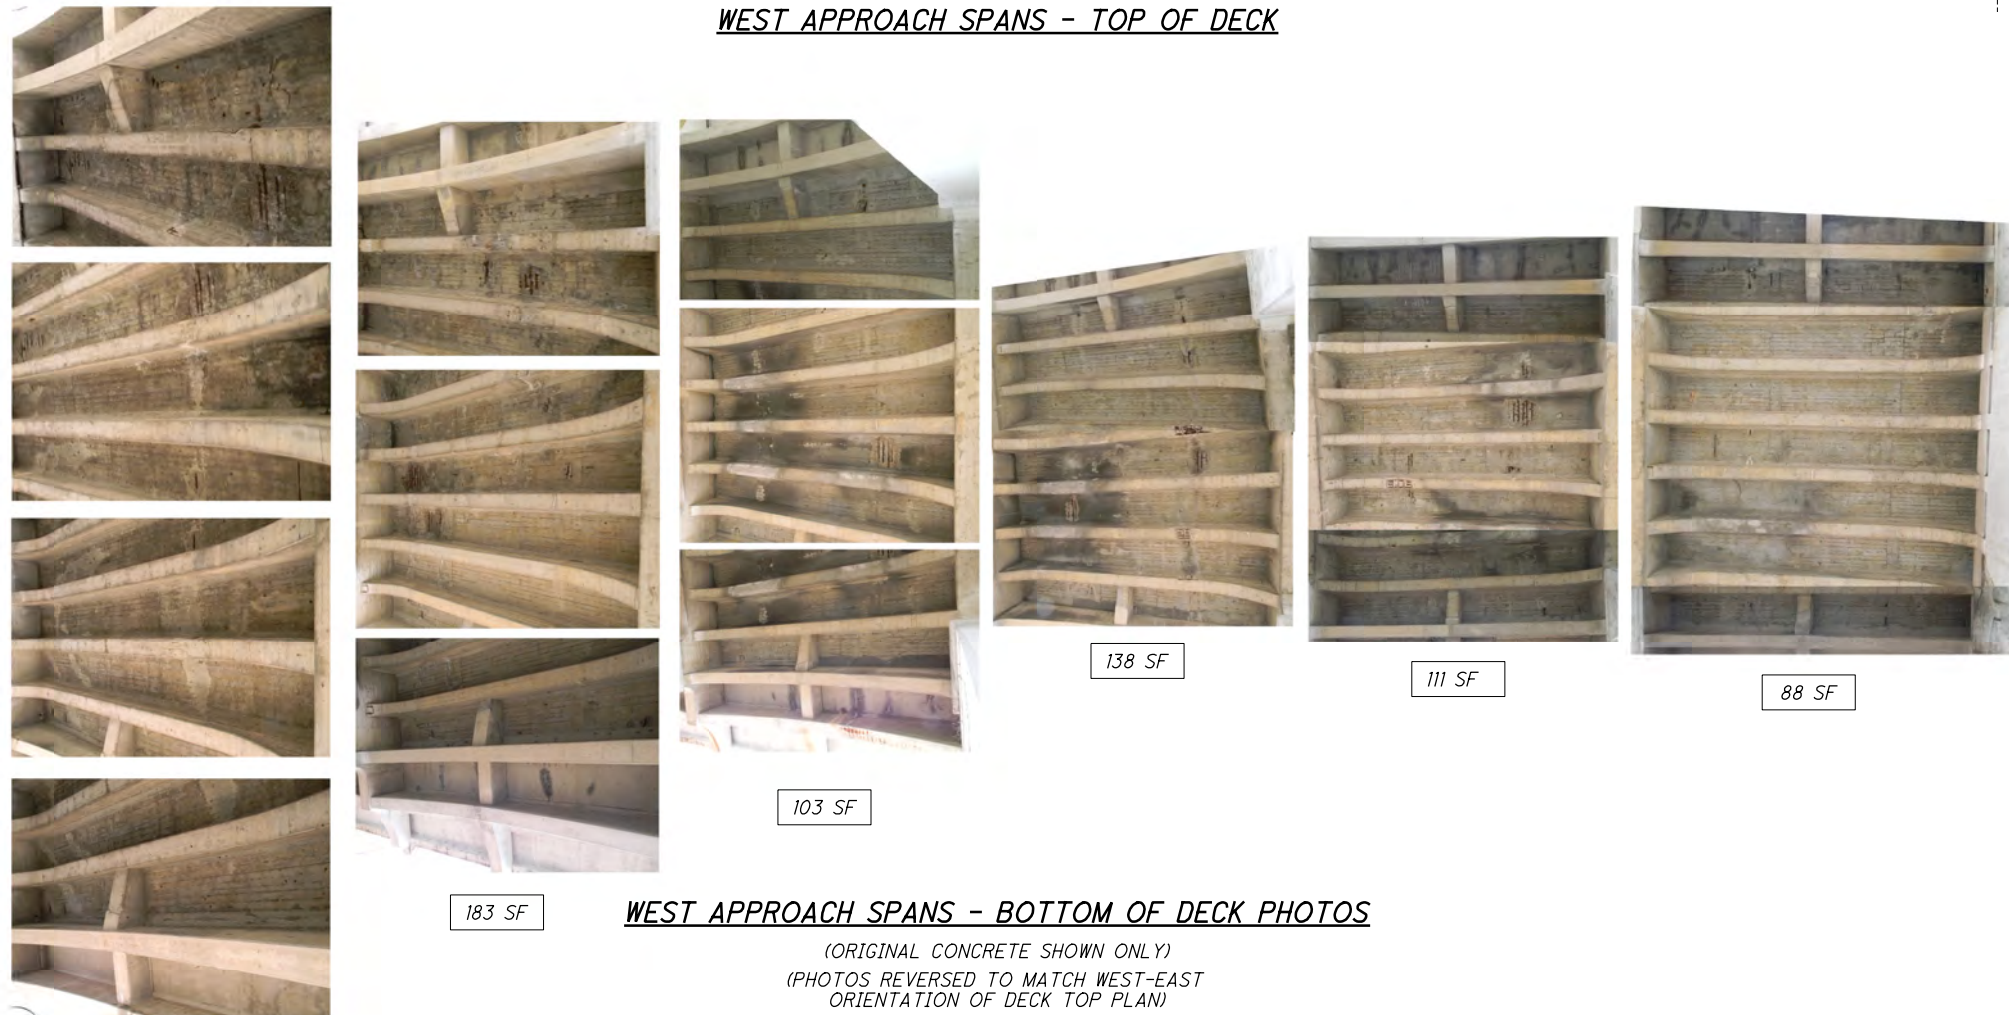
**WEST APPROACH SPANS - BOTTOM OF DECK PHOTOS**

TOTAL ORIGINAL DECK UNDERSIDE AREA NOT COUNTING STRINGERS AND BRACKETS = 5259 SF  
 TOTAL AREA OF DETERIORATION = 813 SF  
 15% DETERIORATION

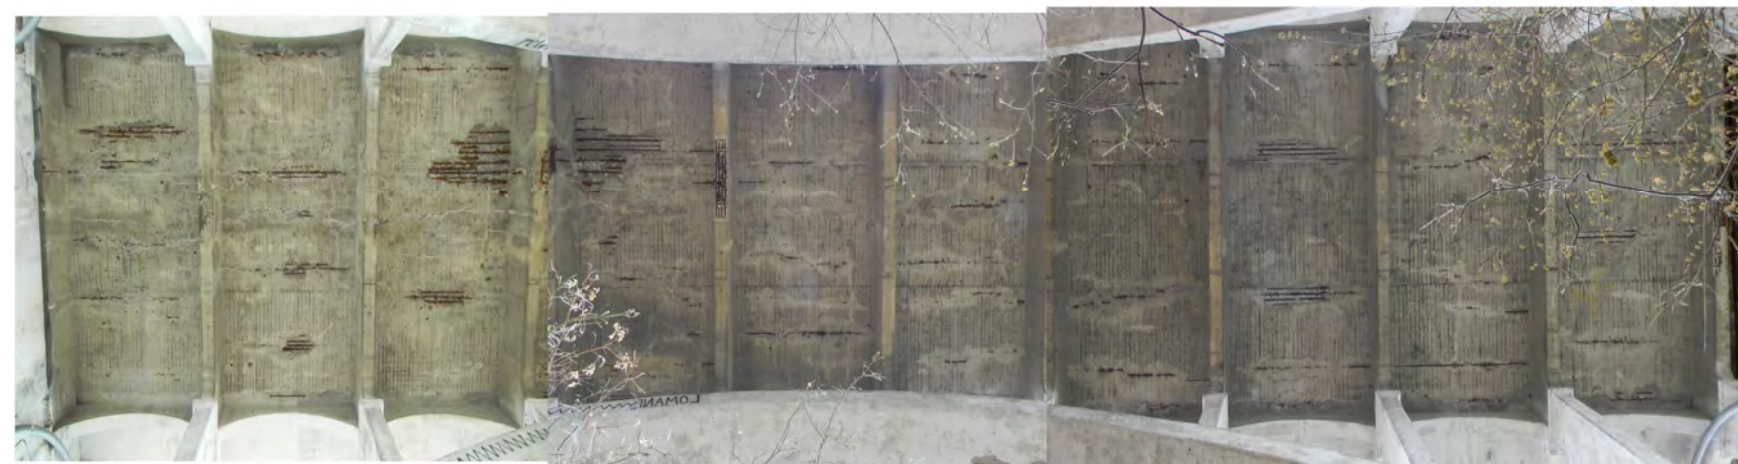
**ARCH A - BOTTOM OF DECK PHOTO**

258 SF
195 SF
215 SF
393 SF
216 SF
255 SF
212 SF
233 SF
215 SF
192 SF

TOTAL ORIGINAL DECK UNDERSIDE AREA NOT COUNTING FLOOR BEAMS = 5644 SF  
 TOTAL AREA OF DETERIORATION = 2384 SF  
 42% DETERIORATION

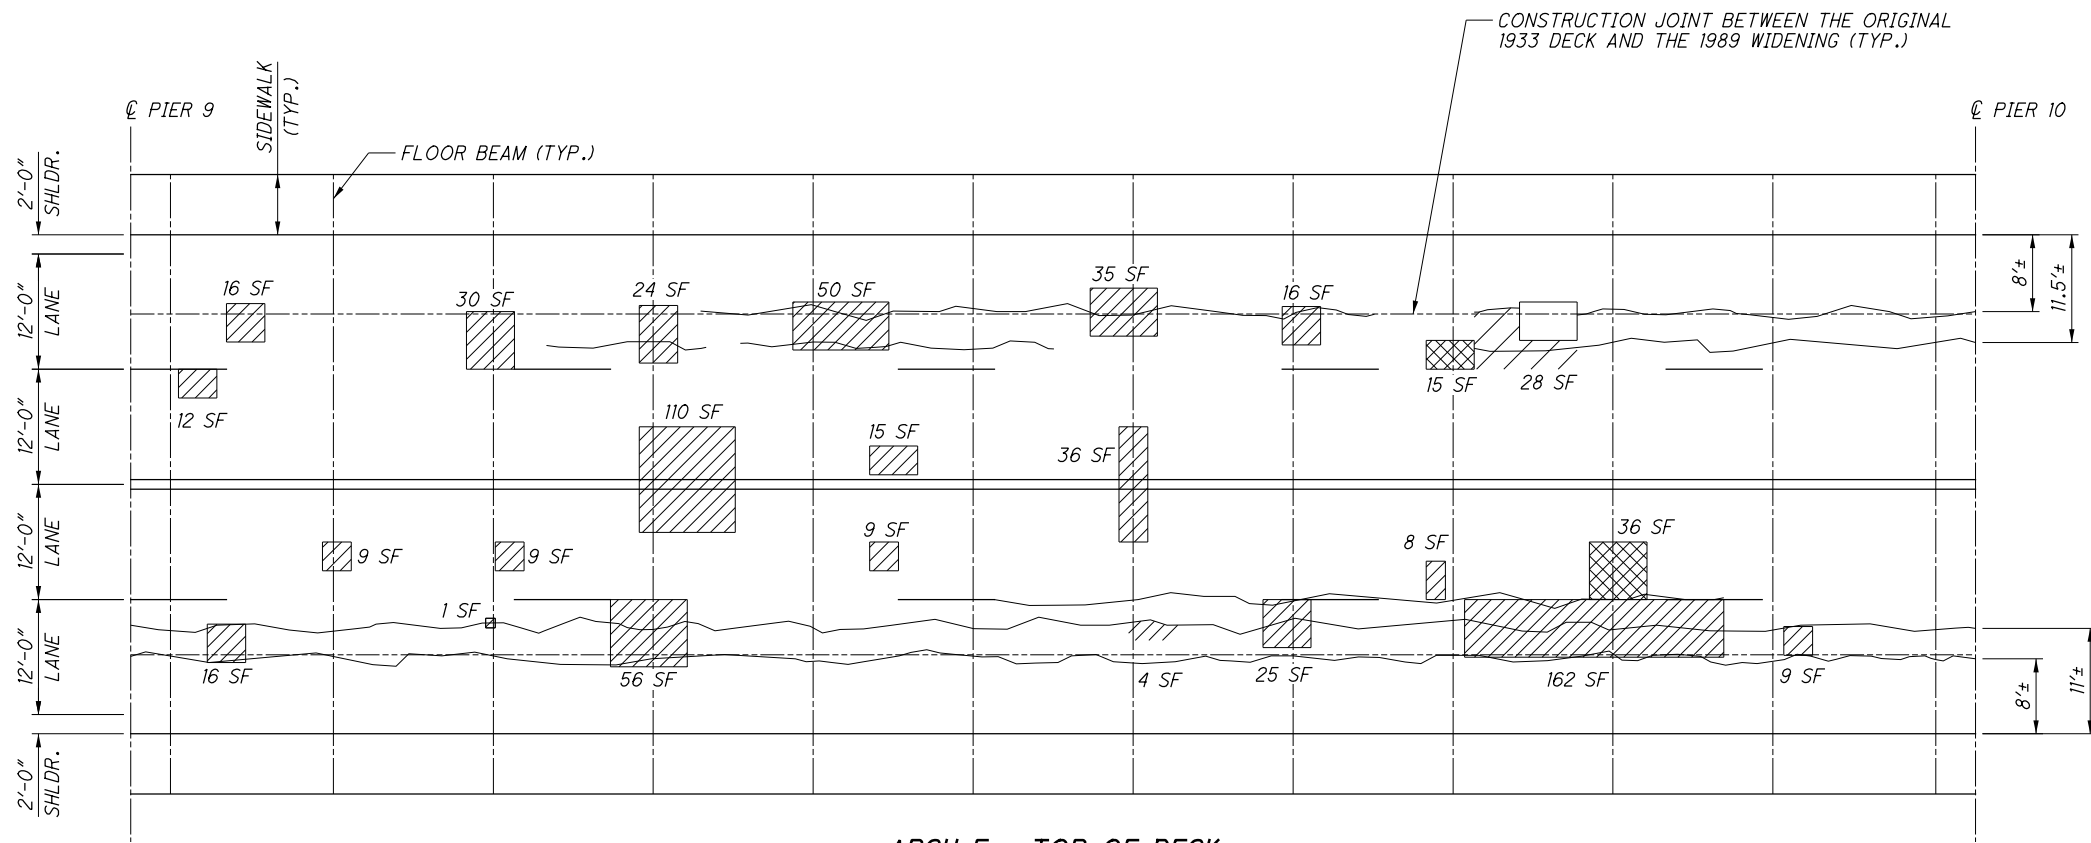
**ARCH E - TOP OF DECK**

TOTAL AREA OF OVERLAY = 9997 SF  
 TOTAL AREA OF DETERIORATION (SPALLS AND DELAMINATIONS ONLY) = 731 SF  
 7% DETERIORATION EXCLUDING CRACKS

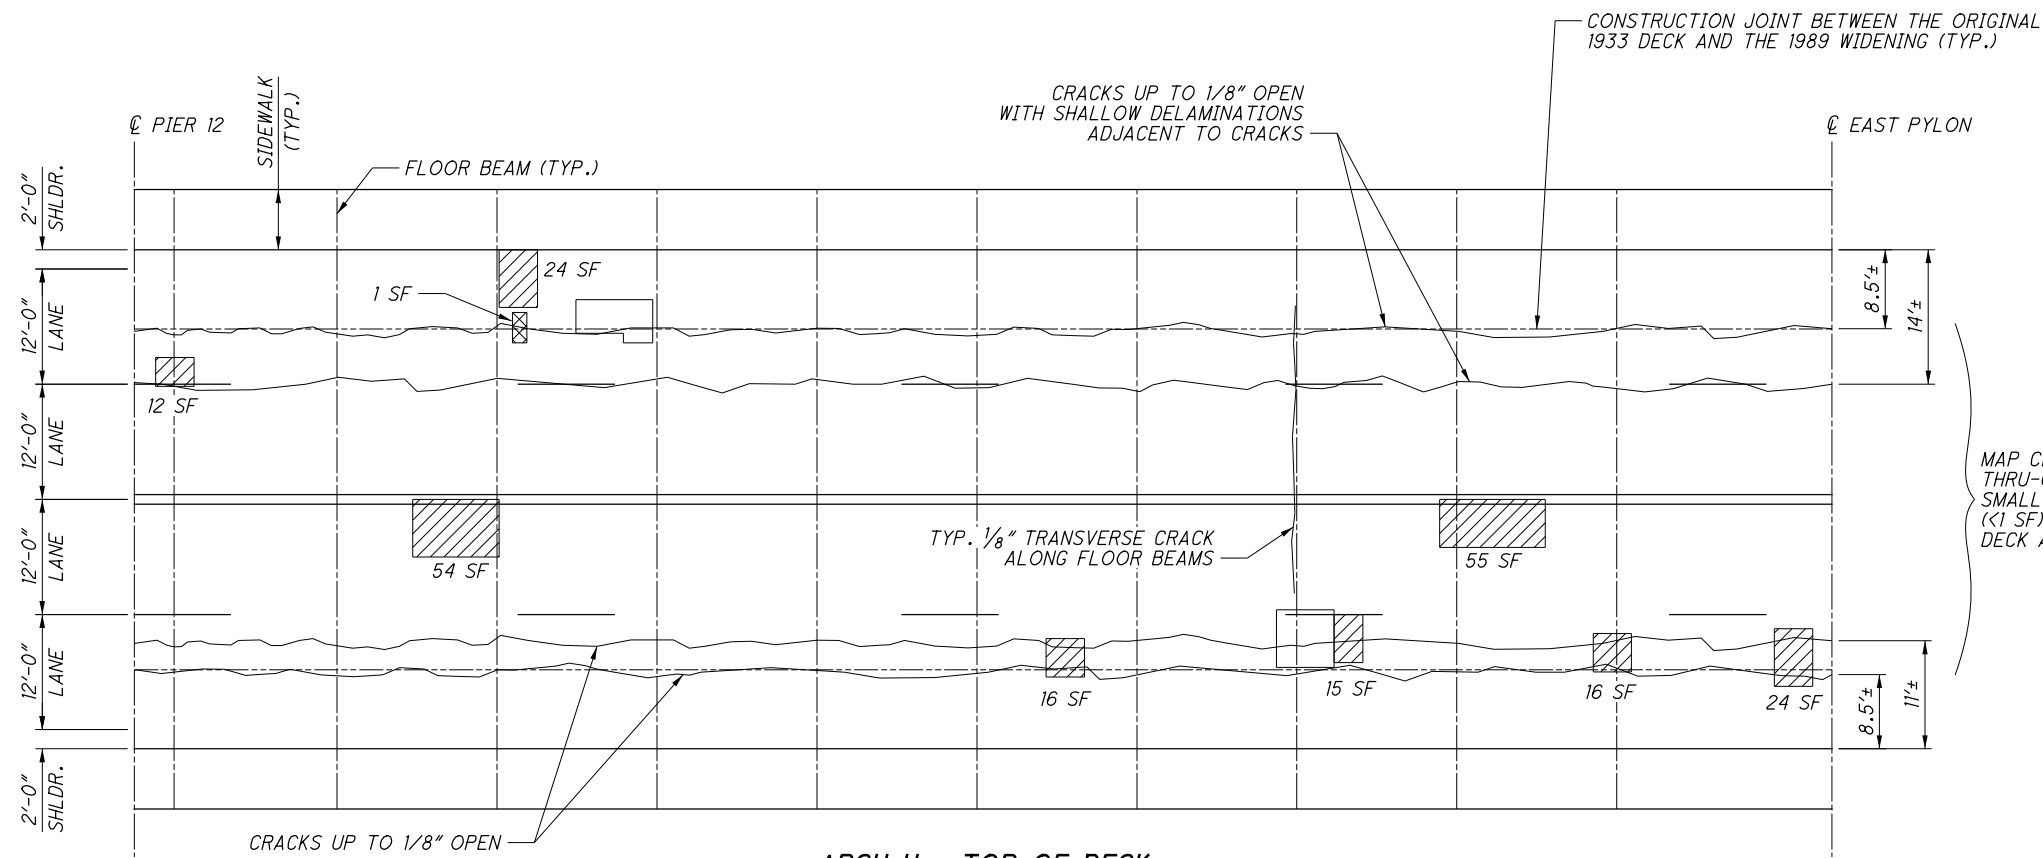
**ARCH H - TOP OF DECK**

TOTAL AREA OF OVERLAY = 9198 SF  
 TOTAL AREA OF DETERIORATION (SPALLS AND DELAMINATIONS ONLY) = 217 SF  
 3% DETERIORATION EXCLUDING CRACKS

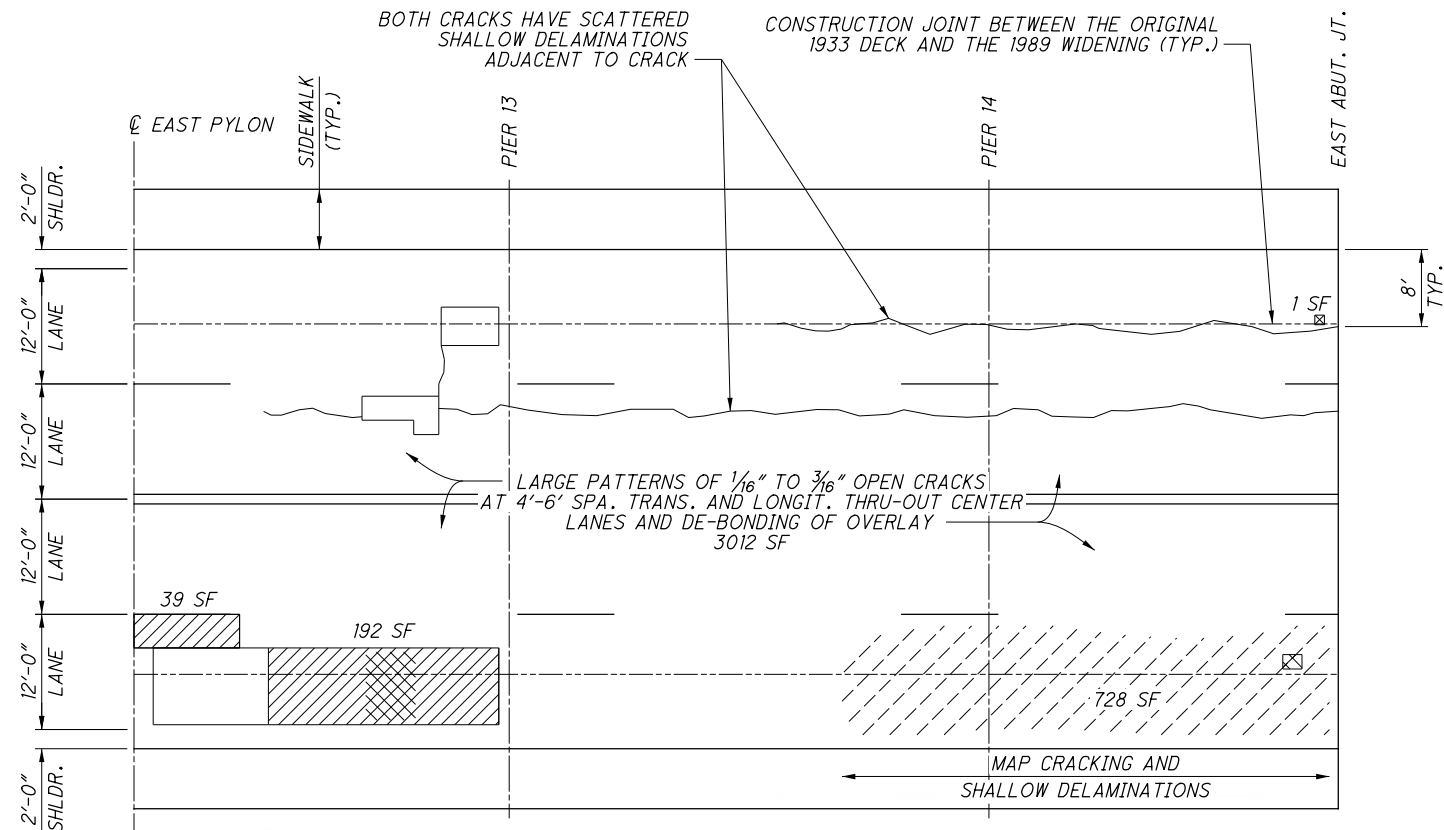
**EAST APPROACH SPANS - TOP OF DECK**

TOTAL AREA OF OVERLAY = 6525 SF  
 TOTAL AREA OF DETERIORATION (SPALLS AND DELAMINATIONS ONLY) = 3972 SF  
 61% DETERIORATION EXCLUDING CRACKS

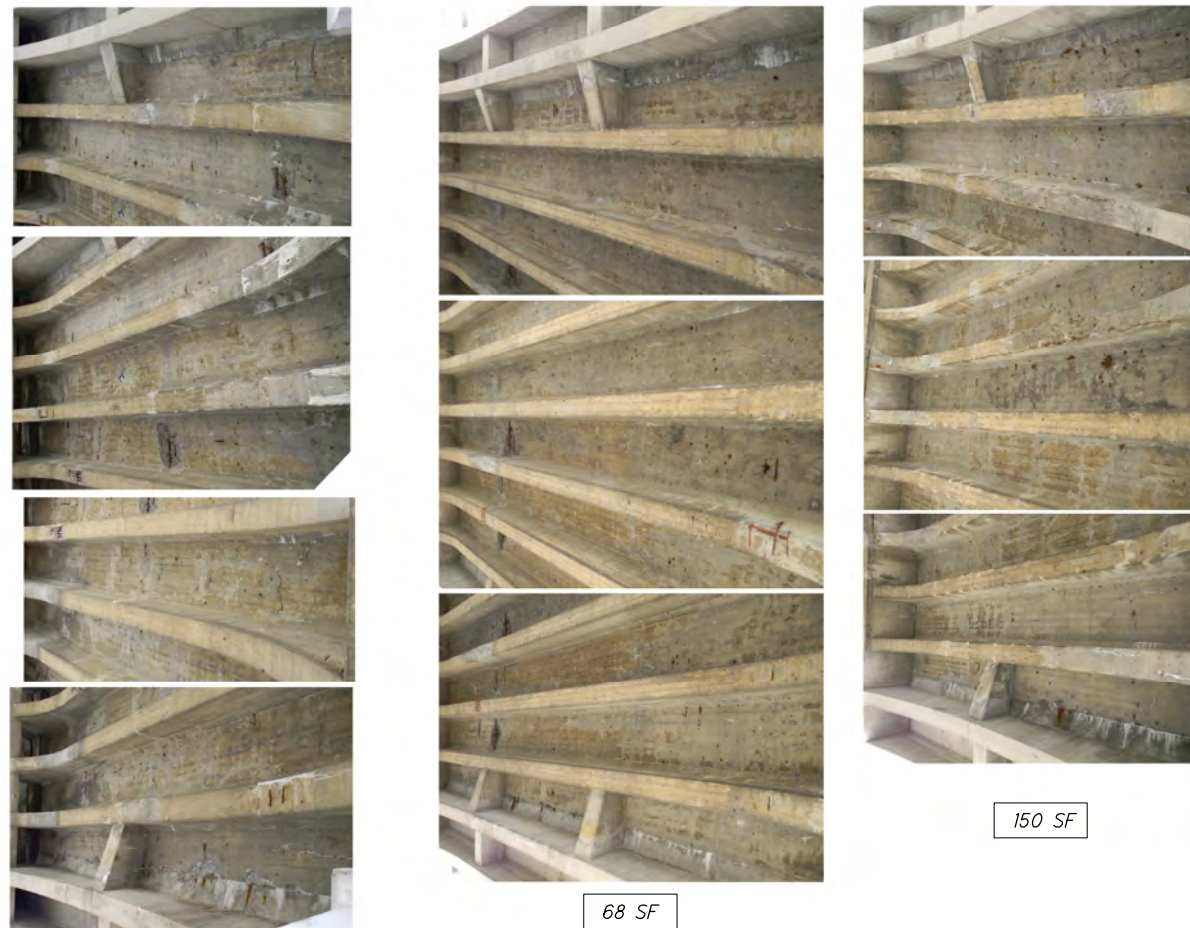
**EAST APPROACH SPANS - BOTTOM OF DECK PHOTOS**

TOTAL ORIGINAL DECK UNDERSIDE AREA NOT COUNTING STRINGERS AND BRACKETS = 3096 SF  
 TOTAL AREA OF DETERIORATION = 380 SF  
 12% DETERIORATION
