Re: Report for Bridge Deck Coring
Cuy-17-2.83
PID No.: 101682
Cleveland, Cuyahoga County, Ohio
PSI Project No.: 01412287

Pavement Coring
CUY-17-2.83 (PID No.: 101682)
Cuyahoga County, Ohio

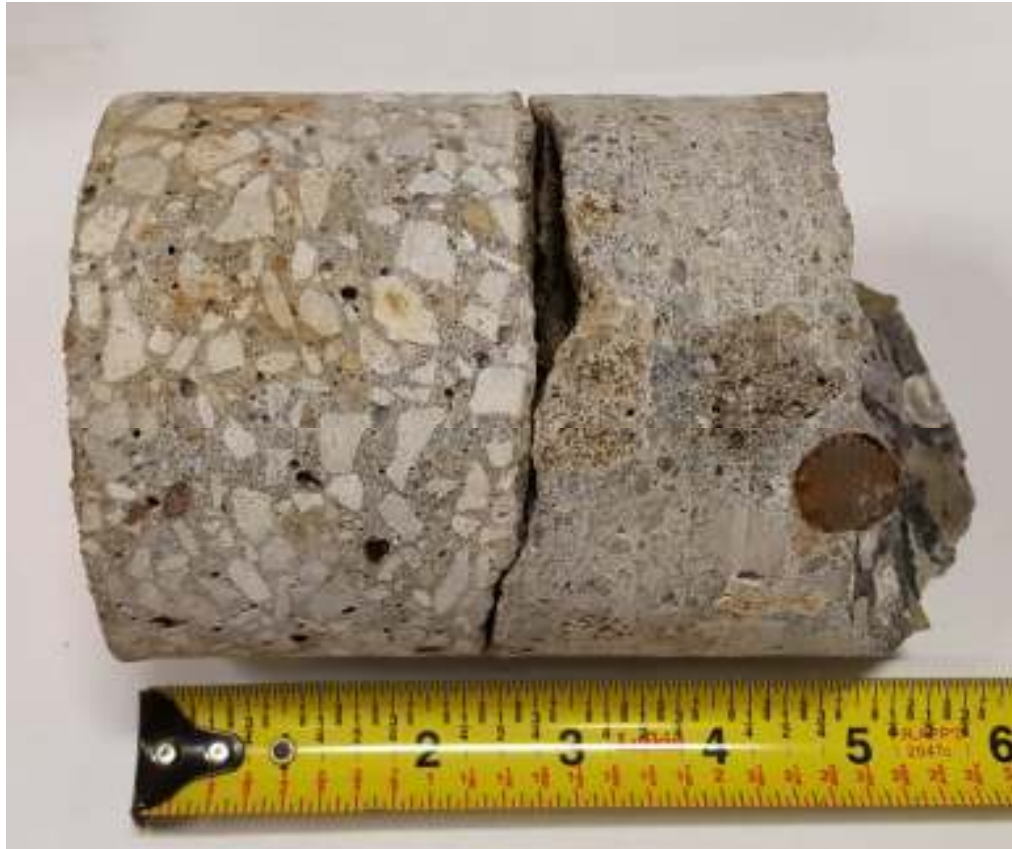
Core Number	Location	Layers	Core Composition		Remarks	
			LMC Overlay	Bridge Deck		
C-1	CUY-17-2.83 WB-LL-MOL Latitude : 41.420399° Longitude : -81.860990°	A	2 ½"	--	Good Condition	
		B	--	2 ½"	Poor Condition, Broke Down While Coring

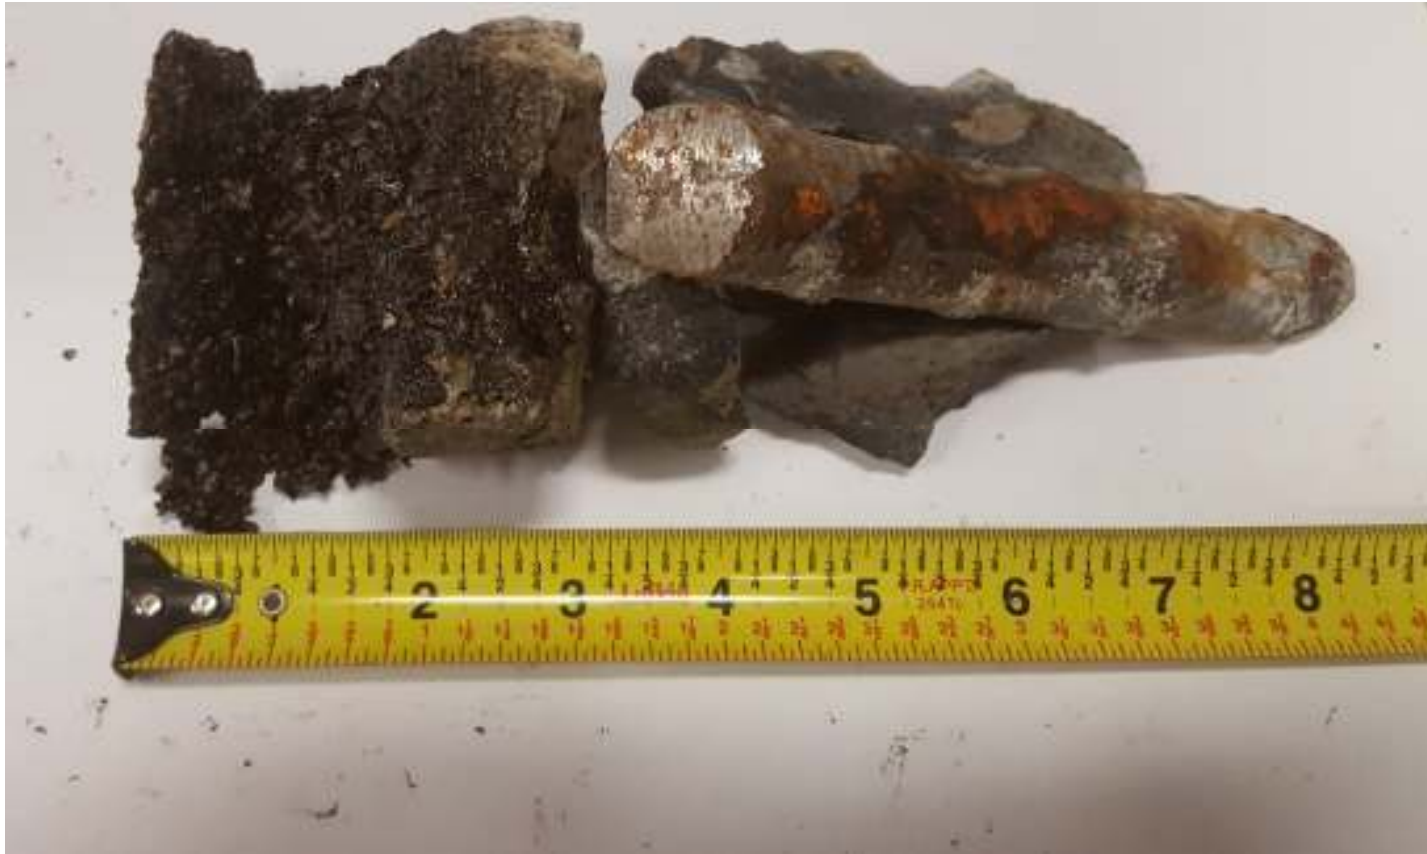
Core Number	Location	Layers	Core Composition		Remarks	
			Asphalt Patch	Bridge Deck		
C-2	CUY-17-2.83 EB-LL-LWT Latitude : 41.420313° Longitude : -81.860838°	A	1 3/4"	--	Poor Condition	
		B	--	1/2"	Poor Condition, Broke Down While Coring

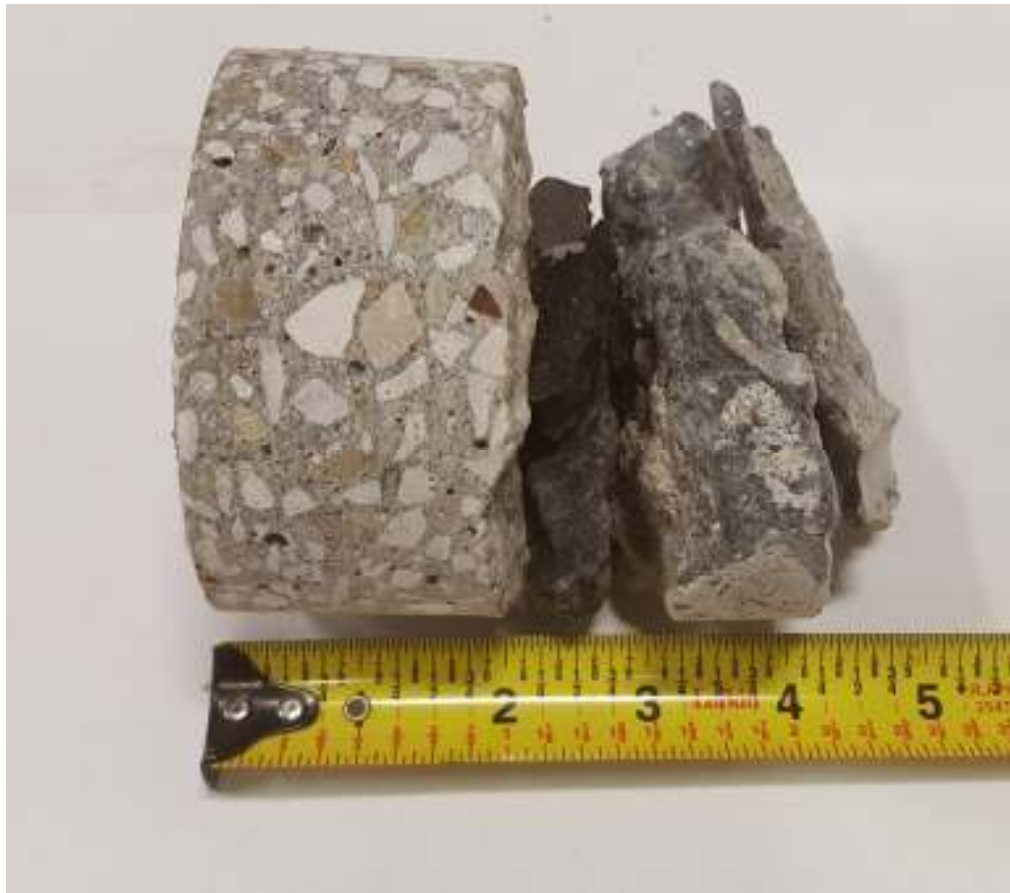
Core Number	Location	Layers	Core Composition		Remarks	
			LMC Overlay	Bridge Deck		
C-3	CUY-17-2.83 WB-LL-LWT Latitude : 41.420335° Longitude : -81.860699°	A	2"	--	Good Condition	
		B	--	2 ½"	Poor Condition, Broke Down While Coring

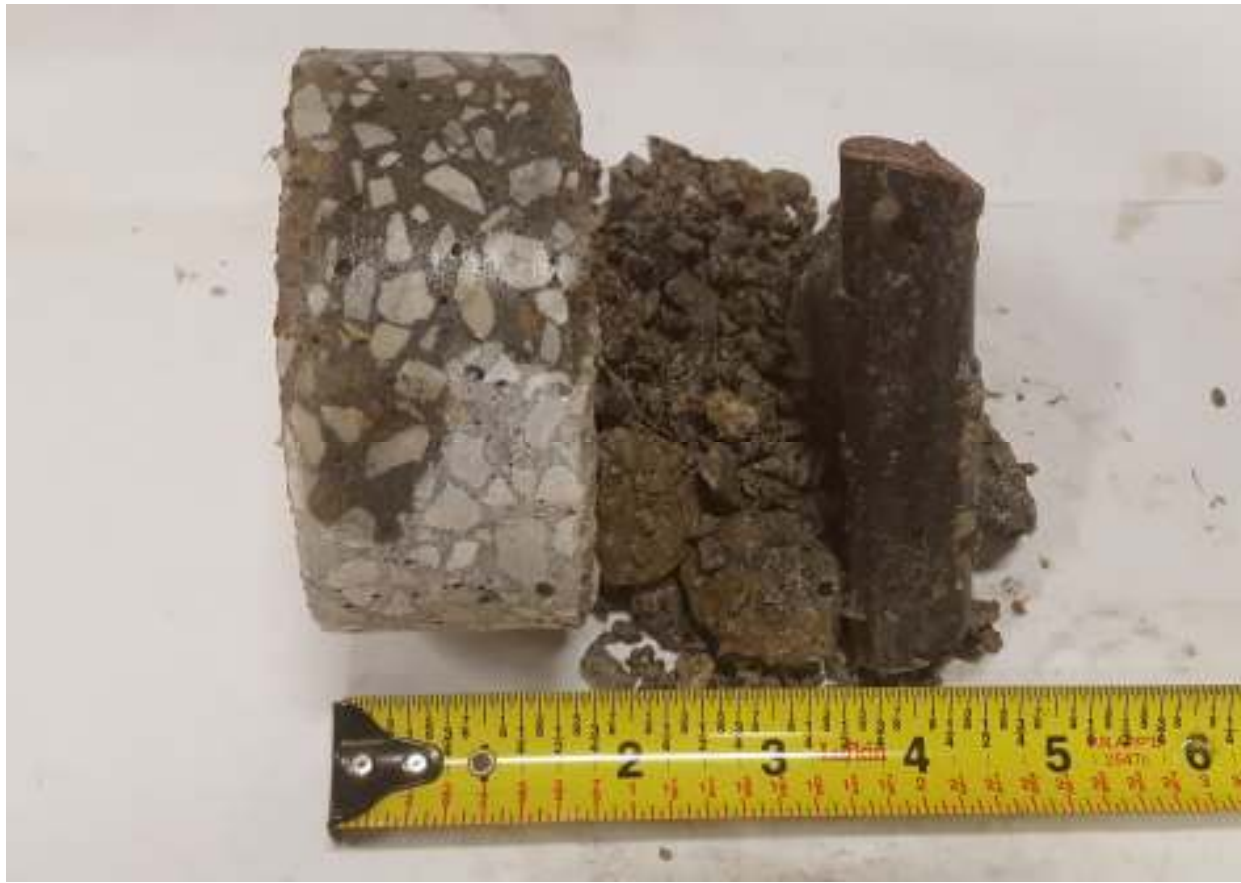
Core Number	Location	Layers	Core Composition		Remarks	
			LMC Overlay	Bridge Deck		
C-4	CUY-17-2.83 EB-LL-RWL Latitude : 41.420042° Longitude : -81.859821°	A	1 3/4"	--	Good Condition	
		B	--	2 3/4"	Poor Condition, Broke Down While Coring

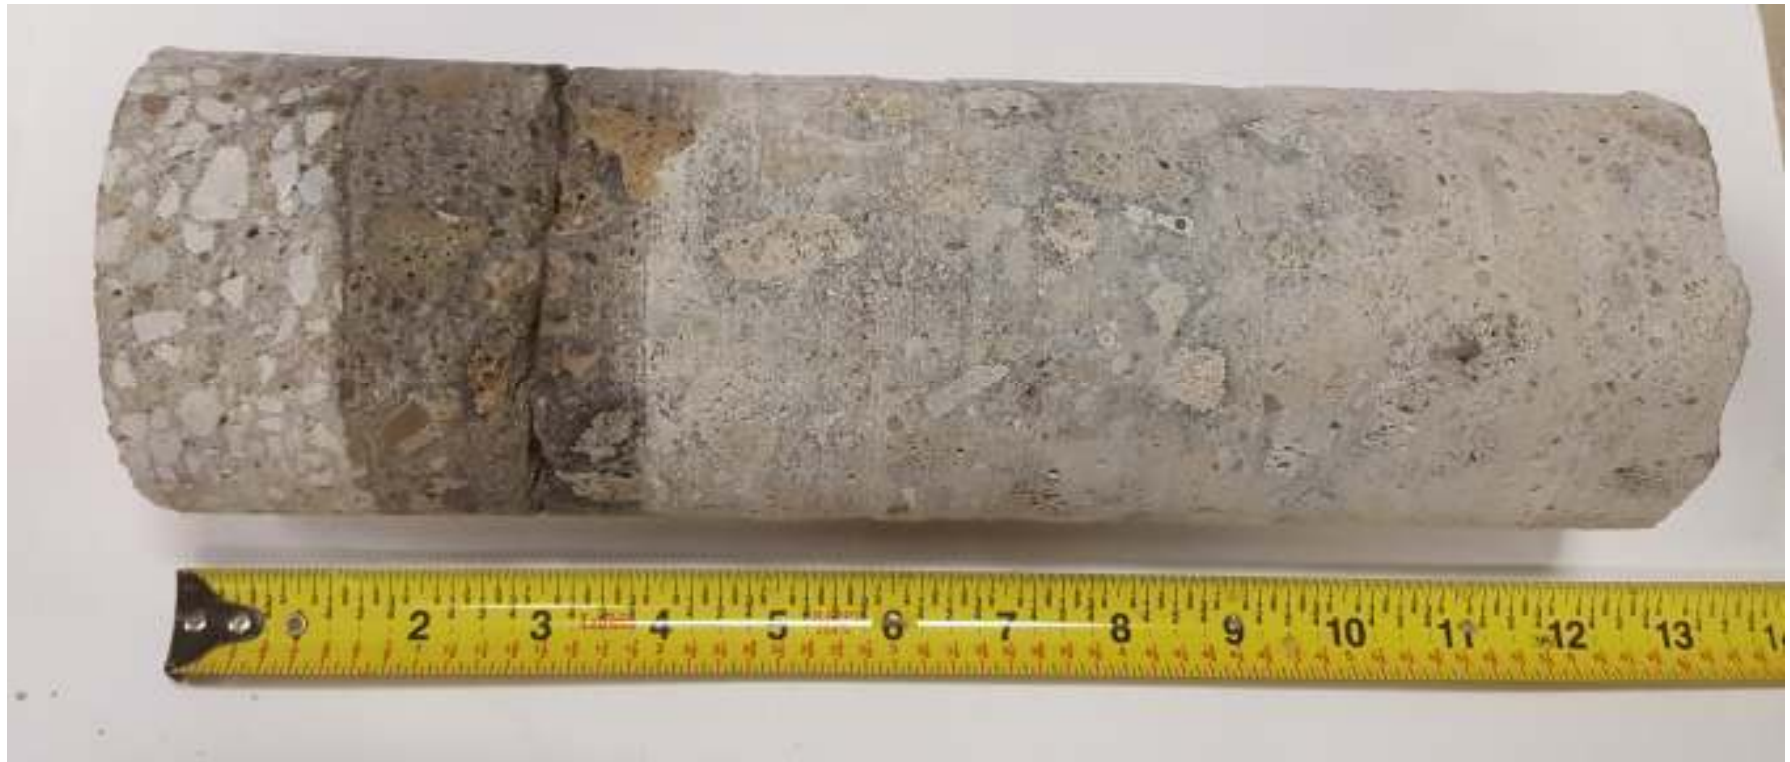
Core Number	Diameter (in)	Height (in)	Area (in ²)	H/D	Load (lbs)	Correction Factor	Compressive Strength (psi)
C-5	3.70	7.90	10.75	2.14	84,060	1.00	7,819

Core Number	Location	Layers	Core Composition		Remarks	
			LMC Overlay	Bridge Deck		
C-5	CUY-17-2.83 WB-LL-RWT Latitude : 41.420042° Longitude : -81.859659°	A	1 3/4"	--	Good Condition	
		B	--	10 3/4"	Good Condition, Separated During Coring

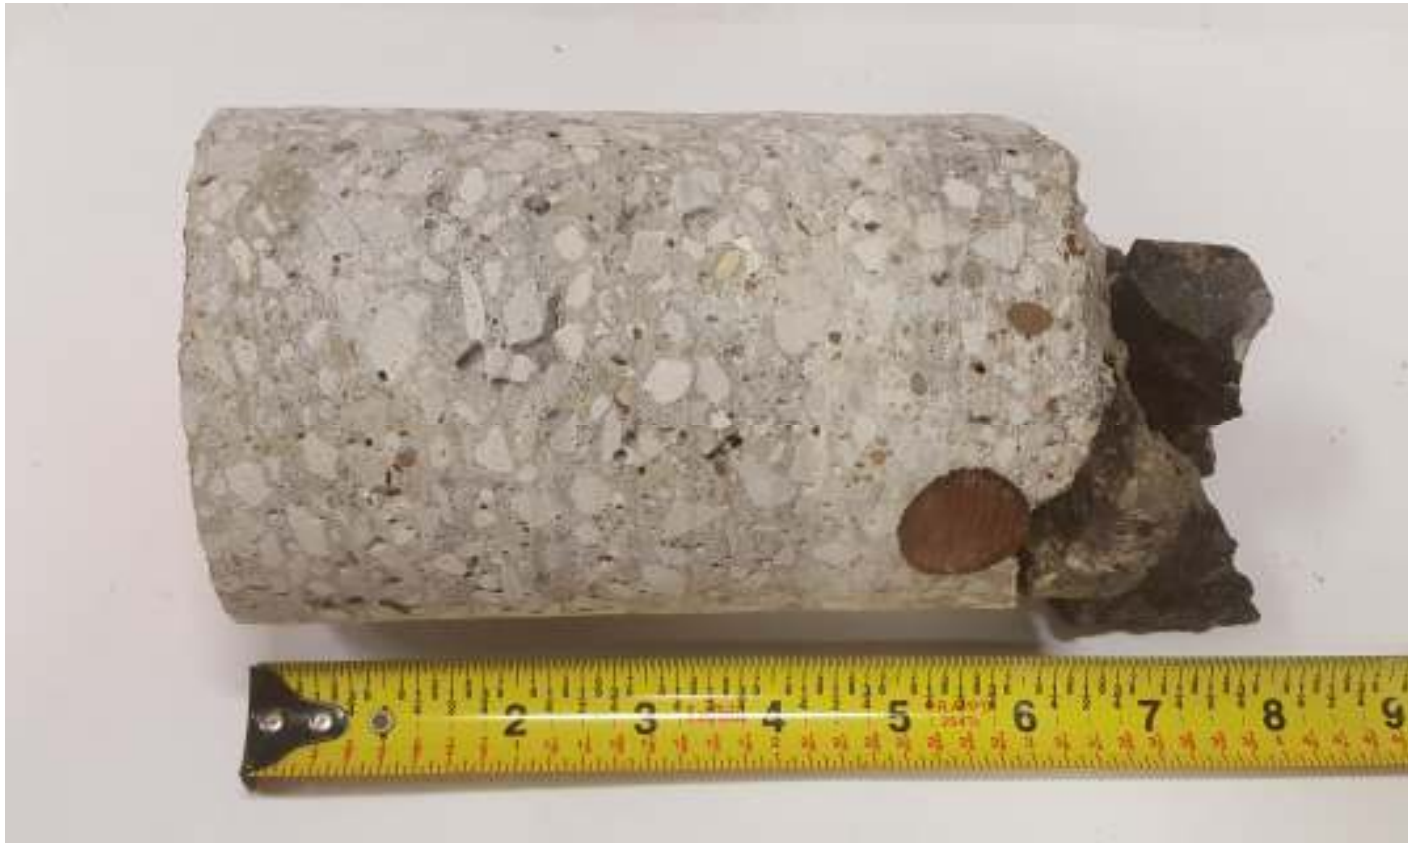
Core Number	Location	Layers	Core Composition		Remarks	
			LMC Overlay	Bridge Deck		
C-6	CUY-17-2.83 WB-LL-LWT Latitude : 41.419970° Longitude : -81.859344°	A	6"	--	Good Condition, Separated During Coring	
		B	--	1"	Poor Condition, Broke Down While Coring

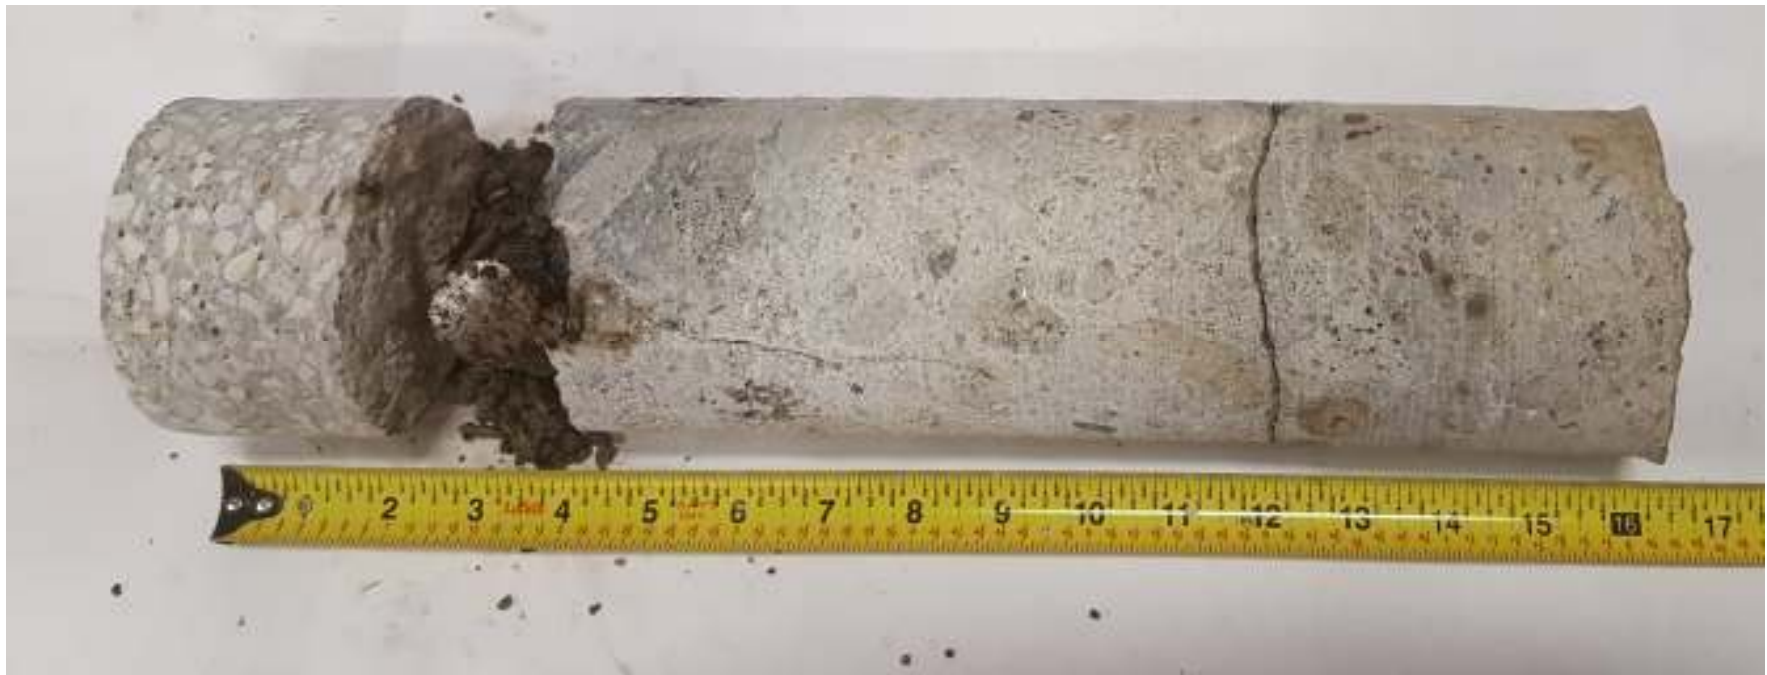
Core Number	Location	Layers	Core Composition		Remarks
			LMC Overlay	Bridge Deck	
C-7	CUY-17-2.83 WB-LL-RWT Latitude : 41.419709° Longitude : -81.858395°	A	2 ½"	--	Good Condition, Separated During Coring
		B	--	14"	Fair Condition, Crack Down Middle Prior to Coring

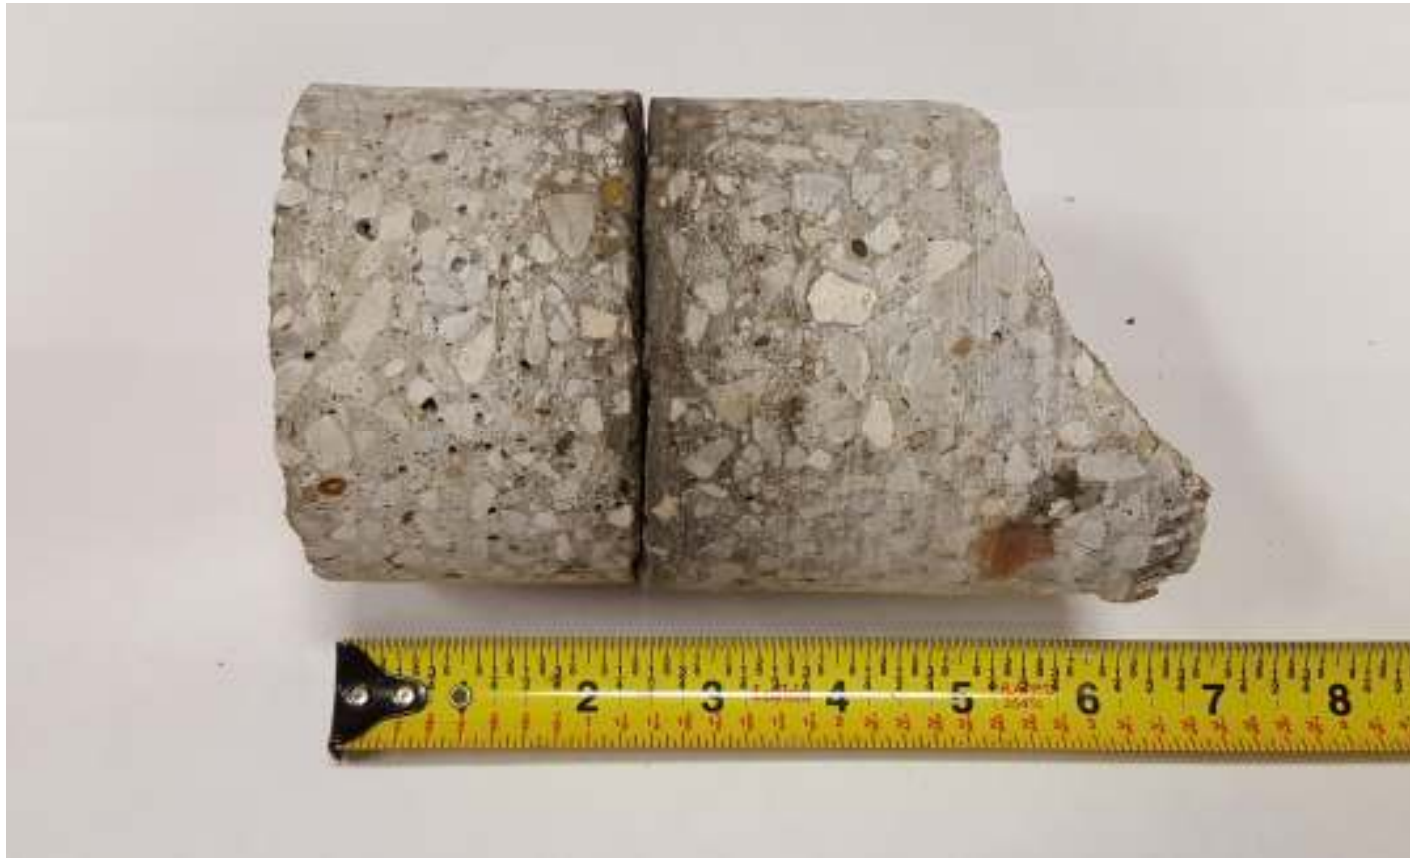
Core Number	Location	Layers	Core Composition		Remarks
			LMC Overlay	Bridge Deck	
C-8	CUY-17-2.83 WB-LL-RWT Latitude : 41.418968° Longitude : -81.855589°	A	5 ¼"	--	Good Condition
		B	--	--	--

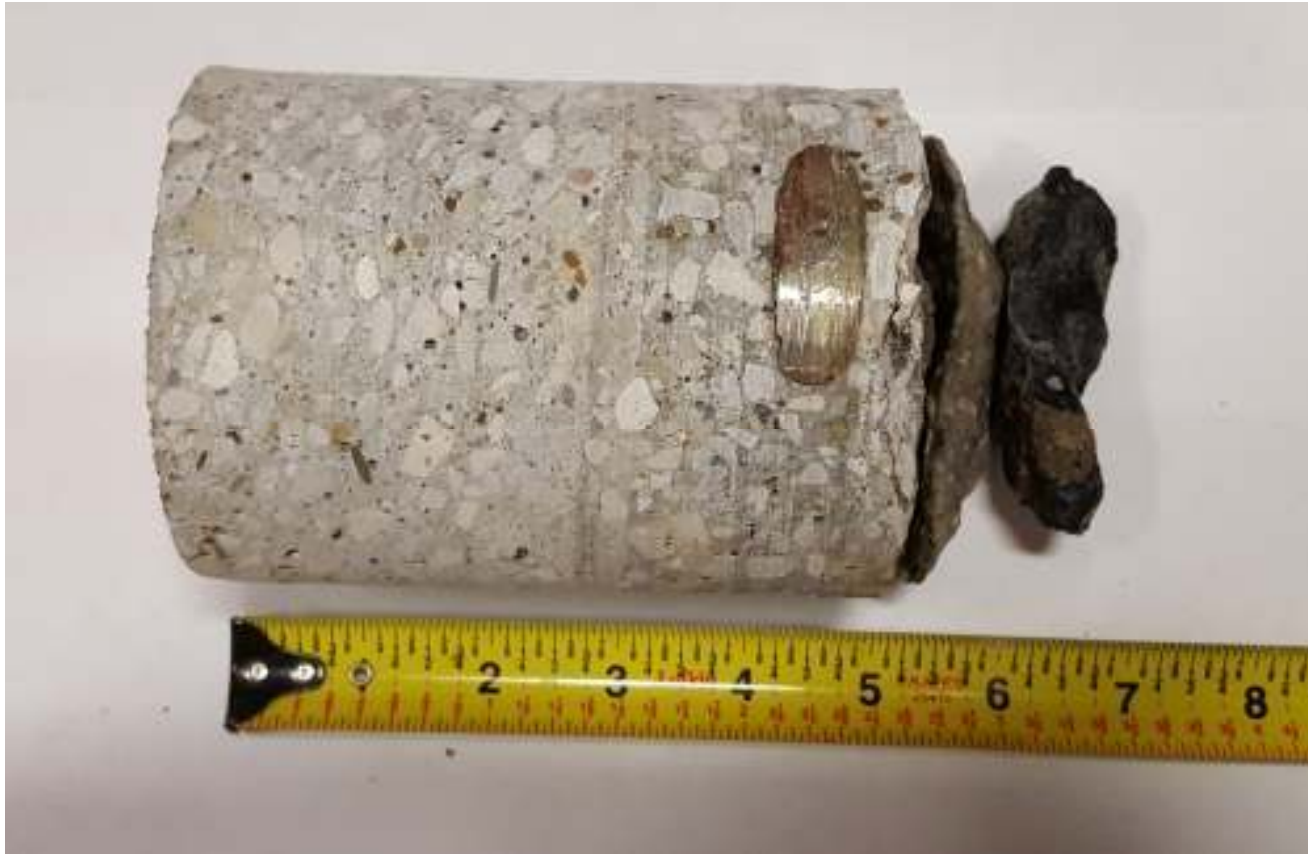
Core Number	Location	Layers	Core Composition		Remarks	
			LMC Overlay	Bridge Deck		
C-9	CUY-17-2.83 EB-LL-MOL Latitude : 41.418875° Longitude : -81.855413°	A	5"	--	Good Condition	
		B	--	1"	Poor Condition, Broke Down While Coring
