Physical Condition Report for

CUY-006-1456

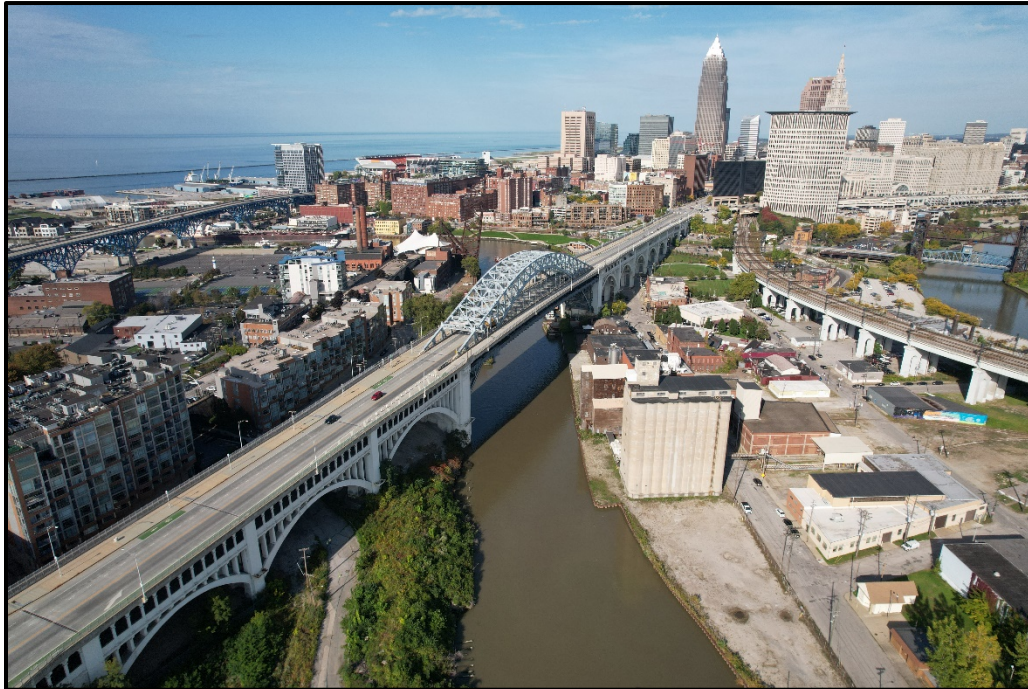
2022 Routine and Fracture Critical Inspection

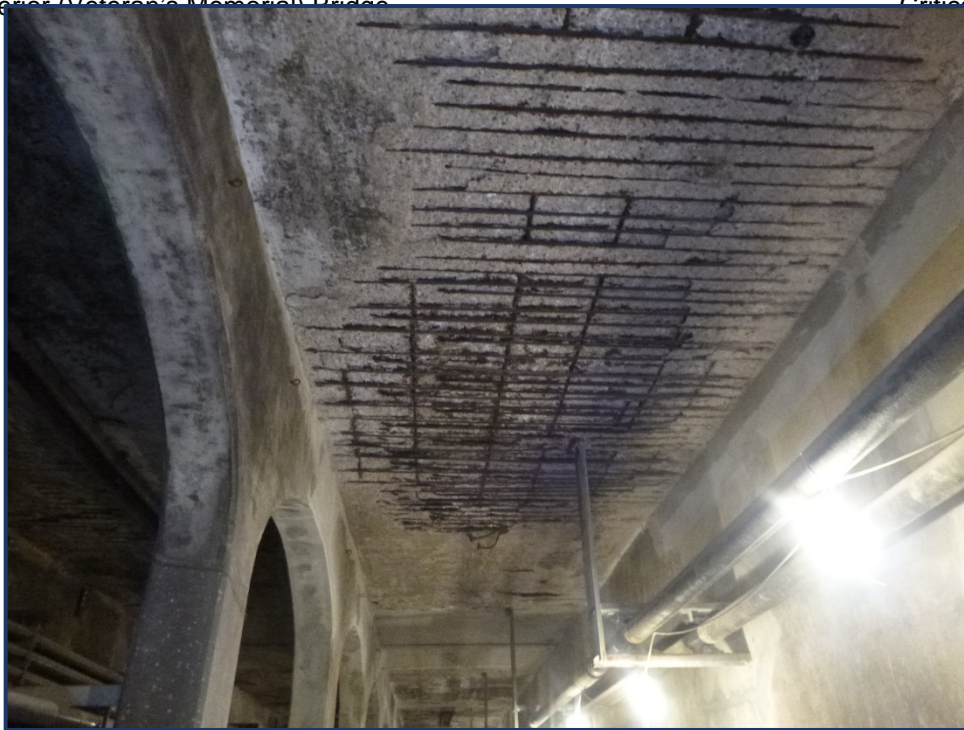
Photo 12-1 – Detroit Ave Tunnel, Typical Spalling of Non-structural Deck

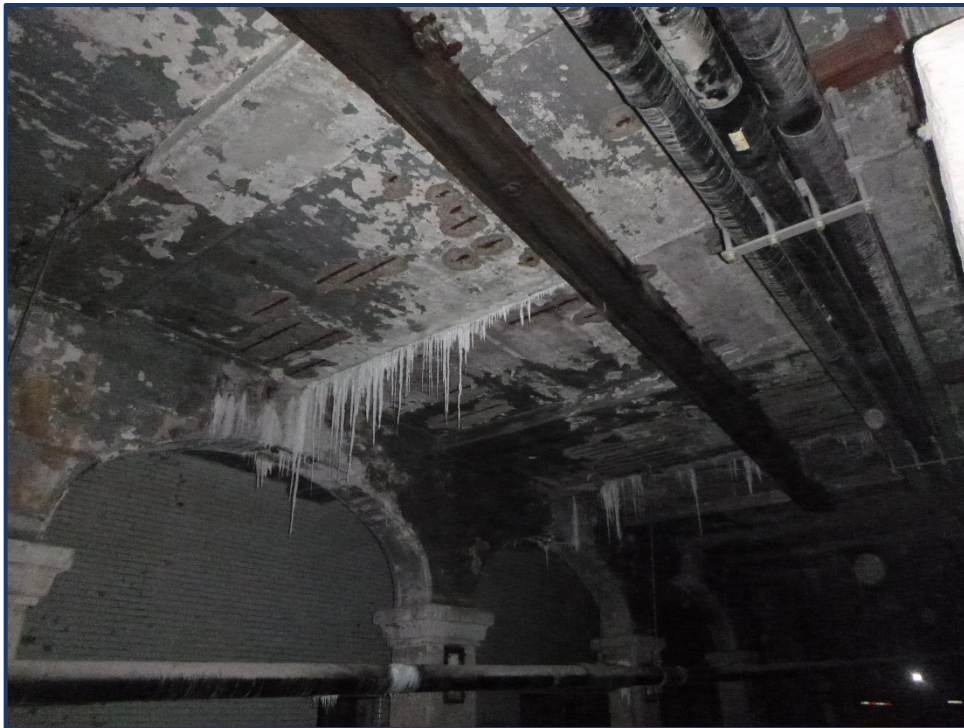
Photo 12-2 – West Station, Typical Scattered Deck Spalling with Saturation and Efflorescence

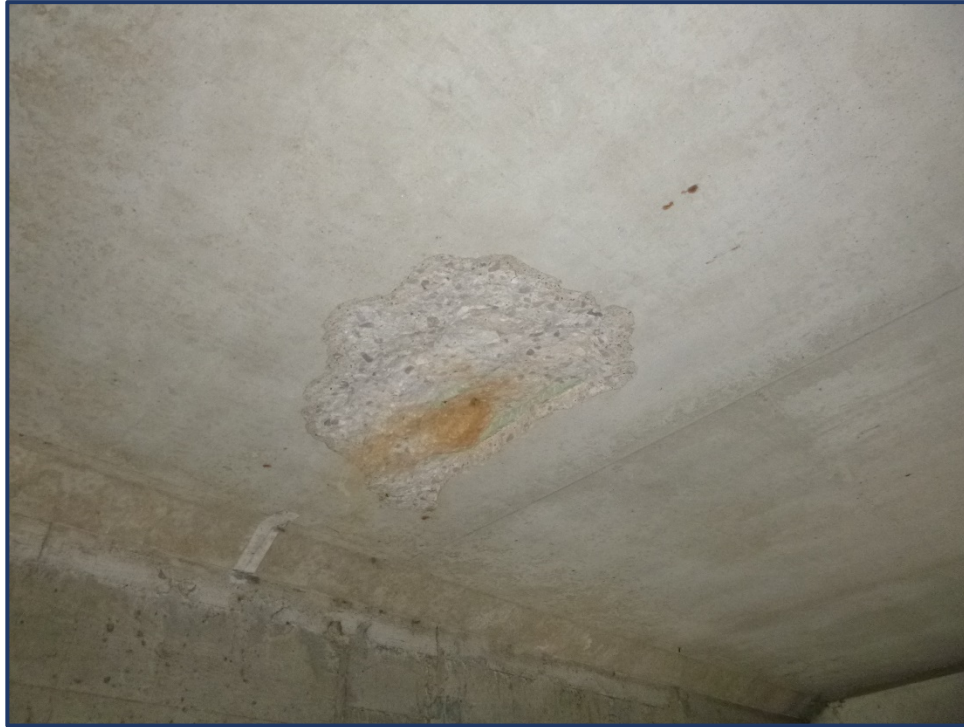
Photo 12-3 – Main Spans, Typical Scattered Deck Spalling with Exposed Reinforcing

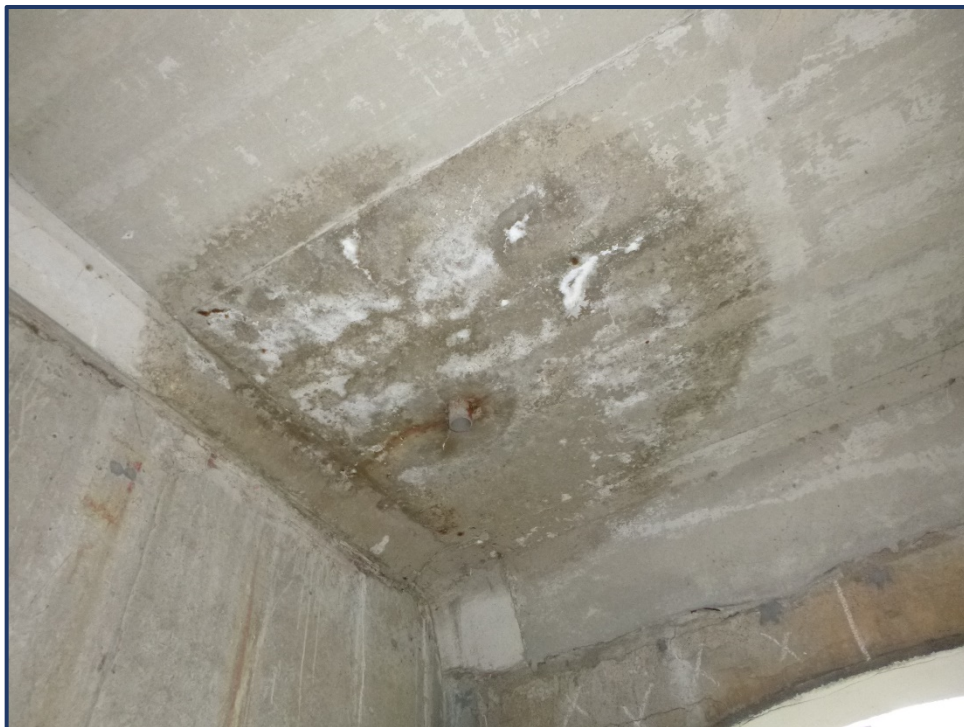
Photo 12-4 – Main Spans, Deck Saturation with Mottling and Efflorescence

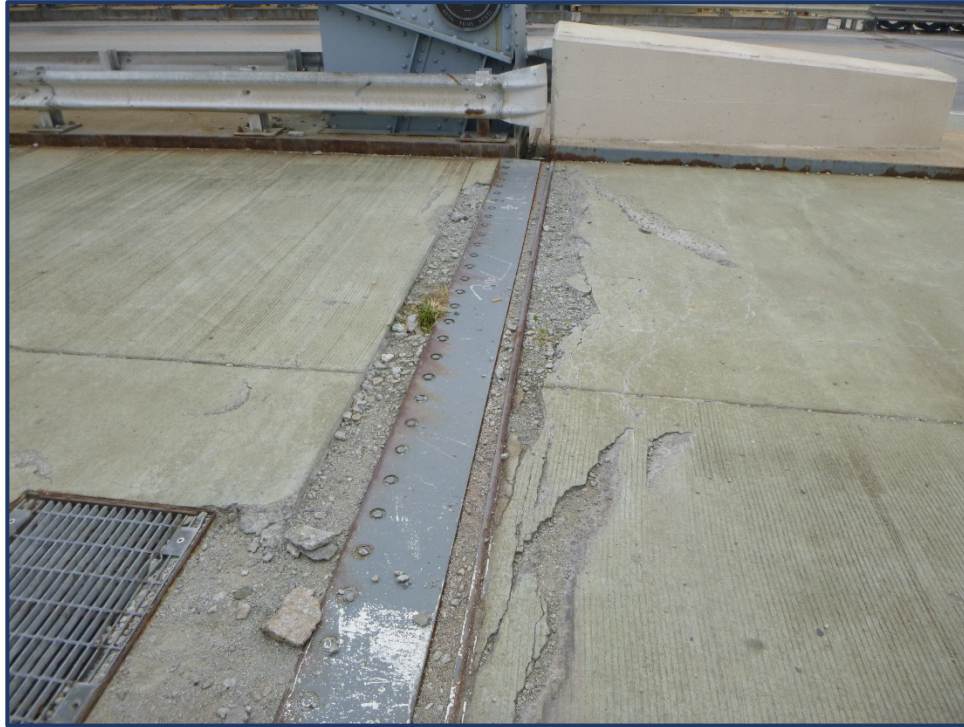
Photo 300-2 – Joint in Span 4 at PP5, Spalling and Cracking of Header at North Sidewalk Expansion Joint

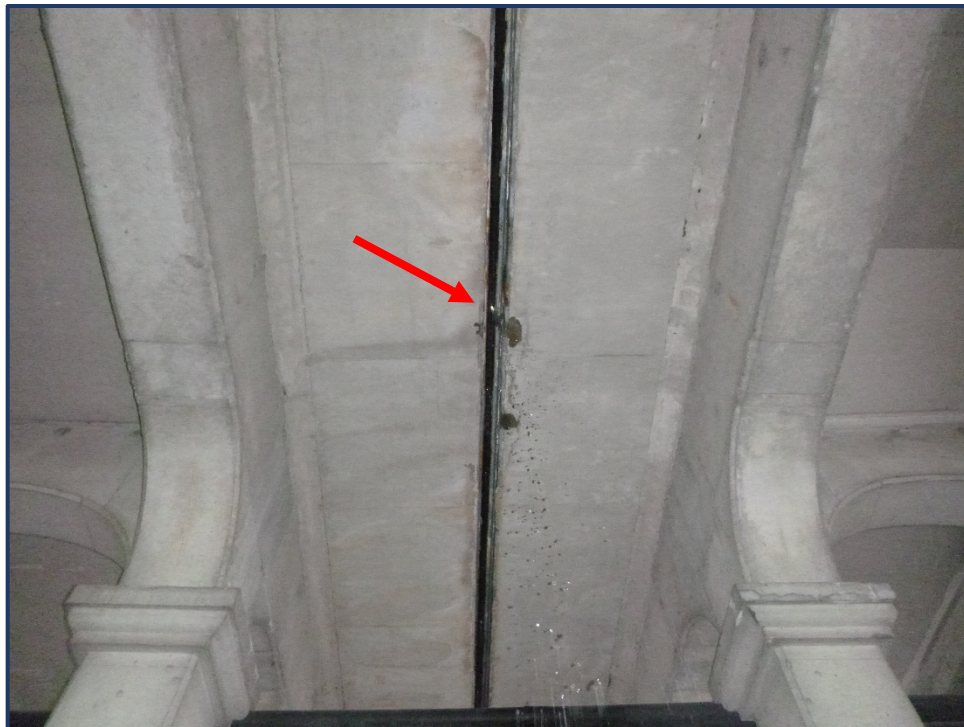
Photo 300-3 – Pier 10 Joint, Section of Seal Tearing

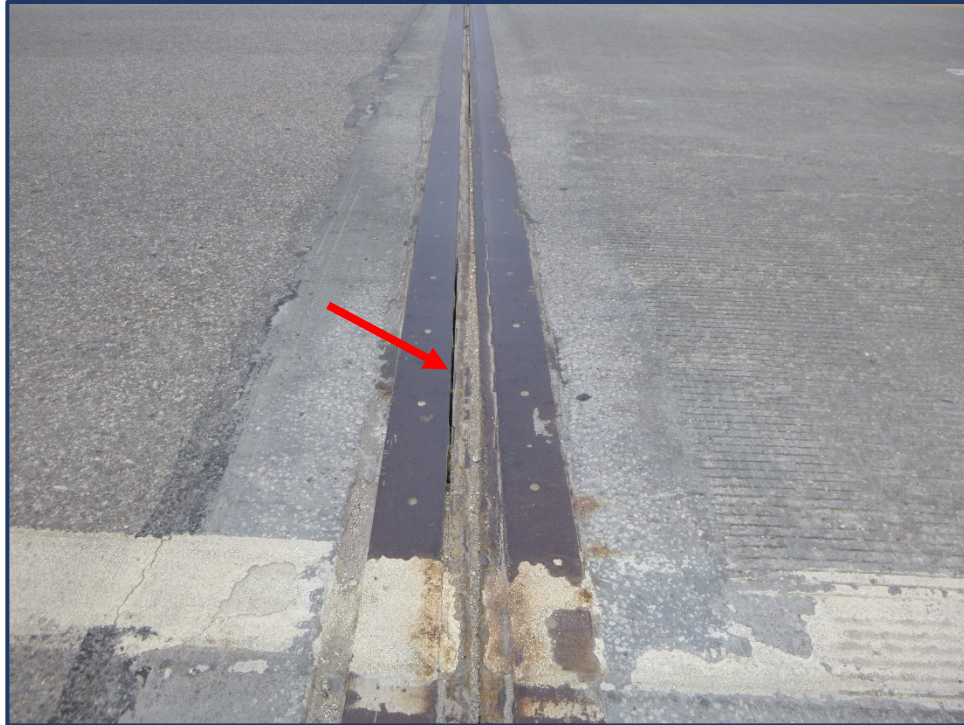
Photo 300-4 Joint 1A, Section of Broken Intermittent Fillet Welds in Joint Armor

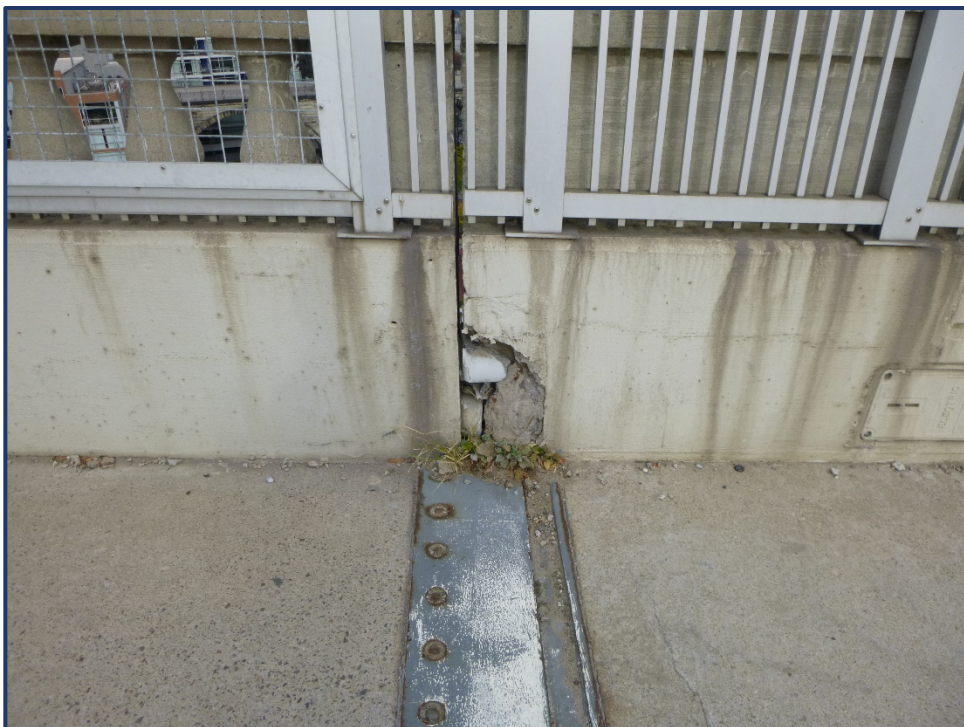
Photo 331-1 – South Rail, Typical Spalling at Deck Joints

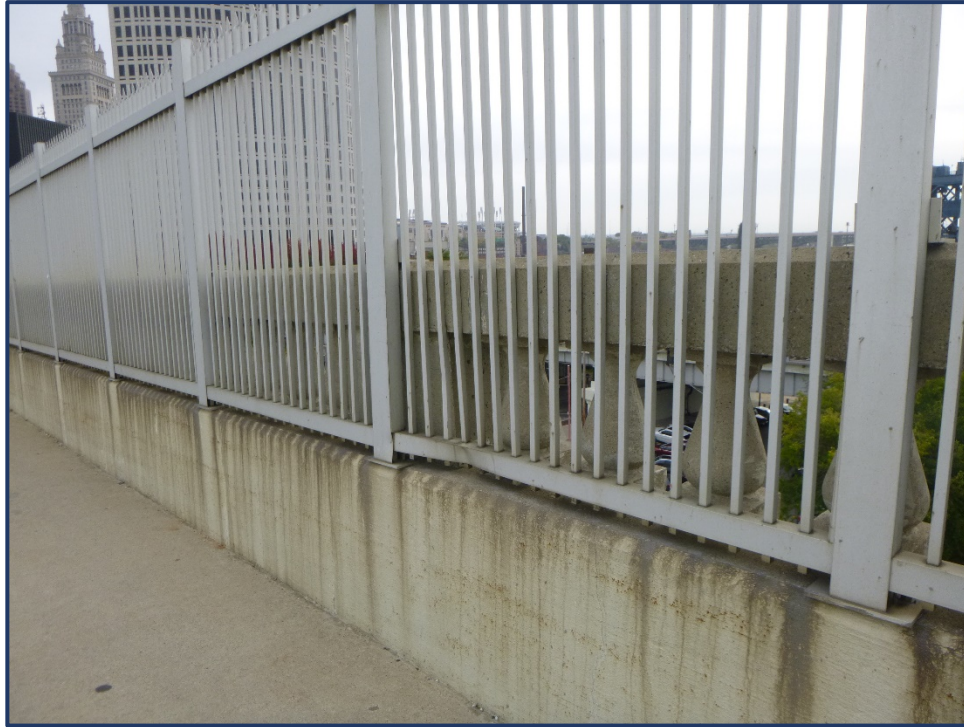
Photo 331-2 – South Rail Fence, Area of Damage

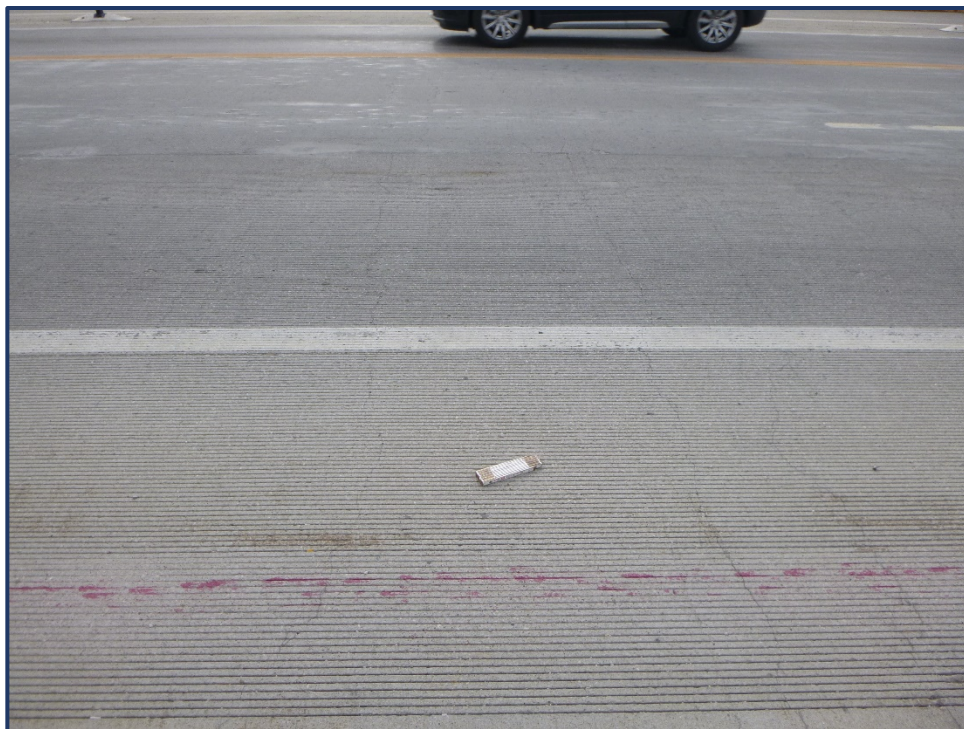
Photo 510-1 – Map Cracking in Wearing Surface

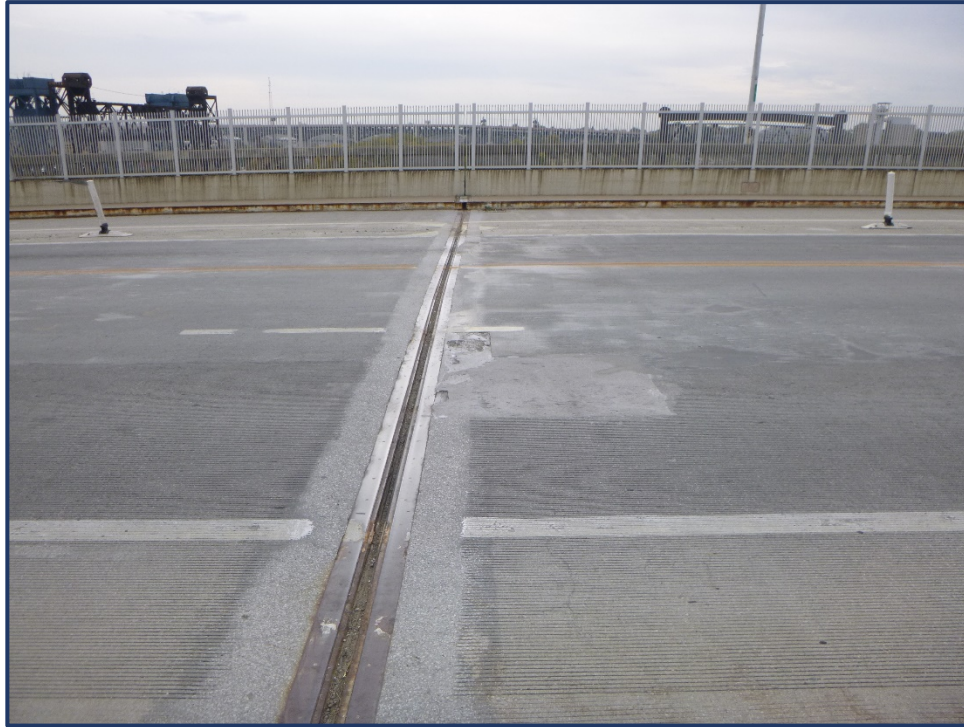
Photo 510-2 – Area of Concrete Patching in Wearing Surface

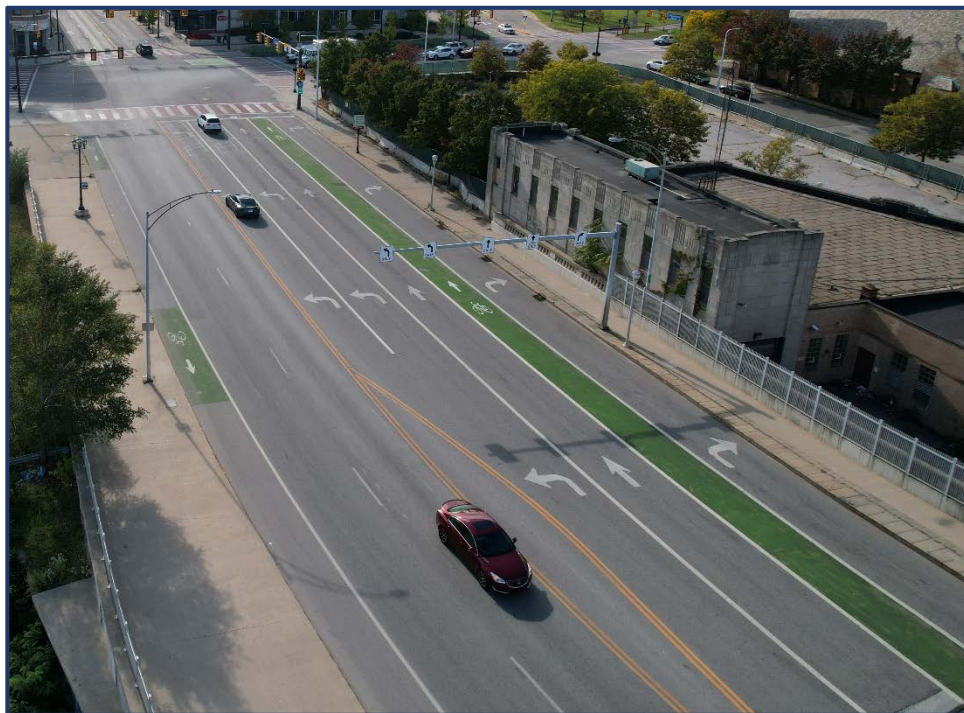
Photo 510-3 – West Station, Areas of Cracking in Wearing Surface

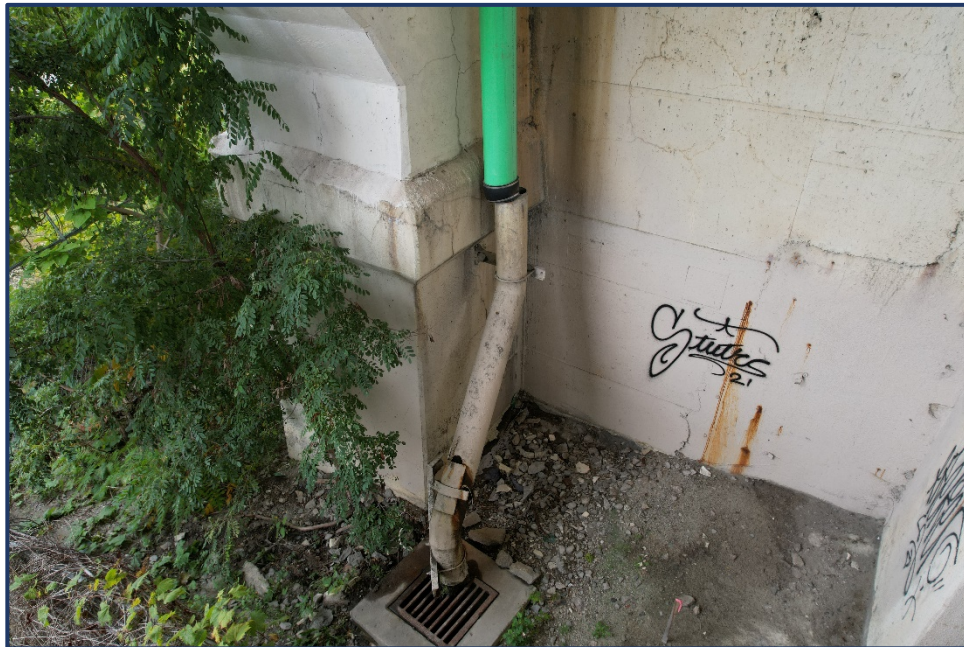
Photo 815-1 – Pier 1, East Face, South Downspout Fully Clogged at Catch Basin and Disconnected at Outlet Section

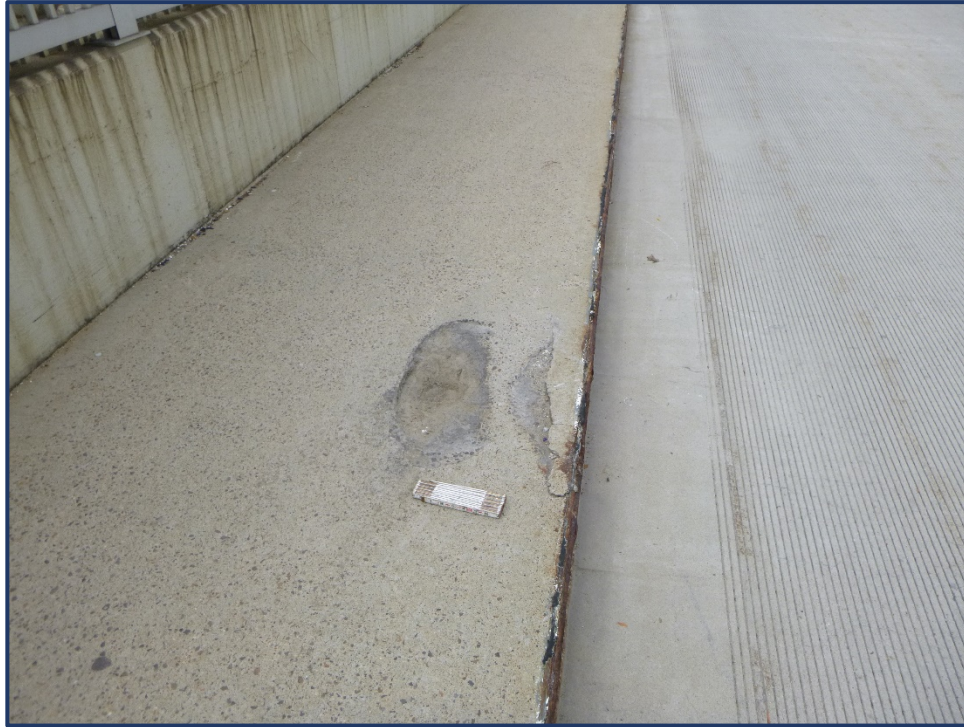
Photo CS-1 – South Sidewalk, Typical Edge Spalling

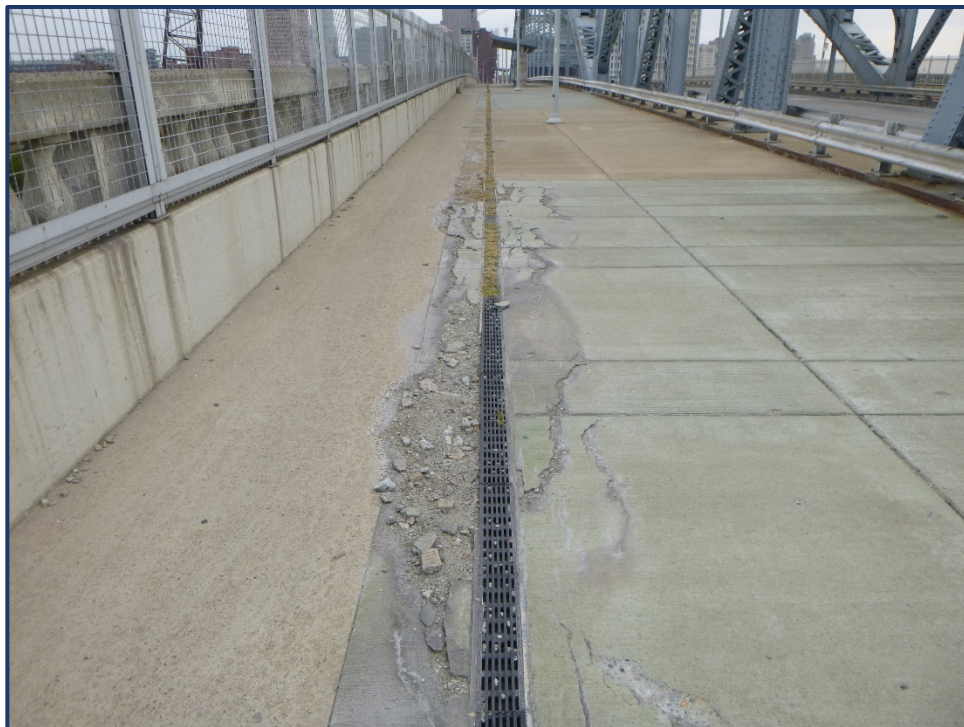
Photo CS-2 – Span 4 North Sidewalk, Spalling, Delamination and Cracking along Longitudinal Drain

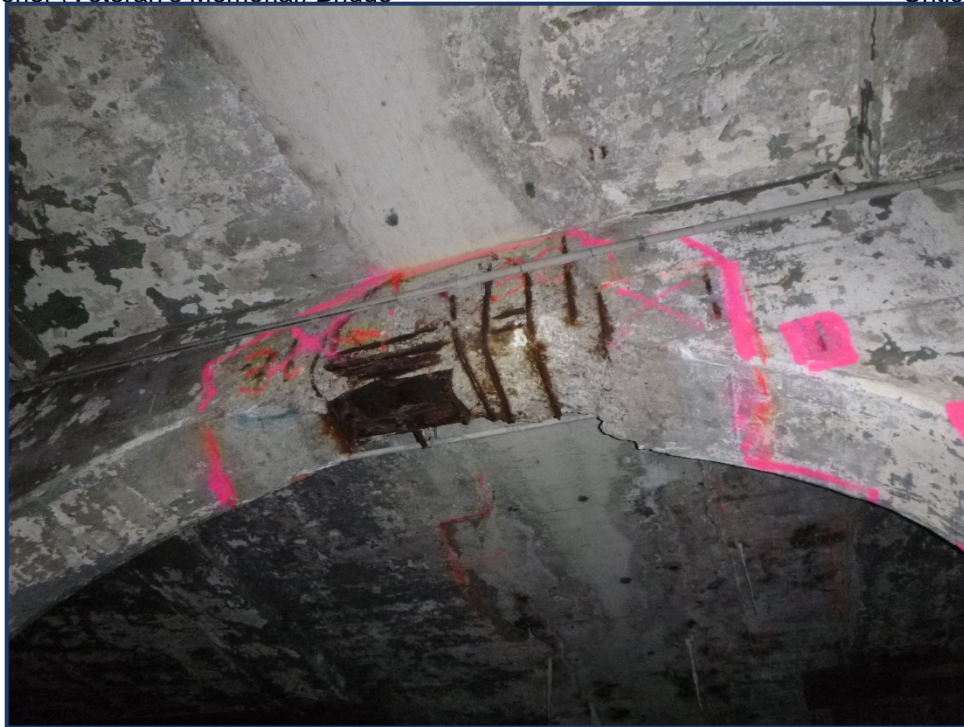
Photo 110-1 – West Station, Spalling of Concrete Beam

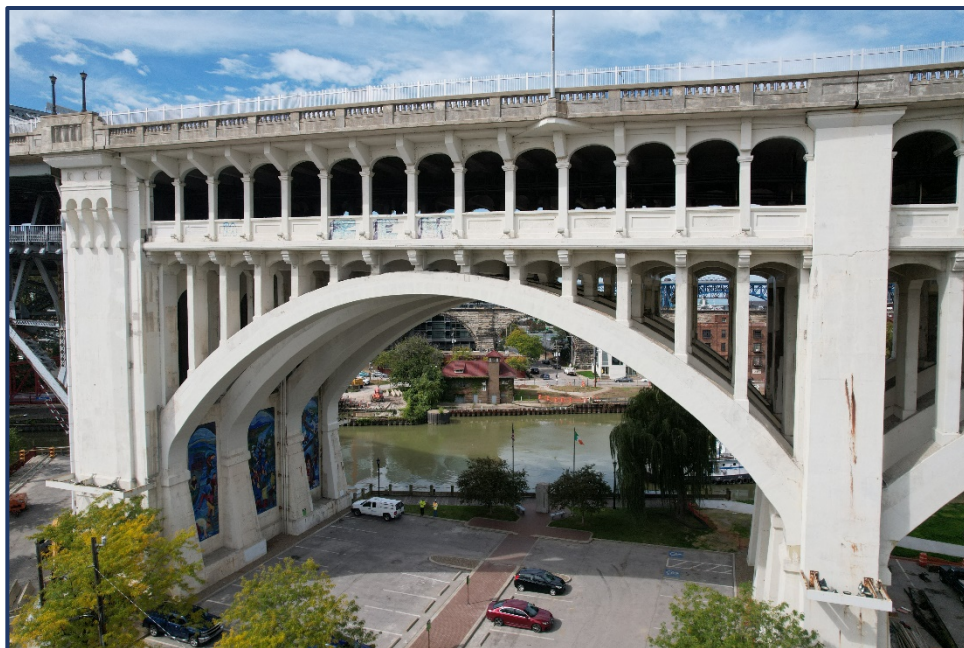
Photo 144-1 – Span 5 Reinforced Concrete Arches

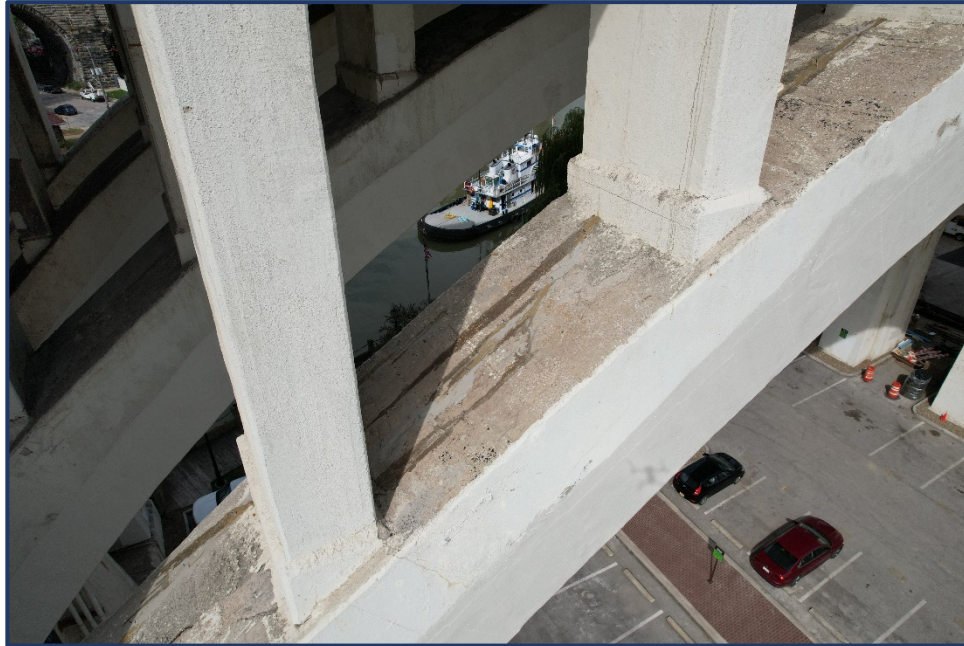
Photo 144-2 – Span 5, South Exterior Arch, Sealed Cracks on Top of Arch, with FRP on Underside

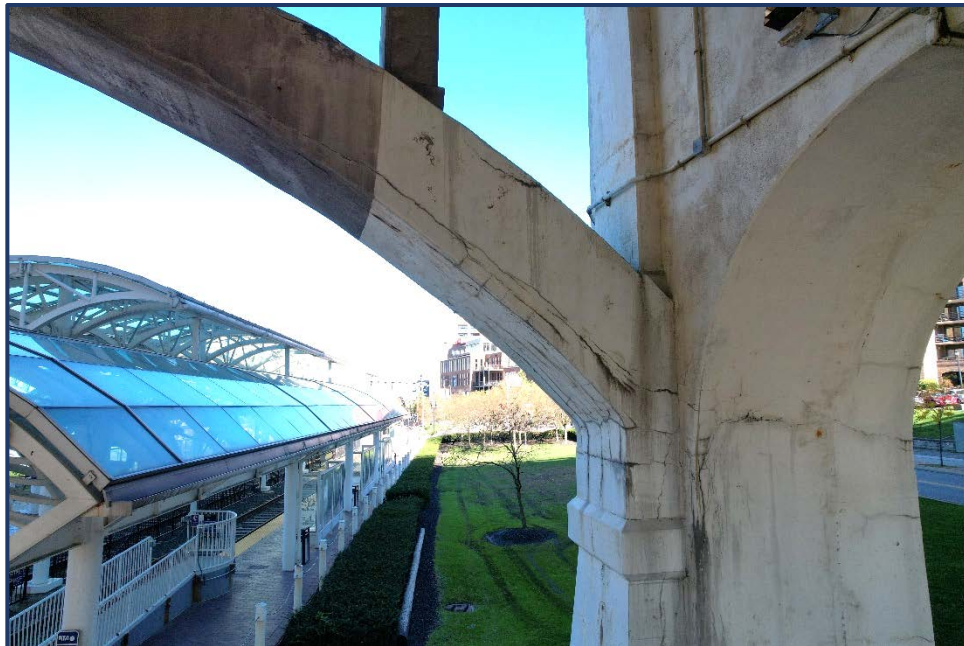
Photo 144-3 – Span 11, North Exterior Arch, Map Cracking and Delamination of Arch Rib

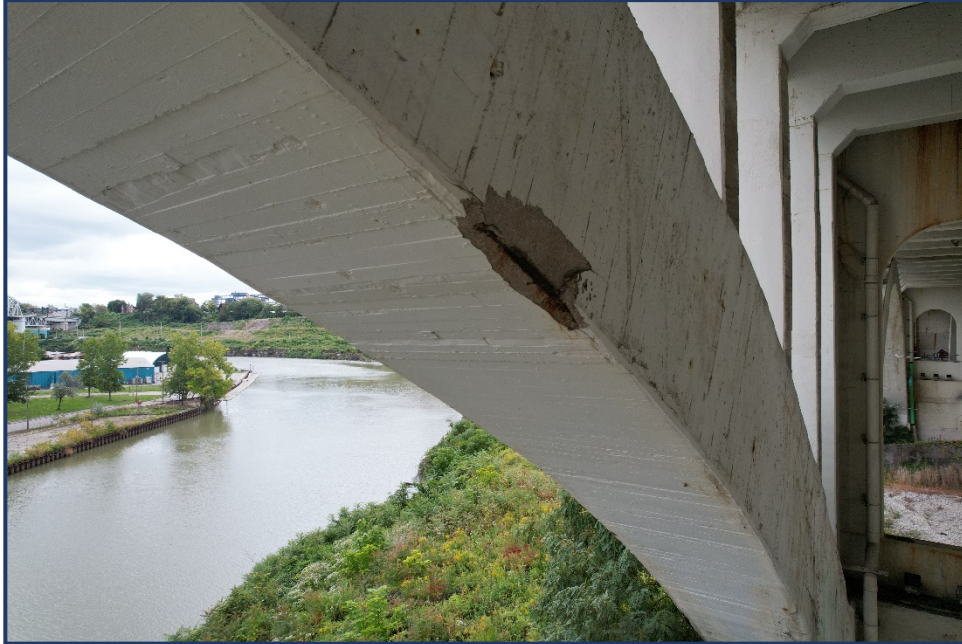
Photo 144-4 – Span 3, South Exterior Arch, Spall with Exposed Reinforcing

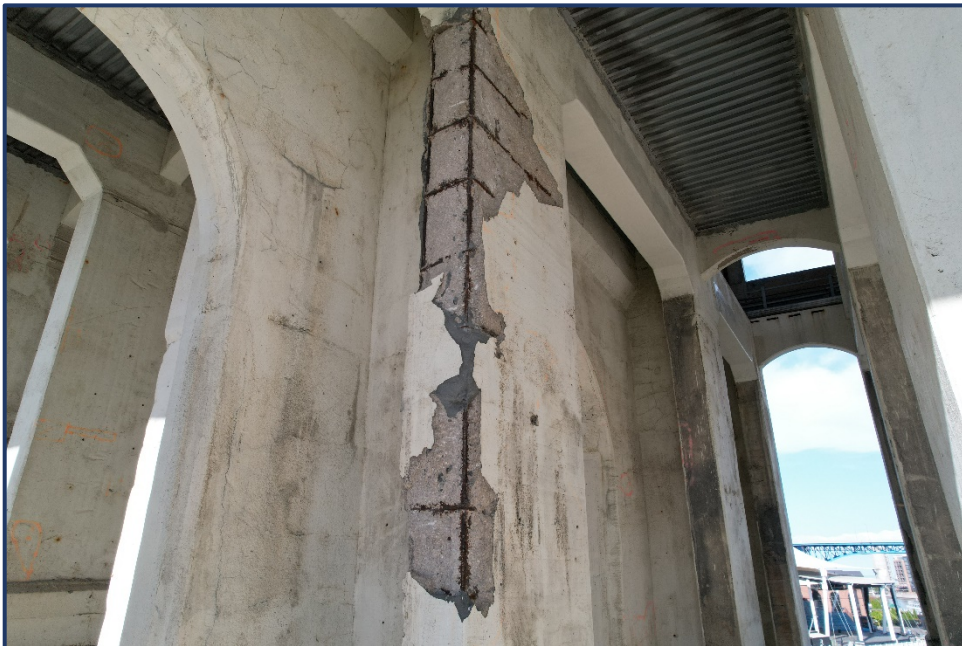
Photo 144-5 – Span 8, South Interior Arch, Spalling with Exposed Reinforcing of Arch Column

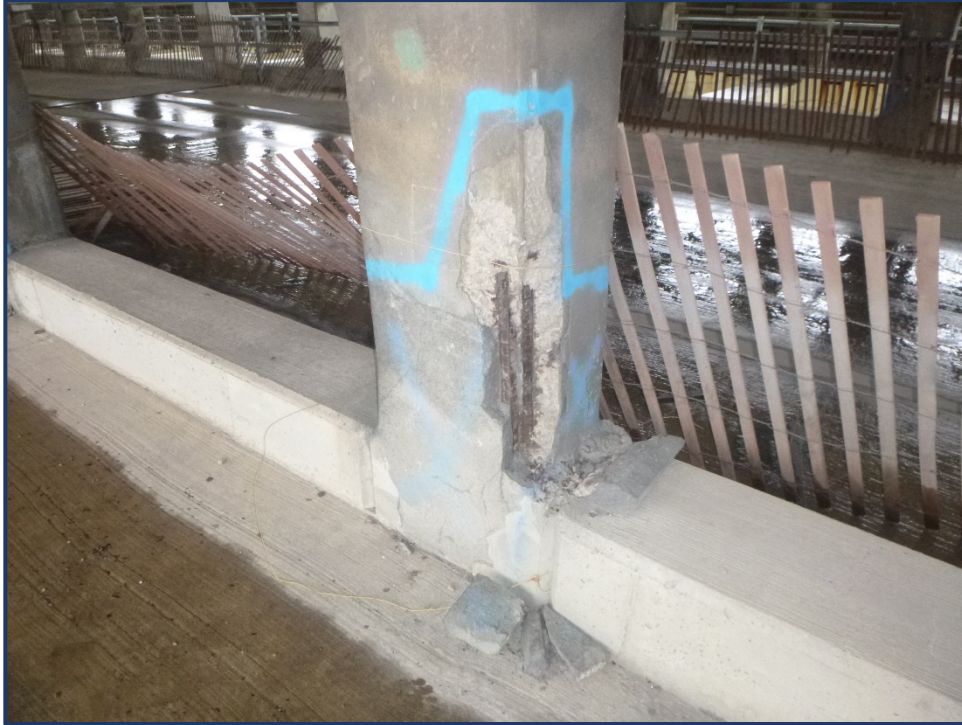
Photo 144-6 – Span 6, South Interior Arch, Spalling of Arch Column

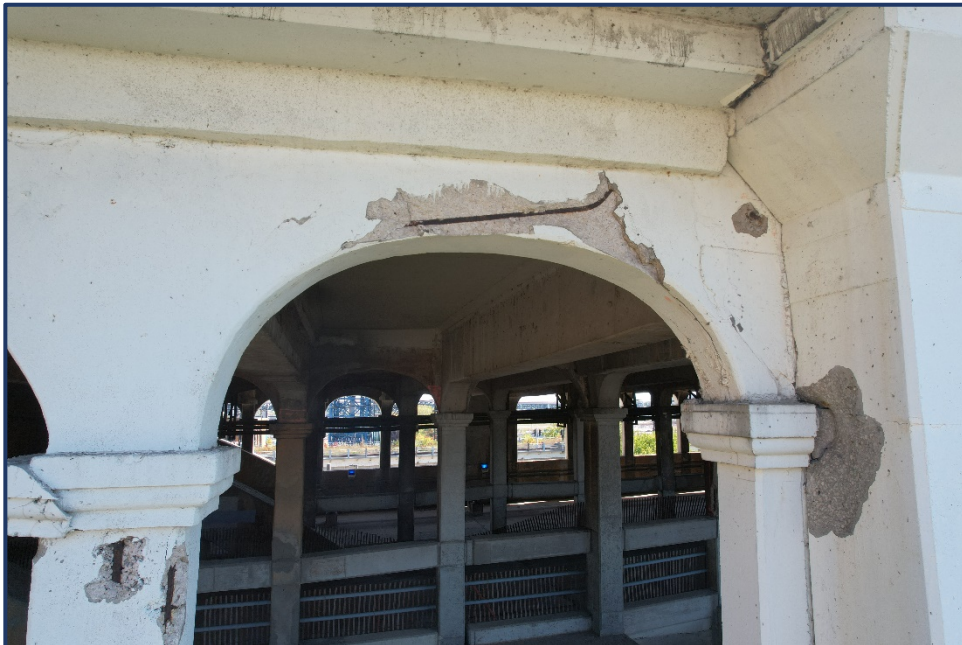
Photo 144-7 – Span 12, North Exterior Arch, Spalling with Exposed Reinforcing of Jack Arch

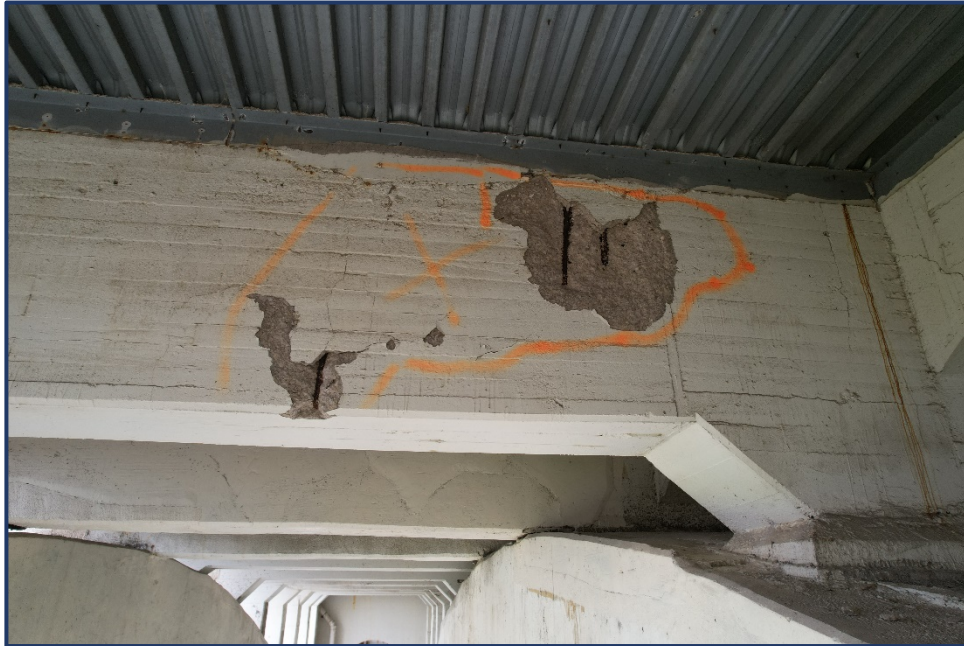
Photo 155-1 – Span 2, Lower Deck Floorbeam, South Bay, Delamination and Spalling with Exposed Reinforcing

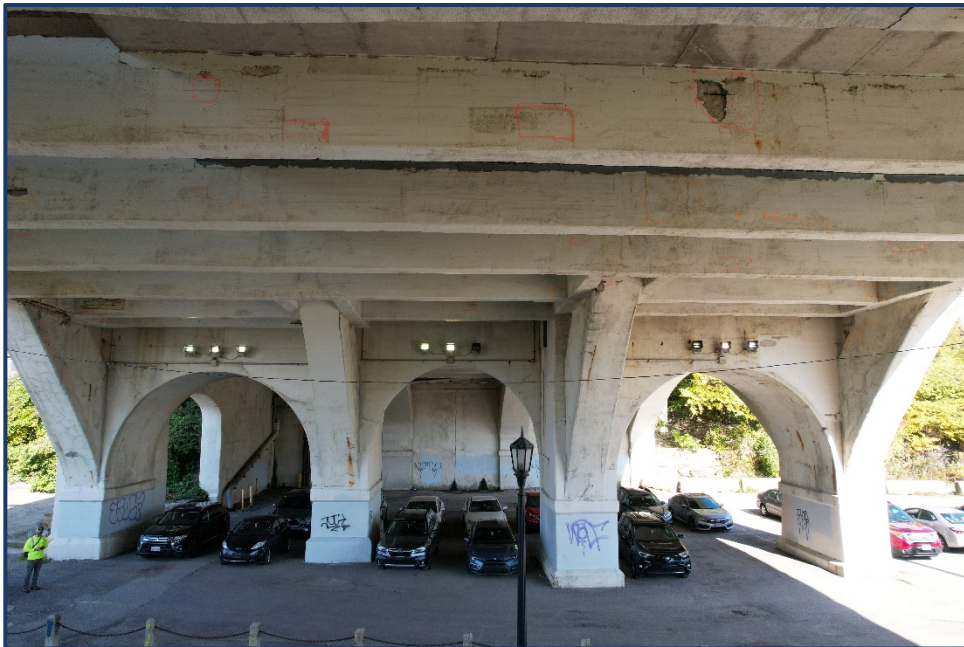
Photo 155-2 – Span 12, Widespread Cracking, Delamination and Spalling of Lower Deck Floorbeams

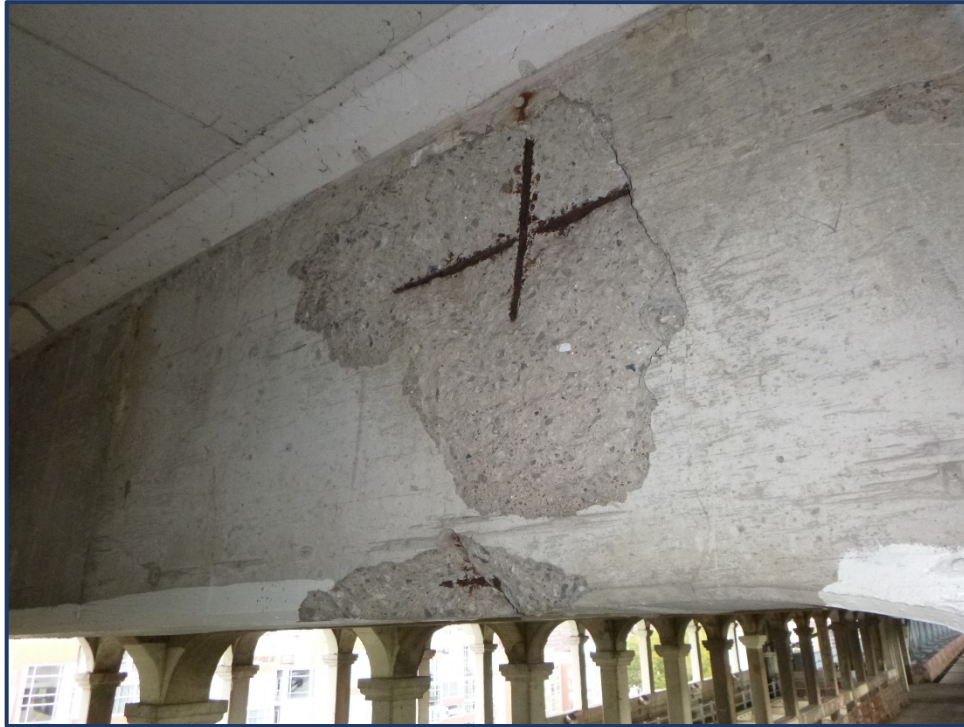
Photo 155-3 – Span 3, Upper Deck FB 3, Center Bay, Spalling and Delamination

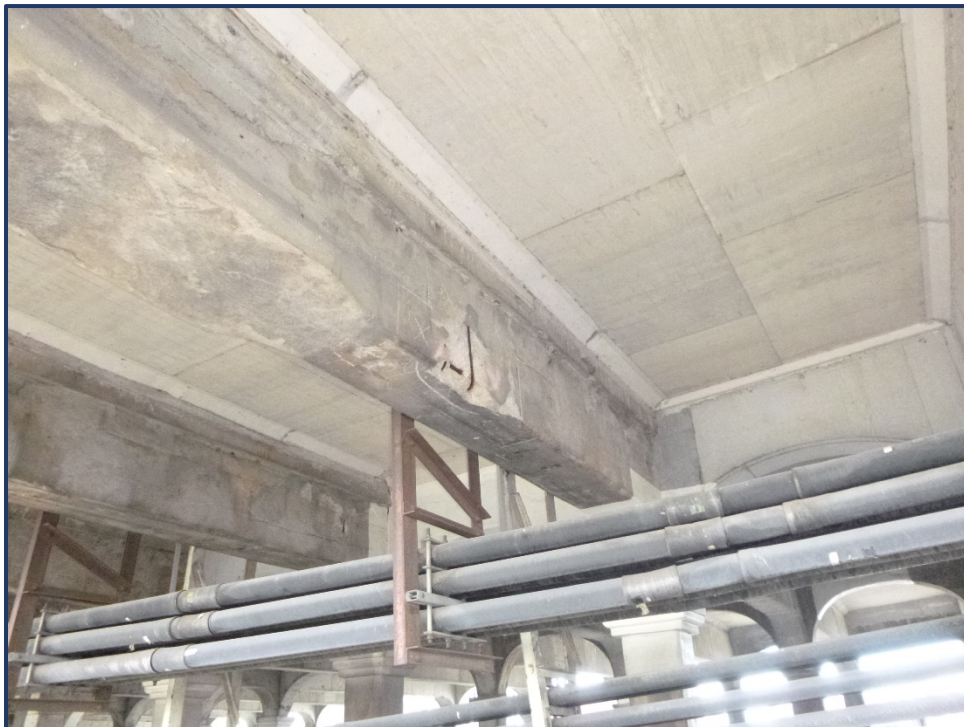
Photo 155-4 – Span 3, Upper Deck FB 11, South Bay, Spalling and Delamination

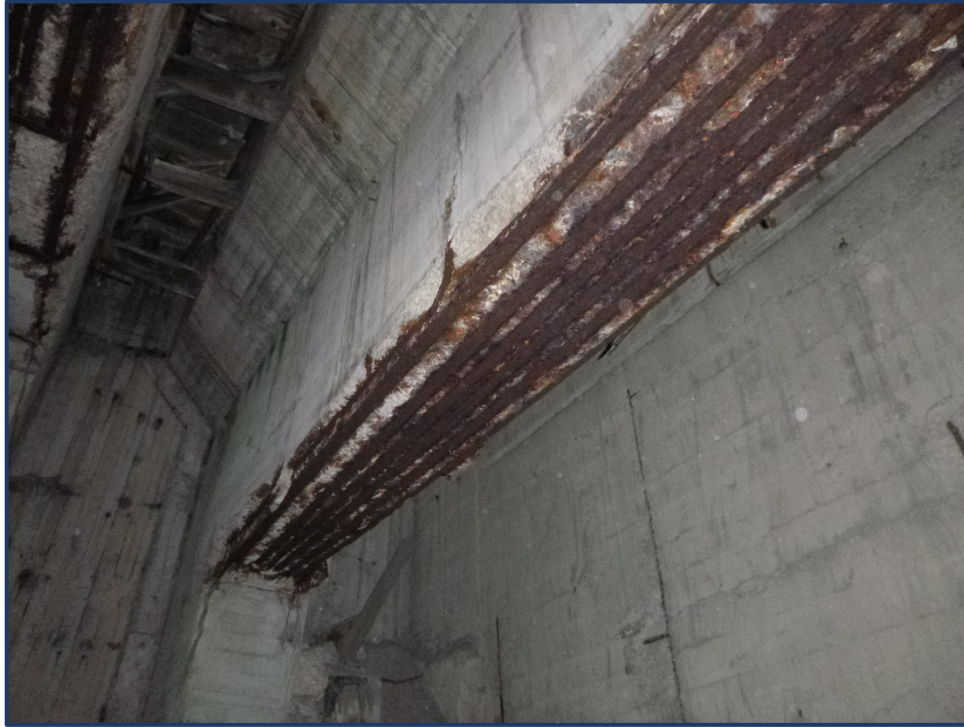
Photo 155-5 – East Abutment Chamber Floorbeams, Typical Spalling with Deteriorated Reinforcing

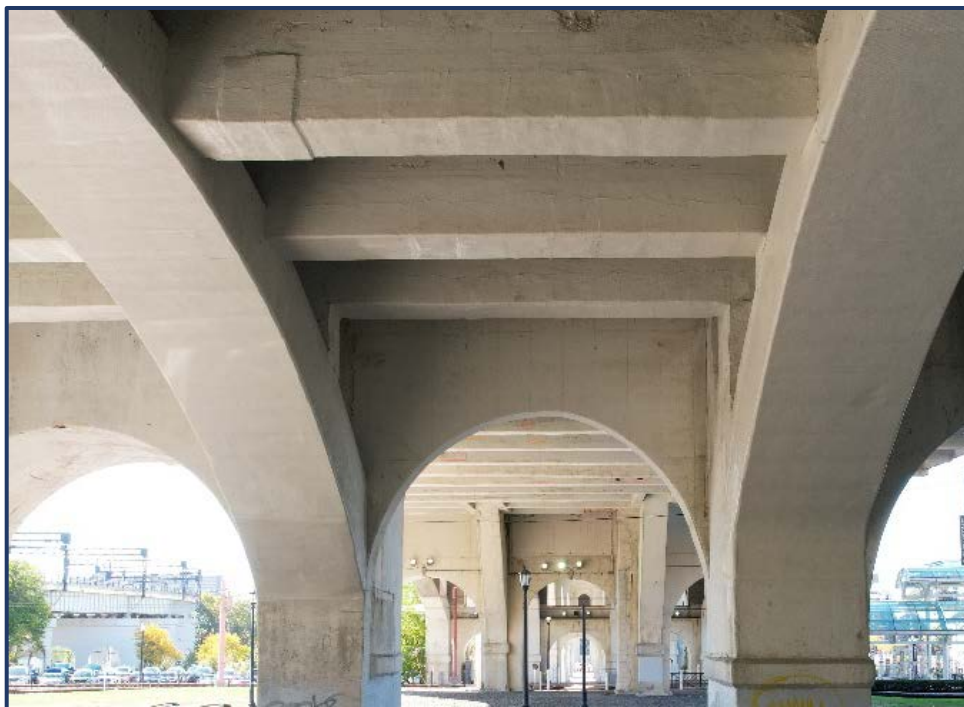
Photo 155-6 – Span 13, FRP on Underside of Lower Deck Floorbeams

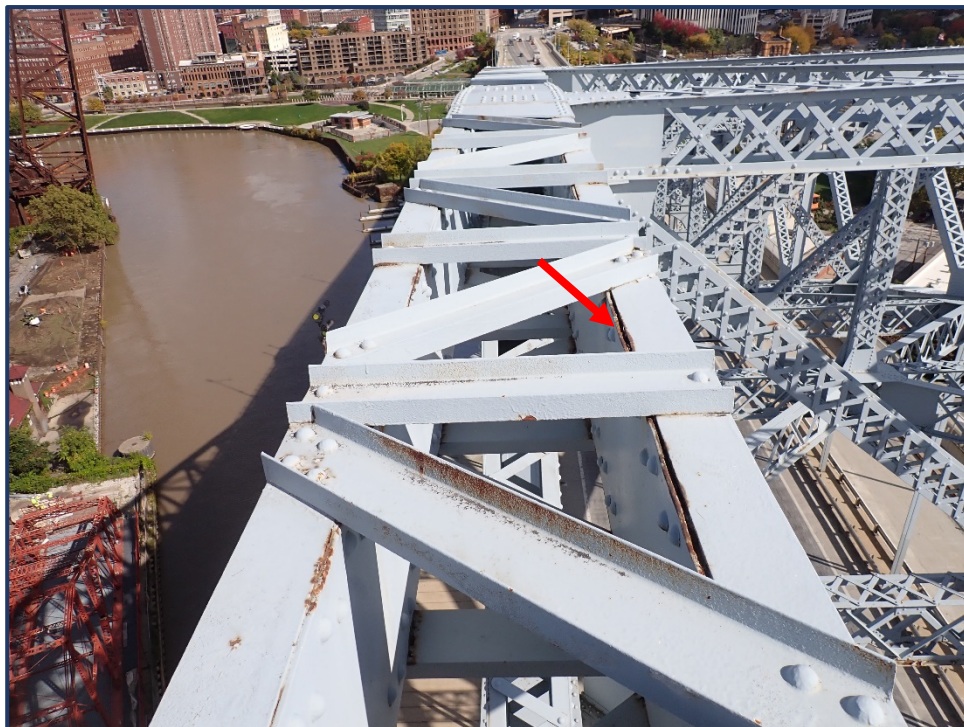
Photo 120-2 – Span 4, North Truss, U12-U11', Active Pack Rust between Web Plate and Flange Angles.

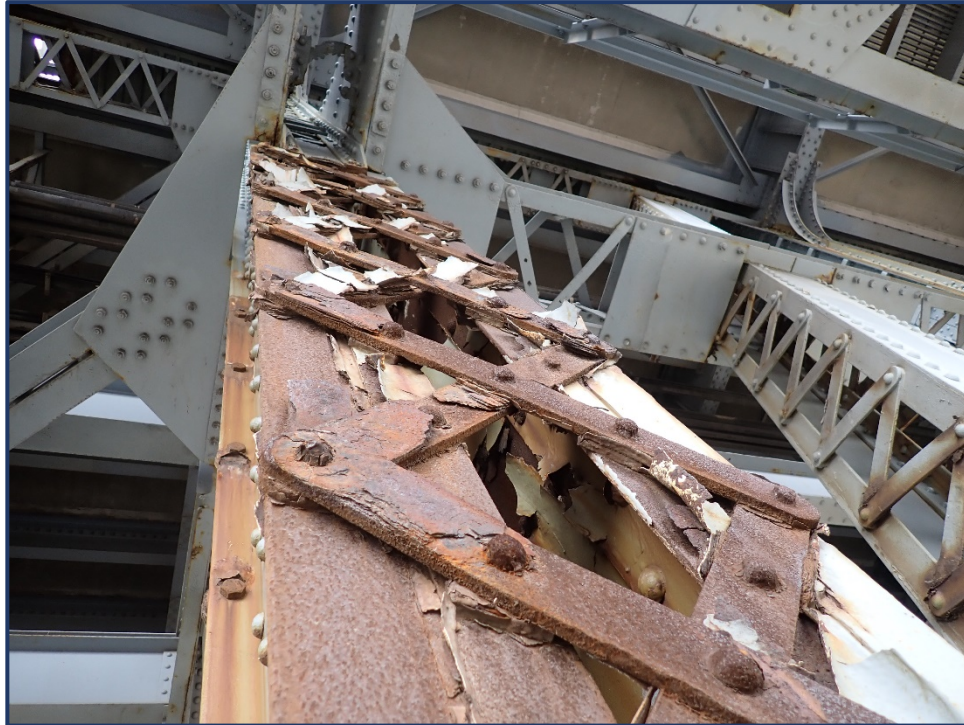
Photo 120-3 – Span 4, South Truss, U2”-L2’, Active Corrosion extending down from Upper Deck

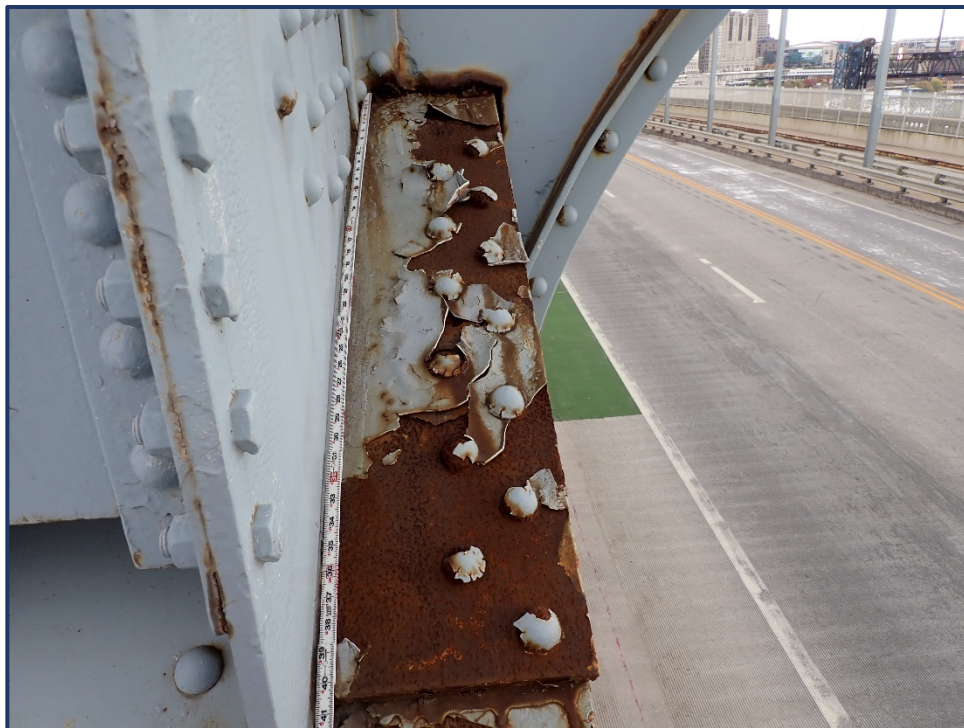
Photo 120-4 – Span 4, North Truss, L5-L6, Active Corrosion at Lateral Bracing
