Physical Condition Report for

CUY-006-1456

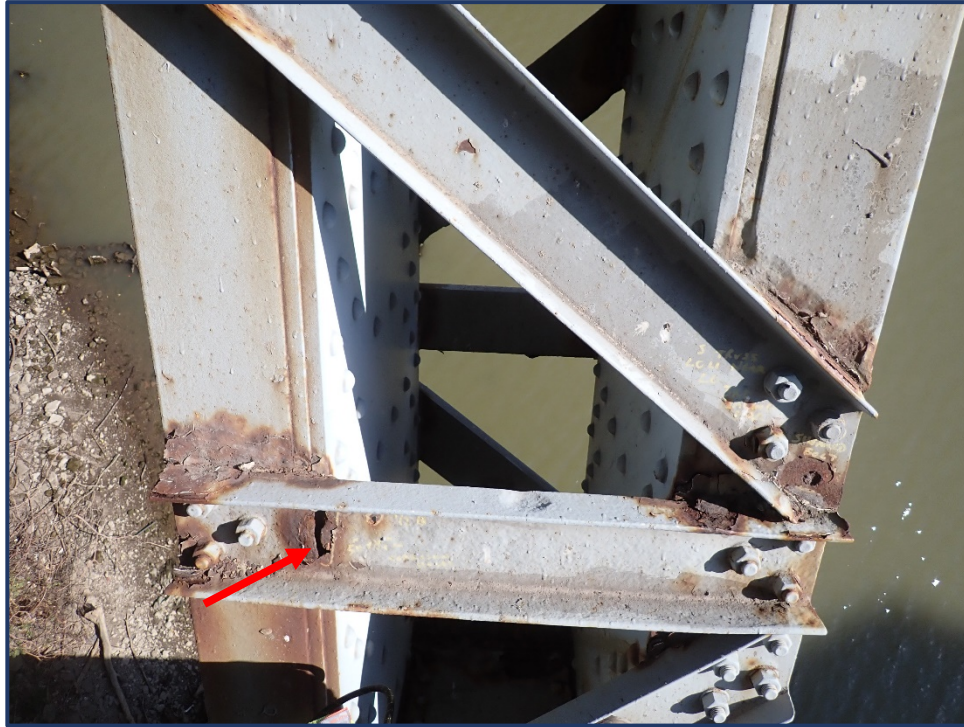
Photo 120-5 – Span 4, South Truss, L0-L1, Active Section Loss and Corrosion Hole in Lacing Bar

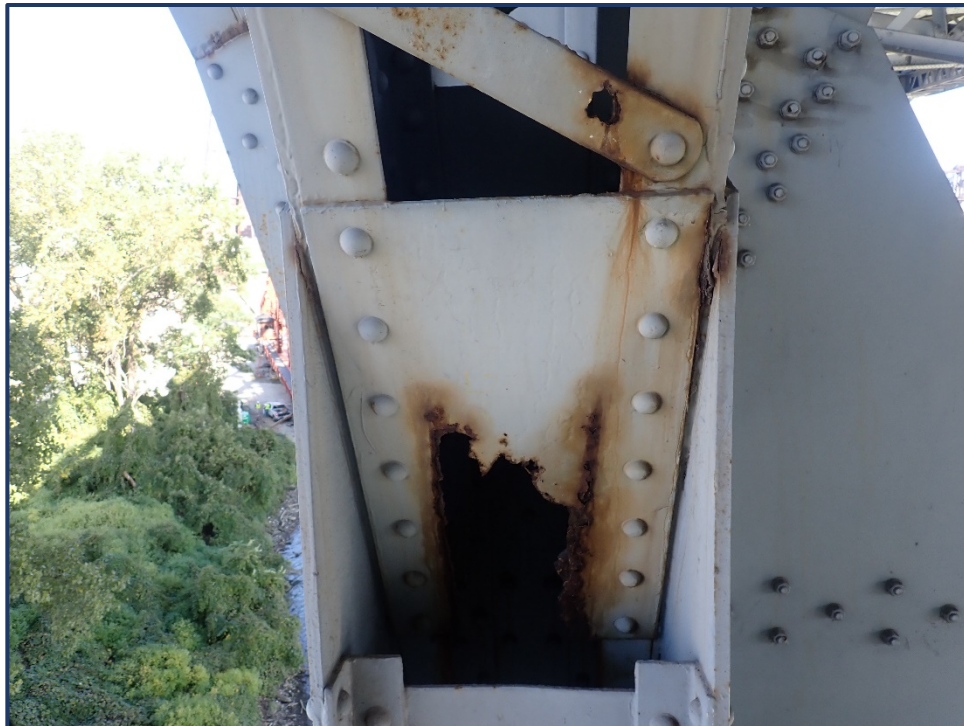
Photo 120-6 – Span 4, North Truss, U1-L2, Perforations in Batten Plate, with Reactivating Corrosion

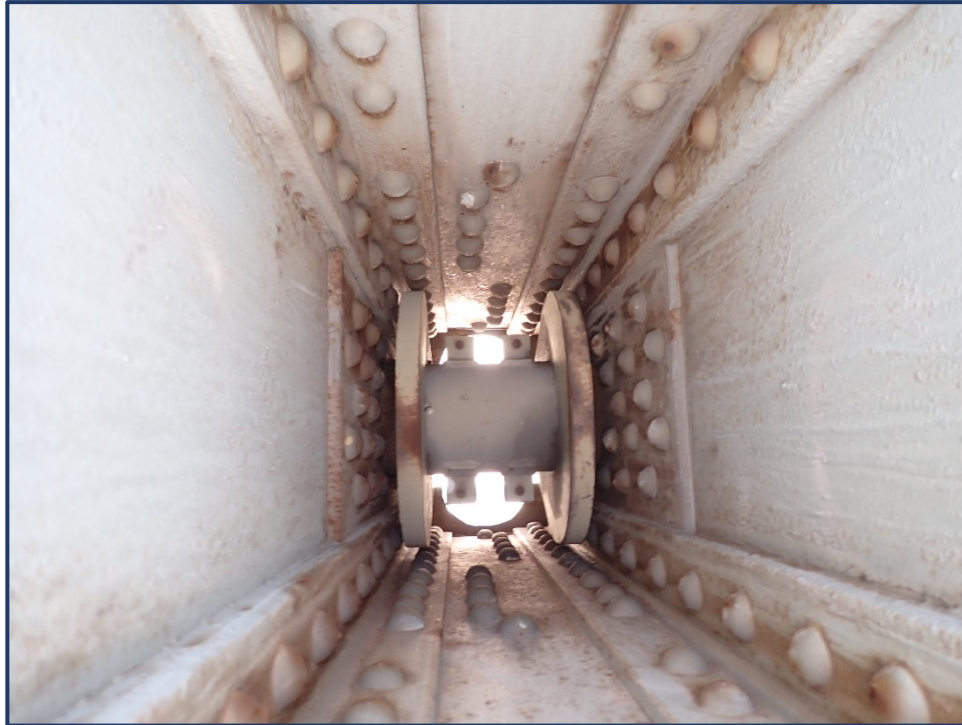
Photo 120-7– Span 4, South Truss, L11, Reactivating Pitting around Hanger Pin

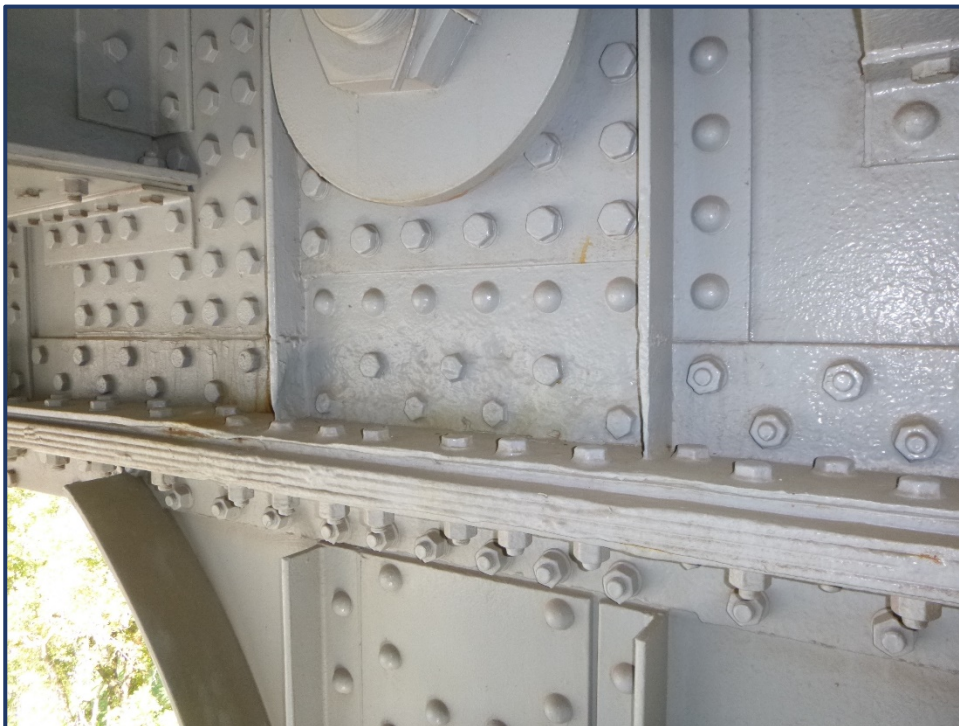
Photo 152-1 – Span 4, Upper FBs, Typical Painted over Pitting and Pack Rust at Deck Opening

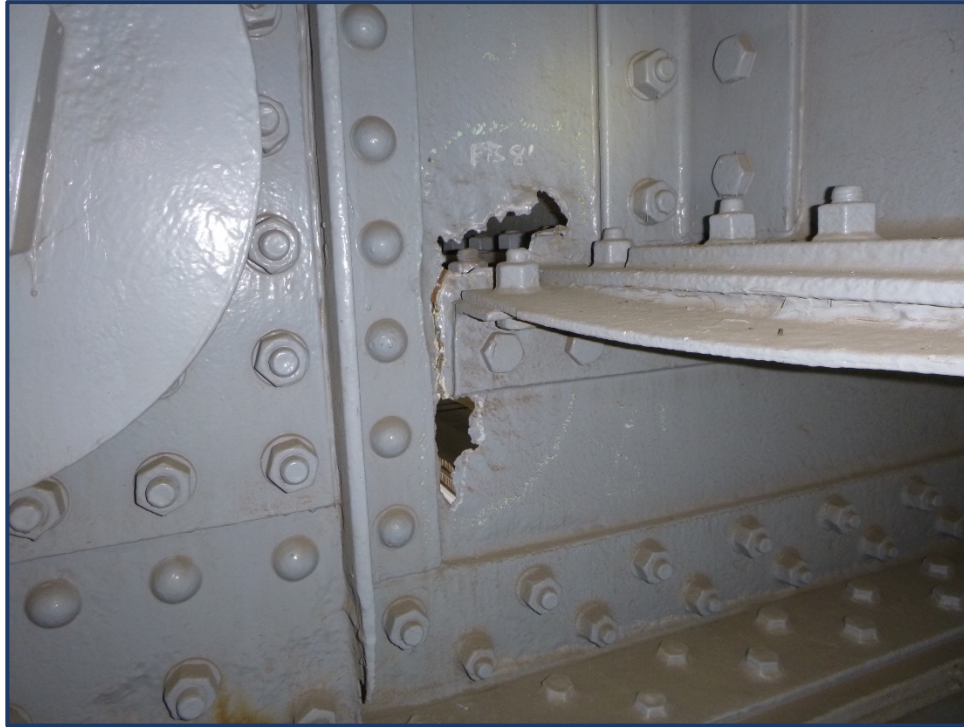
Photo 152-2 – Span 4, Upper FB8', Corrosion Holes in Web, N. of Stringer E

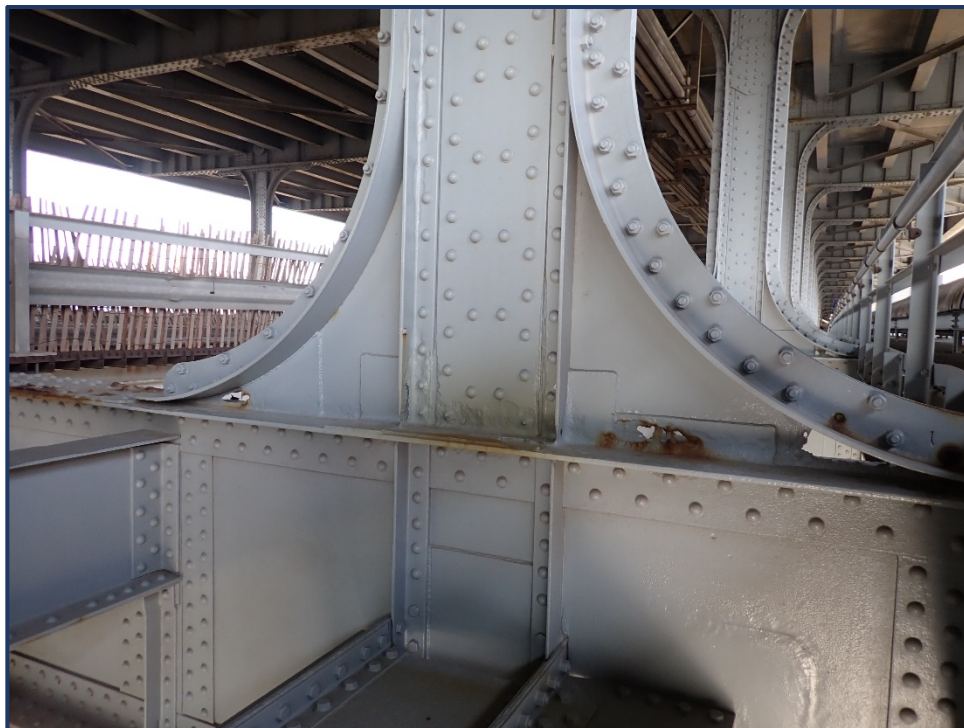
Photo 152-3 – Span 4, Lower FB10 at South Truss, Reactivating Painted Over Section Loss in Top Flange and Stiffeners

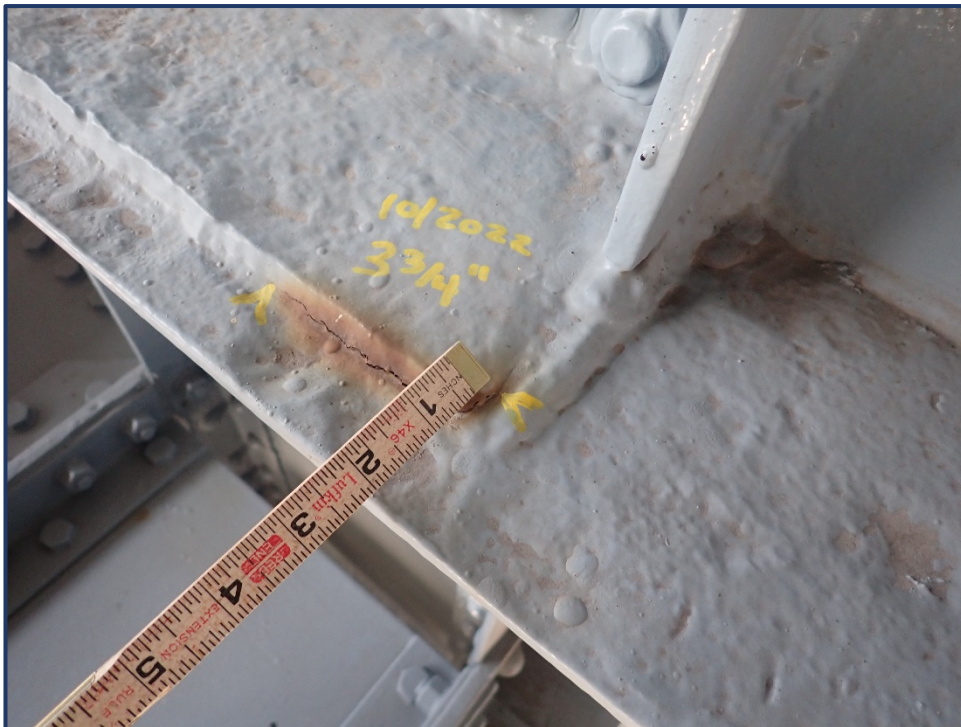
Photo 152-5 – Span 4, Lower FB9', North End, West Face, Crack in Top Flange Stiffener Retrofit

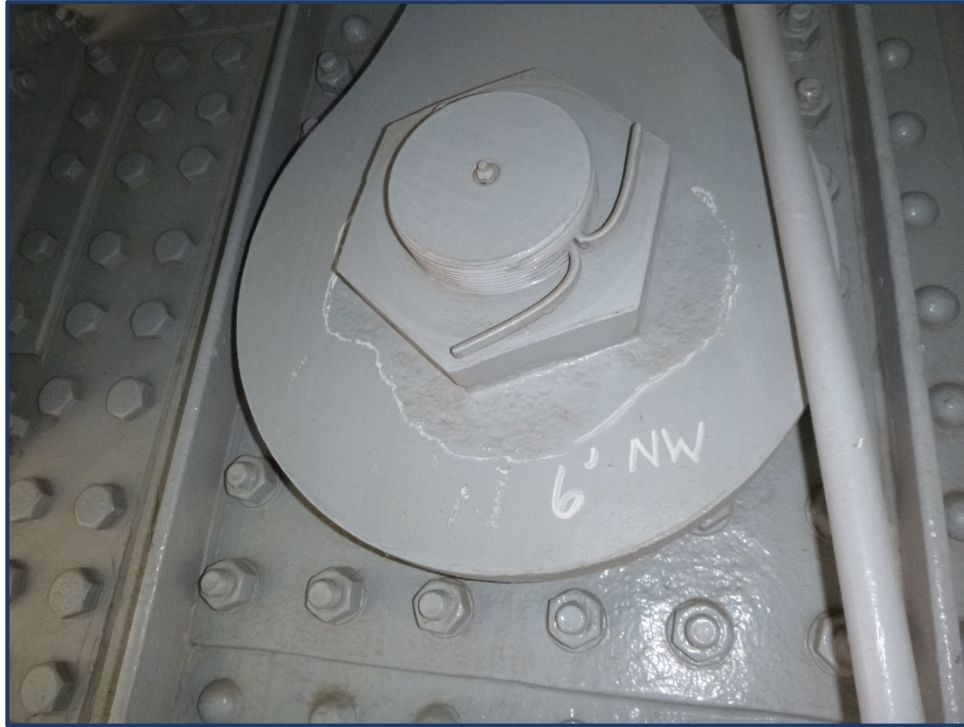
Photo 161-1 – Span 4, North Truss, Hanger Connection at Upper FB8', Painted over Pitting around Pin

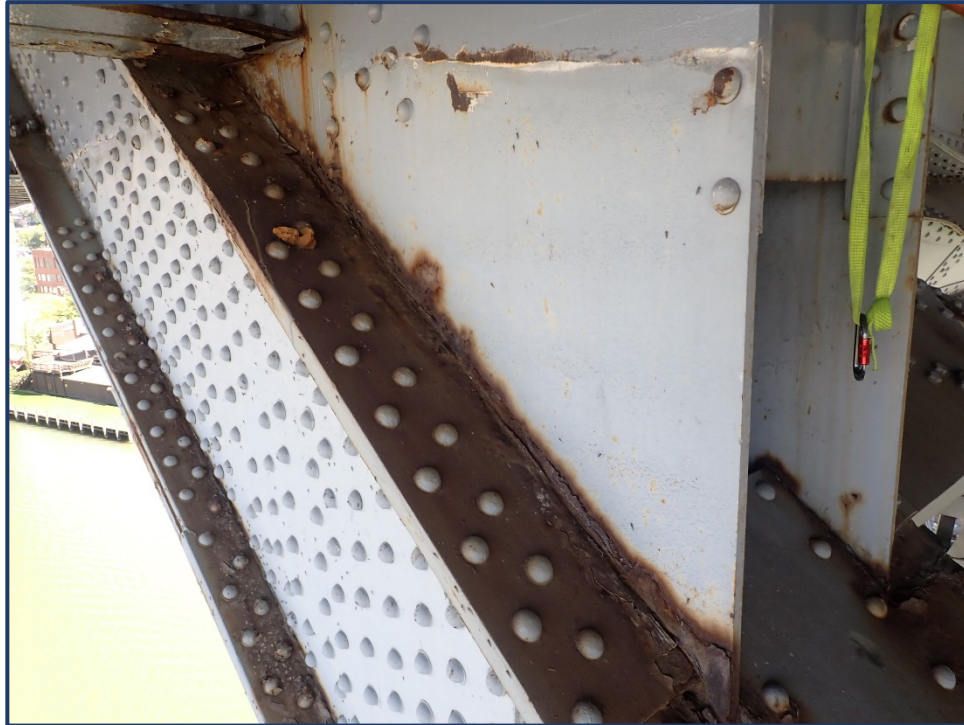
Photo 162-2 – Span 4, North Truss, L3 South Gusset Plate, Active Pitting & Pack Rust

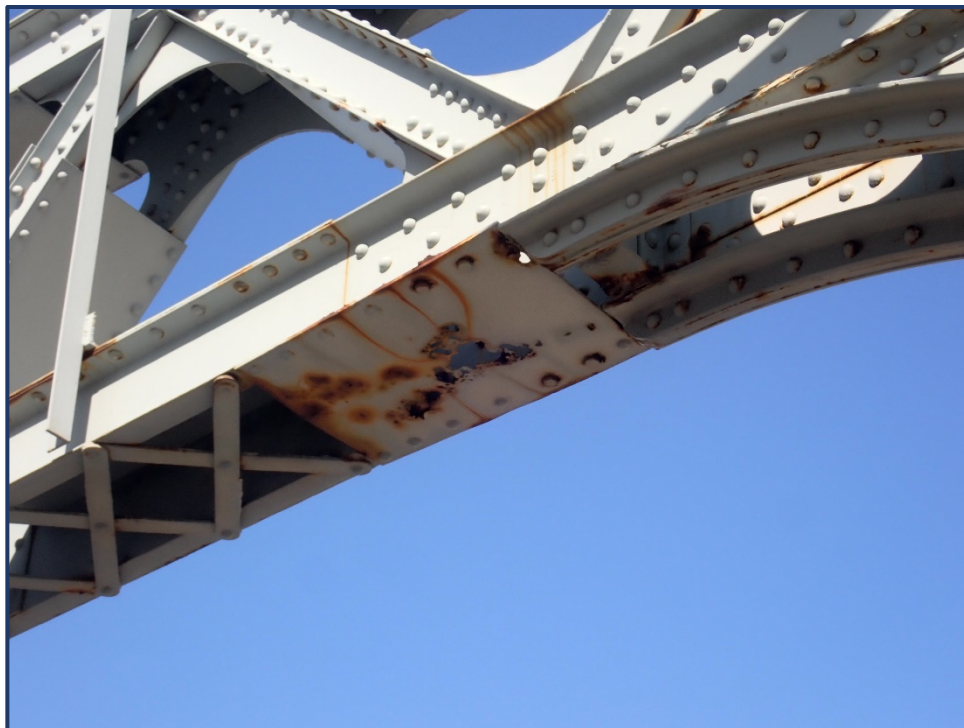
Photo BR-1 – Active Corrosion and Pack Rust on Sway Bracing Members

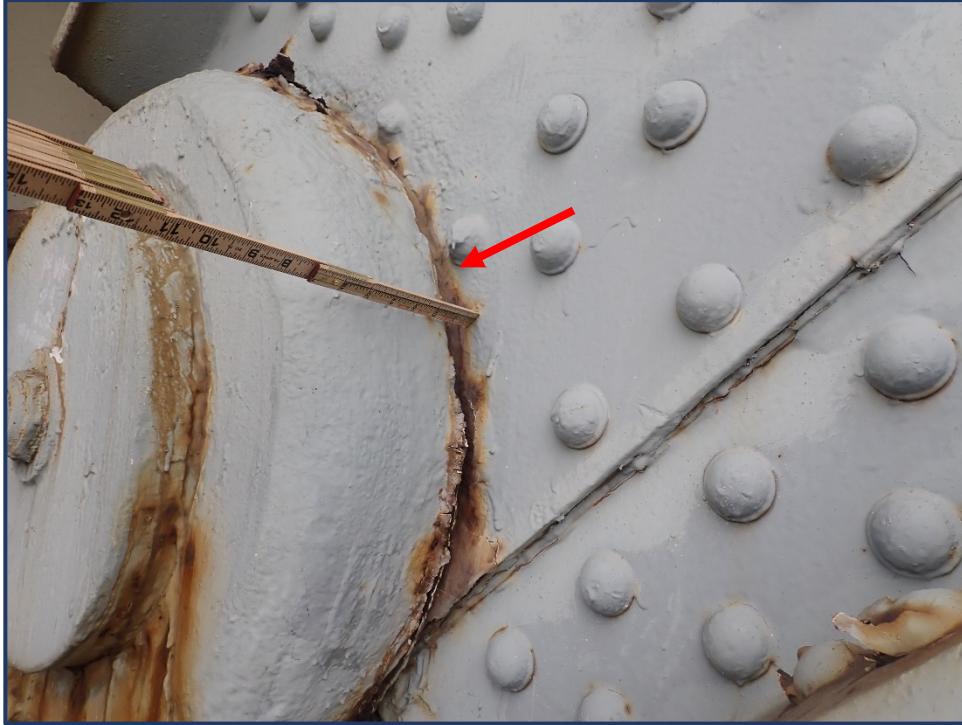
Photo 313-1 – Span 4, North Truss, L0' Bearing, Pack Rust Around Pin

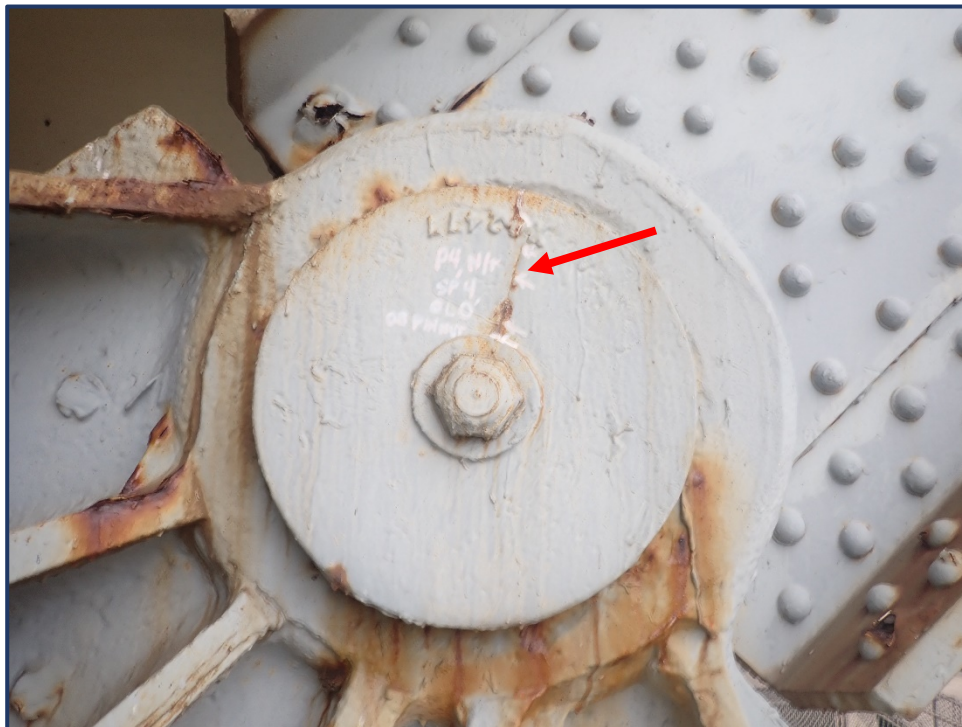
Photo 313-2 – Span 4, North Truss, L0' Bearing, Crack in North Pin Cover Plate

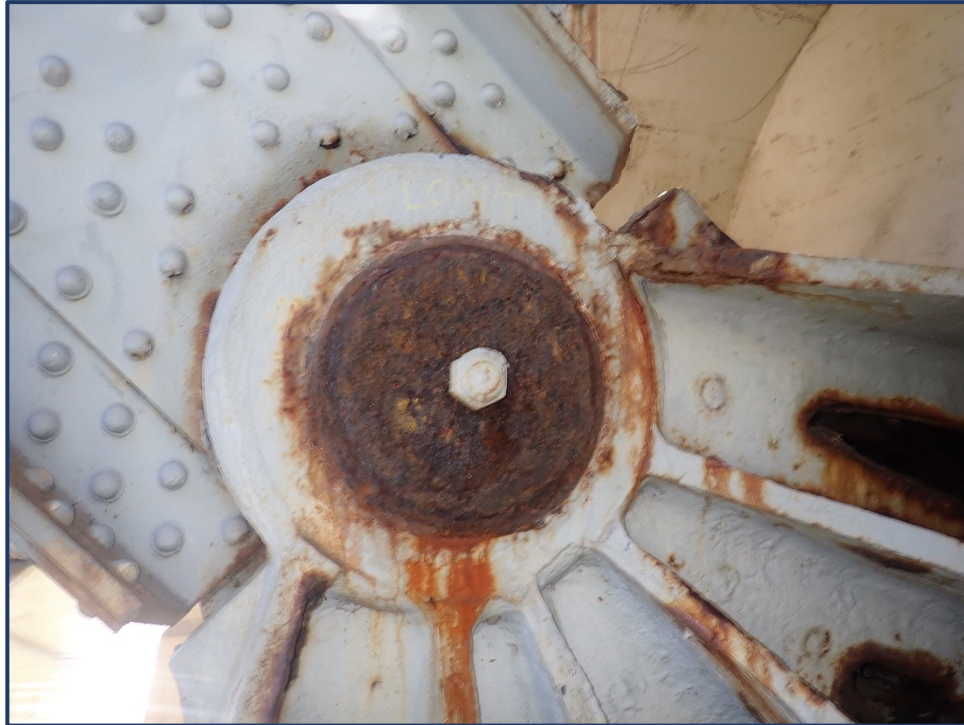
Photo 313-3 – Span 4, North Truss, L0 Bearing, Missing Pin Cover Plate

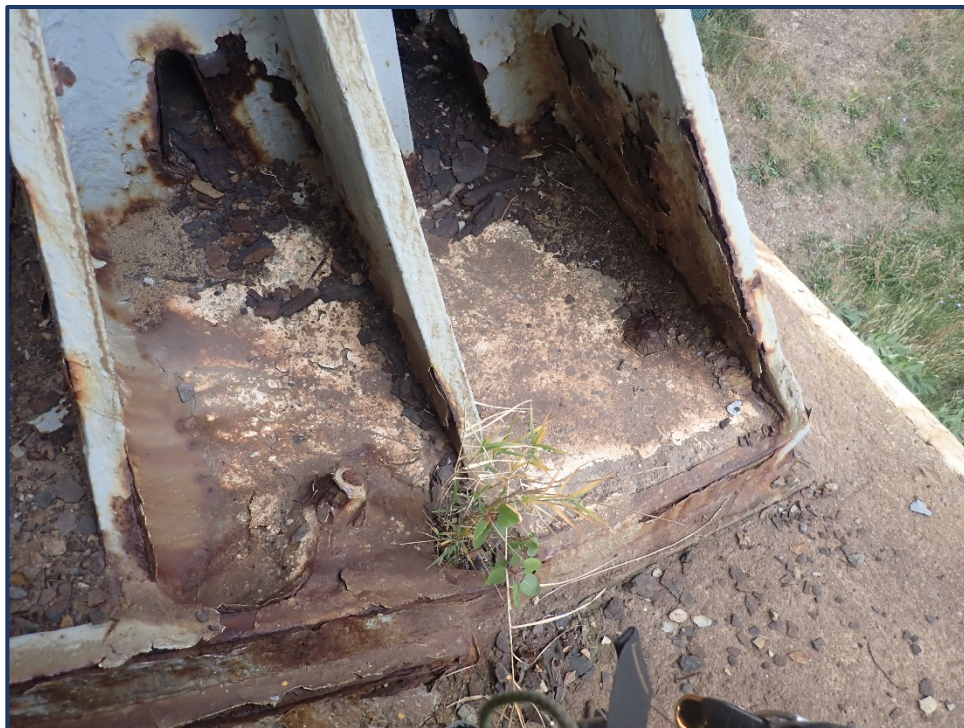
Photo 313-4 – Span 4, North Truss, L0' Bearing, Anchor Bolt & Nut Section Loss

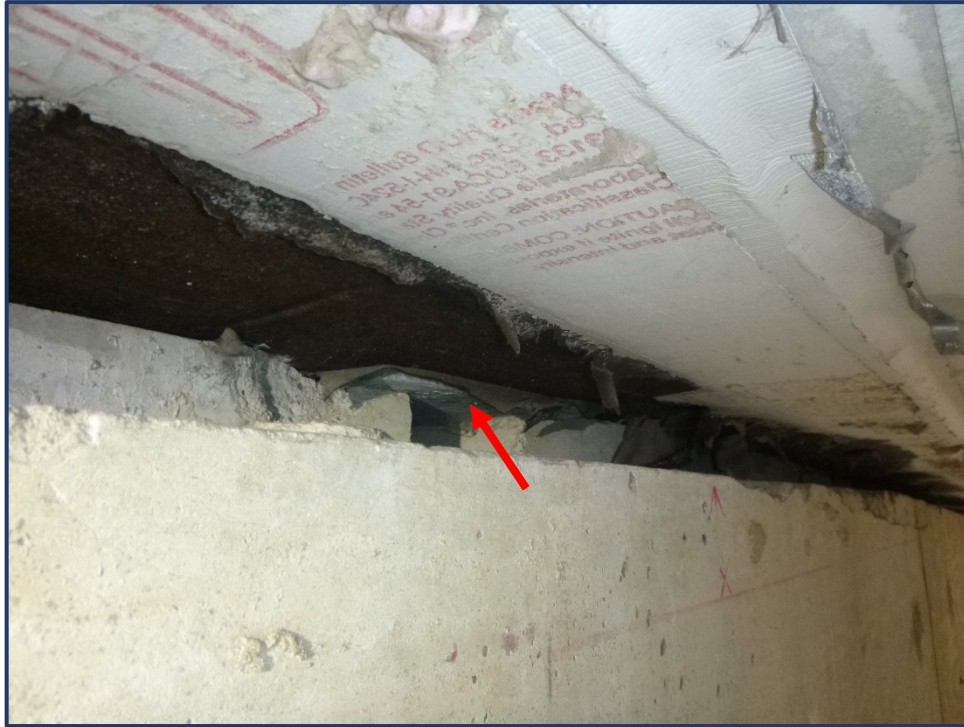
Photo 313-5 – Pier 11, Slab/Floorbeam Bearing Plates between Ribs B & C, Shifting/Missing Bearing Plates

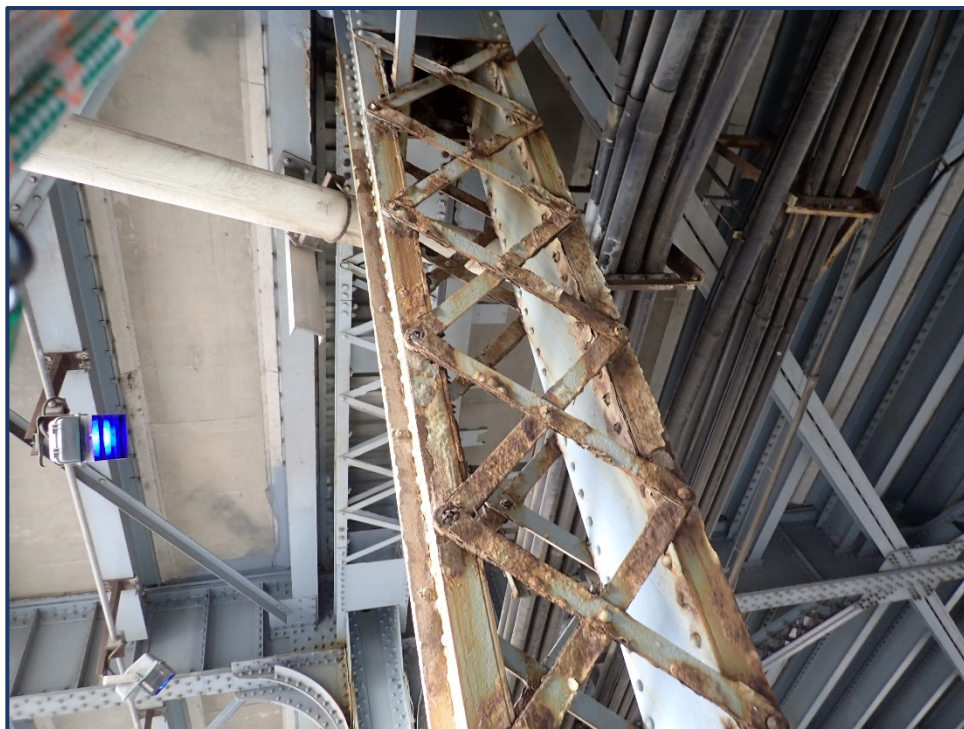
Photo 515-1 – Span 4, Peeling Paint and Surface Corrosion Below Upper Deck

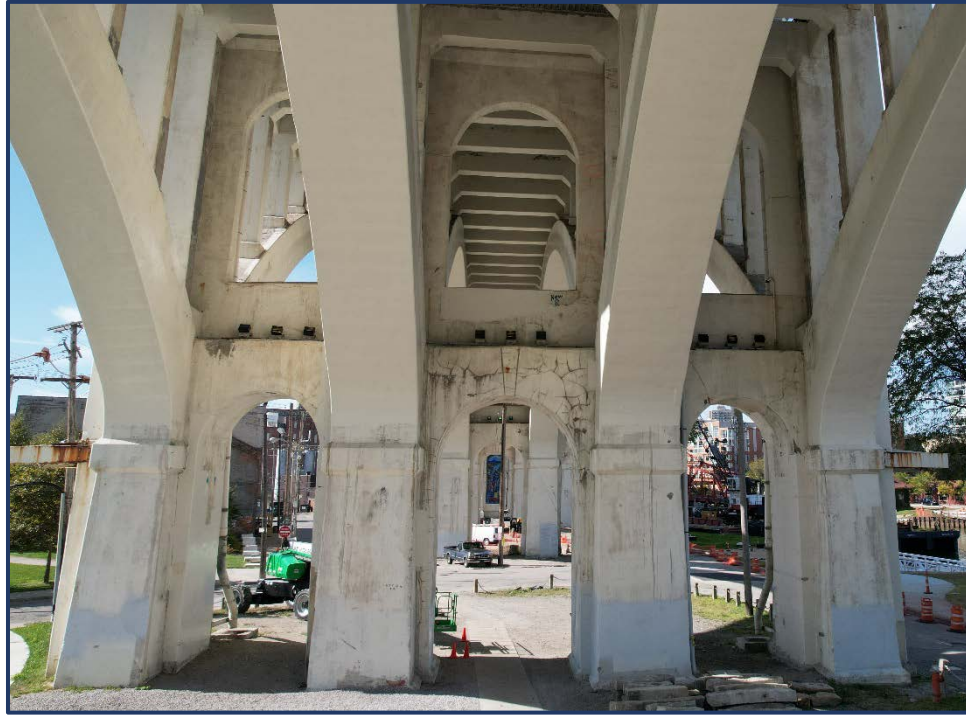
Photo 205-1 – Pier 8, West Face, Typical Patching and Cracking

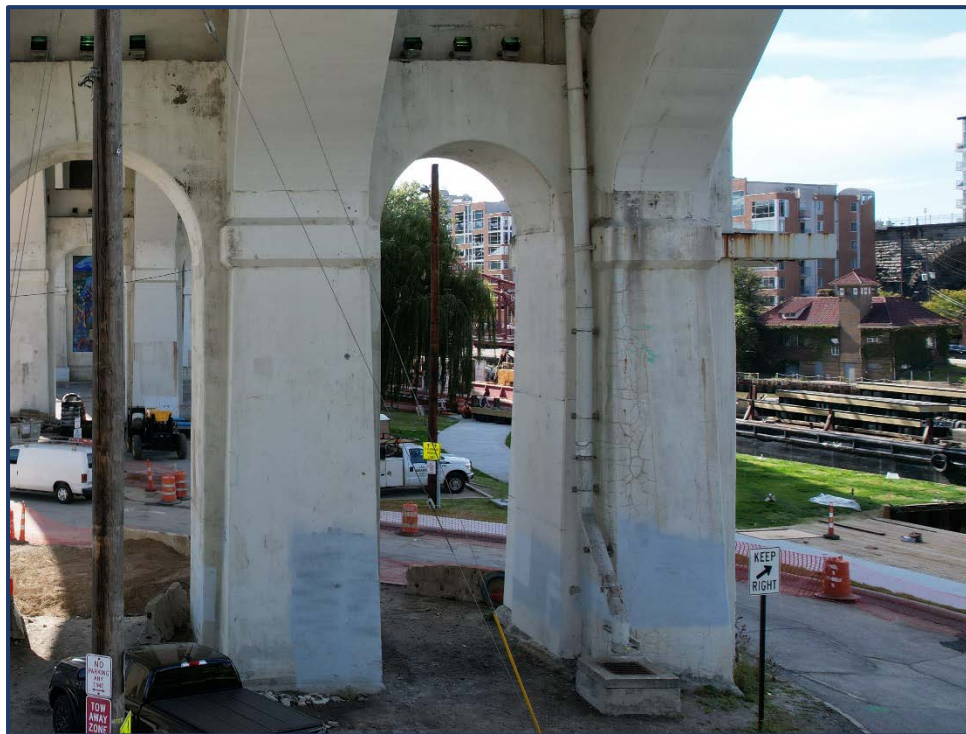
Photo 205-2 – Pier 6, East Face, Cracking of North Column

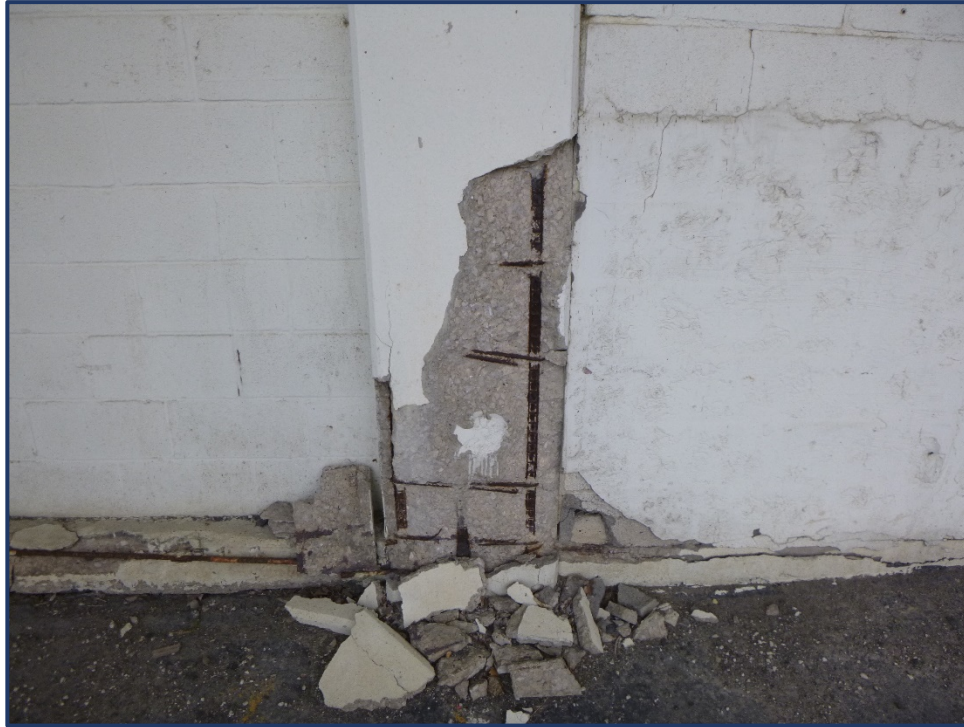
Photo 205-3 – Span 1A, Typical Column Spalling with Exposed Reinforcing

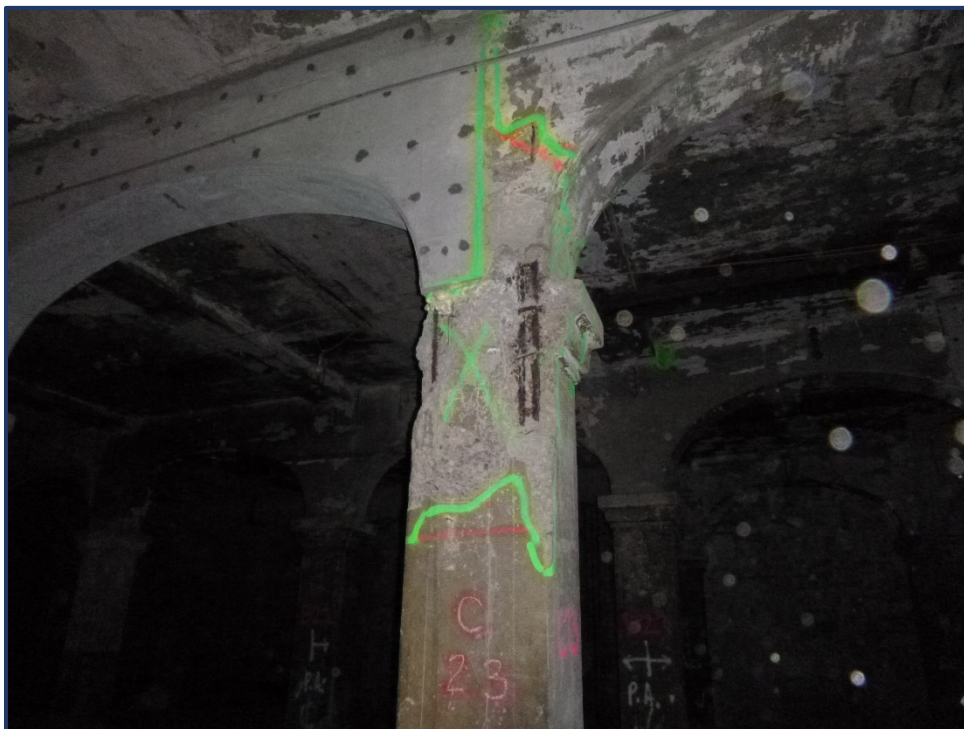
Photo 205-4 – West Station, Column Spalling with Exposed Reinforcing

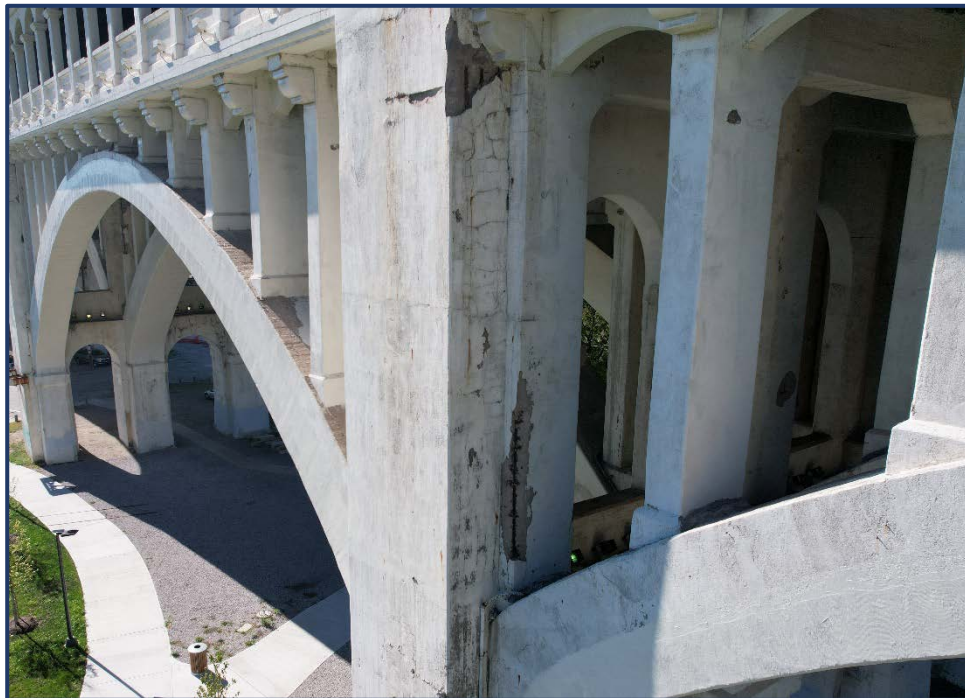
Photo 205-5 – Pier 10, South Tower, Widespread Delamination and Spalling with Exposed Reinforcing

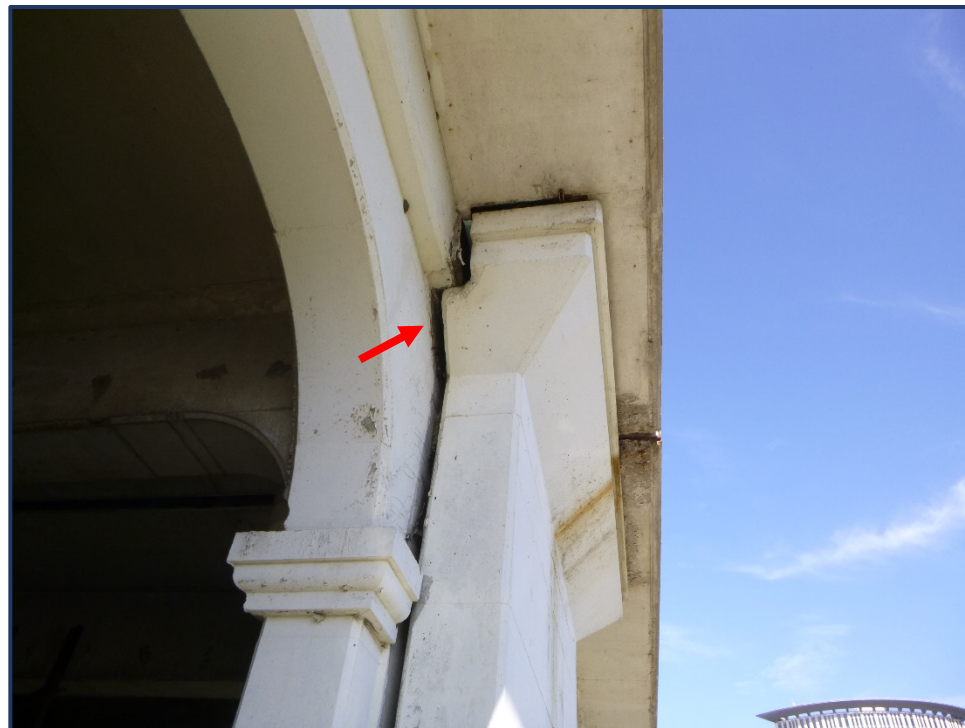
Photo 205-6 – Pier 6, South Tower Leaning Away from Bridge at Top

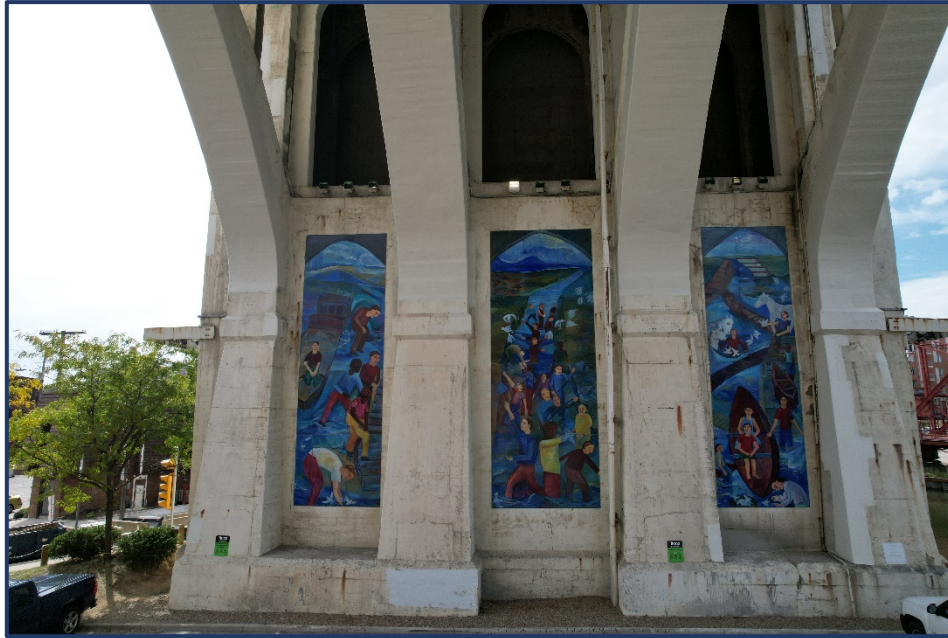
Photo 210-1 – Pier 4, East Face, Typical Map Cracking in Lower Portion

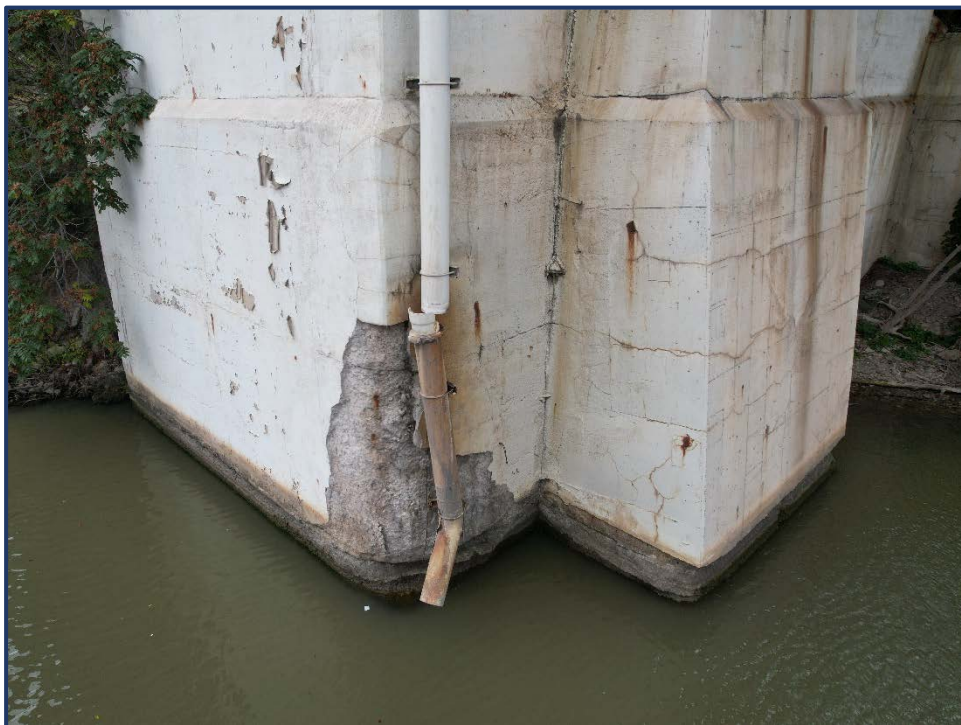
Photo 210-2 – Pier 3, Southeast Corner, Spalling and Delamination at Waterline

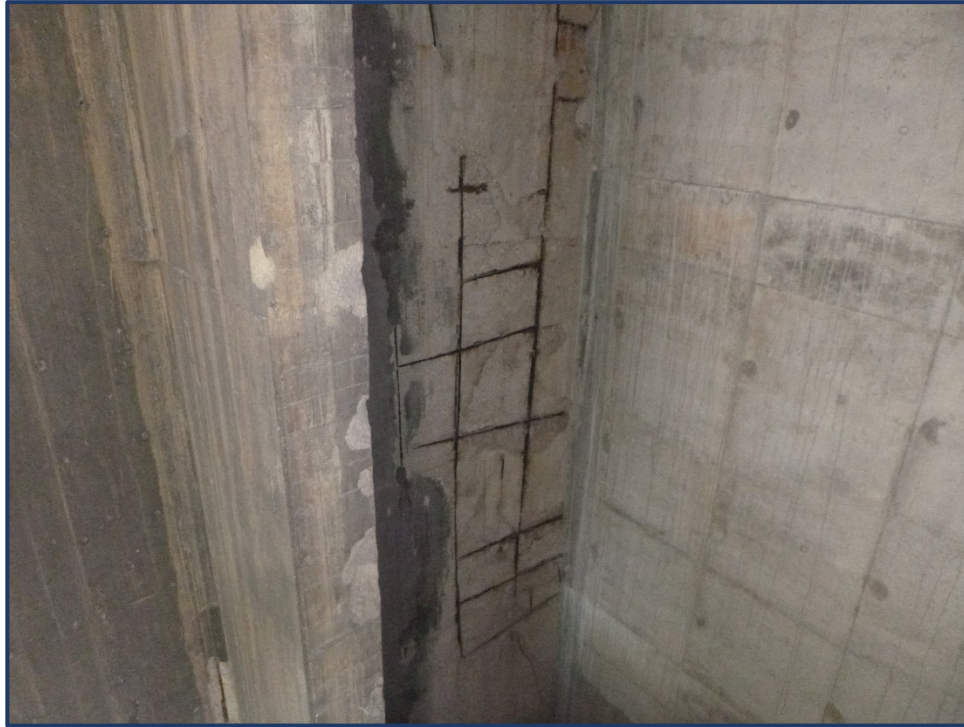
Photo 210-3 – Pier 4, Typical Spalling of Interior Face of Pier Walls

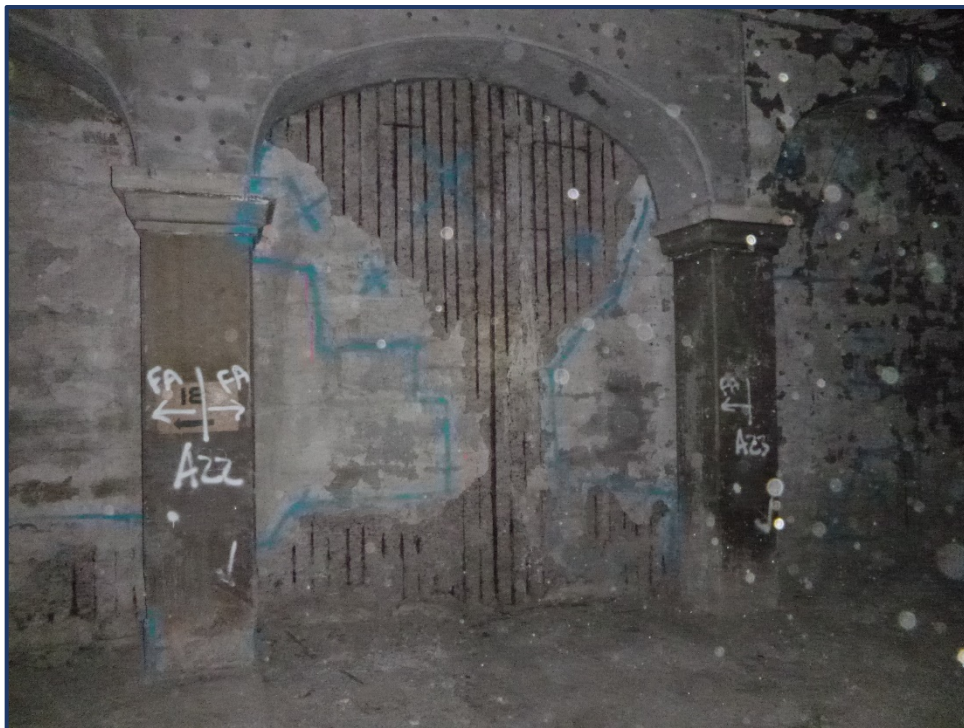
Photo 215-1 – West Station, Spalling with Exposed Reinforcing on Walls

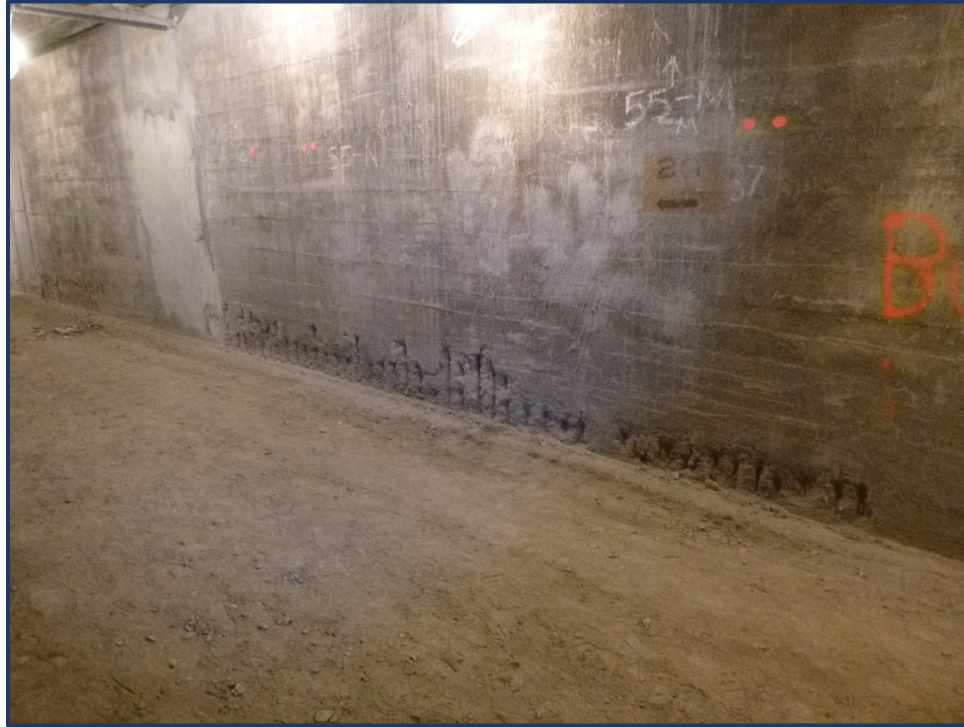
Photo 215-2 – Detroit Ave. Tunnel, Typical Spalling on Lower Portions of Walls

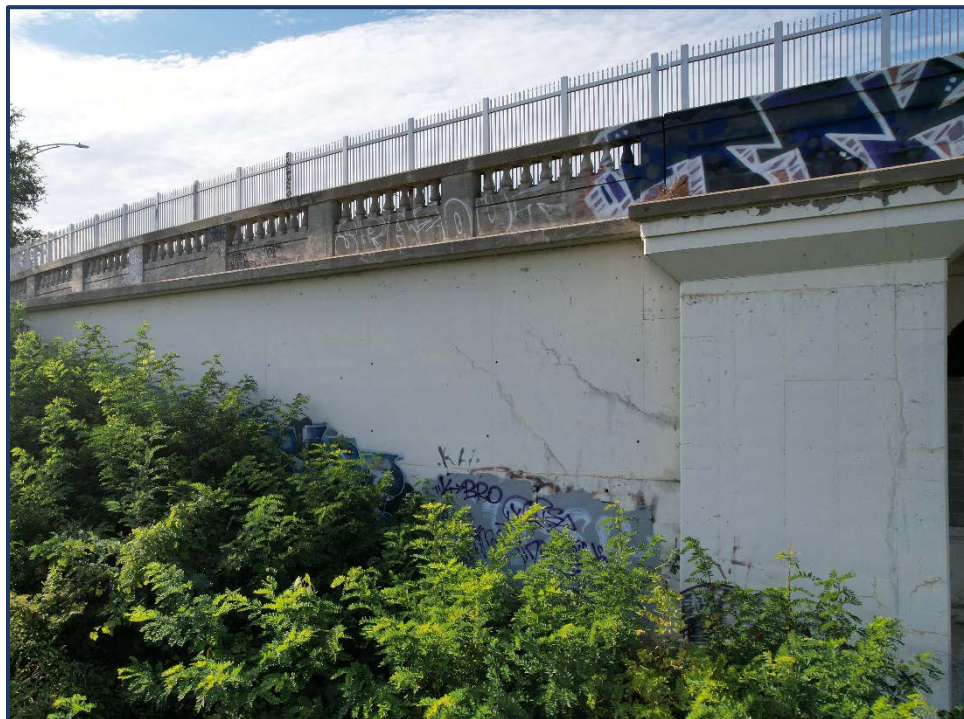
Photo WW-1 – West Abutment South Wingwall, Areas of Cracking

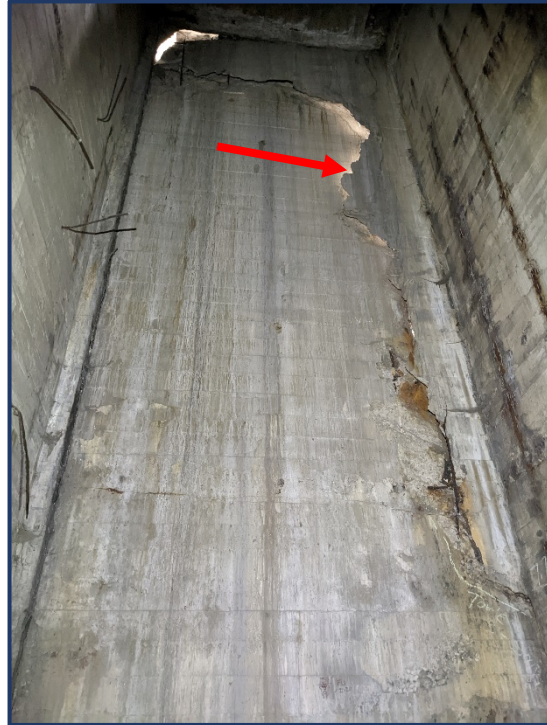
Photo WW-2 – West Abutment Chamber, Crack Through Wall at Tower B

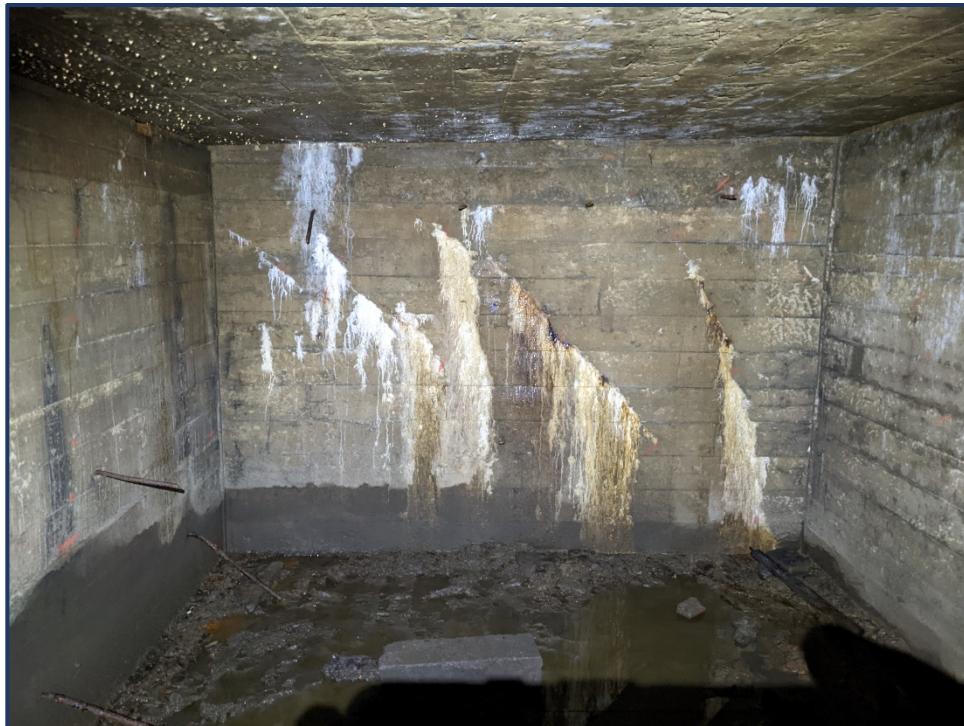
Photo AC-1 – West Abutment Chamber, Typical Cracking with Efflorescence

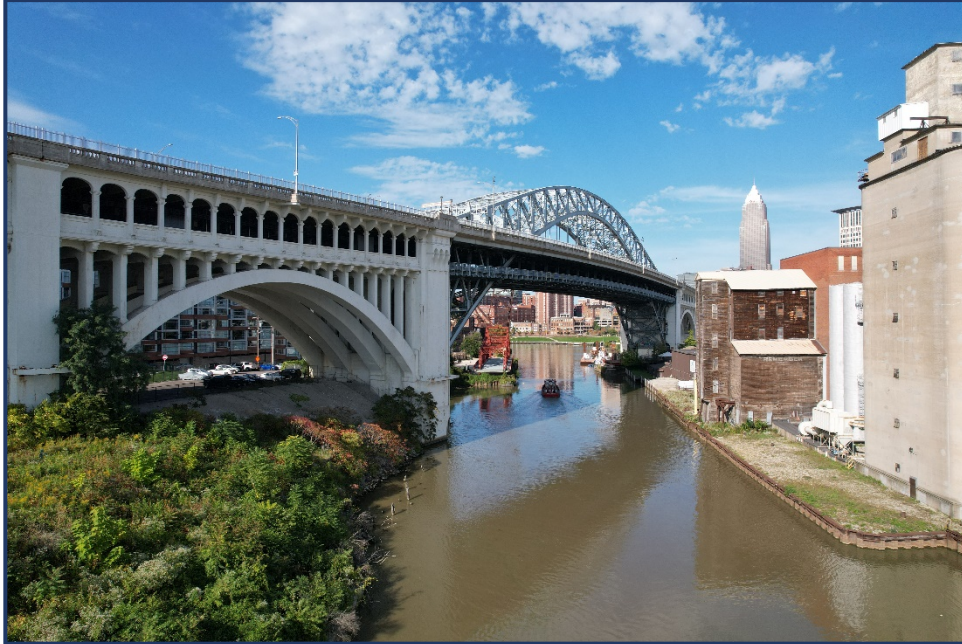
Photo CH-1 – Upstream Channel, Looking North

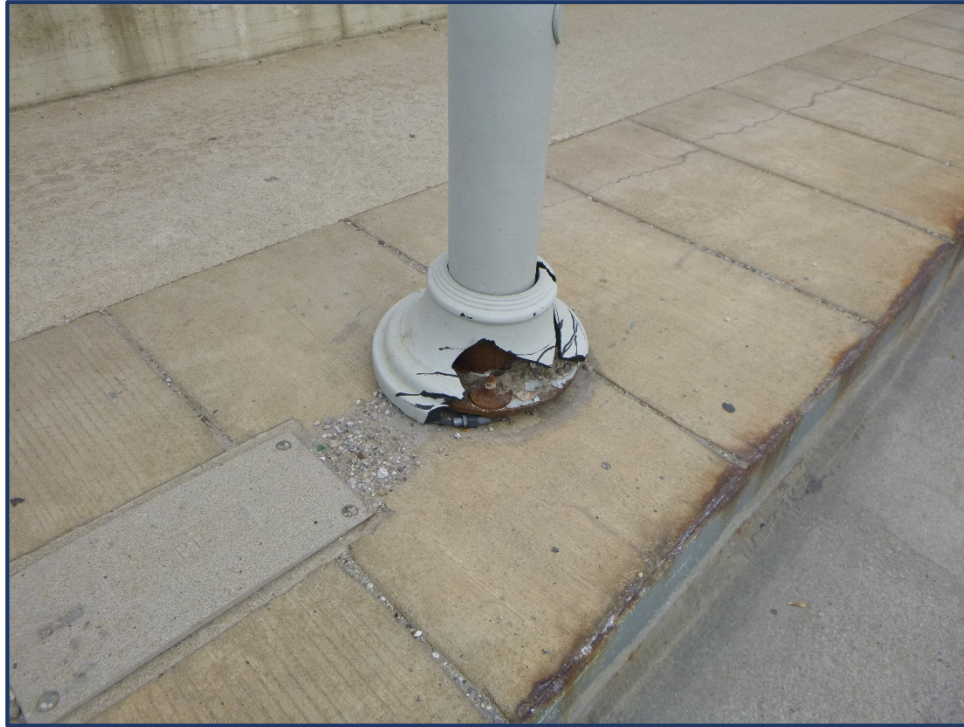
Photo UT-3 – Broken Light Pole Base Cover on North Sidewalk

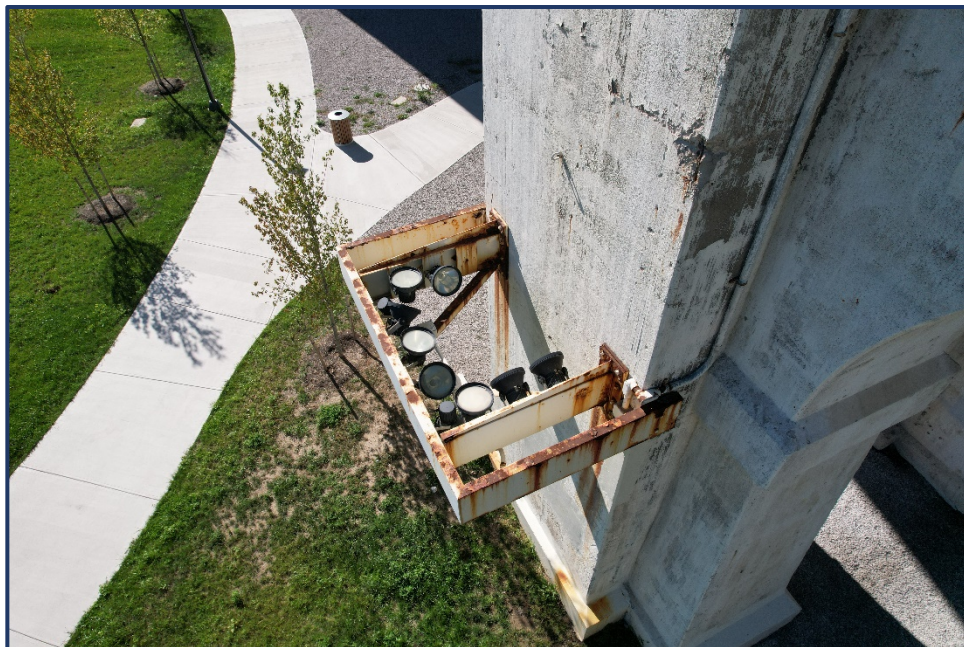
Photo UT-4 – Typical Corrosion and Minor Section Loss on Tower Light Brackets
