Physical Condition Report for

CUY-006-1456

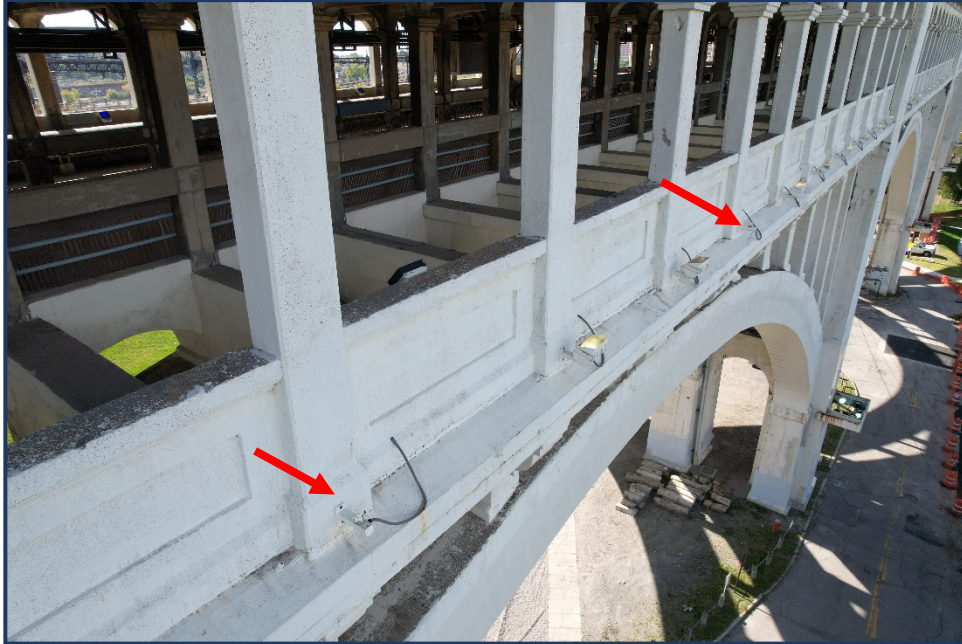
Photo UT-5 – Broken Architectural Lights, Span 8 North Fascia

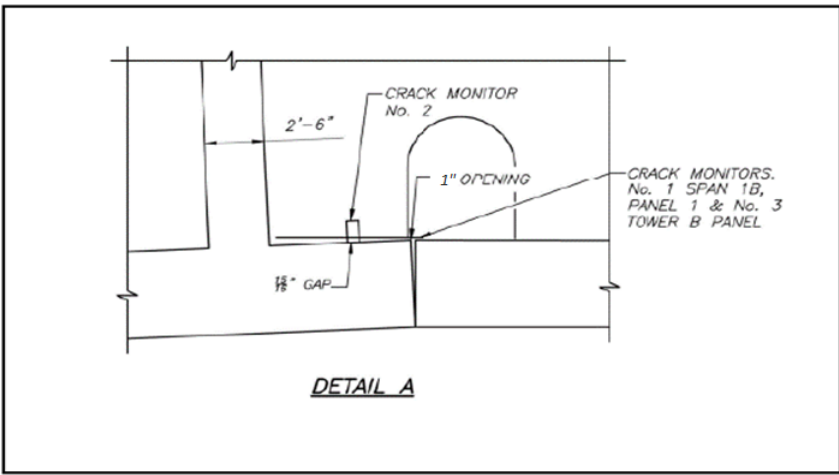
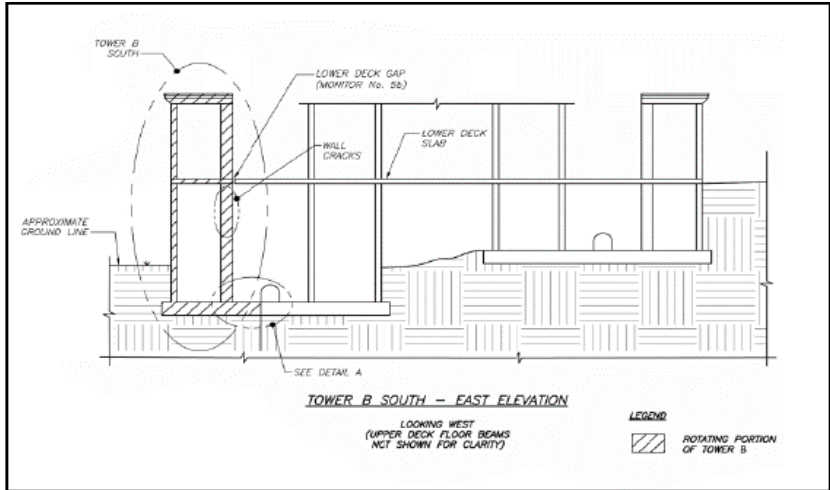
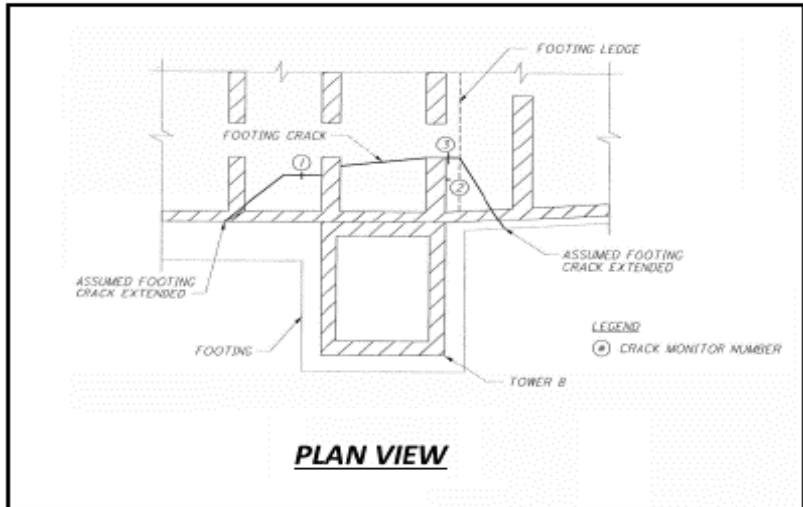
Table 6: Crack Gage Measurements - Span 1A Cellular Construction South Wall

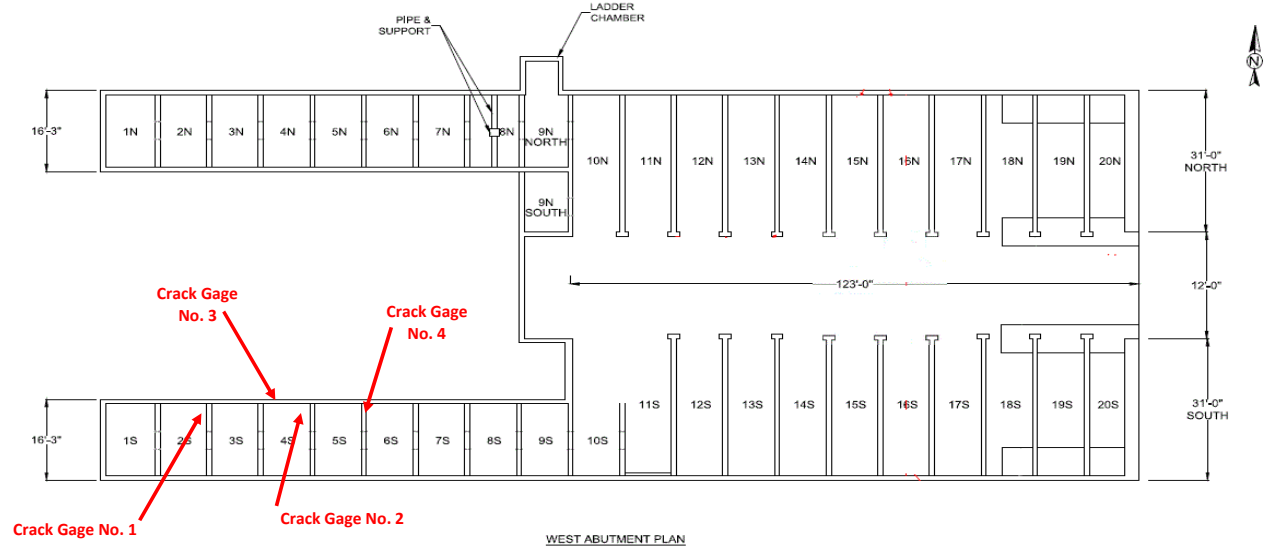
Date	No. 1		No. 2		No. 3		No. 4	
	V (mm)	H (mm)	V (mm)	H (mm)	V (mm)	H (mm)	V (mm)	H (mm)
5/17/07	0.0	0.0	0.0	0.0	0.0	0.0	0.0	0.0
4/16/13	2.0	1.0	2.5	0.3	0.0	0.0	0.8	0.2
10/3/14	2.3	1.0	3.0	0.6	0.0	0.0	0.8	0.2
8/16/15	2.8	1.1	4.5	0.8	0.0	0.0	0.9	0.5
9/14/16	3.0	1.1	4.8	0.8	0.0	0.0	1.0	0.5
11/27/17								
10/22/18							1.1	1.0
11/18/19							1.3	1.0
10/22/20					0.0	0.0	1.5	1.0
10/29/21	6.0	1.3	6.0	1.0	0.0	0.00	1.5	1.0
10/31/22	6.0	2.0	6.0	1.0			1.5	1.0

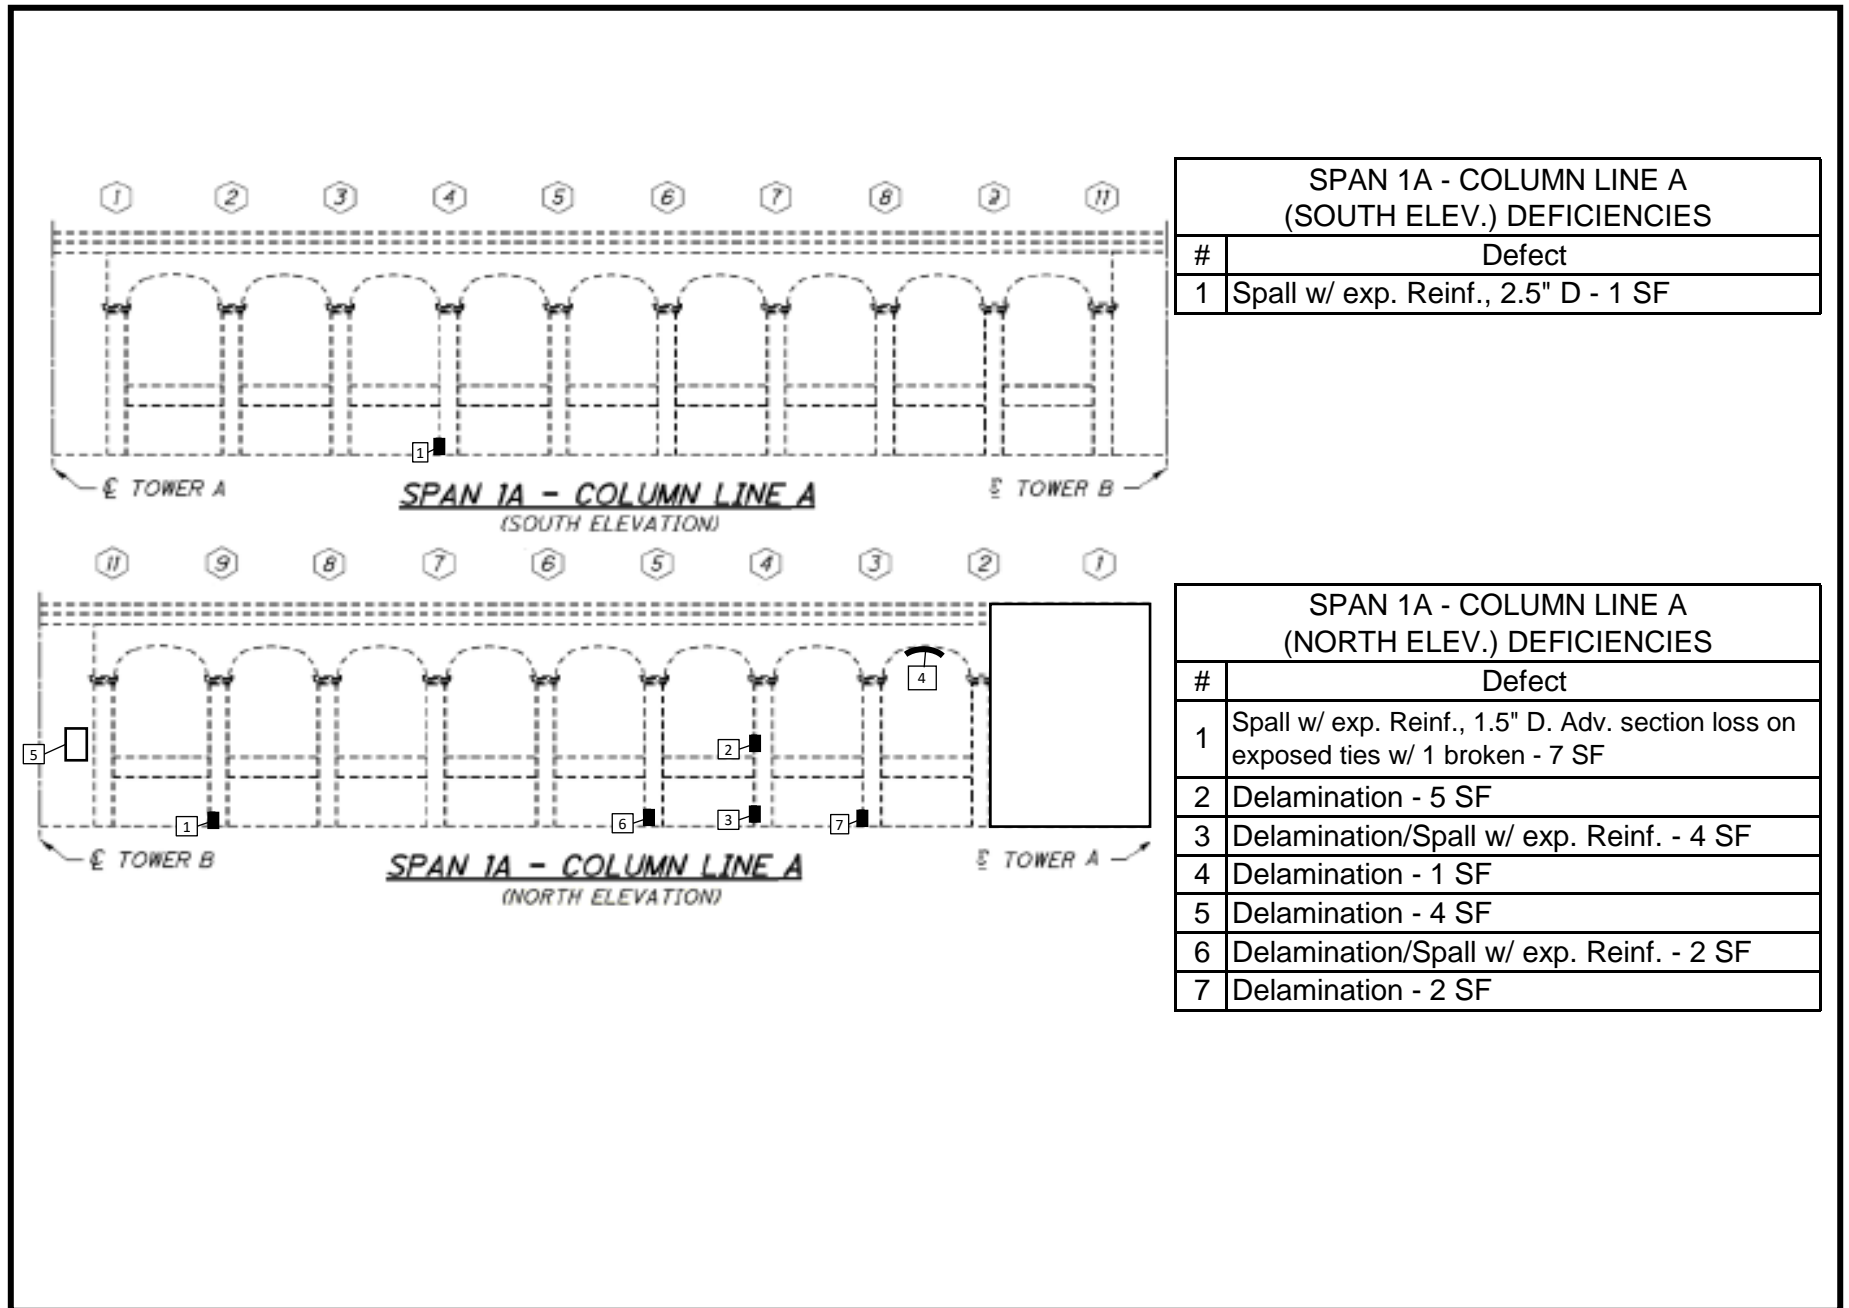
APPENDIX C – OPEN SPANDREL ARCH, TRUSS, FLOOR SYSTEM, AND SUBSTRUCTURE DRAWINGS AND DEFICIENCIES

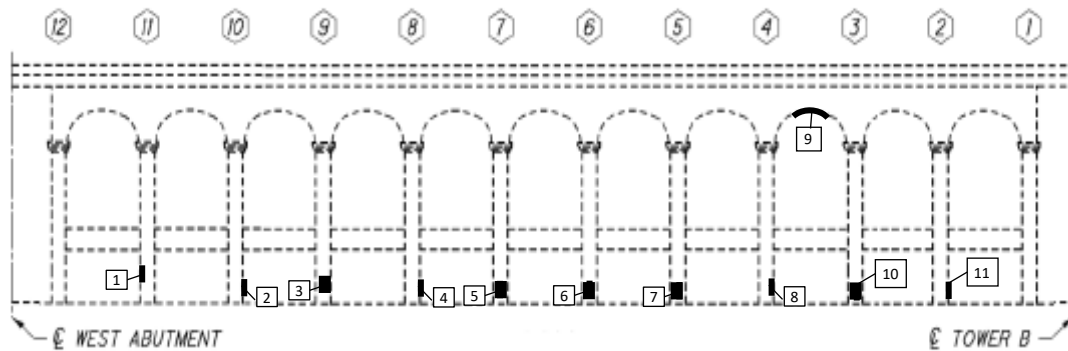
SPAN 1B - COLUMN LINE B NORTH ELEVATION

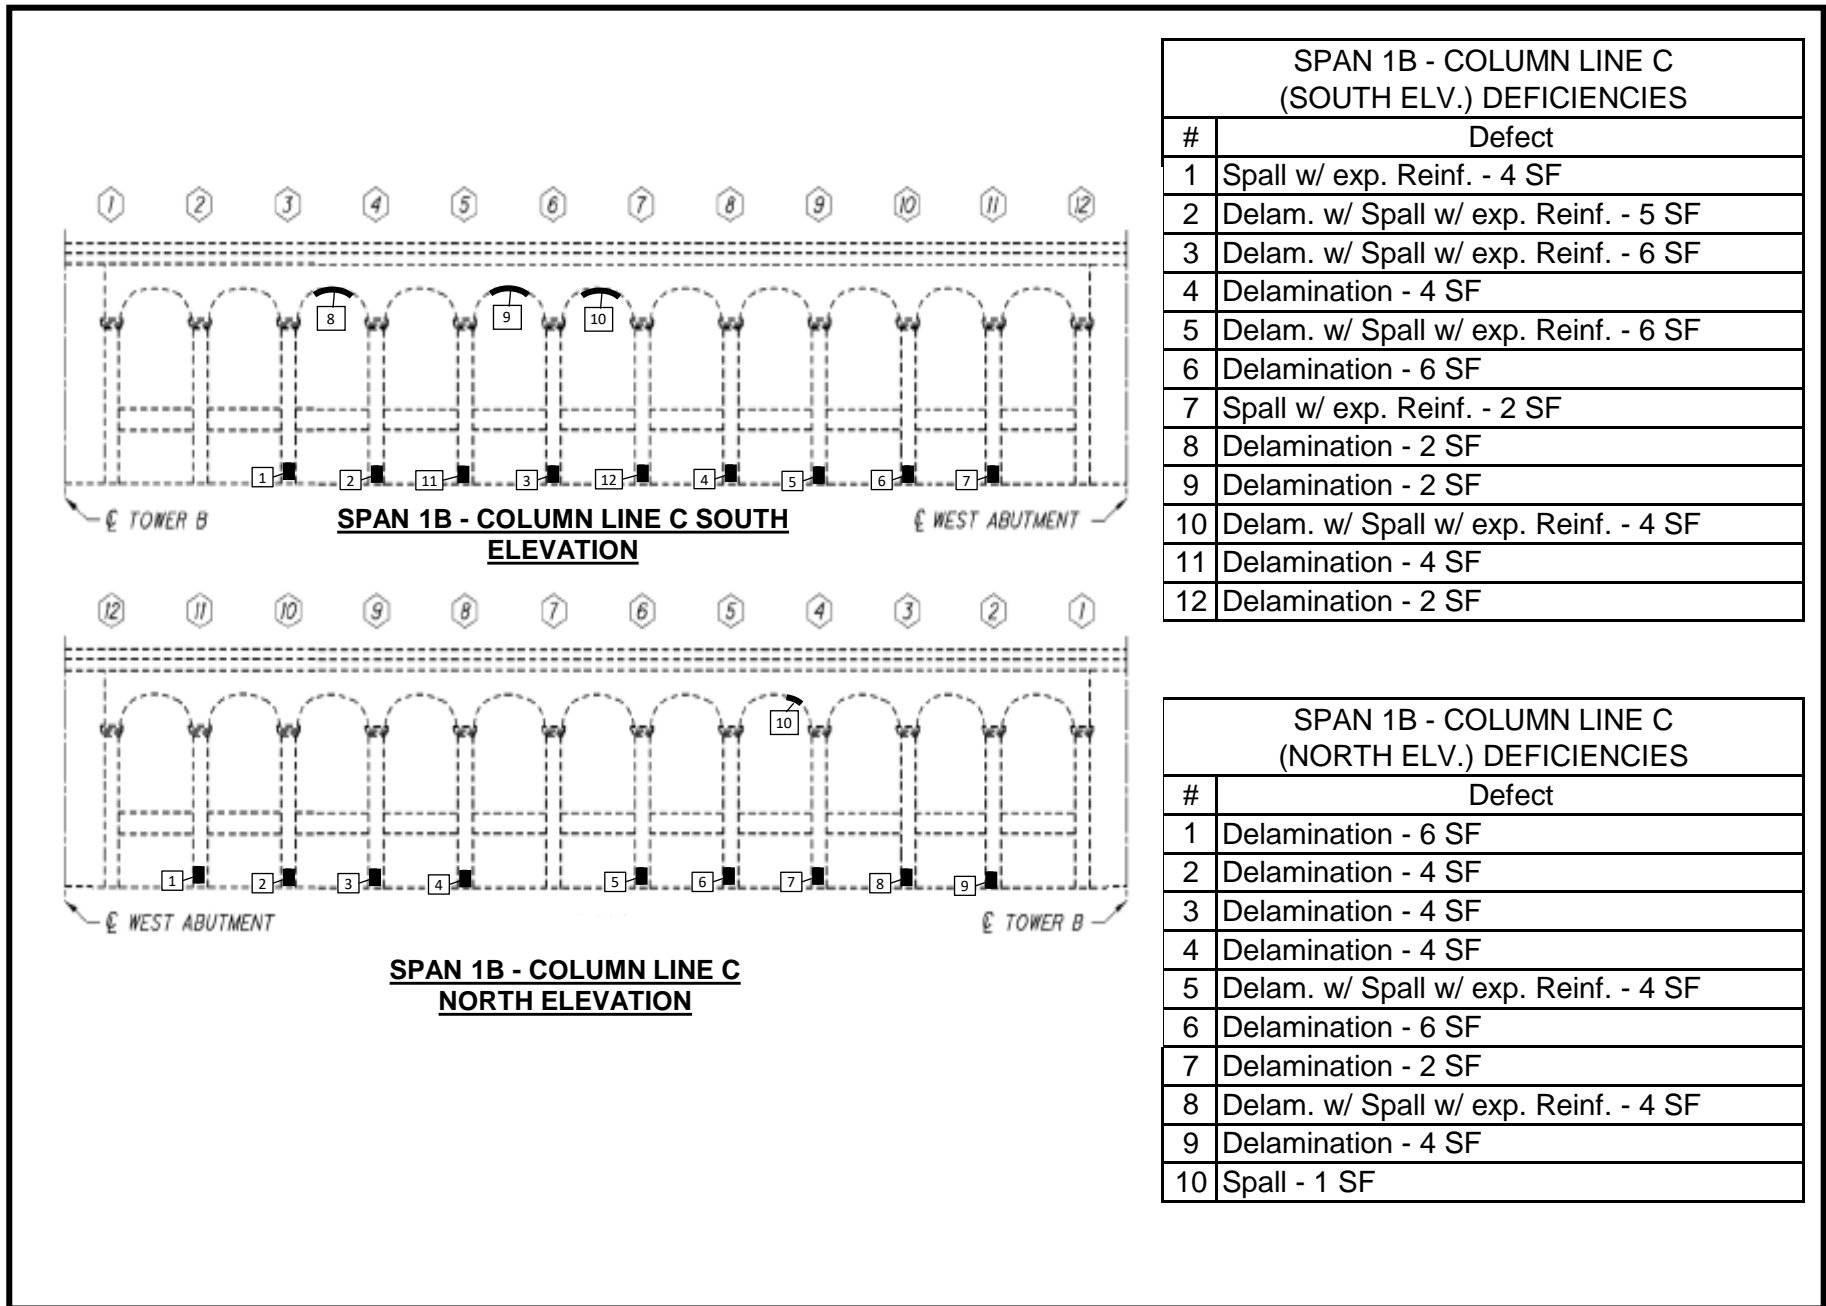
#	Defect
1	Spall w/ exp. Reinf. - 3 SF
2	Delam. w/ Spall w/ exp. Reinf. - 4 SF
3	Spall w/ exp. Reinf., 3" D - 5 SF
4	Delamination - 6 SF
5	Delamination - 4 SF
6	Spall w/ exp. Reinf., 2.5" D - 3 SF
7	Spall w/ exp. Reinf., 2" D - 4 SF
8	Delam. w/ Spall w/ exp. Reinf. - 4 SF
9	Delamination - 3 SF
10	Spall w/ exp. Reinf., 2.5" D - 6 SF
11	Spall w/ exp. Reinf., 4" D - 2 SF

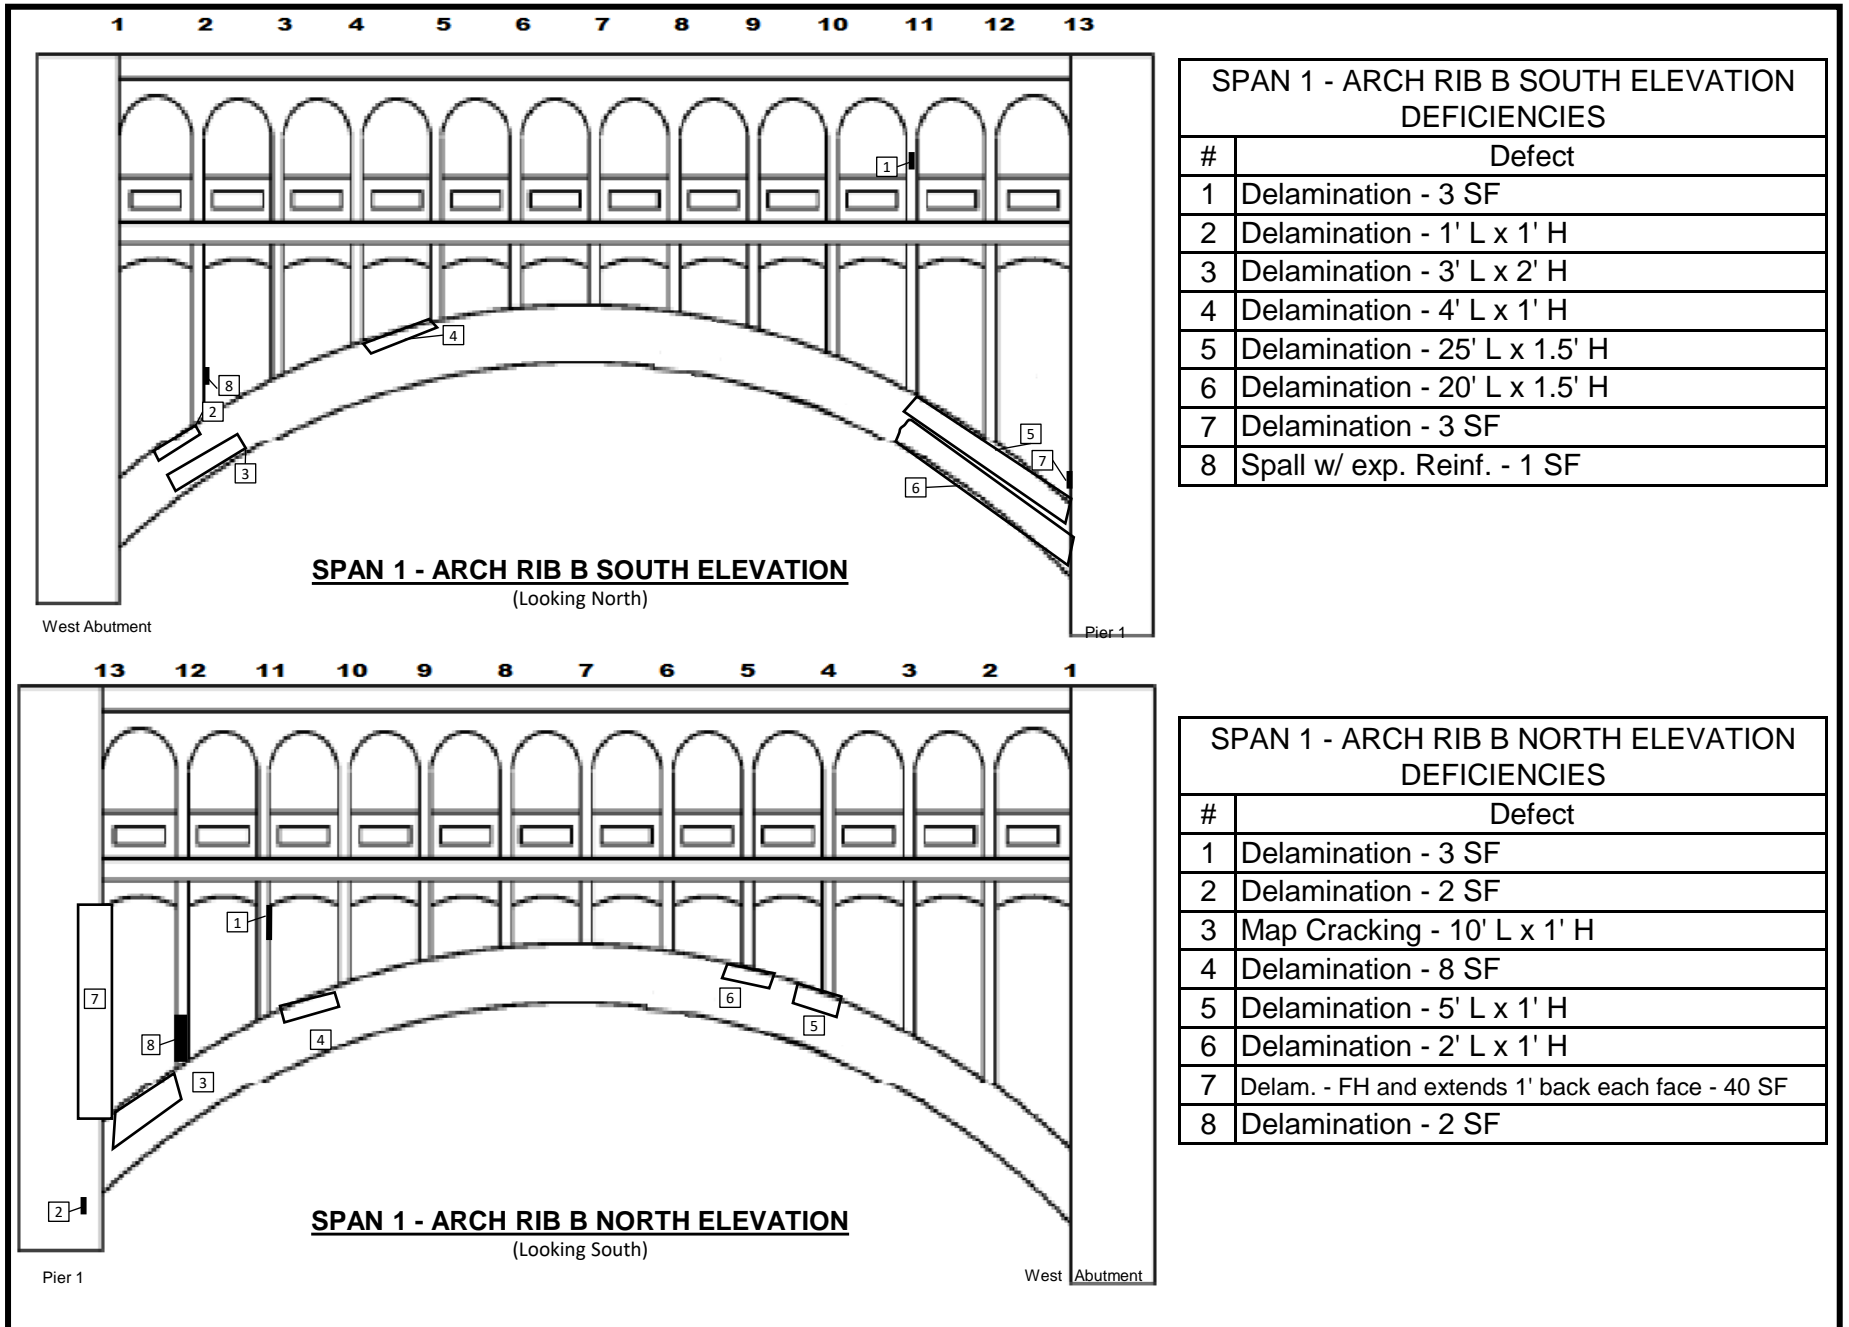
SPAN 1 - ARCH RIB B SOUTH ELEVATION DEFICIENCIES	
#	Defect
1	Delamination - 3 SF
2	Delamination - 1' L x 1' H
3	Delamination - 3' L x 2' H
4	Delamination - 4' L x 1' H
5	Delamination - 25' L x 1.5' H
6	Delamination - 20' L x 1.5' H
7	Delamination - 3 SF
8	Spall w/ exp. Reinf. - 1 SF

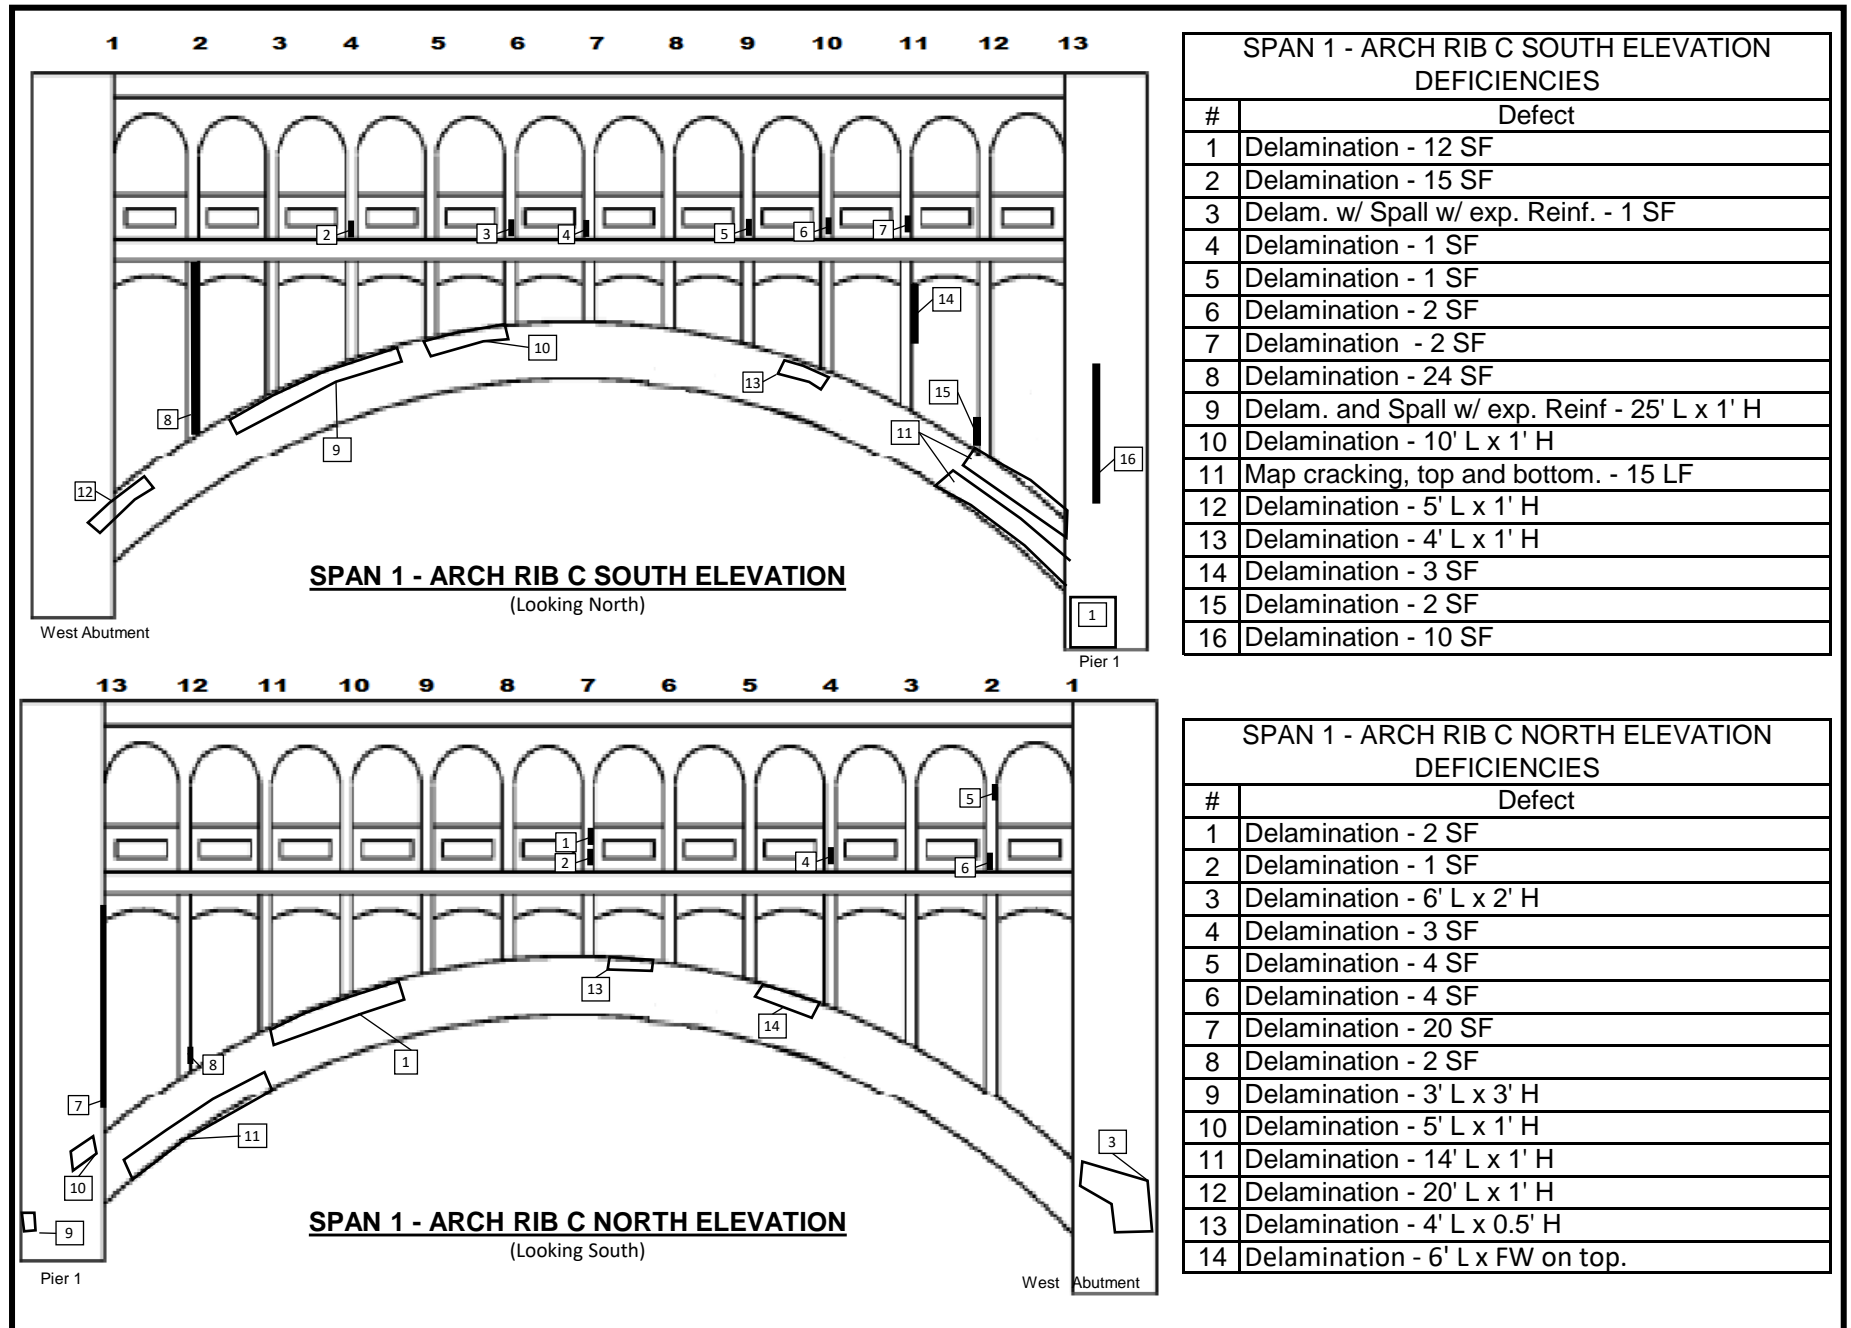
SPAN 1 - ARCH RIB B NORTH ELEVATION DEFICIENCIES	
#	Defect
1	Delamination - 3 SF
2	Delamination - 2 SF
3	Map Cracking - 10' L x 1' H
4	Delamination - 8 SF
5	Delamination - 5' L x 1' H
6	Delamination - 2' L x 1' H
7	Delam. - FH and extends 1' back each face - 40 SF
8	Delamination - 2 SF

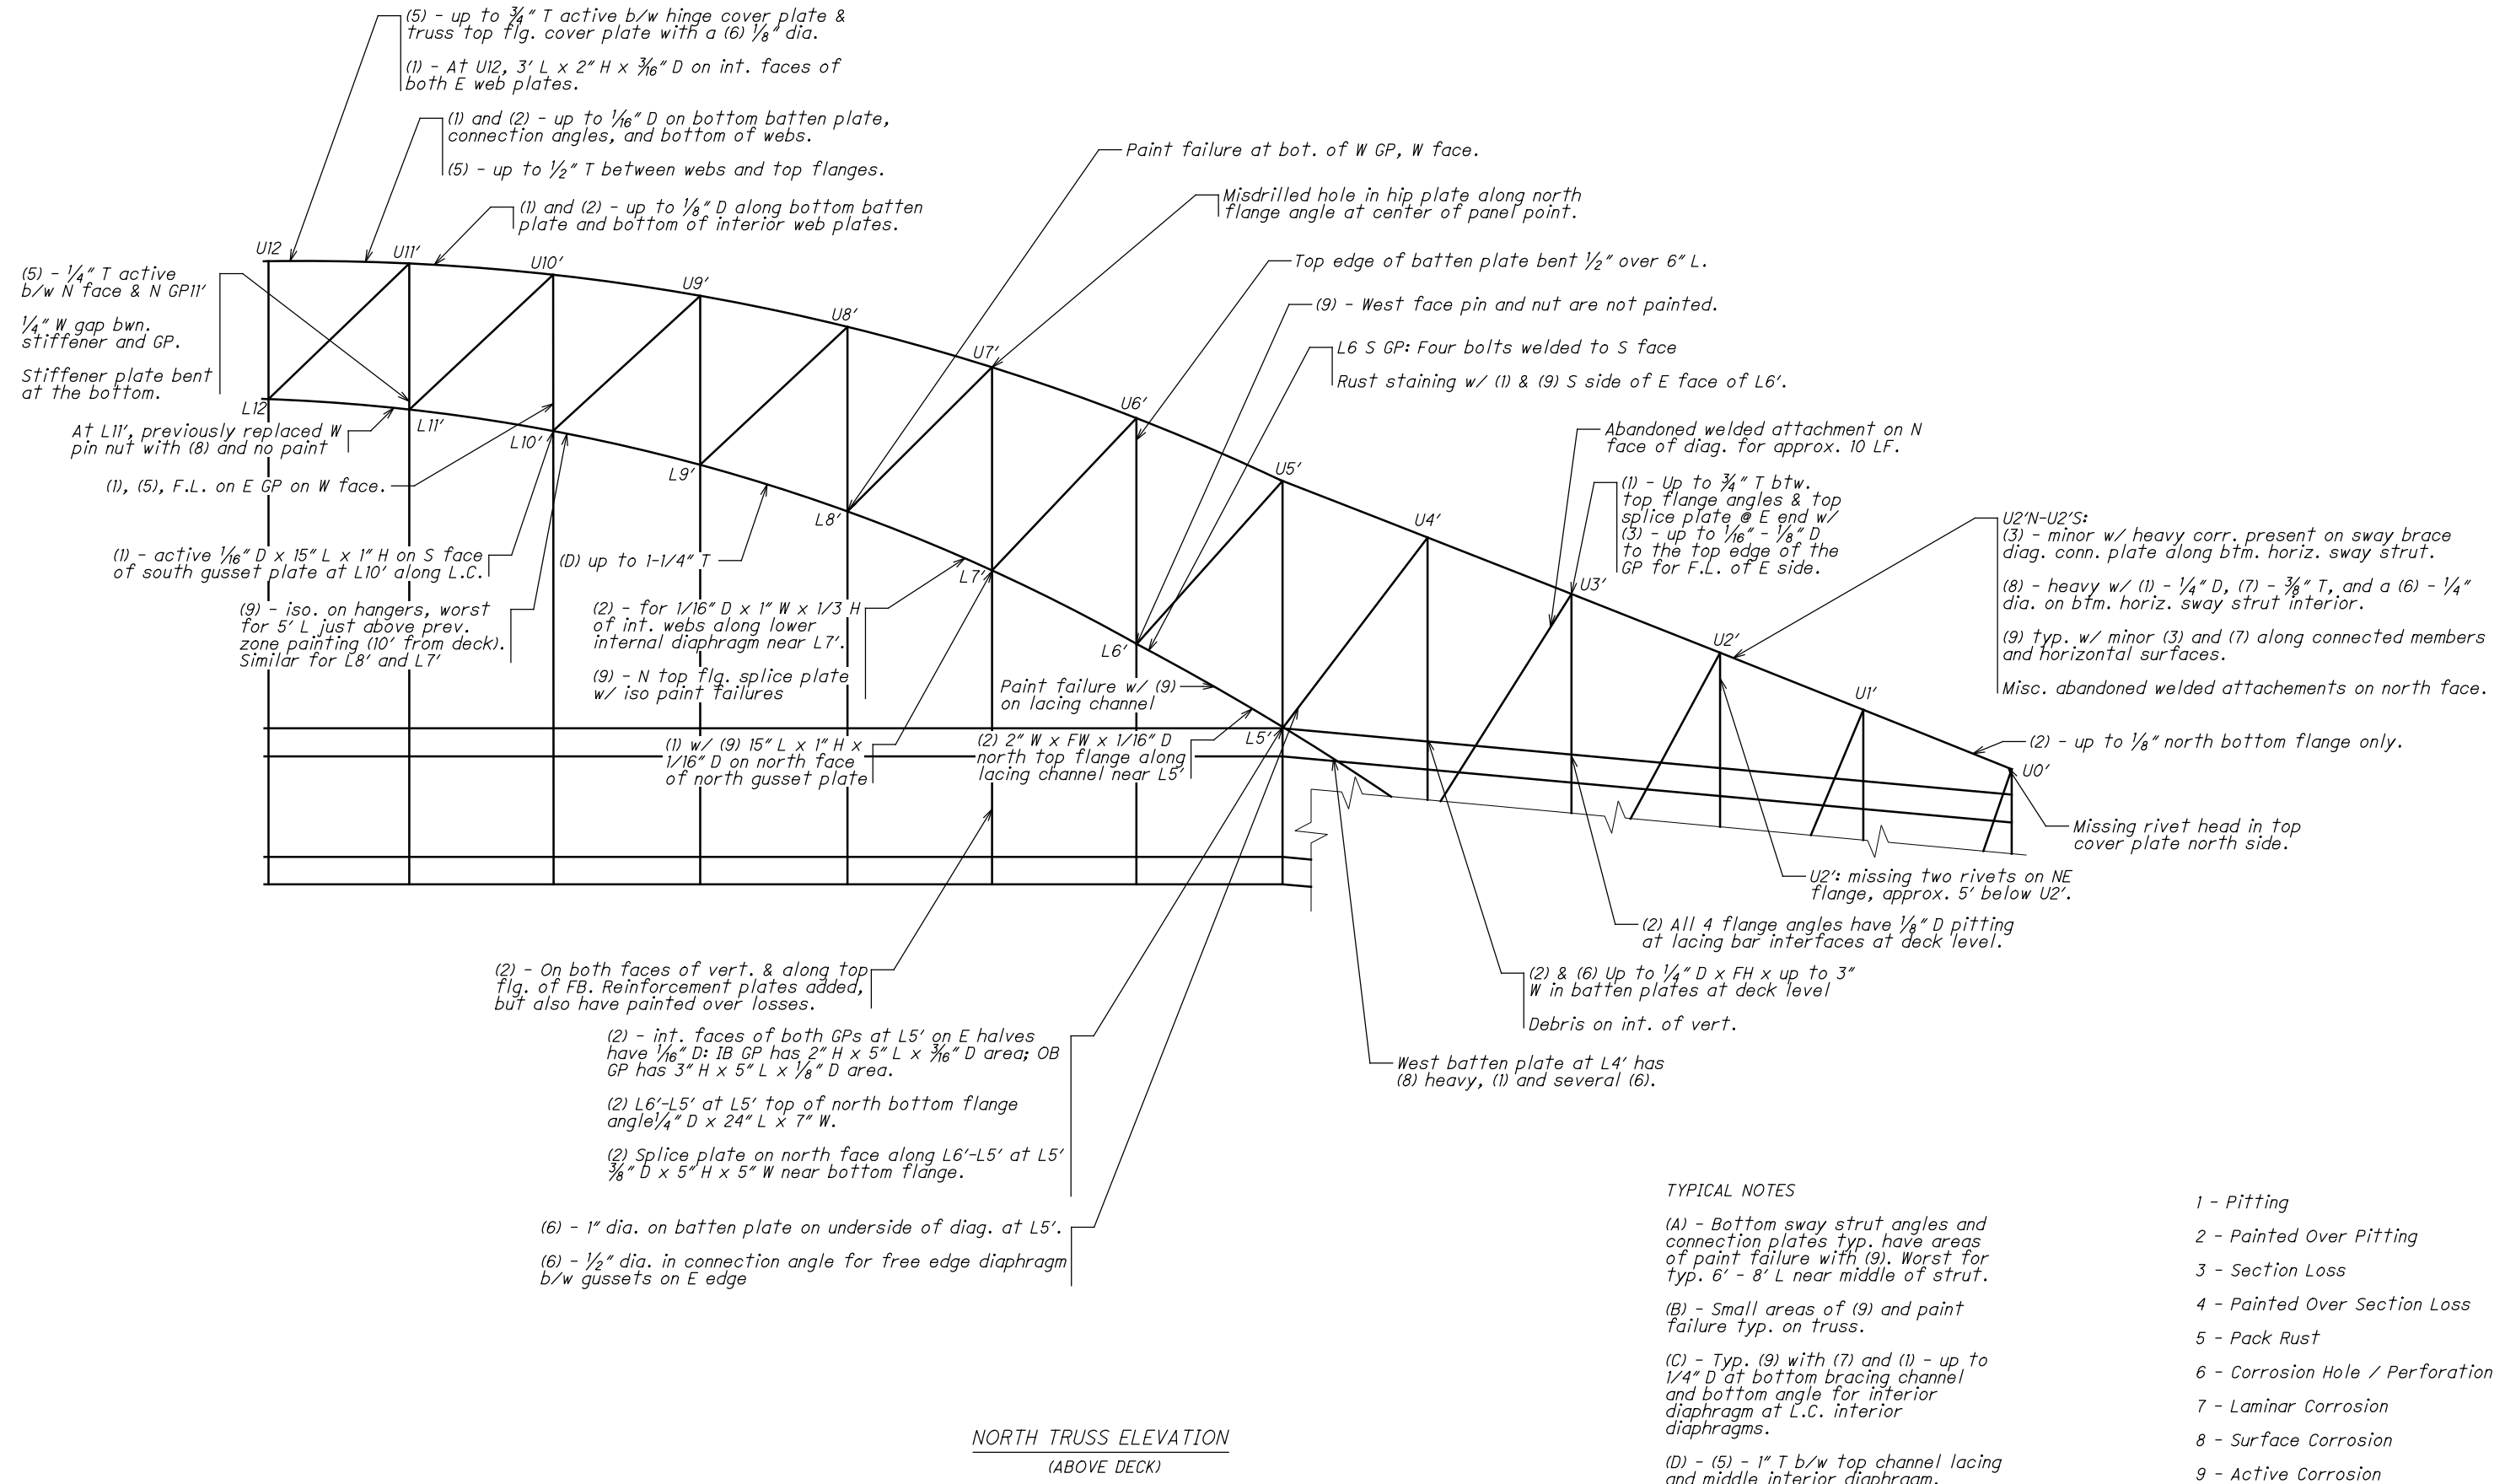
NORTH TRUSS ELEVATION
(ABOVE DECK)

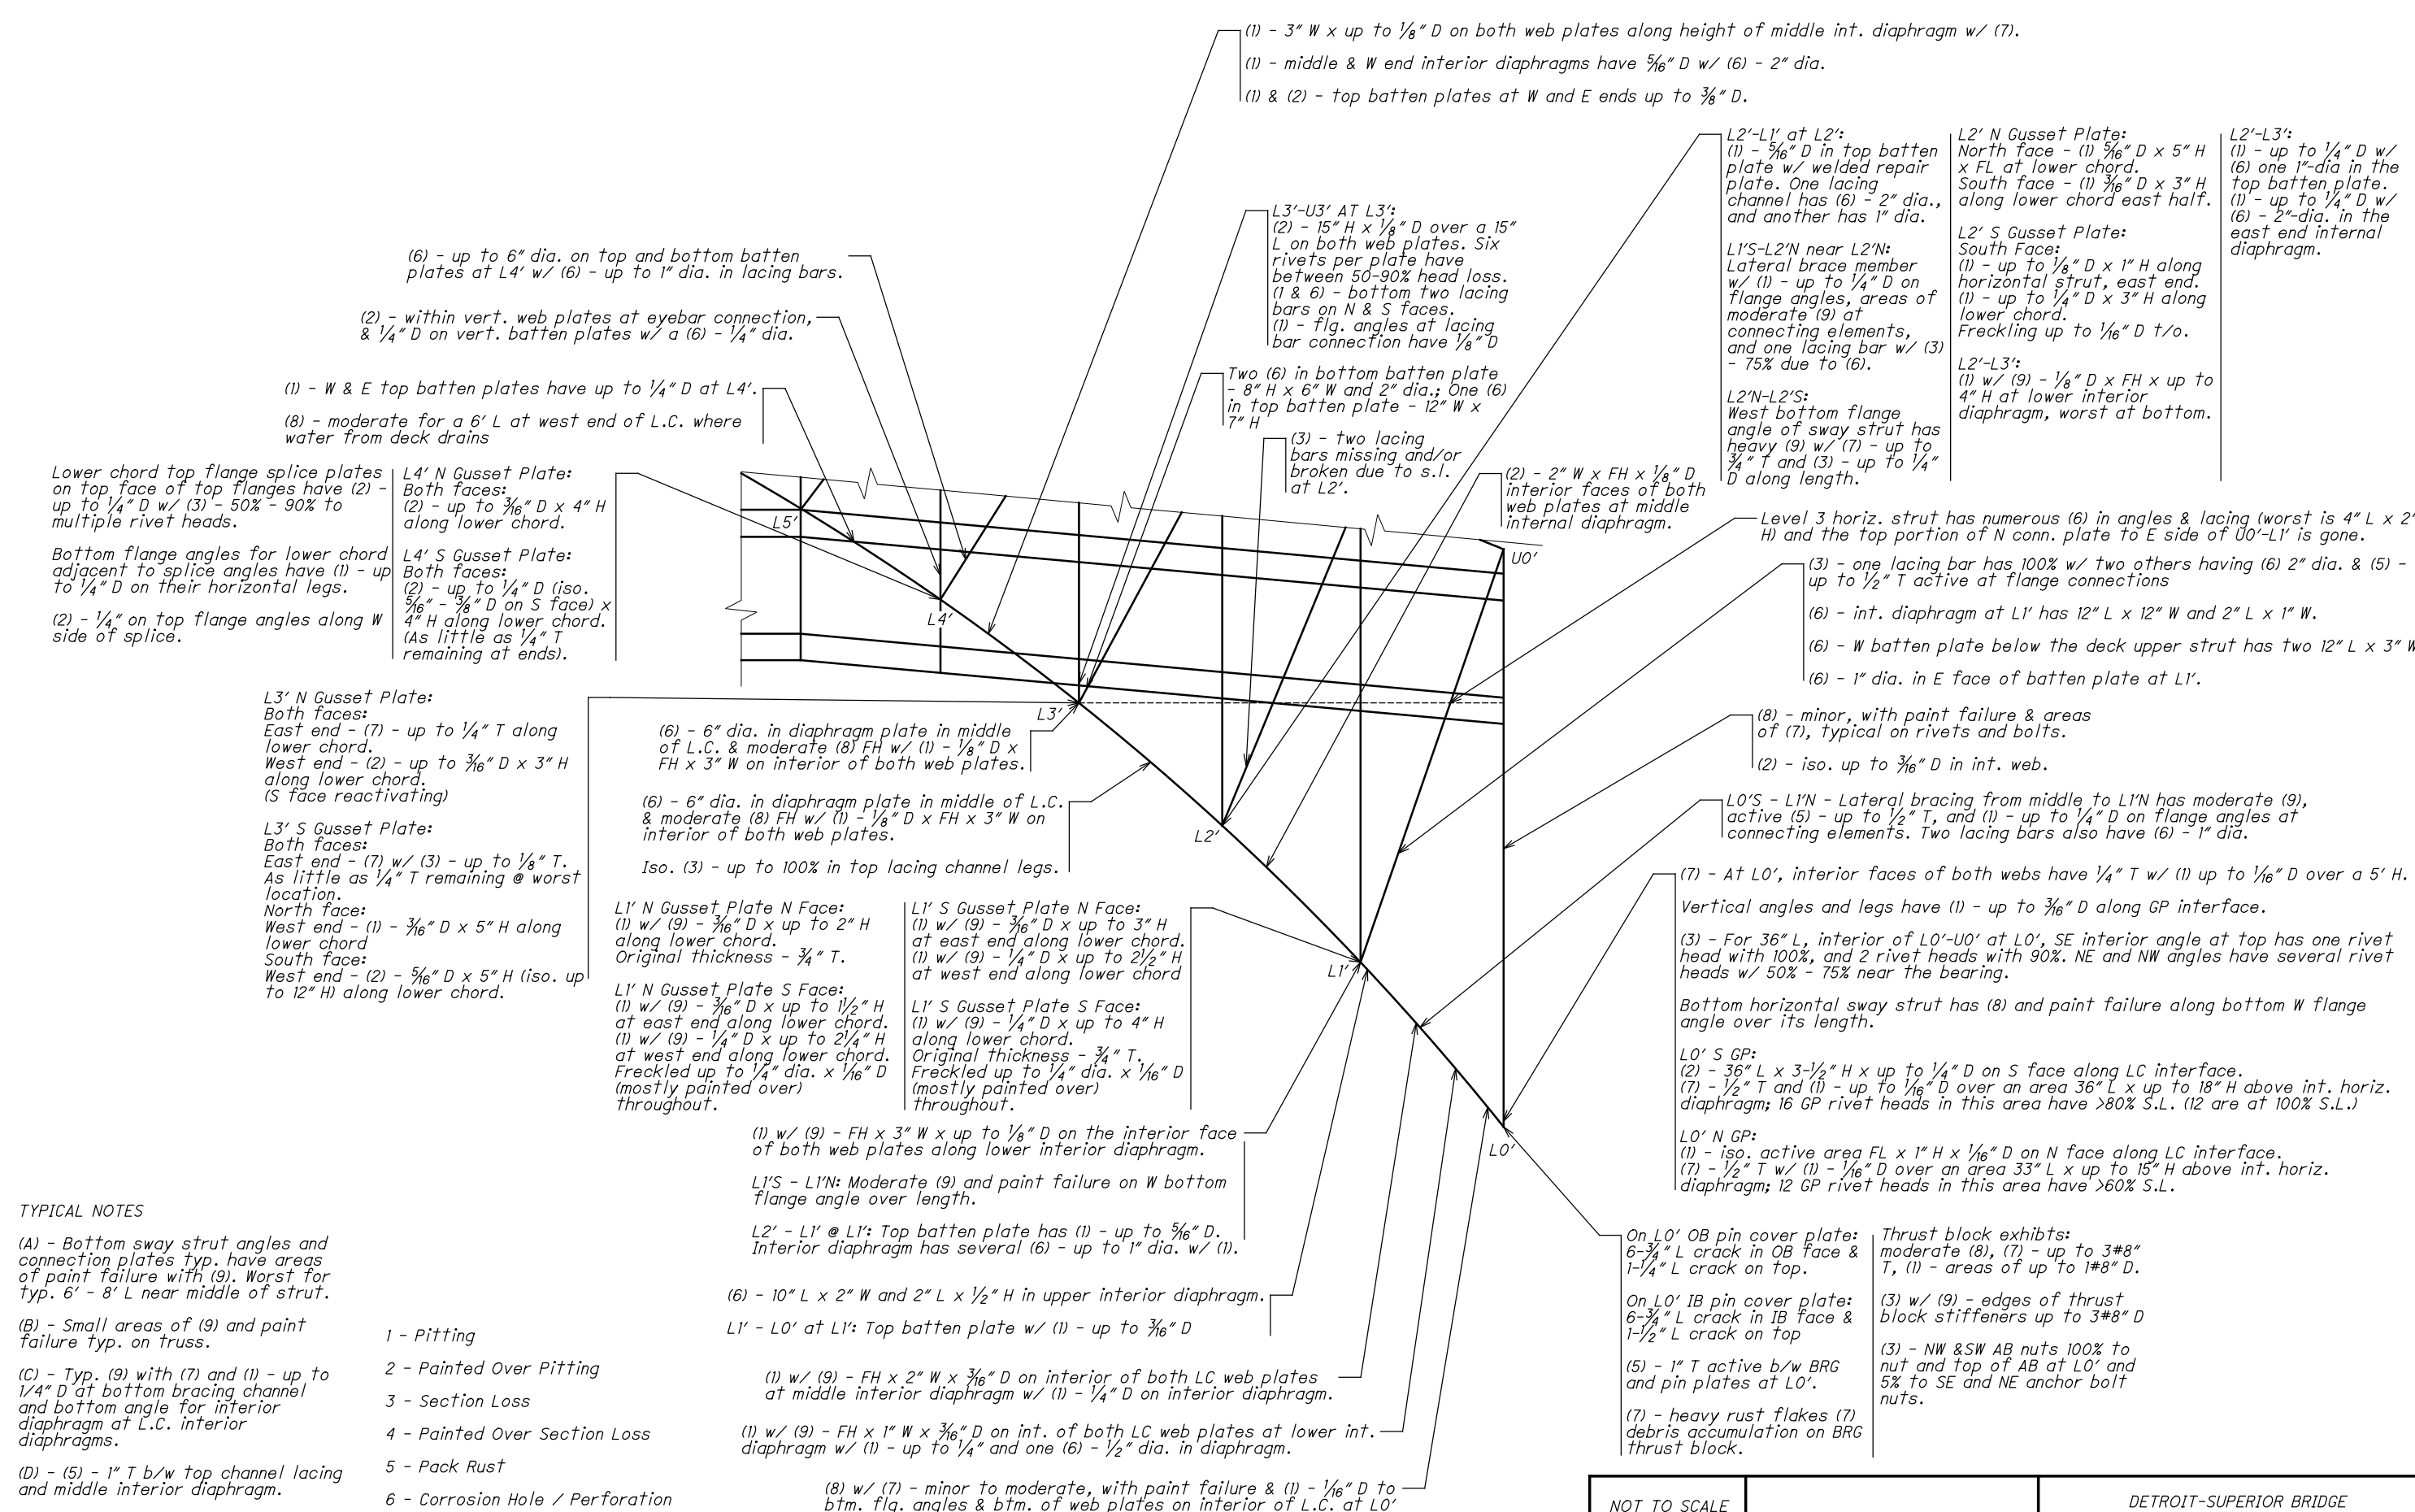
NOT TO SCALE	<p>3745 MEDINA ROAD, SUITE A, MEDINA, OH 44256</p>	DETROIT-SUPERIOR BRIDGE	
DATE 2022		CUY-6-14.56	
		SPAN 4 NORTH TRUSS ELEVATION	PAGE C-3
