Physical Condition Report for

CUY-006-1456

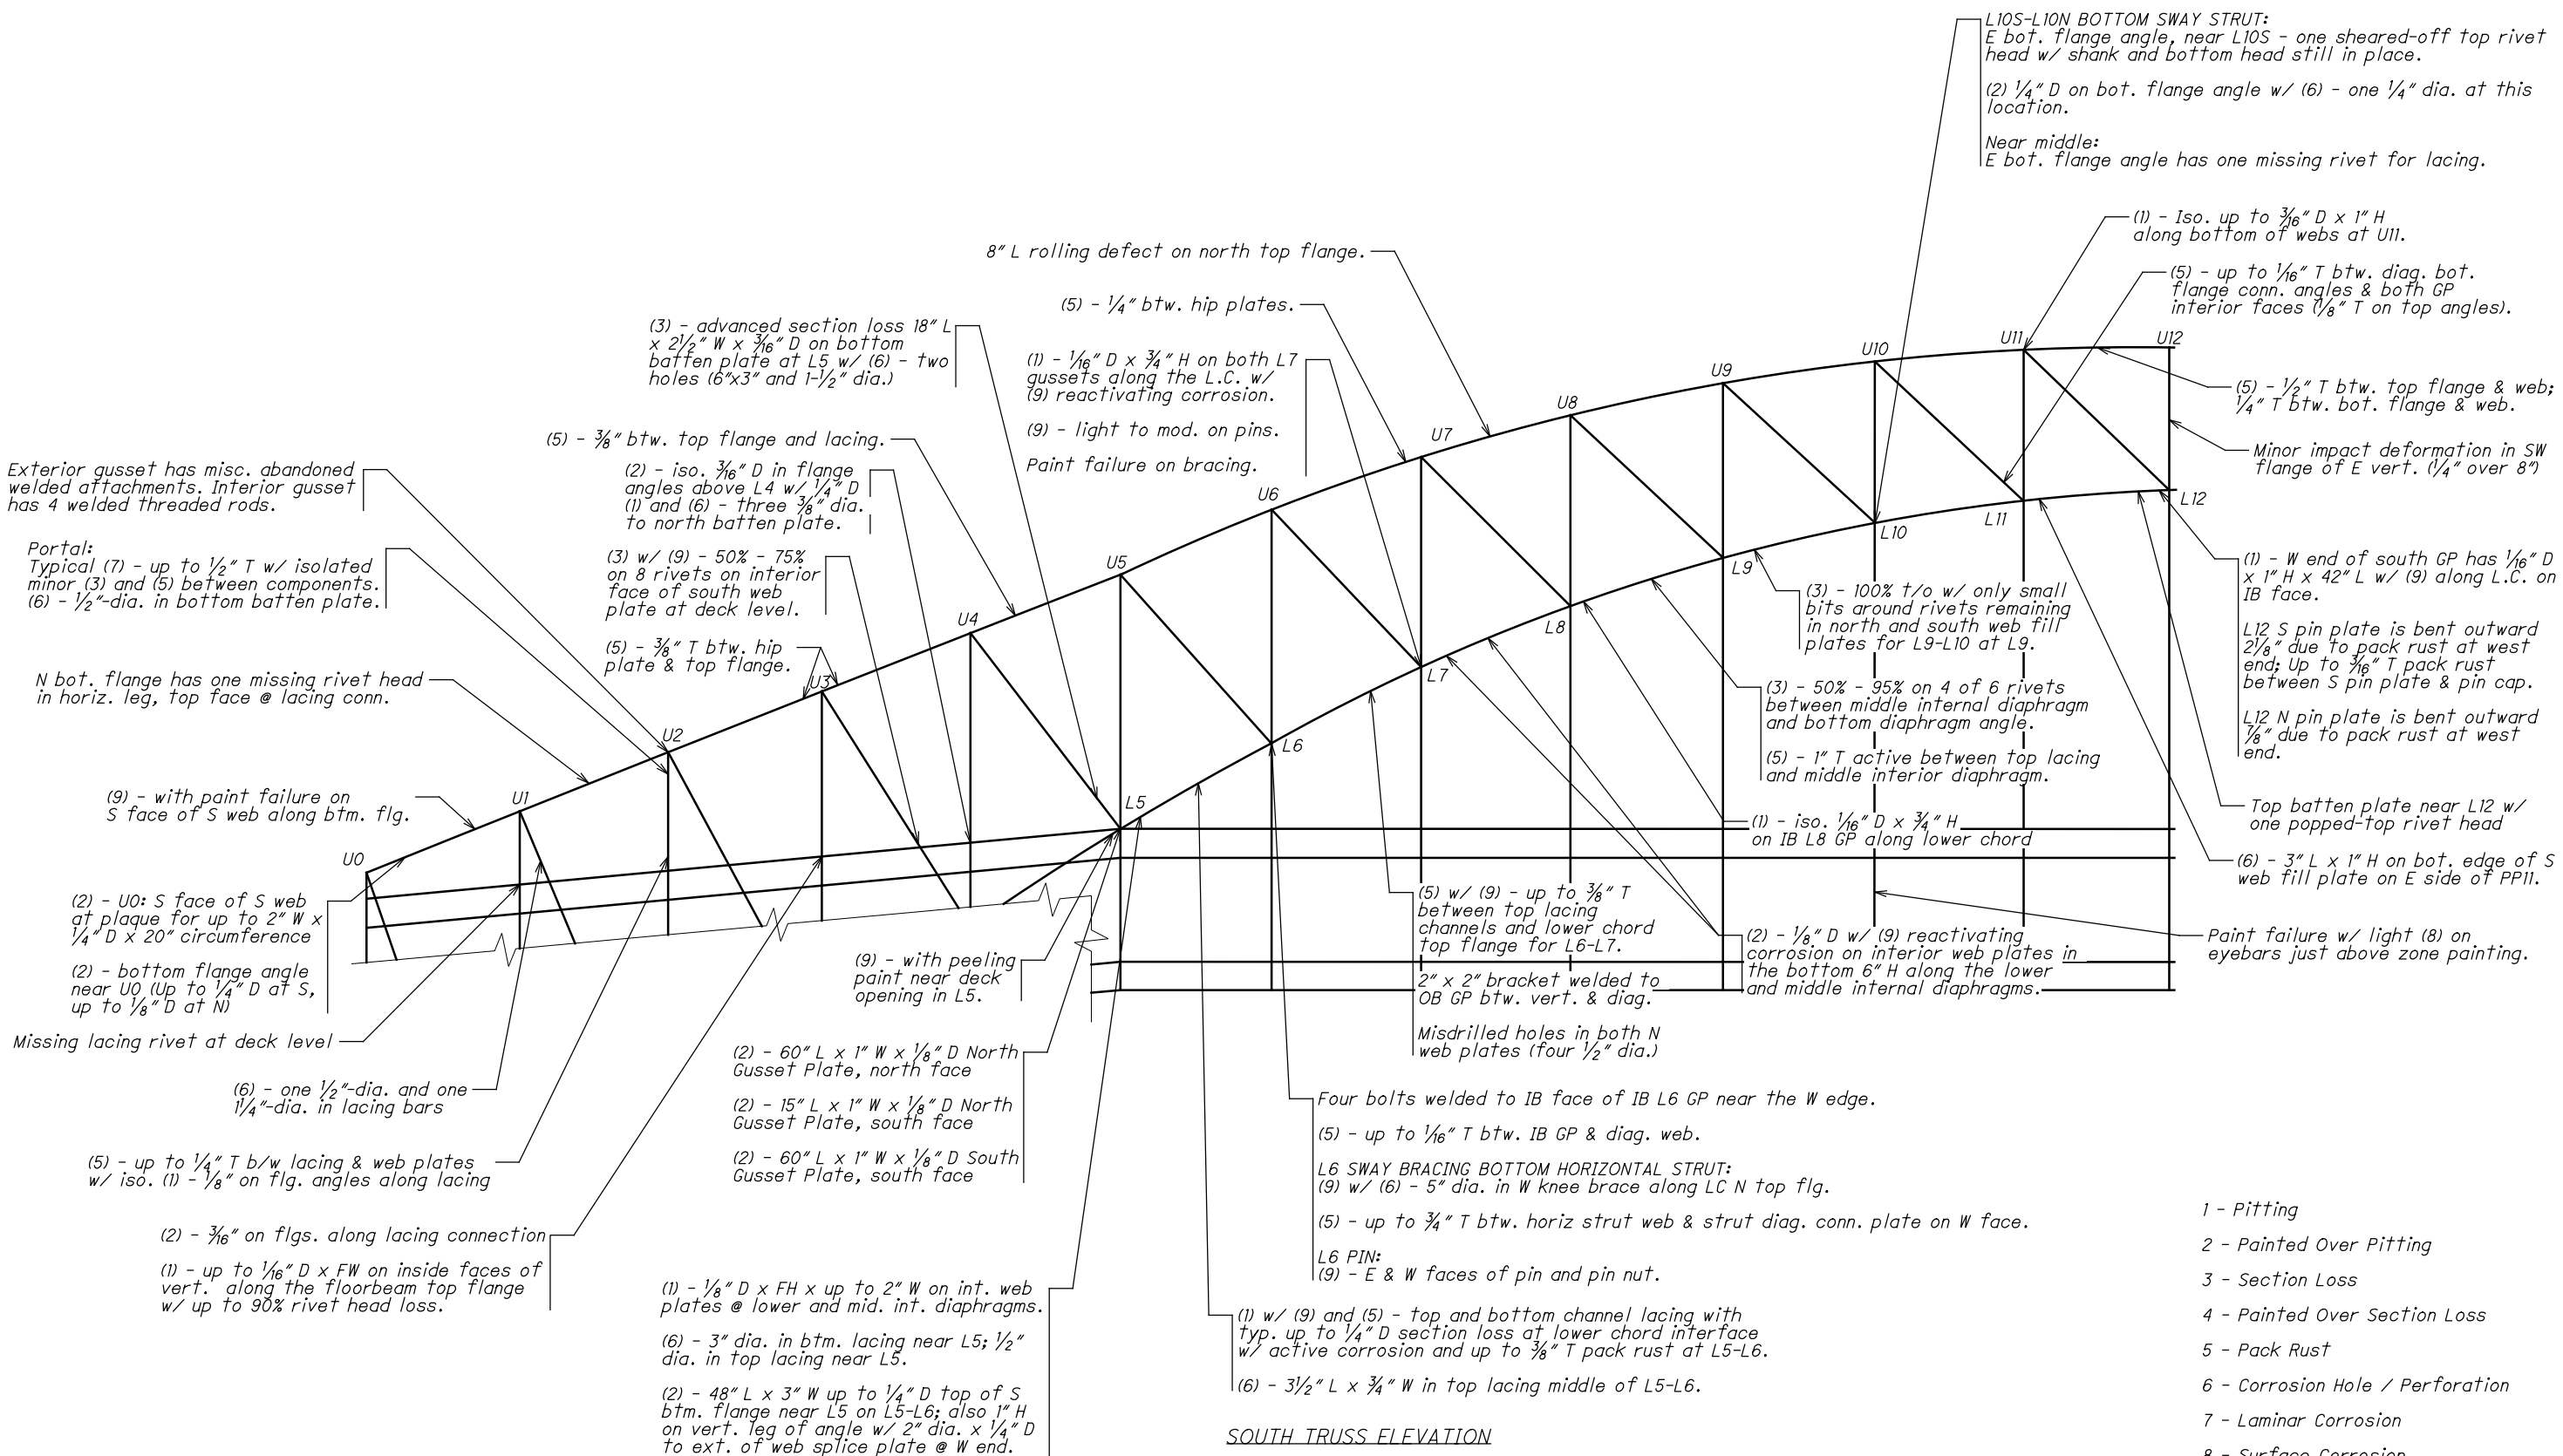
NOT TO SCALE	3745 MEDINA ROAD, SUITE A, MEDINA, OH 44256	DETROIT-SUPERIOR BRIDGE	
DATE 2022		CUY-6-14.56	
		SPAN 4 NORTH TRUSS ELEVATION	PAGE C-4

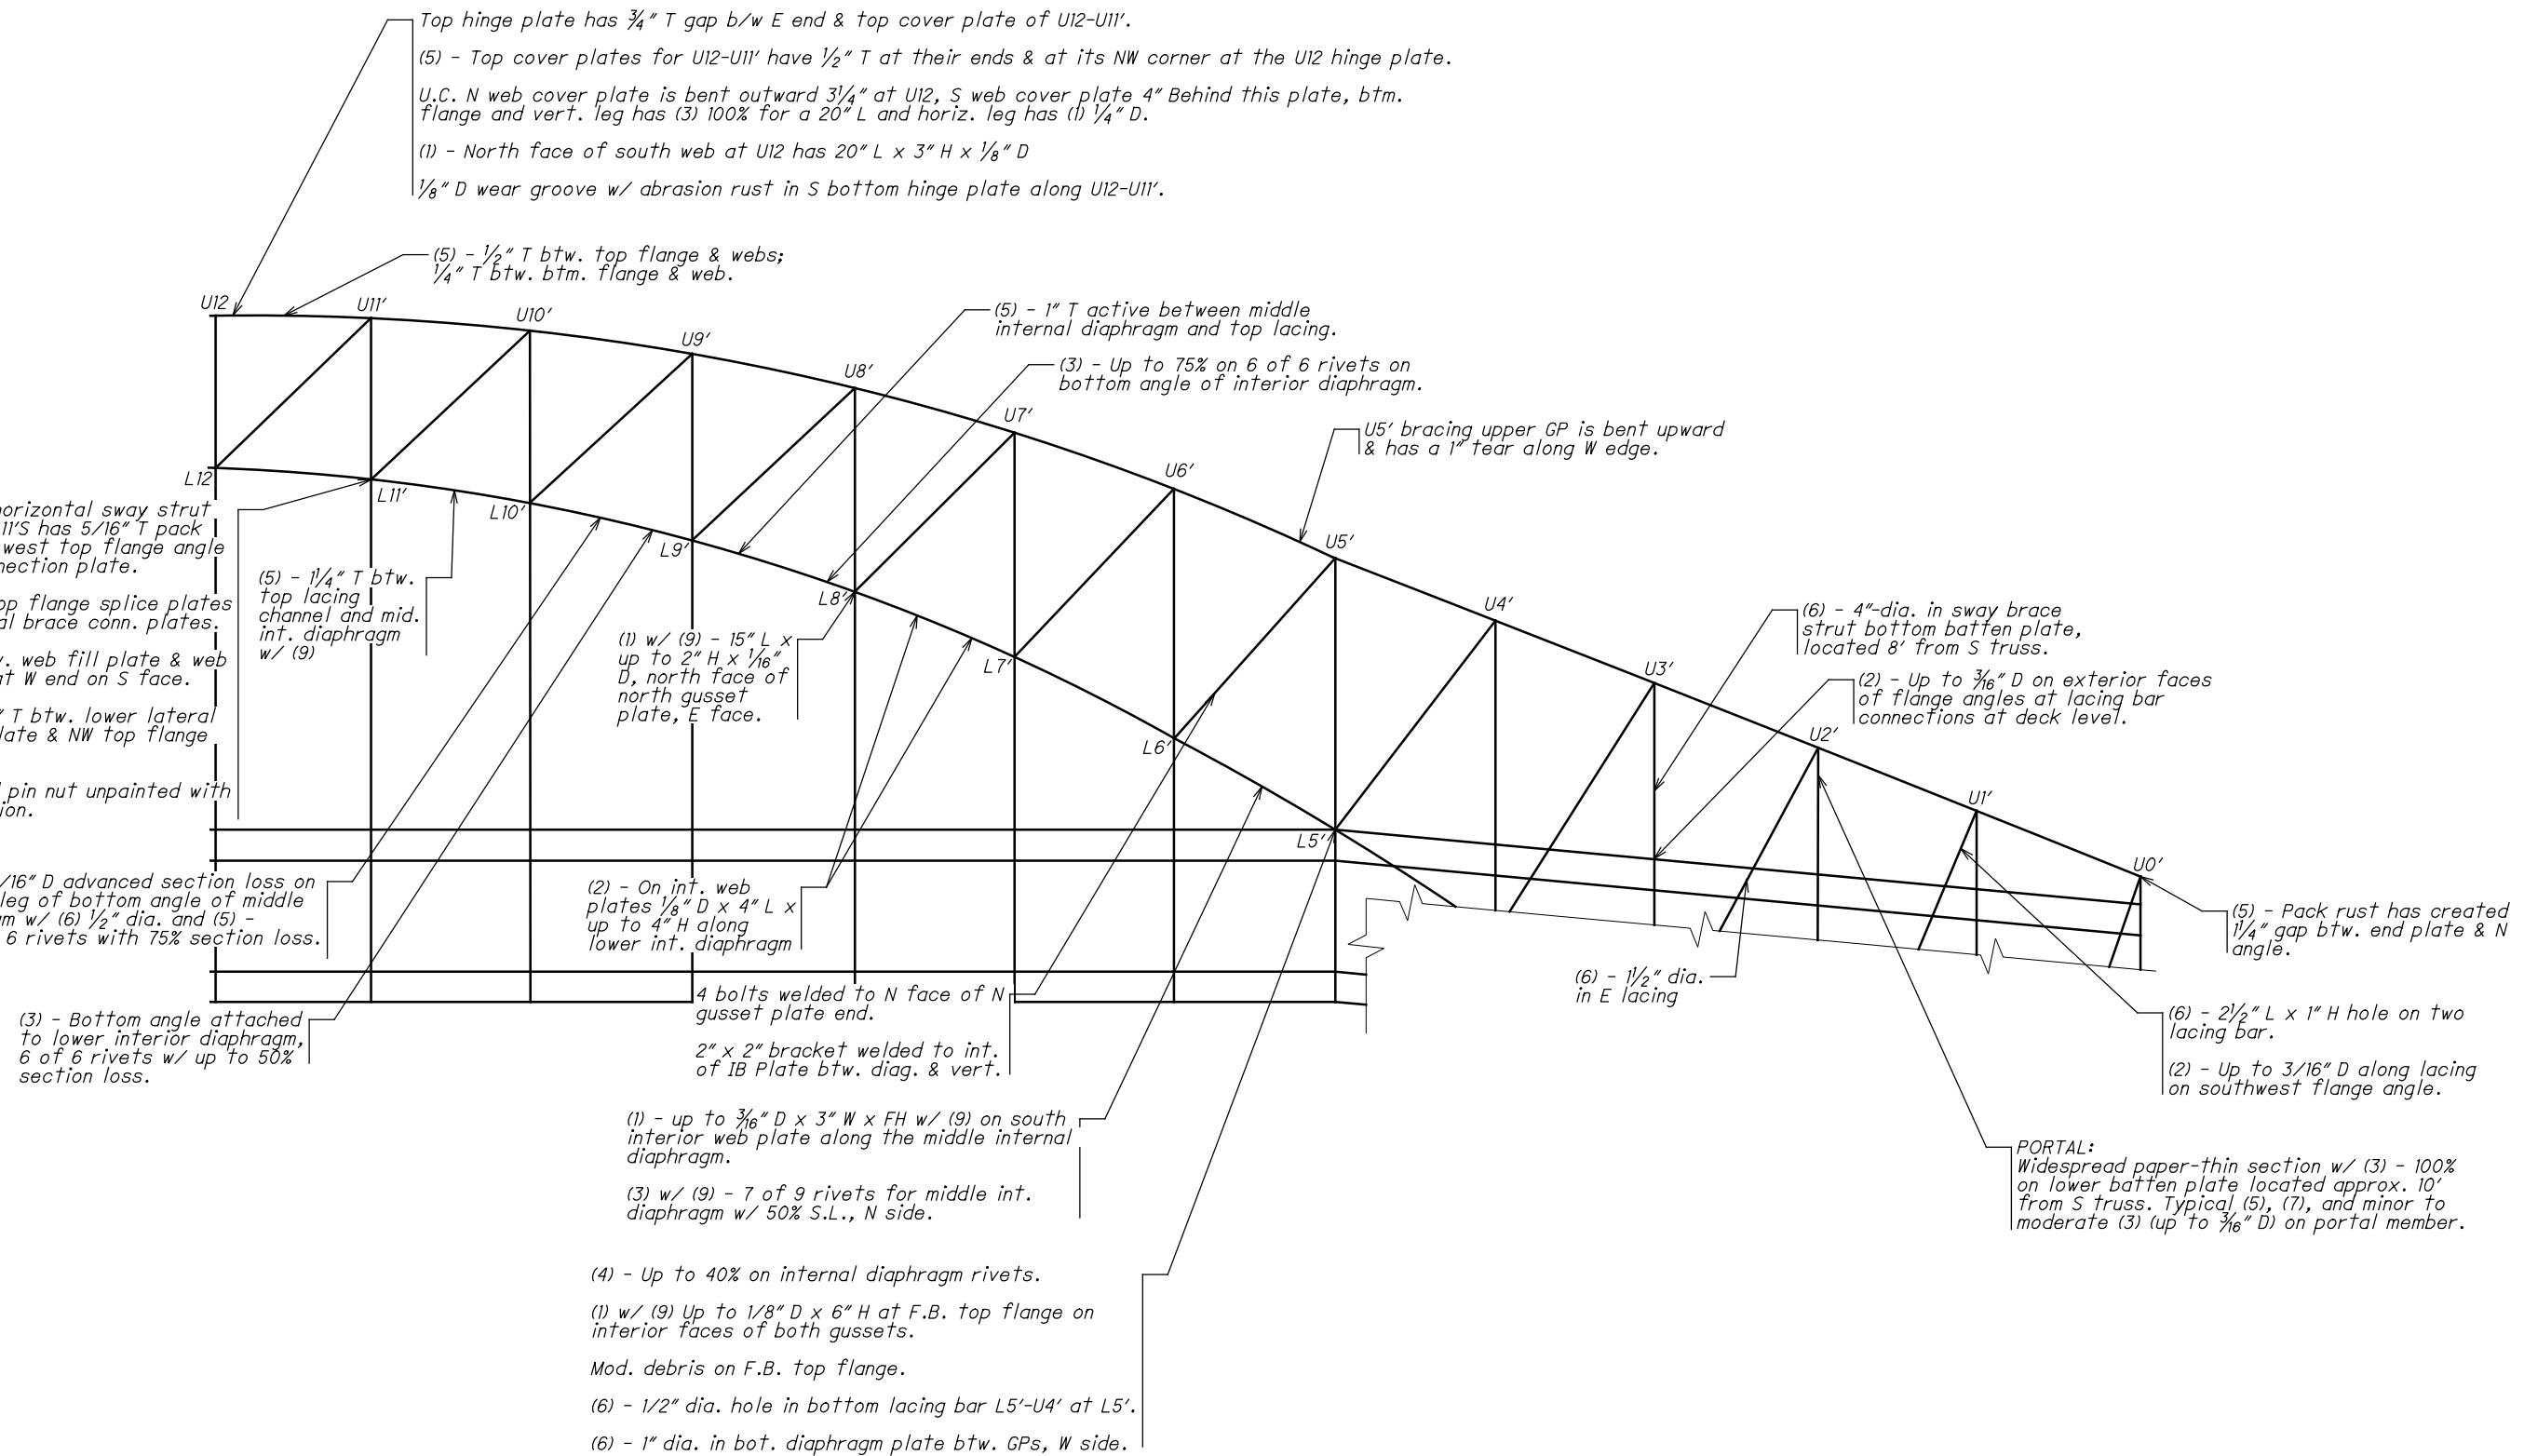
SOUTH TRUSS ELEVATION
(ABOVE DECK)

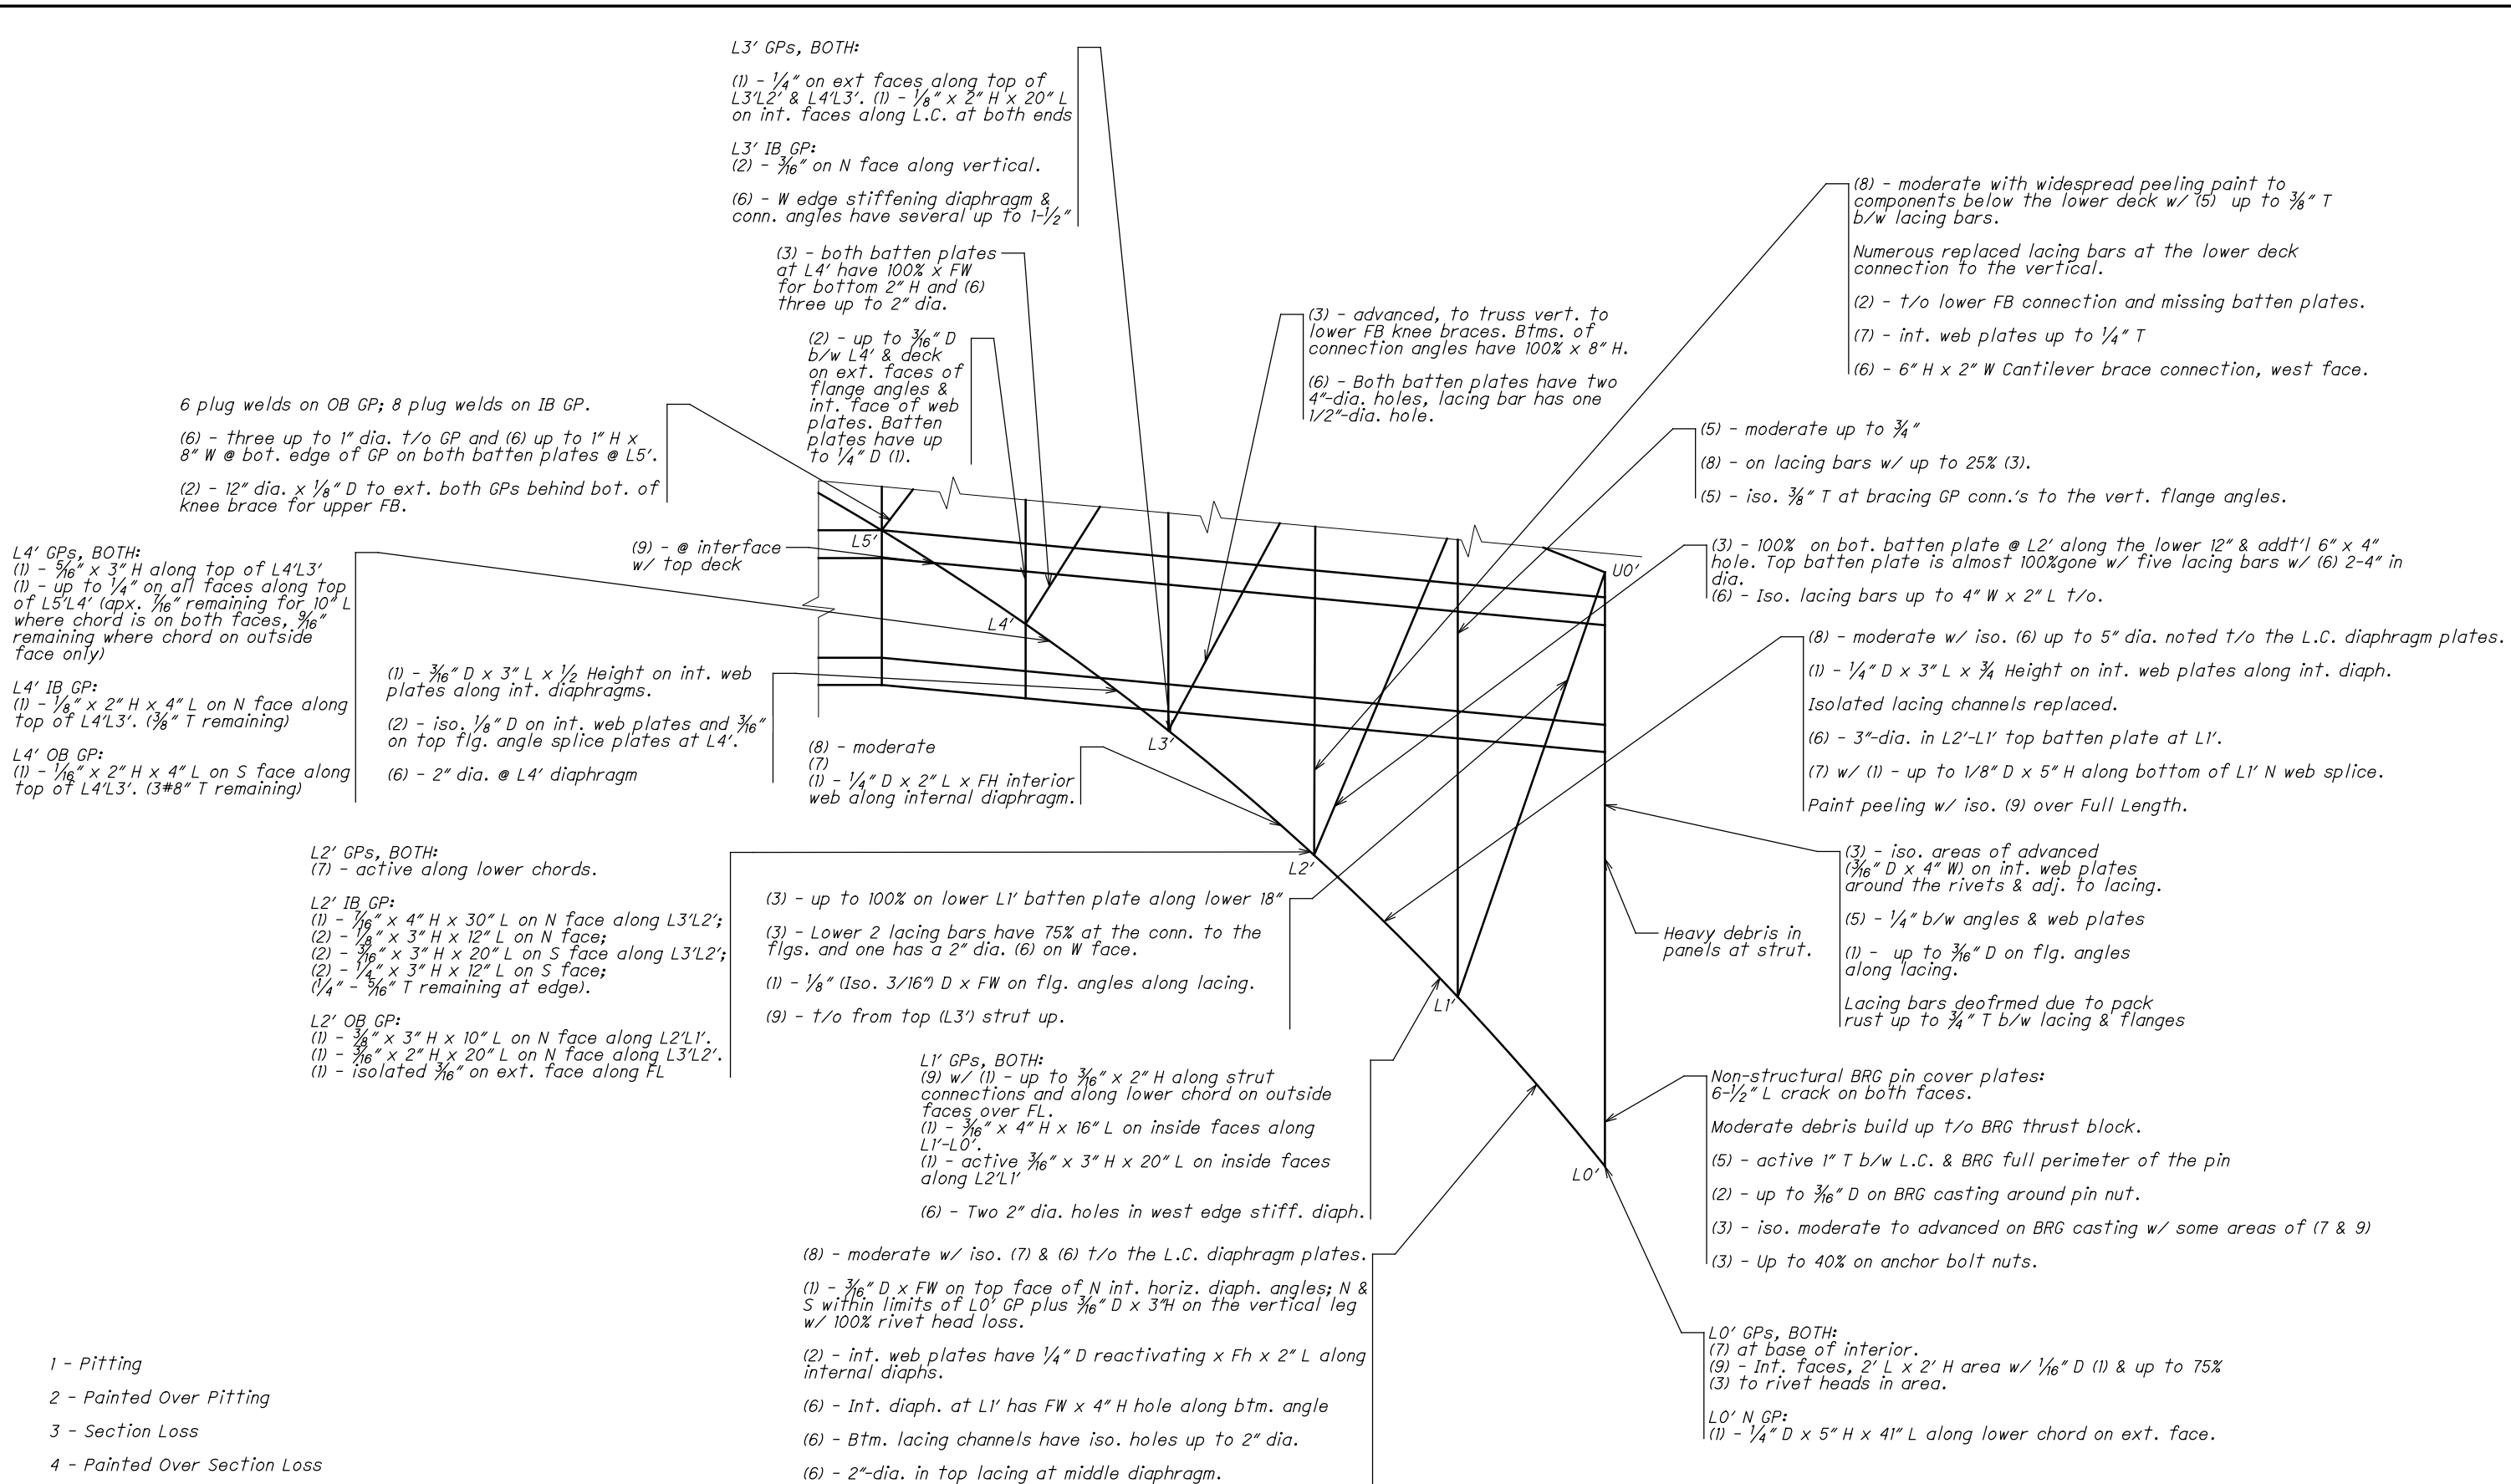
- 1 - Pitting
- 2 - Painted Over Pitting
- 3 - Section Loss
- 4 - Painted Over Section Loss
- 5 - Pack Rust
- 6 - Corrosion Hole / Perforation
- 7 - Laminar Corrosion
- 8 - Surface Corrosion
- 9 - Active Corrosion

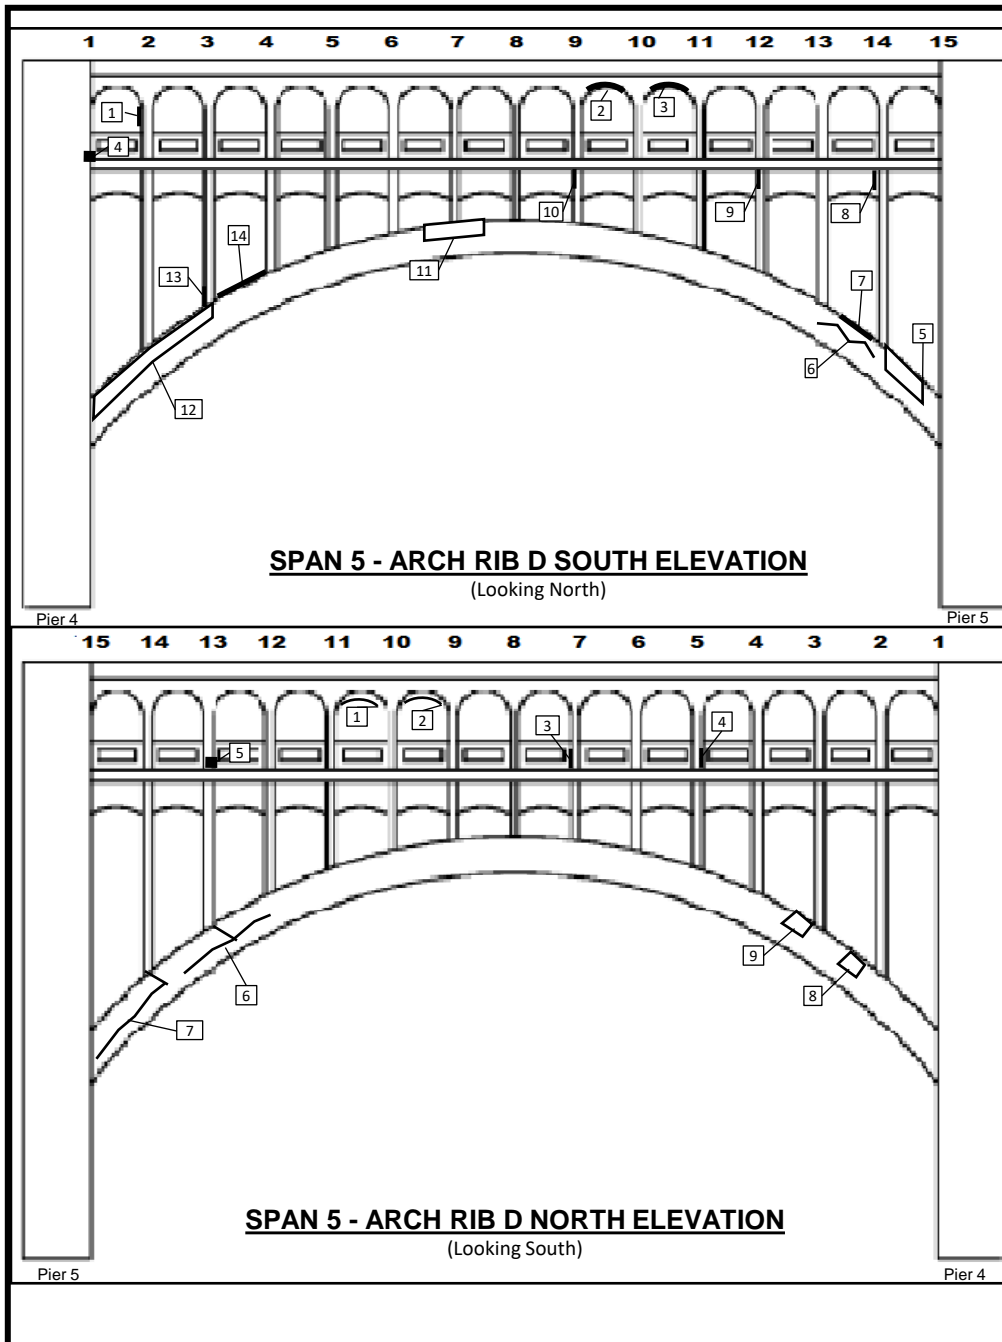
SPAN 5 - ARCH RIB D SOUTH ELEVATION DEFICIENCIES	
#	Defect
1	Delamination - 2 SF
2	Delamination - 2 SF
3	Delamination - 6 SF
4	Incomplete Repair - 3 SF
5	Map Cracking - 10' L x 3' H
6	1/16" Crack - 10 LF
7	Delamination - 8' L x 2' W
8	Delamination - 1 SF
9	Spalling - 3 SF
10	Delamination - 1 SF
11	Delamination - 6' L x 1' H
12	Vertical hairline cracking spa. @ 3' w/ some map cracking - 20 LF
13	Delamination - 2 SF
14	3/32" crack, appears to be partially filled - 8 LF

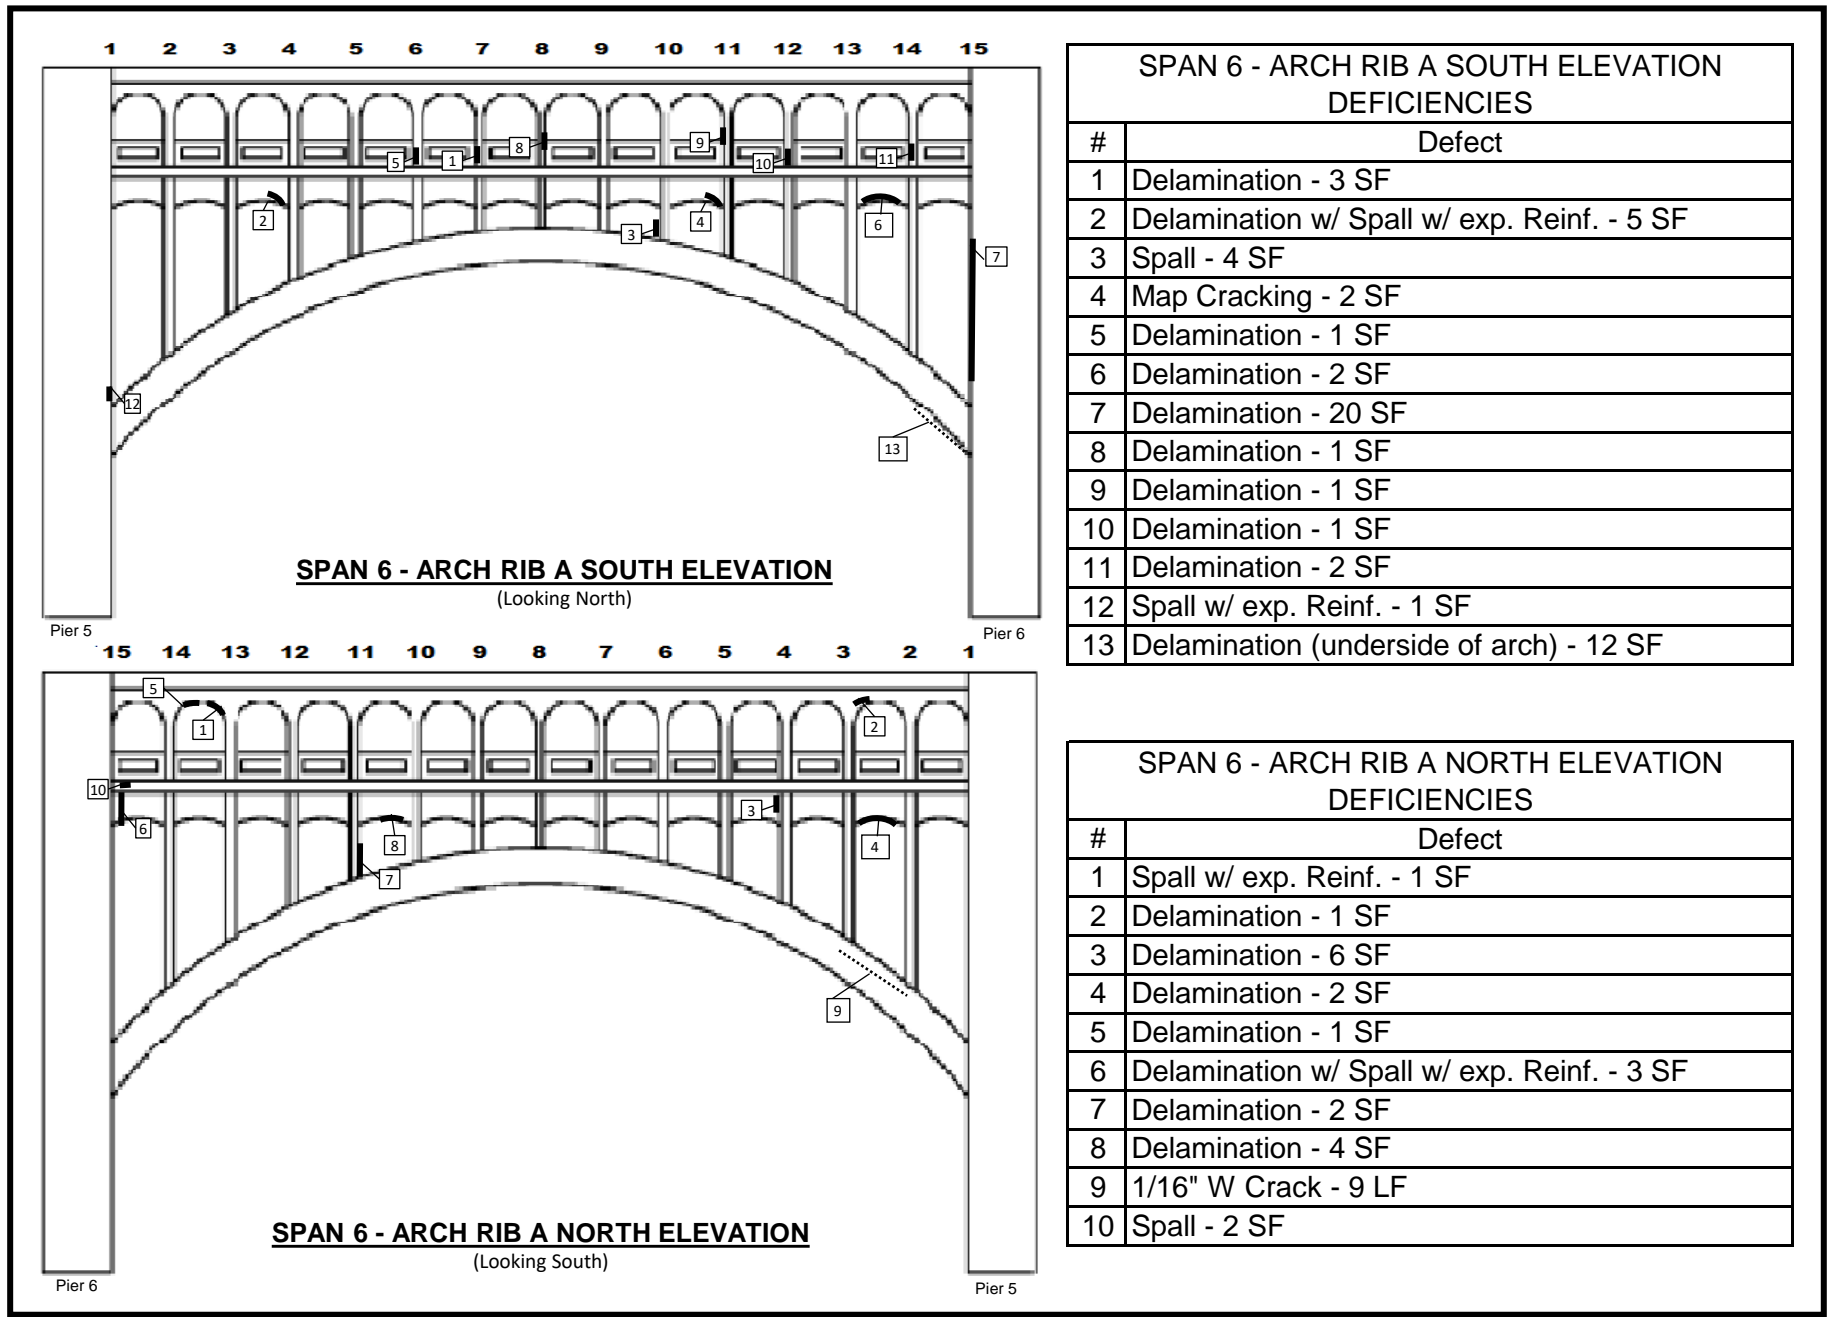
SPAN 5 - ARCH RIB D NORTH ELEVATION DEFICIENCIES	
#	Defect
1	Delamination - 6 SF
2	Delamination - 5 SF
3	Delamination - 1 SF
4	Delamination - 3 SF
5	Delamination - 1 SF
6	Hairline cracks, 2' L & 9' L
7	Hairline cracks, 2' L & 9' L
8	Map cracking - 2' L x 3' H
9	Map cracking - 6' L x 2.5' H

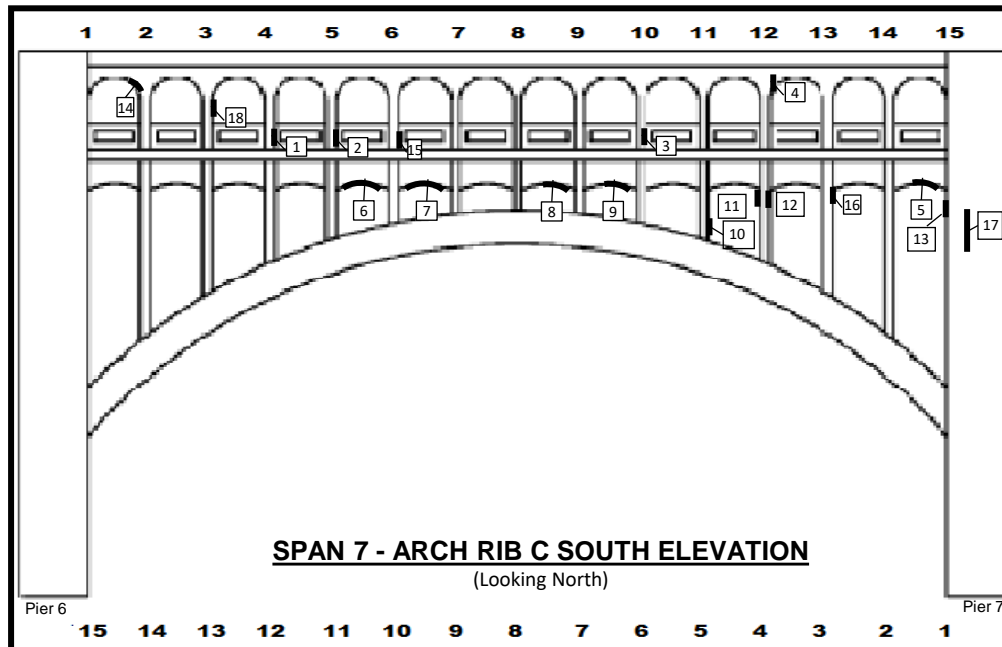
SPAN 7 - ARCH RIB C SOUTH ELEVATION DEFICIENCIES	
#	Defect
1	Delamination - 2 SF
2	Delamination w/ Spall w/ exp. Reinf., 3" D - 5 SF
3	Delamination - 2 SF
4	Spall w/ exp. Reinf., 2" D - 2 SF
5	Delamination - 6 SF
6	Delamination - 6 SF
7	Delamination - 4 SF
8	Delamination - 4 SF
9	Delamination - 4 SF
10	Delamination - 1 SF
11	Delamination - 4 SF
12	Spall w/ exp. Reinf. - 1 SF
13	Delamination - 8 SF
14	Delamination - 2 SF
15	Delamination - 2 SF
16	Delamination - 1 SF
17	Delamination - 2 SF
18	Spall - 2 SF

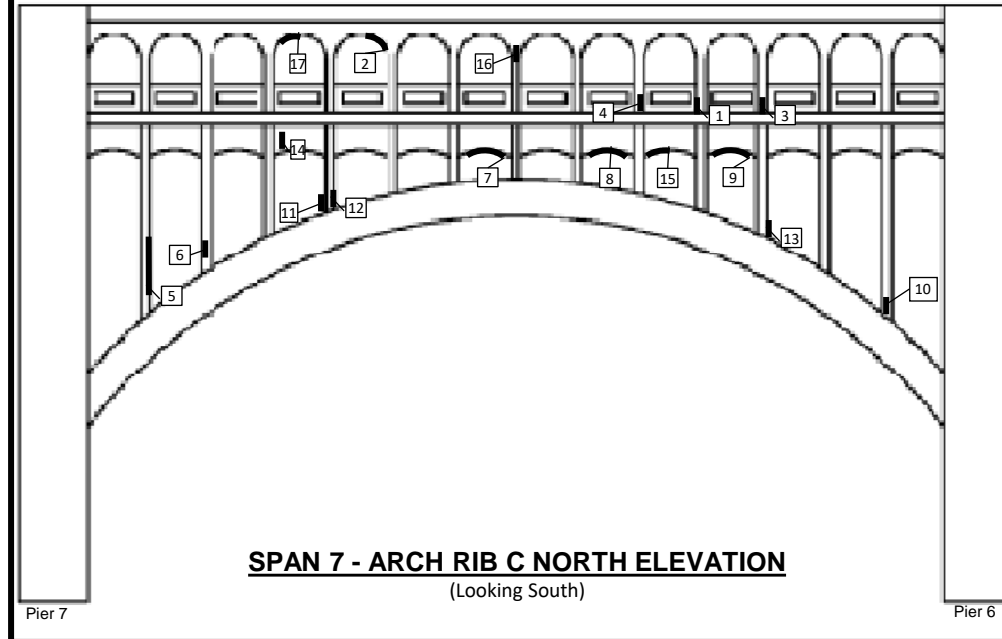
SPAN 7 - ARCH RIB C NORTH ELEVATION DEFICIENCIES	
#	Defect
1	Delamination - 2 SF
2	Spall, 3" D - 4 SF
3	Delamination - 2 SF
4	Delamination w/ Spall w/ exp. Reinf., 1.5" D - 2 SF
5	Delamination - 20 SF
6	Delamination - 2 SF
7	Delamination - 10 SF
8	Delamination - 2 SF
9	Delamination - 3 SF
10	Delamination - 3 SF
11	Delamination - 1 SF
12	Delamination - 1 SF
13	Spall w/ exp. Reinf. - 1 SF
14	Delamination - 10 SF
15	Delamination - 2 SF
16	Spall - 1 SF
17	Spall - 1 SF

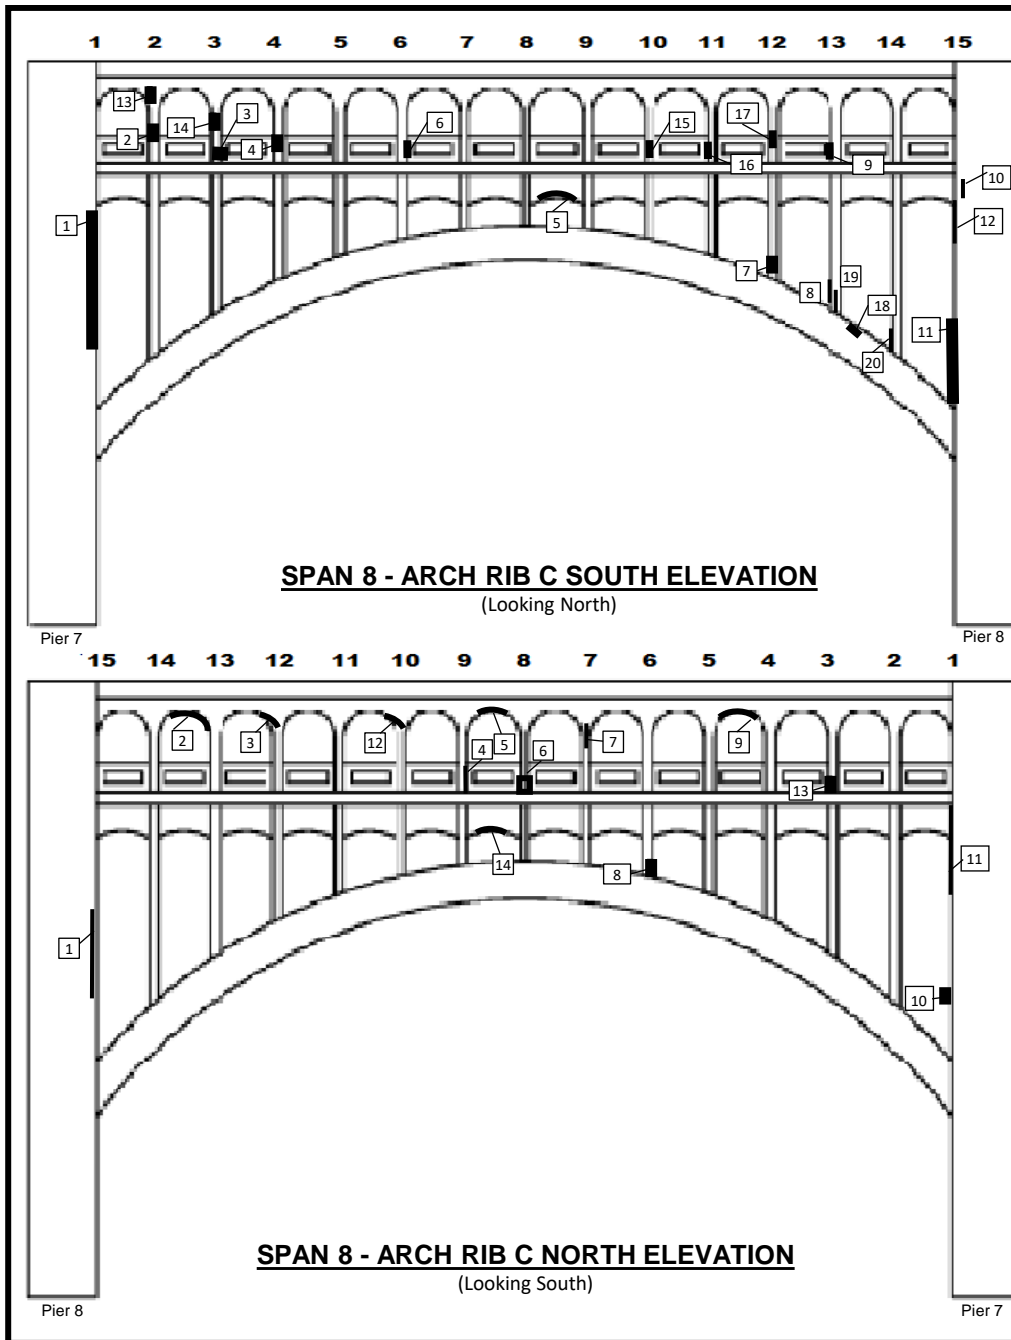
SPAN 8 - ARCH RIB C SOUTH ELEVATION DEFICIENCIES	
#	Defect
1	Spall w/ exp. Reinf. 30% S.L. of bars at south end. 2 adj. shear stirrups w/ complete S.L. - 175 SF.
2	Delamination w/ Spall w/ exp. Reinf. - 5 SF
3	Delamination - 1 SF
4	Delamination - 3 SF
5	Delamination - 6 SF
6	Delamination w/ Spall w/ exp. Reinf. - 3 SF
7	Spall w/ exp. Reinf., 2" D - 1 SF
8	Delamination - 2 SF
9	Core sample location
10	Spall w/ exp. Reinf. - 1 SF
11	Delamination - 40 SF
12	Delamination - 12 SF
13	Delamination - 1 SF
14	Spall w/ exp. Reinf. - 1 SF
15	Delamination - 2 SF
16	Delamination - 2 SF
17	Delamination w/ Spall w/ exp. Reinf. - 1 SF
18	Spall - 1' L x 1' H
19	Delamination - 1 SF
20	Delamination - 1 SF
SPAN 8 - ARCH RIB C NORTH ELEVATION DEFICIENCIES

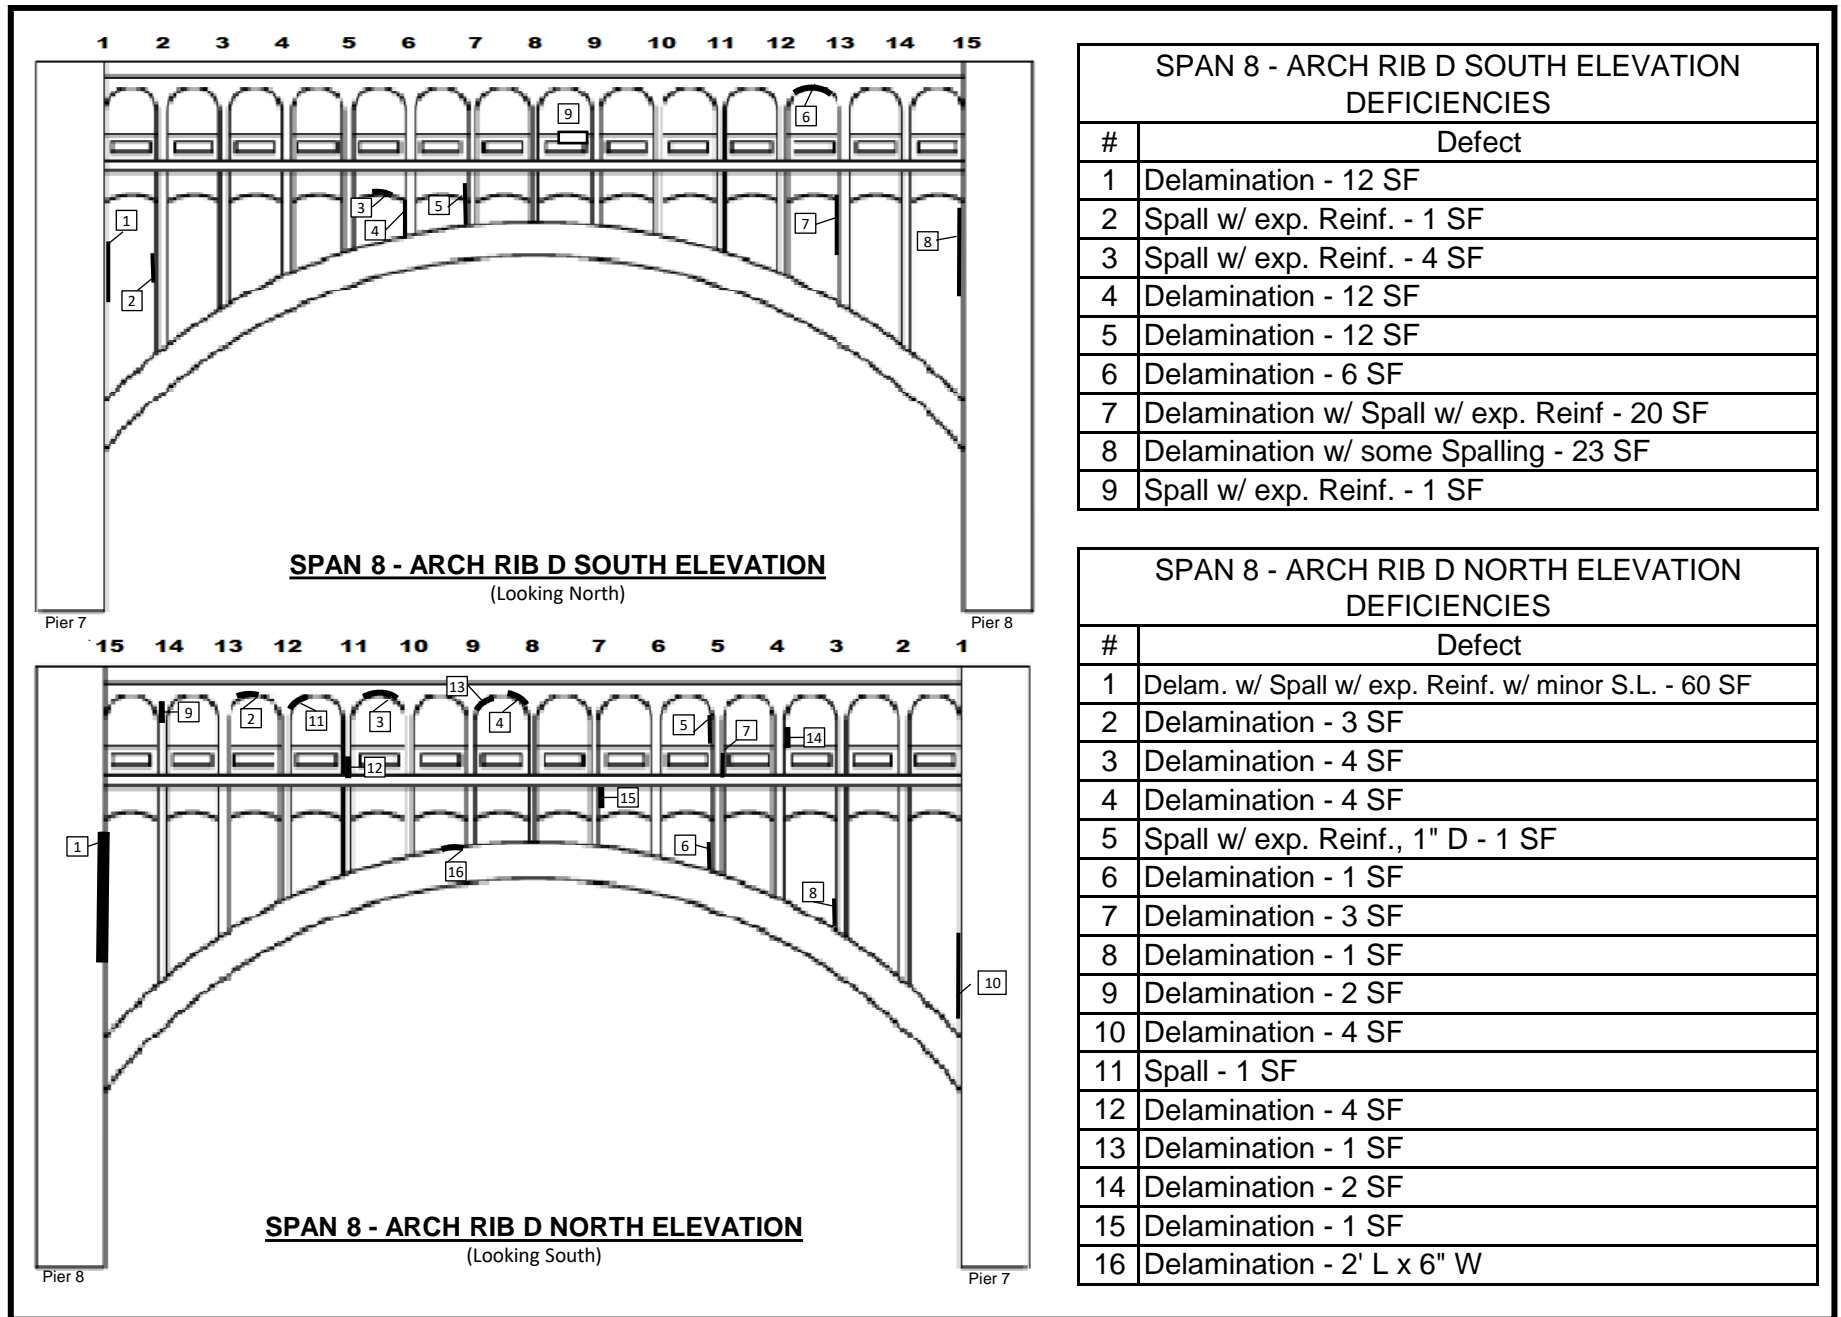
#	Defect
1	Delamination - 15 SF
2	Delamination w/ Spall w/ exp. Reinf., 0.5" D - 4 SF
3	Spall w/ exp. Reinf., 4" D - 1 SF
4	Spall w/ exp. Reinf., 1" D - 1 SF
5	Spall w/ exp. Reinf., 1.5" D - 1 SF
6	Spall - 1 SF
7	Delamination w/ Spall - 2 SF
8	Spall w/ exp. Reinf. - 1 SF
9	Delamination w/ Spall w/ exp. Reinf. - 2 SF
10	Delamination - 4 SF
11	Delam. w/ Spall w/ exp. Reinf., 4" D - 20 SF. 1 exp. Tie w/ 50% S.L. (tie is broken on S face).
12	Delamination w/ Spall - 1 SF
13	Delamination - 1 SF
14	Delamination - 1 SF
