Physical Condition Report for

CUY-006-1456

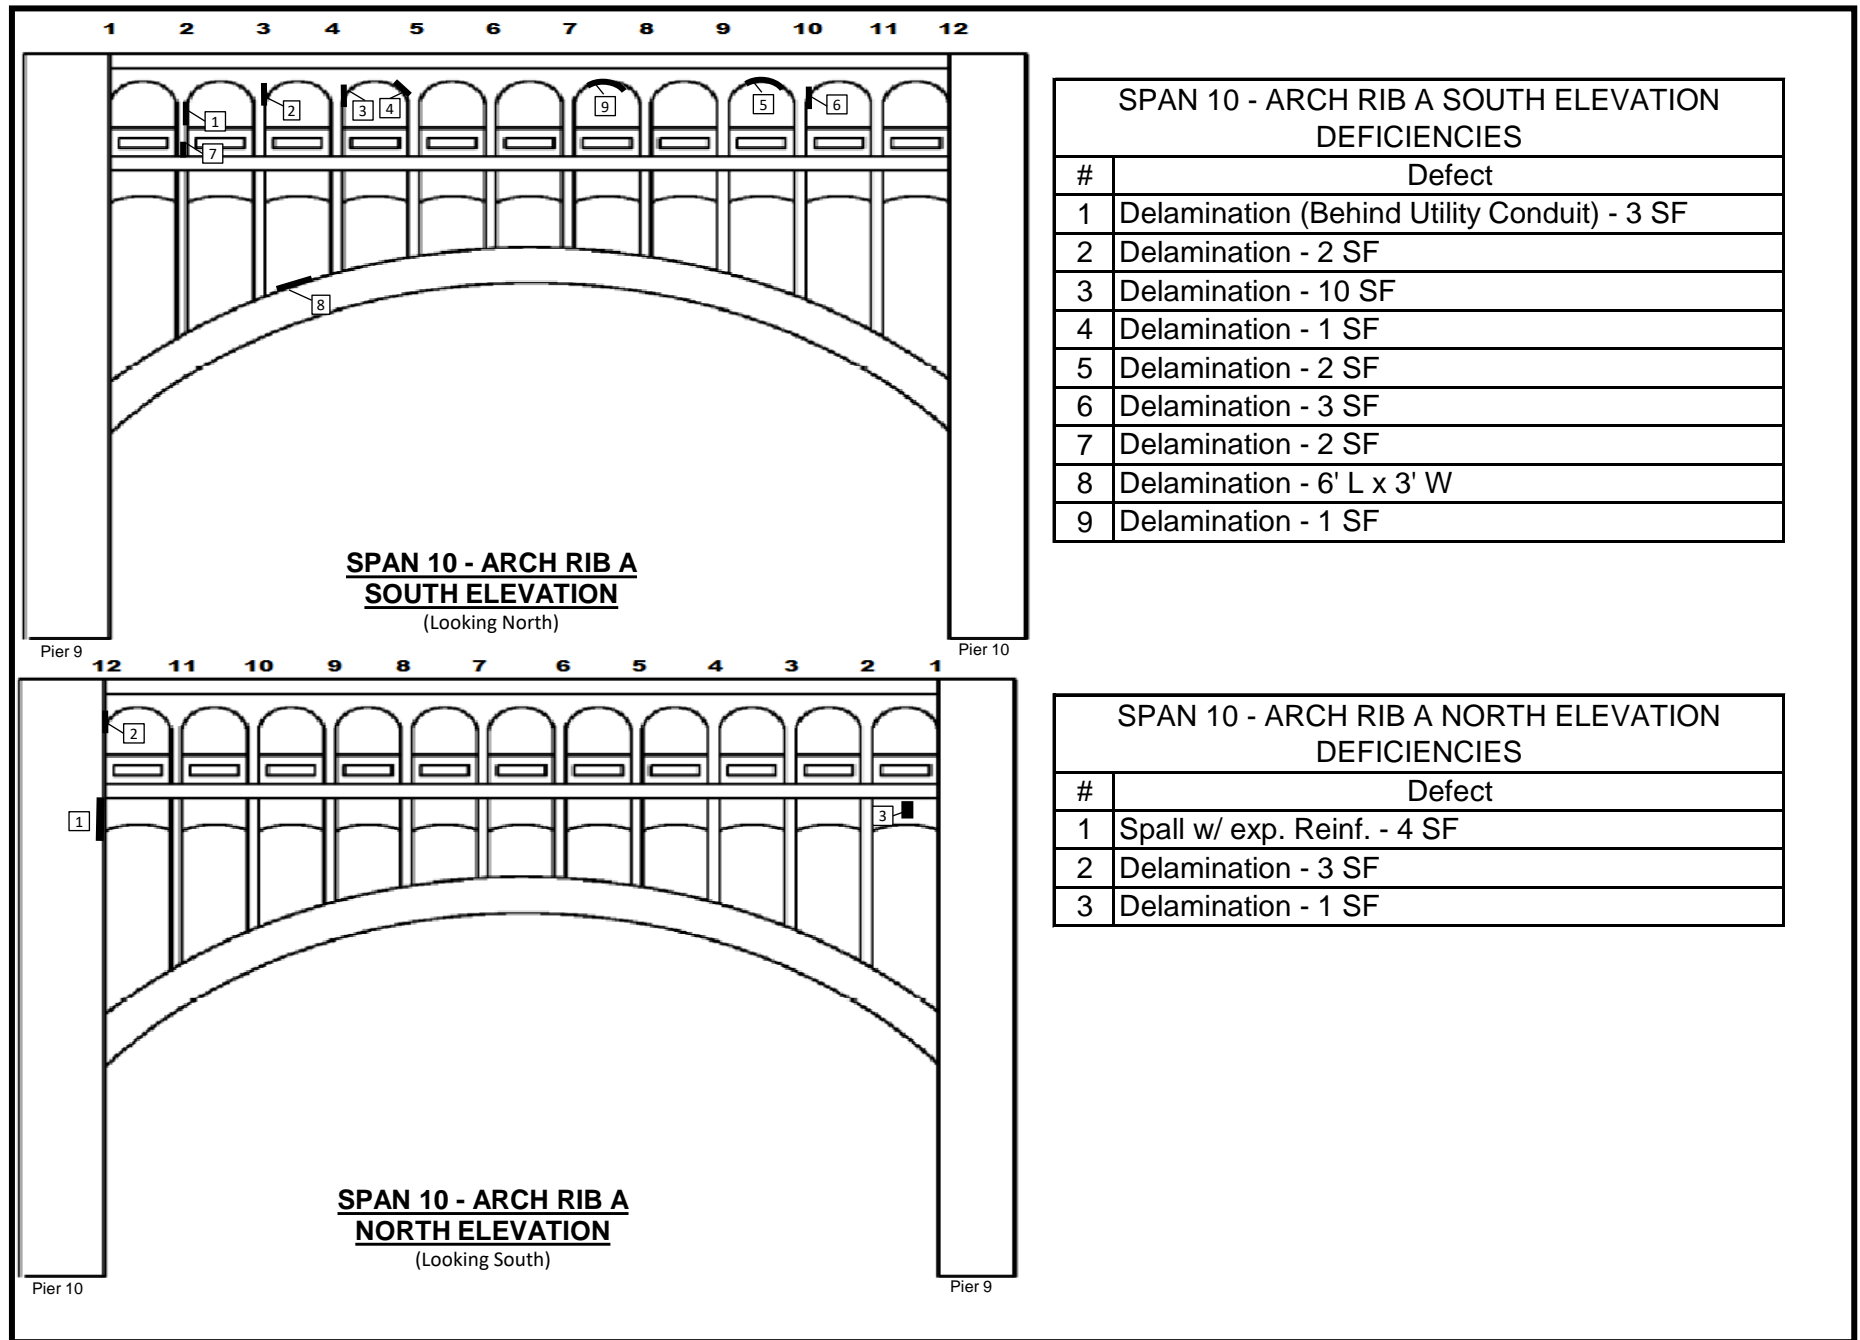
SPAN 10 - ARCH RIB A SOUTH ELEVATION DEFICIENCIES	
#	Defect
1	Delamination (Behind Utility Conduit) - 3 SF
2	Delamination - 2 SF
3	Delamination - 10 SF
4	Delamination - 1 SF
5	Delamination - 2 SF
6	Delamination - 3 SF
7	Delamination - 2 SF
8	Delamination - 6' L x 3' W
9	Delamination - 1 SF

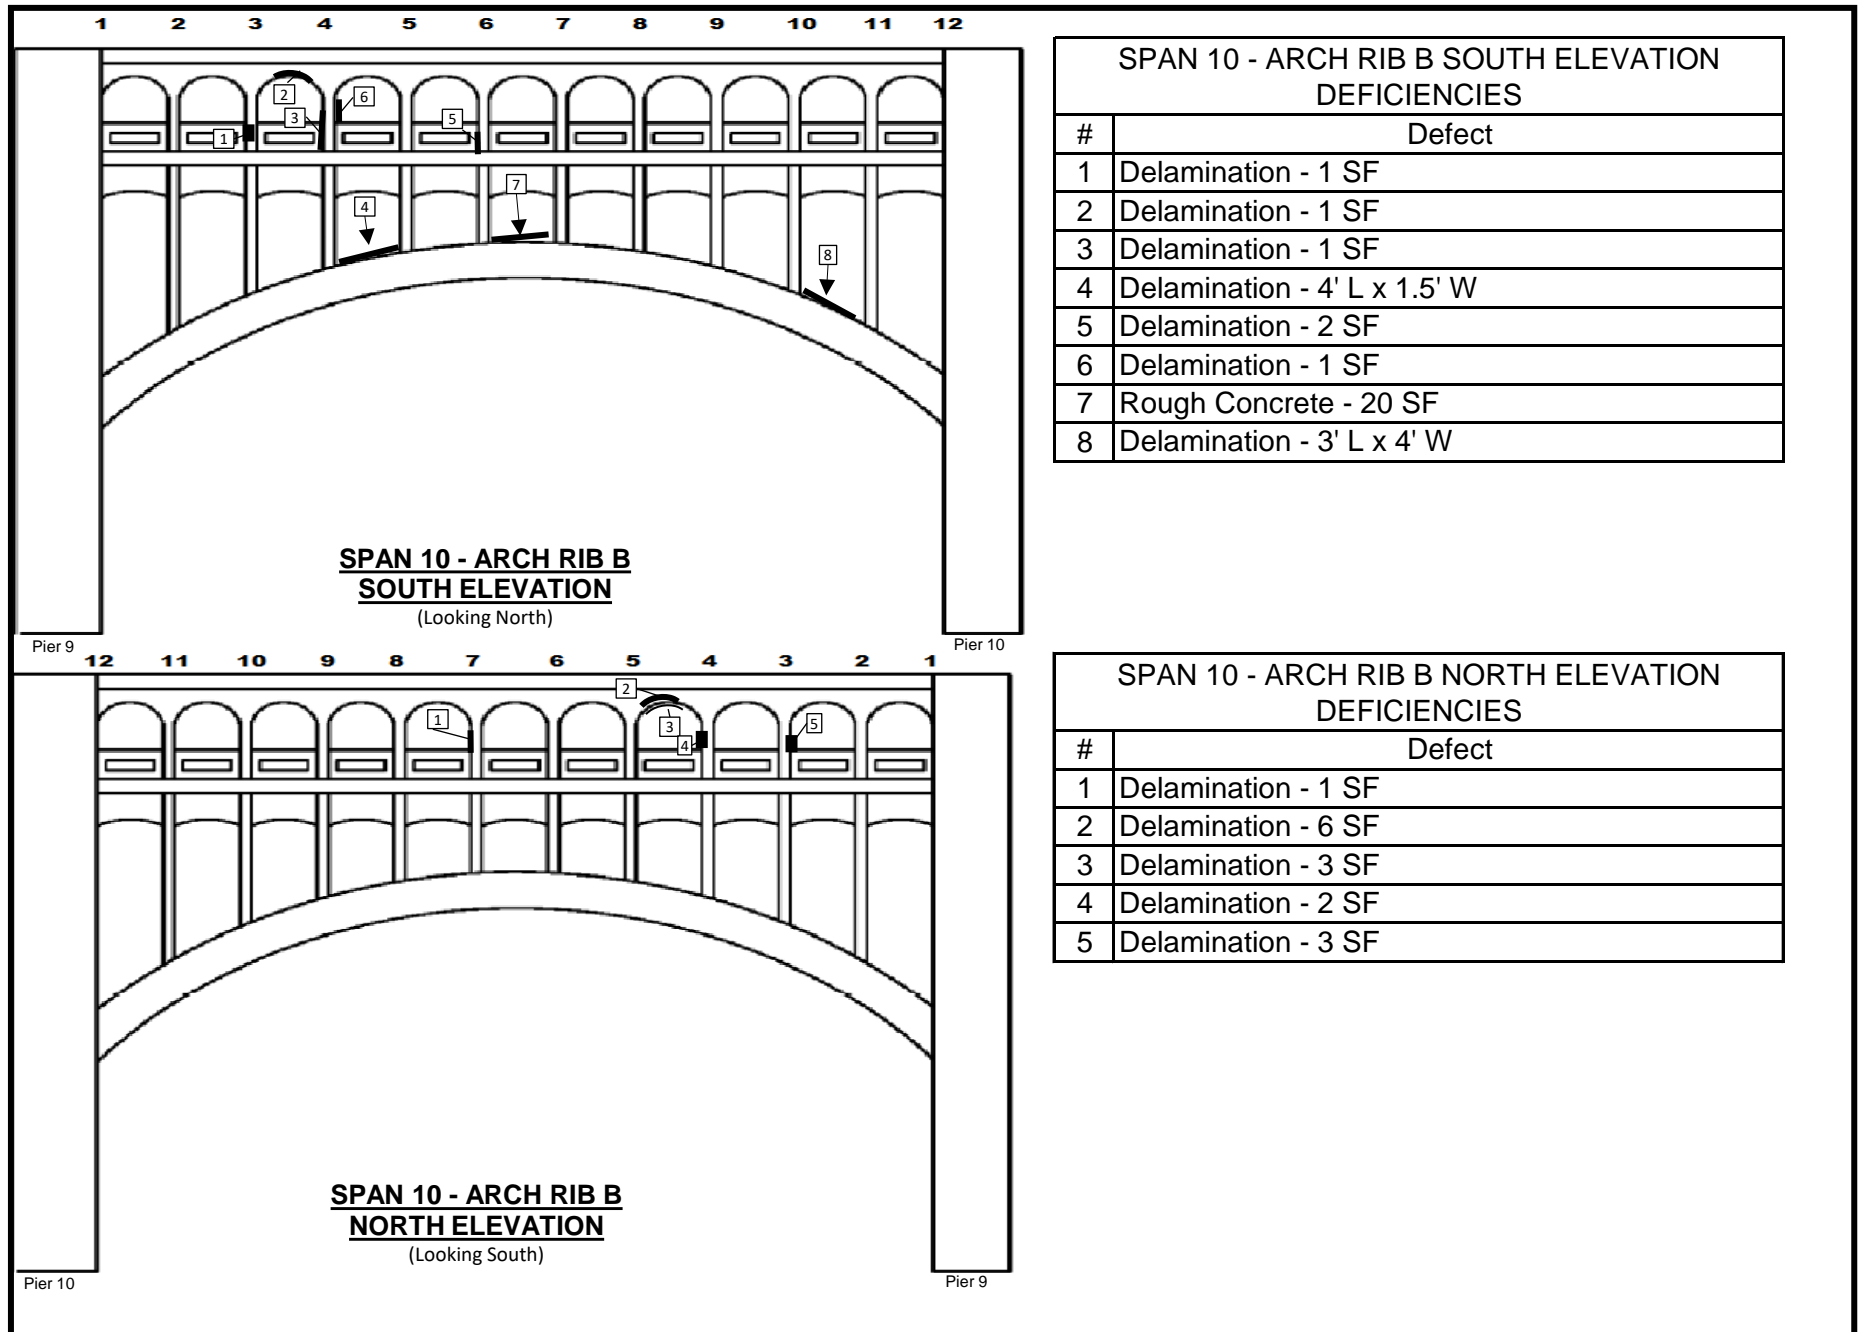
SPAN 10 - ARCH RIB A NORTH ELEVATION DEFICIENCIES	
#	Defect
1	Spall w/ exp. Reinf. - 4 SF
2	Delamination - 3 SF
3	Delamination - 1 SF

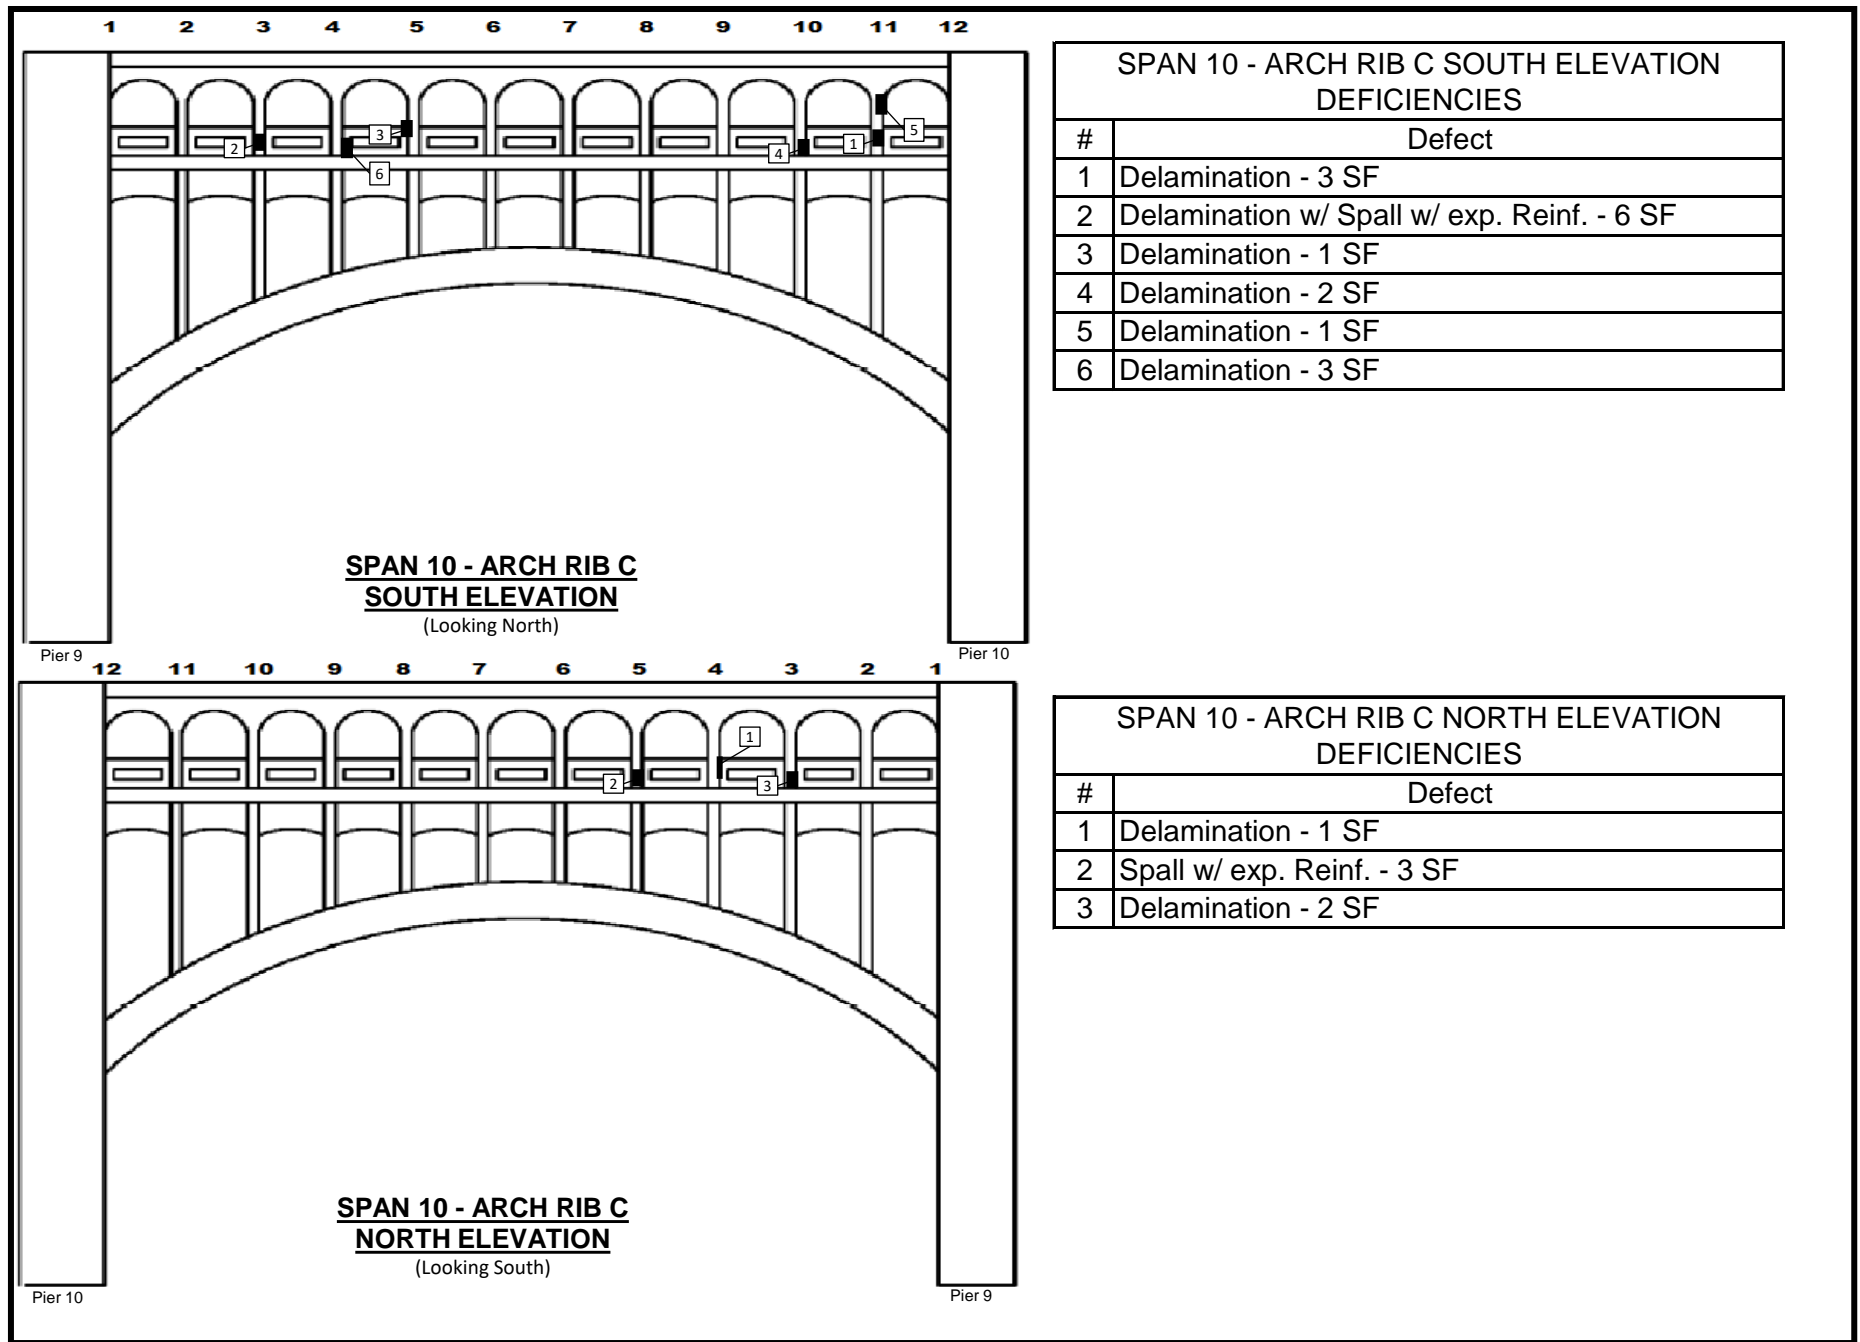
SPAN 10 - ARCH RIB C SOUTH ELEVATION DEFICIENCIES	
#	Defect
1	Delamination - 3 SF
2	Delamination w/ Spall w/ exp. Reinf. - 6 SF
3	Delamination - 1 SF
4	Delamination - 2 SF
5	Delamination - 1 SF
6	Delamination - 3 SF

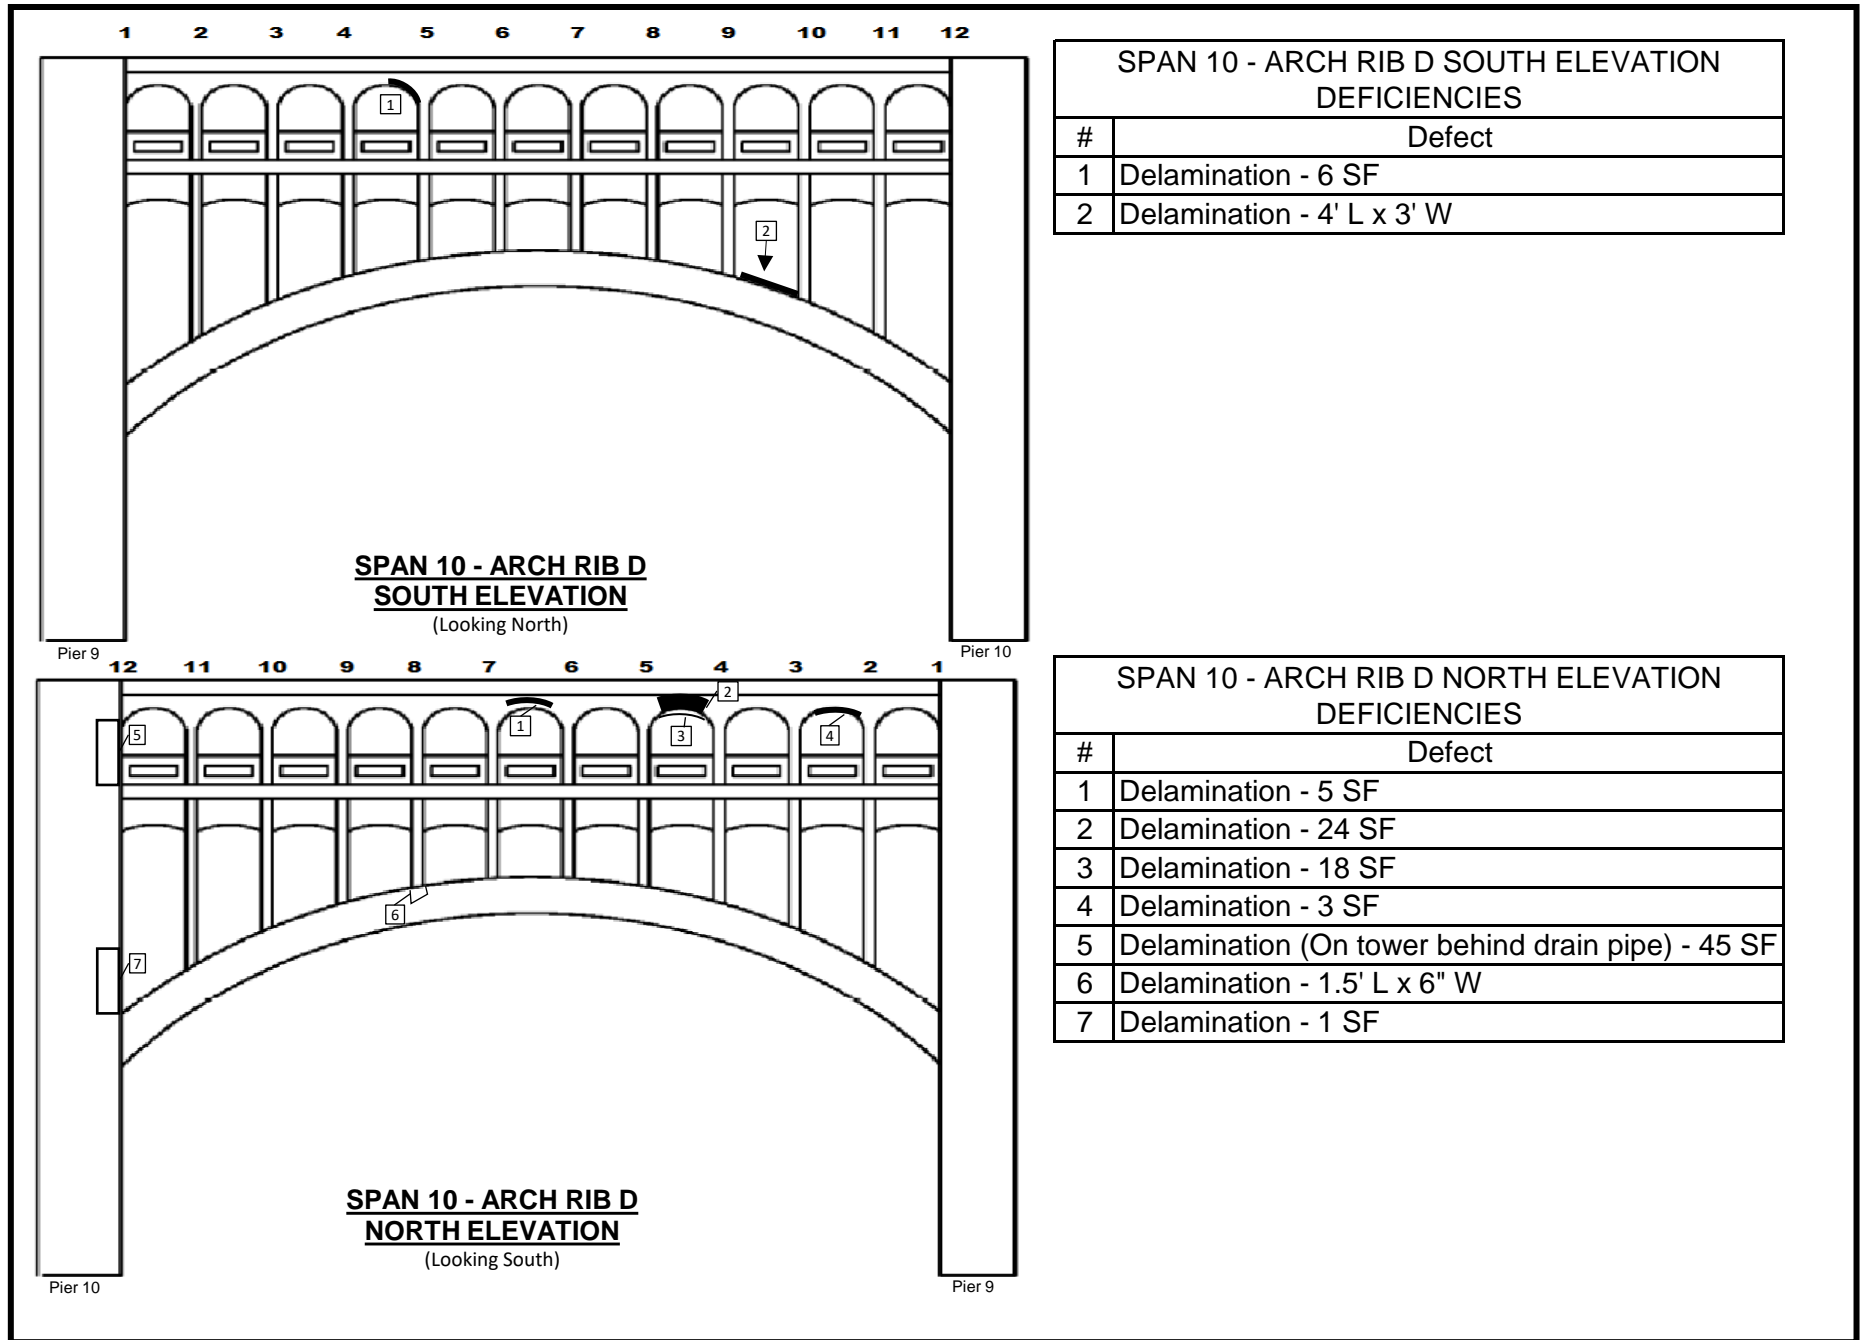
SPAN 10 - ARCH RIB D SOUTH ELEVATION DEFICIENCIES	
#	Defect
1	Delamination - 6 SF
2	Delamination - 4' L x 3' W

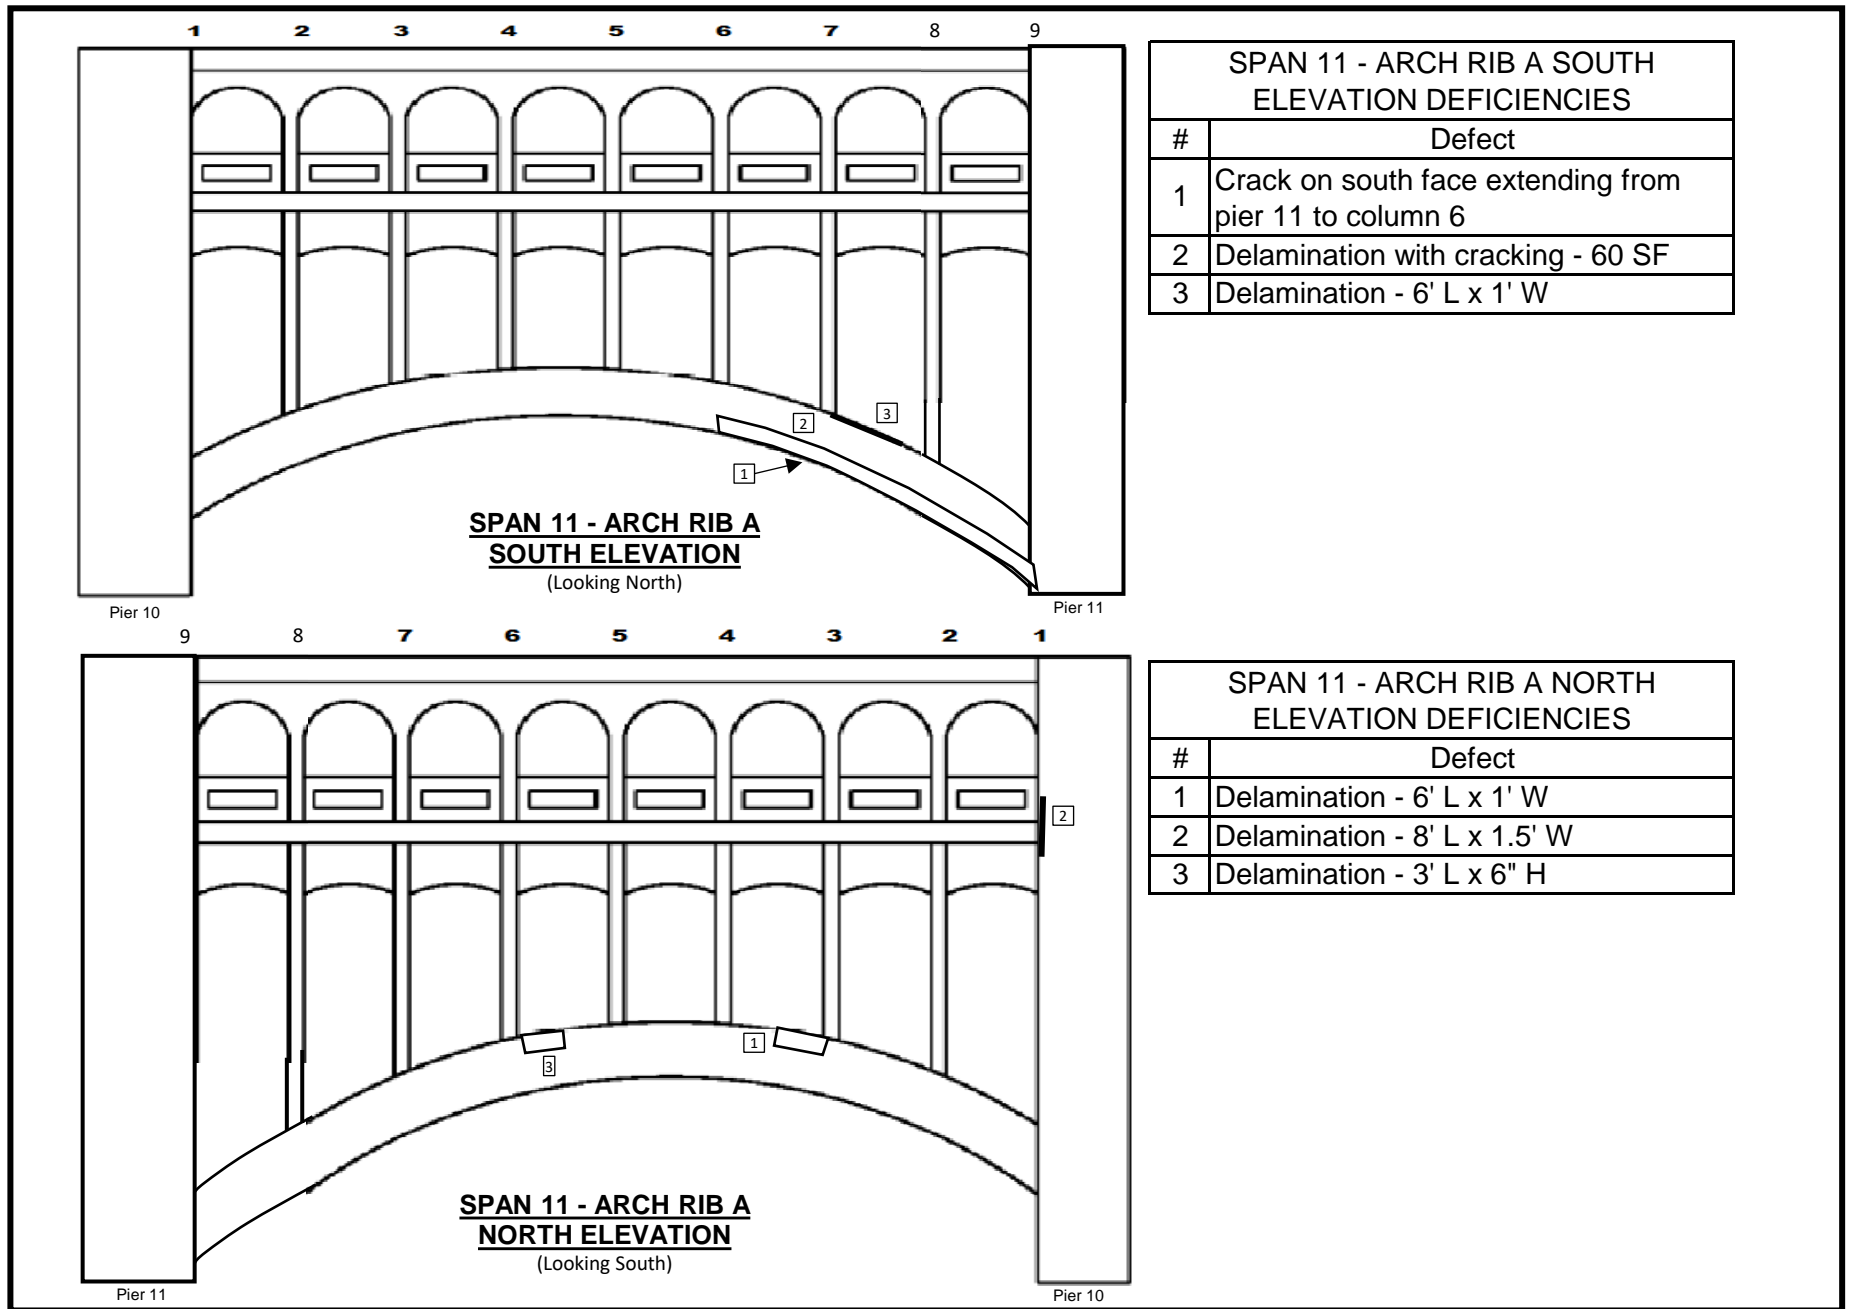
SPAN 10 - ARCH RIB D NORTH ELEVATION DEFICIENCIES	
#	Defect
1	Delamination - 5 SF
2	Delamination - 24 SF
3	Delamination - 18 SF
4	Delamination - 3 SF
5	Delamination (On tower behind drain pipe) - 45 SF
6	Delamination - 1.5' L x 6" W
7	Delamination - 1 SF

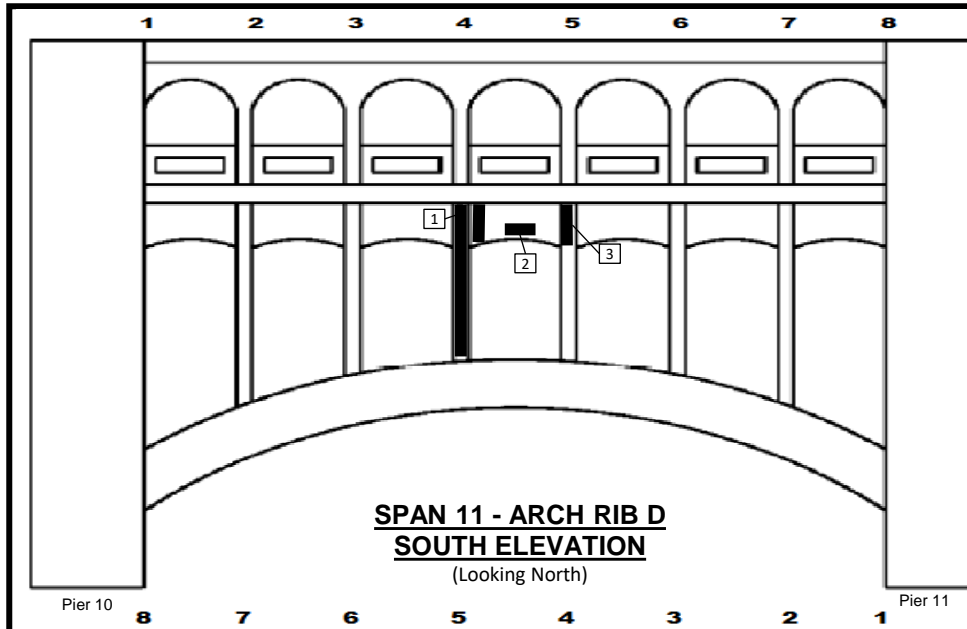
SPAN 11 - ARCH RIB D SOUTH ELEVATION DEFICIENCIES	
#	Defect
1	Spall w/ exp. Reinf., 6" D - 1.5' W x Full H
2	Delamination - 2 SF
3	Delamination - 2 SF

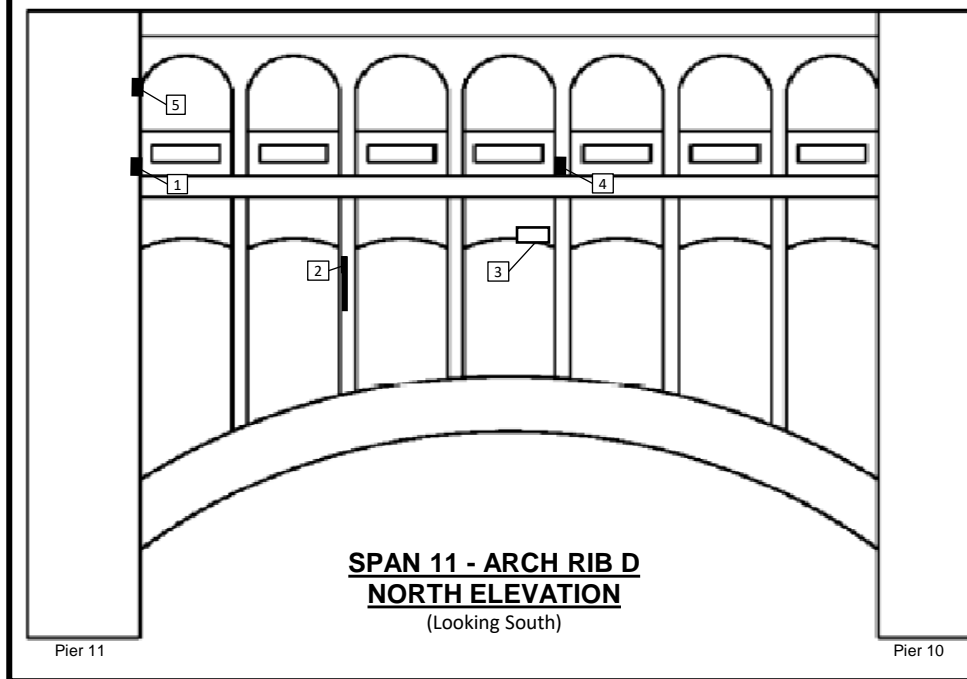
SPAN 11 - ARCH RIB D NORTH ELEVATION DEFICIENCIES	
#	Defect
1	Delamination - 2 SF
2	Delamination - 2 SF
3	Delamination - 4 SF
4	Delamination - 2 SF
5	Spall - 2 SF

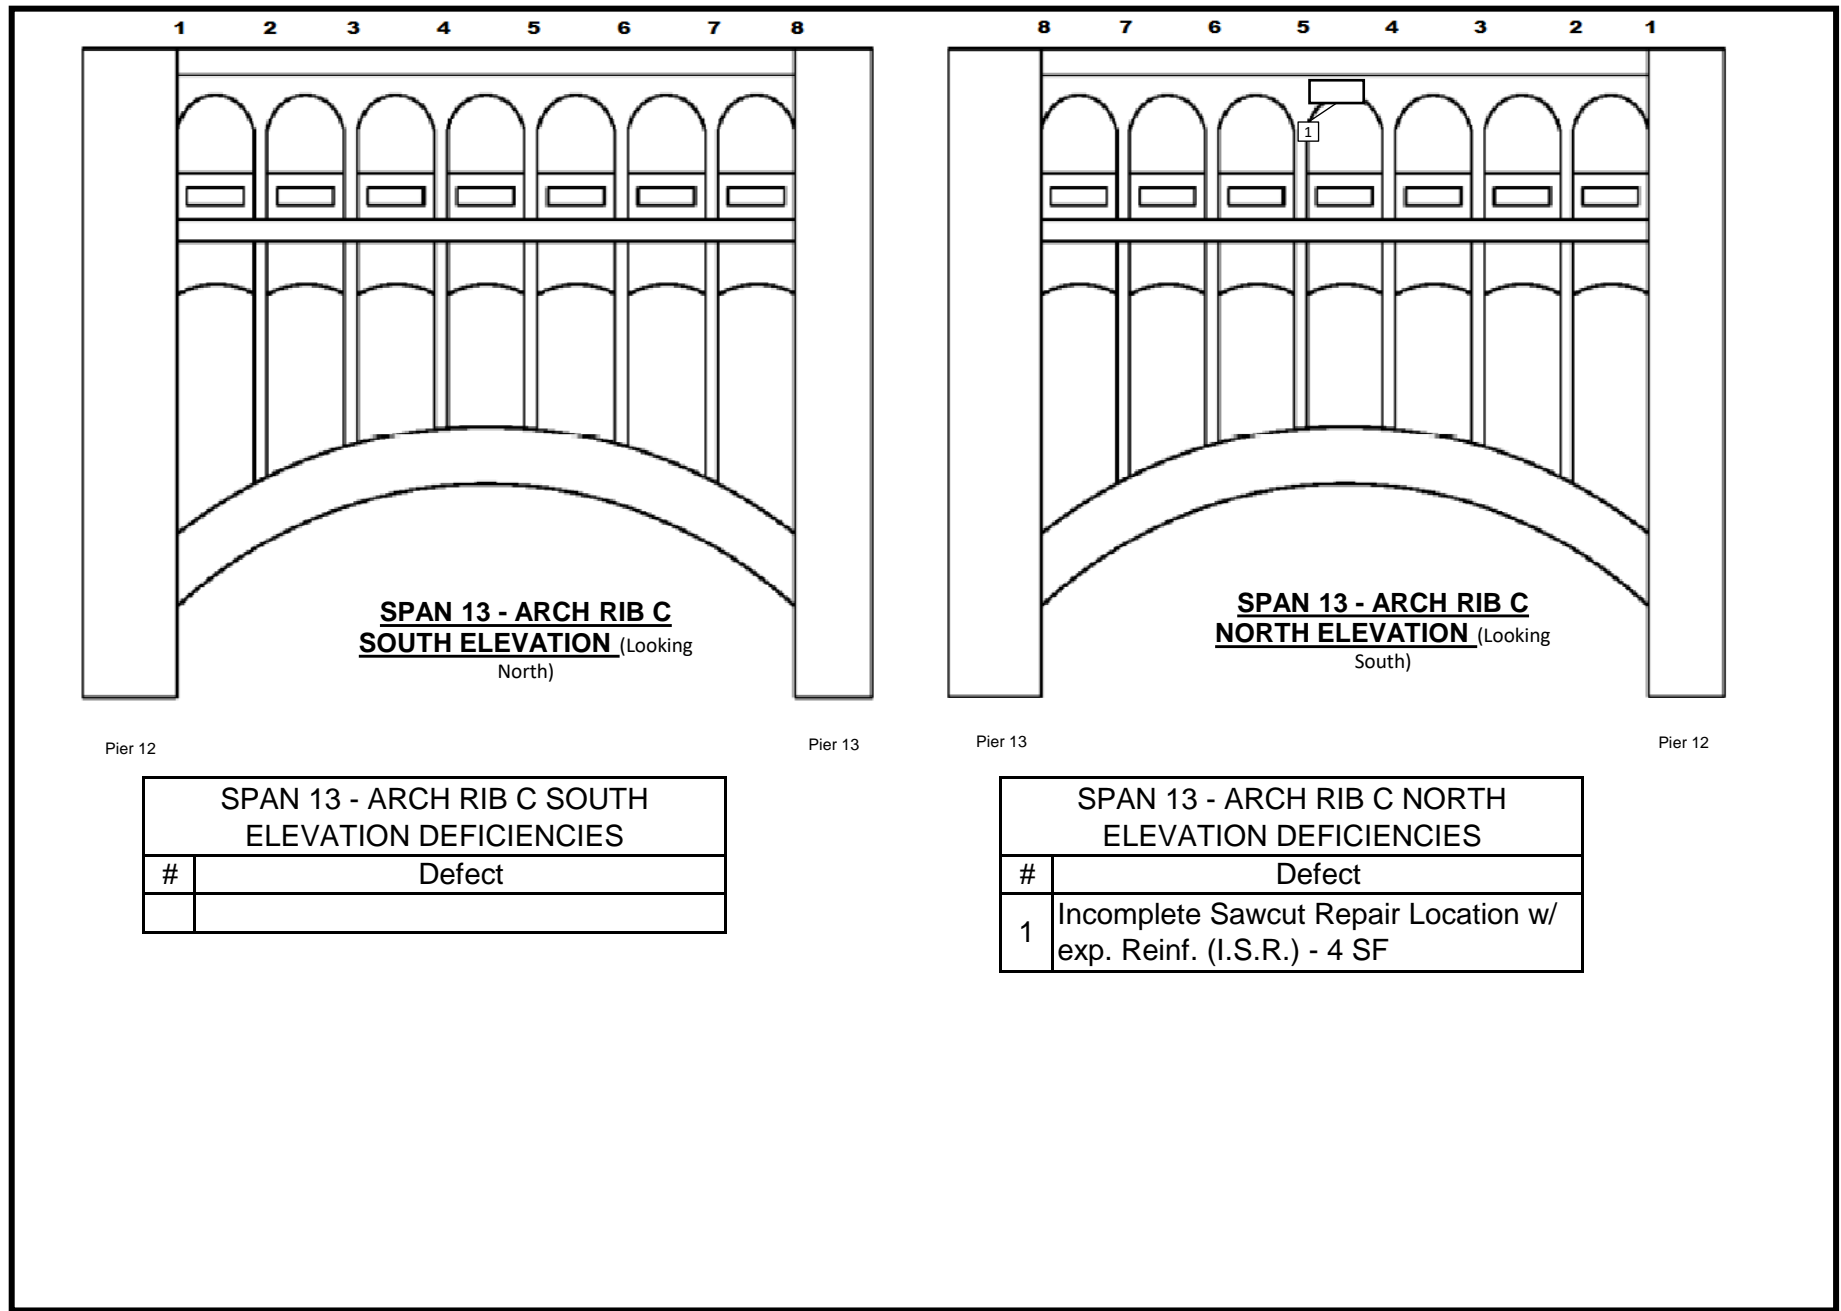
SPAN 13 - ARCH RIB C SOUTH ELEVATION DEFICIENCIES

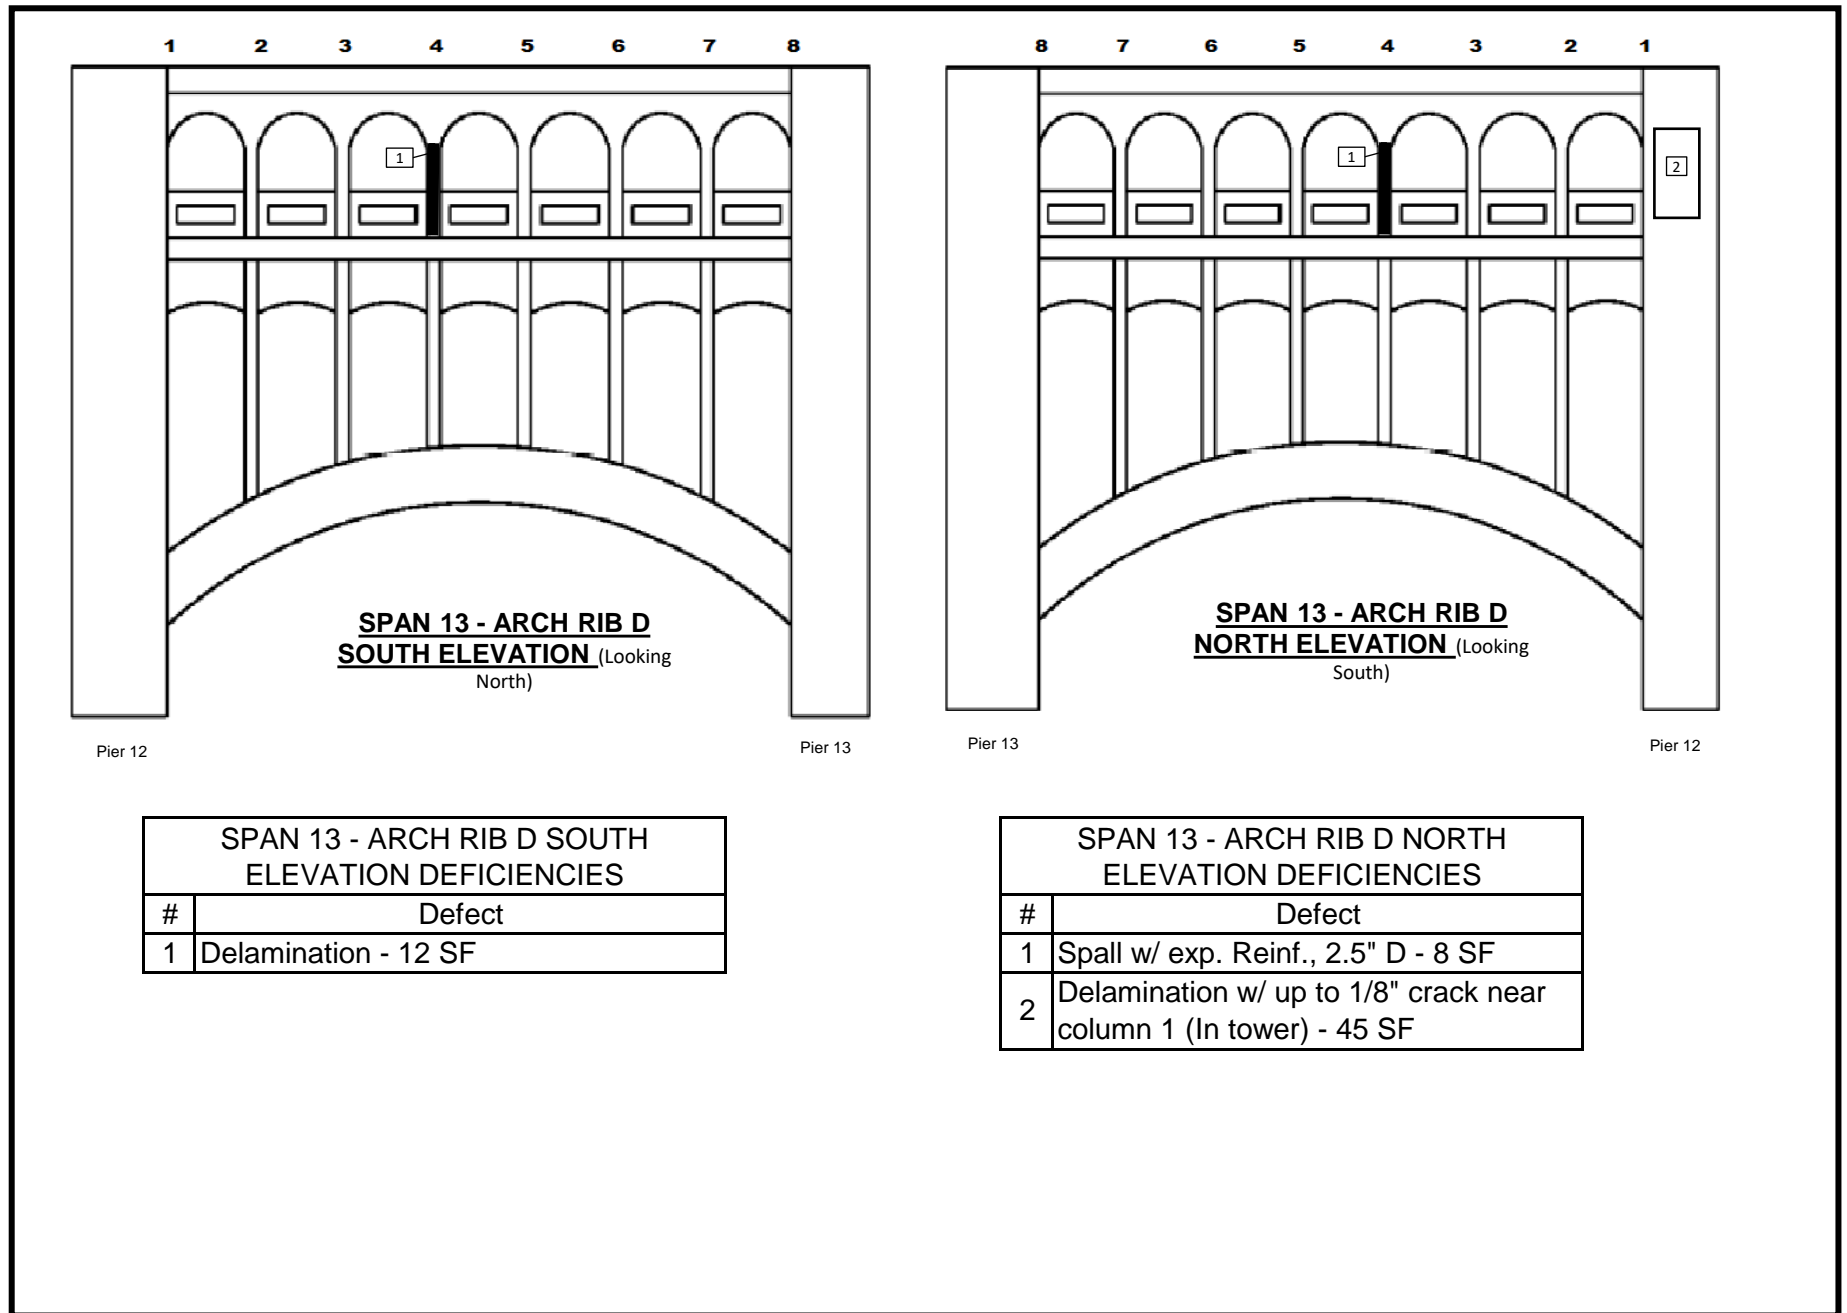
#	Defect
1	Incomplete Sawcut Repair Location w/ exp. Reinf. (I.S.R.) - 4 SF

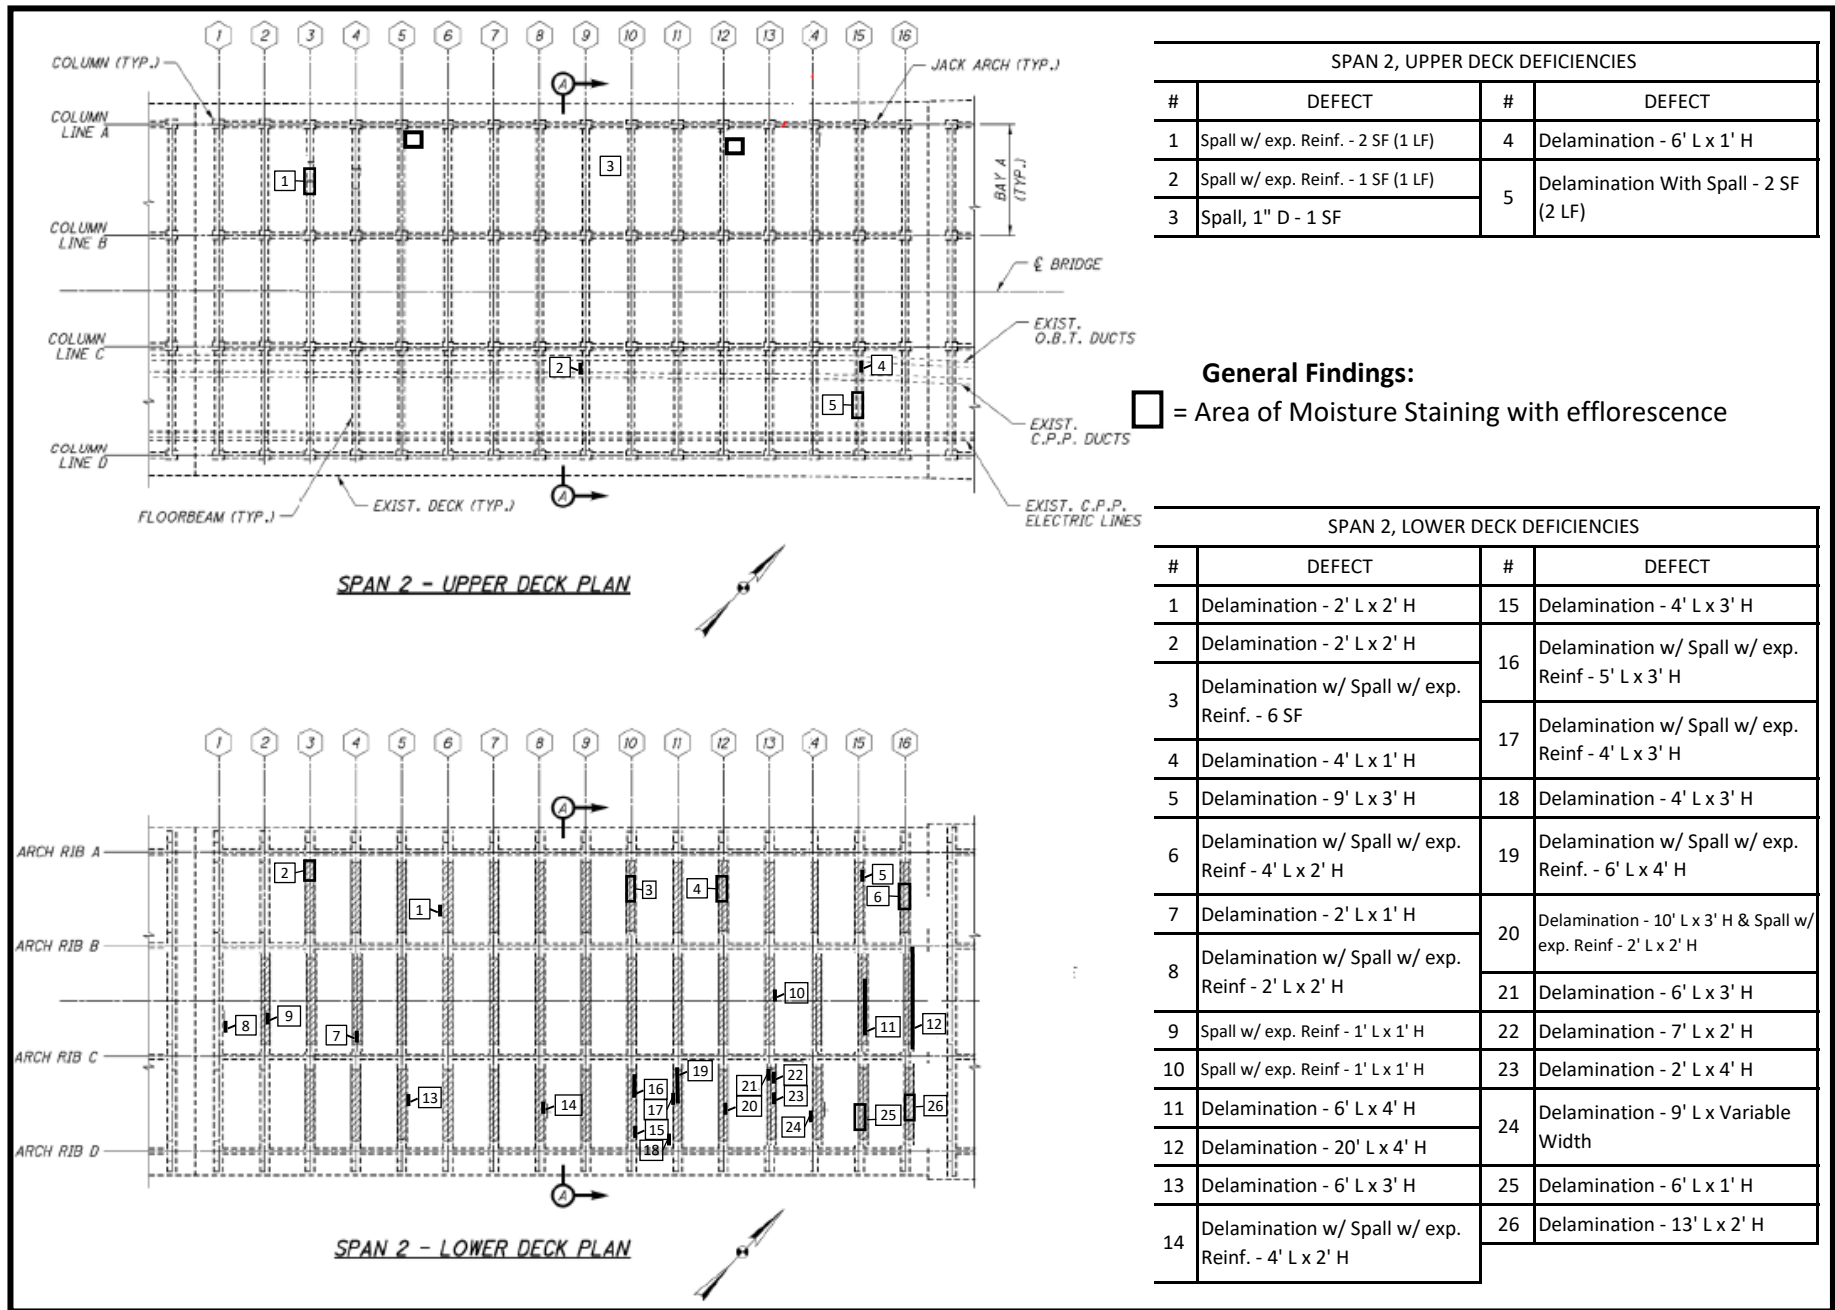
Appendix C - Open Spandrel Arch, Truss, Floor System, and Substructure Drawings and Deficiencies
