Physical Condition Report for

CUY-006-1456

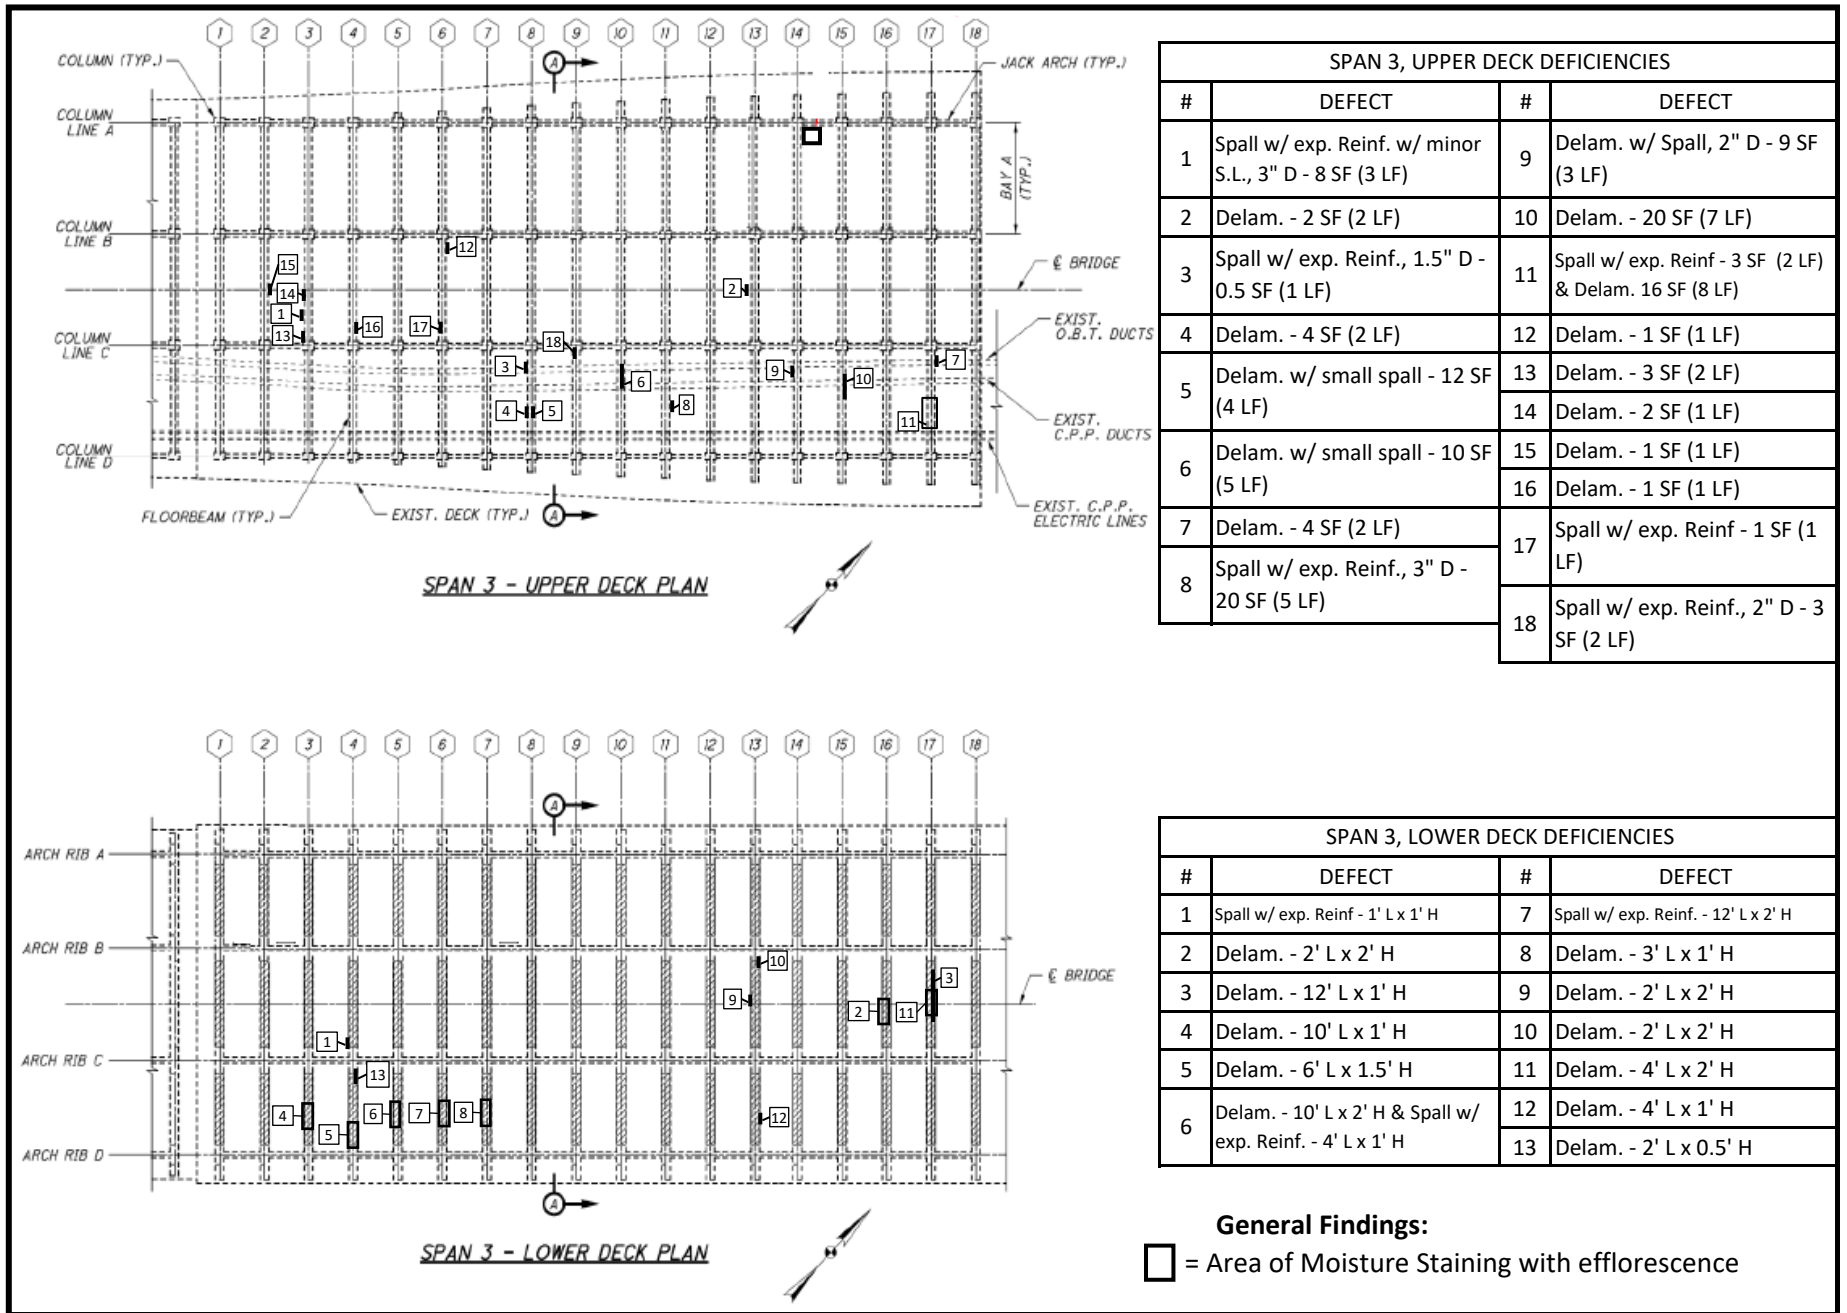
Appendix C - Open Spandrel Arch, Truss, Floor System, and Substructure Drawings and Deficiencies

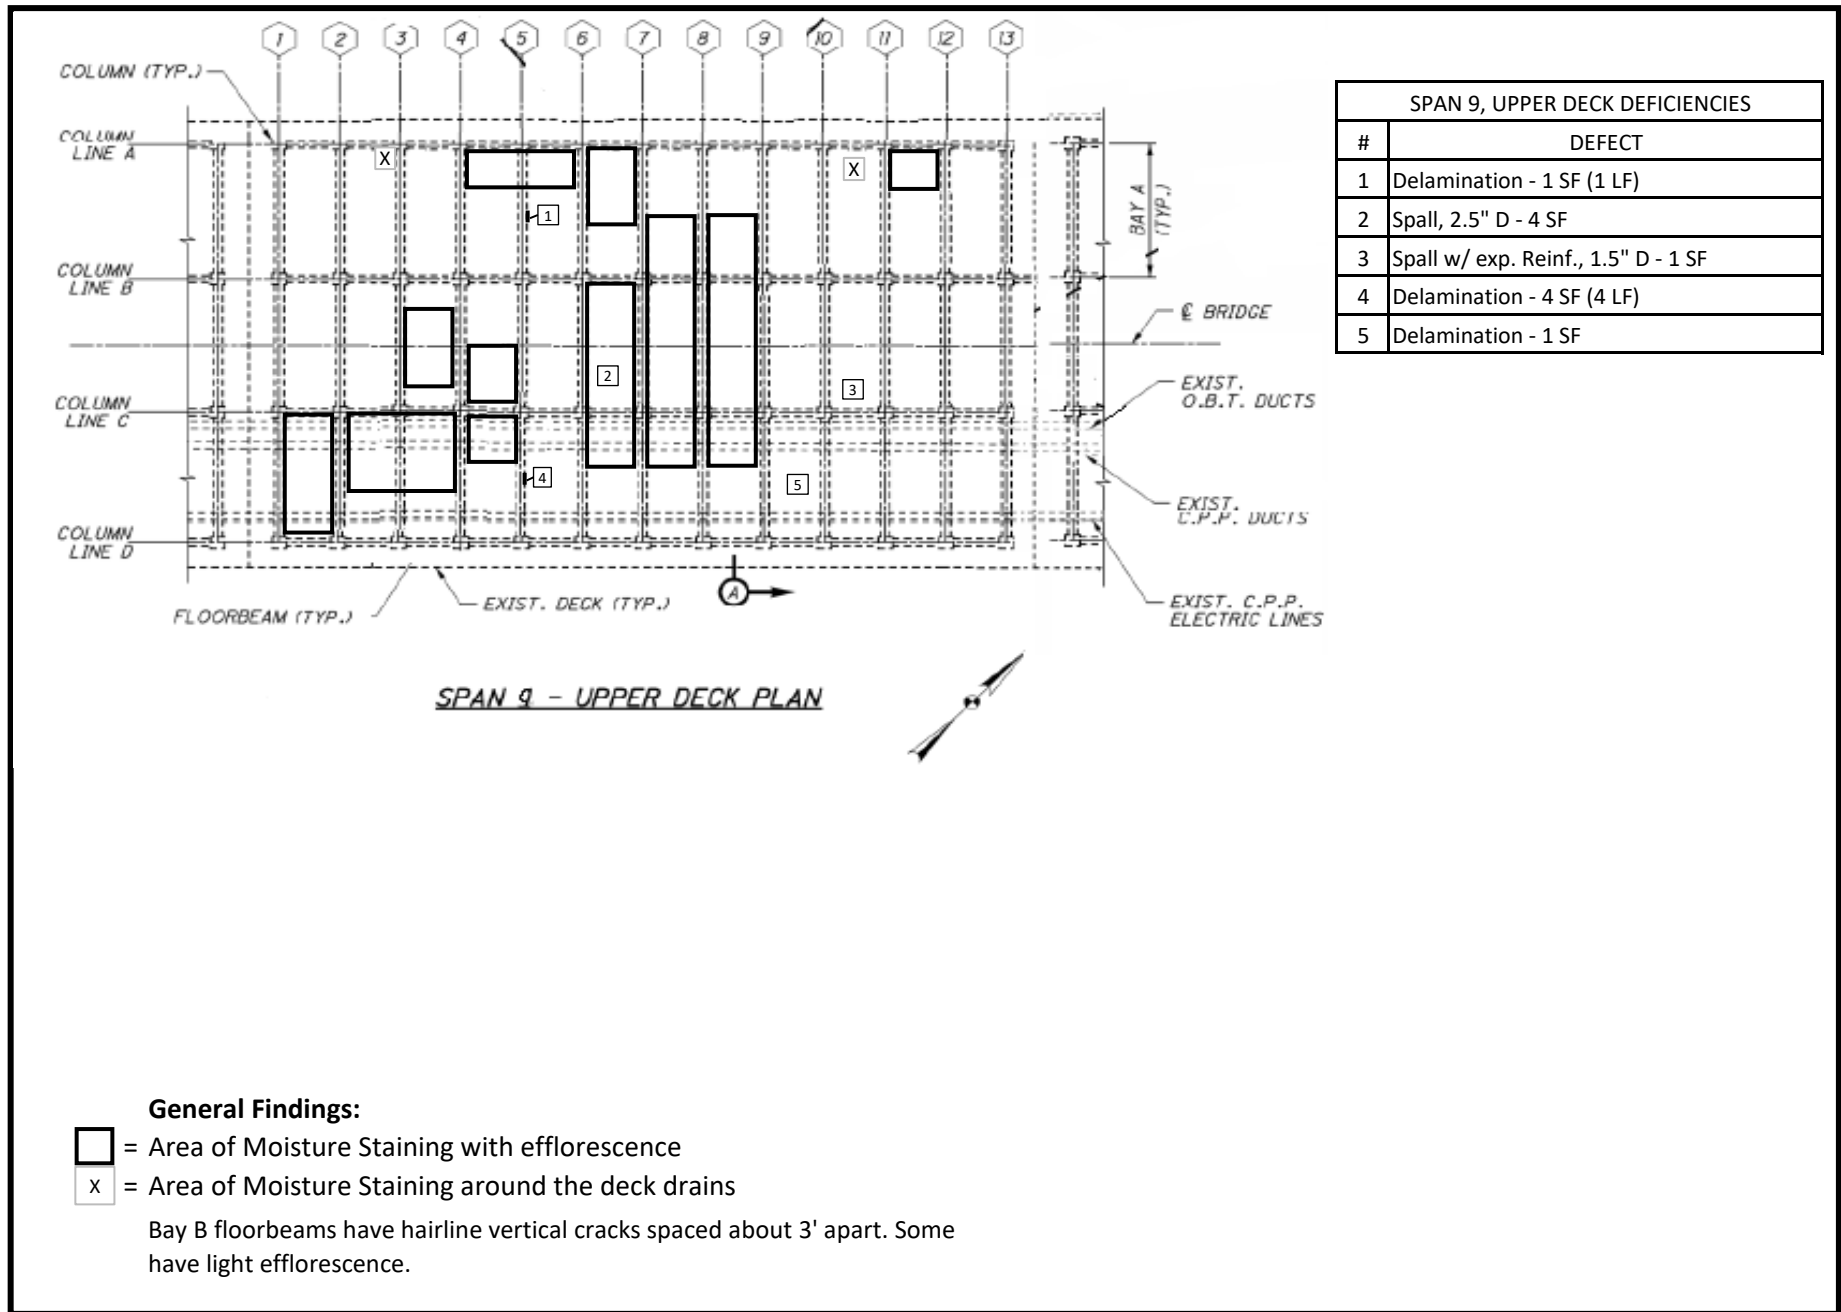
SPAN 9, LOWER DECK DEFICIENCIES	
#	Defect
1	Delamination - 1' L x 1' H
2	Delamination - 1' L x 2' H
3	Delamination - 2' L x 2' H
4	Delamination - 4' L x 2' H
5	Delamination - 1' L x 1' H

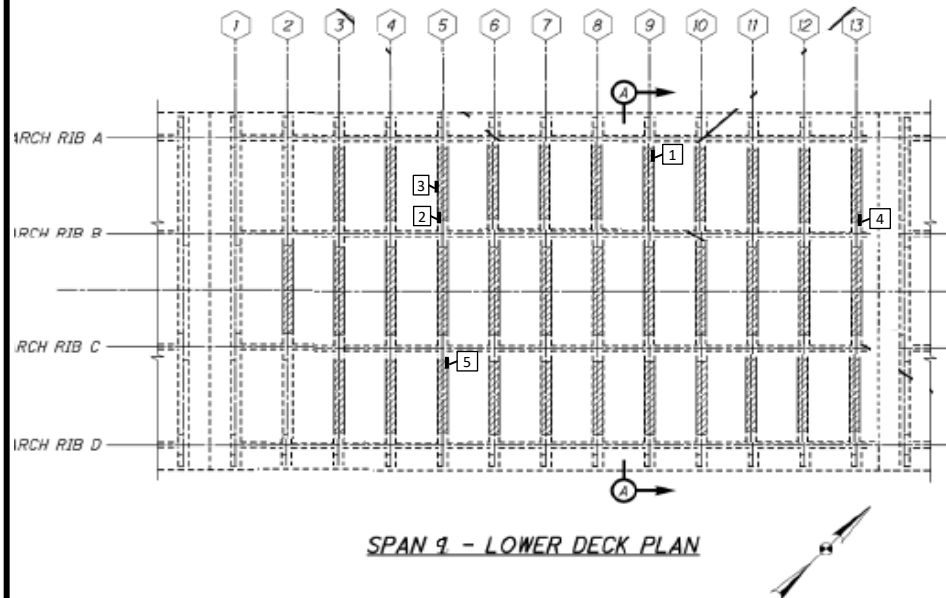
SPAN 9 - LOWER DECK PLAN

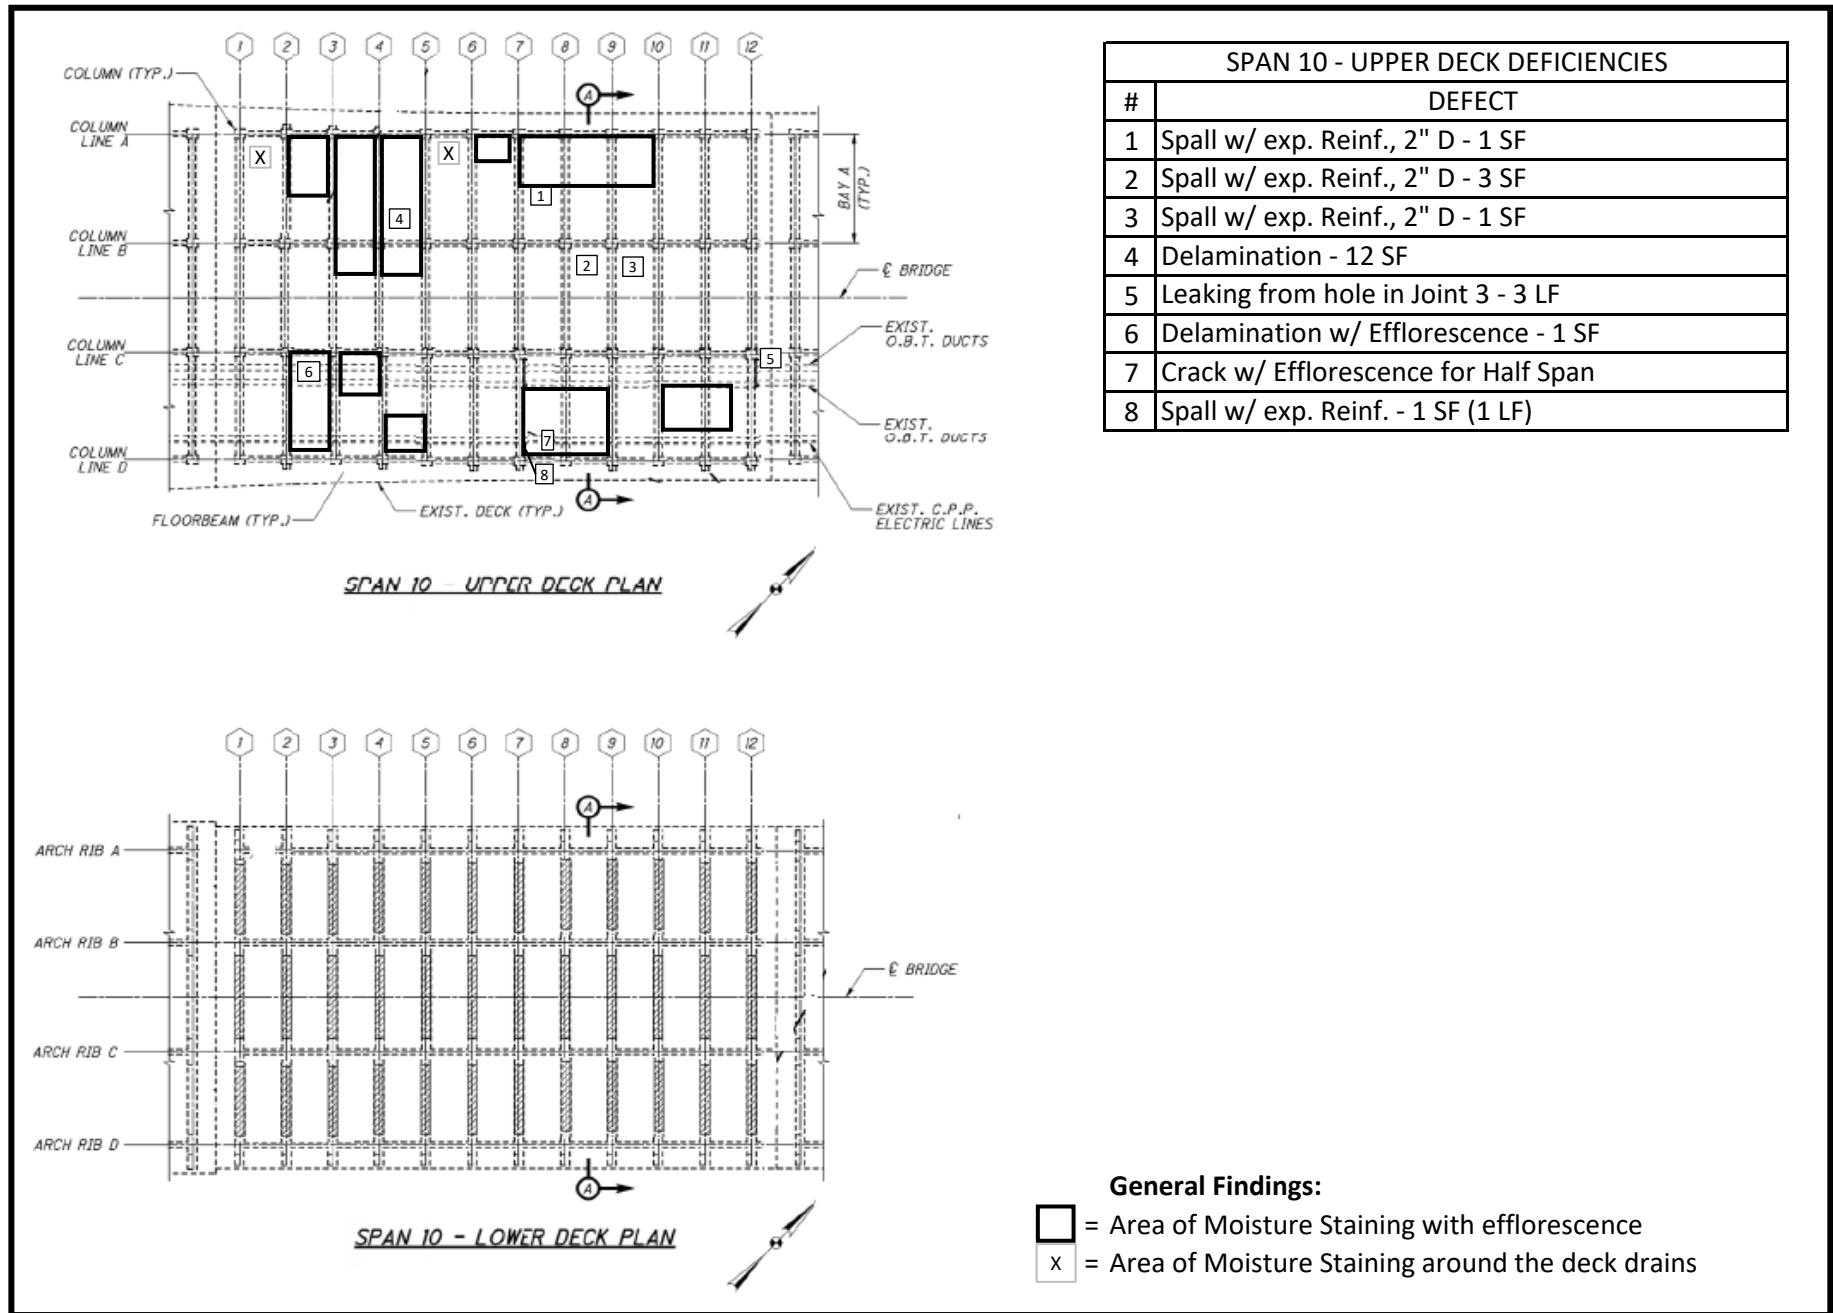
Bay B floorbeams have hairline vertical cracks spaced about 3' apart. Some have light efflorescence.

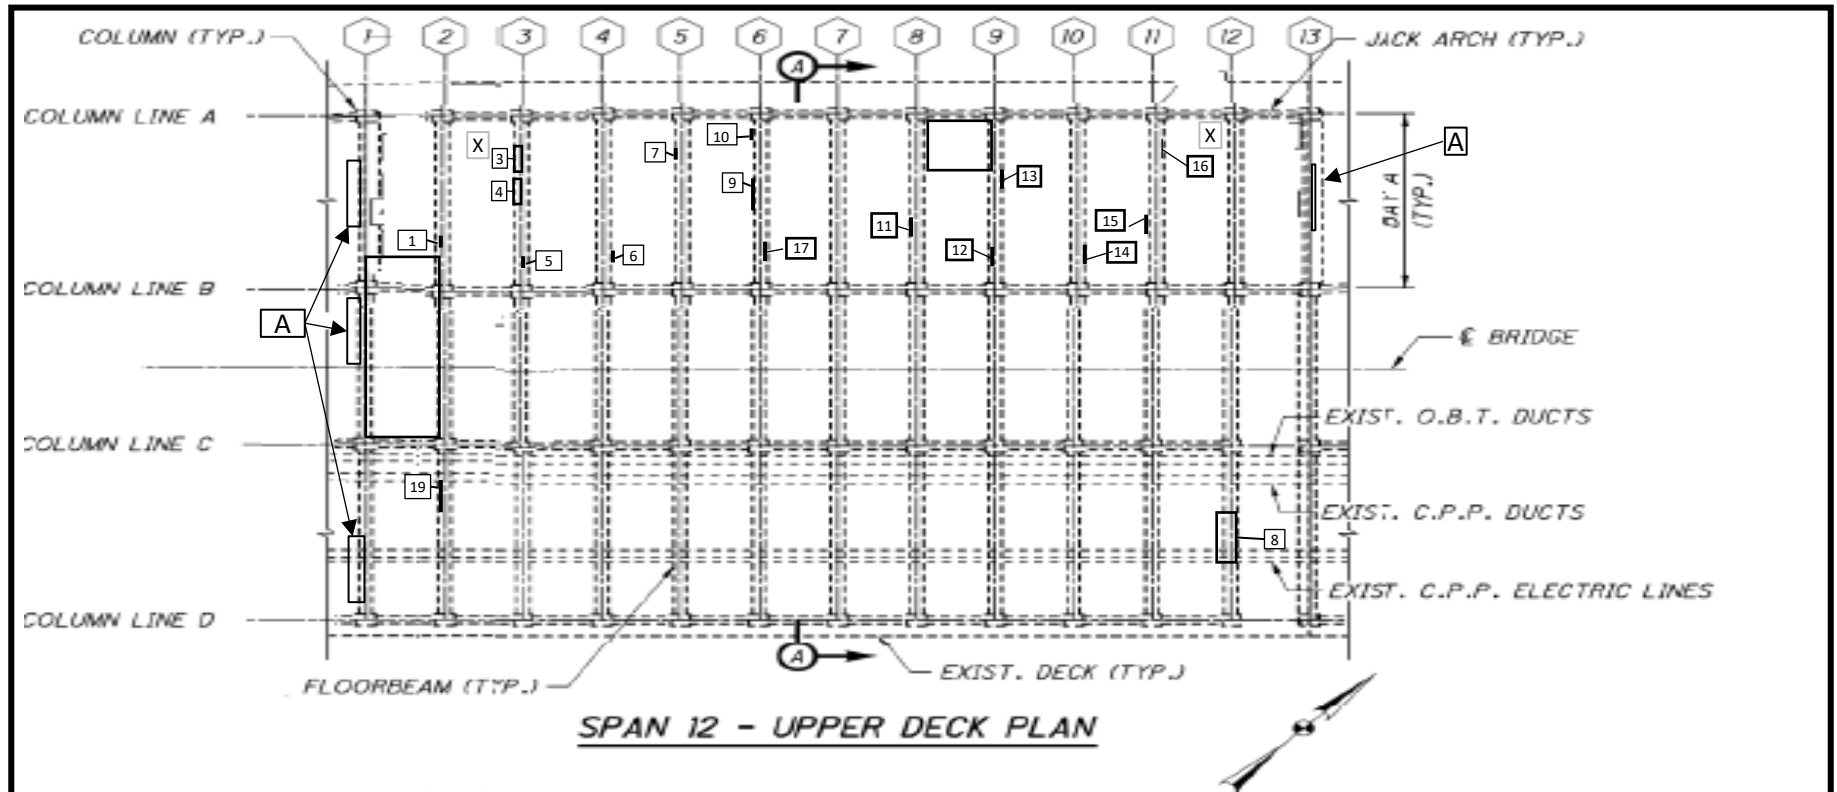
SPAN 12 - UPPER DECK PLAN

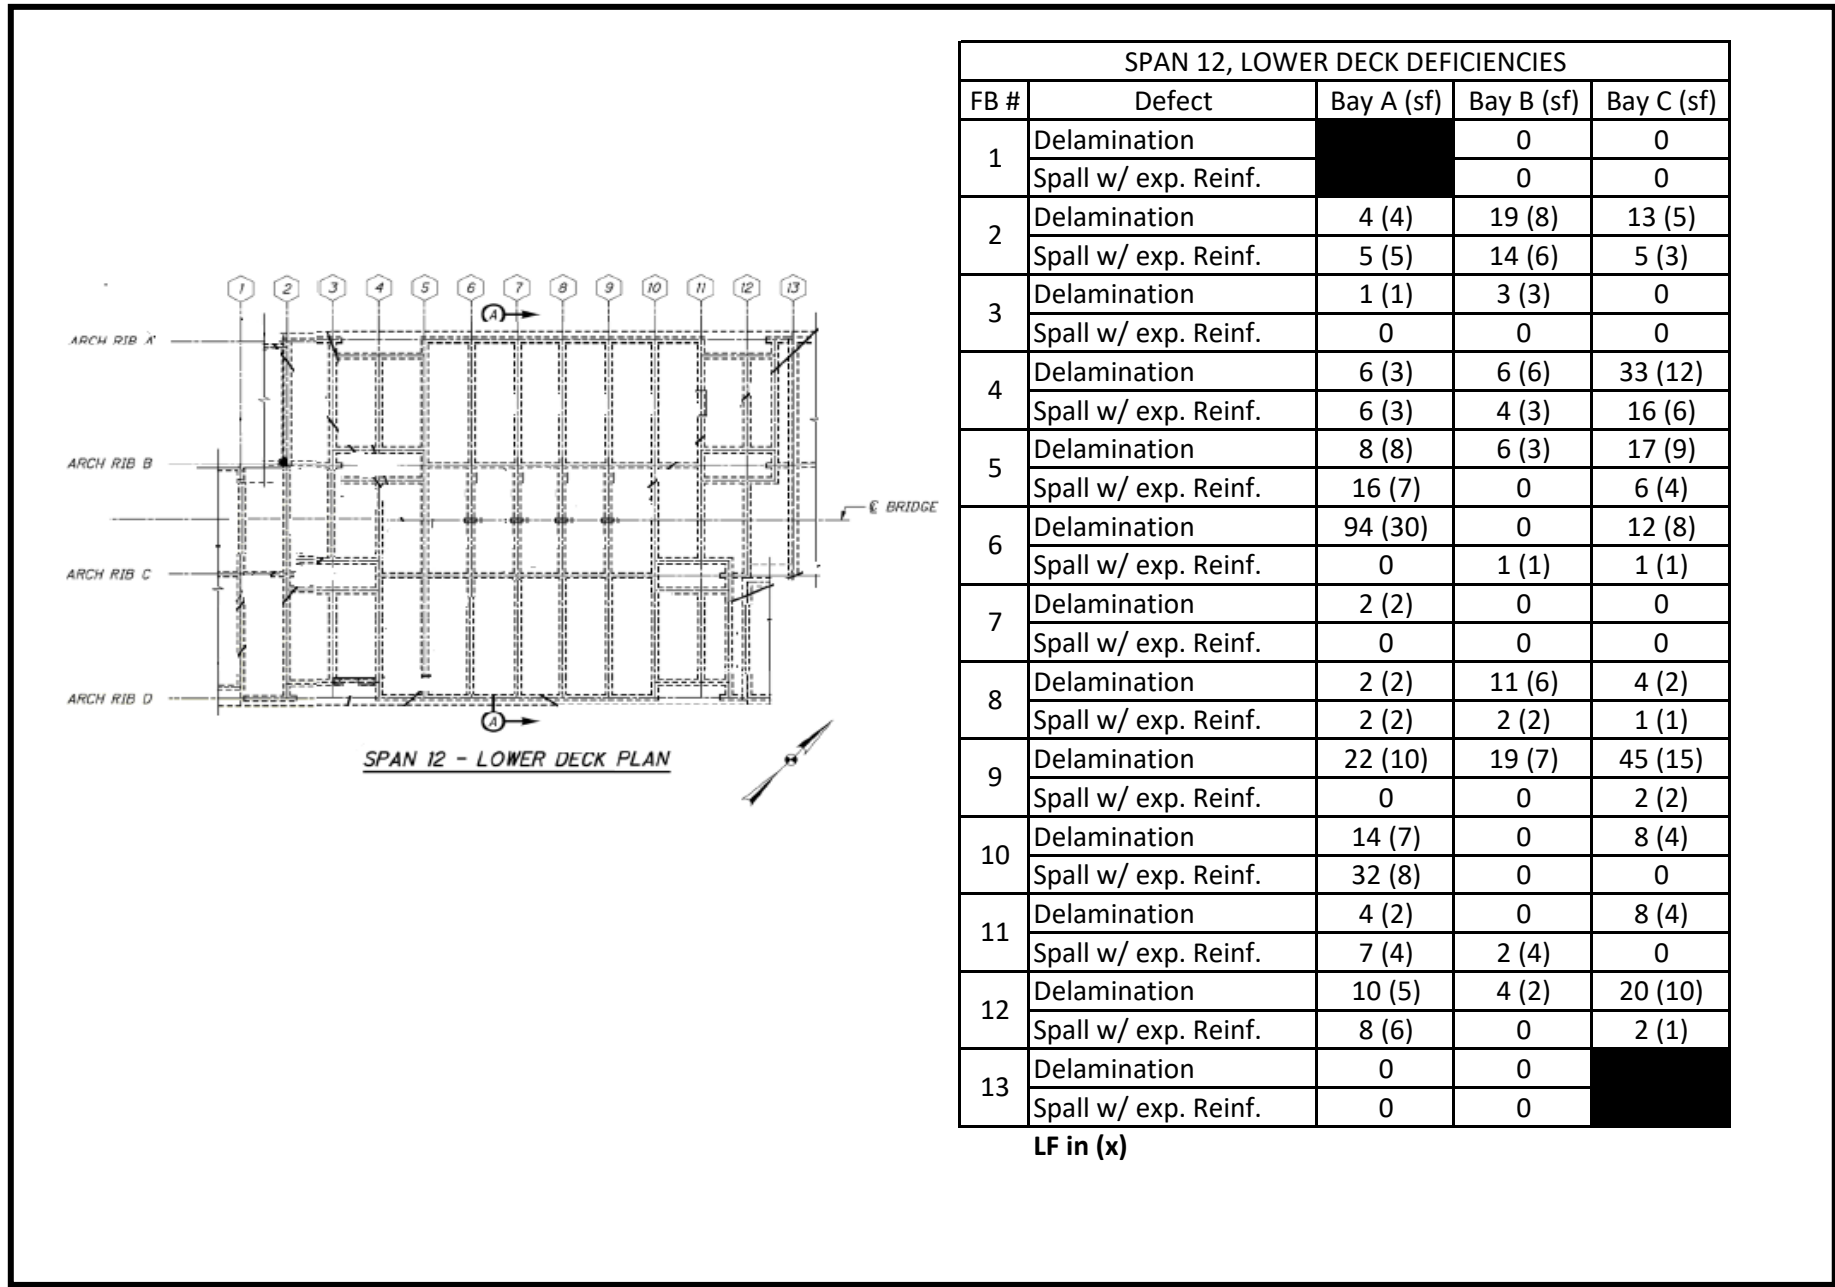
SPAN 12 - UPPER DECK FINDINGS:

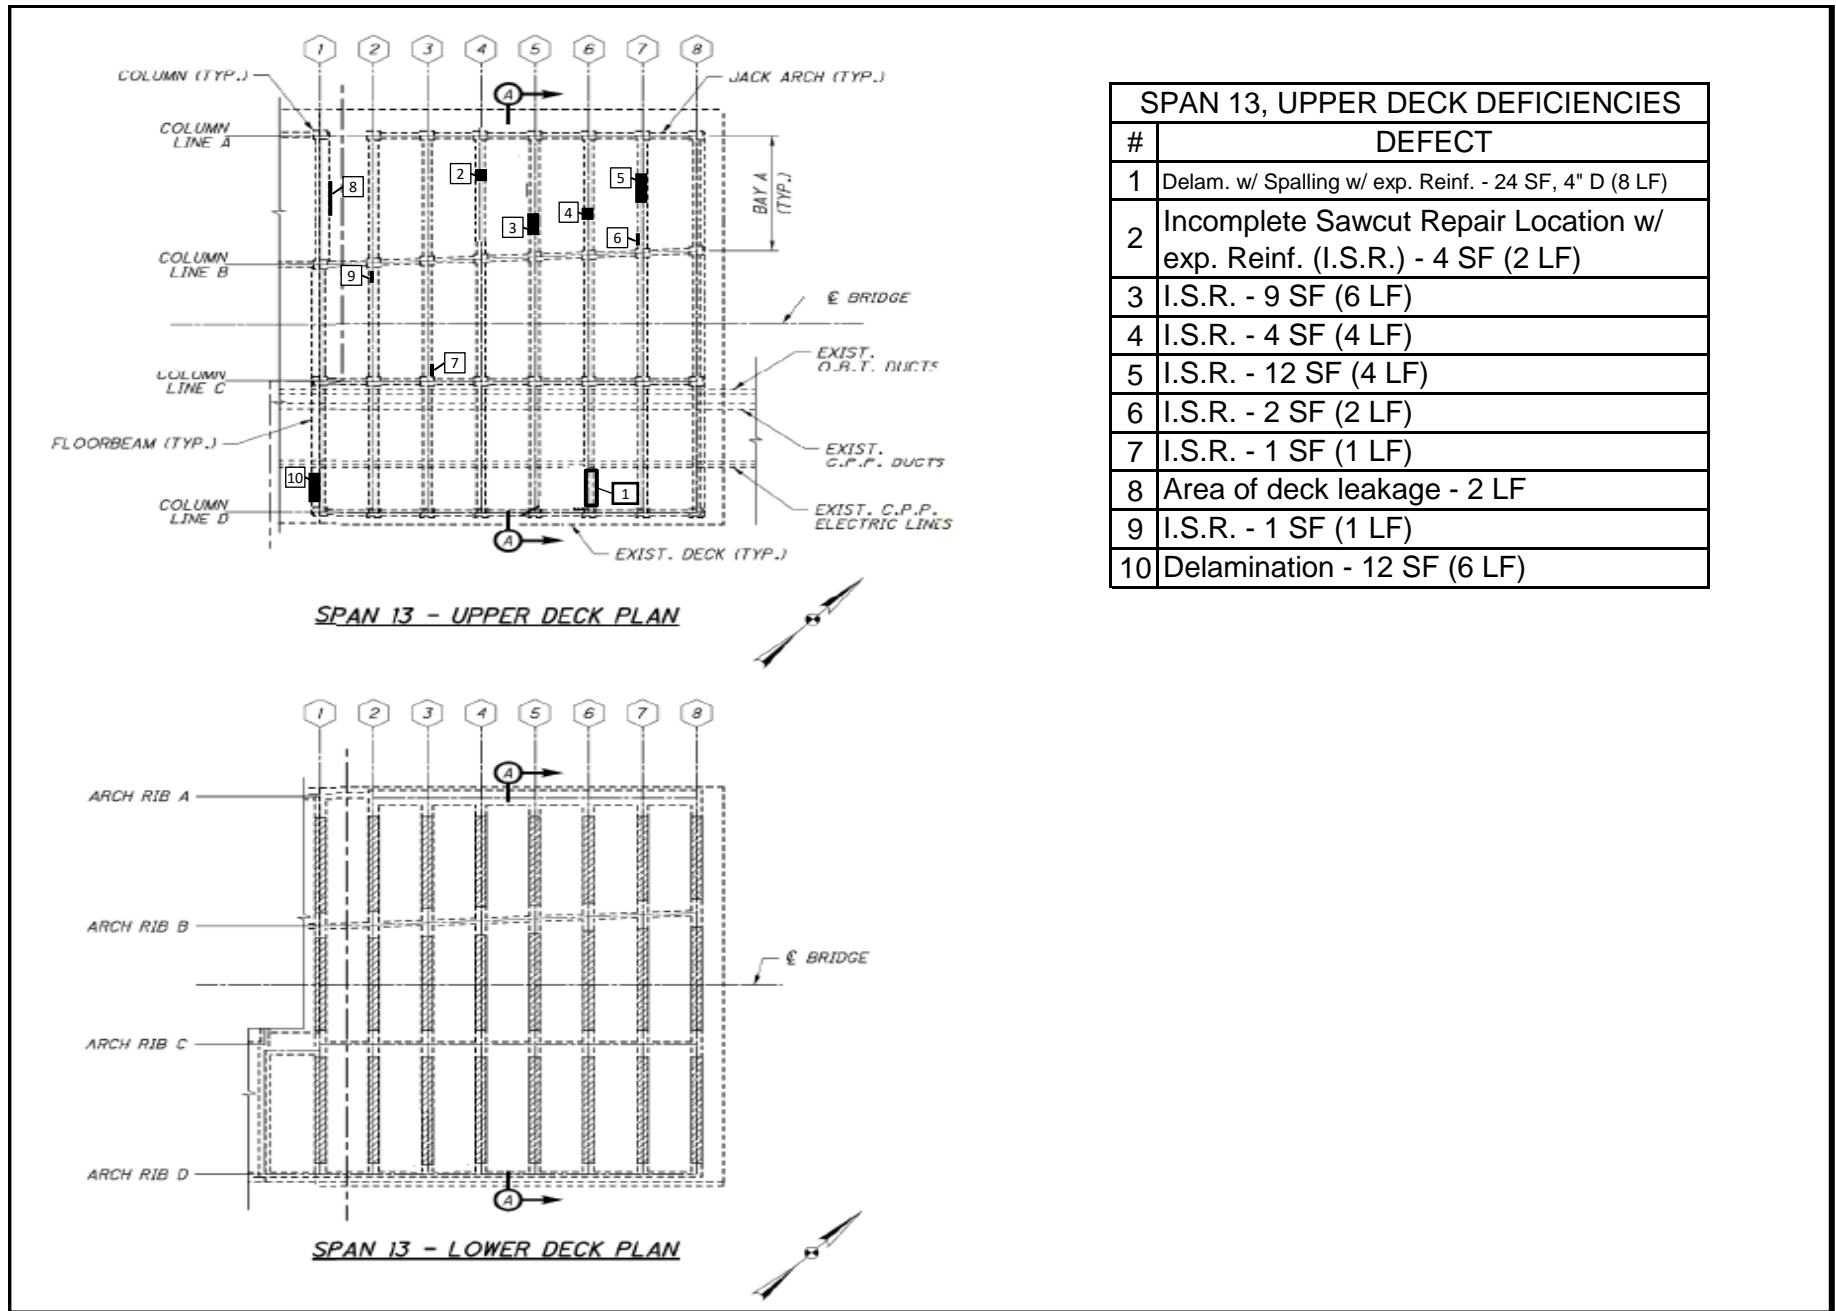
Joint	Location	Description
Pier 11	Ribs A-B	One plate missing and one displaced 3.5" east
	Ribs B-C	Two plates missing and one plate displaced up to 1.5" west
	Ribs C-D	Six plates displaced up to 6.5" west
Pier 12	Ribs A-B	One plate missing and three displaced up to 1" east

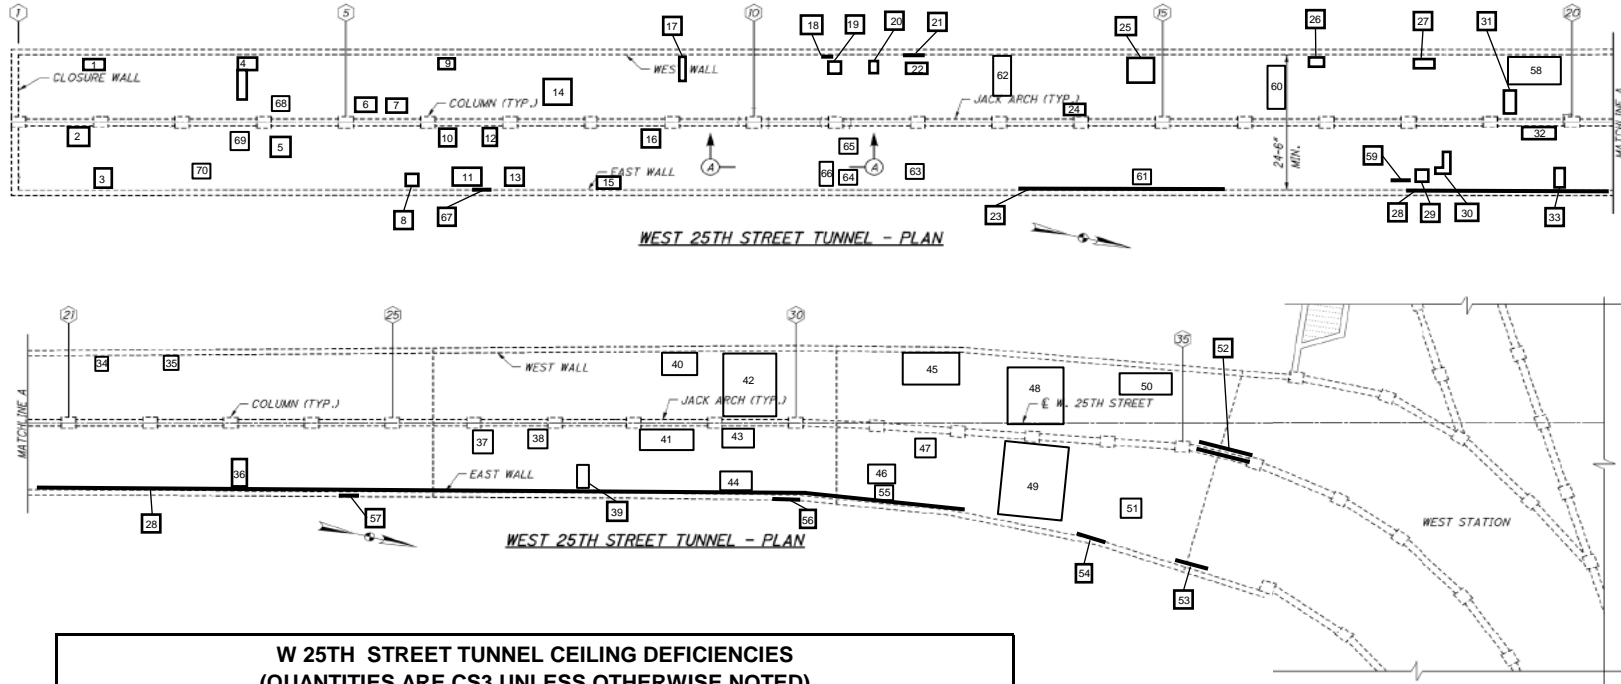
W 25TH STREET TUNNEL CEILING DEFICIENCIES (QUANTITIES ARE CS3 UNLESS OTHERWISE NOTED)									
#	SF	#	SF	#	SF	#	SF	#	SF
1	12	14	10	31	5	44	9	61	5
2	20	15	4	32	5	45	40	62	12 (CS2)
3	30	16	16	33	10 (CS2)	46	3	63	2
4	40	17	24	34	1	47	4	64	2
5	6	19	4	35	2	48	50	65	9 (CS2)
6	2	20	1	36	15	49	300	66	15
7	1	22	15	37	15	50	28	68	3
8	4	24	12	38	2	51	16	69	1
9	20	25	10	39	8	55	15	70	1
10	30	26	2	40	54	57	1		
11	16	27	6	41	45	58	30 (CS2)		
12	5	29	2	42	77	59	2		
13	25	30	5	43	9	60	10

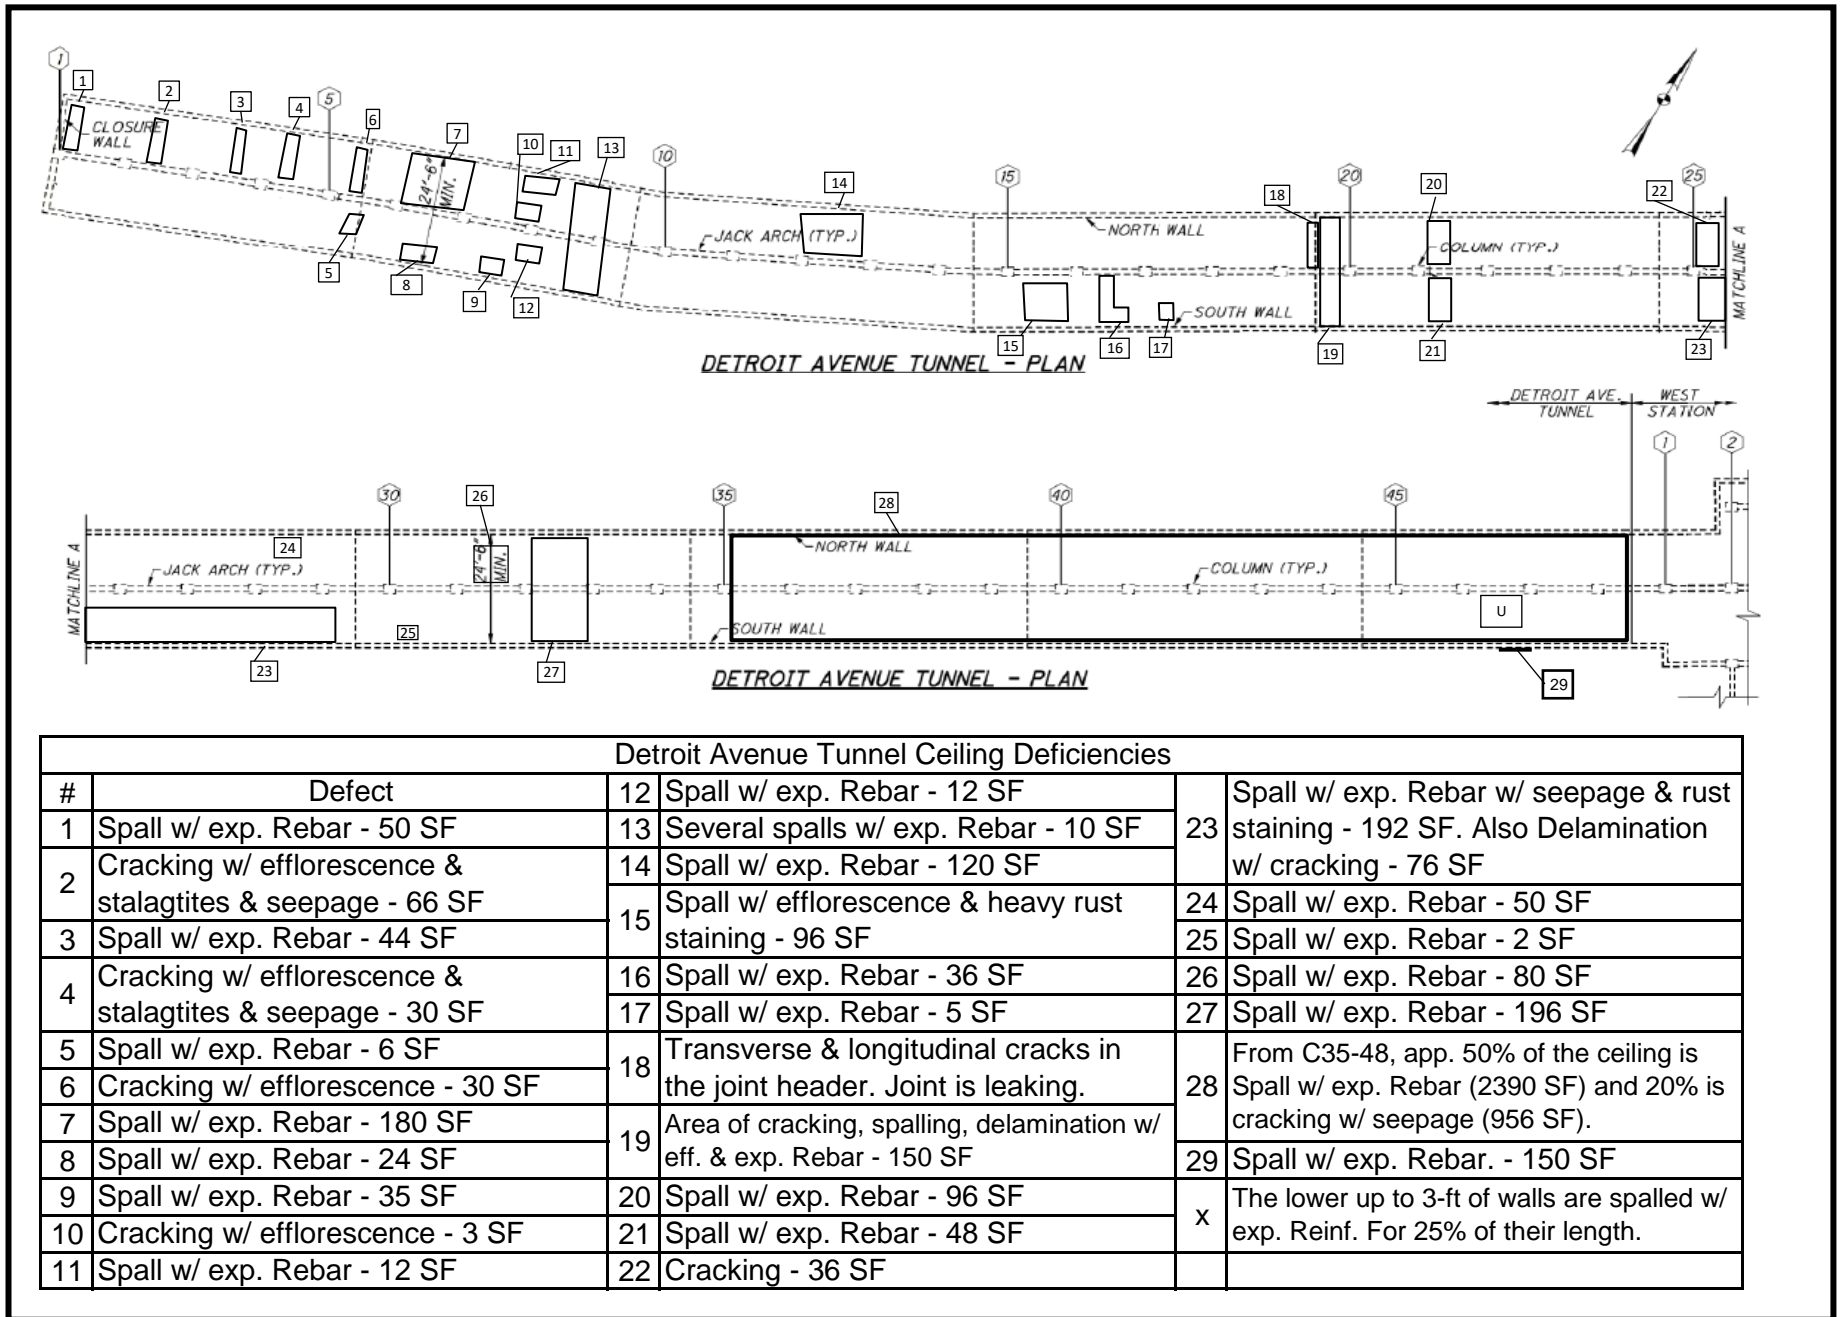
W 25TH STREET TUNNEL DEFICIENCIES	
#	Comments
18	Bottom of wall - 2 SF
21	Bottom of wall - 18 SF
23	Bottom of wall - 60 SF
28	Bottom of wall - 2.5' high spalling from columns
52	Top of arch - 75% of length, both faces
53	Wall - Full Height x 4' Spall w/ exp. Reinf.
54	Top of Wall - 12 SF
56	Top of wall - 10 SF Spall w/ exp. Reinf.
67	Top of wall - 4 SF Spall w/ exp. Reinf.

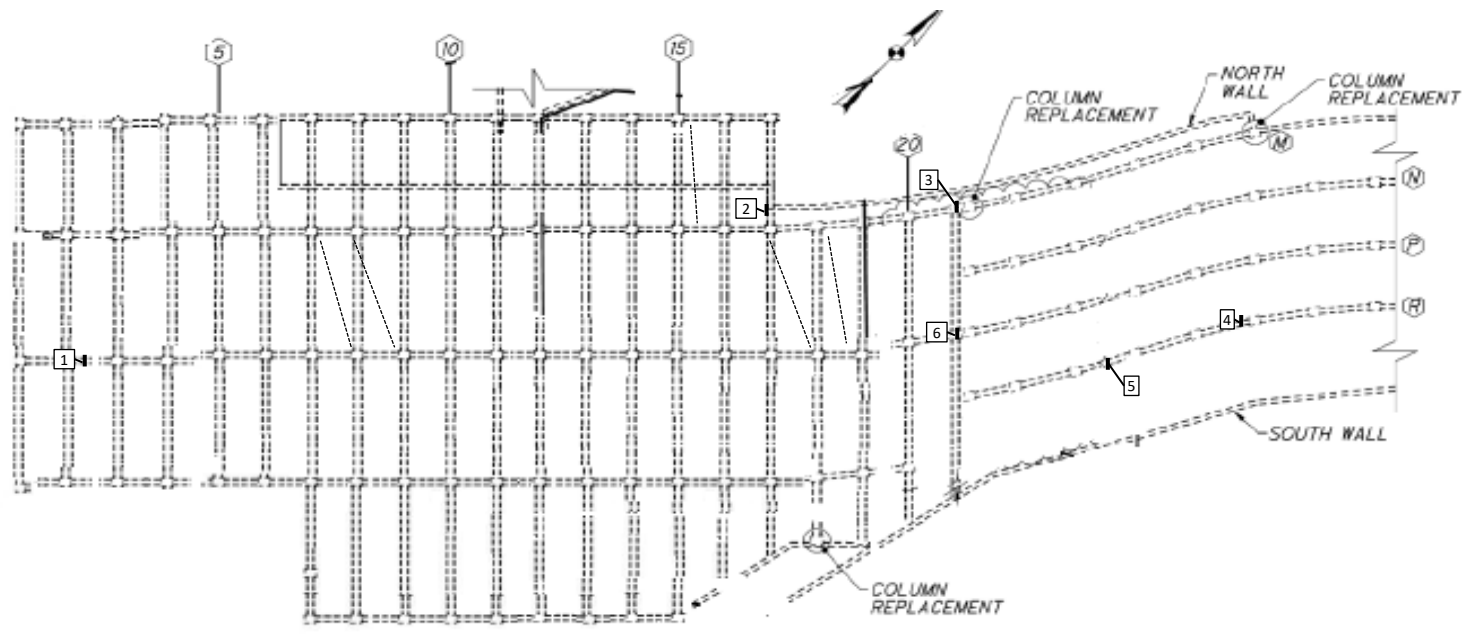
EAST STATION & SUBWAY - PLAN

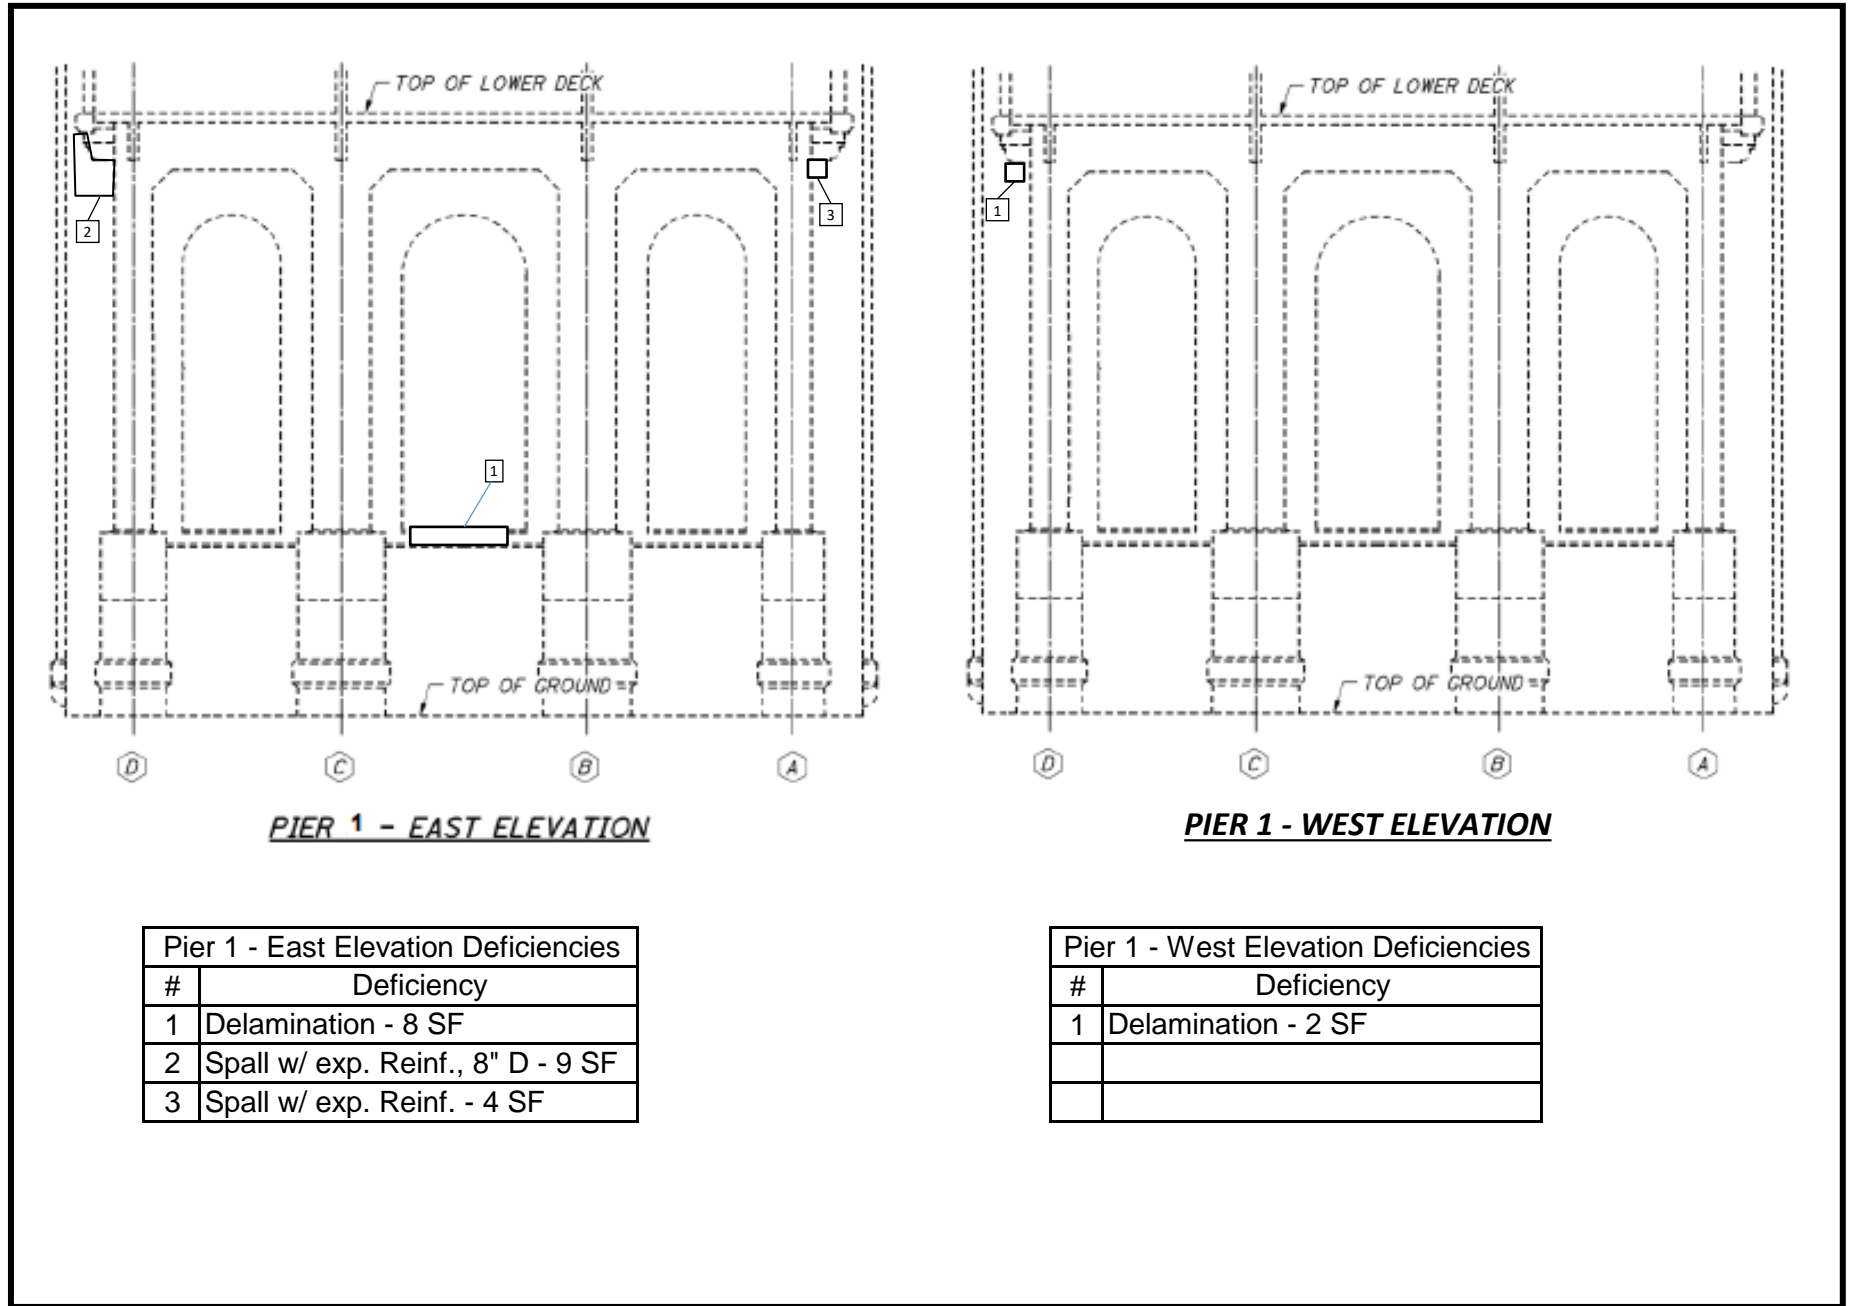
EAST STATION & SUBWAY DEFICIENCIES	
#	DEFECT
1	Spall w/ exp. Reinf. - 1 SF, 1" D (underside of arch)
2	Spall w/ exp. Reinf. - 24 SF (in wall) and Spall - 6 SF (in btm of FB)
3	Spall w/ exp. Reinf. - 6 SF (top of Col. 22)
4	Spall w/ exp. Reinf. (N. side of jack arch 26-27) - 1 SF (1 LF)
5	Spall w/ exp. Reinf. (S. side of jack arch 24-25) - 1 SF (1 LF)
6	Delamination (Both sides of Col. 22) - 2 SF

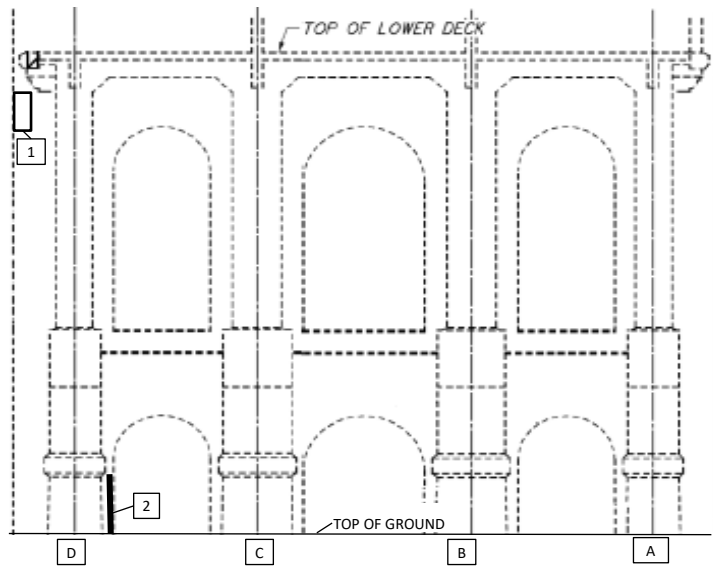
PIER 2 - EAST ELEVATION

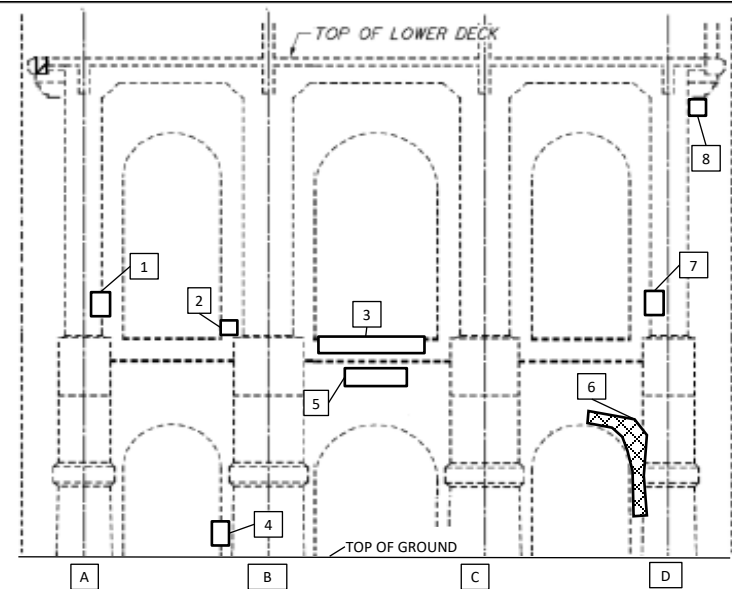
PIER 2 - WEST ELEVATION

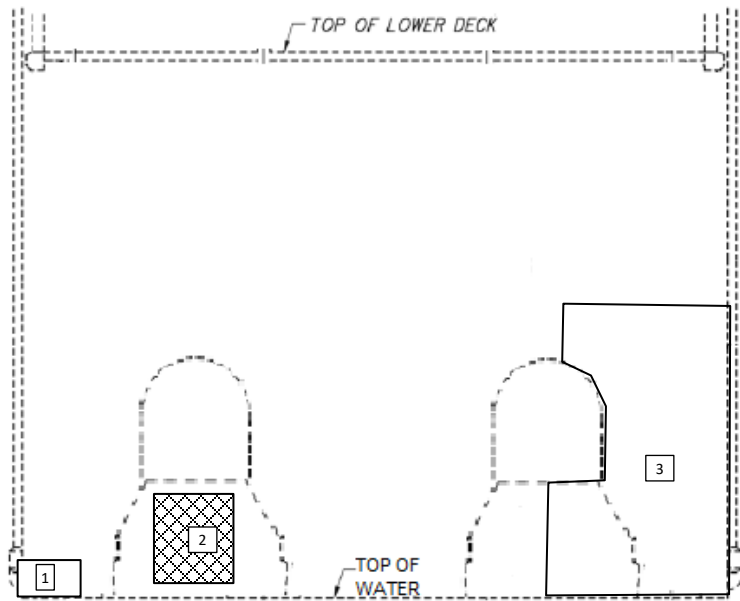
PIER 3 - EAST ELEVATION

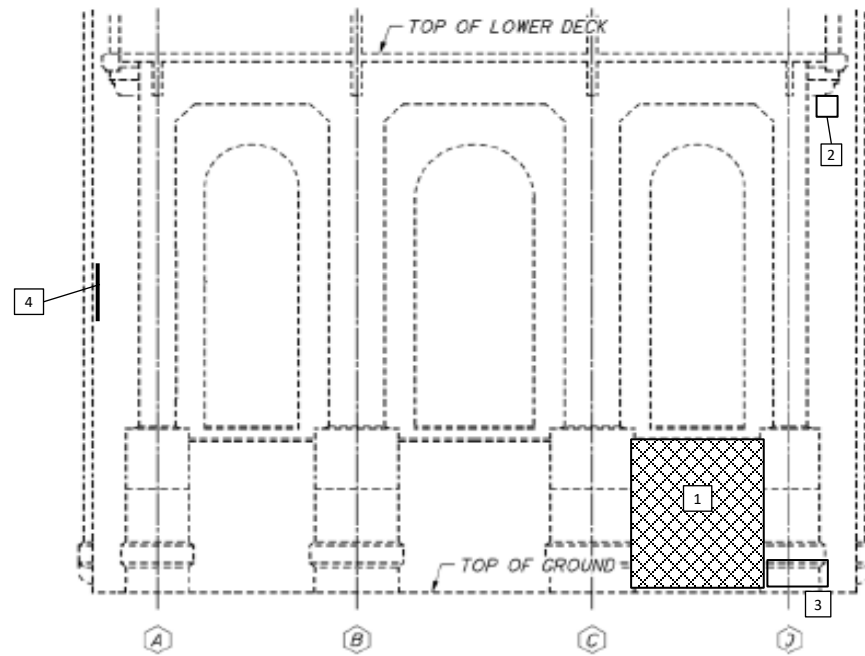
PIER 3 - WEST ELEVATION
