Physical Condition Report for

CUY-006-1456

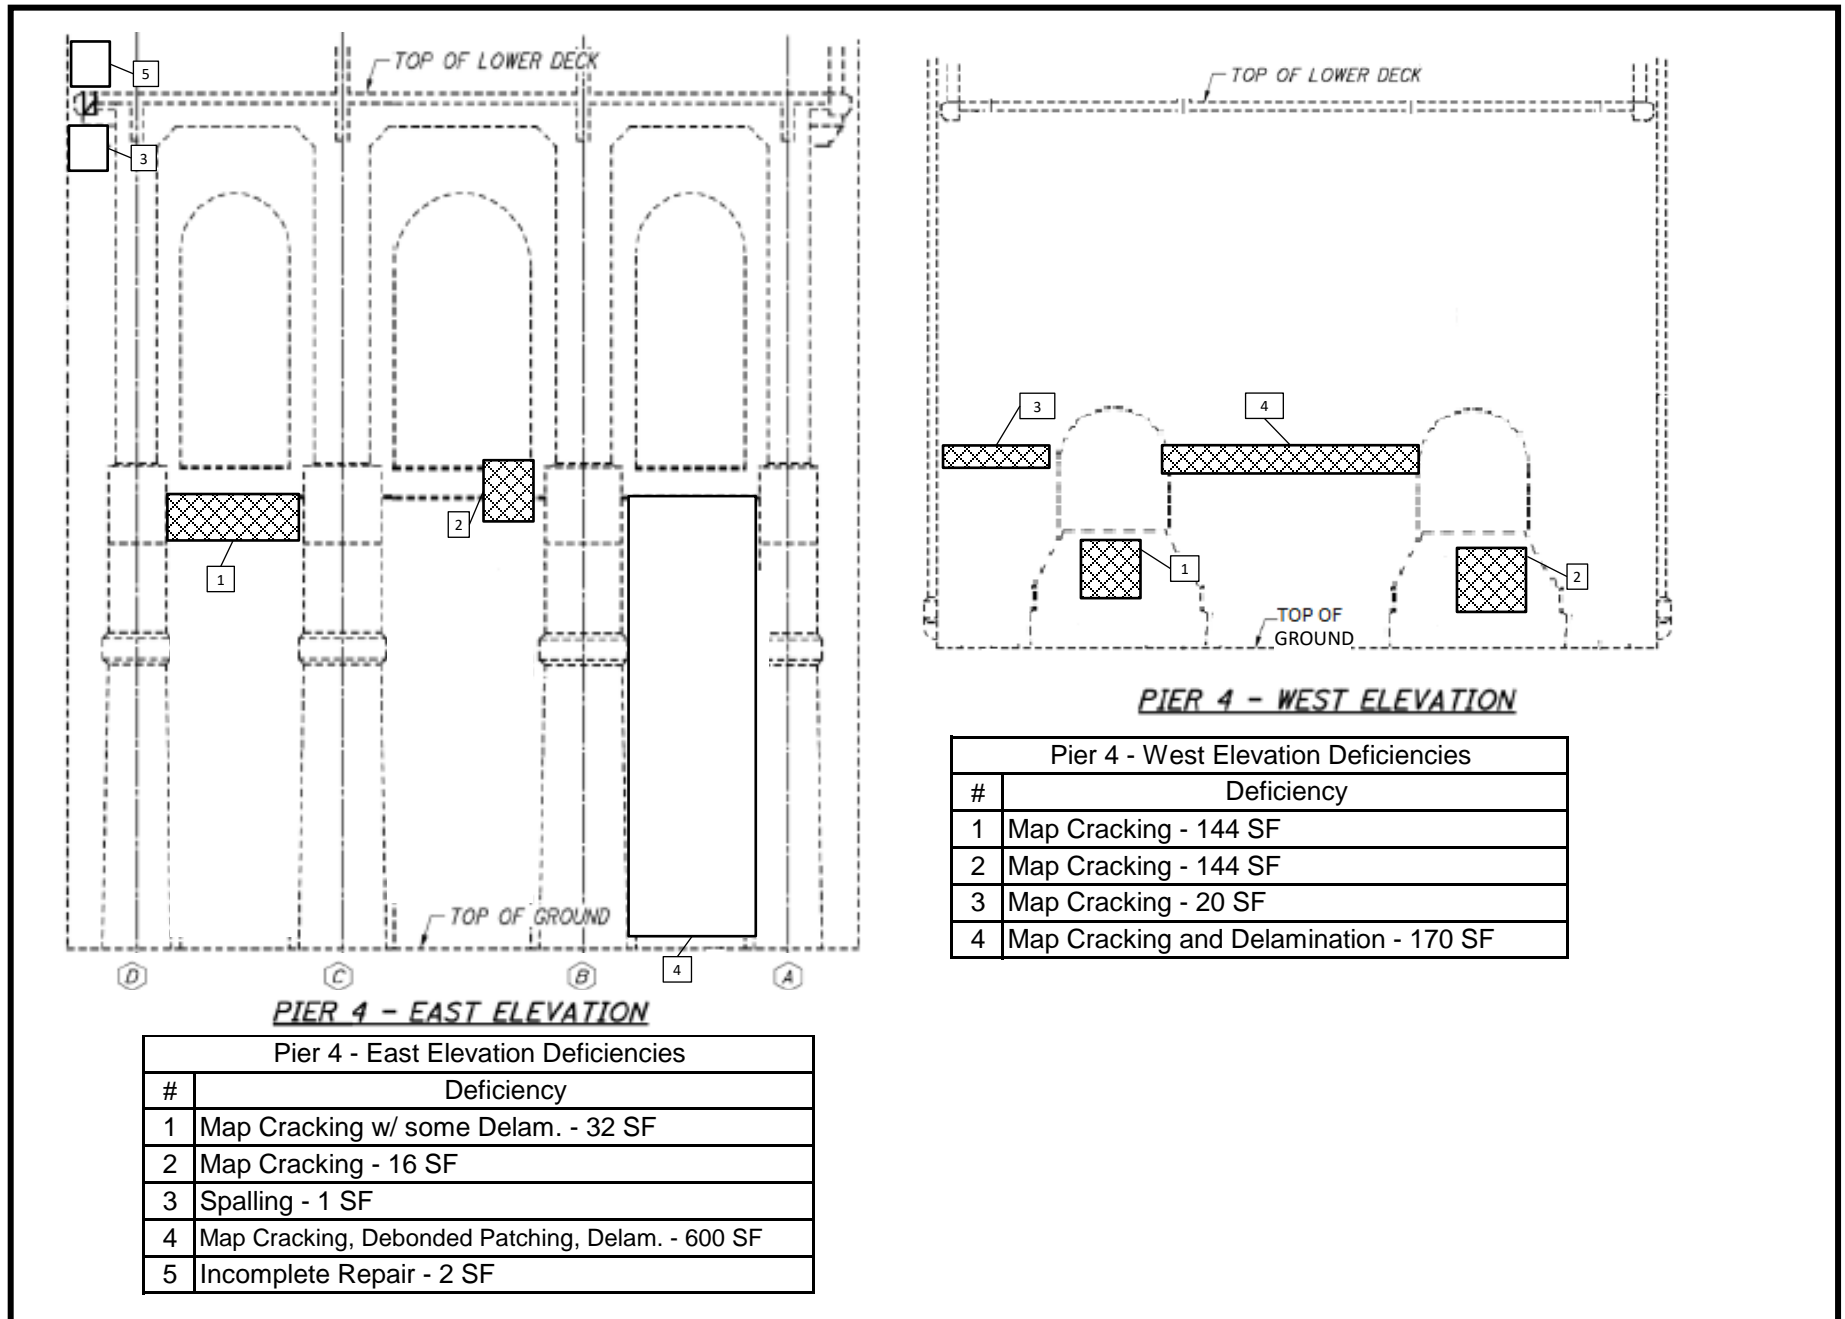
Pier 3 - West Elevation Deficiencies	
#	Deficiency
1	Map Cracking - 80 SF
2	Spall - 1 SF
3	Base of pier has 1" D abrasion for 1' above the waterline. Embankment is steep and erodible despite placement of rubble rip rap.
4	Spall w/ exp. Reinf., 1.5" D - 5 SF

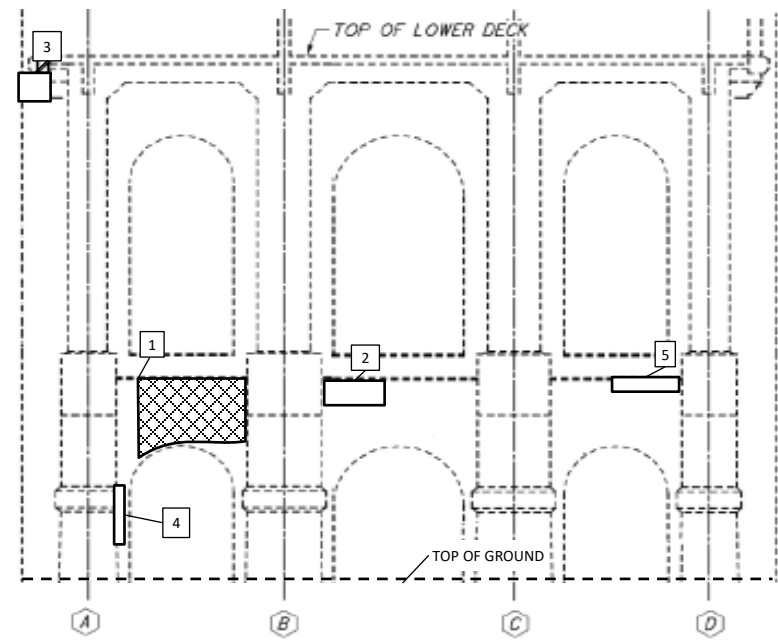
PIER 10 - EAST ELEVATION

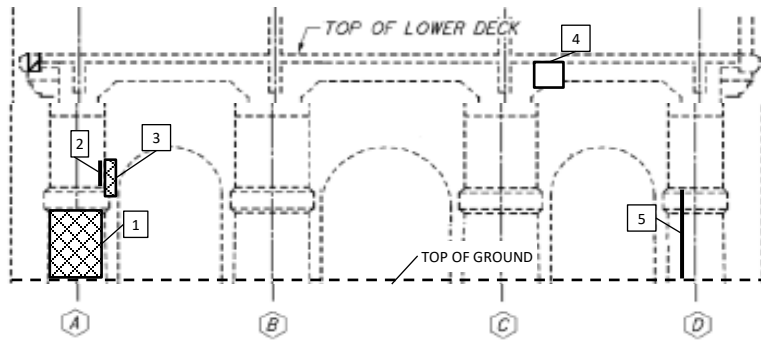
PIER 11 - WEST ELEVATION

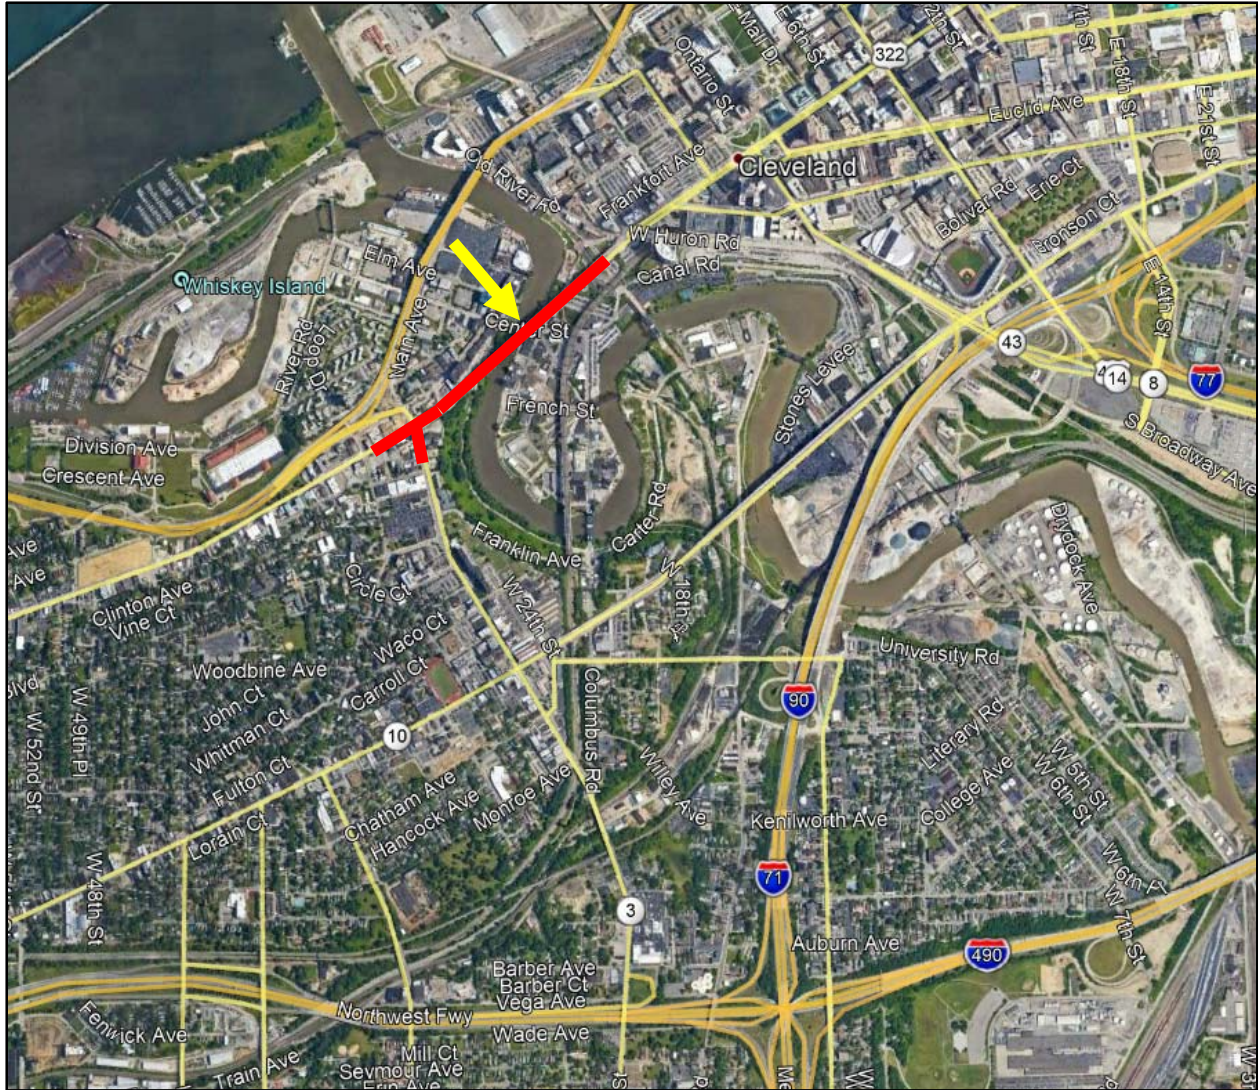
Figure 2: CUY-6-1456 in Cleveland over the Cuyahoga River

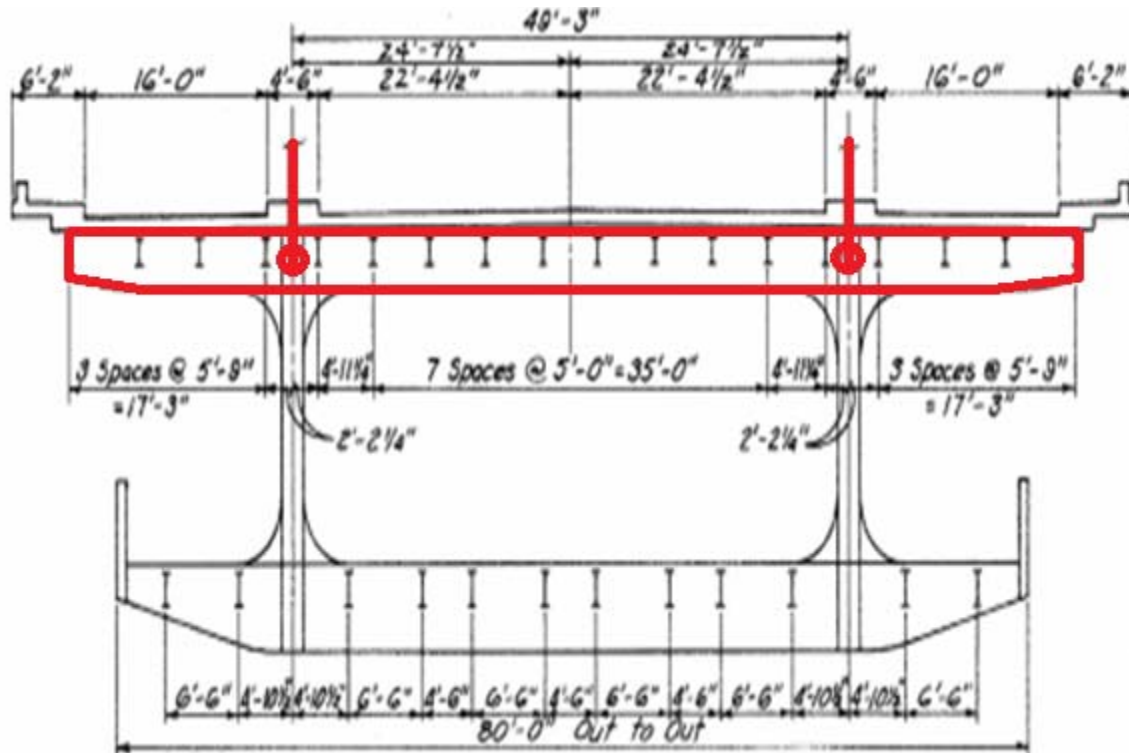
Figure 4: Fracture Critical Member Locations (Highlighted Red)

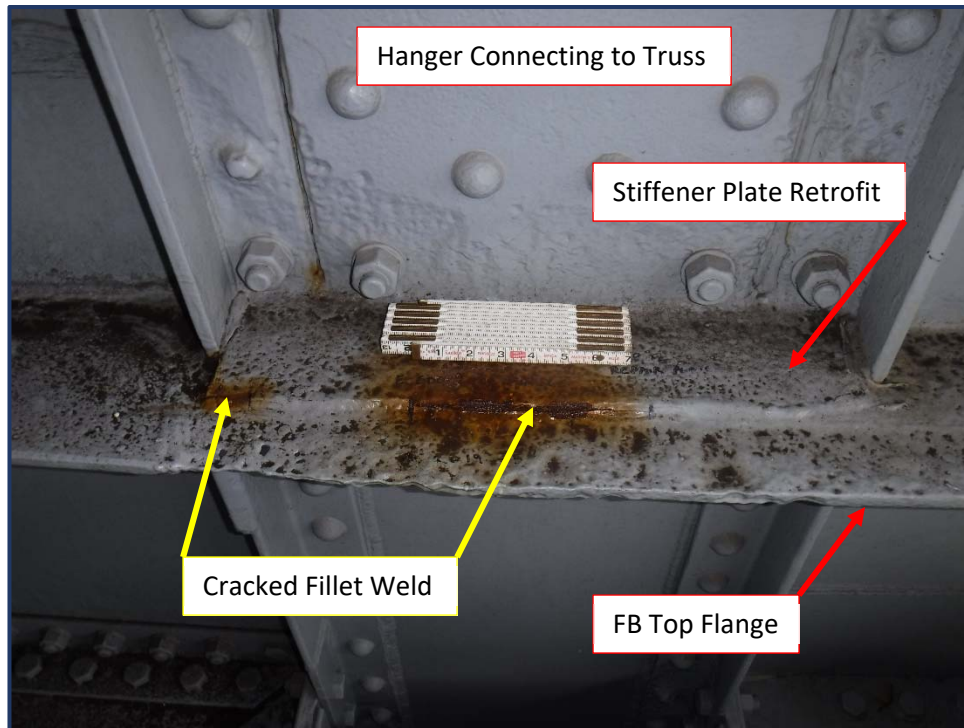
Photo 1a – Cracking at Lower Deck Floorbeam Stiffener Plate Retrofit

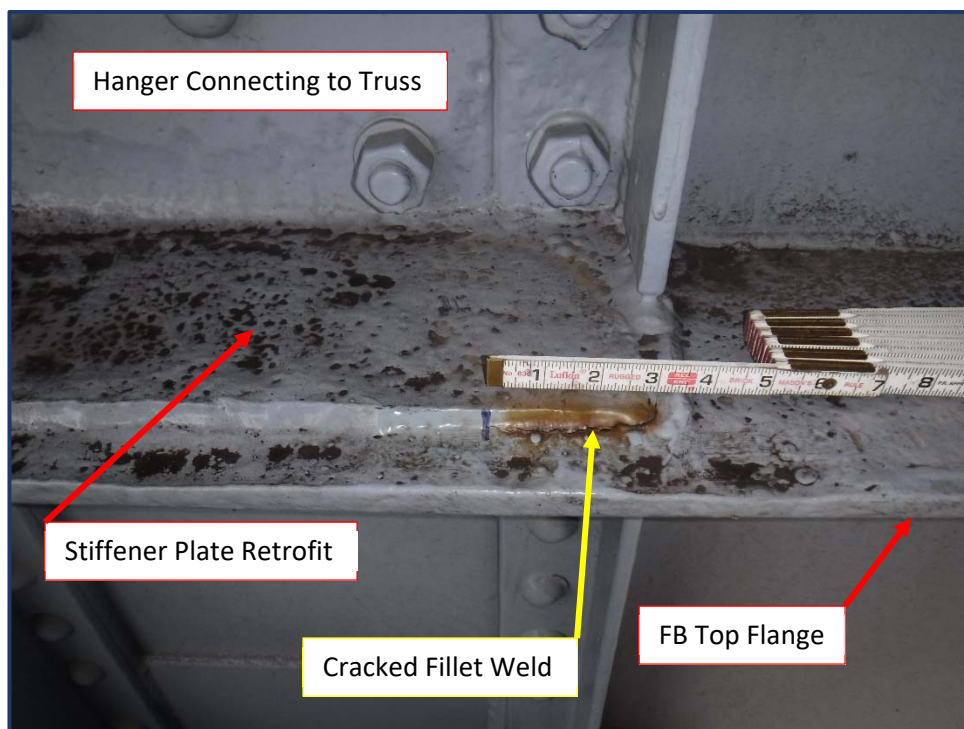
Photo 1b – Cracking at Lower Deck Floorbeam Stiffener Plate Retrofit
