Physical Condition Report for

CUY-006-1456

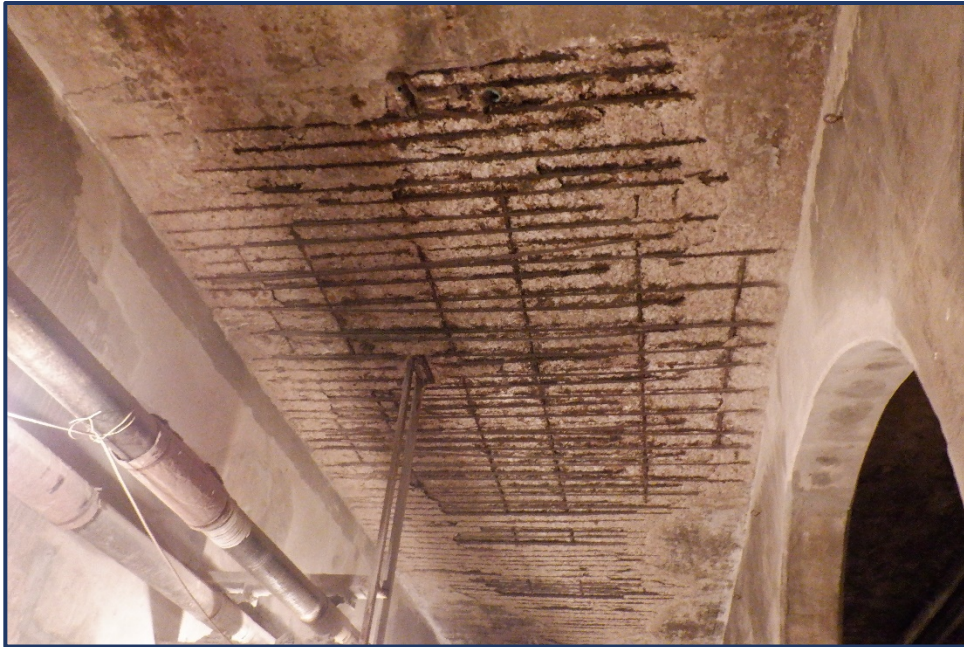
Photo 12-1 – Detroit Ave Tunnel, Typical Spalling of Non-structural Deck

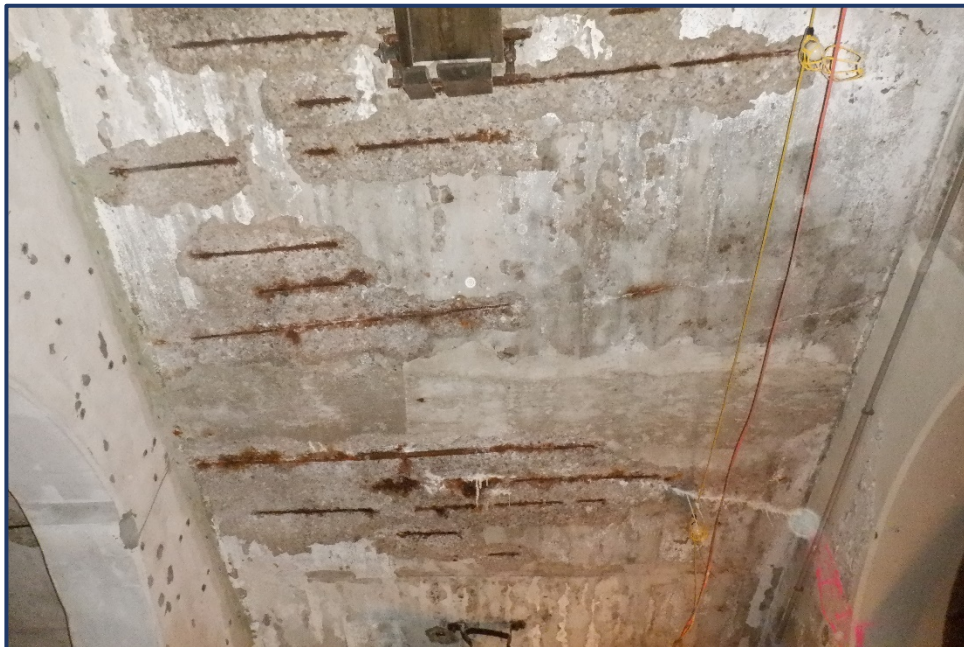
Photo 12-2 – West Station, Typical Scattered Deck Spalling with Saturation and Efflorescence

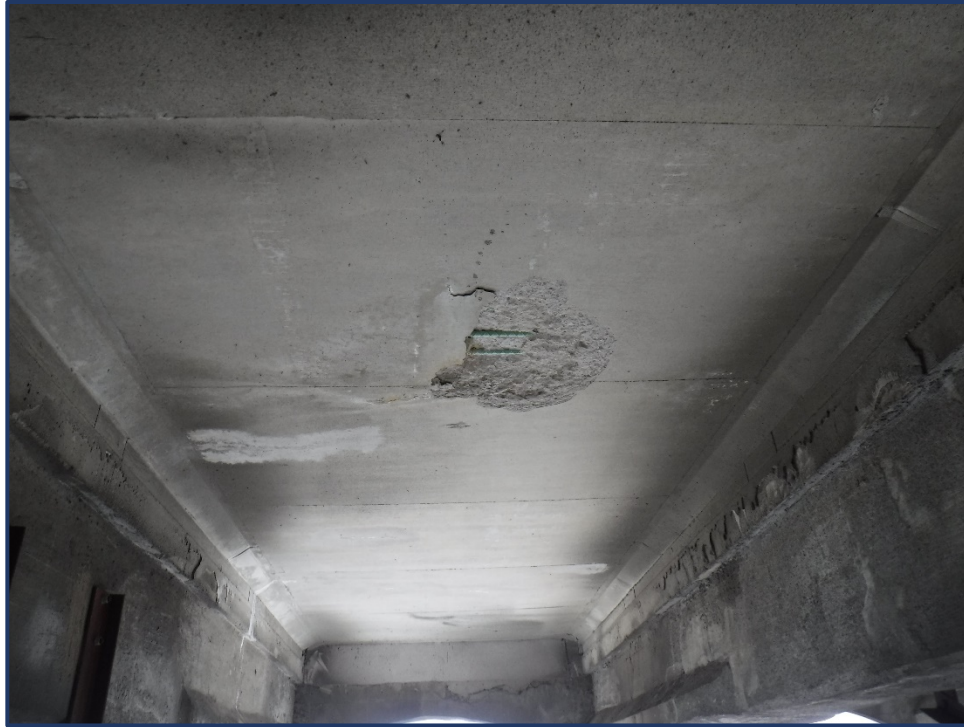
Photo 12-3 – Main Spans, Typical Scattered Deck Spalling

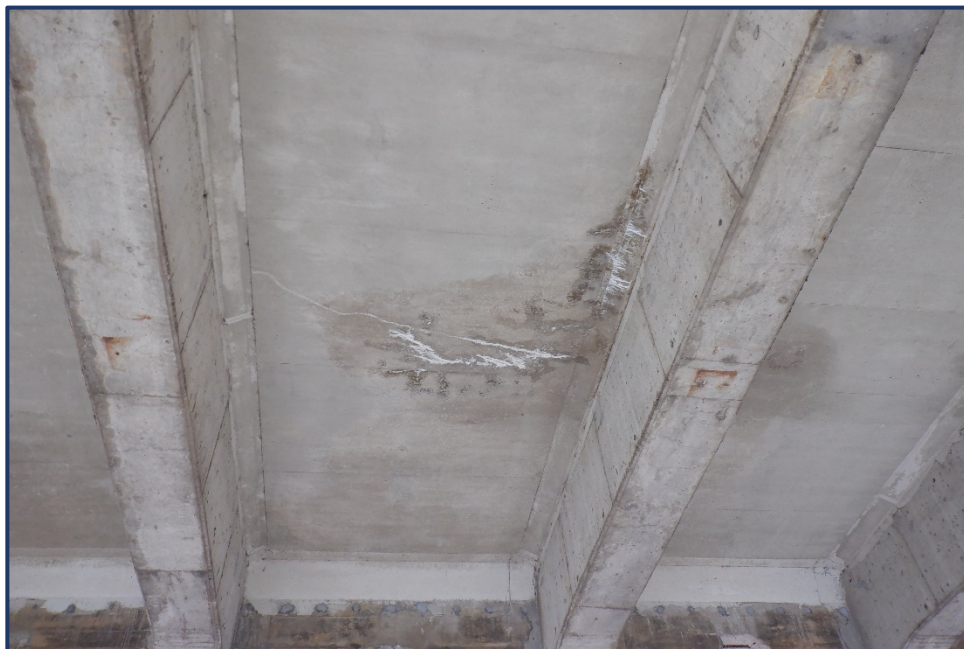
Photo 12-4 – Main Spans, Deck Saturation with Mottling and Efflorescence

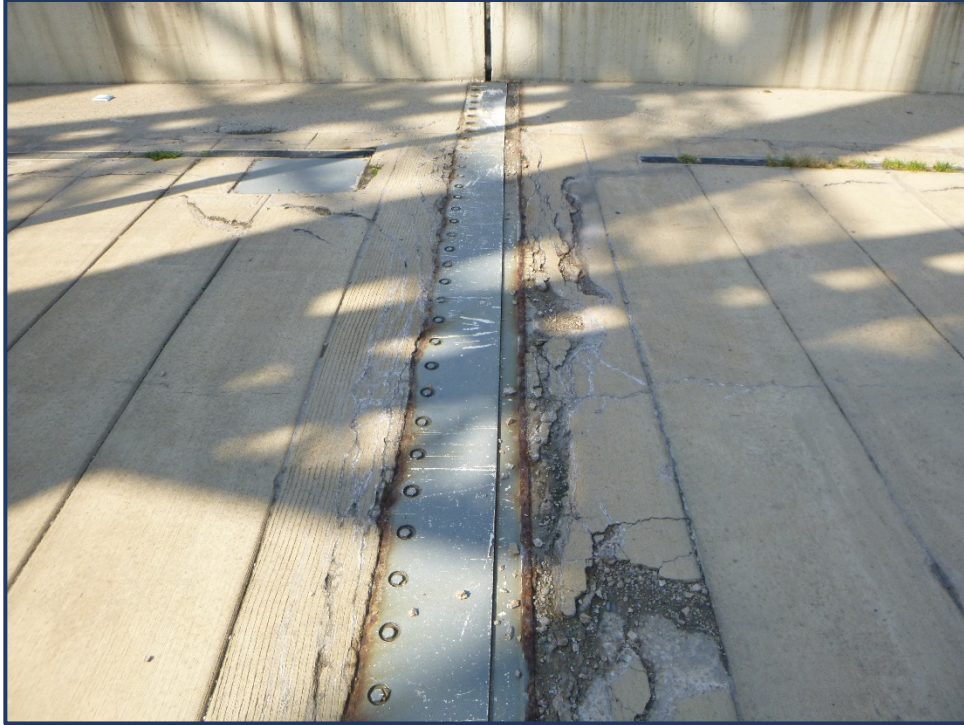
Photo 300-2 – Joint in Span 4 at PP5, Spalling and Cracking of Header at North Sidewalk Expansion Joint

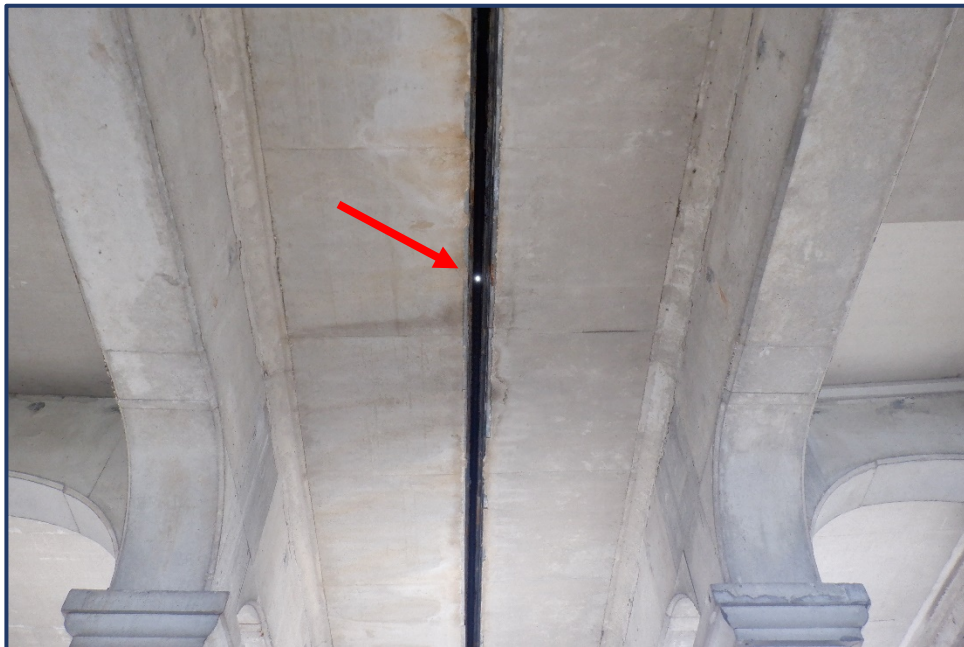
Photo 300-3 – Pier 10 Joint, 4' Section of Seal Tearing

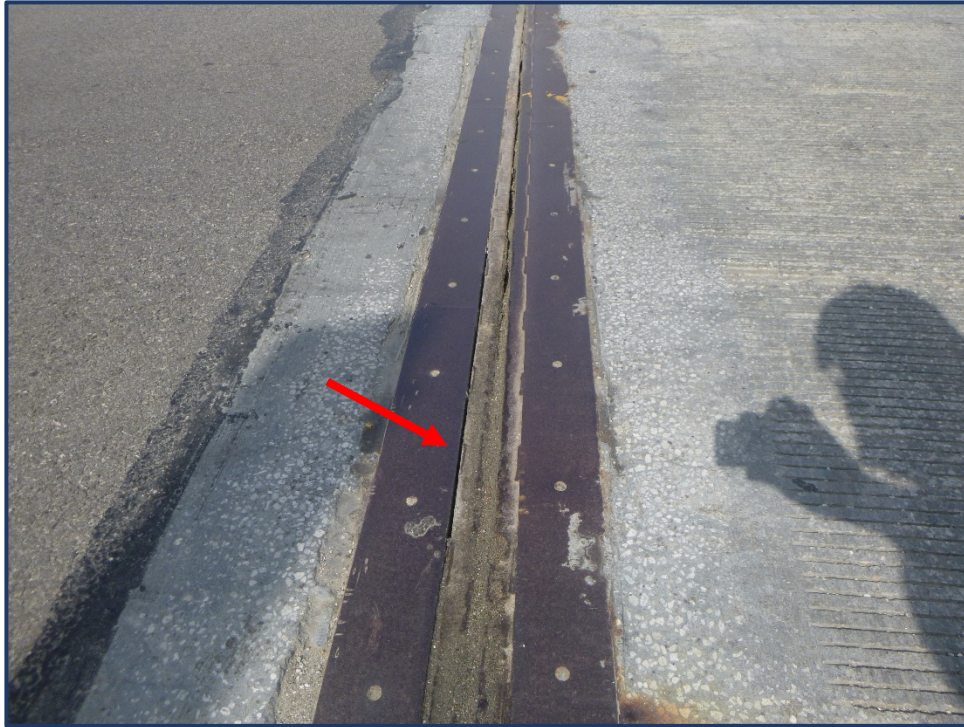
Photo 300-4 Joint 1A, 2' Section of Broken Intermittent Fillet Welds in Joint Armor

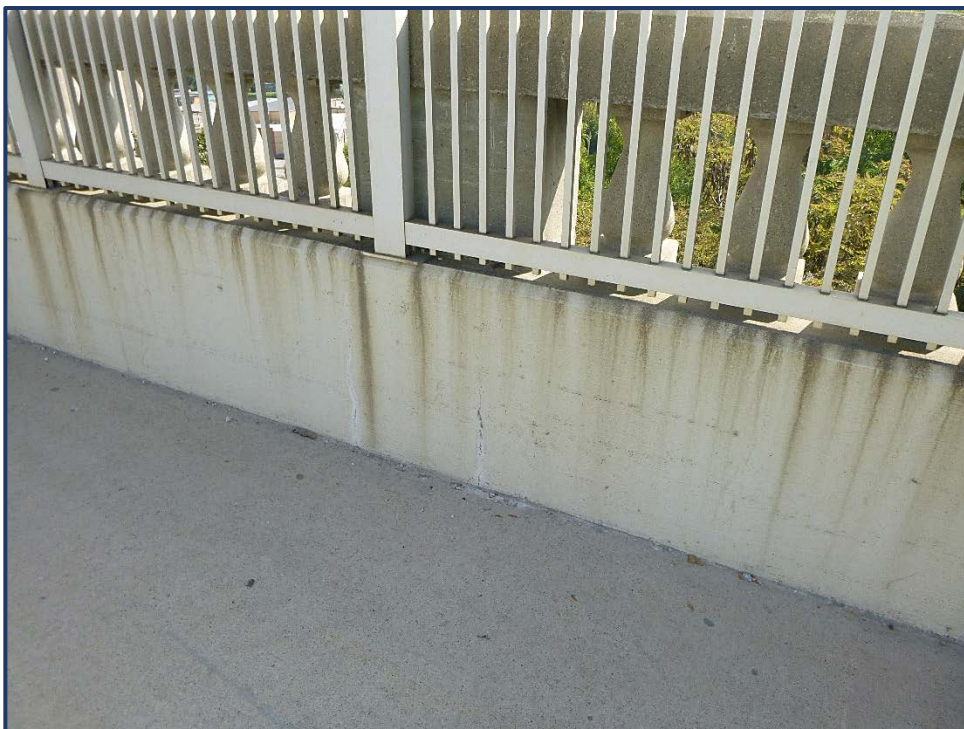
Photo 331-1 – South Rail, Typical Cracking and Staining

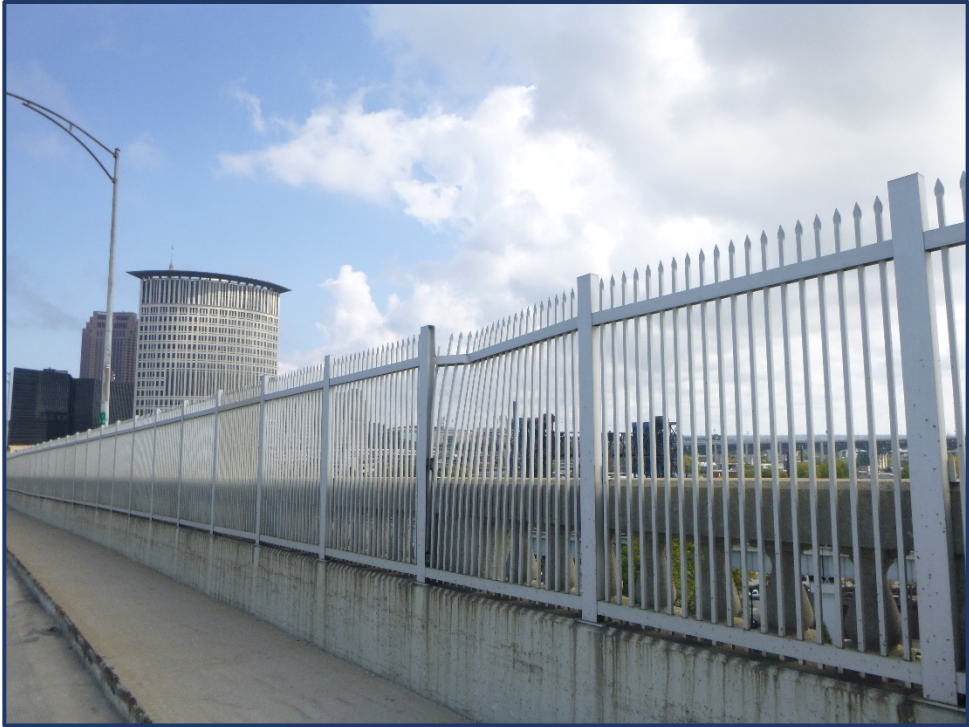
Photo 331-2 – South Rail Fence, Area of Damage in Span 5

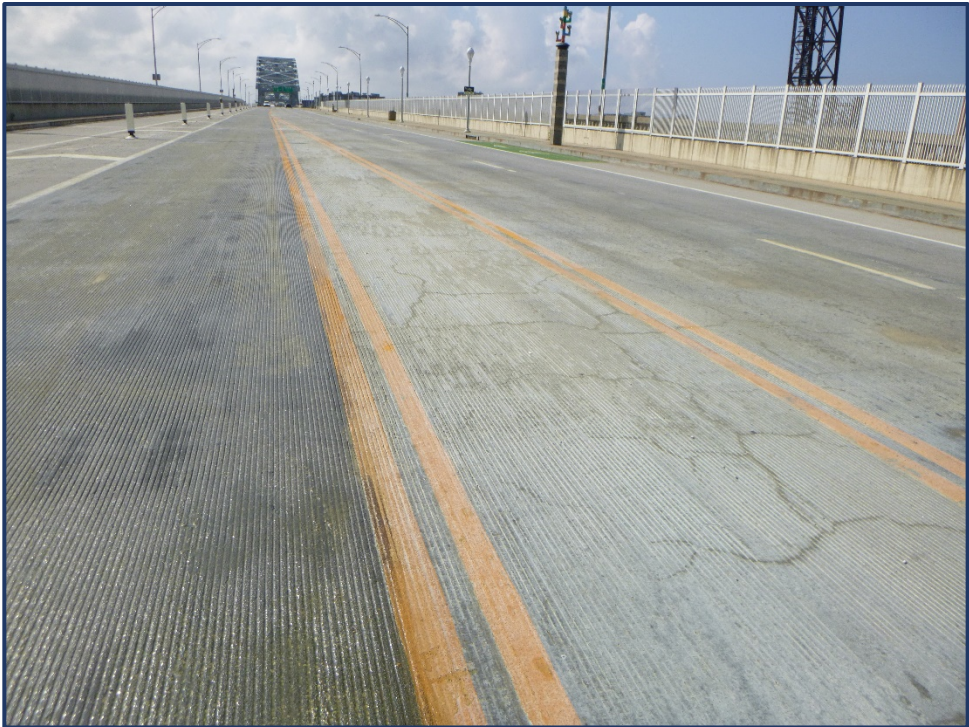
Photo 510-1 – Map Cracking in Wearing Surface

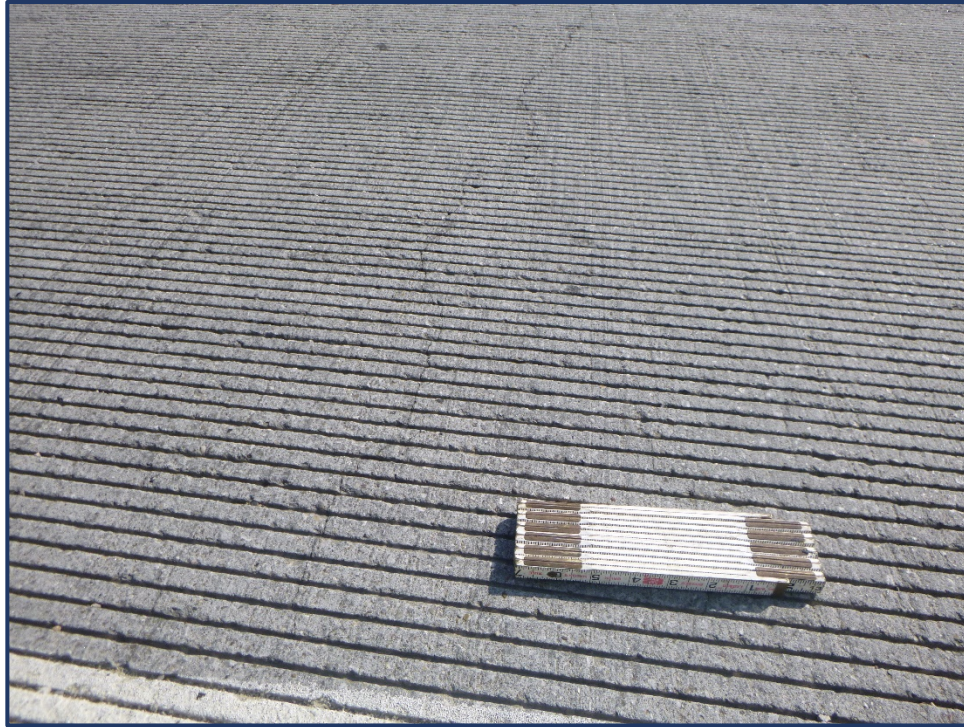
Photo 510-2 – Map Cracking in Wearing Surface

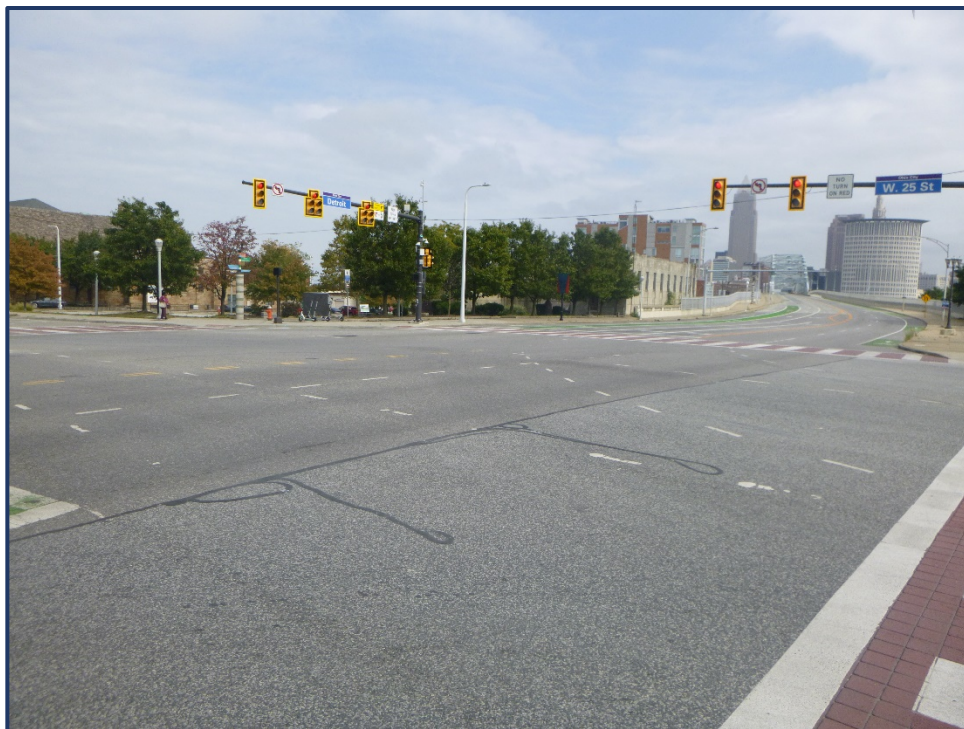
Photo 510-3 – West Station, Areas of Cracking in Wearing Surface

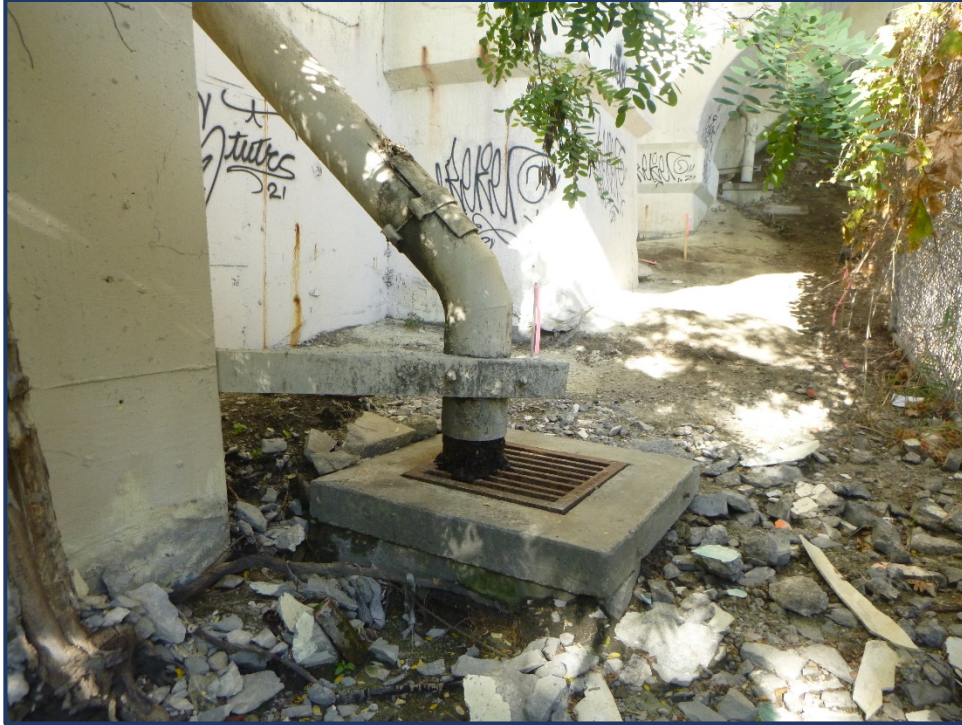
Photo 815-1 – Pier 1, East Face, South Downspout Fully Clogged.

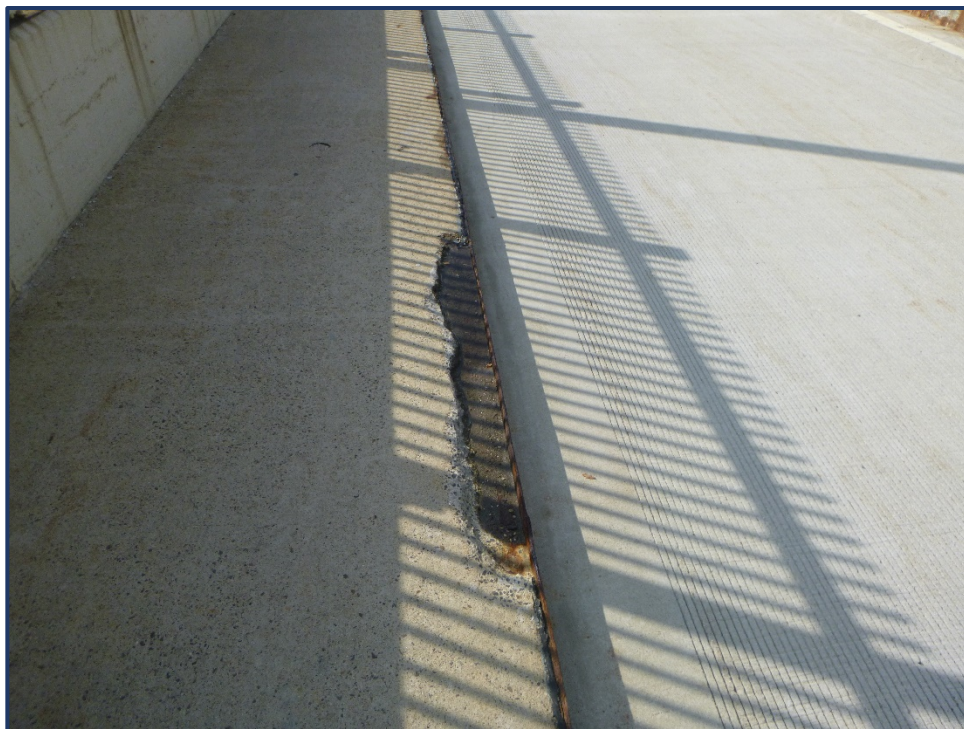
Photo CS-1 – South Sidewalk, Typical Edge Spalling

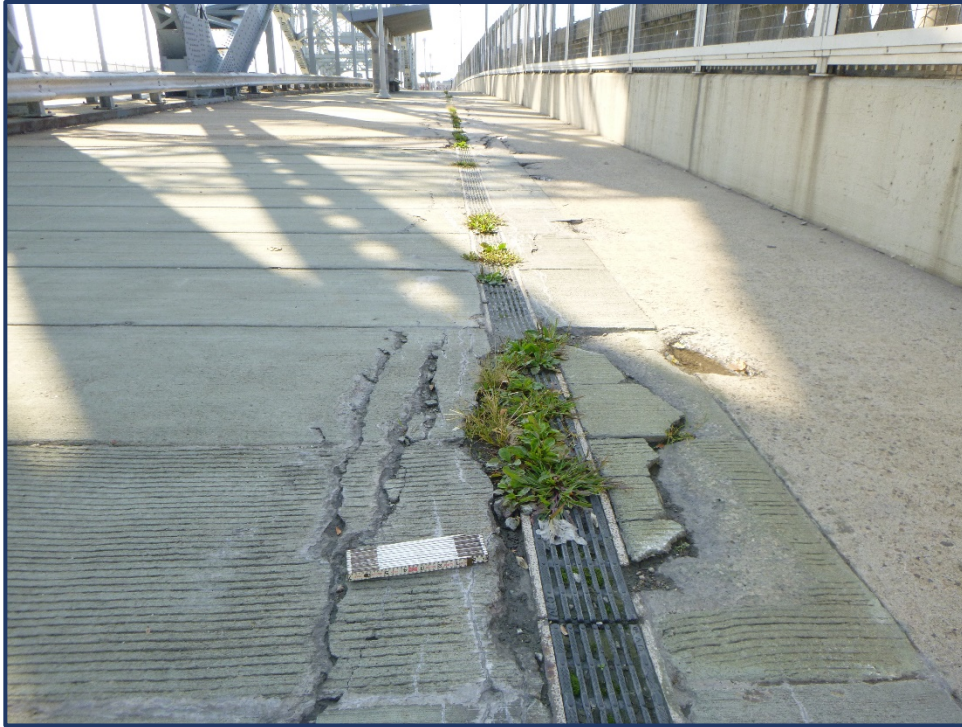
Photo CS-2 – Span 4 North Sidewalk, Delamination and Cracking along Longitudinal Drain

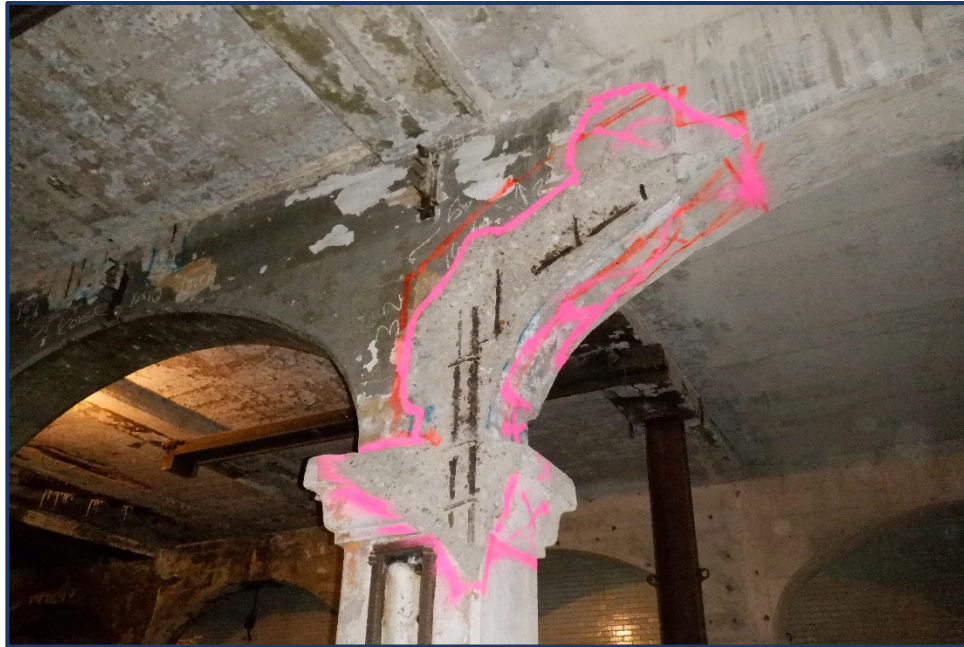
Photo 110-1 – West Station, Spalling of Concrete Beam

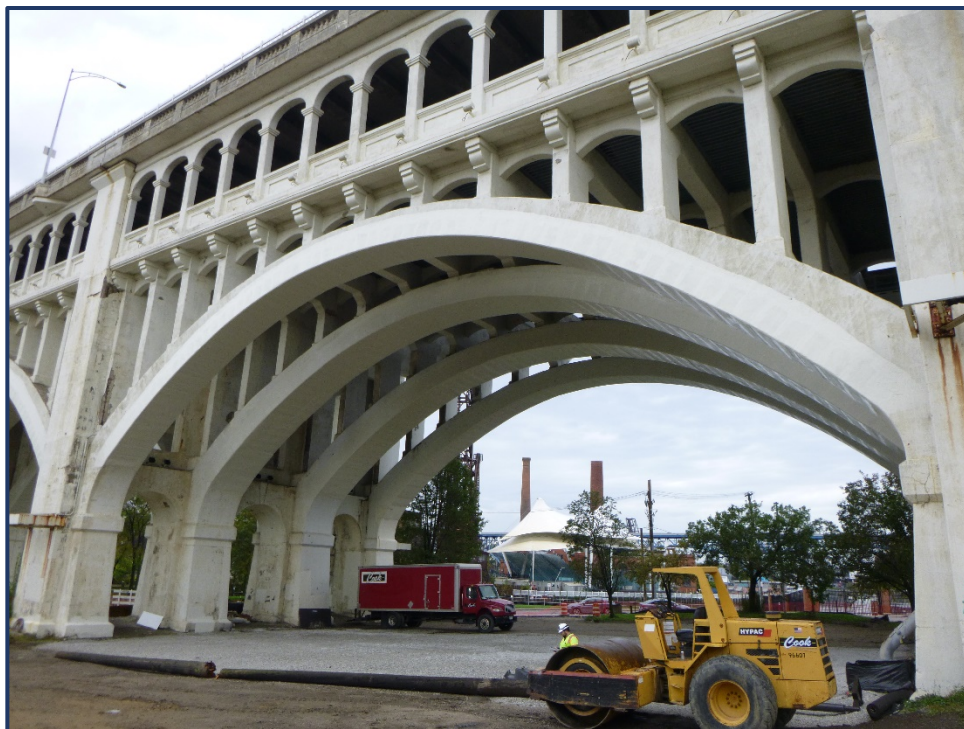
Photo 144-1 – Span 9 Reinforced Concrete Arches

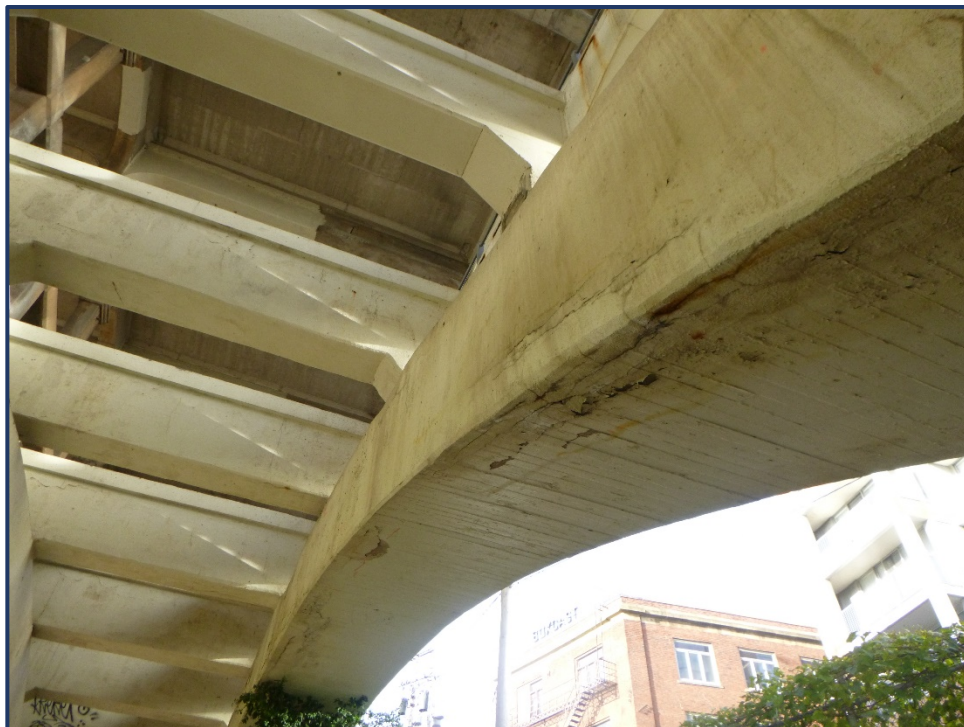
Photo 144-3 – Span 1, North Exterior Arch, Map Cracking and Delamination of Arch Rib

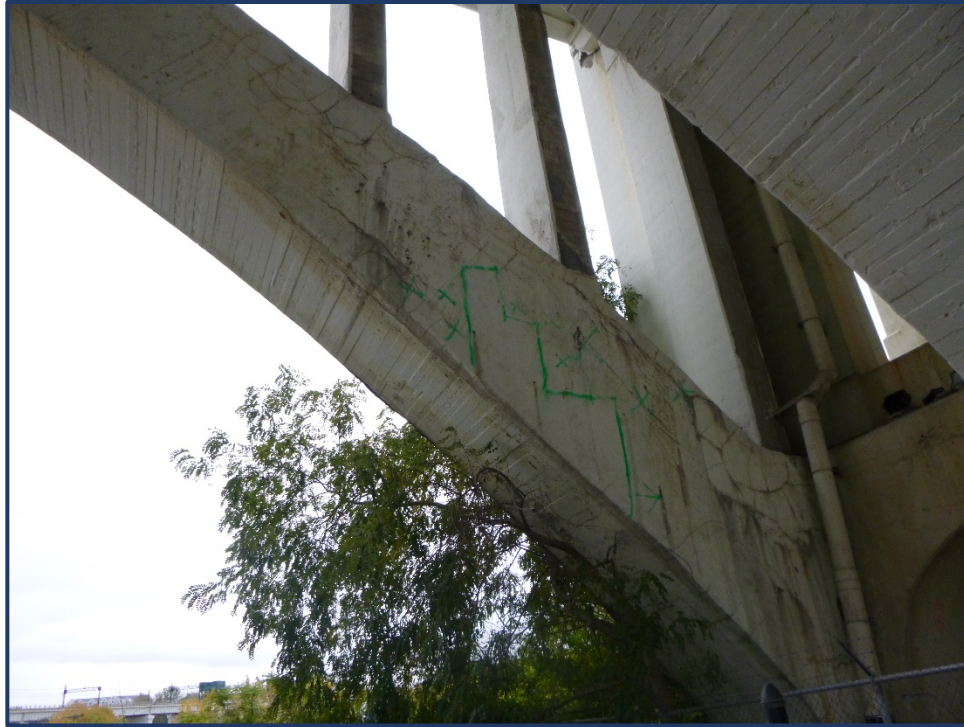
Photo 144-4 – Span 3, South Exterior Arch, Map Cracking and Delamination of Arch Rib

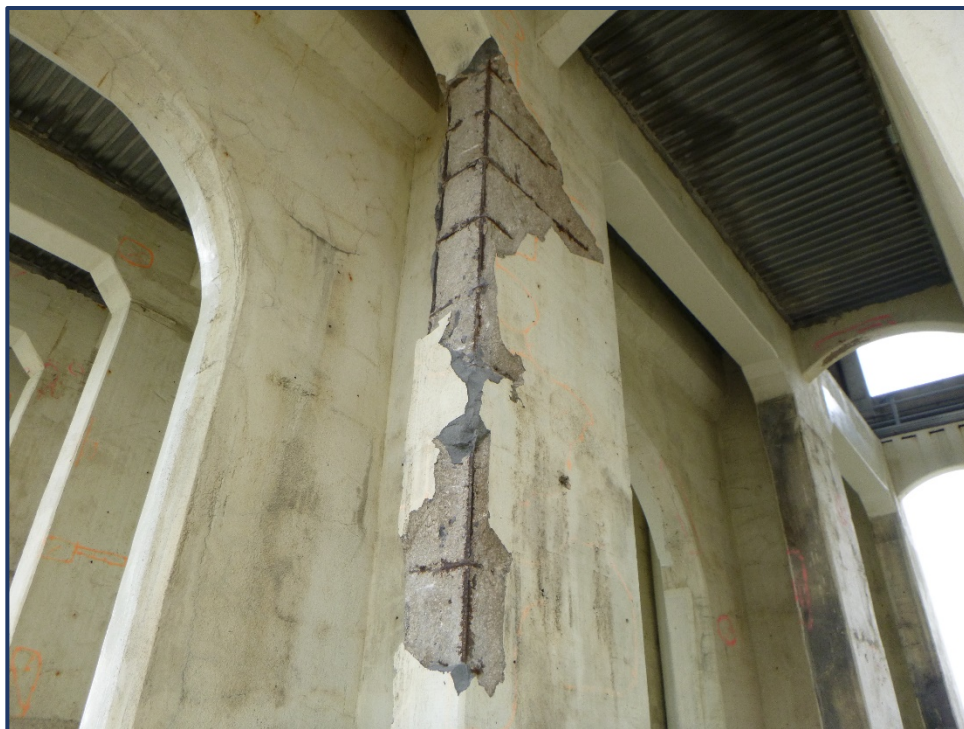
Photo 144-5 – Span 8, South Interior Arch, Spalling of Arch Column

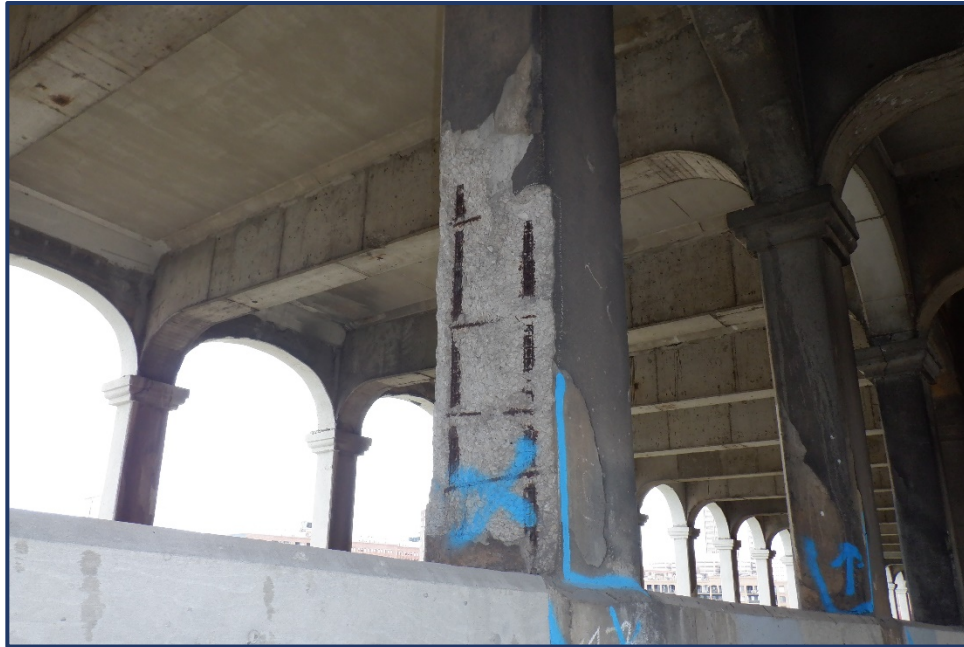
Photo 144-6 – Span 7, North Interior Arch, Spalling of Arch Column

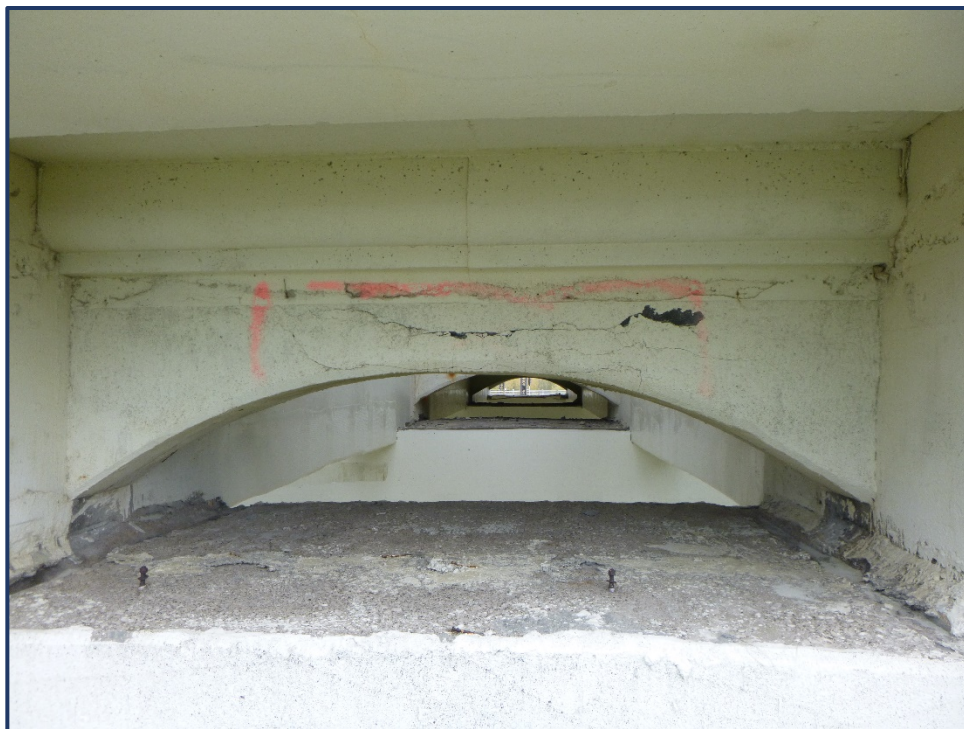
Photo 144-7 – Span 8, North Exterior Arch, Cracking and Delamination of Jack Arch

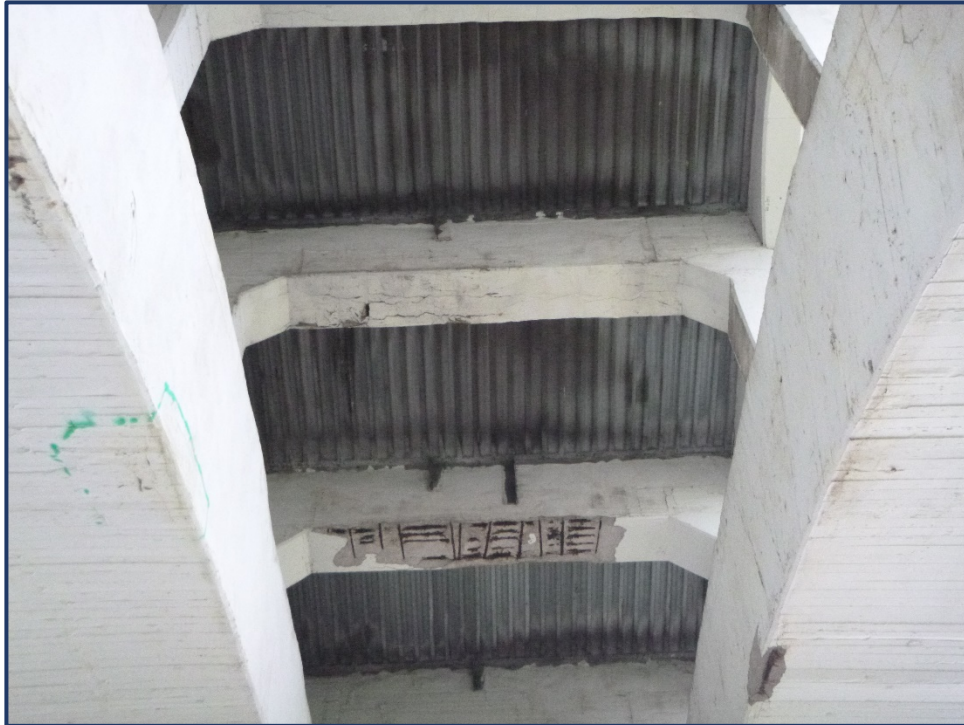
Photo 155-1 – Span 3, Lower Deck FBs, South Bay, Cracking, Delamination and Spalling with Exposed Reinforcing

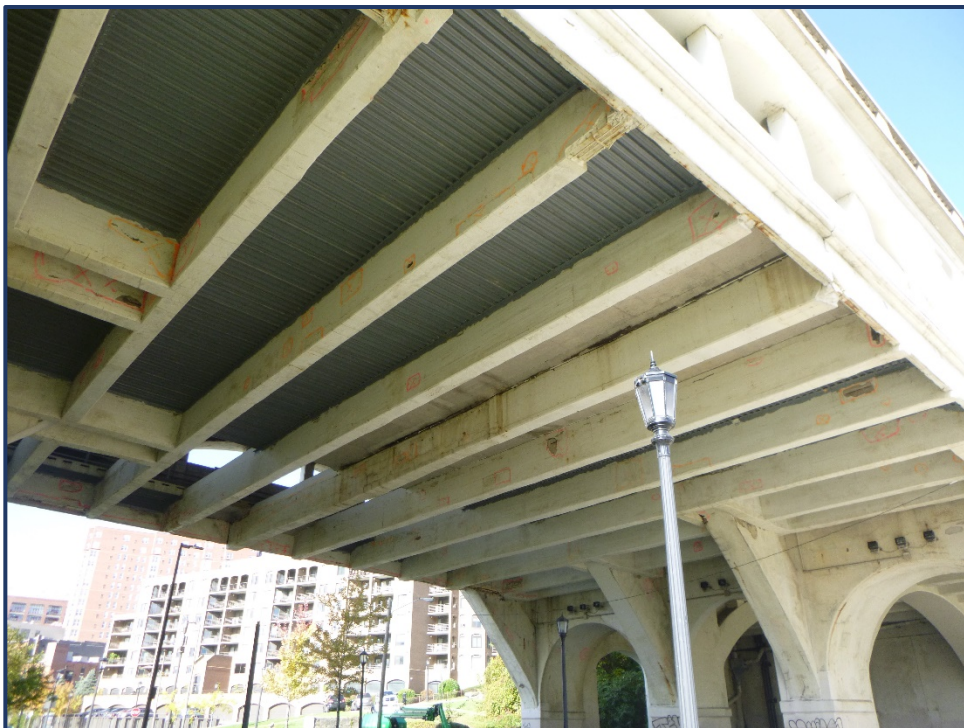
Photo 155-2 – Span 12, Widespread Cracking, Delamination and Spalling of Lower Deck Floorbeams

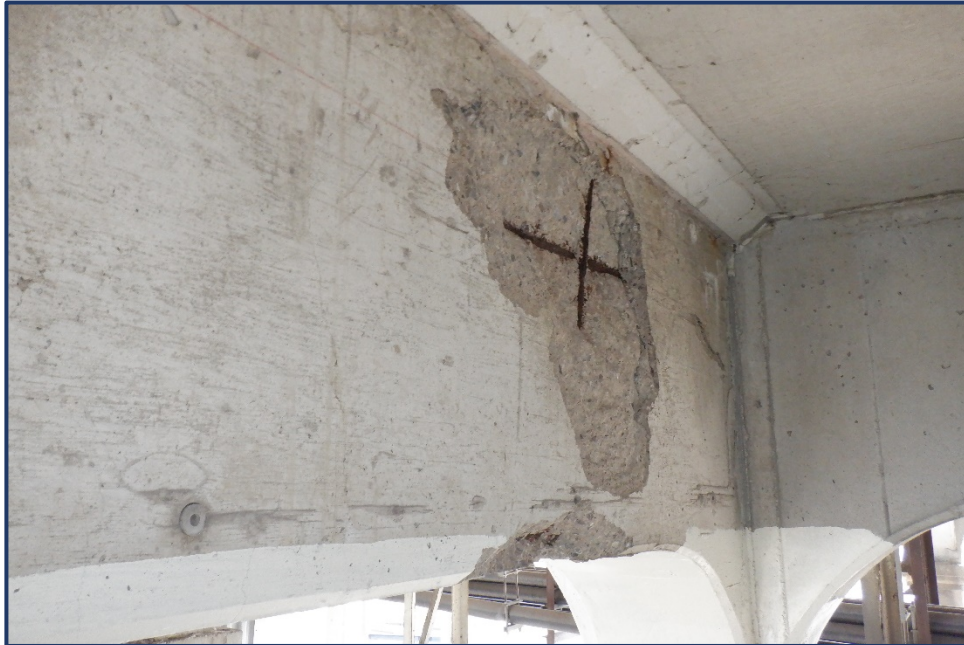
Photo 155-3 – Span 3, Upper Deck FB 3, Center Bay, Spalling and Delamination

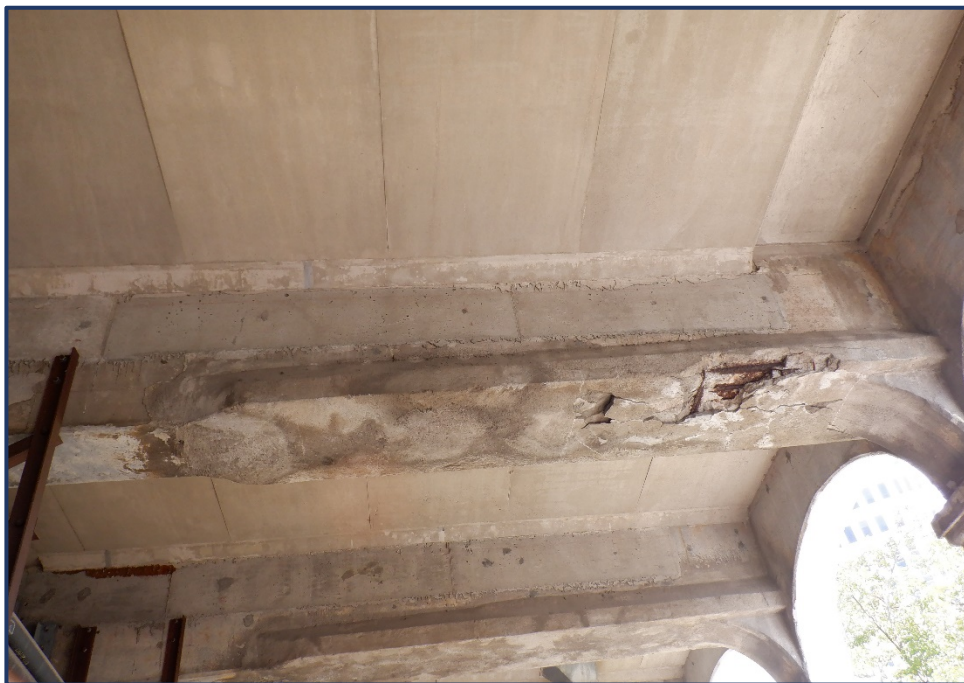
Photo 155-3 – Span 13, Upper Deck FB 6, South Bay, Spalling and Delamination

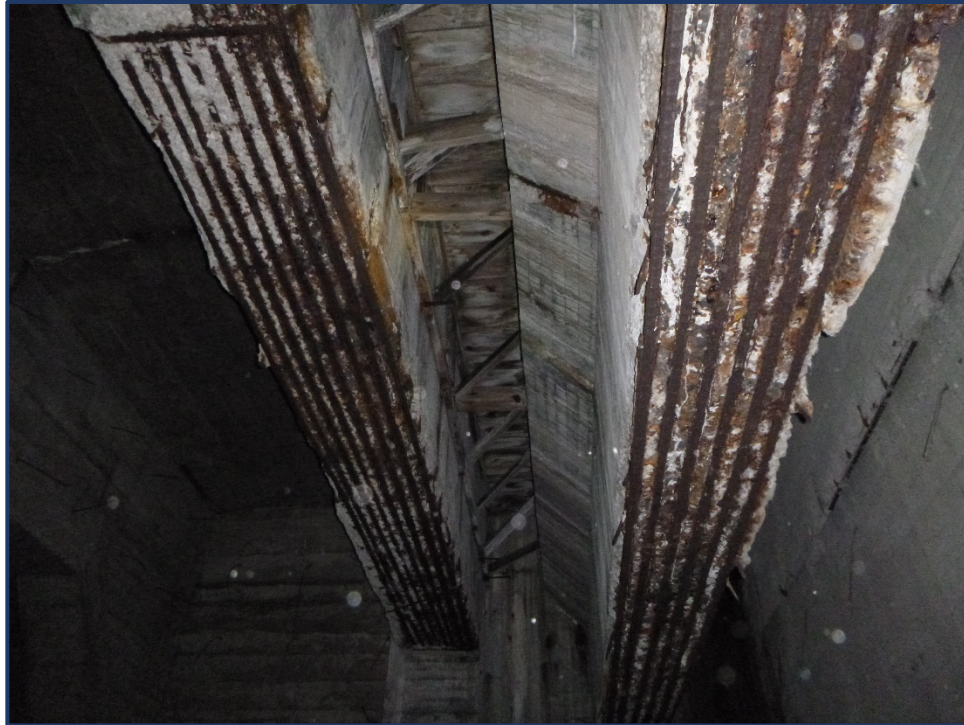
Photo 155-4 – East Abutment Chamber Floorbeams, Typical Spalling

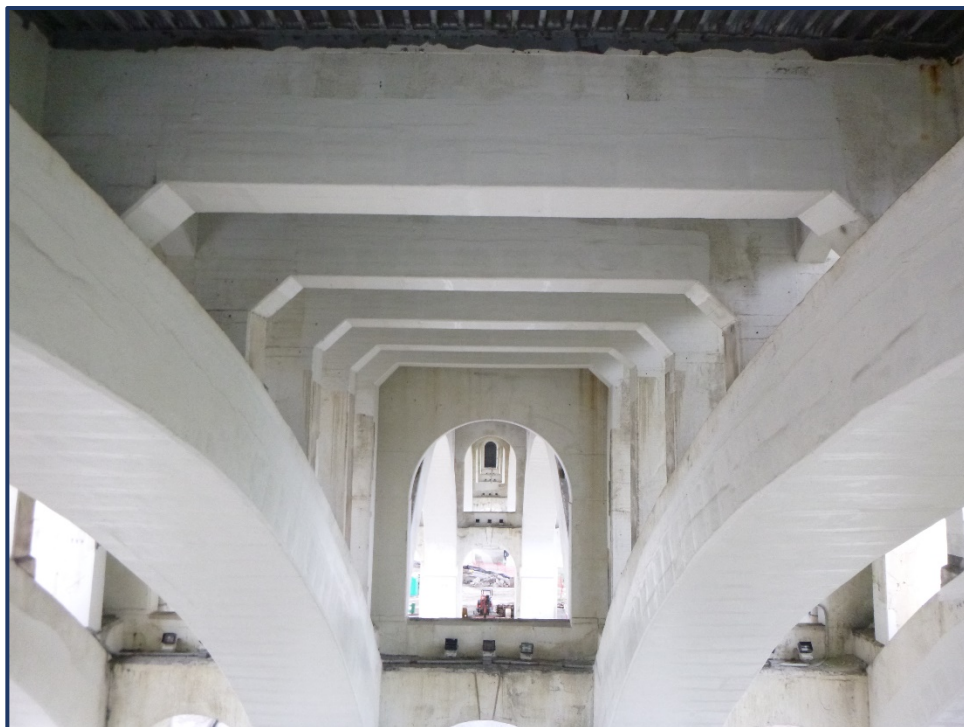
Photo 155-5 – Span 10, FRP on Underside of Lower Deck Floorbeams

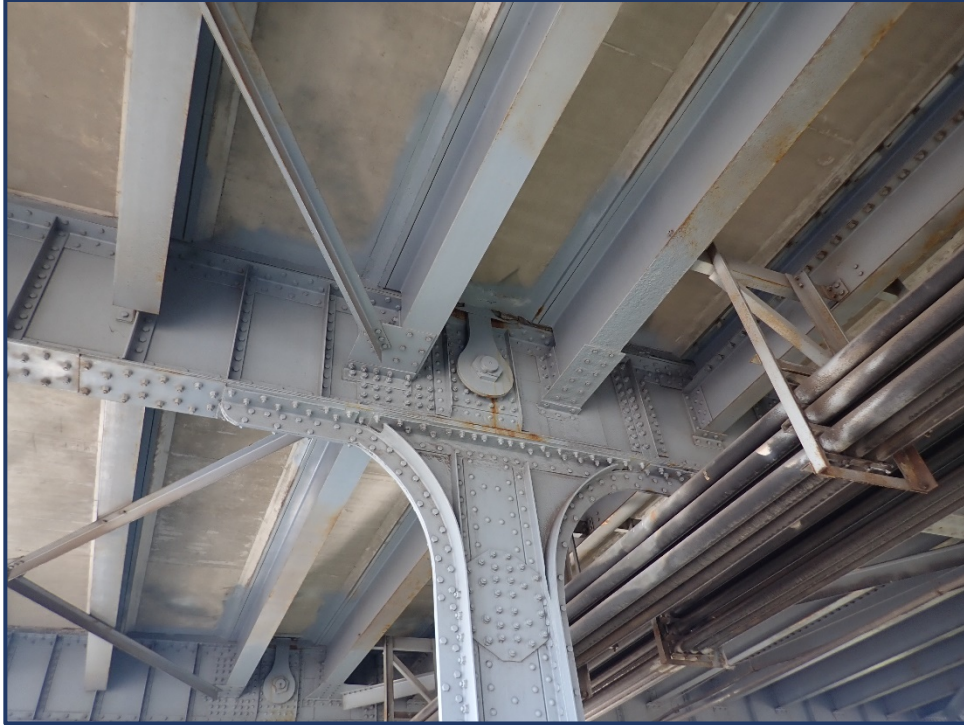
Photo 113-1 – Span 4, Upper Deck Stringers, Typical Surface Corrosion and Minor Pitting on Stringer Ends

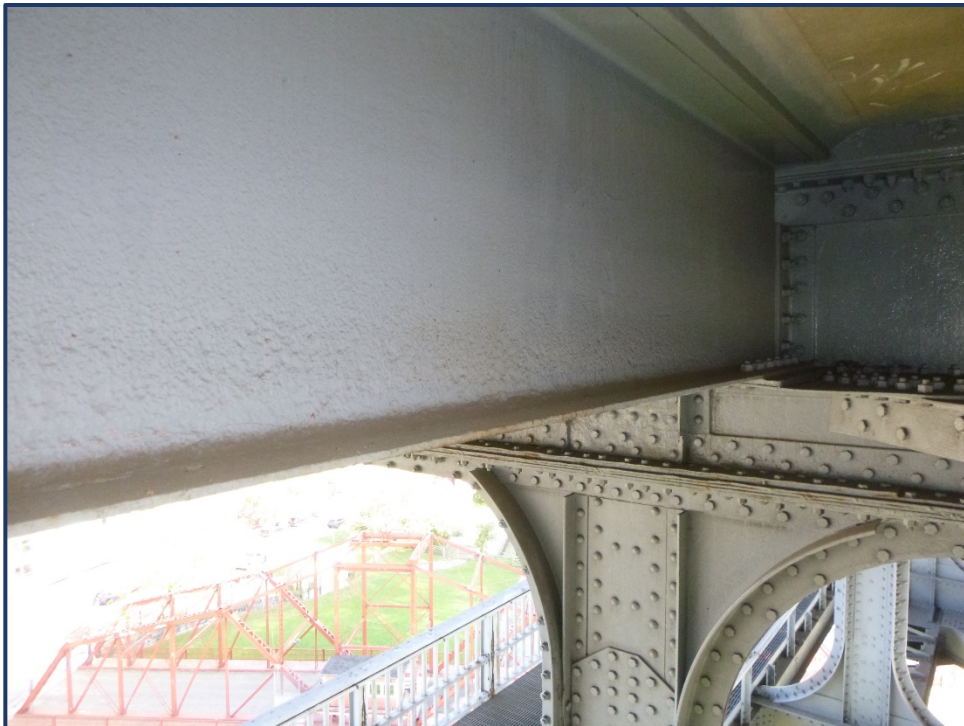
Photo 113-2 – Span 4, Upper Deck Stinger E, Bay 4'-5', Active Pitting Corrosion and Painted over Pitting

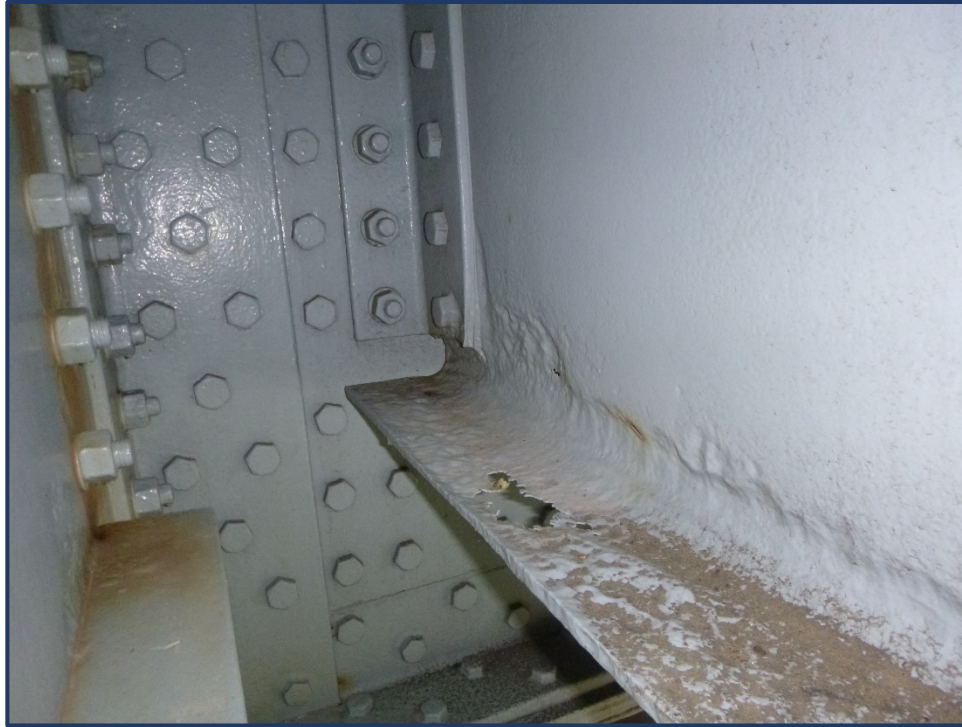
Photo 113-3 – Span 4, Upper Deck Stinger E, Bay 2-3, 5" L x 2" W Perforation at FB3

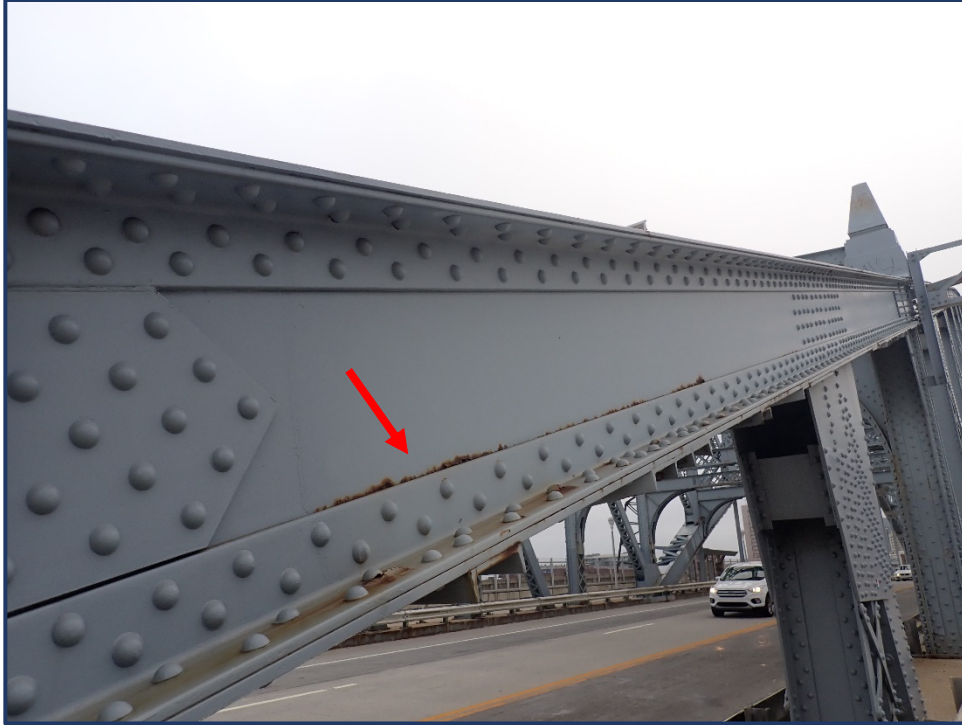
Photo 120-1 – Span 4, South Truss, U0-U1, Active Pack Rust between Web Plate and Flange Angles.

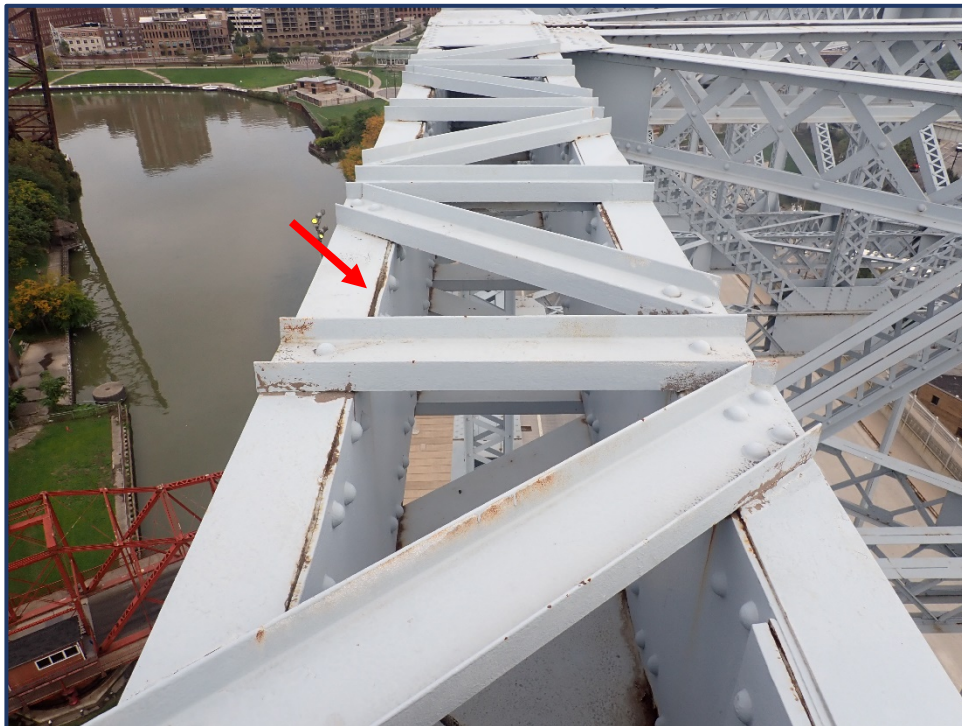
Photo 120-1 – Span 4, North Truss, U11-U12, Active Pack Rust between Web Plate and Flange Angles.
