Physical Condition Report for

CUY-006-1456

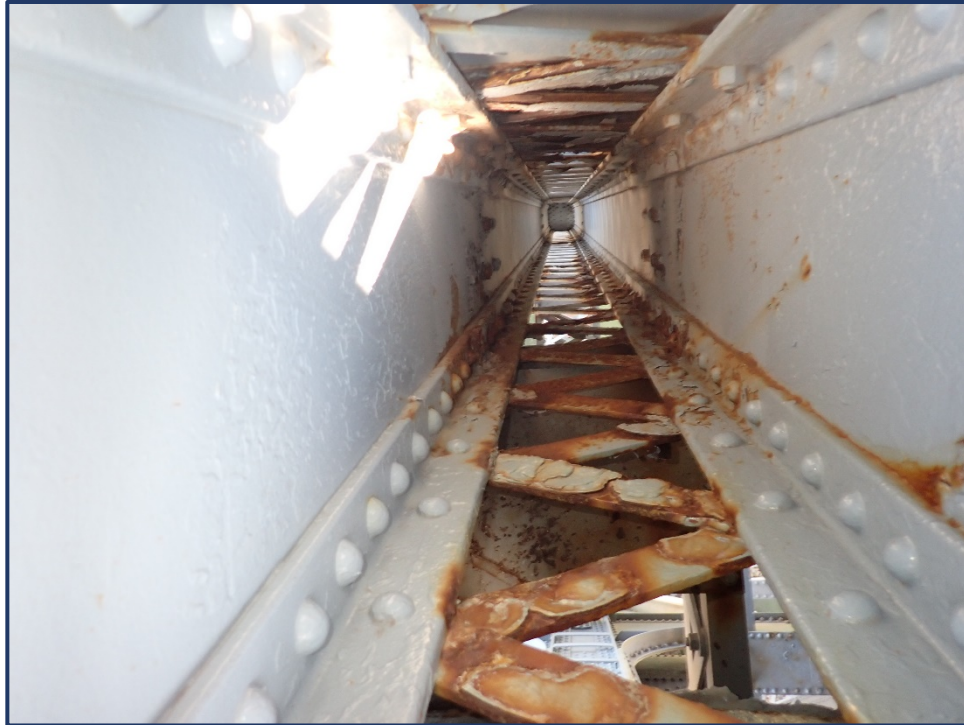
Photo 120-2 – Span 4, North Truss, U1'-L2', Active Corrosion extending down from Upper Deck

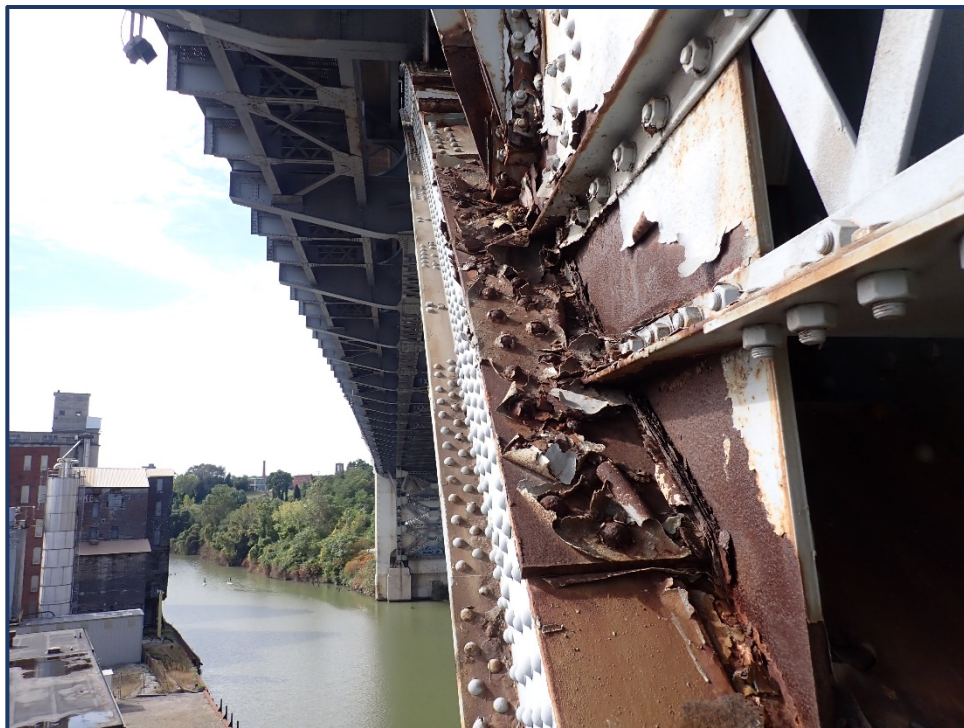
Photo 120-3 – Span 4, South Truss, L2'-L3", Active Corrosion and Pack Rust

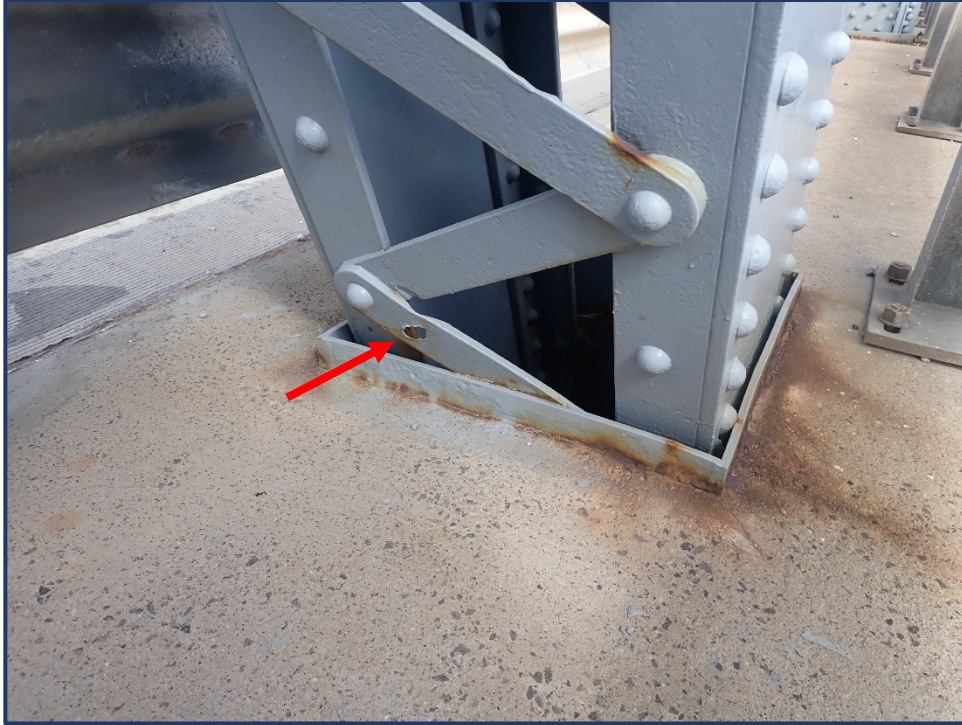
Photo 120-4 – Span 4, South Truss, U1-L1, Painted Over Section Loss and Corrosion Hole in Lacing Bar at Deck Level

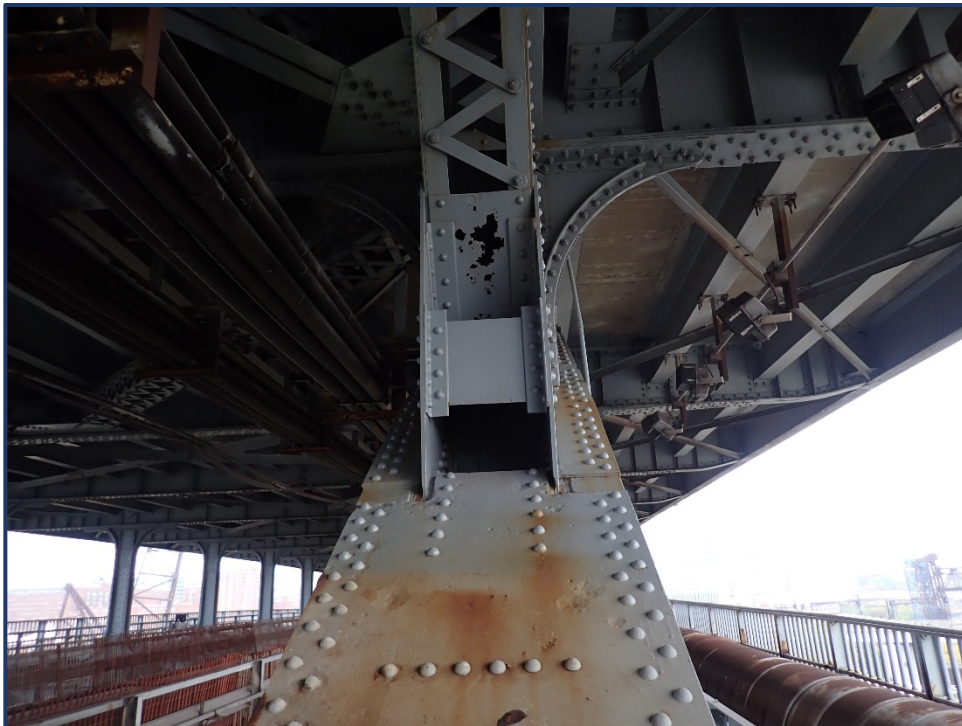
Photo 120-5 – Span 4, South Truss, U3-L4,, Perforations in Batten Plate, with Reactivating Corrosion

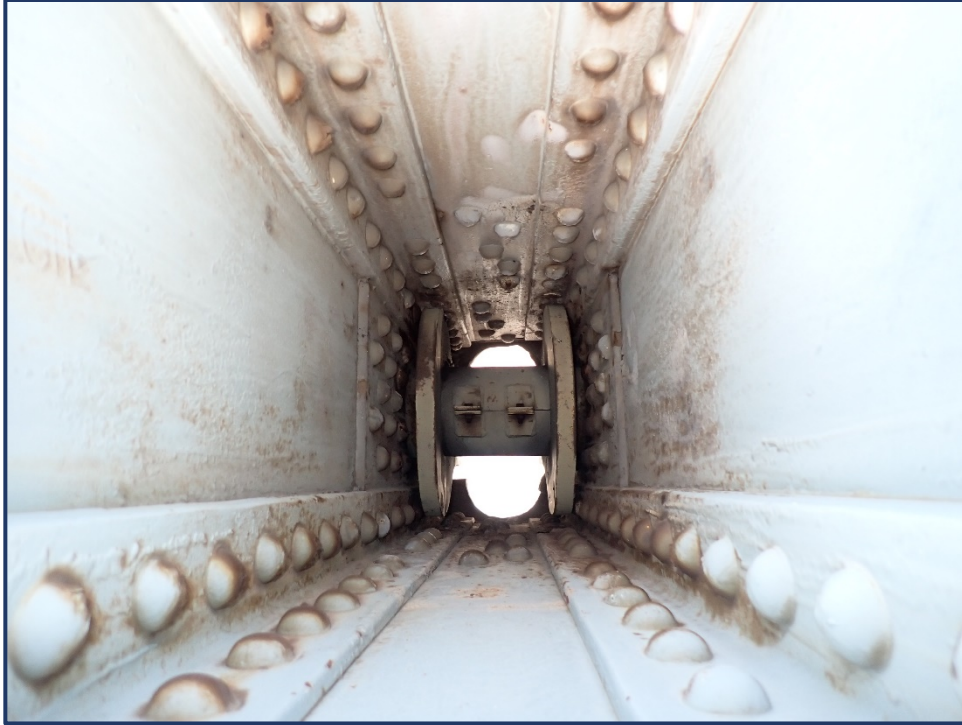
Photo 120-6 – Span 4, North Truss, L10, Reactivating Pitting around Hanger Pin

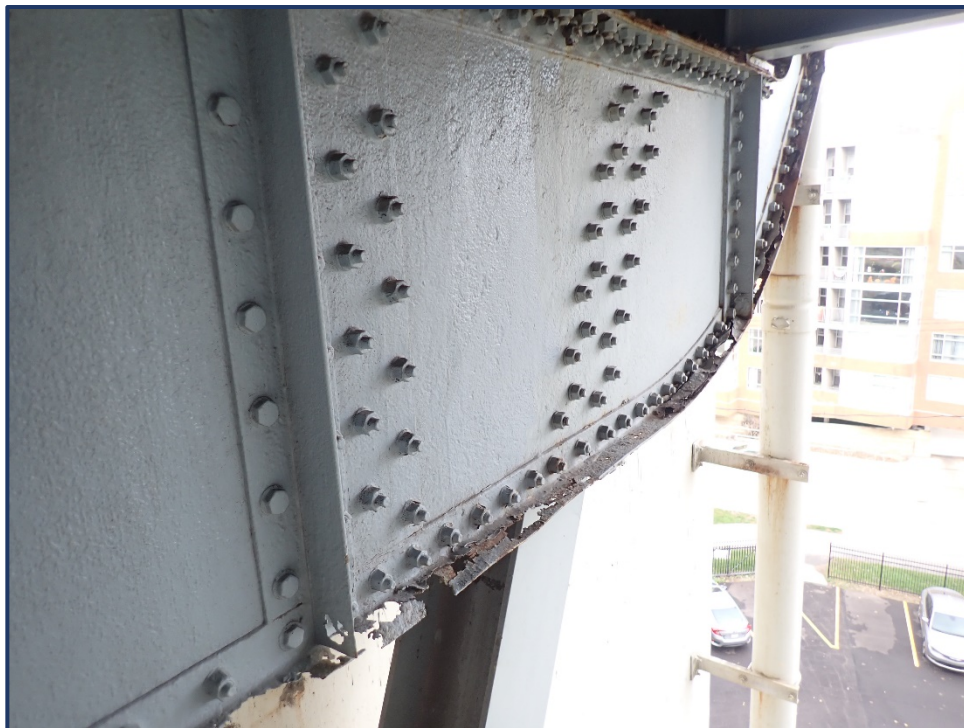
Photo 152-3 – Span 4, Lower FB0, North End, Perforations and Active Corrosion of Bottom Flanges

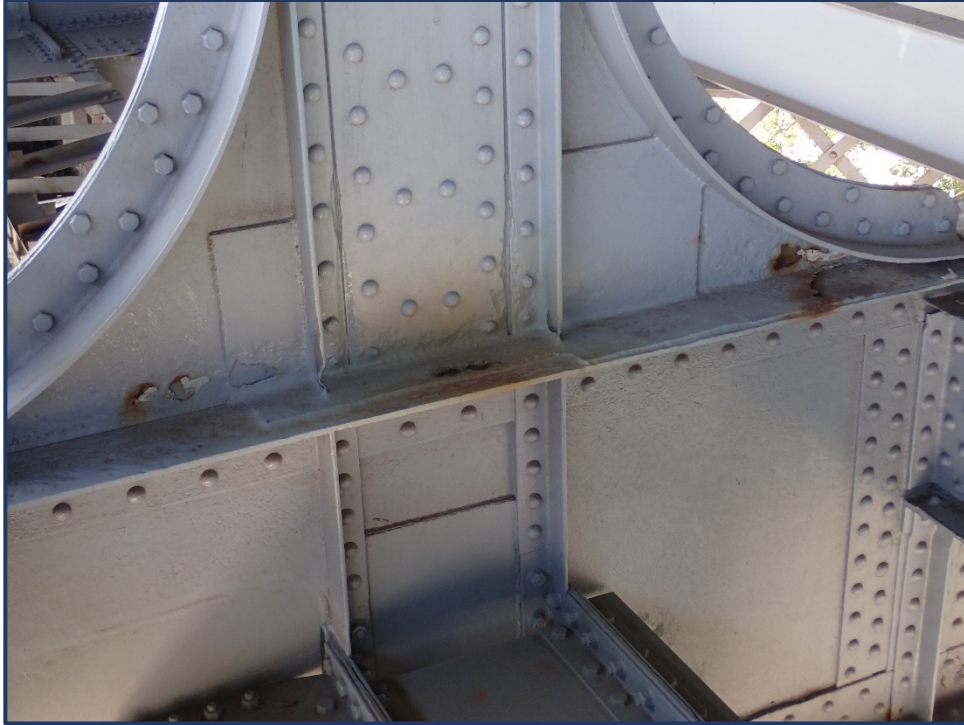
Photo 152-4 – Span 4, Lower FB9 at South Truss, Pitting and Perforations

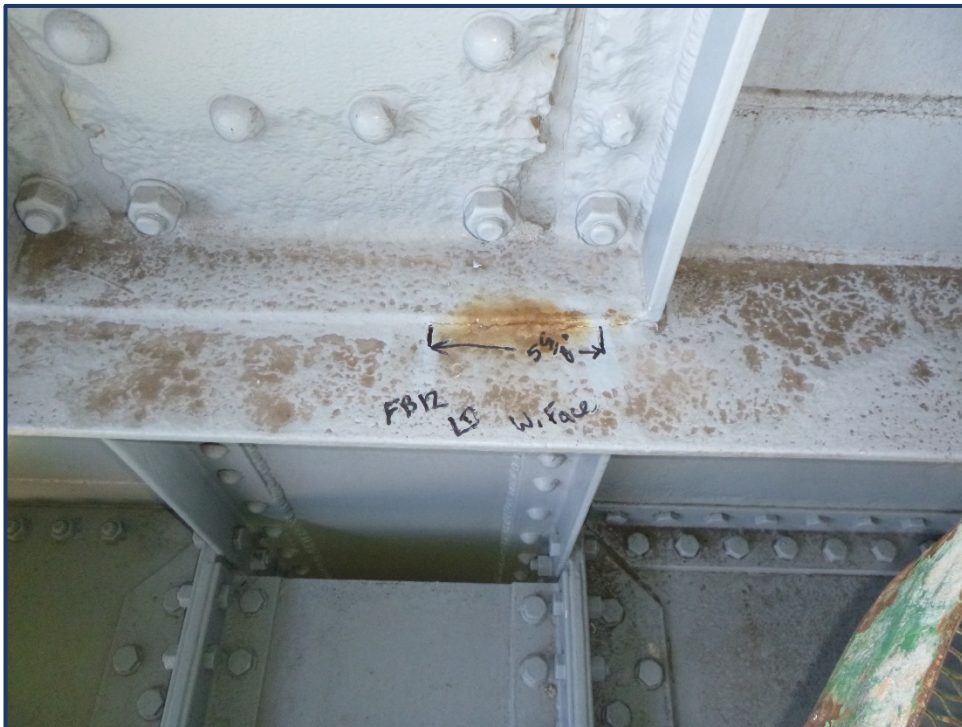
Photo 152-5 – Span 4, Lower FB12, North End, West Face, 5-5/8" Crack in Top Flange Stiffener Retrofit

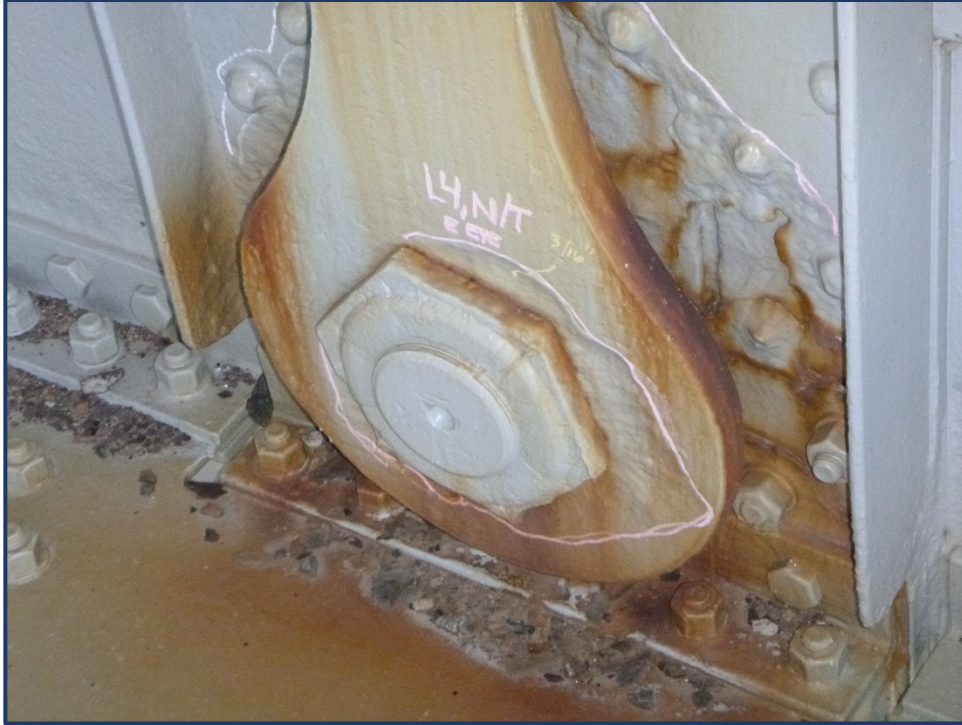
Photo 161-1 – Span 4, North Truss, Hanger Connection at Lower FB4, Pitting around Pin

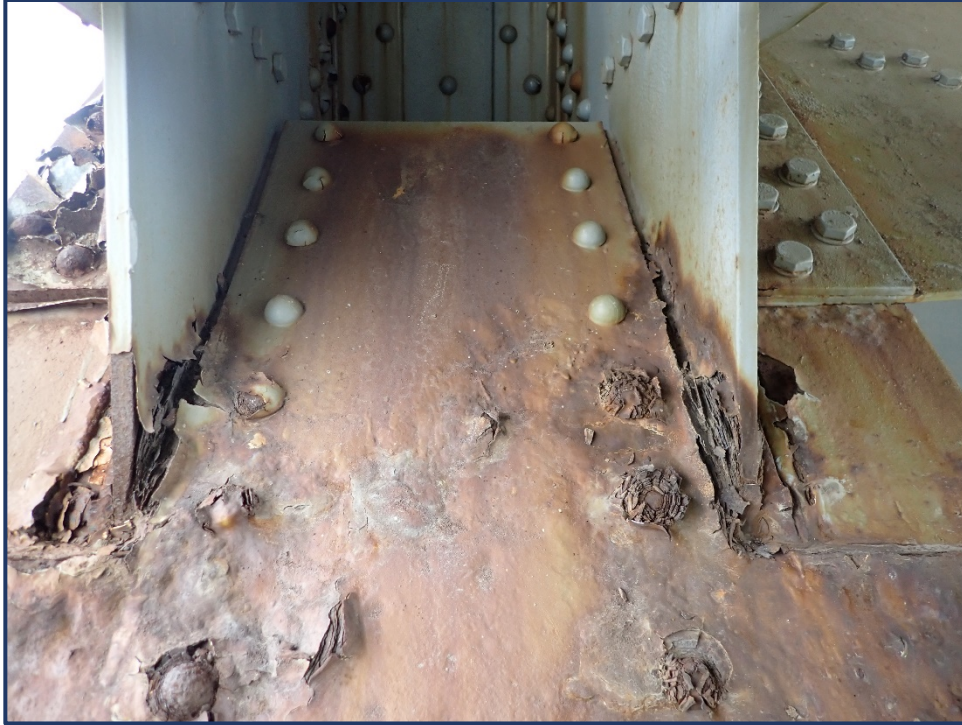
Photo 162-2 – Span 4, South Truss, L2' Gusset Plates, Active Pitting & Pack Rust

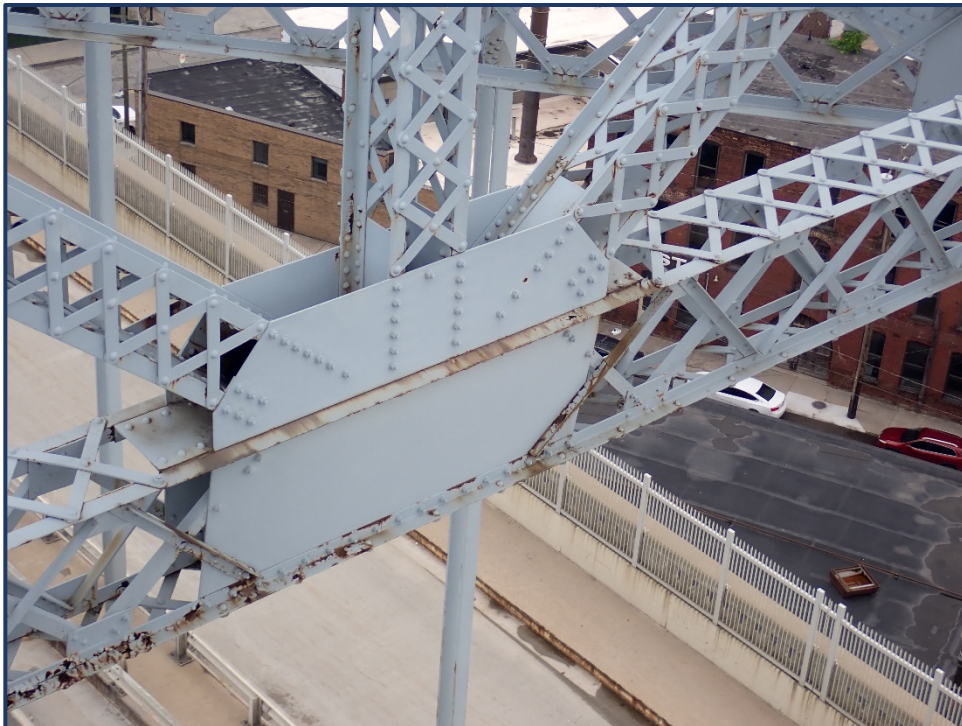
Photo BR-1 – Active Corrosion and Pack Rust on Sway Bracing Members

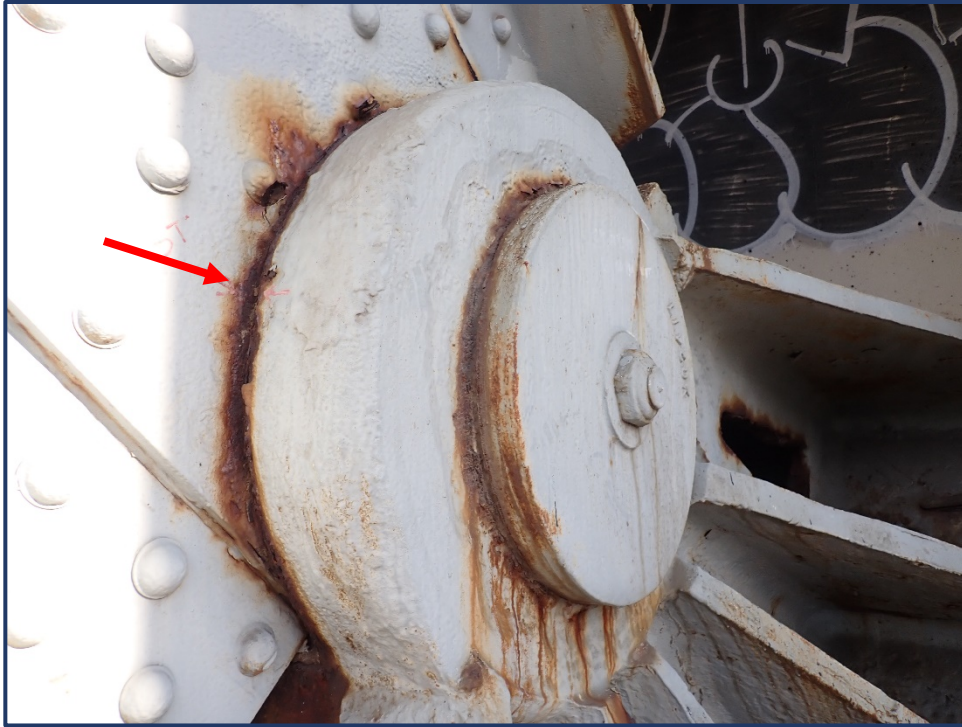
Photo 313-1 – Span 4, South Truss, L0' Bearing, Pack Rust Around Pin

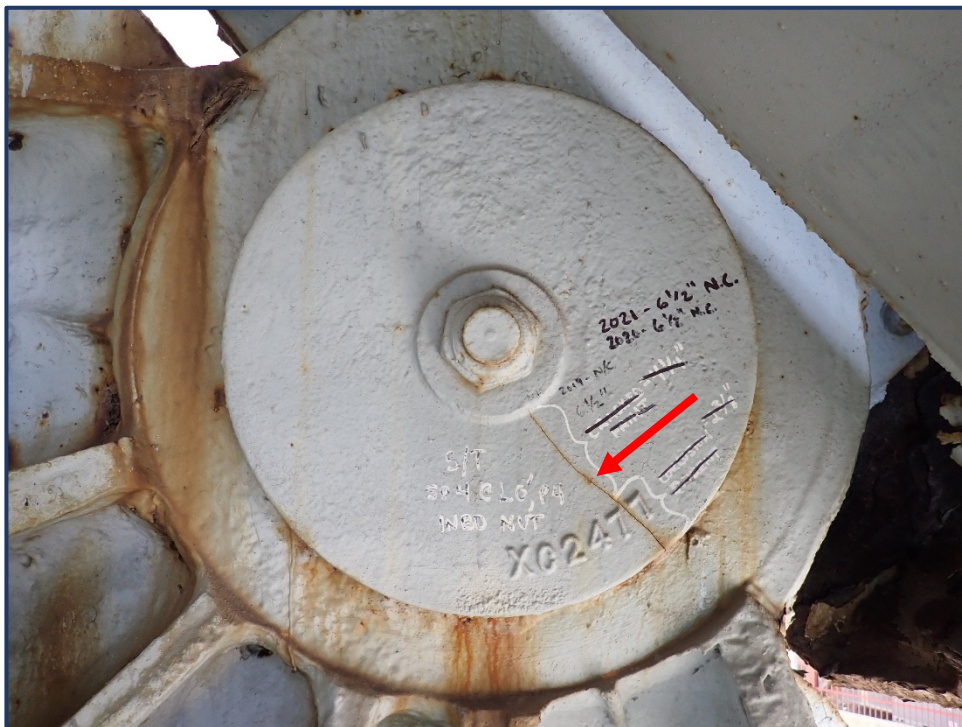
Photo 313-2 – Span 4, South Truss, L0' Bearing, Crack in North Pin Cover Plate

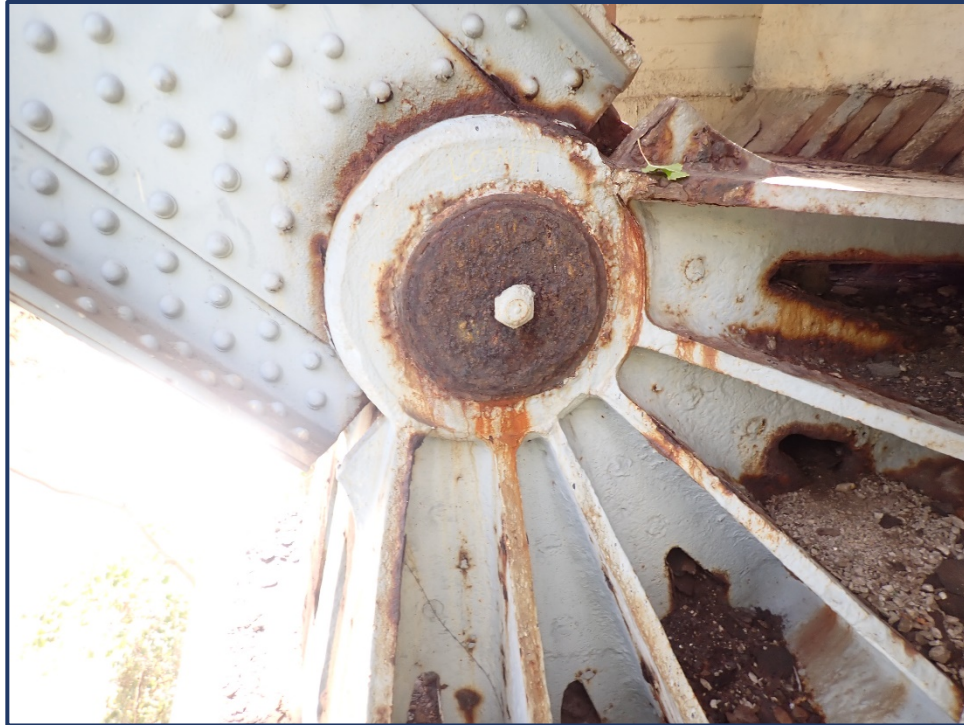
Photo 313-3 – Span 4, North Truss, L0 Bearing, Missing Pin Cover Plate

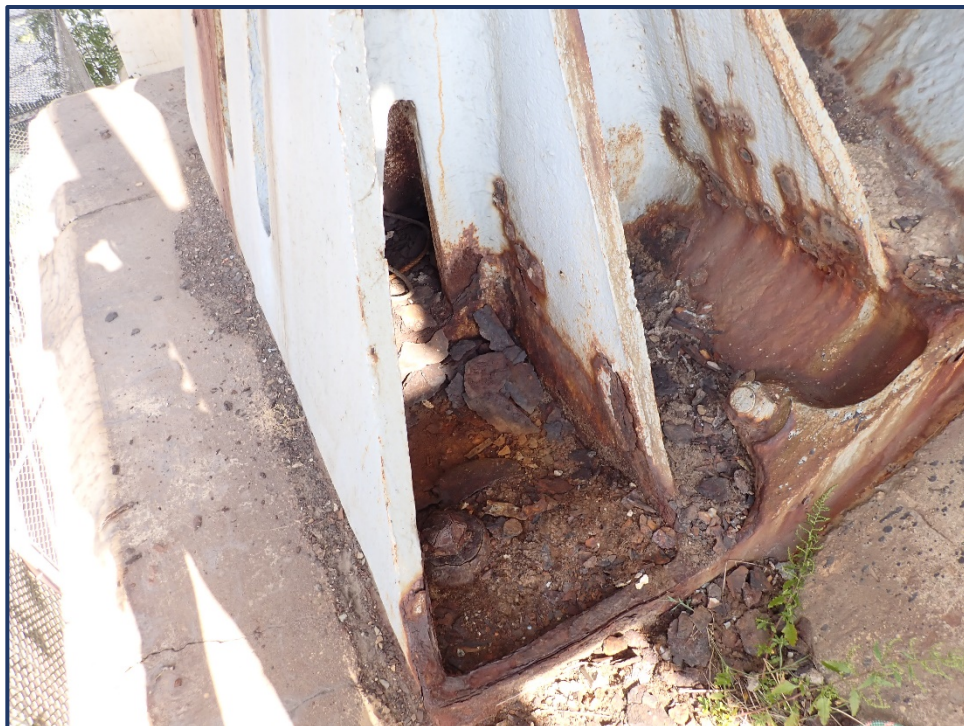
Photo 313-4 – Span 4, South Truss, L0' Bearing, Anchor Bolt & Nut Section Loss

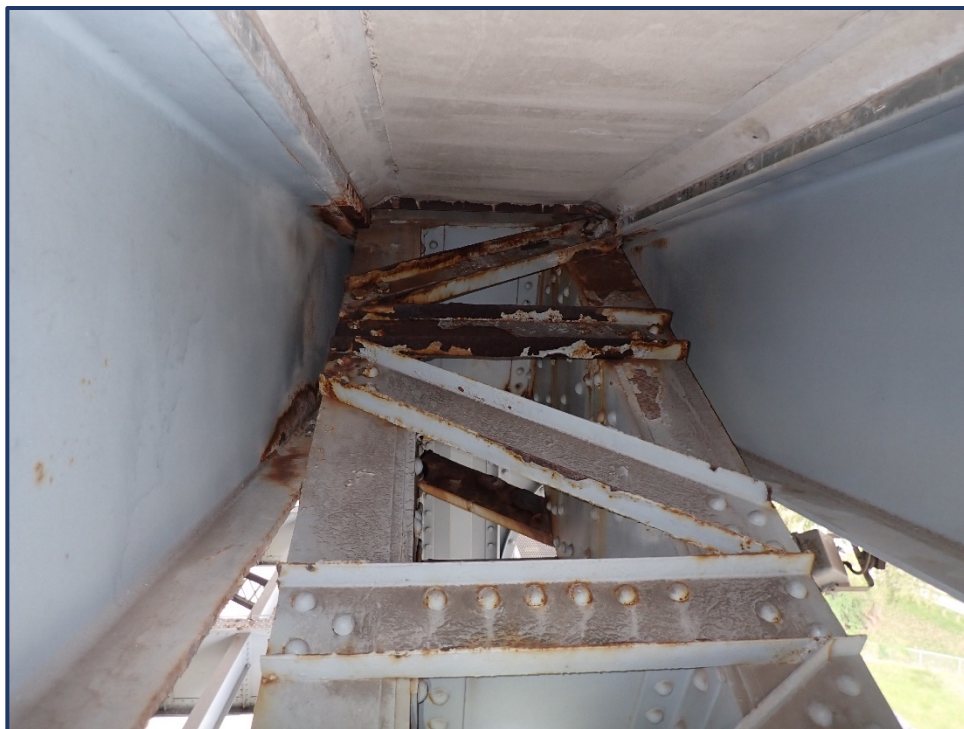
Photo 515-1 – Span 4, Peeling Paint and Surface Corrosion Below Upper Deck

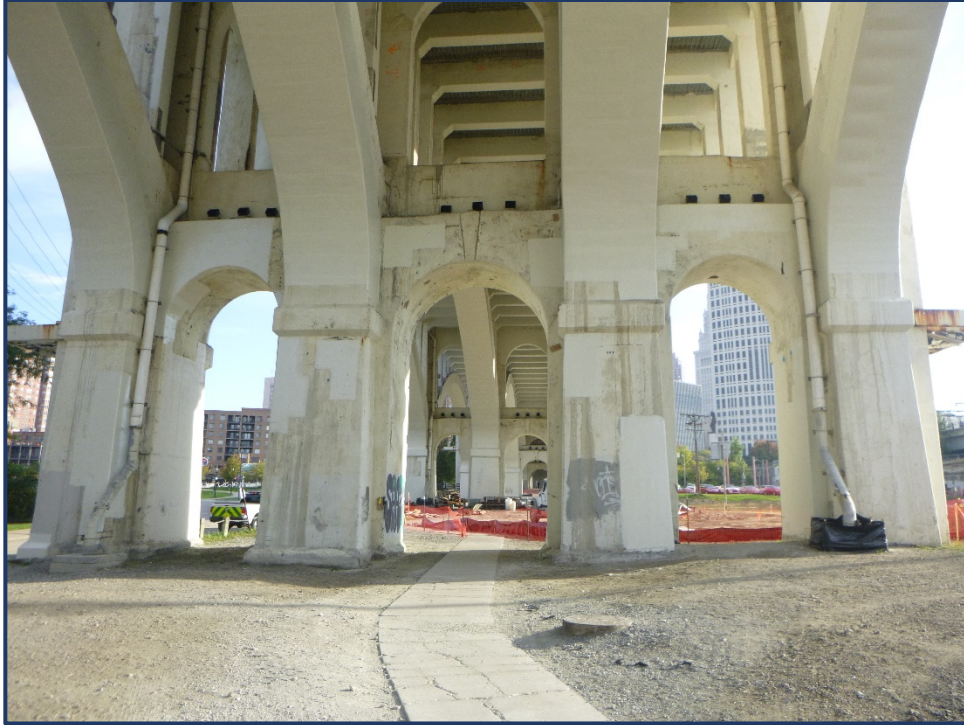
Photo 205-1 – Pier 7, West Face

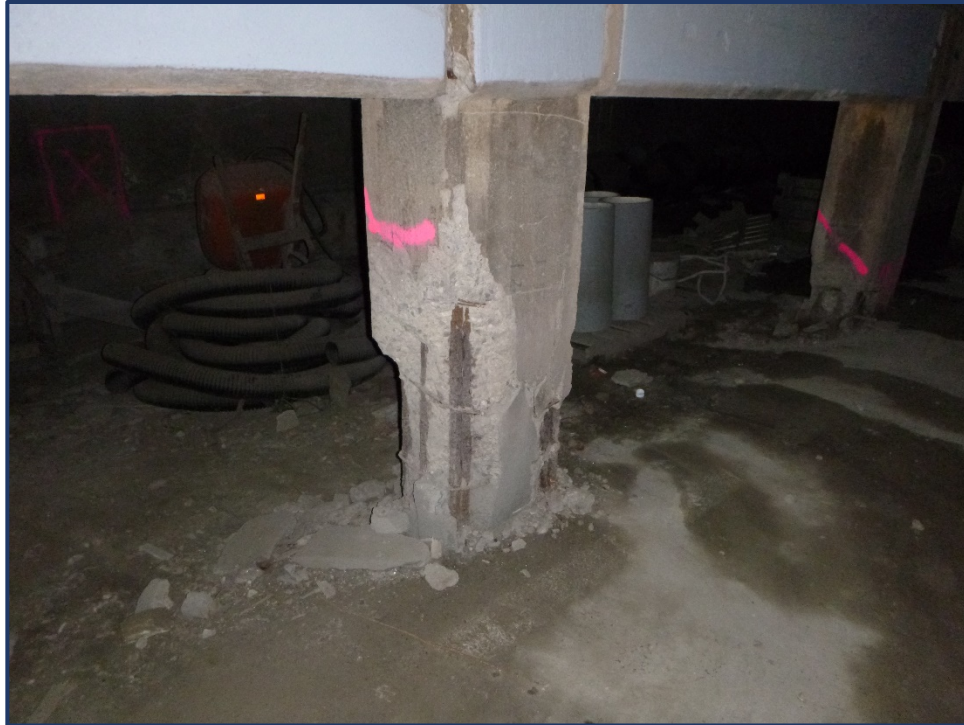
Photo 205-3 – Span 1A, Typical Column Spalling with Exposed Reinforcing

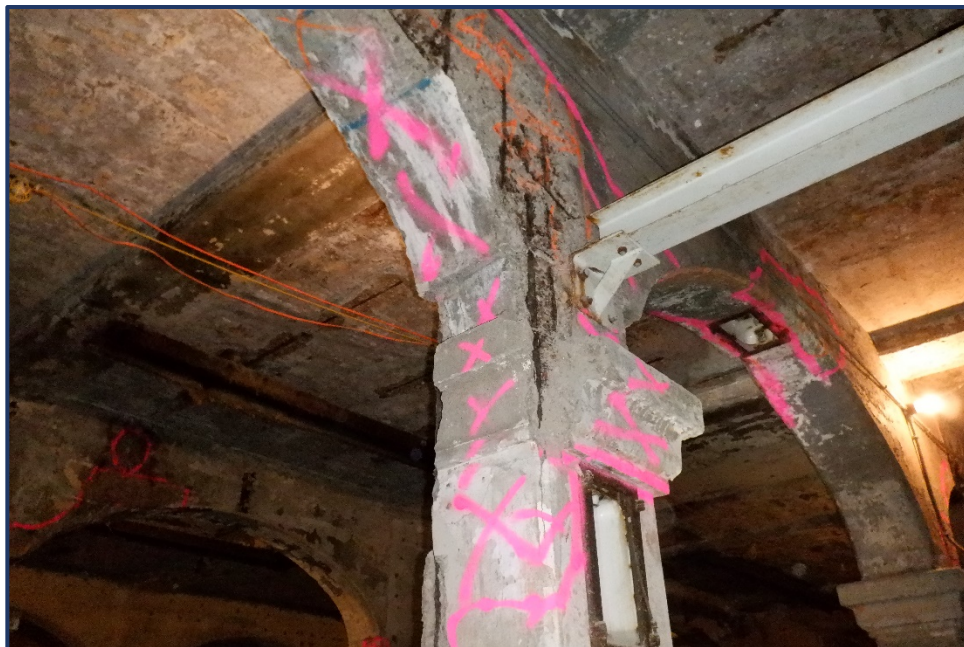
Photo 205-4 – West Station, Column Spalling with Exposed Reinforcing

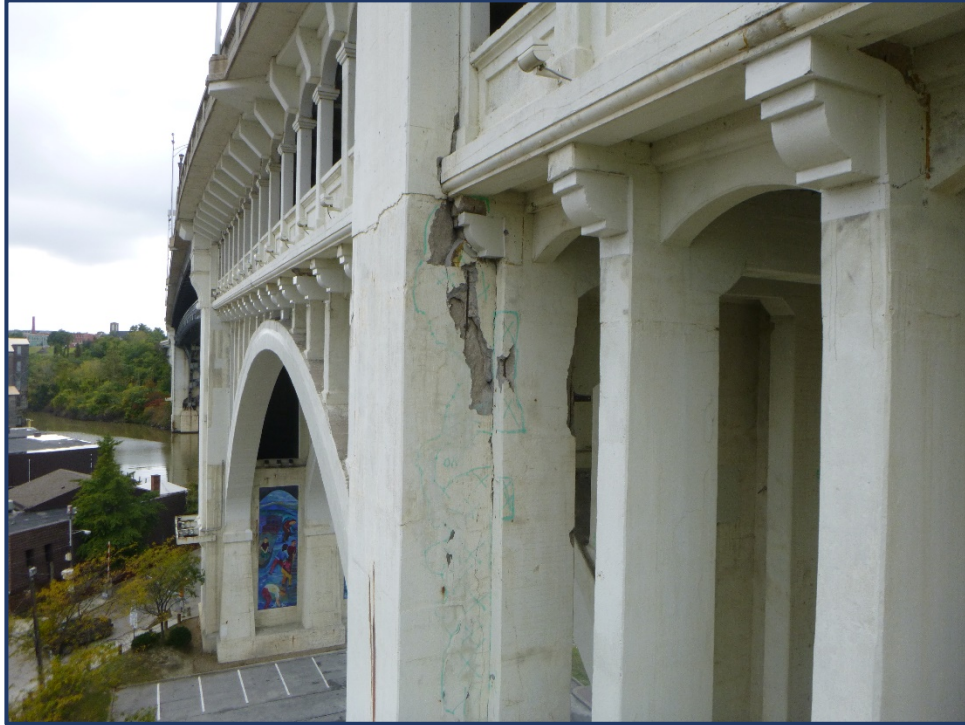
Photo 205-5 – Pier 5, South Tower, Widespread Delamination and Spalling with Exposed Reinforcing

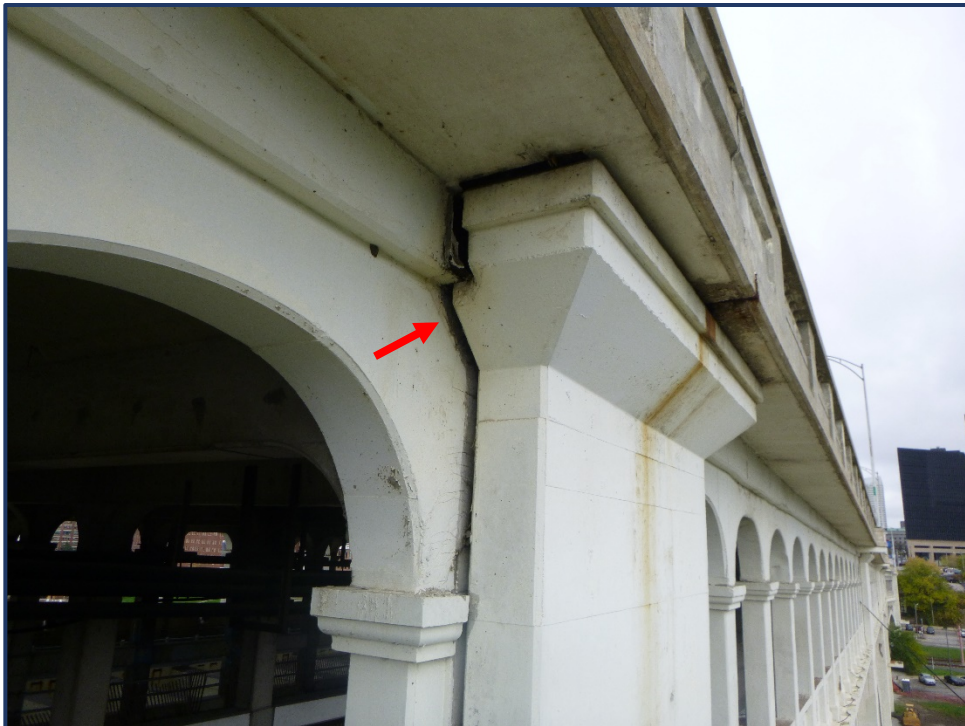
Photo 205-6 – Pier 6, South Tower Leaning Away from Bridge at Top

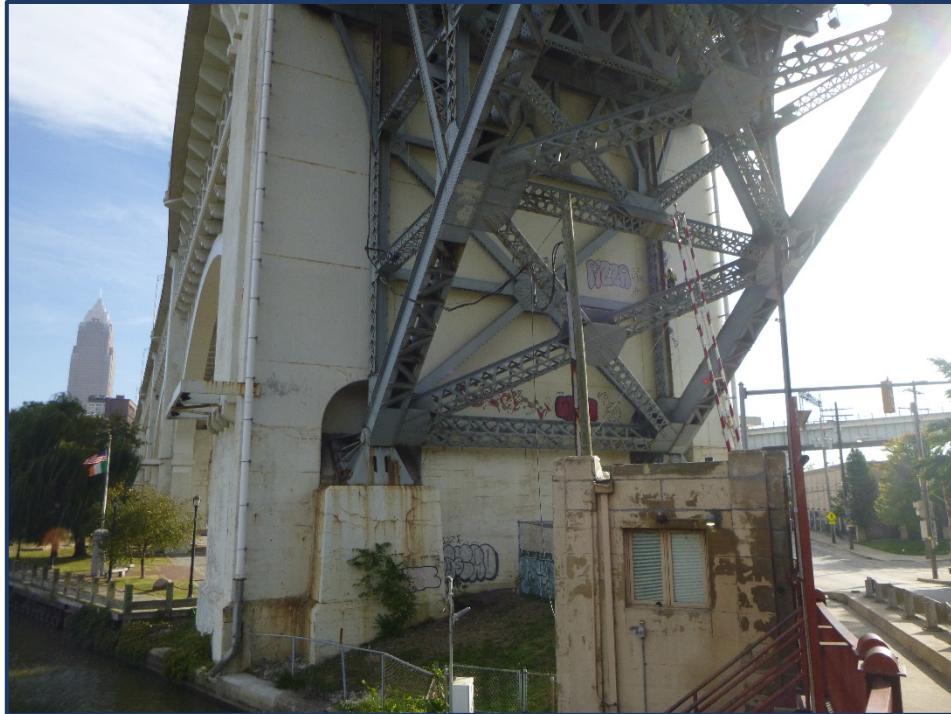
Photo 210-1 – Pier 4, West Face, Typical Map Cracking in Lower Portion

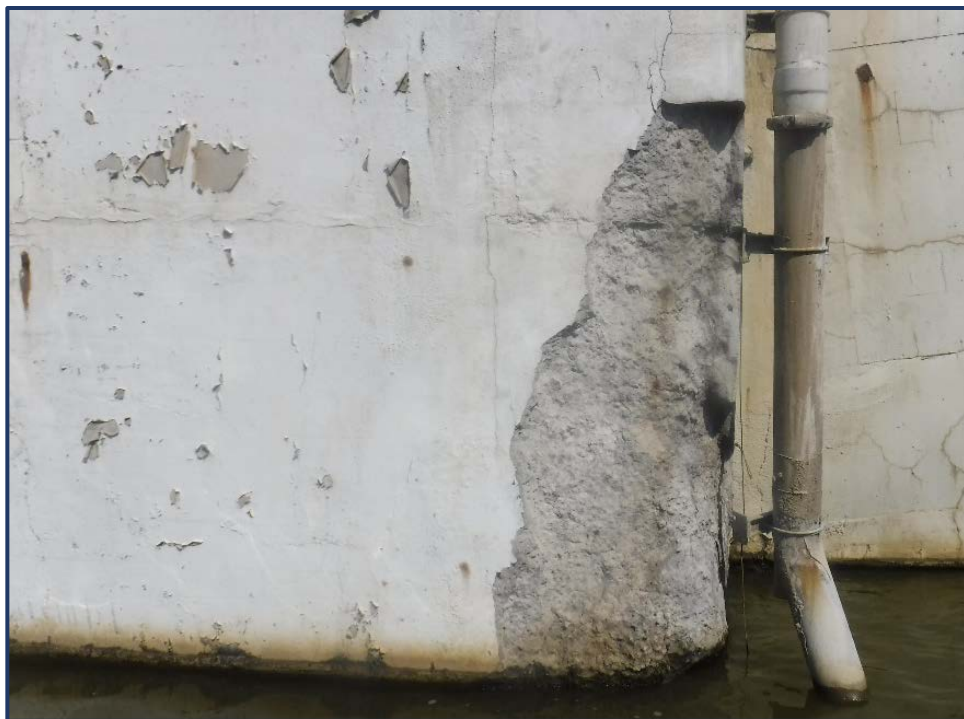
Photo 210-2 – Pier 3, Southeast Corner, Spalling at Waterline

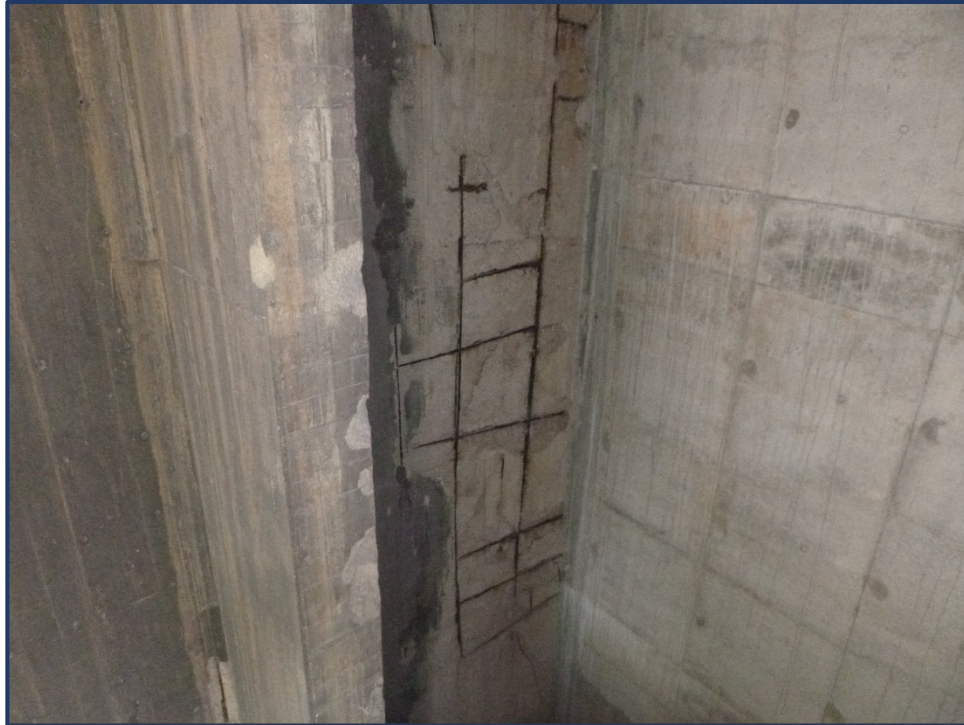
Photo 210-3 – Pier 4, Typical Spalling of Interior Face of Pier Walls

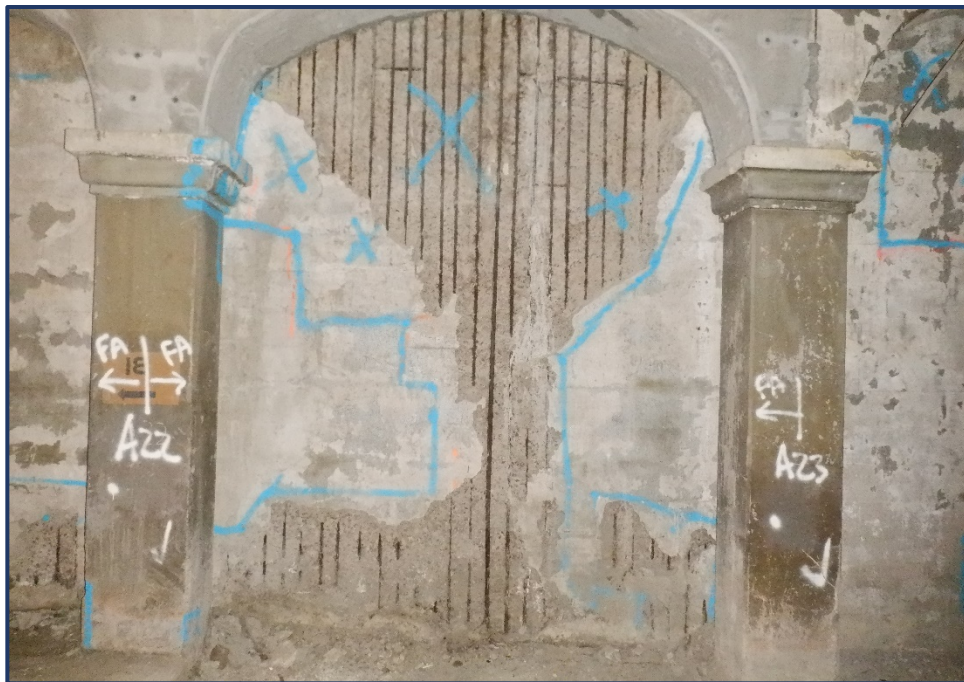
Photo 215-1 – West Station, Spalling with Exposed Reinforcing on Walls

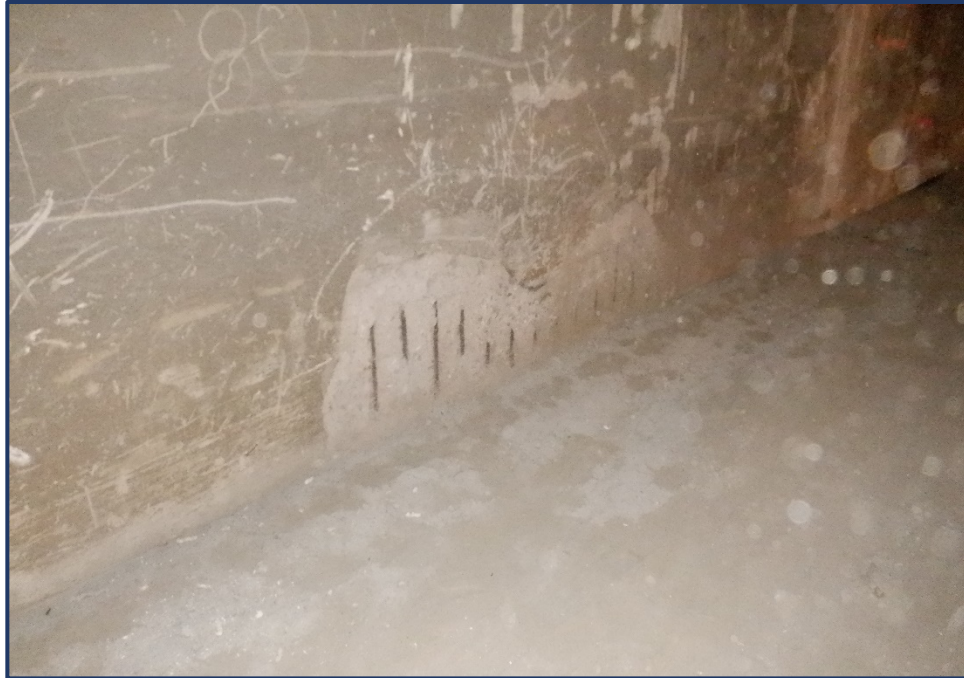
Photo 215-2 – Detroit Ave. Tunnel, Typical Spalling on Lower Portions of Walls

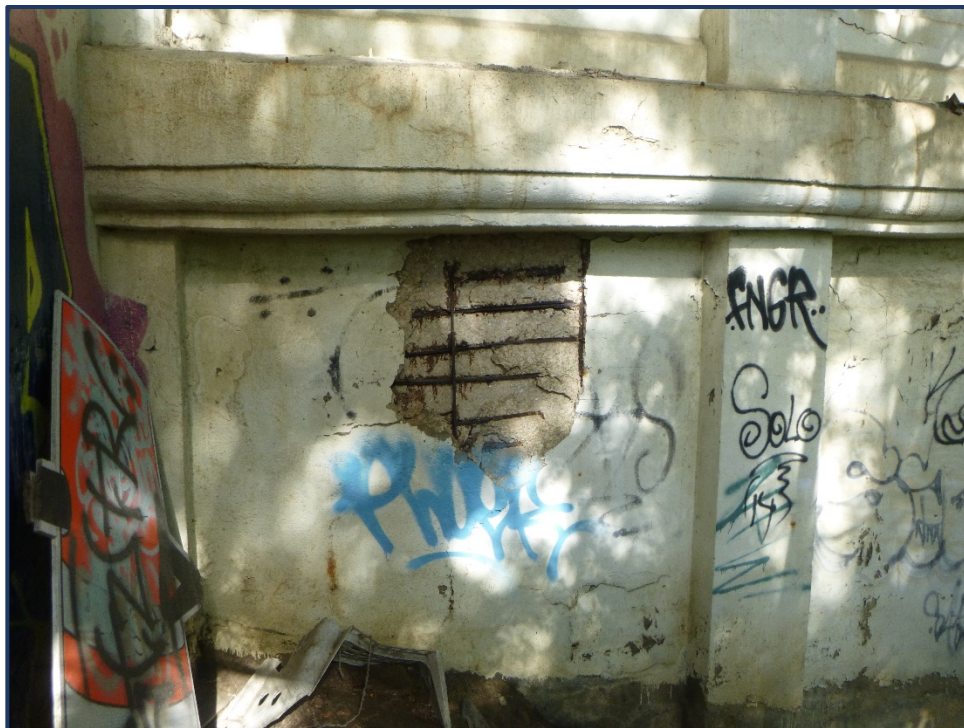
Photo WW-1 – Span 1A South Wingwall, Area of Spalling with Exposed Reinforcing

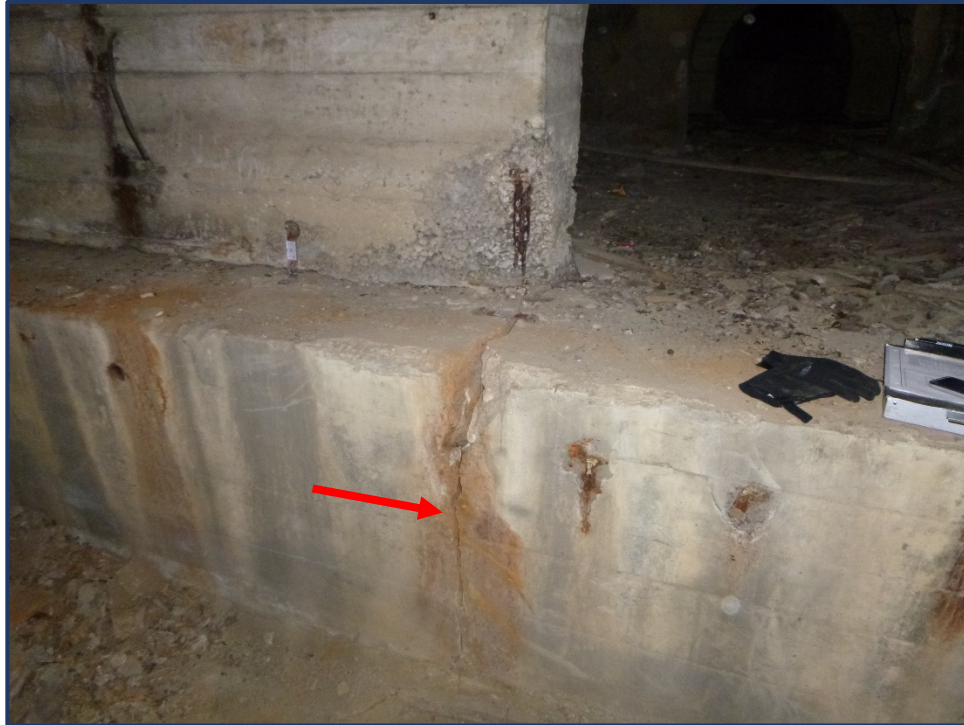
Photo WW-2 – West Abutment Chamber, Crack Through Footing at Tower B

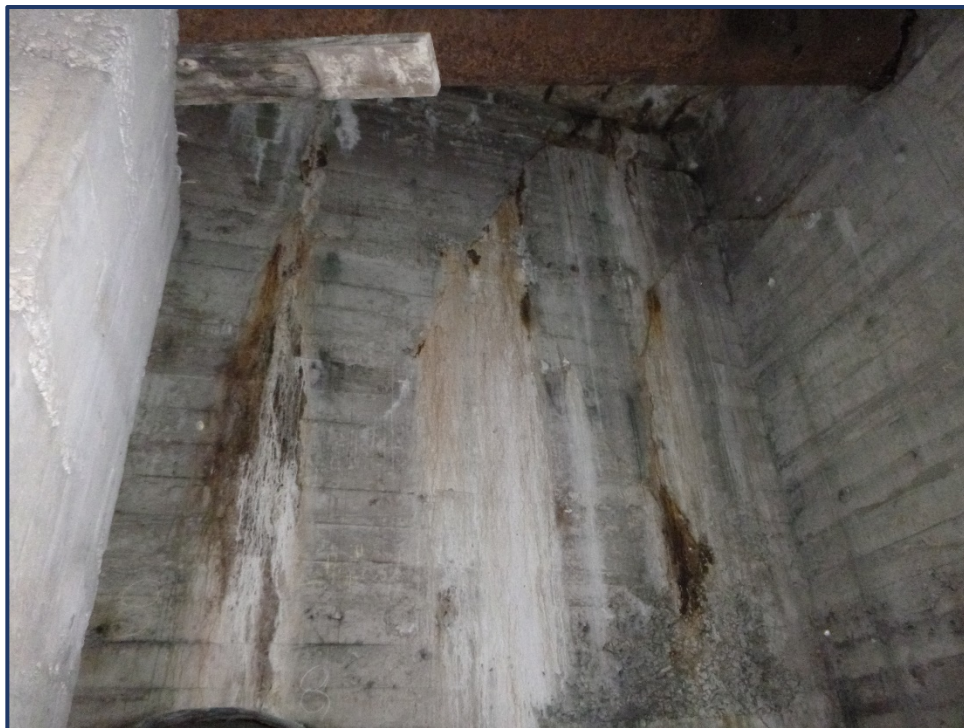
Photo AC-1 – West Abutment Chamber, Typical Cracking with Staining and Shallow Spalling

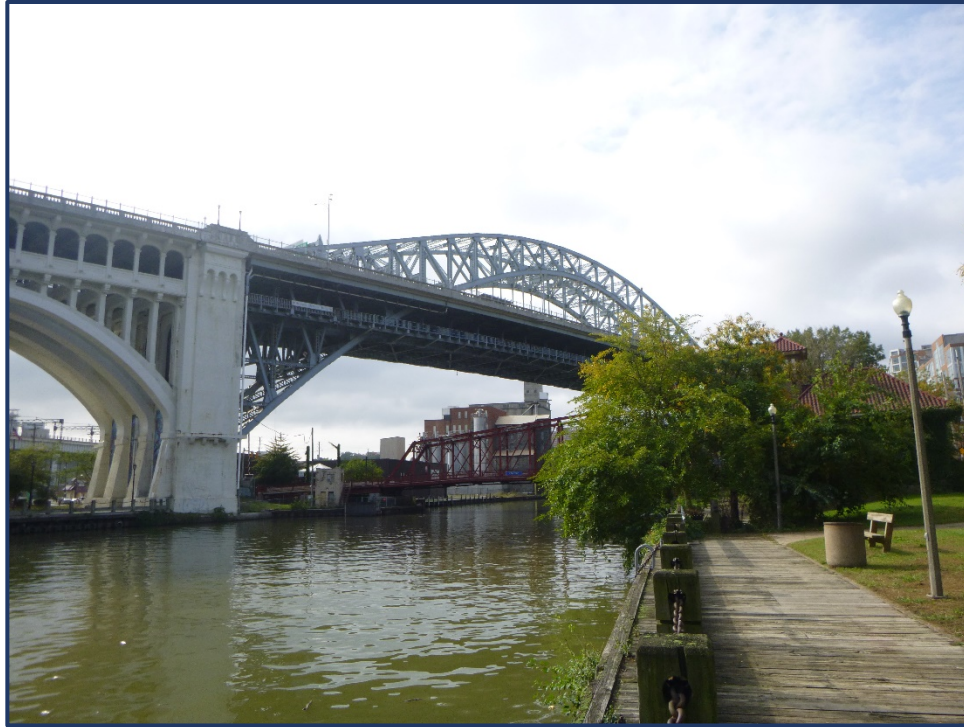
Photo CH-1 – Downstream Channel, Looking South

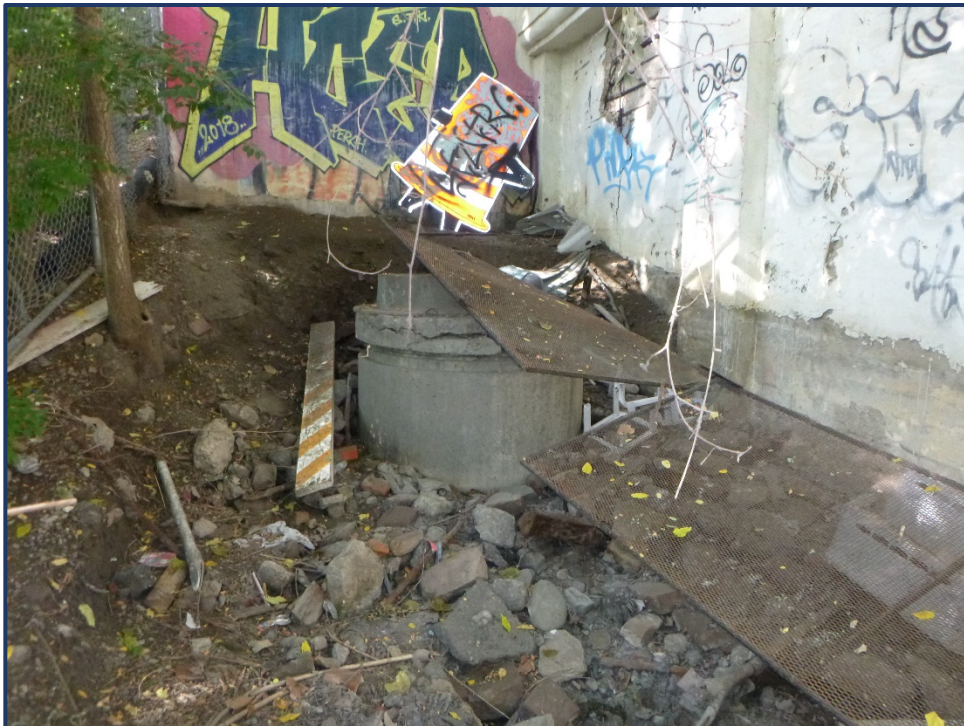
Photo APR-6 – Failed Preventive Access Steel Mesh on South Side of Span 1A

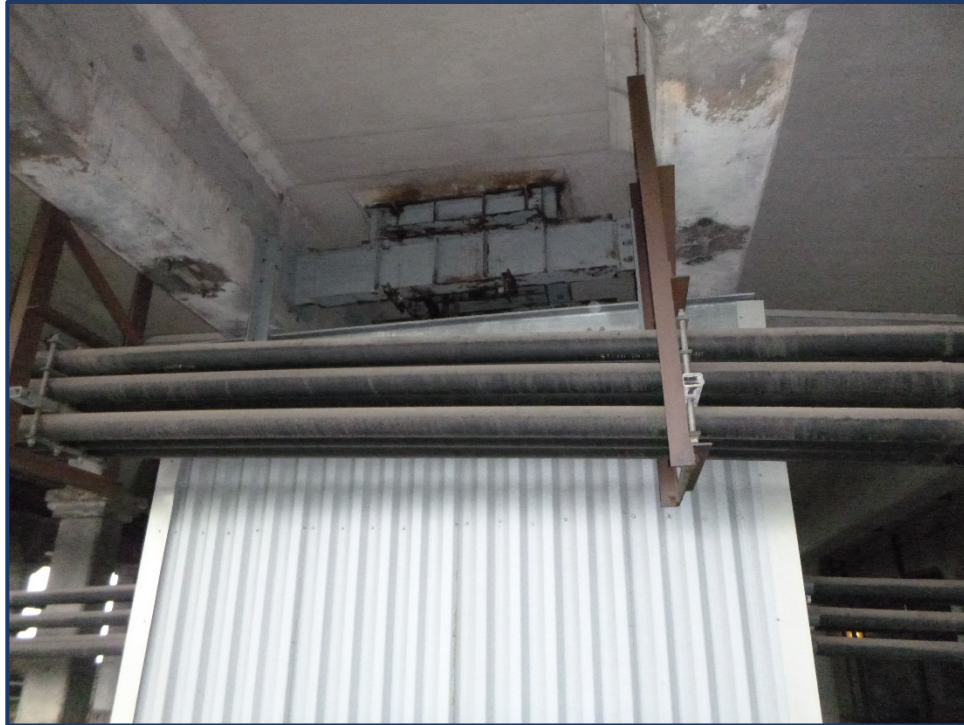
Photo UT-1 – Deteriorated Lower Deck Utility Junction Chamber Support.
