Physical Condition Report for

CUY-006-1456

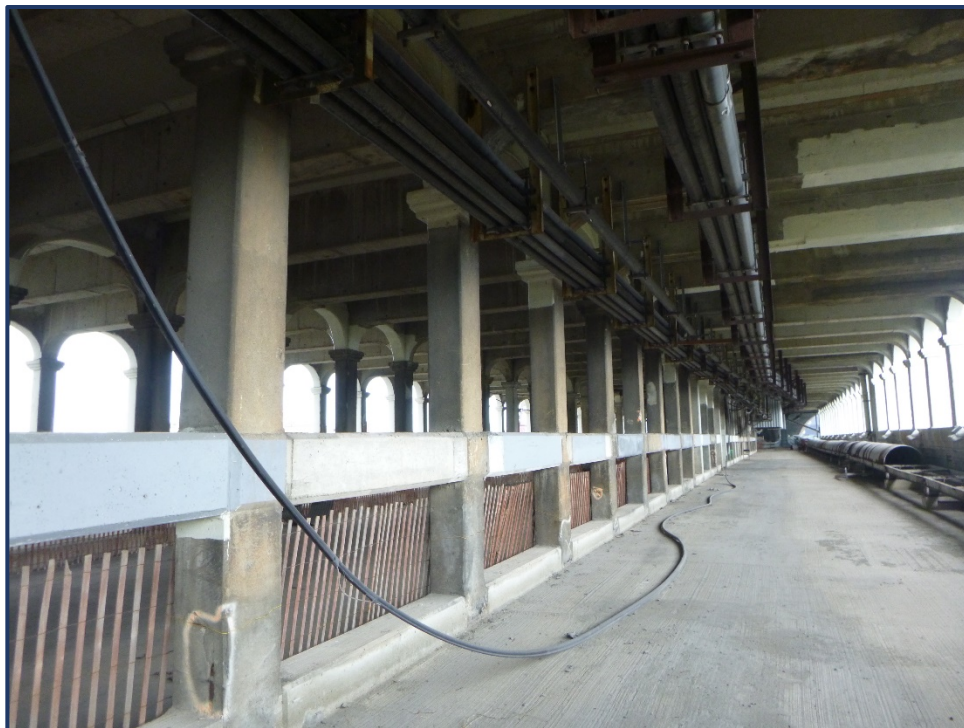
Photo UT-2 – Sagging Utility Line on Maintenance Deck

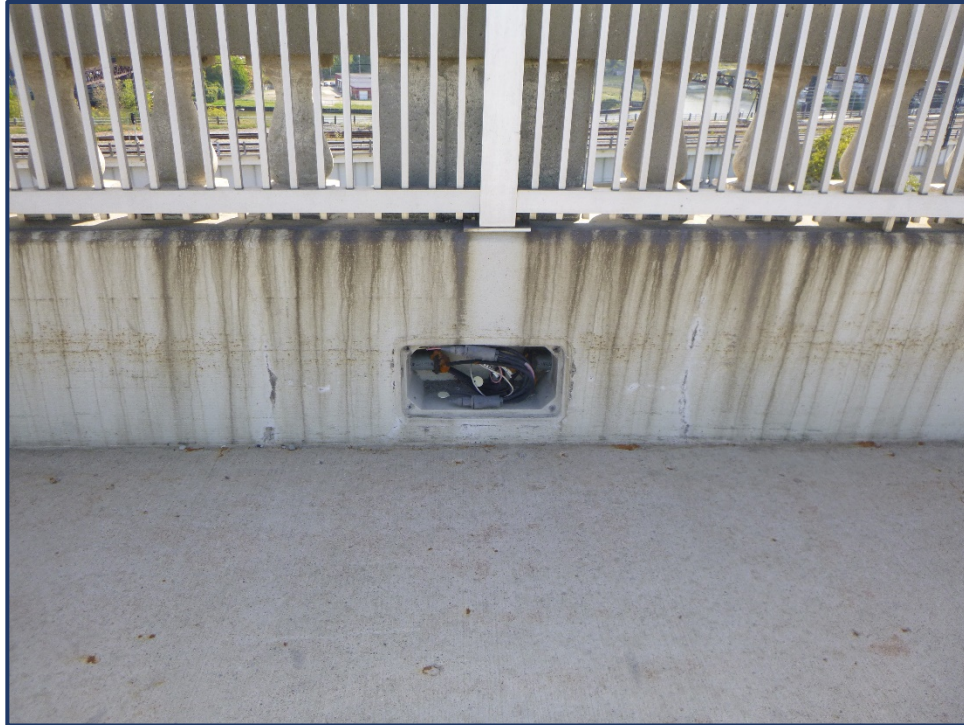
Photo UT-3 – Missing Electric Junction Box Cover, South Railing, Span 7

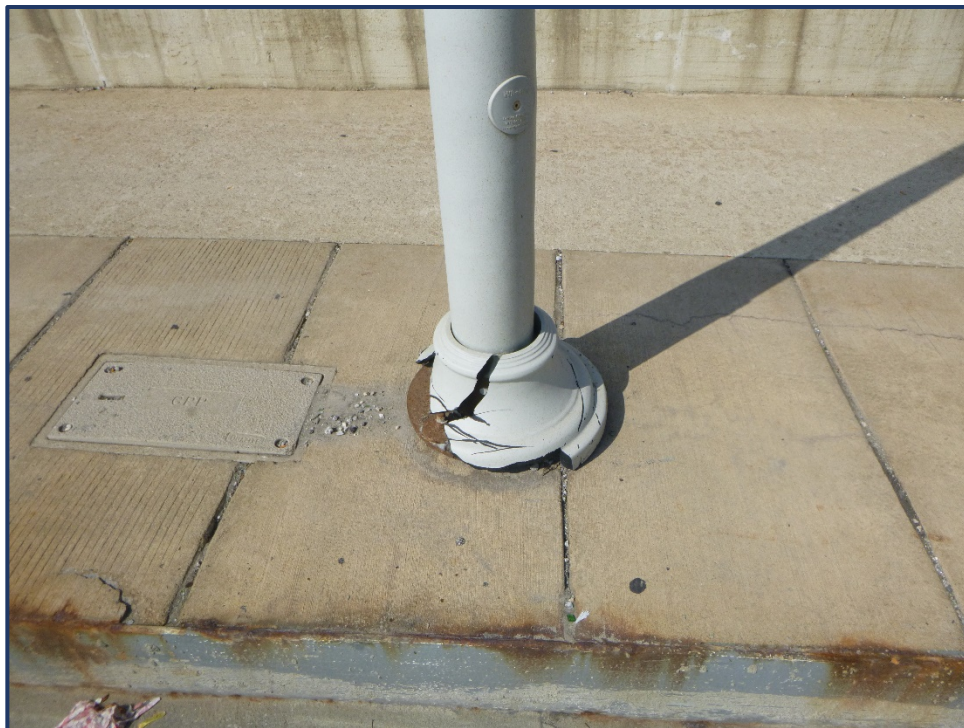
Photo UT-4 – Broken Light Pole Base Cover on North Sidewalk

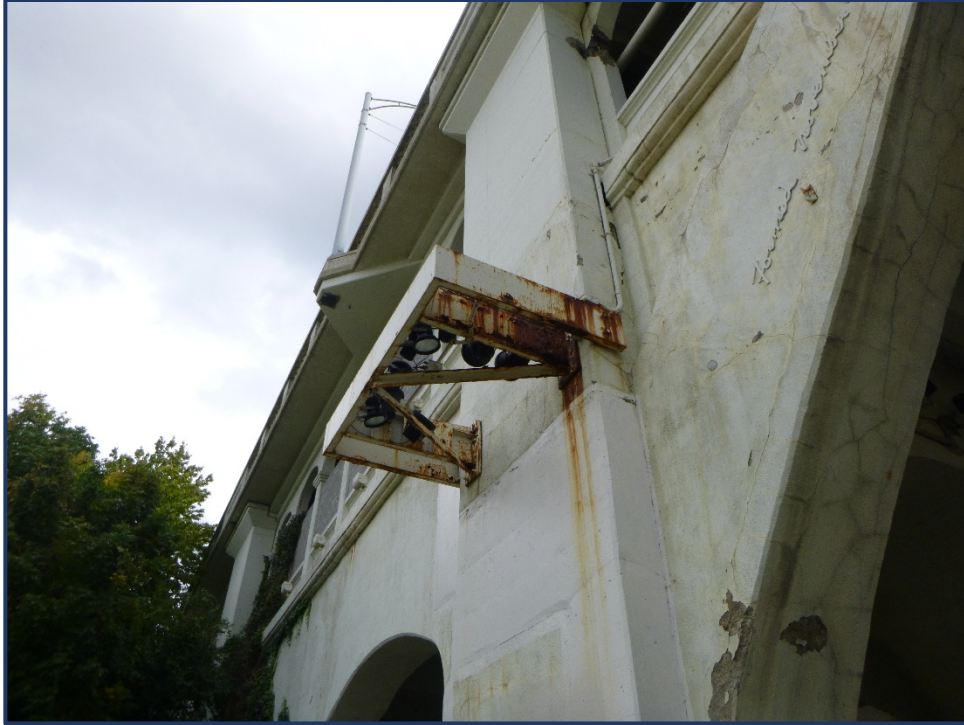
Photo UT-5 – Typical Corrosion and Minor Section Loss on Tower Light Brackets

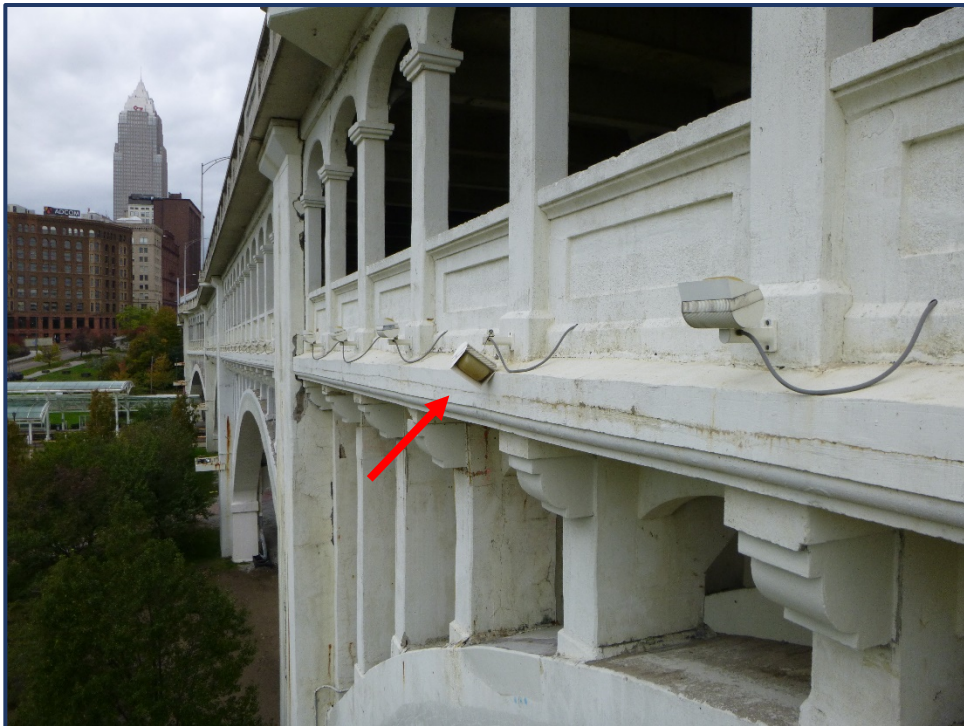
Photo UT-6 – Broken Architectural Light, Span 8 North Fascia

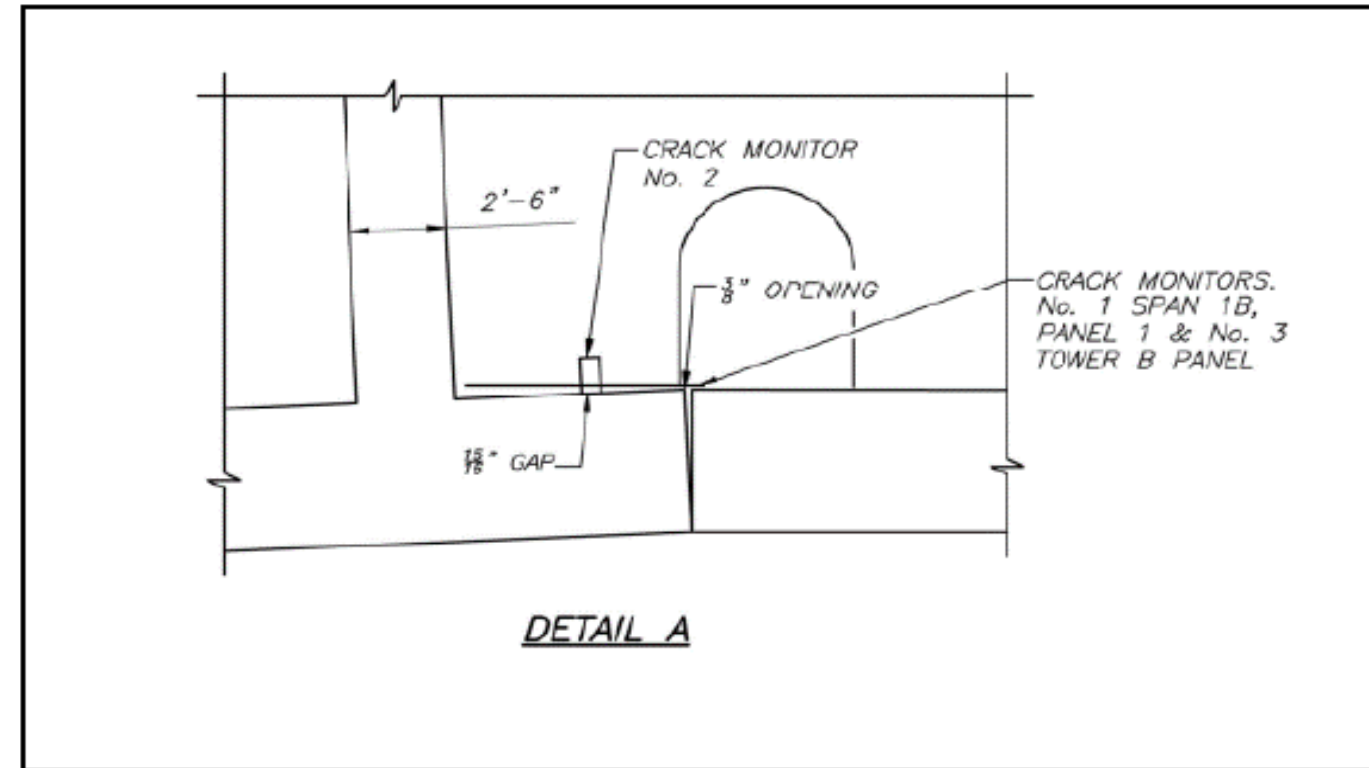
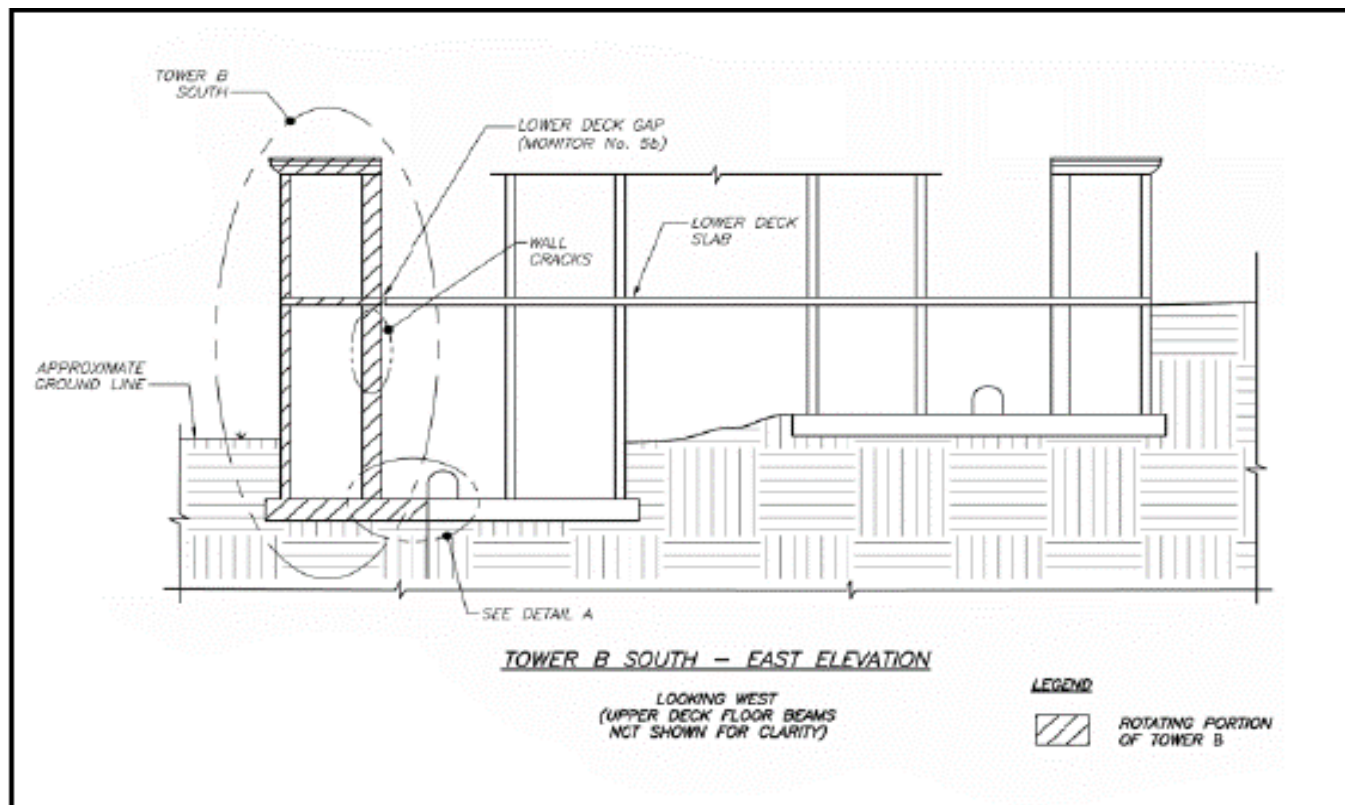
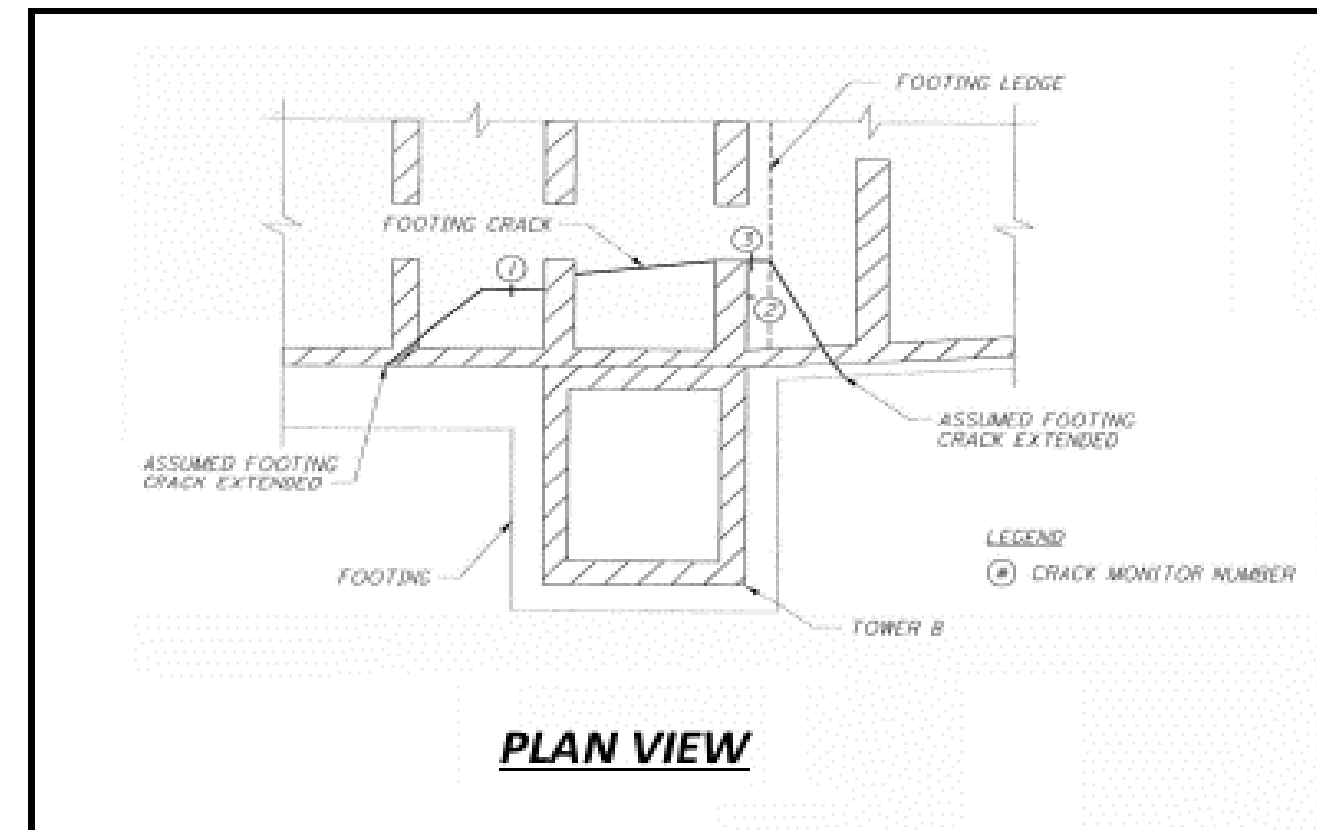
Table 6: Crack Gage Measurements - Span 1A Cellular Construction South Wall

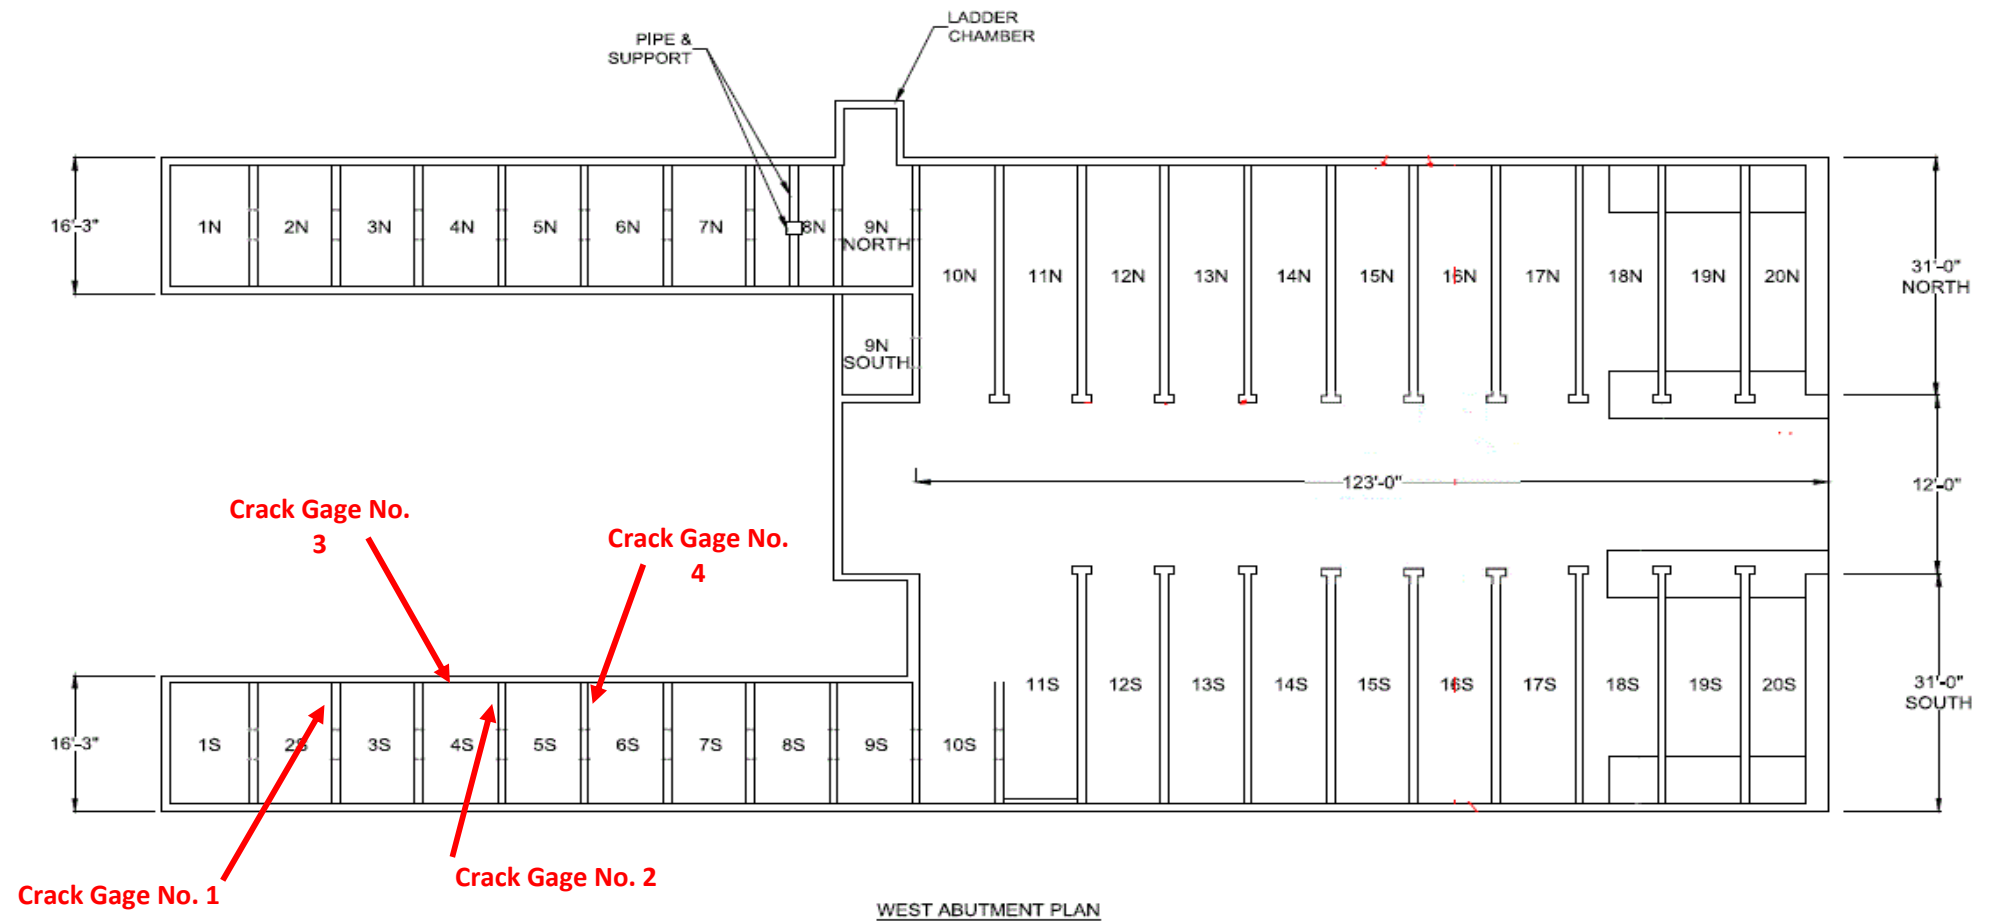
Date	No. 1		No. 2		No. 3		No. 4	
	V (mm)	H (mm)	V (mm)	H (mm)	V (mm)	H (mm)	V (mm)	H (mm)
5/17/07	0.0	0.0	0.0	0.0	0.0	0.0	0.0	0.0
4/16/13	2.0	1.0	2.5	0.3	0.0	0.0	0.8	0.2
10/3/14	2.3	1.0	3.0	0.6	0.0	0.0	0.8	0.2
8/16/15	2.8	1.1	4.5	0.8	0.0	0.0	0.9	0.5
9/14/16	3.0	1.1	4.8	0.8	0.0	0.0	1.0	0.5
11/27/17								
10/22/18							1.1	1.0
11/18/19							1.3	1.0
10/22/20					0.0	0.0	1.5	1.0
10/29/21	6.0	1.3	6.0	1.0	0.0	0.00	1.5	1.0

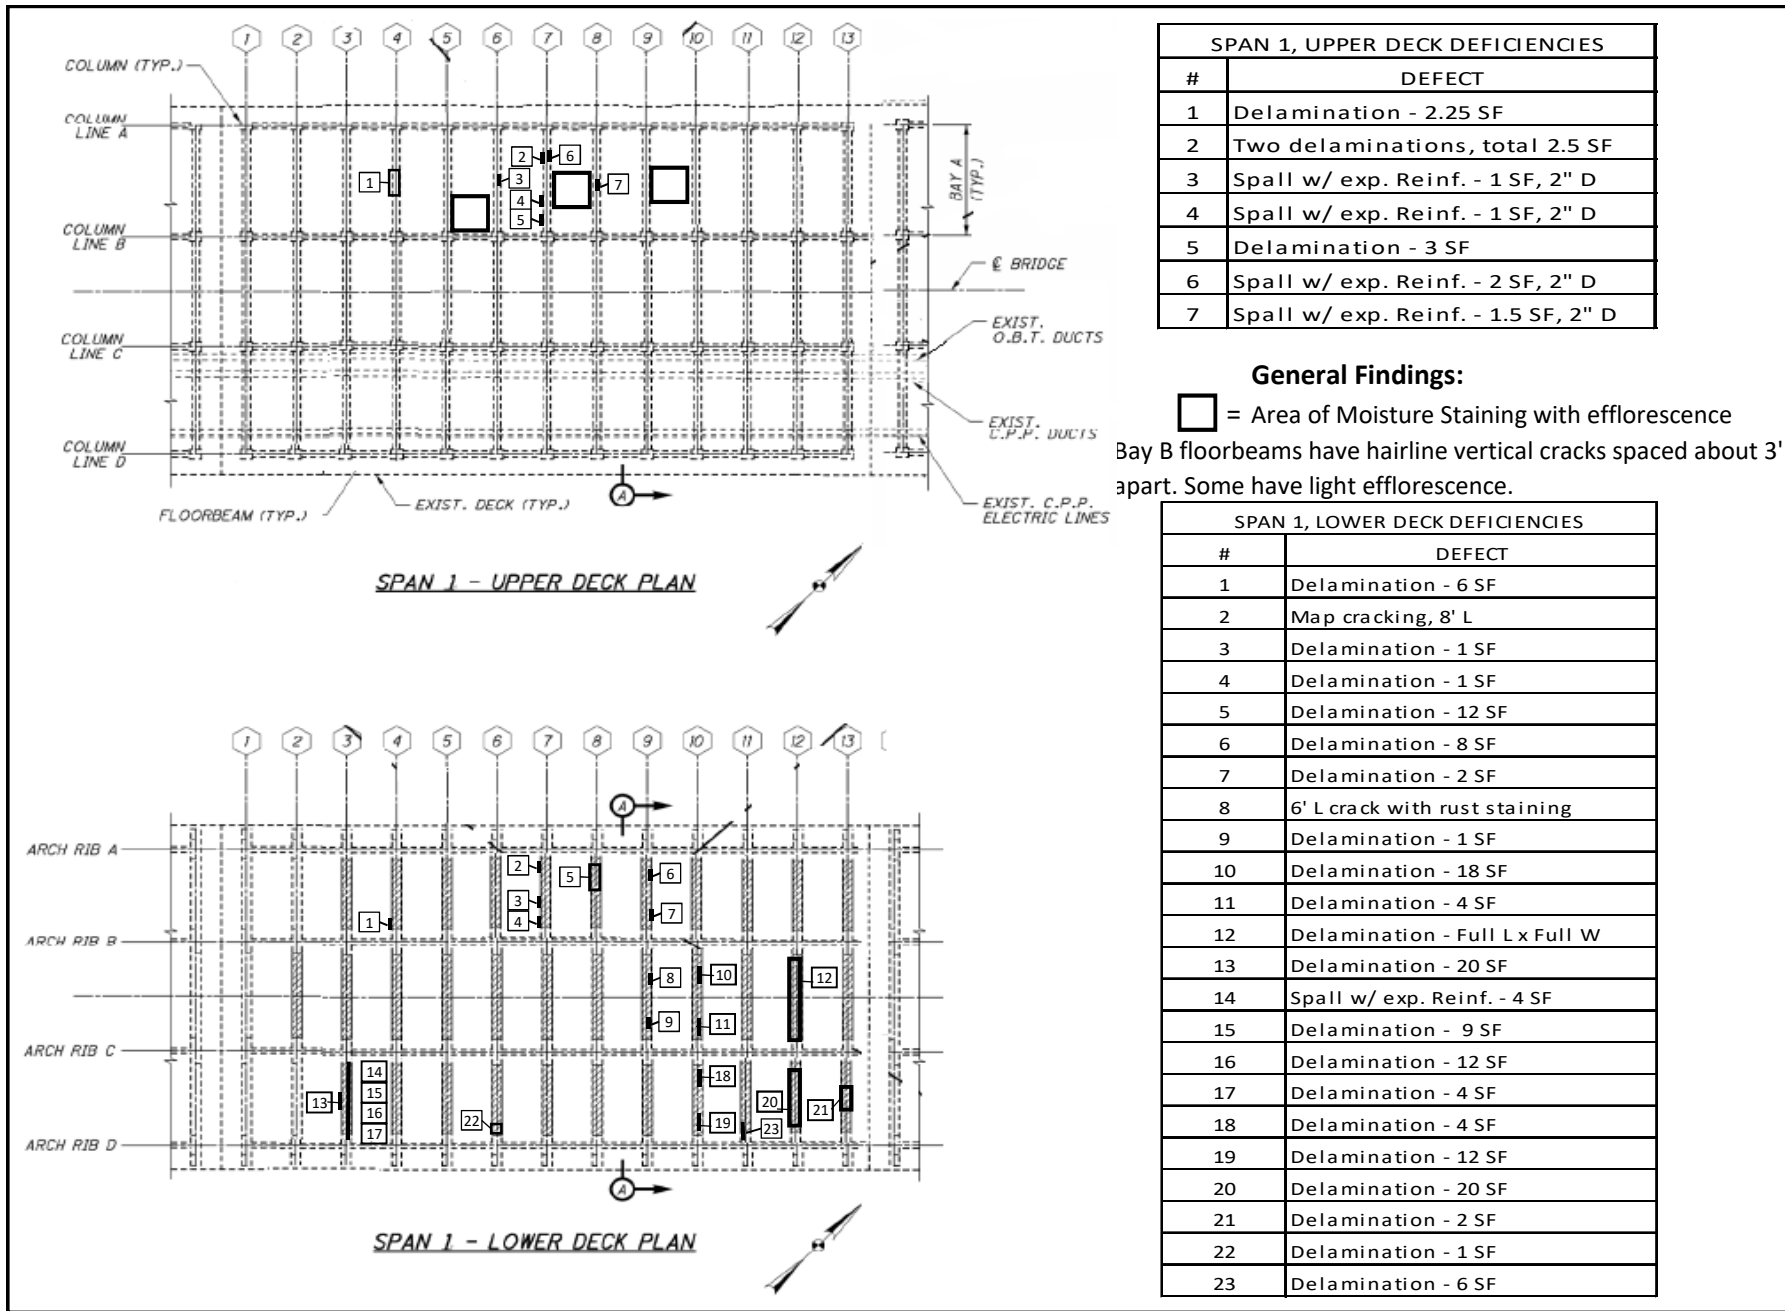
**APPENDIX C – OPEN SPANDREL ARCH, TRUSS,
FLOOR SYSTEM, AND SUBSTRUCTURE
DRAWINGS AND DEFICIENCIES**

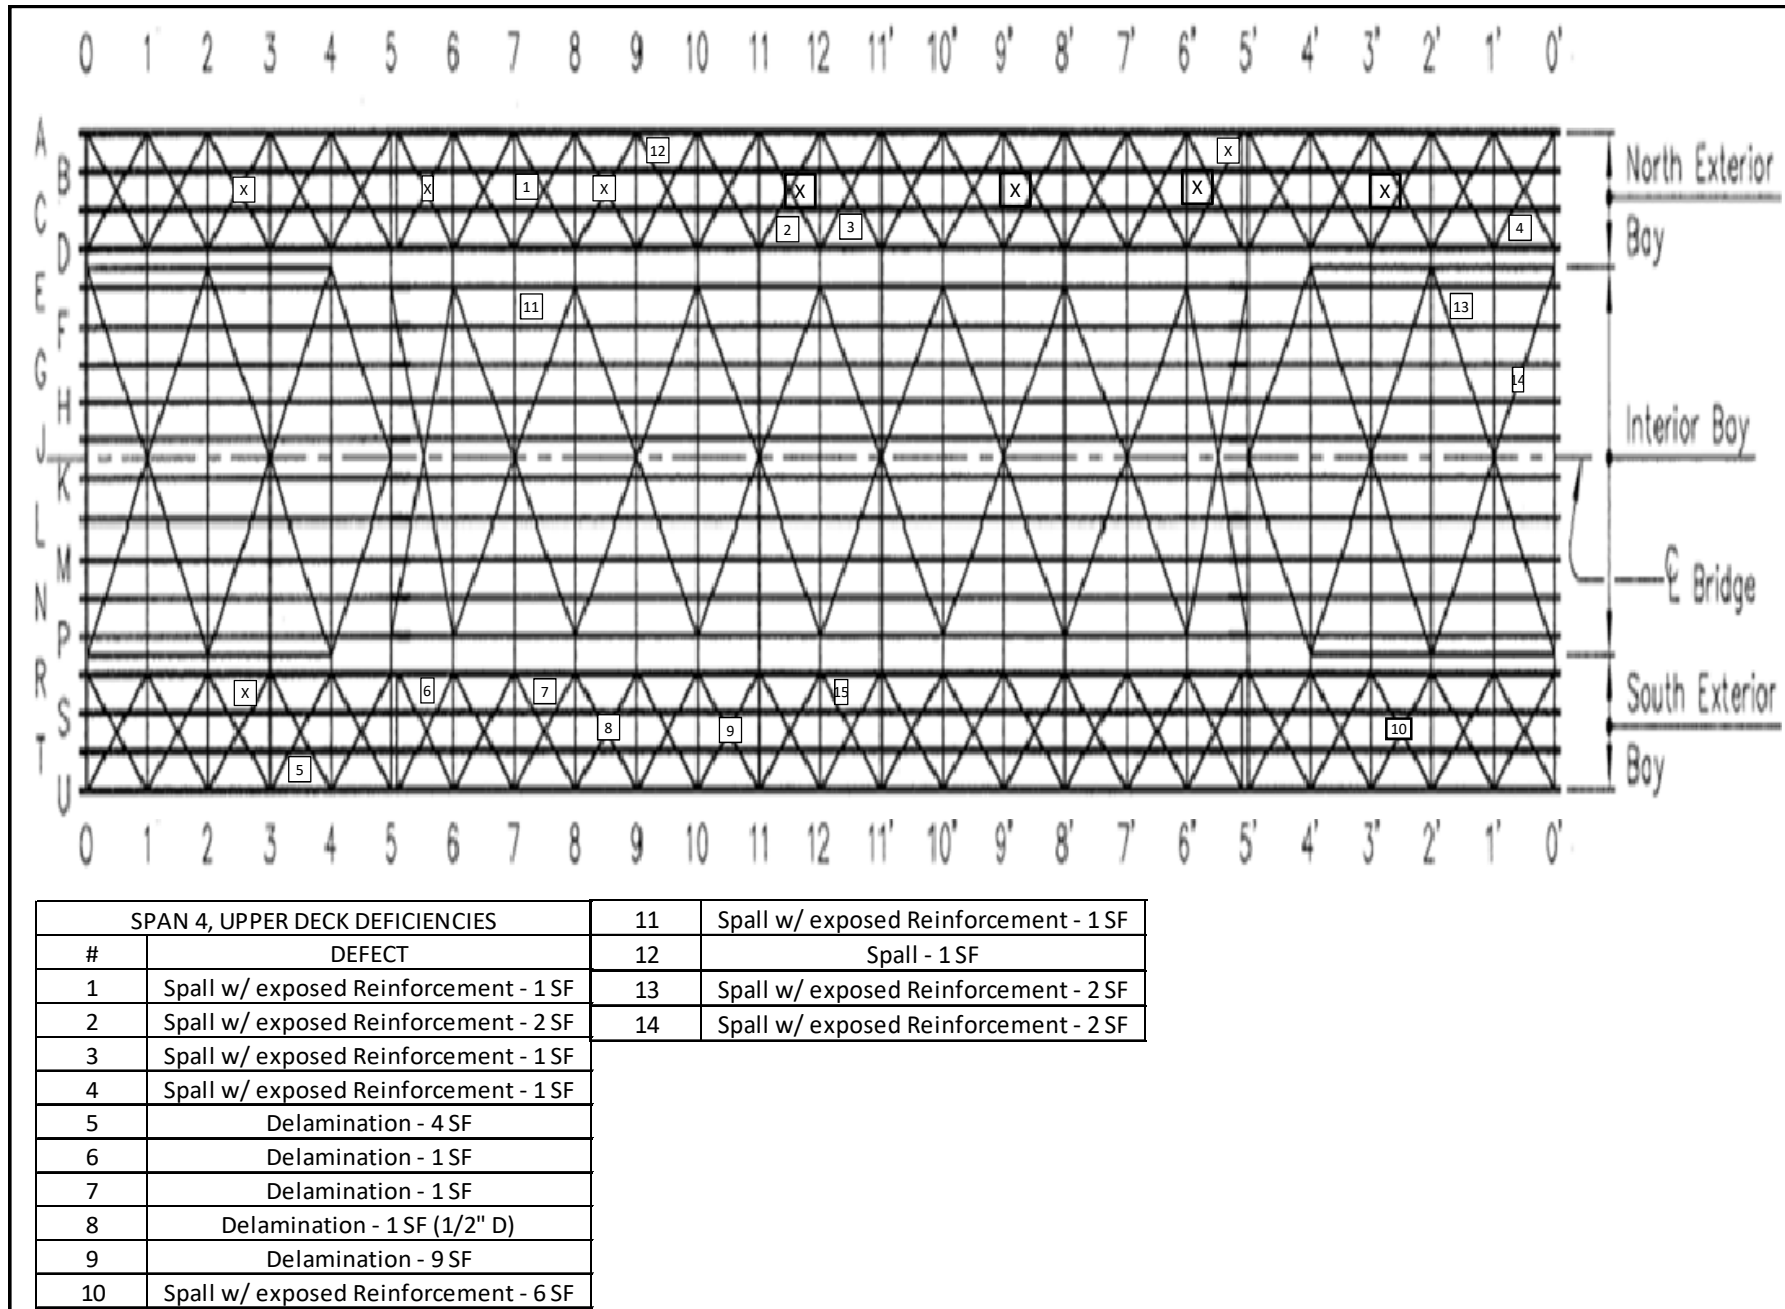
Appendix C - Open Spandrel Arch, Truss, Floor System, and Substructure Drawings and Deficiencies

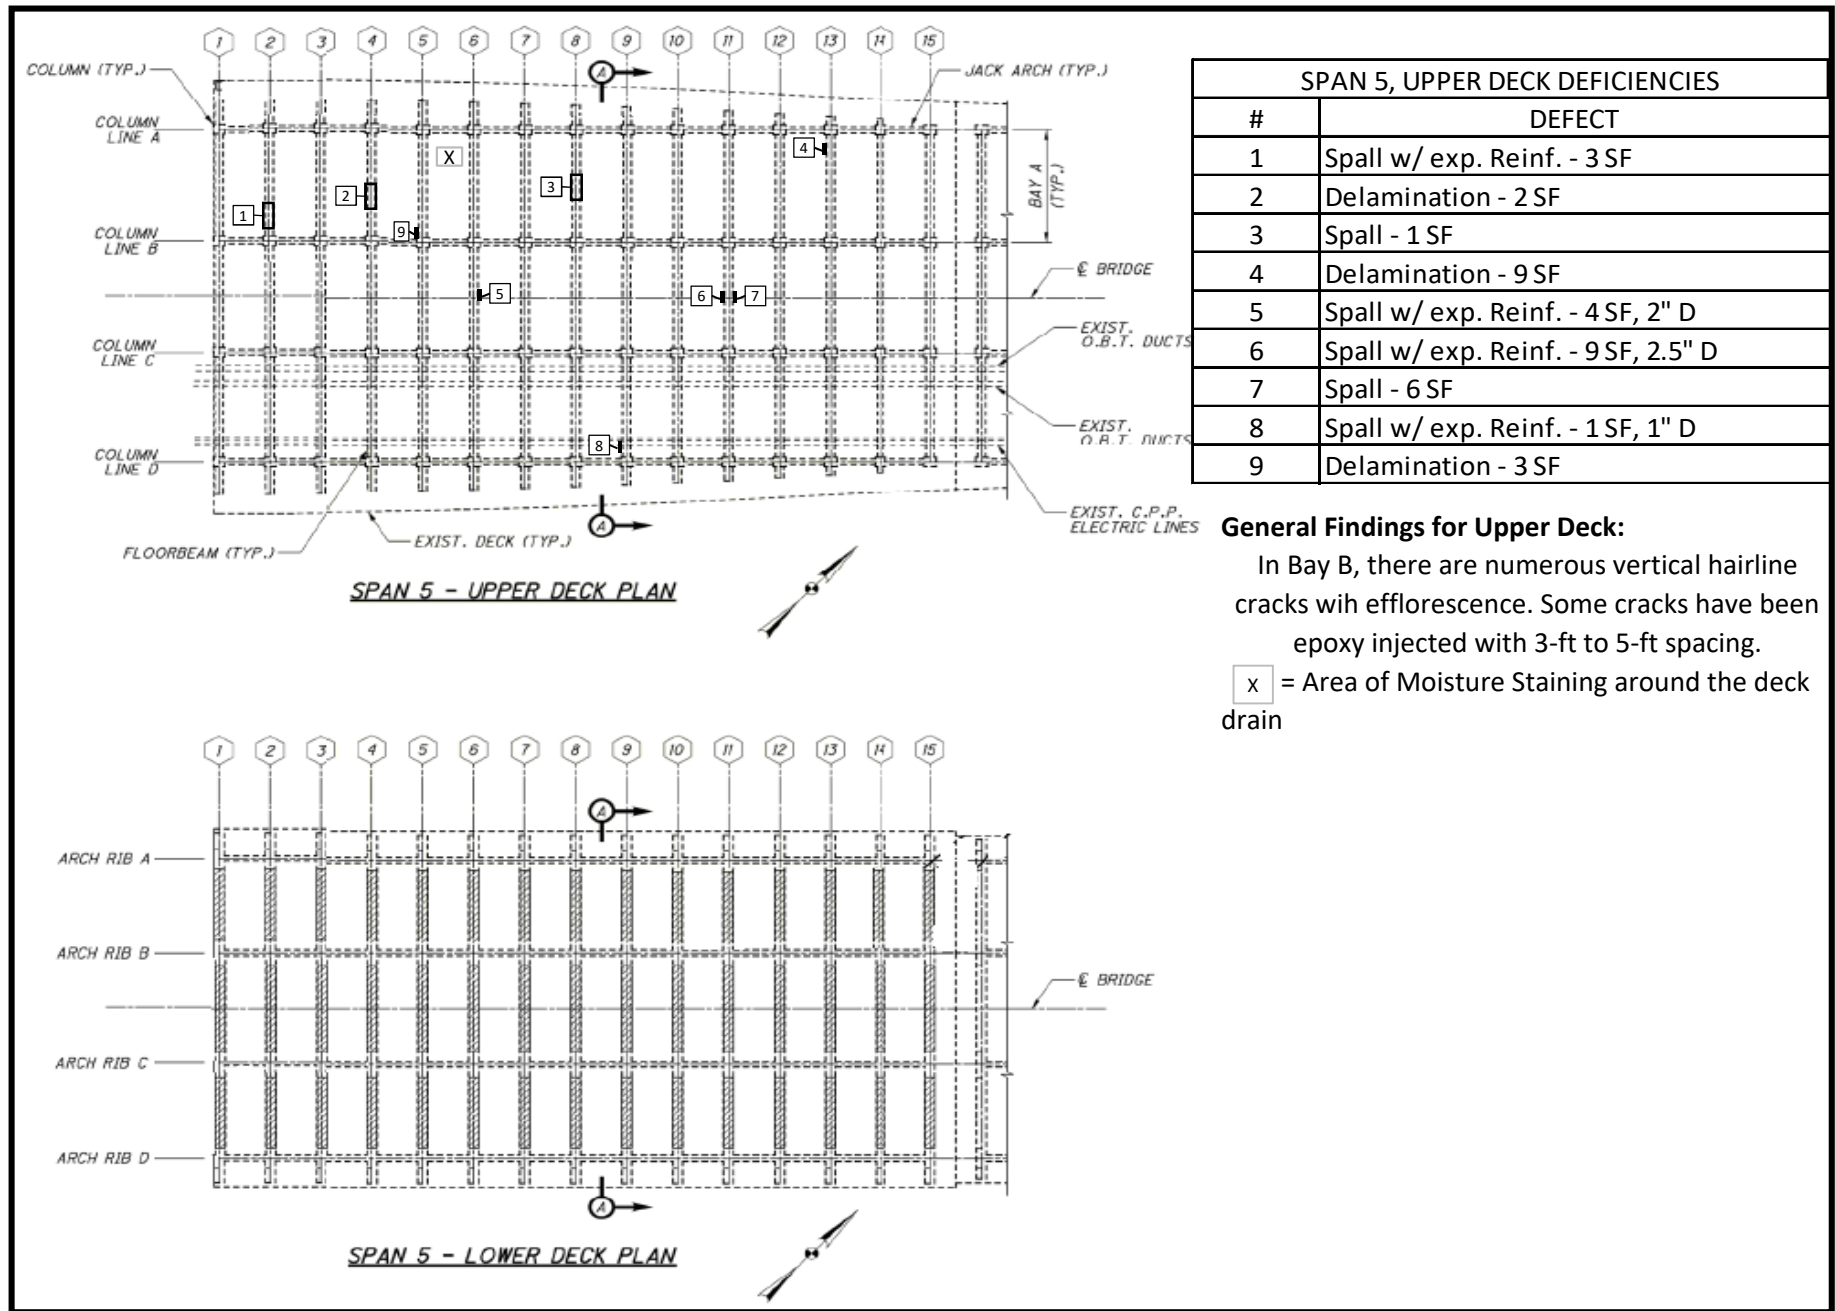
SPAN 5, UPPER DECK DEFICIENCIES	
#	DEFECT
1	Spall w/ exp. Reinf. - 3 SF
2	Delamination - 2 SF
3	Spall - 1 SF
4	Delamination - 9 SF
5	Spall w/ exp. Reinf. - 4 SF, 2" D
6	Spall w/ exp. Reinf. - 9 SF, 2.5" D
7	Spall - 6 SF
8	Spall w/ exp. Reinf. - 1 SF, 1" D
9	Delamination - 3 SF

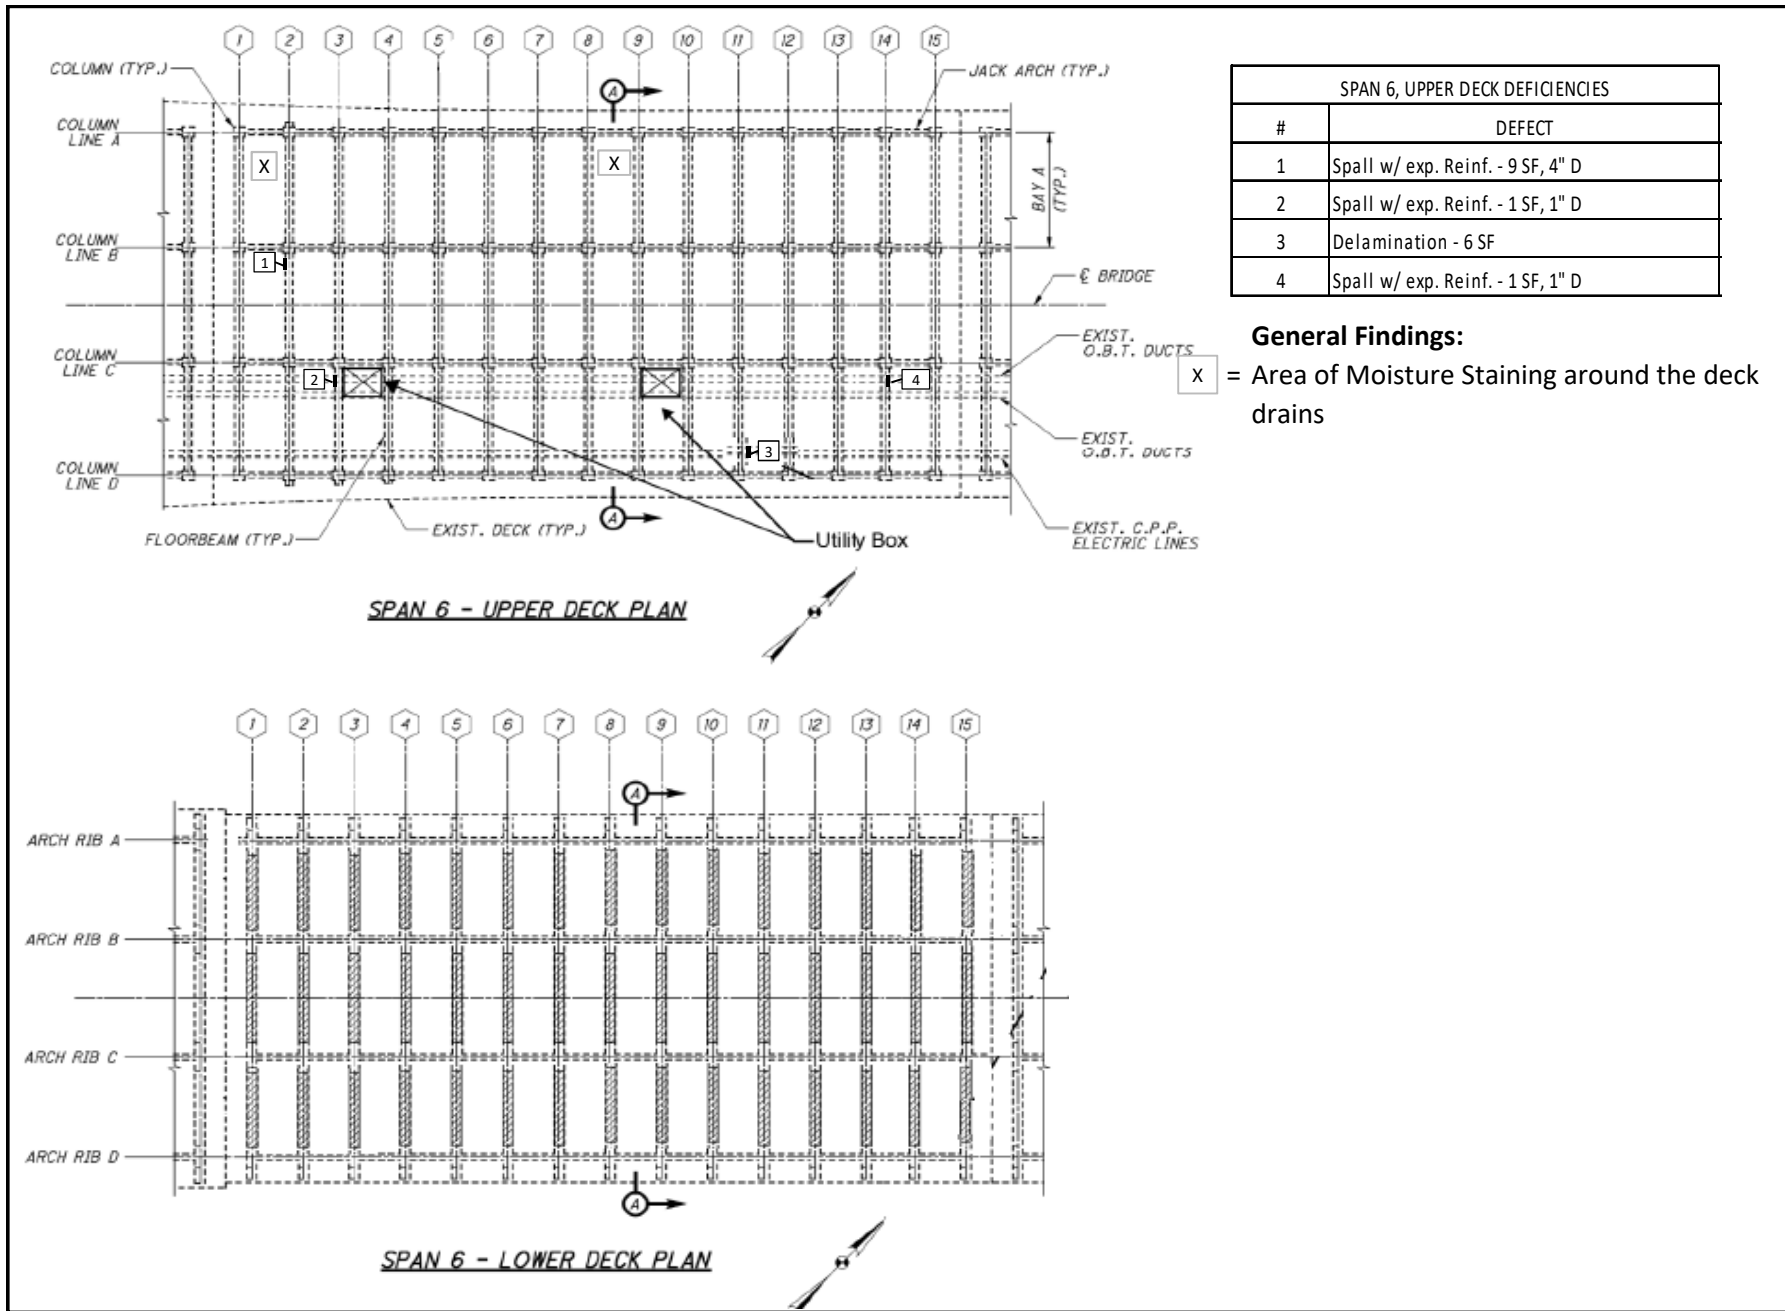
X = Area of Moisture Staining around the deck drain

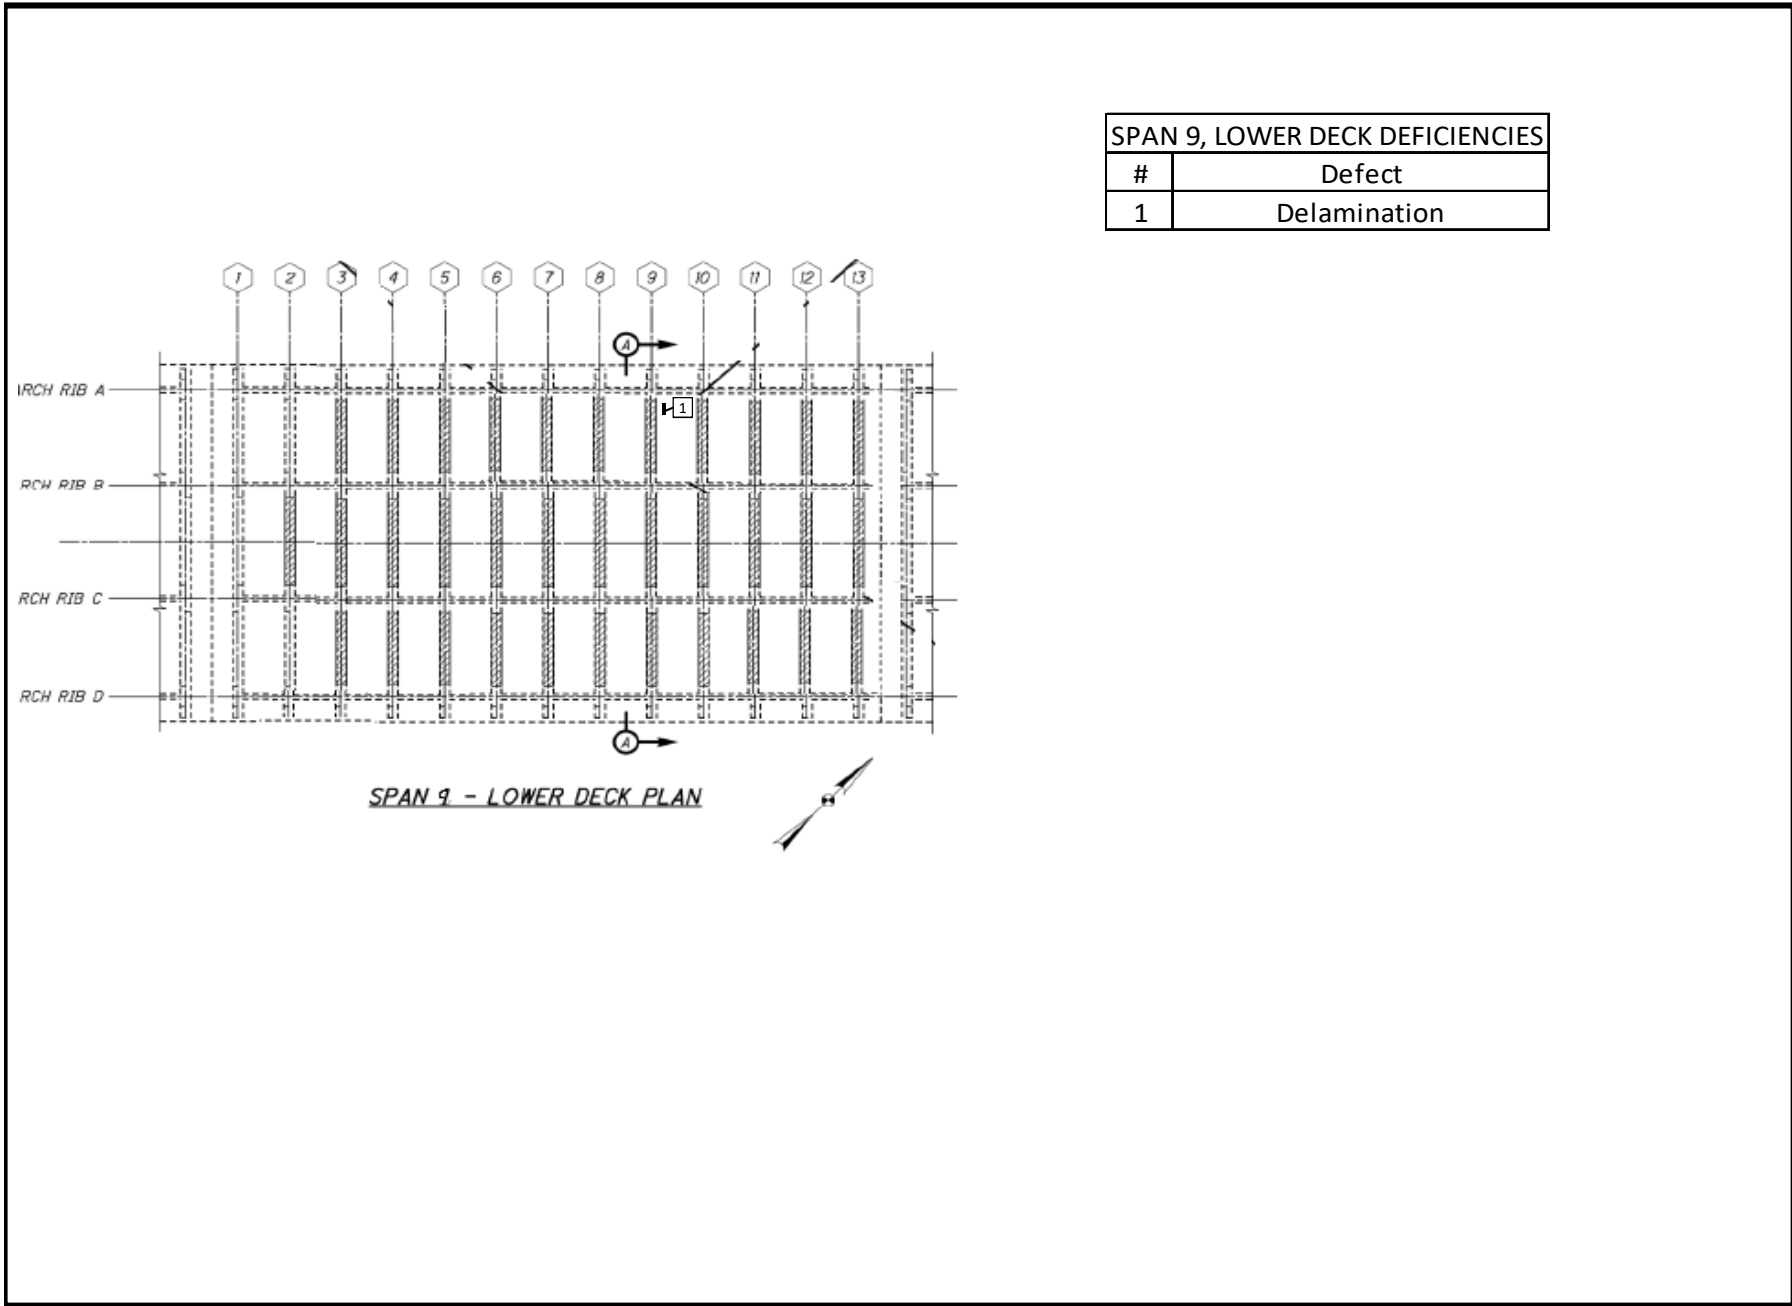
SPAN 9, LOWER DECK DEFICIENCIES	
#	Defect
1	Delamination

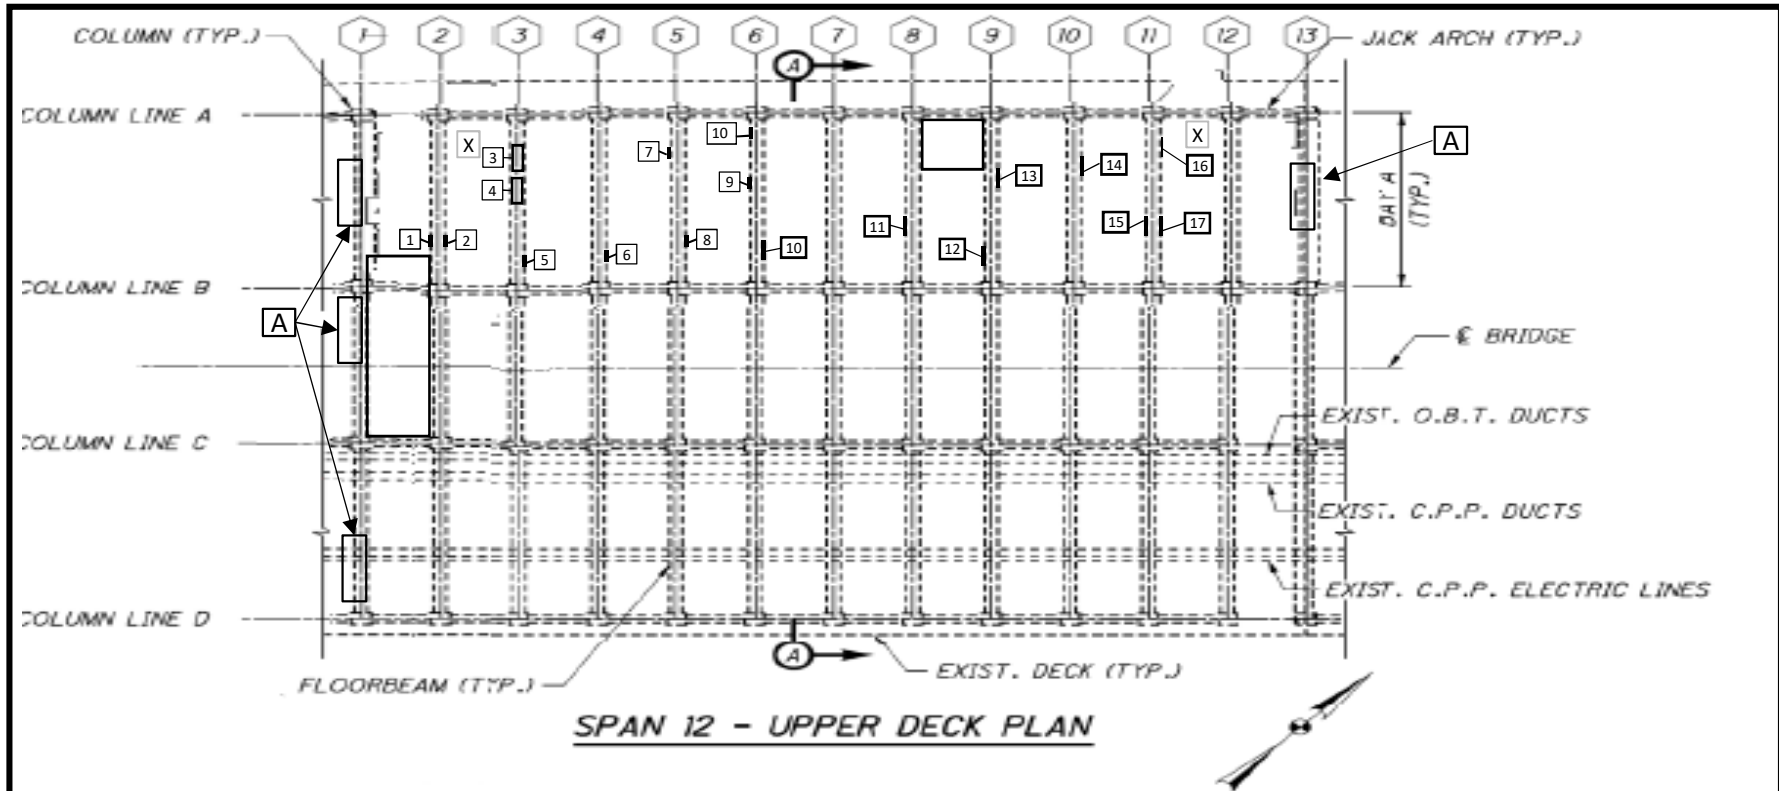
SPAN 12 - UPPER DECK PLAN

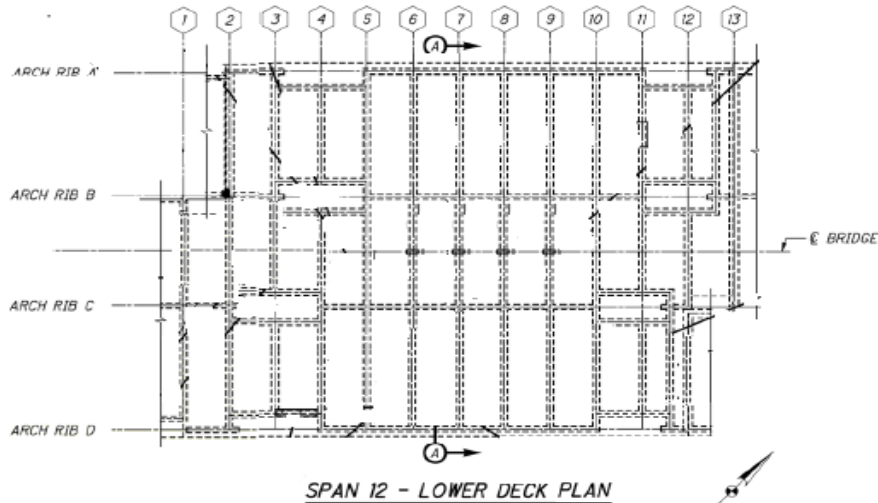
SPAN 12, LOWER DECK DEFICIENCIES				
FB #	Defect	Bay A (sf)	Bay B (sf)	Bay C (sf)
1	Delamination		0	0
	Spall w/ exp. Reinf.		0	0
2	Delamination	4	19	13
	Spall w/ exp. Reinf.	5	14	5
3	Delamination	1	3	0
	Spall w/ exp. Reinf.	0	0	0
4	Delamination	6	6	33
	Spall w/ exp. Reinf.	6	2	16
5	Delamination	8	0	17
	Spall w/ exp. Reinf.	16	0	5
6	Delamination	94	0	12
	Spall w/ exp. Reinf.	0	1	1
7	Delamination	2	0	0
	Spall w/ exp. Reinf.	0	0	0
8	Delamination	2	11	4
	Spall w/ exp. Reinf.	2	2	1
9	Delamination	22	19	45
	Spall w/ exp. Reinf.	0	0	2
10	Delamination	14	0	8
	Spall w/ exp. Reinf.	32	0	0
11	Delamination	4	0	8
	Spall w/ exp. Reinf.	7	2	0
12	Delamination	10	4	20
	Spall w/ exp. Reinf.	8	0	2
13	Delamination	0	0	
	Spall w/ exp. Reinf.	0	0
