Physical Condition Report for

CUY-006-1456

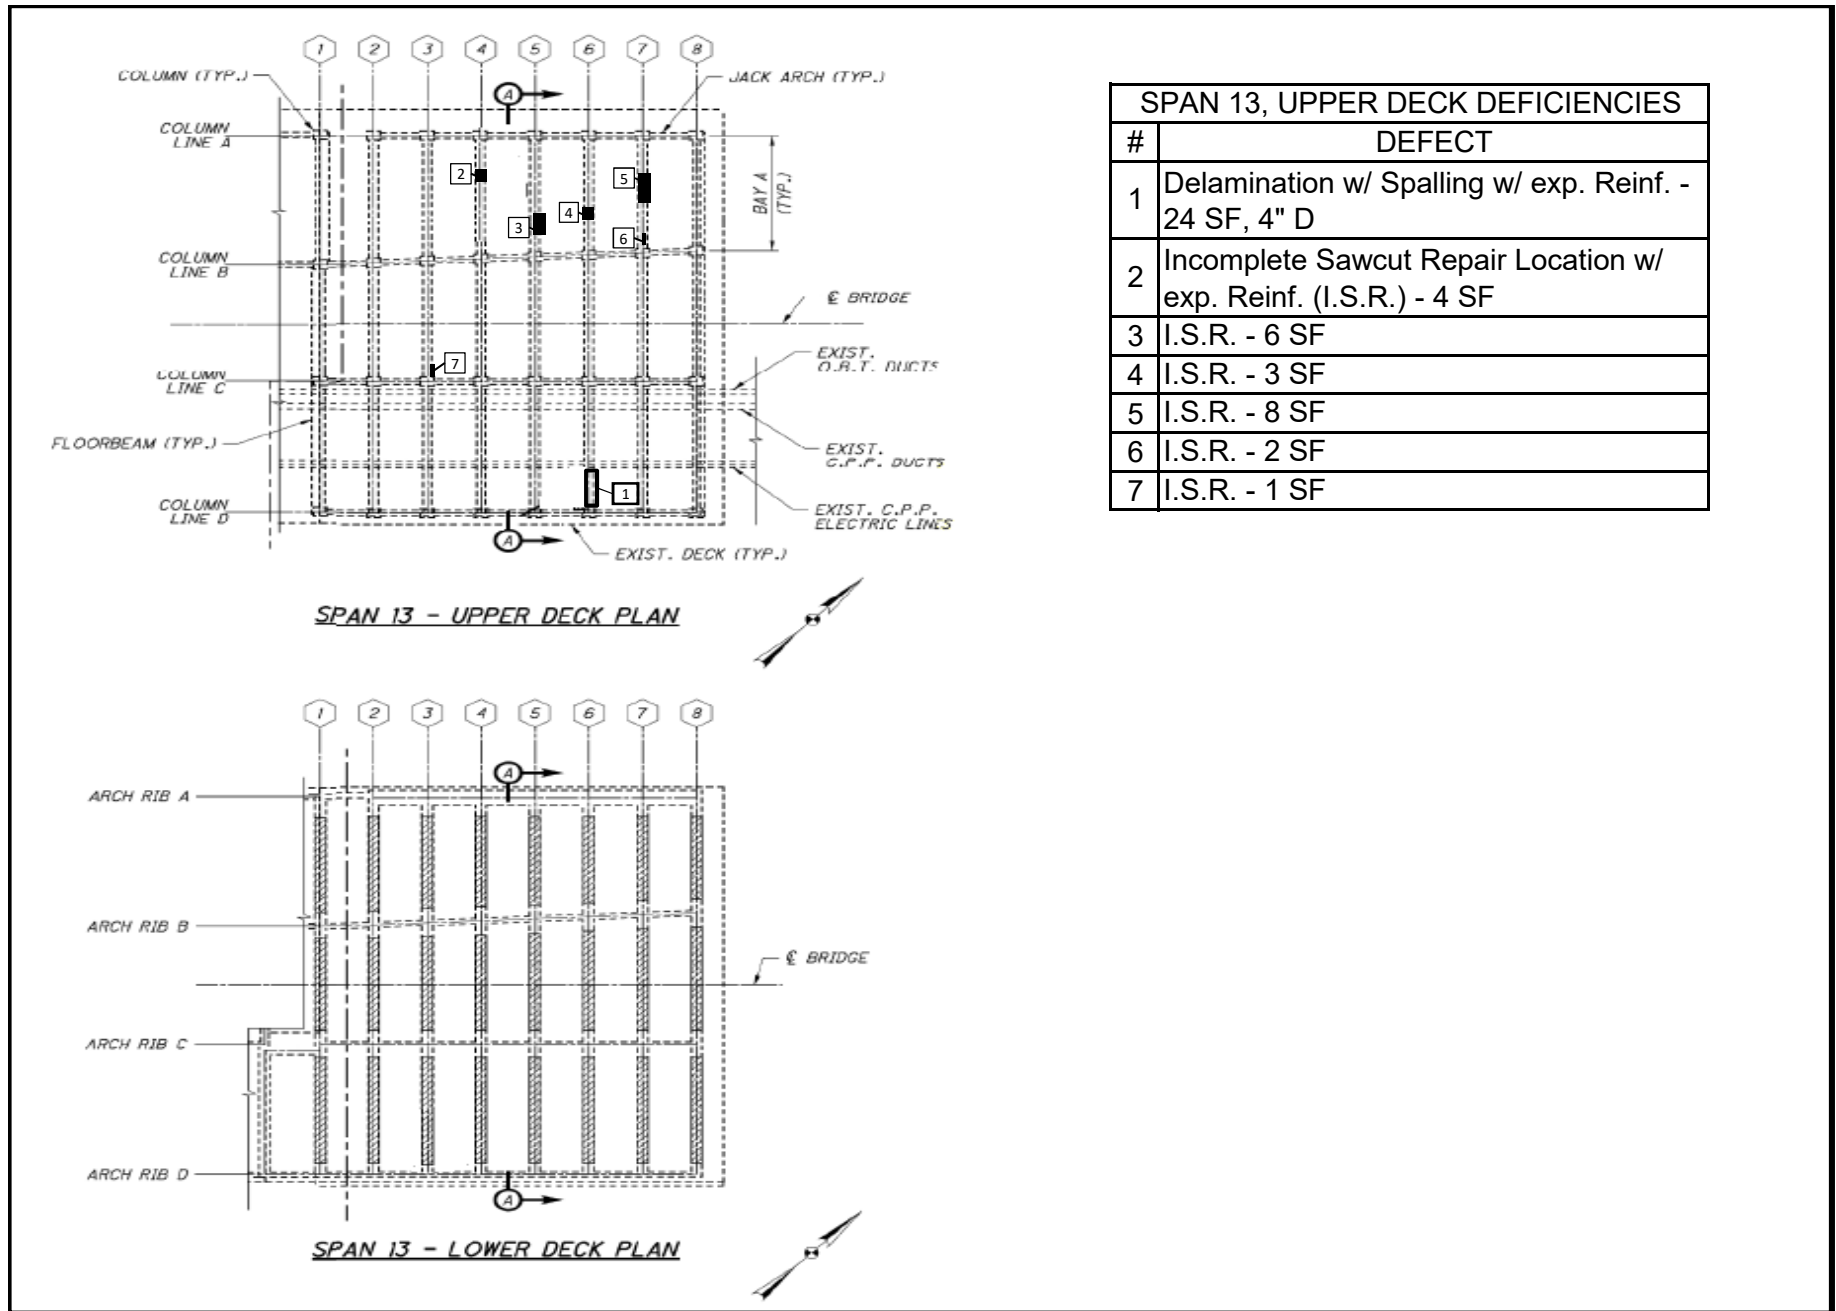
Joint	Location	Description
Pier 11	Ribs A-B	One plate missing and one displaced 4" east
	Ribs B-C	Two plates missing and two plate displaced up to 2" west
	Ribs C-D	Six plates displaced up to 6.5" west
Pier 12	Ribs A-B	One plate missing and two displaced up to 1" east

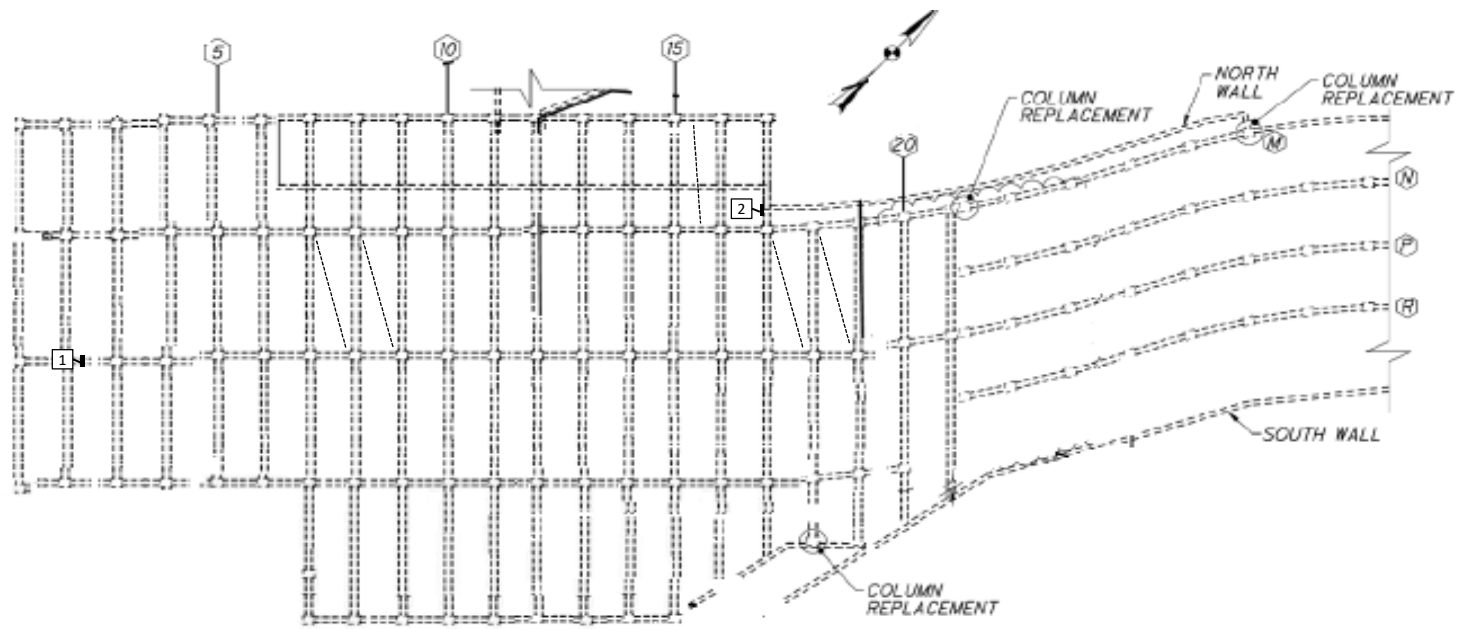
EAST STATION & SUBWAY - PLAN

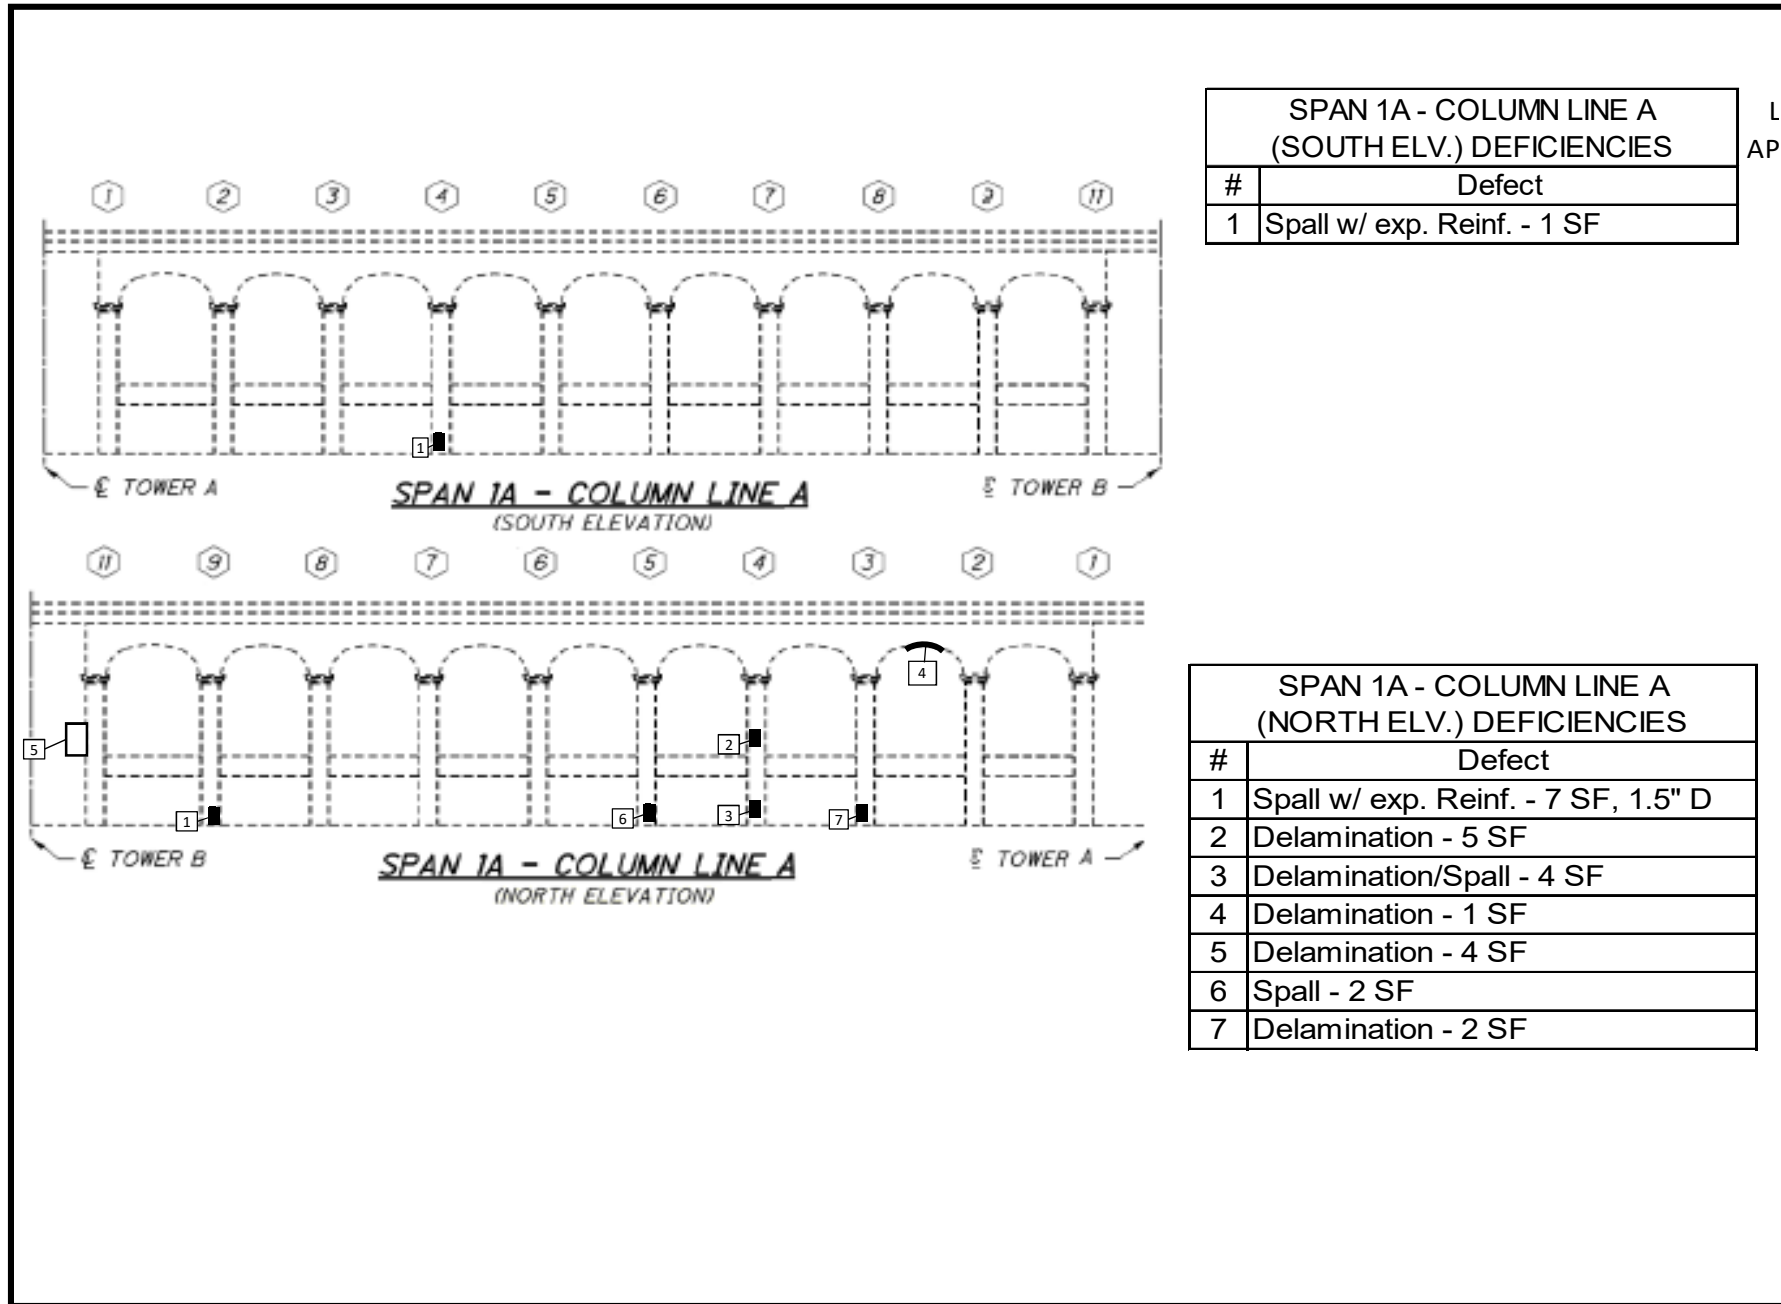
EAST STATION & SUBWAY DEFICIENCIES	
#	DEFECT
1	Spall w/ exp. Reinf. - 1 SF, 1" D (underside of arch)
2	Spall - 24 SF (in wall) and Spall - 6 SF (in btm of FB)

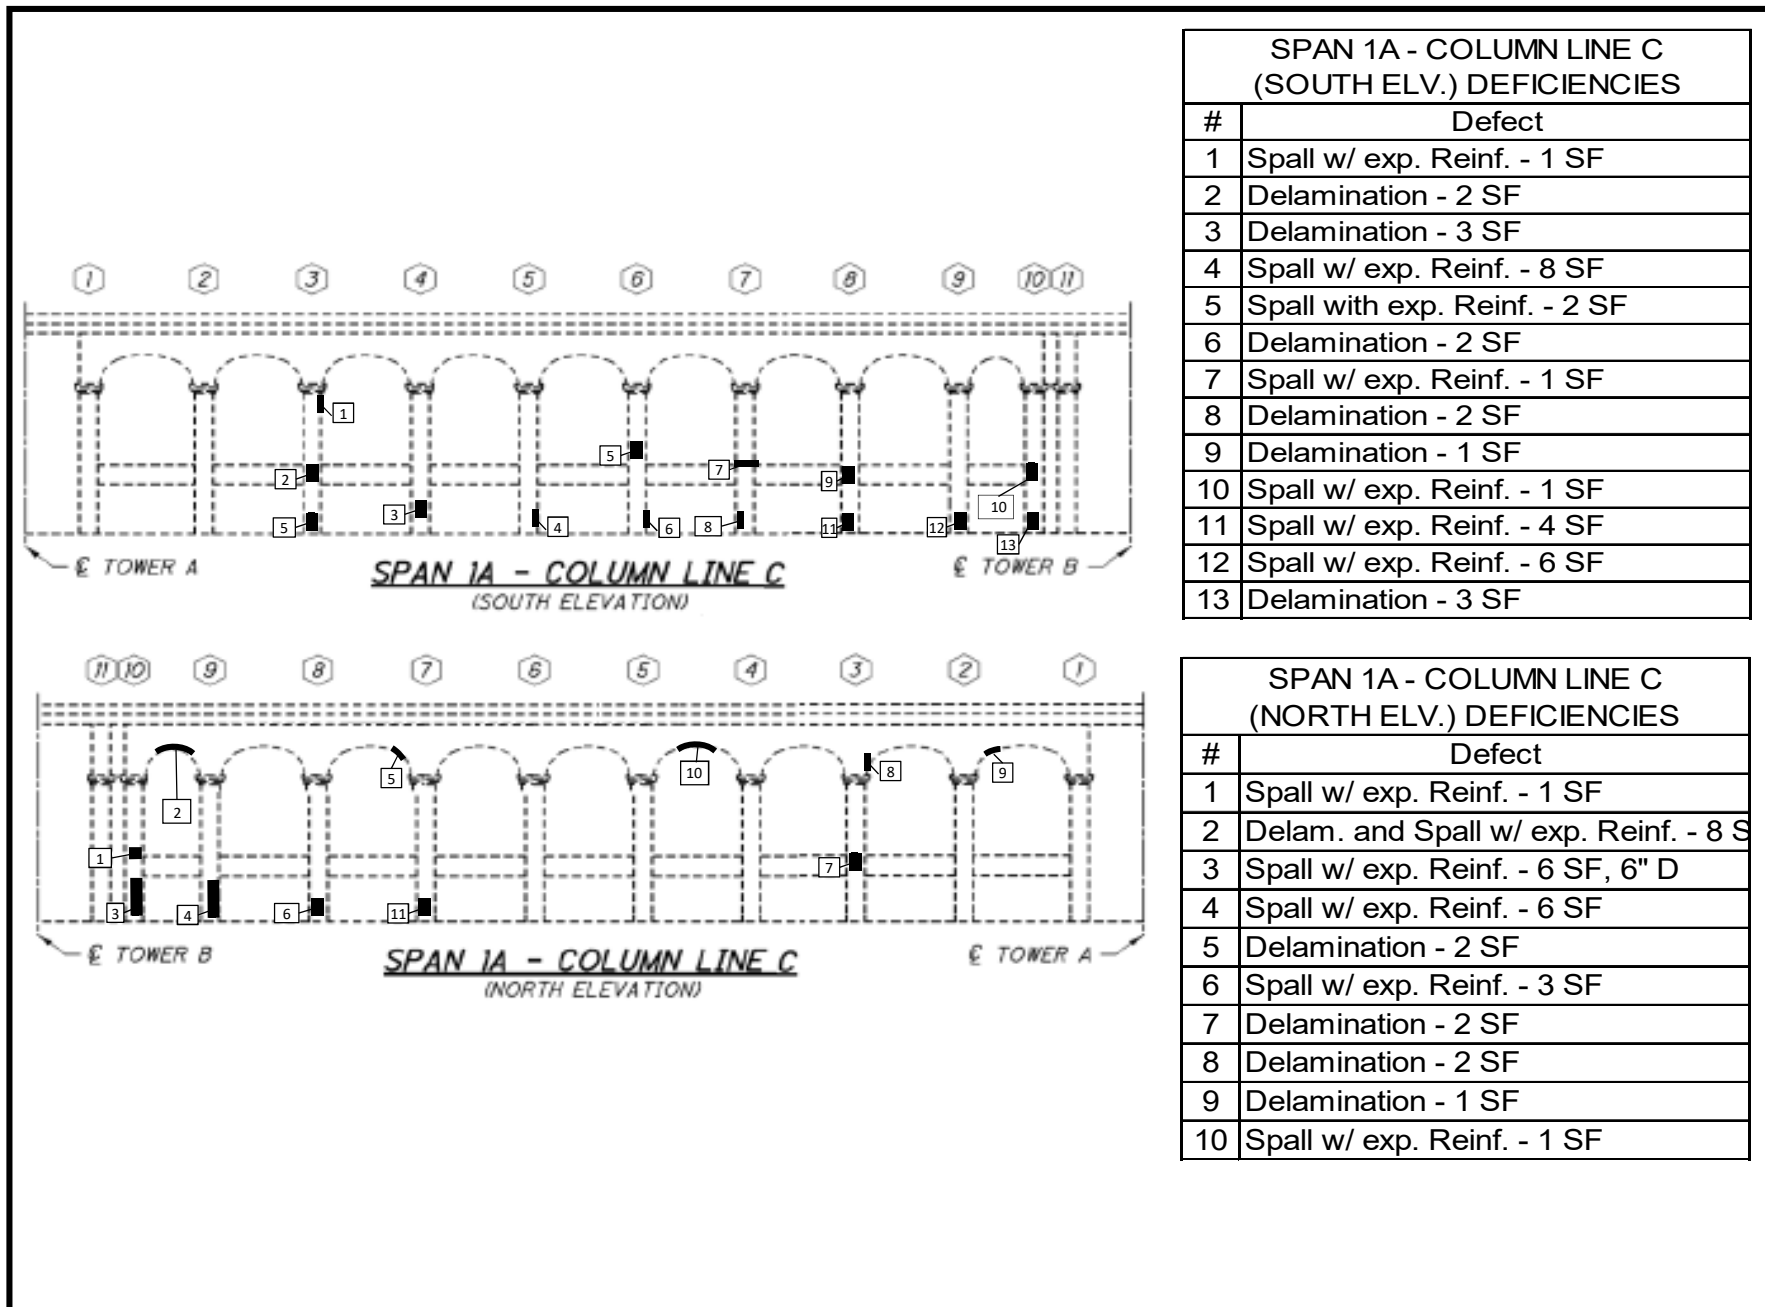
SPAN 1A - COLUMN LINE D (SOUTH ELV.) DEFICIENCIES	
#	Defect
1	Face of cap has a 1'-4" W x Full H x 6" D spall
2	Delamination - 6 SF
3	Spall w/ exp. Reinf. - 3 SF
4	Delamination - 4 SF
5	Spall w/ exp. Reinf. - 16 SF, within a Delamination - 42 SF
6	Delamination - 24 SF
7	Delamination - 6 SF
8	Spall - 5 SF, 8" D
9	Embankment along the south side of Span 1A has significant erosion for the full length. At the west end, there is a 15' Diameter x 4' D erosion ditch around the manhole. An erosion ditch extends from the manhole towards the east typ. 3' W x 2' D.

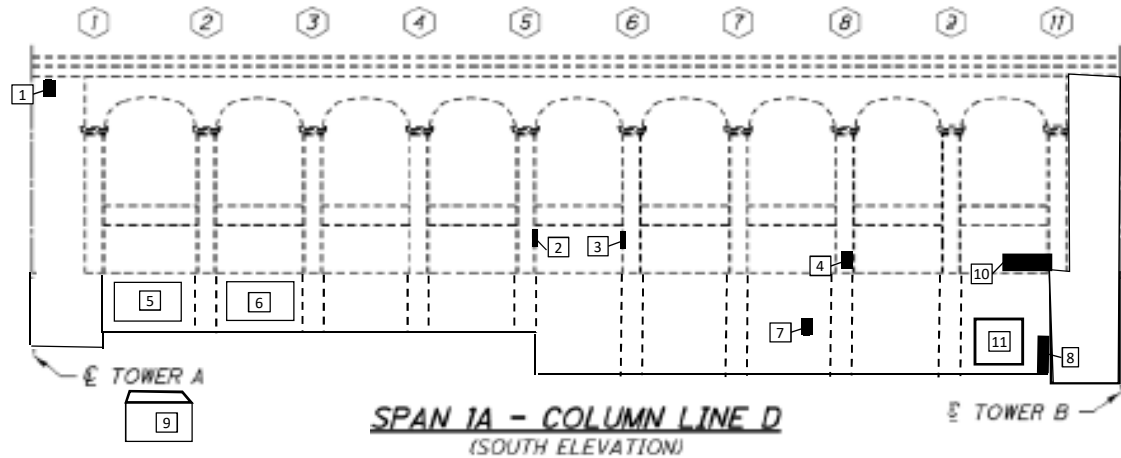
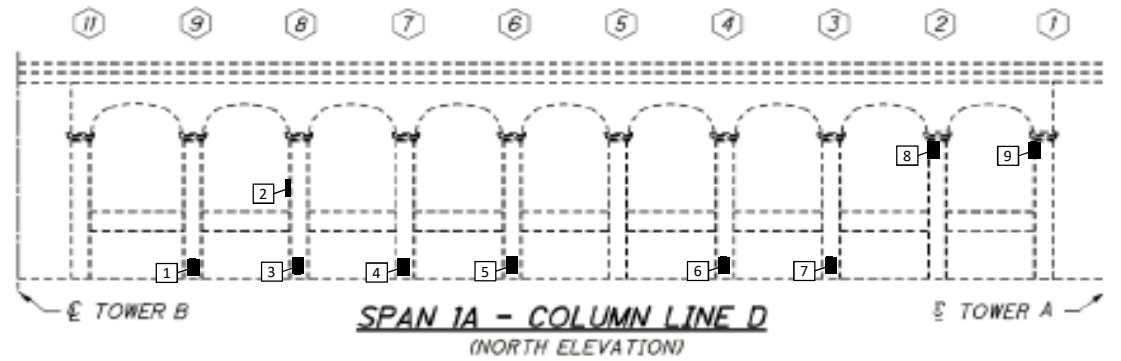
SPAN 1A - COLUMN LINE D (NORTH ELV.) DEFICIENCIES	
#	Defect
1	Spall w/ exp. Reinf - 7 SF
2	Delamination - 1 SF
3	Spall w/ exp. Reinf - 6 SF
4	Spall w/ exp. Reinf - 6 SF
5	Spall w/ exp. Reinf - 4 SF
6	Spall w/ exp. Reinf. - 8 SF
7	Delamination - 6 SF
8	Delamination - 6 SF
9	Delamination - 6 SF

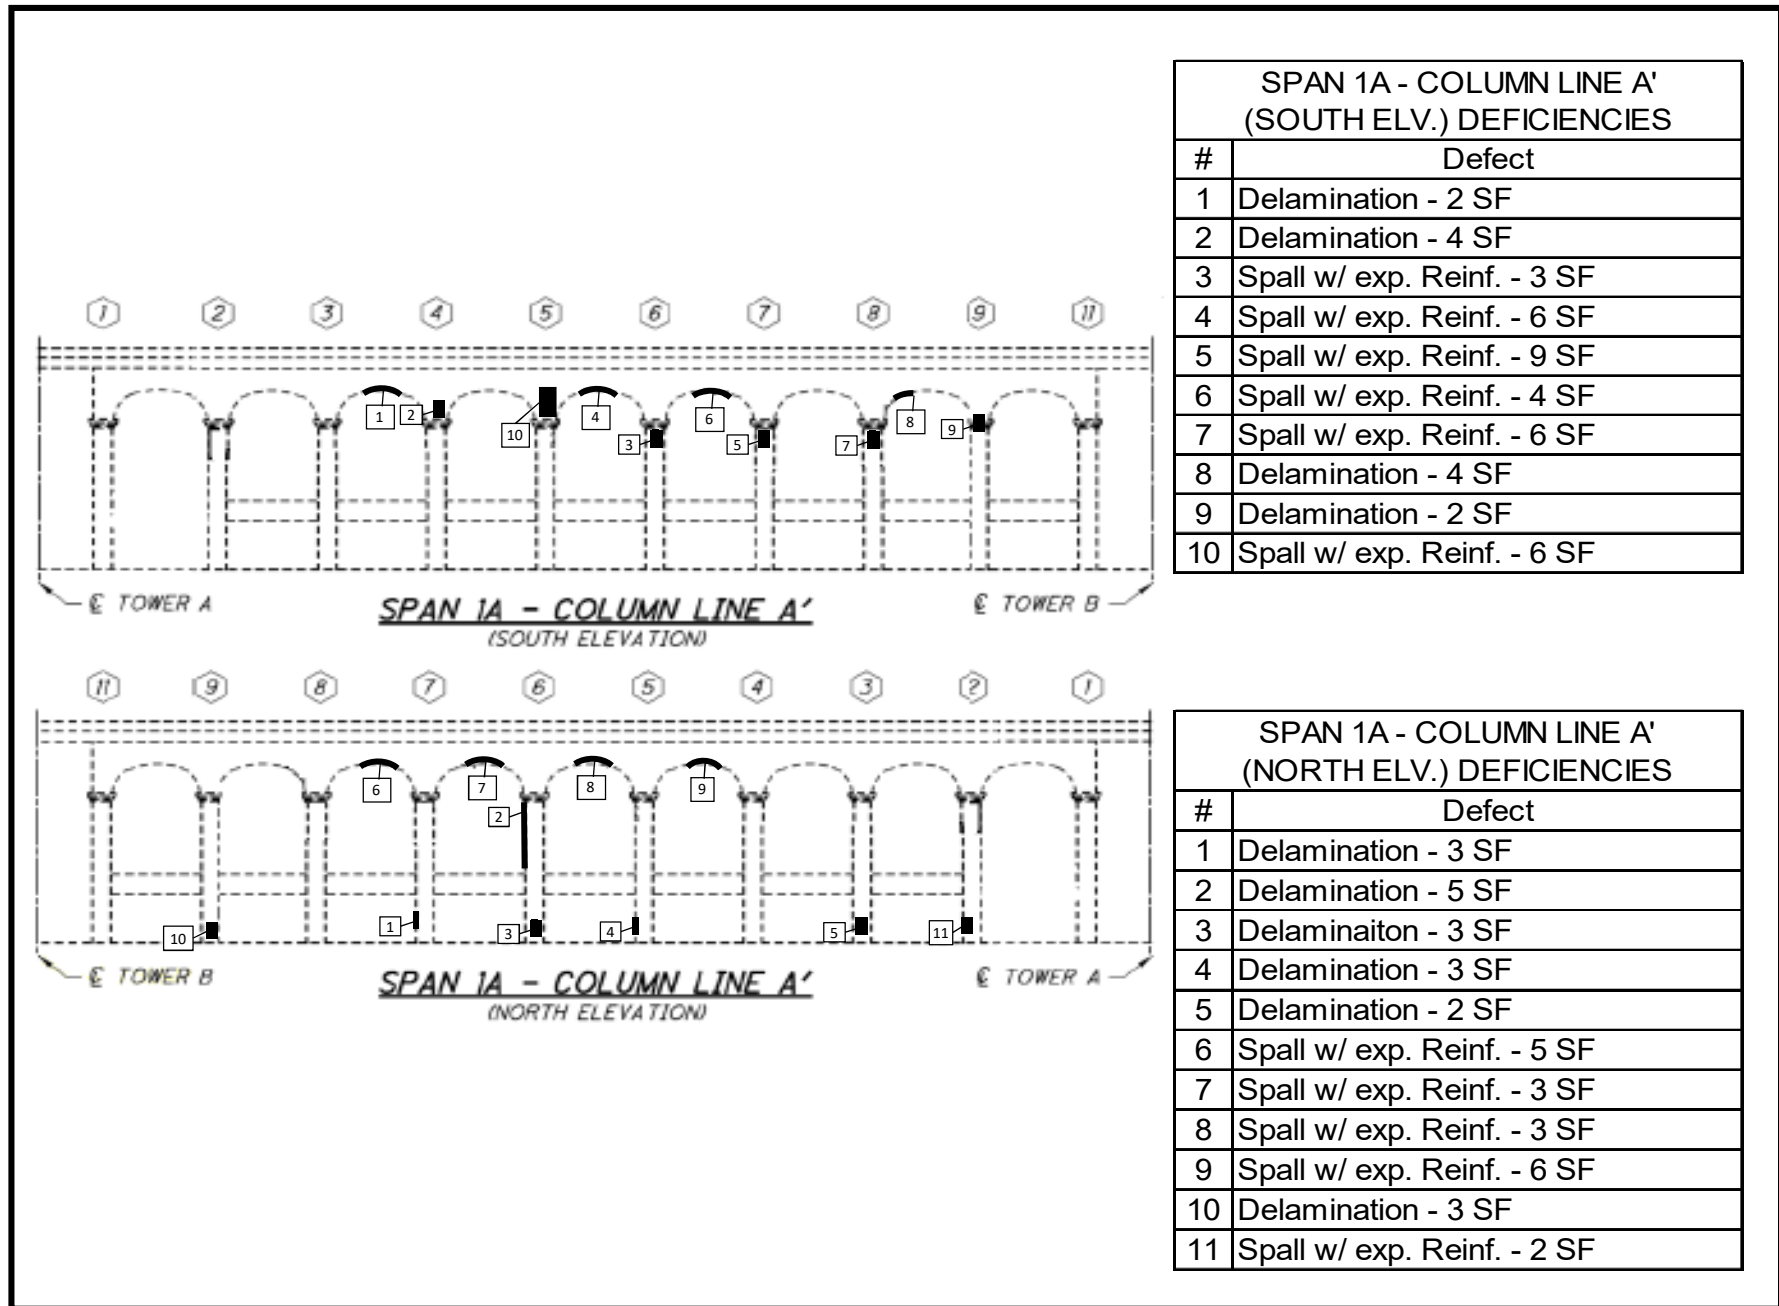
SPAN 1A - COLUMN LINE C' (SOUTH ELV.) DEFICIENCIES	
#	Defect
1	Spall w/ exp. Reinf. - 2 SF
2	Spall w/ exp. Reinf. - 6 SF
3	Spall w/ exp. Reinf. - 2 SF
4	Spall - 6.5 SF, 3" D
5	Spall w/ exp. Reinf. - 4 SF
6	Spall w/ exp. Reinf. - 3 SF
7	Spall w/ exp. Reinf. - 4 SF
8	Delamination - 4 SF
9	Delamination - 4 SF
10	Spall w/ exp. Reinf. - 3 SF
11	Spall w/ exp. Reinf. - 3 SF

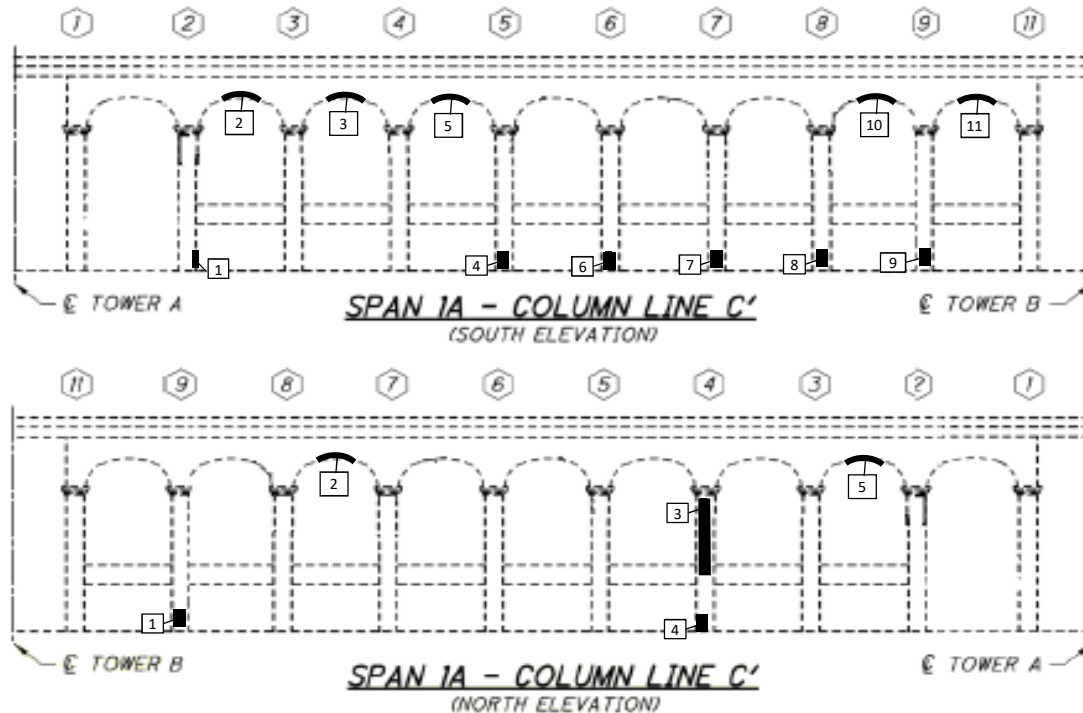
**SPAN 1B - COLUMN LINE A
(SOUTH ELV.) DEFICIENCIES**

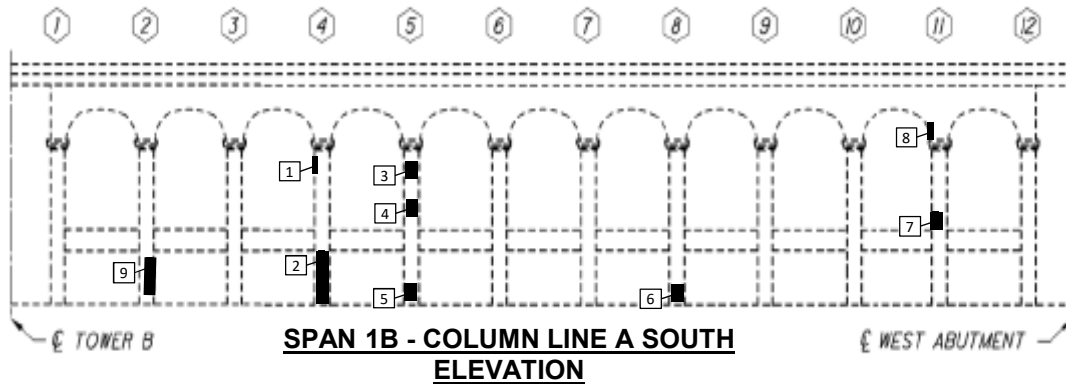
**SPAN 1B - COLUMN LINE A
(NORTH ELV.) DEFICIENCIES**

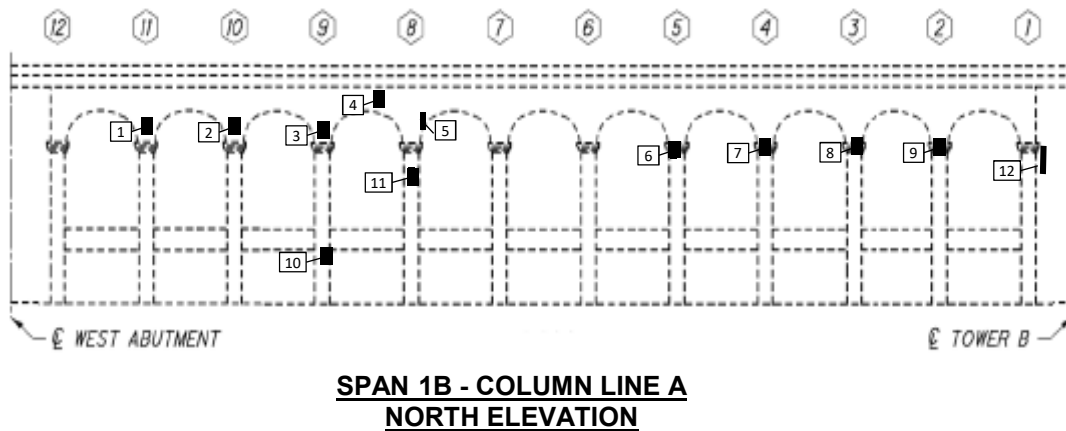
SPAN 1B - COLUMN LINE B
(SOUTH ELV.) DEFICIENCIES

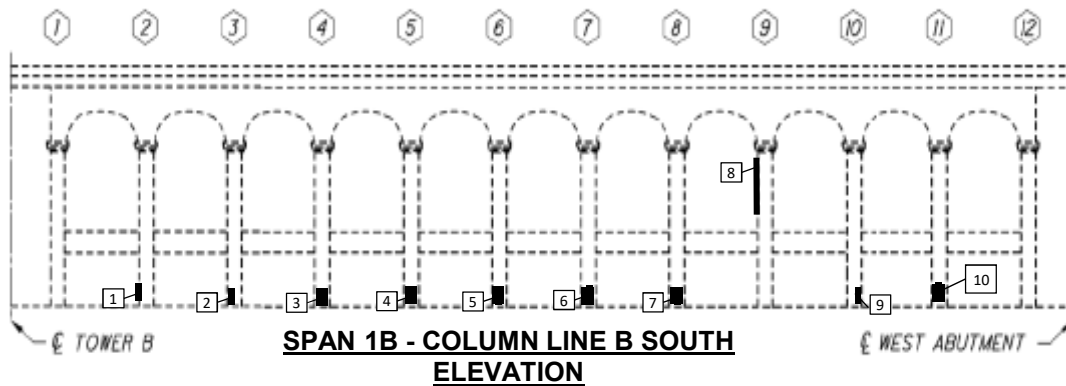
SPAN 1B - COLUMN LINE B
(NORTH ELV.) DEFICIENCIES

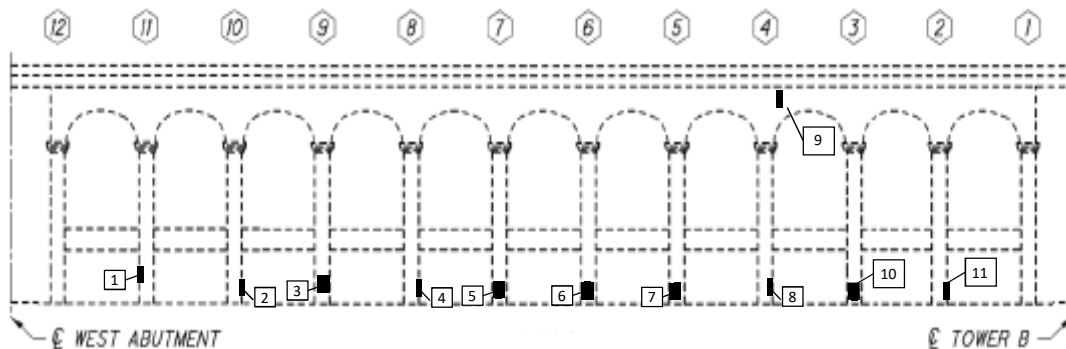
**SPAN 1B - COLUMN LINE C
(SOUTH ELV.) DEFICIENCIES**

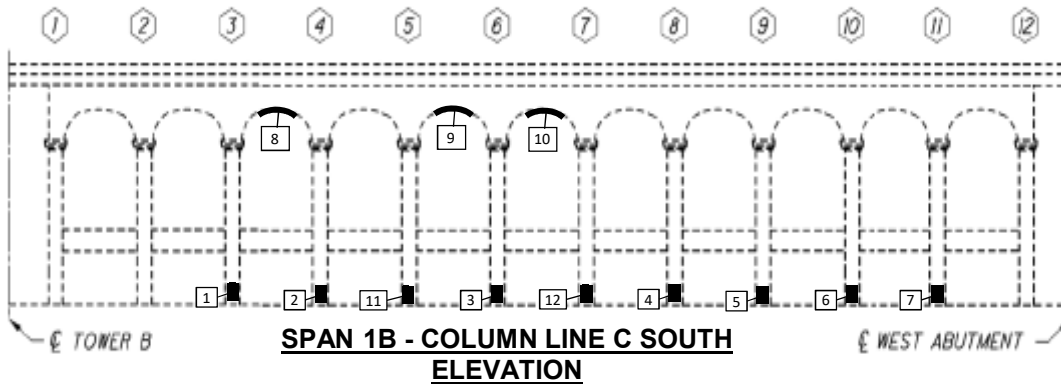
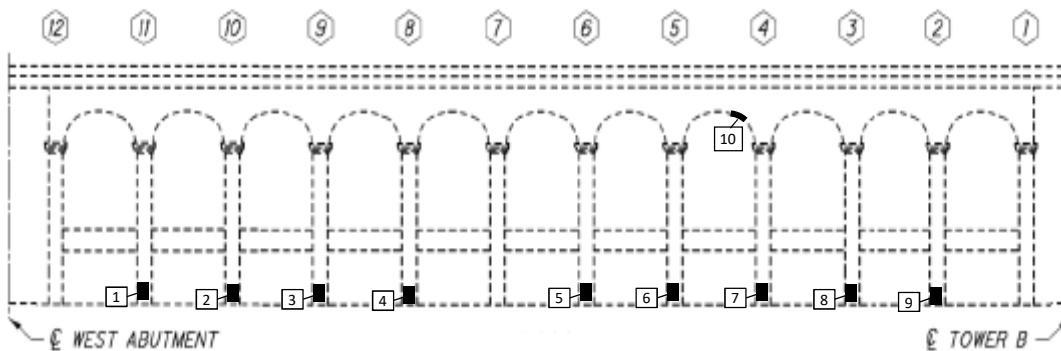
**SPAN 1B - COLUMN LINE C
NORTH ELEVATION**

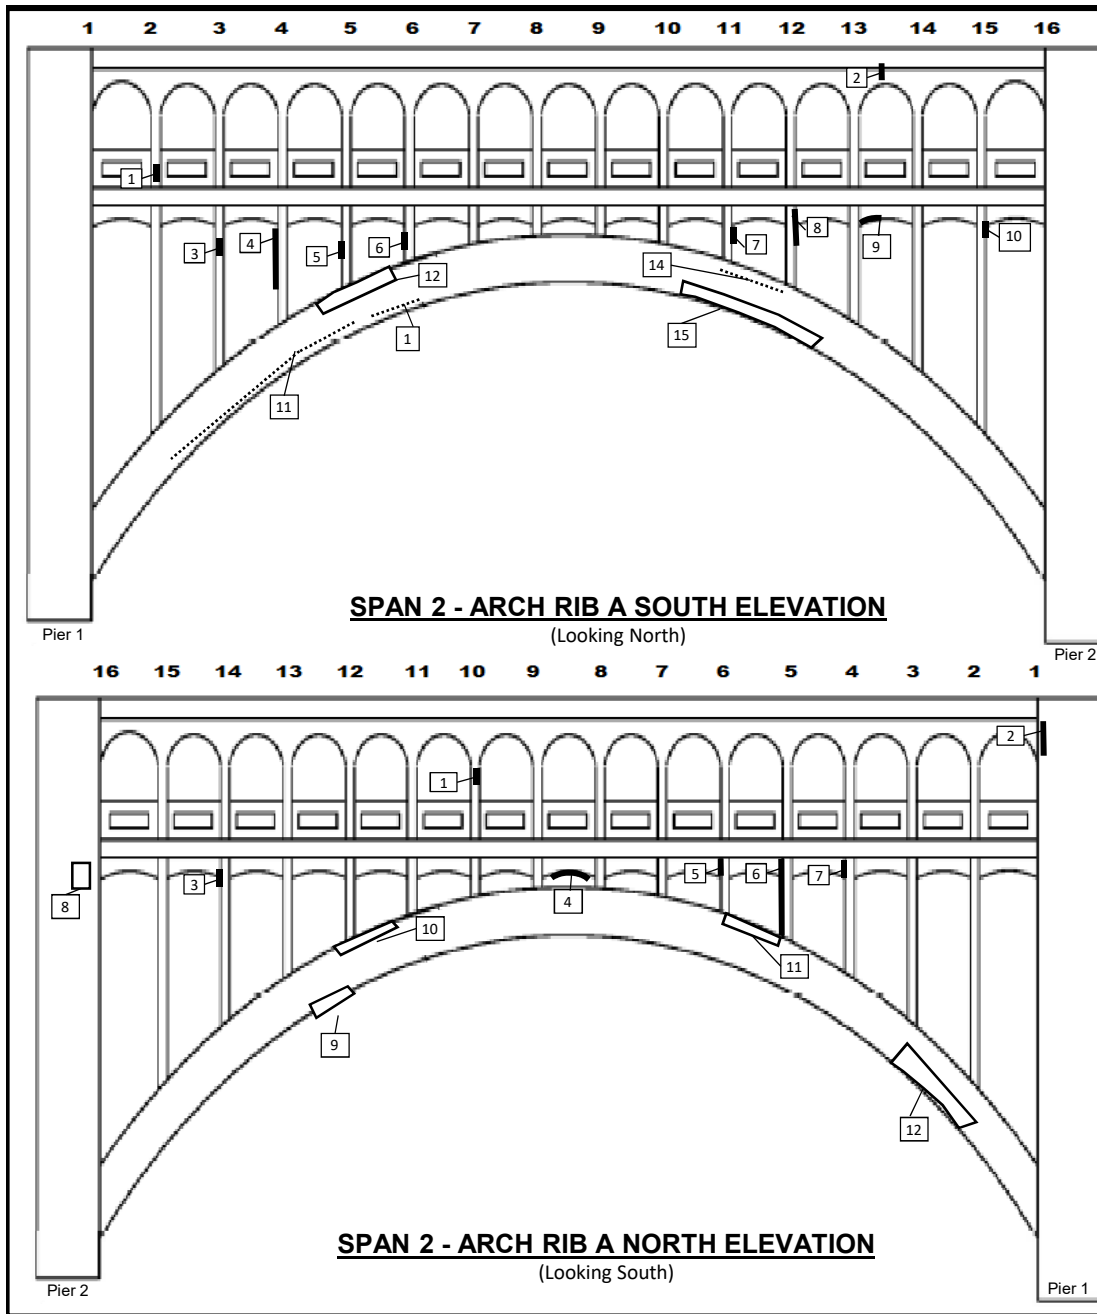
RIB A SOUTH ELEV. DEFICIENCIES	
#	Defect
1	Delamination - 3 SF
2	Delamination - 5 SF
3	Spall w/ exp. Reinf. - 6 SF
4	Spall w/ exp. Reinf. - 14 SF
5	Delamination - 2 SF
6	Delamination - 6 SF
7	Delamination - 1 SF
8	Spall w/ exp. Reinf. - 8 SF
9	Delamination w/ Spall w/ exp. Reinf. - 12 SF
10	Delamination - 3 SF
11	25' L x up to 1/8" W crack
12	Delamination - 8 SF
13	5' L x 1/16" W crack
14	15' L crack w/ efflorescence
15	Delamination - 28 SF

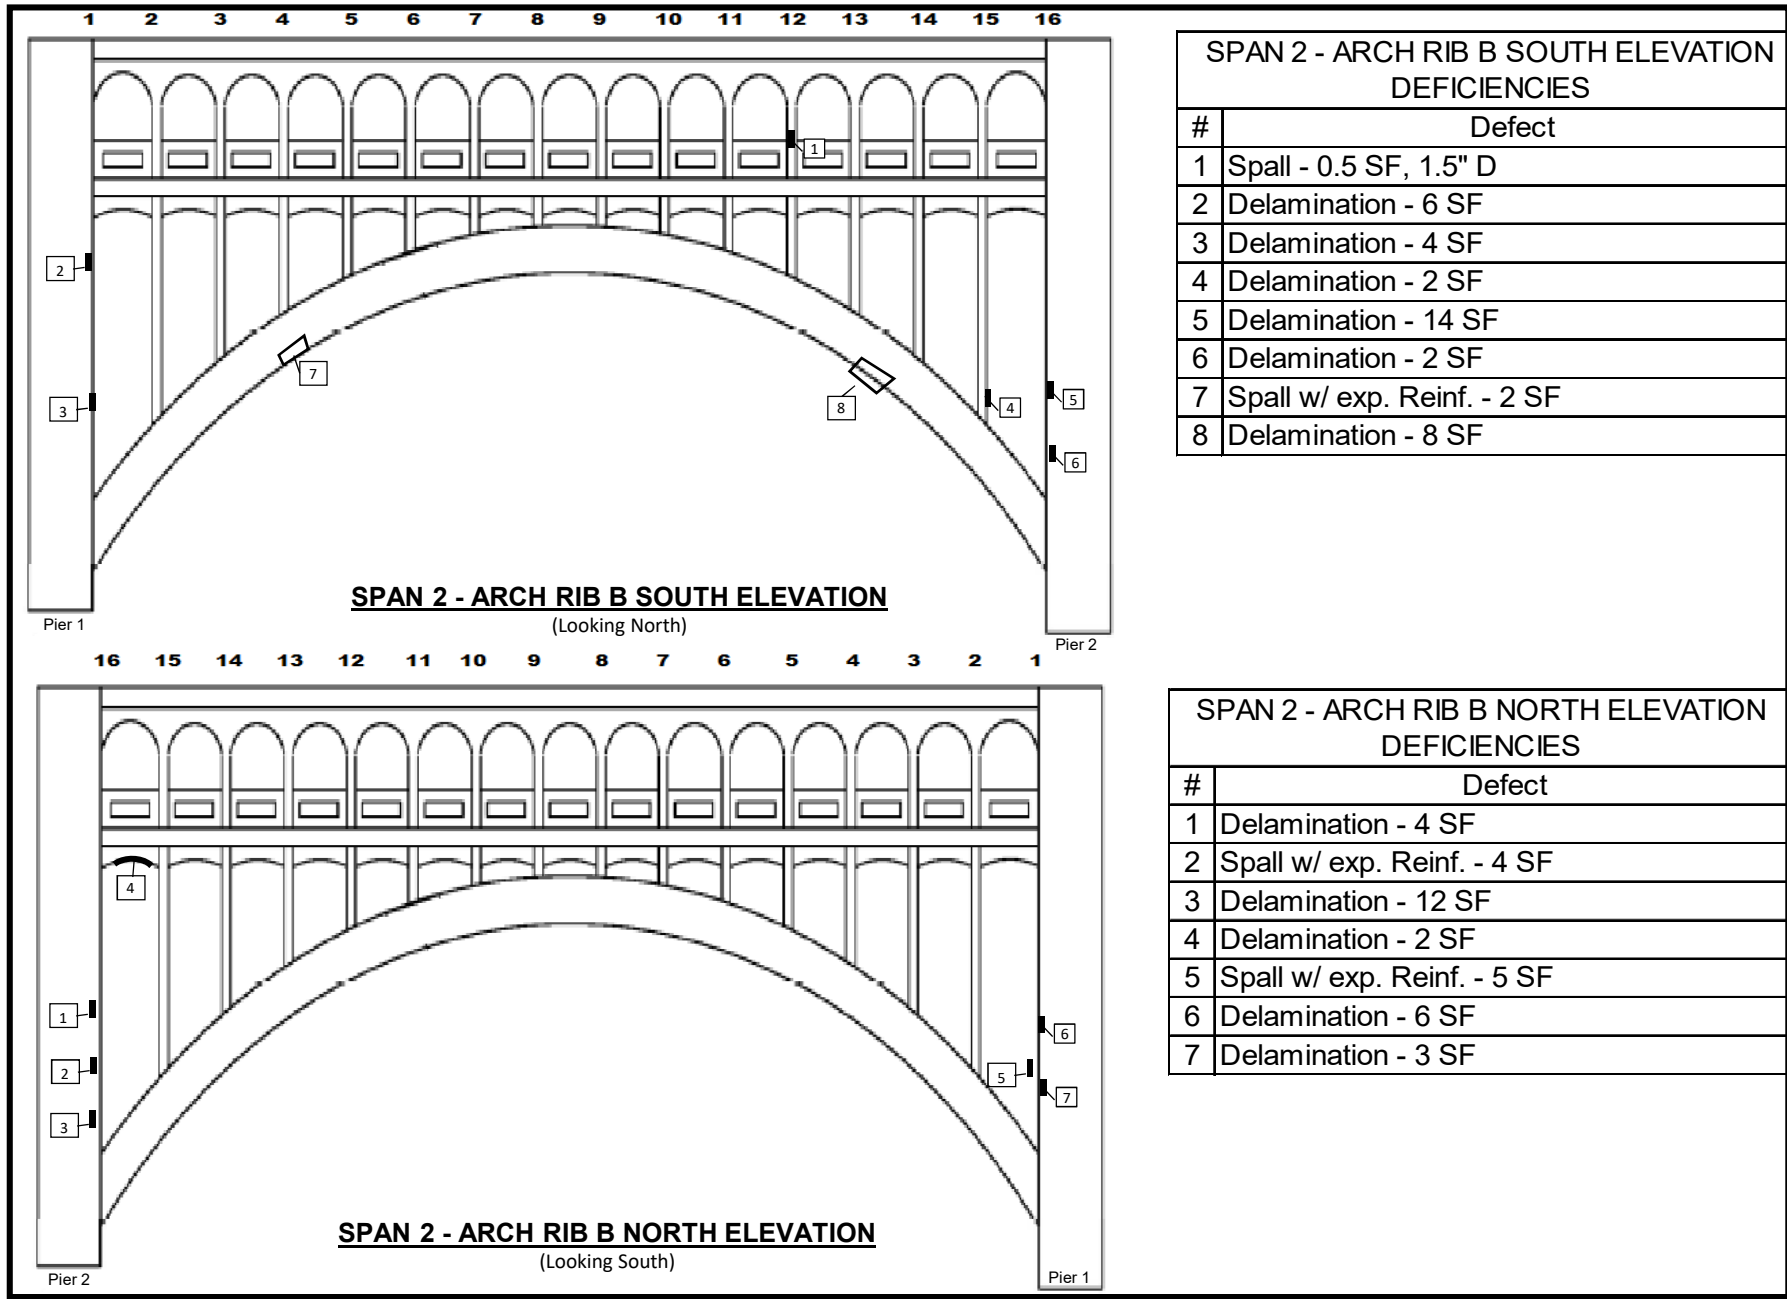
SPAN 2 - ARCH RIB B SOUTH ELEVATION DEFICIENCIES

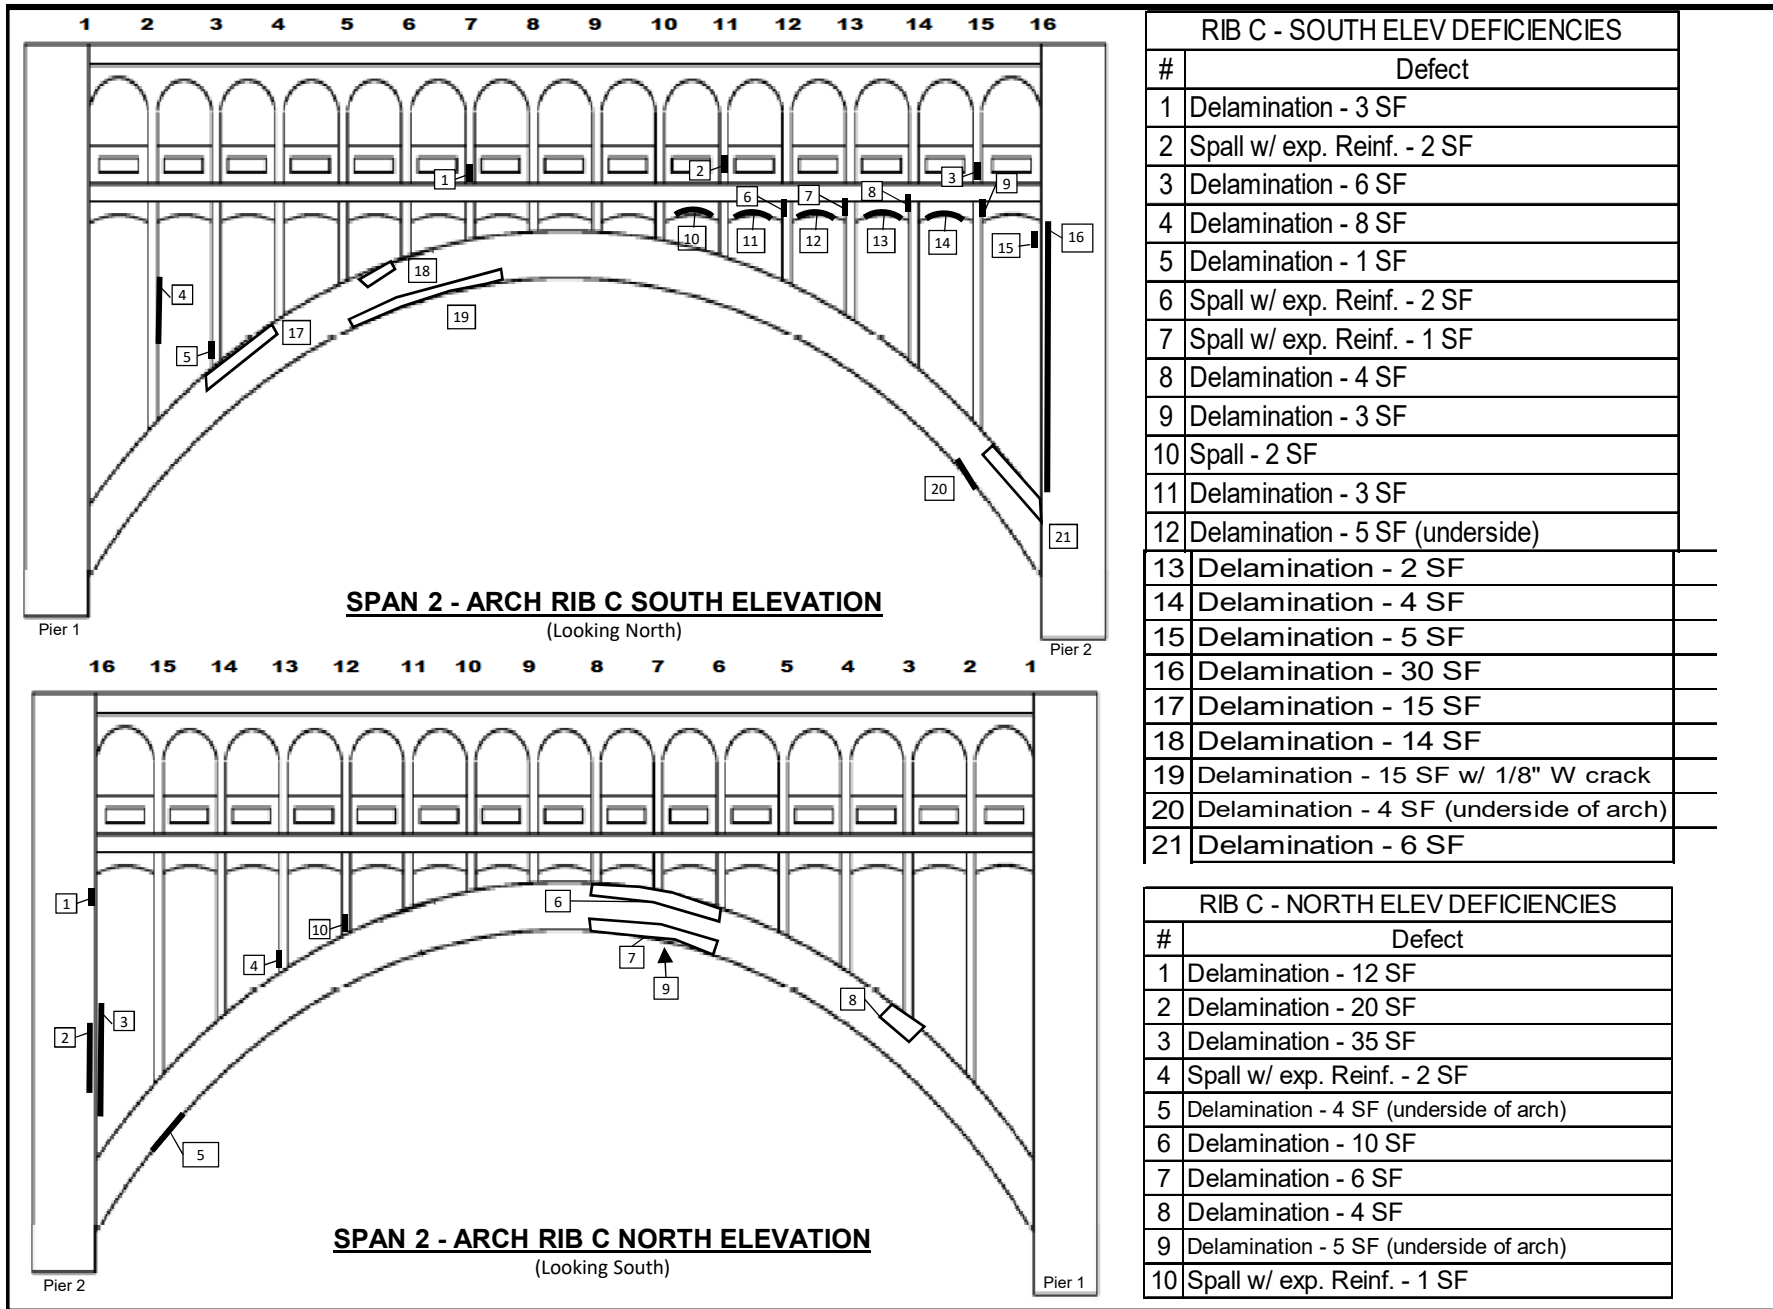
#	Defect
1	Delamination - 4 SF
2	Spall w/ exp. Reinf. - 4 SF
3	Delamination - 12 SF
4	Delamination - 2 SF
5	Spall w/ exp. Reinf. - 5 SF
6	Delamination - 6 SF
7	Delamination - 3 SF
