Physical Condition Report for

CUY-006-1456

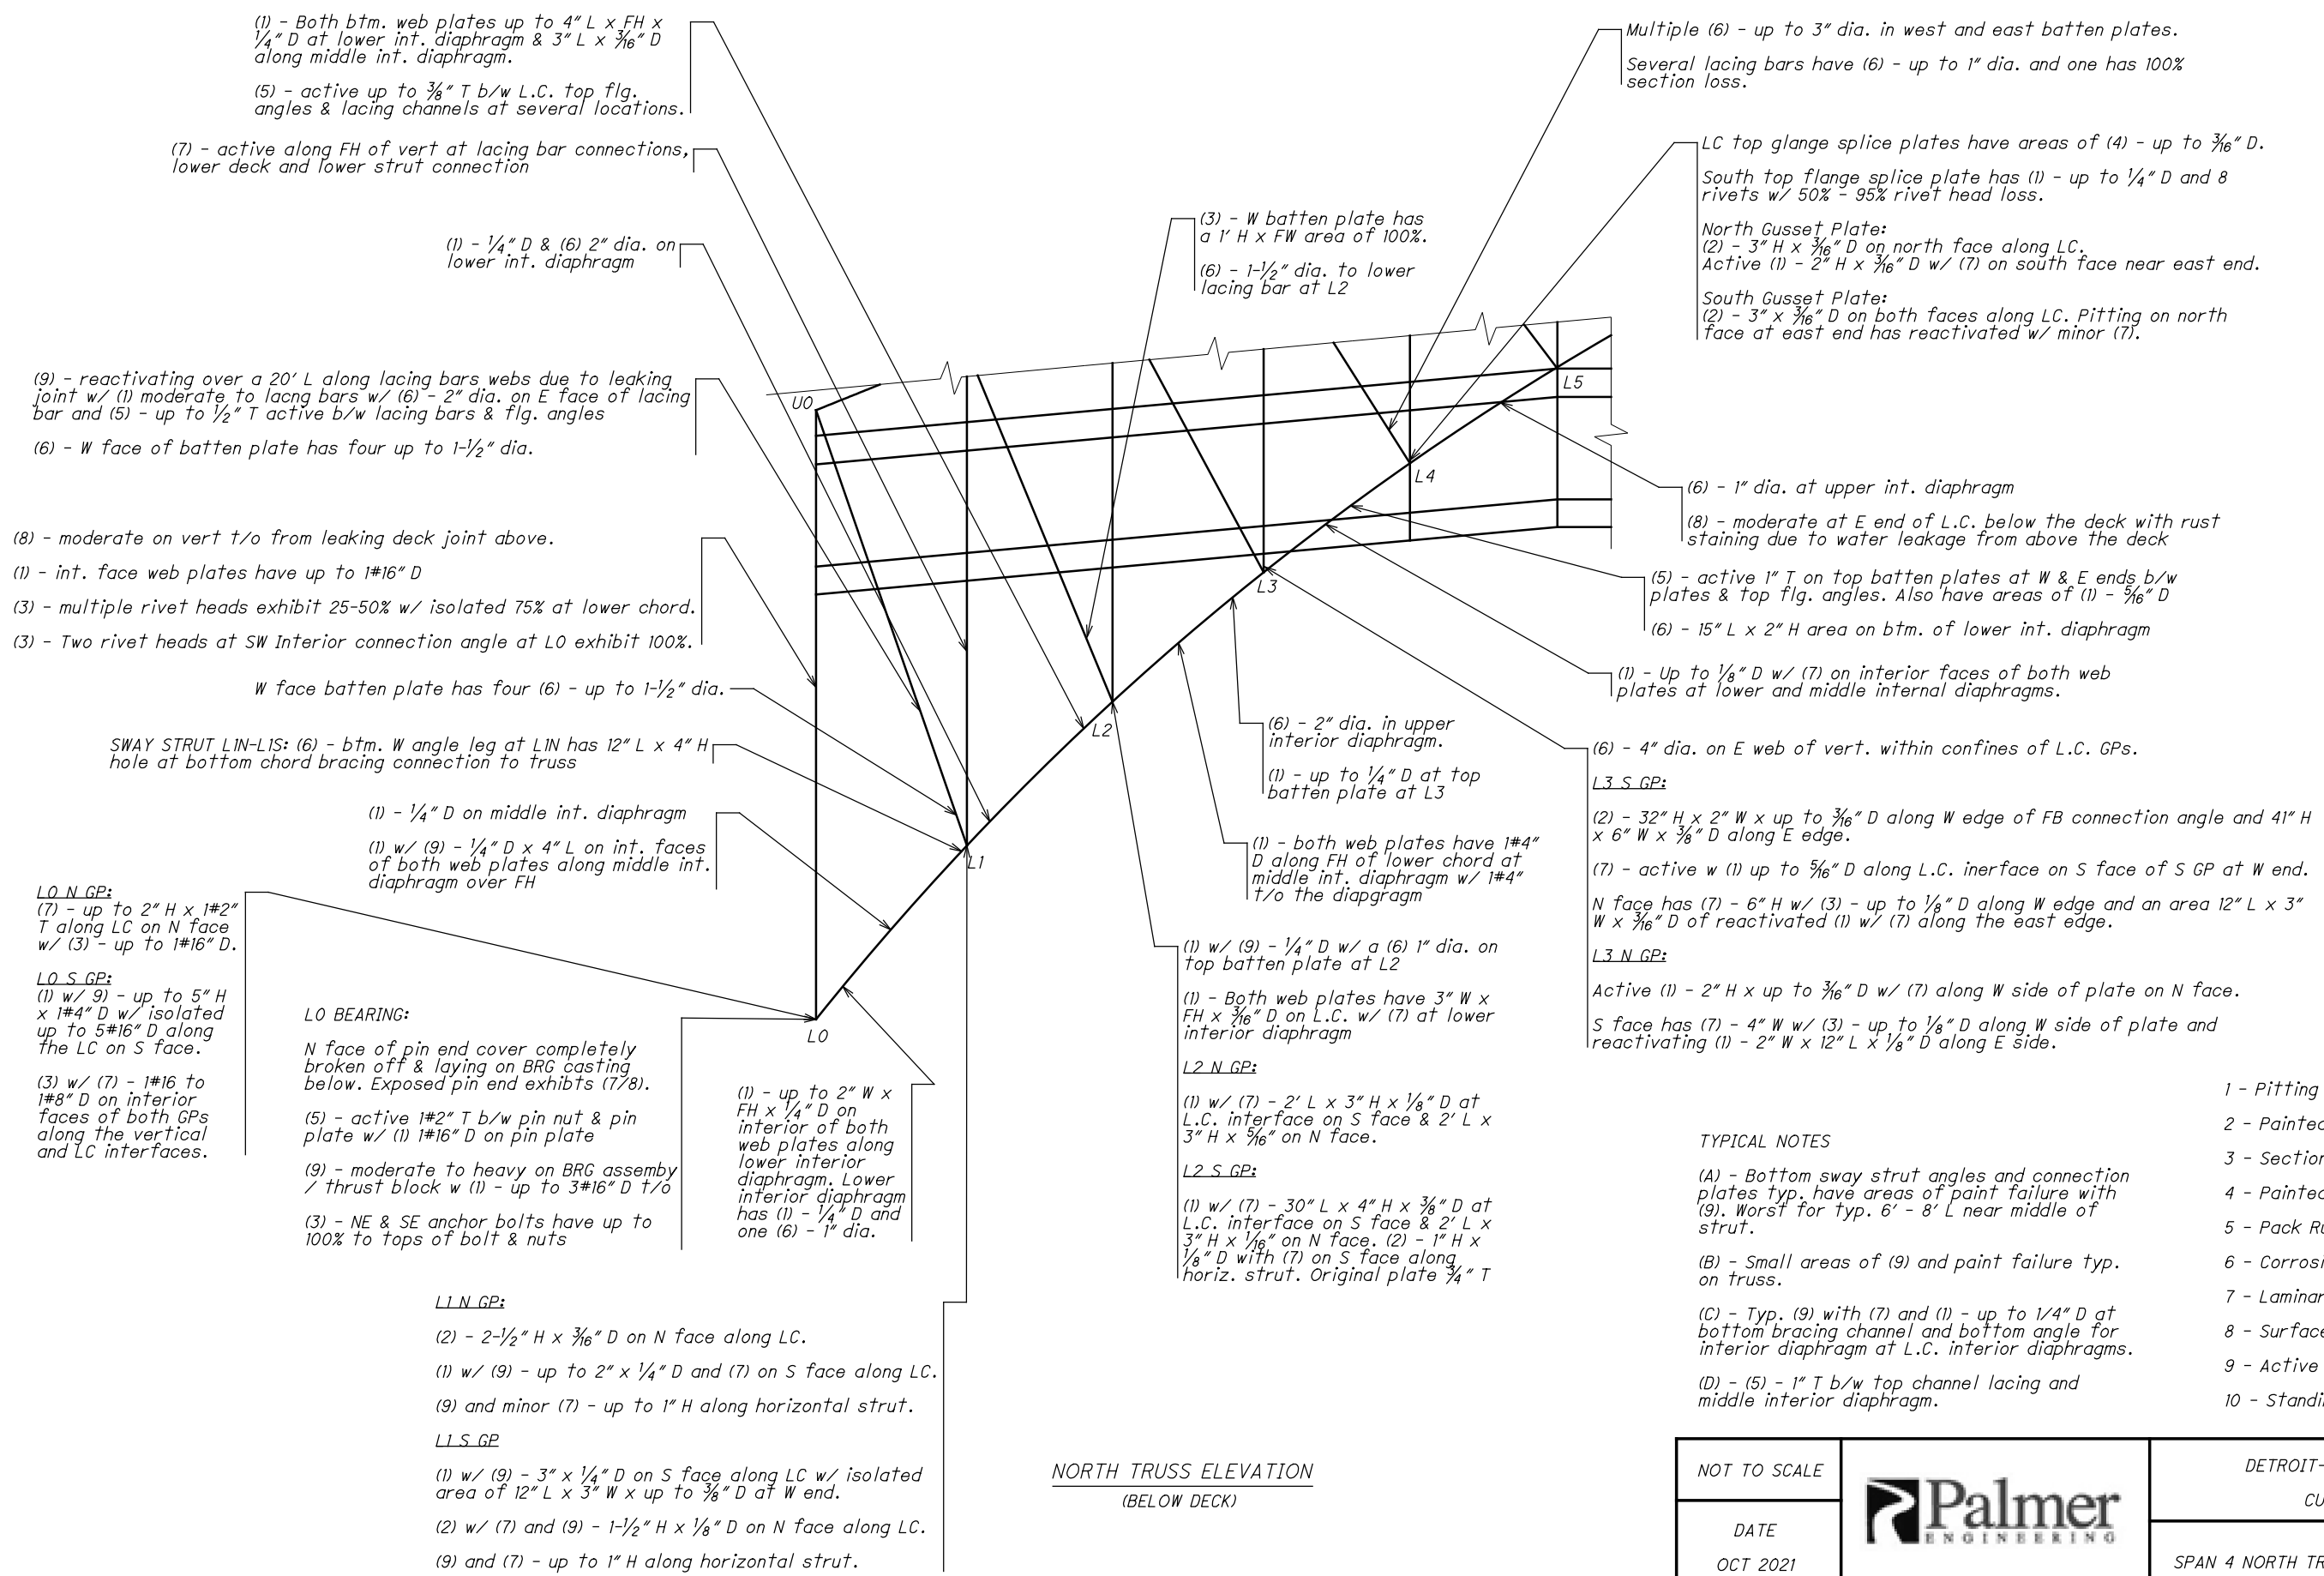
(1) - Both btm. web plates up to 4" L x FH x 1/4" D at lower int. diaphragm & 3" L x 3/16" D along middle int. diaphragm.

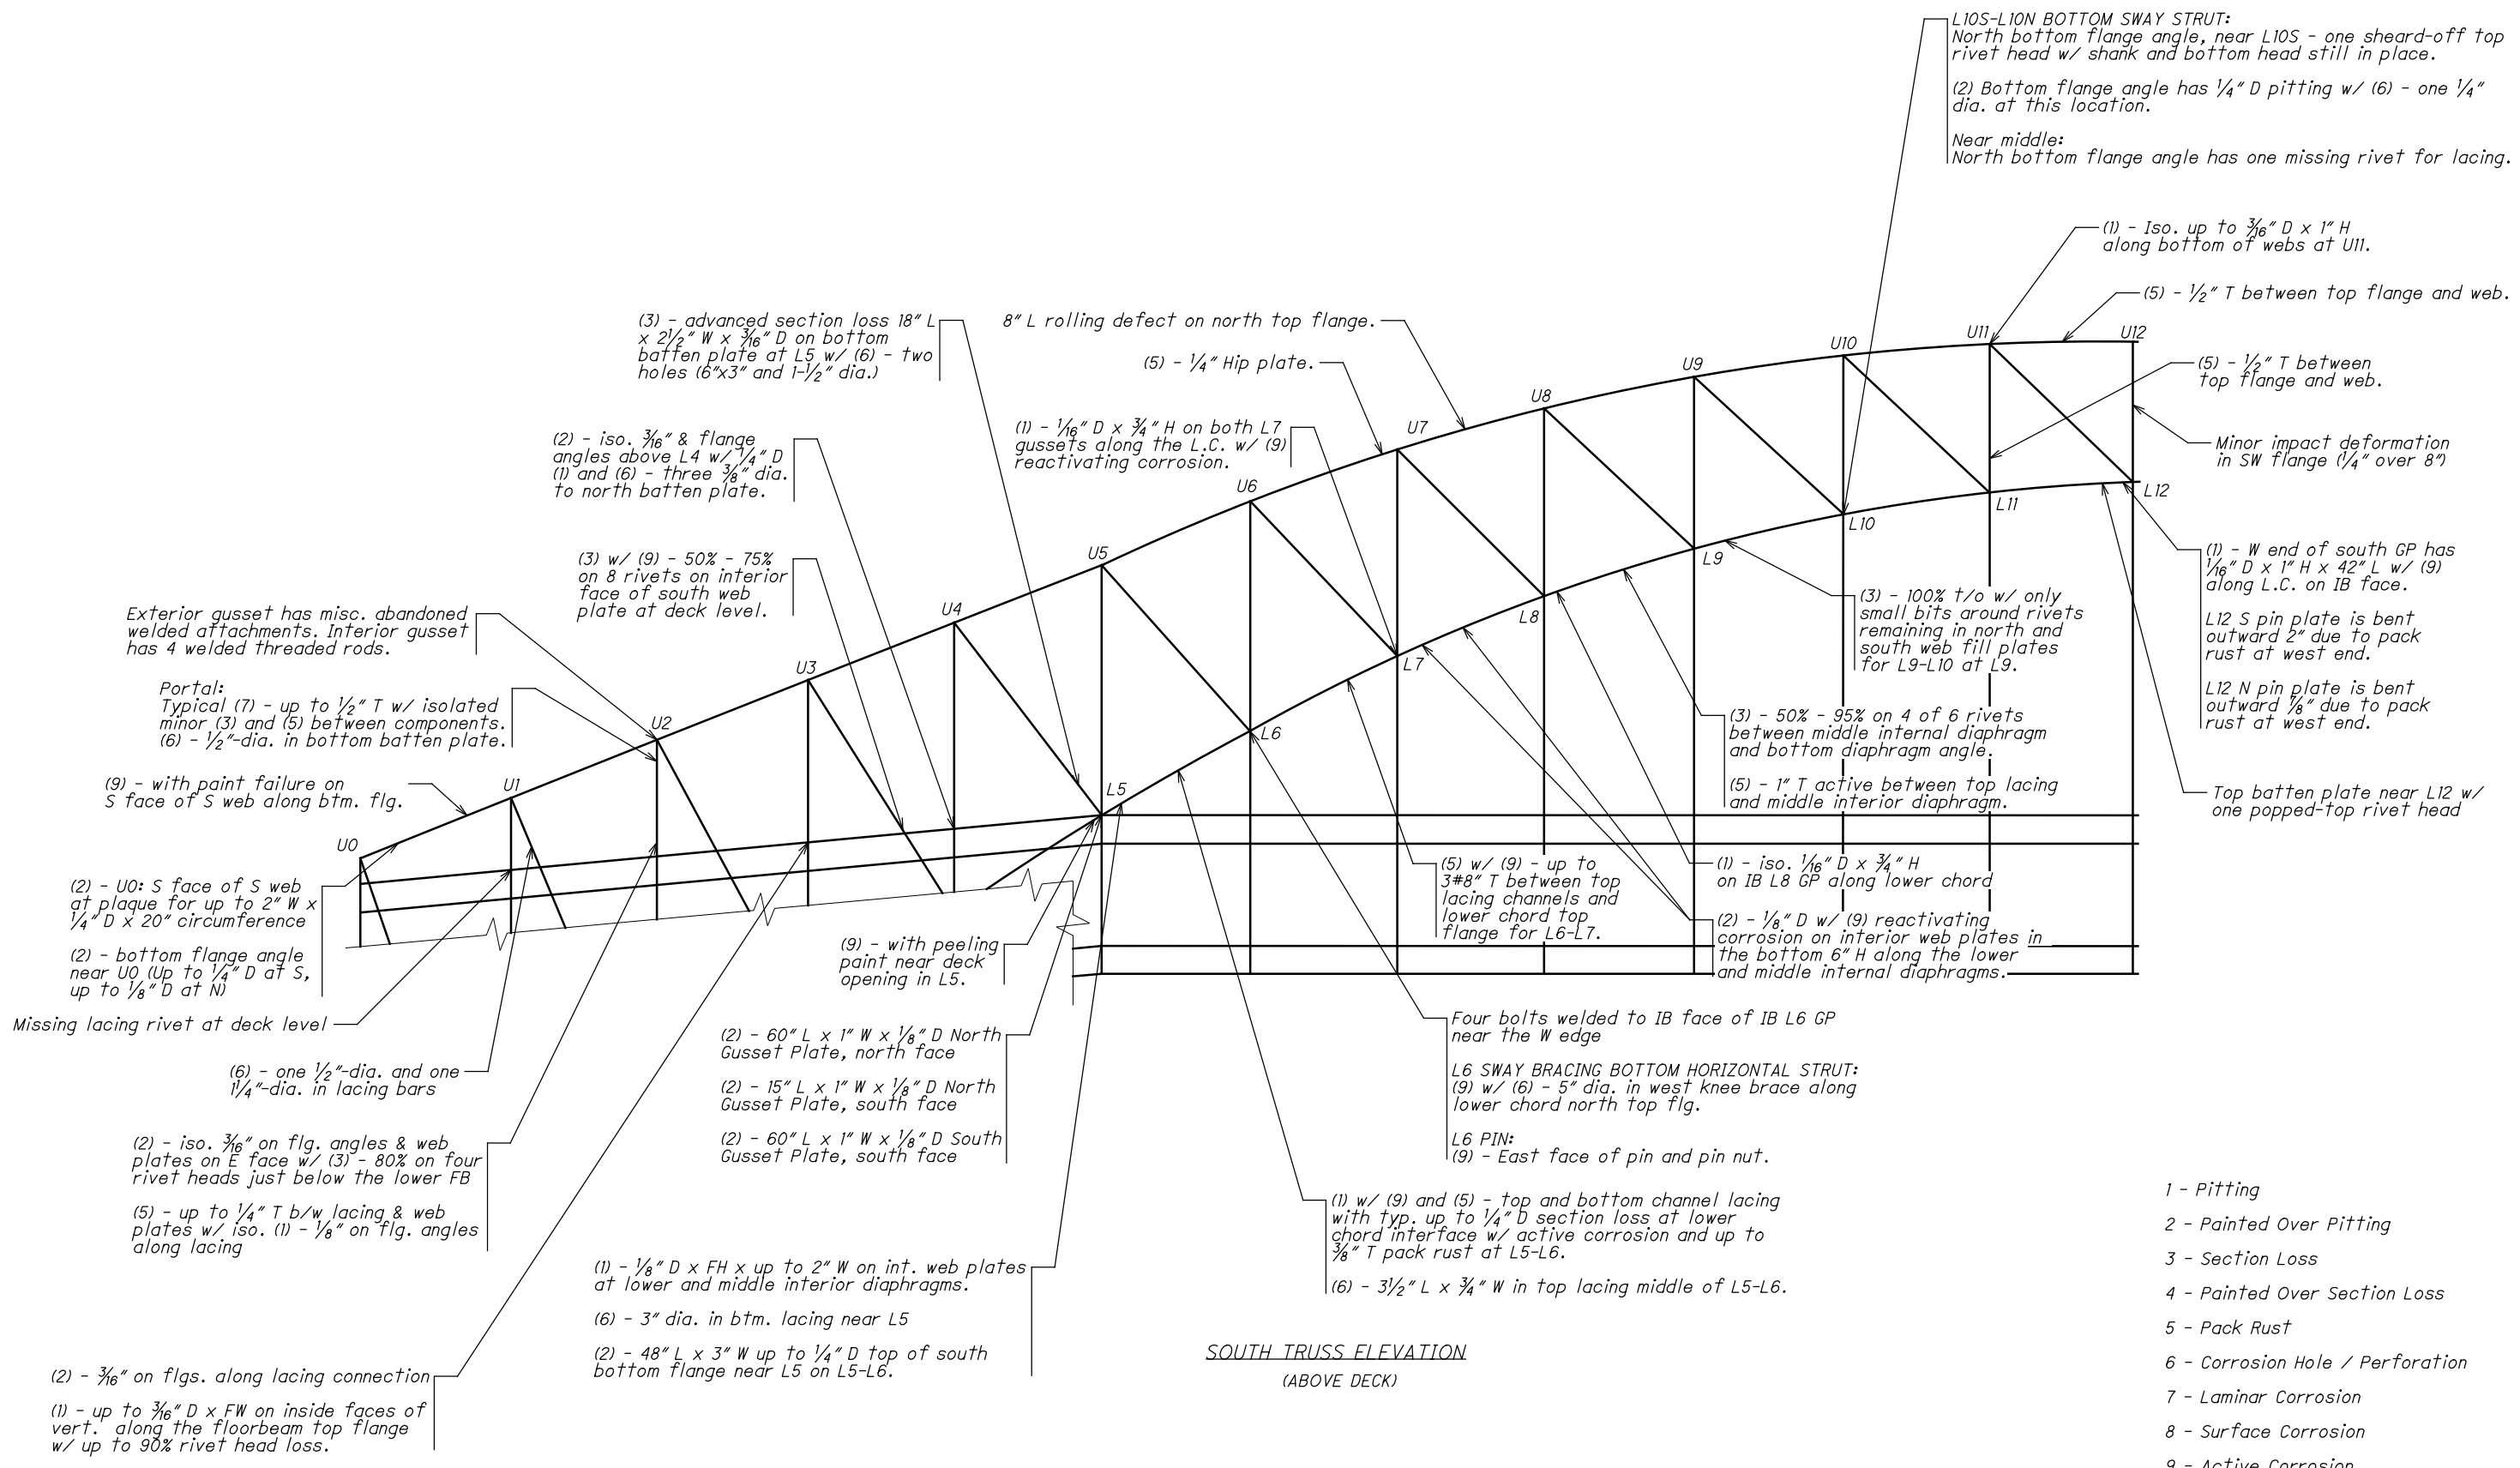
SOUTH TRUSS ELEVATION
(ABOVE DECK)

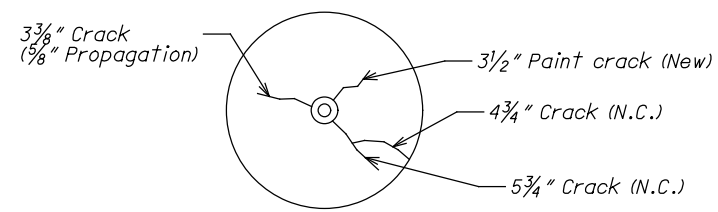
South Truss L0 Bearing
 North Pin Cover Plate
 (Not to scale)

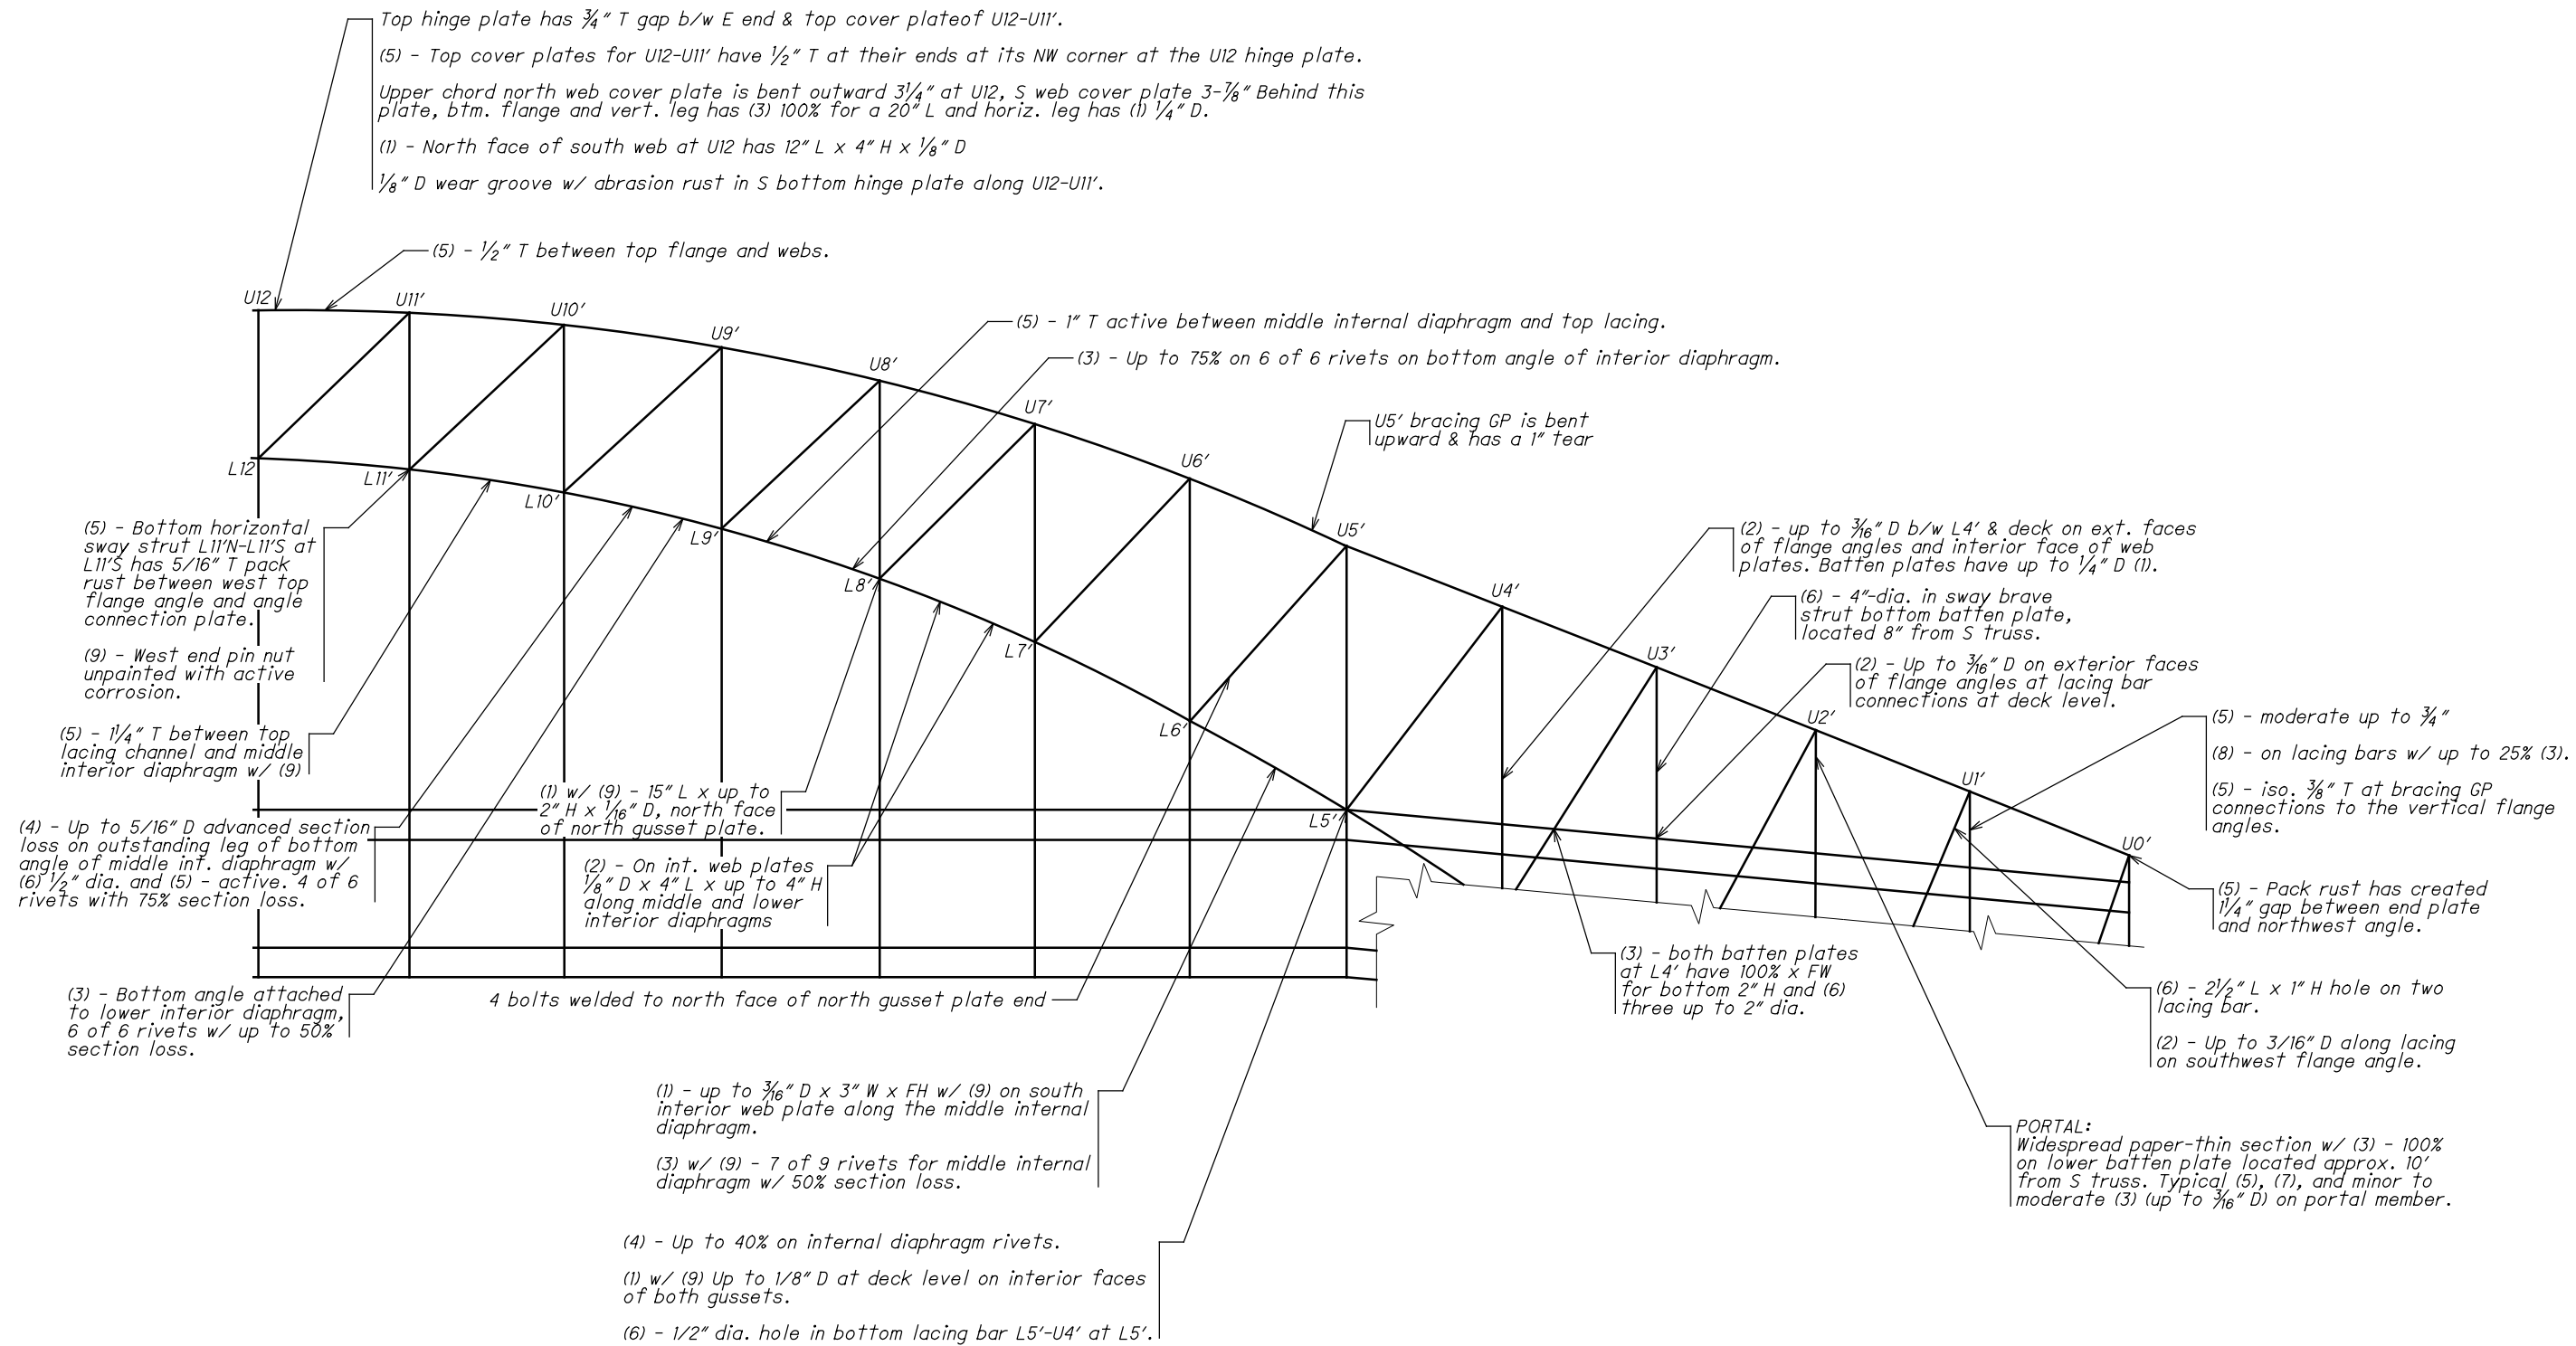
SOUTH TRUSS ELEVATION
(ABOVE DECK)

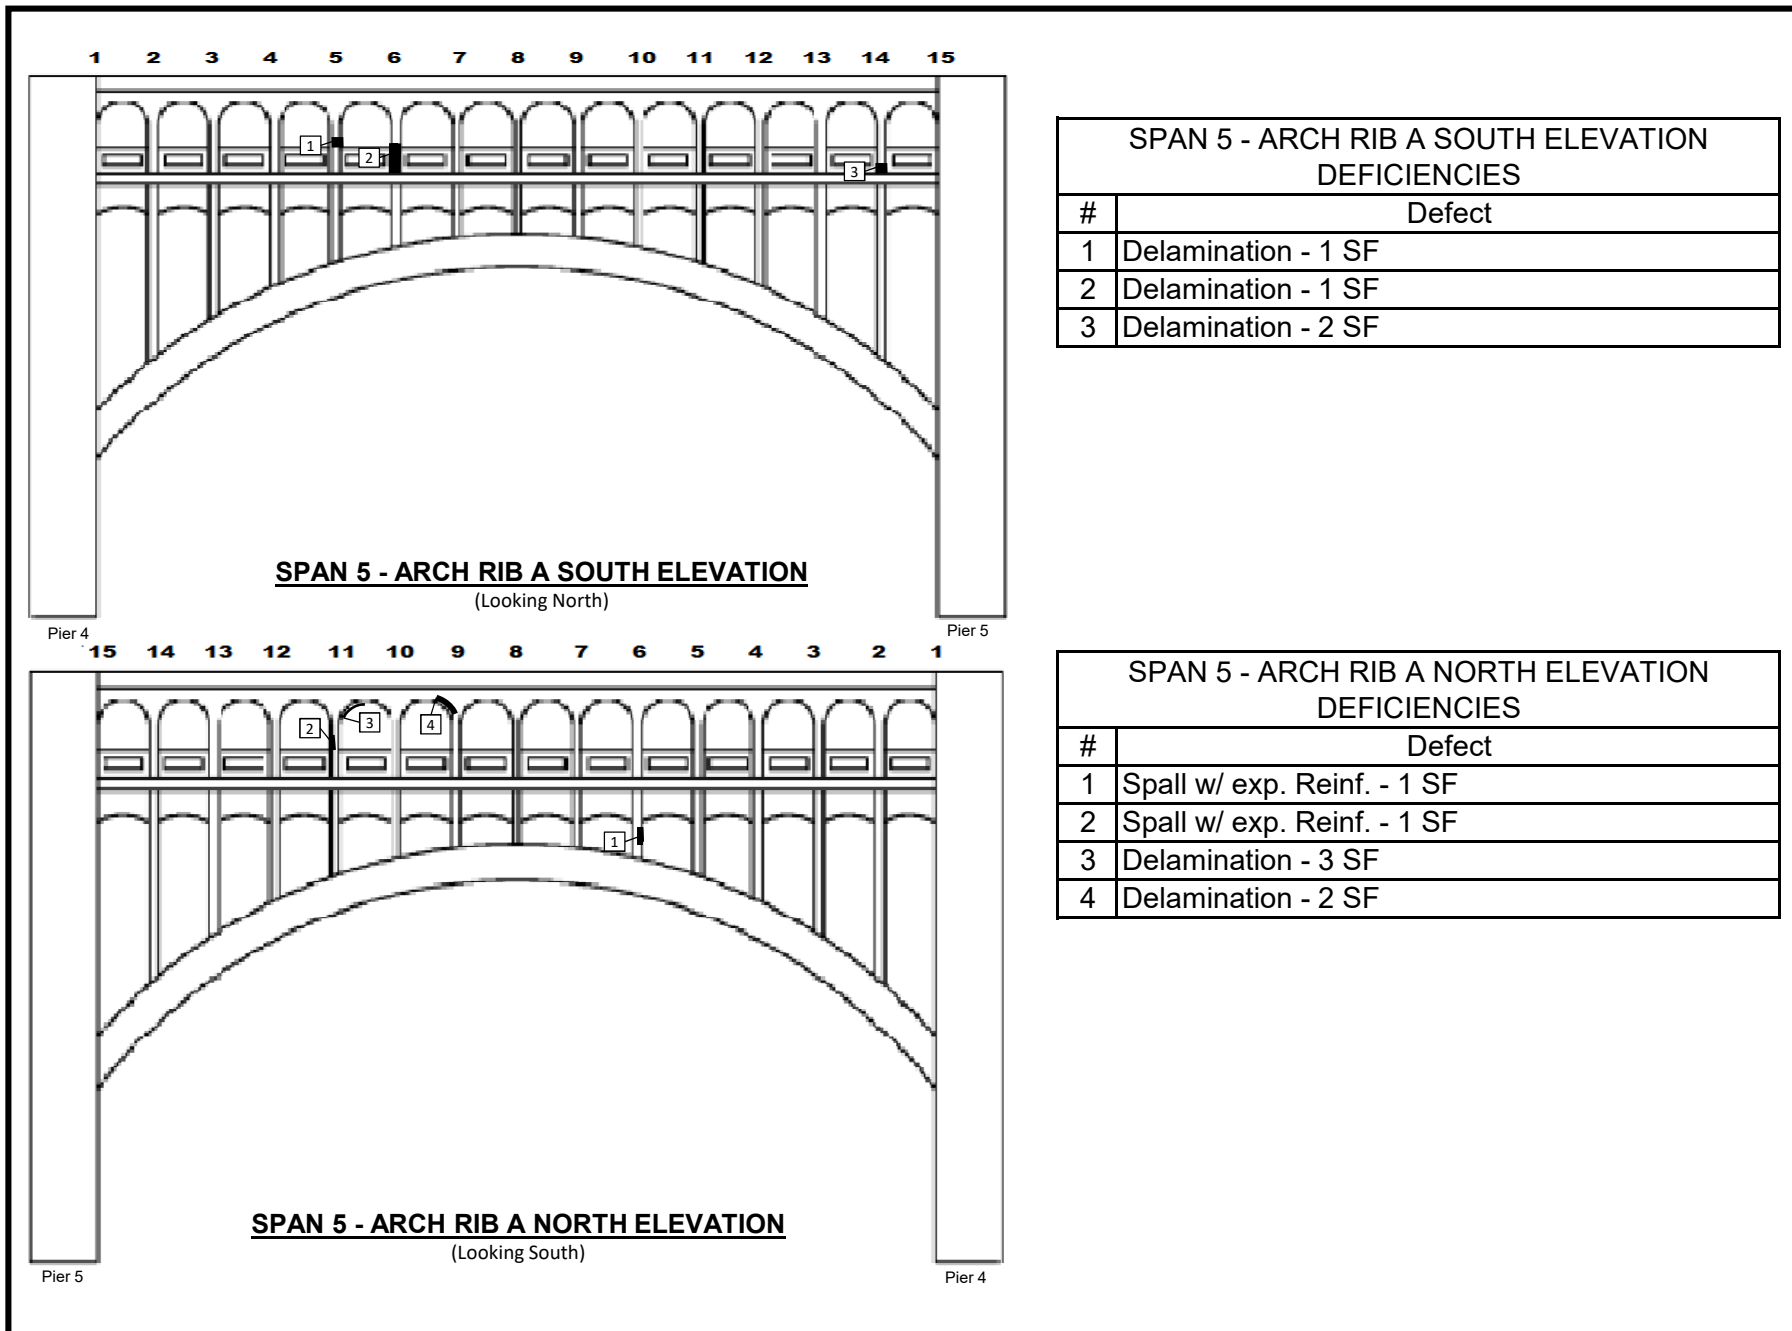
SPAN 5 - ARCH RIB A SOUTH ELEVATION DEFICIENCIES	
#	Defect
1	Delamination - 1 SF
2	Delamination - 1 SF
3	Delamination - 2 SF

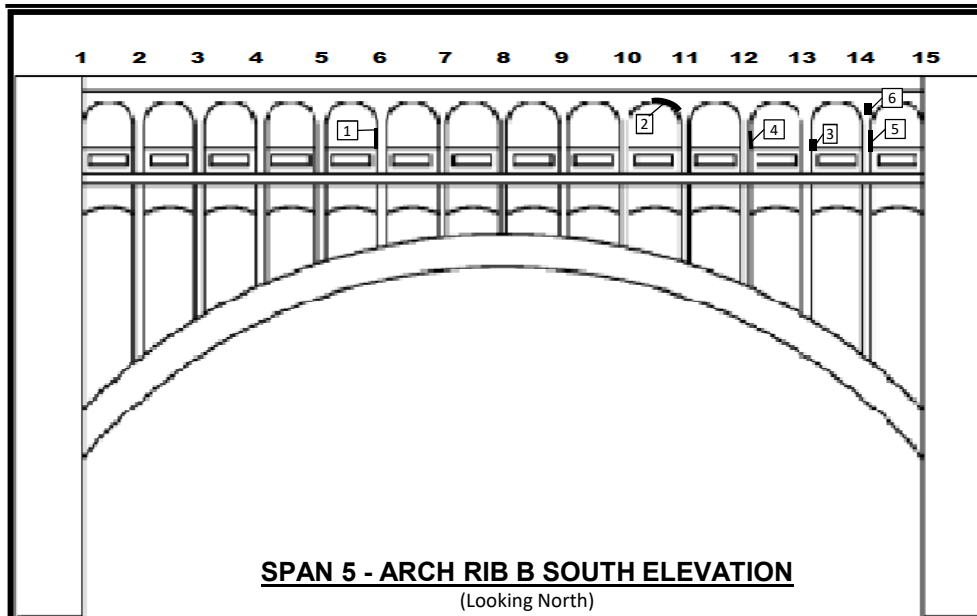
SPAN 5 - ARCH RIB B SOUTH ELEVATION
(Looking North)

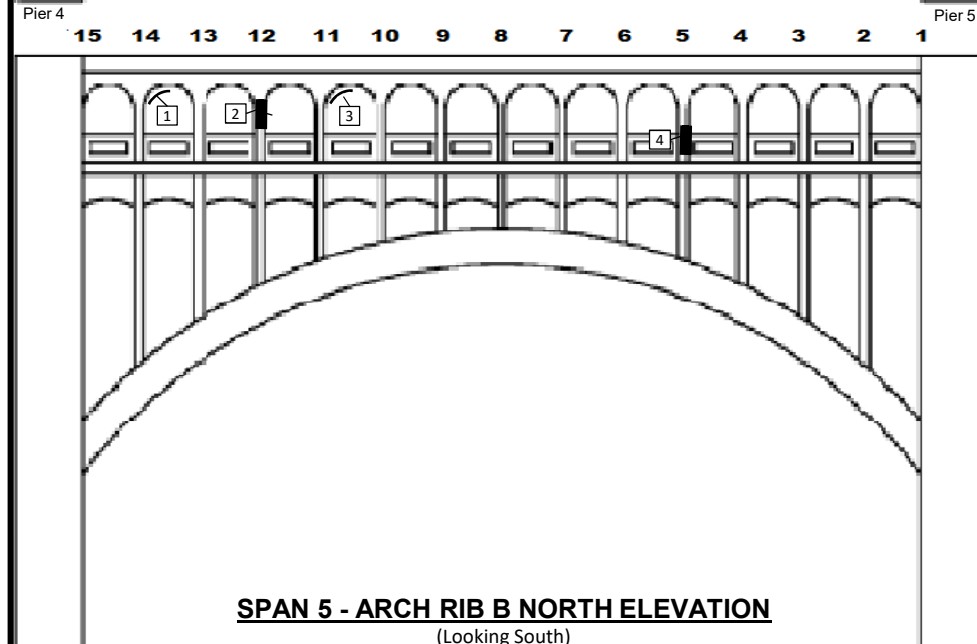
SPAN 5 - ARCH RIB B NORTH ELEVATION
(Looking South)

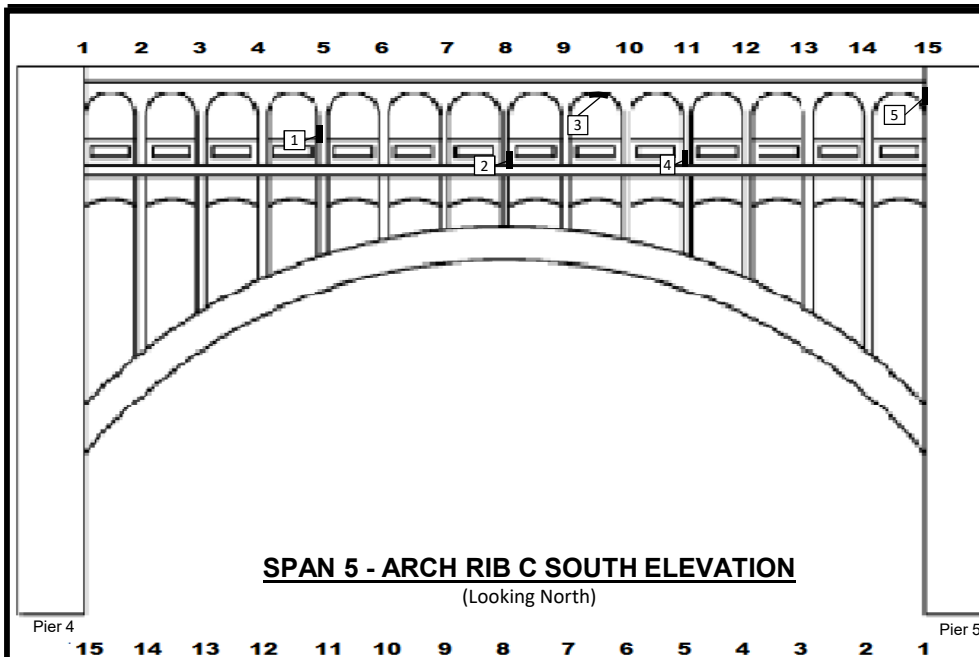
SPAN 5 - ARCH RIB C SOUTH ELEVATION DEFICIENCIES	
#	Defect
1	Spall w/ exp. Reinf. - 1 SF
2	Delamination w/ Spall w/ exp. Reinf. - 4 SF
3	Spall w/ exp. Reinf. - 1 SF
4	Delamination - 4 SF
5	Spall w/ exp. Reinf. - 2 SF

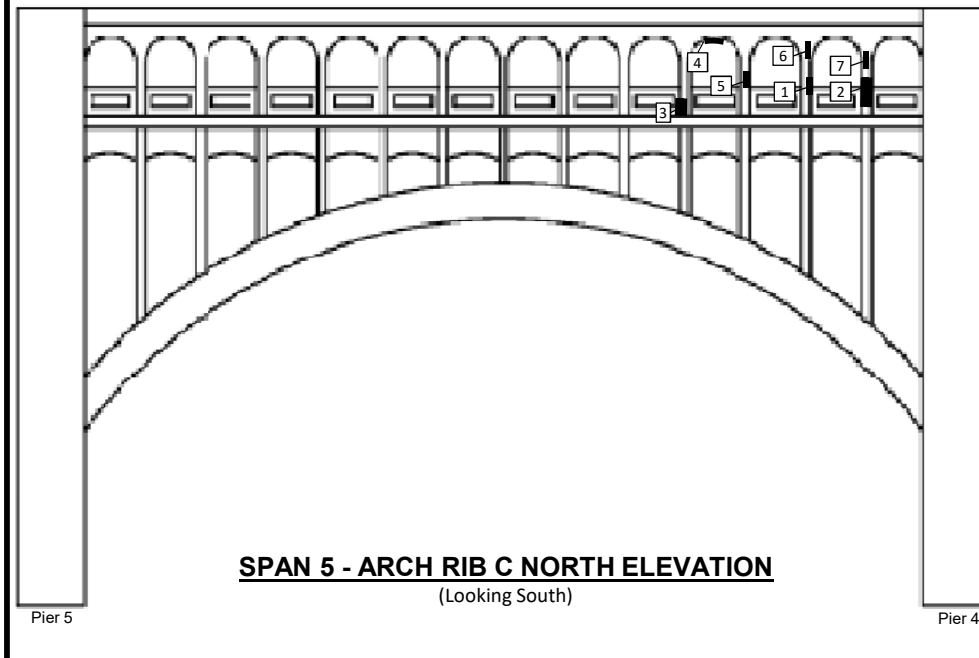
SPAN 5 - ARCH RIB C NORTH ELEVATION DEFICIENCIES	
#	Defect
1	Spall w/ exp. Reinf. - 1 SF, 1" D
2	Spall w/ exp. Reinf. - 1 SF, 1.5" D
3	Delamination - 2 SF
4	Delamination - 2 SF
5	Delamination - 2 SF
6	Delamination - 3 SF
7	Delamination - 5 SF

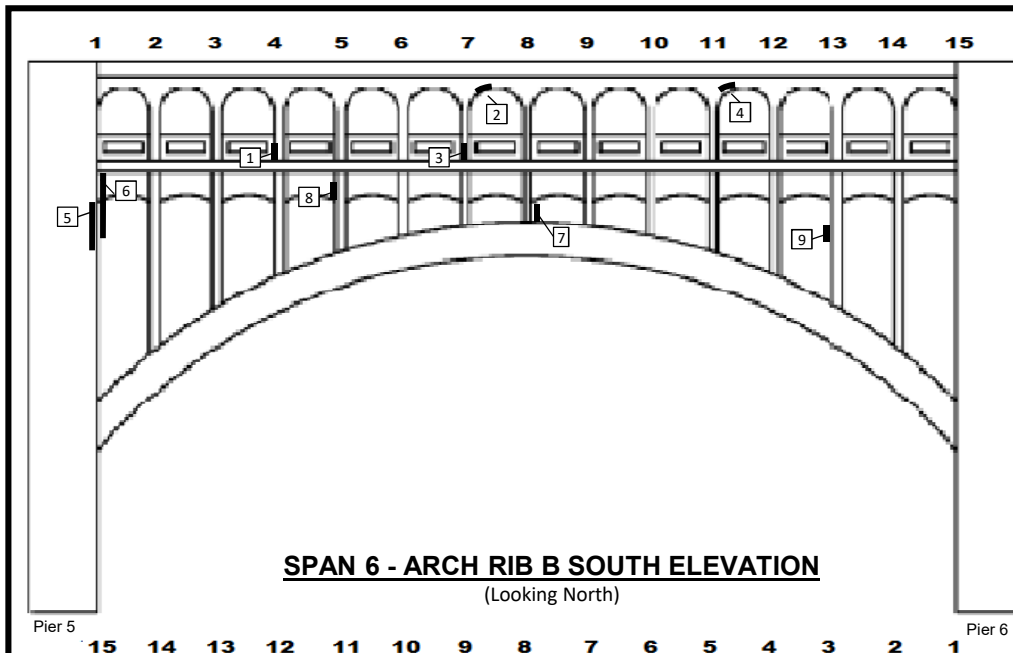
SPAN 6 - ARCH RIB B SOUTH ELEVATION DEFICIENCIES	
#	Defect
1	Delamination - 2 SF
2	Delamination - 4 SF
3	Delamination - 3 SF
4	Spall - 4 SF, 4" D
5	Delamination - 16 SF
6	Delamination - 5 SF
	Spall w/ exp. Reinf. - 15 SF
7	Delamination - 1 SF
8	Delamination - 4 SF
9	Spall w/ exp. Reinf. - 16 SF

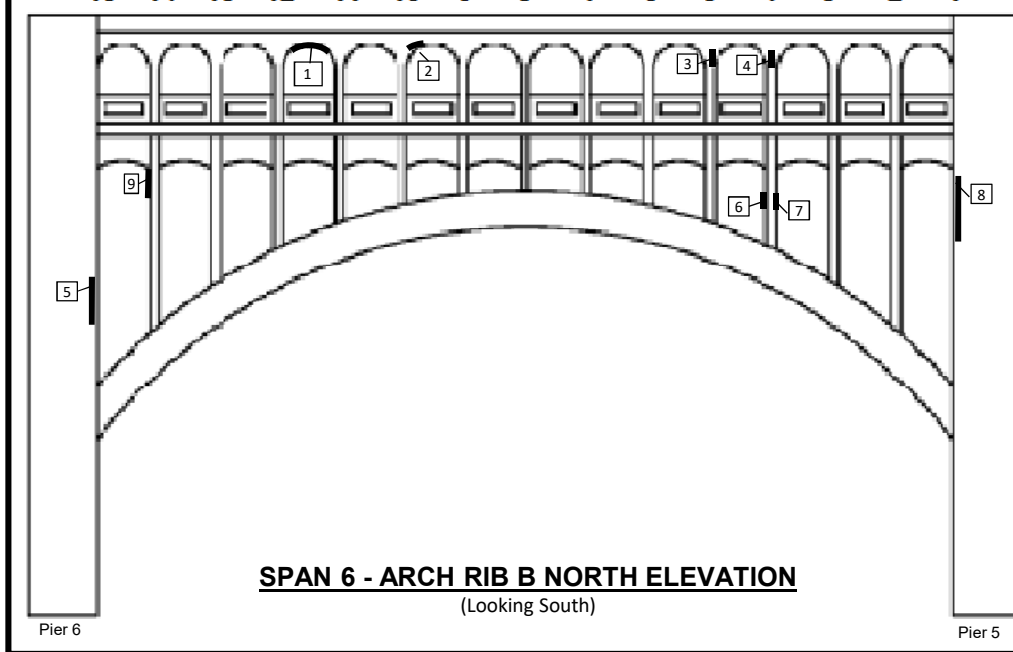
SPAN 6 - ARCH RIB B NORTH ELEVATION DEFICIENCIES	
#	Defect
1	Delamination - 24 SF
2	Spall w/ exp. Reinf. - 1 SF
3	Delamination - 4.5 SF
4	Delamination - 2 SF
5	Delamination - 8 SF
6	Delamination - 1 SF
7	Delamination - 1 SF
8	Delamination - 8 SF
9	Spall w/ exp. Reinf. - 2 SF

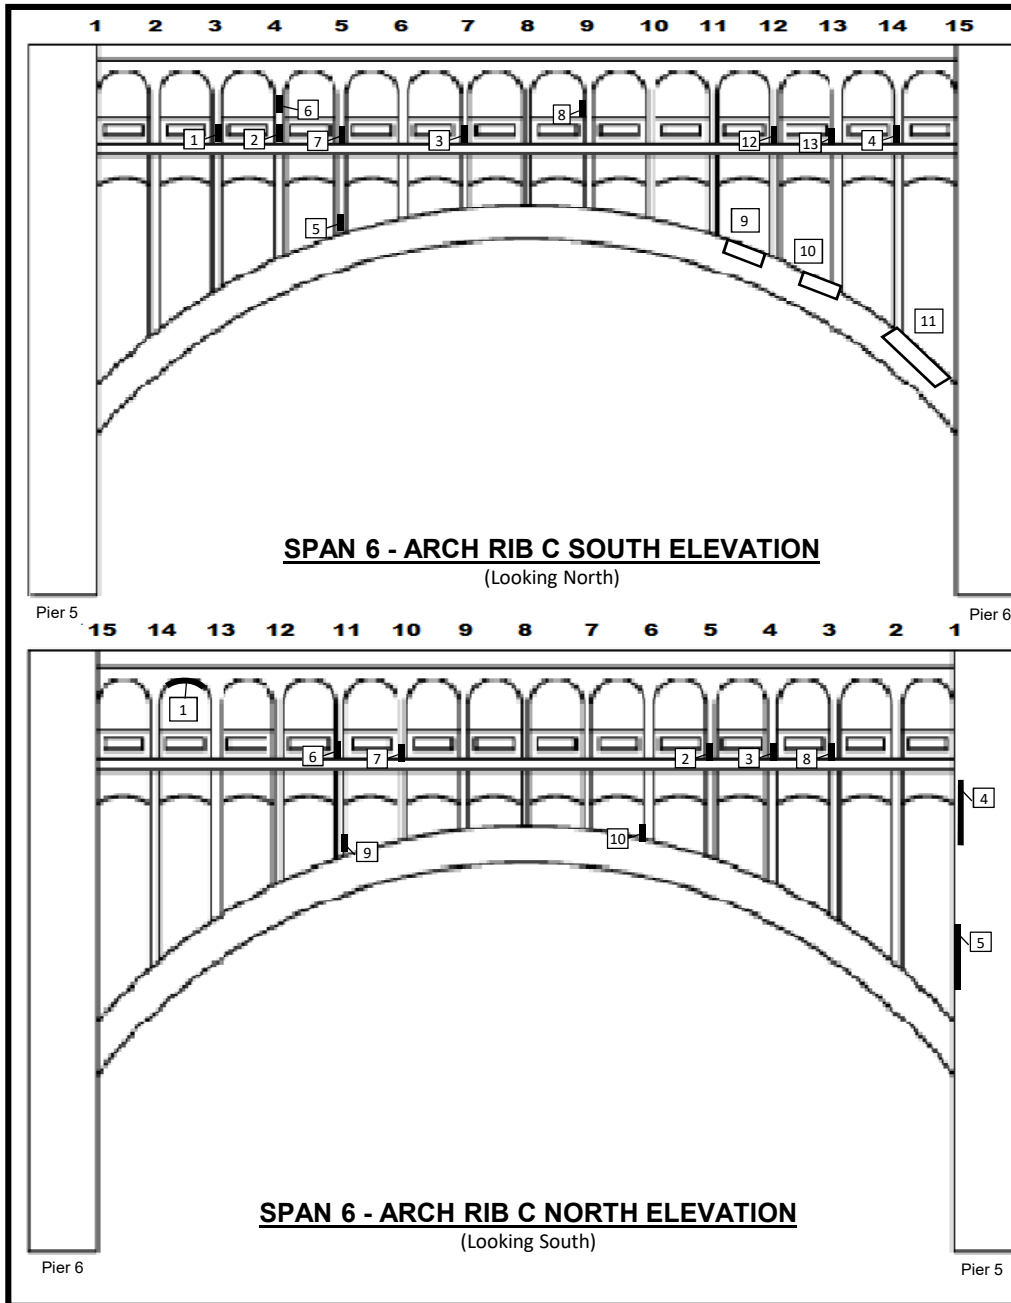
SPAN 6 - ARCH RIB C SOUTH ELEVATION DEFICIENCIES	
#	Defect
1	Spall w/ exp. Reinf. - 2 SF, 2" D
2	Spall w/ exp. Reinf. - 1 SF, 3" D Delamination - 9 SF
3	Spall w/ exp. Reinf. - 1 SF, 2" D
4	Delamination - 3 SF
5	Spall w/ exp. Reinf. - 1 SF
6	Delamination - 1 SF
7	Delamination - 4 SF
8	Delamination - 1 SF
9	Delamination - 12 SF
10	Delamination - 10 SF Delamination - SF (topside of arch)
11	Delamination - 20 SF
12	Delamination - 2 SF
13	Delamination - 1 SF

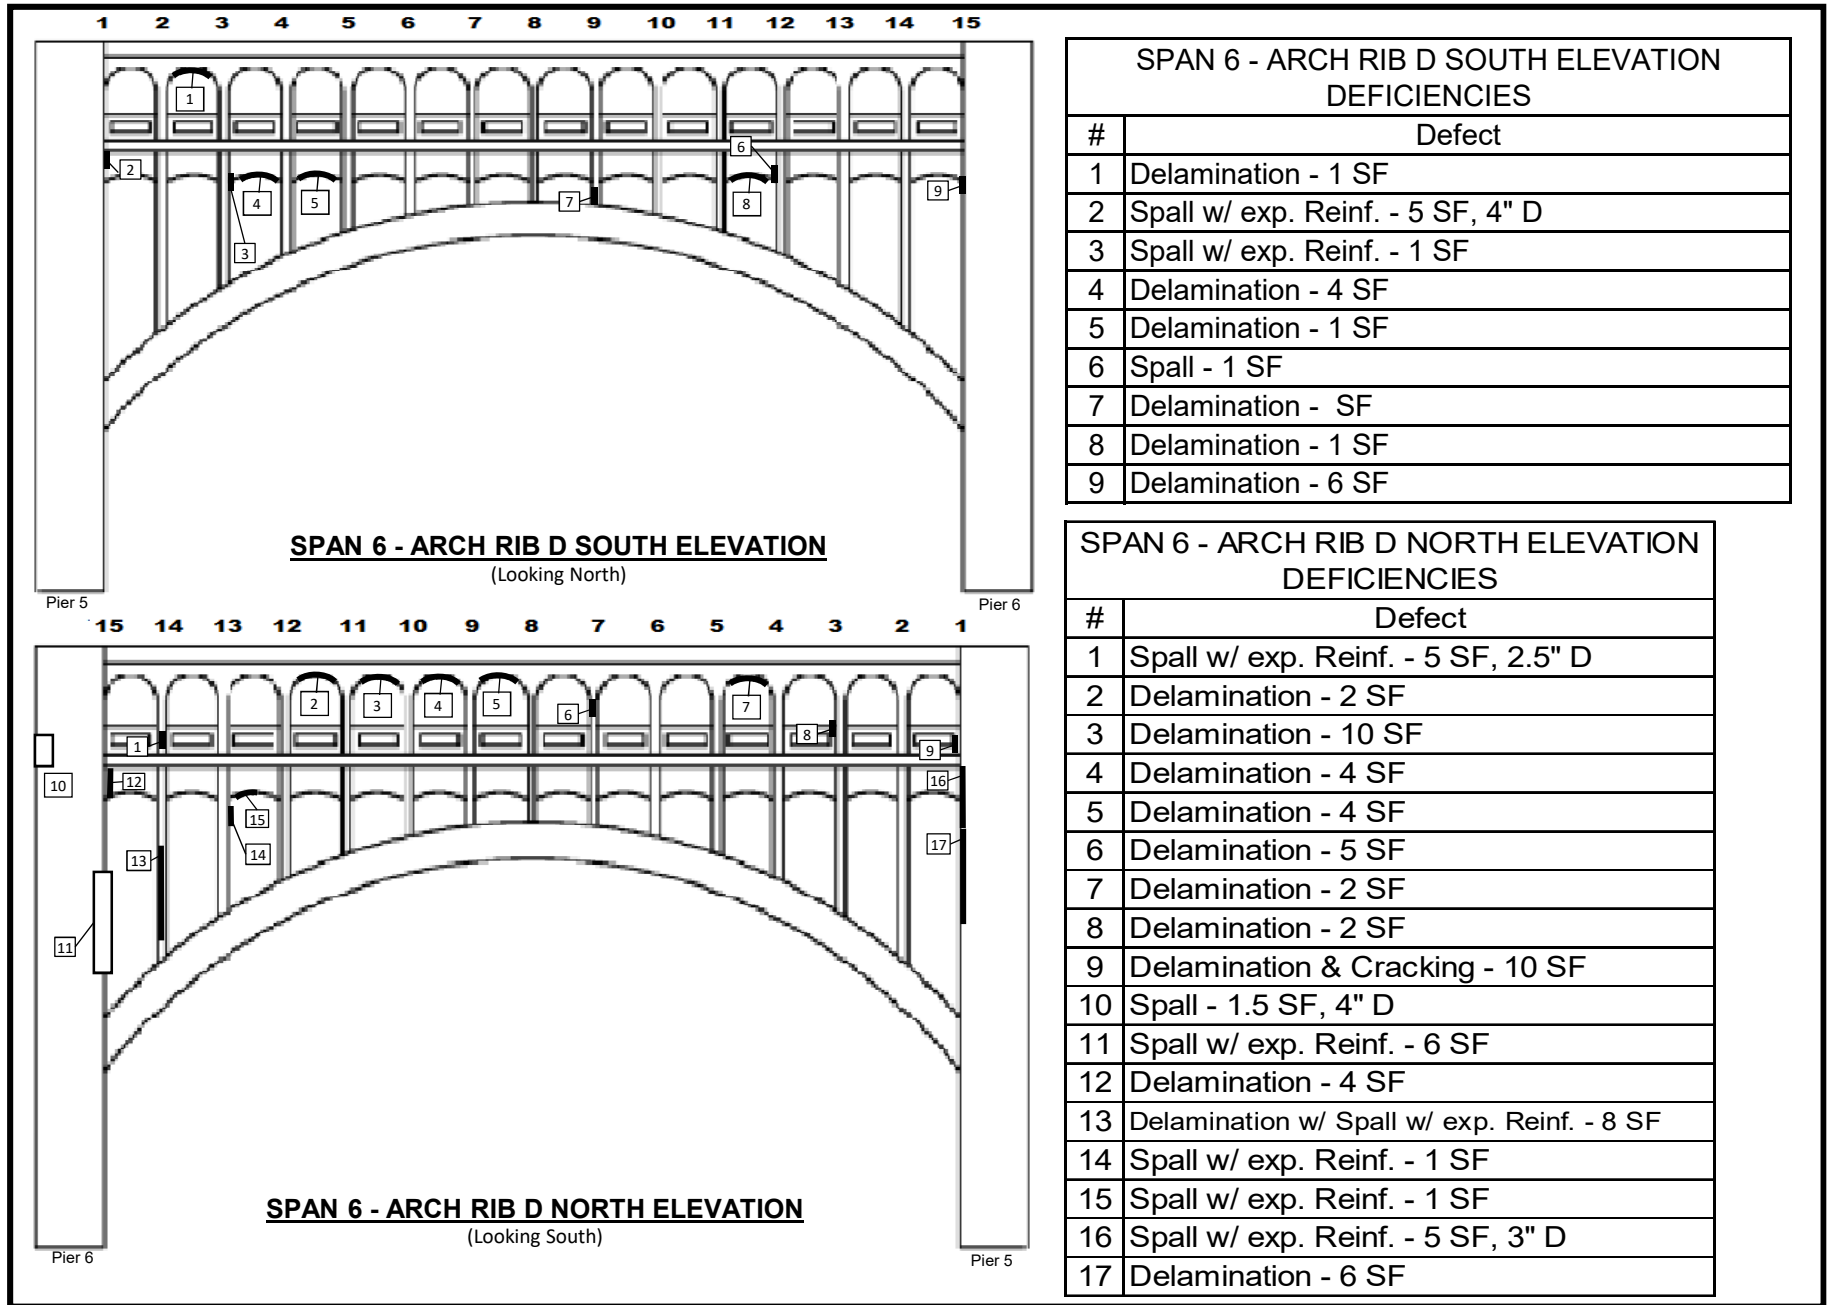
SPAN 6 - ARCH RIB C NORTH ELEVATION DEFICIENCIES	
#	Defect
1	Delamination - 2 SF
2	Spall w/ exp. Reinf. - 1 SF
3	Delamination - 4 SF
4	Spall w/ exp. Reinf. - 10 SF
5	Spall w/ exp. Reinf. - 15 SF
6	Delamination w/ Spall w/ exp. Reinf - 3 SF
7	Delamination - 3 SF
8	Delamination - 4 SF
9	Delamination - 1 SF

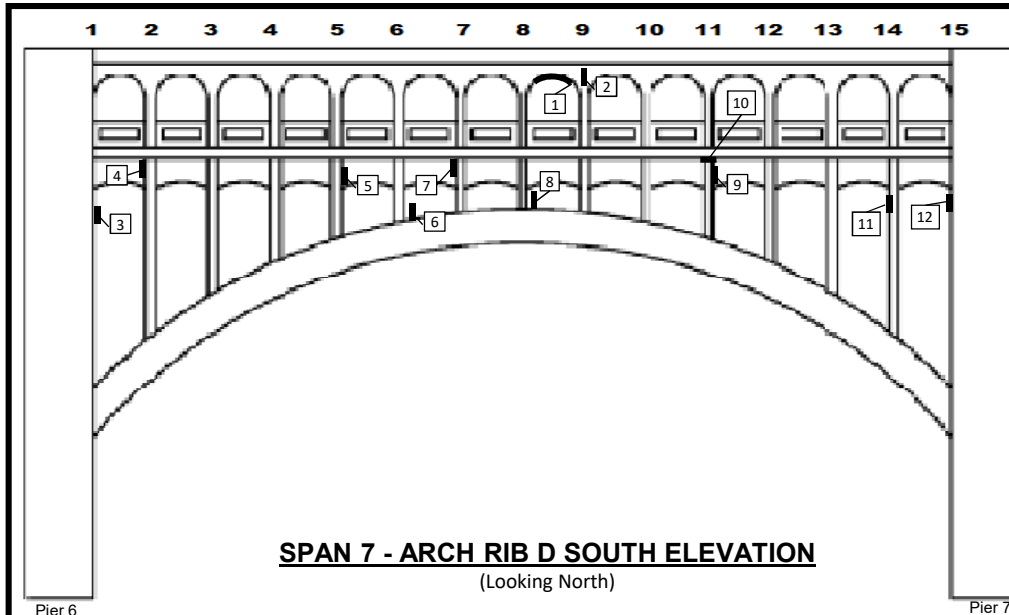
SPAN 7 - ARCH RIB D SOUTH ELEVATION DEFICIENCIES	
#	Defect
1	Delamination - 4 SF
2	Delamination - 5 SF
3	Delamination - 4 SF
4	Delamination w/ Spall w/ exp. Reinf. - 12 SF
5	Delamination - 3 SF
6	Delamination - 2 SF
7	Delamination - 3 SF
8	Spall w/ exp. Reinf - 1 SF
9	Delamination - 3 SF
10	Delamination - 6 SF
11	Delamination - 6 SF
12	Delamination - 4 SF

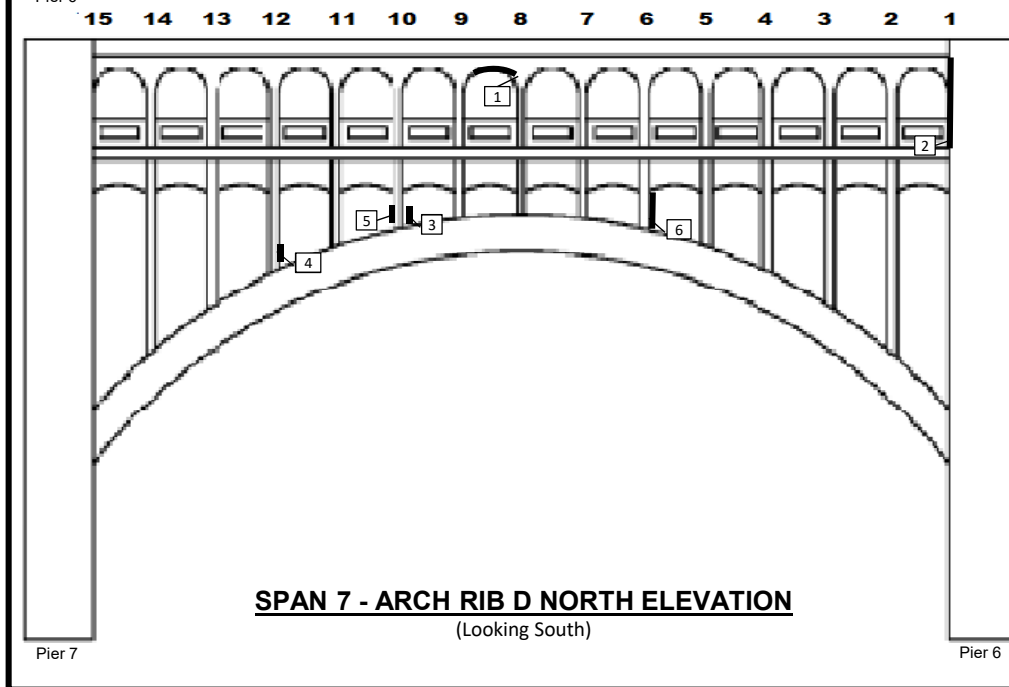
SPAN 7 - ARCH RIB D NORTH ELEVATION DEFICIENCIES	
#	Defect
1	Delamination - 4 SF
2	5' Tall x Full Depth x 1/8" W crack
3	Spall w/ exp/ Reinf. - 1 SF
4	Delamination - 1 SF
5	Spall w/ exp. Reinf. - 1 SF
6	Delamination - 6 SF
