Physical Condition Report for

CUY-006-1456

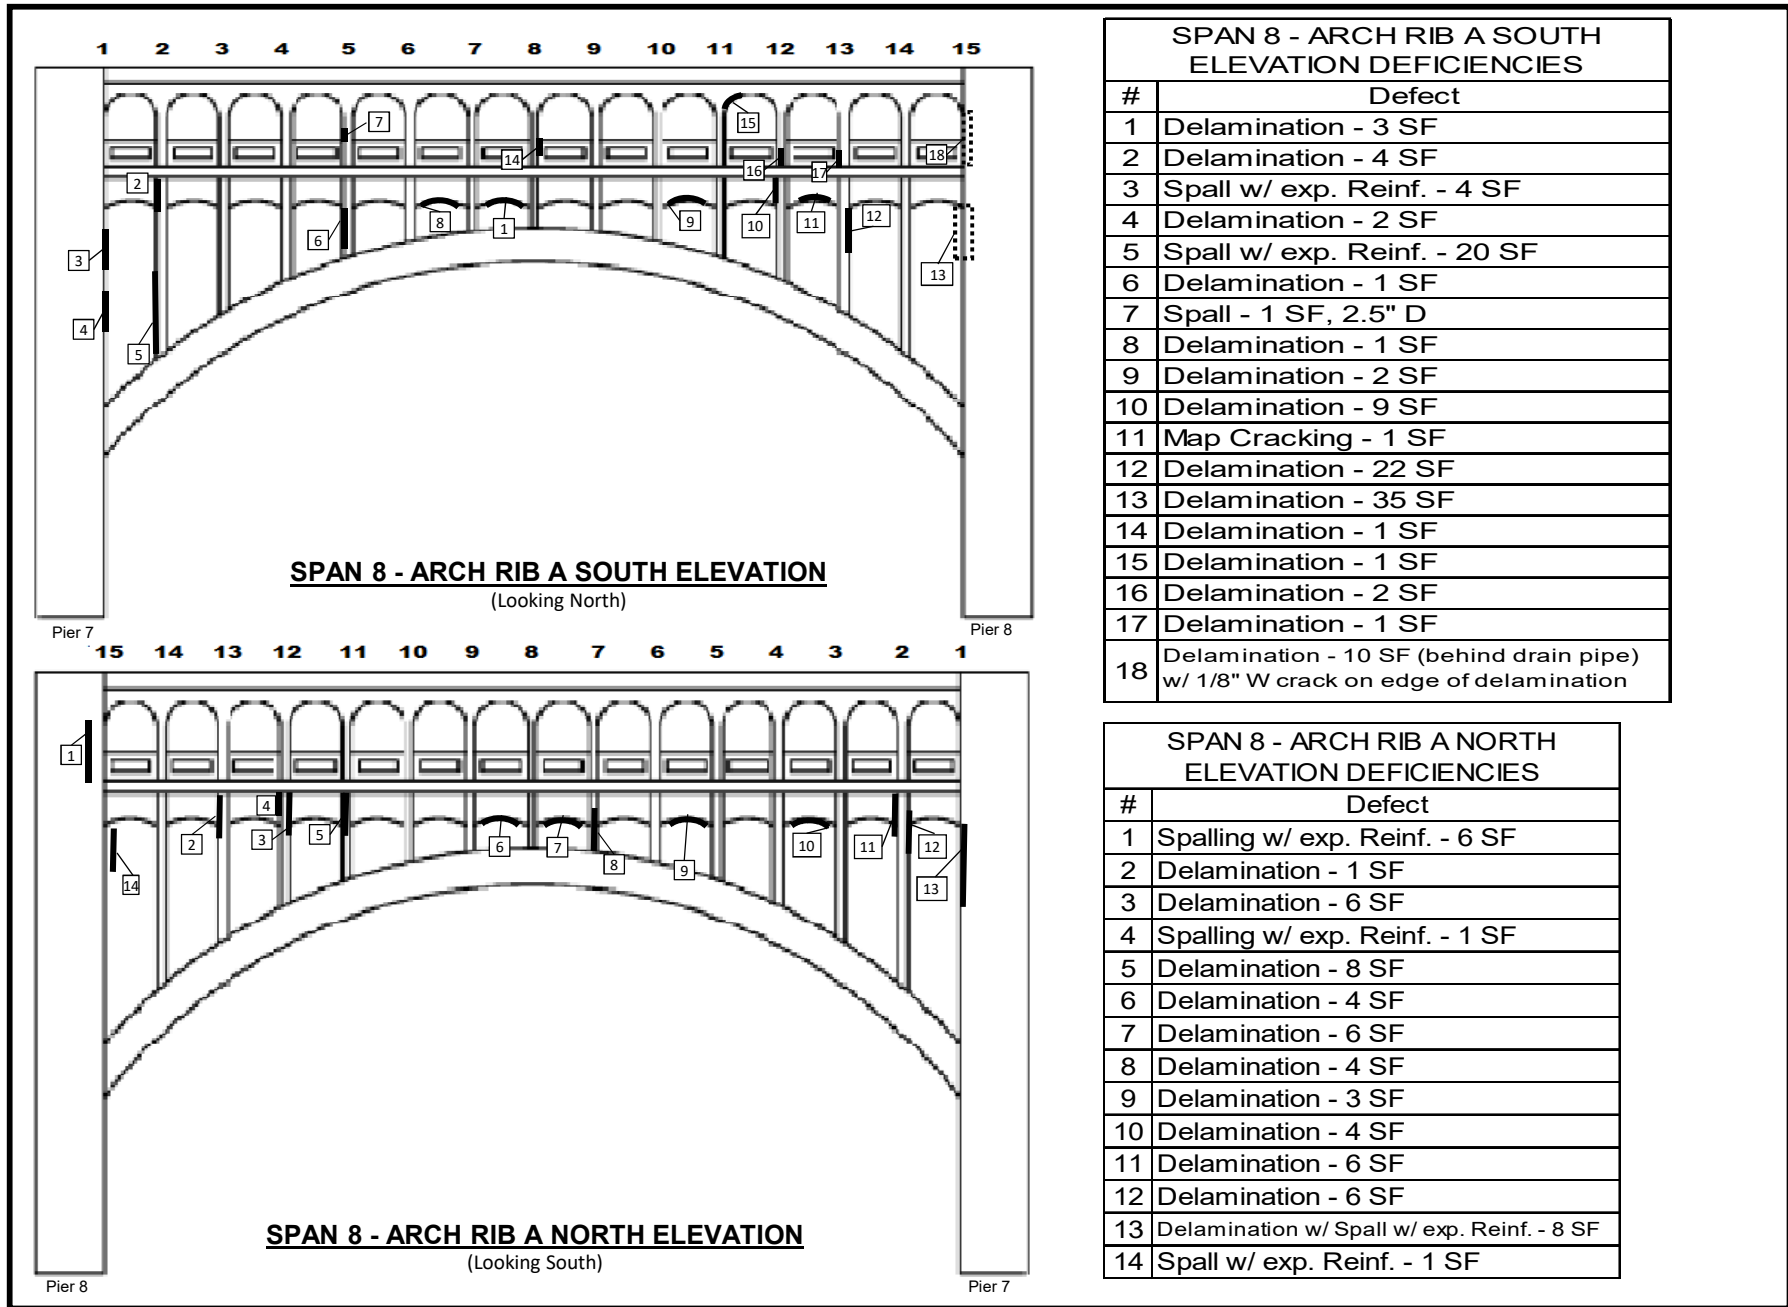
SPAN 7 - ARCH RIB D NORTH ELEVATION DEFICIENCIES	
#	Defect
1	Delamination - 4 SF
2	5' Tall x Full Depth x 1/8" W crack
3	Spall w/ exp/ Reinf. - 1 SF
4	Delamination - 1 SF
5	Spall w/ exp. Reinf. - 1 SF
6	Delamination - 6 SF

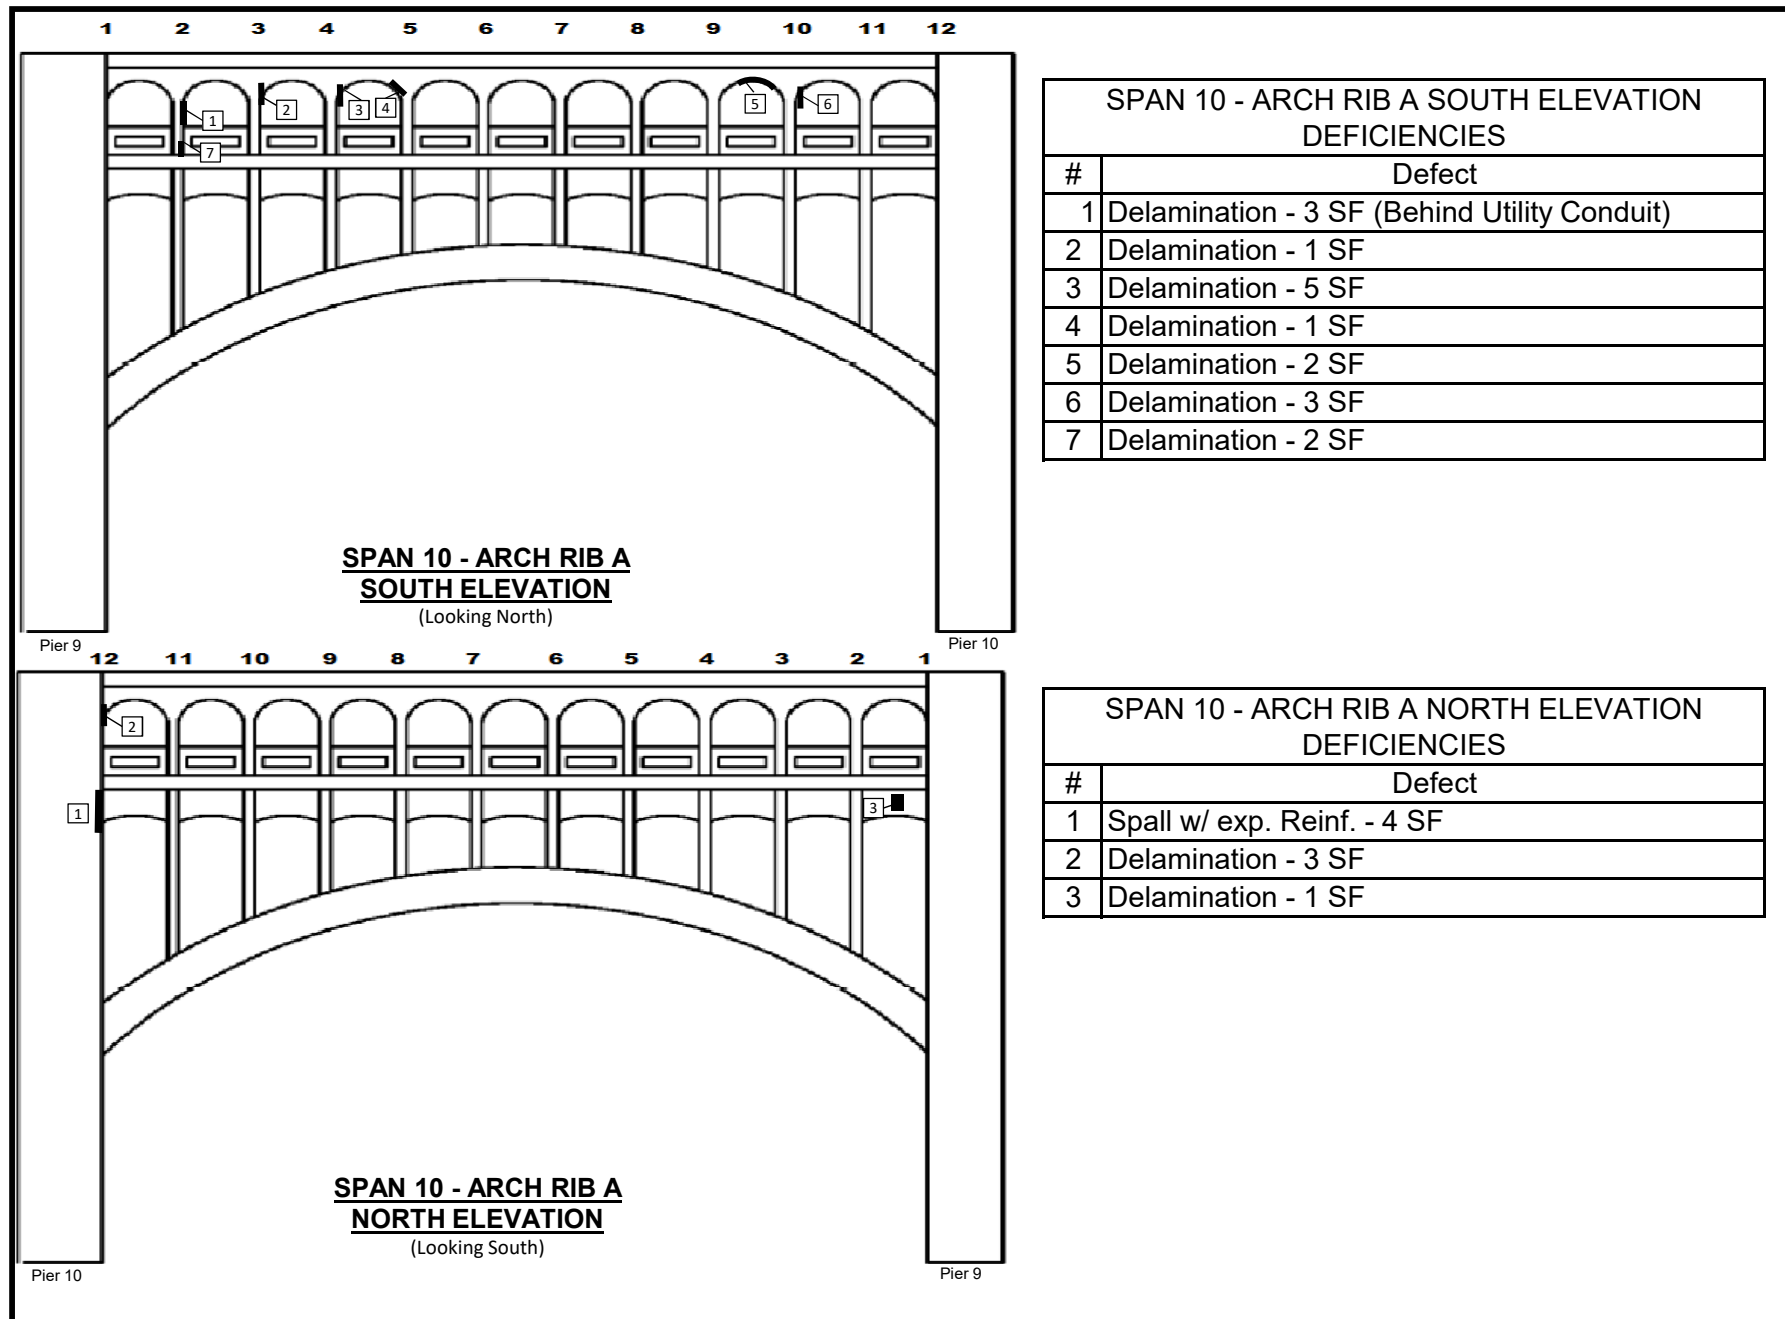
SPAN 10 - ARCH RIB A SOUTH ELEVATION DEFICIENCIES	
#	Defect
1	Delamination - 3 SF (Behind Utility Conduit)
2	Delamination - 1 SF
3	Delamination - 5 SF
4	Delamination - 1 SF
5	Delamination - 2 SF
6	Delamination - 3 SF
7	Delamination - 2 SF

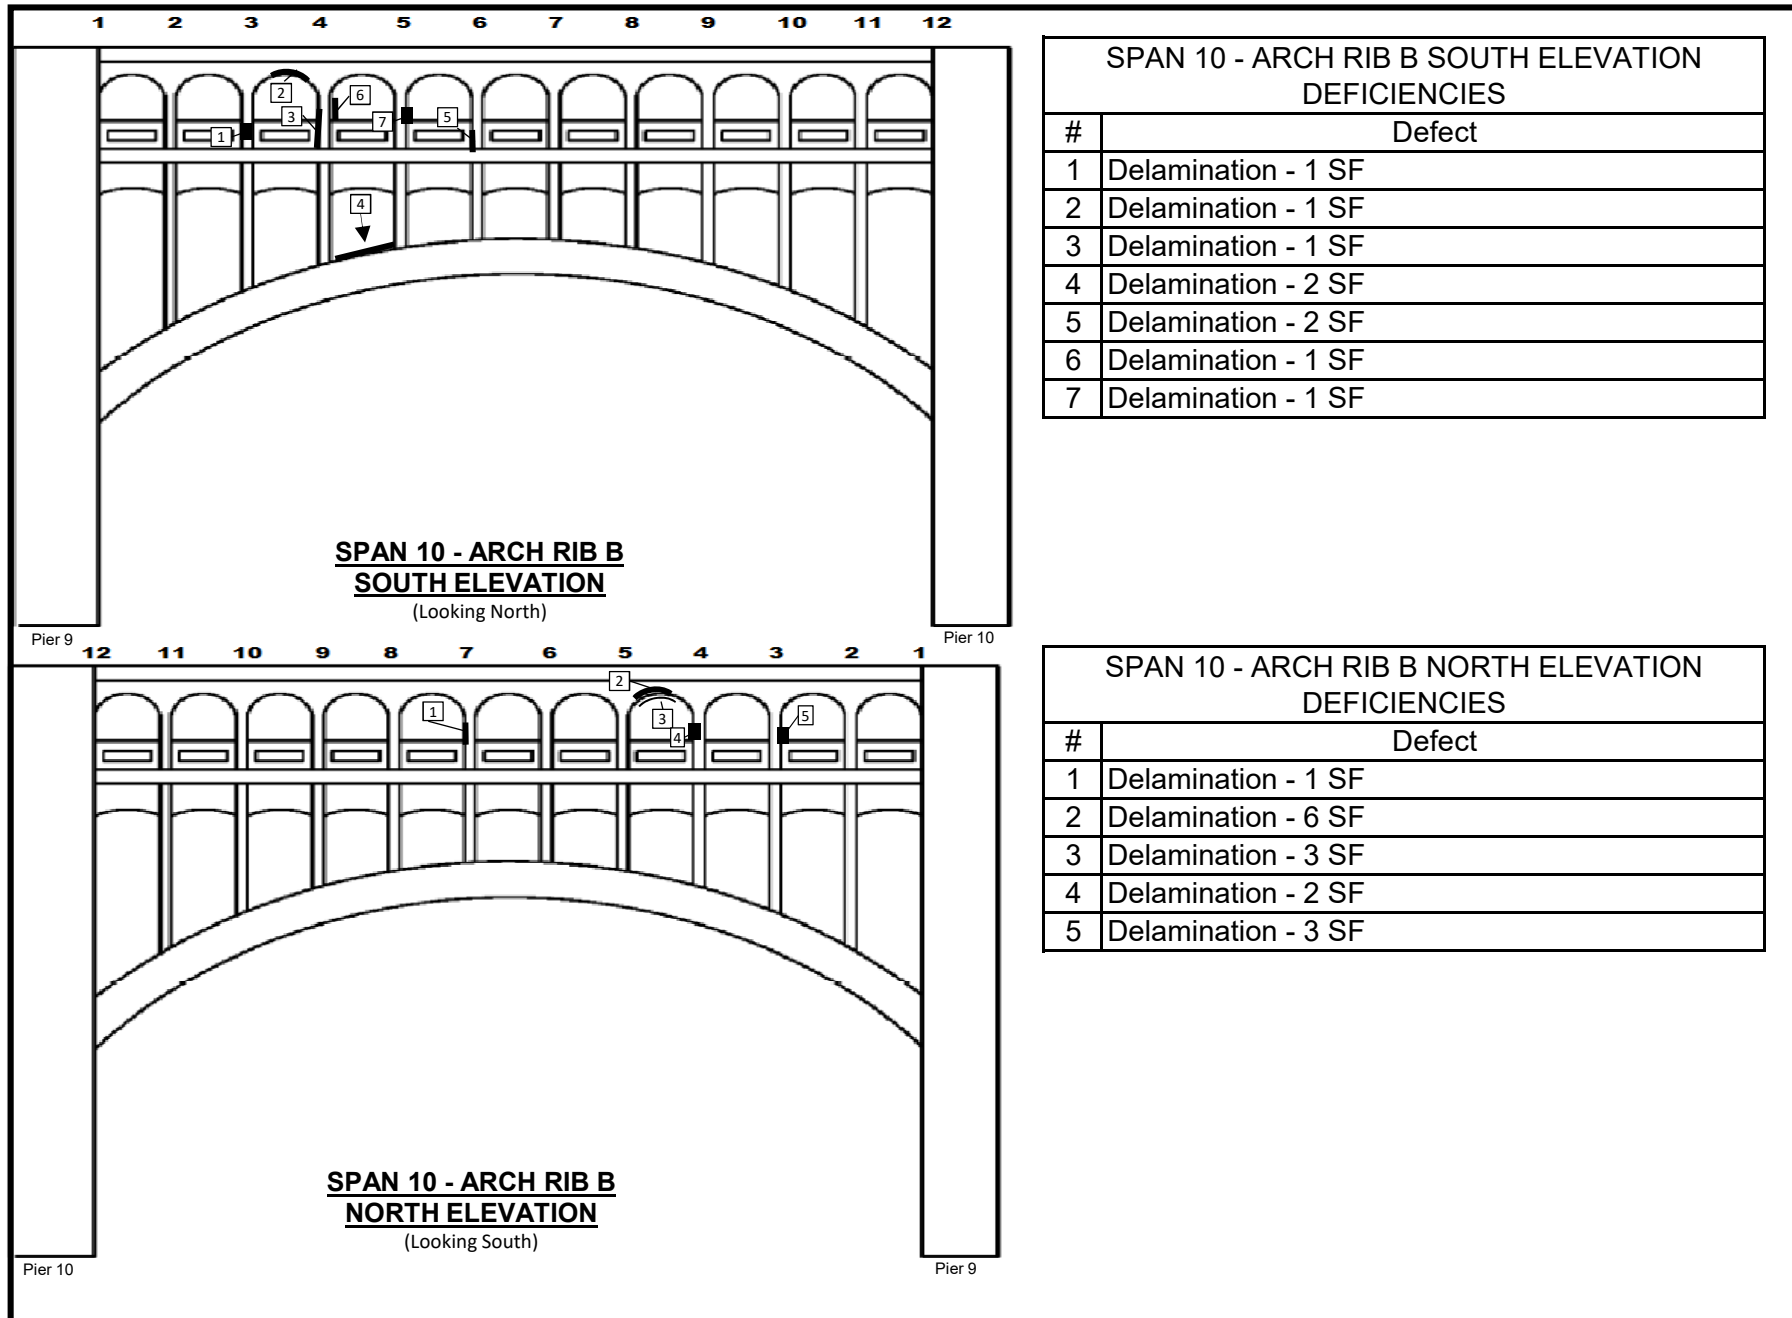
SPAN 10 - ARCH RIB A NORTH ELEVATION DEFICIENCIES	
#	Defect
1	Spall w/ exp. Reinf. - 4 SF
2	Delamination - 3 SF
3	Delamination - 1 SF

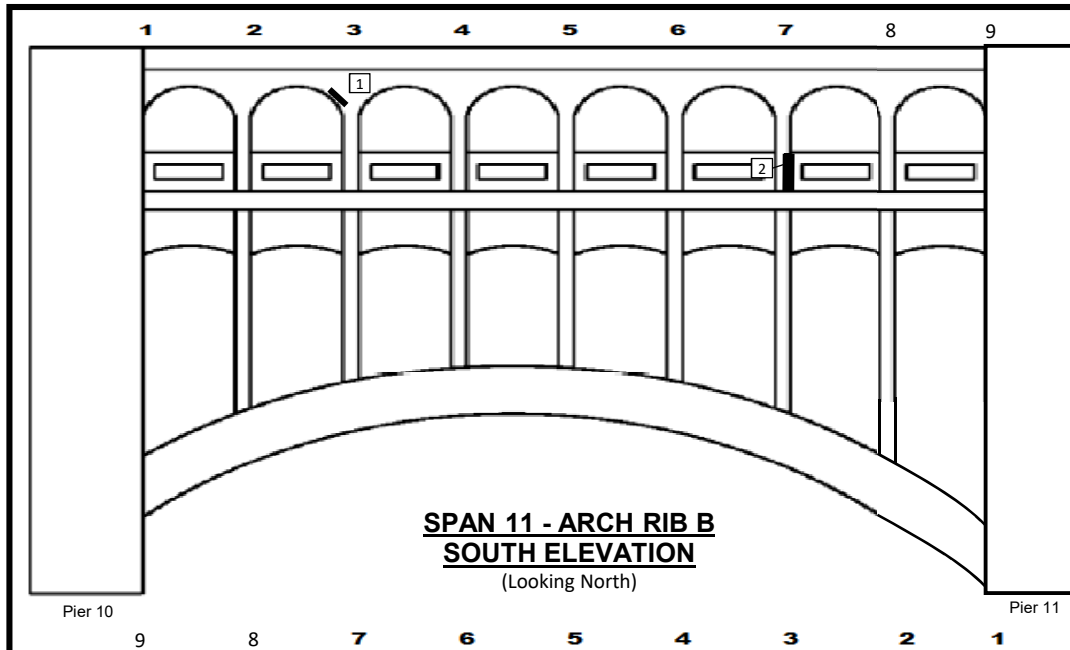
SPAN 11 - ARCH RIB B SOUTH ELEVATION DEFICIENCIES	
#	Defect
1	Delamination - 1 SF
2	Spall w/ exp. Reinf. - 1 SF, 3" D

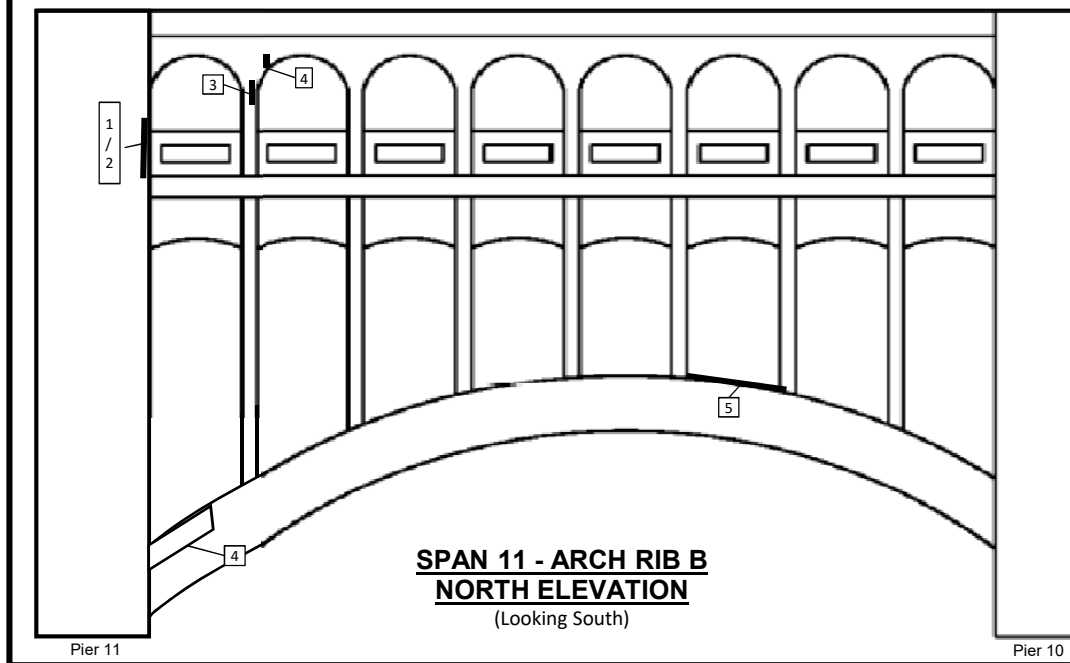
SPAN 11 - ARCH RIB B NORTH ELEVATION DEFICIENCIES	
#	Defect
1	Spall w/ exp Reinf. - 1 SF, 3" D
2	Delamination - 35 SF
3	Delamination - 3 SF
4	Spall - 3 SF, 3" D
5	Delamination - 6 SF
6	Delamination - 4 SF

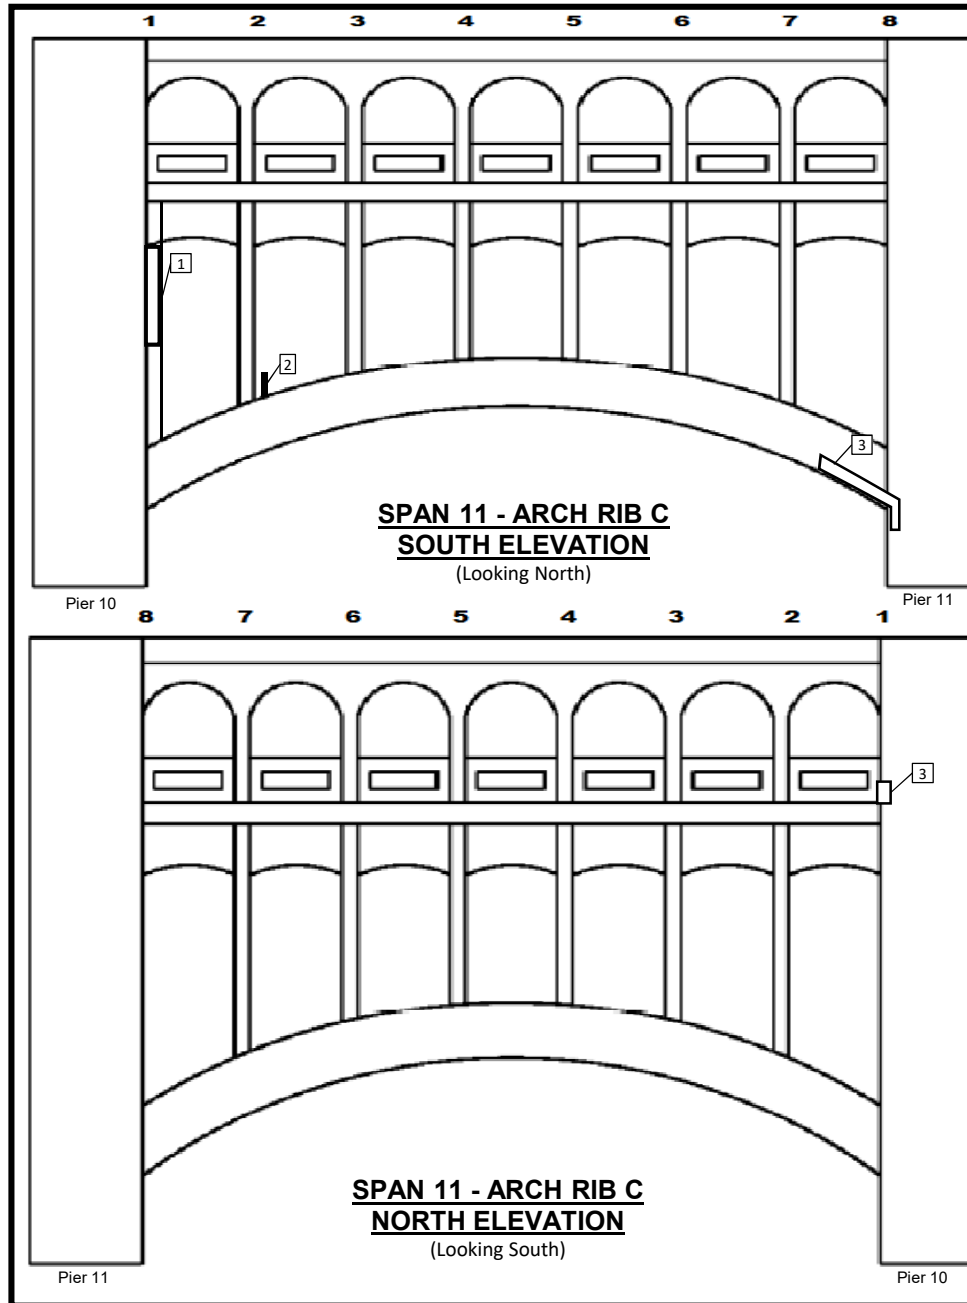
SPAN 11 - ARCH RIB C SOUTH ELEVATION DEFICIENCIES	
#	Defect
1	Delamination - 8 SF
2	Delamination - 1 SF
3	Delamination - 6 SF

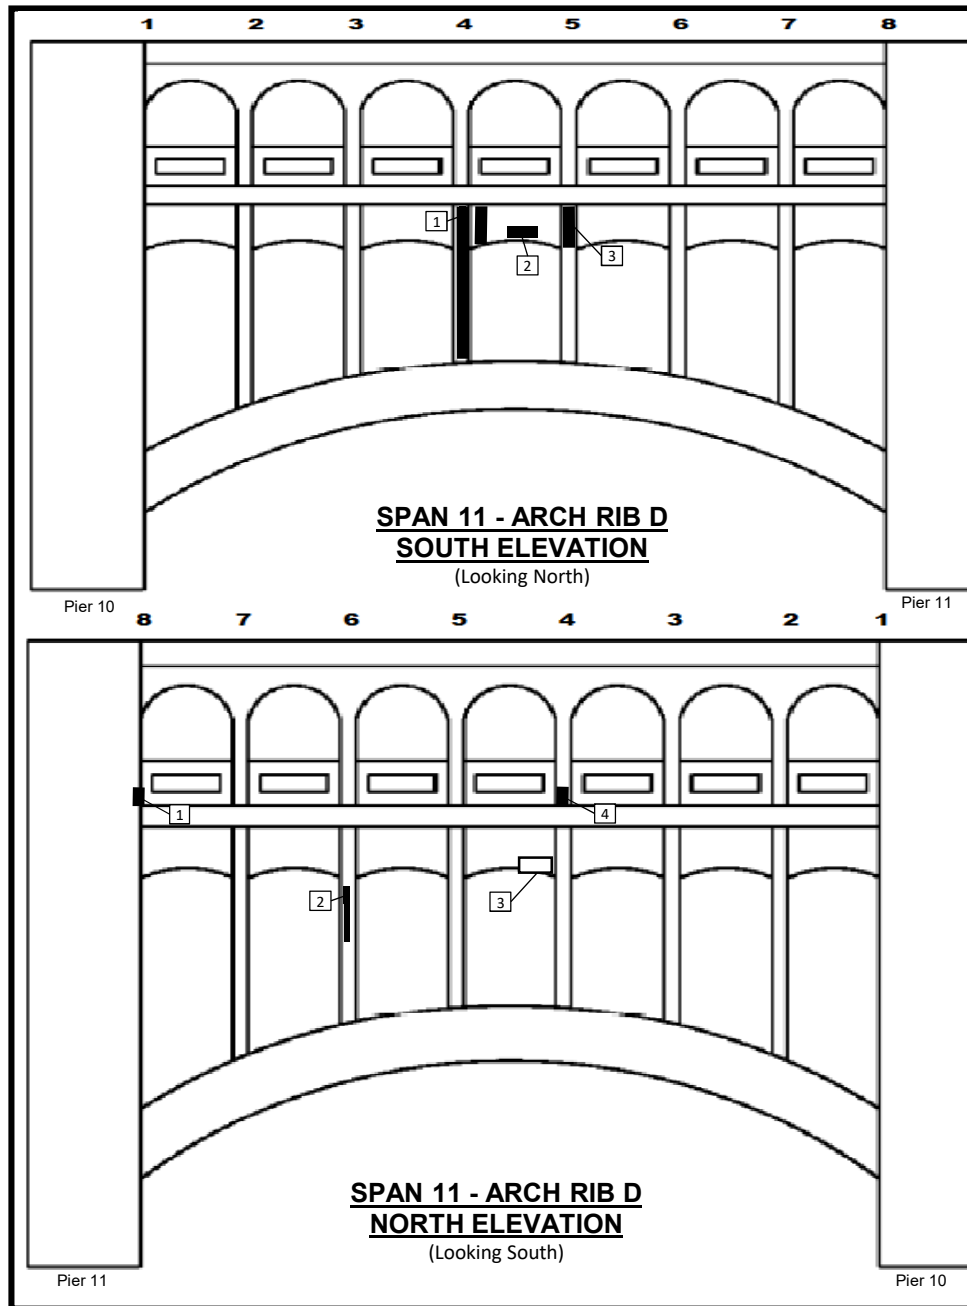
SPAN 11 - ARCH RIB D SOUTH ELEVATION DEFICIENCIES	
#	Defect
1	Spall w/ exp. Reinf. - 1.5' W x Full H, 6" D
2	Delamination - 2 SF
3	Delamination - 2 SF

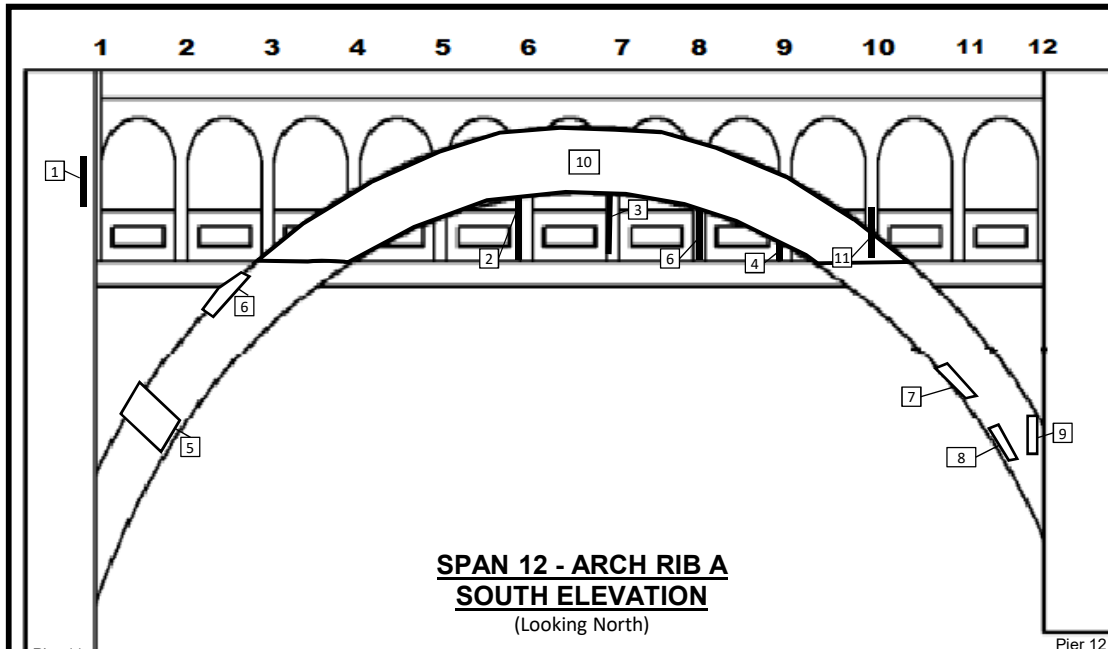
Note: All concrete encased steel hangers sound delaminated due to only 4"± cover between steel hanger and outside face of concrete.

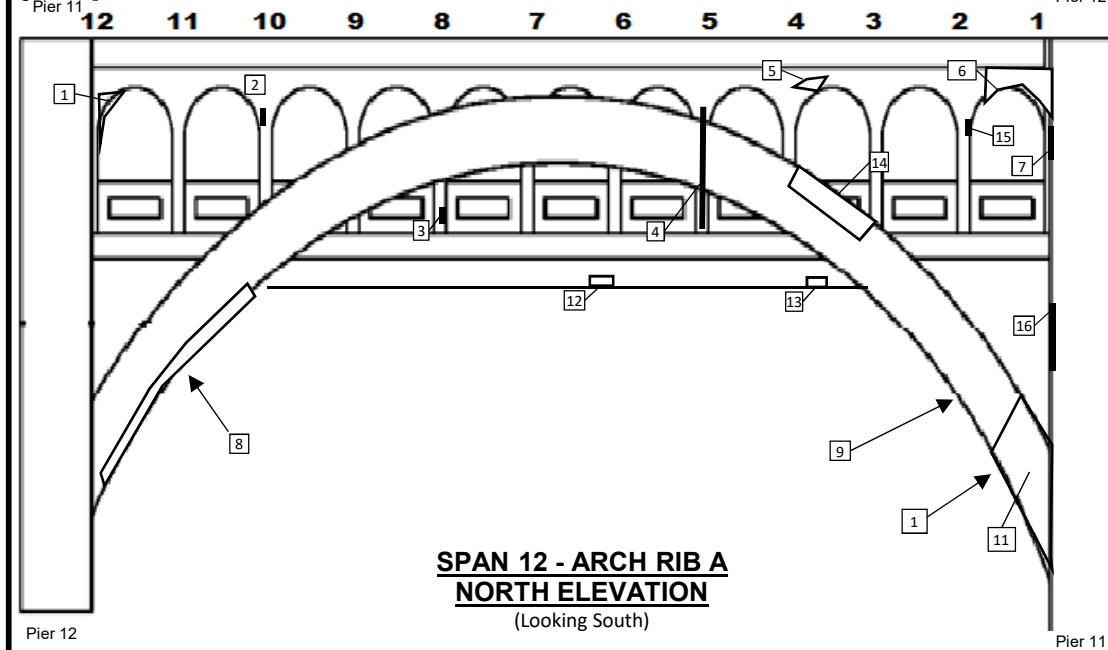
SPAN 12 - RIB A NORTH ELEVATION DEFICIENCIES			
#	Defect	#	Defect
1	Spall w/ exp. Reinf - 12 SF, 6" D	9	Delamination - 5 SF (U.o.A)
2	Spall w/ exp. Reinf - 1 SF, 2" D	10	Delamination - 18 SF (U.o.A)
3	Spall w/ exp. Reinf - 1 SF, 2" D	11	Delamination - 20 SF
4	Delamination - 8 SF	12	Spall - 1 SF
5	Spall w/ exp. Reinf - 1 SF, 2" D	13	Spall - 1 SF
		14	Delamination - 15 SF
6	Entire face of arch is spalling and delaminated, up to 3" D	15	Spall w/ exp. Reinf. - 1 SF
7	Spall - 8 SF, 4" D (on pier)	16	Delamination w/ Spall w/ exp. Reinf. - 4 SF (on pier)

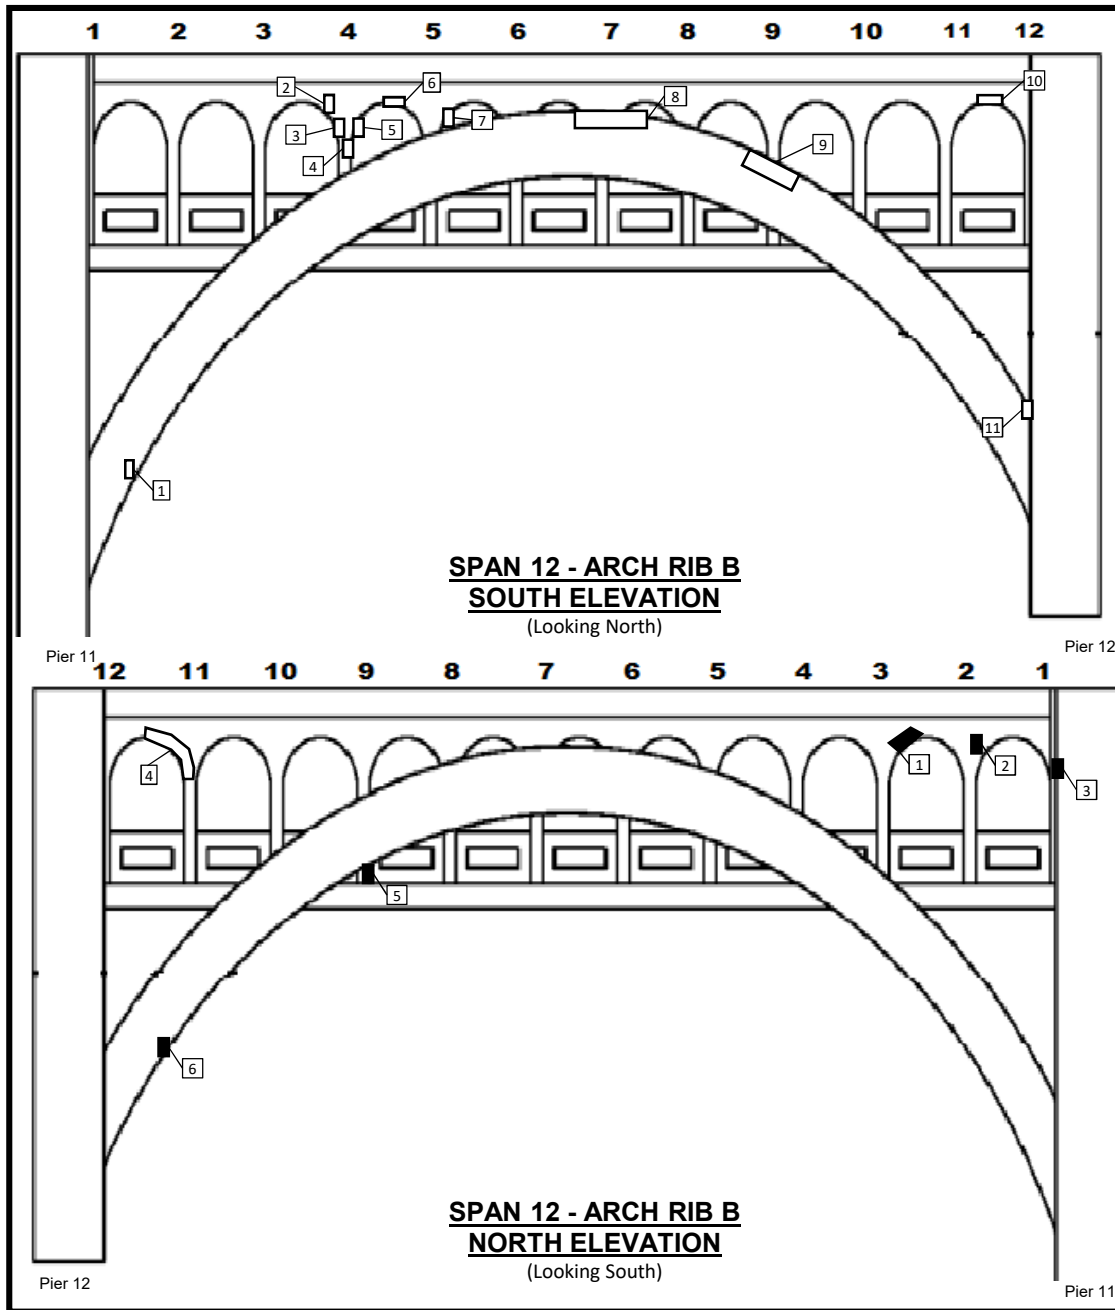
Note: All concrete encased steel hangers sound delaminated due to only 4"± cover between steel hanger and outside face of concrete.

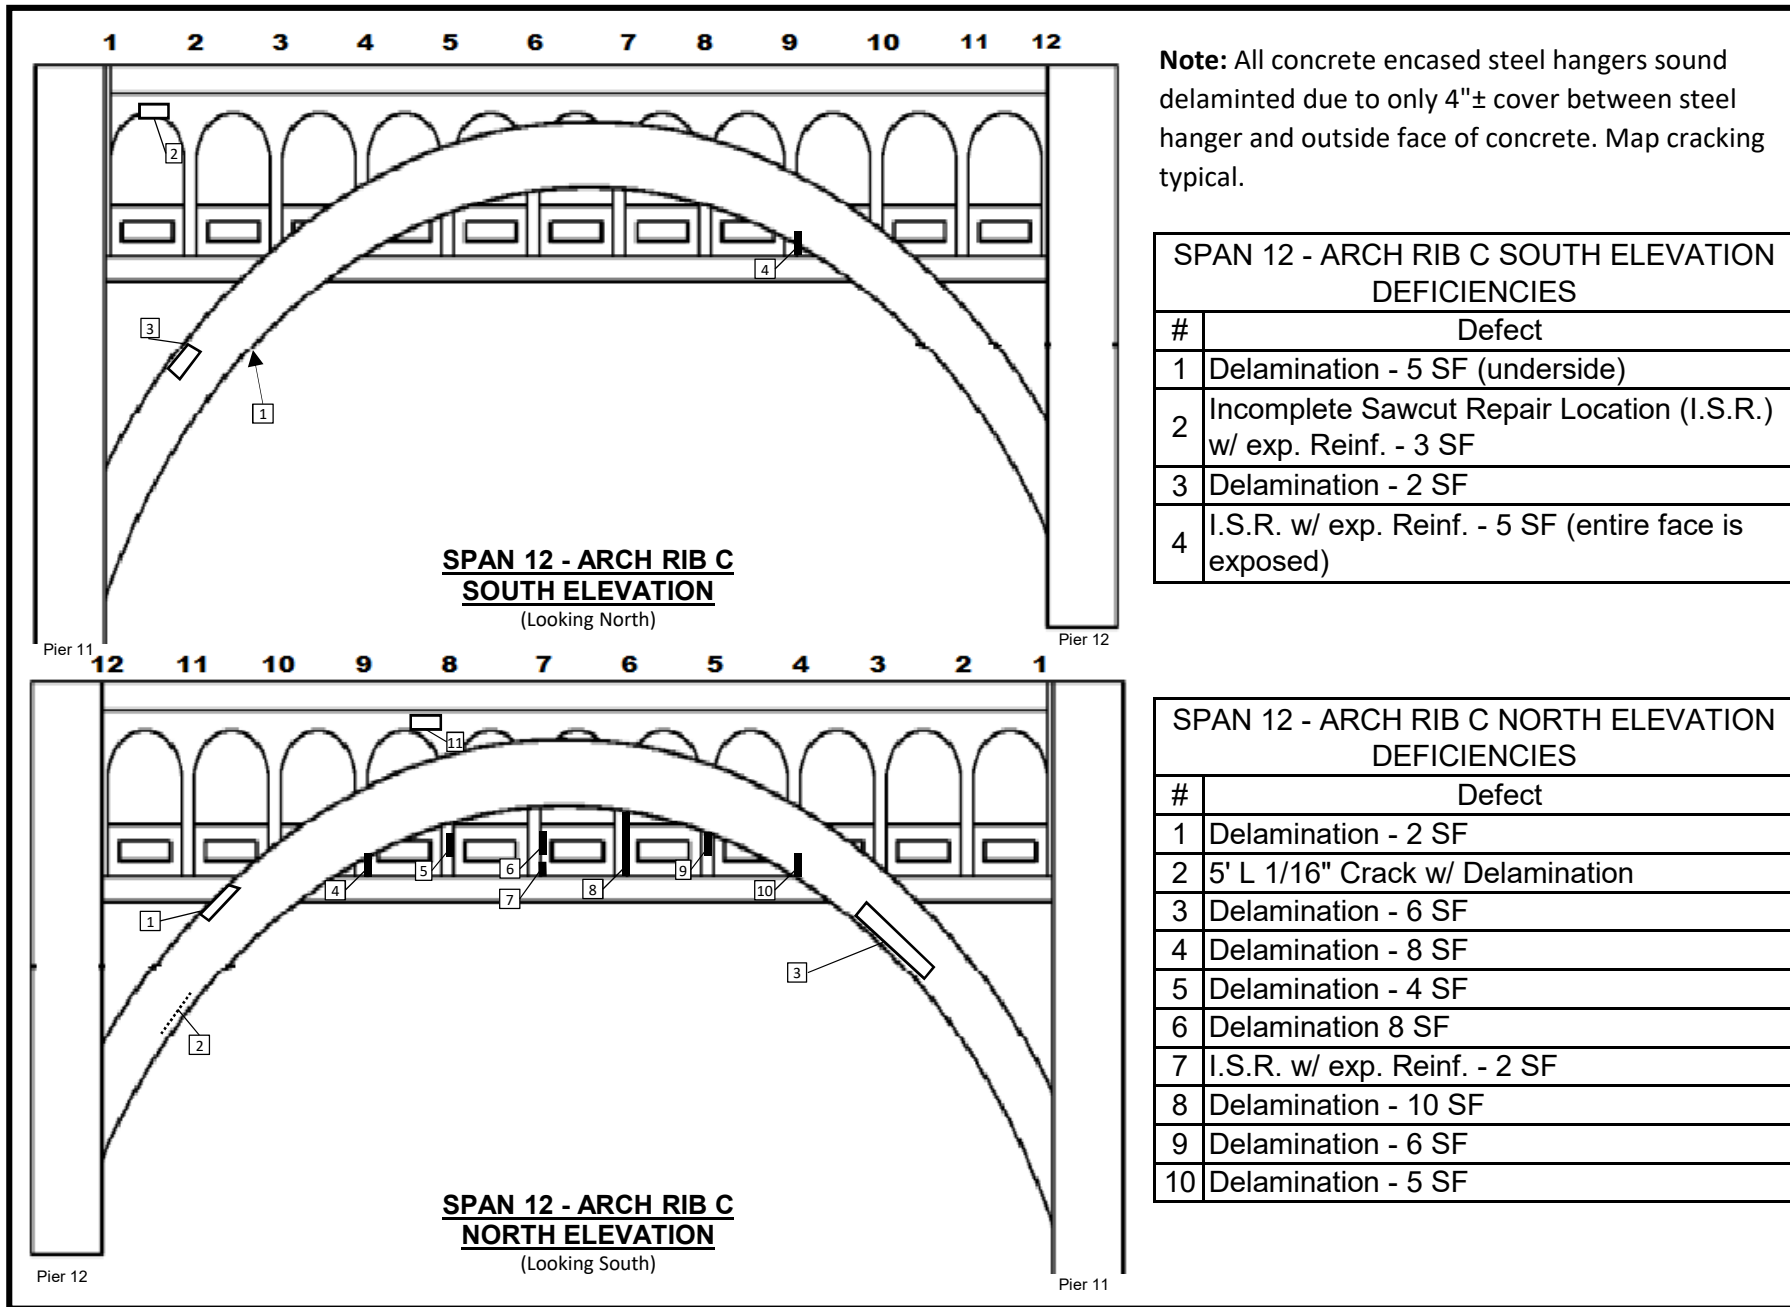
SPAN 12 - ARCH RIB B NORTH ELEVATION DEFICIENCIES	
#	Defect
1	Delamination - 1.5 SF
2	Delamination - 1 SF
3	Delamination - 1 SF
4	Delamination - 1 SF
5	Delamination - 9 SF
6	Delamination - 6 SF

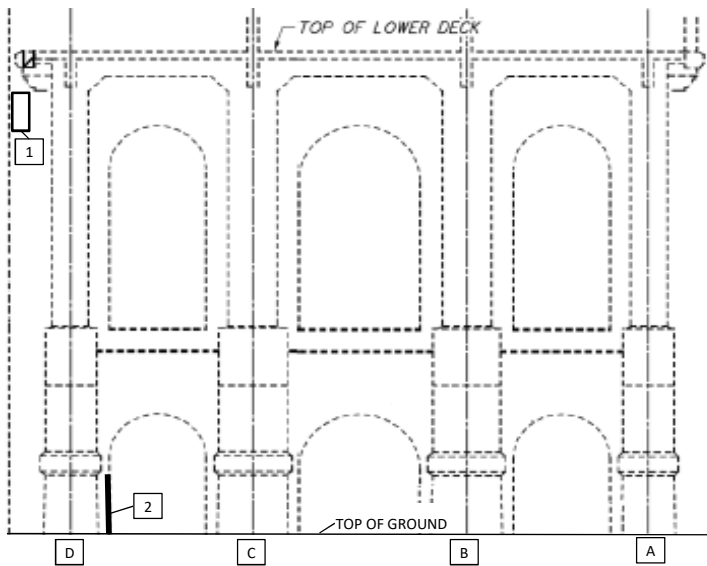
PIER 2 - EAST ELEVATION

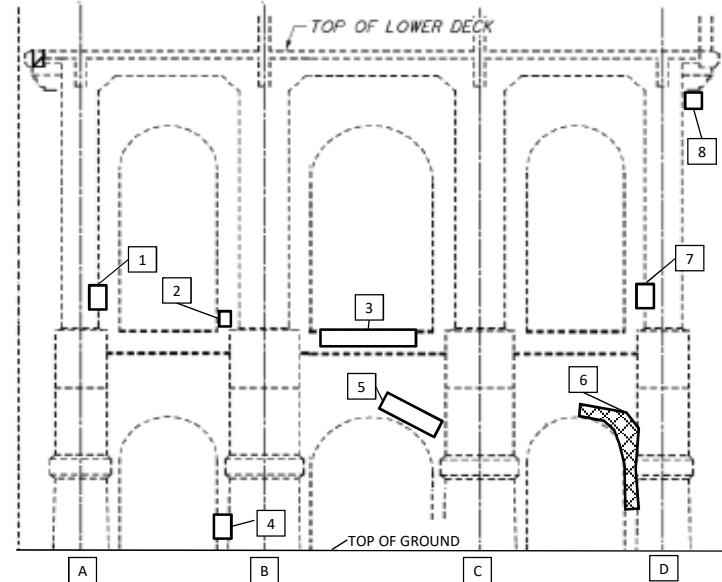
PIER 2 - WEST ELEVATION

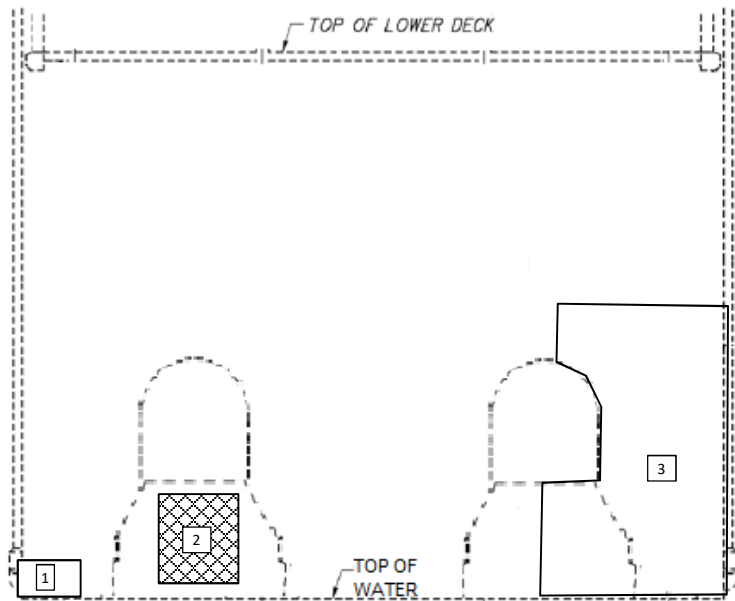
PIER 3 - EAST ELEVATION

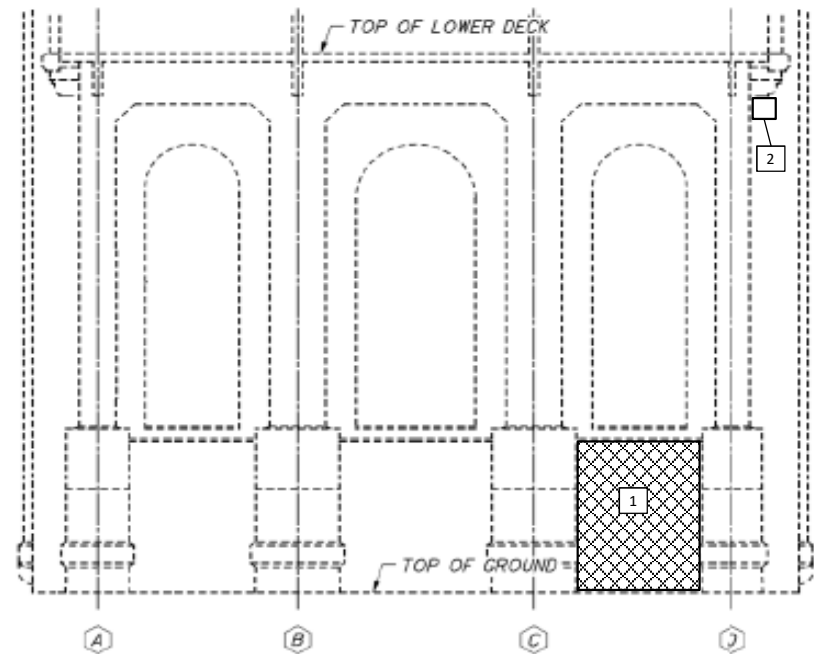
PIER 3 - WEST ELEVATION

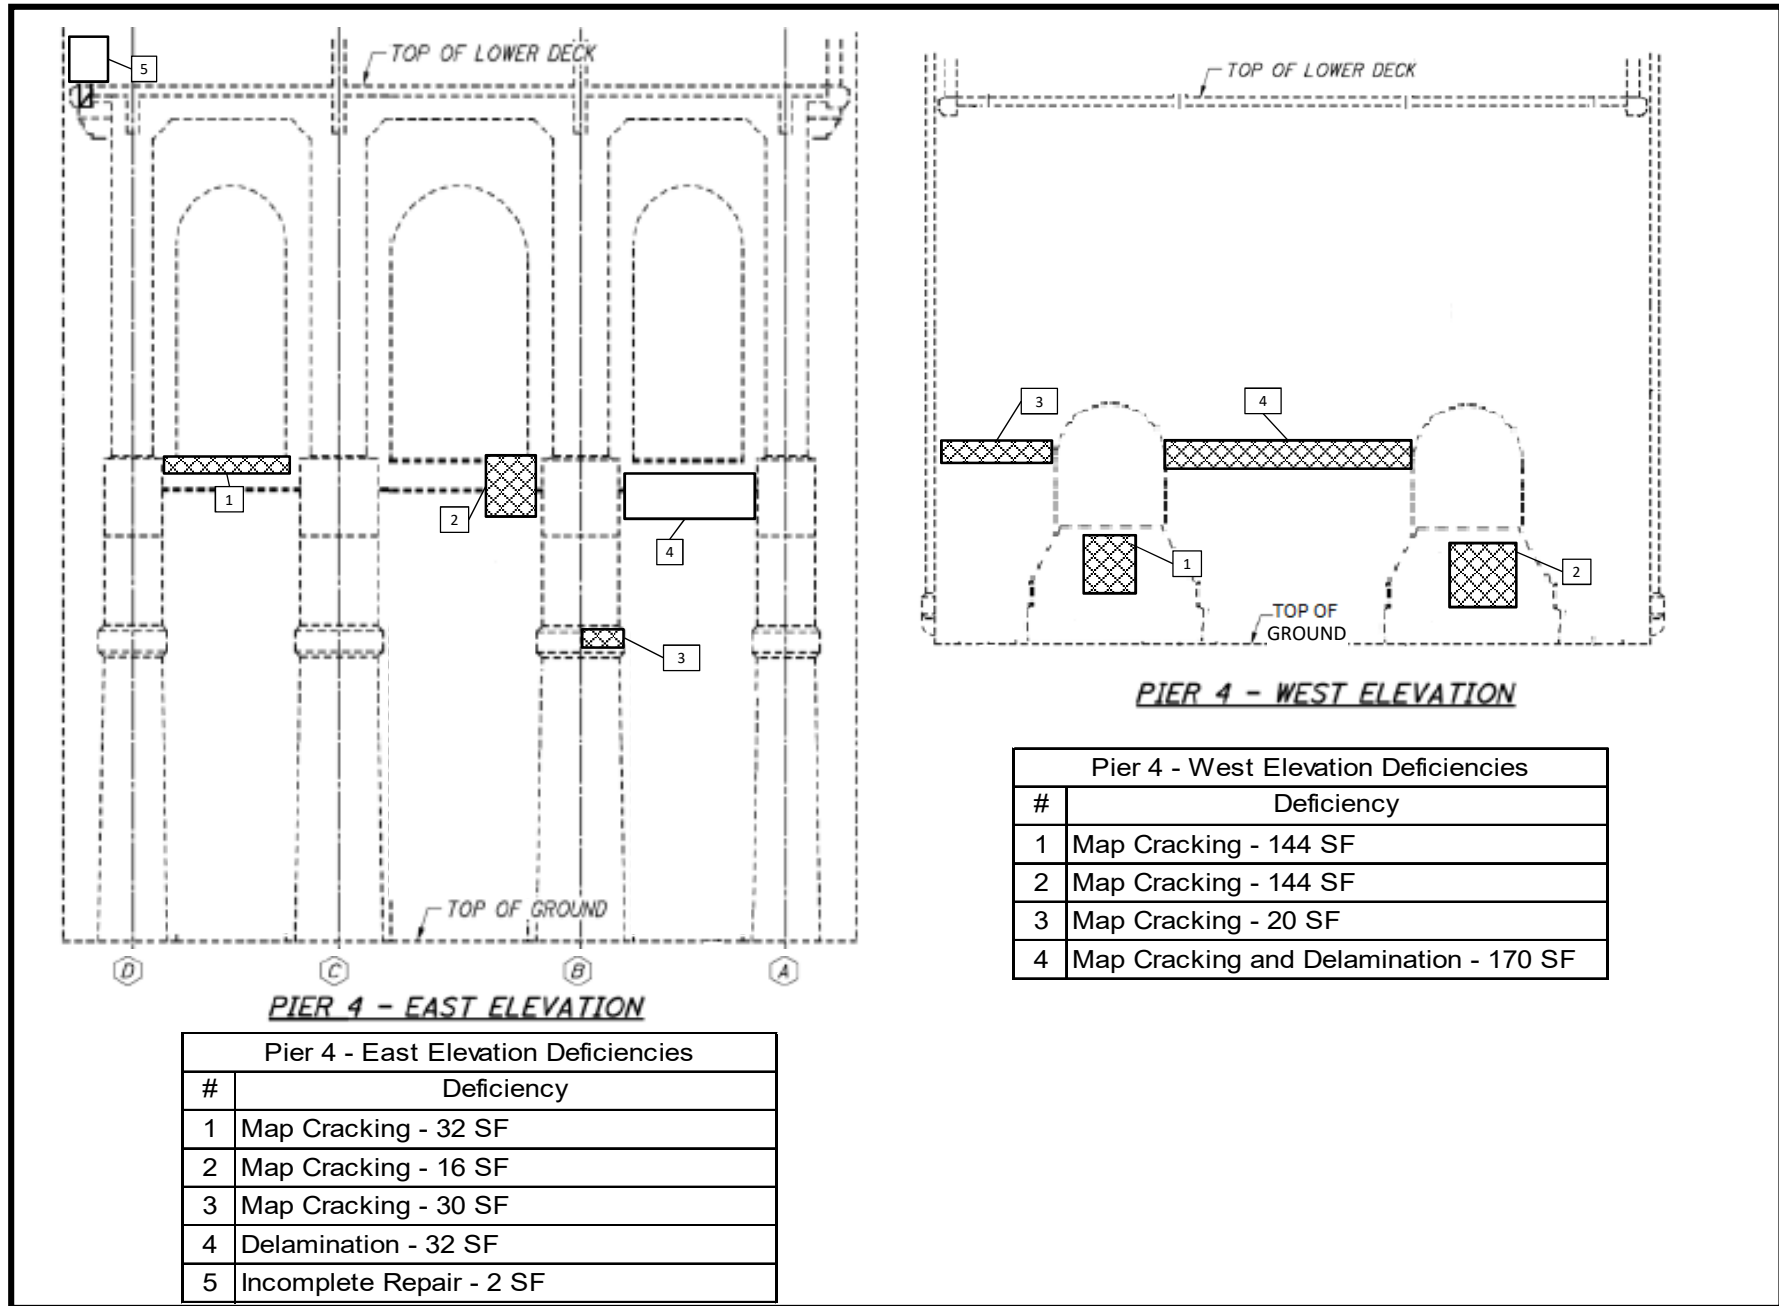
Pier 3 - West Elevation Deficiencies	
#	Deficiency
1	Map Cracking
2	Spall - 1 SF

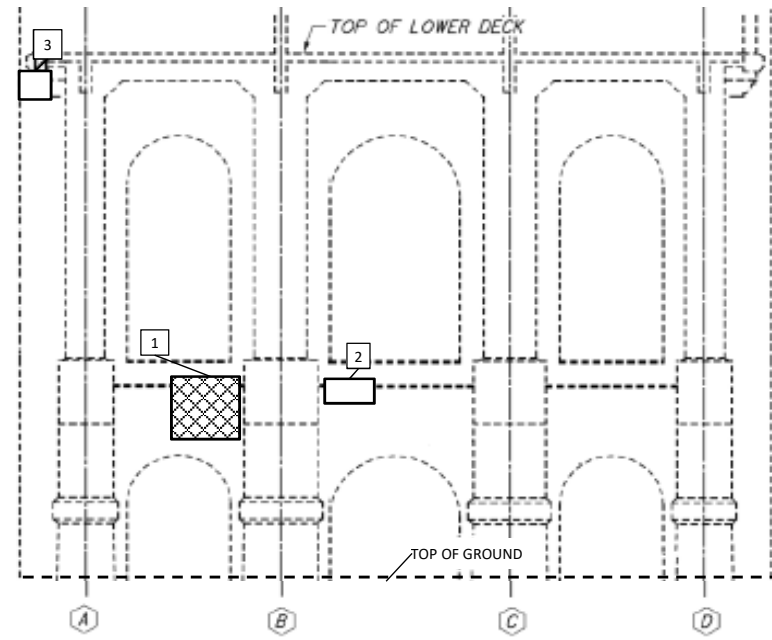
PIER 10 - EAST ELEVATION

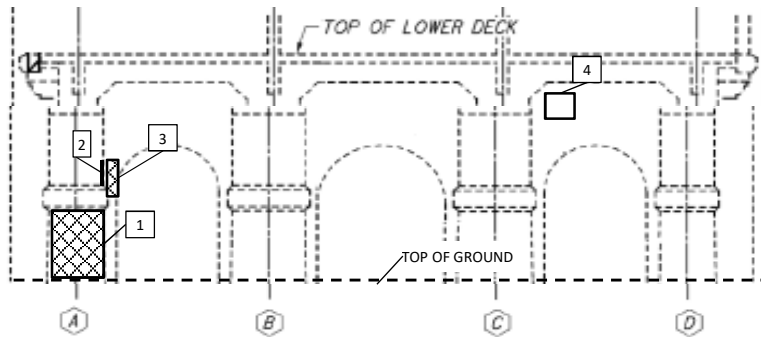
PIER 11 - WEST ELEVATION
