**OHIO DEPARTMENT OF TRANSPORTATION
2017 REHABILITATION FEASIBILITY STUDY
PID NO 99972**

**DETROIT-SUPERIOR BRIDGE OVER CUYAHOGA RIVER
BRIDGE NO. CUY-6-1456**

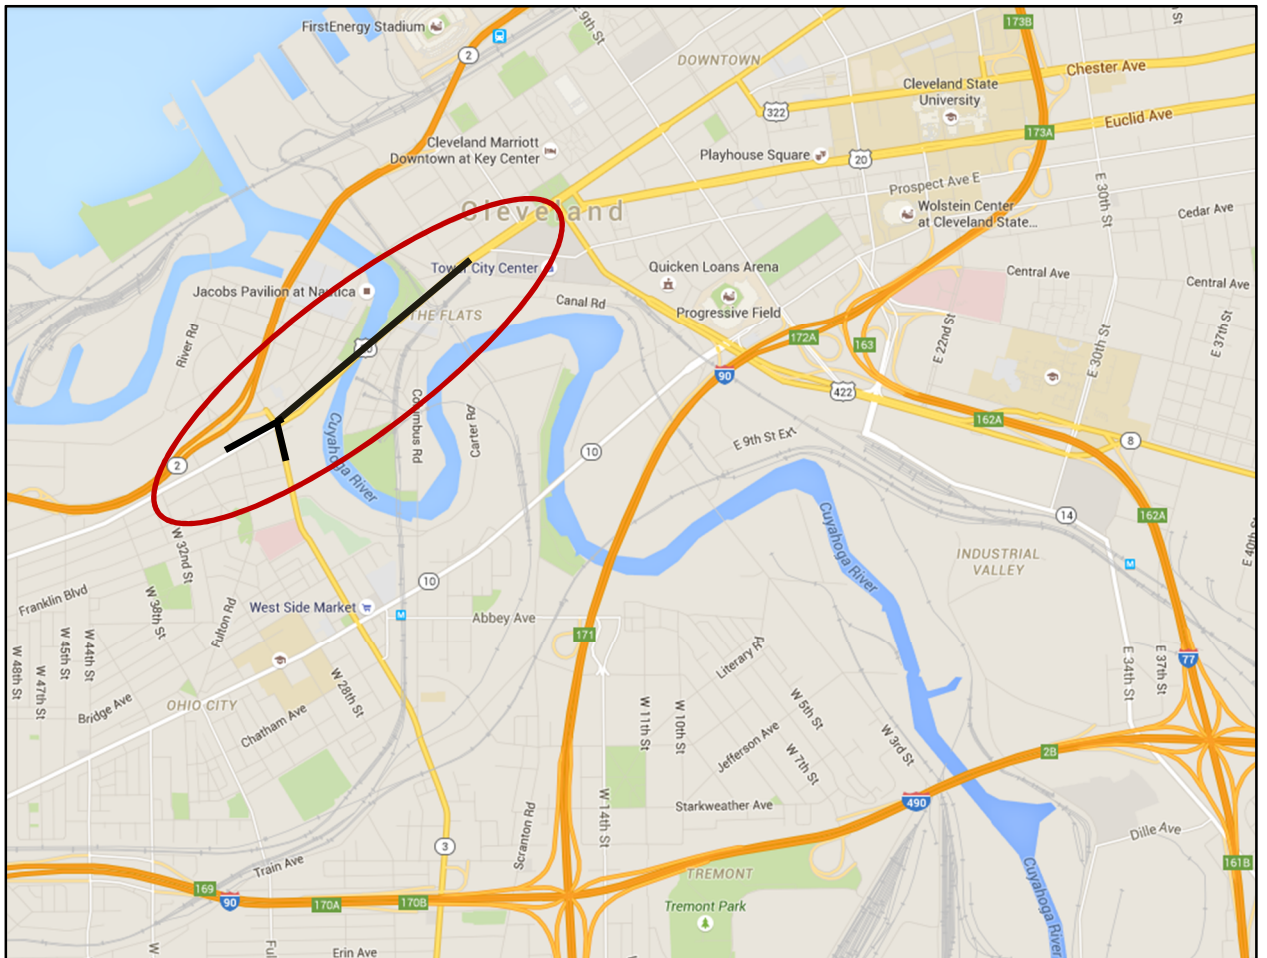
Figure 1 – Location of CUY-6-1456 (Circled).

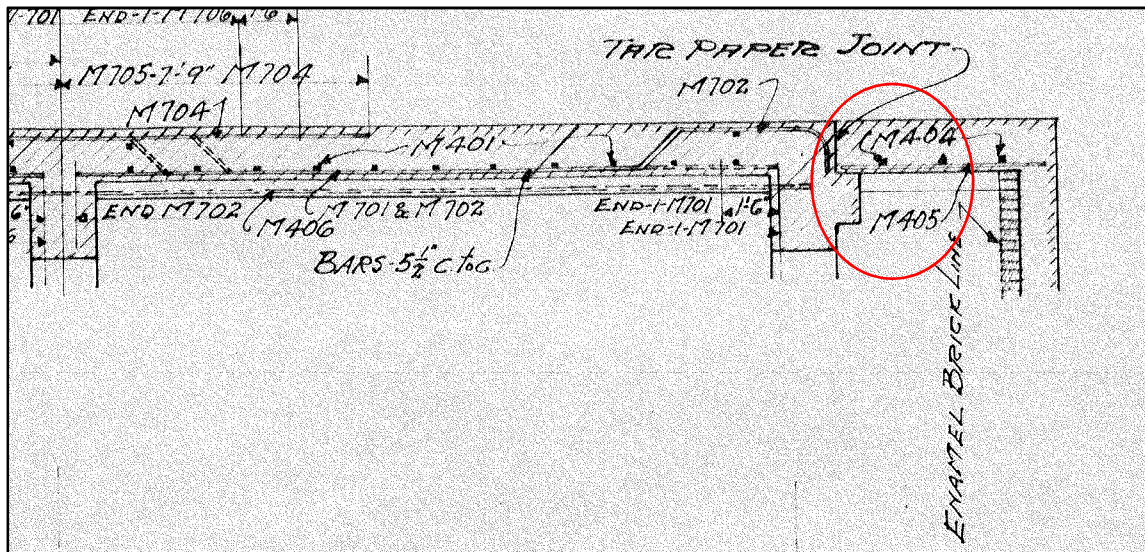
Figure 4 – Longitudinal Construction Joint (Circled, referenced as Tar Paper Joint), Above Line A North Face, Original Construction Drawing No. A2246.

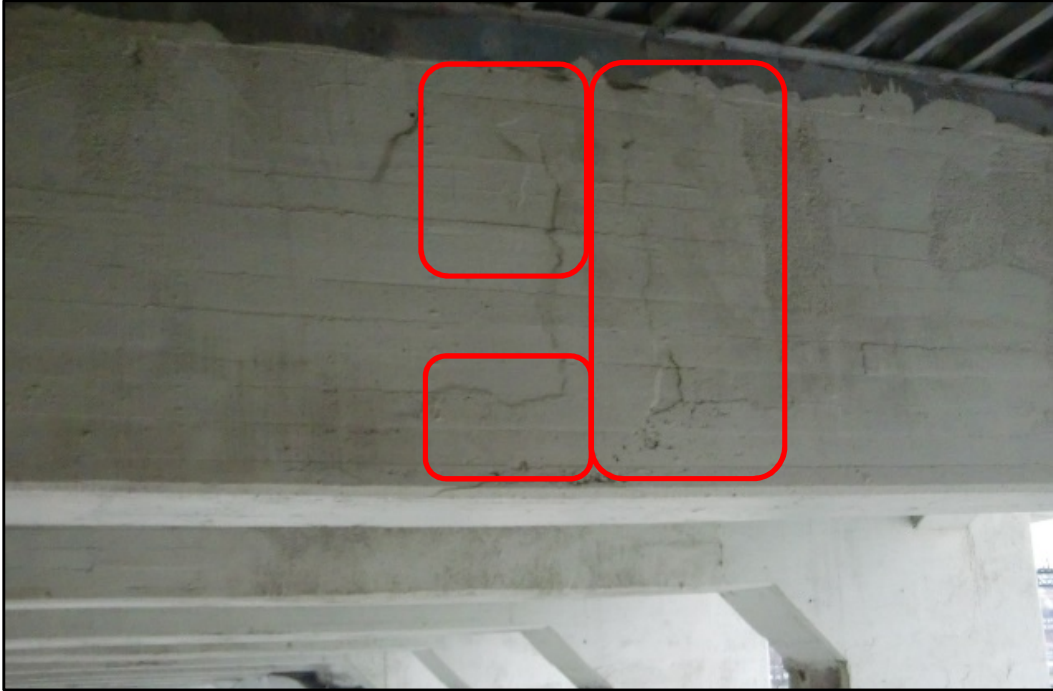
Photo 3 – Newly Developing Lower Deck Floor Beam Delaminations (Circled), South Bay, Span 8.

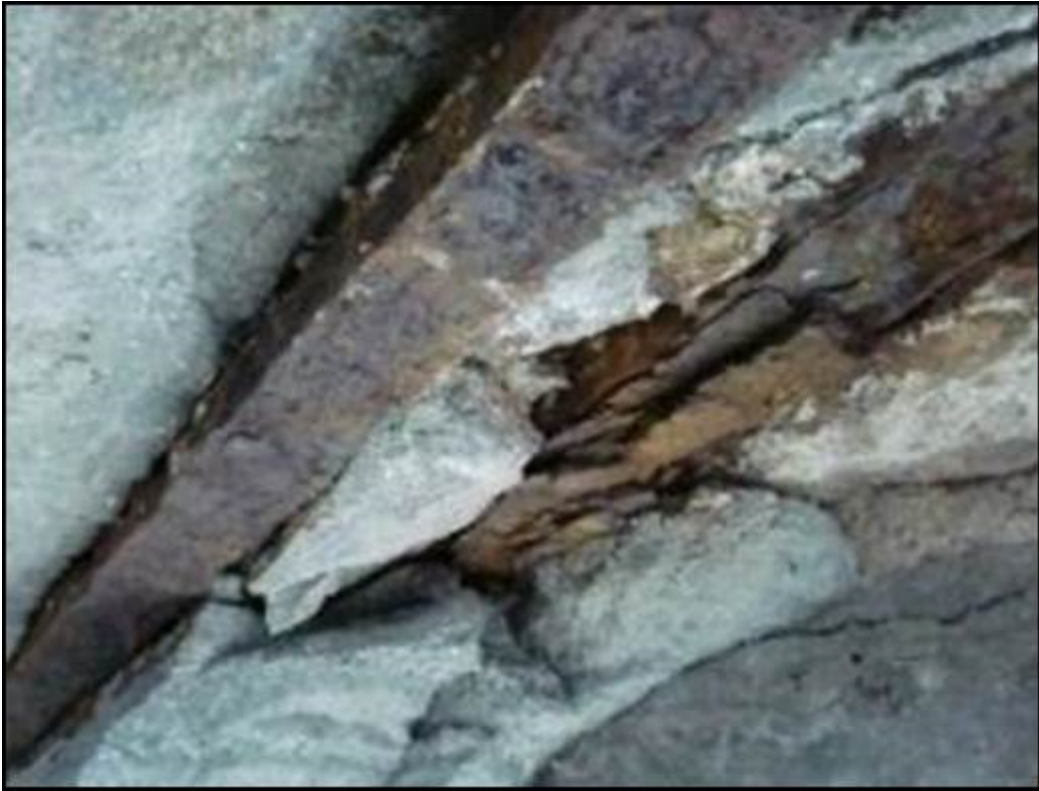
Photo 4 – Reinforcing Steel with Active Corrosion, Lower Deck Floorbeam 14, South Bay, Span 6.

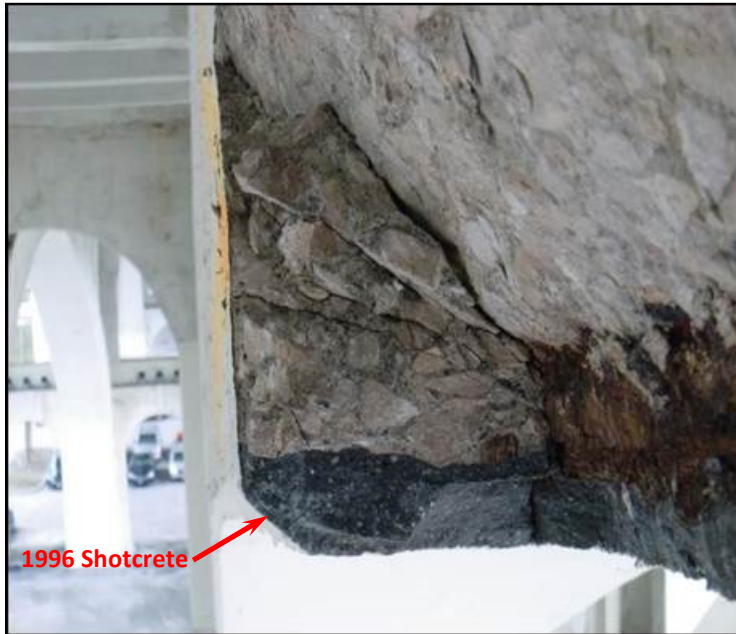
Photo 5 – Spalled Original Concrete & Secure 1996 Shotcrete Patch, Span 7 South Interior Arch Rib.

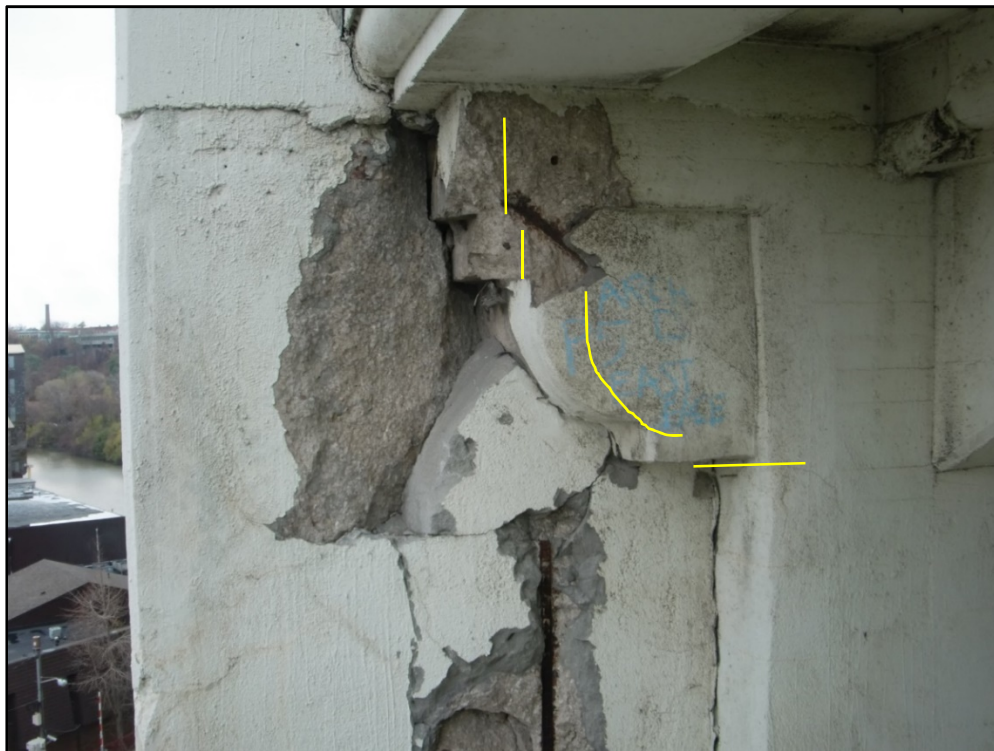
Photo 6 – Spalled & Loose Concrete Due to Ineffective Bond Breaker (Location denoted in yellow), Pier 5 Lower Deck Pier Shaft & South Lower Deck Corbel 1, Span 6.

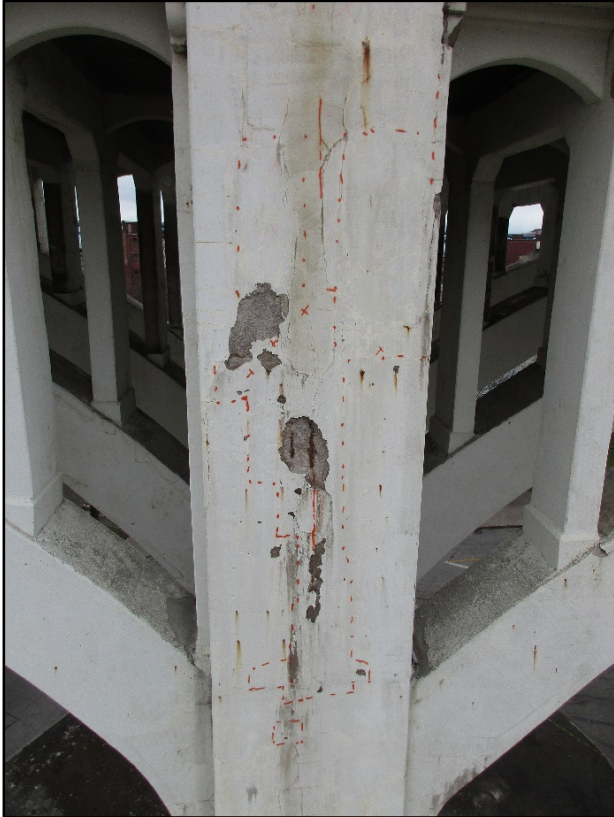
Photo 7 – Deep Concrete Deterioration, Pier 6 South Lower Deck Pier Shaft.

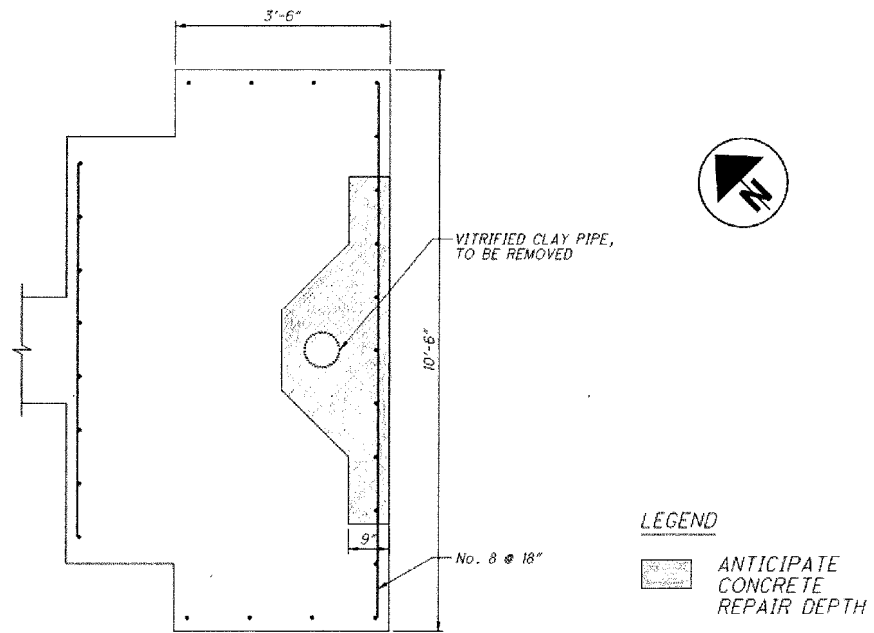
Figure 5 – Estimated Deterioration Depth, Pier 6 South Lower Deck Pier Shaft.

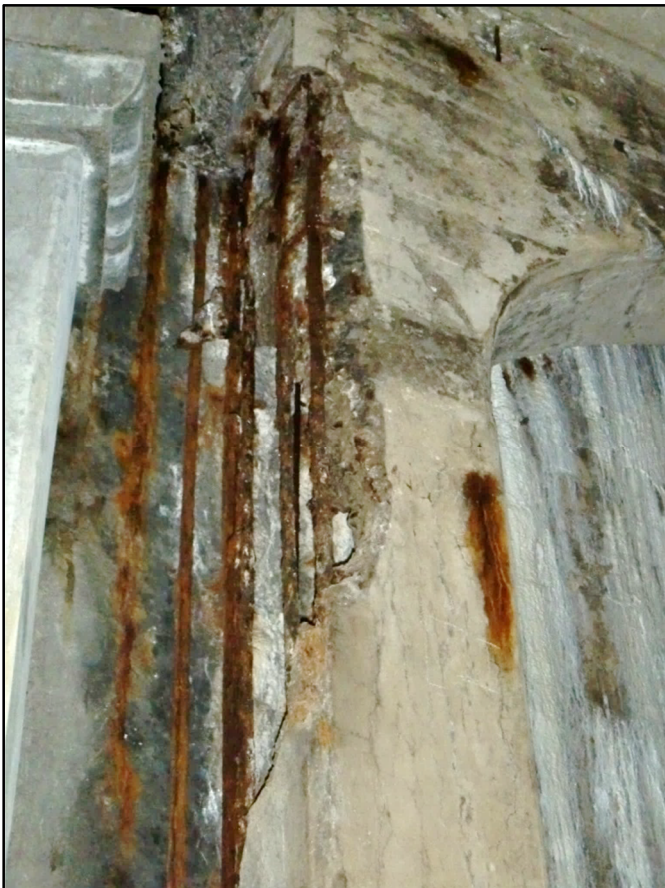
Photo 8 – 60% Section Loss, Column M22, East Station.

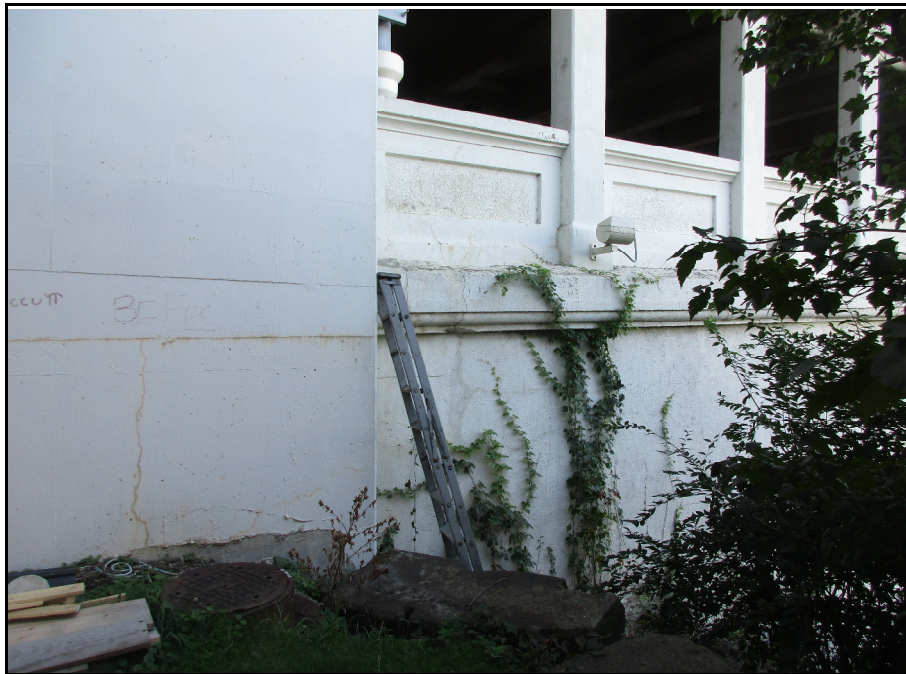
Photo 9 – Ladder Used by Vandals to Access Lower Deck, Span 13 at East Abutment.

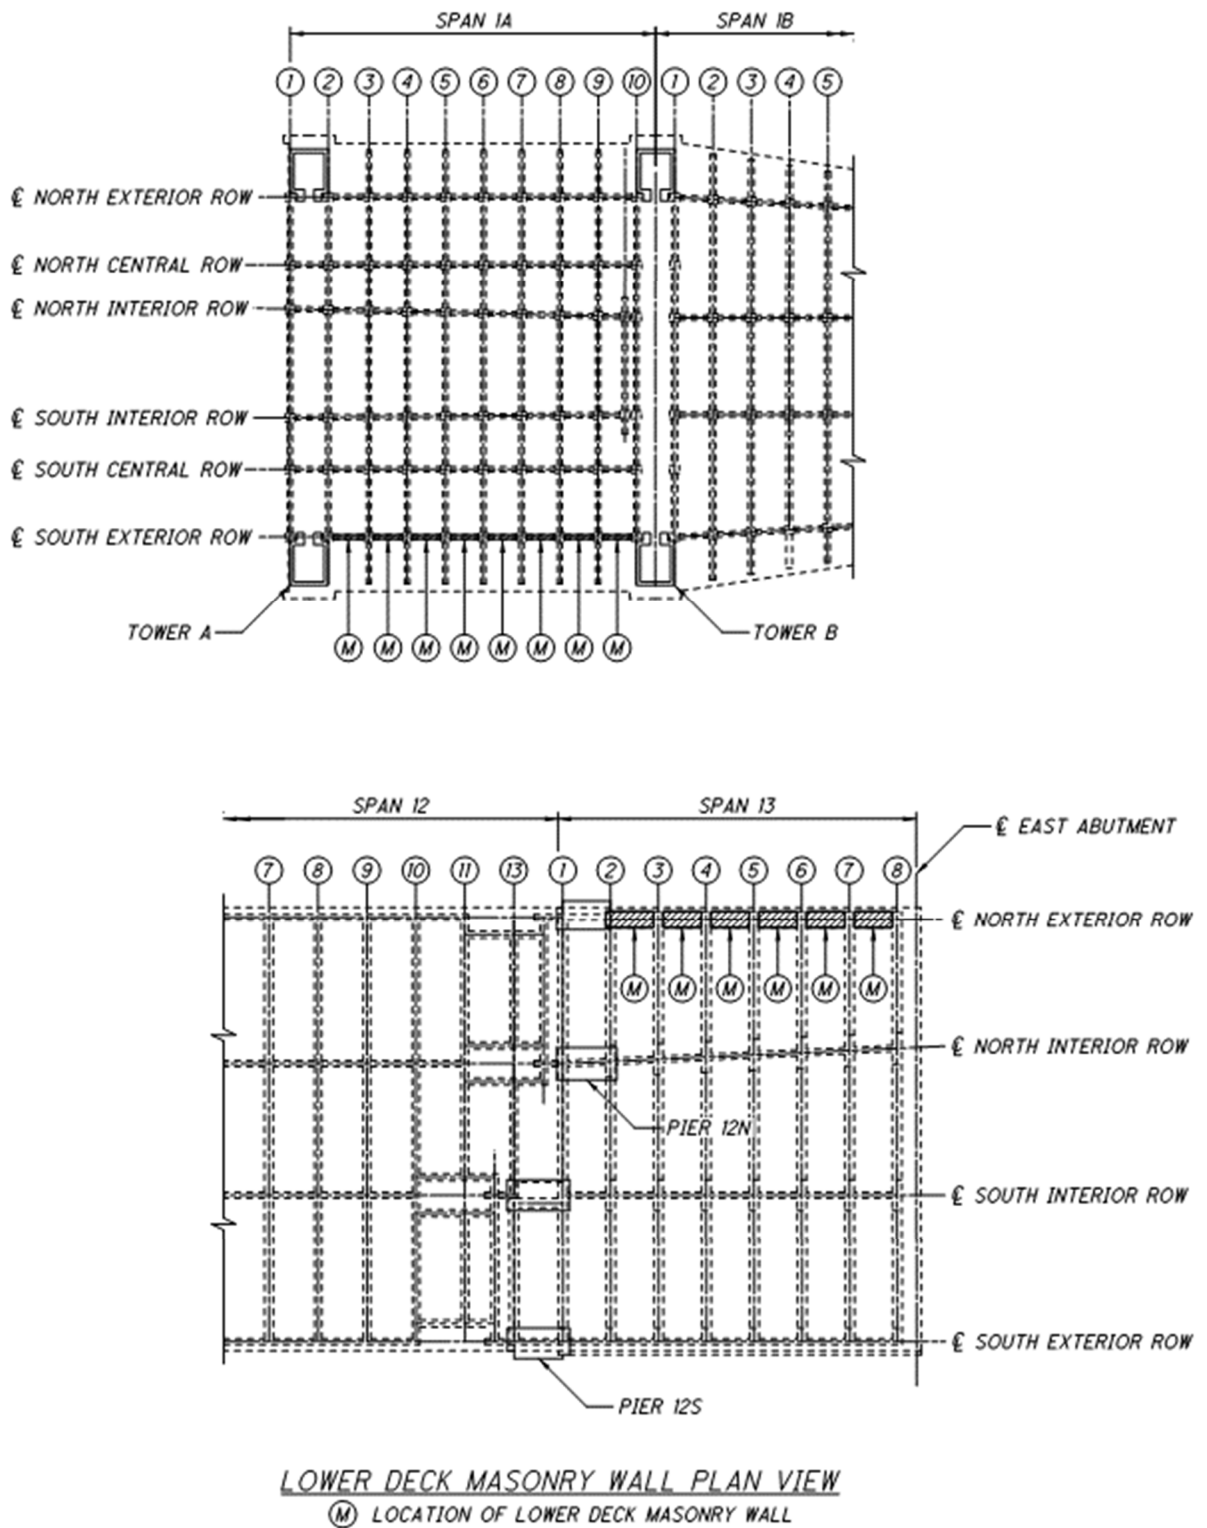
Figure 6 – Recommended Location of Security Wall.

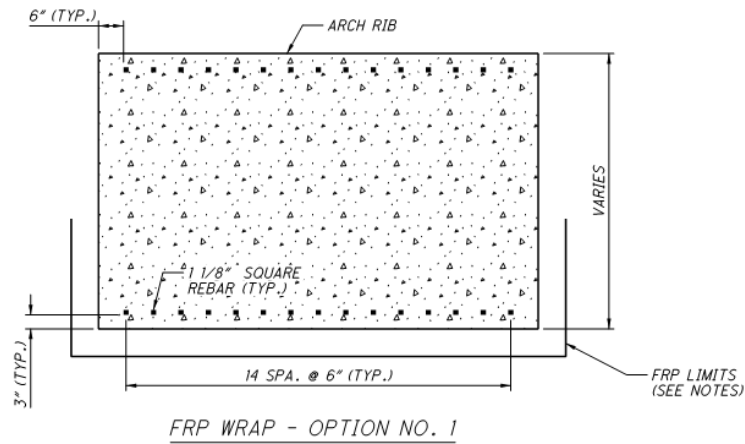
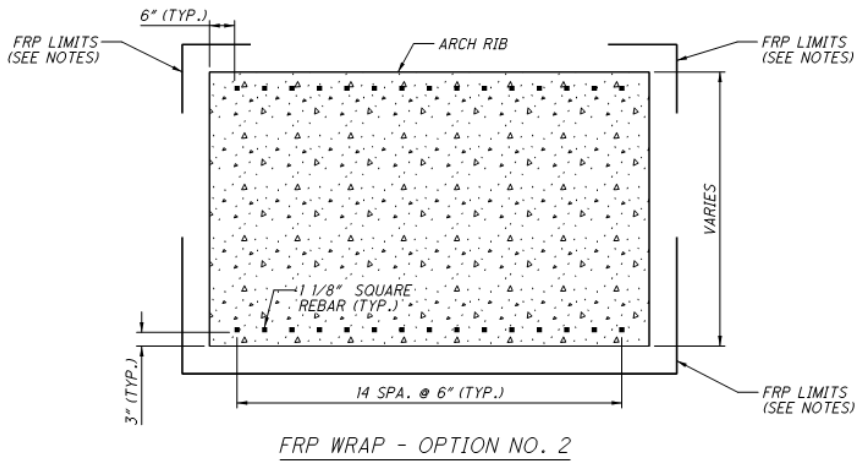
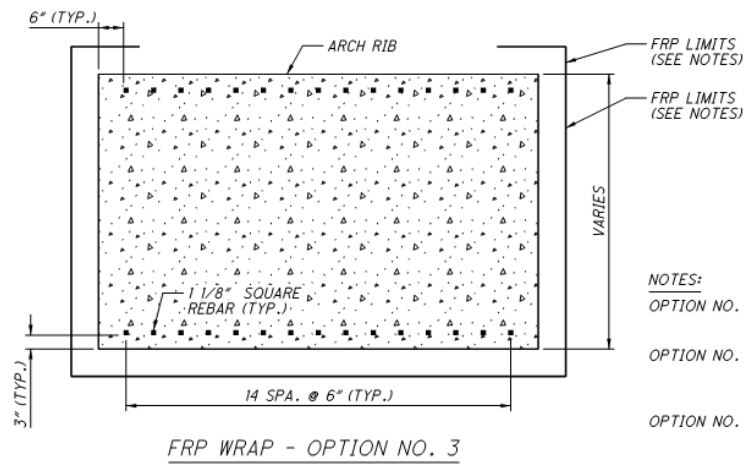
- NOTES:**
- OPTION NO. 1 - FRP Wrap INCLUDES FULL UNDERSIDE AND 2'-6" OF SIDES.
 - OPTION NO. 2 - FRP Wrap INCLUDES FULL UNDERSIDE AND 2'-6" OF SIDES AND 1'-6" OF TOP CORNERS.
 - OPTION NO. 3 - FRP Wrap INCLUDES FULL UNDERSIDE AND SIDES AND 1'-6" OF TOP CORNERS.

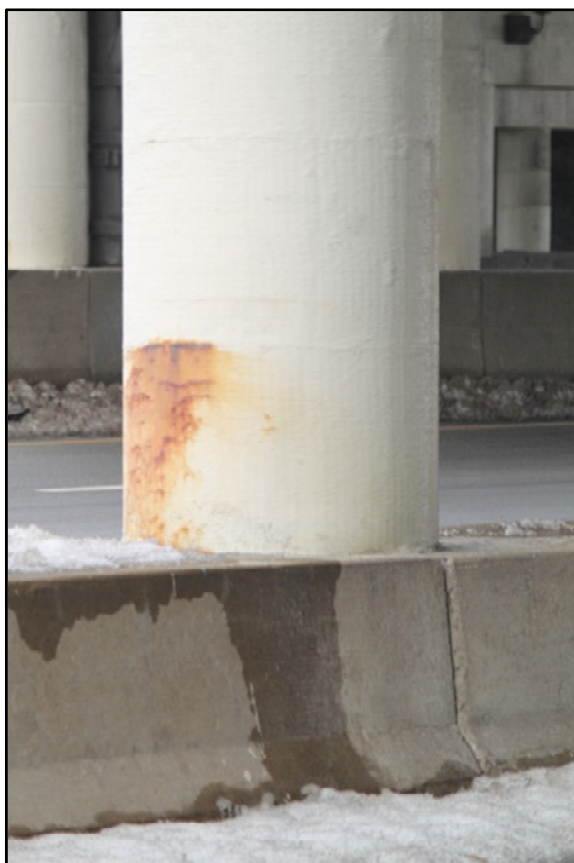
Photo 10 – Active Concrete Corrosion Beneath FRP Wrap, Pier 1, CUY-71-1679 (Fulton Road over I-71).

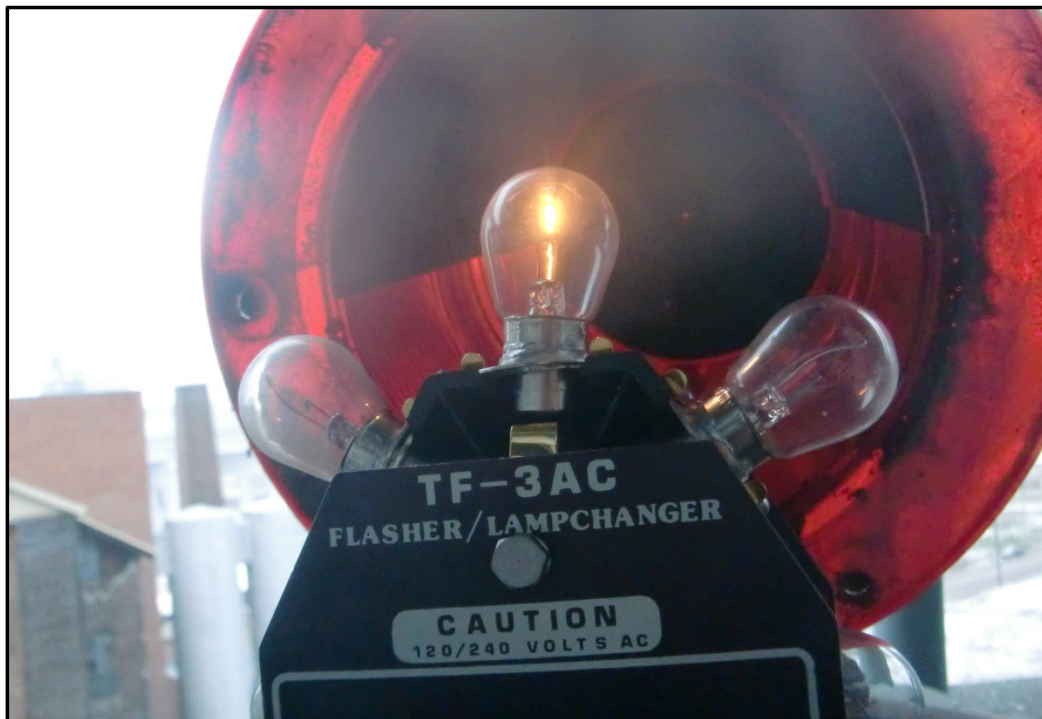
Photo 11 - Power Verification of Navigation Light (West Edge of Channel, South Face shown).

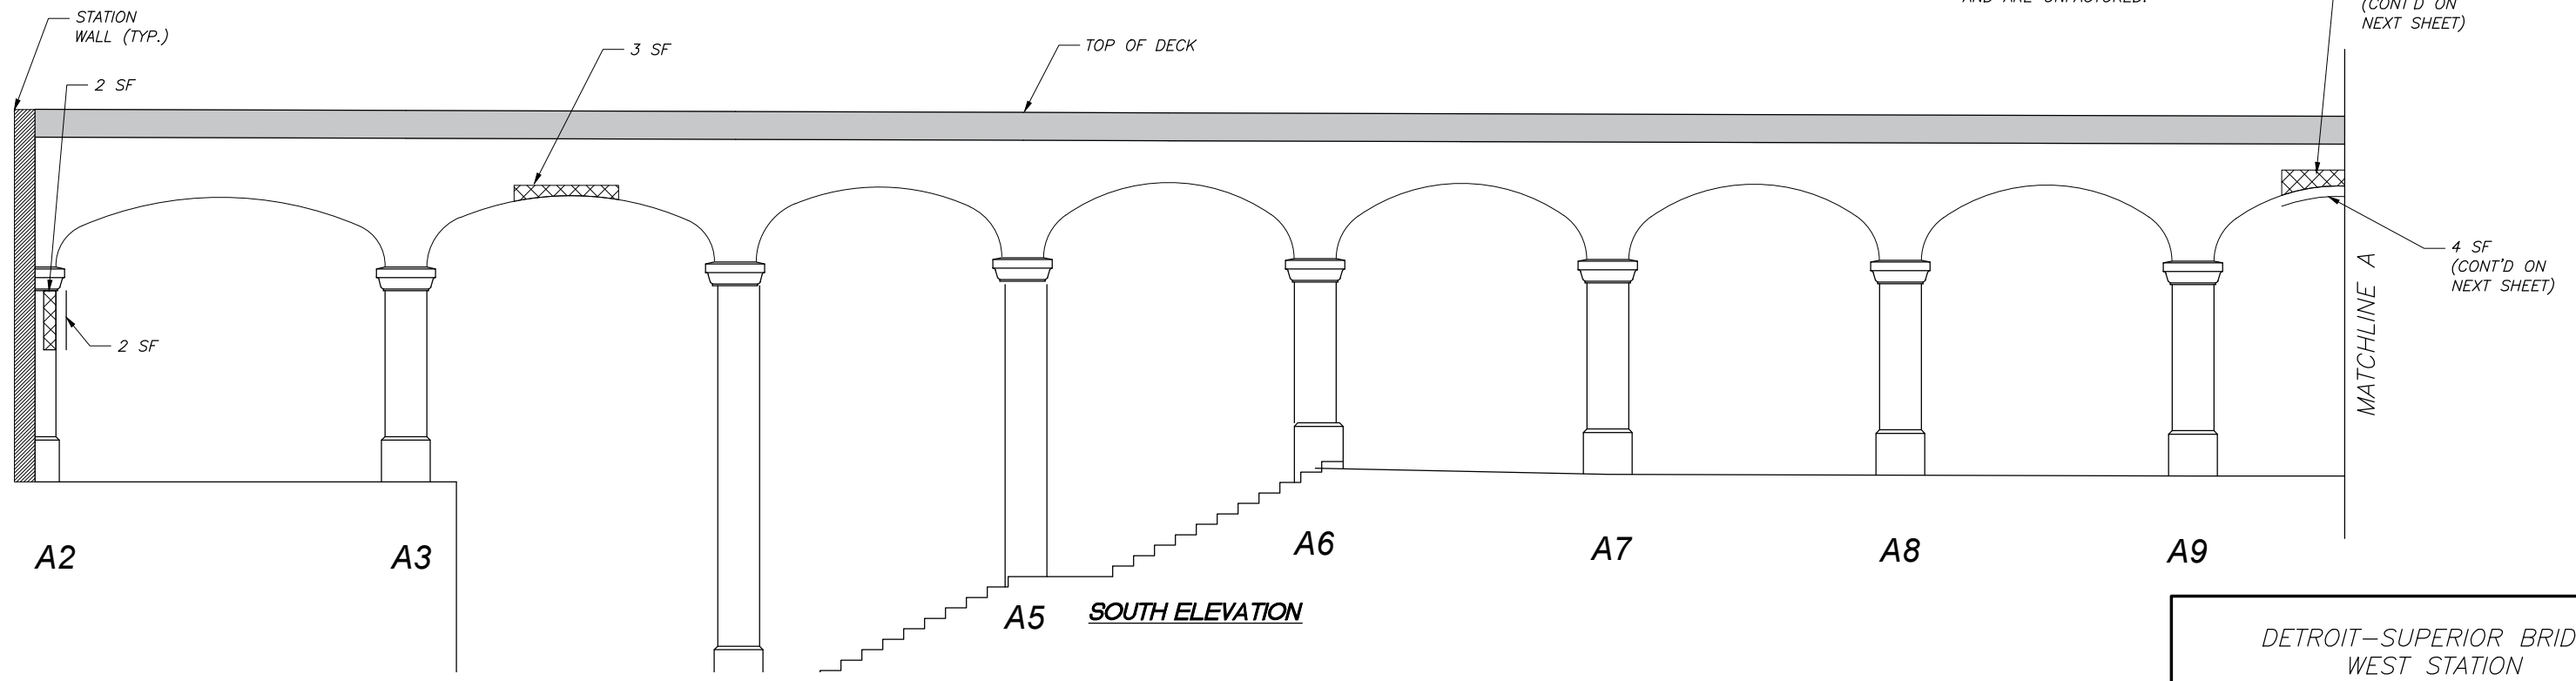
NOTE: ALL DETERIORATION QUANTITIES ARE FROM FIELD MEASUREMENTS AND ARE UNFACTORED.

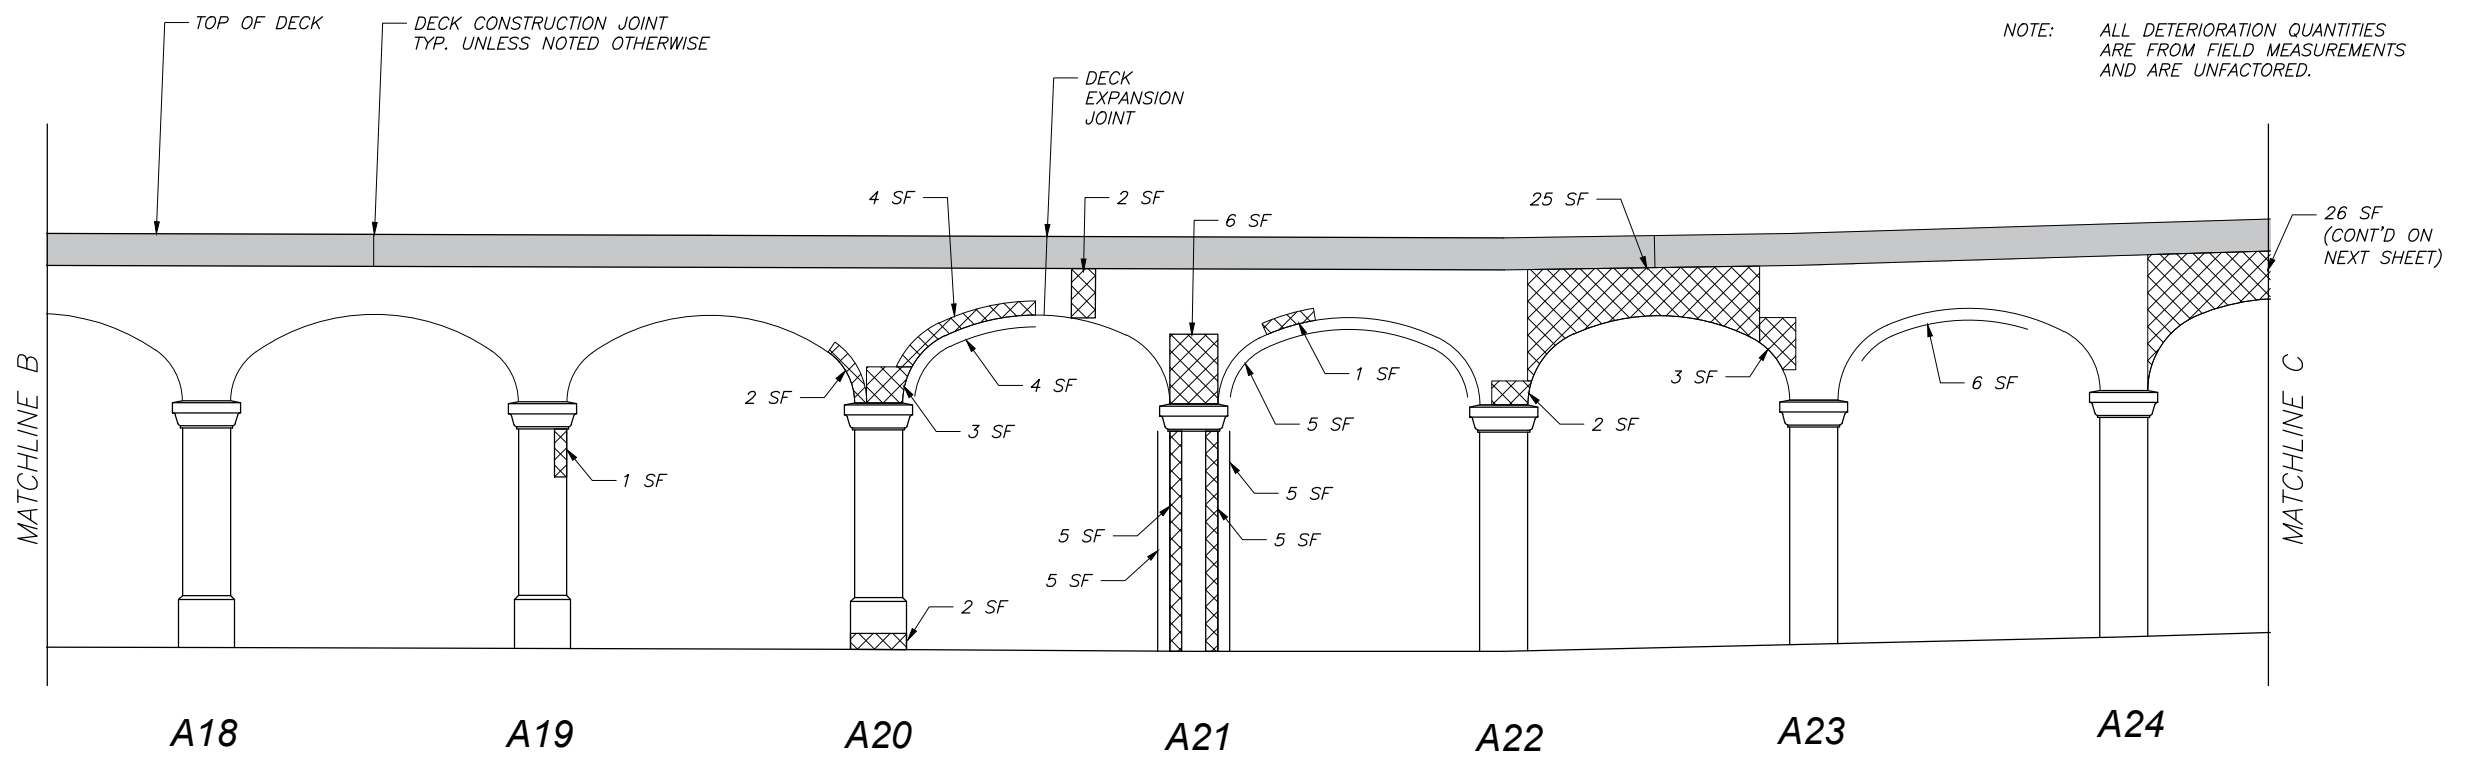
NOTE: ALL DETERIORATION QUANTITIES ARE FROM FIELD MEASUREMENTS AND ARE UNFACTORED.

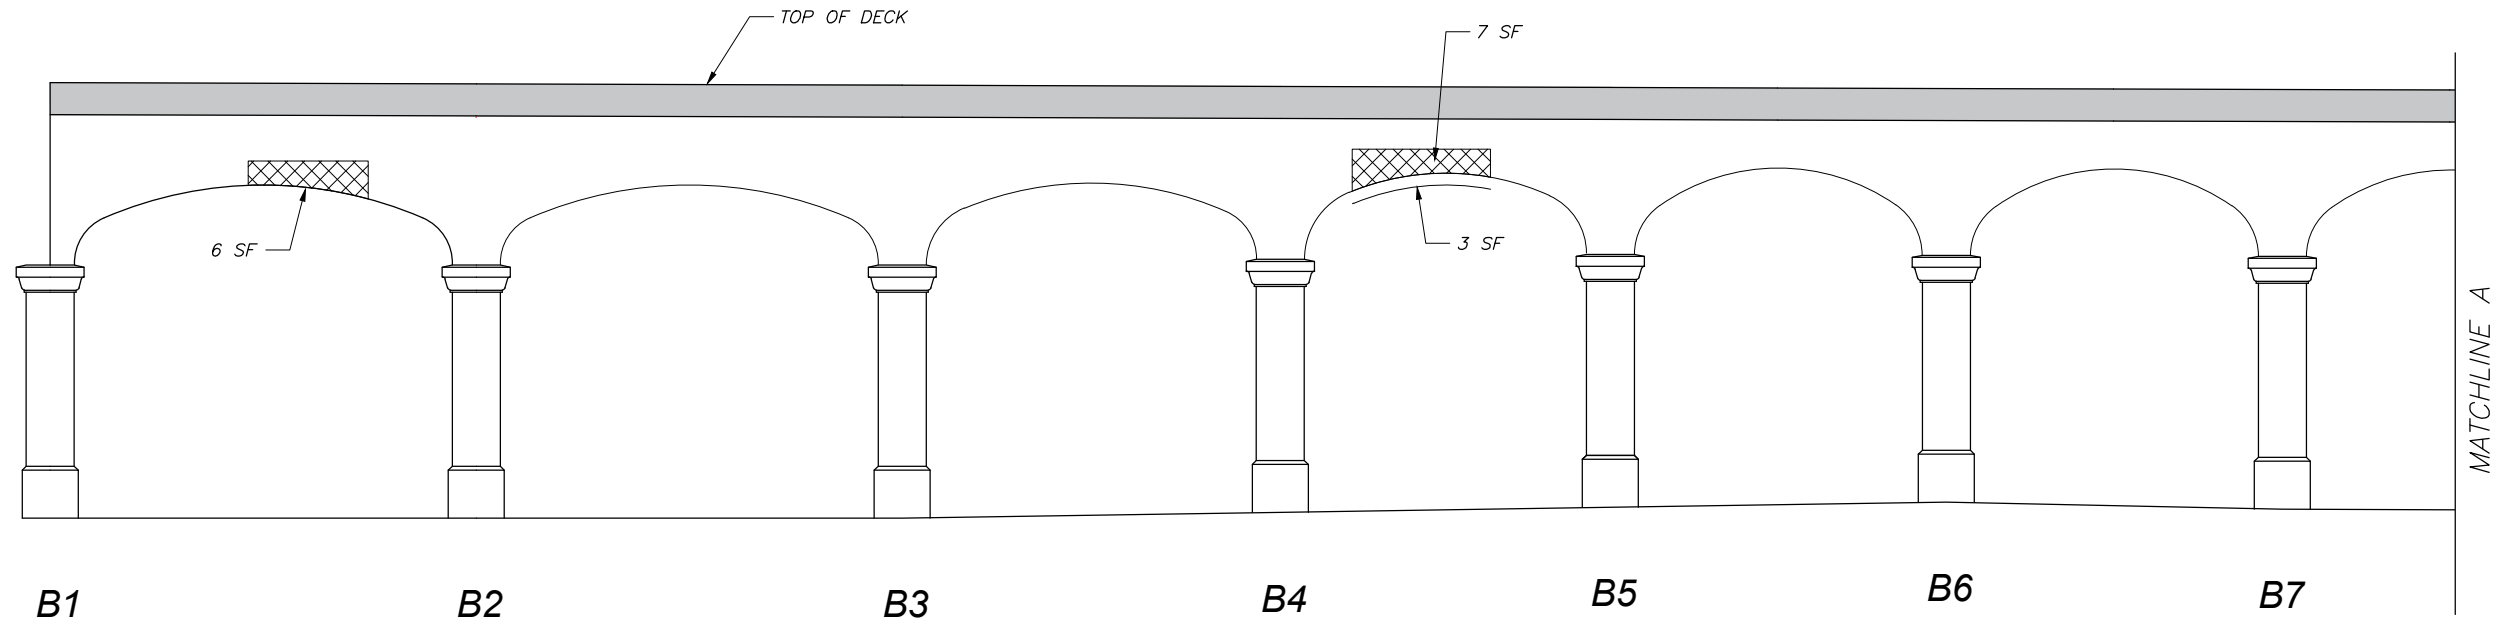
B1 B2 B3 B4 B5 B6 B7

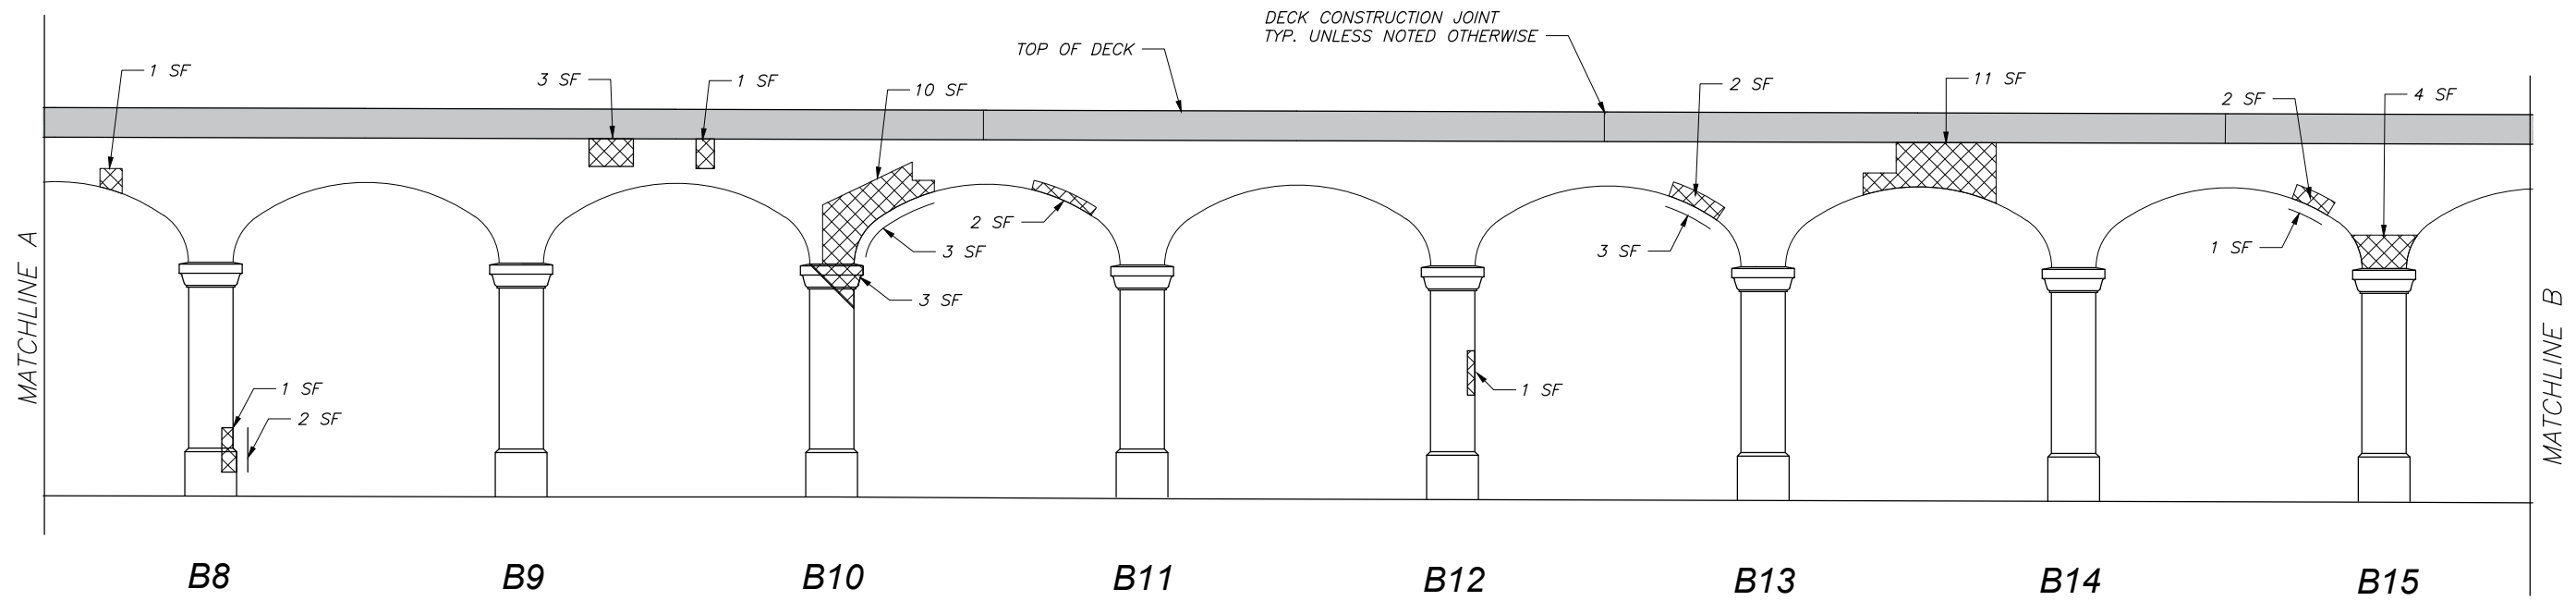
NOTE: ALL DETERIORATION QUANTITIES ARE FROM FIELD MEASUREMENTS AND ARE UNFACTORED.

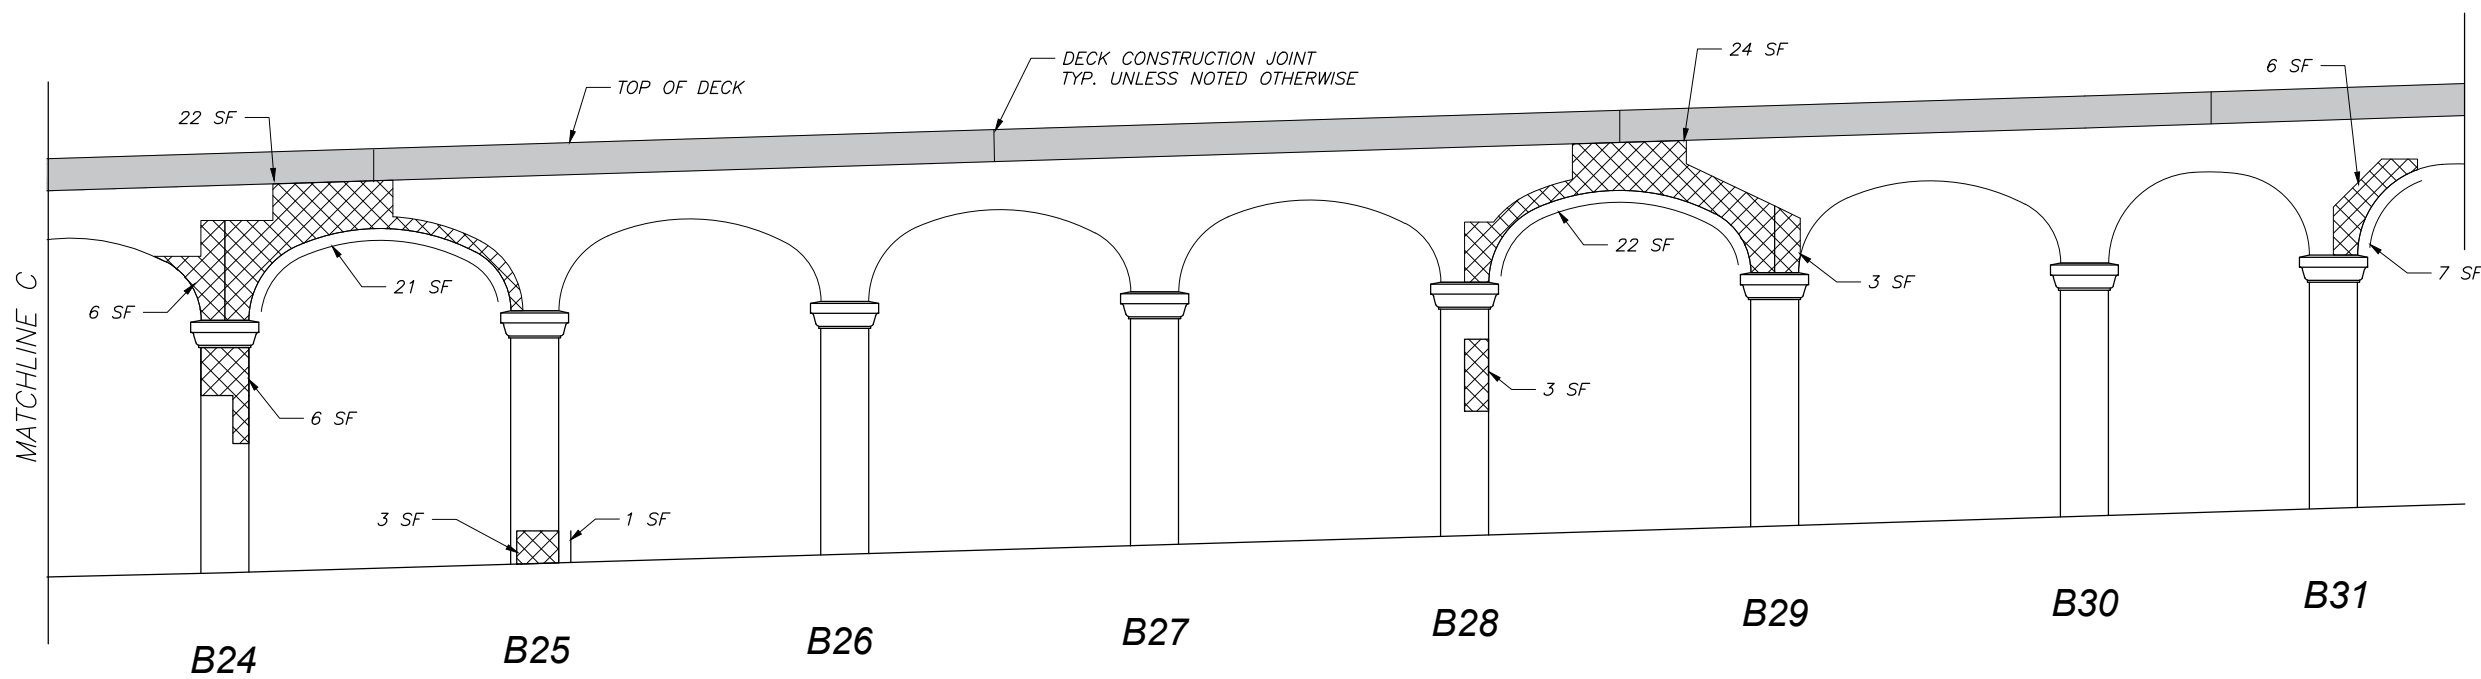
NOTE: ALL DETERIORATION QUANTITIES ARE FROM FIELD MEASUREMENTS AND ARE UNFACTORED.

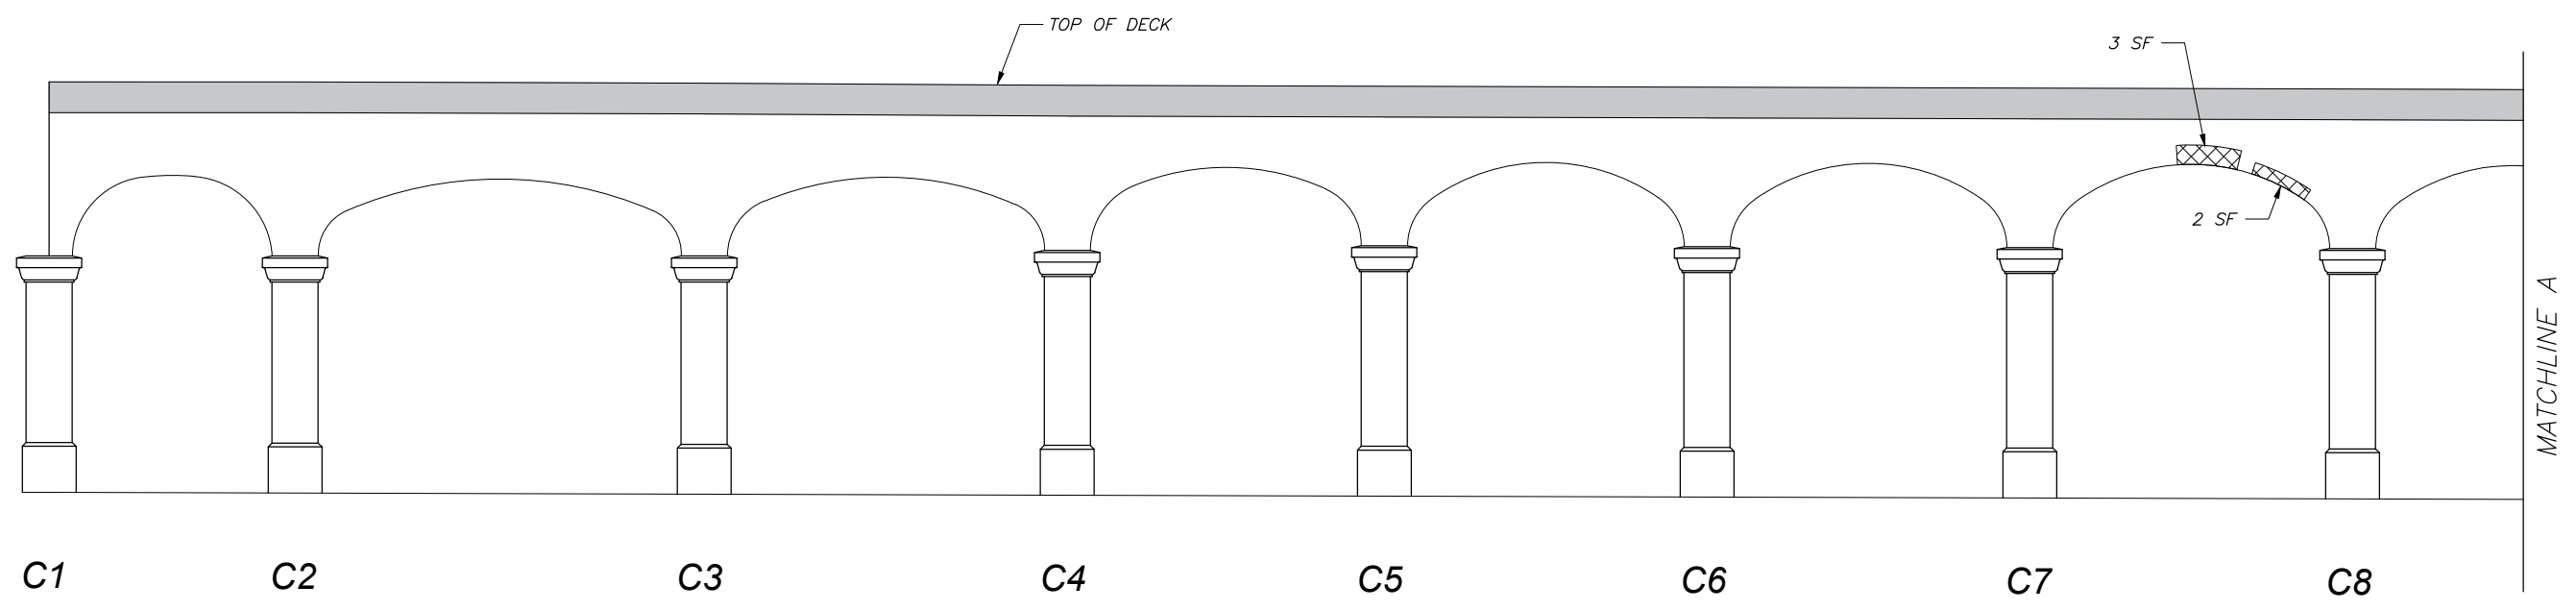
C1 C2 C3 C4 C5 C6 C7 C8

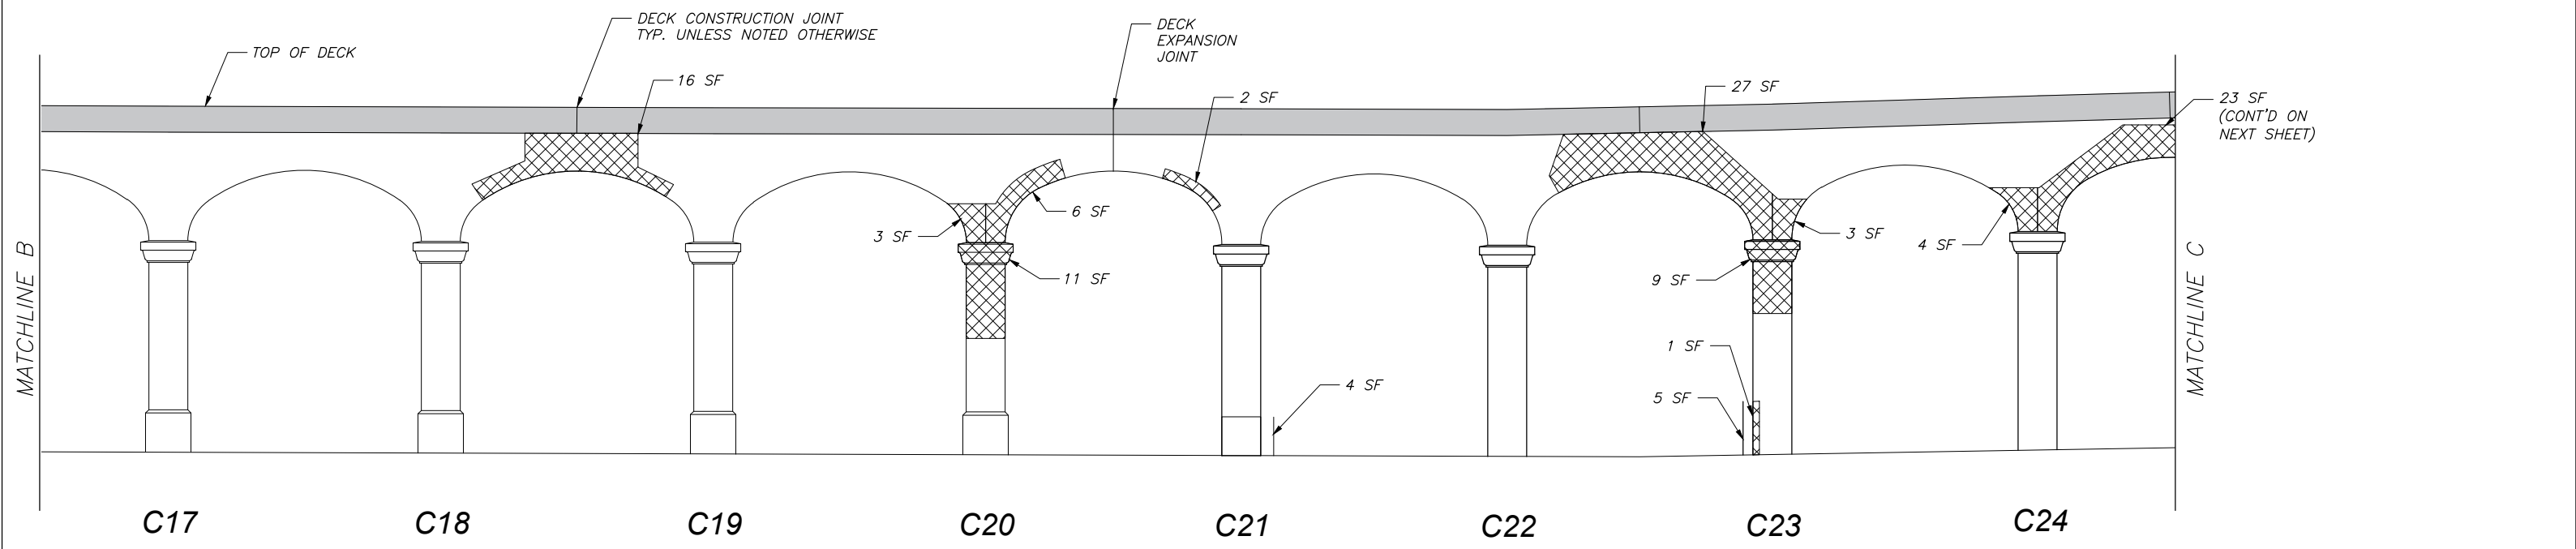
NOTE: ALL DETERIORATION QUANTITIES ARE FROM FIELD MEASUREMENTS AND ARE UNFACTORED.
