**OHIO DEPARTMENT OF TRANSPORTATION
2017 REHABILITATION FEASIBILITY STUDY
PID NO 99972**

**DETROIT-SUPERIOR BRIDGE OVER CUYAHOGA RIVER
BRIDGE NO. CUY-6-1456**

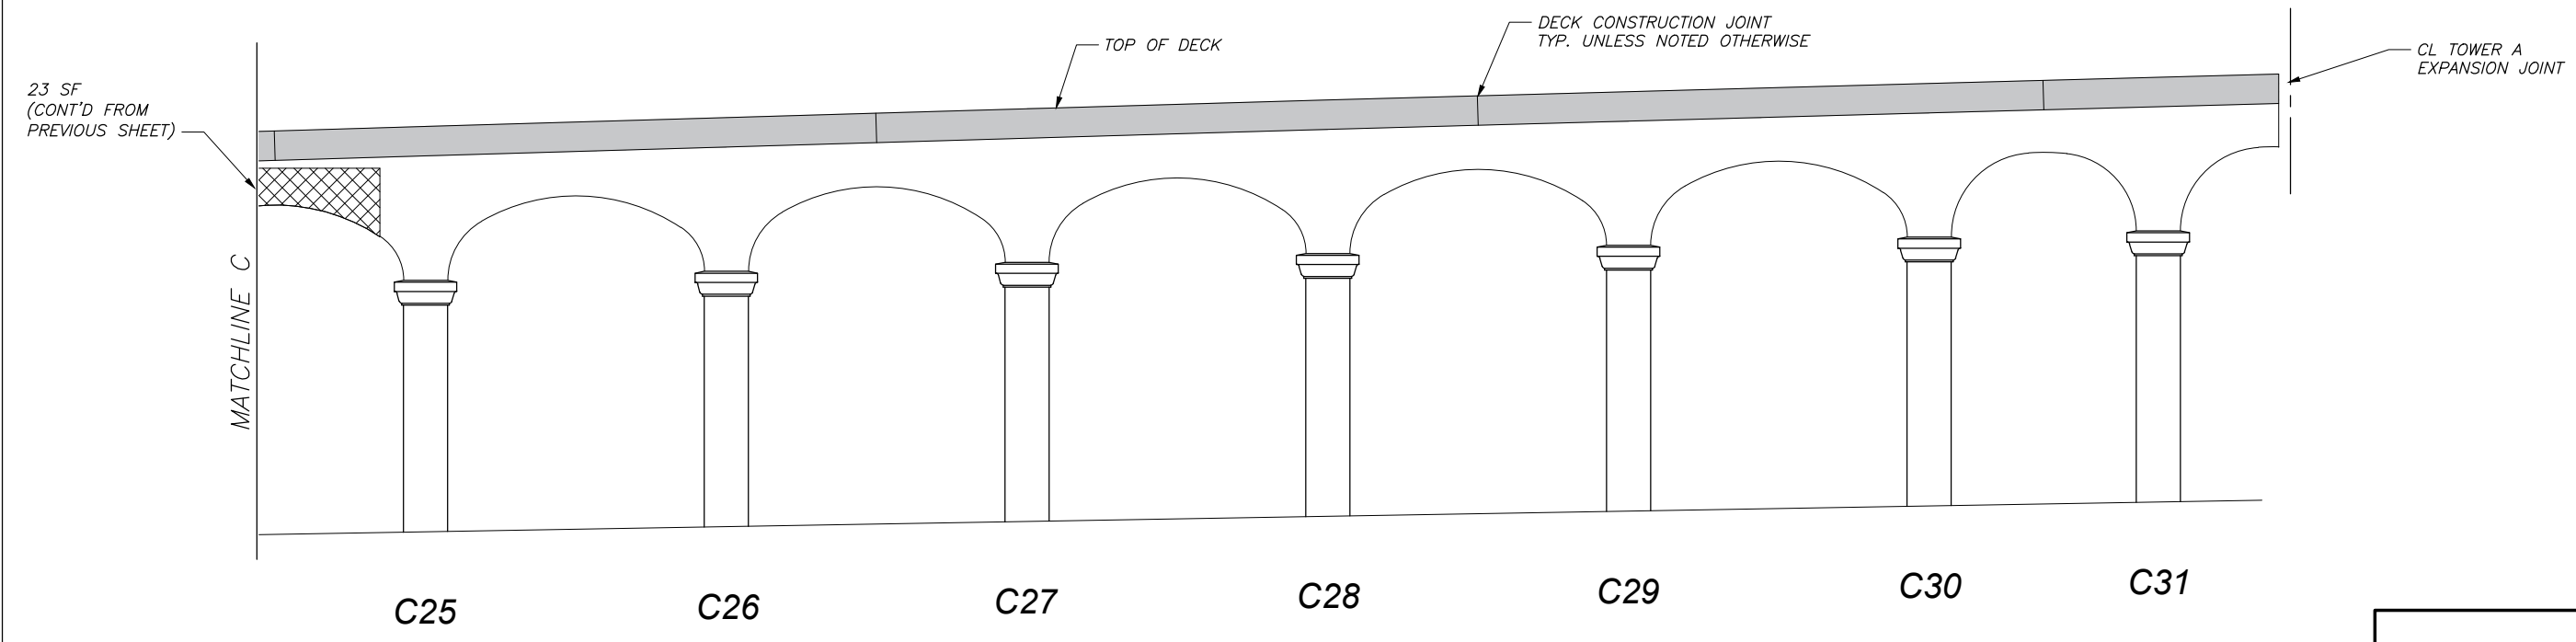
NOTE: ALL DETERIORATION QUANTITIES ARE FROM FIELD MEASUREMENTS AND ARE UNFACTORED.

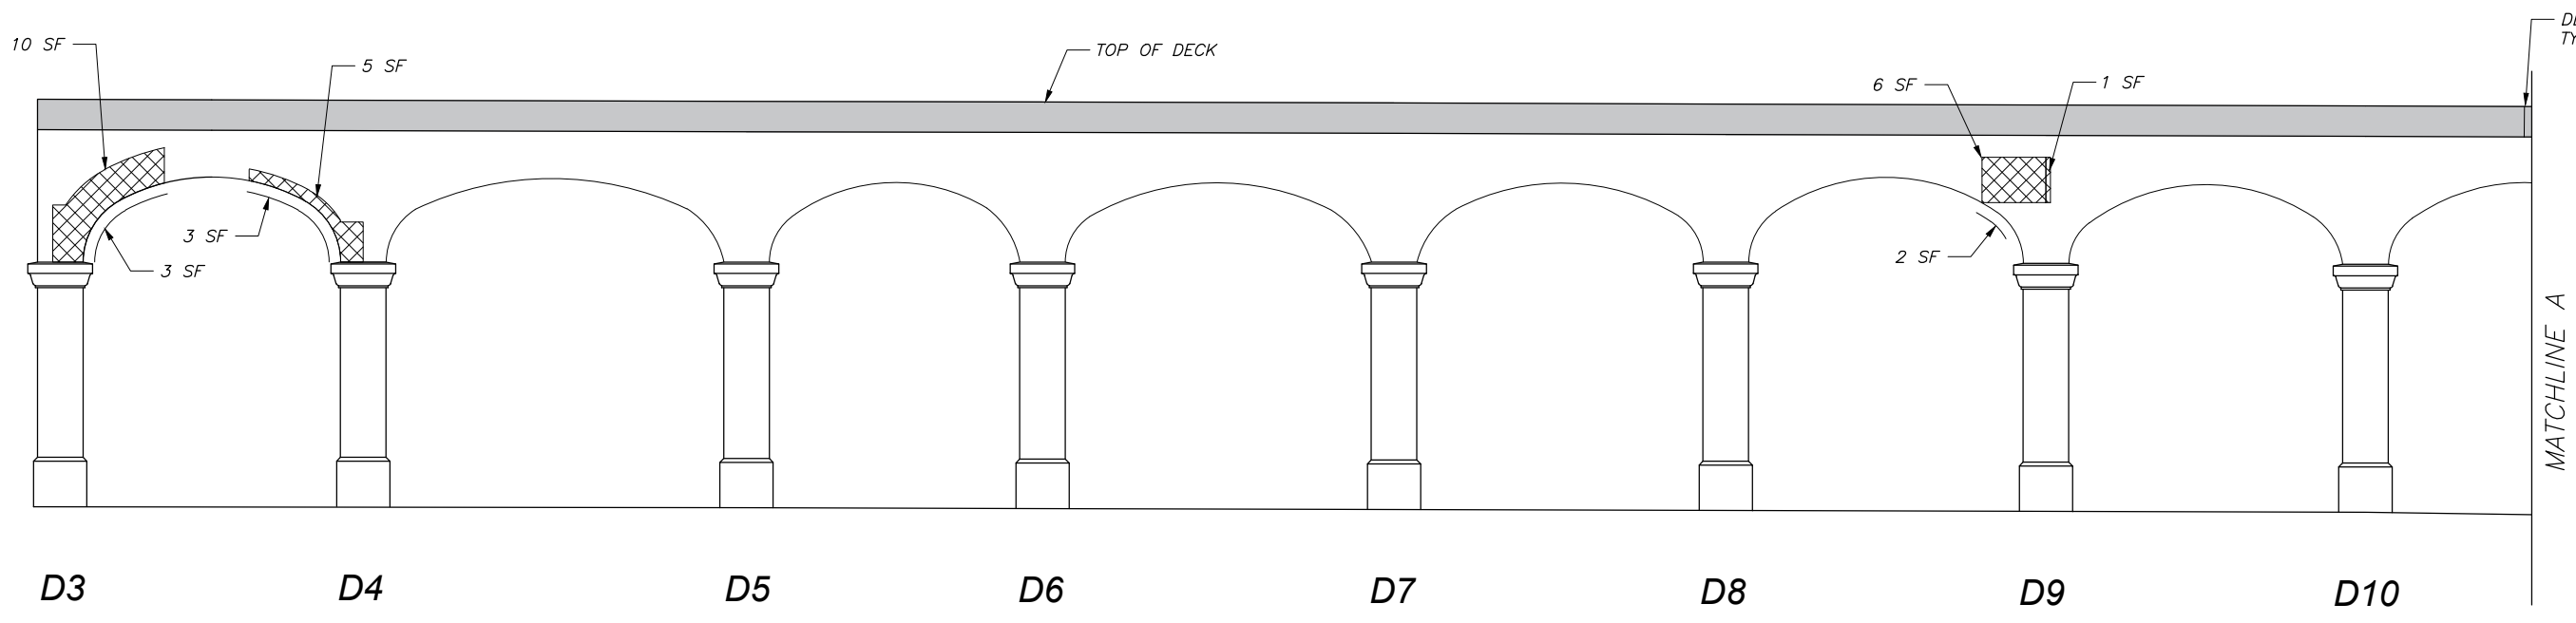
D3 D4 D5 D6 D7 D8 D9 D10

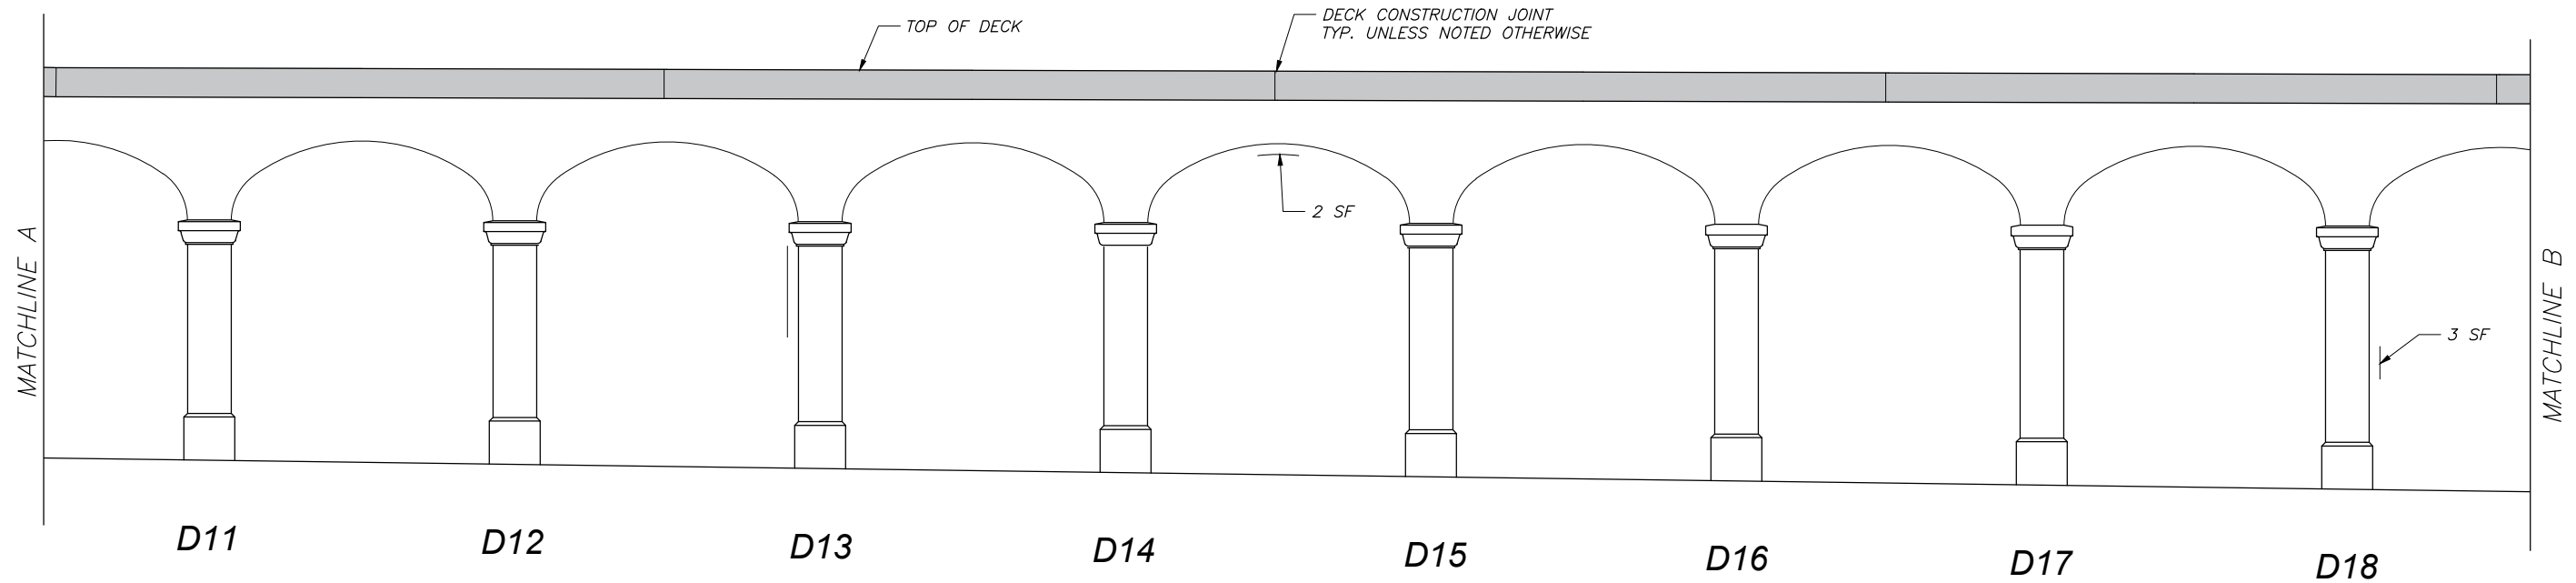
NOTE: ALL DETERIORATION QUANTITIES ARE FROM FIELD MEASUREMENTS AND ARE UNFACTORED.

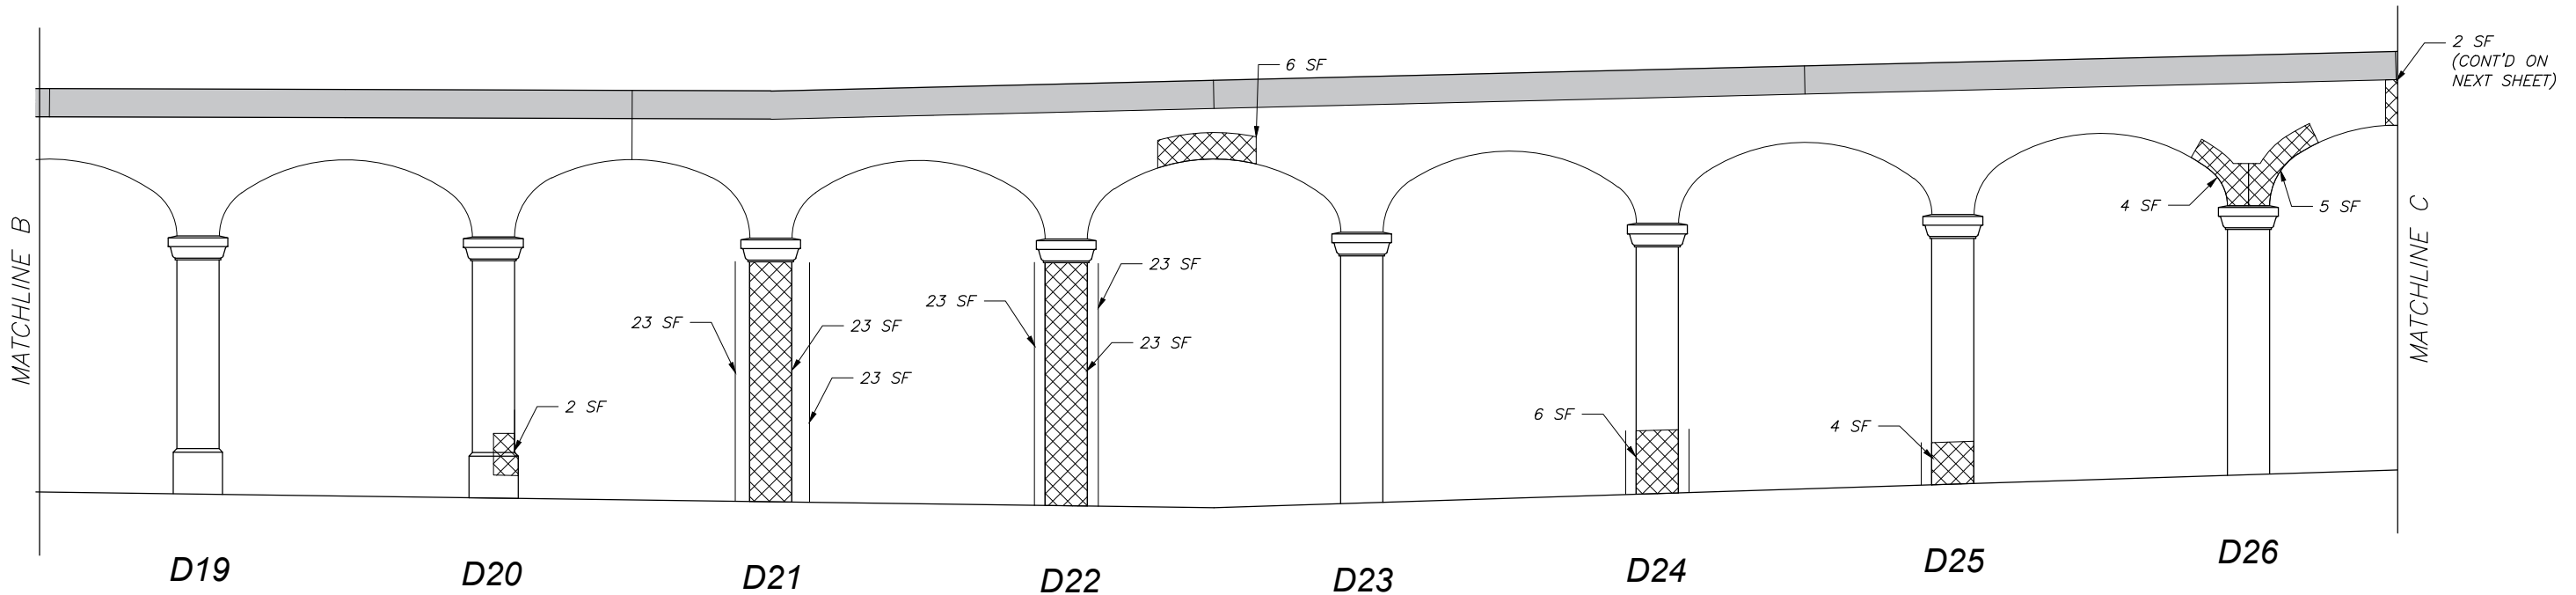
DETROIT-SUPERIOR BRIDGE
WEST STATION
LINE D, COLUMNS D11 TO D18
