**Underwater Inspection Report for
CUY-006-1456
SFN 1800930
U.S. Route 6 over the Cuyahoga River in Cuyahoga County, OH
July 8, 2020**

Structure File No.: 1800930
Construction Date: 1917. Major Rehab 1997.
Facility: U.S. Route 6
Featured Intersection: Cuyahoga River
County: Cuyahoga
Structure Type: Steel Thru-Arch, Concrete Deck Arch
Number of Spans: Thirteen
Total Length: 2656 feet
Abutments: Reinforced Concrete Wall on Spread Footings
Piers: Reinforced Concrete Towers on Spread Footings
Slope/Channel Protection: Dumped rock and vegetation on west bank. Sheet piling on east bank.

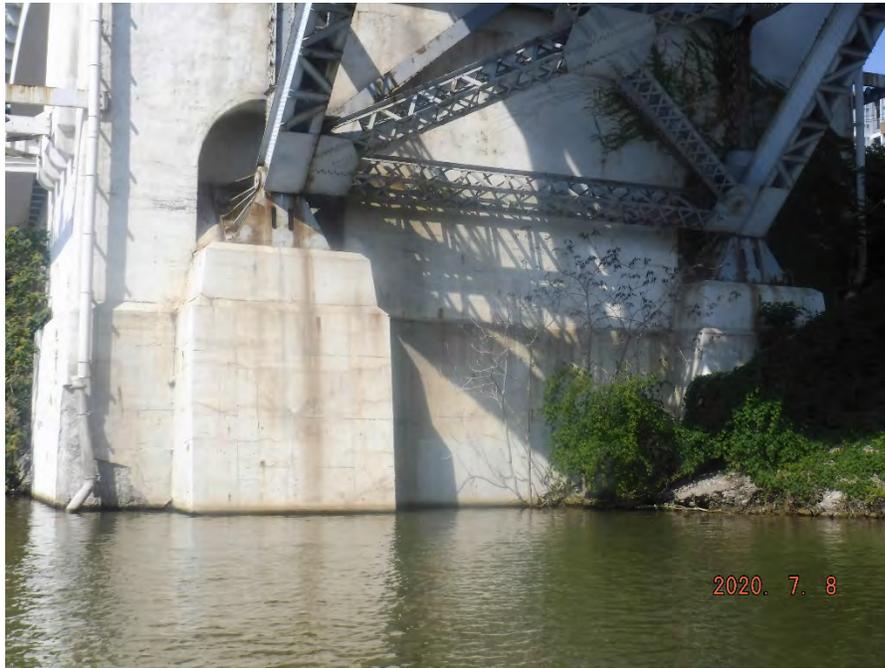
Photo 3 – Pier 3 East Elevation. Looking West.

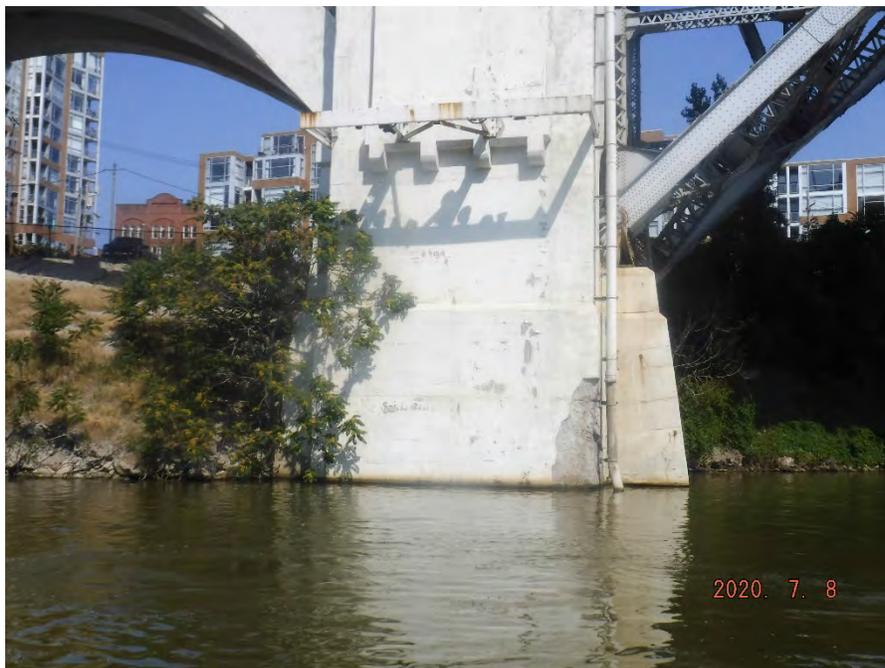
Photo 4 – Pier 3 South Elevation. Looking North.

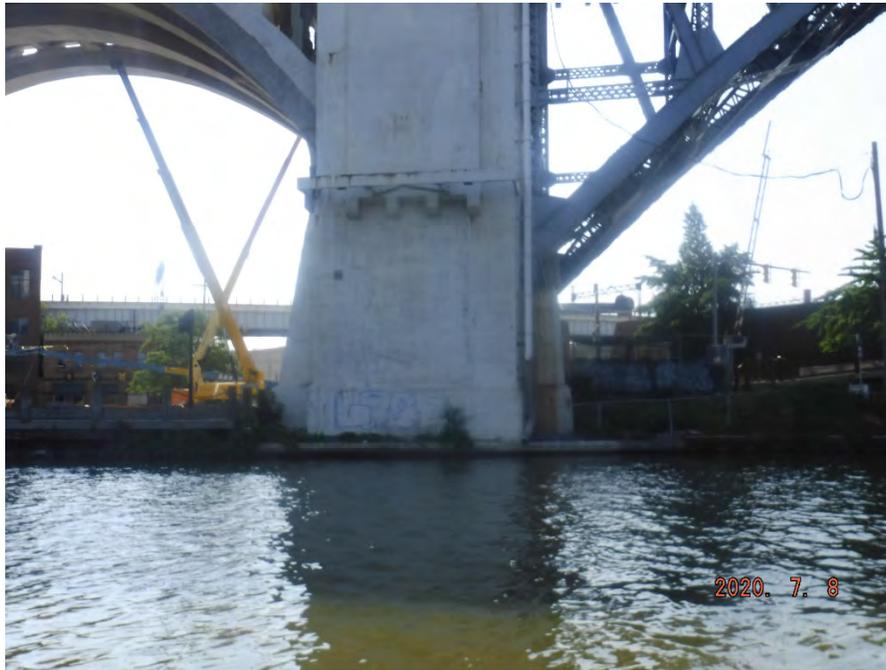
Photo 5 – Pier 4 North Face. Looking South.

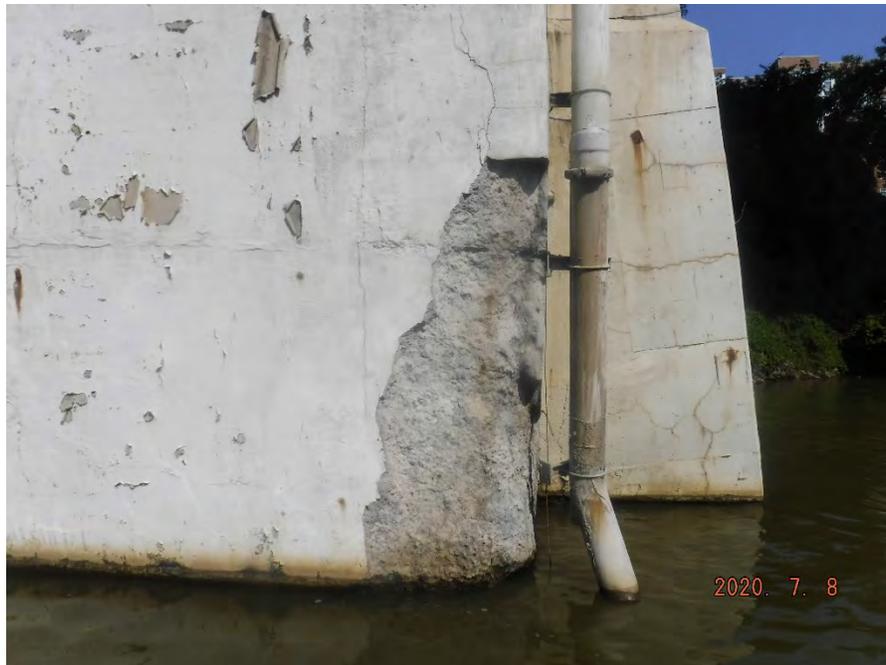
- At scattered locations there is minor scaling with exposed aggregate.
- A corner spall 12 feet high x 10 feet wide x 2 feet deep located at the southeast corner of the pier has advanced in severity since the 2015 underwater inspection (*see Photo 6*).

Photo 6 – Pier 3 Spalling on Southeast Corner. Looking North.

Underwater bridge inspection of the substructure elements should continue to be performed at a maximum interval of 60 months. Underwater inspections should also take place following any significant or potentially damaging event. We recommend a fendering system be installed to protect Pier 3 from boat and barge impacts. Repair the broken scupper drain at Pier 3. Resurface Pier 3 concrete faces. Grout voids in the sheet pile and concrete at Pier 4.

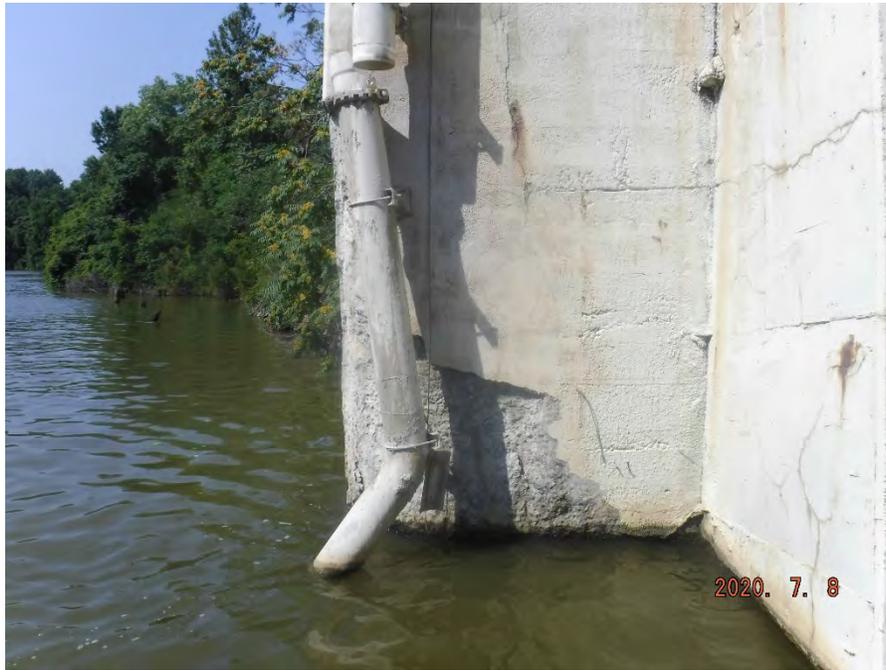
Photo 7 – Pier 3 Spalling and Detached Downspout on Southeast Corner. Looking West.

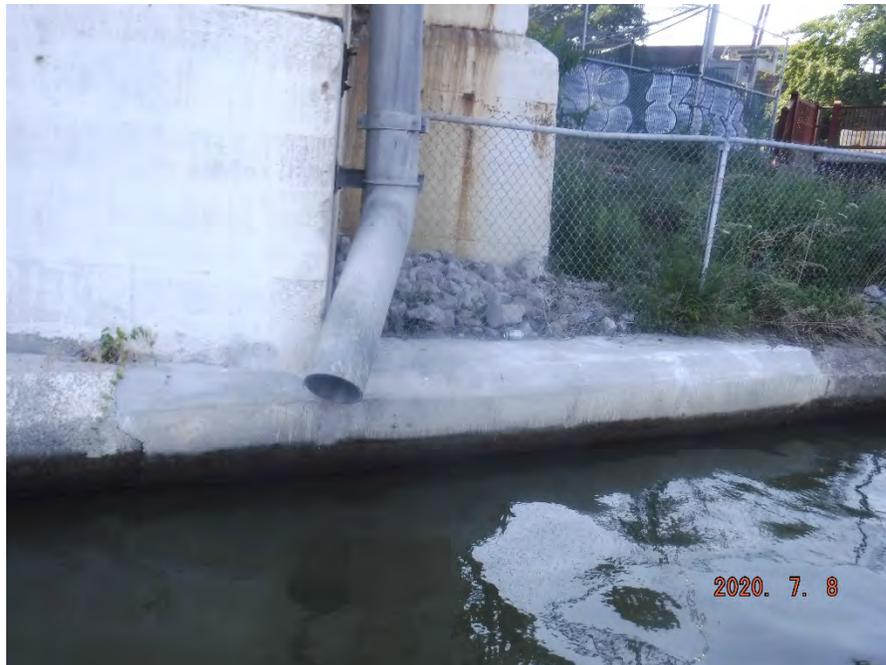
- Repairs of the sheet pile wall on the north side of the pier have been completed since the last underwater inspection. These include concrete patching, redirecting a scupper downspout, filling sinkholes with rock, and addressing voids at wall interfaces (see *Photo 8*).

Photo 8 – Pier 4 Repaired Top of Sheet Pile Wall at Northwest Corner. Looking South..

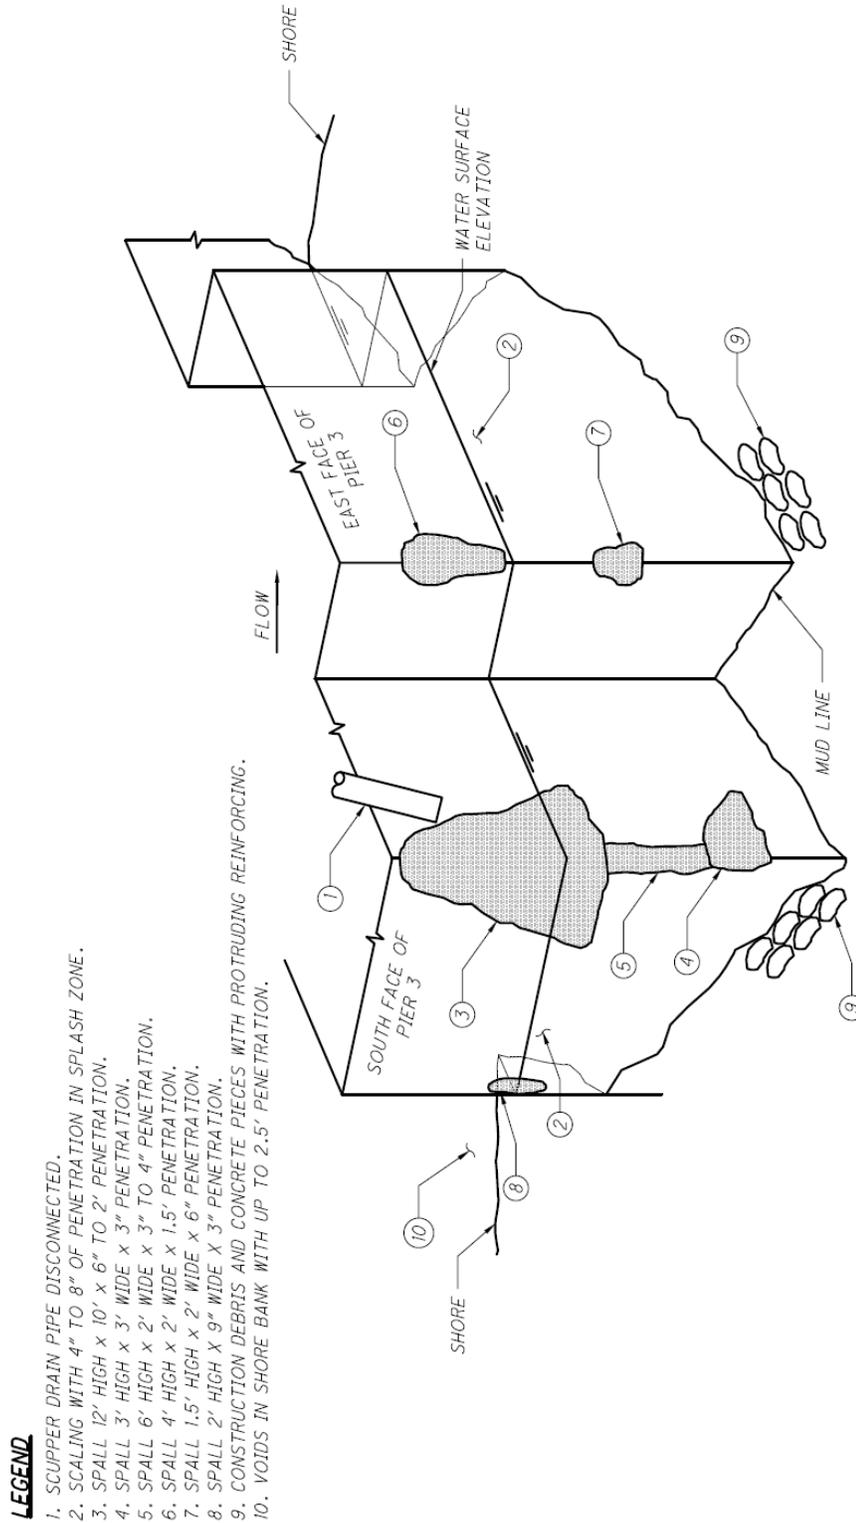
PIER 3 ELEVATION
(NOT TO SCALE)

- A corner spall 3 feet high x 3 feet wide x 3 inches deep located 6 feet above mudline at the southeast corner of the pier was confirmed as documented in underwater inspection done in 2015 and has not advanced in severity.

- A corner spall on southeast corner of the pier 6 feet high x 2 feet wide x 4 inches deep, located between the two spalls mentioned above, was confirmed as documented in underwater inspection done in 2015 and has not advanced in severity.

- A corner spall 4 feet high x 2 feet wide x 1.5 feet deep located at a corner on the east face of the pier in splash zone was confirmed as documented in underwater inspection done in 2015 and has not advanced in severity.

- A corner spall 1.5 feet high x 2 feet wide x 6 inches deep located 6 feet above mudline at a corner on the east face of the pier was confirmed as documented in underwater inspection done in 2015 and has not advanced in severity.
- A spall 2 feet high x 9 inches wide x 3 inches deep located at the waterline on the south face of the pier was noted.
- A scupper drain is disconnected allowing water to leak onto south corner contributing to large spall. This condition was noted in the underwater inspection done in 2015 and has not advanced in severity (see *Photo 7*).
- Voids in the southwest embankment near the pier with 2.5 feet of penetration confirmed as documented in underwater inspection done in 2015 and have not advanced in severity.
- For sketches of Pier 3 and the above mentioned defects see the INSPECTION SKETCHES report section.
